Facility Condition Assessment Summary Report

Duckrey School

School District of Philadelphia
S446001; Duckrey
Final
Site Assessment Report

January 30, 2017

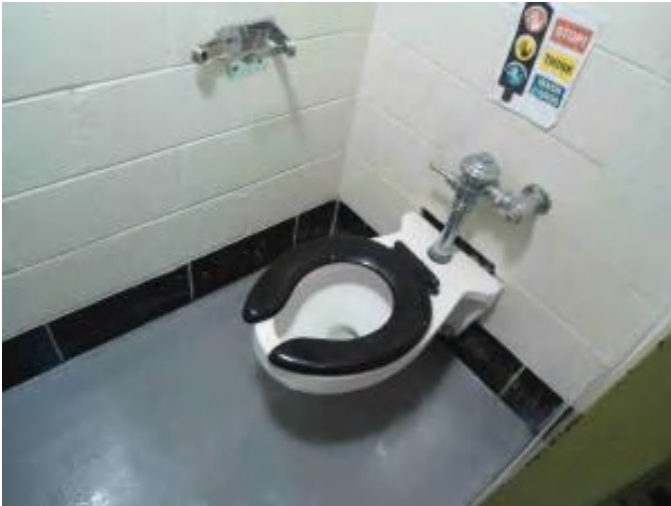
System: C1010 - Partitions

Location: Restrooms

Distress: Damaged

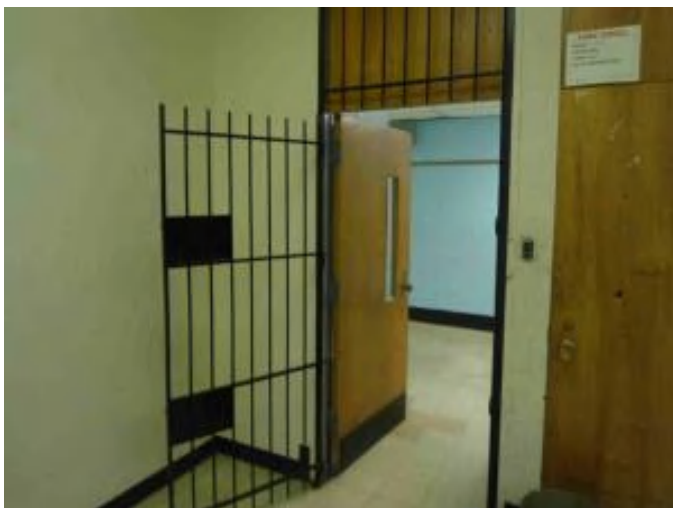
System: C1020 - Interior Doors

Location: Building Wide

Distress: Damaged

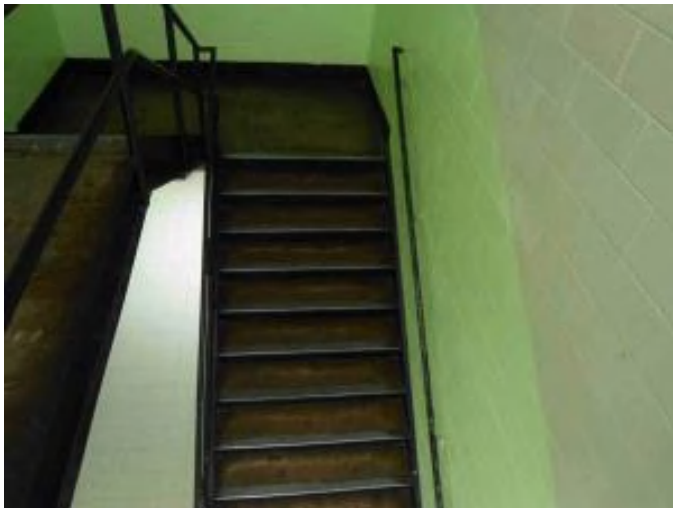
System: C2010 - Stair Construction

Location: Stairs

Distress: Building / MEP Codes

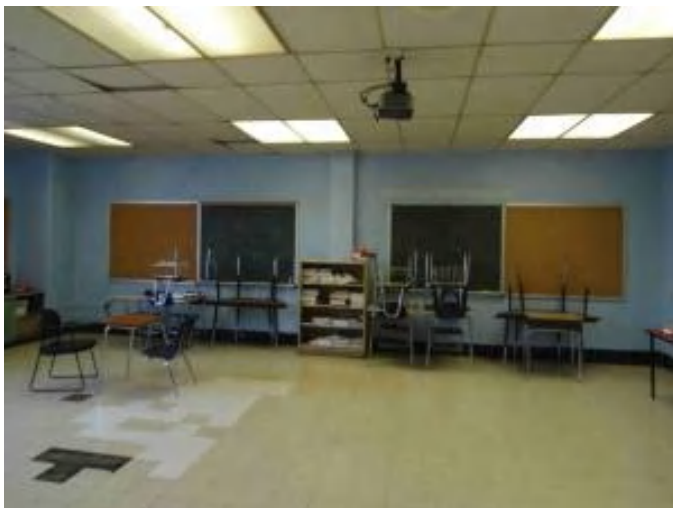
System: C3020413 - Vinyl Flooring

Location: Classrooms

Distress: Health Hazard / Risk

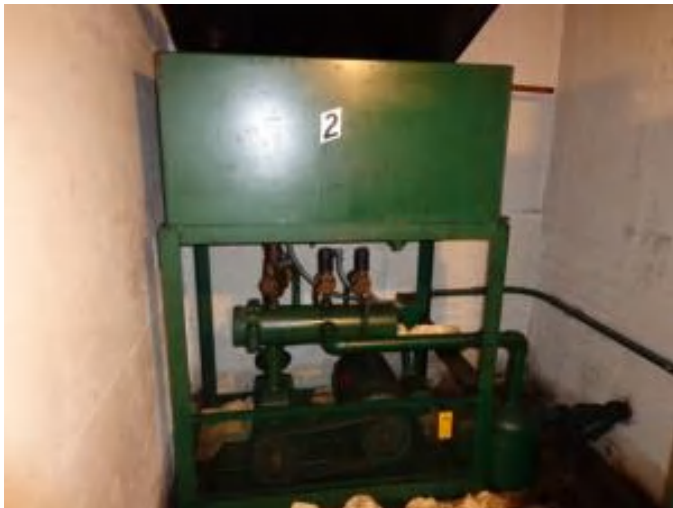
System: D1010 - Elevators and Lifts

Location: Freight Elevator Machine Room

Distress: Damaged

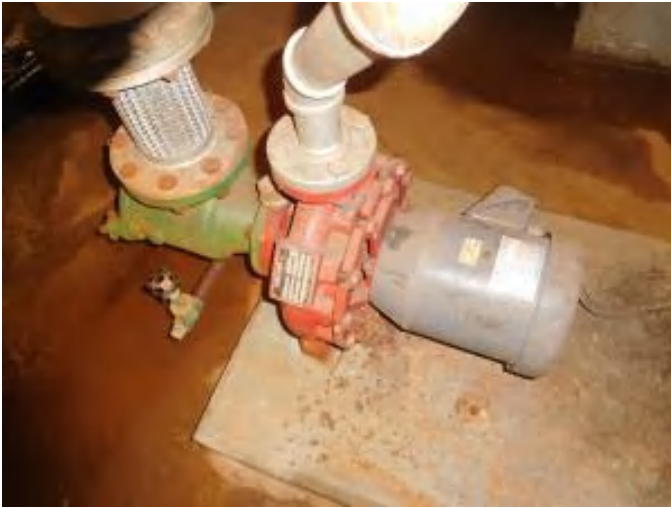
System: D3020 - Heat Generating Systems

Location: mechanical room

Distress: Beyond Service Life

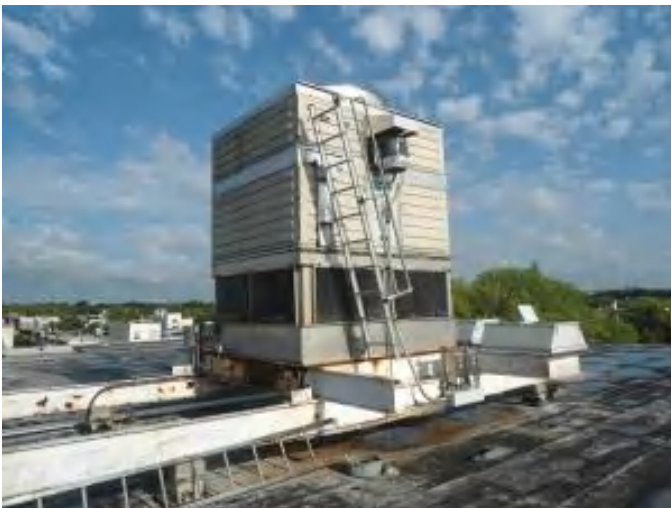
System: D3030 - Cooling Generating Systems

Location: roof

Distress: Beyond Service Life

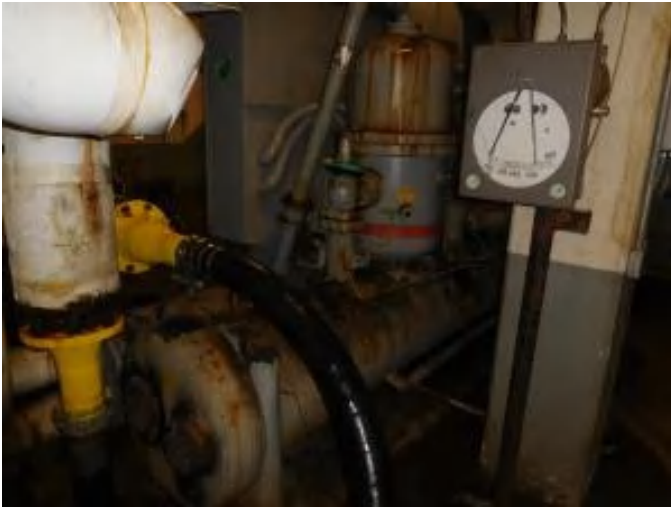
System: D3030 - Cooling Generating Systems

Location: mechanical room

Distress: Beyond Service Life

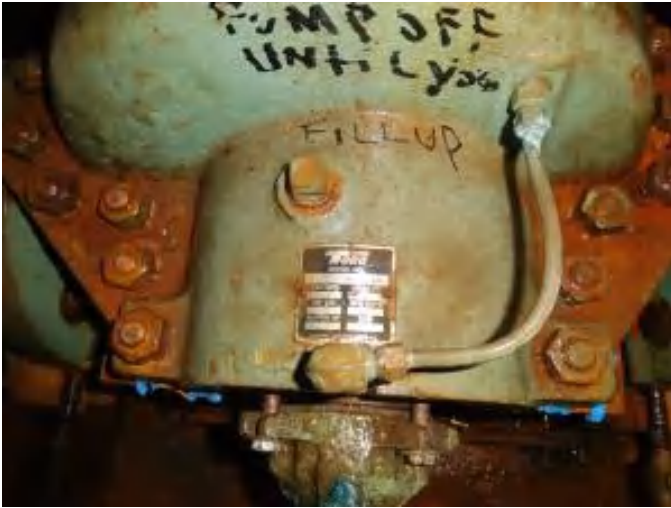
System: D3030 - Cooling Generating Systems

Location: mechanical room

Distress: Beyond Service Life

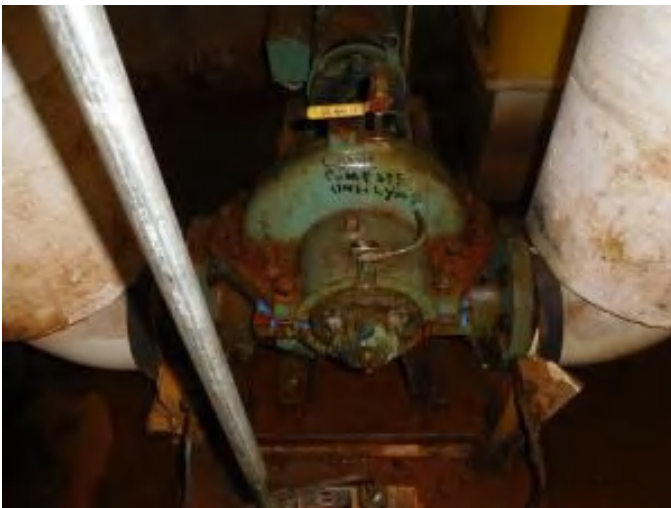
System: D3030 - Cooling Generating Systems

Location: mechanical room

Distress: Beyond Service Life

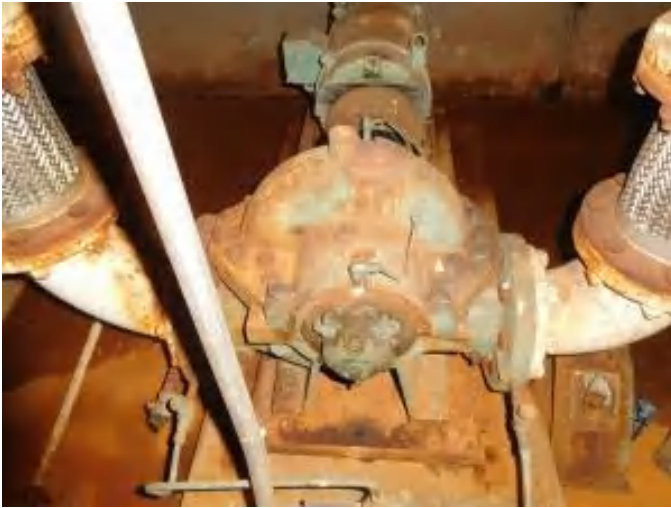
System: D3030 - Cooling Generating Systems

Location: mechanical room

Distress: Beyond Service Life

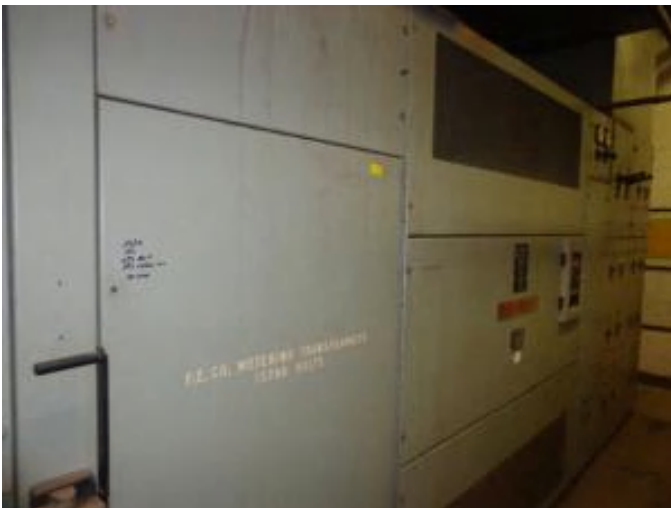
System: D5010 - Electrical Service/Distribution

Location: Main Electrical Room

Distress: Beyond Service Life

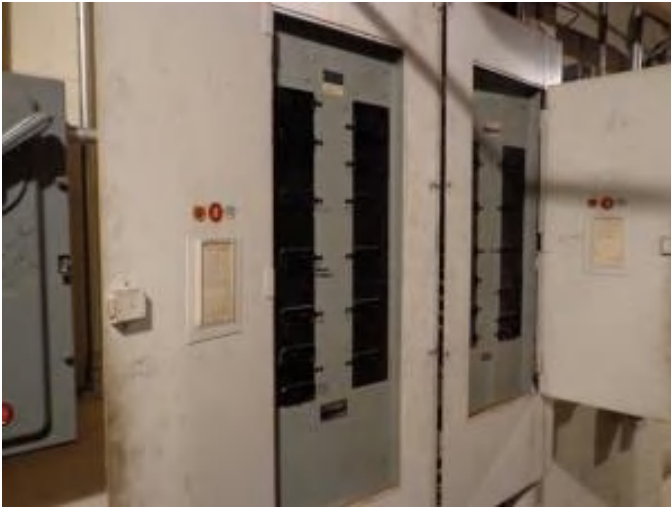
System: D5010 - Electrical Service/Distribution

Location: Building wide
Distress: Beyond Service Life
Category: 3 - Operations / Maint.
Priority: 3 - Response Time (3-4 yrs)
Correction: Replace Panelboard
Qty: 19.00
Unit of Measure: Ea.
Estimate: \$569,292.81
Assessor Name: Craig Anding
Date Created: 10/16/2015

Notes: Replace (19) panelboards, and their feeder conductors, from the original construction project.

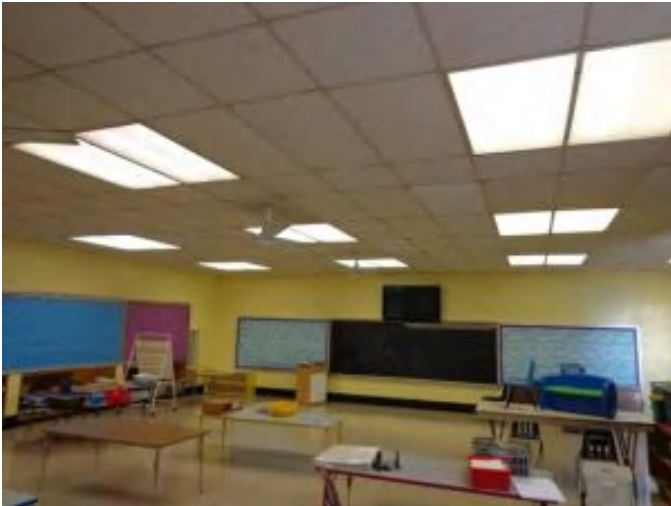
System: D5020 - Lighting and Branch Wiring

Location: Classrooms
Distress: Beyond Service Life
Category: 3 - Operations / Maint.
Priority: 3 - Response Time (3-4 yrs)
Correction: Replace Lighting Fixtures (SF)
Qty: 34,100.00
Unit of Measure: S.F.
Estimate: \$705,578.84
Assessor Name: Craig Anding
Date Created: 10/16/2015

Notes: Replace lighting fixtures and wiring in 31 classrooms (approximately 34,100 SF).

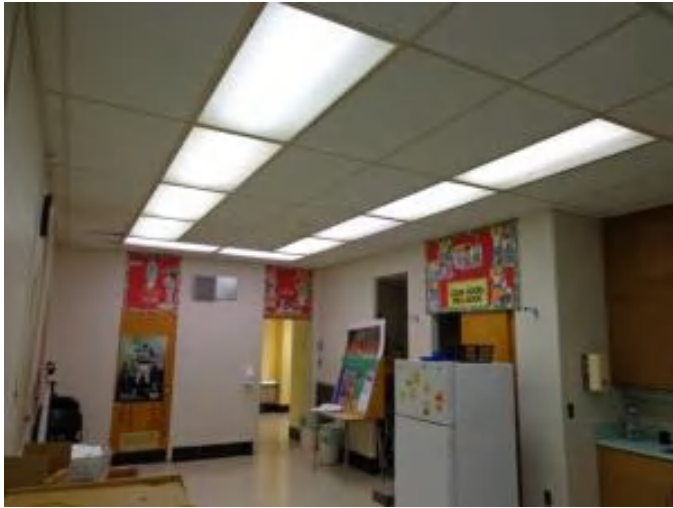
System: D5020 - Lighting and Branch Wiring

Location: Building wide

Distress: Beyond Service Life

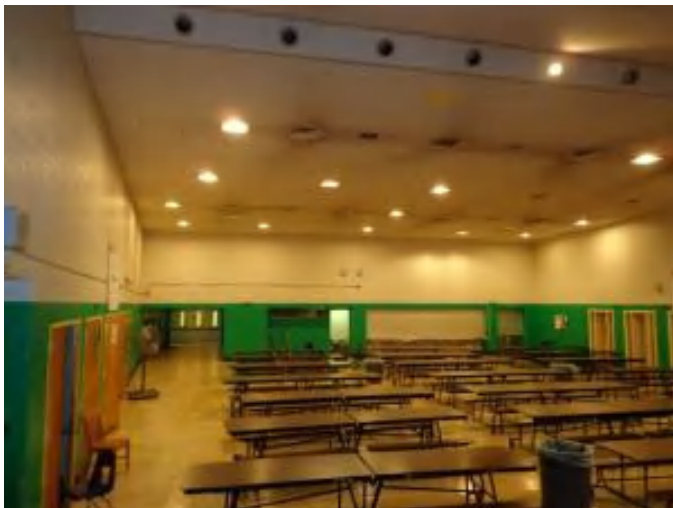
System: D5020 - Lighting and Branch Wiring

Location: Auditorium/cafeteria

Distress: Obsolete

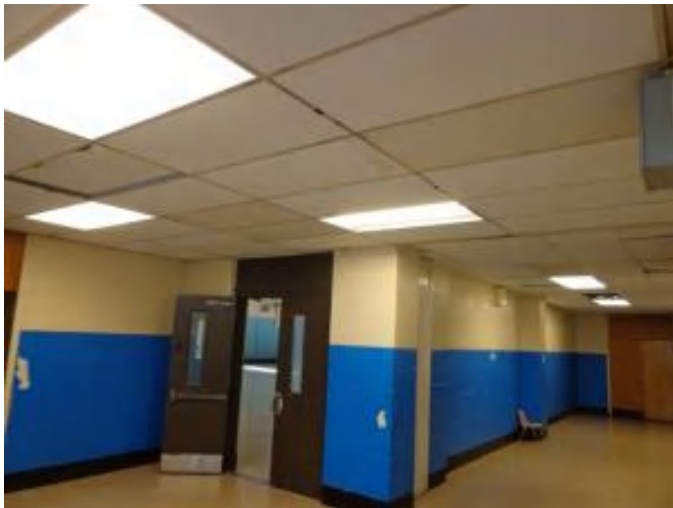
System: D5020 - Lighting and Branch Wiring

Location: North Entrance Lobby
Distress: Damaged
Category: 3 - Operations / Maint.
Priority: 3 - Response Time (3-4 yrs)
Correction: Replace lighting fixtures
Qty: 8.00
Unit of Measure: Ea.
Estimate: \$5,012.28
Assessor Name: Craig Anding
Date Created: 10/16/2015

Notes: Replace a total of (8) fluorescent troffers in the north entrance lobby and entrance corridor to the gym.

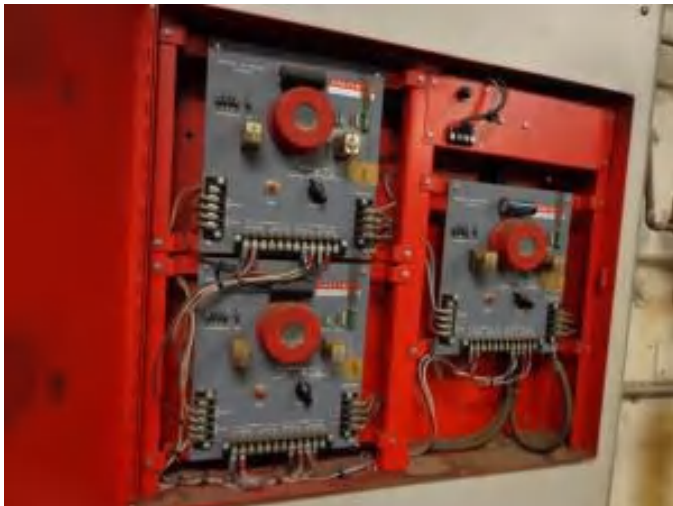
System: D5030 - Communications and Security

Location: Building wide
Distress: Life Safety / NFPA / PFD
Category: 1 - Health & Safety
Priority: 3 - Response Time (3-4 yrs)
Correction: Replace fire alarm system
Qty: 101,115.00
Unit of Measure: S.F.
Estimate: \$449,420.69
Assessor Name: Craig Anding
Date Created: 10/16/2015

Notes: Replace fire alarm system with an addressable system.

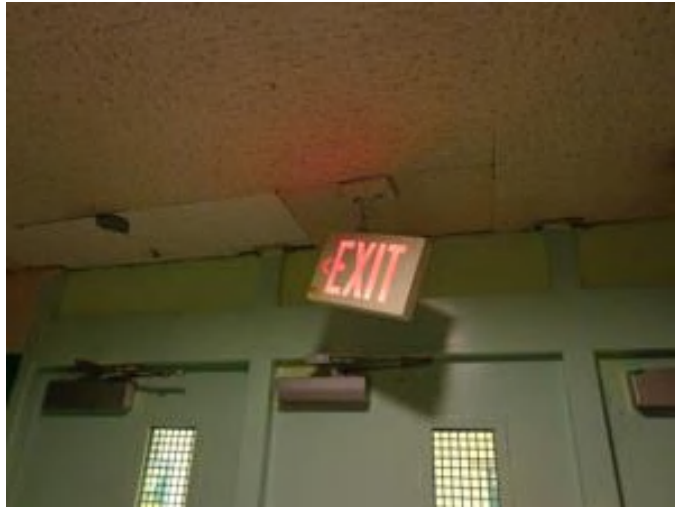
System: D5090 - Other Electrical Systems

Location: Building wide

Distress: Damaged

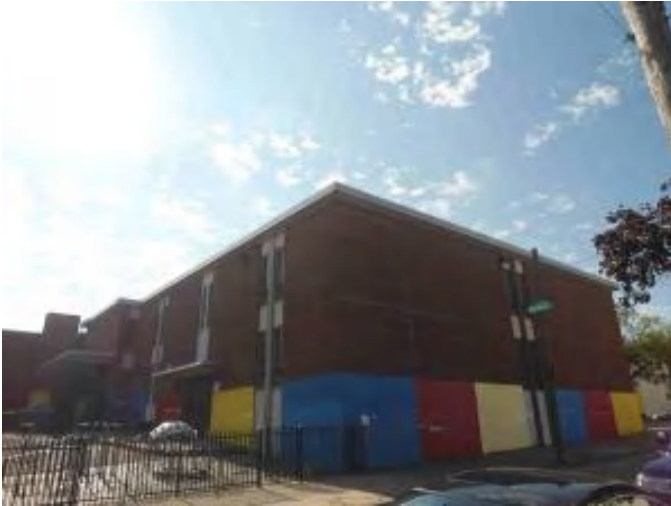
System: B2020 - Exterior Windows

As indicated in the photos several of the windows appear to be original. Several of the windows no longer work and will require attention prior to an overall effort. Overall, the windows are in fair condition based on the year of installation or last renovation. The entire exterior window system is recommended to be replaced with units that retain their dimensions and profiles, but that incorporate updated energy-efficient features.

Location: Building Wide

Distress: Damaged

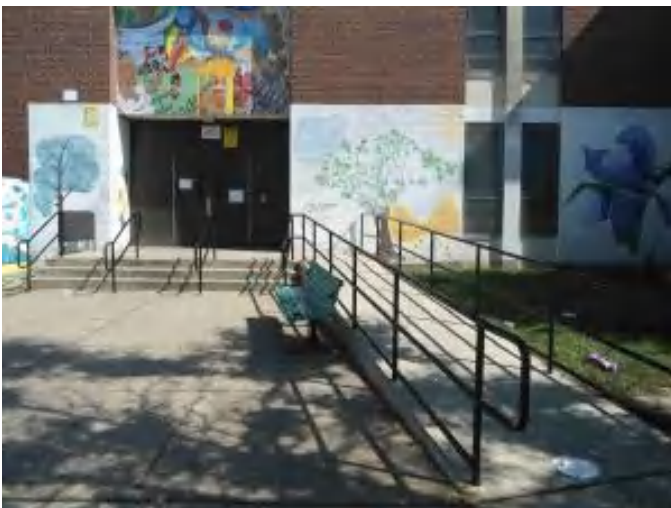
System: B2030 - Exterior Doors

The exterior doors are metal applications with metal frames. The exterior door system for this school is a very high traffic system. The doors are in fair condition but are aging at a faster rate than expected based on traffic and condition. The exterior door system, store front and service doors are recommended for upgrade.

Location: Exterior Elevation

Distress: Damaged

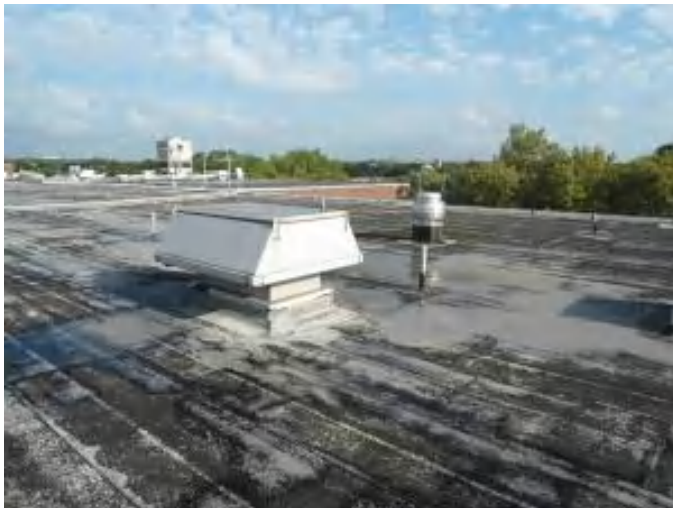
System: B3010105 - Built-Up

Location: Roof
Distress: Damaged
Category: 3 - Operations / Maint.
Priority: 4 - Response Time (4-5 yrs)
Correction: Remove and Replace Built Up Roof
Qty: 40,000.00
Unit of Measure: S.F.
Estimate: \$1,355,280.44
Assessor Name: Craig Anding
Date Created: 11/18/2015

Notes: The main built up roof section extends the entire school while the two small sections cover the lower level classrooms and loading dock. This roofing system is a built up application that was installed in the early 1990'S. This roof has been seal coated several times to extend the life cycle of the application. Although there are no reports or evidence of active leaks it's only a matter of time based on current condition and age. Considering the age and condition of the roofing systems, universal upgrades are recommended. Remove and replace roof sections.

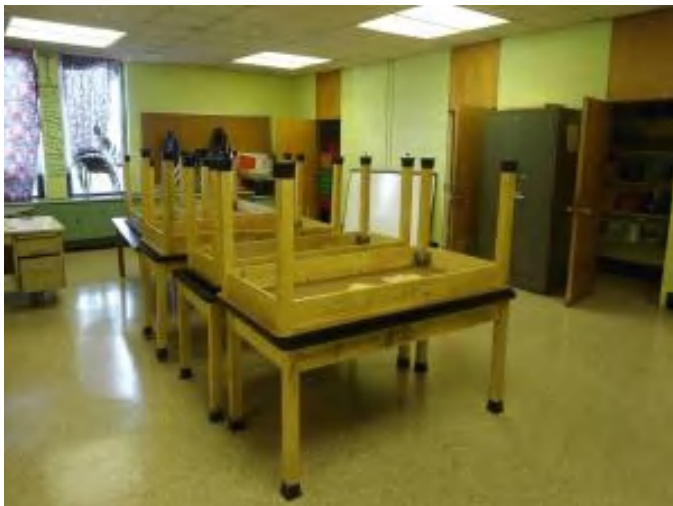
System: C1010 - Partitions

Location: Science Classrooms
Distress: Damaged
Category: 3 - Operations / Maint.
Priority: 4 - Response Time (4-5 yrs)
Correction: Remodel existing classroom for lab use - approx 900 GSF - with chemical storage room, 15 tables + instructors table
Qty: 2.00
Unit of Measure: Ea.
Estimate: \$705,498.17
Assessor Name: Craig Anding
Date Created: 11/19/2015

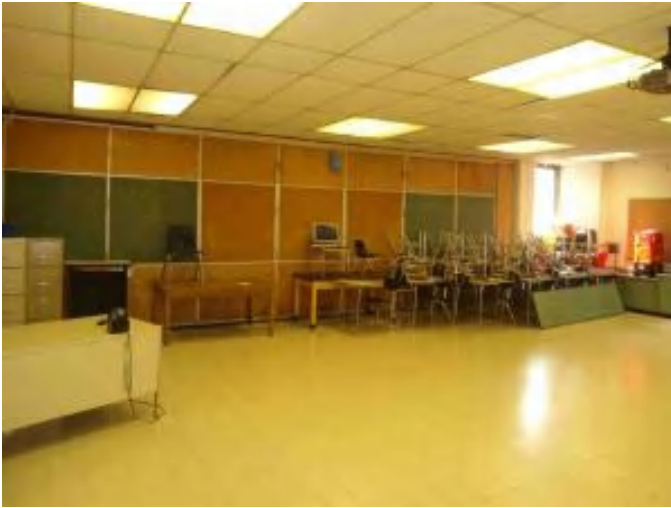
System: C1010 - Partitions

Location: Classrooms
Distress: Life Safety / NFPA / PFD
Category: 1 - Health & Safety
Priority: 4 - Response Time (4-5 yrs)
Correction: Remove folding partition
Qty: 3,000.00
Unit of Measure: S.F.
Estimate: \$67,221.72
Assessor Name: Craig Anding
Date Created: 11/18/2015

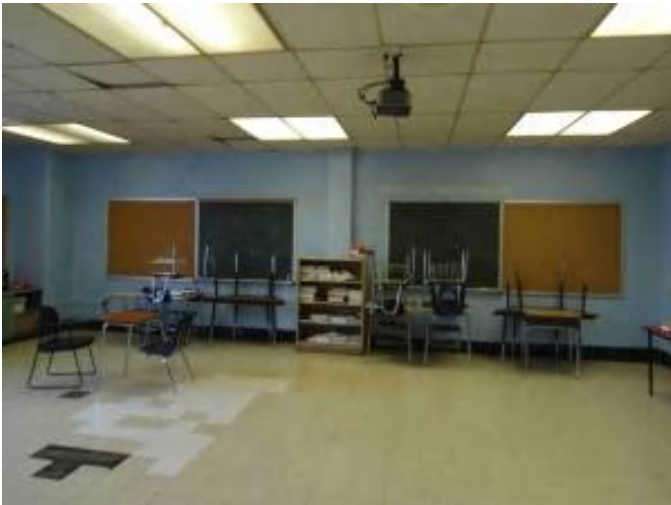
System: C1030 - Fittings

There are several tack boards in the hallways for student displays. The systems are damaged and beyond the expected service life for this application. Remove and replace tack boards is recommended.

Location: Building Wide
Distress: Damaged
Category: 3 - Operations / Maint.
Priority: 4 - Response Time (4-5 yrs)
Correction: Remove and replace tackboards - select size
Qty: 10.00
Unit of Measure: Ea.
Estimate: \$7,927.26
Assessor Name: Craig Anding
Date Created: 11/18/2015

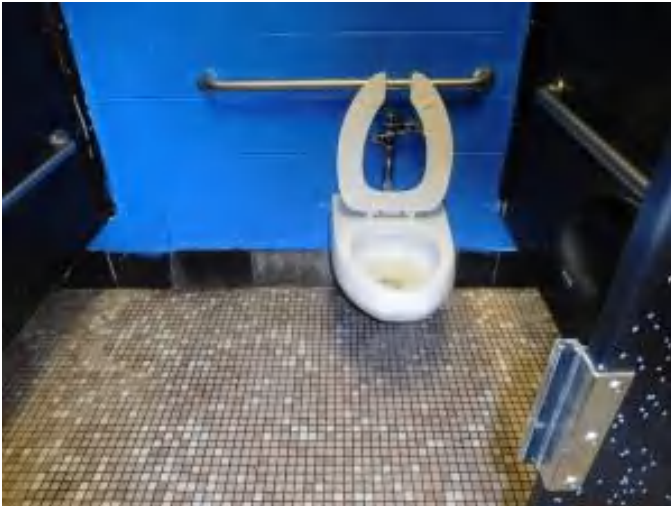
System: D2010 - Plumbing Fixtures

Location: toilet rooms

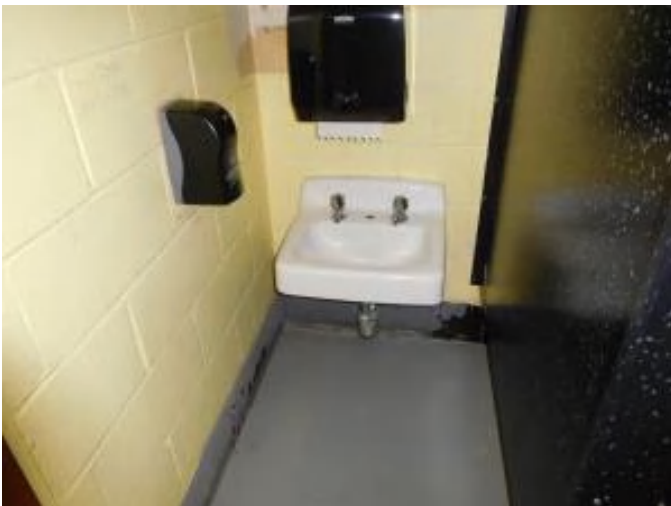
System: D2010 - Plumbing Fixtures

Location: toilet rooms

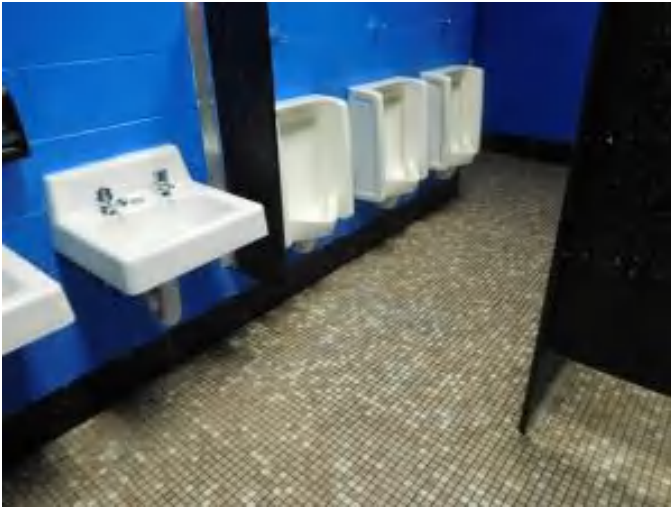
System: D2010 - Plumbing Fixtures

Location: toilet rooms

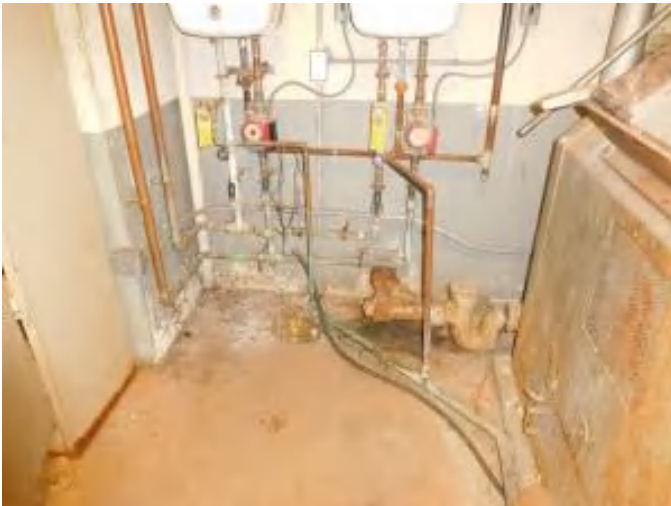
System: D2020 - Domestic Water Distribution

Location: entire building

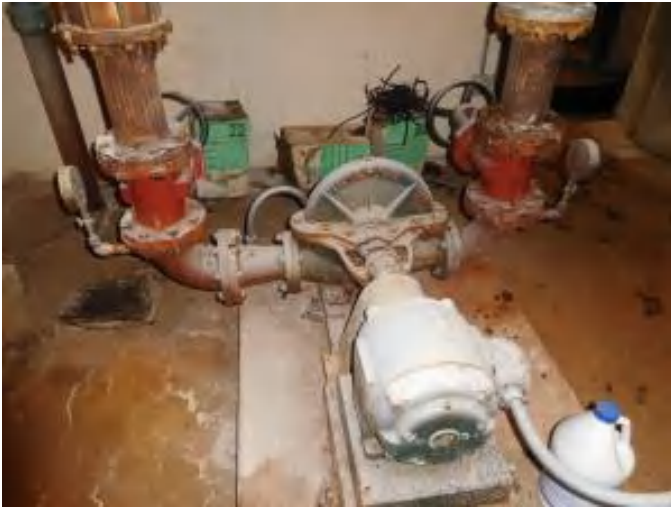
System: D2020 - Domestic Water Distribution

Location: mechanical room
Distress: Beyond Service Life
Category: 3 - Operations / Maint.
Priority: 4 - Response Time (4-5 yrs)
Correction: Replace duplex domestic booster pump set (5 HP)
Qty: 1.00
Unit of Measure: Ea.
Estimate: \$50,533.86
Assessor Name: Craig Anding
Date Created: 11/10/2015

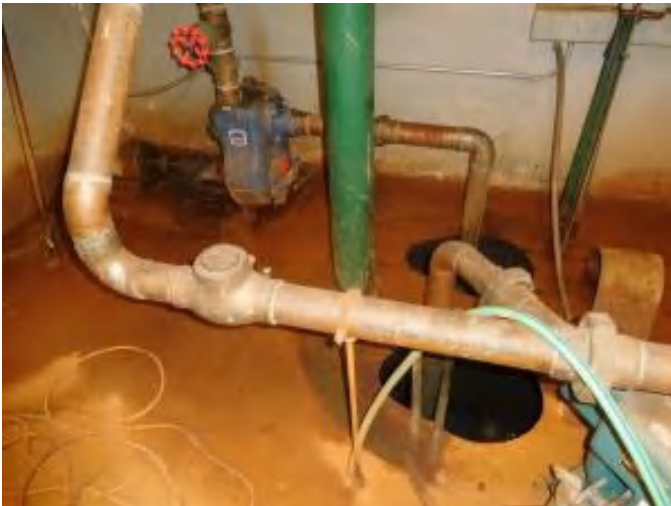
System: D2030 - Sanitary Waste

Location: mechanical room

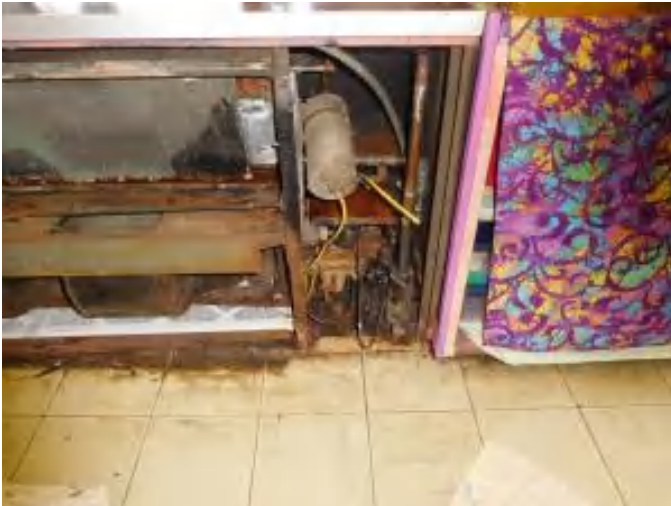
System: D3040 - Distribution Systems

Location: entire building

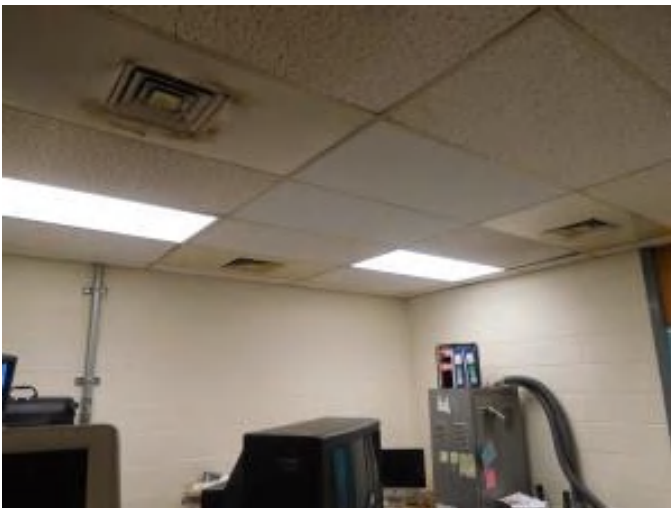
System: D3040 - Distribution Systems

Location: IMC

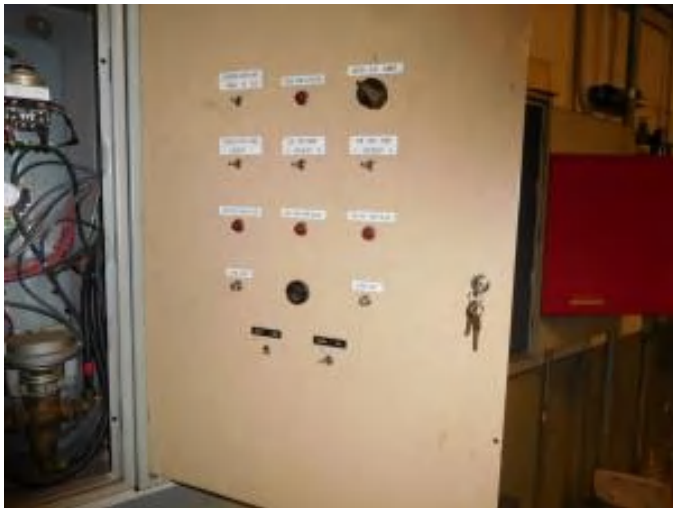
System: D3060 - Controls & Instrumentation

Location: entire building
Distress: Inadequate
Category: 4 - Capital Improvement
Priority: 4 - Response Time (4-5 yrs)
Correction: Replace pneumatic controls with DDC (150KSF)
Qty: 101,115.00
Unit of Measure: S.F.
Estimate: \$1,811,111.45
Assessor Name: Craig Anding
Date Created: 11/10/2015

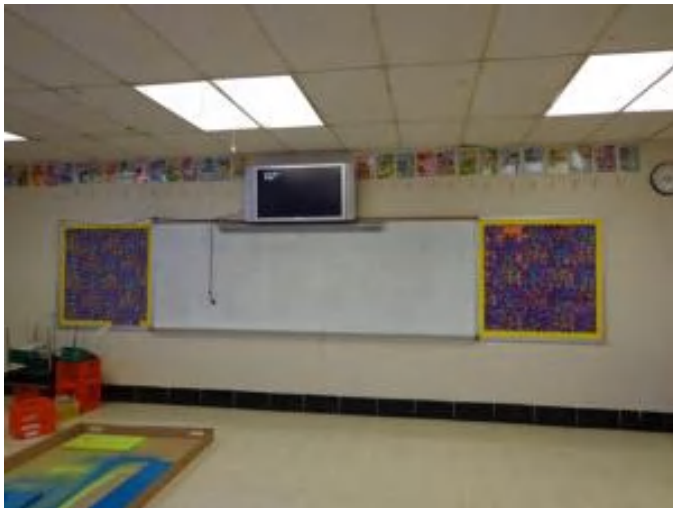
System: D5020 - Lighting and Branch Wiring

Location: Classrooms
Distress: Inadequate
Category: 4 - Capital Improvement
Priority: 4 - Response Time (4-5 yrs)
Correction: Provide surface raceway system and wiring devices
Qty: 930.00
Unit of Measure: L.F.
Estimate: \$129,794.16
Assessor Name: Craig Anding
Date Created: 10/16/2015

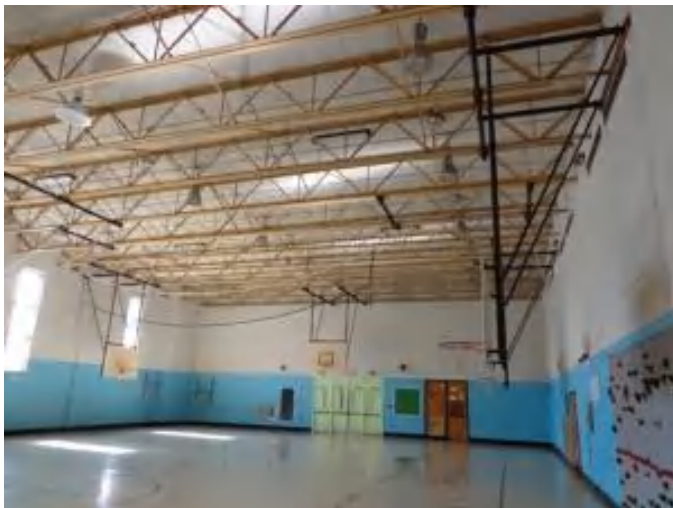
System: D5020 - Lighting and Branch Wiring

Location: Gymnasium
Distress: Beyond Service Life
Category: 3 - Operations / Maint.
Priority: 4 - Response Time (4-5 yrs)
Correction: Replace lighting fixtures
Qty: 18.00
Unit of Measure: Ea.
Estimate: \$66,767.71
Assessor Name: Craig Anding
Date Created: 10/16/2015

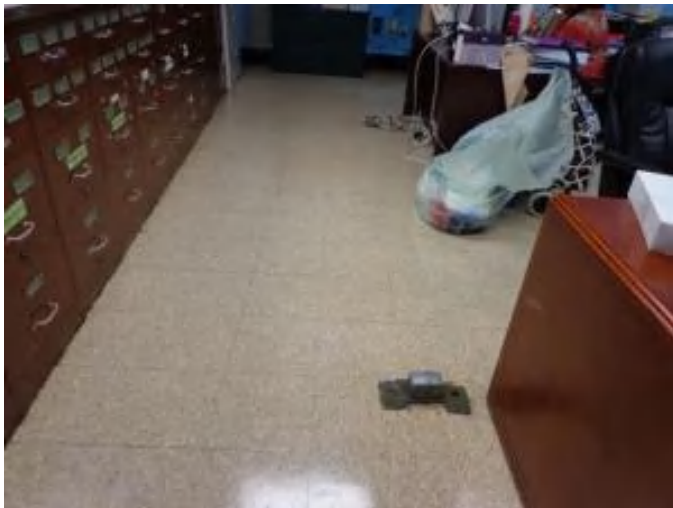
System: D5020 - Lighting and Branch Wiring

Location: Main Office
Distress: Life Safety / NFPA / PFD
Category: 1 - Health & Safety
Priority: 4 - Response Time (4-5 yrs)

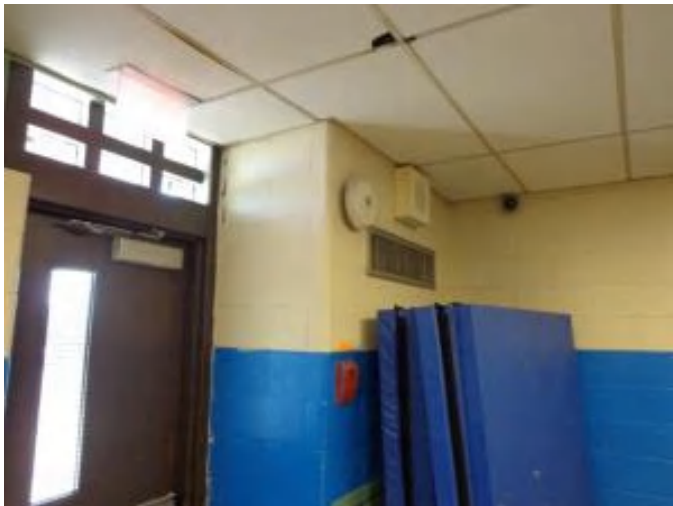
System: D5030 - Communications and Security

Location: Building wide
Distress: Security Issue
Category: 1 - Health & Safety
Priority: 4 - Response Time (4-5 yrs)

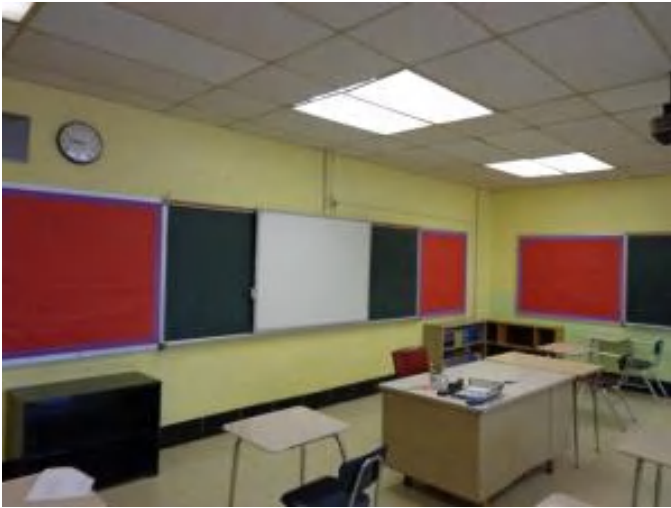
System: D5030 - Communications and Security

Location: Building wide

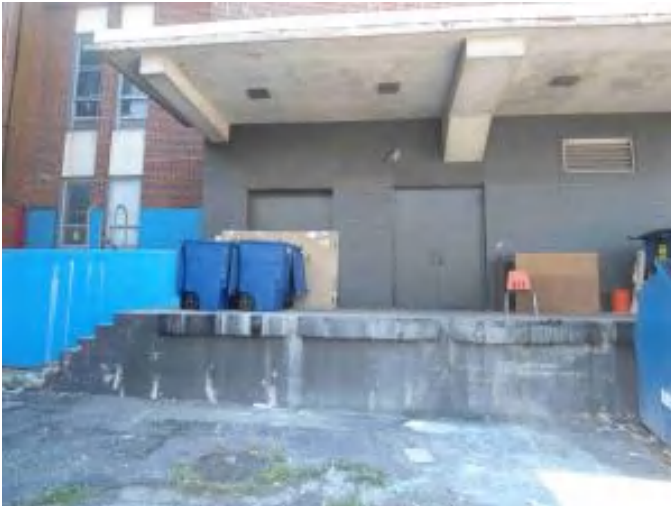
System: E1090 - Other Equipment

Other equipment includes kitchen equipment; loading dock bumpers/levelers. The loading dock is from original construction and in fair condition. The loading dock system is recommended for upgrade to include new concrete work, bumpers and railing replacement.

Location: Loading Dock

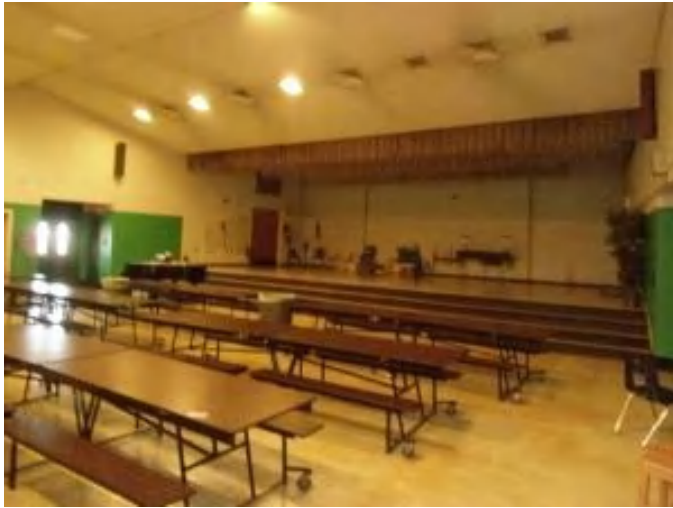
System: E2010 - Fixed Furnishings

The school stage has a stage curtain assembly that appears to be from the original construction. Although it appears as if the main assembly has been removed no replacement was installed. Modern applications are typically fire-proof applications with adjustable tracks and electric support for operation. It is recommended that the missing curtain and track system be upgraded to a new system. Special care should be considered in regards to modern fire proofing for the new installation.

Location: Stage

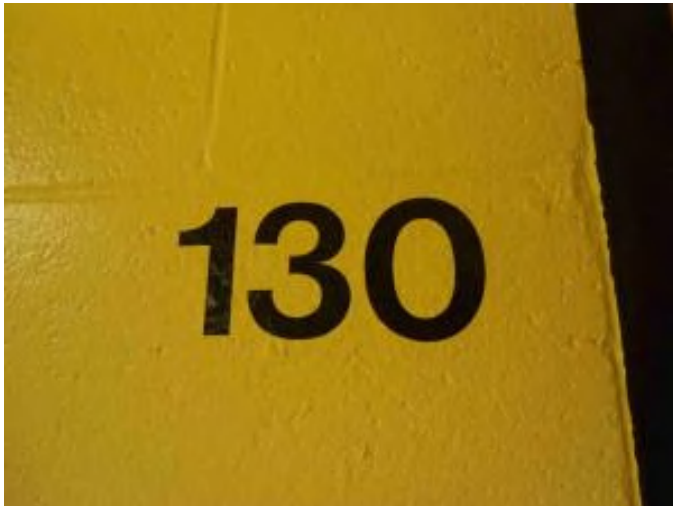
System: C1030 - Fittings

Location: Building Wide

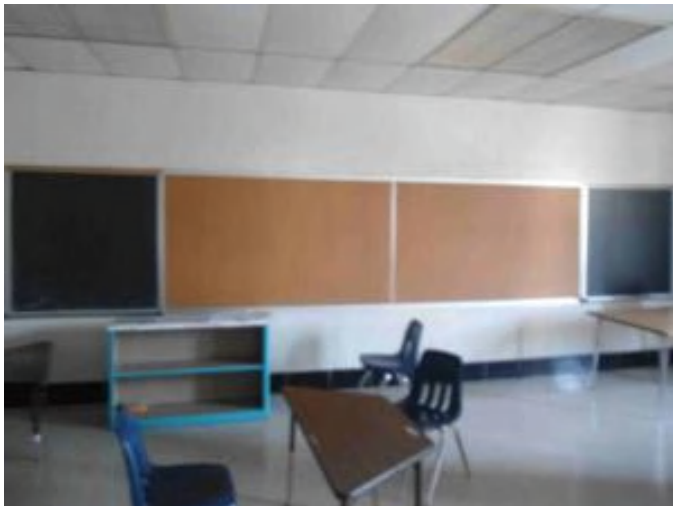
System: C1030 - Fittings

The classroom chalk boards are original to the buildings construction. This system is damaged and beyond its expected life, universal upgrades are warranted. Remove and upgrade chalk boards to new marker board systems.

Location: Classrooms

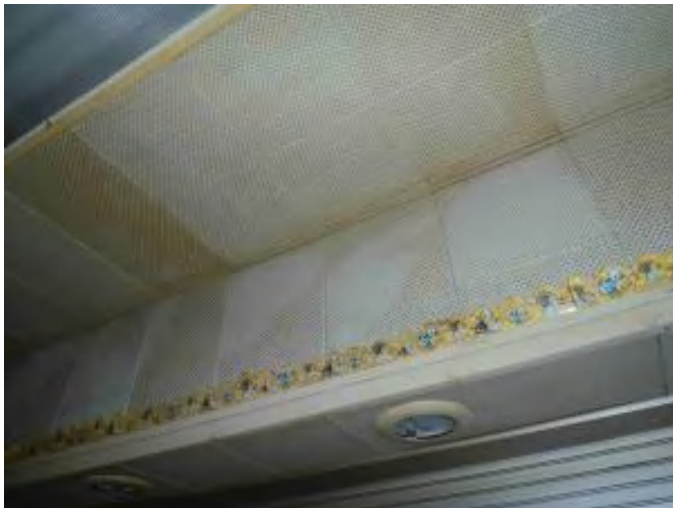
System: C3030 - Ceiling Finishes

Location: Building Wide

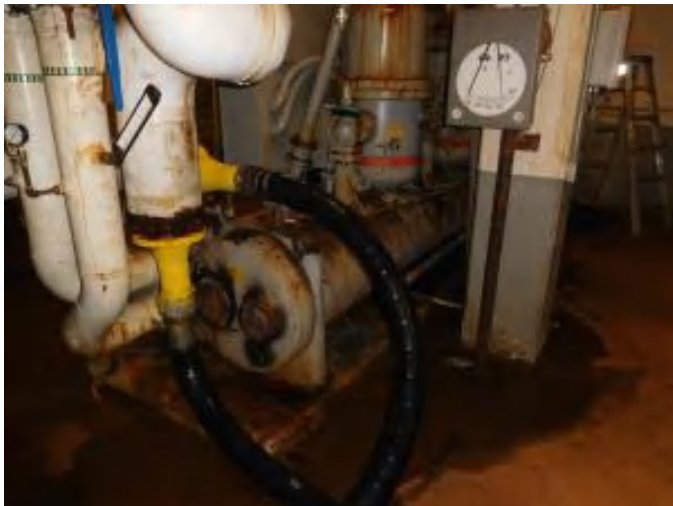
System: D3030 - Cooling Generating Systems

Location: roof, mechanical room

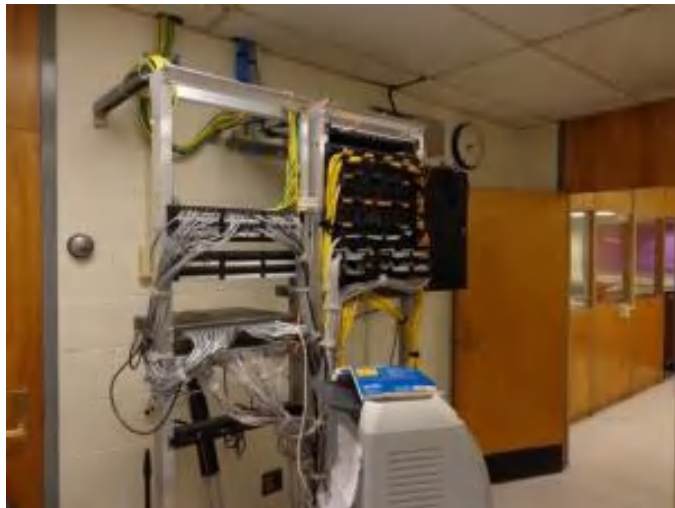
System: D5030 - Communications and Security

Location: Classrooms

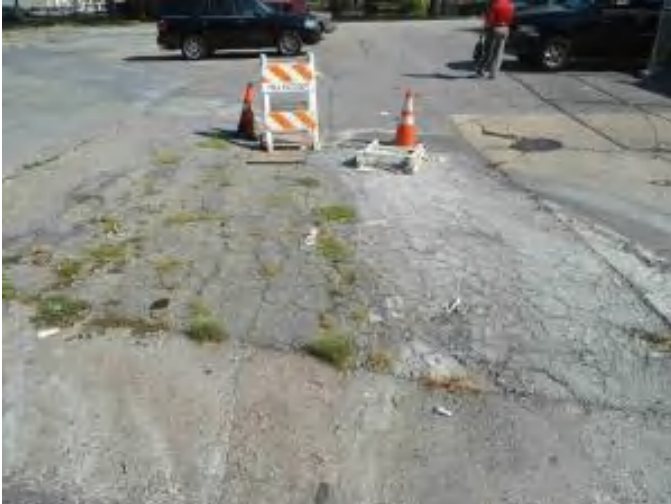
System: G2040 - Site Development

Location: Loading Dock

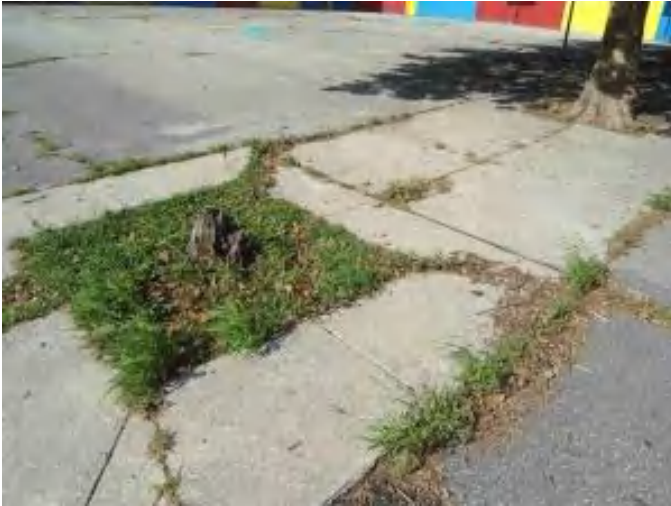
System: G2030 - Pedestrian Paving

Location: Site

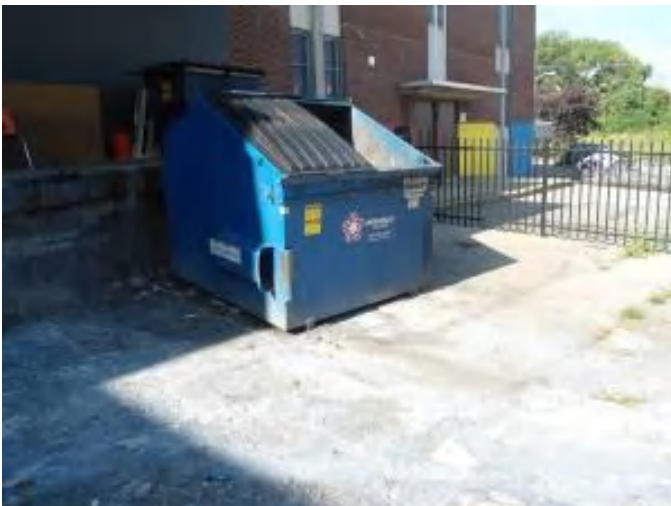
System: G2040 - Site Development

Location: Site

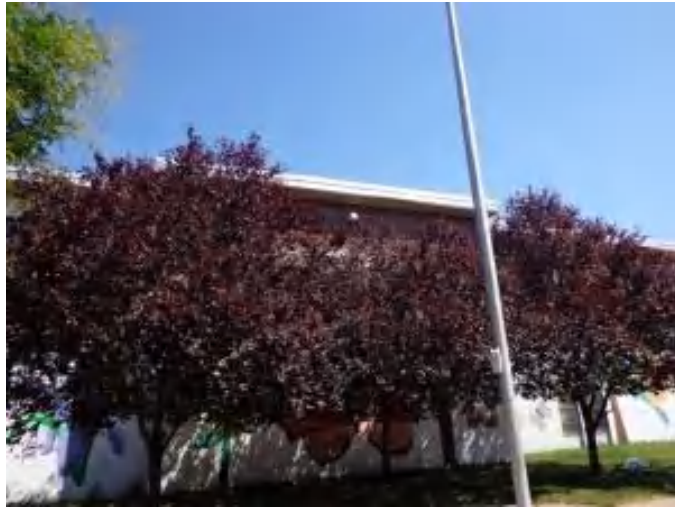
System: G4030 - Site Communications & Security

Location: Site Exterior

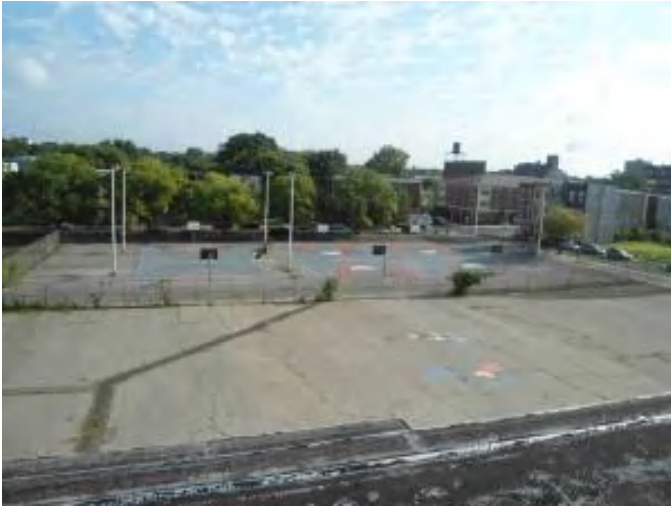
System: G2020 - Parking Lots

Location: Site

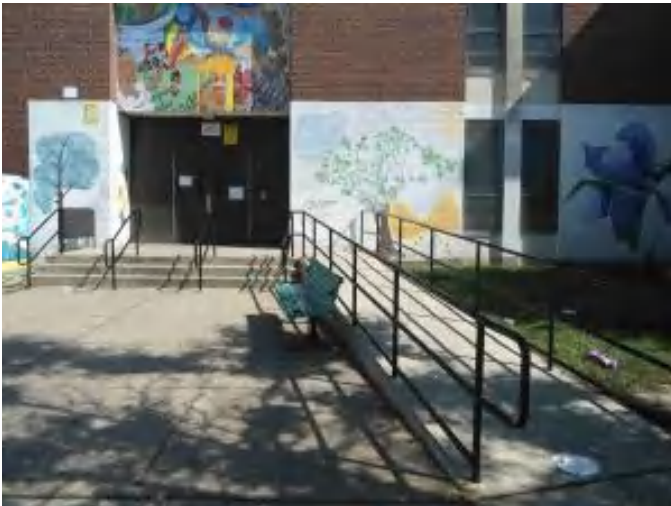
System: G2030 - Pedestrian Paving

Location: Exterior Elevation

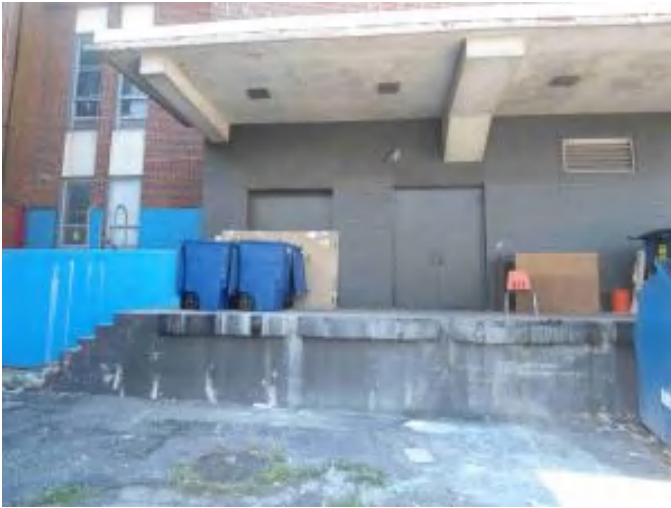
System: G2040 - Site Development

Location: Loading Dock

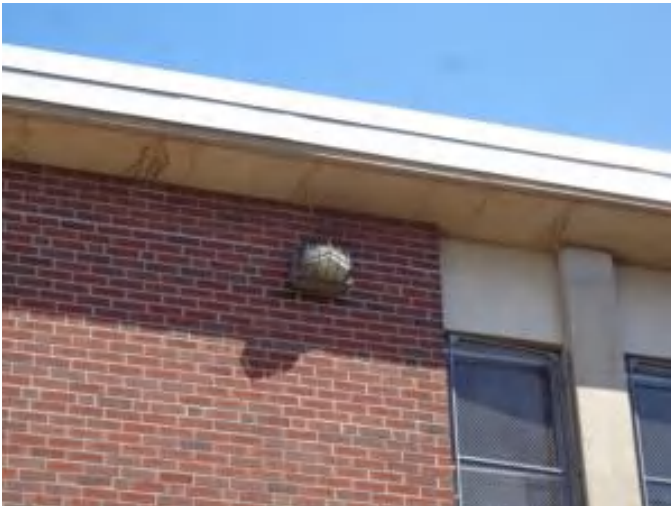
System: G4020 - Site Lighting

Location: Site lighting

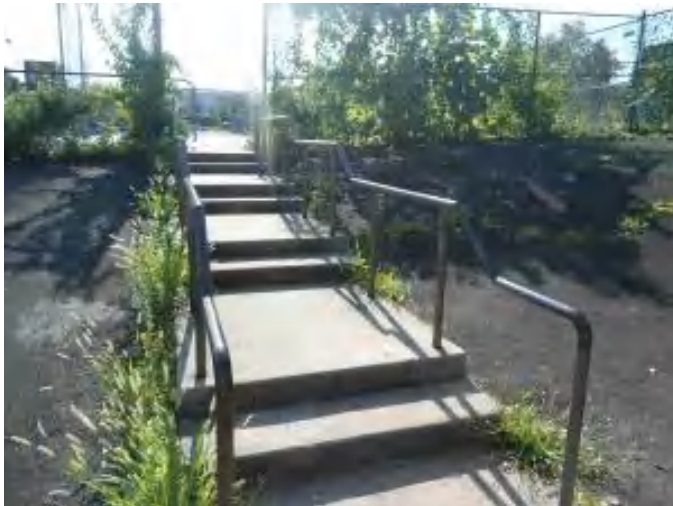
System: G2030 - Pedestrian Paving

Location: Site

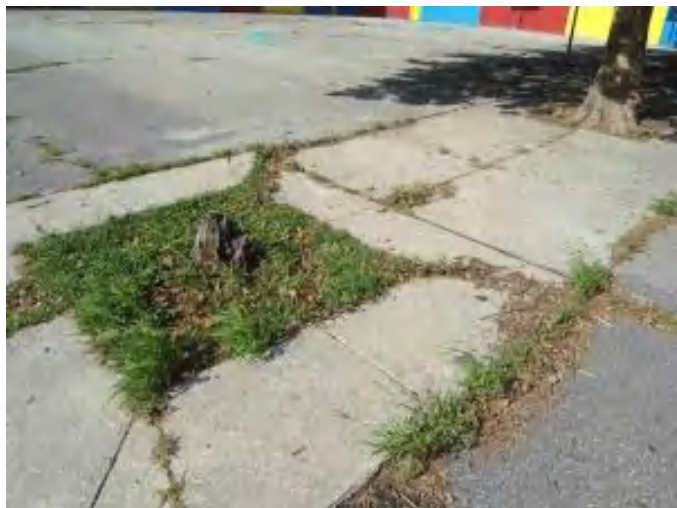
System: G2050 - Landscaping & Irrigation

Location: Site
