Facility Condition Assessment Summary Report

Dunbar School

School District of Philadelphia
S525001;Dunbar
Final
Site Assessment Report
February 1, 2017

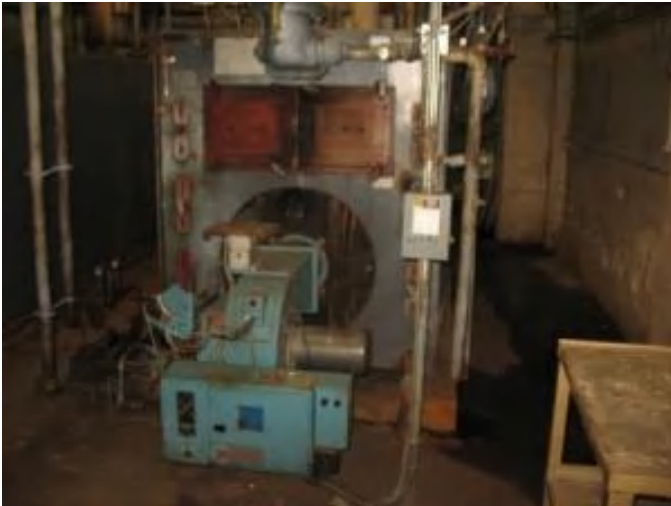
System: D3020 - Heat Generating Systems

Location: Boiler room

Distress: Health Hazard / Risk

Notes: Replace the existing 4,286MBH cast iron boilers, which are beyond their service lives and leak exhaust gases into the boiler room.

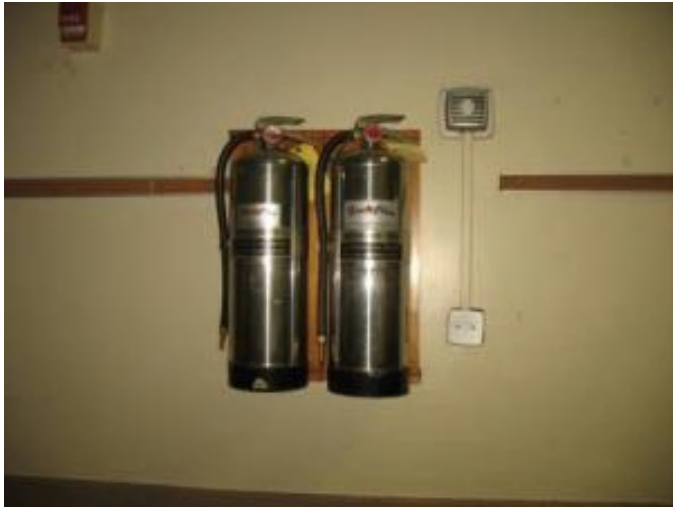
System: D4010 - Sprinklers

Location: Throughout building

Distress: Life Safety / NFPA / PFD

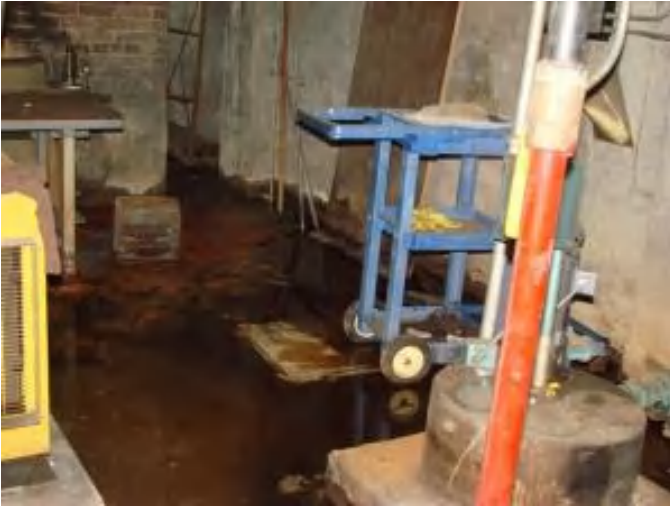
System: A2020 - Basement Walls

Location: Interiors/ Basement

Distress: Health Hazard / Risk

Notes: Remove mold from basement walls (boiler room and mechanical spaces)

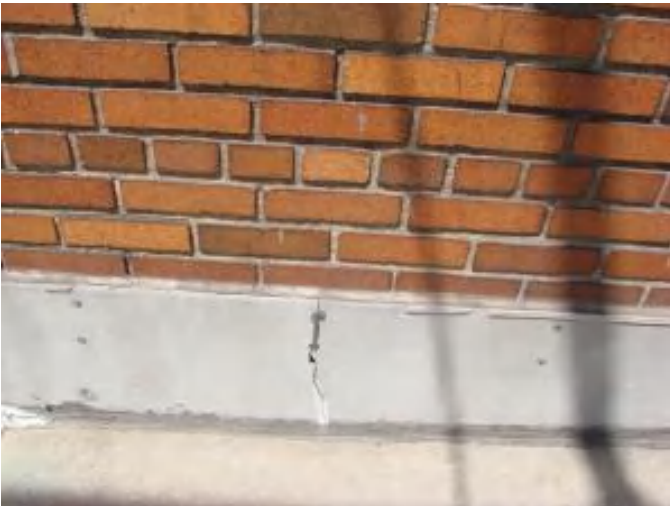
System: B2010 - Exterior Walls

The building envelope is typically masonry with face brick with decorative stone portals at entrance doors. In general, masonry is in fair to poor condition with deteriorated and missing mortar from joints; some face brick buckling and cracks are evident. The penthouse walls show thermal cracking just below concrete roof slab. Water penetration through wall has been reported.

Location: Exterior

Distress: Building Envelope Integrity

Notes: Repair cracks in masonry, tuck-point all walls

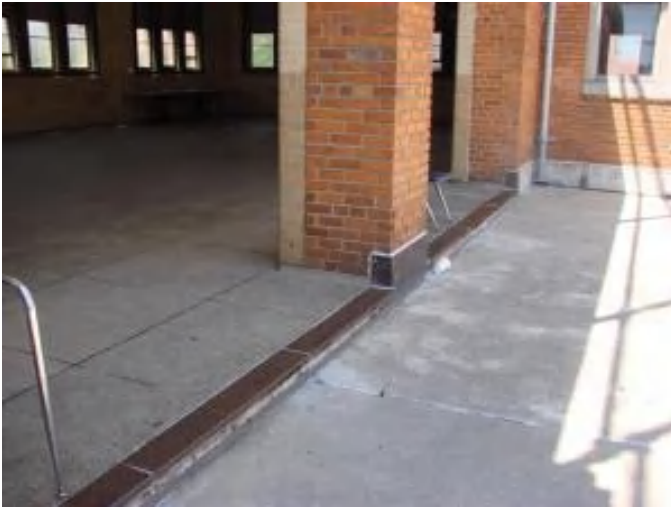
System: B3010105 - Built-Up

Roofing is typically built-up in fair condition. All roofing and flashing is typically in poor condition with some deterioration of the built-up system including water ponding and soft spots; play area on the roof is in fair condition; however, leaks have been reported.

Location: Exterior

Distress: Beyond Service Life

Notes: Install all new roofing system including insulation within next 4 to 5 years; tear-down existing roofing; install flashing, counter flashing and reglets

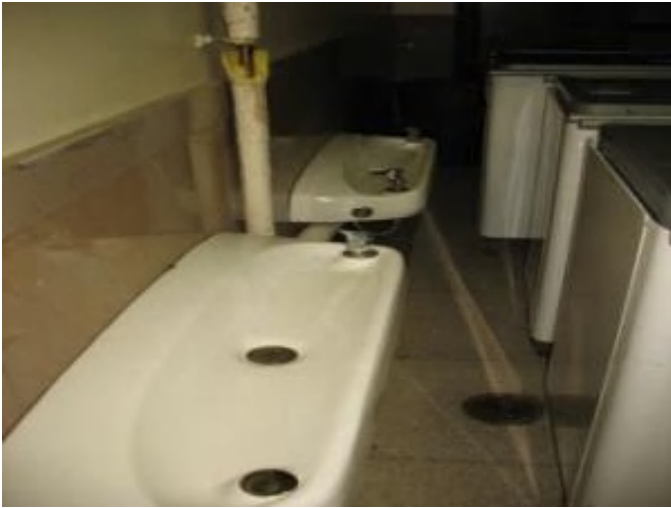
System: D2010 - Plumbing Fixtures

Drinking fountains in the corridors and at the restrooms are a mixture of wall hung with integral refrigerated coolers and wall hung porcelain fountains. The porcelain fountains are well beyond their service life and should be replaced; most are NOT accessible type.

Location: Throughout building

Distress: Beyond Service Life

Notes: Replace the wall hung drinking fountains and integral refrigerated coolers in the corridors and at the restrooms. These units are well beyond their service life and most are NOT accessible type.

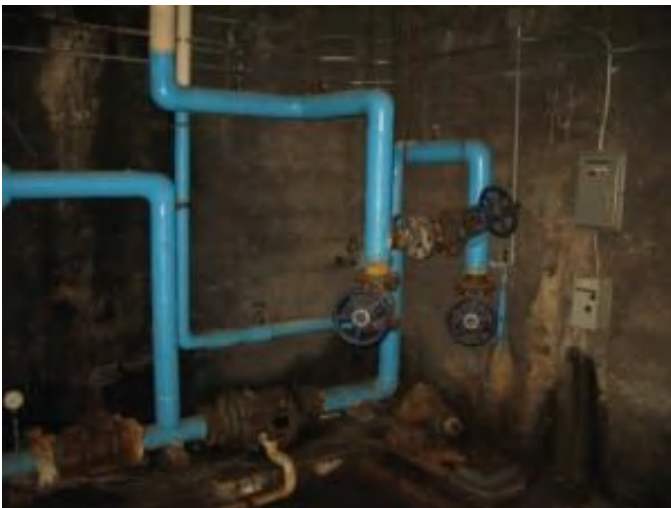
System: D2020 - Domestic Water Distribution

Domestic Water Distribution - A 3" city water service enters the building from N. Twelfth Street. The meter is 2" and located in the basement coal/ash room. A reduced pressure backflow preventer is not installed on the domestic water side. The original domestic hot and cold water distribution piping was replaced with copper piping and sweat fittings. The maintenance staff reports no significant problems with scale build up in the domestic piping and the supply is adequate to the fixtures.

Location: Boiler room

Distress: Beyond Service Life

Notes: Replace domestic water booster pumps and isolation valves and install reduced pressure backflow preventer on incoming domestic water line.

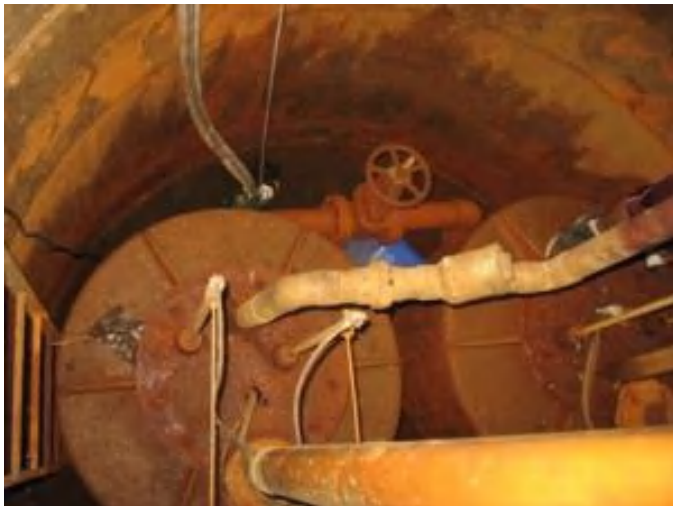
System: D2030 - Sanitary Waste

A sewage ejector pit located in basement receives water from the basement area. It has two pumps that are beyond their service life and covered in rust. The sewage ejector pit has overflowed in the past and both pumps should be replaced to prevent future flooding of the basement. The pit is not sealed, but should be.

Location: Boiler room

Distress: Failing

Notes: Replace existing sewage ejector pump system and piping in the basement as it looks beyond its useful service life.

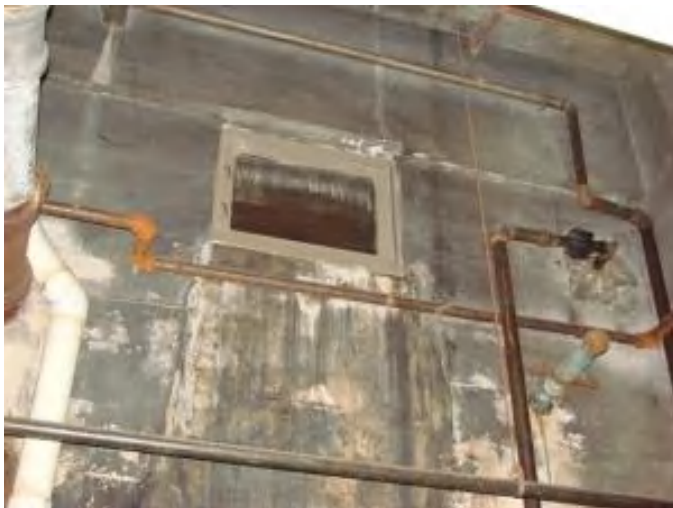
System: D2040 - Rain Water Drainage

Location: Basement

Distress: Inadequate

Notes: Add three area drains to the light wells on the exterior of the building and pipe them to the sump pit in the basement.

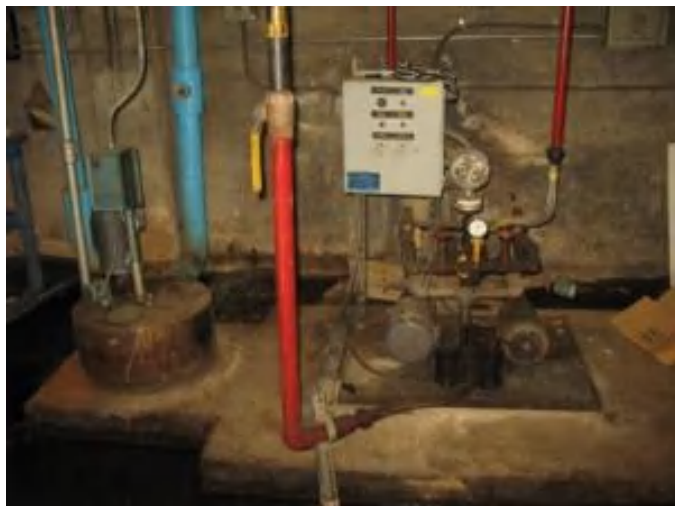
System: D3020 - Heat Generating Systems

Location: Boiler room

Distress: Beyond Service Life

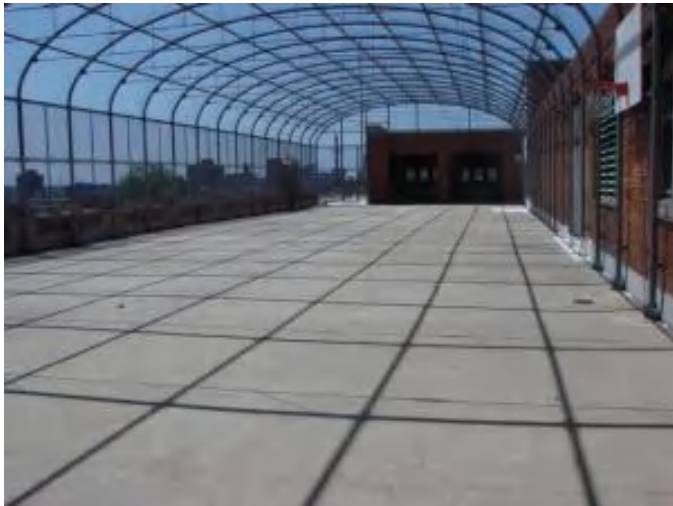
System: B3010120 - Single Ply Membrane

Location: Exterior

Distress: Building Envelope Integrity

Notes: Replace roofing and paving at roof play area

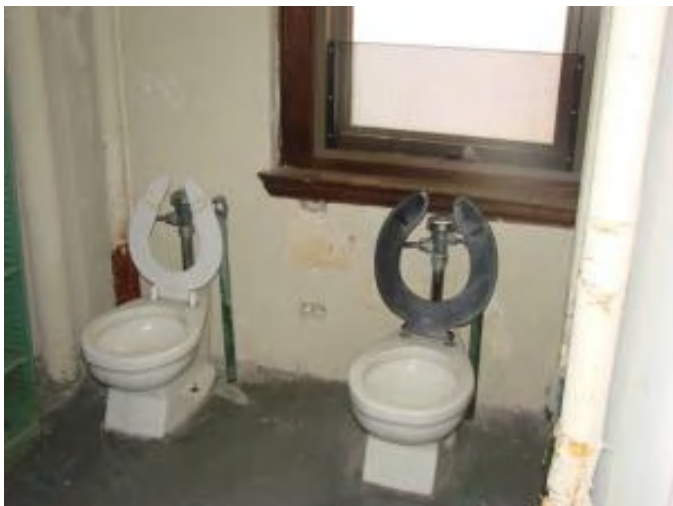
System: C1030 - Fittings

Location: Interiors

Distress: Accessibility

Notes: Provide new toilet accessories including grab bars

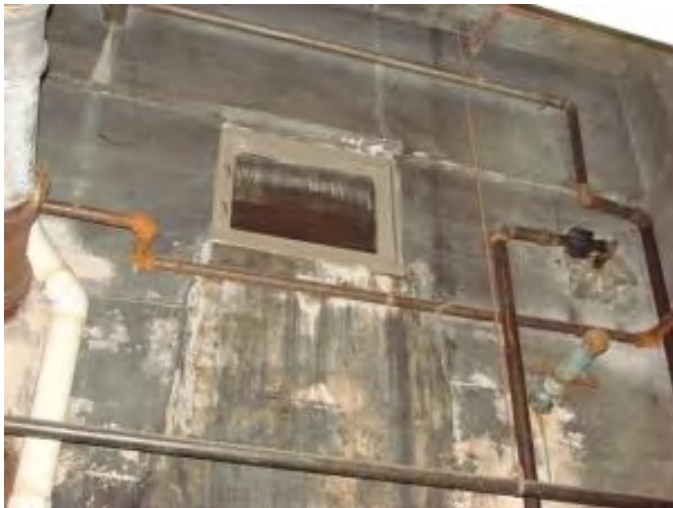
System: C3010230 - Paint & Covering

Location: Interiors

Distress: Damaged

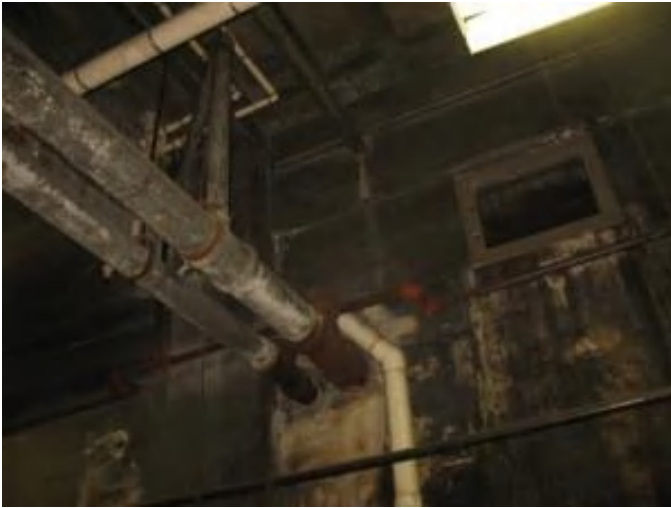
System: D2030 - Sanitary Waste

The maintenance staff reported mostly minor problems with the sanitary waste piping systems. However, the sewer piping has been in service for nearly 80 years and will require more frequent attention from the maintenance staff as time passes. The District should hire a qualified contractor to examine the sanitary waste piping using video cameras to locate and replace any damaged piping and to further quantify the extent of potential failures.

Location: Throughout building

Distress: Health Hazard / Risk

Notes: Hire a qualified contractor to perform a detailed examination of the sanitary waste piping using visual inspection and video cameras to locate and replace any damaged piping and to further quantify the extent of potential failures.

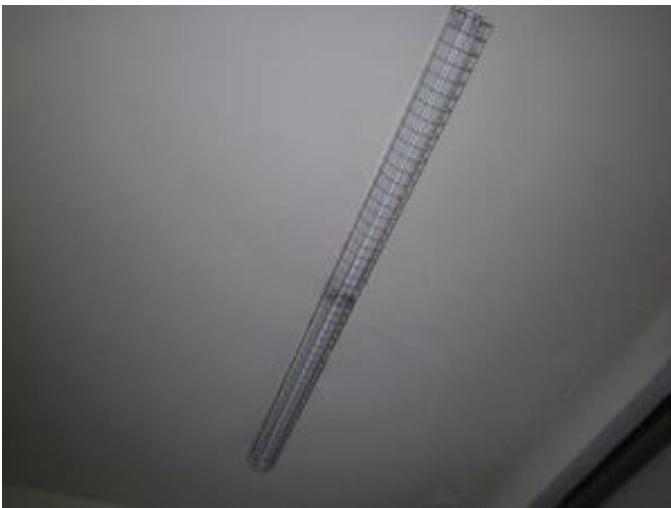
System: D5020 - Lighting and Branch Wiring

Location: Throughout Building

Distress: Energy Efficiency

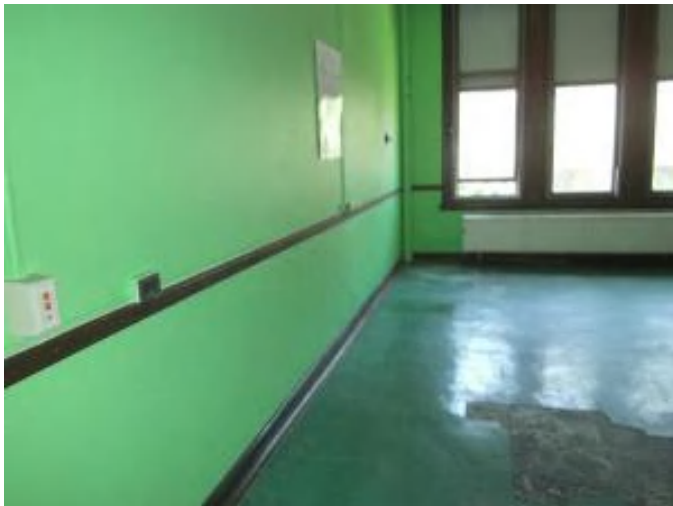
System: D5020 - Lighting and Branch Wiring

Location: Throughout School

Distress: Inadequate

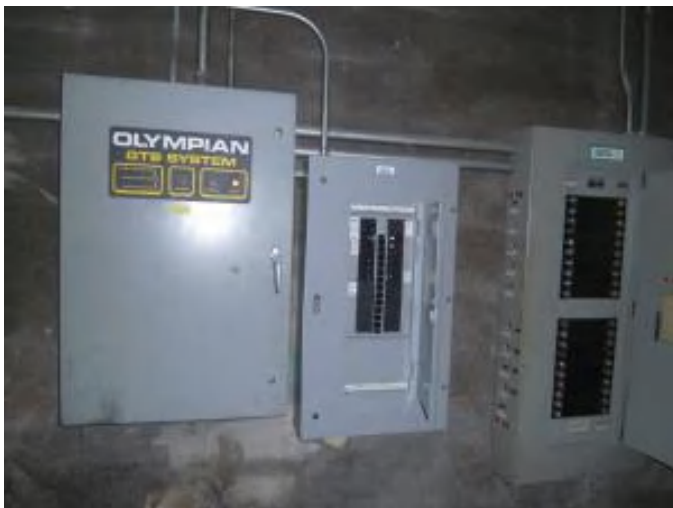
System: D5090 - Other Electrical Systems

Location: Basement

Distress: Inadequate

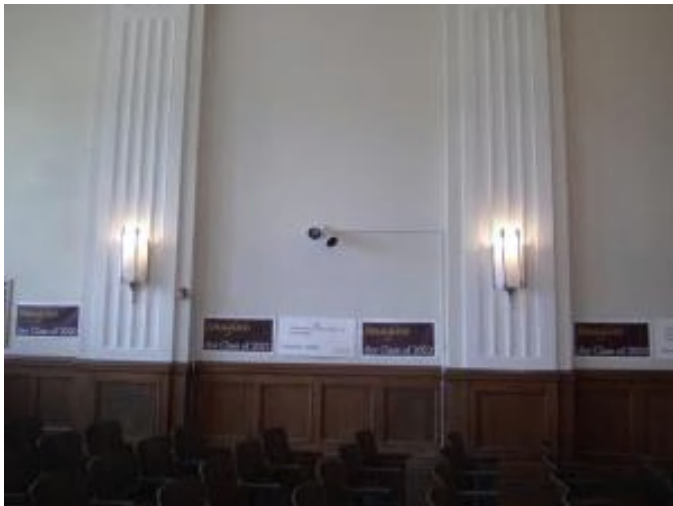
System: D5090 - Other Electrical Systems

Location: Throughout Building

Distress: Life Safety / NFPA / PFD

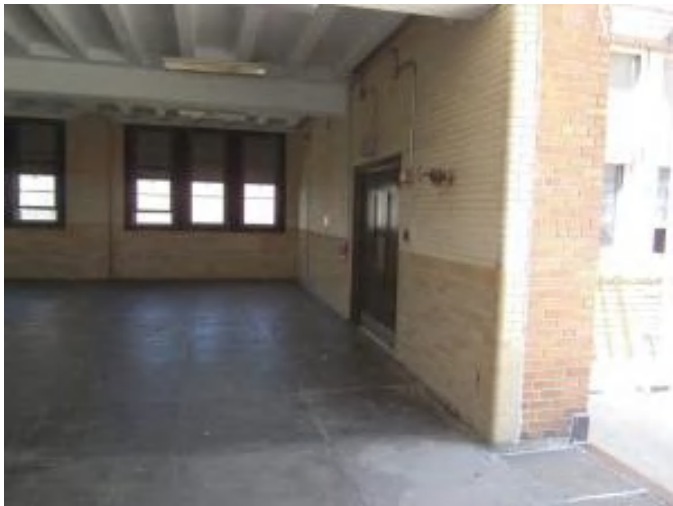
System: D5090 - Other Electrical Systems

Location: Throughout Building

Distress: Life Safety / NFPA / PFD

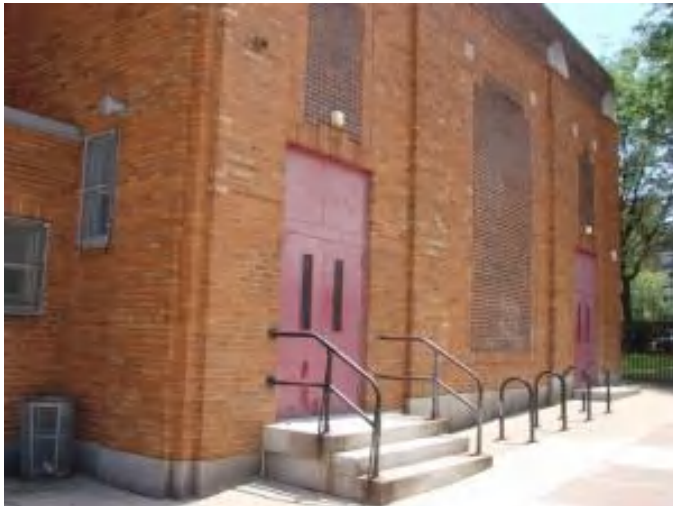
System: B2030 - Exterior Doors

Location: Exterior

Distress: Appearance

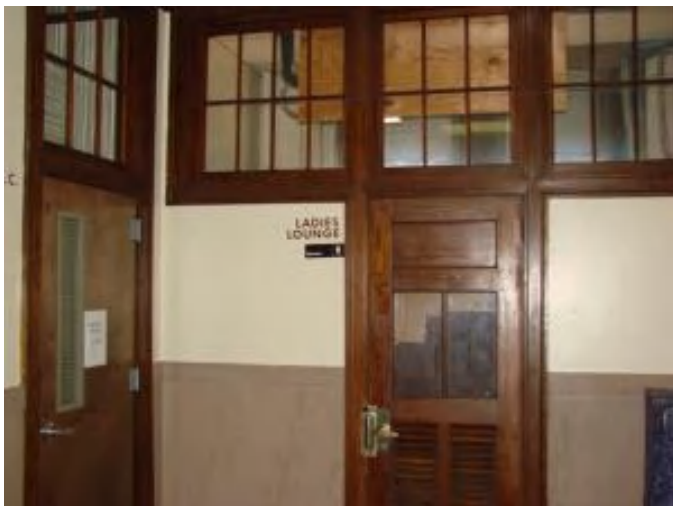
System: C1020 - Interior Doors

Location: Interiors

Distress: Appearance

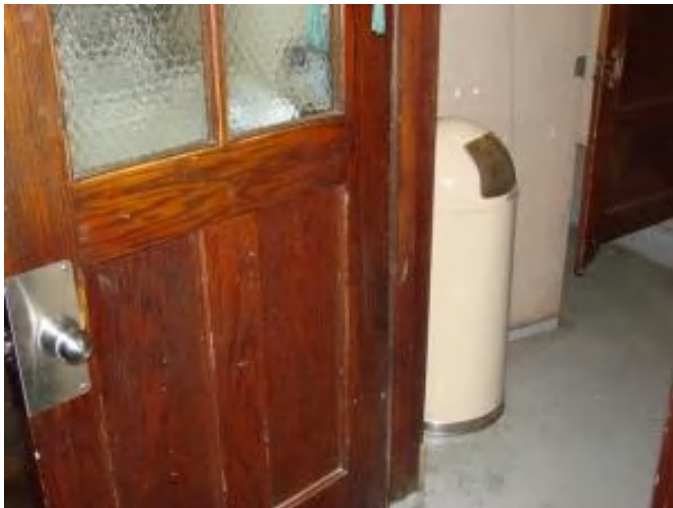
System: C1020 - Interior Doors

Location: Interiors

Distress: Accessibility

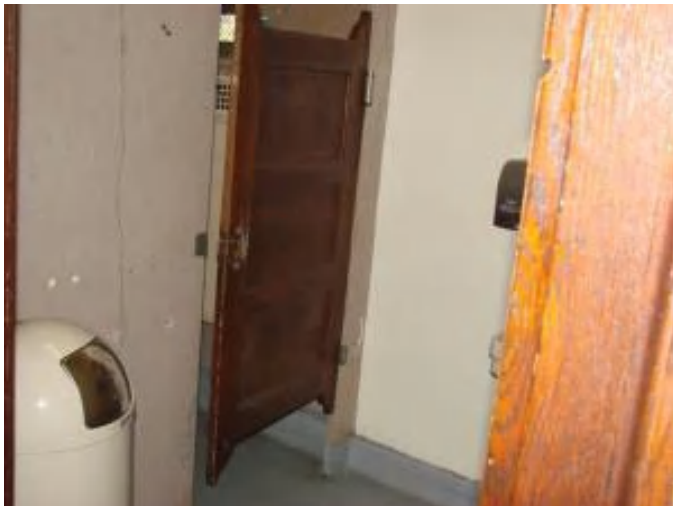
System: C1030 - Fittings

Location: Interiors

Distress: Accessibility

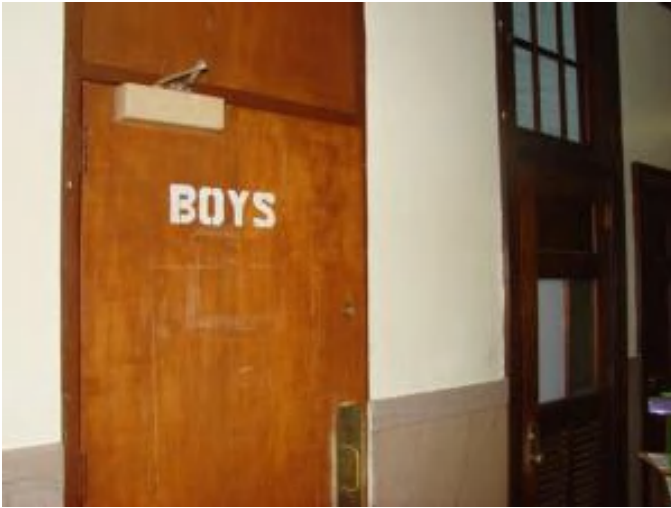
System: C1030 - Fittings

Location: Interiors

Distress: Building / MEP Codes

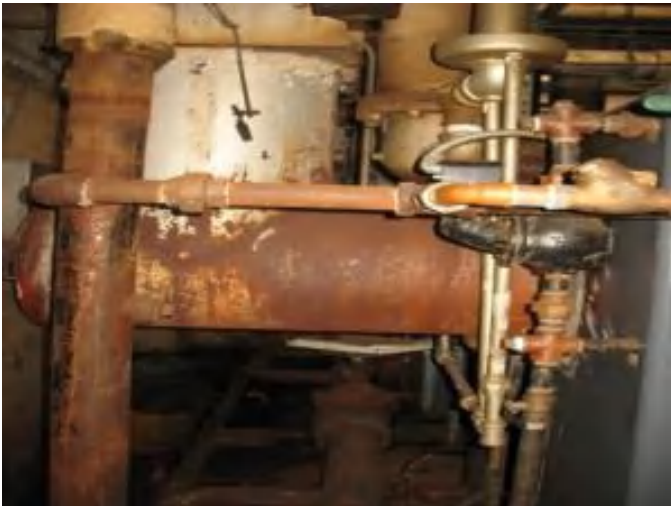
System: D3040 - Distribution Systems

Location: Throughout building

Distress: Beyond Service Life

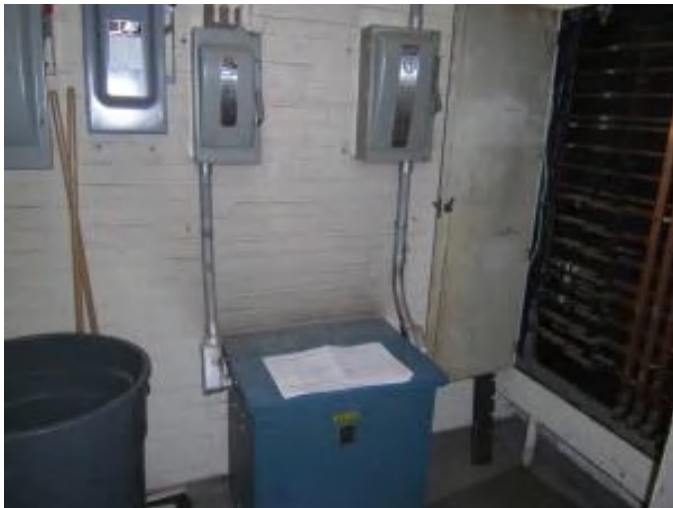
System: D5010 - Electrical Service/Distribution

Location: Throughout Building

Distress: Beyond Service Life

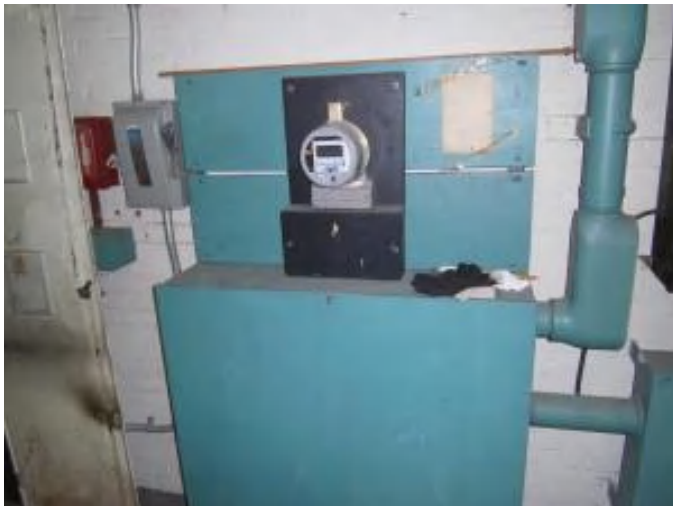
System: D5010 - Electrical Service/Distribution

Location: Basement

Distress: Inadequate

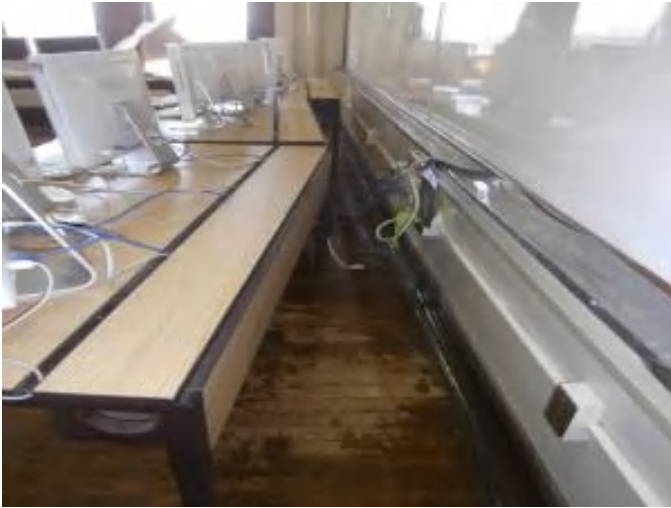
System: D5020 - Lighting and Branch Wiring

Location: Computer Classrooms

Distress: Inadequate

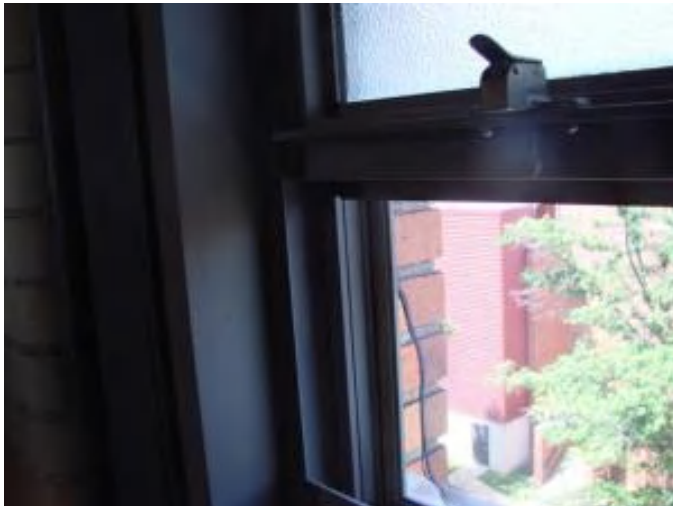
System: B2020 - Exterior Windows

The original windows were replaced approximately in early 1980's with extruded aluminum double hung windows, single glazed with acrylic sheet. Basement and first floor windows are fitted with security screens anchored to masonry at window perimeter. All windows are generally beyond their service life, in poor condition; most are difficult to operate, some hardware is missing.

Location: Exterior

Distress: Beyond Service Life

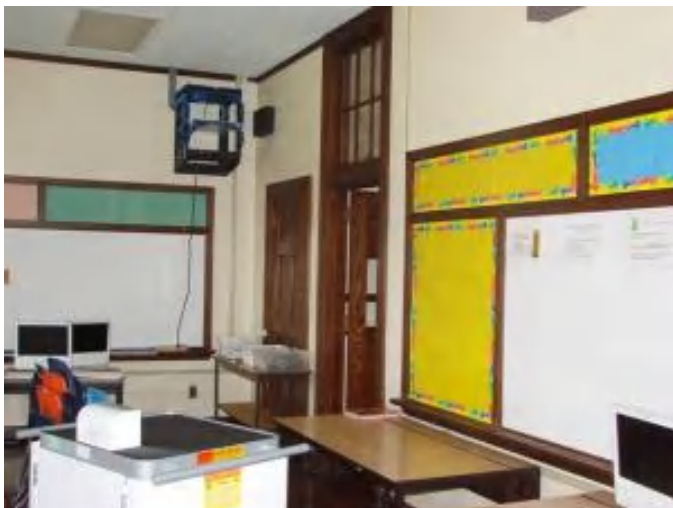
System: C1030 - Fittings

Location: Interiors/ classrooms

Distress: Inadequate

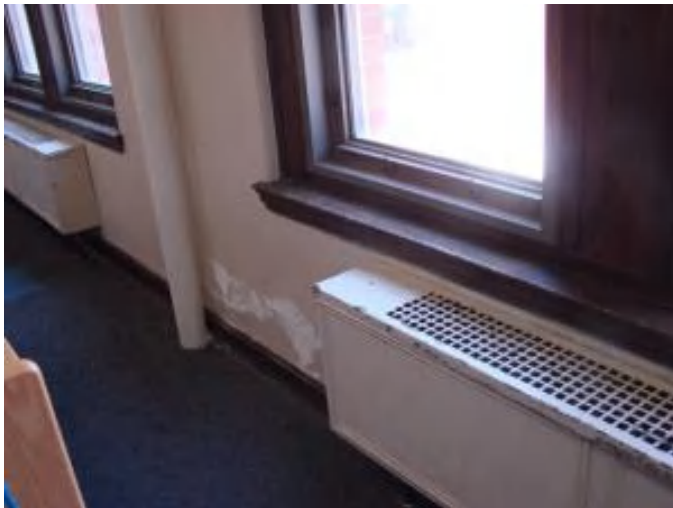
System: C3020411 - Carpet

Location: Interiors

Distress: Beyond Service Life

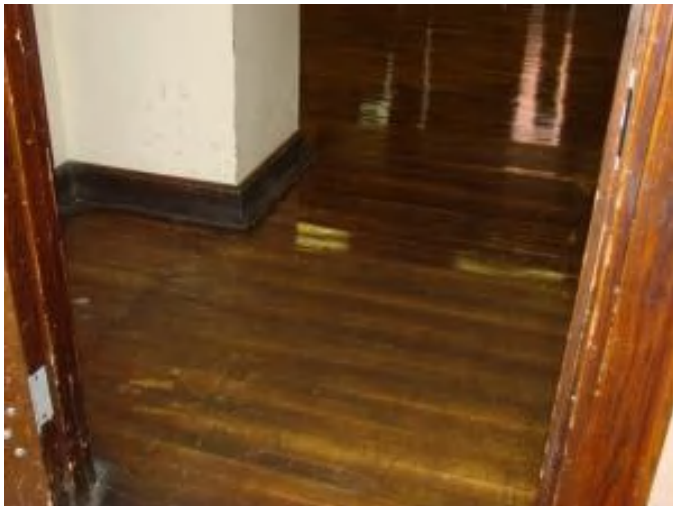
System: C3020414 - Wood Flooring

Location: Interiors

Distress: Maintenance Required

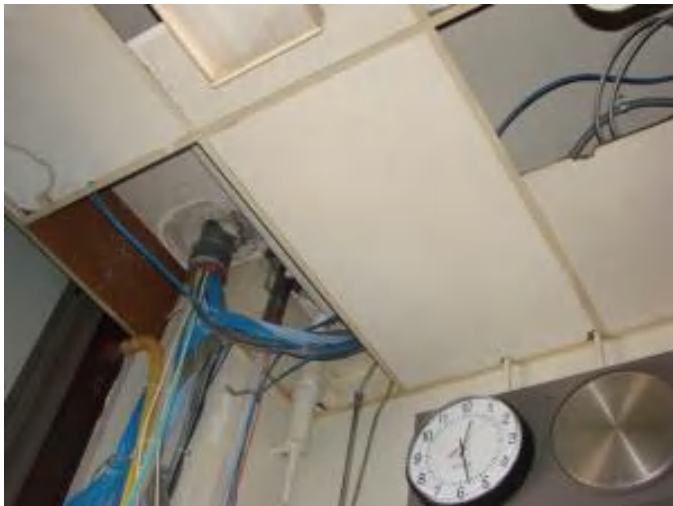
System: C3030 - Ceiling Finishes

Location: Interiors

Distress: Beyond Service Life

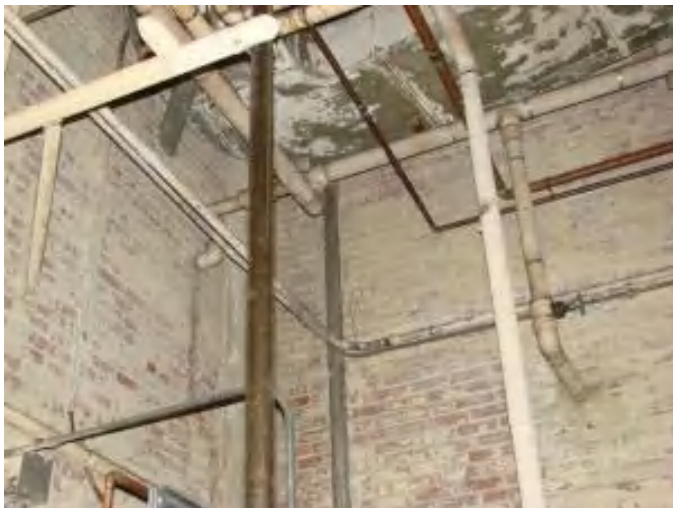
System: C3030 - Ceiling Finishes

Location: Interiors

Distress: Beyond Service Life

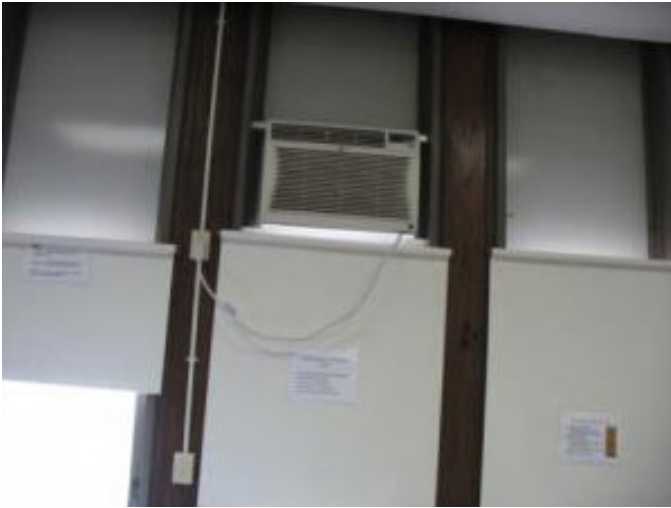
System: D3030 - Cooling Generating Systems

Location: Throughout building

Distress: Inadequate

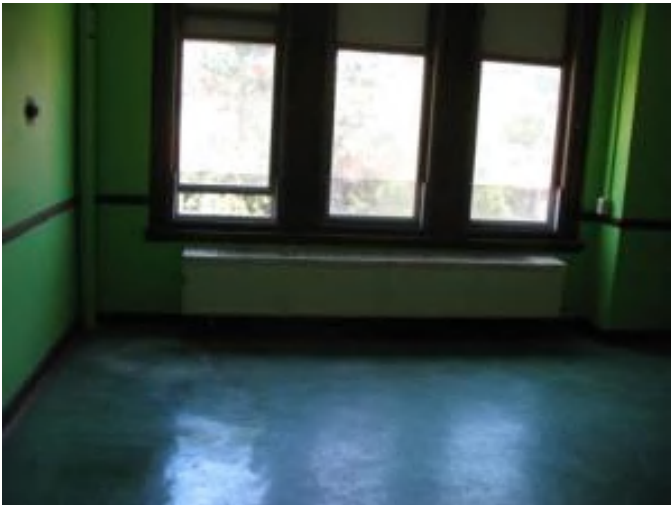
System: D3040 - Distribution Systems

Location: Throughout building

Distress: Building / MEP Codes

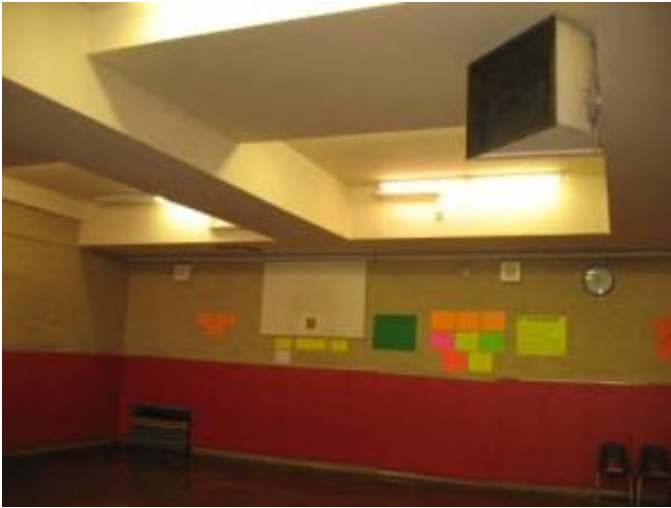
System: D3040 - Distribution Systems

Location: Gymnasium

Distress: Building / MEP Codes

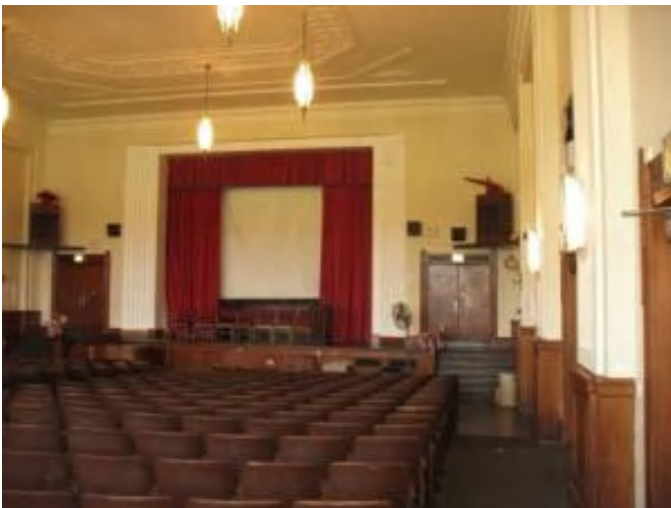
System: D3040 - Distribution Systems

Location: Auditorium

Distress: Building / MEP Codes

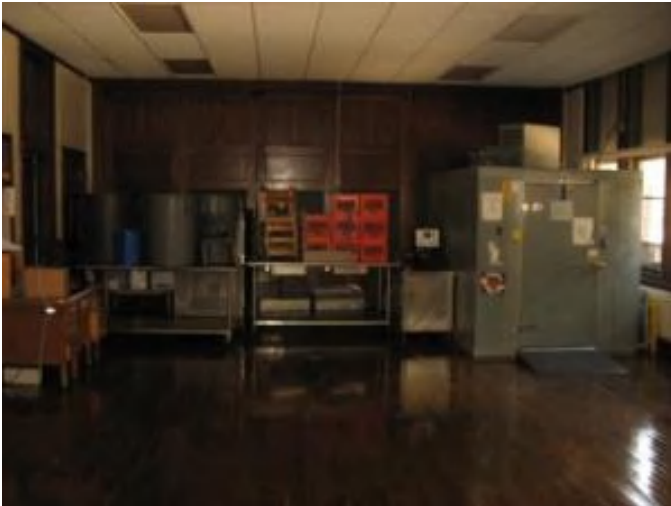
System: D3040 - Distribution Systems

Location: Cafeteria

Distress: Building / MEP Codes

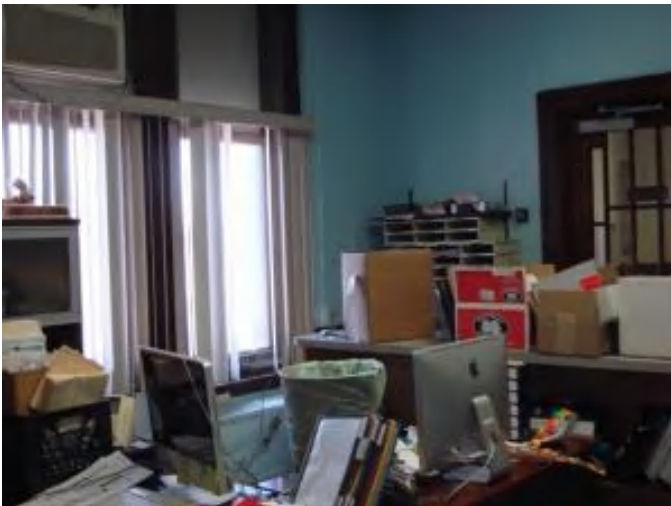
System: D3040 - Distribution Systems

Location: Administration

Distress: Building / MEP Codes

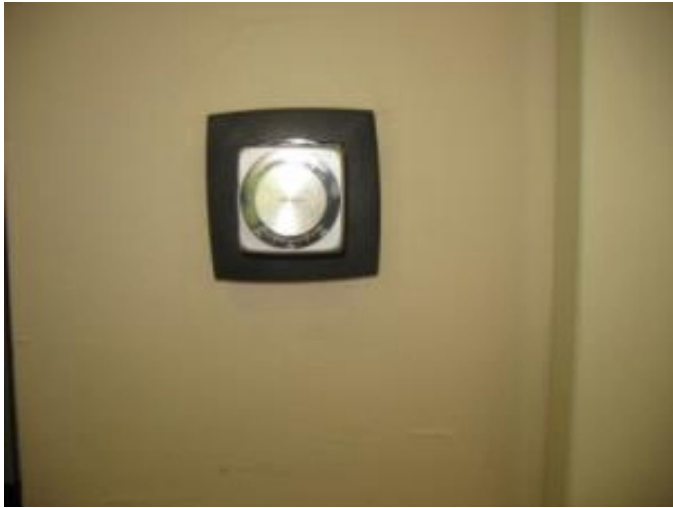
System: D3060 - Controls & Instrumentation

Controls & Instrumentation - The original pneumatic systems still provide basic control functions. Pneumatic room thermostats are intended to control the steam radiator control valves. In reality the radiator control valves are wide open and heating control is achieved via the boilers. Pneumatic control air is supplied from a Robertshaw compressor and Hankison air dryer located in the boiler room. The maintenance staff reports no problems with oil, moisture or dirt in the pneumatic copper tubing. The pneumatic systems are beyond their service life and require too much attention from the maintenance staff. The original control valves and pneumatic actuators are beyond their service life and should be rebuilt or replaced. These controls should be converted to DDC.

Location: Throughout building

Distress: Inadequate

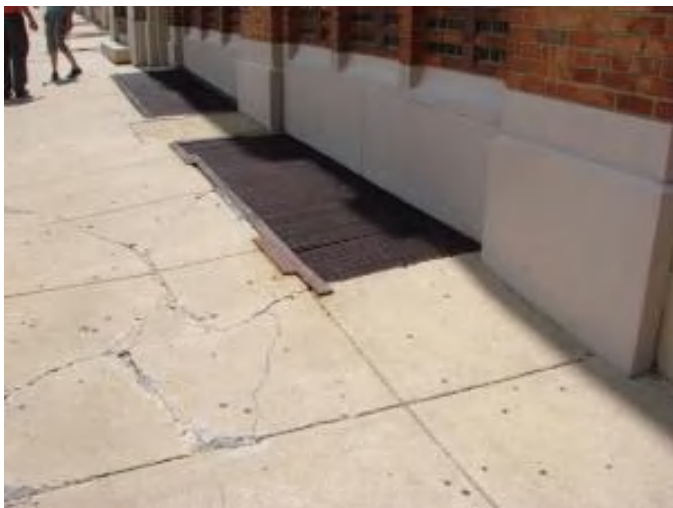
System: G2030 - Pedestrian Paving

Location: Grounds/ Site

Distress: Damaged

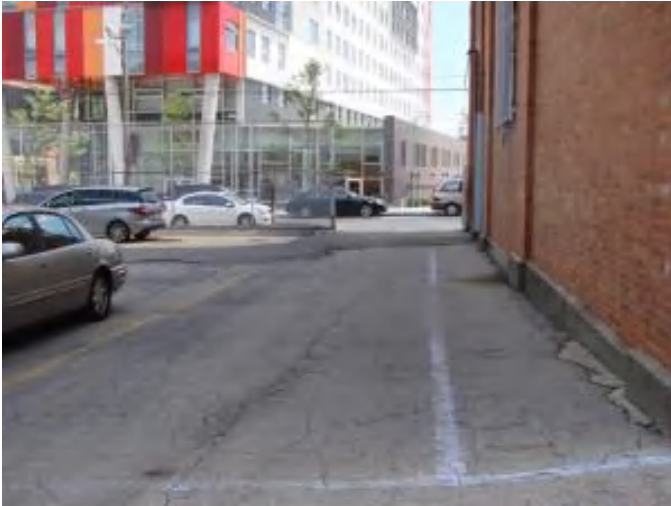
System: G2020 - Parking Lots

Location: Grounds/ Site

Distress: Beyond Service Life

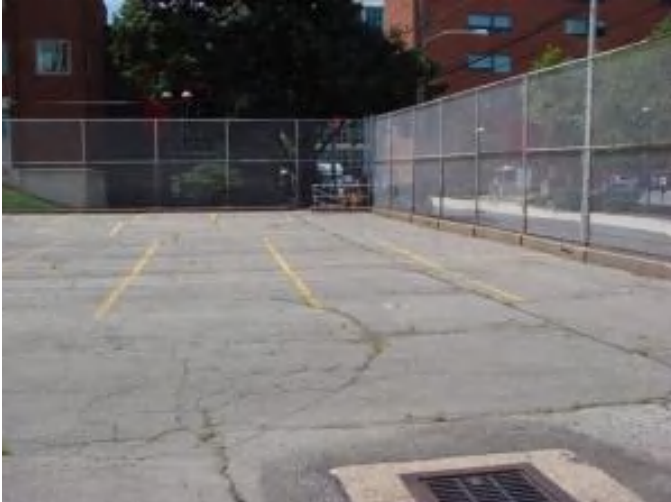
System: G2020 - Parking Lots

Location: Grounds/ Site

Distress: Beyond Service Life

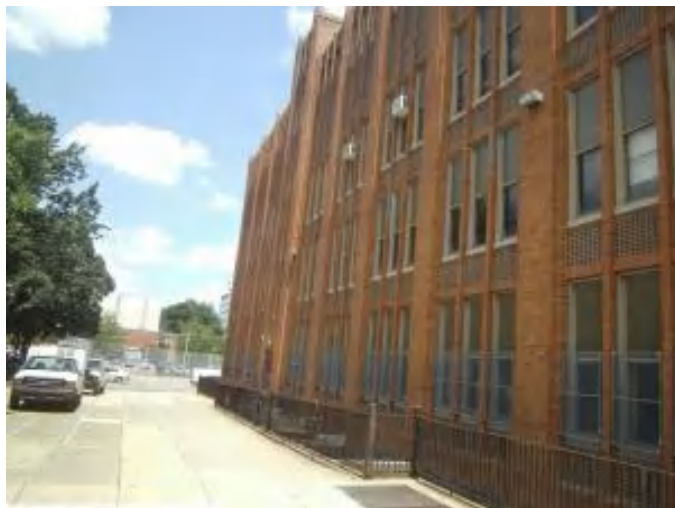
System: G4020 - Site Lighting

Location: Grounds/ Site

Distress: Beyond Service Life

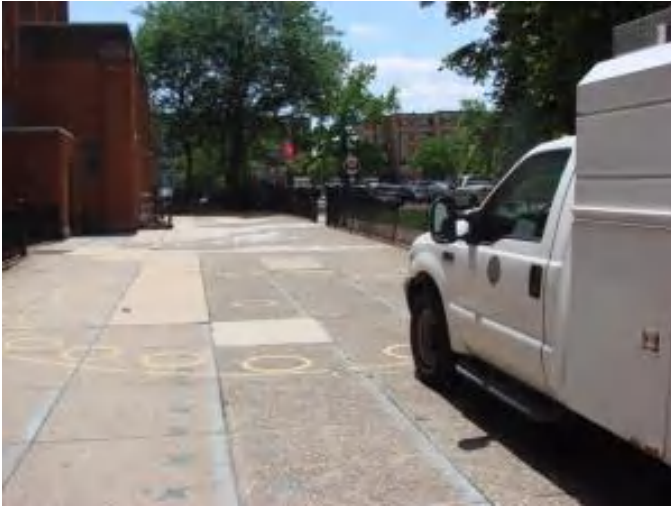
System: G2030 - Pedestrian Paving

Location: Grounds/ Site

Distress: Beyond Service Life

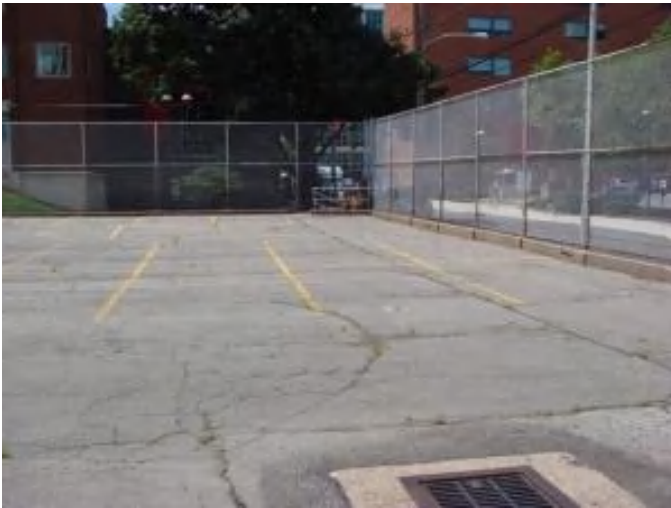
System: G2040 - Site Development

Location: Grounds/ Site

Distress: Damaged

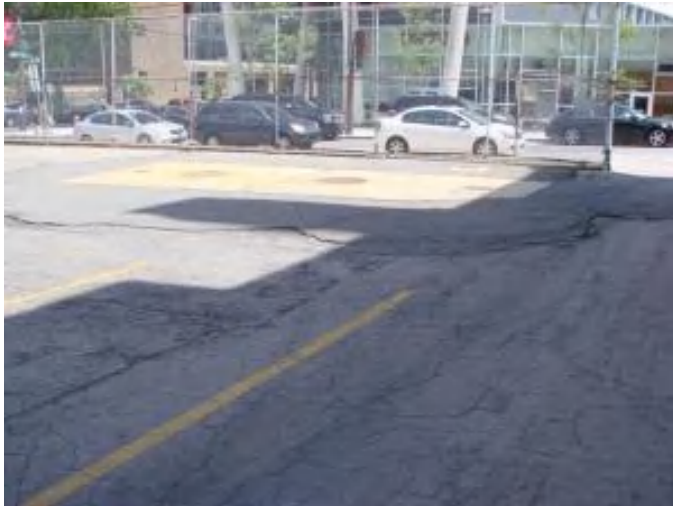
System: G2040 - Site Development

Location: Grounds/ Site

Distress: Beyond Service Life
