Facility Condition Assessment Summary Report

Edison School

Site Assessment Report

February 1, 2017

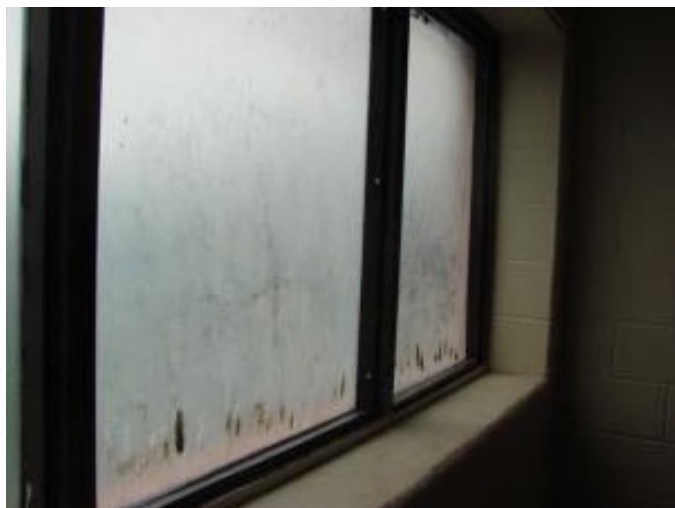
System: B2020 - Exterior Windows

Exterior windows are typically anodized aluminum curtain wall, single, acrylic glazed units with tilt-in operating sections. Substantial number of window glazing panels show signs of UV deterioration and physical damage. First floor windows are fitted with galvanized steel security screens.

Location: Exterior

Distress: Beyond Service Life

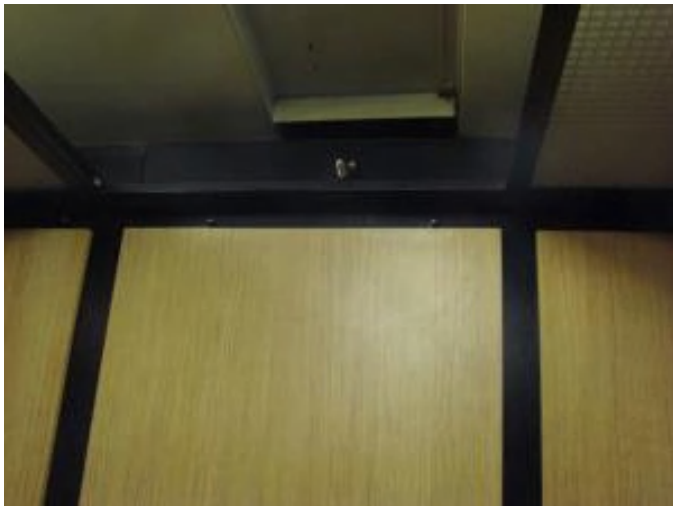
System: D1010 - Elevators and Lifts

The building has one 8,000 lb. hydraulic elevator, in poor condition (deteriorated cabin interior); and one, non-operational 2,500 lb. hydraulic elevator.

Location: Interior

Distress: Beyond Service Life

Notes: Refurbish 8000# elevator cabin

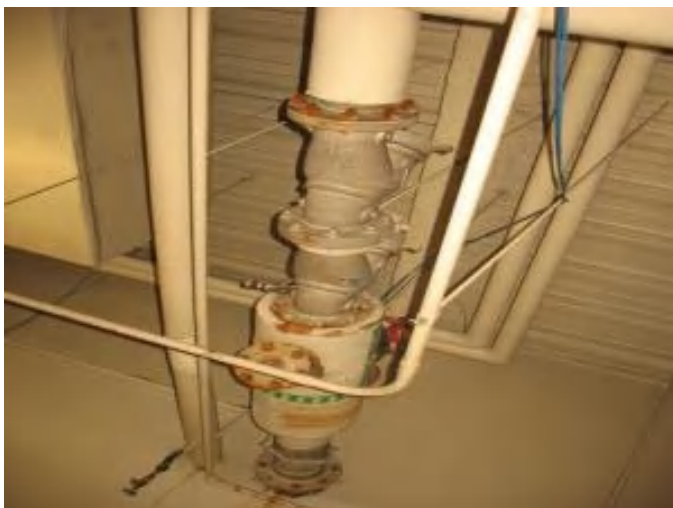
System: D2020 - Domestic Water Distribution

Location: Mechanical room

Distress: Inadequate

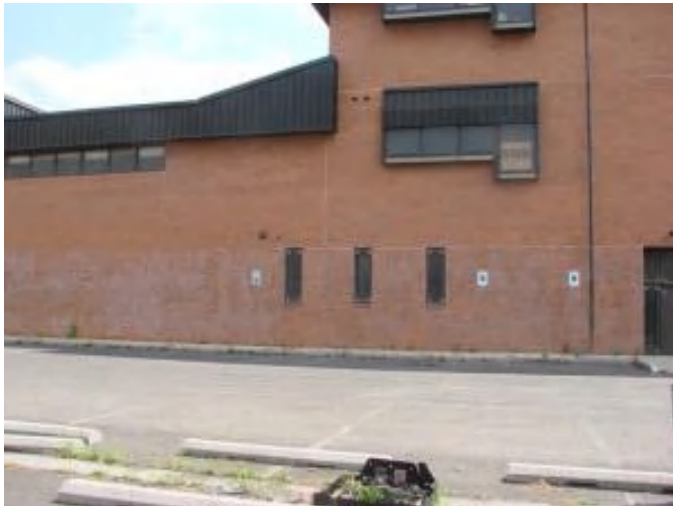
System: B2010 - Exterior Walls

The building envelope typically comprises of face brick over CMU with portions of walls and roof clerestories covered with prefinished, standing seam metal panels; walls are insulated cavity type. Some cracks at corners were observed. First floor walls are covered with anti-graffiti coating which is peeling off the substrate.

Location: Exterior

Distress: Building Envelope Integrity

Notes: Replace anti-graffiti coating – entire building perimeter

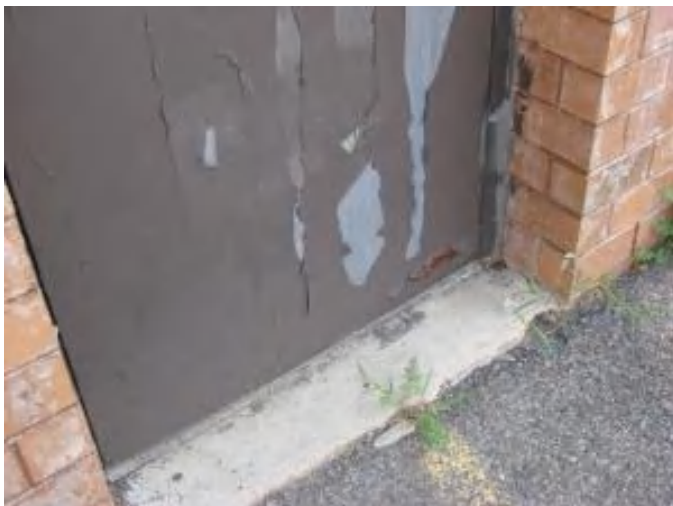
System: B2030 - Exterior Doors

Exterior doors are hollow metal glazed with security screens; service doors are typically hollow metal in hollow metal frames; several overhead, insulated roll-up doors are installed at loading dock and automotive workshops; doors have typically deteriorated, peeling finish with some rusting evident; the are beyond their service life.

Location: Exterior

Distress: Beyond Service Life

Notes: Replace exterior hollow metal doors

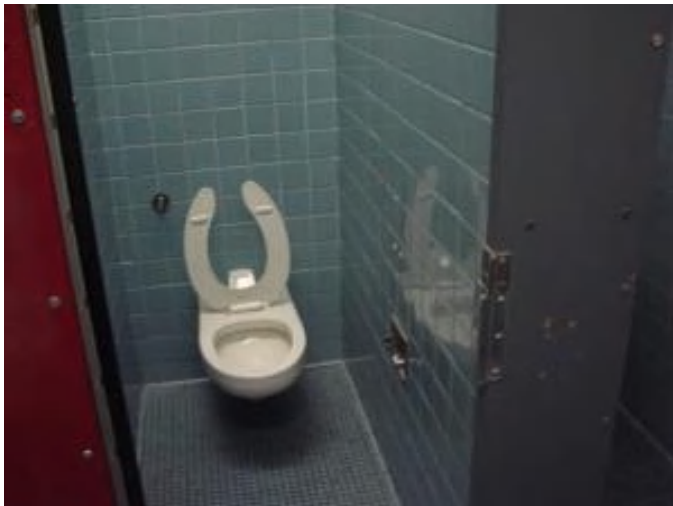
System: C1030 - Fittings

Toilet partitions are typically a mixture of metal and phenolic resin panels, some cubicles are ADA compliant, but in poor condition. Accessories are damaged or missing.

Location: Interior

Distress: Building / MEP Codes

Notes: Replace toilet partitions and accessories; provide accessible compartments

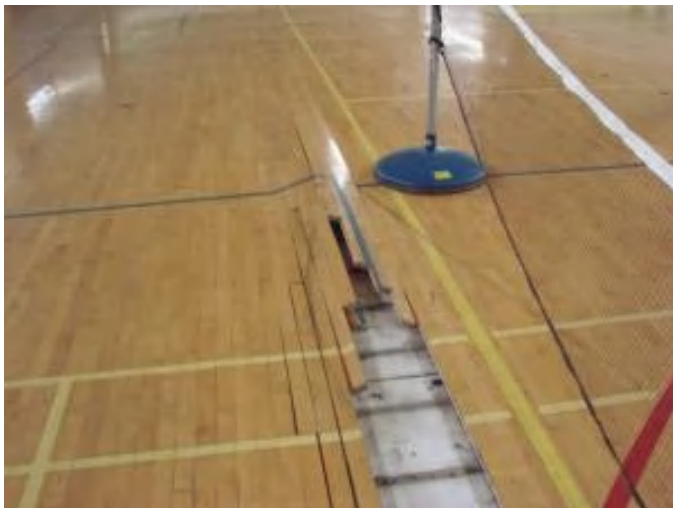
System: C3020414 - Wood Flooring

Flooring in most areas is generally vinyl composition tile, in fair condition; approximately 30% of VCT is deteriorated. Gym has hardwood, athletic flooring showing substantial moisture damage. Flooring in toilets and kitchen area is typically ceramic and quarry tiles in fair condition. Workshops, science classrooms and mechanical spaces have concrete floors, some with epoxy finish.

Location: Interior

Distress: Damaged

Notes: Replace hardwood flooring in gym

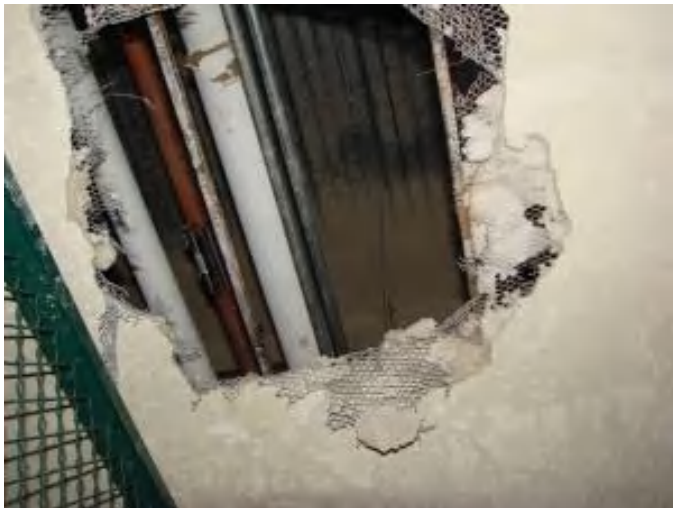
System: C3030 - Ceiling Finishes

Most ceilings are 2x4 suspended acoustical panels; ceiling in gym and clerestories is exposed metal deck, painted. Ceiling in the auditorium theatre is a combination of acoustic tiles and drywall. All ceilings are in poor condition; some ceiling and drywall soffits damage was observed in various locations.

Location: Interior

Distress: Damaged

Notes: Repair drywall soffits and ceilings

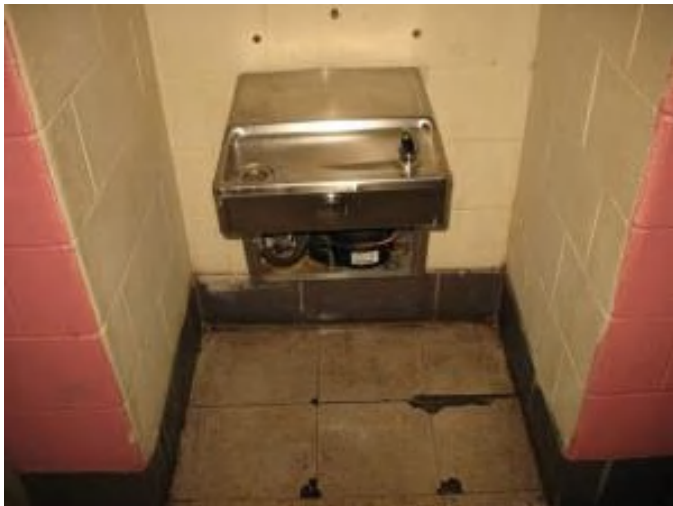
System: D2010 - Plumbing Fixtures

Drinking fountains in the corridors and at the restrooms consist of wall hung fixtures with integral refrigerated coolers. They are within their service life; most are accessible type. Eight (8) of the units have been damaged and should be replaced.

Location: Corridors

Distress: Damaged

Notes: Replace eight (8) wall hung drinking fountains and integral refrigerated coolers in the corridors; many of these units were damaged and not working during the site visit.

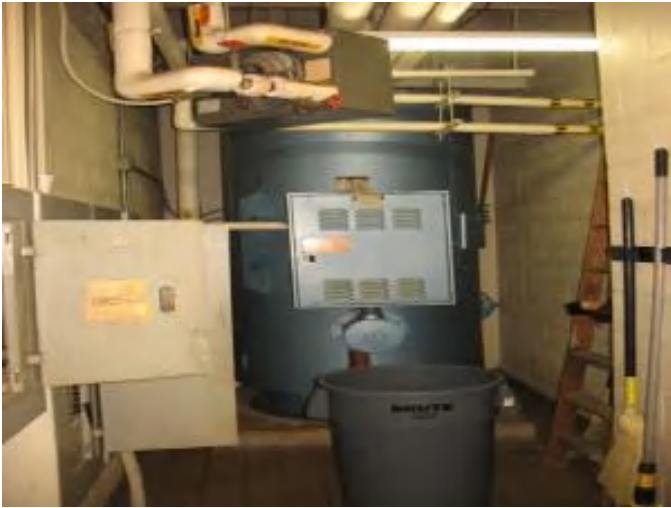
System: D2020 - Domestic Water Distribution

One (1) Patterson Kelley model PKW72V2/8V electric boiler supplies domestic hot water for the Kitchen. It is rated at 72KW input. The Building Engineer reported no issues with this boiler. The boiler was installed in 1986, is beyond its service life, and should be replaced.

Location: Mechanical room

Distress: Failing

Notes: Replace one (1) 72KW electric water heater, which is beyond its service life of 20 years that supplies domestic hot water for the Kitchen.

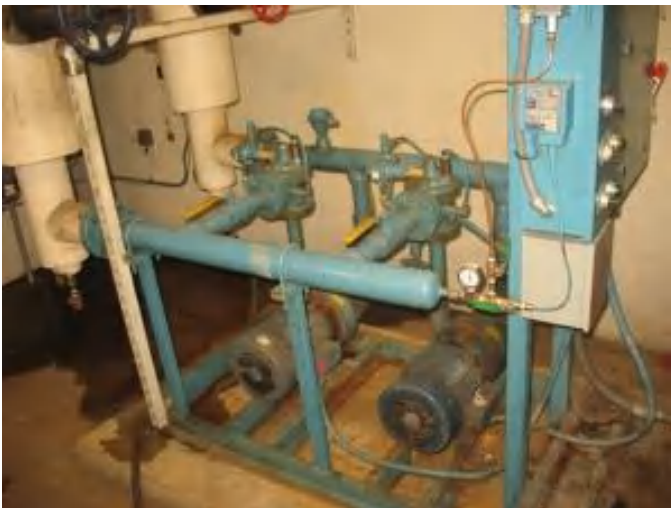
System: D2020 - Domestic Water Distribution

Location: Mechanical room

Distress: Beyond Service Life

Notes: Replace the duplex 7.5HP domestic pressure booster pumps which are nearing the end of their service life to ensure adequate pressure throughout the system.

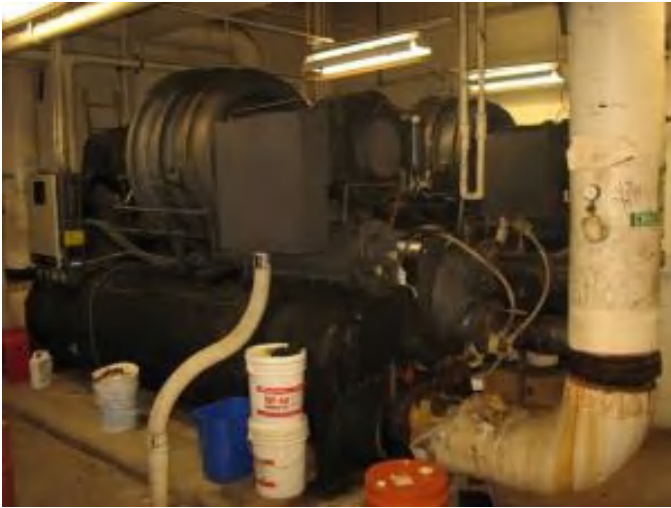
System: D3030 - Cooling Generating Systems

Location: Mechanical room

Distress: Beyond Service Life

Notes: Replace the two (2) existing 500 nominal ton water-cooled centrifugal chillers, located in the first floor mechanical room, which are reaching the end of their service life and utilizes R-11 refrigerant.

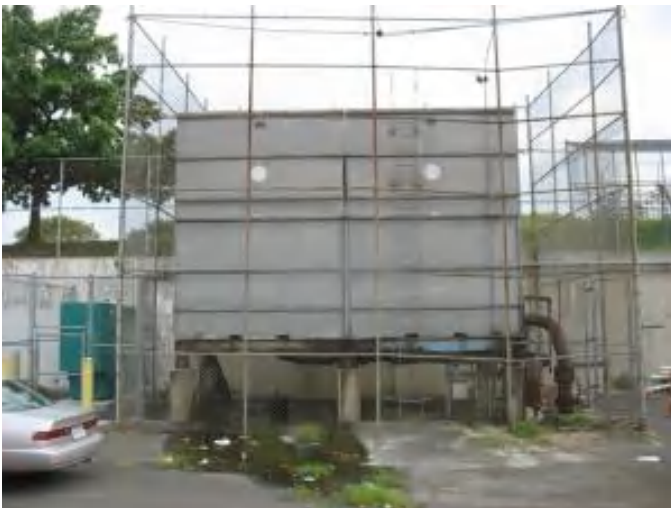
System: D3030 - Cooling Generating Systems

Cooling Generating Systems - Chilled water is generated by two (2) 500 nominal ton Trane Centravac model CVHE water-cooled centrifugal chillers located in the first floor mechanical room. Heat from the chillers is rejected by one (1) single cell BAC model VXT forced draft, counterflow cooling tower located in the parking lot on the North side of the building. The chillers are each equipped with a single three-stage compressor that operate on R-11, which is being phased out of use in the United States due to its high ozone depletion potential. Centrifugal chillers have an anticipated service life of 28 years; these units have been in service 30 years. The District should budget for replacing the chillers over the next 2-5 years. Galvanized metal cooling towers have an anticipated service life of 18 years; this unit has been in service 30 years and is in very poor condition. The District should replace the cooling tower within the next 0-2 years. The Building Engineer reported no issues with the chillers. The cooling tower is in poor condition, it constantly leaks water, and the support frame is rusting out.

Location: Parking lot

Distress: Damaged

Notes: Replace the existing forced draft, counterflow cooling tower which is beyond its service life and leaks water.

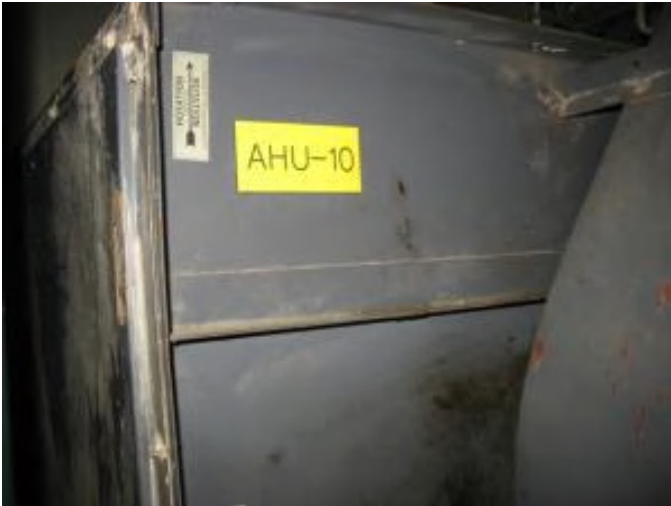
System: D3040 - Distribution Systems

Location: Mechanical Room C

Distress: Energy Efficiency

Notes: Replace AH-10, located in Mechanical Room C, serving the Auditorium which is beyond its service life and should be replaced with a more efficient unit.

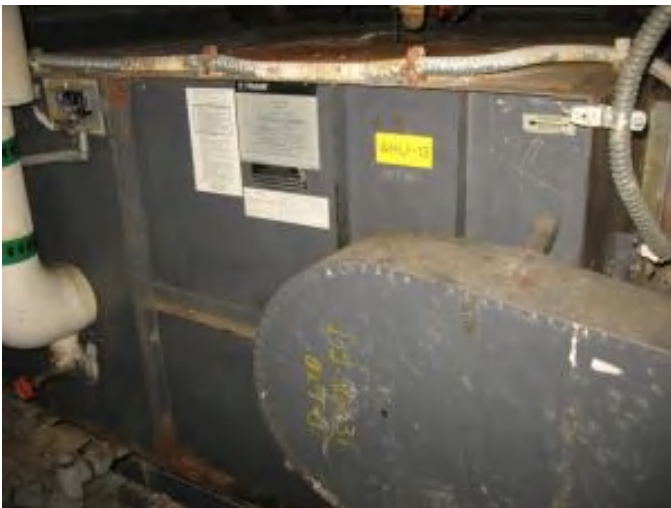
System: D3040 - Distribution Systems

Location: Mechanical Room D

Distress: Damaged

Notes: Replace AH-13, located in Mechanical Room D, serving the first floor NE which showed signs of rust damage.

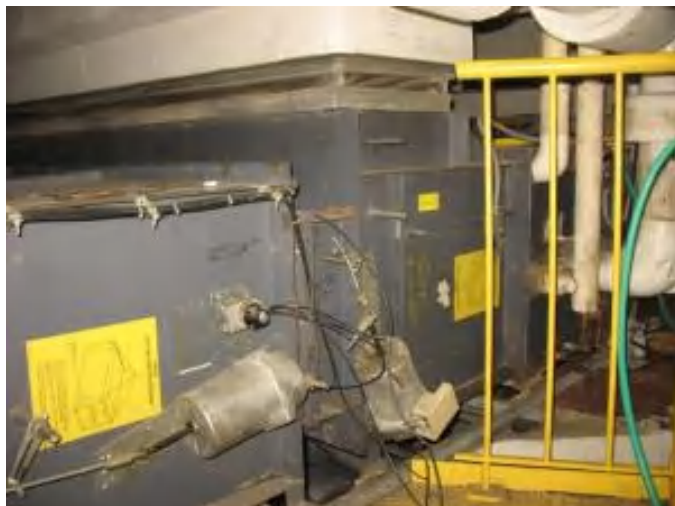
System: D3040 - Distribution Systems

Location: Mechanical Room B

Distress: Energy Efficiency

Notes: Replace AH-3, located in Mechanical Room B, serving the Cafeteria and first floor SW which is beyond its service life and should be replaced with a more efficient unit.

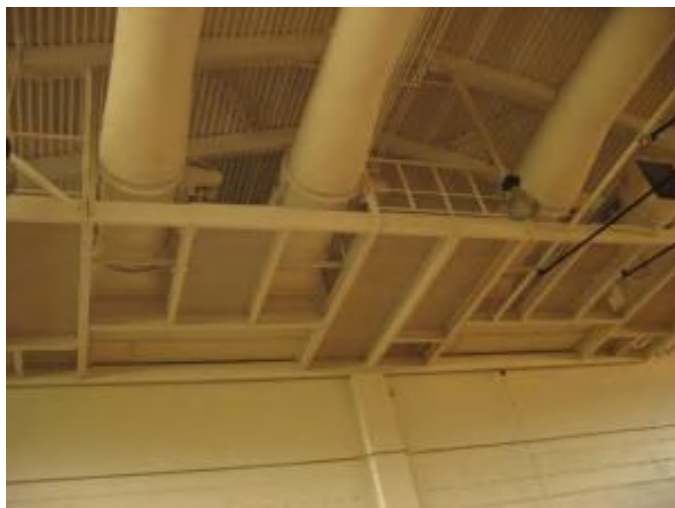
System: D3040 - Distribution Systems

Location: Gymnasium

Distress: Damaged

Notes: Replace two (2) HV units serving the Gymnasium which are at the end of their service life and not operational due to failed motors.

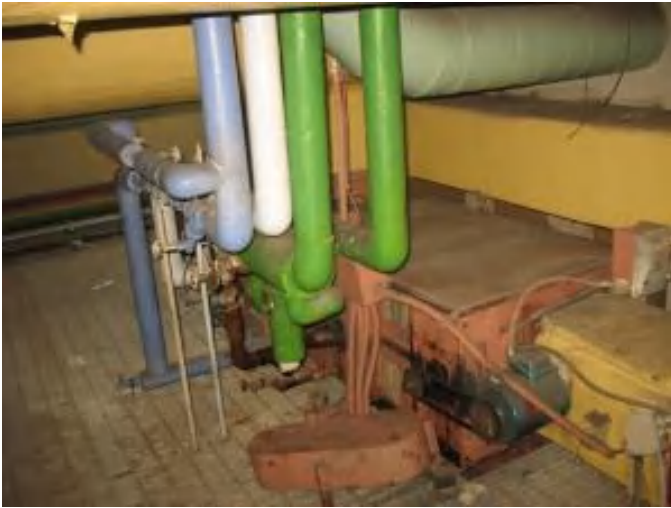
System: D3040 - Distribution Systems

possible human carcinogen and subject to OSHA regulated occupational exposure limits. The liner materials are difficult to maintain and clean. They deteriorate over time and can support microbial growth in the HVAC systems known to cause serious health effects for building occupants. The District should consider replacing these air handling units and the associated supply ductwork systems to eliminate this potential liability problem. Many of the AH units have associated variable air volume (VAV) boxes which control the airflow to specific spaces within the building. Drop ceilings within the classrooms act as return air plenums; the supply air is ducted to the spaces. All units were operational during the site visit, with the exception of the two (2) units serving the Gymnasium, are original to the building and at the end of their 30 year service life. Most units were in good condition, but have a fibrous lines, and the District should consider replacing the units in the next 3-5 years. Two (2) units, AH-13 located in Mechanical Room D and AH-21 located in Mechanical Room E, showed signs of rust damage and should be replaced immediately.

Location: Mechanical Room E

Distress: Damaged

Notes: Replace AH-21 located in Mechanical Room E, serving rooms 154A and 154D showed signs of rust damage.

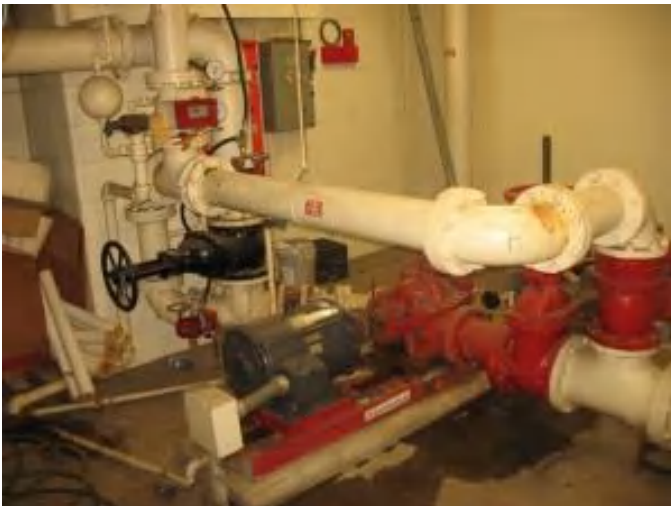
System: D4010 - Sprinklers

Location: Mechanical room

Distress: Damaged

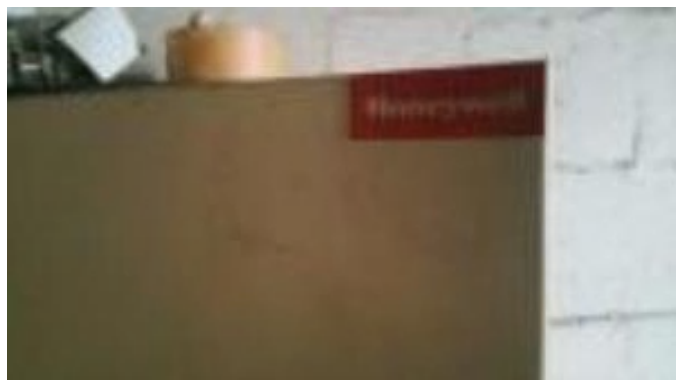
System: D5030 - Communications and Security

Location: Throughout the building

Distress: Beyond Service Life

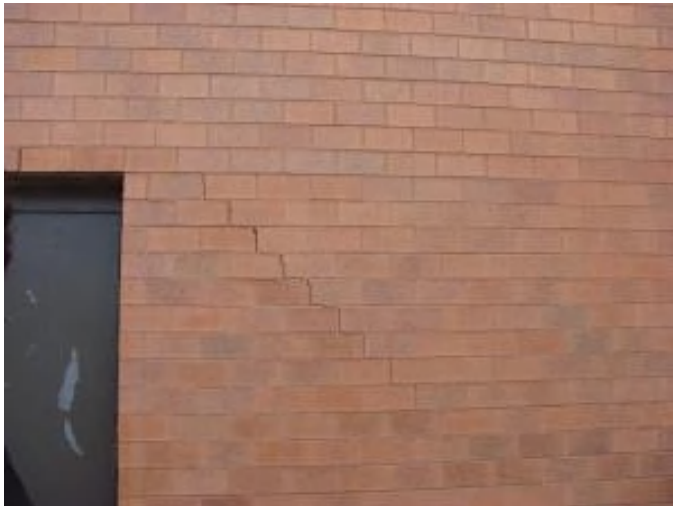
System: B2010 - Exterior Walls

Location: Exterior

Distress: Building Envelope Integrity

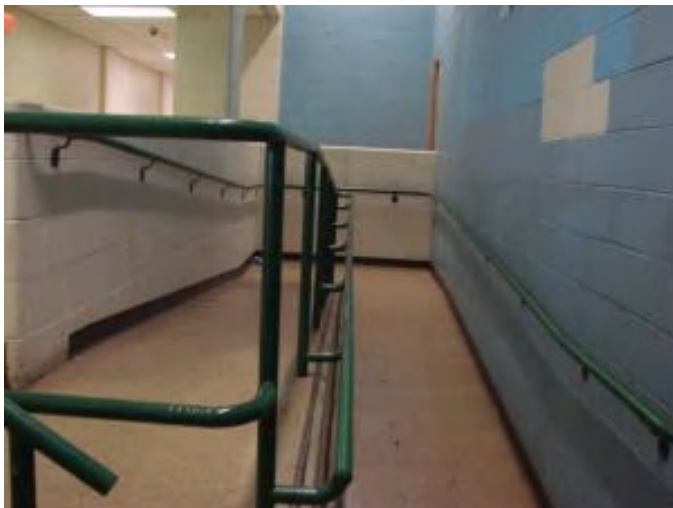
System: C3010230 - Paint & Covering

Location: interior

Distress: Appearance

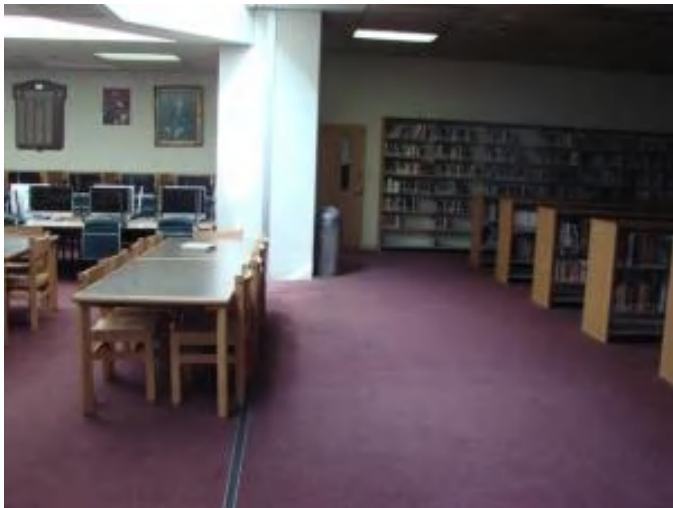
System: C3020411 - Carpet

Location: Interior

Distress: Beyond Service Life

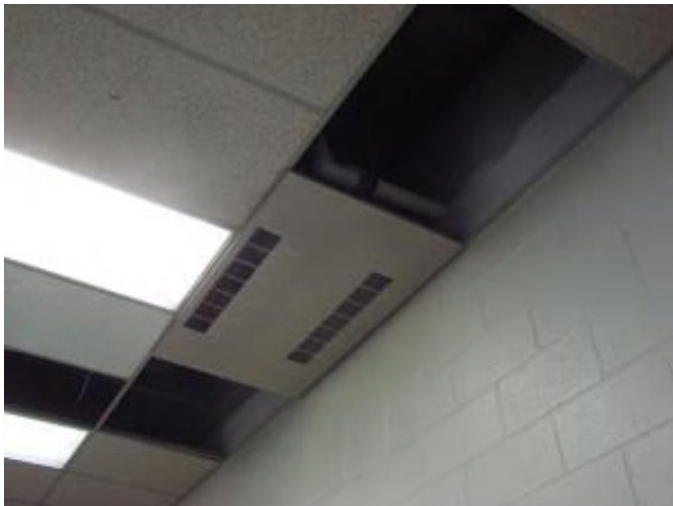
System: C3030 - Ceiling Finishes

Location: Interior

Distress: Beyond Service Life

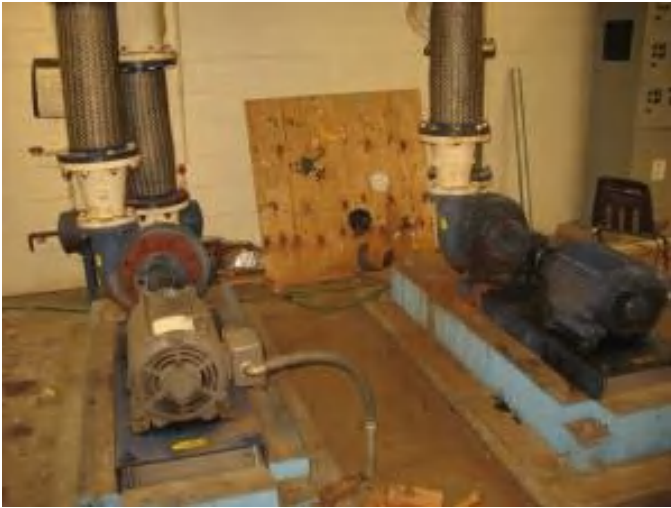
System: D3020 - Heat Generating Systems

Location: Mechanical room

Distress: Beyond Service Life

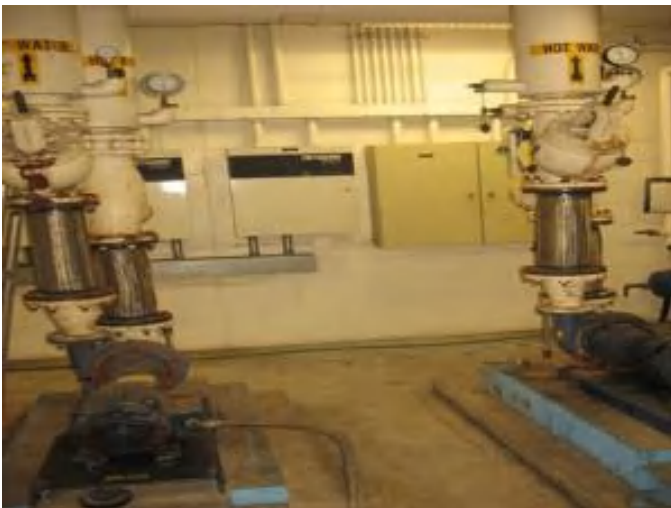
System: D3020 - Heat Generating Systems

Location: Mechanical room

Distress: Beyond Service Life

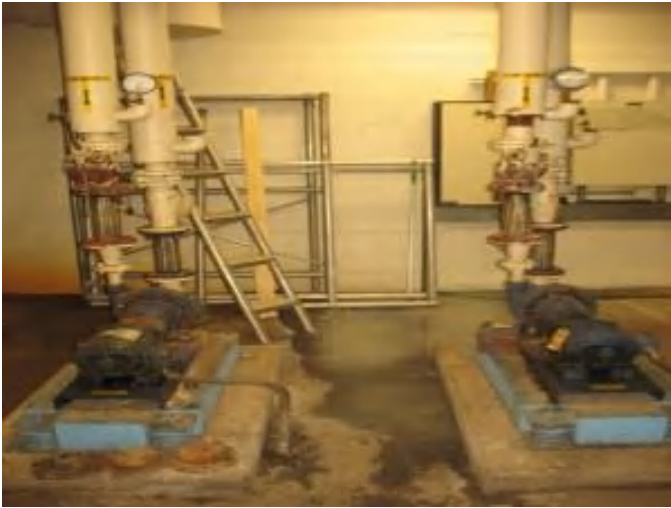
System: D3020 - Heat Generating Systems

Location: Mechanical room

Distress: Beyond Service Life

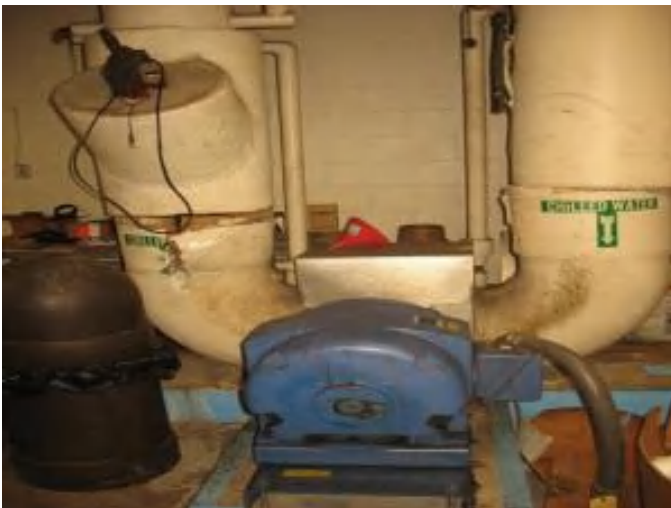
System: D3030 - Cooling Generating Systems

Location: Mechanical room

Distress: Energy Efficiency

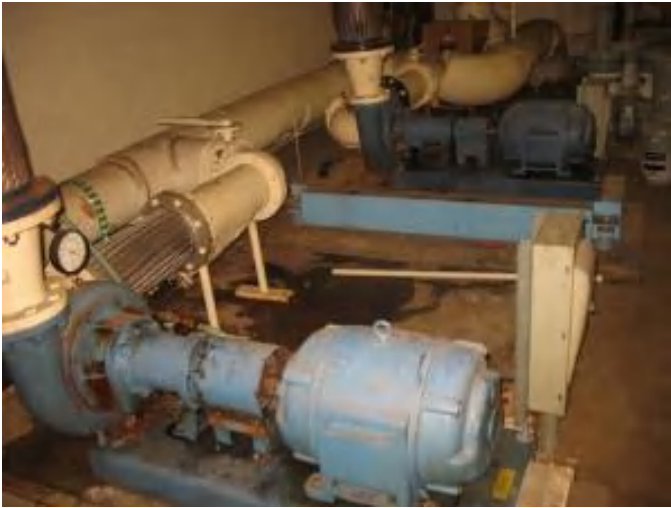
System: D3030 - Cooling Generating Systems

Location: Mechanical room

Distress: Energy Efficiency

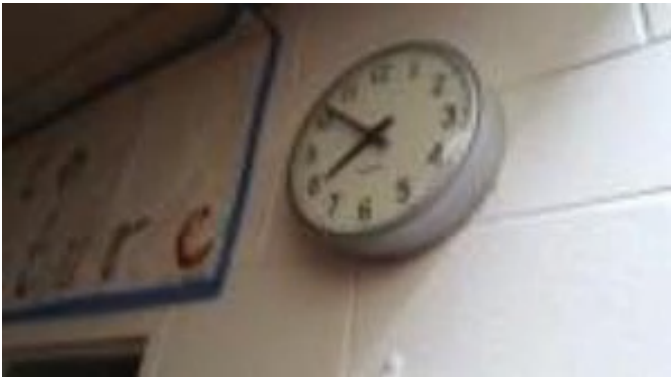
System: D5030 - Communications and Security

Location: Throughout the building

Distress: Beyond Service Life

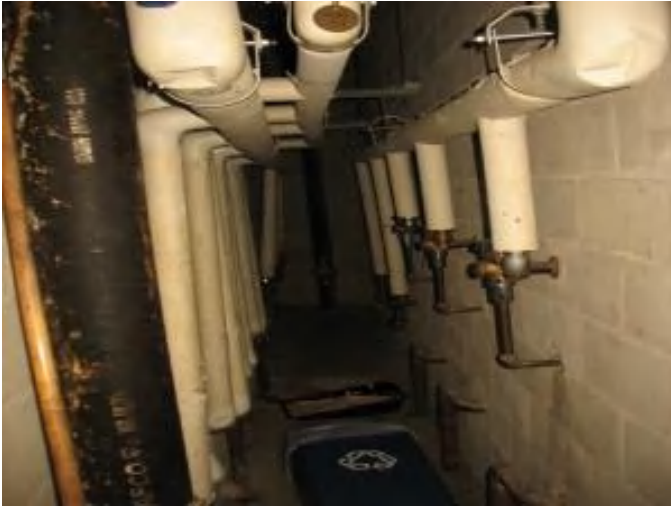
System: D2030 - Sanitary Waste

Location: Throughout building

Distress: Beyond Service Life

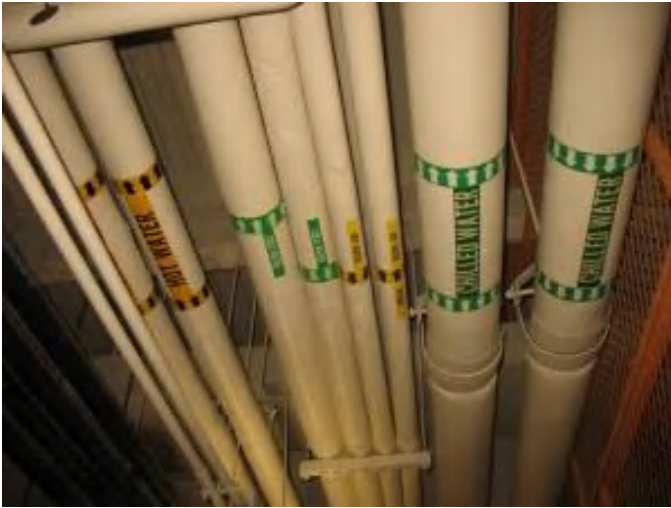
System: D3040 - Distribution Systems

Location: Throughout building

Distress: Beyond Service Life

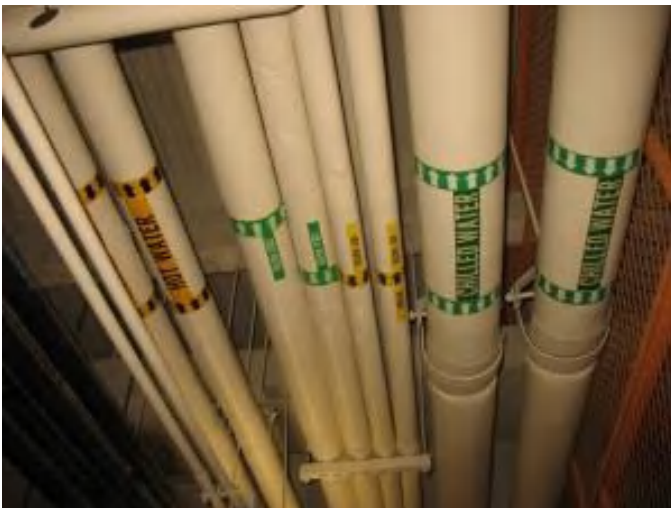
System: D3040 - Distribution Systems

Location: Throughout building

Distress: Beyond Service Life

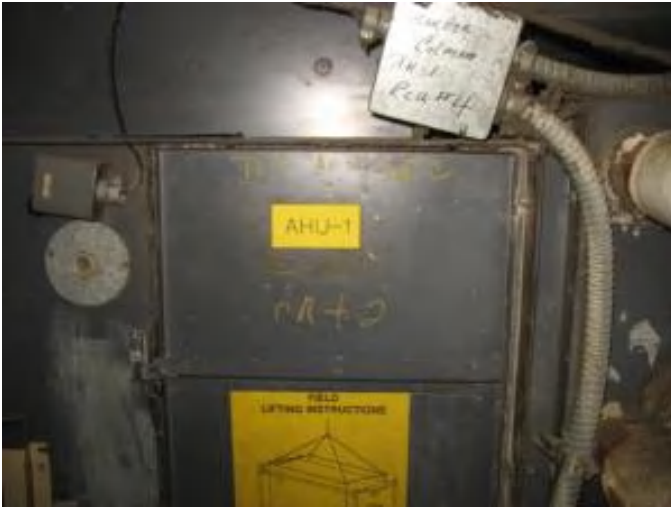
System: D3040 - Distribution Systems

Location: Mechanical Room A

Distress: Energy Efficiency

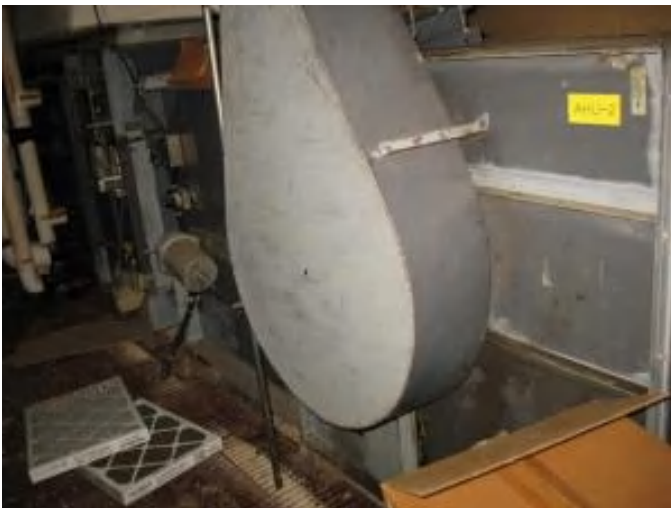
System: D3040 - Distribution Systems

Location: Mechanical Room A

Distress: Energy Efficiency

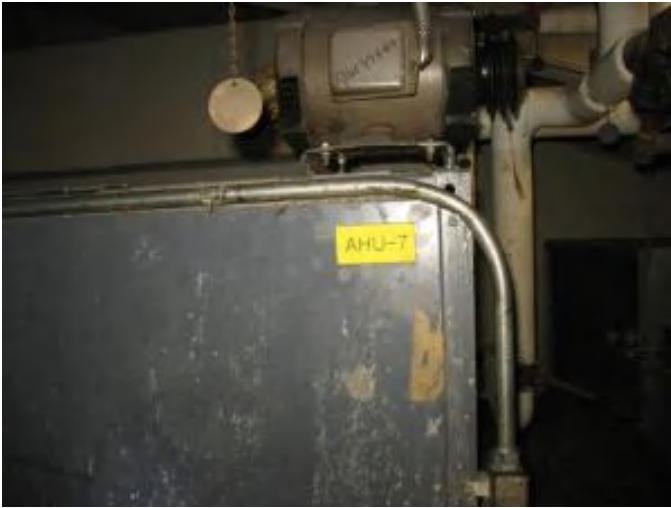
System: D3040 - Distribution Systems

Location: Mechanical Room B

Distress: Energy Efficiency

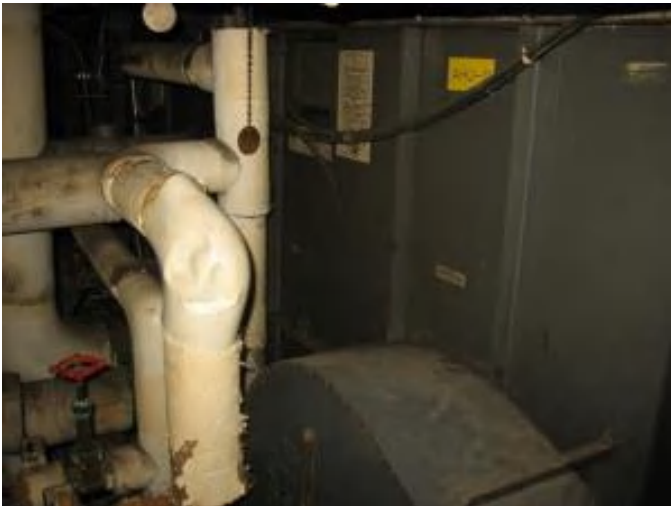
System: D3040 - Distribution Systems

Location: Mechanical Room D

Distress: Energy Efficiency

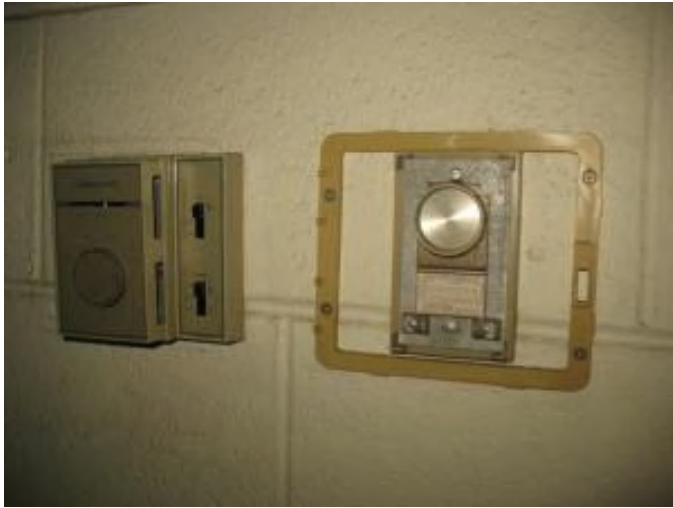
System: D3060 - Controls & Instrumentation

Controls & Instrumentation - The original building management system (BMS) with pneumatic controls and communications network is installed in this building. Pneumatic control air is supplied from two (2) duplex compressors and Hankison air dryer located in the boiler room. The air dryer had a leak in it and oil was spraying on the wall adjacent to the unit. The Building Engineer reported that he can monitor the temperature of each classroom centrally from the BMS, but he cannot adjust it from the computer. Thermostats in each space report the temperature to the BMS and the Building Engineer adjusts the temperature by turning on/off the AHUs serving the spaces. The system is not operating as it should. All major mechanical equipment (chillers, boilers, air handling units, pumps, fans, etc.) are monitored by the system. These controls are beyond their service life and should be converted to DDC.

Location: Throughout building

Distress: Energy Efficiency

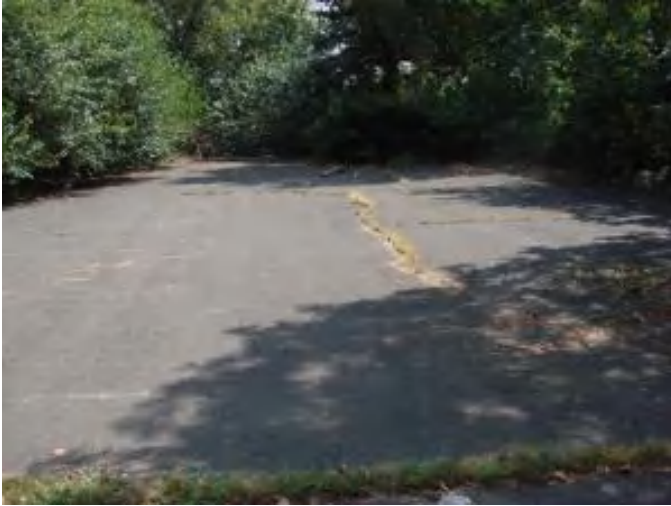
System: G2020 - Parking Lots

Location: Grounds/ site

Distress: Beyond Service Life

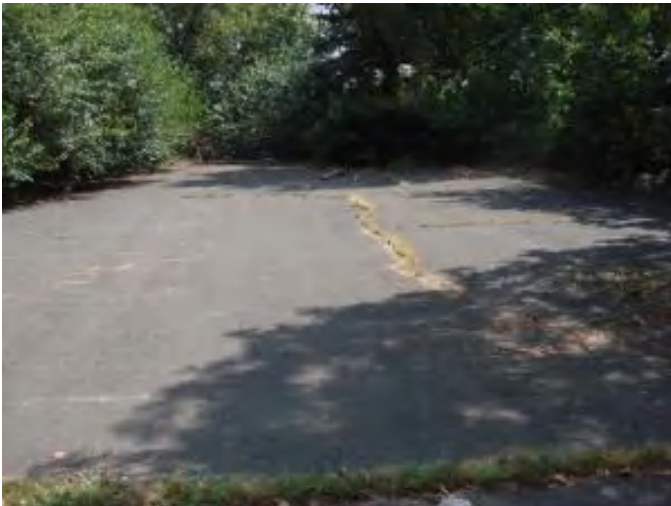
System: G2020 - Parking Lots

Location: Grounds/ site

Distress: Beyond Service Life

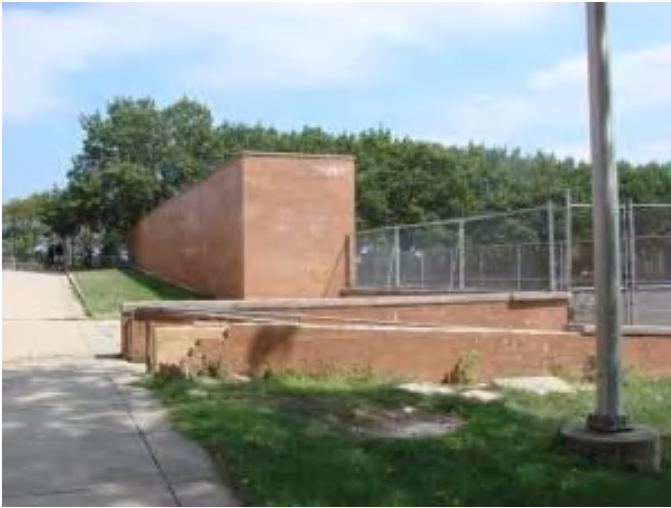
System: G2040 - Site Development

Location: Grounds/ site

Distress: Damaged

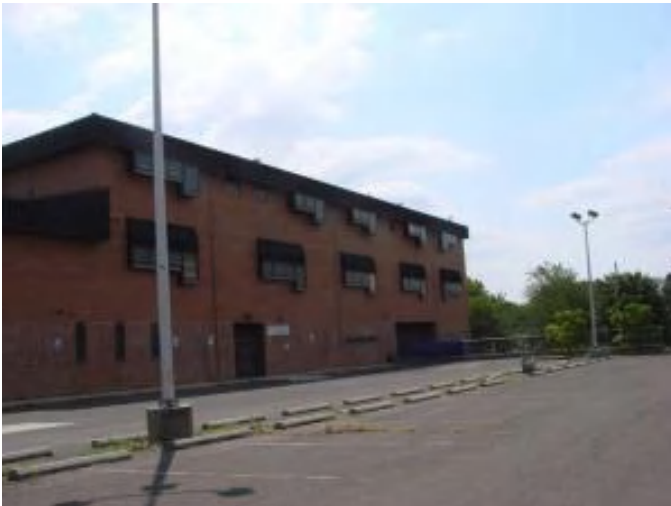
System: G4020 - Site Lighting

Location: Grounds

Distress: Inadequate

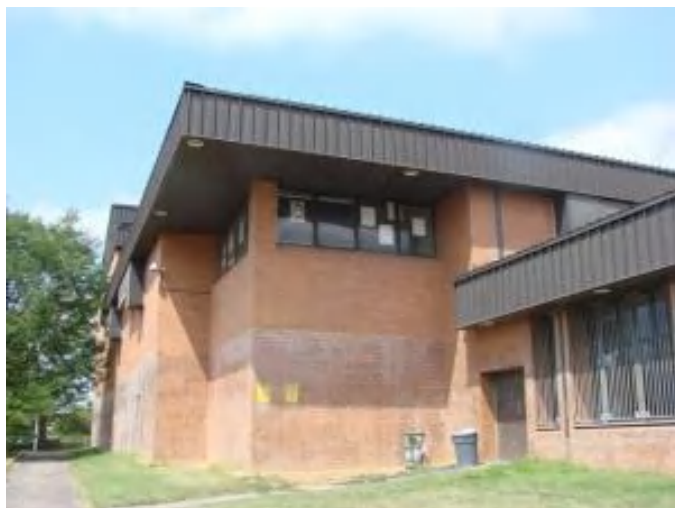
System: G4030 - Site Communications & Security

Location: Grounds

Distress: Inadequate

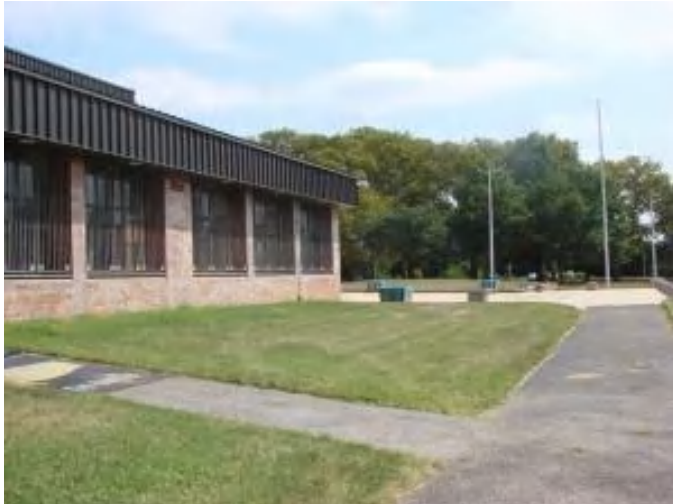
System: G2050 - Landscaping & Irrigation

Location: Grounds/ site

Distress: Beyond Service Life
