Facility Condition Assessment Summary Report

Edmonds, FS School

School District of Philadelphia
S621001;Edmonds, F
Final
Site Assessment Report
January 31, 2017

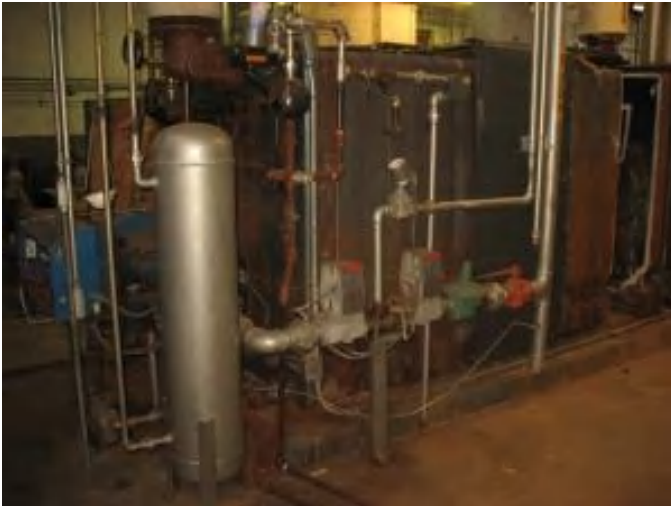
Location: Boiler room

System: D3020 - Heat Generating Systems

Distress: Failing

Notes: Replace the one (1) not-operable existing 5,320MBH cast iron boiler, which is approaching the end of its service life, within the next 0-2 years.

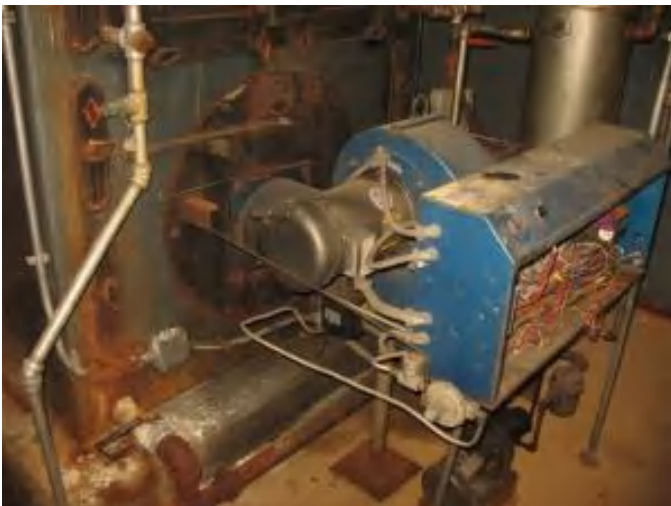
Location: Boiler room

System: D3020 - Heat Generating Systems

Distress: Beyond Service Life

Notes: Replace the two (2) 7071MBH dual fuel boiler burners, which are well beyond their service lives, with new more efficient burners within the next 0-2 years.

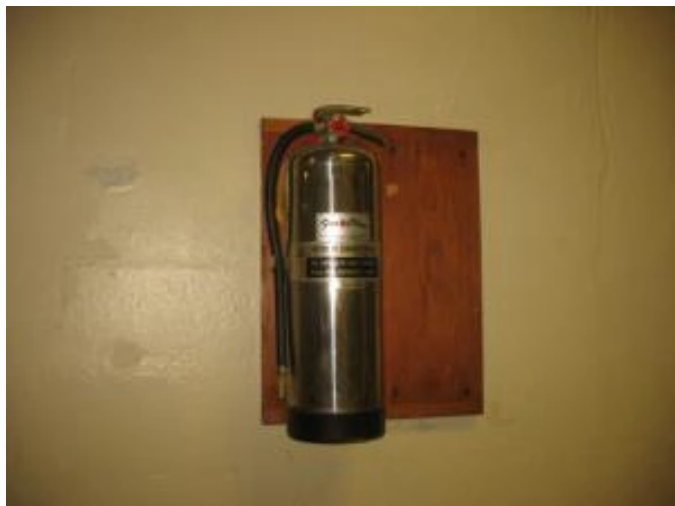
Location: Throughout building

System: D4010 - Sprinklers

Distress: Life Safety / NFPA / PFD

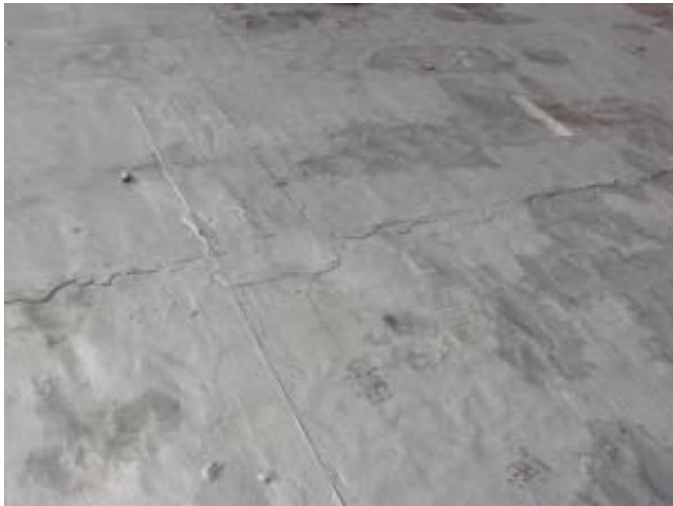
Location: Main building roof

System: B3010105 - Built-Up

Distress: Beyond Service Life

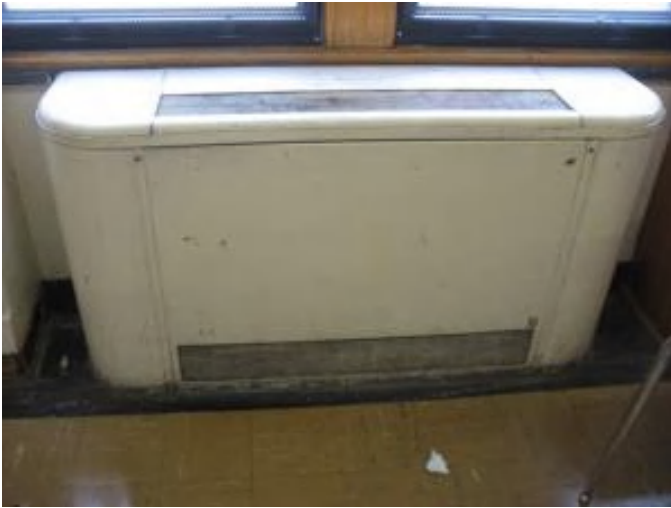
Location: Classrooms

System: D3040 - Distribution Systems

Distress: Beyond Service Life

Notes: Remove the existing unit ventilators and install units with hot and chilled water coils and integral heat exchangers to introduce outdoor air to the building.

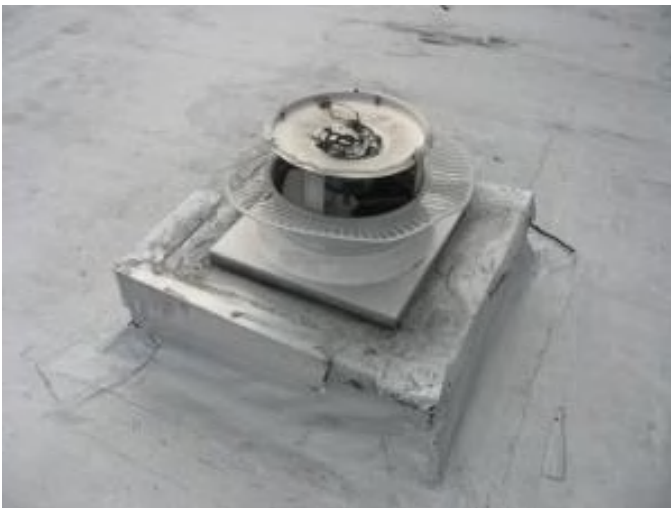
Location: Roof

System: D3040 - Distribution Systems

Distress: Damaged

Notes: Replace four (4) roof mounted exhaust fans serving the restrooms and Kitchen which are damaged and well beyond their service lives.

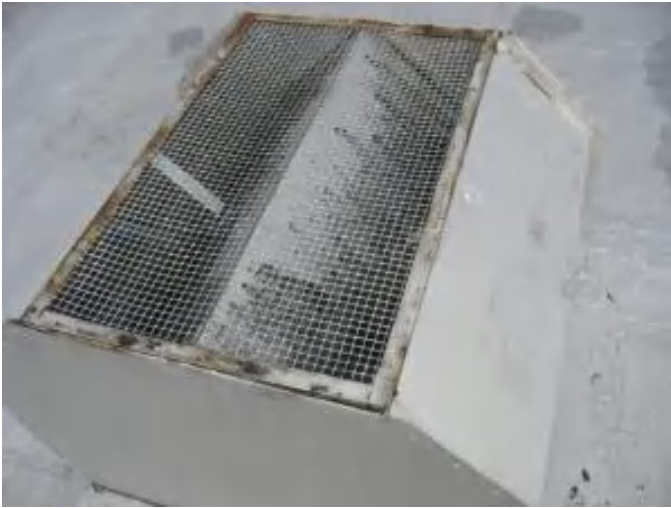
Location: Roof

System: D3040 - Distribution Systems

Distress: Beyond Service Life

Notes: Replace seventeen (17) roof mounted gravity ventilators which are beyond their service lives.

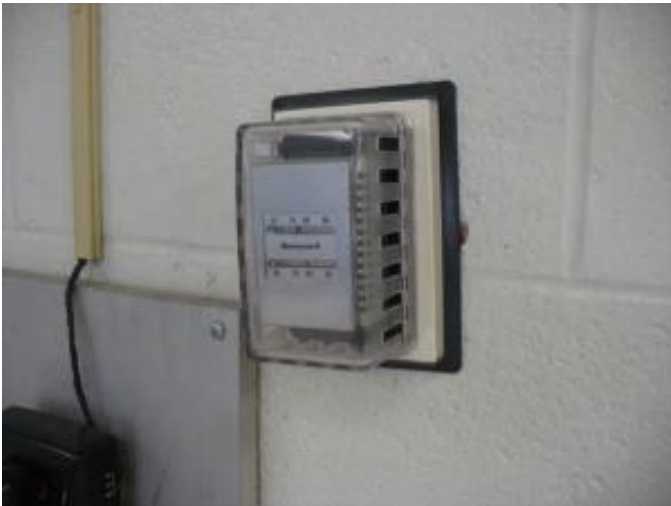
Location: Throughout building

System: D3060 - Controls & Instrumentation

Distress: Failing

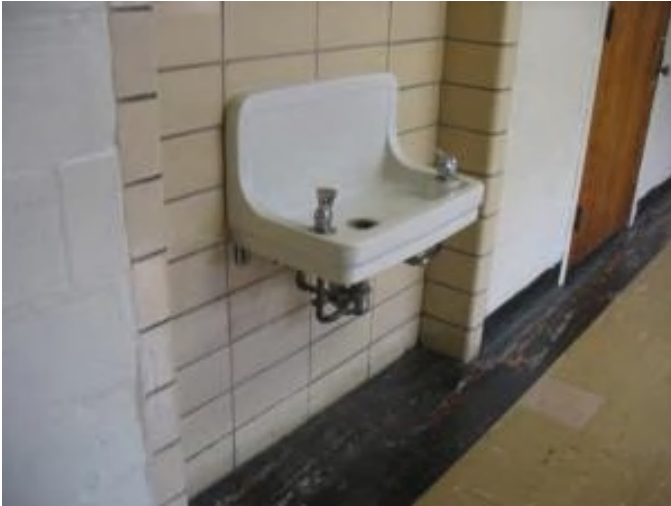
Location: Corridors

System: D2010 - Plumbing Fixtures

Distress: Beyond Service Life

Notes: Replace six (6) porcelain wall hung drinking fountains in the corridors. These units are beyond their service life and most are NOT accessible type.

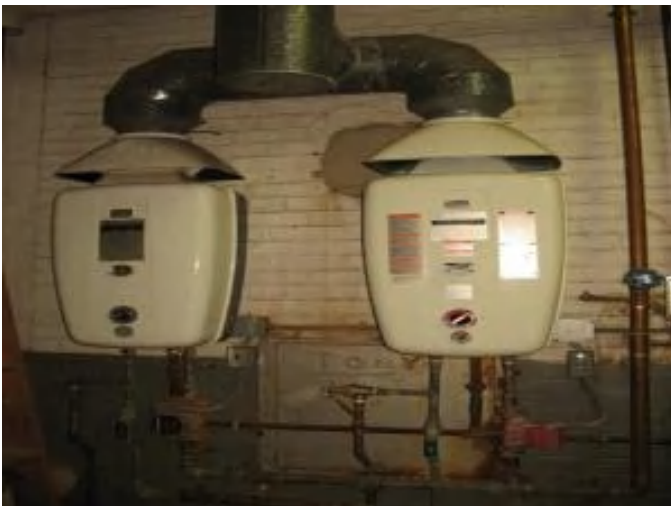
Location: Boiler room

System: D2020 - Domestic Water Distribution

Distress: Beyond Service Life

Notes: Replace the two (2) existing Paloma instant hot water heaters, which are most likely beyond their service lives.

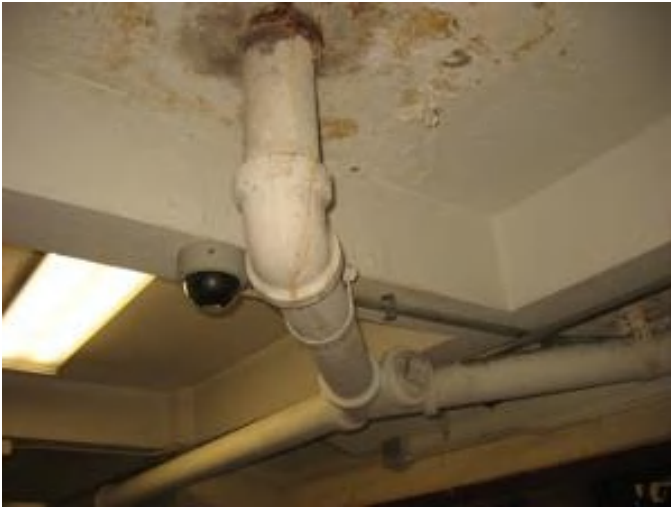
Location: Throughout building

System: D2030 - Sanitary Waste

Distress: Beyond Service Life

Notes: Hire a qualified contractor to perform a detailed examination of the sanitary waste piping using visual inspection and video cameras to locate and replace any damaged piping and to further quantify the extent of potential failures.

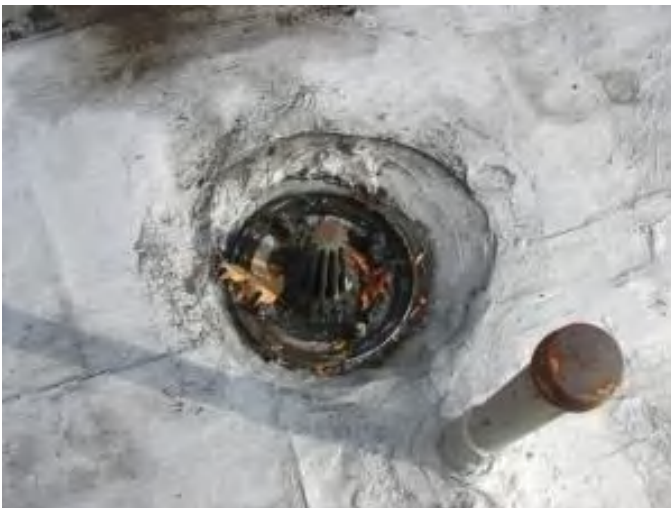
Location: Throughout building

System: D2040 - Rain Water Drainage

Distress: Beyond Service Life

Notes: Hire a qualified contractor to perform a detailed examination of the rain water drainage piping using visual inspection and video cameras to locate and replace any damaged piping and to further quantify the extent of potential failures.

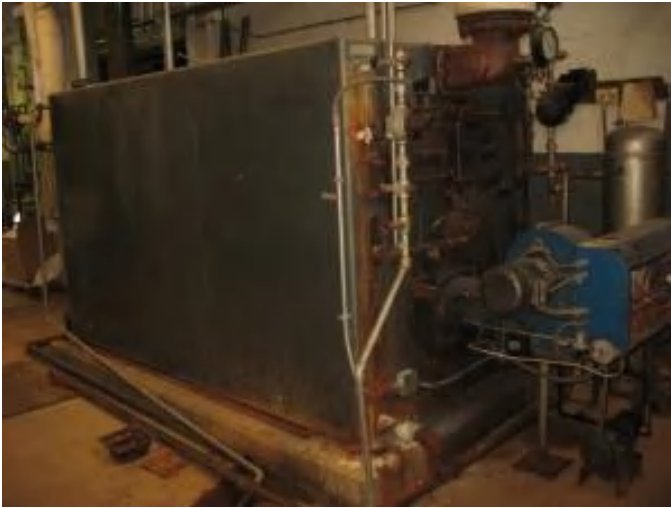
Location: Boiler room

System: D3020 - Heat Generating Systems

Distress: Beyond Service Life

Notes: Replace the one (1) operational existing 5,320MBH cast iron boiler, which is approaching the end of its service life, within the next 3-5 years.

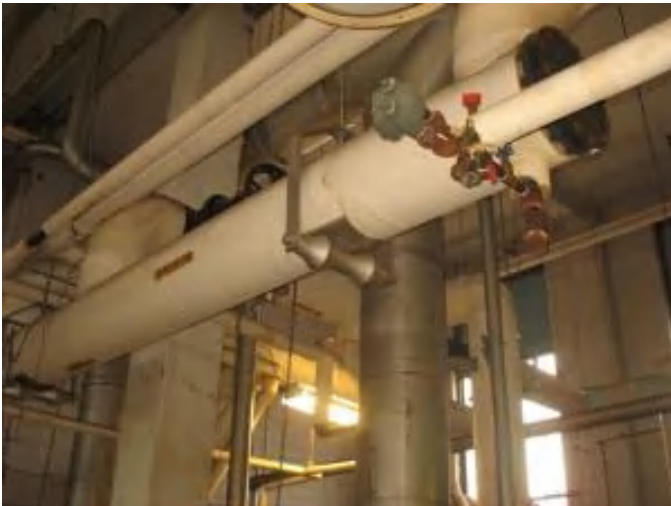
Location: Throughout building

System: D3040 - Distribution Systems

Distress: Beyond Service Life

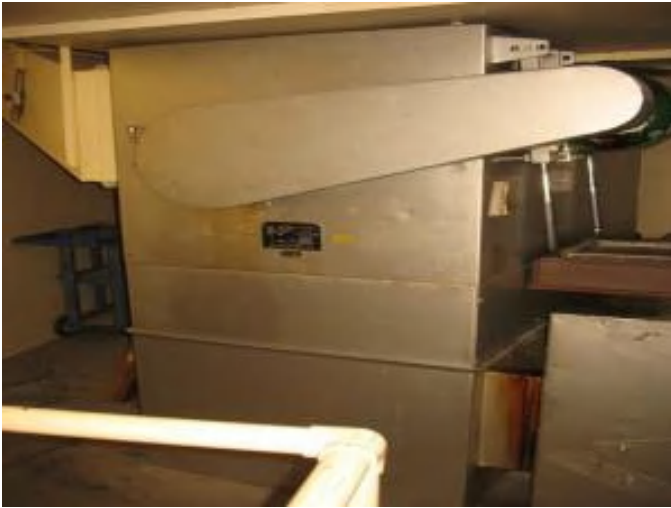
Location: Auditorium

System: D3040 - Distribution Systems

Distress: Beyond Service Life

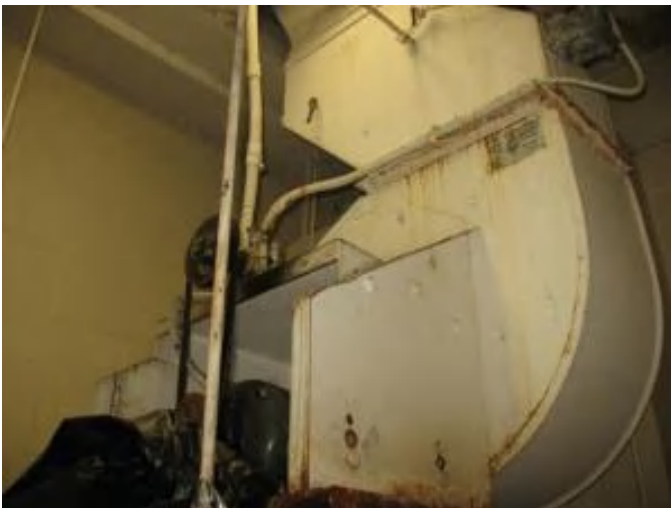
Location: Mechanical rooms

System: D3040 - Distribution Systems

Distress: Beyond Service Life

Notes: Replace four (4) exhaust fans, located on the first and second floors, serving the restrooms which are well beyond their service lives.

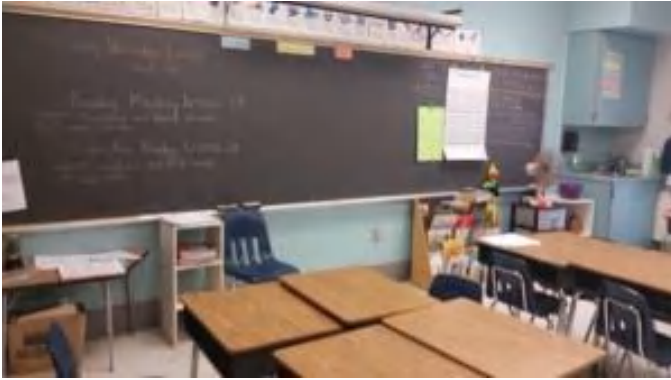
Location: throughout the building

System: D5020 - Lighting and Branch Wiring

Distress: Inadequate

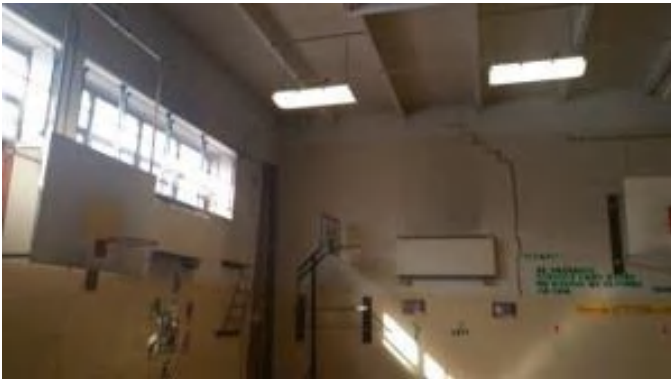
Location: throughout the building

System: D5020 - Lighting and Branch Wiring

Distress: Inadequate

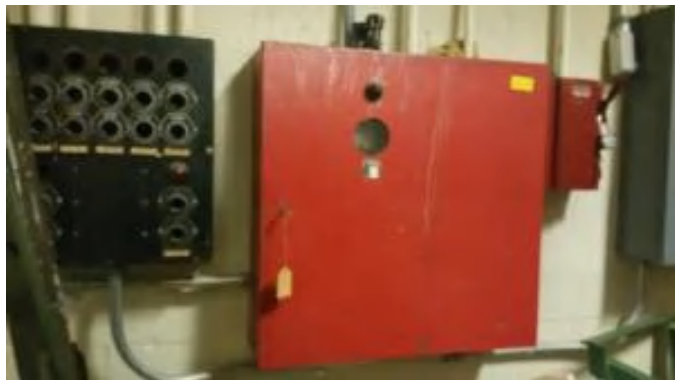
Location: throughout the building

System: D5030 - Communications and Security

Distress: Health Hazard / Risk

Notes: Install new Automated Fire alarm System.

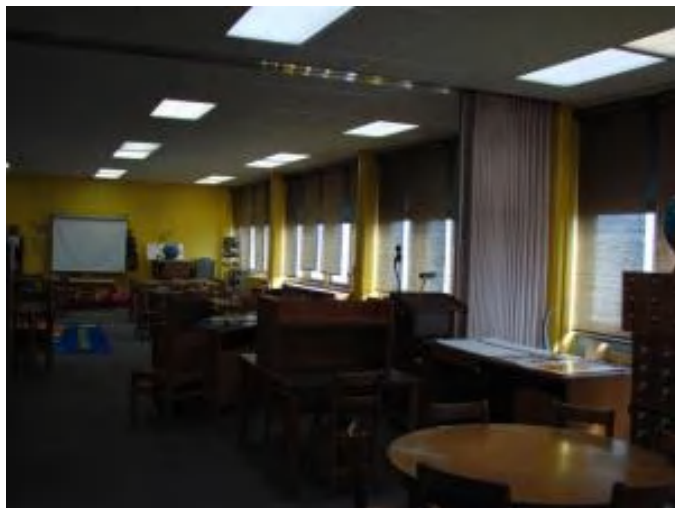
Location: Offices, library; classrooms

System: E1020 - Institutional Equipment

Distress: Beyond Service Life

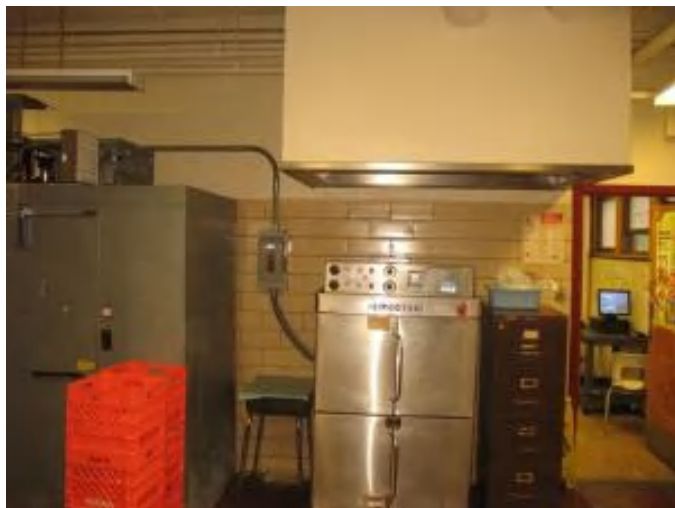
Location: Kitchen

System: E1090 - Other Equipment

Distress: Beyond Service Life

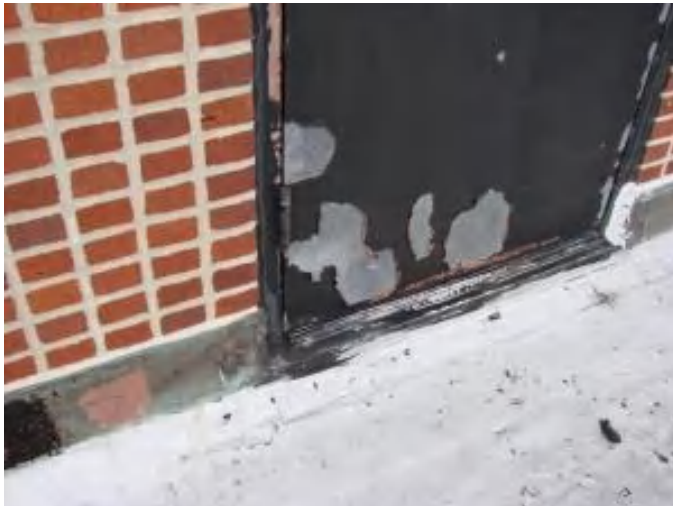
Location: All exterior elevations

System: B2030 - Exterior Doors

Distress: Beyond Service Life

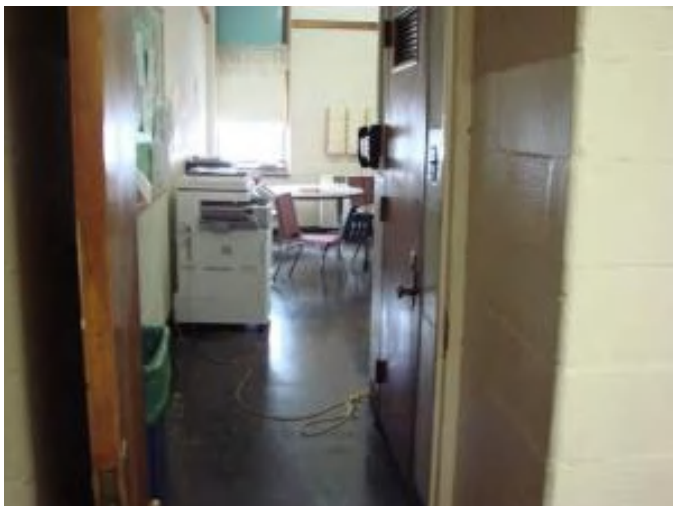
Location: Classroom doors

System: C1020 - Interior Doors

Distress: Inadequate

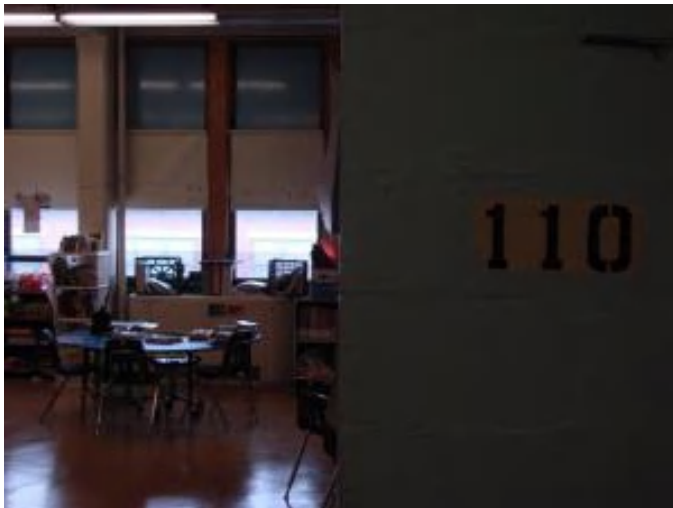
Location: Main building corridors

System: C1030 - Fittings

Distress: Inadequate

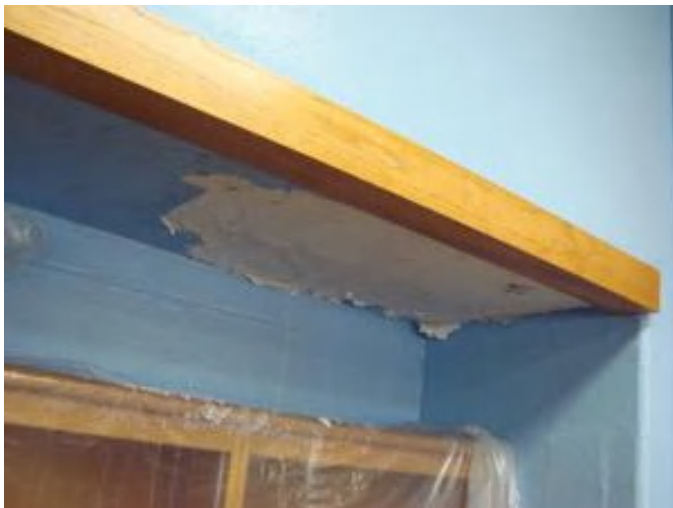
Location: Main building corridor and classroom walls

System: C3010230 - Paint & Covering

Distress: Appearance

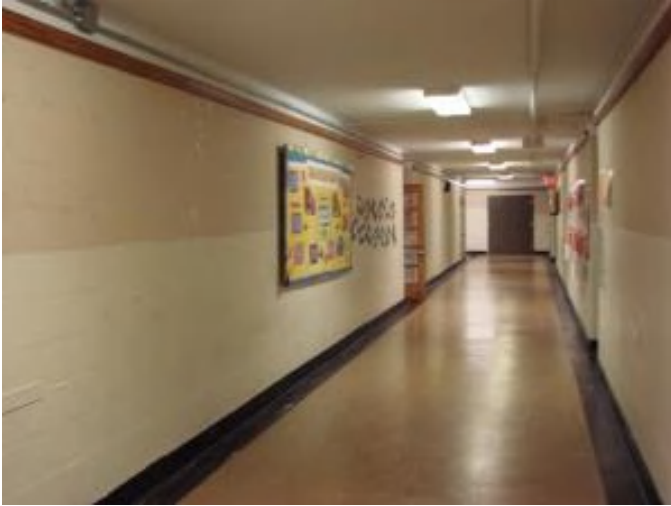
Location: Main building corridor and class rooms

System: C3020413 - Vinyl Flooring

Distress: Beyond Service Life

Notes: Replace all VAT tile

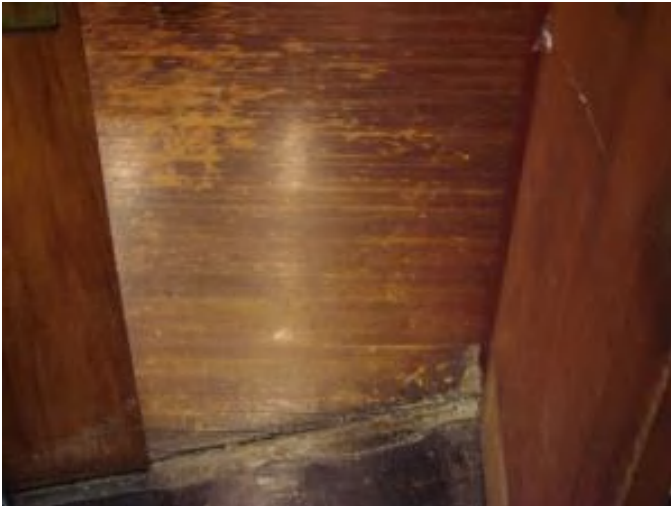
Location: Gym

System: C3020414 - Wood Flooring

Distress: Damaged

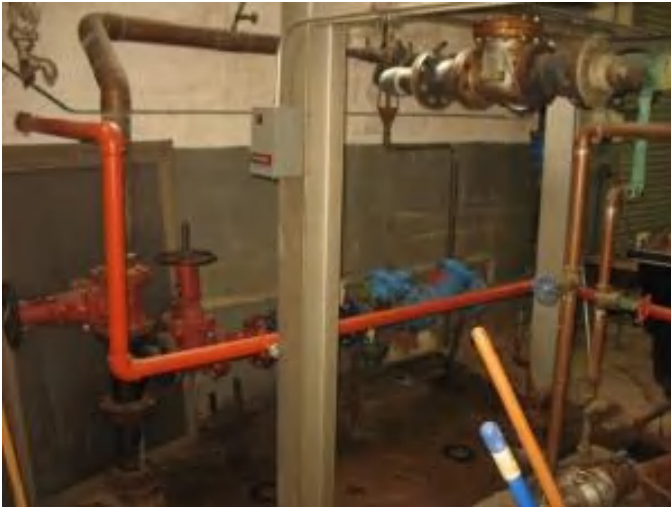
Location: Throughout building

System: D2020 - Domestic Water Distribution

Distress: Beyond Service Life

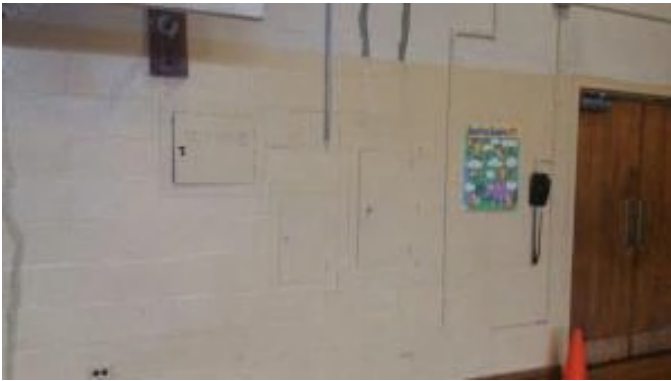
Location: throughout the building

System: D5010 - Electrical Service/Distribution

Distress: Beyond Service Life

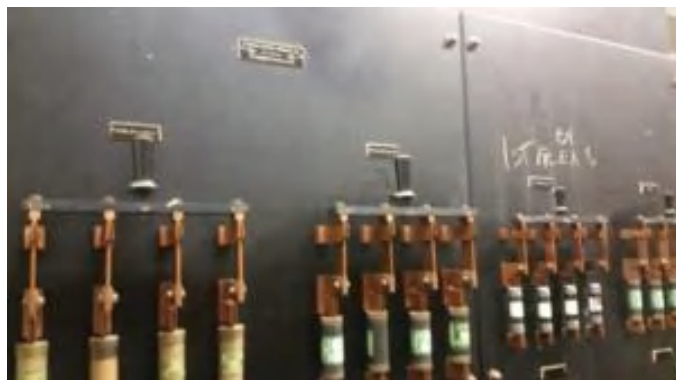
Location: electrical room

System: D5010 - Electrical Service/Distribution

Distress: Beyond Service Life

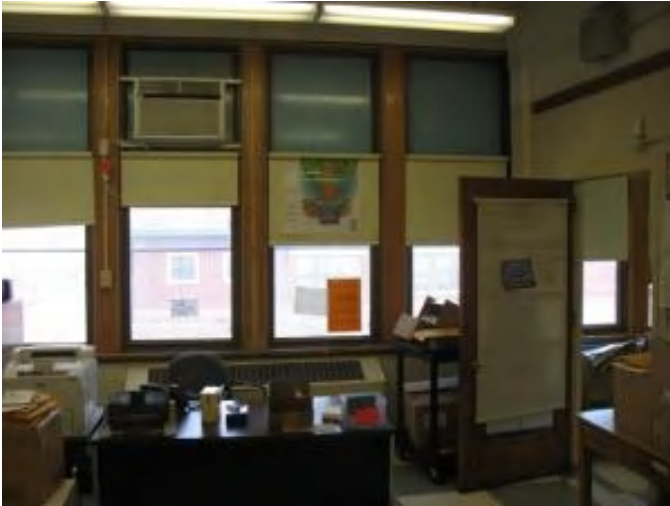
Location: Throughout building

System: D3030 - Cooling Generating Systems

Distress: Inadequate

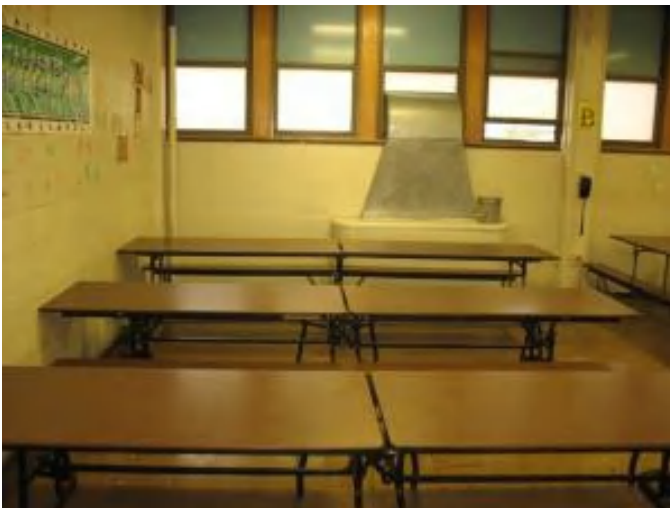
Location: Cafeteria

System: D3040 - Distribution Systems

Distress: Building / MEP Codes

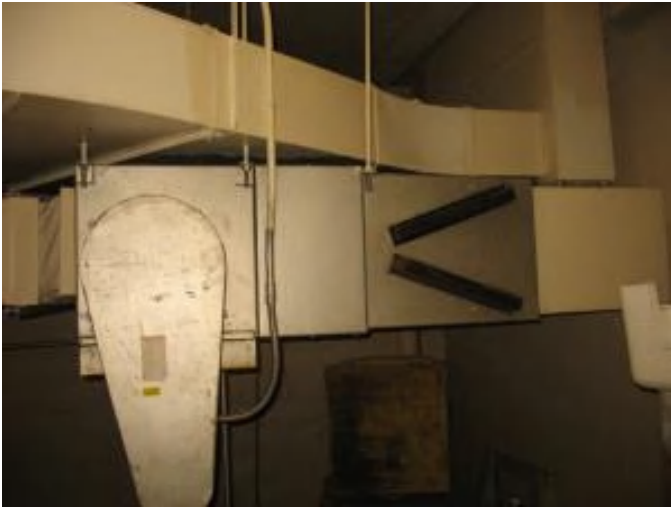
Location: Gymnasium

System: D3040 - Distribution Systems

Distress: Beyond Service Life

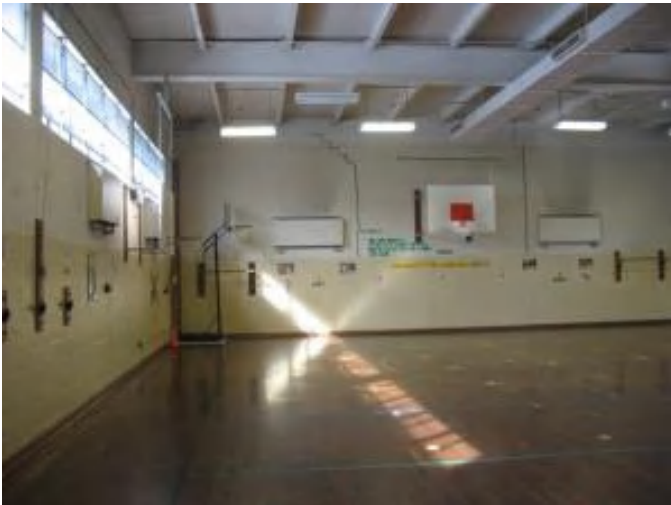
Location: Gymnasium

System: D3040 - Distribution Systems

Distress: Building / MEP Codes

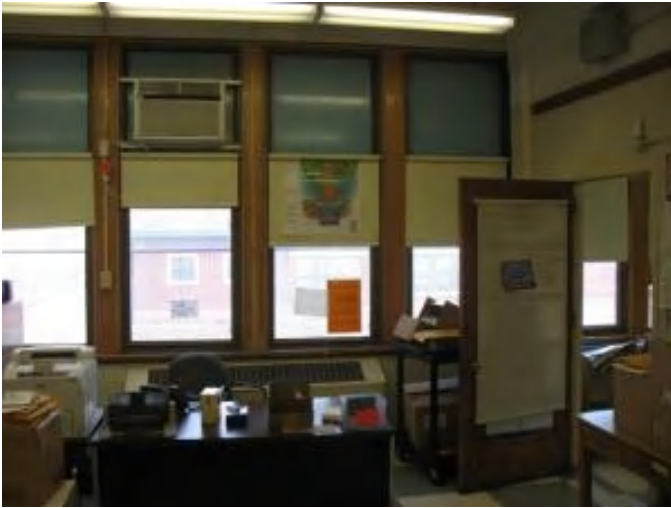
Location: Administration offices

System: D3040 - Distribution Systems

Distress: Building / MEP Codes

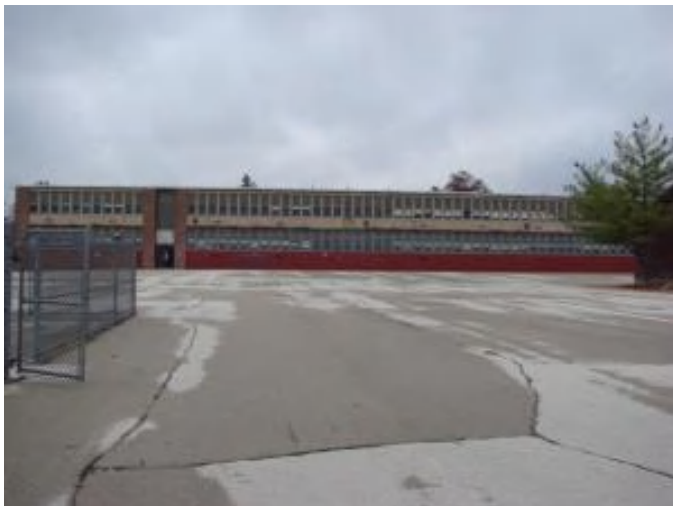
Location: Parking /

System: G2020 - Parking Lots

Distress: Failing

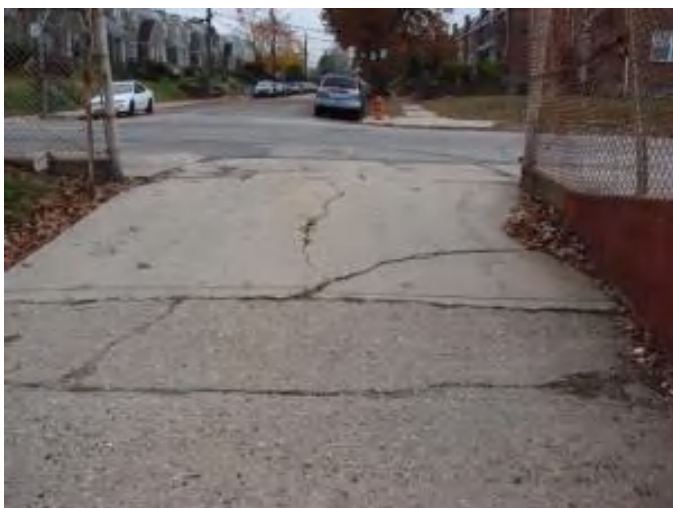
Location: Driveway access to mechanical room

System: G2020 - Parking Lots

Distress: Damaged

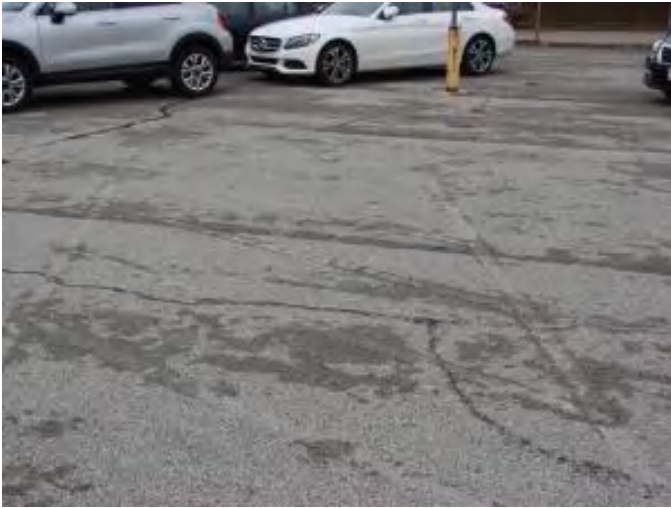
Location: On site parking area

System: G2020 - Parking Lots

Distress: Beyond Service Life

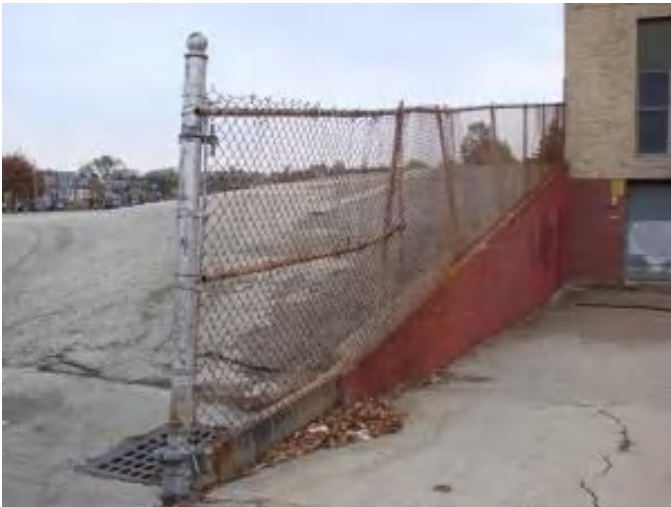
Location: Playground; southeast corner

System: G2040 - Site Development

Distress: Damaged

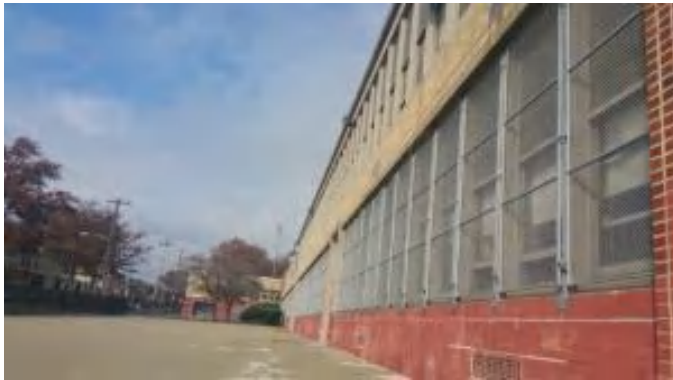
Location: grounds

System: G4030 - Site Communications & Security

Distress: Inadequate
