Facility Condition Assessment Summary Report

El Centro (Old Hunter) School

School District of Philadelphia
S569001; Hunter (Old)
Final
Site Assessment Report

February 1, 2017

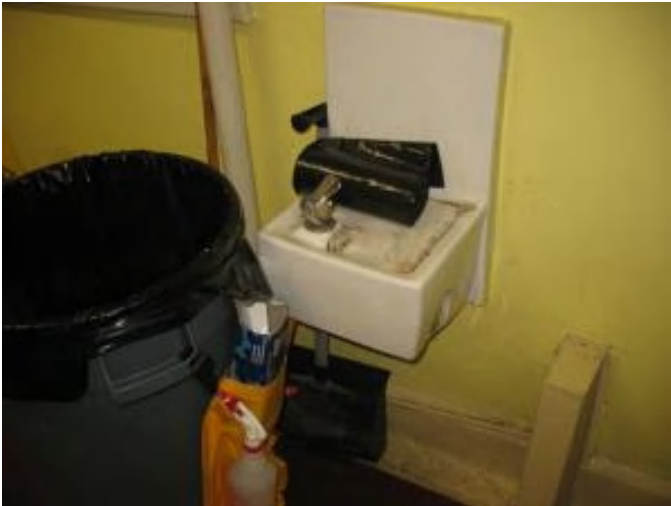
System: D2010 - Plumbing Fixtures

Location: Corridors

Distress: Failing

Notes: Replace eight (8) wall hung drinking fountains in the corridors. These units are well beyond their service lives and no longer functioning.

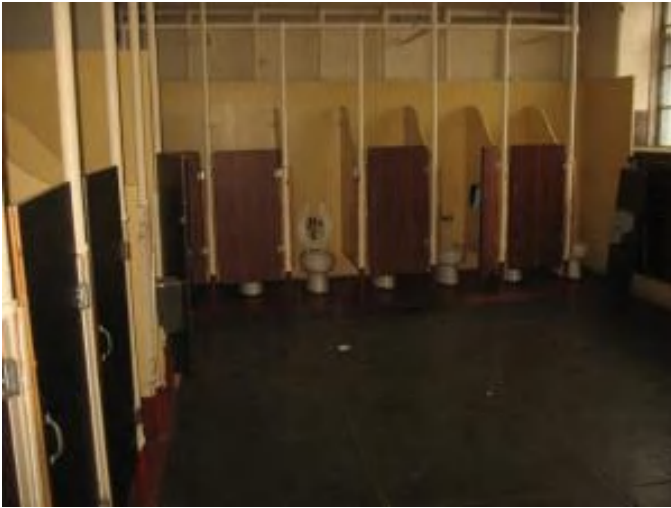
System: D2010 - Plumbing Fixtures

Location: Restrooms

Distress: Beyond Service Life

Notes: Replace ten (10) urinals in the restrooms, which are beyond their service life, with new fixtures.

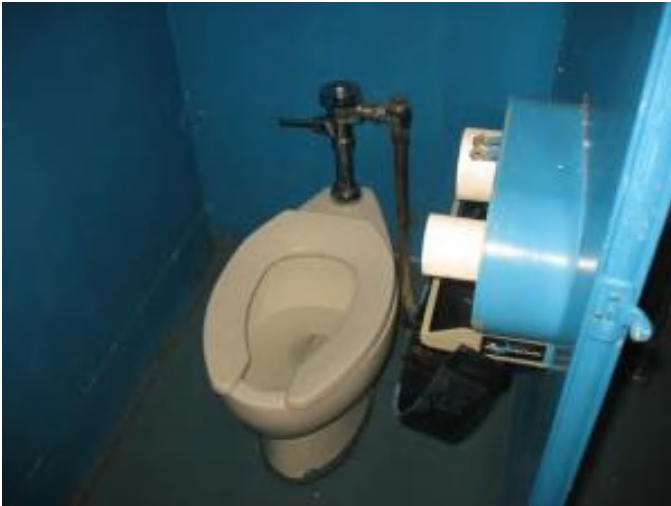
System: D2010 - Plumbing Fixtures

Location: Restrooms

Distress: Beyond Service Life

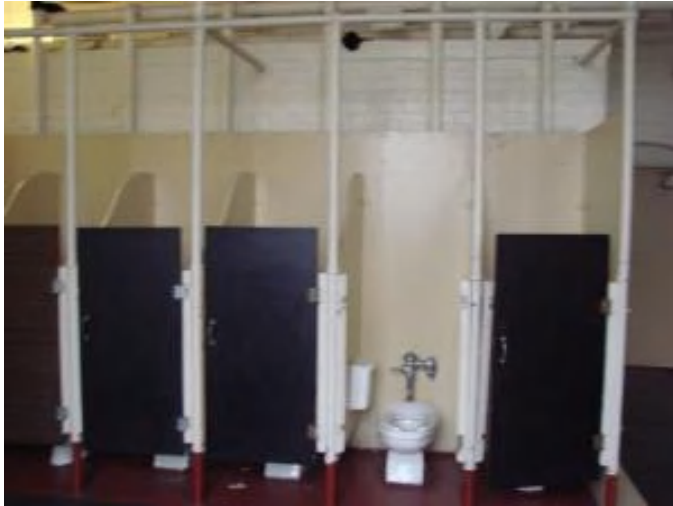
System: C1030 - Fittings

Location: Restrooms

Distress: Accessibility

Notes: Provide new toilet accessories including grab bars

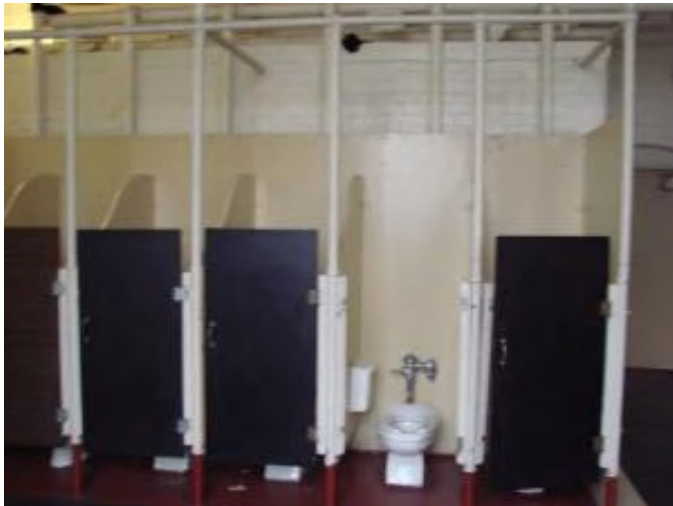
System: D2010 - Plumbing Fixtures

Location: Restrooms

Distress: Accessibility

Notes: Reconfigure toilets on each floor for accessibility, provide new toilet partitions

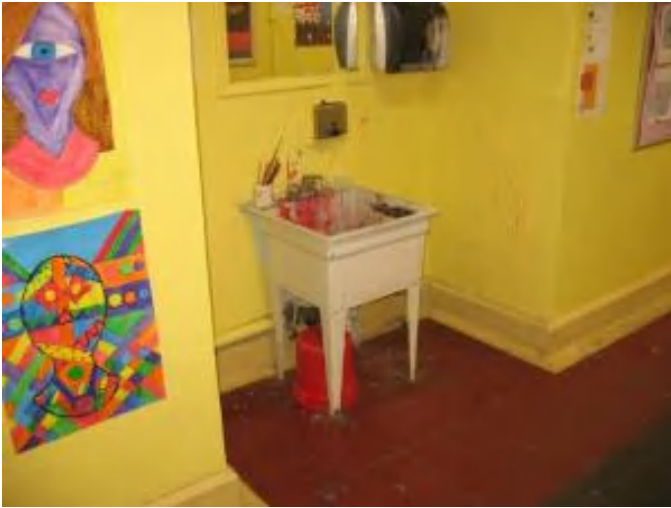
System: D2010 - Plumbing Fixtures

Location: Corridors
Distress: Beyond Service Life
Category: 3 - Operations / Maint.
Priority: 3 - Response Time (3-4 yrs)
Correction: Remove and replace wall janitor or mop sink - insert the quantity
Qty: 4.00
Unit of Measure: Ea.
Estimate: \$31,458.83
Assessor Name: System
Date Created: 01/04/2016

Notes: Replace four (4) sinks in the corridors for use by the janitorial staff which are beyond their service lives.

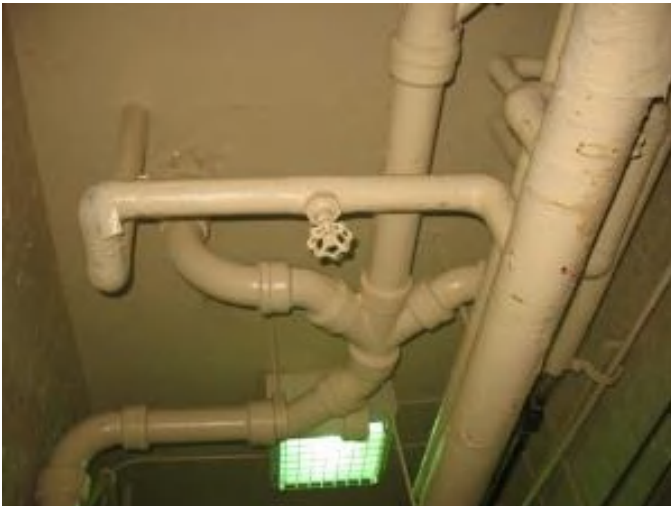
System: D2030 - Sanitary Waste

Location: Throughout building
Distress: Beyond Service Life
Category: 3 - Operations / Maint.
Priority: 3 - Response Time (3-4 yrs)
Correction: Inspect sanitary waste piping and replace damaged sections. (+50KSF)
Qty: 30,500.00
Unit of Measure: S.F.
Estimate: \$149,625.42
Assessor Name: System
Date Created: 01/04/2016

Notes: Hire a qualified contractor to perform a detailed examination of the sanitary waste piping using visual inspection and video cameras to locate and replace any damaged piping and to further quantify the extent of potential failures.

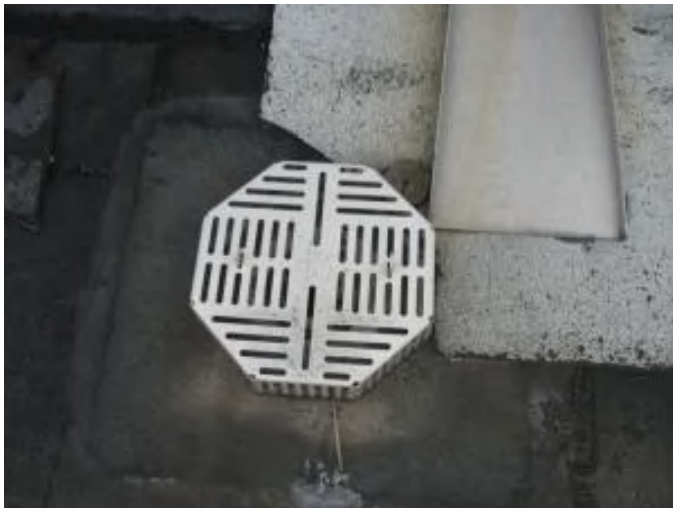
System: D2040 - Rain Water Drainage

Location: Throughout building

Distress: Beyond Service Life

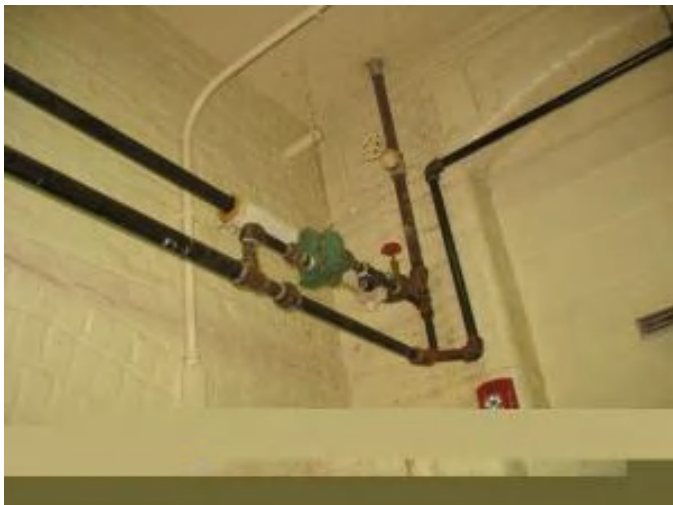
System: D3040 - Distribution Systems

Location: Throughout building

Distress: Beyond Service Life

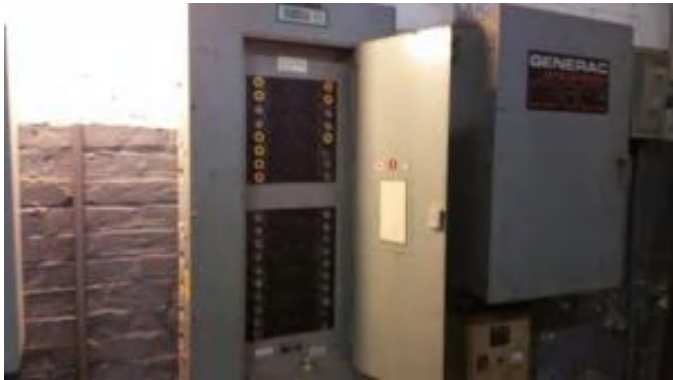
System: D5010 - Electrical Service/Distribution

Location: throughout the building
Distress: Beyond Service Life
Category: 3 - Operations / Maint.
Priority: 3 - Response Time (3-4 yrs)
Correction: Replace Panelboard
Qty: 1.00
Unit of Measure: Ea.
Estimate: \$368,069.78
Assessor Name: System
Date Created: 02/03/2016

Notes: Install new distribution panels 4 in each floor plus two in the basement, and one in the kitchen (9 total).

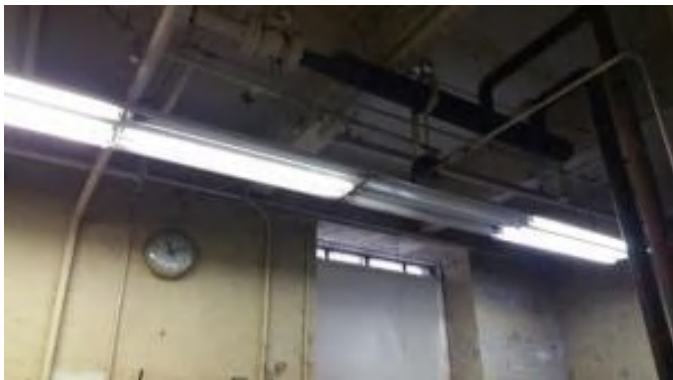
System: D5020 - Lighting and Branch Wiring

Location: throughout the building
Distress: Beyond Service Life
Category: 3 - Operations / Maint.
Priority: 3 - Response Time (3-4 yrs)
Correction: Replace Lighting Fixtures (SF)
Qty: 0.00
Unit of Measure: S.F.
Estimate: \$228,087.75
Assessor Name: System
Date Created: 02/03/2016

Notes: Install new lighting system for 70% of the building.
70% x 30,500 SF = 21,350 SF

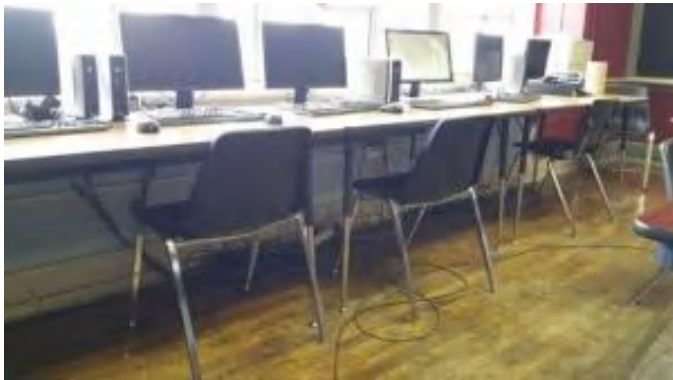
System: D5020 - Lighting and Branch Wiring

Location: throughout the building

Distress: Beyond Service Life

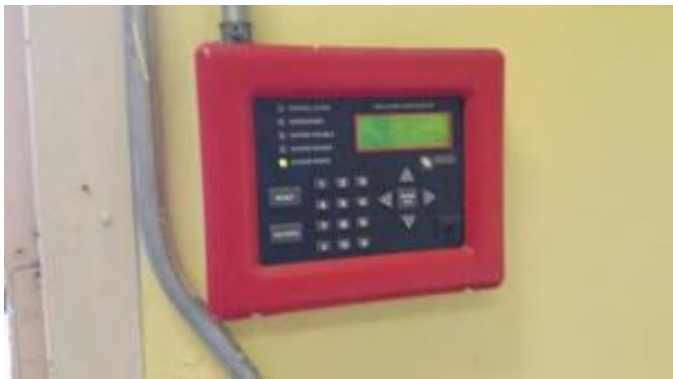
System: D5030 - Communications and Security

Location: throughout the building

Distress: Health Hazard / Risk

Notes: Install new automated FA system.

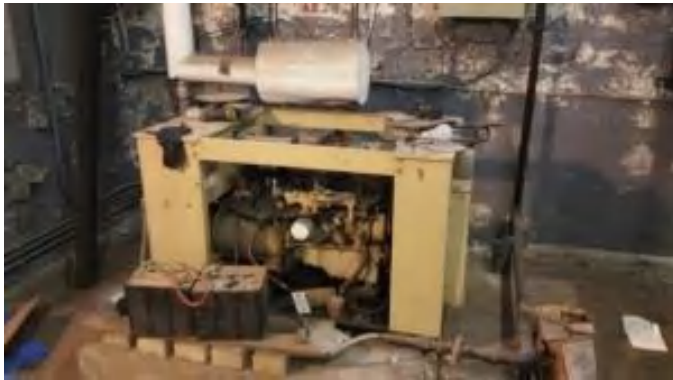
System: D5090 - Other Electrical Systems

Location: electrical room

Distress: Beyond Service Life

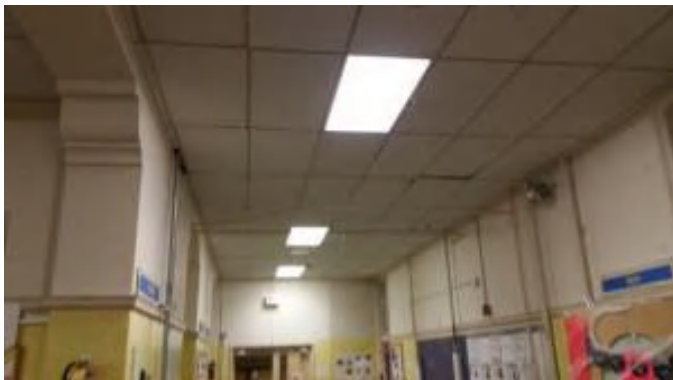
System: D5090 - Other Electrical Systems

Location: throughout the building

Distress: Beyond Service Life

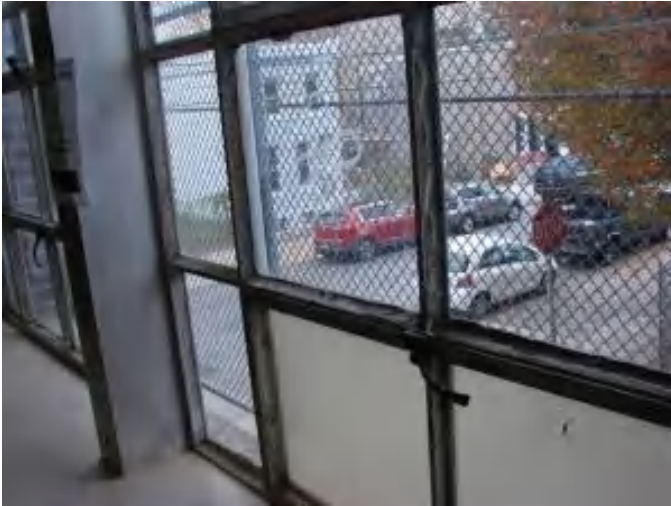
System: B2020 - Exterior Windows

Location: B569001;Hunter (Old)

Distress: Beyond Service Life

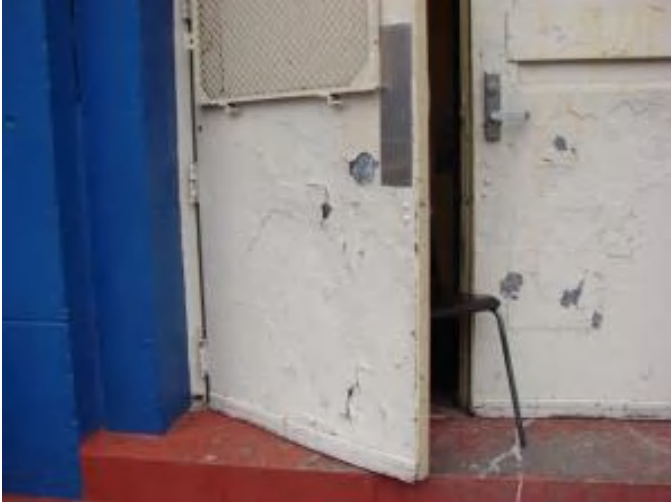
System: B2030 - Exterior Doors

Location: Front and Back elevations

Distress: Beyond Service Life

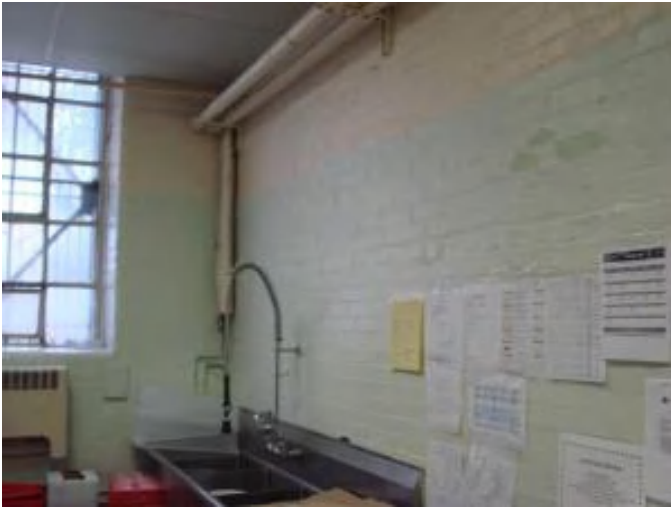
System: C3010230 - Paint & Covering

Location: B569001;Hunter (Old)

Distress: Appearance

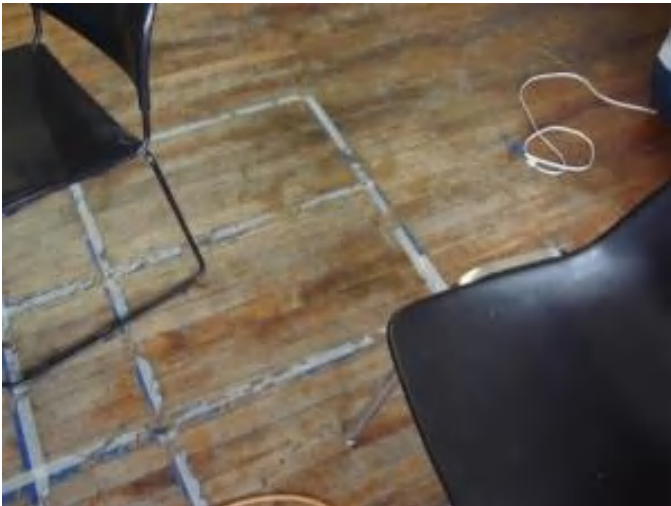
System: C3020414 - Wood Flooring

Location: Hard wood flooring; all floors

Distress: Appearance

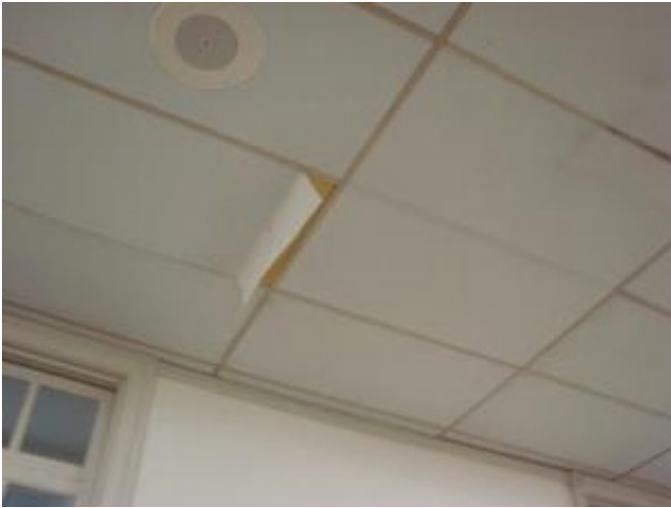
System: C3030 - Ceiling Finishes

Location: Entire building

Distress: Beyond Service Life

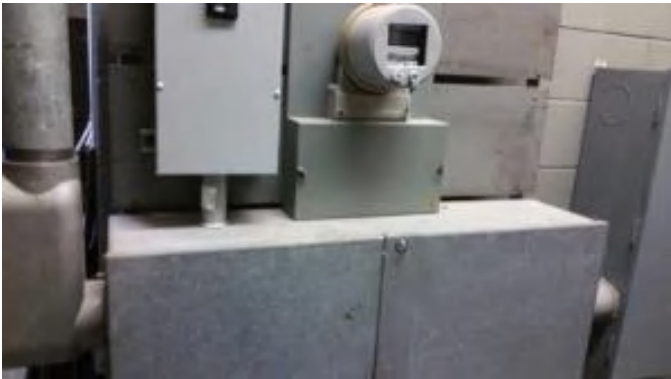
System: D5010 - Electrical Service/Distribution

Location: electrical room

Distress: Beyond Service Life

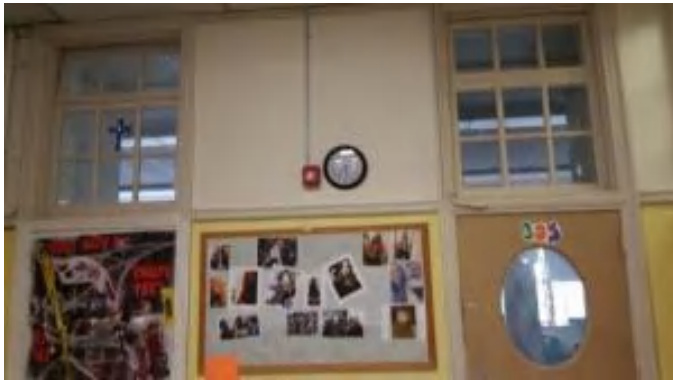
System: D5030 - Communications and Security

Location: throughout the building
Distress: Inadequate
Category: 4 - Capital Improvement
Priority: 4 - Response Time (4-5 yrs)
Correction: Add/Replace Clock System or Components
Qty: 0.00
Unit of Measure: Ea.
Estimate: \$143,420.75
Assessor Name: System
Date Created: 02/03/2016

Notes: Install new Clock System.

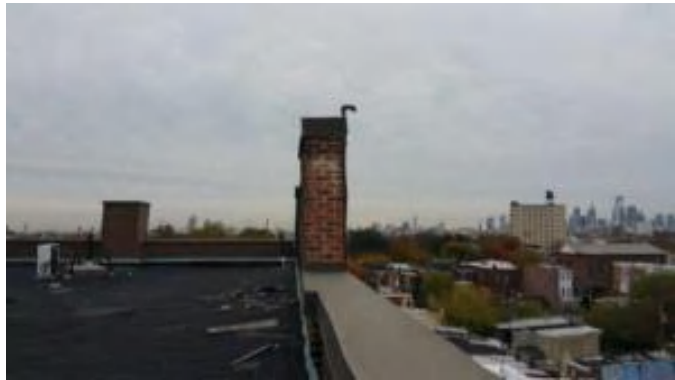
System: D5090 - Other Electrical Systems

Location: roof

Distress: Inadequate

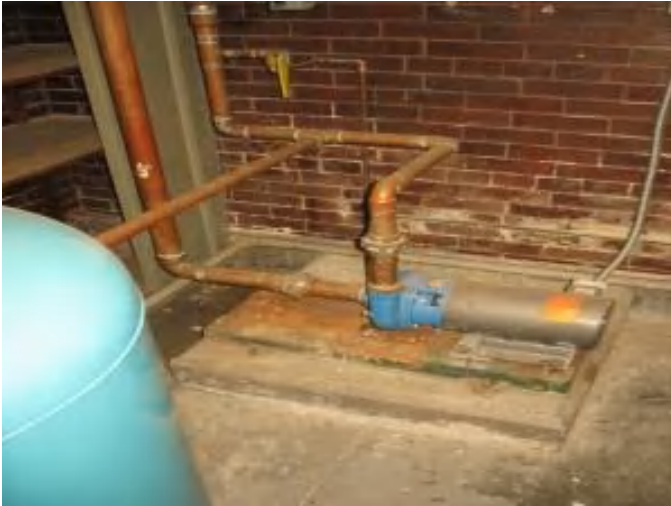
System: D2020 - Domestic Water Distribution

Location: Throughout building

Distress: Beyond Service Life

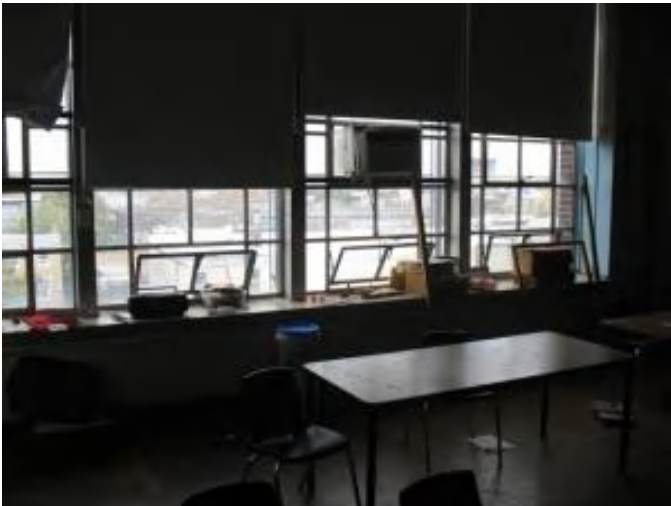
System: D3030 - Cooling Generating Systems

Location: Throughout building

Distress: Inadequate

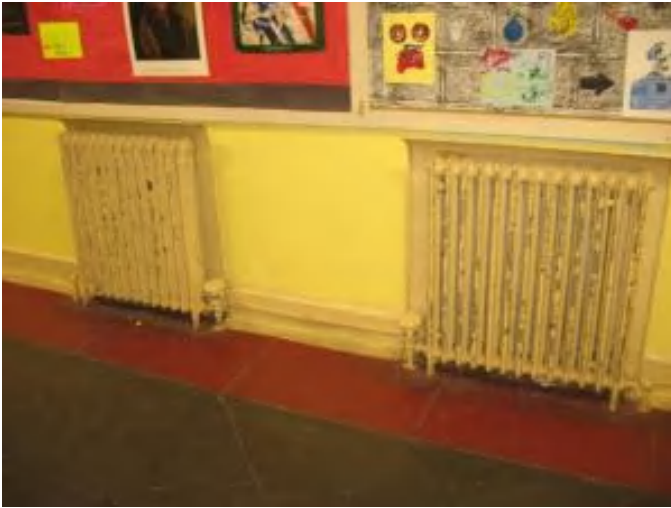
System: D3040 - Distribution Systems

Location: Throughout building
Distress: Building / MEP Codes
Category: 2 - Code Compliance
Priority: 5 - Response Time (> 5 yrs)
Correction: Provide classroom FC units and dedicated OA ventilation system. (20 clsrms)
Qty: 30.00
Unit of Measure: C
Estimate: \$2,491,829.70
Assessor Name: System
Date Created: 01/04/2016

Notes: Remove the existing cast iron steam radiators and install units with hot and chilled water coils and integral heat exchangers to introduce outdoor air to the building.

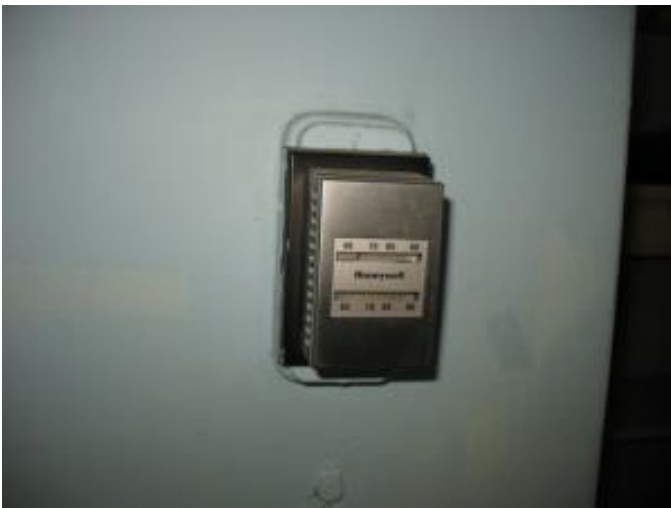
System: D3060 - Controls & Instrumentation

Location: Throughout building
Distress: Failing
Category: 4 - Capital Improvement
Priority: 5 - Response Time (> 5 yrs)
Correction: Replace pneumatic controls with DDC (75KSF)
Qty: 30,500.00
Unit of Measure: S.F.
Estimate: \$654,291.32
Assessor Name: System
Date Created: 01/04/2016

Notes: Replace the pneumatic controls for the HVAC systems with modern DDC modules, valves and actuators to improve reliability and energy efficiency. Provide a new building automation system (BAS) with communication interface to the preferred system in use throughout the District.

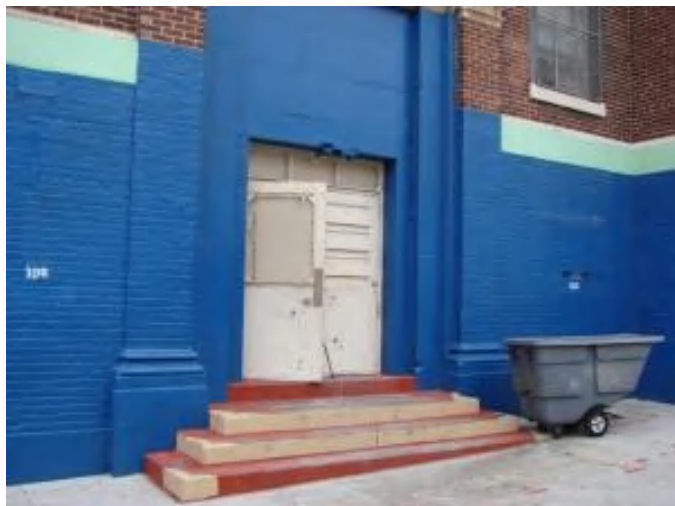
System: G2030 - Pedestrian Paving

Location: Front Entrance

Distress: Accessibility

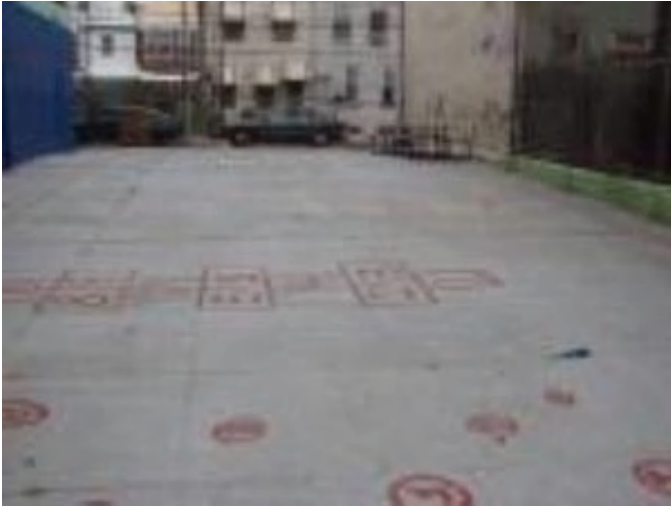
System: G4020 - Site Lighting

Location: grounds

Distress: Inadequate

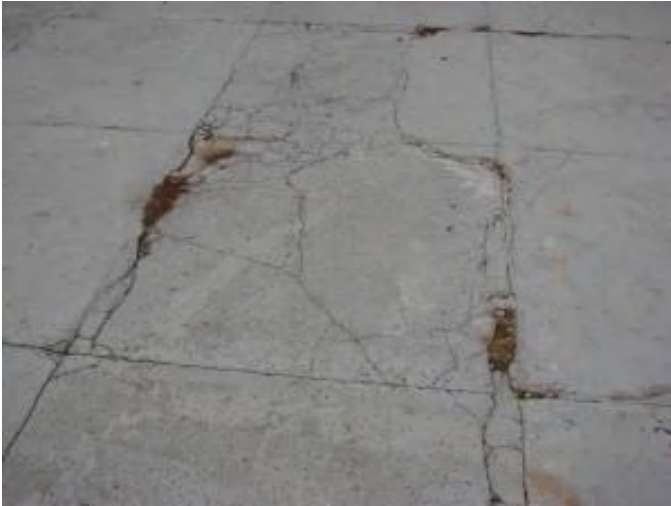
System: G2030 - Pedestrian Paving

Location: Playground; southeast corner

Distress: Damaged

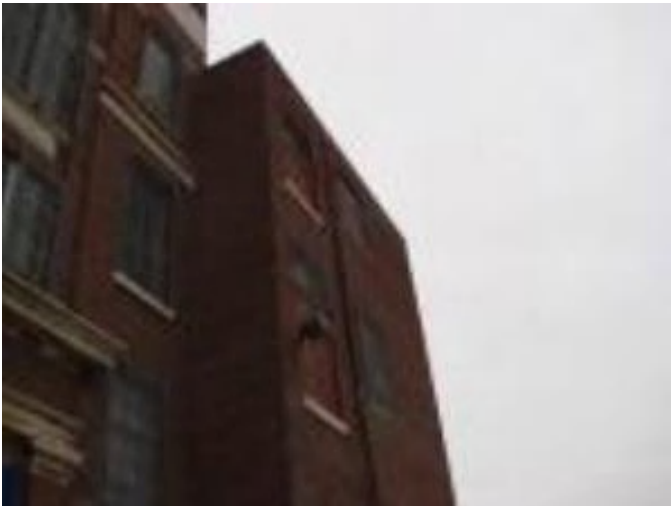
System: G4030 - Site Communications & Security

Location: grounds

Distress: Inadequate
