## Facility Condition Assessment Summary Report

### Ellwood School

School District of Philadelphia  
**S726001;Ellwood**  
Final  
**Site Assessment Report**  
January 31, 2017

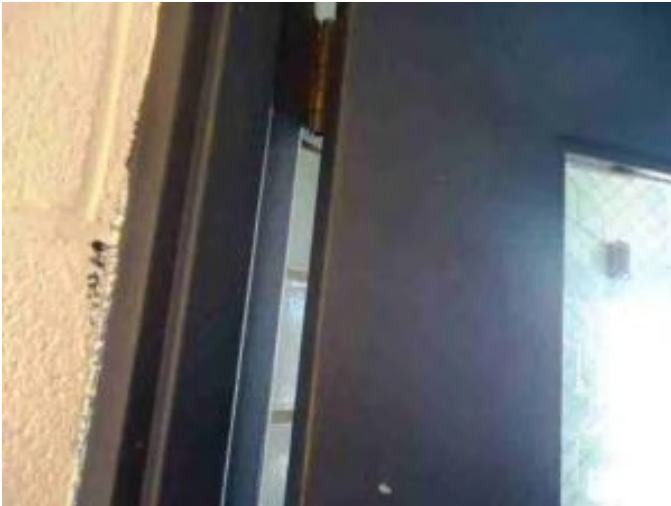
#### System: C1010 - Partitions

**Location:** Stairs

**Distress:** Damaged

**Notes:** A large portion of the interior corridor, exit stair doors are not code compliant. Several doors are typically wood or metal in metal frames with transom lites or sidelights, glass glazing. The older doors are generally in good condition considering the age of the application. To restore the door finishes, universal upgrades are required for the older door applications. Remove and replace original door systems with new code compliant fire rated door system.

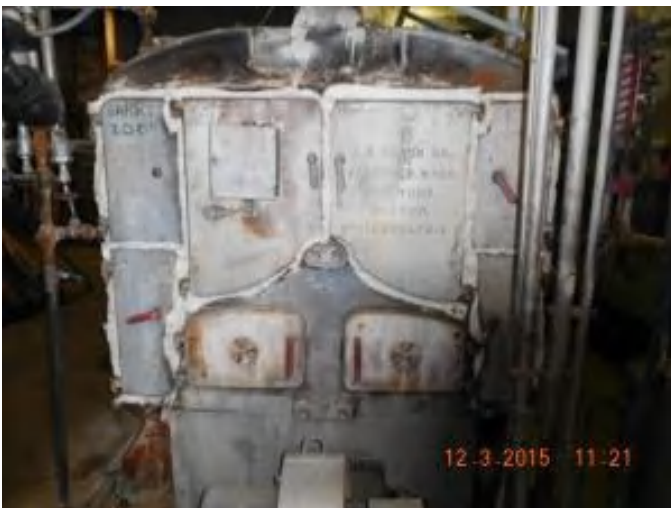
#### System: D3020 - Heat Generating Systems

**Location:** mechanical room

**Distress:** Beyond Service Life

**Notes:** Replace existing boilers with two new cast iron sectional boilers.

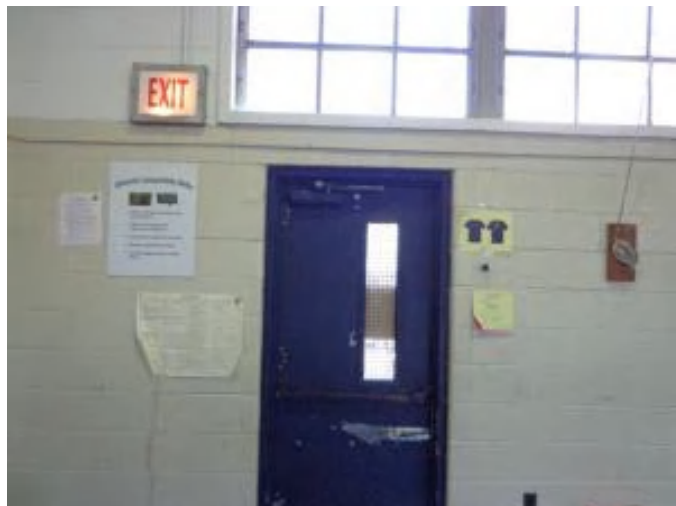
**System: D5030 - Communications and Security**

**Location:** Building wide

**Distress:** Life Safety / NFPA / PFD

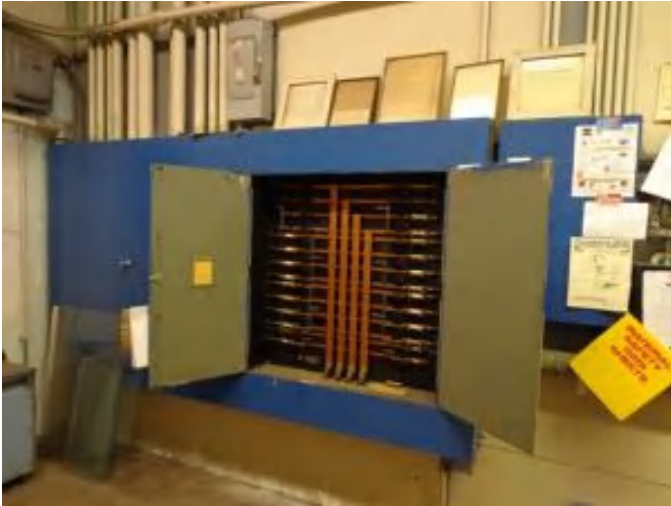
**System: D5010 - Electrical Service/Distribution**

**Location:** Basement Main Electrical Room

**Distress:** Beyond Service Life

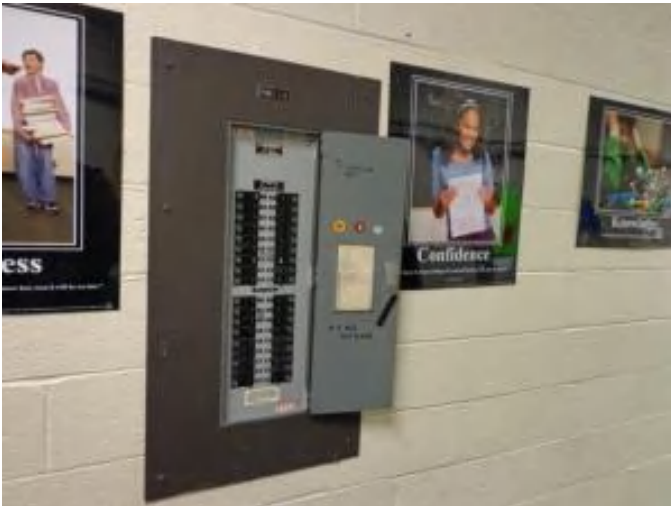
**System: D5010 - Electrical Service/Distribution**

**Location:** Building wide

**Distress:** Beyond Service Life

**Notes:** Replace a total of (14) 120/240V, 1 phase panelboards in the building, including their feeders, and eight (8) safety switches feeding mechanical equipment in the Boiler Room.

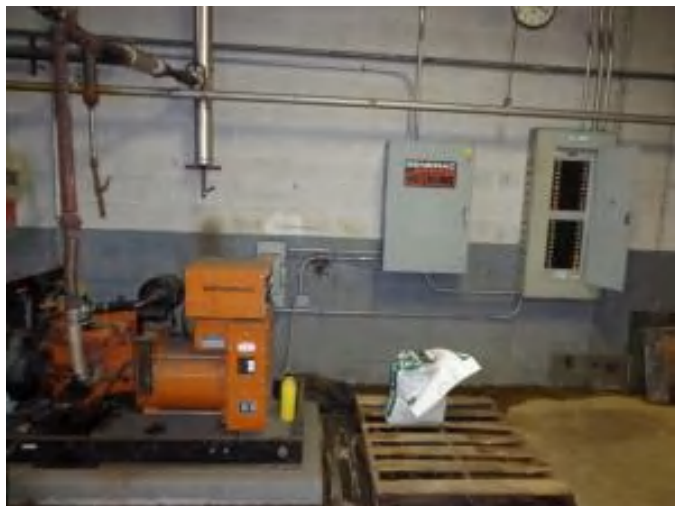
**System: D5090 - Other Electrical Systems**

**Location:** Boiler Room 001B

**Distress:** Beyond Service Life

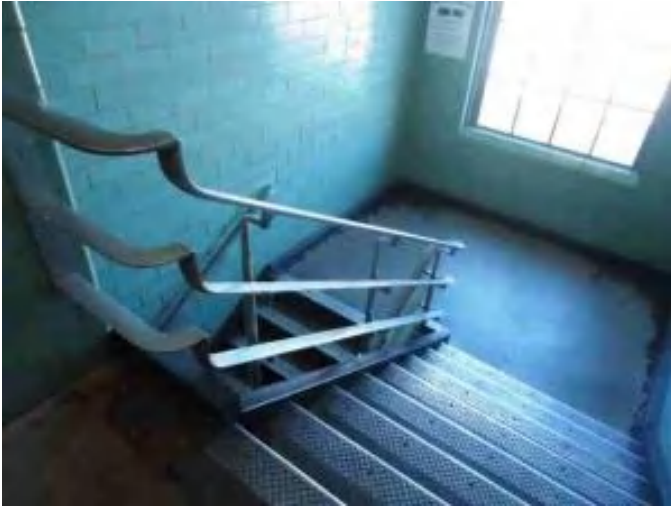
#### System: C2010 - Stair Construction

**Location:** Stairs

**Distress:** Life Safety / NFPA / PFD

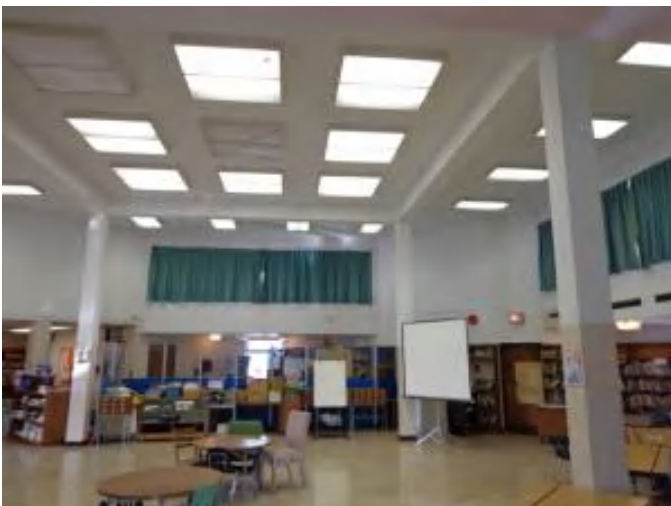
#### System: D5020 - Lighting and Branch Wiring

**Location:** Building wide

**Distress:** Beyond Service Life

**Notes:** Replace all fluorescent lighting systems and branch circuit wiring throughout the building (classrooms and IMC 20,136 SF; Auditorium 3,900 SF; offices, administrative support, restrooms and corridors 21,604 SF; mechanical and storage 6,133 SF).

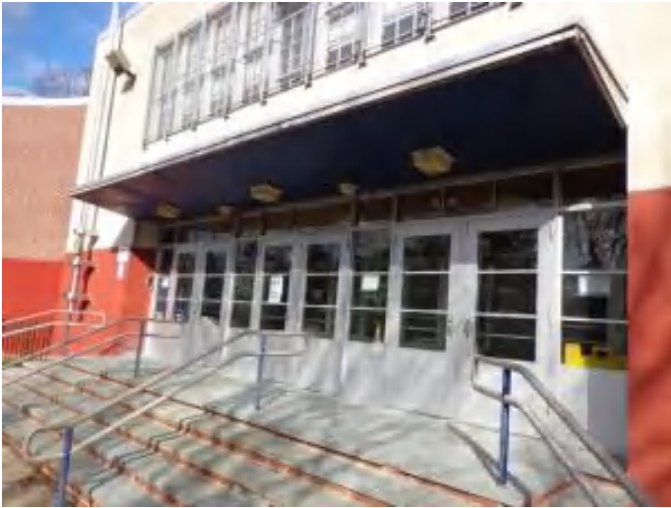
**System: D5020 - Lighting and Branch Wiring**

**Location:** Exit discharges

**Distress:** Beyond Service Life

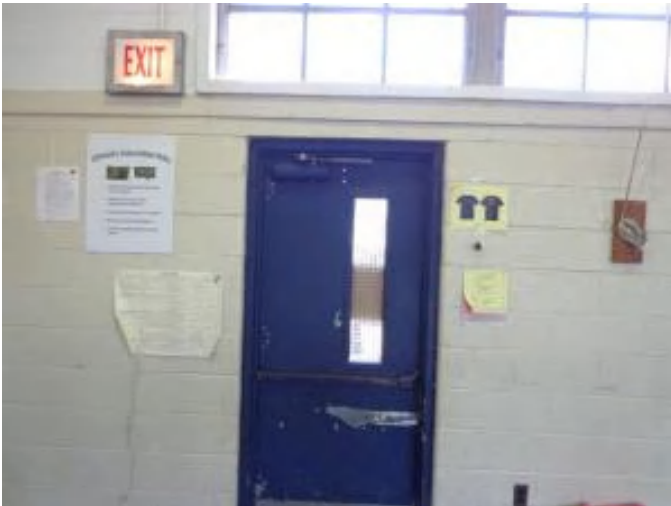
**System: D5090 - Other Electrical Systems**

**Location:** Building wide

**Distress:** Beyond Service Life

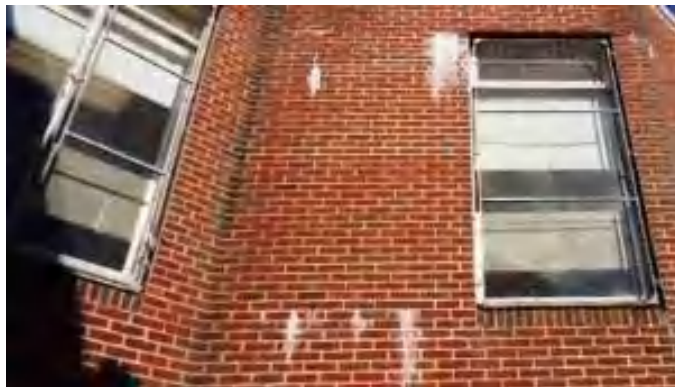
**System: B2010 - Exterior Walls**

**Location:** Exterior Elevation

**Distress:** Damaged

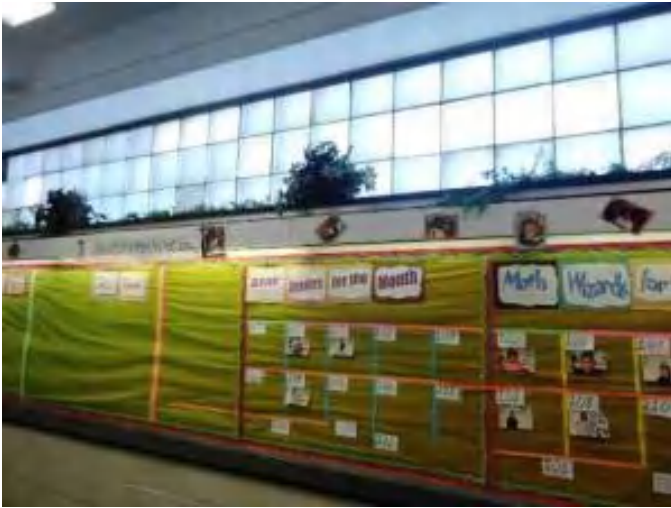
**System: B2020 - Exterior Windows**

**Location:** Exterior Elevation

**Distress:** Damaged

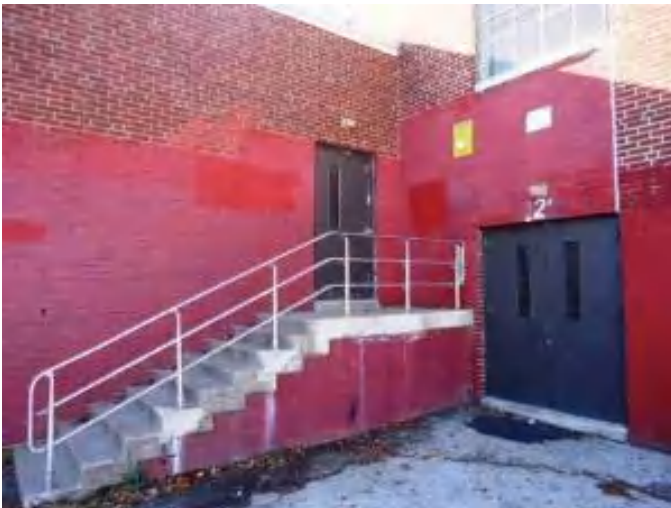
**System: B2030 - Exterior Doors**

**Location:** Exterior Elevation

**Distress:** Damaged

**Notes:** The exterior doors are metal applications with metal frames. The exterior door system for this school is a very high traffic system. Most of the doors are in fair condition but are aging at a faster rate than expected based on traffic and condition. The service doors on the roof have expired and failed compromising access to elevator rooms and tower rooms. The exterior door system, store front and service doors are recommended for upgrade.

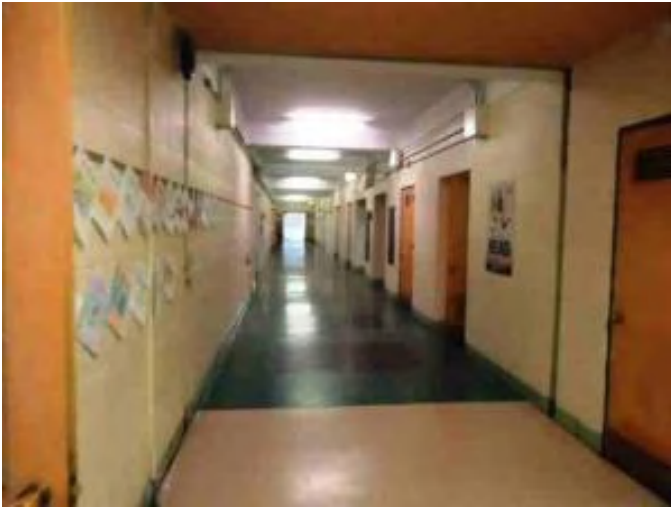
**System: C1020 - Interior Doors**

**Location:** Building Wide

**Distress:** Damaged

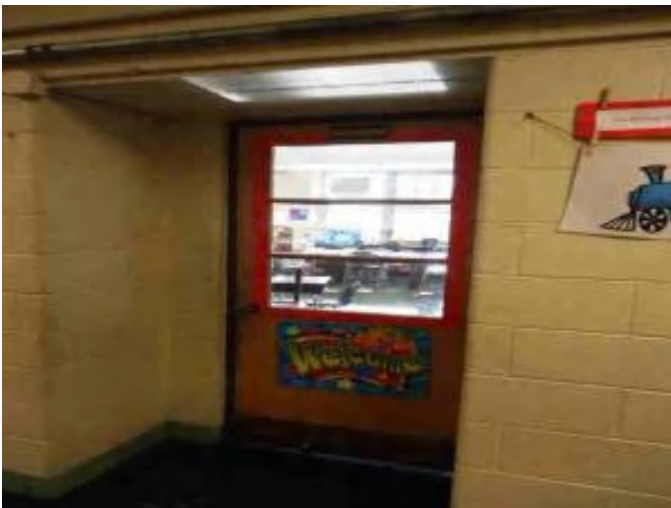
**System: C1030 - Fittings**

**Location:** Building Wide

**Distress:** Damaged

**Notes:** There is no directional signage and room signage is a custom design in places and scarce or painted with no consistency in others. Accessibility signage criteria have been established for the physically challenged. These include mounting heights, contrast and finish, raised and Braille characters and pictograms, and character proportions and heights. It is recommended that compliant signage be installed throughout the building.

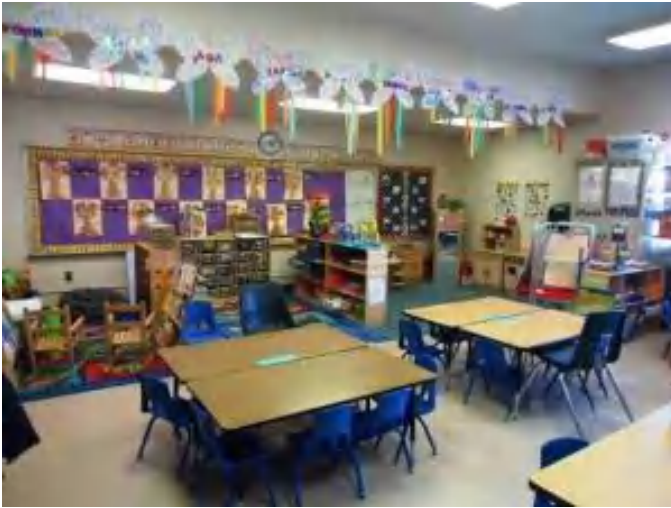
**System: C1030 - Fittings**

**Location:** Classrooms

**Distress:** Damaged

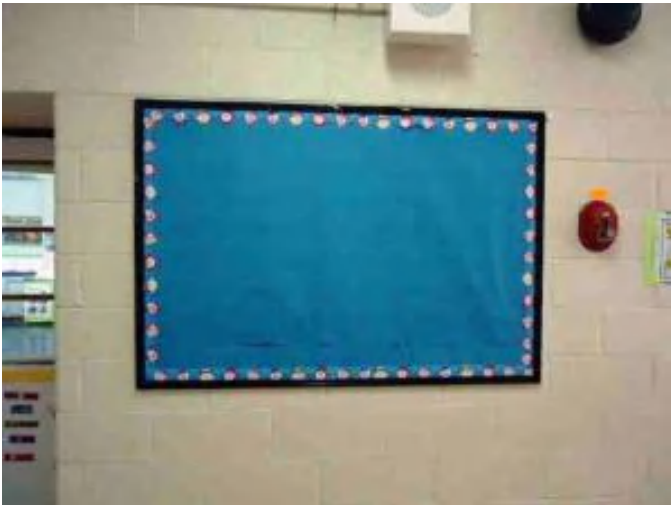
**System: C1030 - Fittings**

**Location:** Hallways

**Distress:** Damaged

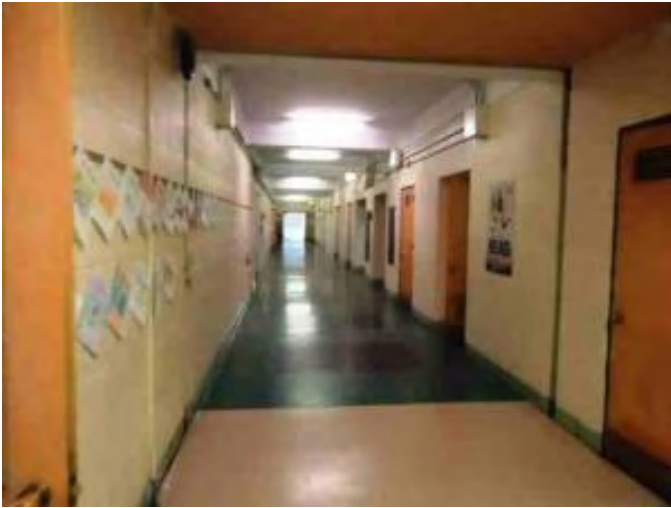
**System: C3020413 - Vinyl Flooring**

**Location:** Building Wide

**Distress:** Damaged

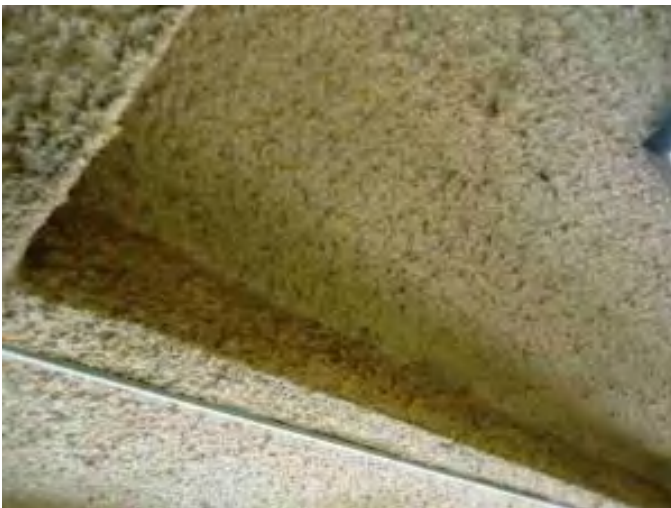
**System: C3030 - Ceiling Finishes**

**Location:** Building Wide

**Distress:** Damaged

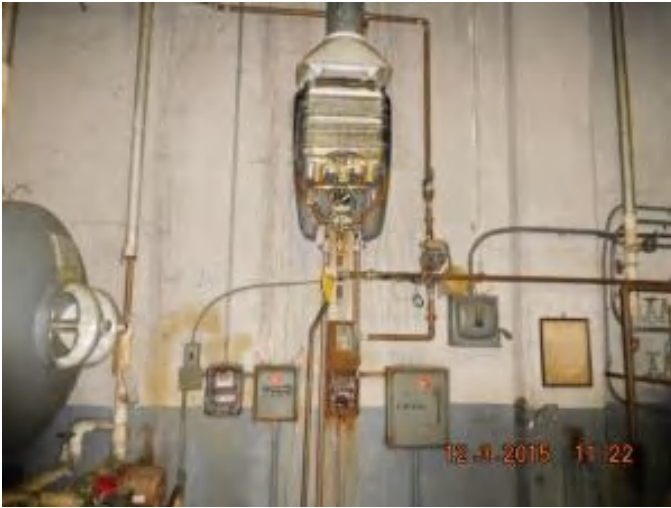
**System: D2020 - Domestic Water Distribution**

**Location:** entire building

**Distress:** Beyond Service Life

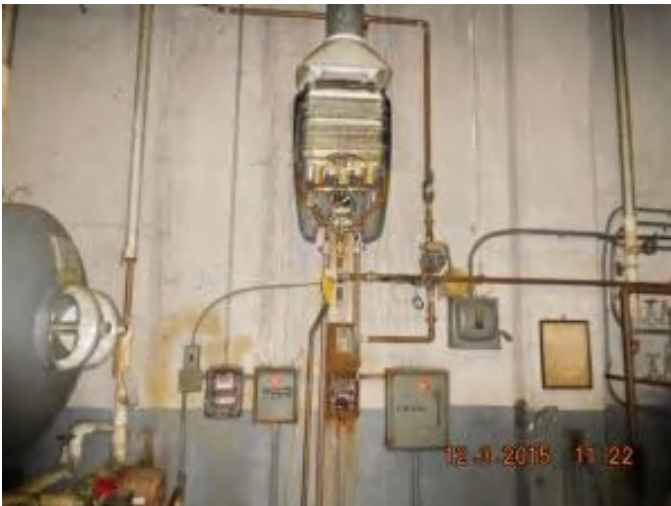
**System: D2020 - Domestic Water Distribution**

**Location:** mechanical room

**Distress:** Beyond Service Life

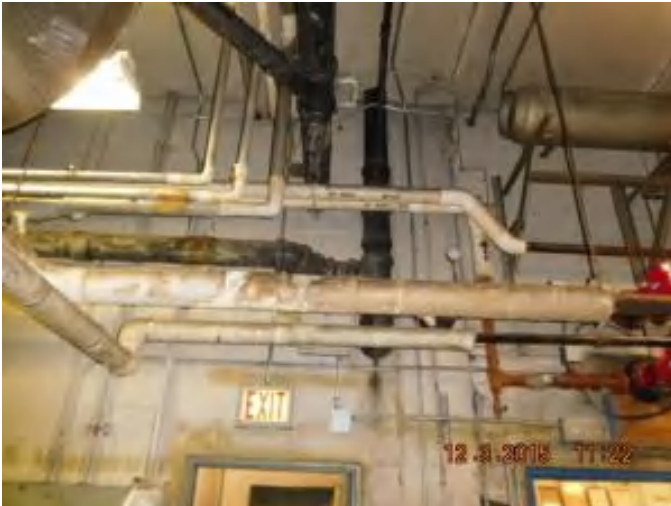
**System: D2030 - Sanitary Waste**

**Location:** entire building

**Distress:** Beyond Service Life

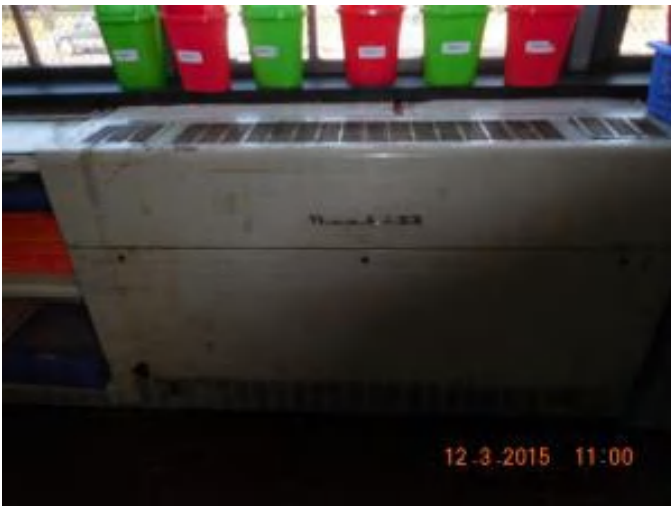
**System: D3040 - Distribution Systems**

**Location:** classrooms

**Distress:** Building / MEP Codes

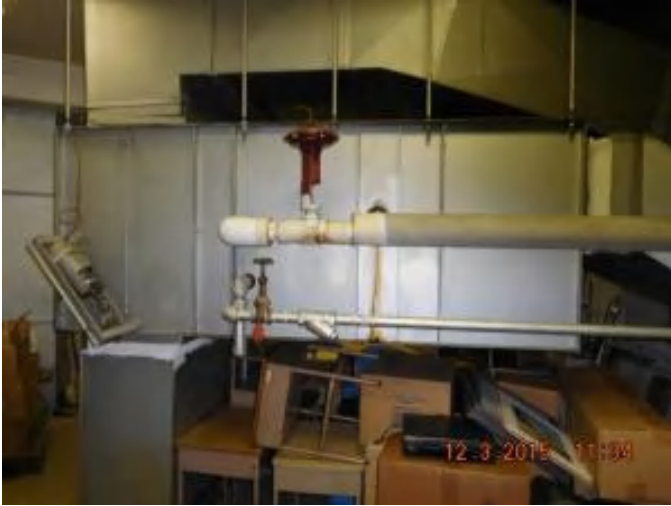
**System: D3040 - Distribution Systems**

**Location:** auditorium

**Distress:** Building / MEP Codes

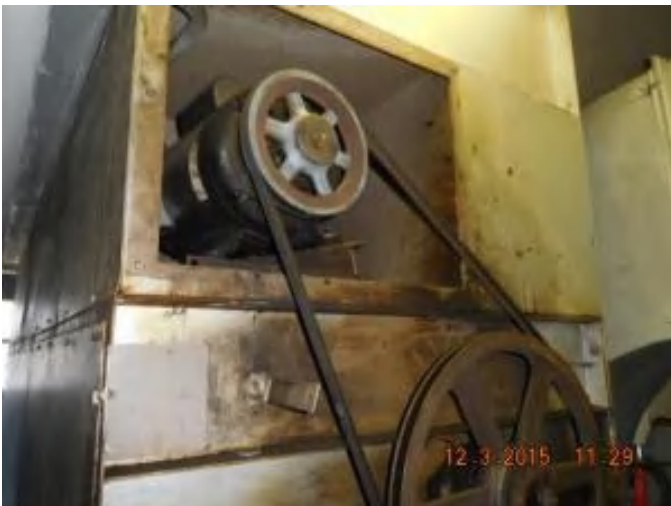
**System: D3040 - Distribution Systems**

**Location:** cafeteria/ gymnasium

**Distress:** Building / MEP Codes

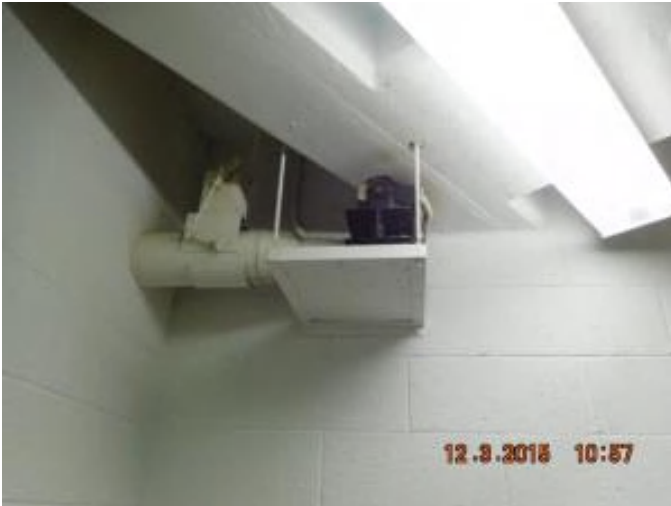
**System: D3040 - Distribution Systems**

**Location:** toilet rooms

**Distress:** Building / MEP Codes

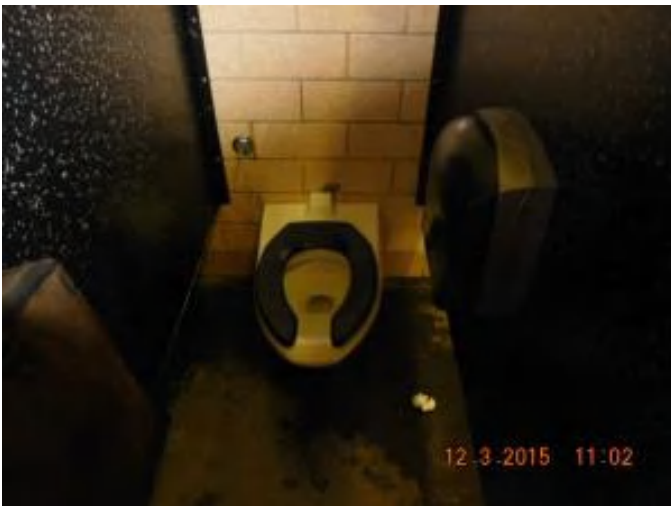
**System: D3040 - Distribution Systems**

**Location:** toilet rooms

**Distress:** Building / MEP Codes

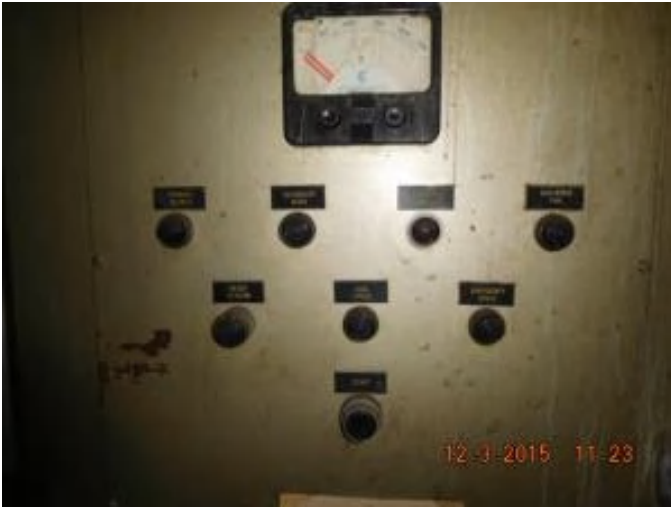
**System: D3060 - Controls & Instrumentation**

**Location:** entire building

**Distress:** Beyond Service Life

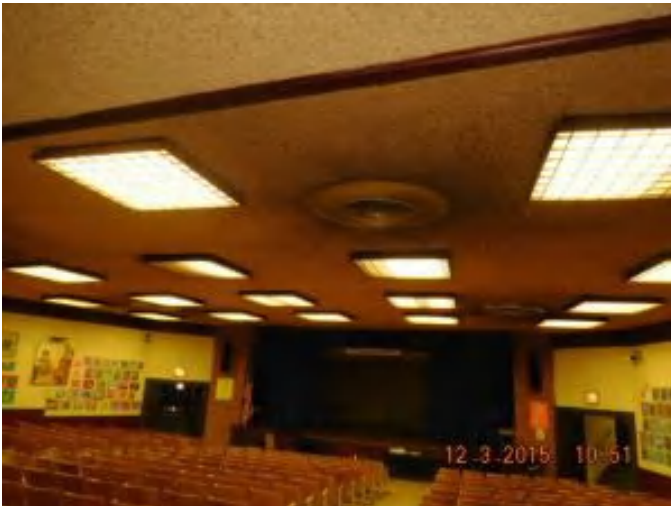
**System: D4010 - Sprinklers**

**Location:** entire building

**Distress:** Life Safety / NFPA / PFD

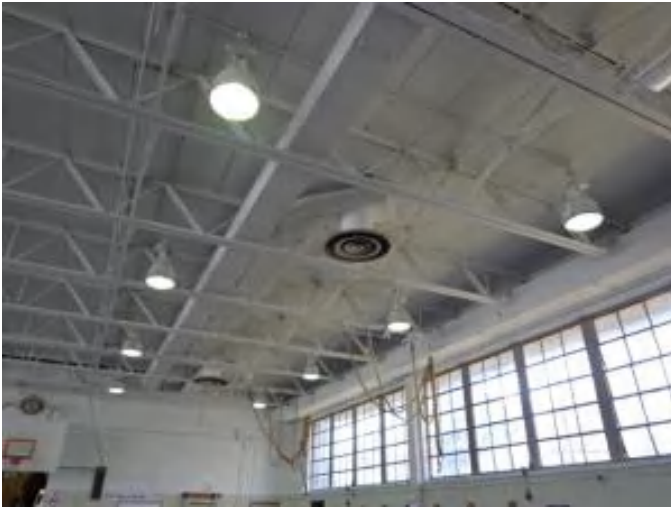
**System: D5020 - Lighting and Branch Wiring**

**Location:** Cafeteria/Gymnasium

**Distress:** Beyond Service Life

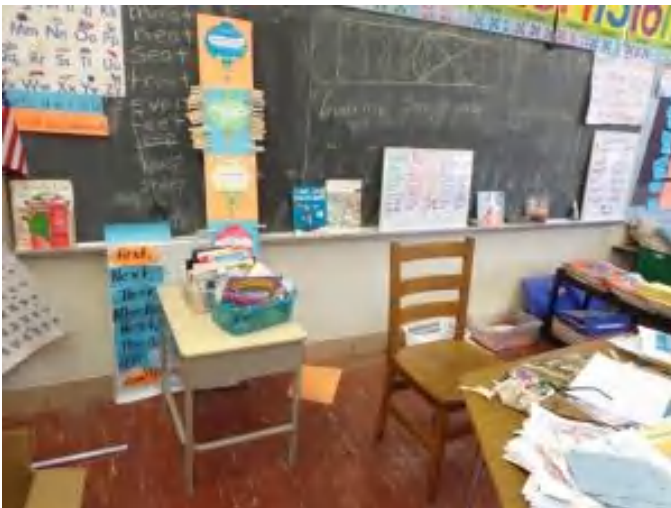
**System: D5020 - Lighting and Branch Wiring**

**Location:** Classrooms

**Distress:** Inadequate

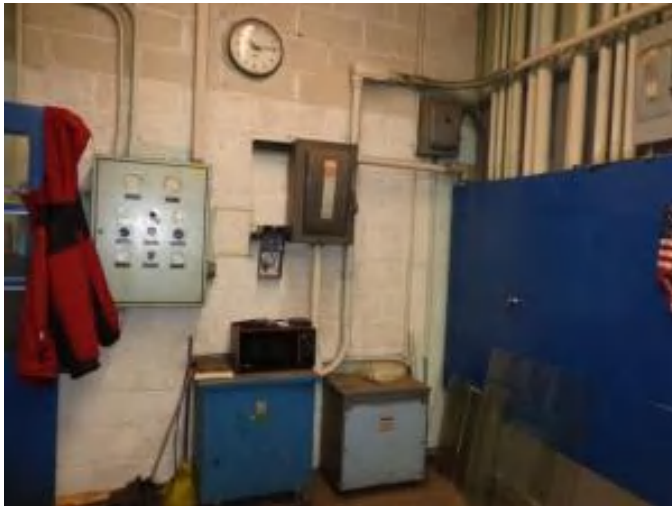
**System: D5030 - Communications and Security**

**Location:** Building wide

**Distress:** Inadequate

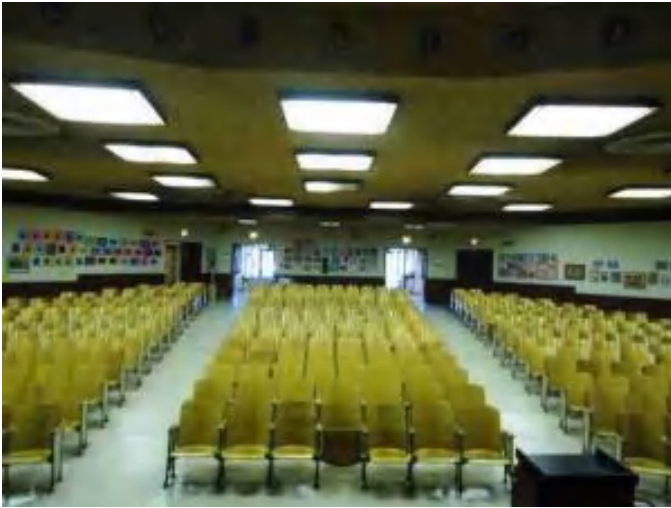
**System: E2010 - Fixed Furnishings**

**Location:** Auditorium

**Distress:** Damaged

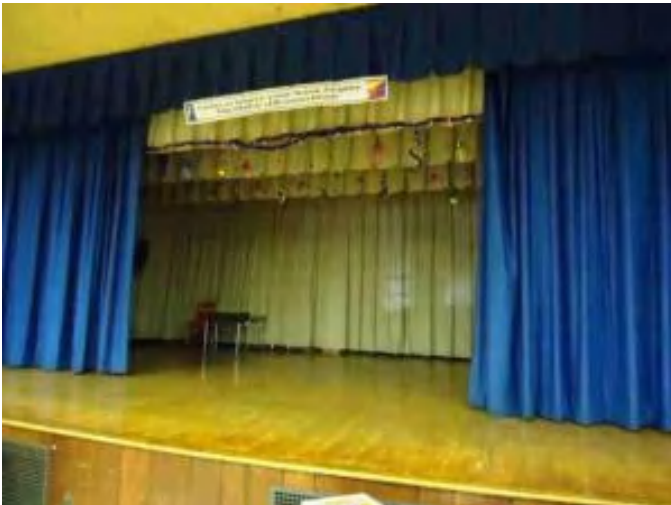
**System: E2010 - Fixed Furnishings**

**Location:** Stage

**Distress:** Life Safety / NFPA / PFD

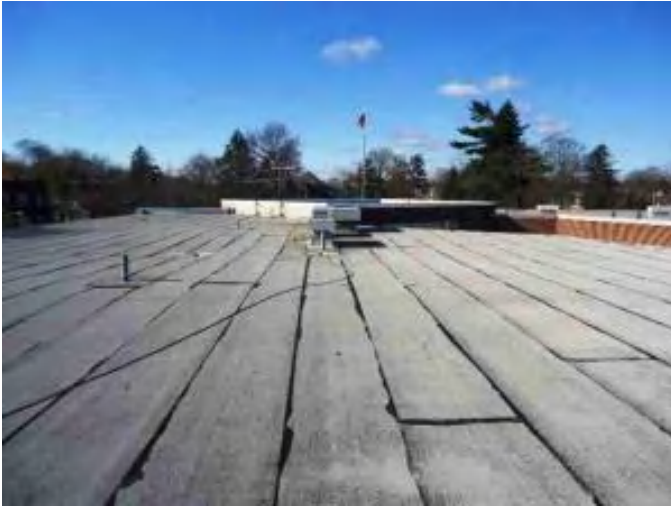
**System: B3010105 - Built-Up**

**Location:** Roof

**Distress:** Damaged

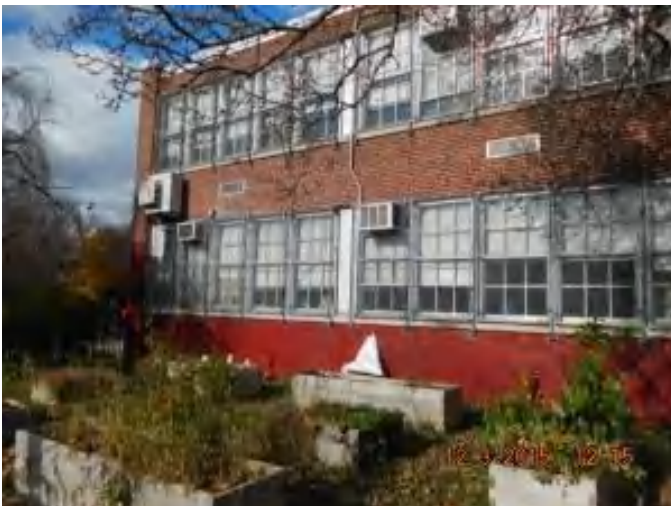
**System: D3030 - Cooling Generating Systems**

**Location:** roof, mechanical room

**Distress:** Inadequate

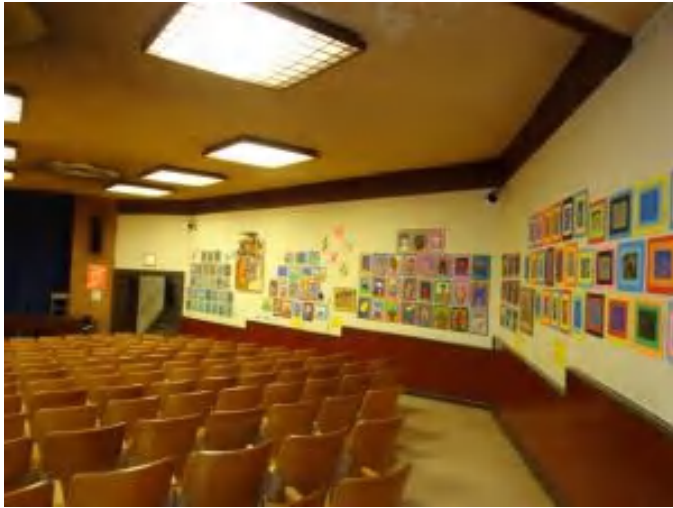
**System: D5020 - Lighting and Branch Wiring**

**Location:** Auditorium

**Distress:** Energy Efficiency

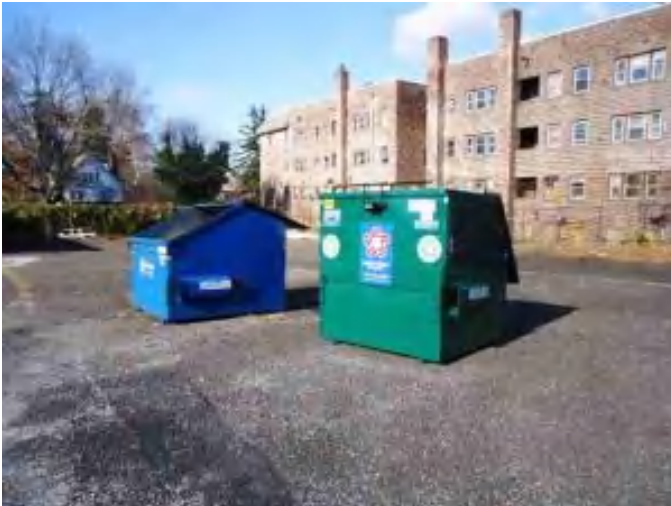
#### System: G2040 - Site Development

**Location:** Site

**Distress:** Damaged

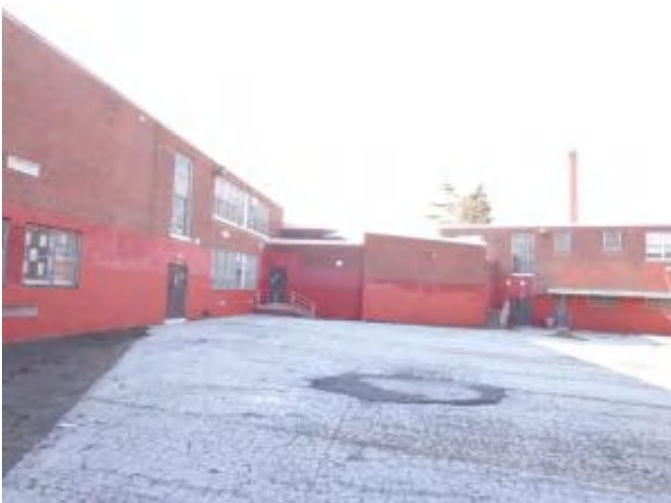
#### System: G4030 - Site Communications & Security

**Location:** Site

**Distress:** Life Safety / NFPA / PFD

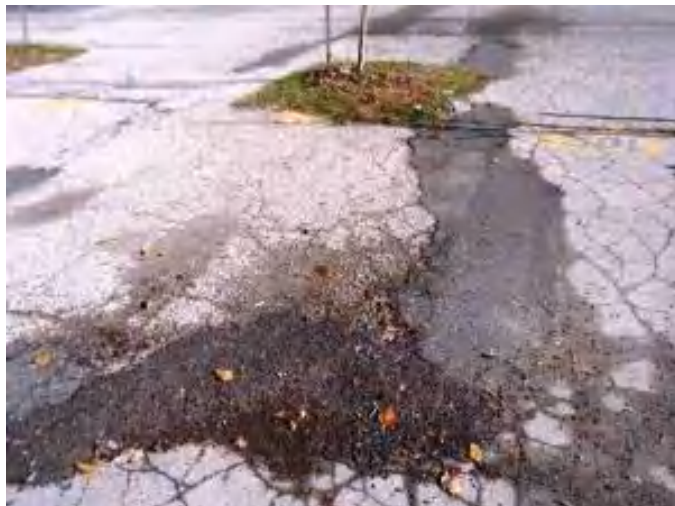
**System: G2030 - Pedestrian Paving**

**Location:** Site

**Distress:** Damaged
