Facility Condition Assessment Summary Report

Engineering and Science (Carver) School

School District of Philadelphia
S403001;Carver
Final
Site Assessment Report

February 2, 2017

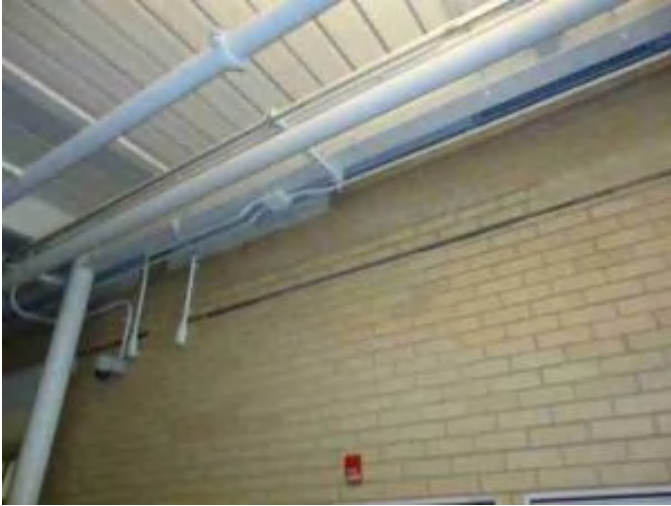
Location: Original School Wall

The original schools exterior brick surfaces are generally in fair to good condition for their age. In some locations, bricks have cracked or spalled and should be replaced. The area near room 138 is a new interior wall that at one time was an exterior wall prior to the 2008 addition. This area will require additional effort as water is currently causing issues with the finish. The repointing of deteriorated mortar joints is also recommended, using mortar of a similar color and consistency as the original. Following the detailed examination of the brick and repair of mortar construction joints, the entire building should be pressure washed to remove stains and embedded pollutants. If moisture is found to be penetrating the masonry facade, the application of a spray sealant to the suspected exterior masonry surface is recommended.

Distress: Damaged

Notes: The original schools exterior brick surfaces are generally in fair to good condition for their age. In some locations, bricks have cracked or spalled and should be replaced. The area near room 138 is a new interior wall that at one time was an exterior wall prior to the 2008 addition. This area will require additional effort as water is currently causing issues with the finish. The repointing of deteriorated mortar joints is also recommended, using mortar of a similar color and consistency as the original. Following the detailed examination of the brick and repair of mortar construction joints, the entire building should be pressure washed to remove stains and embedded pollutants. If moisture is found to be penetrating the masonry facade, the application of a spray sealant to the suspected exterior masonry surface is recommended.

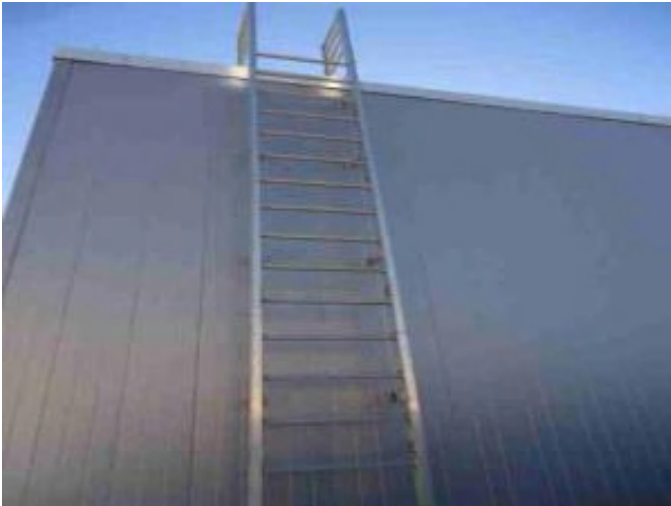
The ladder mounted to the exterior wall that provides access to the roof is over 20 feet in height and does not meet the current OSHA standards for safety. "Ladders with cages as defined in 1910.27(c)(3) of the OSHA standard requires a safety cage and landing for access to extended roof levels. This deficiency provides a budgetary consideration to remove the existing roof ladder and replace with a new ladder and cage with landing for safe roof access.

Location: Roof Ladder
Distress: Building / MEP Codes
Category: 2 - Code Compliance
Priority: 2 - Response Time (2-3 yrs)
Correction: Add fixed ladders to wall
Qty: 25.00
Unit of Measure: V.L.F.
Estimate: \$6,934.61
Assessor Name: Craig Anding
Date Created: 11/02/2015

Notes: The ladder mounted to the exterior wall that provides access to the roof is over 20 feet in height and does not meet the current OSHA standards for safety. "Ladders with cages as defined in 1910.27(c)(3) of the OSHA standard requires a safety cage and landing for access to extended roof levels. This deficiency provides a budgetary consideration to remove the existing roof ladder and replace with a new ladder and cage with landing for safe roof access.

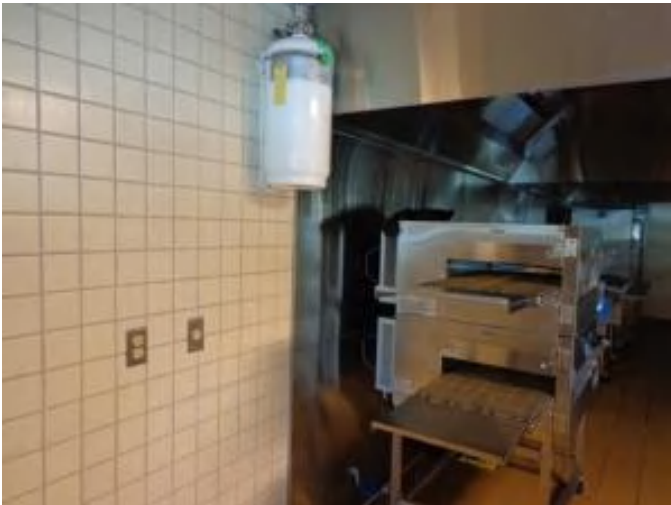
Location: Kitchen
Distress: Life Safety / NFPA / PFD
Category: 1 - Health & Safety
Priority: 2 - Response Time (2-3 yrs)
Correction: Replace Wiring Device
Qty: 5.00
Unit of Measure: Ea.
Estimate: \$1,712.35
Assessor Name: Craig Anding
Date Created: 11/24/2015

Notes: Replace five (5) duplex receptacles in the kitchen with GFCI type receptacles to comply with NFPA 70, NEC Article 210.8 (B) for GFCI protection for personnel.

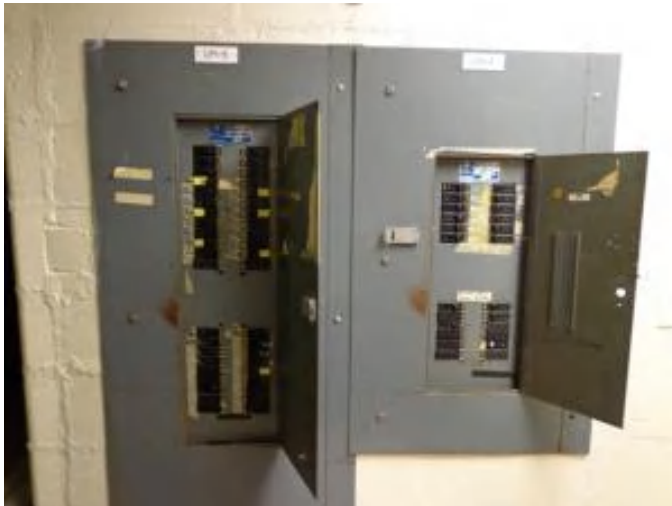
Location: Auditorium

Except for Panelboards LP1-5 and LP1-6, which are located adjacent to the auditorium, all of the electrical service entrance and distribution equipment was replaced in the 2008 Addition and Renovation project. The remaining useful life of this equipment is 23 years. Panelboards LP1-5 and LP1-6 should be replaced within the next 3 to 4 years.

Distress: Beyond Service Life

Notes: Replace 225A Panelboards LP1-5 and LP1-6, located adjacent to the Auditorium, within the next 3 to 4 years.

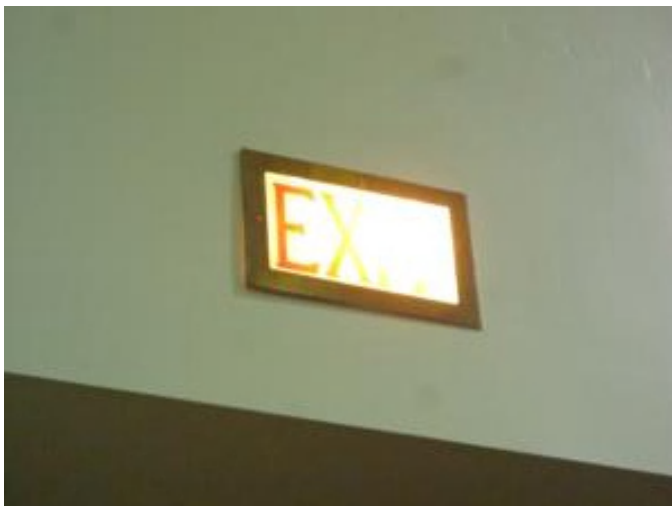
Location: Auditorium

Distress: Appearance

Notes: Replace four (4) incandescent type exit signs in the Auditorium with LED type.

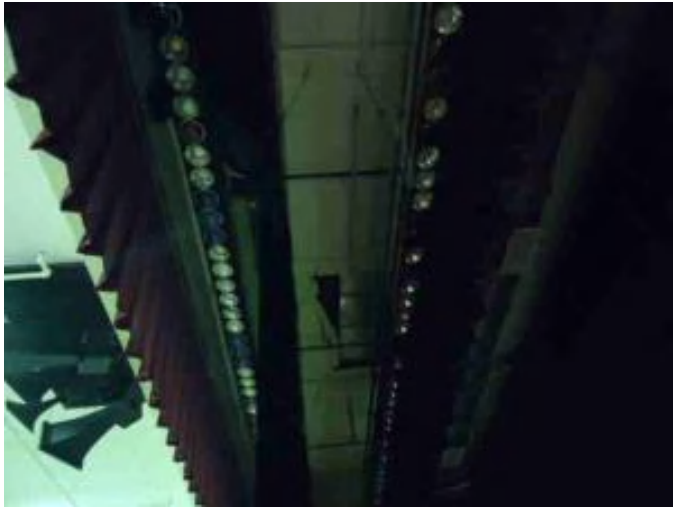
Location: Stage

The institutional equipment includes: library equipment; stage equipment. The school stage has a stage curtain assembly that appears to be from the original construction. Modern applications are typically fire-proof applications with adjustable tracks and electric support for operation. The curtains are torn in a few sections and the track is not functioning properly, overall the system is in poor condition. It is recommended that the curtain and track system be upgraded to a new system. Special care should be considered in regards to modern fire proofing for the new installation.

Distress: Life Safety / NFPA / PFD

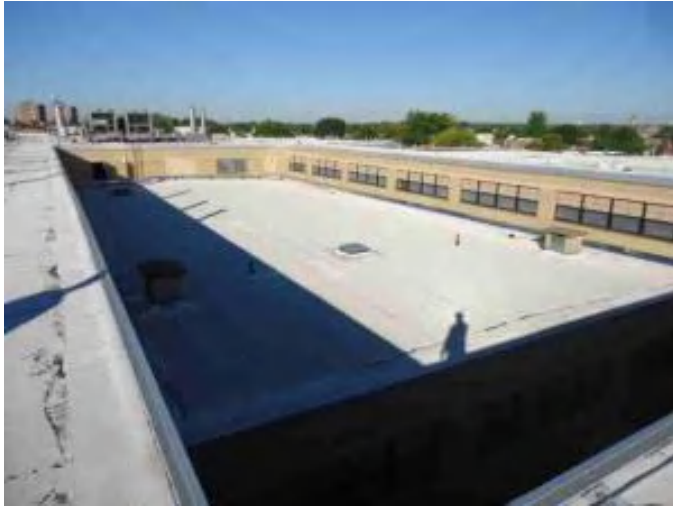
Location: Original School Roof

There are a number of roof sections and different roof elevations ranging from the main roof to the mechanical roof. The major differences are between the 1948 construction and the 2008 construction roof sections. Parapet heights, coping materials, and the height of the flashing also varies in different sections. The 1948 roof is a built up application that was installed in the early 1990'S. The 2008 built up roofs are in like new condition. There are numerous leaks including but not limited to Main Street, Library, Weight room, Cafeteria and the Girls locker room. Considering the condition of the 1948 roofing systems, universal upgrades are recommended. Remove and replace the 1948 roof sections. This deficiency also includes consideration for roof repairs for the new roof that connects to the 1948 structure. This roof is expected to have a life cycle that will expire within the next ten years.

Distress: Damaged

Notes: There are a number of roof sections and different roof elevations ranging from the main roof to the mechanical roof. The major differences are between the 1948 construction and the 2008 construction roof sections. Parapet heights, coping materials, and the height of the flashing also varies in different sections. The 1948 roof is a built up application that was installed in the early 1990'S. The 2008 built up roofs are in like new condition. There are numerous leaks including but not limited to Main Street, Library, Weight room, Cafeteria and the Girls locker room. Considering the condition of the 1948 roofing systems, universal upgrades are recommended. Remove and replace the 1948 roof sections. This deficiency also includes consideration for roof repairs for the new roof that connects to the 1948 structure. This roof is expected to have a life cycle that will expire within the next ten years.

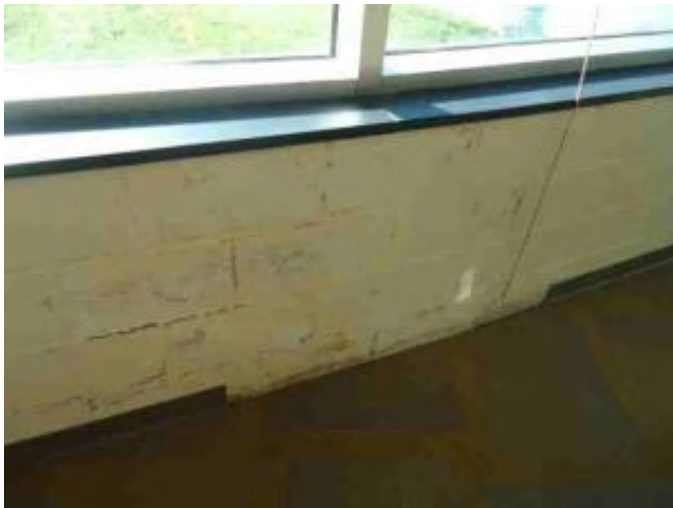
There are painted walls, trim, and some painted ceilings in this building. In the older sections of the building, some textured concrete surfaces have been painted. The interior finishes in this school in good to fair condition and will require an almost continuous program of renewal of the applied finishes to maintain an acceptable appearance. The finishes in the new section are in excellent to good condition. Cyclical painting should be considered for a standard approach to maintaining the quality of the interior finishes. It is recommended that all previously painted surfaces be repainted according to established cycles for this occupancy and use type. Minor repairs should be completed before work begins.

Location: Building Wide
Distress: Damaged
Category: 3 - Operations / Maint.
Priority: 4 - Response Time (4-5 yrs)
Correction: Repair and repaint all interior walls - SF of wall surface
Qty: 5,000.00
Unit of Measure: S.F.
Estimate: \$33,869.39
Assessor Name: Craig Anding
Date Created: 11/02/2015

Notes: There are painted walls, trim, and some painted ceilings in this building. In the older sections of the building, some textured concrete surfaces have been painted. The interior finishes in this school in good to fair condition and will require an almost continuous program of renewal of the applied finishes to maintain an acceptable appearance. The finishes in the new section are in excellent to good condition. Cyclical painting should be considered for a standard approach to maintaining the quality of the interior finishes. It is recommended that all previously painted surfaces be repainted according to established cycles for this occupancy and use type. Minor repairs should be completed before work begins.

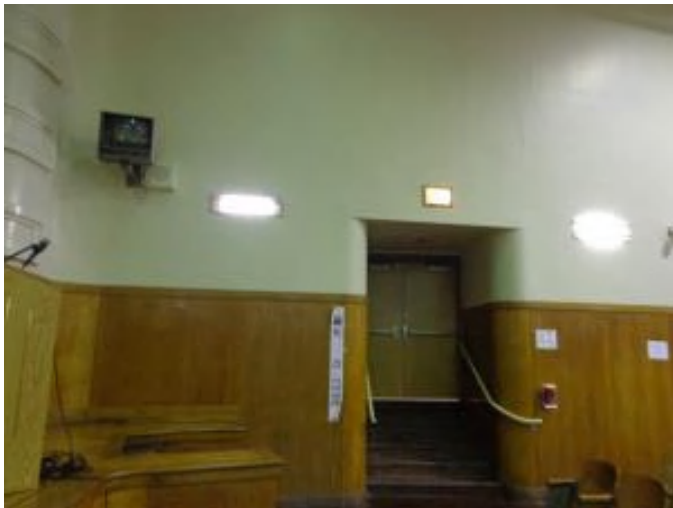
Location: Auditorium
Distress: Maintenance Required
Category: 3 - Operations / Maint.
Priority: 4 - Response Time (4-5 yrs)
Correction: Maintain Lighting Fixtures
Qty: 14.00
Unit of Measure: Ea.
Estimate: \$5,739.21
Assessor Name: Craig Anding
Date Created: 11/24/2015

Notes: In the Auditorium, replace ballasts and T12 fluorescent lamps in all (14) wall mounted fixtures along the sides and back of the room. Replace missing shielding on four (4) wall mounted fixtures.

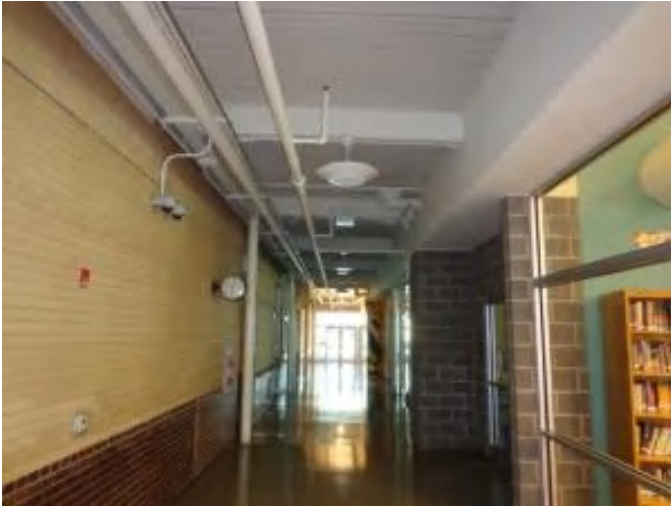
Location: Student Main Street

Student Main Street, which is the corridor running in the east-west direction between the existing 1949 building and the 2008 Addition is illuminated with pendant mounted direct/indirect compact fluorescent fixtures. The Building Engineer reported that the illumination level was too low for the corridor. Additional lighting fixtures are recommended.

Distress: Inadequate

Notes: Provide increased illumination in Student Main Street, which is the corridor running in the east-west direction between the existing 1949 building and the 2008 Addition, by providing additional pendant mounted, direct/indirect compact fluorescent fixtures. Estimate addition of (9) fixtures.

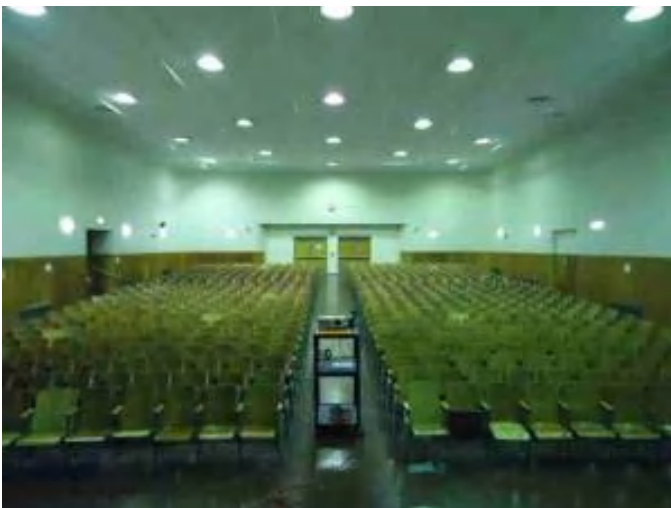
Location: Auditorium

Furnishings include: fixed casework; window shades/blinds; and fixed auditorium seating. The fixed seating for this school is from the original construction. The systems are in fair condition considering the age and usage. This project provides a budgetary consideration for universal upgrades for the fixed seating and furnishing of this school. Ensure that ADA requirements are followed with the new seating layout.

Distress: Damaged

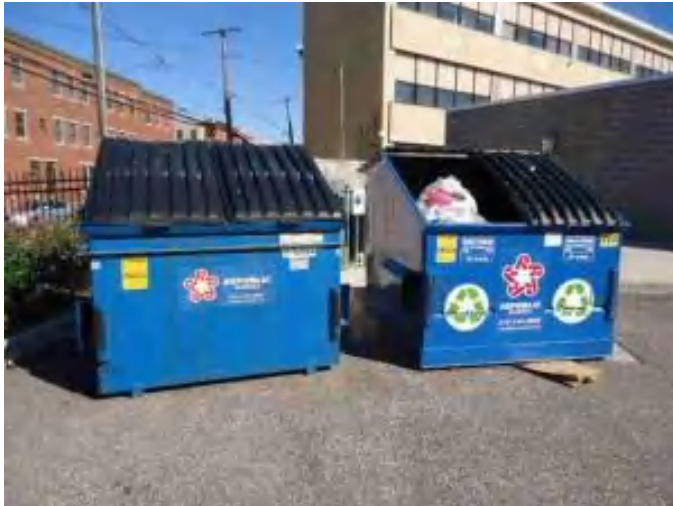
Location: Site

Distress: Health Hazard / Risk

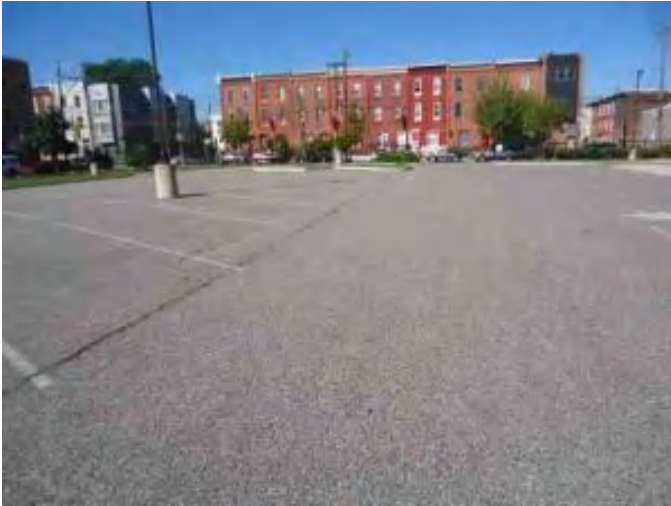
Location: Parking Lot

Distress: Damaged
