Facility Condition Assessment Summary Report

Franklin Learning Center School

S229001; Franklin Learning Center

Final
Site Assessment Report

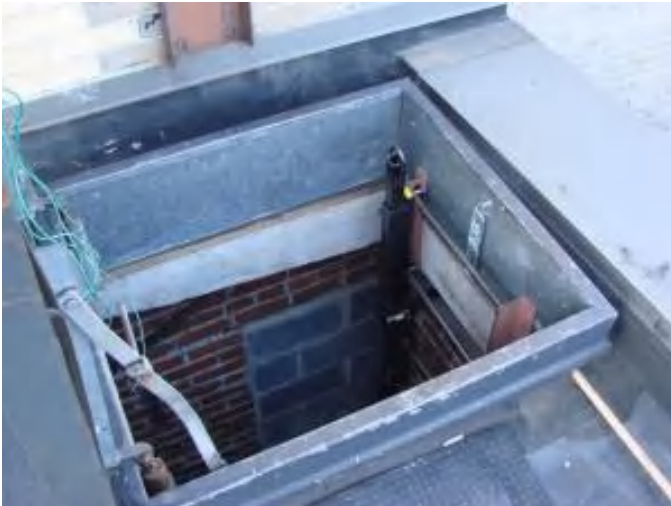
System: B3020 - Roof Openings

Roofing is a combination of shingle covered; sloped roofs and EPDM covered flat roofs. All roofing and flashing is typically in poor condition with some shingles missing and membrane beyond service life. Leaks have not been reported. A roof access hatch is located close to flat roof parapet with no protective guard rails (as required by OSHA).

Distress: Building / MEP Codes

Notes: Provide safety guard rail at roof edge near roof hatch per OSHA requirements

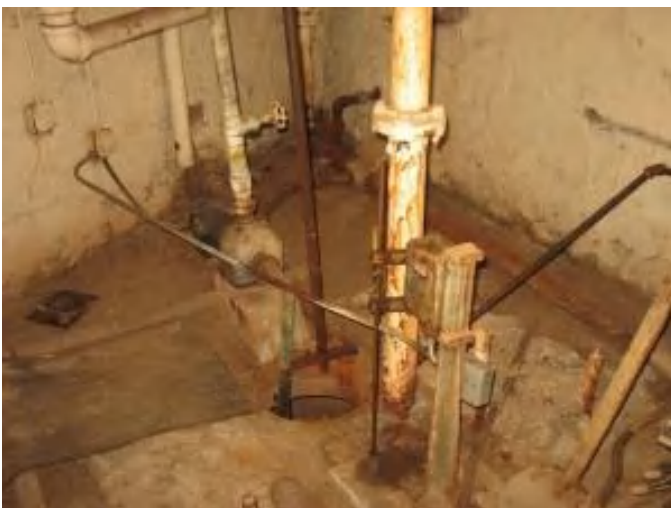
System: D2030 - Sanitary Waste

A sewage ejector pit located in the basement mechanical room receives sewage from the basement area and condensate return pit. It has a single pump that is beyond its service life and was not operational at the time of the site visit. The pump system should be replaced to prevent flooding of the basement. The pit is not sealed, but should be.

Distress: Health Hazard / Risk

Notes: Replace existing sewage ejector pump system and piping in the basement as it is beyond its service life and was not functional during the site visit.

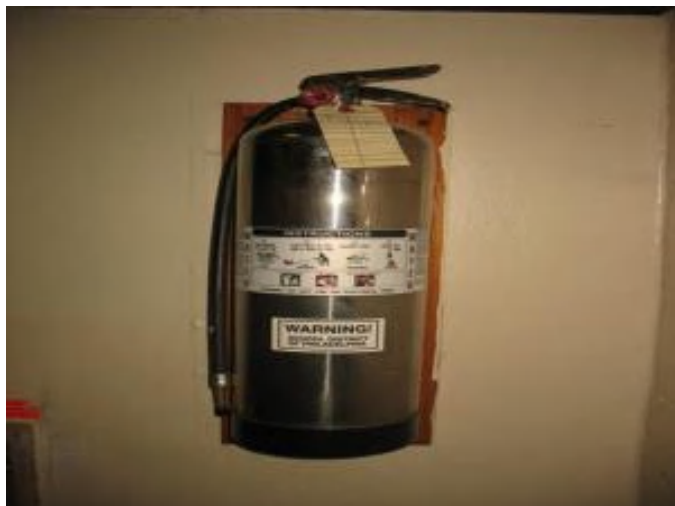
System: D4010 - Sprinklers

Distress: Life Safety / NFPA / PFD

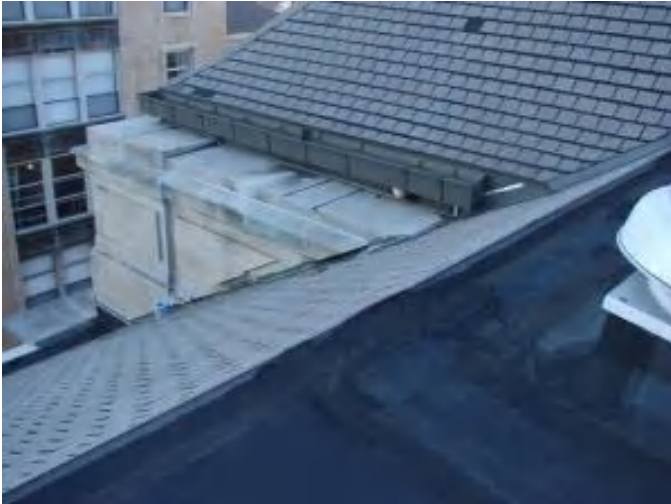
System: B3010105 - Built-Up

Distress: Beyond Service Life

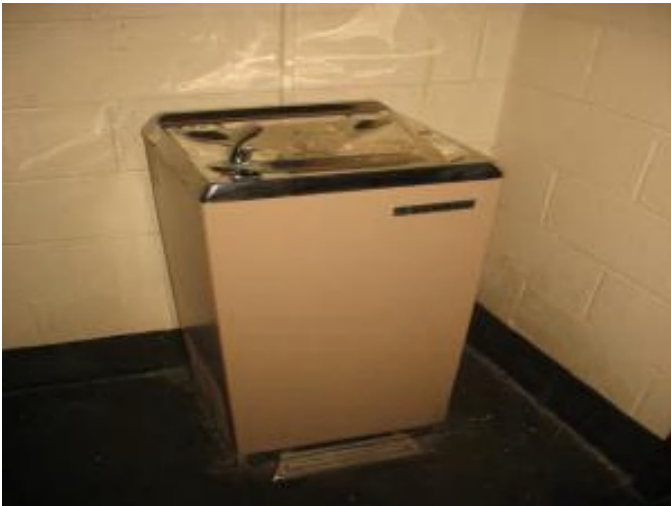
System: D2010 - Plumbing Fixtures

Drinking fountains in the corridors consist of new handicap accessible wall hung fixtures with integral refrigerated coolers and older non-accessible wall hung fixtures with integral refrigerated coolers. The older units are well beyond their service life and should be replaced; these are NOT accessible type.

Distress: Beyond Service Life

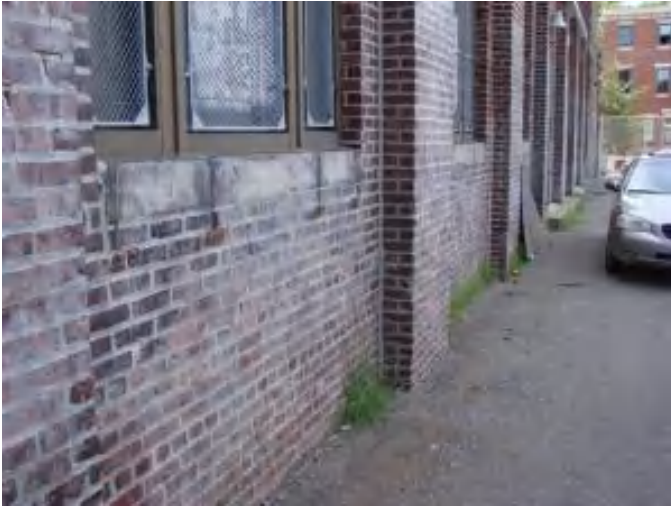
System: B2010 - Exterior Walls

The building envelope is typically masonry with face brick with decorative terracotta friezes and quoining at main entrances doors. In general, masonry is in fair condition with some deteriorated and missing mortar from joints.

Distress: Building Envelope Integrity

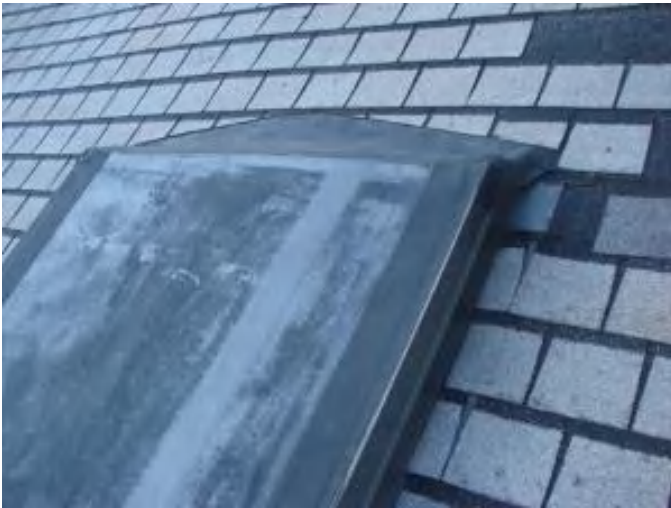
System: B3010140 - Shingle & Tile

Distress: Beyond Service Life

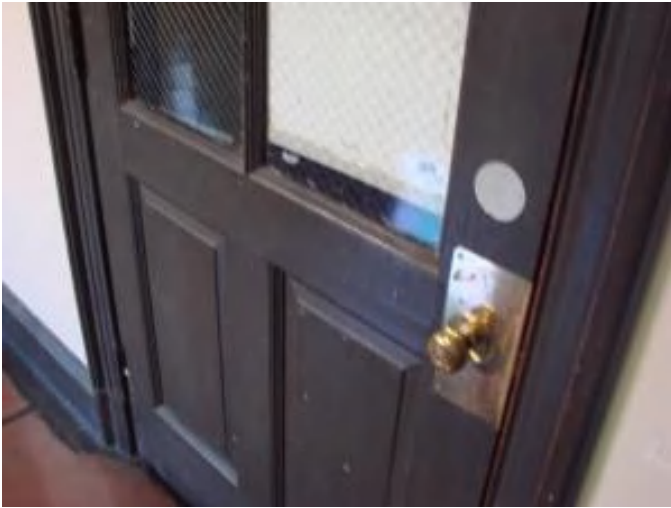
System: C1020 - Interior Doors

Distress: Accessibility

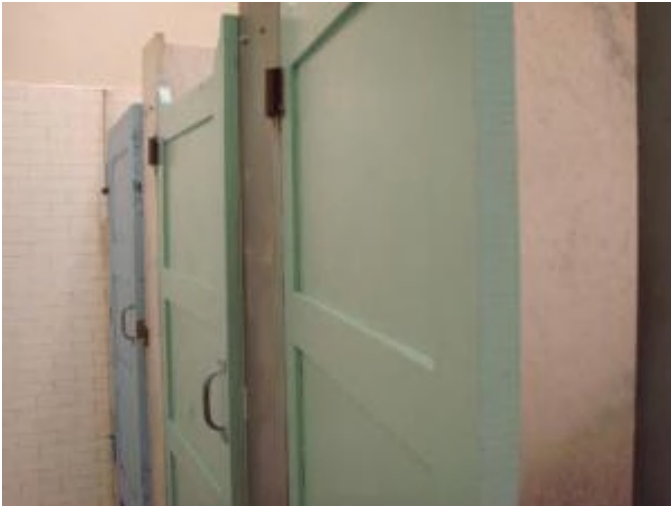
System: C1030 - Fittings

Distress: Beyond Service Life

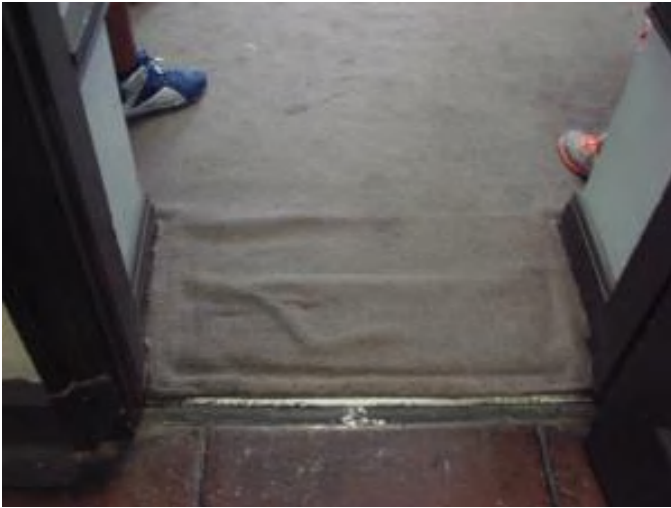
System: C3020411 - Carpet

Location: Interior
Distress: Beyond Service Life
Category: 3 - Operations / Maint.
Priority: 3 - Response Time (3-4 yrs)
Correction: Remove and replace carpet
Qty: 2,900.00
Unit of Measure: S.F.
Estimate: \$32,453.22
Assessor Name: System
Date Created: 12/23/2015

Notes: Replace carpet (various locations)

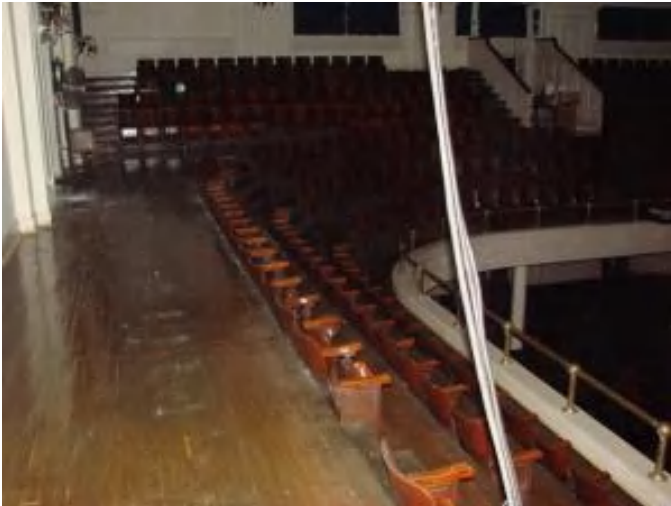
System: C3020414 - Wood Flooring

Flooring in classrooms, and auditorium is generally hardwood, (40% requires refinishing); and patterned concrete in most corridors. Some classrooms have VCT installed in 2012. Floor in toilets is typically ceramic tile installed in 2012. Main entrance hallway floor has a combination of terrazzo and marble finish in good condition.

Location: Interior
Distress: Damaged
Category: 3 - Operations / Maint.
Priority: 3 - Response Time (3-4 yrs)
Correction: Remove and replace partial area of wood flooring and refinish entire floor - set replacement area
Qty: 31,700.00
Unit of Measure: S.F.
Estimate: \$379,431.61
Assessor Name: System
Date Created: 12/23/2015

Notes: Repair (20%) refinish hardwood flooring (60%)

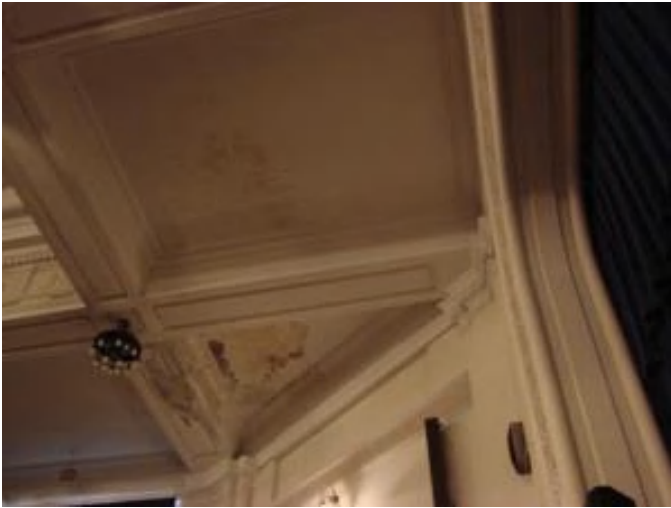
System: C3030 - Ceiling Finishes

Ceilings are a mixture of 2x4 suspended acoustical panels and exposed plastered ceilings; cafeteria and kitchen has 1x1 perforated metal tiles, beyond their service life. Plaster in auditorium shows sign of serious water damage.

Location: Interior
Distress: Beyond Service Life
Category: 3 - Operations / Maint.
Priority: 3 - Response Time (3-4 yrs)
Correction: Repair and resurface plaster ceilings - 2 coats plaster
Qty: 84,000.00
Unit of Measure: S.F.
Estimate: \$499,152.90
Assessor Name: System
Date Created: 12/23/2015

Notes: Repair (10%) and repaint all ceilings

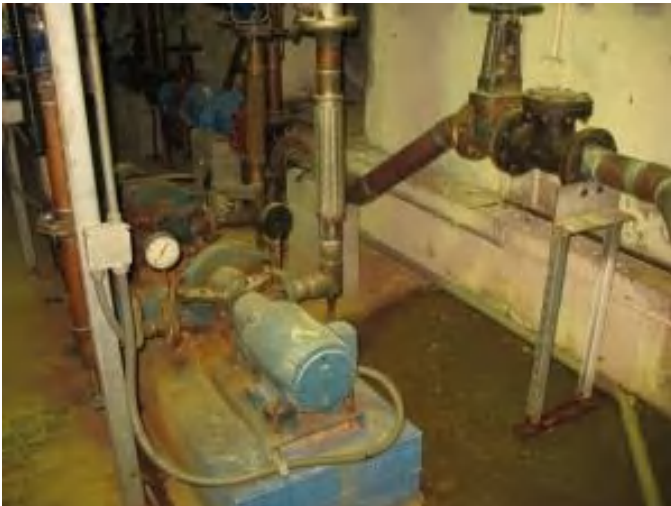
System: D2020 - Domestic Water Distribution

Location: Throughout building
Distress: Beyond Service Life
Category: 3 - Operations / Maint.
Priority: 3 - Response Time (3-4 yrs)
Correction: Replace domestic water piping (150 KSF)
Qty: 150,000.00
Unit of Measure: S.F.
Estimate: \$622,060.37
Assessor Name: System
Date Created: 11/09/2015

Notes: Hire a qualified contractor to perform a detailed inspection of the domestic water piping, in use for an unknown amount of time, and replace any damaged piping.

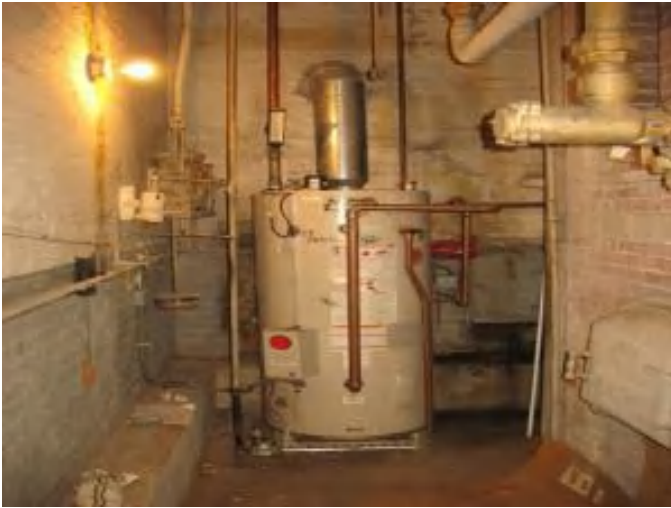
System: D2020 - Domestic Water Distribution

One A.O. Smith Master Fit gas fired, 80 gallon, vertical hot water heater with circulating pump supplies hot water for domestic use. The unit is located in the mechanical room on the basement level and has an installation date of 2005. The hot water heater is equipped with a T&P relief valve. The domestic hot water heater is reaching the end of its service life and should be replaced in the next 1-3 years.

Distress: Beyond Service Life

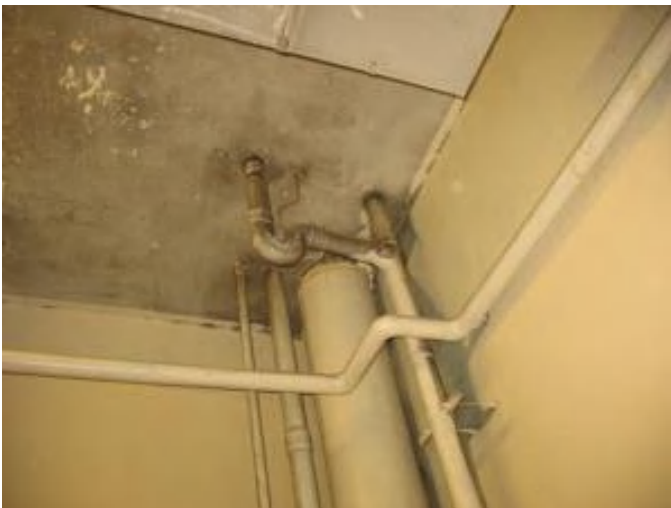
System: D2030 - Sanitary Waste

Sanitary Waste - The original sanitary sewer piping is still in use and is a mixture of threaded galvanized piping and cast iron with hub and spigot fittings. Some repairs have been made with HDPE piping with no-hub fittings.

The maintenance staff reported mostly minor problems with the sanitary waste piping systems. The original sewer piping has been in service for over 100 years and will require more frequent attention from the maintenance staff as time passes. The District should hire a qualified contractor to examine the sanitary waste piping using video cameras to locate and replace any damaged piping and to further quantify the extent of potential failures.

Distress: Beyond Service Life

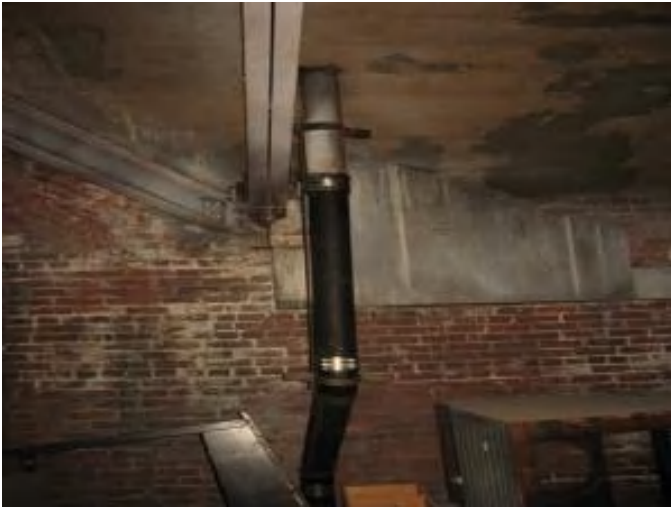
System: D2040 - Rain Water Drainage

Rain Water Drainage - Rain water drains from the roof are routed through mechanical chases in the building and appear to be original. Some of the original galvanized piping has been repaired with HDPE piping and no-hub fittings. External PVC rain leaders are installed in the internal courtyard of the building. The Building Engineer reported that rain leaders leak in several places within the building. The District should hire a qualified contractor to examine the rain water drainage piping using video cameras to locate and replace any damaged piping and to further quantify the extent of potential failures.

Distress: Beyond Service Life

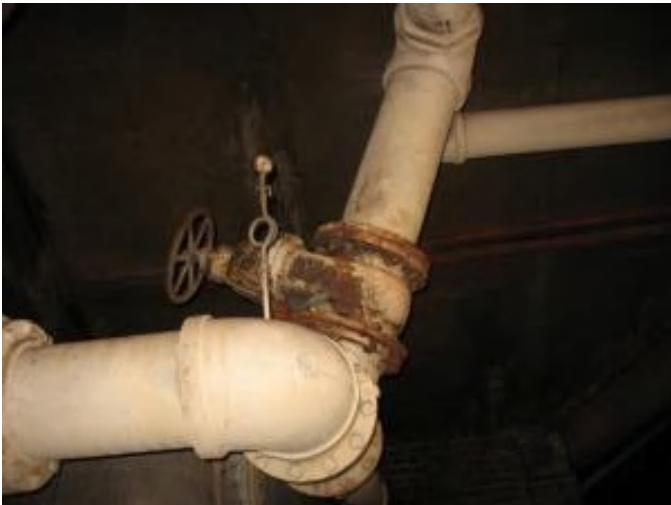
System: D3040 - Distribution Systems

Steam piping mains from the basement level run up through the building to the radiators and air handling units (AHUs) on all four floors. The distribution piping has been in use well beyond its service life and will require more frequent attention from the maintenance staff to address pipe/valve failures as time passes. The District should hire a qualified contractor to examine the steam piping and perform additional testing to locate and replace any damaged piping and to further quantify the extent of potential failures. The District should budget for replacing this piping over the next 10 years.

Distress: Beyond Service Life

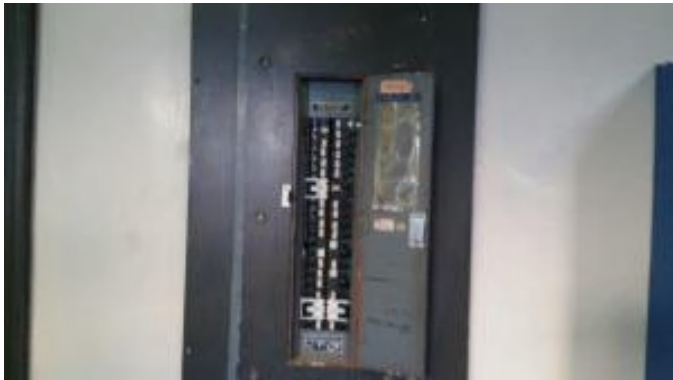
System: D5010 - Electrical Service/Distribution

Location: throughout the building
Distress: Beyond Service Life
Category: 3 - Operations / Maint.
Priority: 3 - Response Time (3-4 yrs)
Correction: Replace Electrical Distribution System (U)
Qty: 1.00
Unit of Measure: Ea.
Estimate: \$436,291.13
Assessor Name: System
Date Created: 12/17/2015

Notes: Install a new Distribution system throughout the building for lighting, receptacles loads.

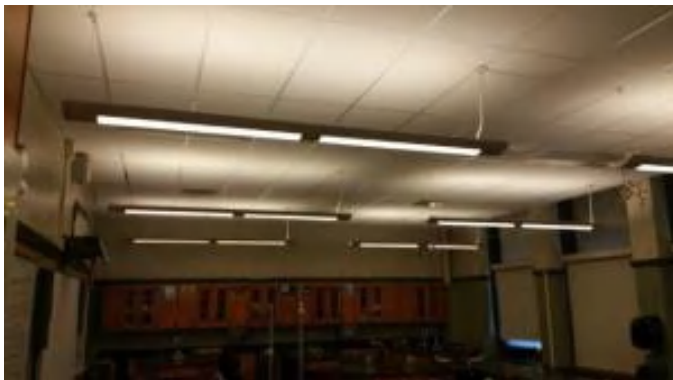
System: D5020 - Lighting and Branch Wiring

Location: throughout the building
Distress: Beyond Service Life
Category: 3 - Operations / Maint.
Priority: 3 - Response Time (3-4 yrs)
Correction: Replace Lighting Fixtures (SF)
Qty: 0.00
Unit of Measure: S.F.
Estimate: \$1,562,116.46
Assessor Name: System
Date Created: 12/17/2015

Notes: Install a new lighting system for the entire building

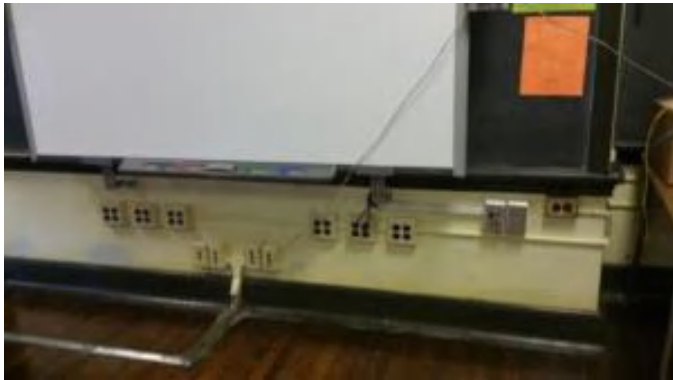
System: D5020 - Lighting and Branch Wiring

Distress: Beyond Service Life

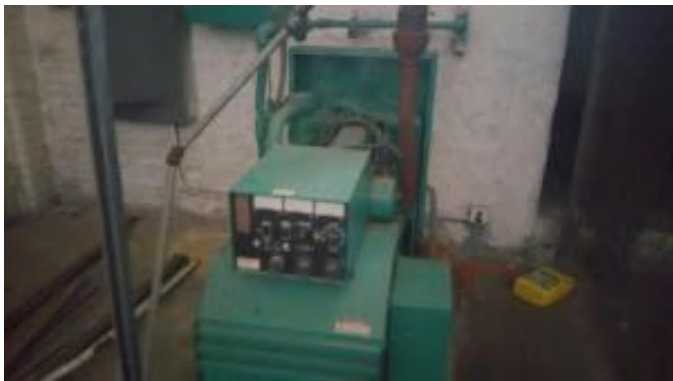
System: D5090 - Other Electrical Systems

Distress: Inadequate

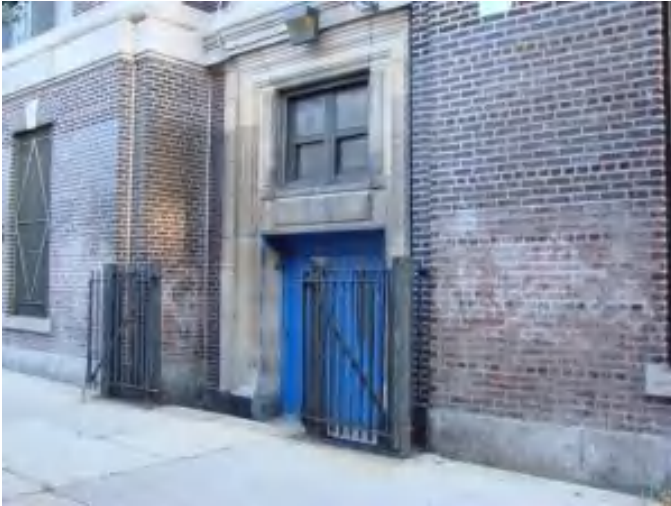
System: B2030 - Exterior Doors

Exterior doors are typically hollow metal in fair to poor condition with peeling paint and rusting. They are beyond their service life. The main entrance doors are heavy wood and frame with transoms. Both, doors and frames are ornamented, with metal screens and wire glazing; they are in various stages of deterioration and in need of restoration or replacement.

Distress: Beyond Service Life

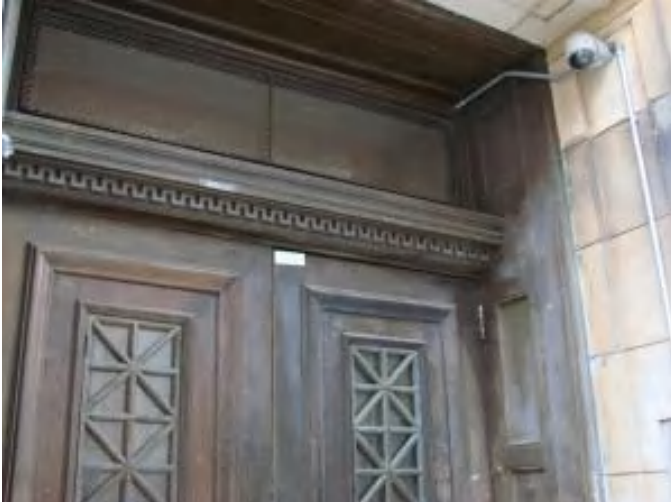
System: B2030 - Exterior Doors

Distress: Damaged

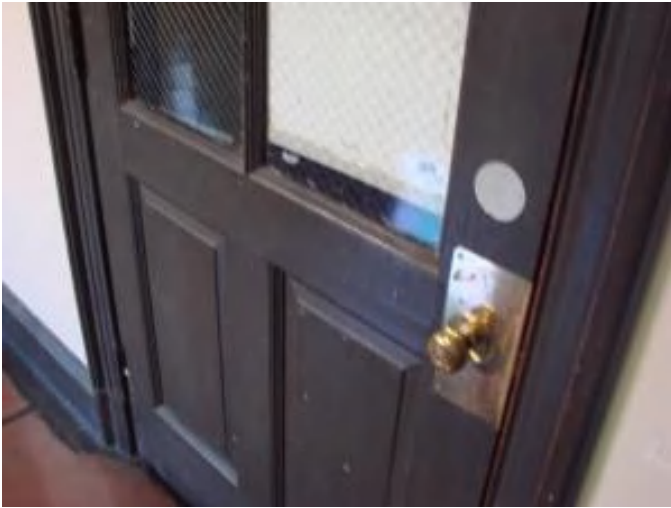
System: C1020 - Interior Doors

Location: Interior
Distress: Beyond Service Life
Category: 3 - Operations / Maint.
Priority: 4 - Response Time (4-5 yrs)
Correction: Remove and replace interior doors - wood doors with wood frame - per leaf
Qty: 150.00
Unit of Measure: Ea.
Estimate: \$698,150.85
Assessor Name: System
Date Created: 12/23/2015

Notes: Replace interior doors

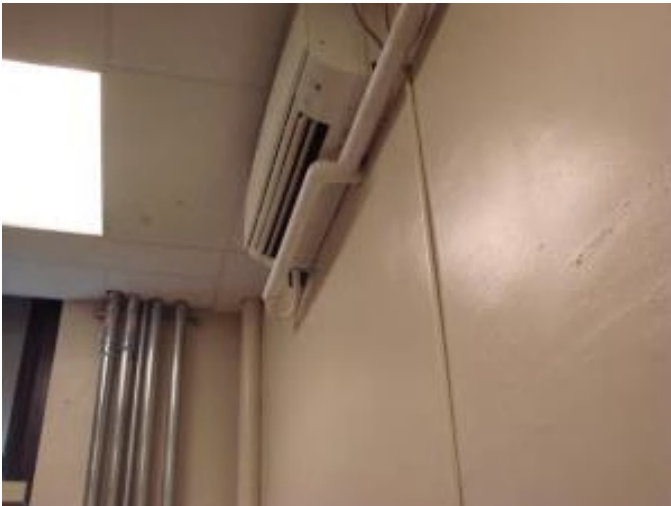
System: C3010230 - Paint & Covering

The interior wall finishes are generally painted plaster or CMU and some painted brick. Walls in toilets are covered with ceramic tile installed in 2012. Generally, paint is in fair condition with some deterioration in stairways and other spaces.

Location: Interior
Distress: Appearance
Category: 3 - Operations / Maint.
Priority: 4 - Response Time (4-5 yrs)
Correction: Repair and repaint all interior walls - SF of wall surface
Qty: 180,000.00
Unit of Measure: S.F.
Estimate: \$999,698.76
Assessor Name: System
Date Created: 12/23/2015

Notes: Repair (15%) and repaint all walls

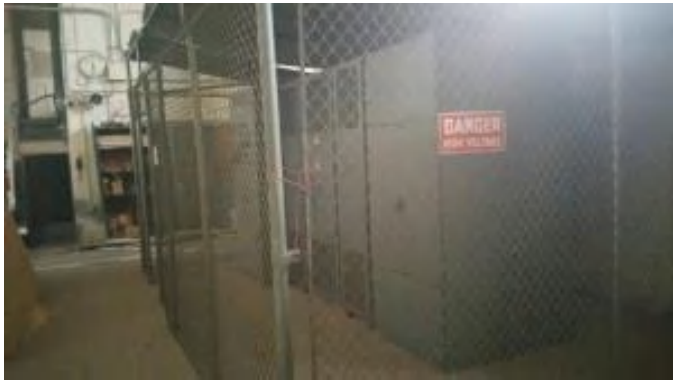
System: D5010 - Electrical Service/Distribution

Distress: Inadequate

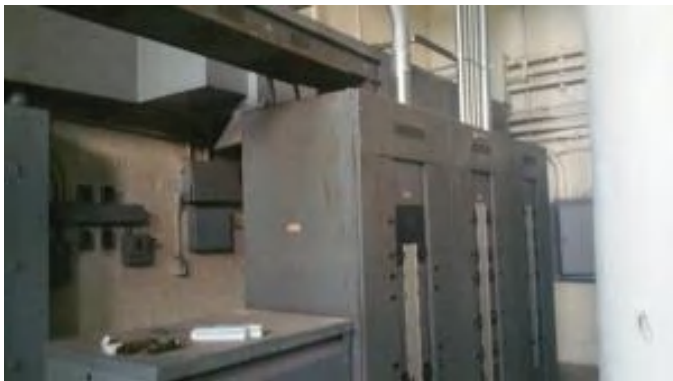
System: D5010 - Electrical Service/Distribution

Distress: Inadequate

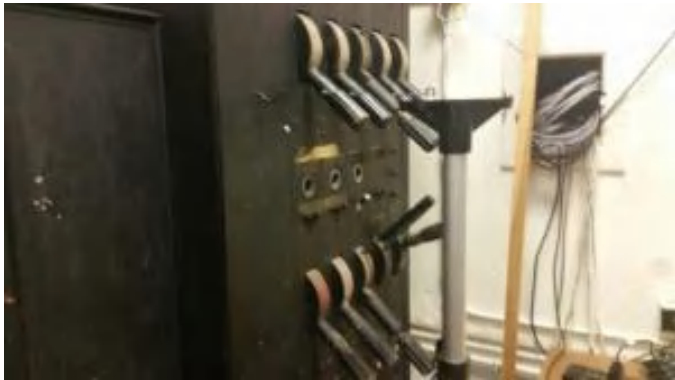
System: D5020 - Lighting and Branch Wiring

Location: throughout the building
Distress: Inadequate
Category: 4 - Capital Improvement
Priority: 4 - Response Time (4-5 yrs)
Correction: Add Lighting Fixtures
Qty: 1.00
Unit of Measure: Ea.
Estimate: \$50,507.79
Assessor Name: System
Date Created: 12/17/2015

Notes: Install a new auditorium stage lighting and controls

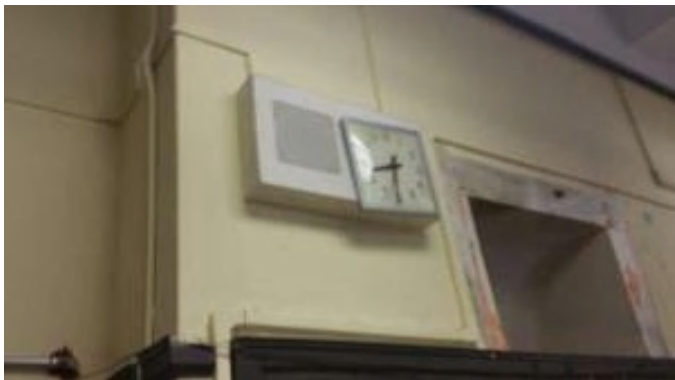
System: D5030 - Communications and Security

Location: throughout the building
Distress: Beyond Service Life
Category: 3 - Operations / Maint.
Priority: 4 - Response Time (4-5 yrs)
Correction: Add/Replace Clock System or Components
Qty: 0.00
Unit of Measure: Ea.
Estimate: \$225,120.45
Assessor Name: System
Date Created: 12/17/2015

Notes: Install a new Clock System

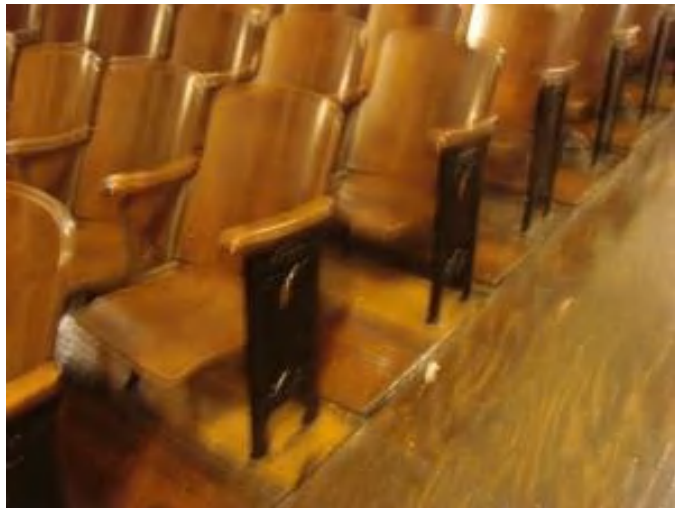
System: E2010 - Fixed Furnishings

Furnishings include fixed casework in classrooms, corridors and offices, generally in good condition; window shades/blinds, generally in good condition; fixed auditorium seating is original, generally in fair to poor condition; some seats are damaged.

Distress: Damaged

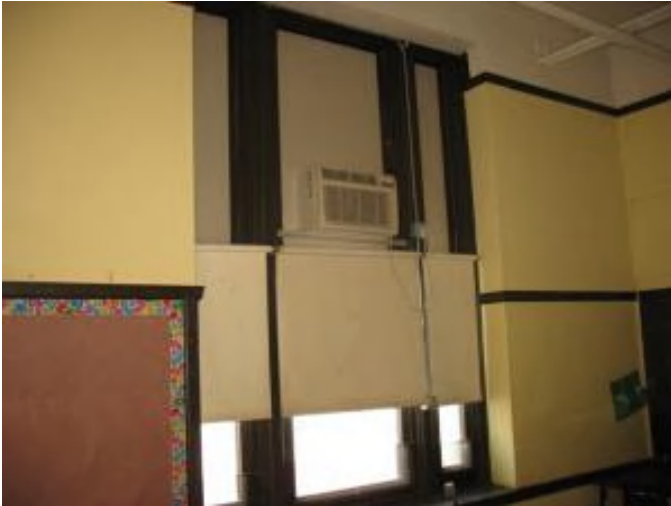
System: D3030 - Cooling Generating Systems

Terminal & Package Units - Several of the classrooms in the school building have window air conditioning units that have an anticipated service life of only 10 years. Installing a 400 ton air-cooled chiller with pumps located in a mechanical room and chilled water distribution piping would supply more reliable air conditioning for the building with a much longer service life.

Distress: Inadequate

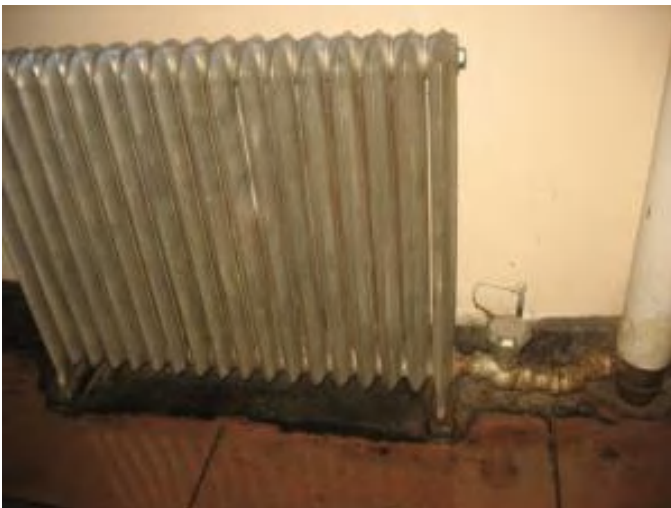
System: D3040 - Distribution Systems

Distress: Building / MEP Codes

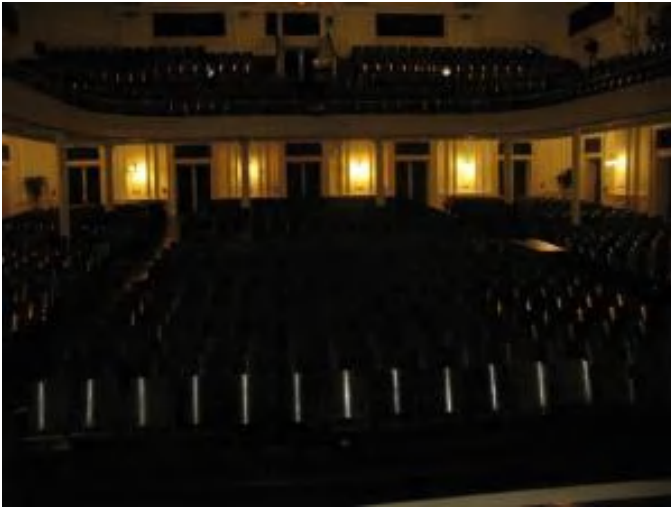
System: D3040 - Distribution Systems

Distress: Building / MEP Codes

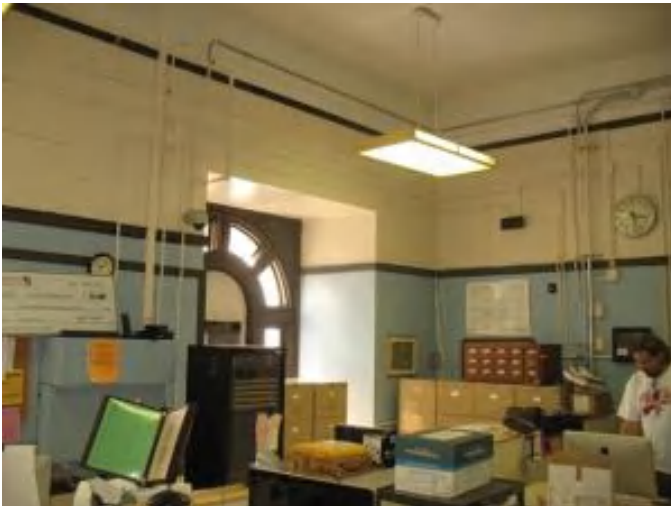
System: D3040 - Distribution Systems

Distress: Building / MEP Codes

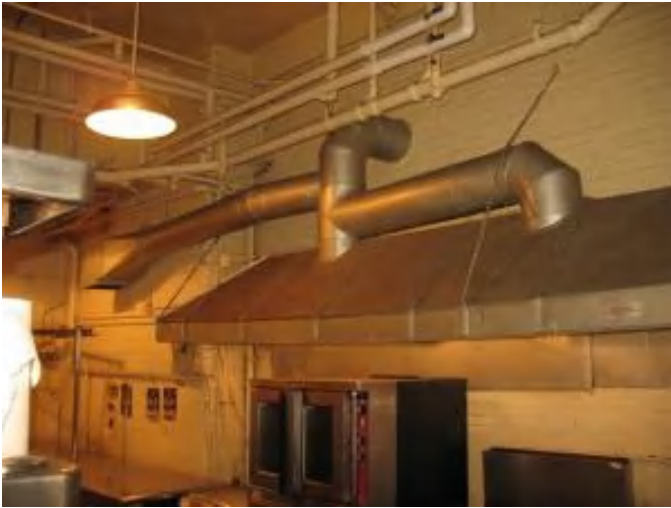
System: D3040 - Distribution Systems

Distress: Building / MEP Codes

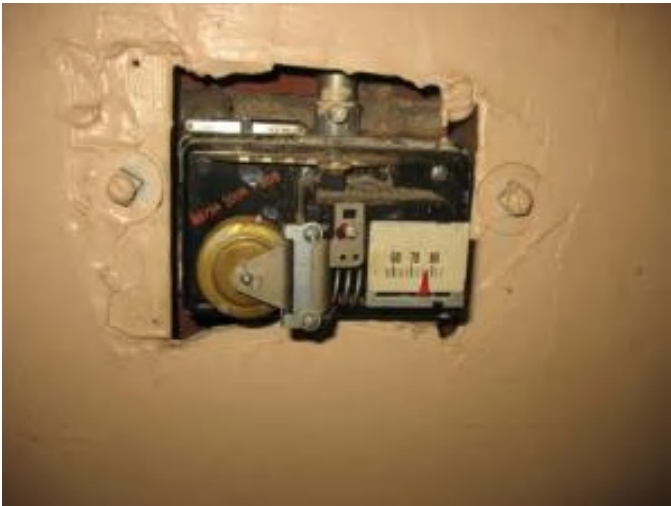
System: D3060 - Controls & Instrumentation

Distress: Inadequate

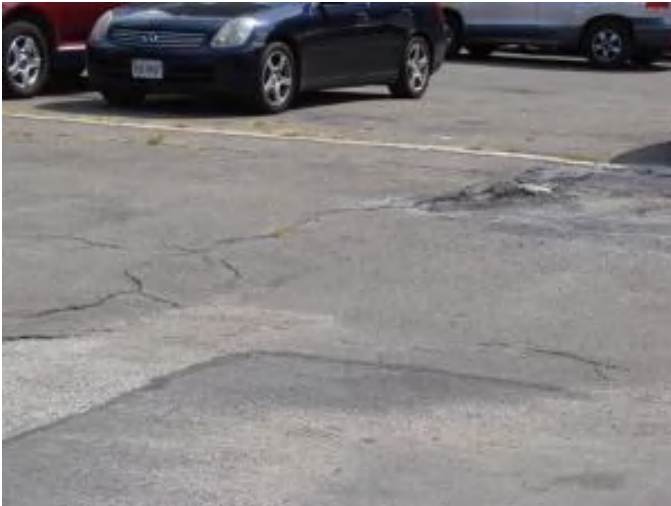
System: G2020 - Parking Lots

Distress: Beyond Service Life

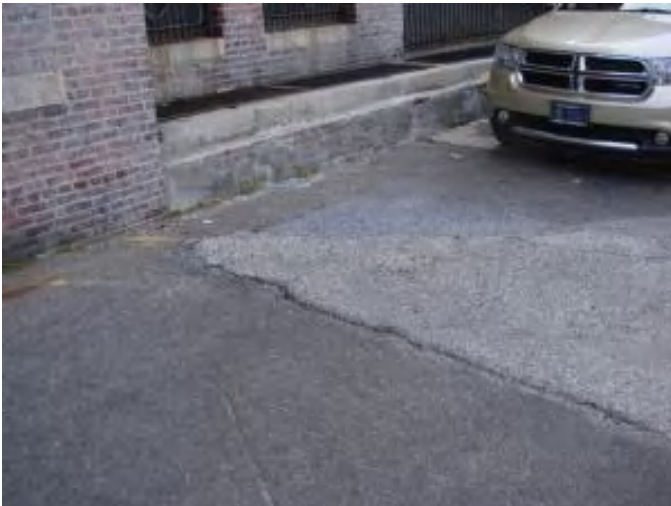
System: G2020 - Parking Lots

Distress: Beyond Service Life

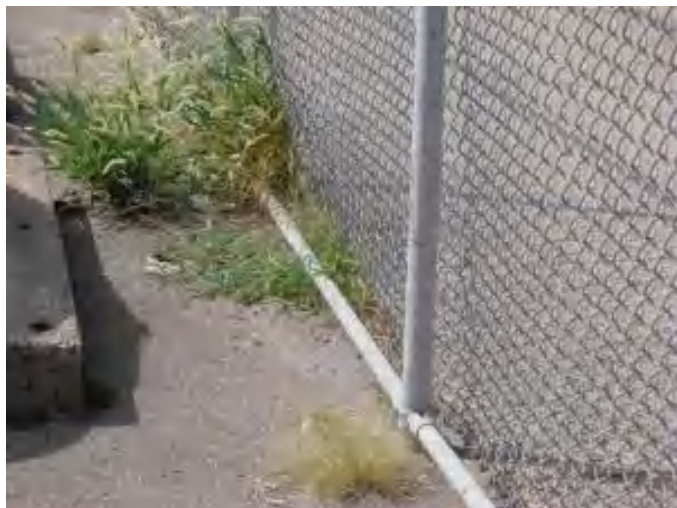
System: G2040 - Site Development

Chain link fence along east property line is damaged and rusting. There is no playground or landscaping.

Distress: Security Issue
