### Farrell School

**S838001;Farrell**

**Site Assessment Report**

January 31, 2017

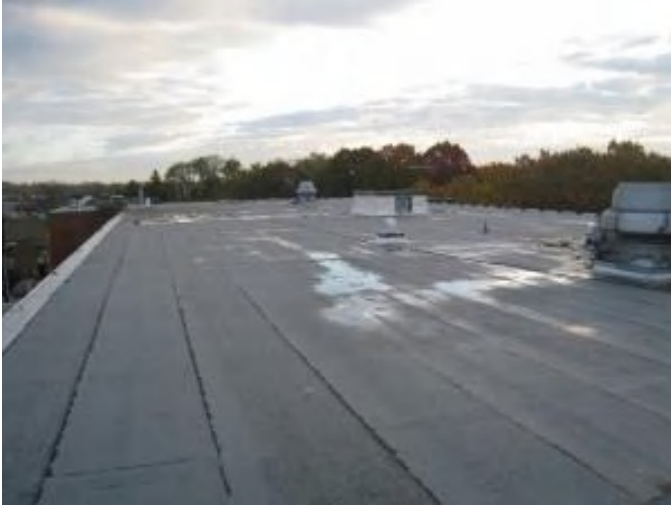
#### **System: B3010105 - Built-Up**

**Location:** roofs

**Distress:** Failing

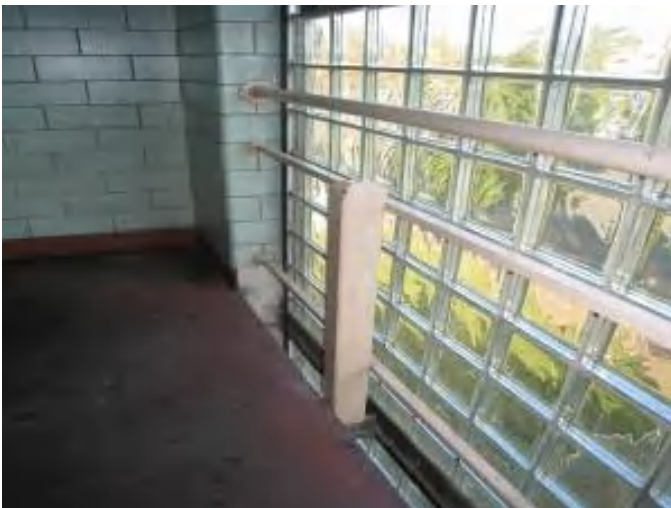
#### **System: C2010 - Stair Construction**

**Location:** stairways

**Distress:** Building / MEP Codes

**Notes:** Replace stairway handrails and guards with code compliant systems (220ft rail; 320ft rail+guard)

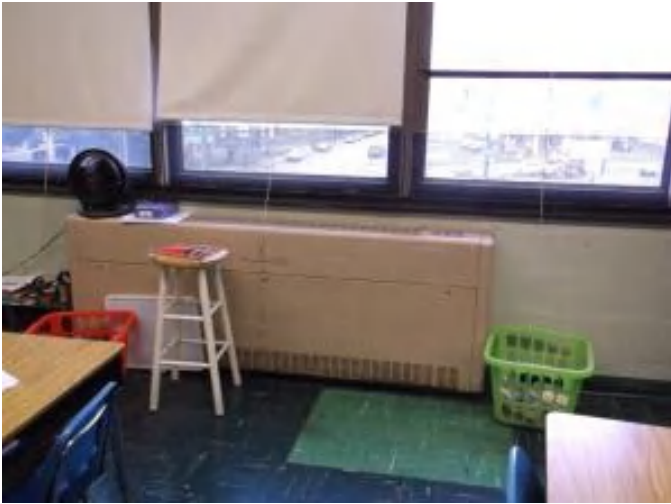
**System: D3040 - Distribution Systems**

**Location:** Throughout the building

**Distress:** Beyond Service Life

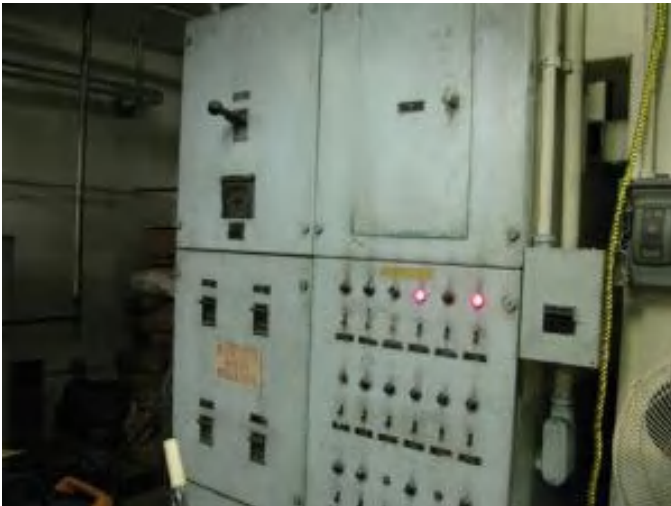
**System: D5010 - Electrical Service/Distribution**

**Location:** Electrical Room

**Distress:** Beyond Service Life

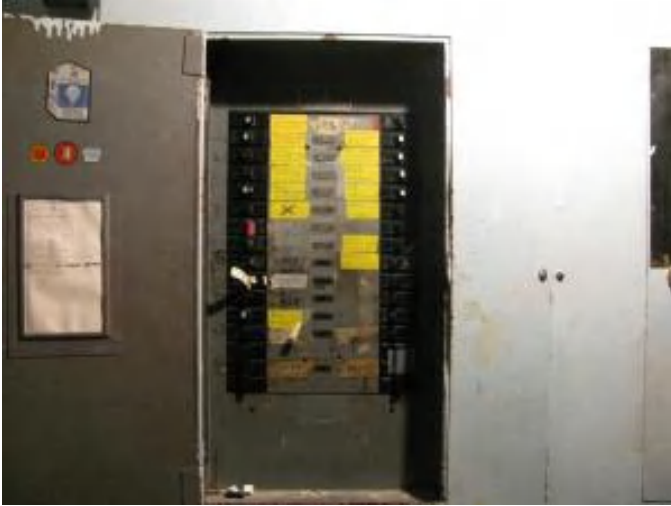
**System: D5010 - Electrical Service/Distribution**

**Location:** Entire Building

**Distress:** Beyond Service Life

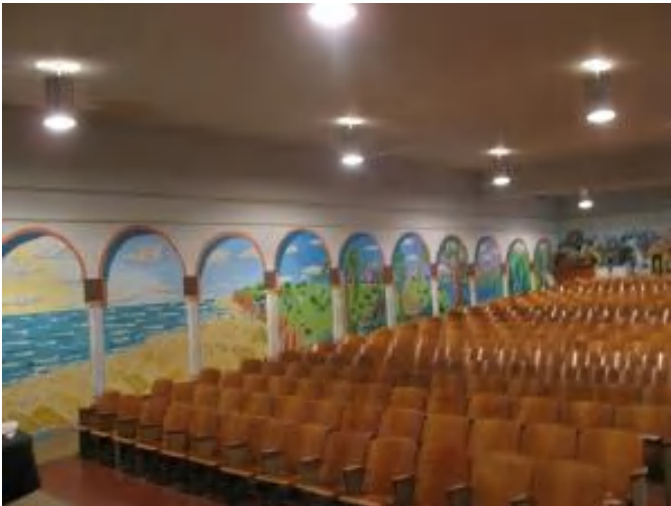
**System: D5020 - Lighting and Branch Wiring**

**Location:** B838001;Farrell

**Distress:** Beyond Service Life

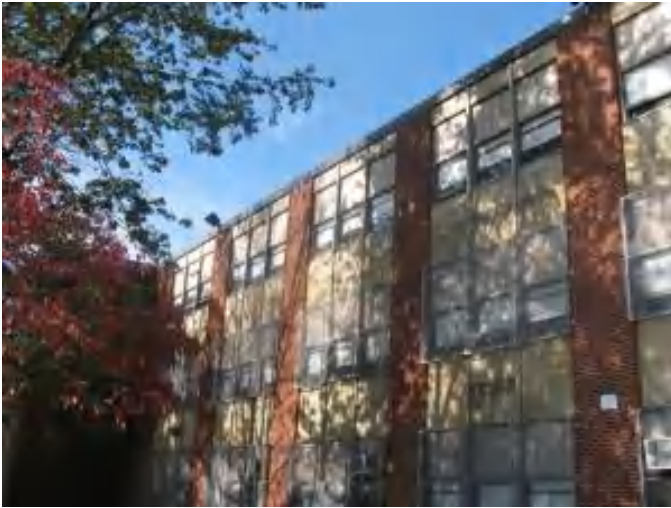
**System: D5030 - Communications and Security**

**Location:** Entire Building

**Distress:** Life Safety / NFPA / PFD

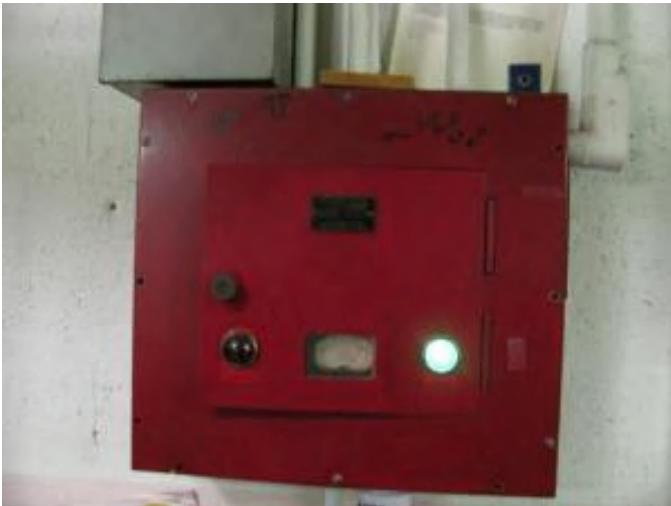
**System: D5030 - Communications and Security**

**Location:** Entire Building

**Distress:** Beyond Service Life

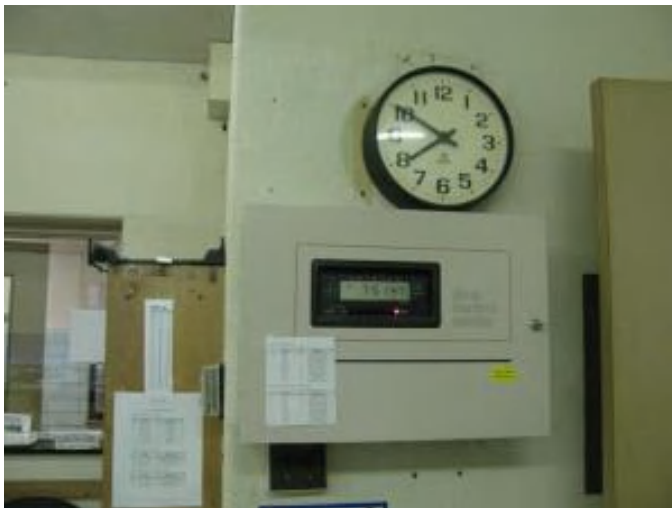
**System: D5030 - Communications and Security**

**Location:** B838001;Farrell

**Distress:** Damaged

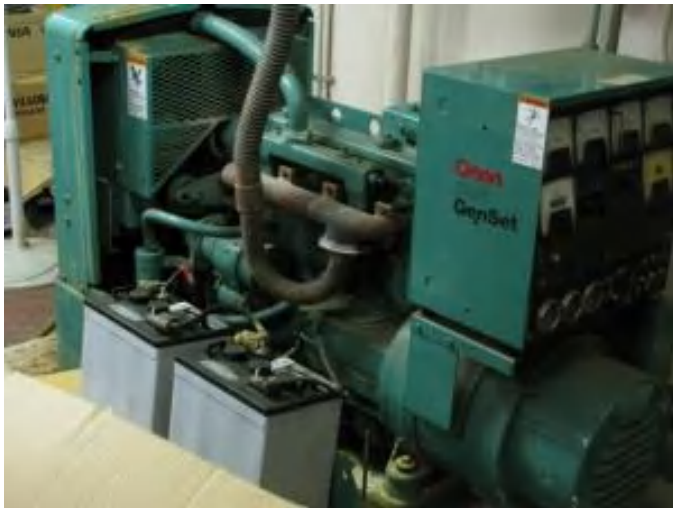
**System: D5090 - Other Electrical Systems**

**Location:** Boiler Room

**Distress:** Beyond Service Life

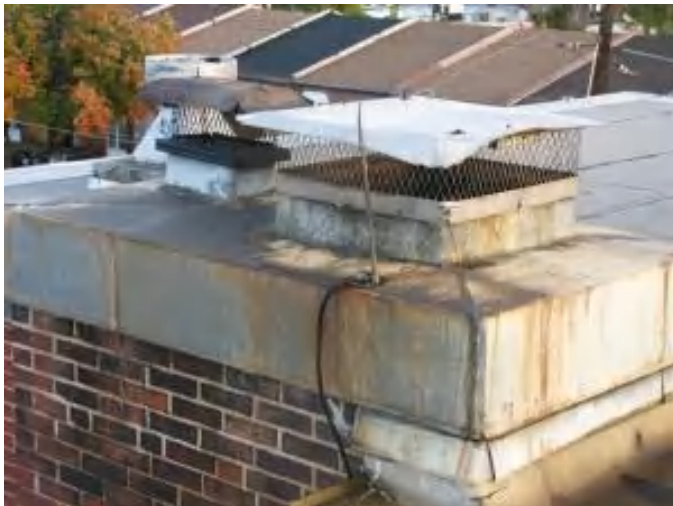
**System: D5090 - Other Electrical Systems**

**Location:** Roof

**Distress:** Life Safety / NFPA / PFD

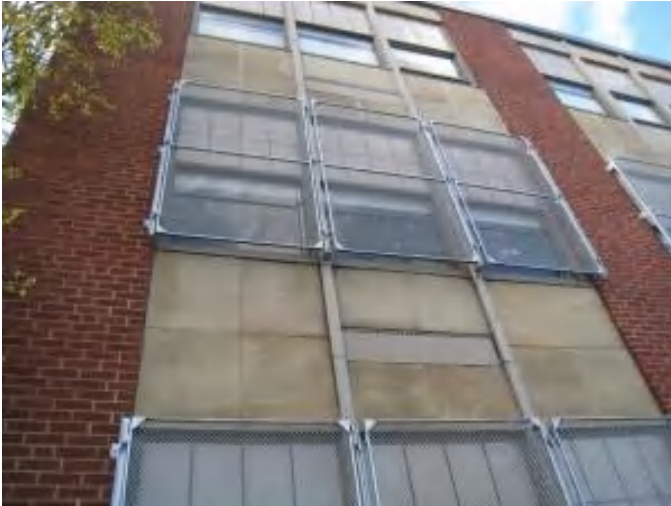
**System: B2010 - Exterior Walls**

**Location:** exterior - limestone panels

**Distress:** Building Envelope Integrity

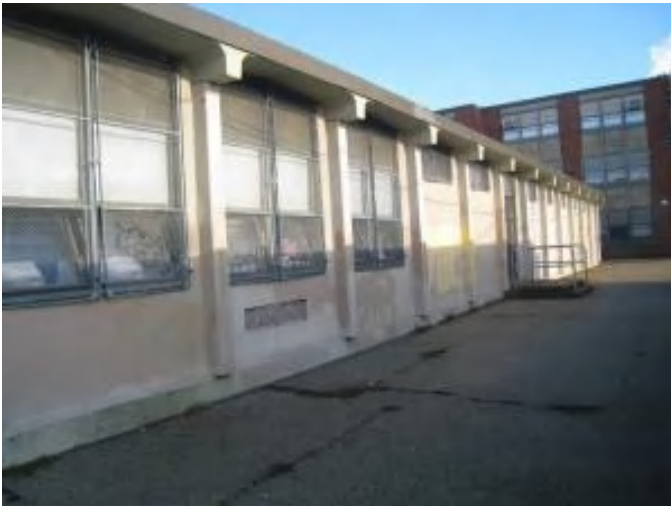
**System: B2010 - Exterior Walls**

**Location:** Annex exterior walls

**Distress:** Appearance

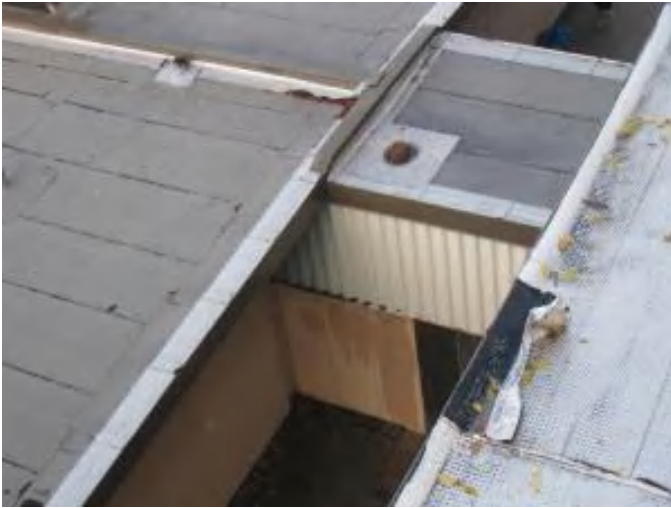
**System: B2010 - Exterior Walls**

**Location:** exterior of Annex vestibule

**Distress:** Appearance

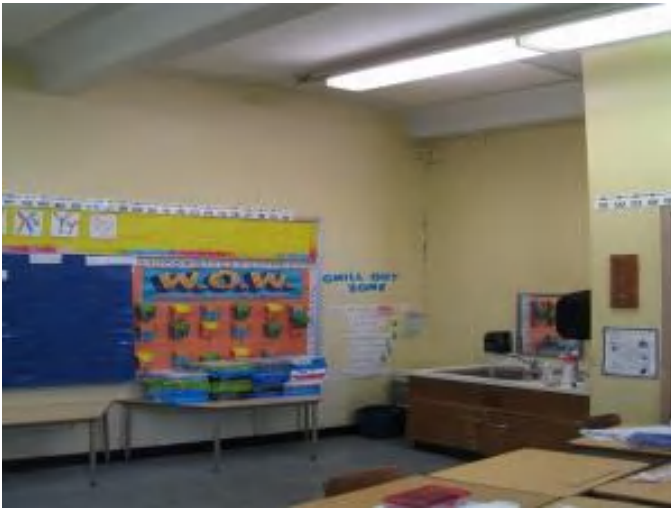
**System: B2010 - Exterior Walls**

**Location:** interior block walls

**Distress:** Damaged

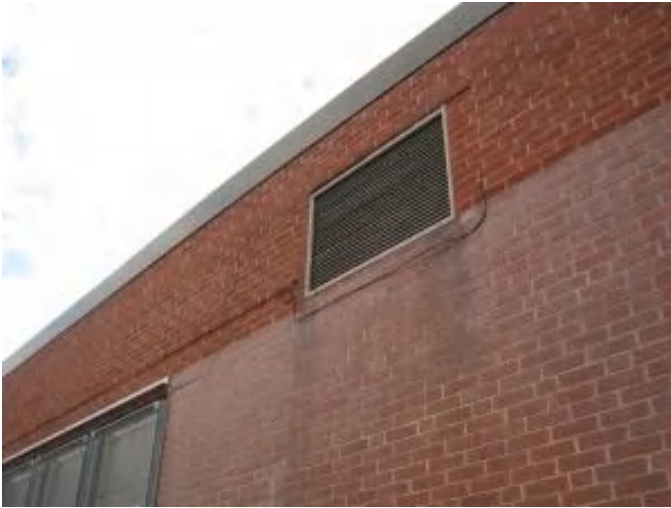
**System: B2010 - Exterior Walls**

**Location:** exterior walls

**Distress:** Building Envelope Integrity

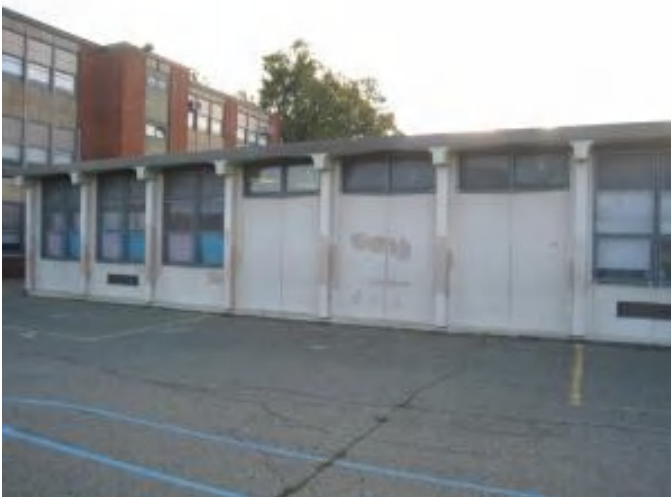
**System: B2020 - Exterior Windows**

**Location:** exterior walls

**Distress:** Failing

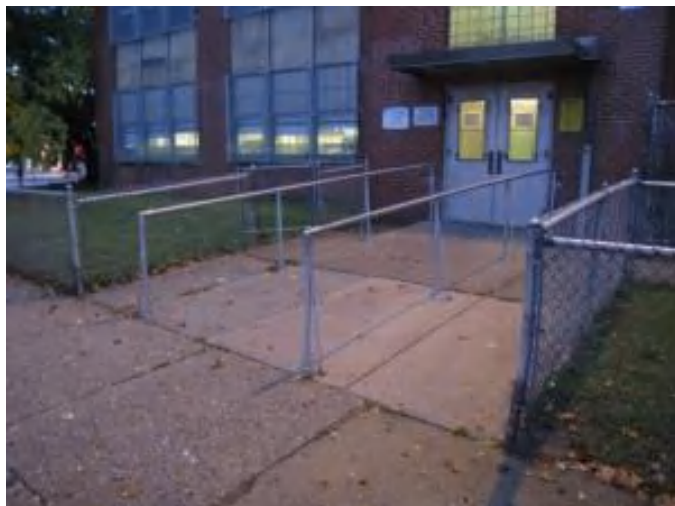
**System: B2030 - Exterior Doors**

**Location:** exterior walls

**Distress:** Damaged

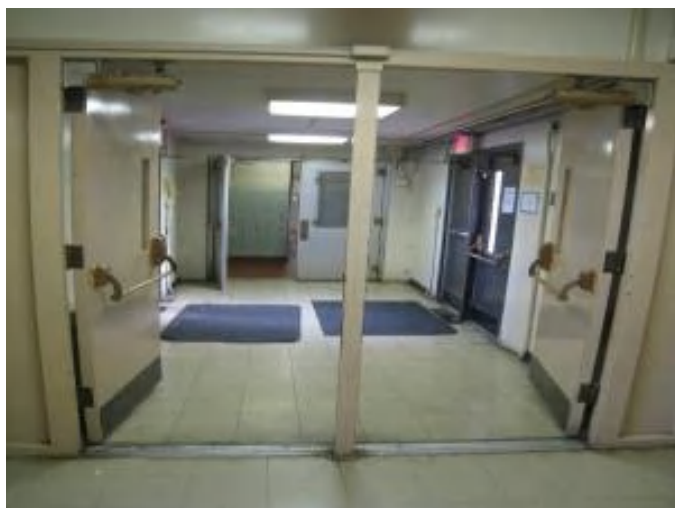
**System: C1020 - Interior Doors**

**Location:** corridor doors

**Distress:** Building / MEP Codes

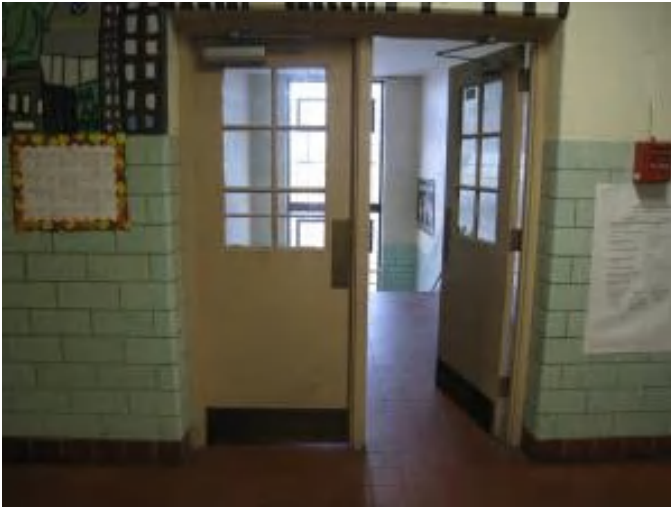
**System: C1020 - Interior Doors**

**Location:** mechanical rooms and stairs

**Distress:** Building / MEP Codes

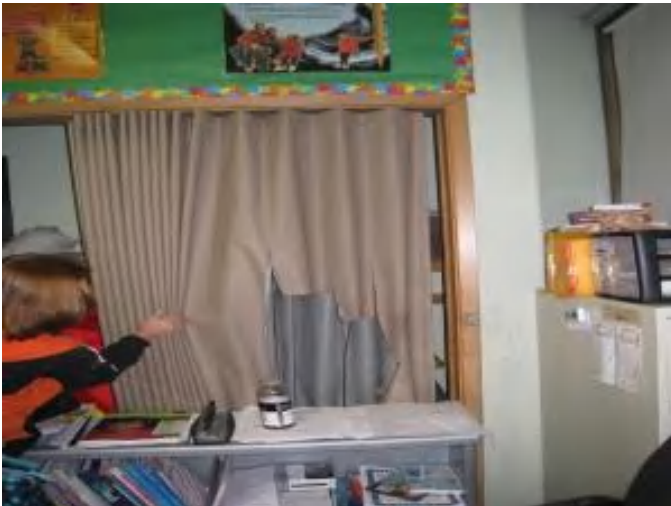
**System: C1020 - Interior Doors**

**Location:** closets / storage areas

**Distress:** Damaged

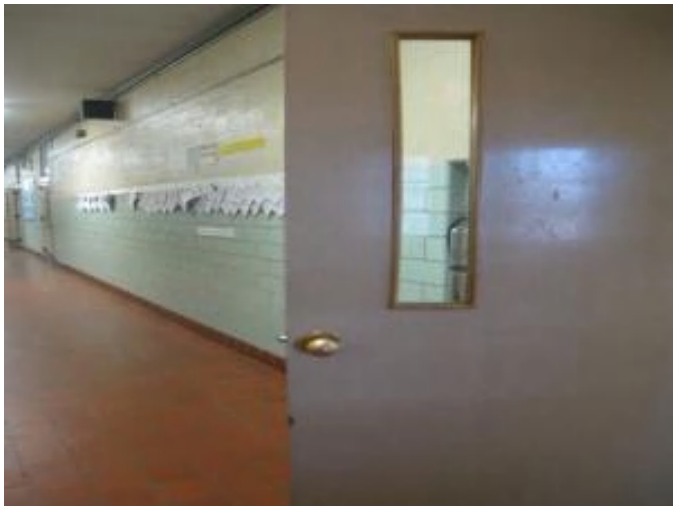
**System: C1020 - Interior Doors**

**Location:** classroom and office doors

**Distress:** Security Issue

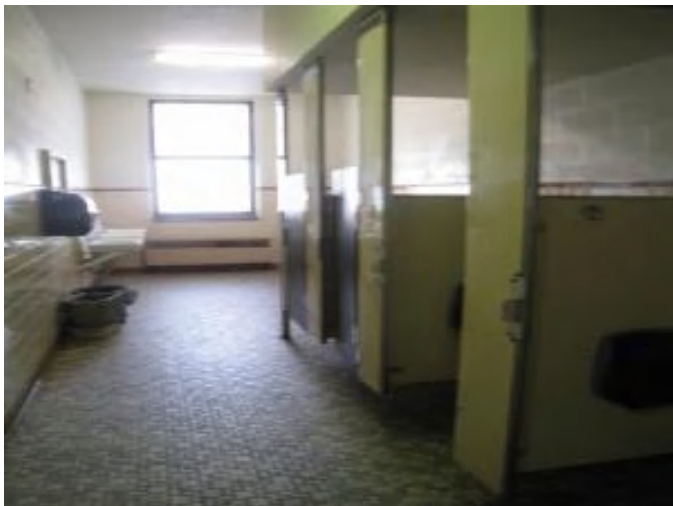
**System: C1030 - Fittings**

**Location:** toilet rooms

**Distress:** Damaged

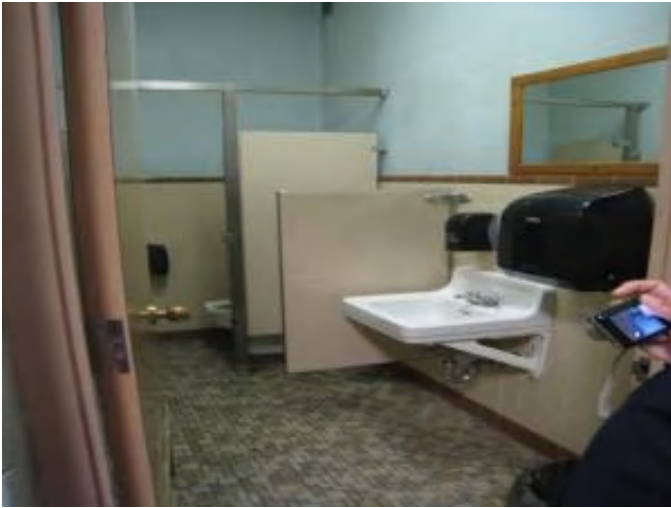
**System: C1030 - Fittings**

**Location:** toilet rooms

**Distress:** Inadequate

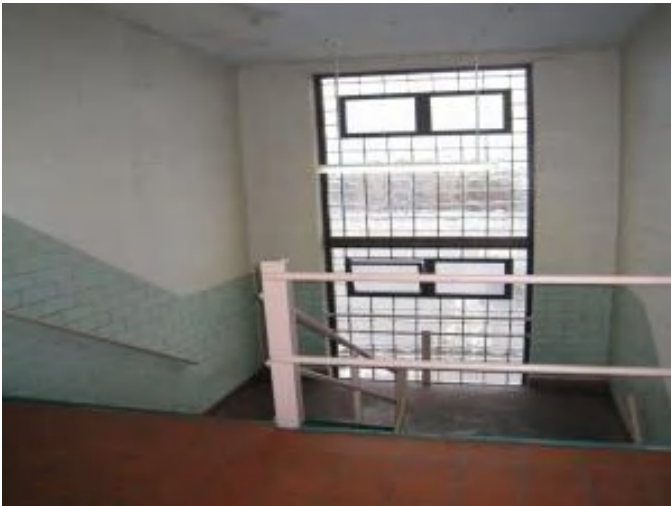
**System: C3010230 - Paint & Covering**

**Location:** interior block walls

**Distress:** Appearance

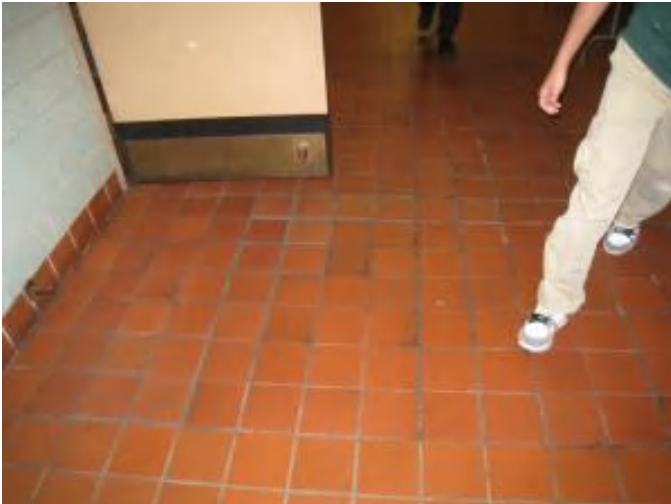
**System: C3020412 - Terrazzo & Tile**

**Location:** 2nd floor corridor

**Distress:** Failing

**Notes:** Replace second floor quarry tile with VCT (3,000sf)

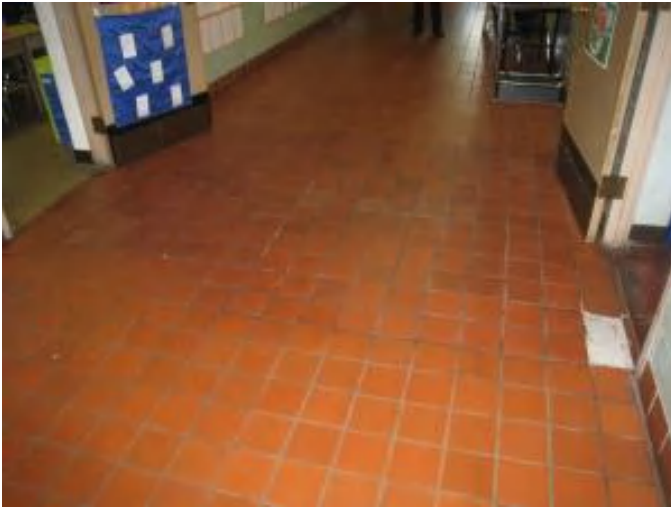
**System: C3020412 - Terrazzo & Tile**

**Location:** corridors with quarry tile

**Distress:** Damaged

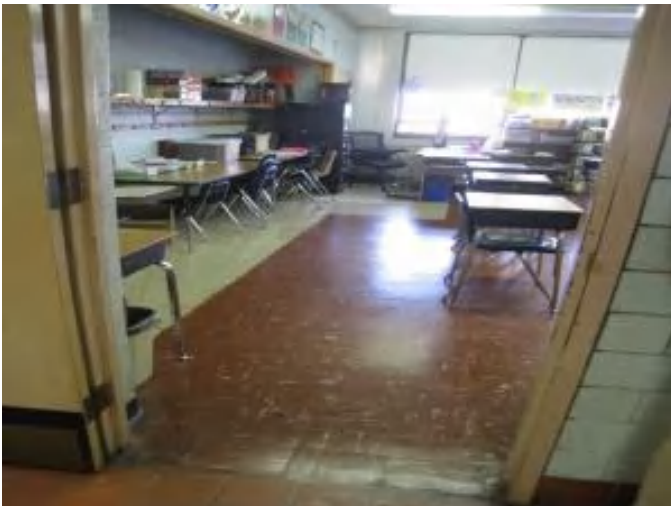
**System: C3020413 - Vinyl Flooring**

**Location:** classroom, office, auditorium

**Distress:** Failing

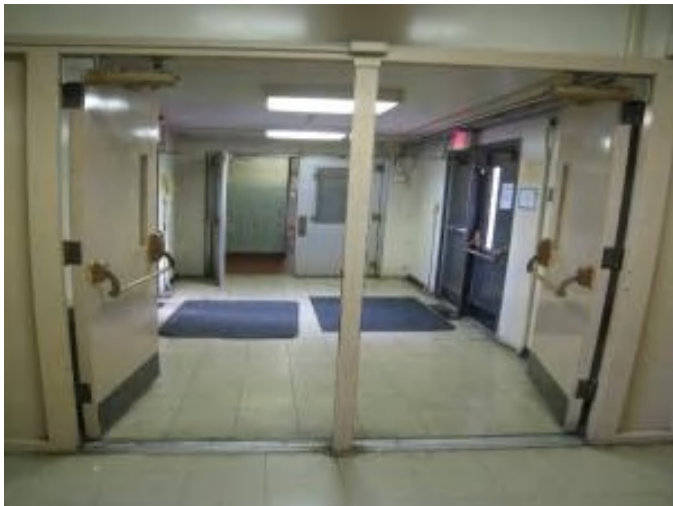
**System: C3020413 - Vinyl Flooring**

**Location:** gym and Annex building

**Distress:** Damaged

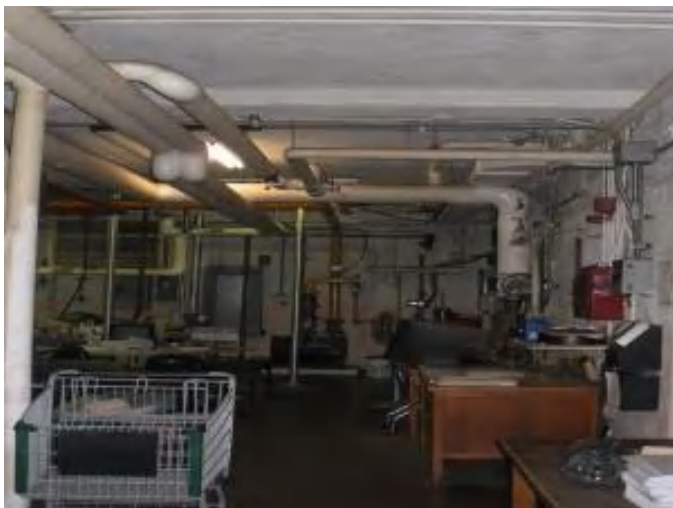
**System: C3020415 - Concrete Floor Finishes**

**Location:** basement, stairway platforms

**Distress:** Appearance

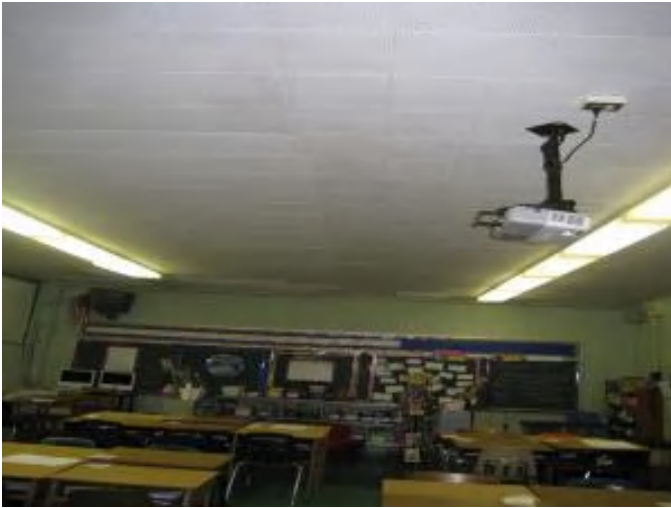
**System: C3030 - Ceiling Finishes**

**Location:** ceilings - many locations

**Distress:** Failing

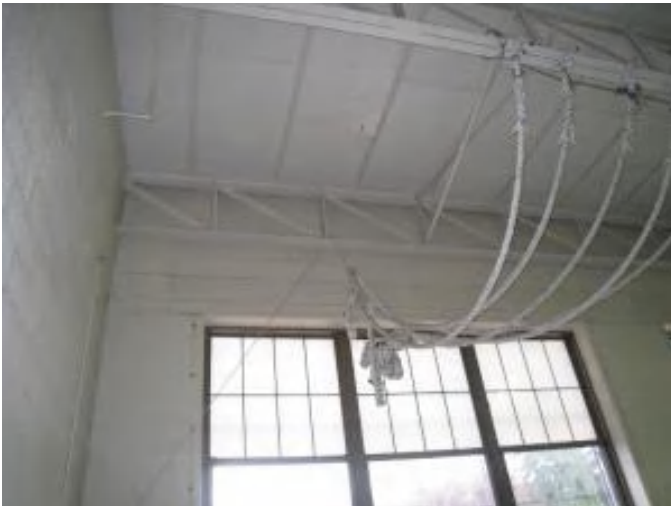
**System: C3030 - Ceiling Finishes**

**Location:** gymnasium

**Distress:** Damaged

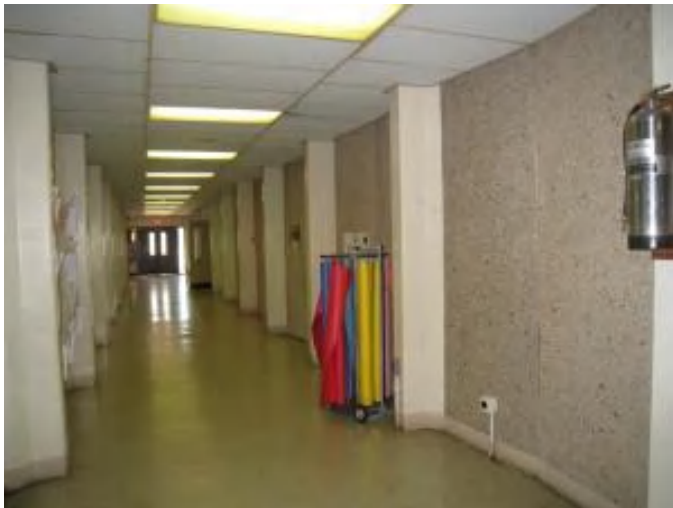
**System: C3030 - Ceiling Finishes**

**Location:** annex corridor

**Distress:** Failing

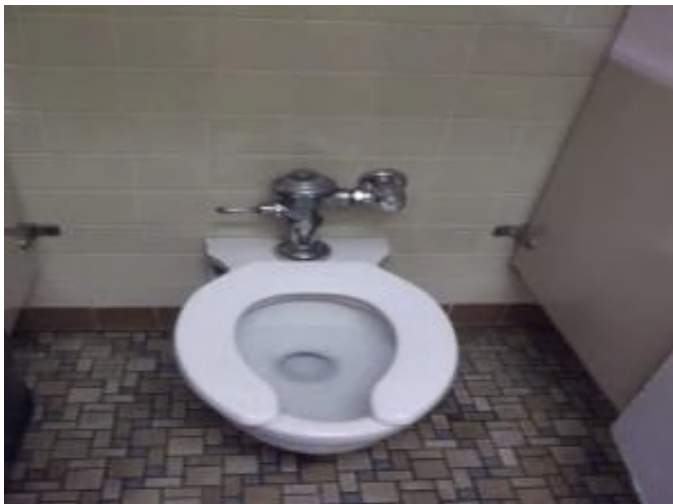
**System: D2010 - Plumbing Fixtures**

**Location:** Throughout the building

**Distress:** Beyond Service Life

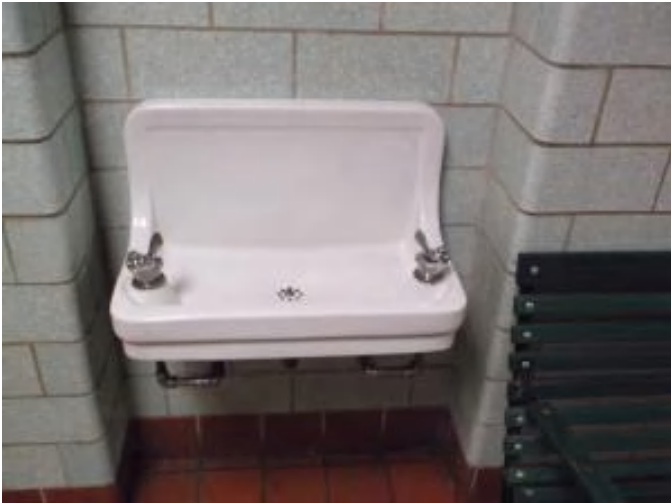
**System: D2010 - Plumbing Fixtures**

**Location:** Throughout the building

**Distress:** Beyond Service Life

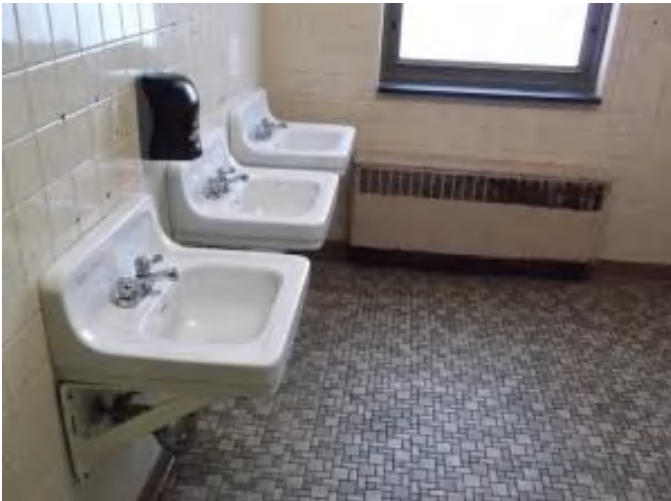
**System: D2010 - Plumbing Fixtures**

**Location:** Throughout the building

**Distress:** Beyond Service Life

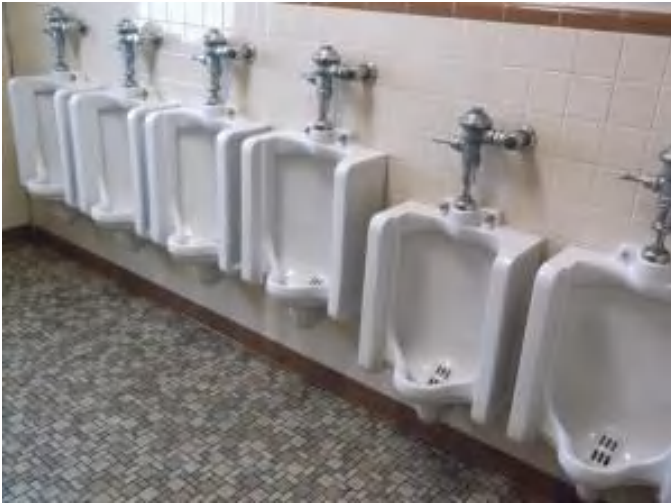
**System: D2010 - Plumbing Fixtures**

**Location:** Throughout the building

**Distress:** Beyond Service Life

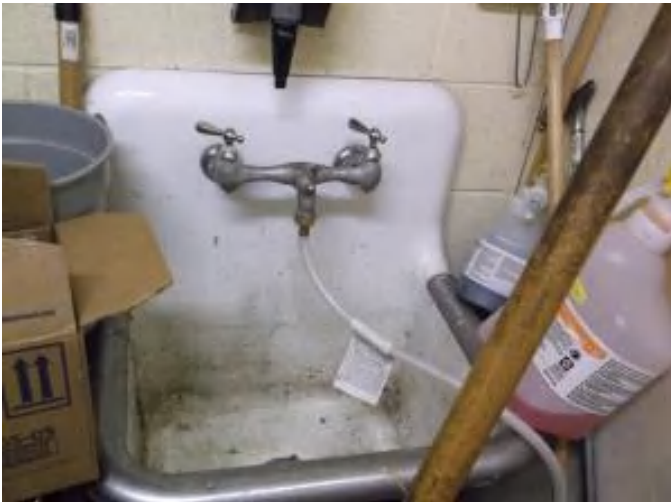
**System: D2010 - Plumbing Fixtures**

**Location:** Throughout the building

**Distress:** Beyond Service Life

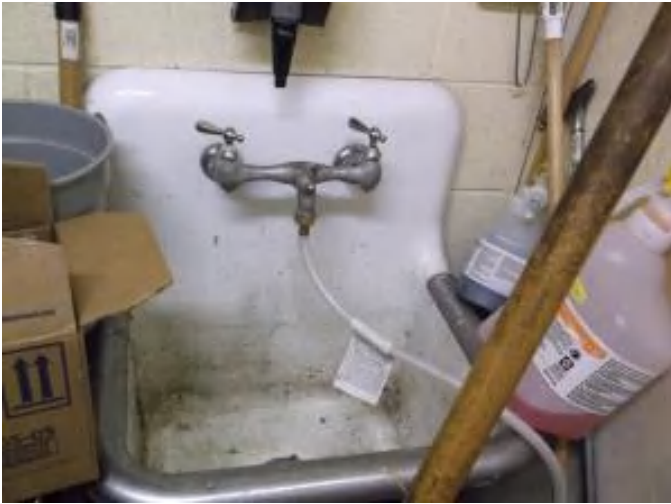
**System: D2010 - Plumbing Fixtures**

**Location:** Throughout the building

**Distress:** Beyond Service Life

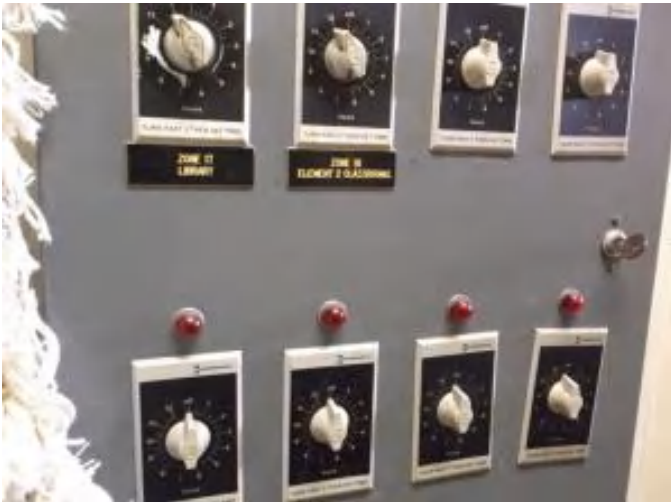
**System: D3060 - Controls & Instrumentation**

**Location:** Throughout the building

**Distress:** Beyond Service Life

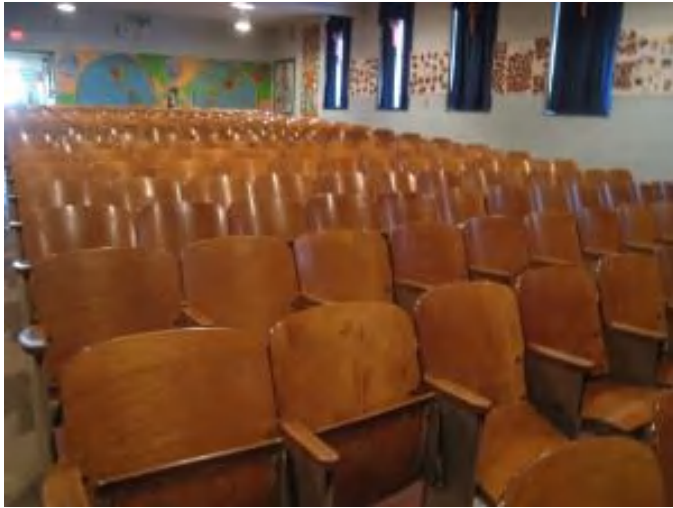
**System: E2010 - Fixed Furnishings**

**Location:** auditorium

**Distress:** Damaged

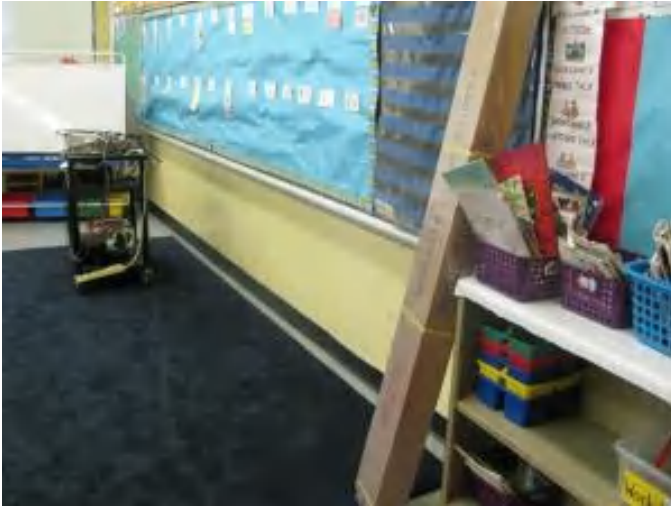
**System: D5020 - Lighting and Branch Wiring**

**Location:** Entire Building

**Distress:** Beyond Service Life

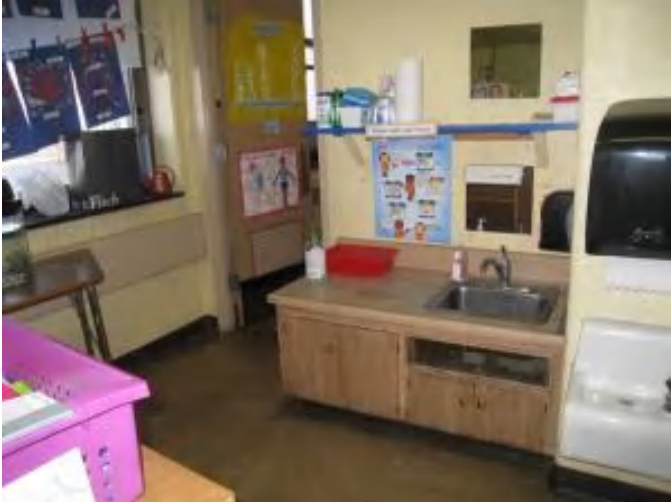
**System: E2010 - Fixed Furnishings**

**Location:** kindergarten

**Distress:** Damaged

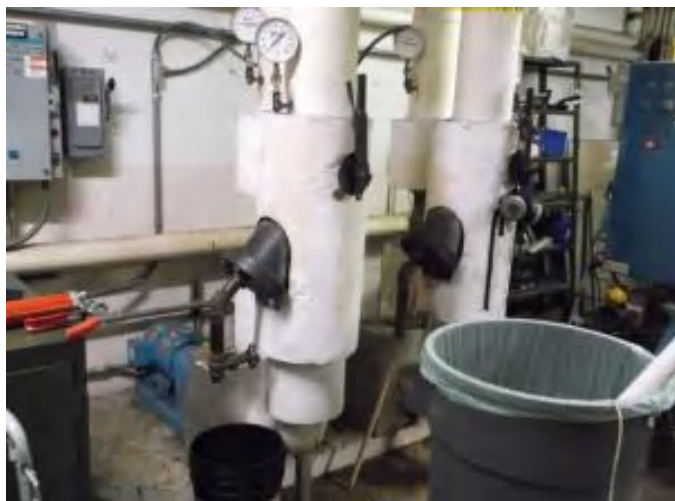
**System: D3020 - Heat Generating Systems**

**Location:** Main boiler mechanical equipment room

**Distress:** Beyond Service Life

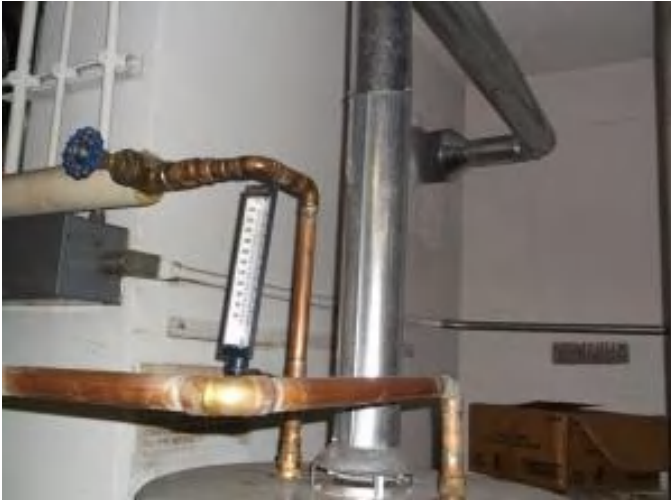
**System: D2020 - Domestic Water Distribution**

**Location:** Throughout the building

**Distress:** Beyond Service Life

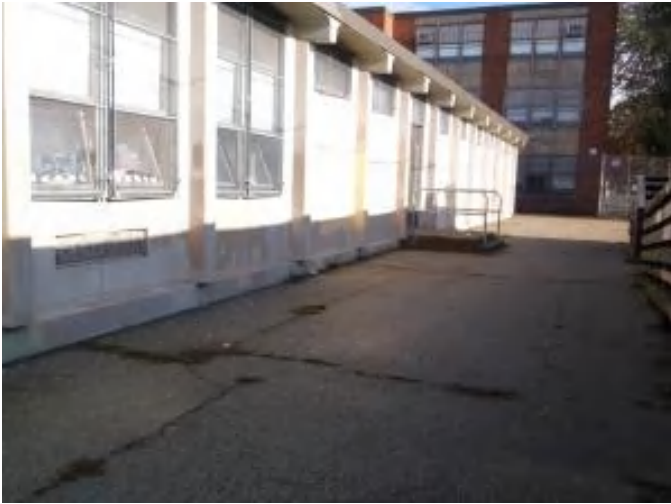
**System: D3030 - Cooling Generating Systems**

**Location:** Throughout the building

**Distress:** Inadequate

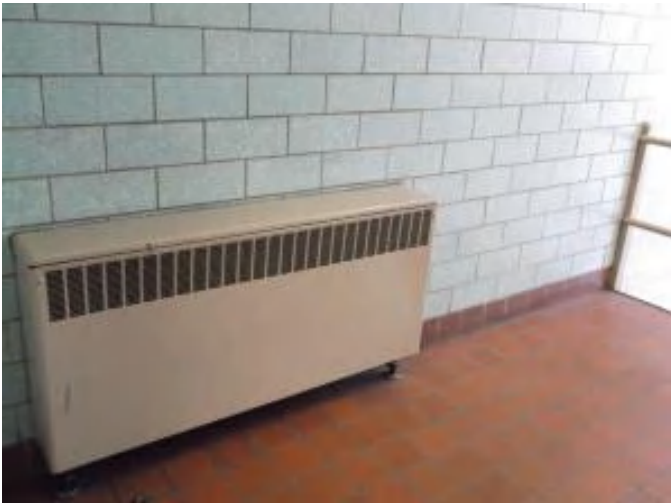
**System: D3040 - Distribution Systems**

**Location:** Throughout the building

**Distress:** Beyond Service Life

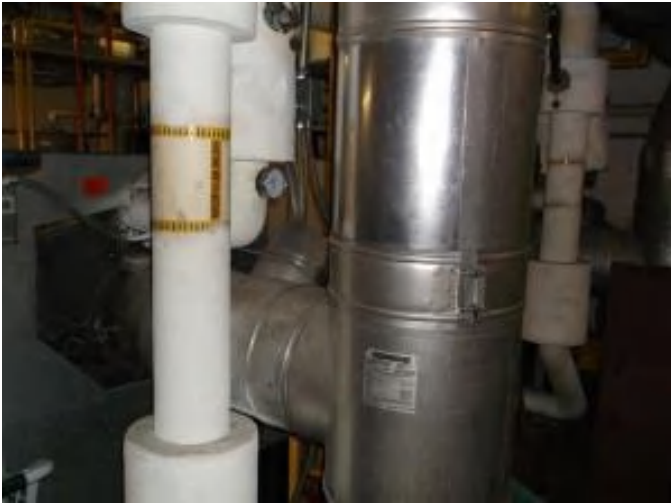
**System: D3040 - Distribution Systems**

**Location:** Throughout the building

**Distress:** Beyond Service Life

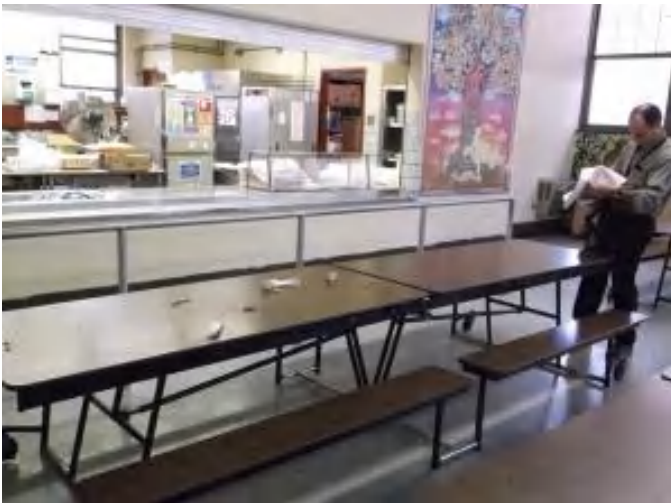
**System: D3040 - Distribution Systems**

**Location:** Cafeteria

**Distress:** Beyond Service Life

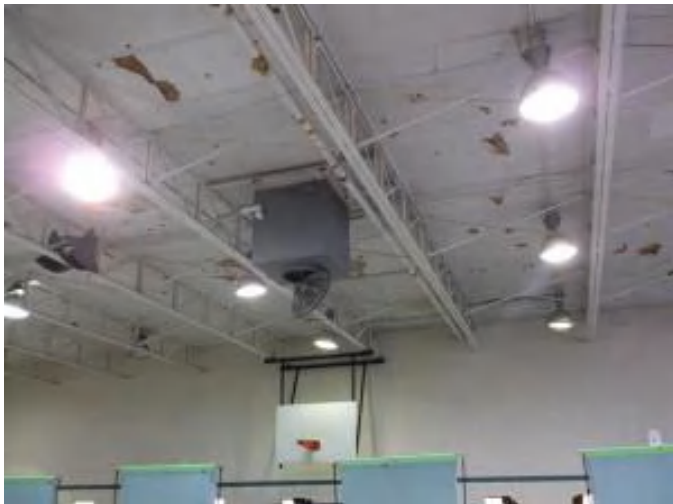
**System: D3040 - Distribution Systems**

**Location:** Gymnasium

**Distress:** Beyond Service Life

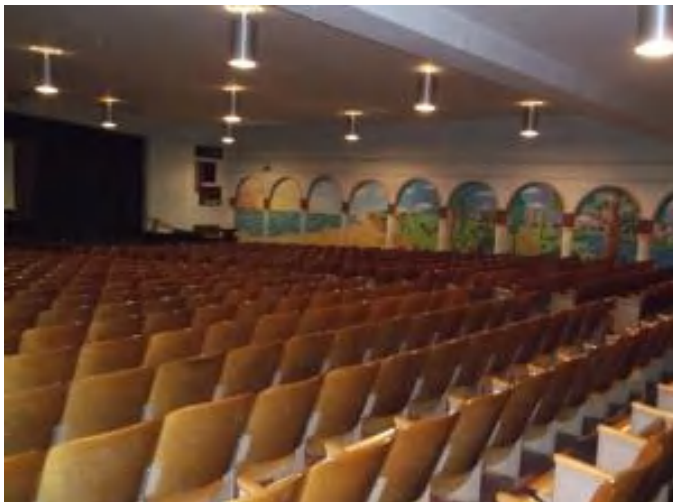
**System: D3040 - Distribution Systems**

**Location:** Auditorium

**Distress:** Beyond Service Life

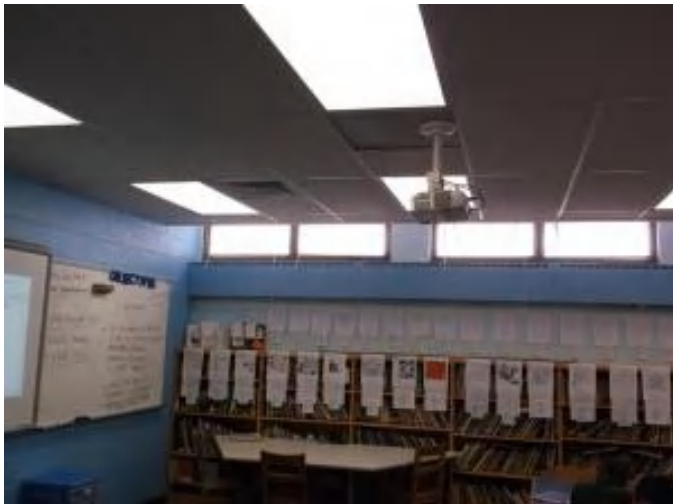
**System: D4010 - Sprinklers**

**Location:** Throughout the building

**Distress:** Life Safety / NFPA / PFD
