Facility Condition Assessment Summary Report

Fell School

School District of Philadelphia
S219001;Fell and Thomas
Final
Site Assessment Report
January 30, 2017

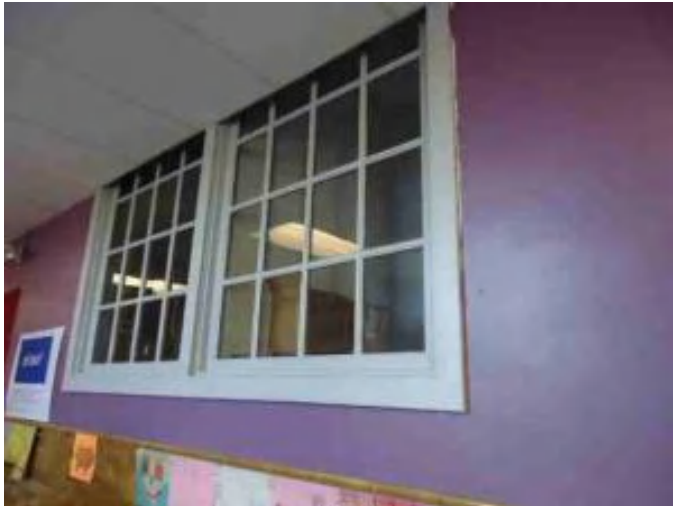
Location: Hallways

There are several transom lites and sidelights constructed into hallway wall systems. It is recommended that the lites and sidelights be removed and replaced with a fire rated wall construction. The deficiency provides a budgetary consideration to correct the hallway, transoms, lites and sidelights.

System: C1010 - Partitions

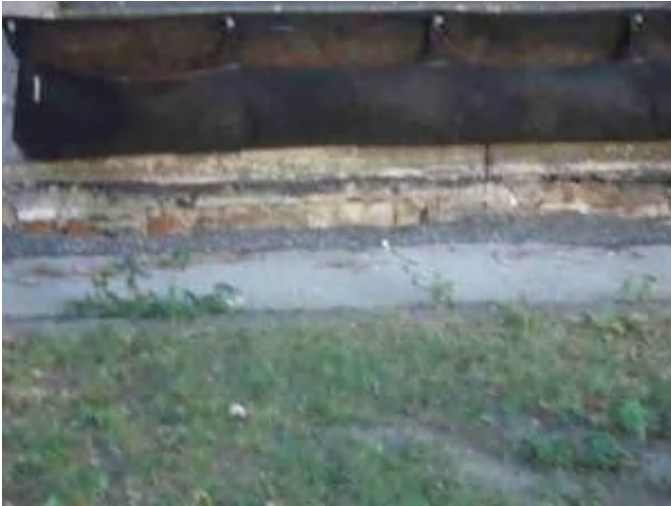
Location: Basement Wall

There is evidence of water infiltration through the basement foundations wall facing the South Hutchinson street exterior. To improve the integrity of the basement wall excavation and waterproofing system upgrades are recommended. Improve the slope of the grade away from the foundation prior to restoring the landscaping system.

System: A2020 - Basement Walls

Distress: Damaged

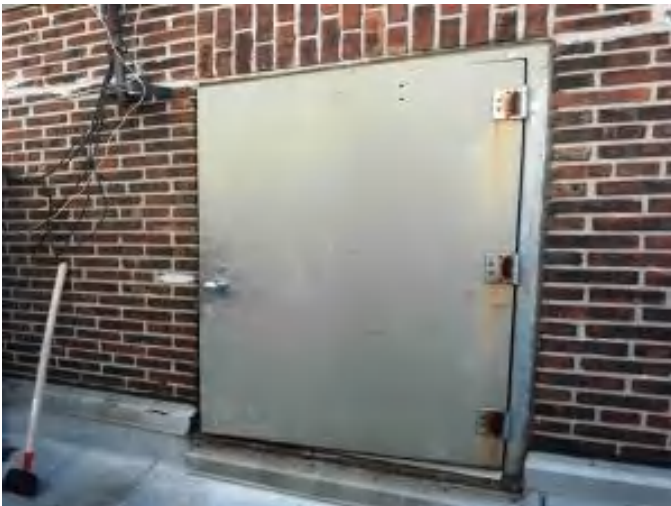
Location: Roof

The roof access exterior service doors are metal applications with metal frames. The service doors were not a part of the 2006 exterior door upgrade effort. The doors are in poor condition and aging at a faster rate than expected. The exterior service doors are recommended for upgrade. The new doors are expected to retain their dimensions and profiles, but that incorporate updated energy-efficient features.

System: B2030 - Exterior Doors

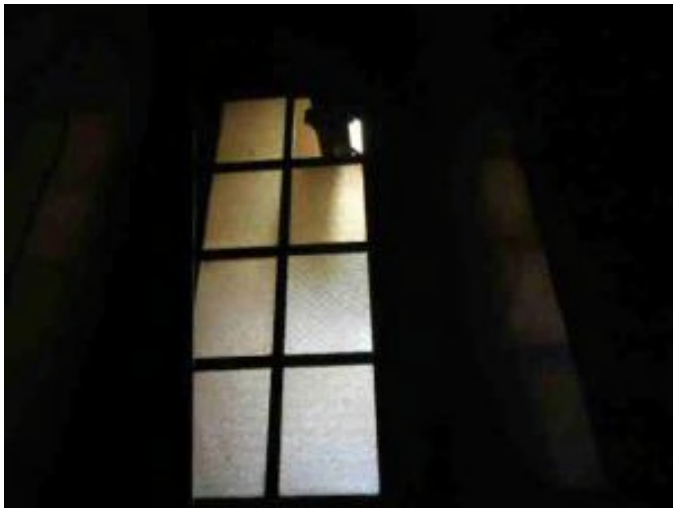
Location: Mechanical Room

The mechanical room has several penetrations and as indicted in the photos an industrial window that has been compromised with several holes for equipment. Also, note the electrical modifications recently completed at this school has left several closet penetrations open. This deficiency provides a budgetary consideration to properly enclose the areas and to meet the current fire life safety requirements for mechanical spaces.

System: C1010 - Partitions

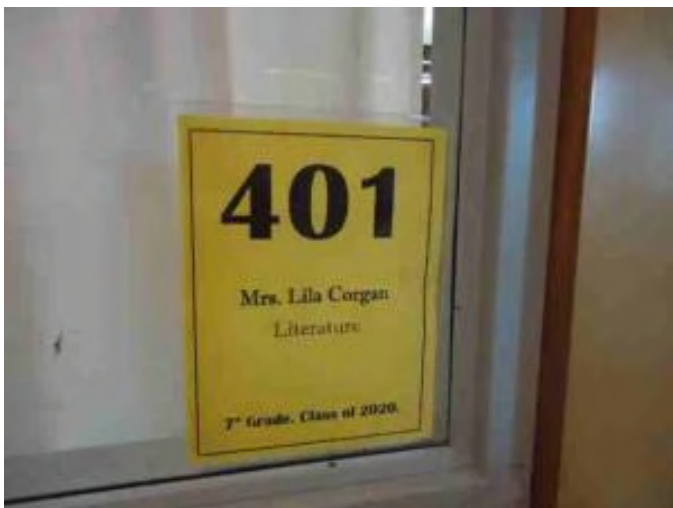
Location: Building Wide

There is no directional signage and room signage is a custom design in places and scarce or painted with no consistency in others. Accessibility signage criteria have been established for the physically challenged. These include mounting heights, contrast and finish, raised and Braille characters and pictograms, and character proportions and heights. It is recommended that compliant signage be installed throughout the building.

System: C1030 - Fittings

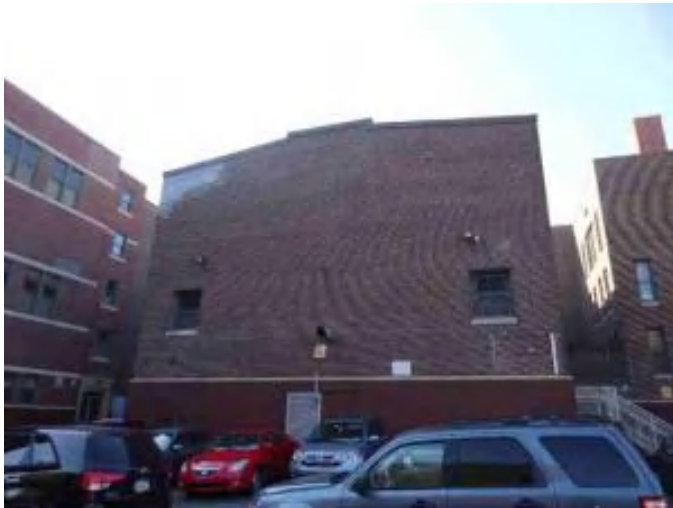
Location: Exterior Elevation

The exterior brick surfaces are generally in good condition for their age. The Northern wall facing the parking lot has a section that raises some concern. The bricks have cracked or spalled in the alcove and should be replaced. As indicated in the photos this area is a consistent line of degradation. The repointing of deteriorated mortar joints is also recommended, using mortar of a similar color and consistency as the original. Following the detailed examination of the brick and repair of mortar construction joints, the entire building should be pressure washed to remove stains and embedded pollutants. If moisture is found to be penetrating the masonry facade, the application of a spray sealant to the suspected exterior masonry surface is recommended.

System: B2010 - Exterior Walls

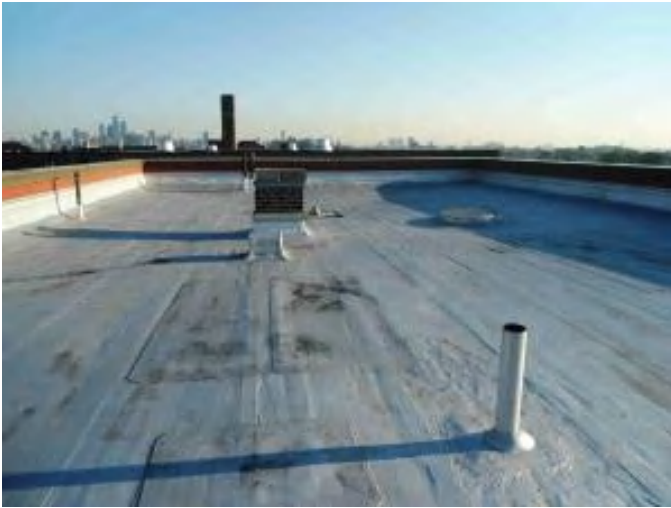
Location: Roof

There are a number of roof sections and different roof elevations ranging from the main roof to the mechanical roof. The built up application was reported to have been installed in the early 1980'S. As indicated in the photos several repairs were recently completed however, the current age and condition of the roofing systems warrant universal upgrades. This deficiency provides a budgetary consideration for removal and replacement of the Built Up roofing system.

System: B3010105 - Built-Up

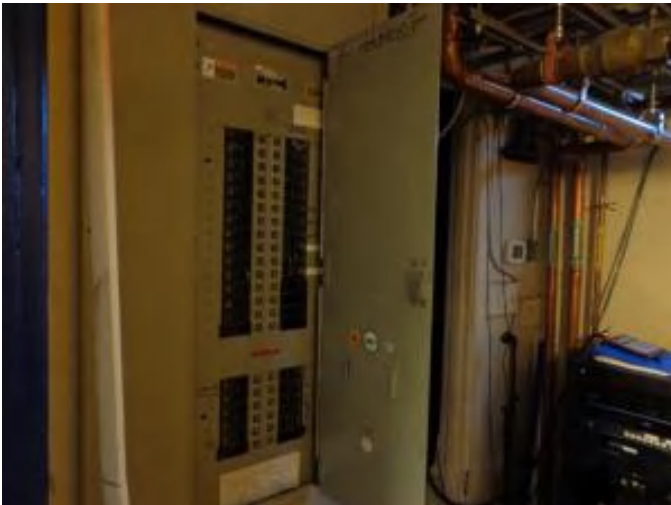
Location: Auditorium Stage

System: D5010 - Electrical Service/Distribution

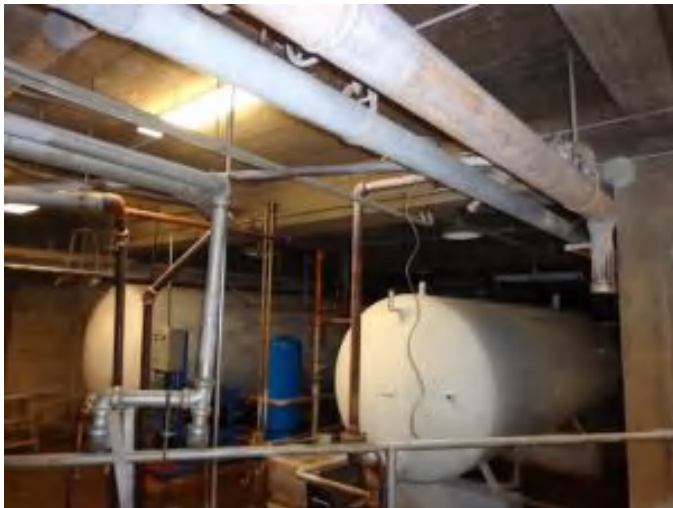
Lighting-- Lighting fixtures in most areas of the building were replaced when the building was renovated in 2008. There are only a few spaces, such as the mechanical/electrical rooms in the Basement, that still have some fluorescent fixtures with T12 lamps. All other areas with linear fluorescent fixtures have T8 lamps.

System: D5020 - Lighting and Branch Wiring

Location: Mechanical/electrical rooms
Distress: Obsolete
Category: 3 - Operations / Maint.
Priority: 3 - Response Time (3-4 yrs)
Correction: Replace lighting fixtures
Qty: 20.00
Unit of Measure: Ea.
Estimate: \$20,725.55
Assessor Name: Craig Anding
Date Created: 12/15/2015

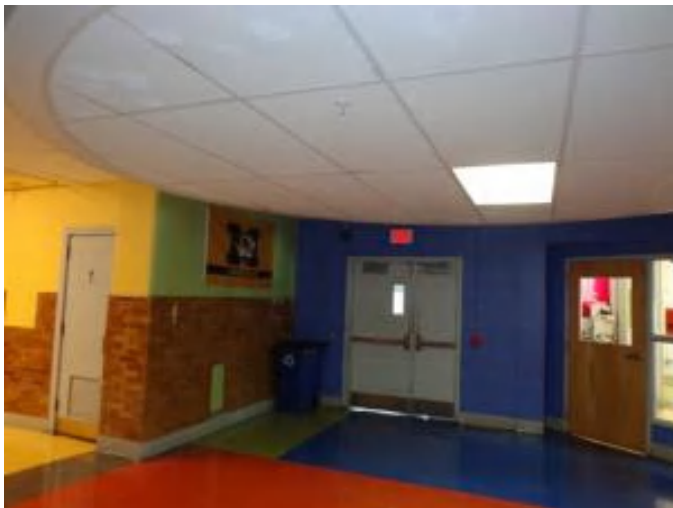
System: D5090 - Other Electrical Systems

Location: West end of Floors 1 to 4
Distress: Life Safety / NFPA / PFD
Category: 2 - Code Compliance
Priority: 3 - Response Time (3-4 yrs)
Correction: Add Emergency/Exit Lighting
Qty: 8.00
Unit of Measure: Ea.
Estimate: \$13,478.74
Assessor Name: Craig Anding
Date Created: 12/15/2015

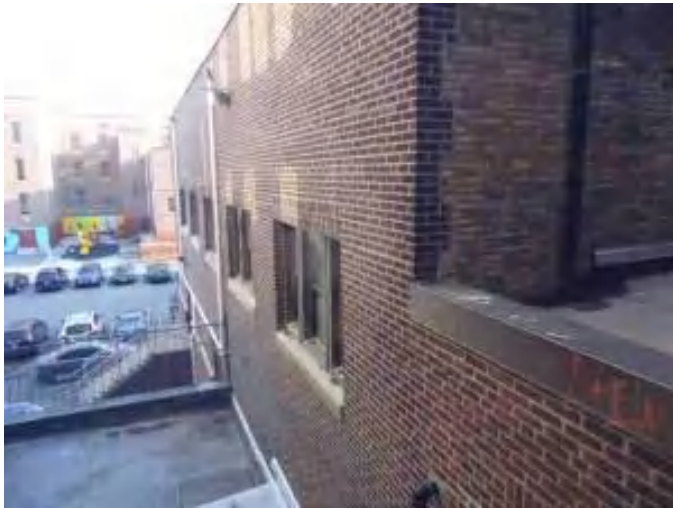
Location: Exterior Elevation

The exterior windows have been upgraded from the original applications. The window system is estimated to have been installed in the 1990's. Several of the windows no longer work and will require attention prior to an overall effort. Overall, the windows are in good condition based on the year of installation or last renovation. The entire exterior window system is recommended to be replaced with units that retain their dimensions and profiles, but that incorporate updated energy-efficient features

System: B2020 - Exterior Windows

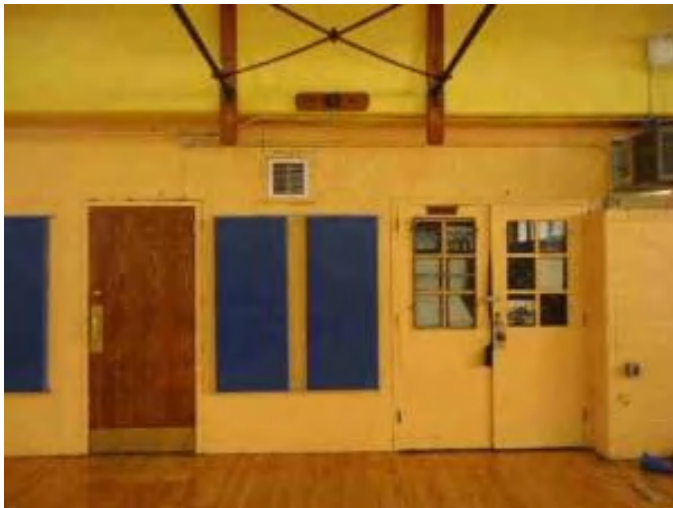
Location: Gym

Interior doors are typically wood in wood frames with glass glazing. Other interior doors include hollow metal in hollow metal frames at some of the stairwells and exit ways, access doors. Doors are generally in like new condition as the system was upgraded as part of an interior renovation effort in 2006. A few doors appear to have been low priority during this effort such as the doors in the store room area and Gym. This deficiency provides a budgetary consideration to replace a portion of the interior doors overlooked during that effort.

System: C1020 - Interior Doors

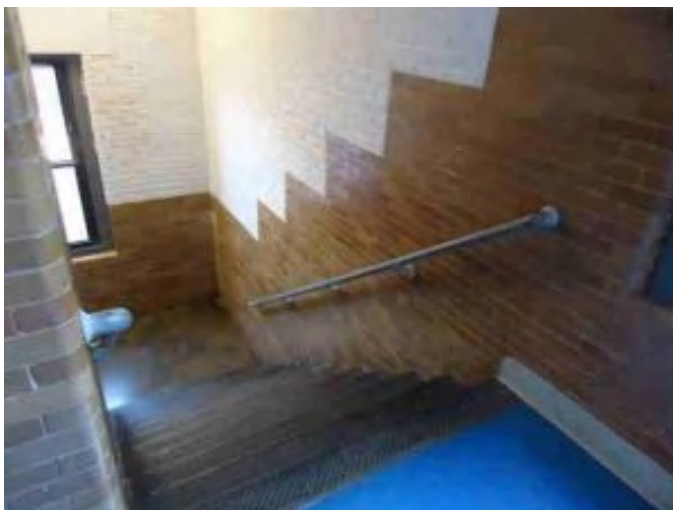
Location: Stairs

Current requirements for stairs indicate that they have graspable handrails on both sides, that the rails have a specific end geometry, and that the handrails continue horizontally at the landings. In addition, guardrails must prevent the passage of a 4 inch diameter sphere (6 inches in the triangle formed by the lower rail and tread/riser angle). It appears as if the entire hand and guard rail system was upgraded during the 2006 renovation effort. However, the rail extensions were not included in this effort. This deficiency provides a budgetary consideration for rail extension on each floor.

System: C2010 - Stair Construction

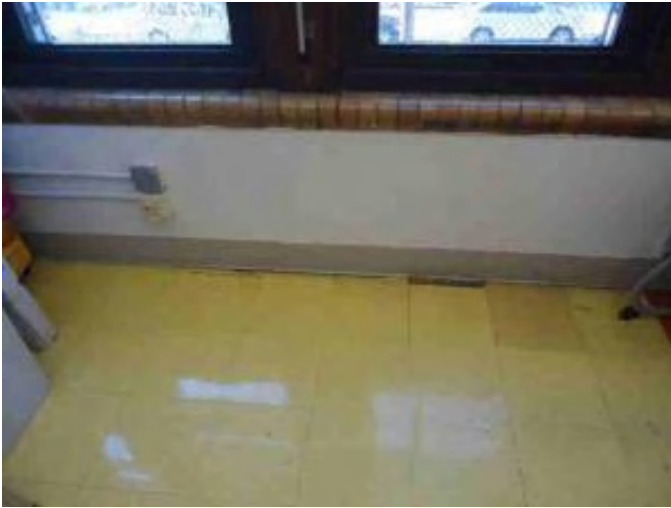
System: C3020413 - Vinyl Flooring

Location: Classroom
Distress: Health Hazard / Risk
Category: 1 - Health & Safety
Priority: 4 - Response Time (4-5 yrs)
Correction: Remove VAT and replace with VCT - SF of area
Qty: 2,000.00
Unit of Measure: S.F.
Estimate: \$30,333.34
Assessor Name: Craig Anding
Date Created: 12/28/2015

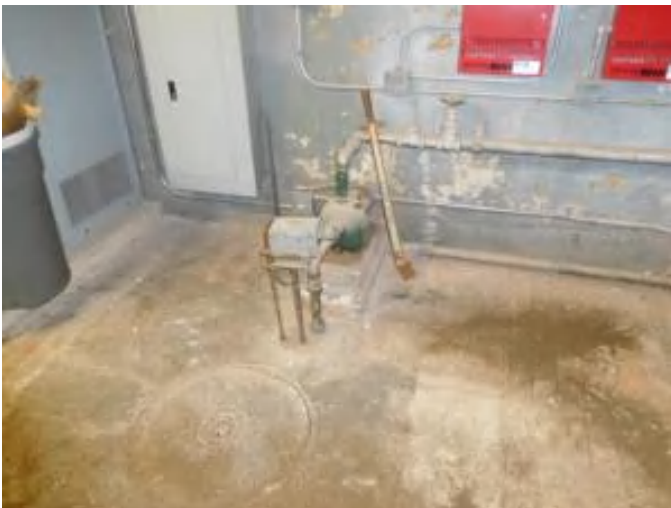
Plumbing fixtures in toilet rooms were replaced in 2006 and should be serviceable twenty five more years. The water heaters should be serviceable for fifteen more years. The cast iron piping has exceeded the anticipated service life. Rainwater and vent piping should continue functioning, but the sanitary and waste piping should be inspected to determine condition and replace damaged portions. Supply piping should have remaining service life of fifteen years.

System: D2030 - Sanitary Waste

Location: entire building
Distress: Beyond Service Life
Category: 3 - Operations / Maint.
Priority: 4 - Response Time (4-5 yrs)
Correction: Inspect sanitary waste piping and replace damaged sections. (+100KSF)
Qty: 82,000.00
Unit of Measure: S.F.
Estimate: \$348,221.74
Assessor Name: Craig Anding
Date Created: 11/28/2015

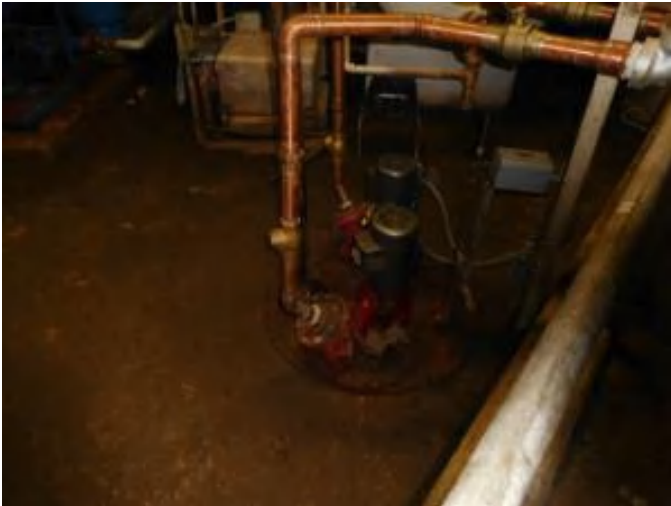
System: D2030 - Sanitary Waste

Location: mechanical room
Distress: Beyond Service Life
Category: 3 - Operations / Maint.
Priority: 4 - Response Time (4-5 yrs)
Correction: Replace sanitary sewage ejector pit and pumps. (48" dia.)
Qty: 2.00
Unit of Measure: Ea.
Estimate: \$61,371.91
Assessor Name: Craig Anding
Date Created: 11/28/2015

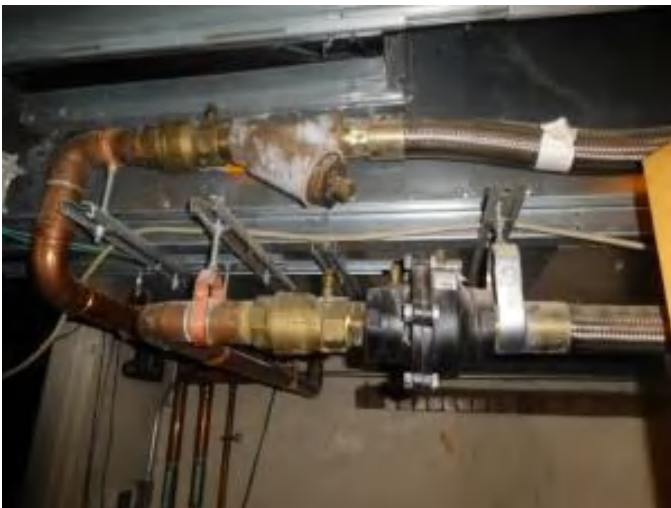
System: D3060 - Controls & Instrumentation

Location: entire building
Distress: Inadequate
Category: 4 - Capital Improvement
Priority: 4 - Response Time (4-5 yrs)
Correction: Replace pneumatic controls with DDC (75KSF)
Qty: 82,000.00
Unit of Measure: S.F.
Estimate: \$1,759,068.94
Assessor Name: Craig Anding
Date Created: 11/28/2015

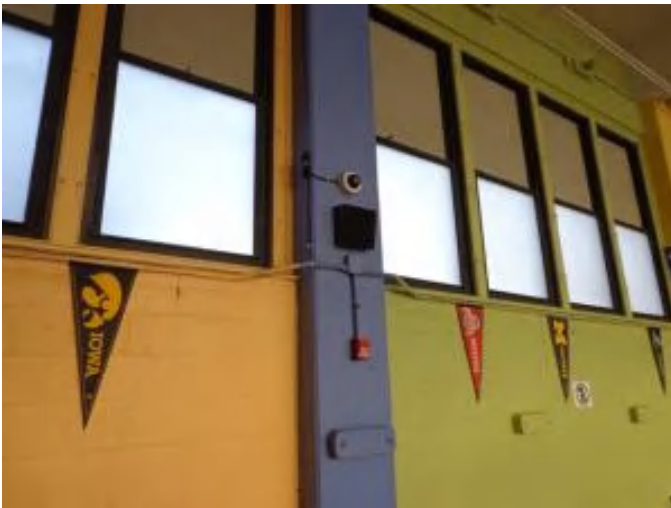
System: D5030 - Communications and Security

Location: Building wide
Distress: Beyond Service Life
Category: 3 - Operations / Maint.
Priority: 4 - Response Time (4-5 yrs)
Correction: Add/Replace Video Surveillance System
Qty: 12.00
Unit of Measure: Ea.
Estimate: \$102,439.03
Assessor Name: Craig Anding
Date Created: 12/15/2015

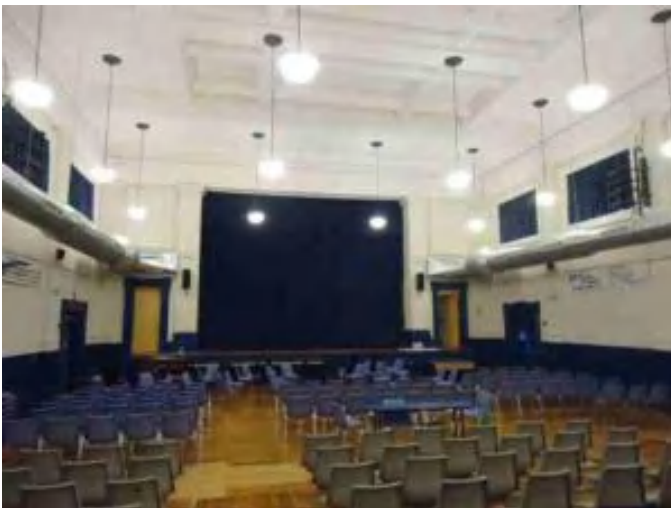
The school stage has a stage curtain assembly that appears to be from the original construction. Modern applications are typically fire-proof applications with adjustable tracks and electric support for operation. The curtains are torn in a few sections and the track is not functioning properly, overall the system is in poor condition. It is recommended that the curtain and track system be upgraded to a new system. Special care should be considered in regards to modern fire proofing for the new installation.

System: E2010 - Fixed Furnishings

Location: Stage
Distress: Life Safety / NFPA / PFD
Category: 1 - Health & Safety
Priority: 4 - Response Time (4-5 yrs)
Correction: Remove and replace stage curtain - insert the LF of track and SF of curtain
Qty: 1.00
Unit of Measure: Ea.
Estimate: \$13,831.55
Assessor Name: Craig Anding
Date Created: 12/28/2015

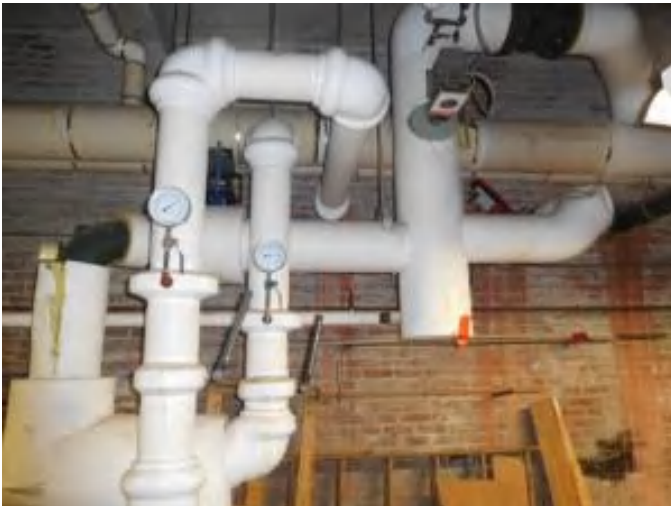
Location: mechanical room

System: D3020 - Heat Generating Systems

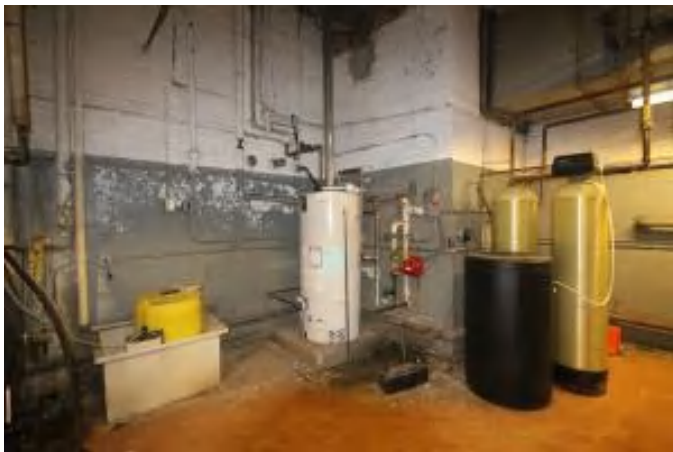
Location: Boiler room

System: D2020 - Domestic Water Distribution

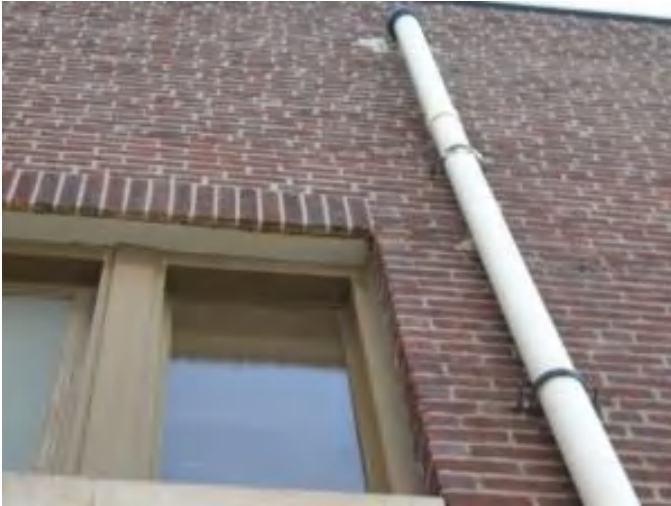
Location: Exterior walls

System: B2010 - Exterior Walls

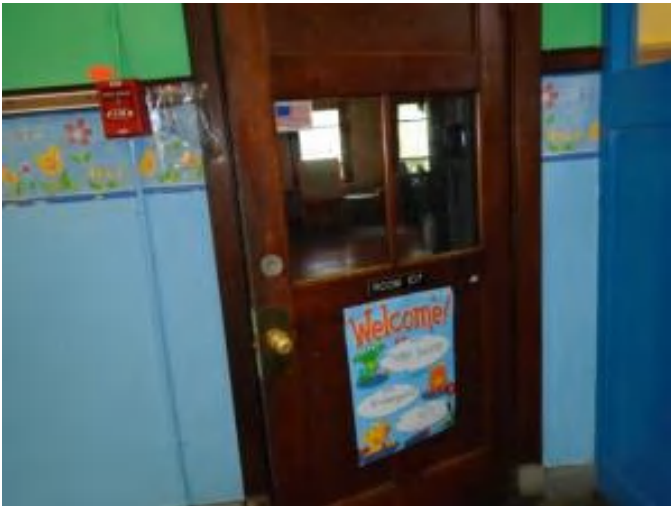
Location: Throughout

System: C1020 - Interior Doors

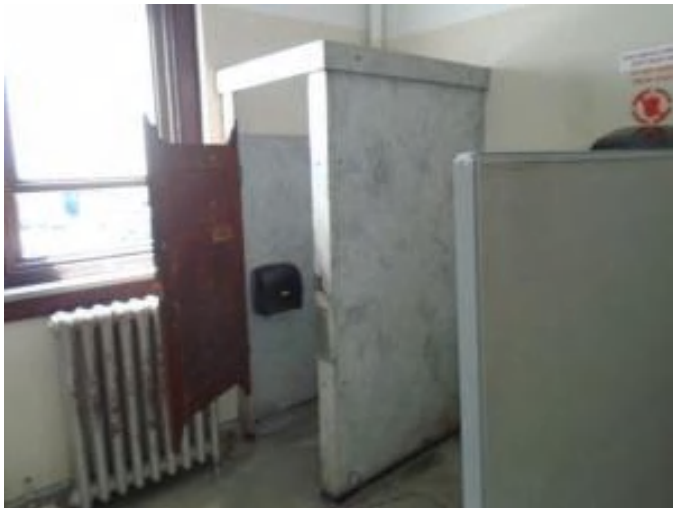
System: C1030 - Fittings

Location: Toilets
Distress: Accessibility
Category: 2 - Code Compliance
Priority: 2 - Response Time (2-3 yrs)
Correction: Remove and replace damaged toilet partitions - handicap units
Qty: 8.00
Unit of Measure: Ea.
Estimate: \$7,822.84
Assessor Name: System
Date Created: 09/16/2015

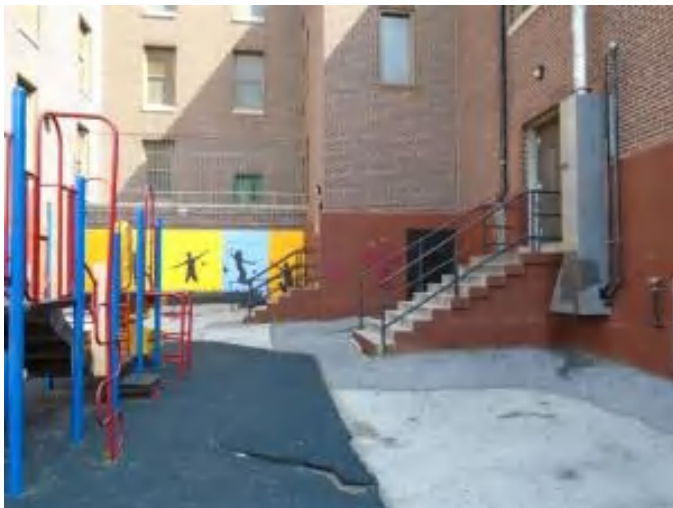
System: D1010 - Elevators and Lifts

Location: TBD
Distress: Accessibility
Category: 2 - Code Compliance
Priority: 2 - Response Time (2-3 yrs)
Correction: Add external 4 stop elevator - adjust the electrical run lengths to hook up the elevator
Qty: 1.00
Unit of Measure: Ea.
Estimate: \$1,012,601.25
Assessor Name: System
Date Created: 09/16/2015

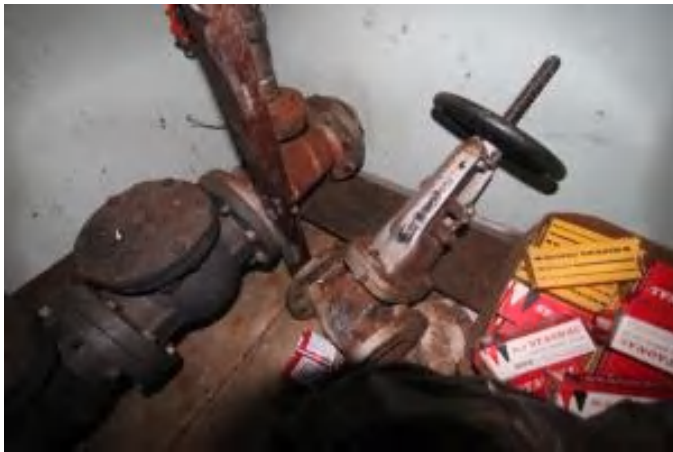
Location: Cafeteria dining room closet.

System: D2020 - Domestic Water Distribution

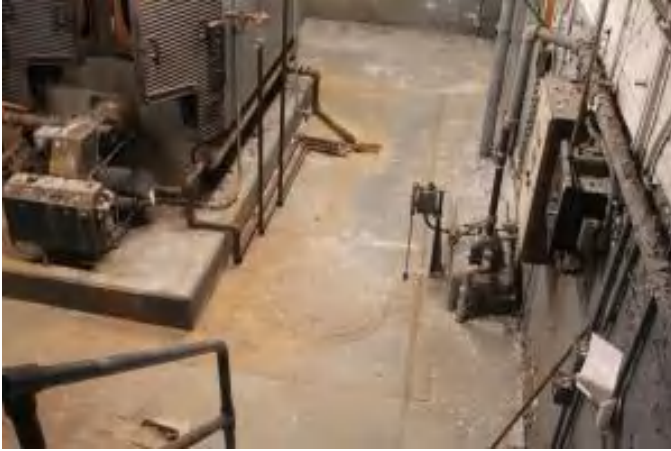
Location: Boiler room

System: D2030 - Sanitary Waste

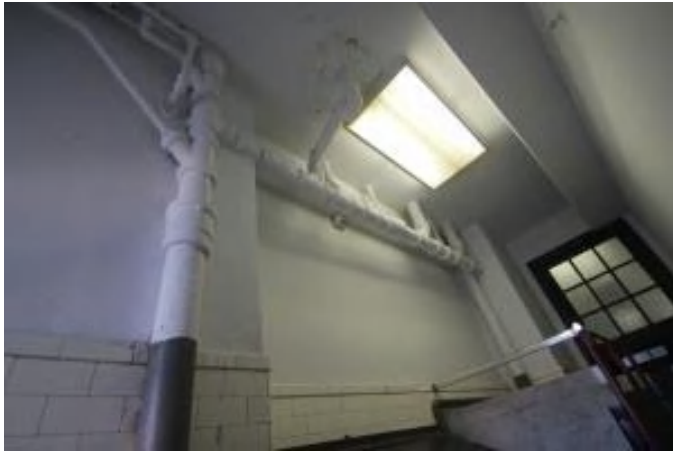
System: D3040 - Distribution Systems

Location: Toilet rooms
Distress: Building / MEP Codes
Category: 2 - Code Compliance
Priority: 2 - Response Time (2-3 yrs)
Correction: Provide inline centrifugal fan and wall outlet louver for restroom exhaust (4 plbg fixtures)
Qty: 10.00
Unit of Measure: Ea.
Estimate: \$172,070.42
Assessor Name: System
Date Created: 10/18/2015

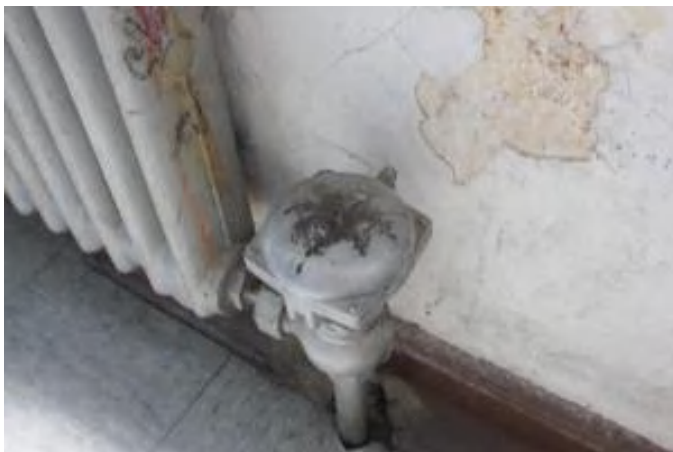
System: D3060 - Controls & Instrumentation

Location: Entire building
Distress: Obsolete
Category: 3 - Operations / Maint.
Priority: 2 - Response Time (2-3 yrs)
Correction: Replace pneumatic controls with DDC (75KSF)
Qty: 61,000.00
Unit of Measure: S.F.
Estimate: \$1,308,575.10
Assessor Name: System
Date Created: 10/18/2015

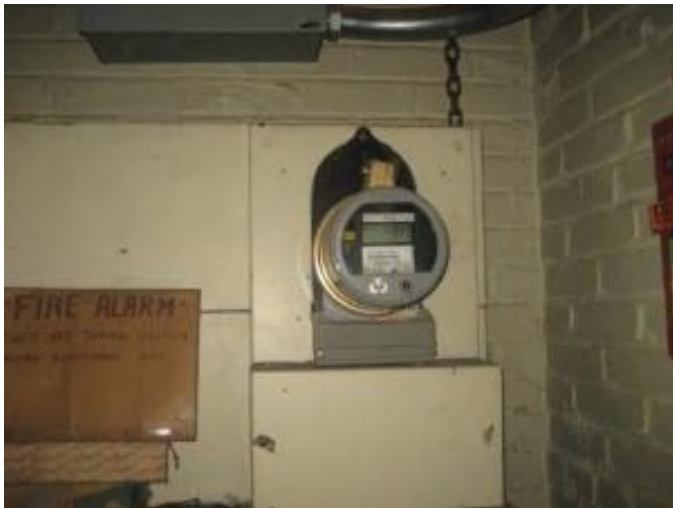
System: D5010 - Electrical Service/Distribution

Location: Basement
Distress: Inadequate
Category: 4 - Capital Improvement
Priority: 2 - Response Time (2-3 yrs)
Correction: Replace Switchboard
Qty: 1.00
Unit of Measure: Ea.
Estimate: \$415,067.67
Assessor Name: System
Date Created: 10/20/2015

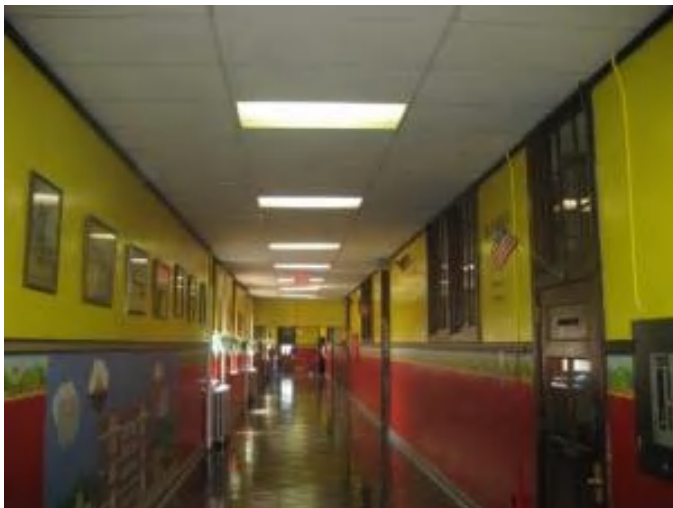
System: D5020 - Lighting and Branch Wiring

Location: Entire Building
Distress: Energy Efficiency
Category: 4 - Capital Improvement
Priority: 2 - Response Time (2-3 yrs)
Correction: Replace lighting fixtures
Qty: 726.00
Unit of Measure: Ea.
Estimate: \$618,708.03
Assessor Name: System
Date Created: 10/20/2015

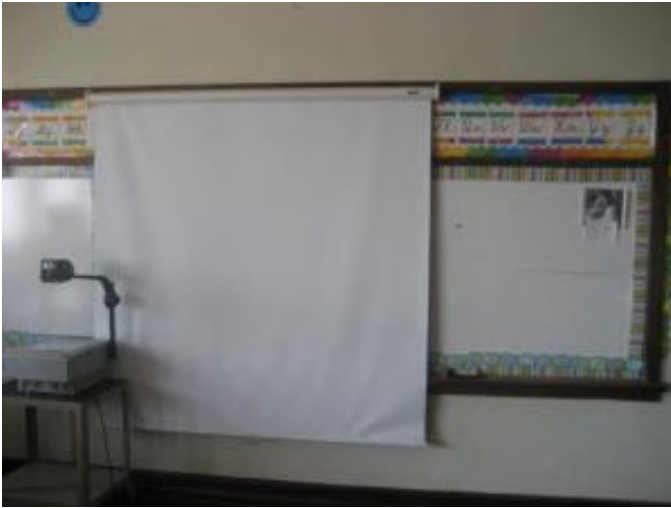
System: D5020 - Lighting and Branch Wiring

Location: Classrooms
Distress: Inadequate
Category: 4 - Capital Improvement
Priority: 2 - Response Time (2-3 yrs)
Correction: Add wiring device
Qty: 112.00
Unit of Measure: Ea.
Estimate: \$41,145.55
Assessor Name: System
Date Created: 10/20/2015

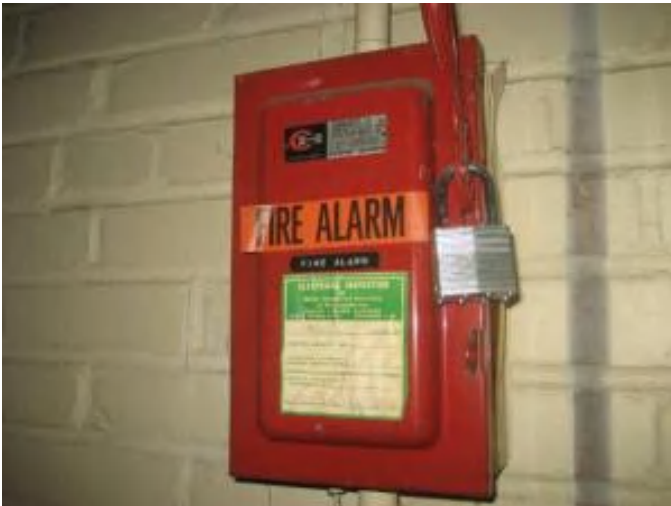
System: D5030 - Communications and Security

Location: Entire Building
Distress: Building / MEP Codes
Category: 2 - Code Compliance
Priority: 2 - Response Time (2-3 yrs)
Correction: Replace fire alarm system
Qty: 1.00
Unit of Measure: S.F.
Estimate: \$162,996.83
Assessor Name: System
Date Created: 10/20/2015

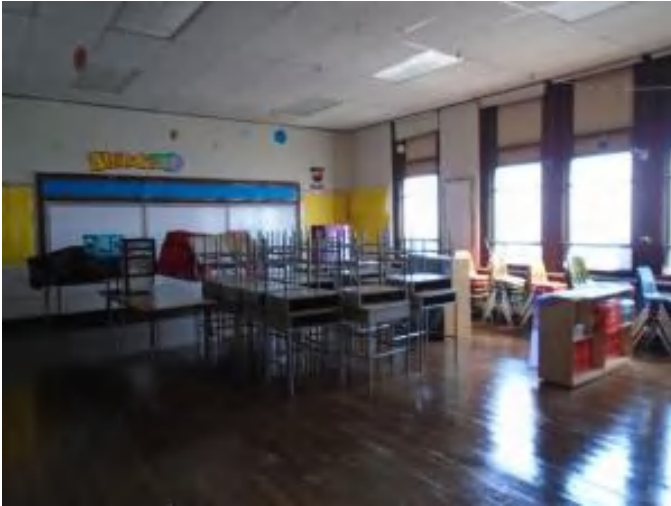
Location: Various

System: C3020414 - Wood Flooring

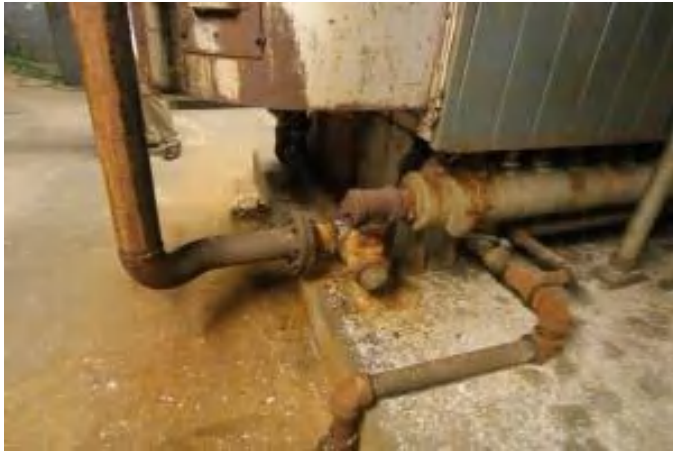
Location: Boiler room

System: D3020 - Heat Generating Systems

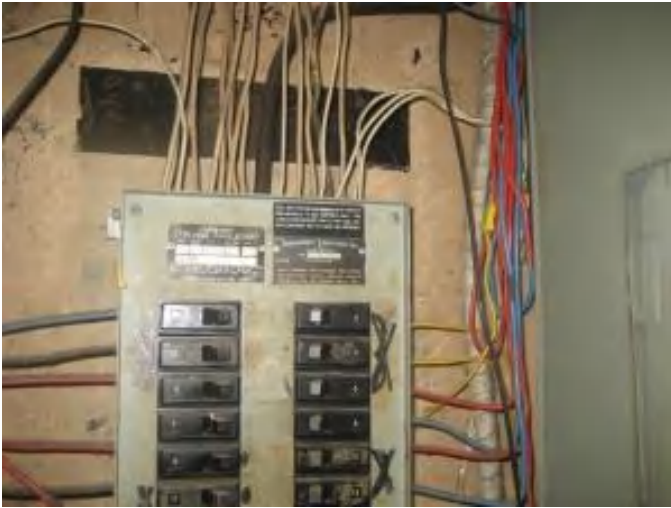
Location: Entire Building
Distress: Inadequate
Category: 4 - Capital Improvement
Priority: 3 - Response Time (3-4 yrs)
Correction: Replace Panelboard
Qty: 16.00
Unit of Measure: Ea.
Estimate: \$395,360.33
Assessor Name: System
Date Created: 10/20/2015

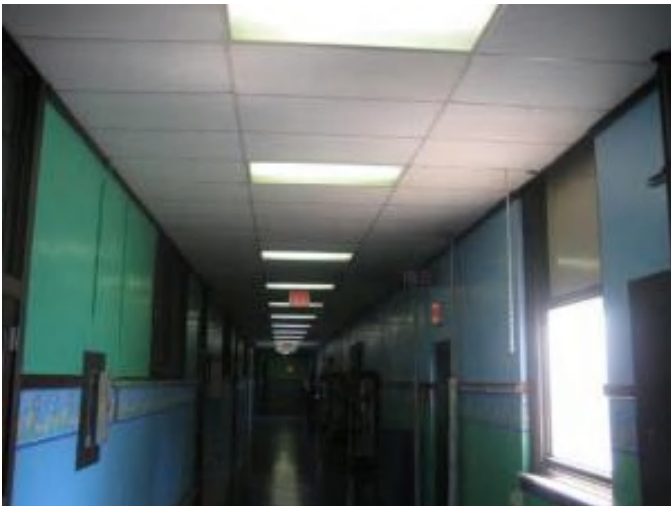
Location: Entire Building
Distress: Security Issue
Category: 1 - Health & Safety
Priority: 3 - Response Time (3-4 yrs)
Correction: Add/Replace Video Surveillance System
Qty: 18.00
Unit of Measure: Ea.
Estimate: \$70,603.05
Assessor Name: System
Date Created: 10/20/2015

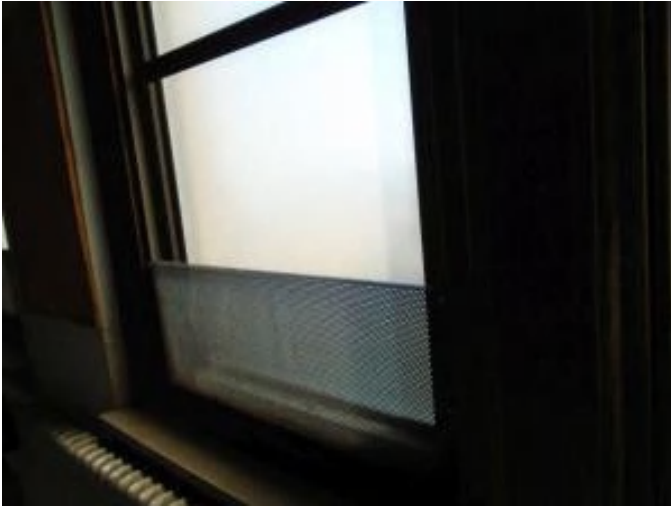
Location: Windows
Distress: Energy Efficiency
Category: 4 - Capital Improvement
Priority: 4 - Response Time (4-5 yrs)
Correction: Remove and replace double slider windows
Qty: 260.00
Unit of Measure: Ea.
Estimate: \$1,311,997.46
Assessor Name: System
Date Created: 09/16/2015

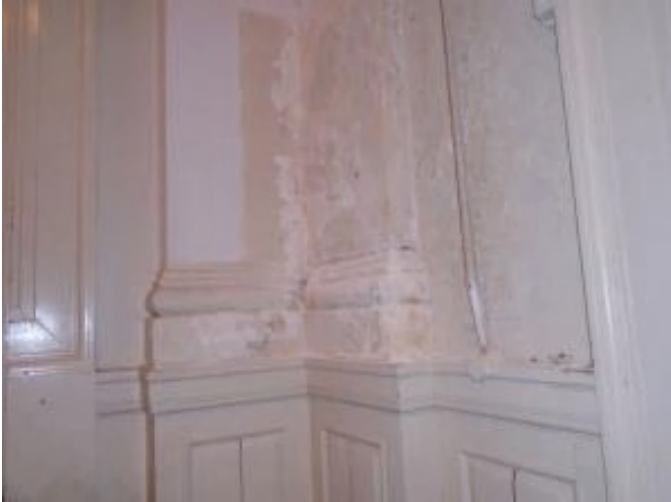
Location: Throughout
Distress: Damaged
Category: 3 - Operations / Maint.
Priority: 4 - Response Time (4-5 yrs)
Correction: Repair substrate and repaint interior walls - SF of wall surface
Qty: 10,000.00
Unit of Measure: S.F.
Estimate: \$85,670.76
Assessor Name: System
Date Created: 09/16/2015

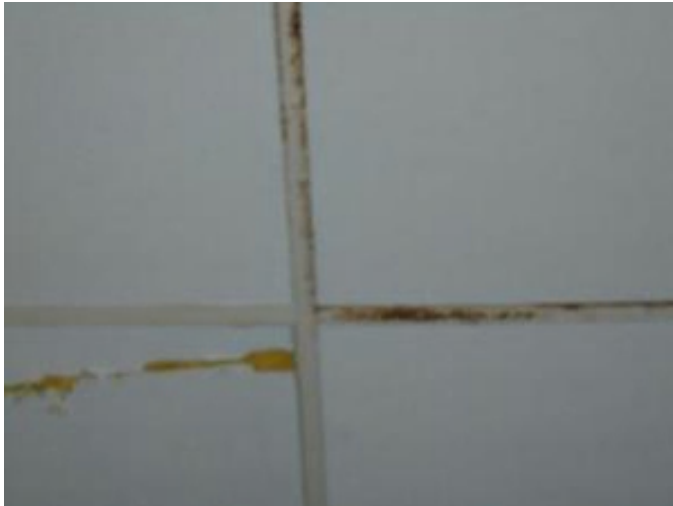
Location: Various
Distress: Beyond Service Life
Category: 3 - Operations / Maint.
Priority: 4 - Response Time (4-5 yrs)
Correction: Remove and replace suspended acoustic ceilings - lighting not included
Qty: 18,300.00
Unit of Measure: S.F.
Estimate: \$276,008.47
Assessor Name: System
Date Created: 09/16/2015

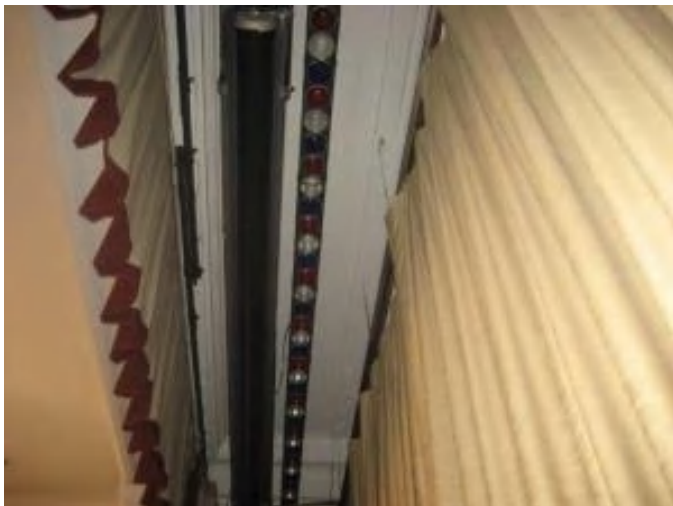
Location: Auditorium
Distress: Inadequate
Category: 4 - Capital Improvement
Priority: 4 - Response Time (4-5 yrs)
Correction: Add/Replace Stage Theatrical Lighting System
Qty: 1.00
Unit of Measure: Ea.
Estimate: \$323,055.06
Assessor Name: System
Date Created: 10/20/2015

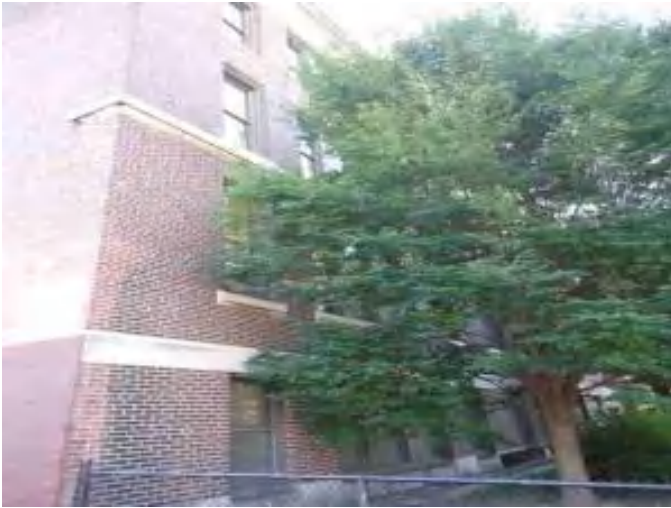
Location: Thomas Site
Distress: Damaged
Category: 3 - Operations / Maint.
Priority: 3 - Response Time (3-4 yrs)
Correction: Replace landscape beds - including irrigation - small areas
Qty: 2,000.00
Unit of Measure: S.F.
Estimate: \$36,501.01
Assessor Name: Hayden Collins
Date Created: 12/28/2015

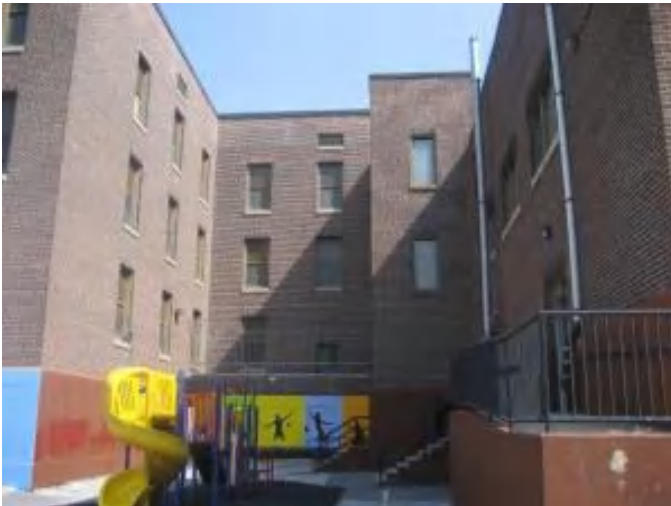
Location: Fell- Building Perimeter
Distress: Security Issue
Category: 1 - Health & Safety
Priority: 3 - Response Time (3-4 yrs)
Correction: Add Video Surveillance System
Qty: 8.00
Unit of Measure: Ea.
Estimate: \$82,171.66
Assessor Name: Hayden Collins
Date Created: 10/20/2015
