## Facility Condition Assessment Summary Report

### Fels High School

**S712001;Fels**

**Site Assessment Report**

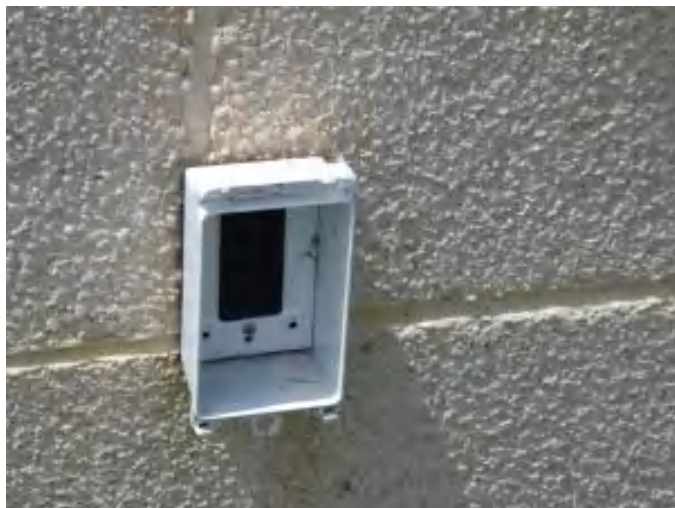
**Location:** exterior walls around bldg

#### System: D5020 - Lighting and Branch Wiring

**Distress:** Damaged

**Correction:** Replace Wiring Device

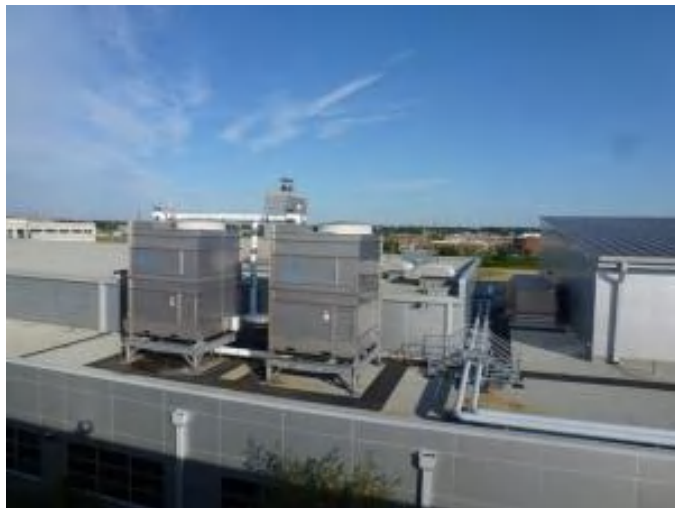
**Location:** roof

#### System: D5090 - Other Electrical Systems

**Distress:** Life Safety / NFPA / PFD

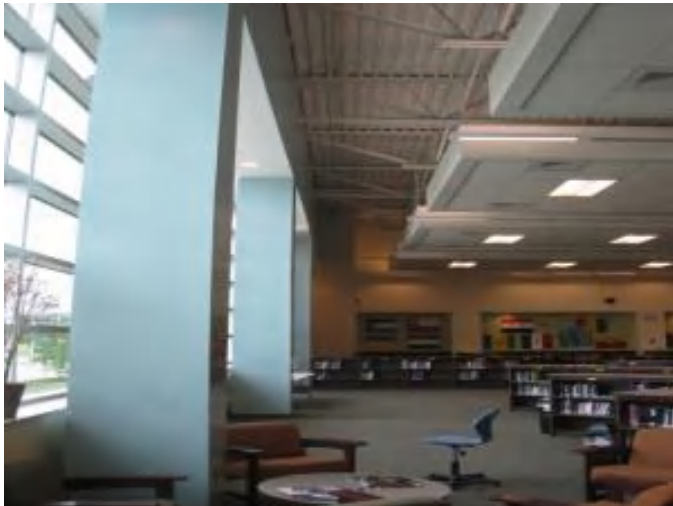
**Location:** entrance vestibules

**System: B1010 - Floor Construction**

**Distress:** Damaged

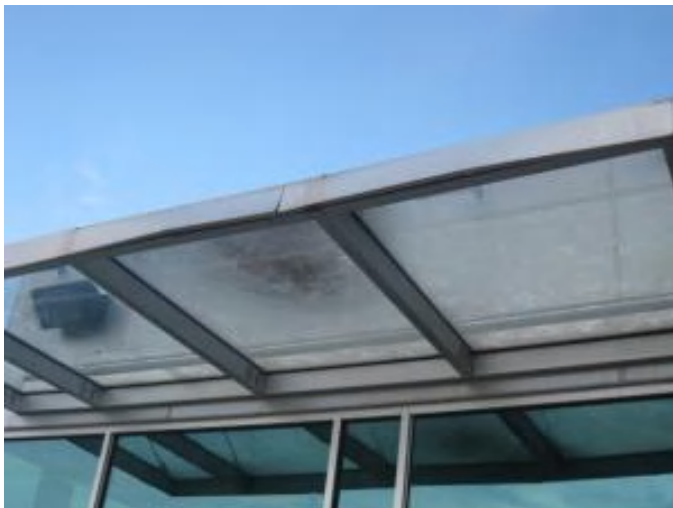
**Location:** exterior glass overhangs

**System: B2010 - Exterior Walls**

**Distress:** Appearance

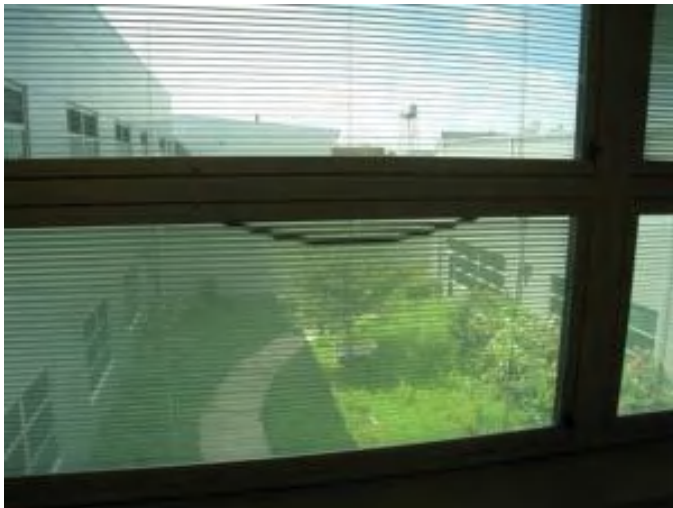
**Location:** exterior windows

**System: B2020 - Exterior Windows**

**Distress:** Appearance

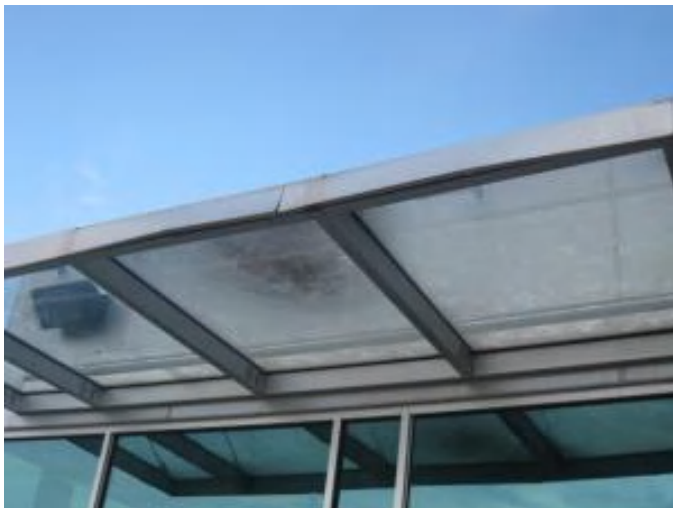
**Location:** glass overhang

**System: B3010105 - Built-Up**

**Distress:** Damaged

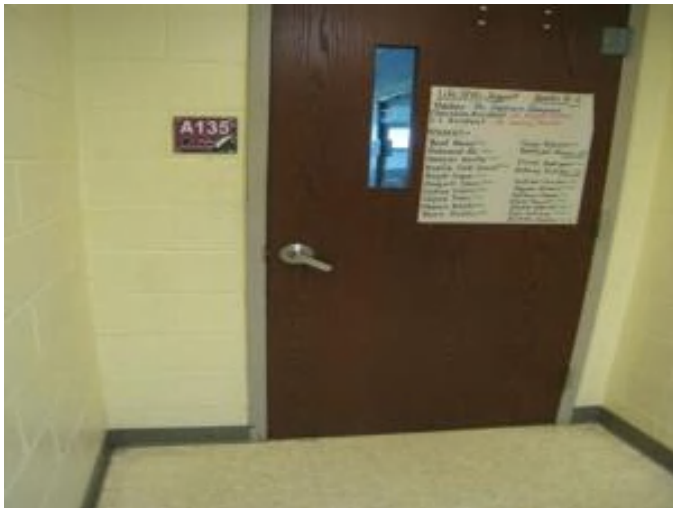
**Location:** all door frames

**System: C1020 - Interior Doors**

**Distress:** Failing

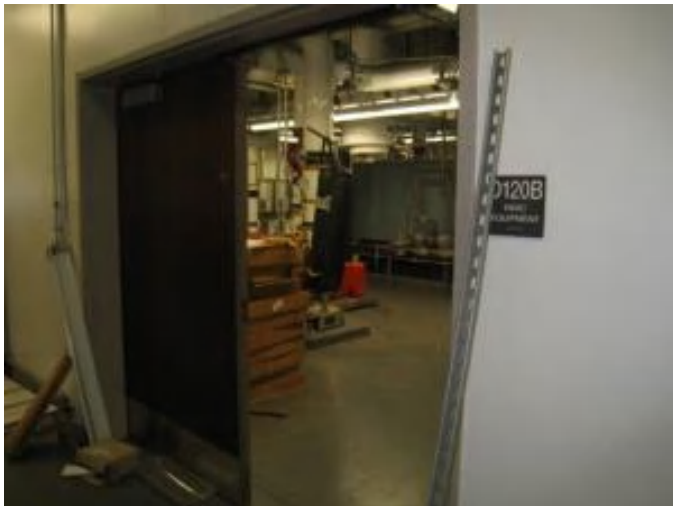
**Location:** interior locations

**System: C1020 - Interior Doors**

**Distress:** Appearance

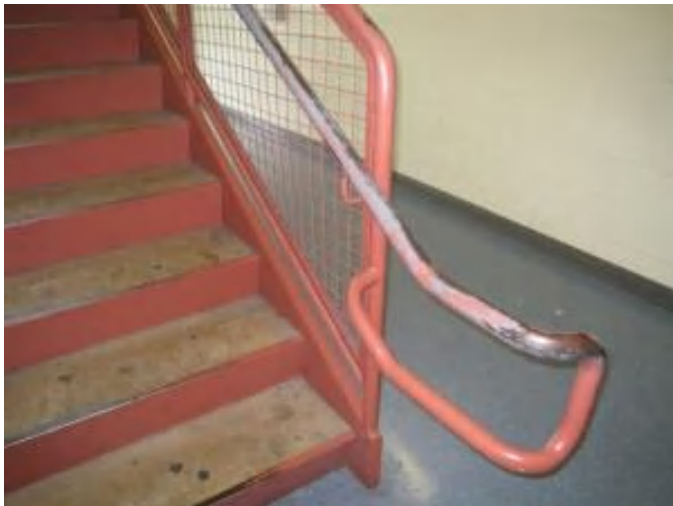
**Location:** stairways

**System: C2010 - Stair Construction**

**Distress:** Appearance

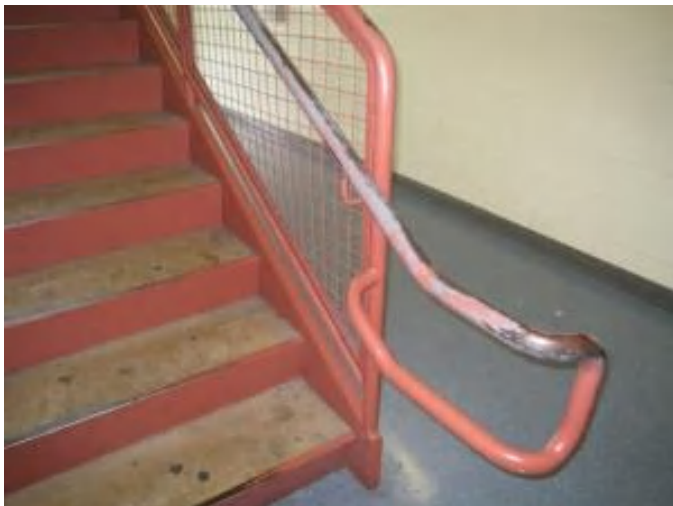
**Location:** stairways

**System: C2010 - Stair Construction**

**Distress:** Appearance

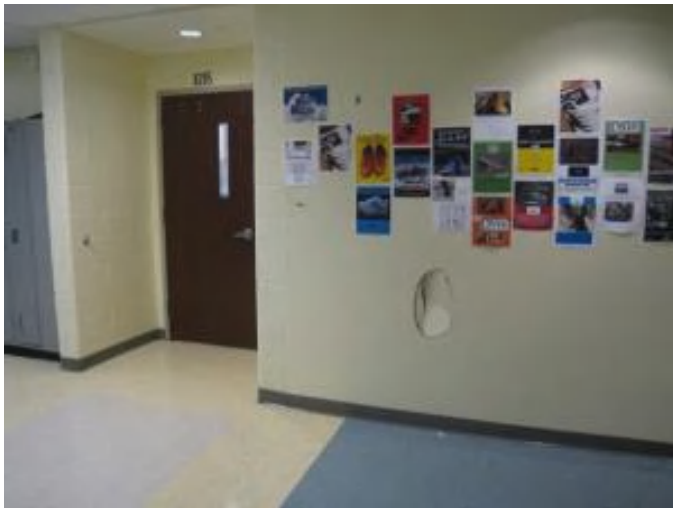
**Location:** classrooms, corridors

**System: C3010230 - Paint & Covering**

**Distress:** Damaged

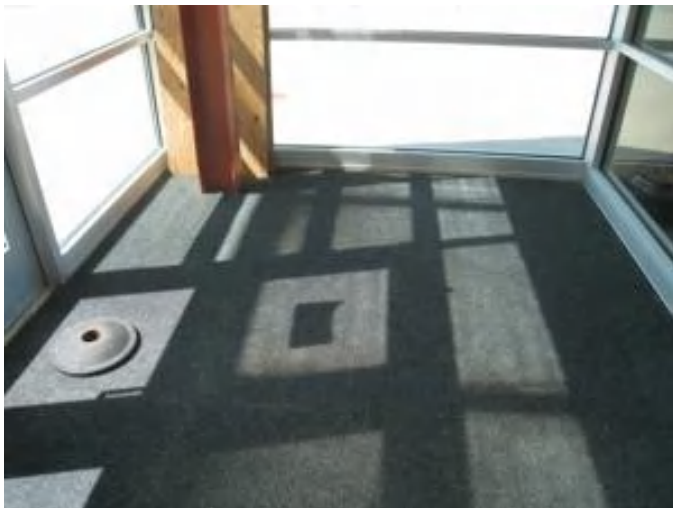
**Location:** multipurpose room, offices, auditorium

**System: C3020411 - Carpet**

**Distress:** Damaged

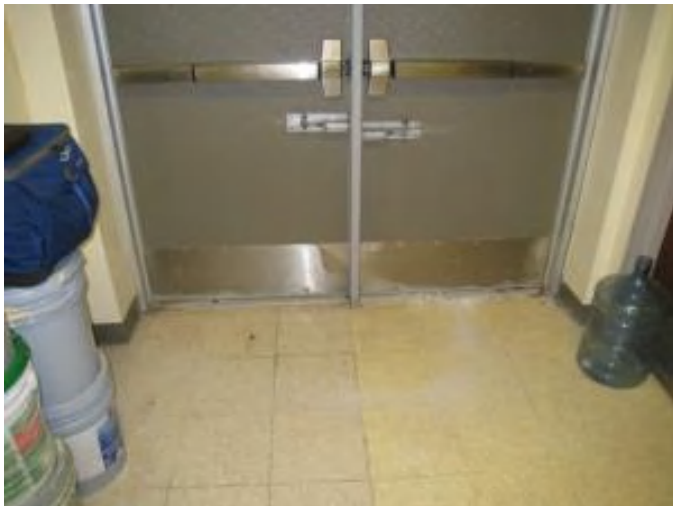
**Location:** VCT floors

**System: C3020413 - Vinyl Flooring**

**Distress:** Damaged

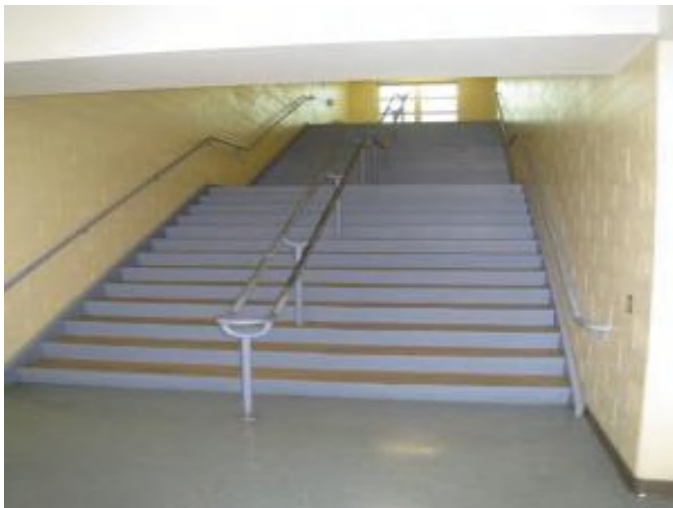
**Location:** mechanical area floors and stair treads

**System: C3020415 - Concrete Floor Finishes**

**Distress:** Appearance

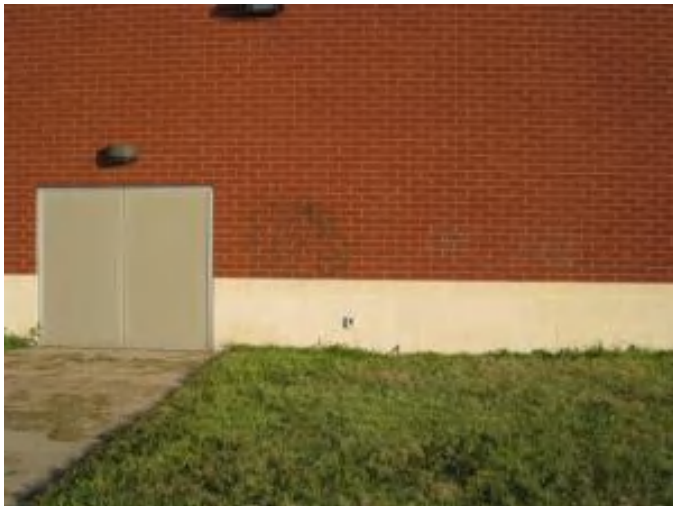
**Location:** around bldg exterior near sidewalk

**System: D2010 - Plumbing Fixtures**

**Distress:** Maintenance Required

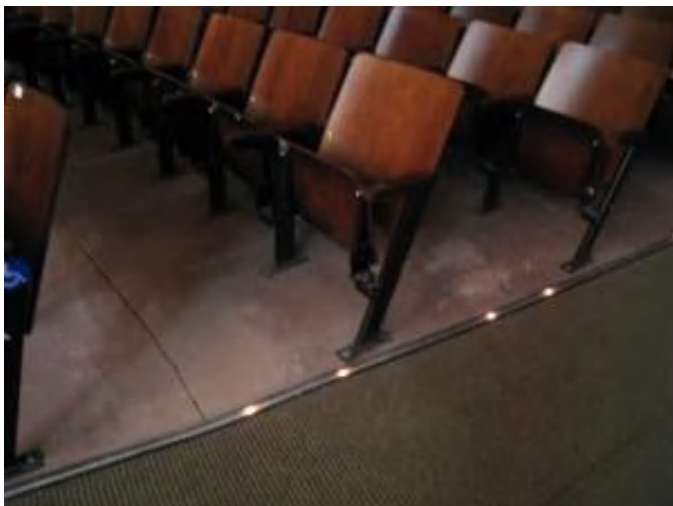
**Location:** auditorium

**System: E2010 - Fixed Furnishings**

**Distress:** Appearance

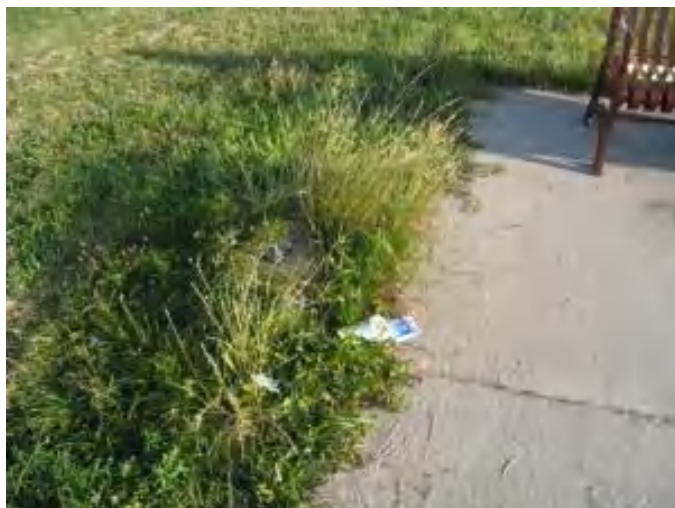
**Location:** Langdon St. side of property

**System: D5020 - Lighting and Branch Wiring**

**Distress:** Security Issue

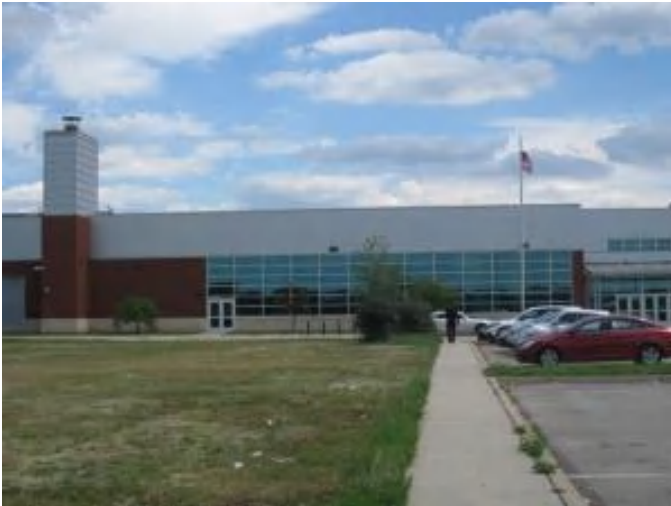
**Location:** parking lot

#### System: G2020 - Parking Lots

**Distress:** Damaged

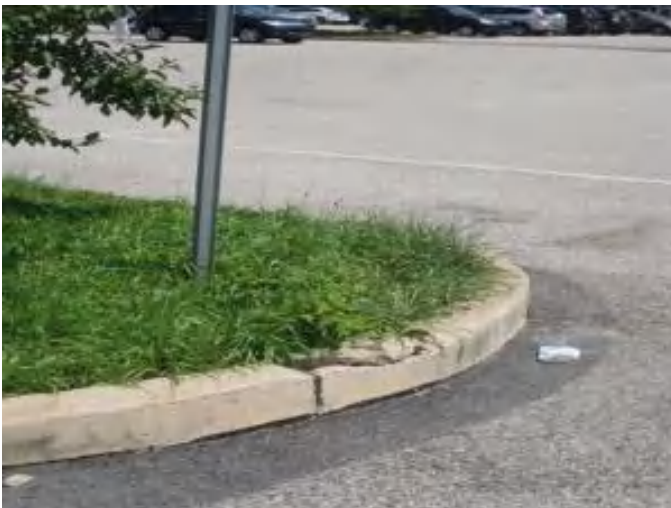
**Location:** parking lot

#### System: G2020 - Parking Lots

**Distress:** Damaged

**Notes:** Repair broken curbing (50ft)

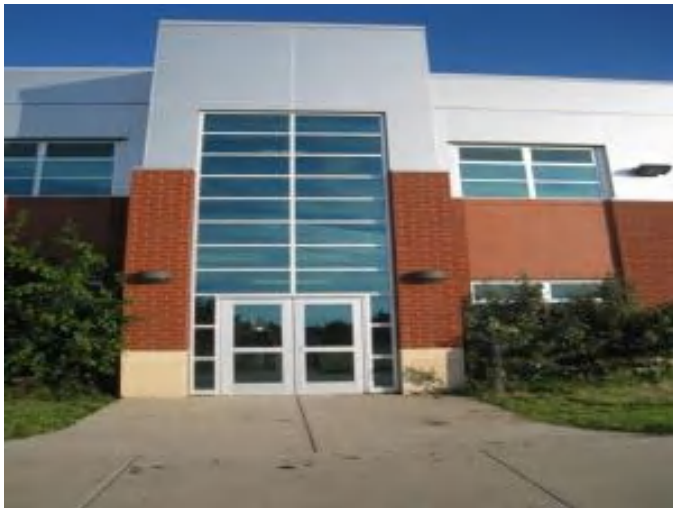
**Location:** concrete walks

**System: G2030 - Pedestrian Paving**

**Distress:** Damaged

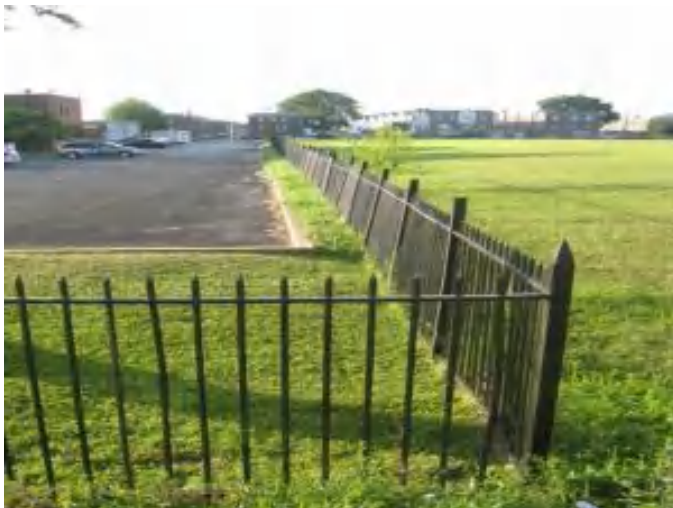
**Location:** northeast side of school

**System: G2040 - Site Development**

**Distress:** Damaged

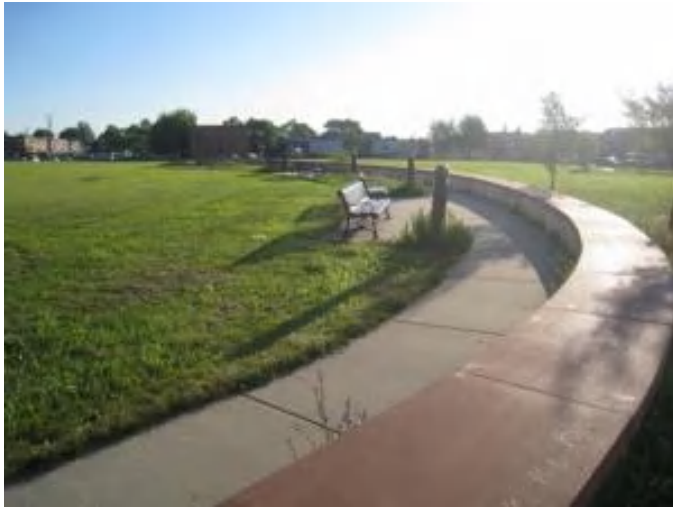
**Location:** Langdon Street side of building

**System: G2040 - Site Development**

**Distress:** Failing

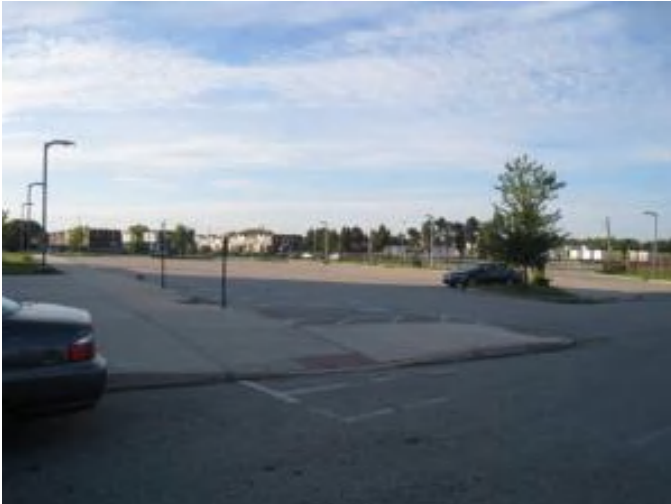
**Location:** parking lots

**System: G2020 - Parking Lots**

**Distress:** Failing
