Facility Condition Assessment Summary Report

Feltonville Arts and Sciences School

S750001;Feltonville Arts

Site Assessment Report

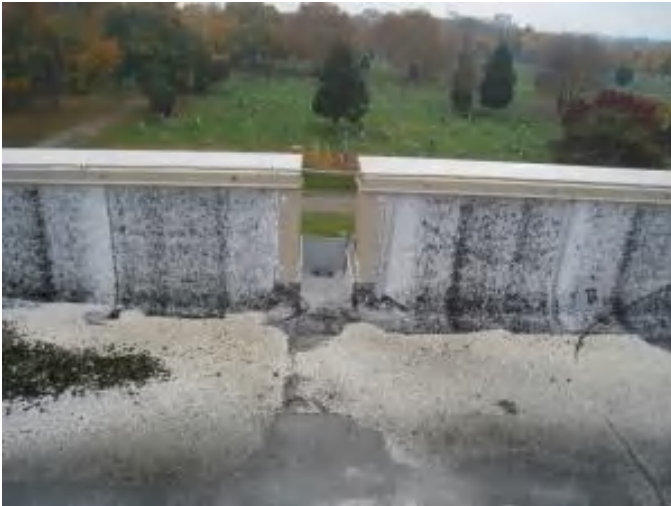
System: B3010105 - Built-Up

Location: roofs - all

Distress: Failing

Notes: Replace all roofing (38,919sf)

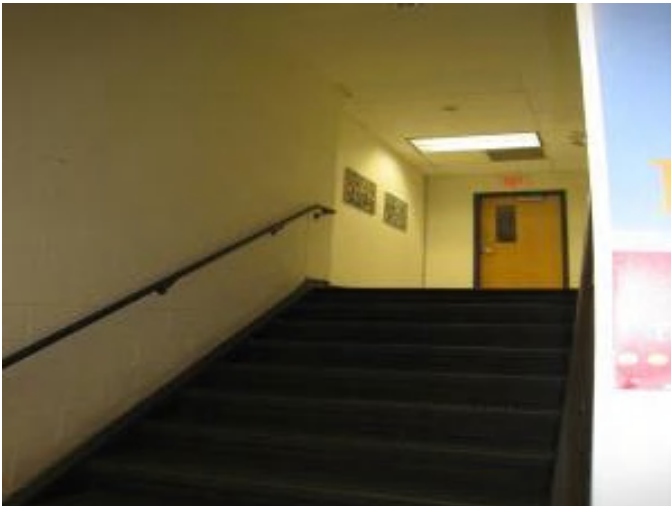
System: C2010 - Stair Construction

Location: old building stairway

Distress: Building / MEP Codes

Notes: Remove and replace stairway handrails and guards with code compliant systems in old building stairway 3 stories = 150ft

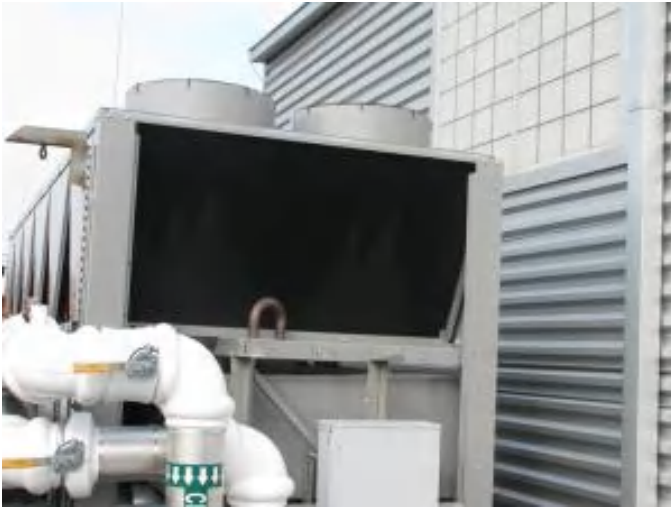
System: D5020 - Lighting and Branch Wiring

Location: Chiller Area

Distress: Life Safety / NFPA / PFD

Notes: Provide exterior lighting fixtures in chiller area. Estimated 2 LED lighting fixtures.

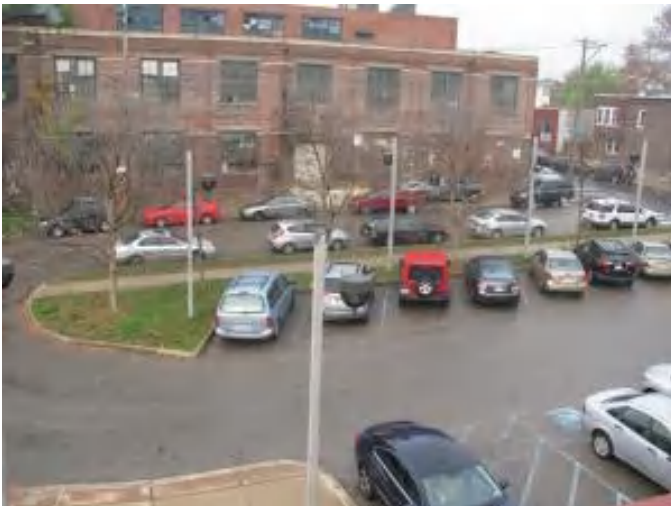
System: D5030 - Communications and Security

Location: Entire Building

Distress: Security Issue

Notes: Replace existing video surveillance system with an adequate video surveillance system including camera and Closed Circuit Television (CCTV) system. Cameras should install in the corridors, school entrance doors and on the walls around the building in order to make fully protection to the school.

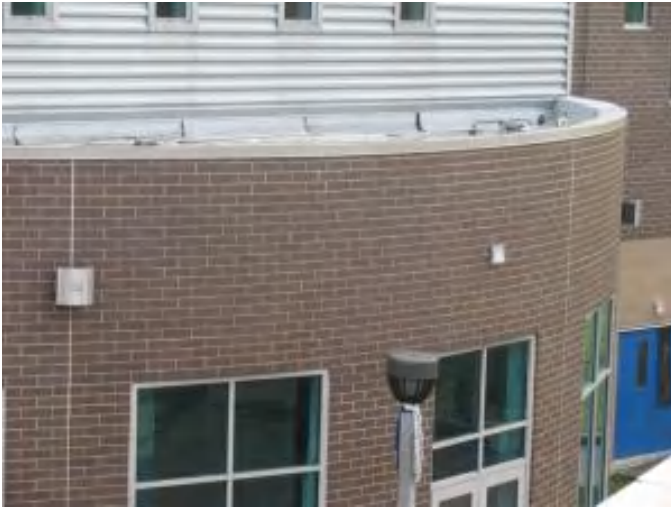
System: D5030 - Communications and Security

Location: B750001;Feltonville Arts

Distress: Life Safety / NFPA / PFD

Notes: Provide speaker on exterior wall and connect them to school paging system. Estimated 4 speakers

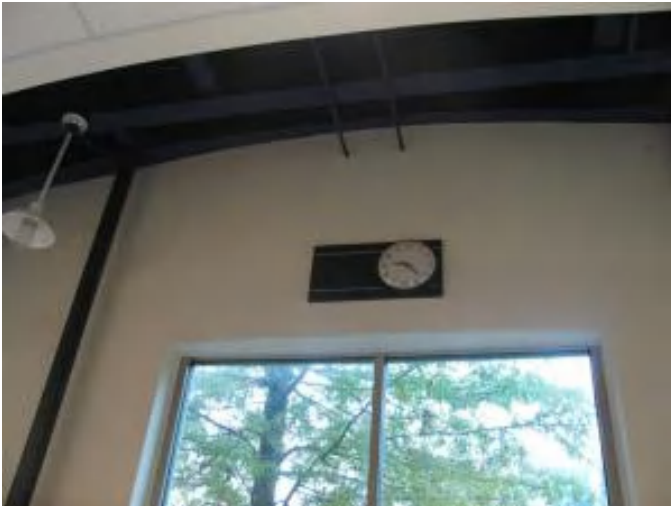
System: D5030 - Communications and Security

Location: Entire Building

Distress: Damaged

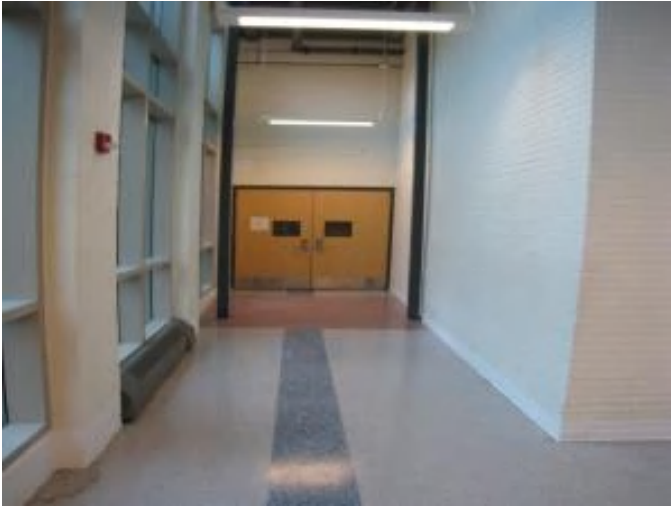
System: A1030 - Slab on Grade

Location: lobby

Distress: Failing

Notes: Repair concrete slab underneath cracking and delaminating terrazzo at old building stairway, then repair terrazzo – in area where new addition meets old building (200sf)

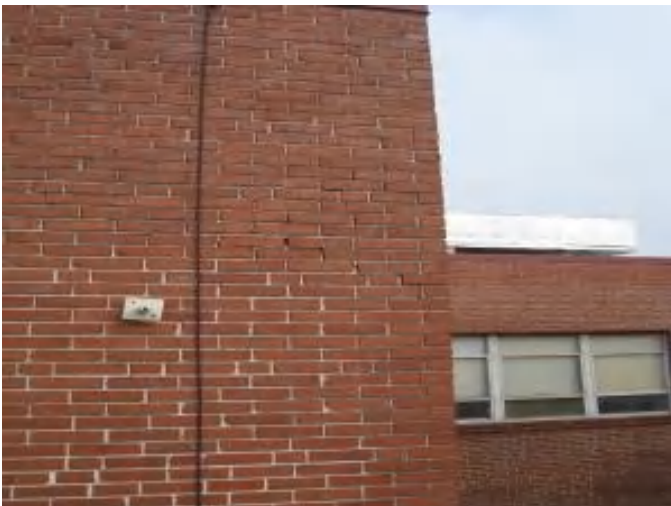
System: B2010 - Exterior Walls

Location: old building, south wall, one story section

Distress: Failing

Notes: Repoint red brick on old building (200sf)

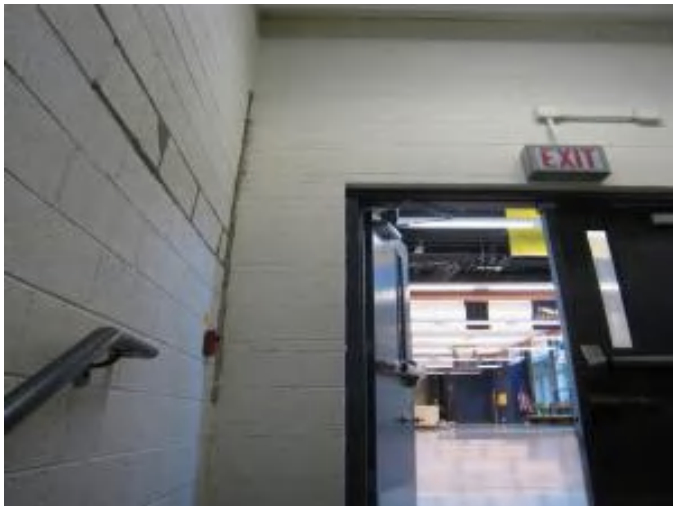
System: B2010 - Exterior Walls

Location: old-new bldg intersection

Distress: Damaged

Notes: Repair cracks in interior block walls in area where new addition meets old building (200sf)

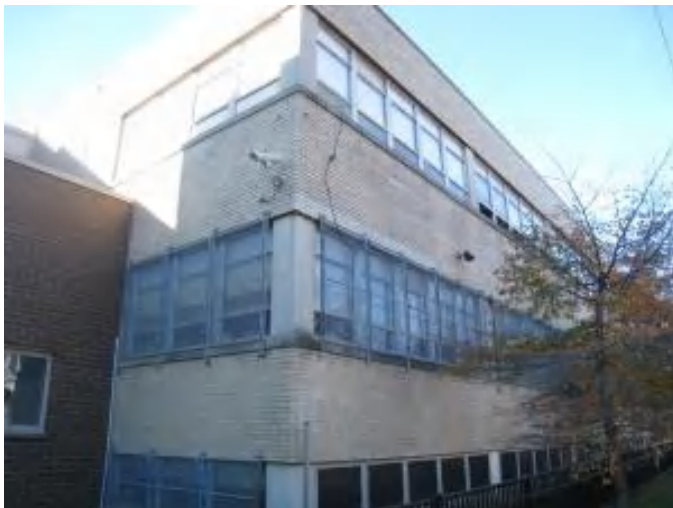
System: B2010 - Exterior Walls

Location: old building, lintels

Distress: Failing

Notes: Repaint all lintels over old windows in old building (550 ft)

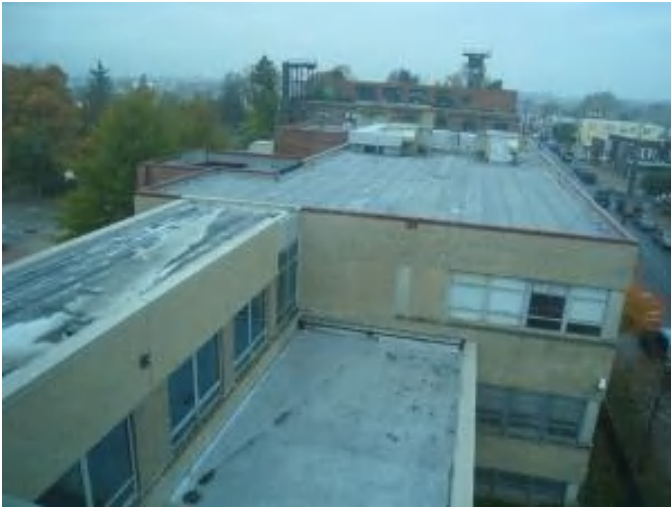
System: B2010 - Exterior Walls

Location: old building, street facade

Distress: Appearance

Notes: Powerwash buff brick on old building and SE section under blue overhang on new building (2500sf)

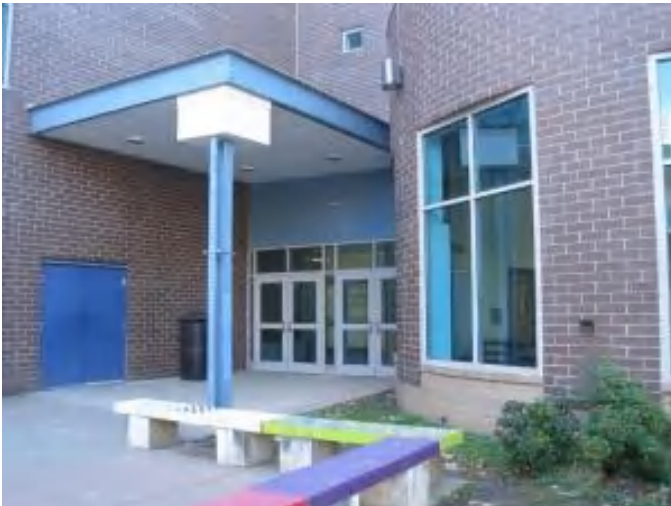
System: B2010 - Exterior Walls

Location: steel columns at entrance, courtyard, and mech area

Distress: Failing

Notes: Repaint 5 steel columns supporting exterior overhangs at entrance, courtyard, mech area (200sf)

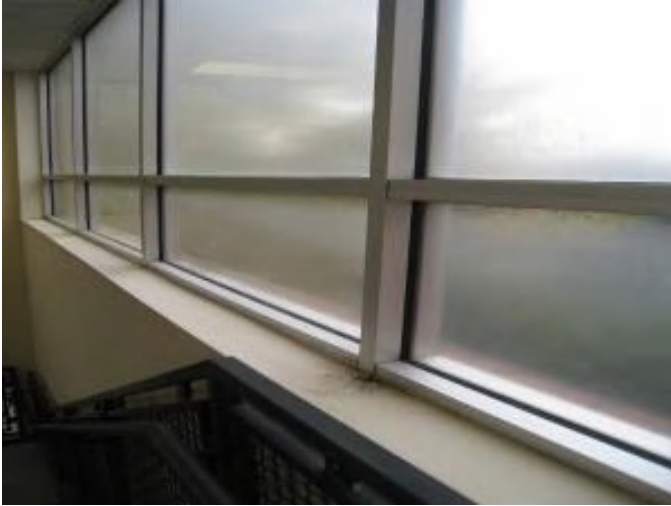
System: B2020 - Exterior Windows

Location: old building, exterior windows

Distress: Beyond Service Life

Notes: Replace all exterior windows in old building with insulated single hung units (114)3.5x6 and (44) 3.5x2

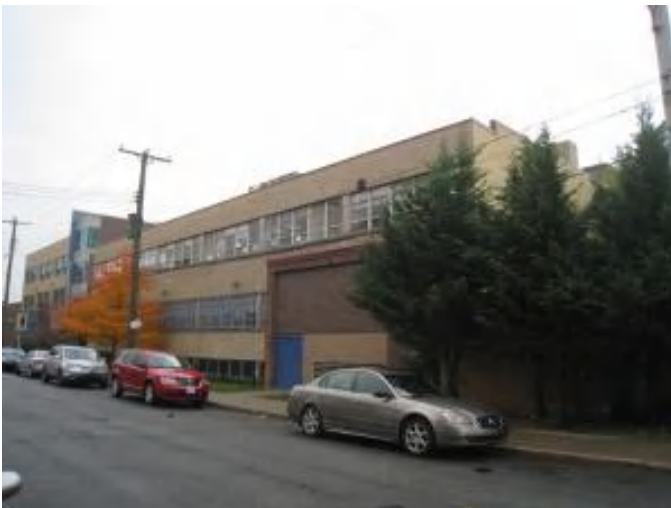
System: B2030 - Exterior Doors

Location: old building exterior doors

Distress: Failing

Notes: Replace exterior hollow metal doors on old building (4 3x7)

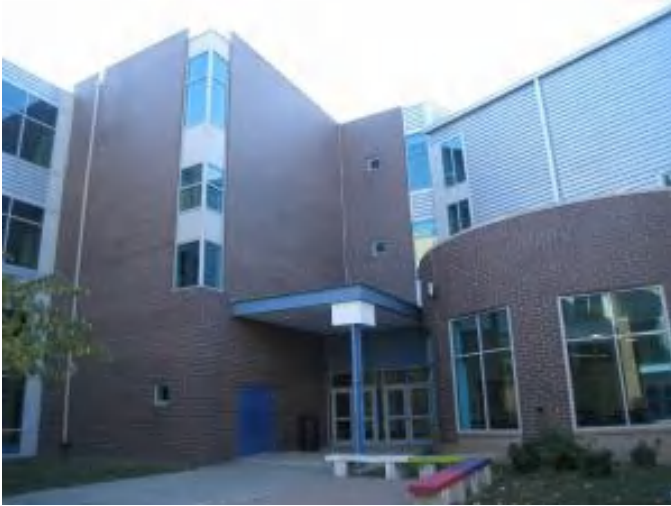
System: B2030 - Exterior Doors

Location: new addition, exterior metal doors

Distress: Appearance

Notes: Repaint exterior hollow metal doors and frames on new addition (9 3x7)

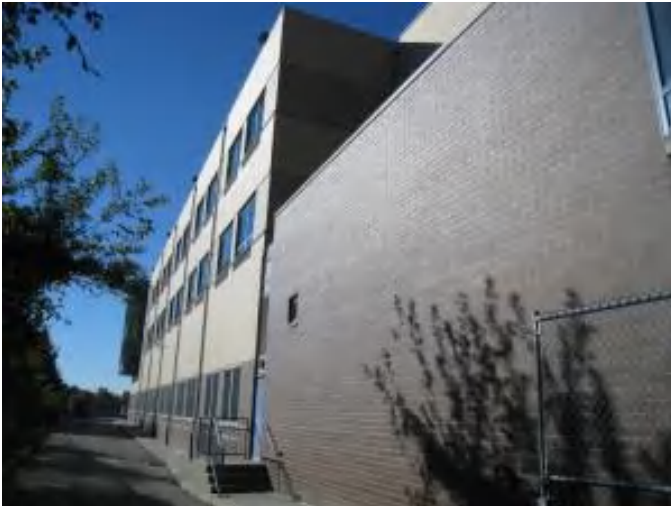
System: B3010105 - Built-Up

Location: roof / masonry wall intersection

Distress: Building Envelope Integrity

Notes: Remove and reinstall all masonry to roof expansion joints where old building meets new building and along low roof intersection to masonry along E. Courtland Street on new addition (200 ft)

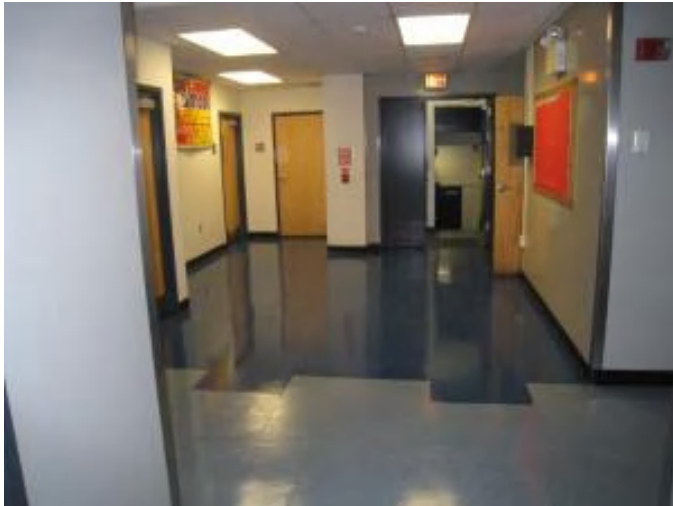
System: C1020 - Interior Doors

Location: classroom and office doors on corridor

Distress: Security Issue

Notes: Provide security hardware for classrooms and offices, locking from inside classroom; replace all in old building, replace some in new addition (40)

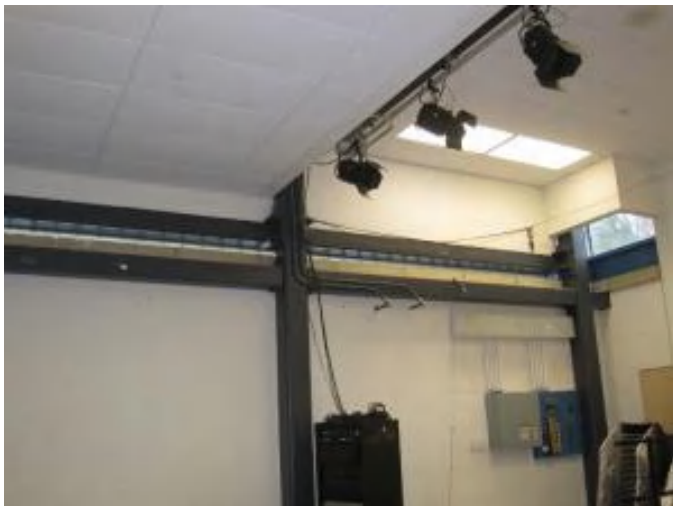
System: C3010230 - Paint & Covering

Location: water damaged walls

Distress: Damaged

Notes: Repair walls damaged by water leaks; repaint walls in old building (1000sf)

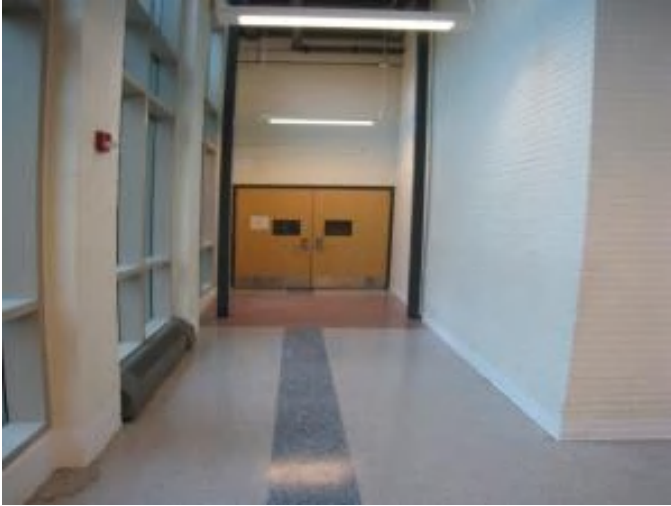
System: C3020412 - Terrazzo & Tile

Location: lobby

Distress: Damaged

Notes: Repair concrete slab underneath cracking and delaminating terrazzo at old building stairway, then repair terrazzo – in area where new addition meets old building (200sf)

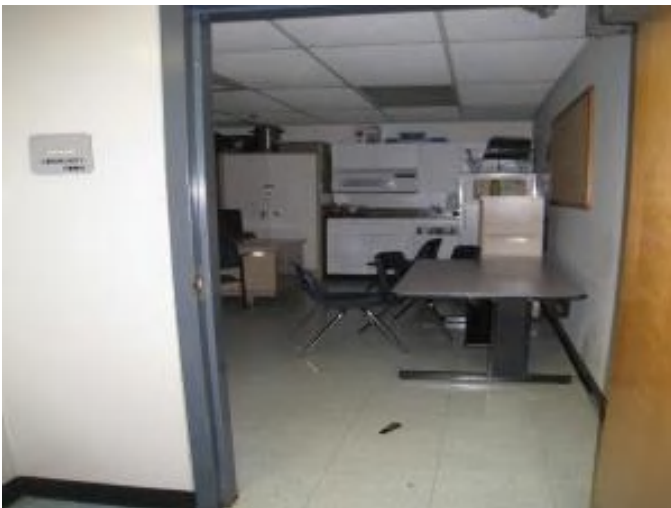
System: C3020413 - Vinyl Flooring

Location: old building floor

Distress: Failing

Notes: Replace VCT in old building (16,000sf)

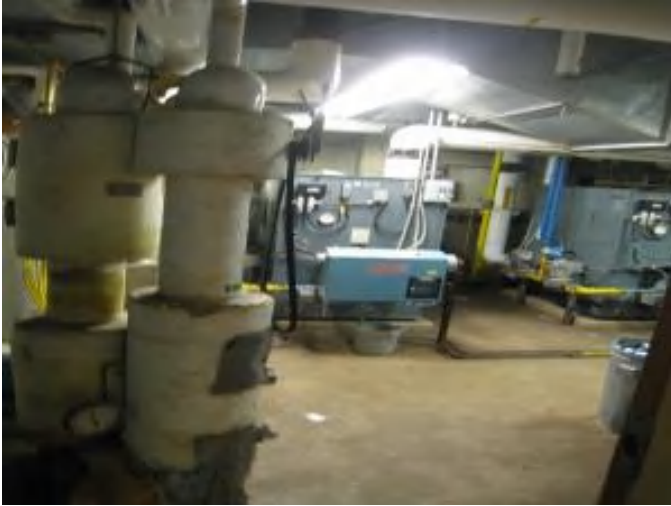
System: C3020415 - Concrete Floor Finishes

Location: old building basement and stairs

Distress: Appearance

Notes: Strip, clean and reseal concrete floors in old building mechanical rooms and stairways and new addition mechanical room. (7200sf)

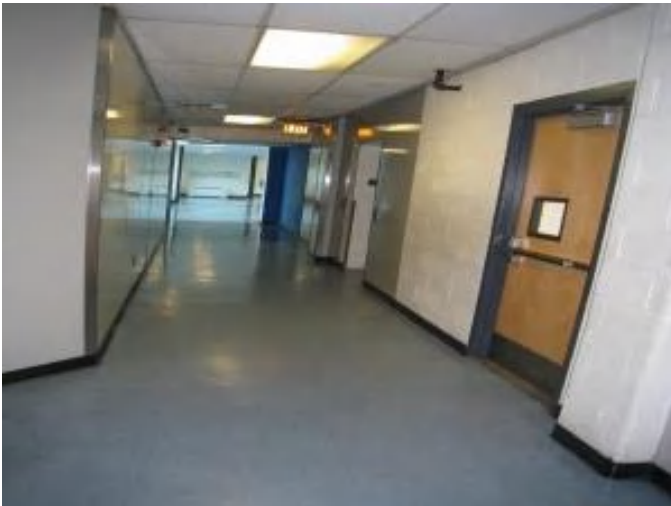
System: C3030 - Ceiling Finishes

Location: ceilings

Distress: Failing

Notes: Replace ceilings with water damage from leaks in new addition; replace old 2x4 ceilings in old building (18,400sf)

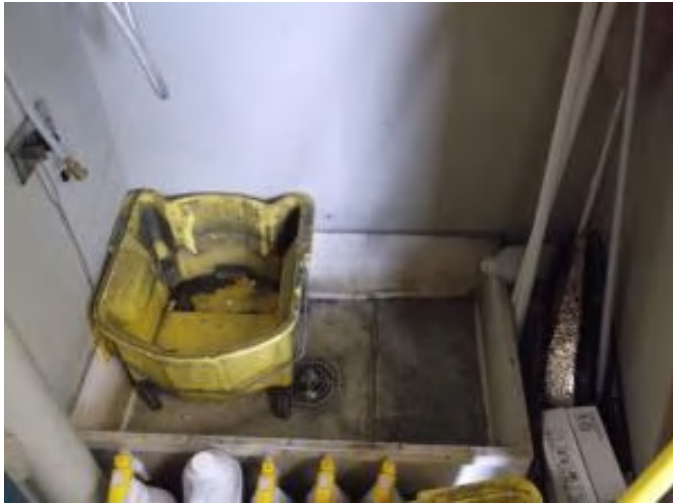
System: D2010 - Plumbing Fixtures

Location: Throughout the building

Distress: Beyond Service Life

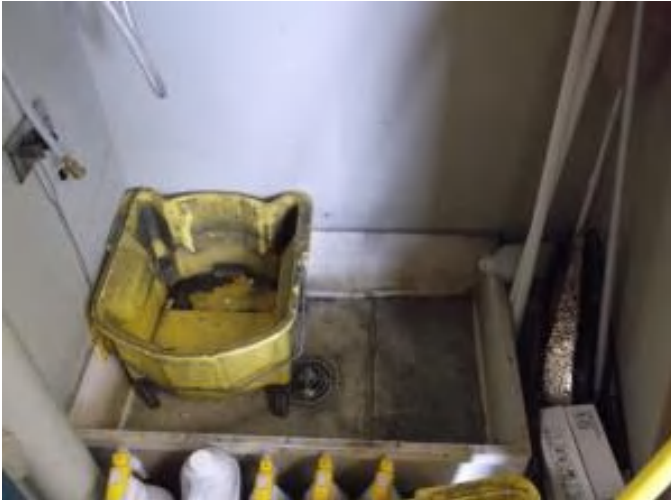
System: D2030 - Sanitary Waste

Location: Throughout the building

Distress: Beyond Service Life

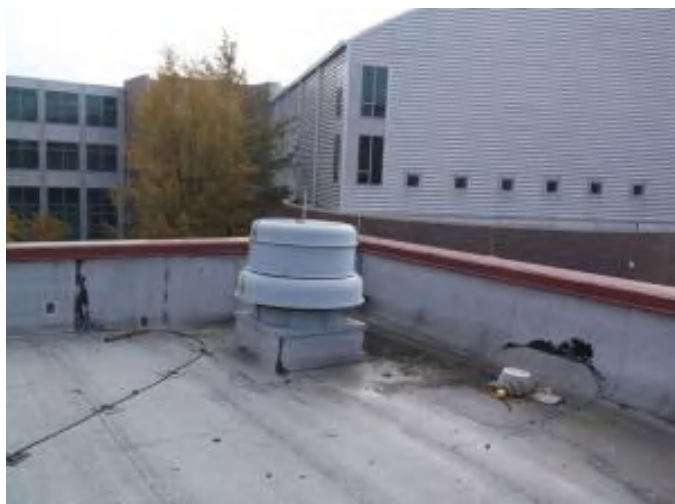
System: D3040 - Distribution Systems

Location: Roof

Distress: Beyond Service Life

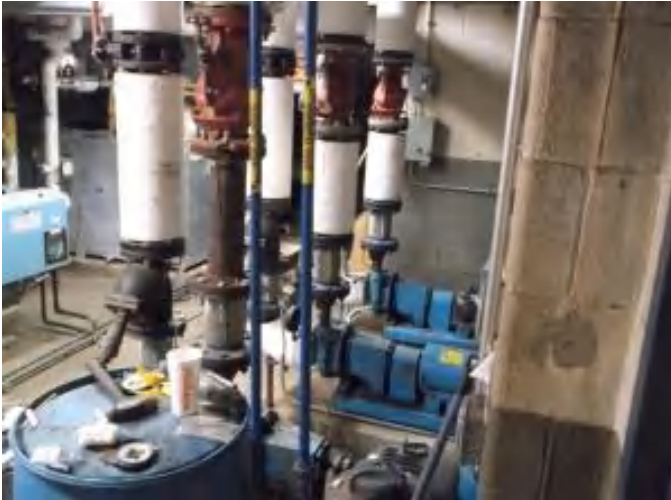
System: D3020 - Heat Generating Systems

Location: Main boiler mechanical equipment room

Distress: Beyond Service Life

Notes: In the Original Wing replace the heating water pumps

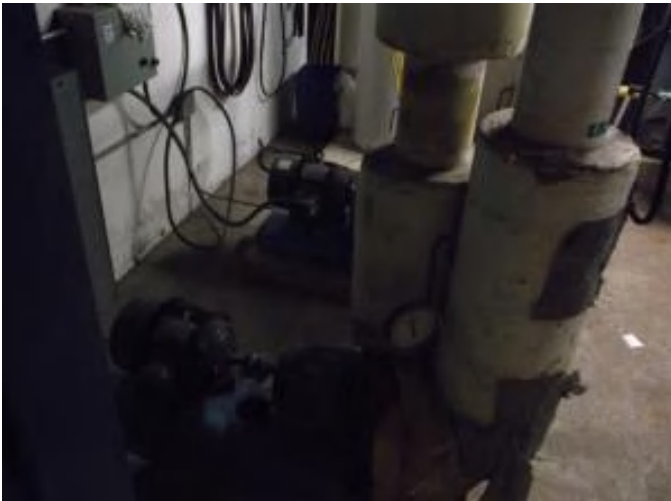
System: D3030 - Cooling Generating Systems

Location: Main boiler mechanical room

Distress: Beyond Service Life

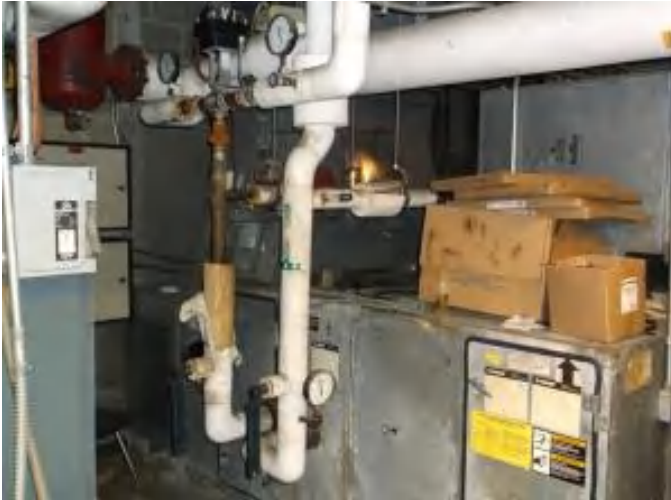
System: D3040 - Distribution Systems

Location: Throughout the building

Distress: Beyond Service Life

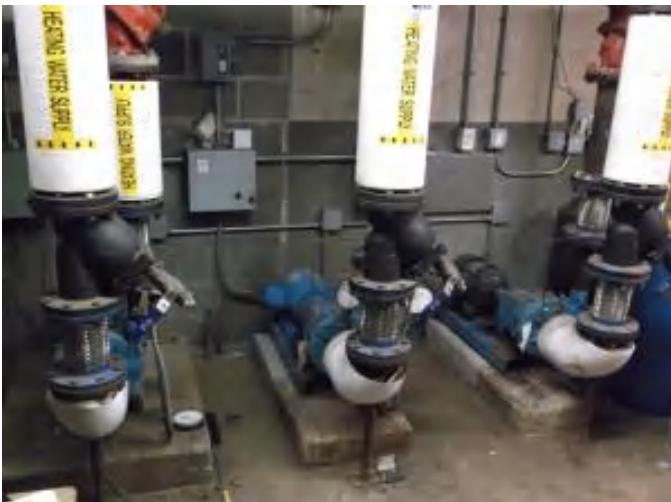
System: D3040 - Distribution Systems

Location: Throughout the building

Distress: Beyond Service Life

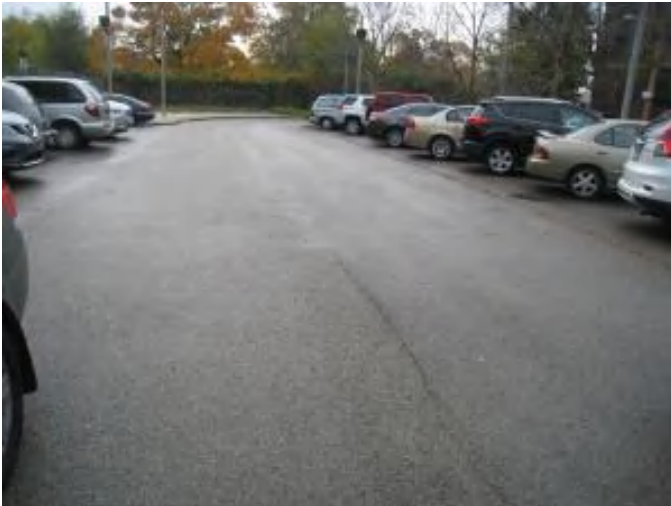
System: G2020 - Parking Lots

Location: faculty parking lot

Distress: Damaged

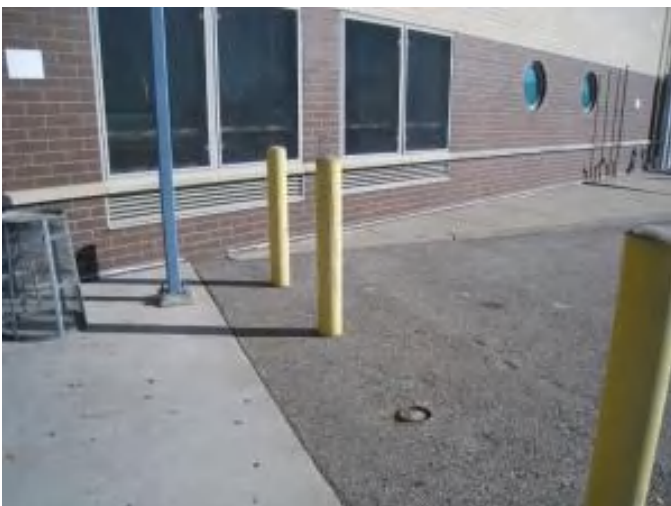
System: G2030 - Pedestrian Paving

Location: mechanical area and play areas

Distress: Failing

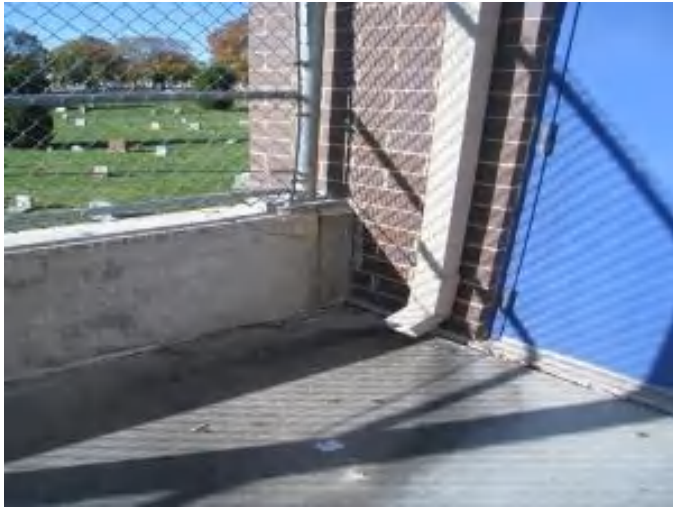
System: G2040 - Site Development

Location: mechanical area - retaining wall

Distress: Failing

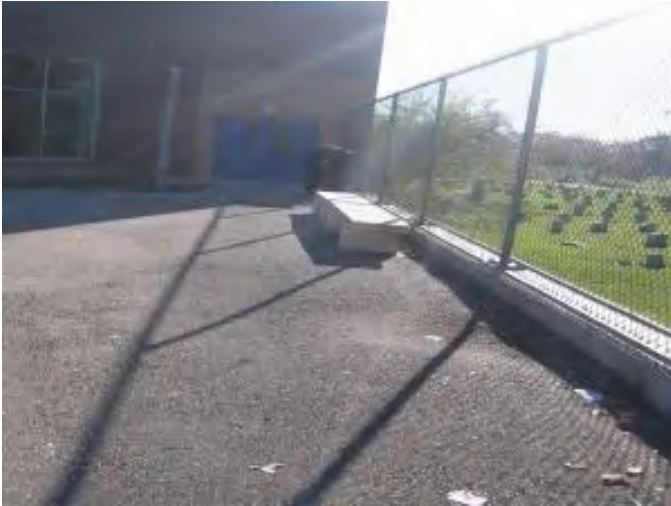
System: G2020 - Parking Lots

Location: mechanical area and play area

Distress: Failing
