Facility Condition Assessment Summary Report

Feltonville Intermediate School

Final
Site Assessment Report

January 31, 2017

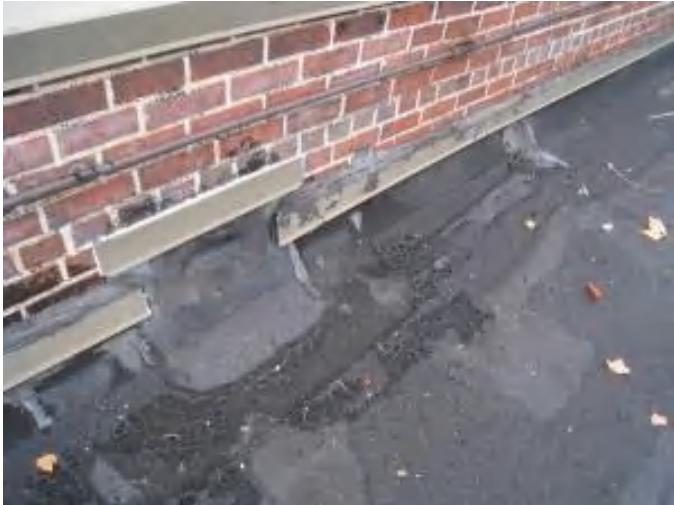
System: B3010105 - Built-Up

Location: roof

Distress: Failing

Notes: Replace all roofing (41,692sf)

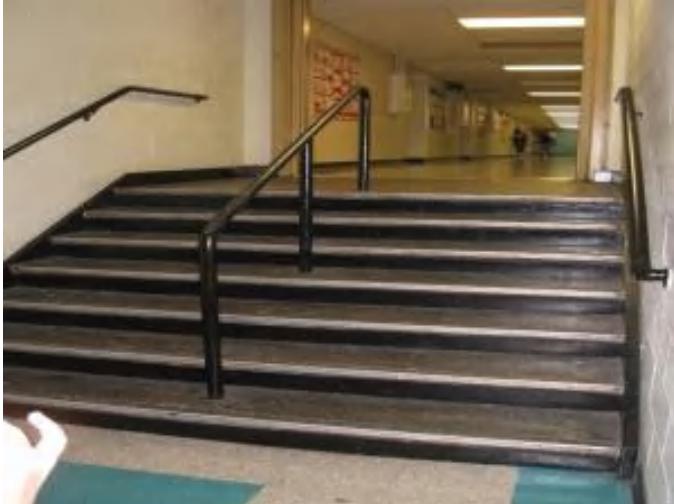
System: C2010 - Stair Construction

Location: stairways

Distress: Building / MEP Codes

Notes: Remove and replace stairway handrails and guards with code compliant systems in stairway 1 - 3 stories = 14 stairway/levels
for all stairways x 50ft/floor (2 half runs) = 700ft

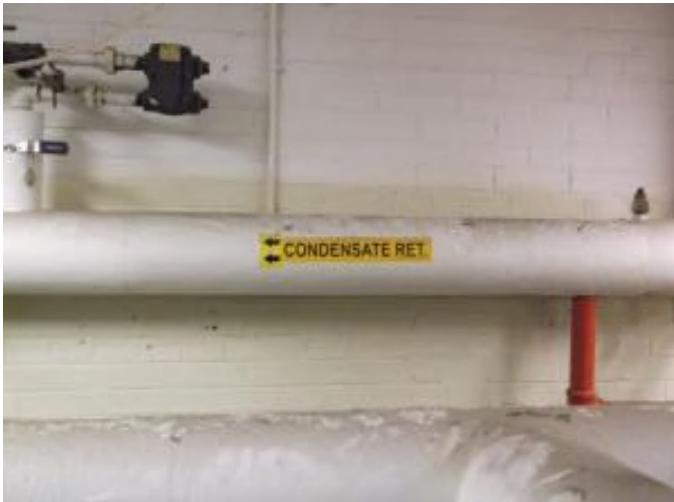
System: D3040 - Distribution Systems

Location: Throughout the school

Distress: Beyond Service Life

Notes: Conduct a steam trap survey to identify and replace failed traps passing live steam into the condensate piping system.

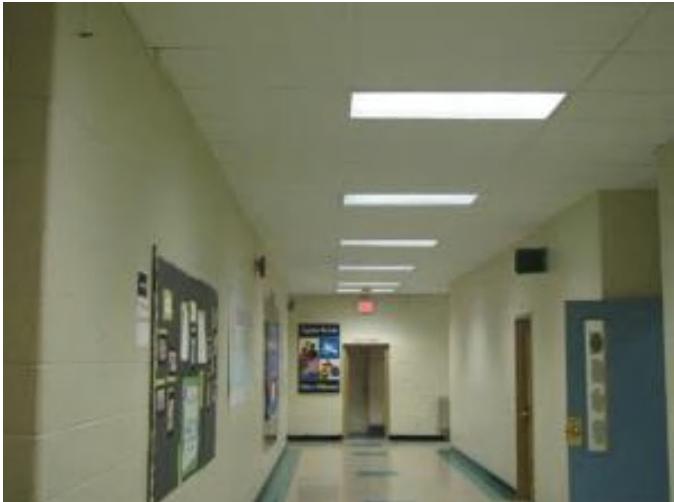
System: D5030 - Communications and Security

Location: Entire Building

Distress: Security Issue

Notes: Provide an adequate video surveillance system including camera and Closed Circuit Television (CCTV) for monitoring the system. Cameras should install in the corridors, school entrance.

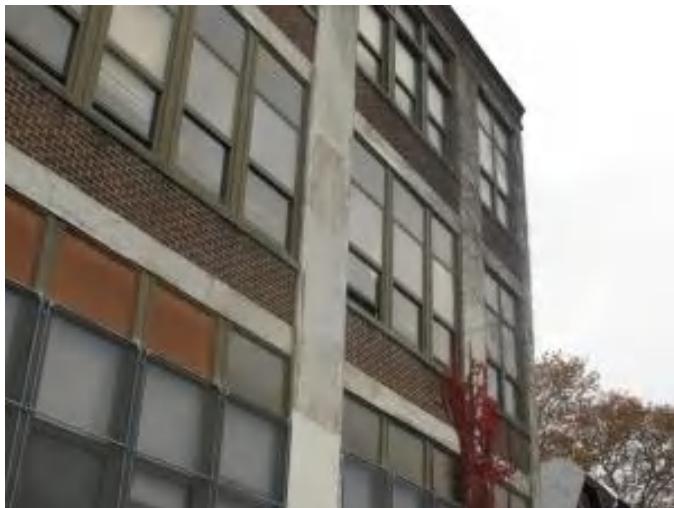
System: D5030 - Communications and Security

Location: Exterior Building

Distress: Inadequate

Notes: Provide speakers on exterior walls to adequately cover the area. Estimated 5 in total.

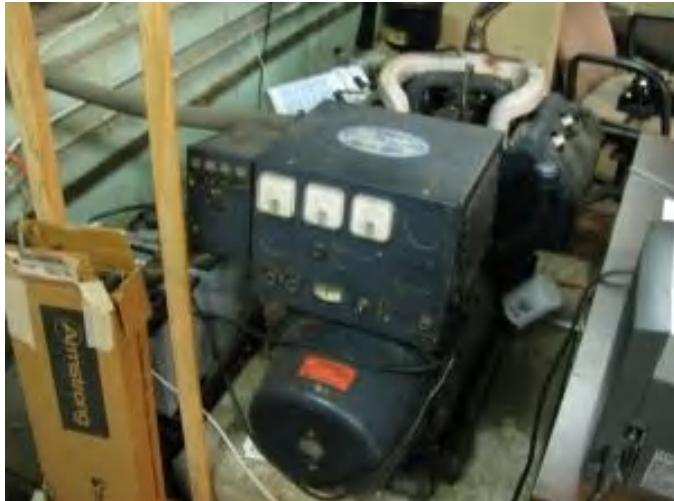
System: D5090 - Other Electrical Systems

Location: Mechanical Room

Distress: Life Safety / NFPA / PFD

Notes: Replace existing emergency generator with a 30KW, 120/208V generator along with respective Automatic Transfer Switch. Replace existing emergency distribution panel board.

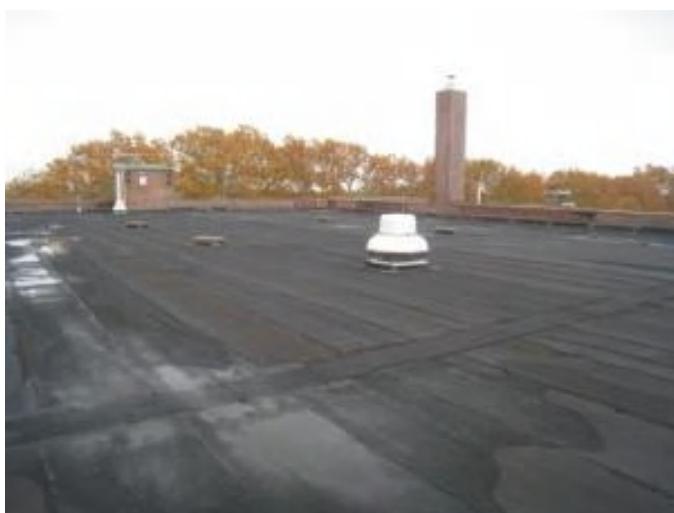
System: D5090 - Other Electrical Systems

Location: Roof

Distress: Life Safety / NFPA / PFD

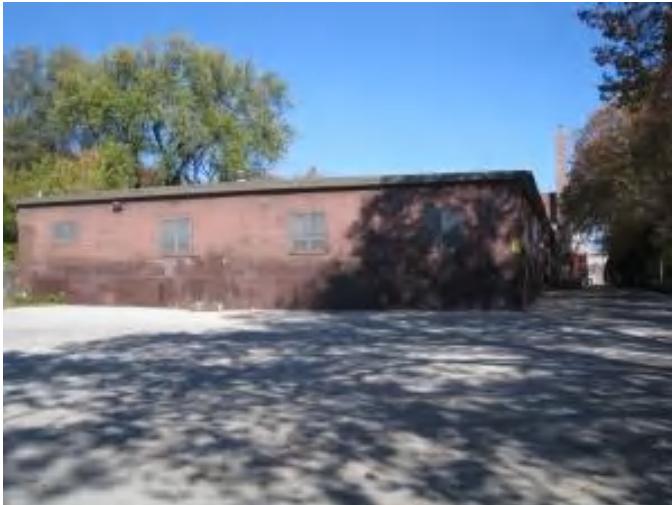
System: B2010 - Exterior Walls

Location: exterior gymnasium walls

Distress: Building Envelope Integrity

Notes: Provide new EIFS (exterior insulation and finish system) on three exterior walls on gym (4,000sf)

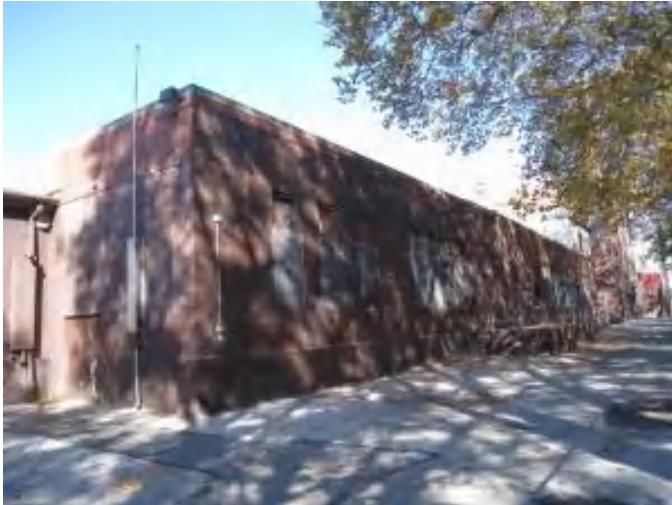
System: B2010 - Exterior Walls

Location: first floor front and east side walls

Distress: Appearance

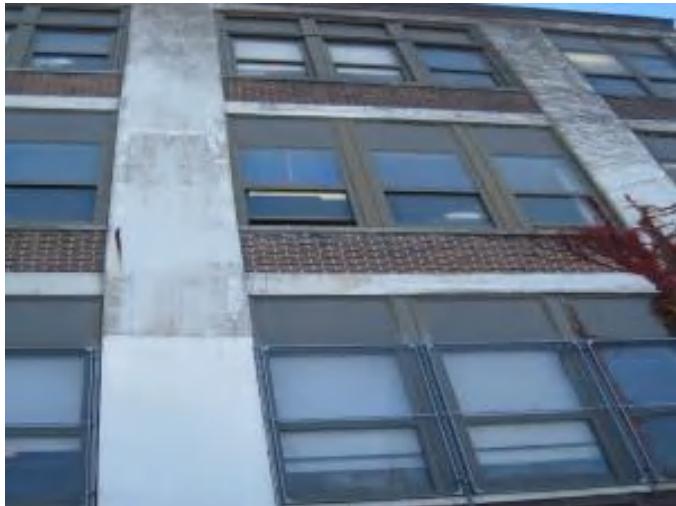
System: B2010 - Exterior Walls

Location: front and side elevations

Distress: Failing

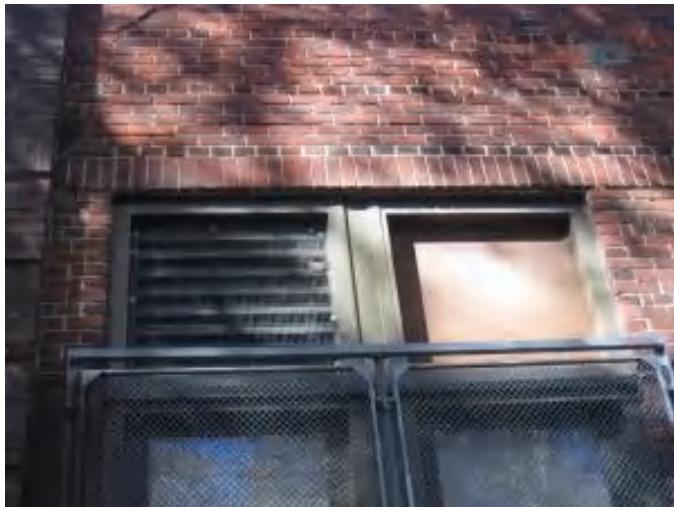
System: B2010 - Exterior Walls

Location: exterior walls, chimney

Distress: Building Envelope Integrity

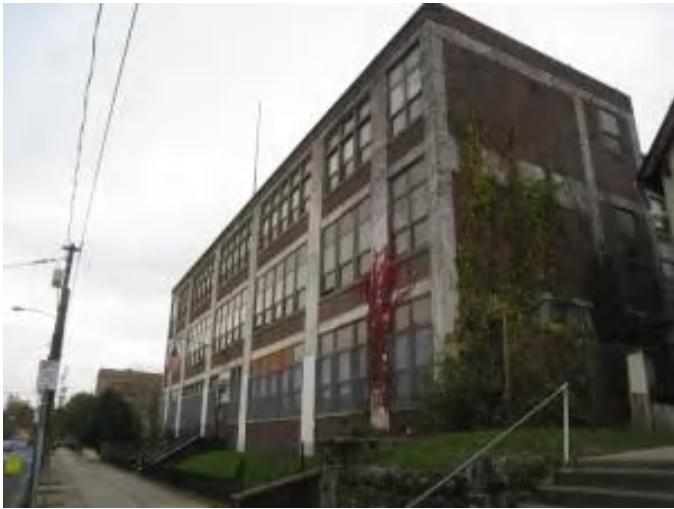
System: B2010 - Exterior Walls

Location: exterior walls front and side brick

Distress: Appearance

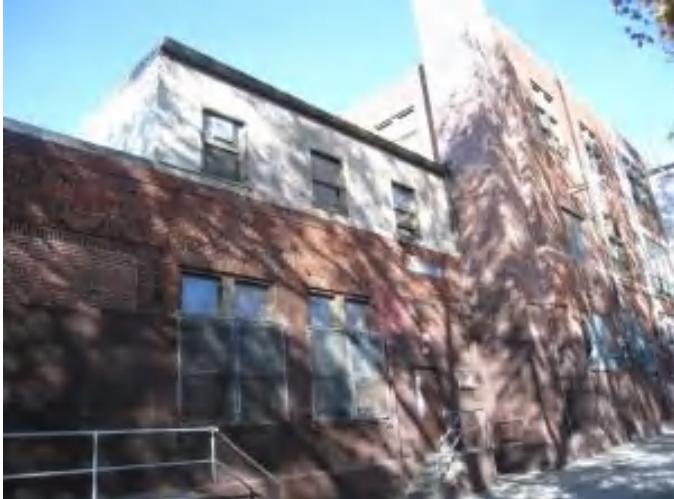
System: B2010 - Exterior Walls

Location: lintels in brick walls

Distress: Damaged

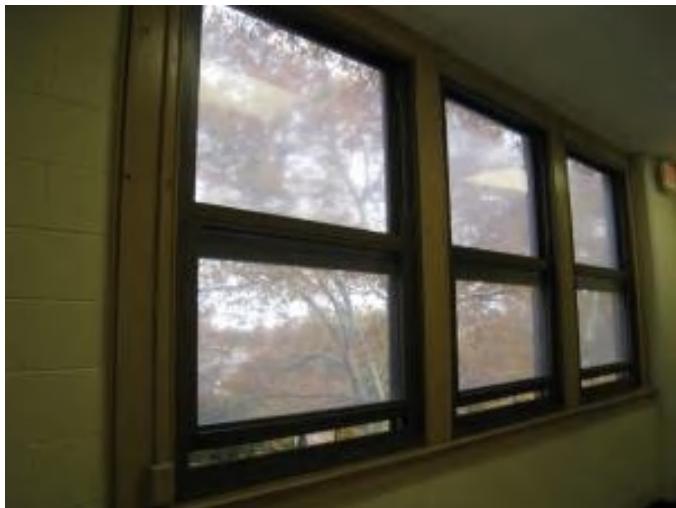
System: B2020 - Exterior Windows

Location: exterior windows

Distress: Failing

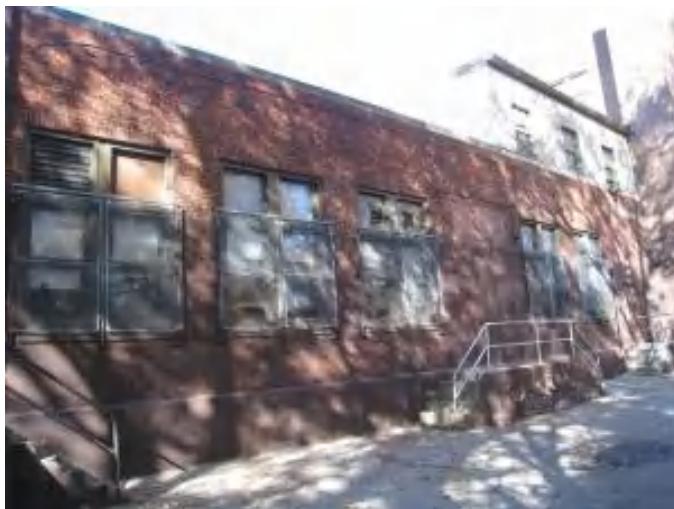
System: B2030 - Exterior Doors

Location: exterior doors

Distress: Failing

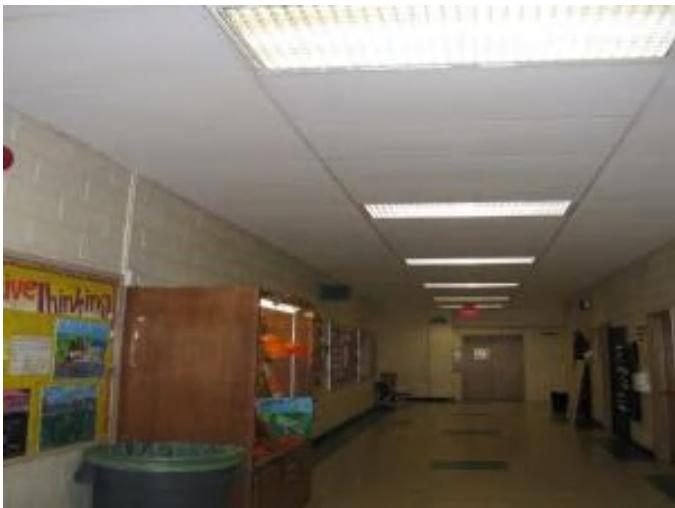
System: C1020 - Interior Doors

Location: interior doors

Distress: Damaged

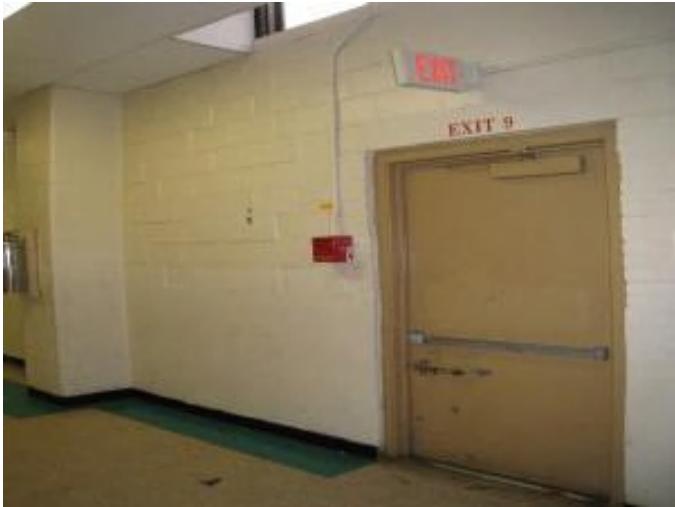
System: C1020 - Interior Doors

Location: interior doors

Distress: Damaged

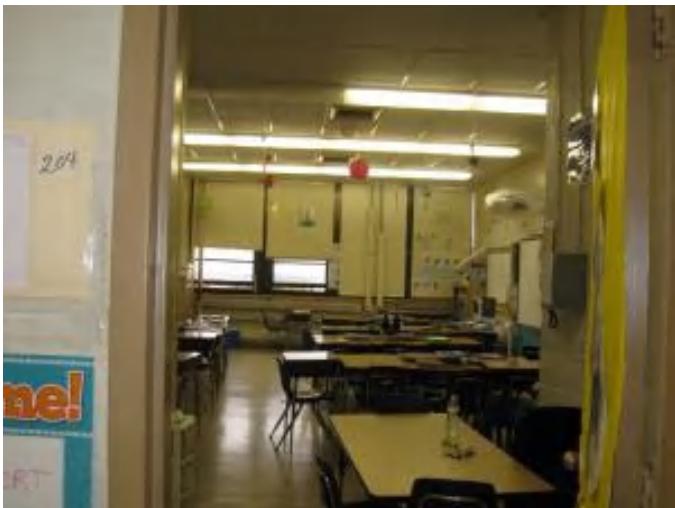
System: C1020 - Interior Doors

Location: corridor doors to classrooms and offices

Distress: Security Issue

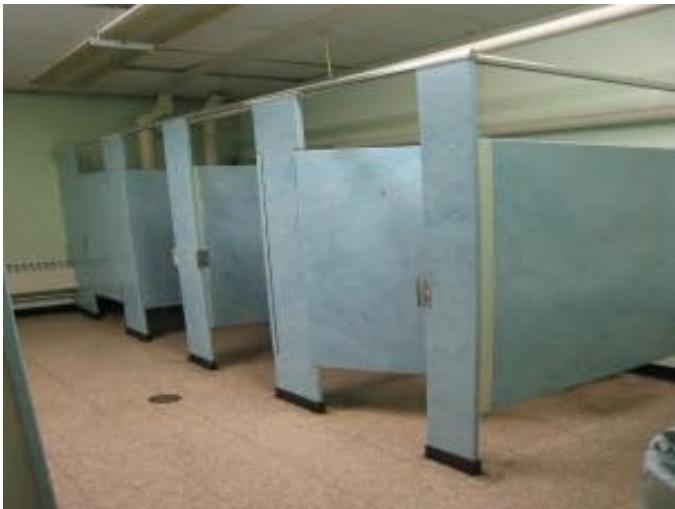
System: C1030 - Fittings

Location: toilet rooms

Distress: Damaged

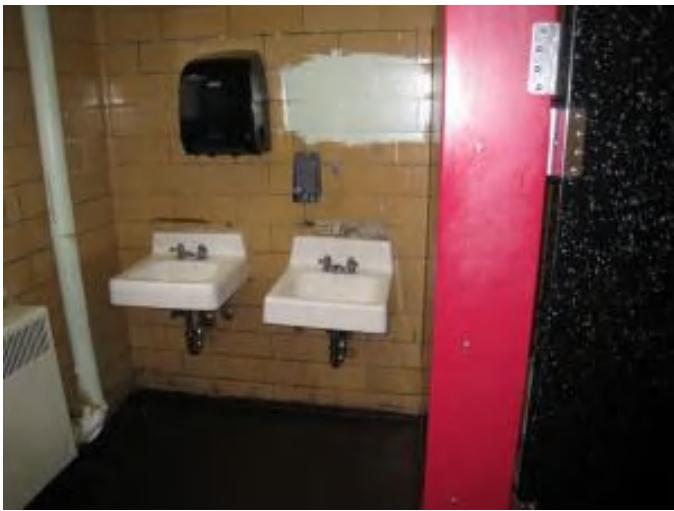
System: C1030 - Fittings

Location: toilet rooms

Distress: Accessibility

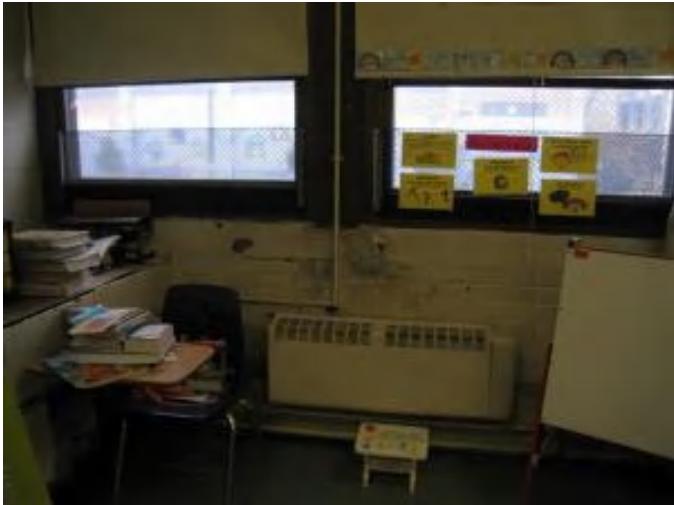
System: C3010230 - Paint & Covering

Location: walls, water damaged

Distress: Appearance

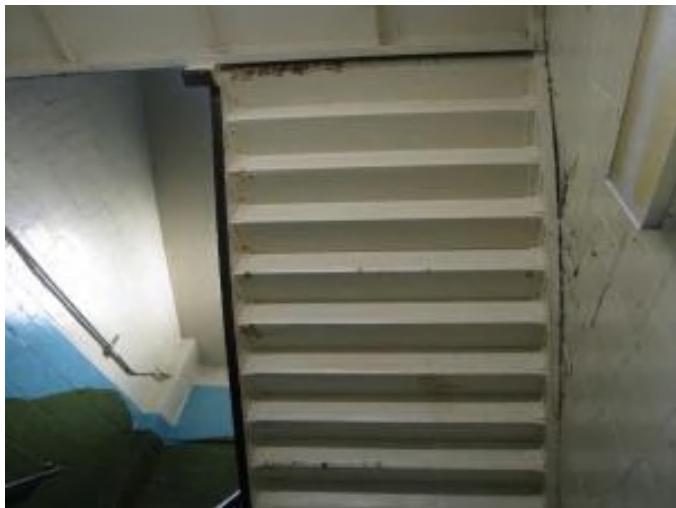
System: C3010230 - Paint & Covering

Location: stairways

Distress: Failing

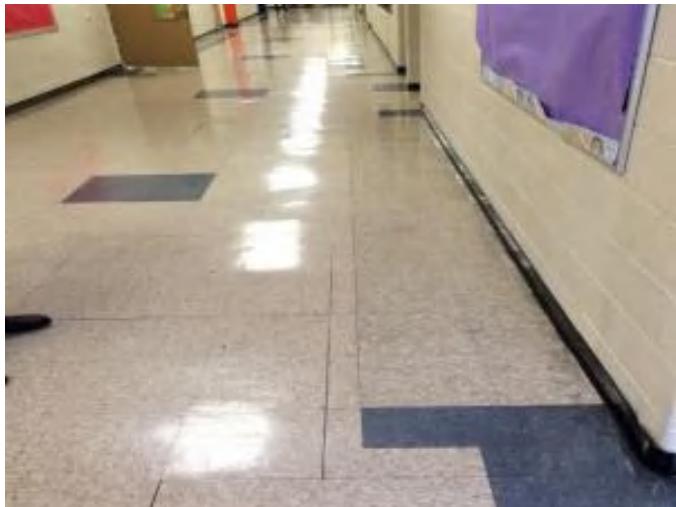
System: C3020413 - Vinyl Flooring

Location: floors

Distress: Damaged

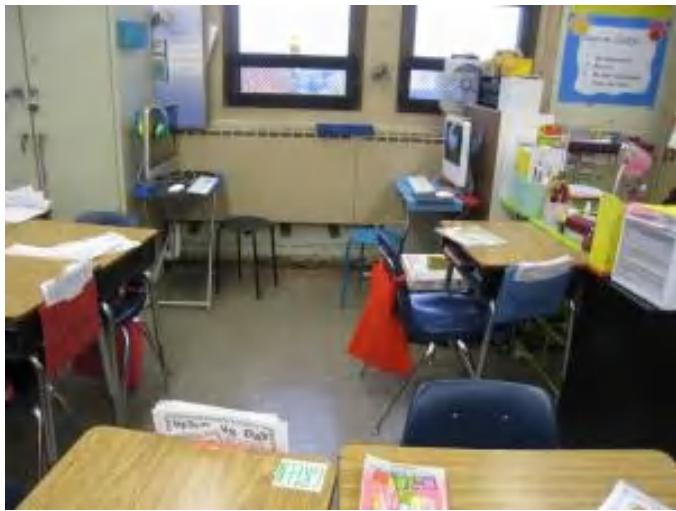
System: C3020413 - Vinyl Flooring

Location: floors - VAT

Distress: Health Hazard / Risk

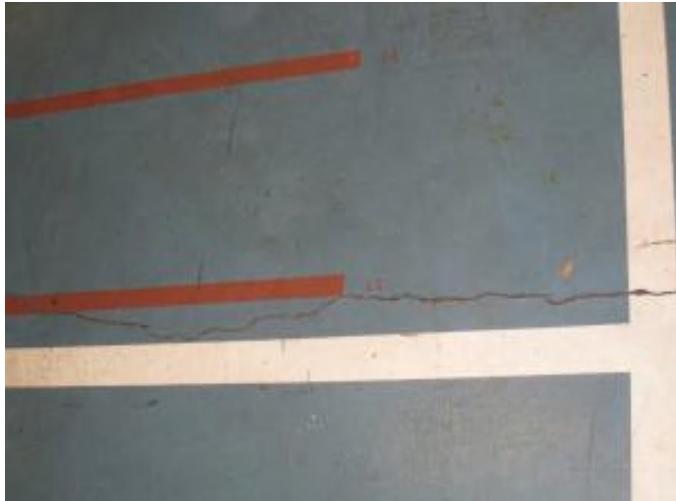
System: C3020413 - Vinyl Flooring

Location: gym floor

Distress: Damaged

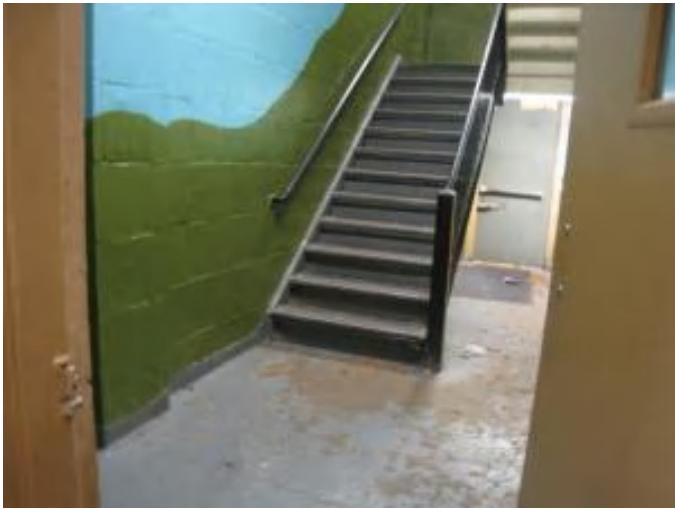
System: C3020415 - Concrete Floor Finishes

Location: mech rooms, toilet rooms, stairways

Distress: Appearance

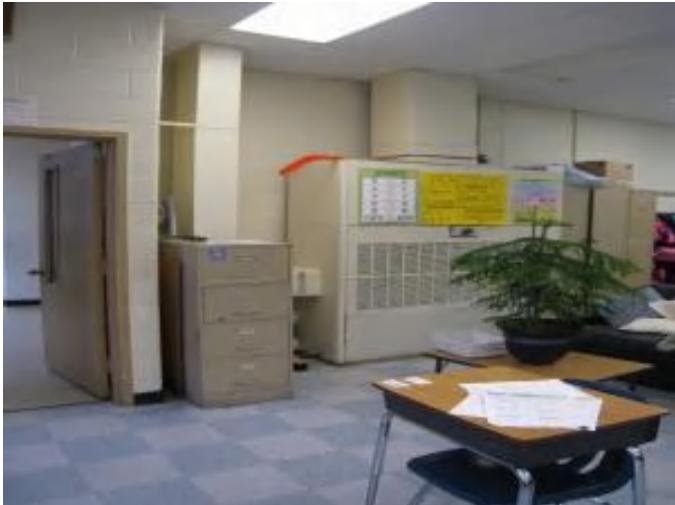
System: C3030 - Ceiling Finishes

Location: ceilings

Distress: Failing

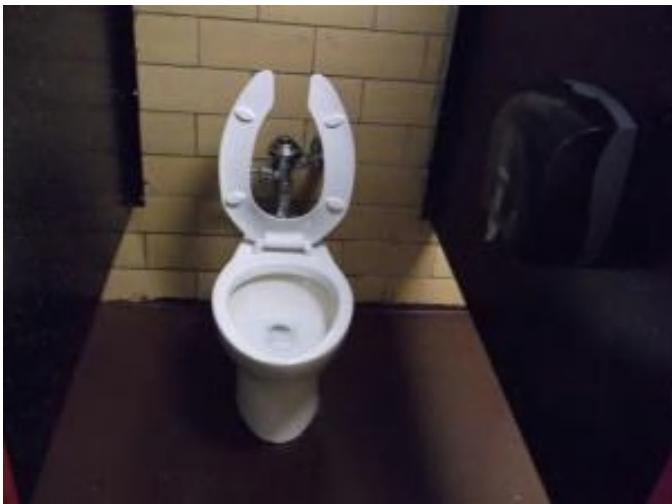
System: D2010 - Plumbing Fixtures

Location: Throughout the school

Distress: Beyond Service Life

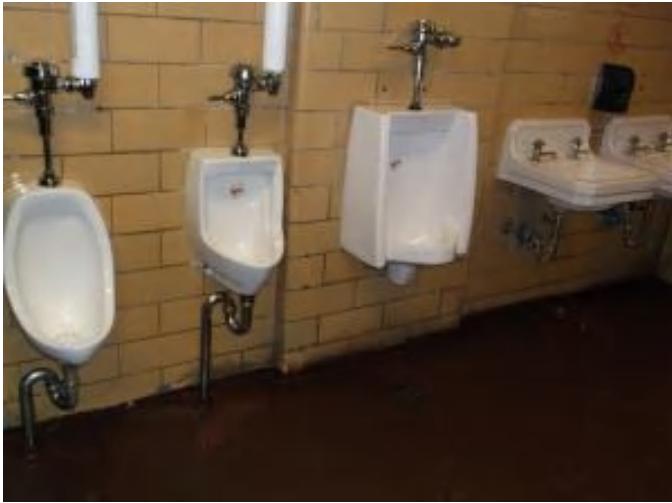
System: D2010 - Plumbing Fixtures

Location: Throughout the school

Distress: Beyond Service Life

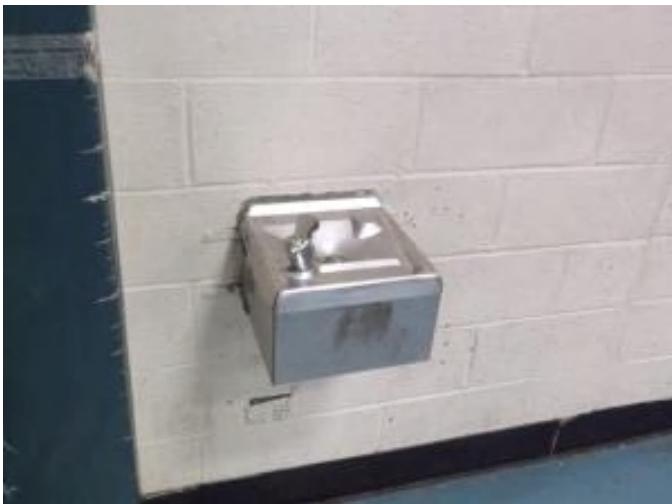
System: D2010 - Plumbing Fixtures

Location: Throughout the school

Distress: Beyond Service Life

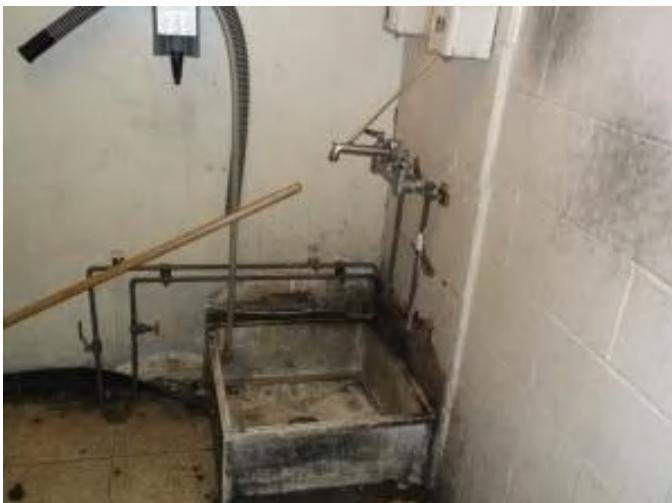
System: D2010 - Plumbing Fixtures

Location: Throughout the school

Distress: Beyond Service Life

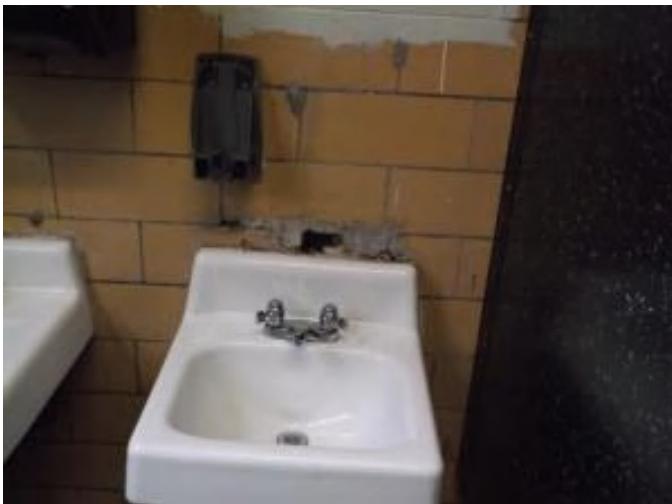
System: D2010 - Plumbing Fixtures

Location: Throughout the school

Distress: Beyond Service Life

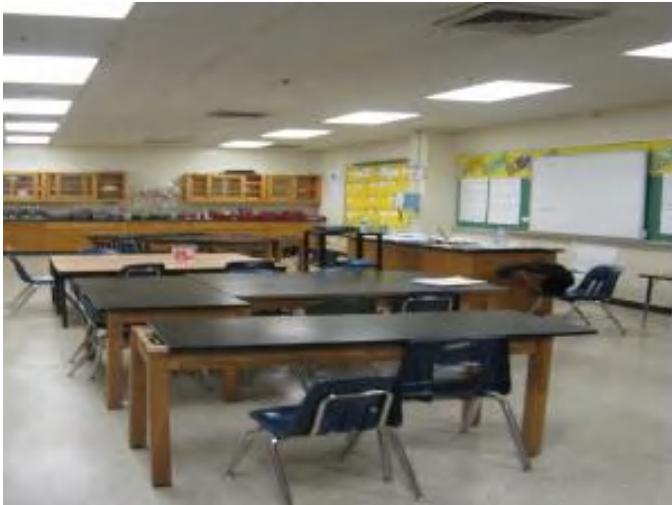
System: E1020 - Institutional Equipment

Location: science rooms

Distress: Failing

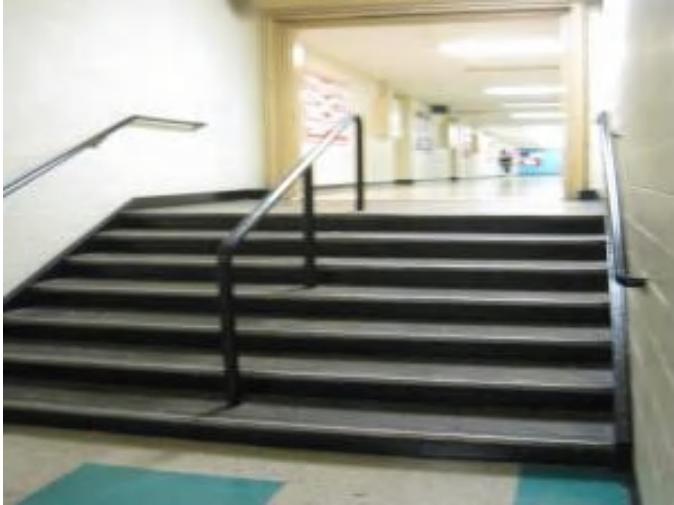
System: B1010 - Floor Construction

Location: ramp in corridor to gym

Distress: Accessibility

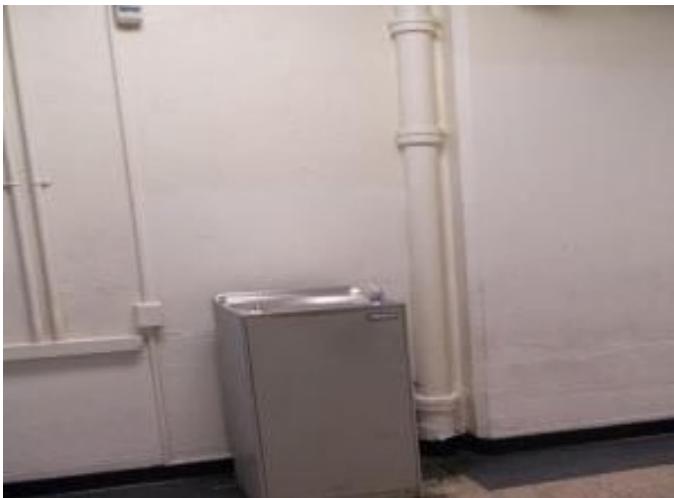
System: D2030 - Sanitary Waste

Location: Throughout the school

Distress: Beyond Service Life

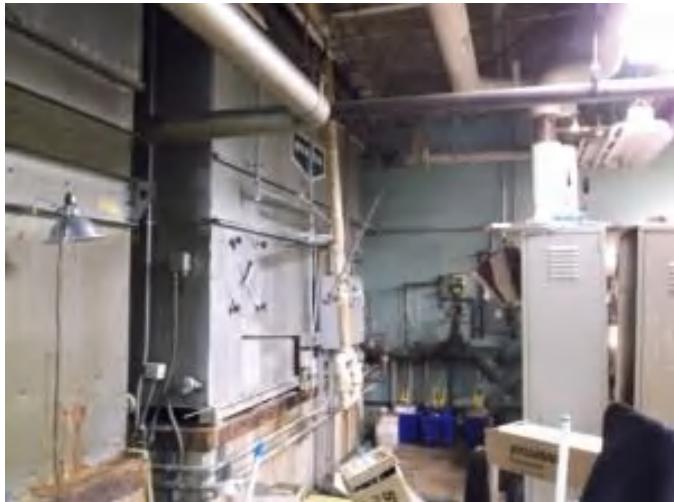
System: D3030 - Cooling Generating Systems

Location: Chiller mechanical equipment room

Distress: Beyond Service Life

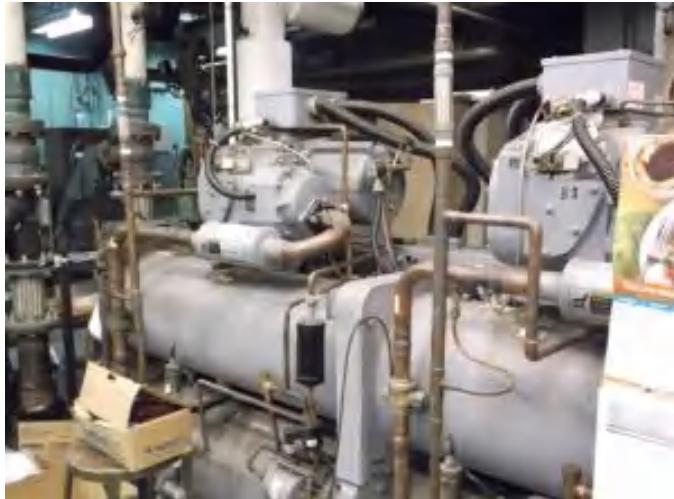
System: D3030 - Cooling Generating Systems

Location: Chiller mechanical equipment room

Distress: Beyond Service Life

Notes: Replace chiller.

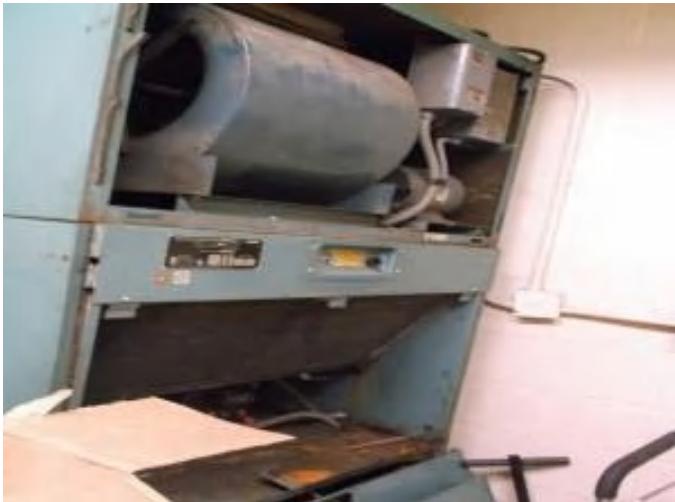
System: D3040 - Distribution Systems

Location: Throughout the school

Distress: Beyond Service Life

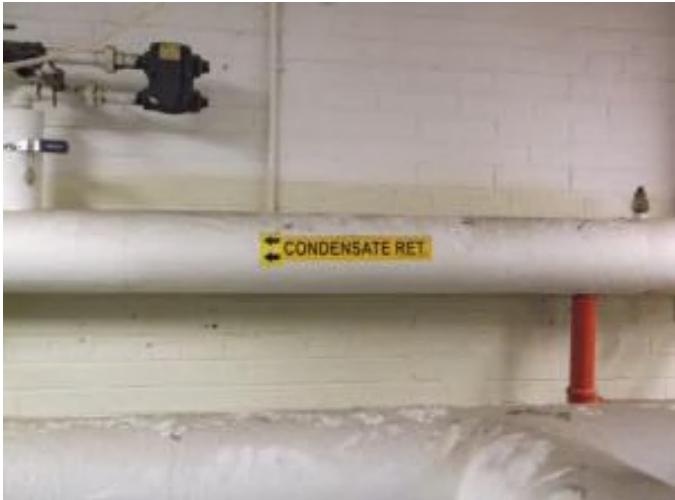
System: D3040 - Distribution Systems

Location: Throughout the school

Distress: Beyond Service Life

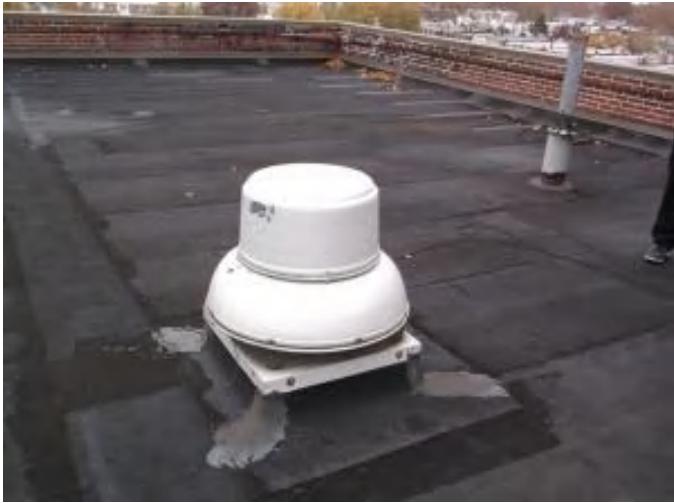
System: D3040 - Distribution Systems

Location: Roof

Distress: Beyond Service Life

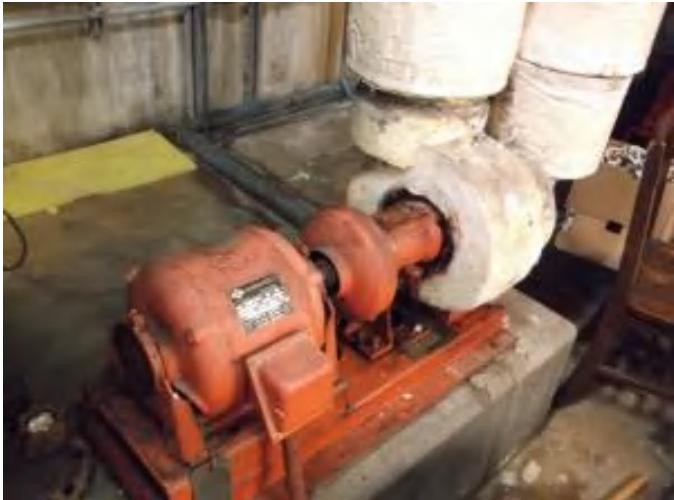
System: D3030 - Cooling Generating Systems

Location: Chiller mechanical equipment room

Distress: Beyond Service Life

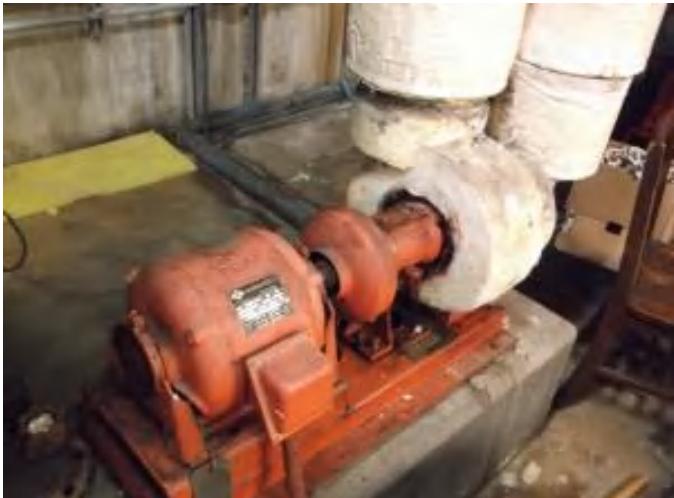
System: D3030 - Cooling Generating Systems

Location: Chiller mechanical equipment room

Distress: Beyond Service Life

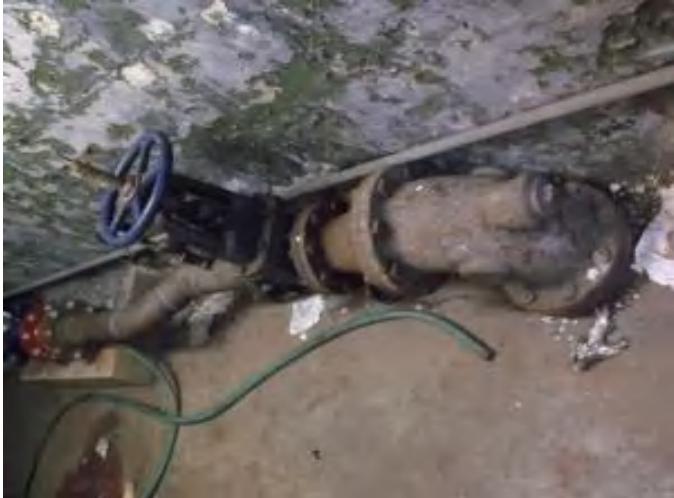
System: D2020 - Domestic Water Distribution

Location: Throughout the school

Distress: Beyond Service Life

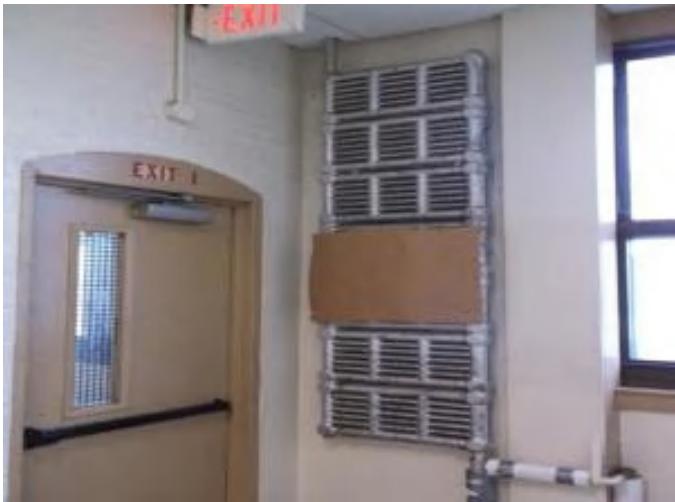
System: D3040 - Distribution Systems

Location: Throughout the school

Distress: Beyond Service Life

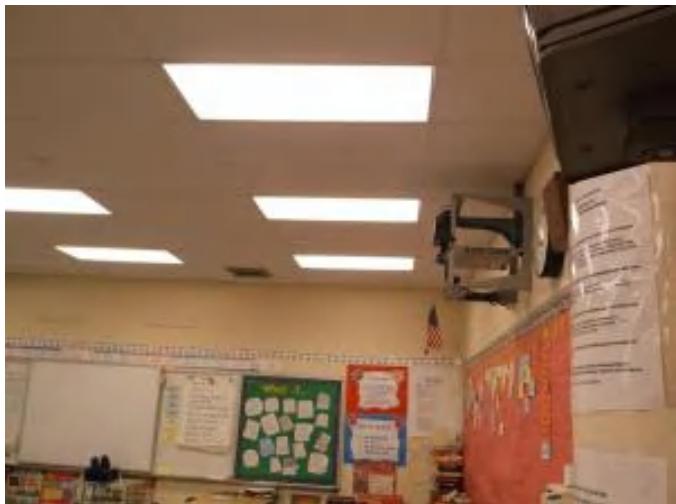
System: D4010 - Sprinklers

Location: Throughout the building

Distress: Life Safety / NFPA / PFD

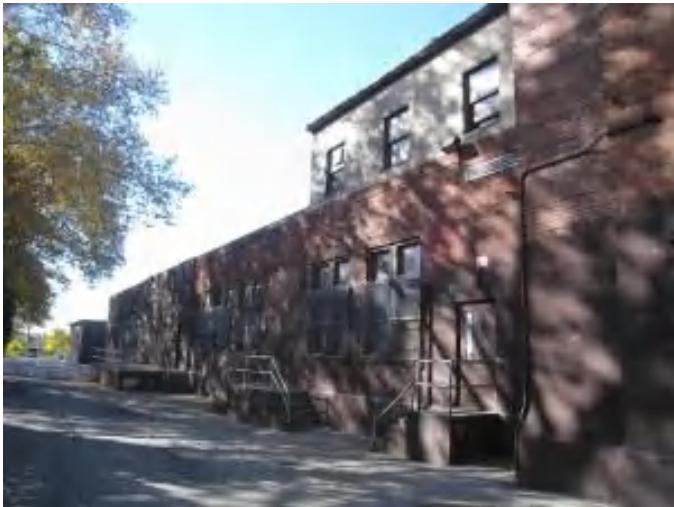
System: G2030 - Pedestrian Paving

Location: east driveway, door to corridor/stair

Distress: Accessibility

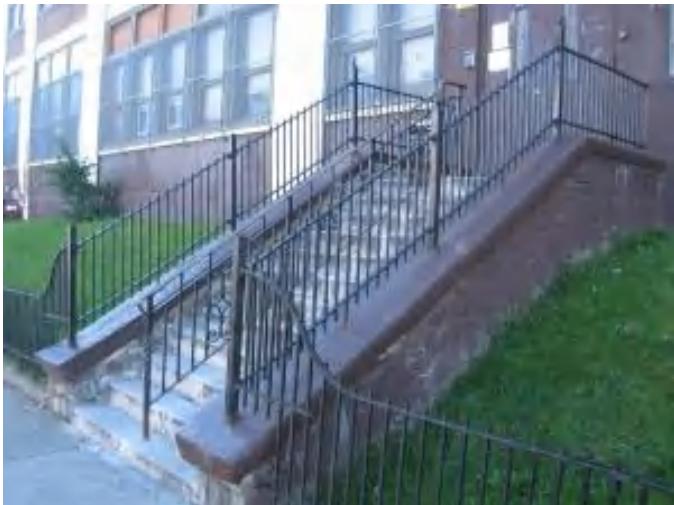
System: G2040 - Site Development

Location: main entrance stair on E. Wyoming Ave.

Distress: Failing

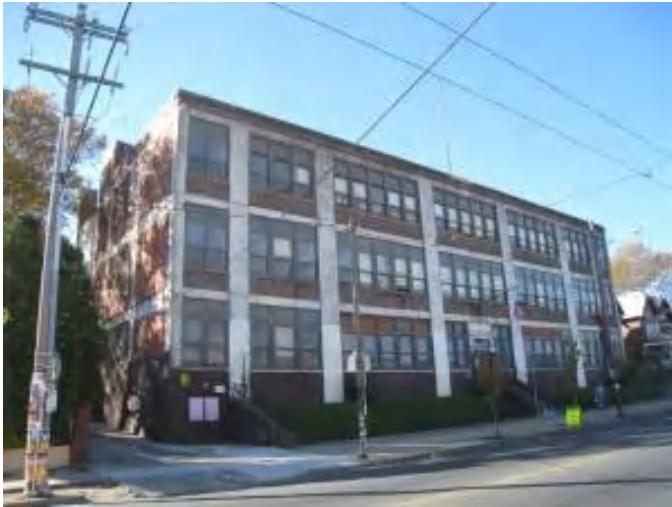
System: G2030 - Pedestrian Paving

Location: sidewalk

Distress: Damaged

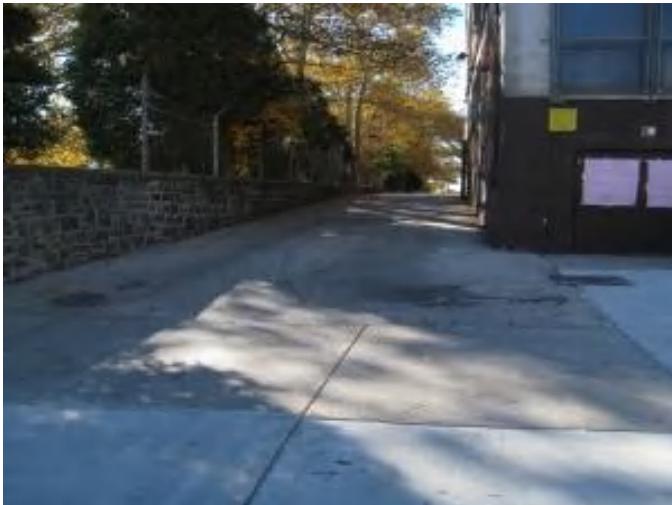
System: G2030 - Pedestrian Paving

Location: vehicle apron

Distress: Damaged

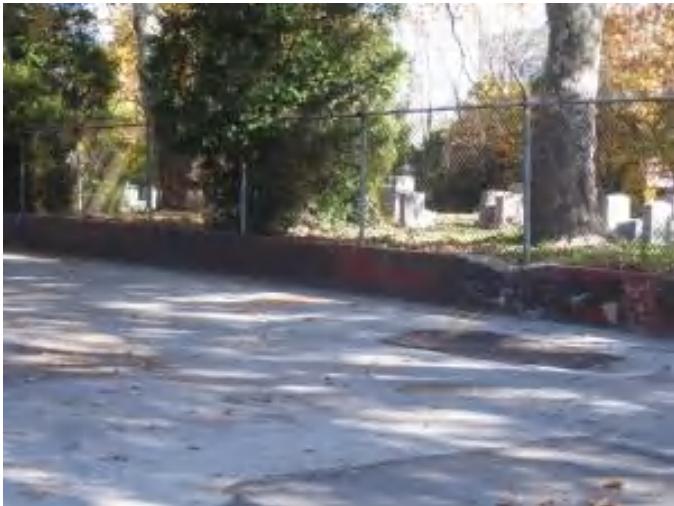
System: G2040 - Site Development

Location: retaining wall along east property line

Distress: Failing

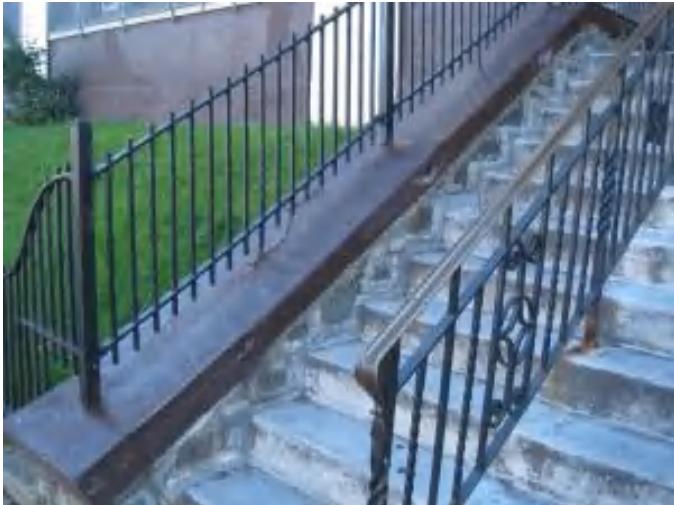
System: G2040 - Site Development

Location: main entrance stair on E. Wyoming Ave.

Distress: Damaged

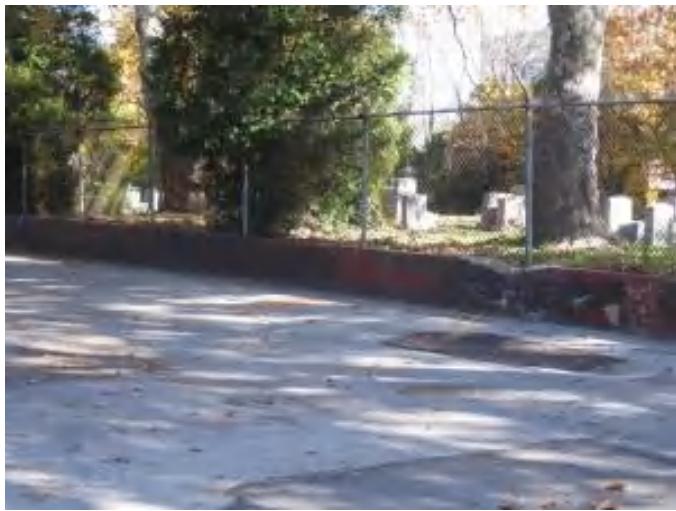
System: G2040 - Site Development

Location: site fence

Distress: Appearance

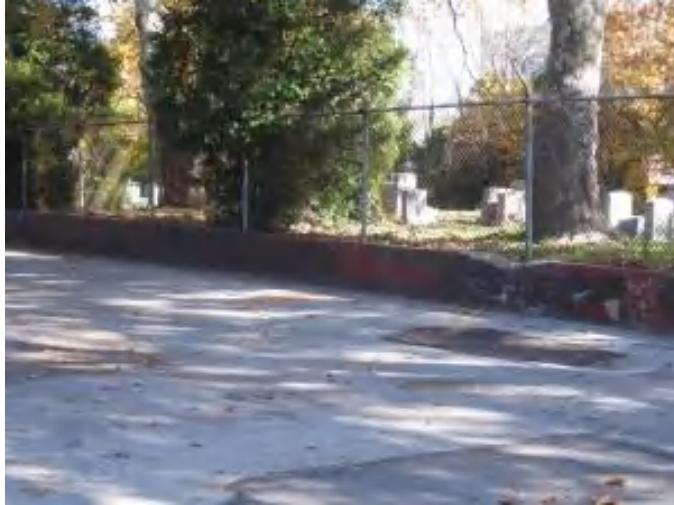
System: G2020 - Parking Lots

Location: driveway and playground

Distress: Failing
