## Facility Condition Assessment Summary Report

### Finletter School

School District of Philadelphia  
**S727001;Finletter**  
Final  
**Site Assessment Report**  
January 31, 2017

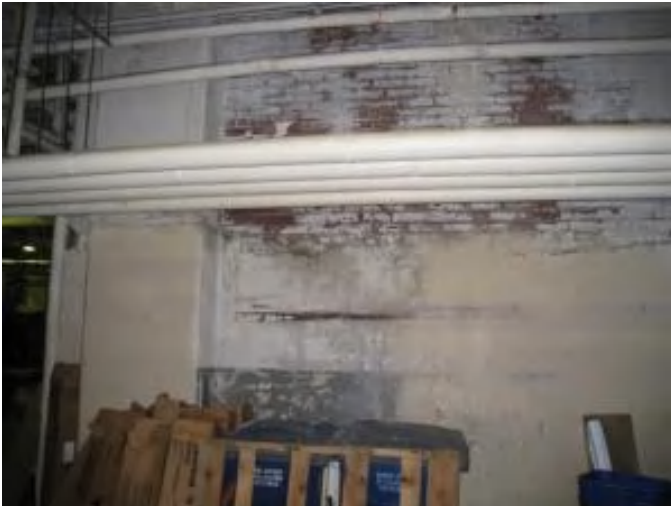
#### System: A2020 - Basement Walls

**Location:** basement

**Distress:** Failing

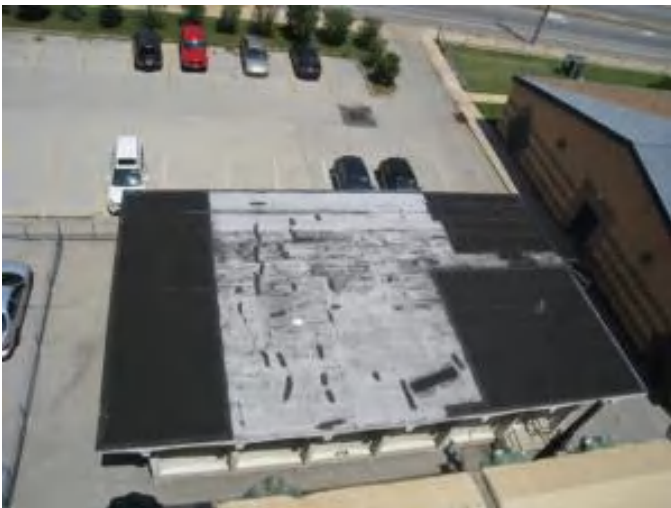
#### System: B3010105 - Built-Up

**Location:** portable building

**Distress:** Damaged

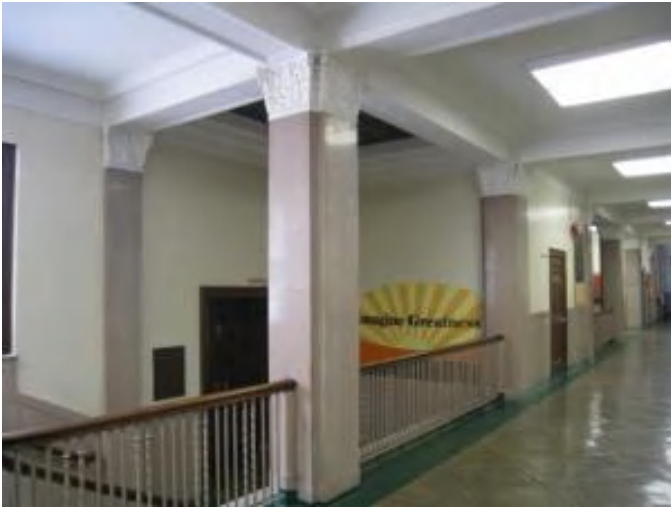
**System: C2010 - Stair Construction**

**Location:** stairways auditorium lobby

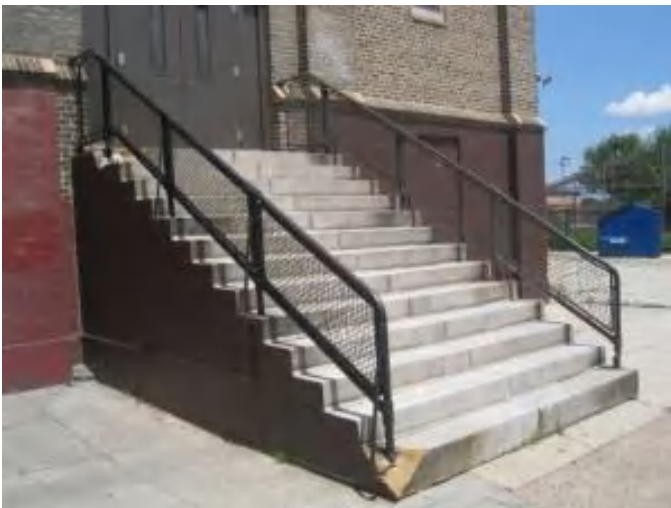
**System: C2010 - Stair Construction**

**Location:** exterior stairs

**Distress:** Failing

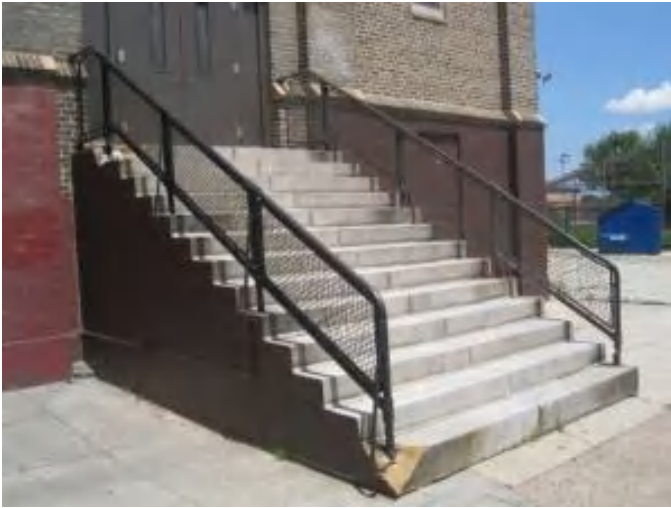
**System: C2010 - Stair Construction**

**Location:** exterior stairs  
**Distress:** Damaged  
**Category:** 3 - Operations / Maint.  
**Priority:** 1 - Response Time (< 2 yr)  
**Correction:** Replace inadequate or install proper stair railing - select appropriate material  
**Qty:** 100.00  
**Unit of Measure:** L.F.  
**Estimate:** \$15,592.70  
**Assessor Name:** System  
**Date Created:** 09/03/2015

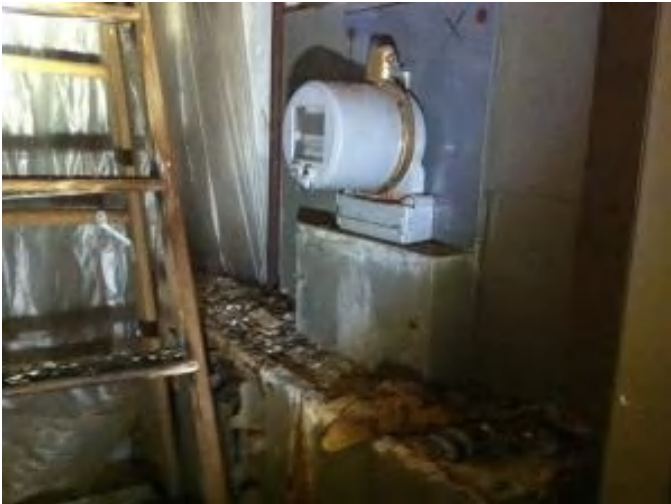
**System: D5010 - Electrical Service/Distribution**

**Location:** Boiler Room in the basement  
**Distress:** Beyond Service Life  
**Category:** 3 - Operations / Maint.  
**Priority:** 1 - Response Time (< 2 yr)  
**Correction:** Replace Switchboard  
**Qty:** 1.00  
**Unit of Measure:** Ea.  
**Estimate:** \$365,053.68  
**Assessor Name:** System  
**Date Created:** 08/13/2015

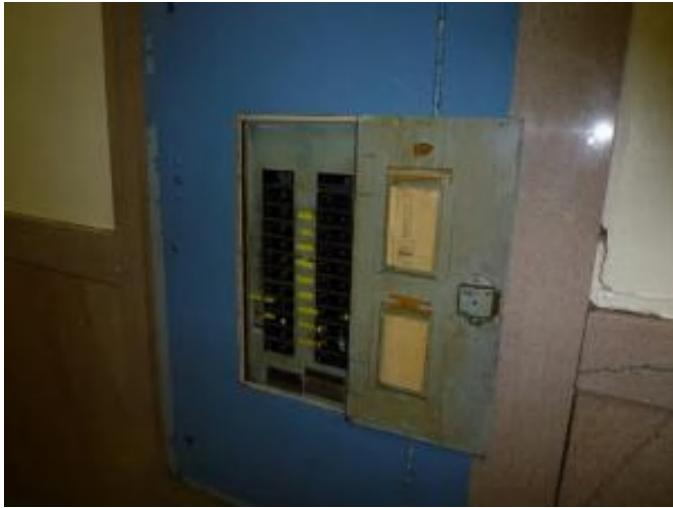
**System: D5010 - Electrical Service/Distribution**

**Location:** Entire Building  
**Distress:** Building / MEP Codes  
**Category:** 3 - Operations / Maint.  
**Priority:** 1 - Response Time (< 2 yr)  
**Correction:** Replace Electrical Distribution System (U)  
**Qty:** 1.00  
**Unit of Measure:** Ea.  
**Estimate:** \$314,103.15  
**Assessor Name:** System  
**Date Created:** 08/13/2015

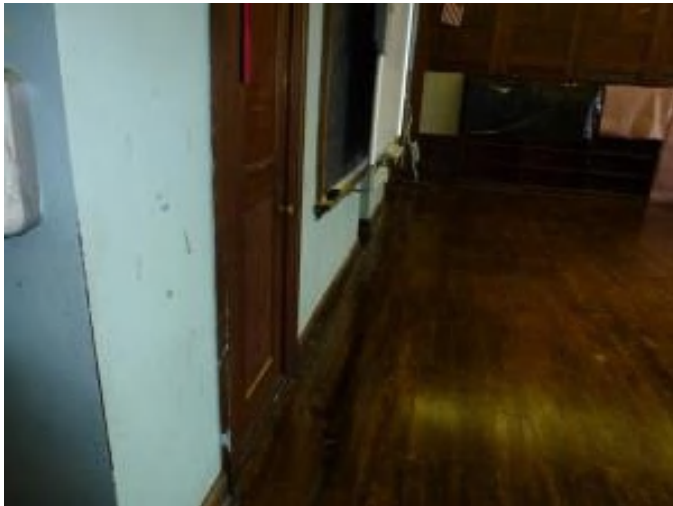
**System: D5020 - Lighting and Branch Wiring**

**Location:** Entire Building  
**Distress:** Inadequate  
**Category:** 4 - Capital Improvement  
**Priority:** 1 - Response Time (< 2 yr)  
**Correction:** Replace Wiring Devices (SF) - surface mounted conduit and boxes  
**Qty:** 1.00  
**Unit of Measure:** S.F.  
**Estimate:** \$417,679.81  
**Assessor Name:** System  
**Date Created:** 08/13/2015

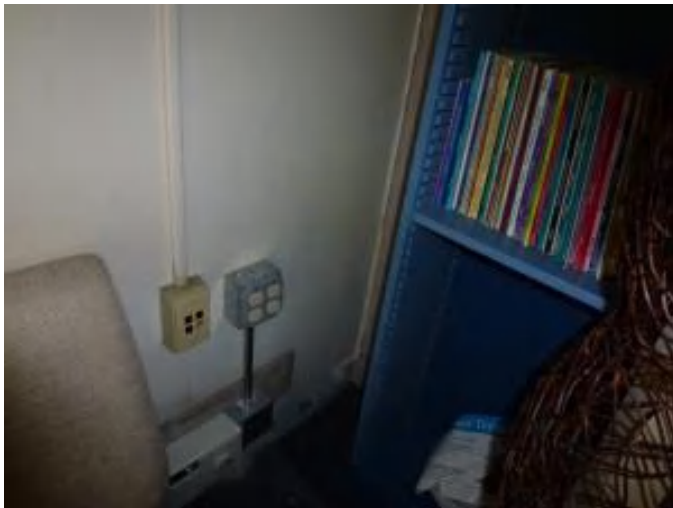
**System: D5020 - Lighting and Branch Wiring**

**Location:** Portable Building  
**Distress:** Life Safety / NFPA / PFD  
**Category:** 1 - Health & Safety  
**Priority:** 1 - Response Time (< 2 yr)  
**Correction:** Replace Wiring Device  
**Qty:** 10.00  
**Unit of Measure:** Ea.  
**Estimate:** \$1,647.57  
**Assessor Name:** System  
**Date Created:** 08/13/2015

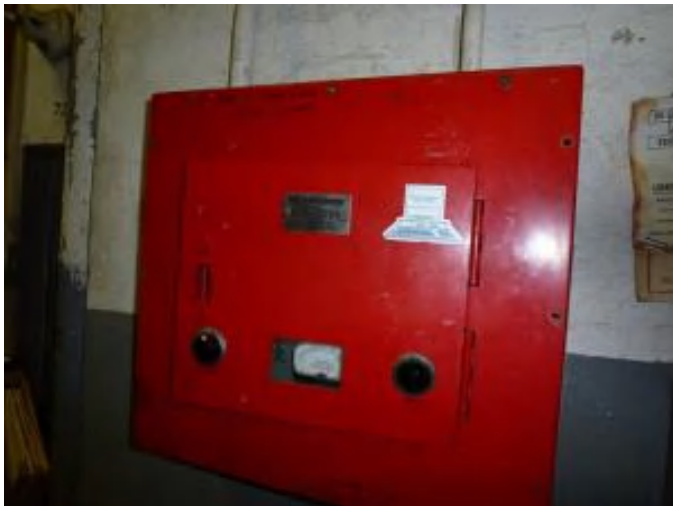
**System: D5030 - Communications and Security**

**Location:** Entire Building  
**Distress:** Beyond Service Life  
**Category:** 3 - Operations / Maint.  
**Priority:** 1 - Response Time (< 2 yr)  
**Correction:** Replace fire alarm system  
**Qty:** 1.00  
**Unit of Measure:** S.F.  
**Estimate:** \$324,719.29  
**Assessor Name:** System  
**Date Created:** 08/13/2015

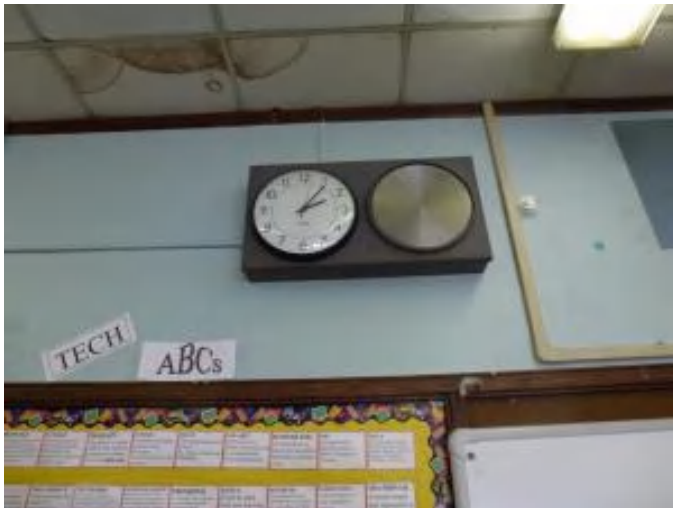
**System: D5030 - Communications and Security**

**Location:** Entire Building

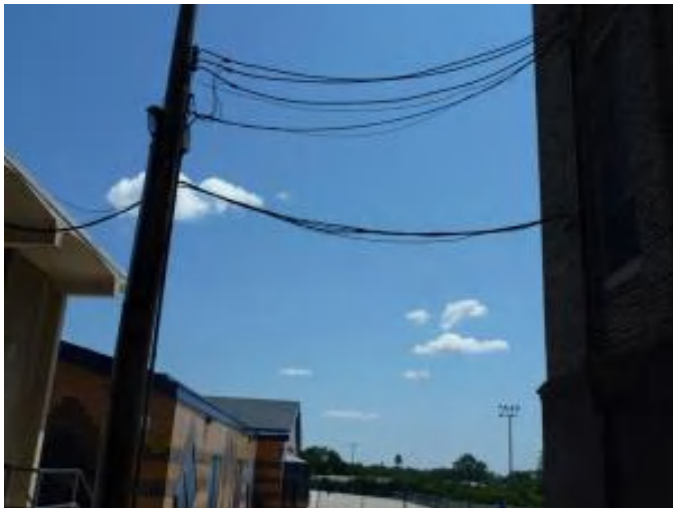
**System: D5030 - Communications and Security**

**Location:** Exterior Building  
**Distress:** Inadequate  
**Category:** 4 - Capital Improvement  
**Priority:** 1 - Response Time (< 2 yr)  
**Correction:** Add/Replace Video Surveillance System  
**Qty:** 1.00  
**Unit of Measure:** Ea.  
**Estimate:** \$27,097.37  
**Assessor Name:** System  
**Date Created:** 08/13/2015

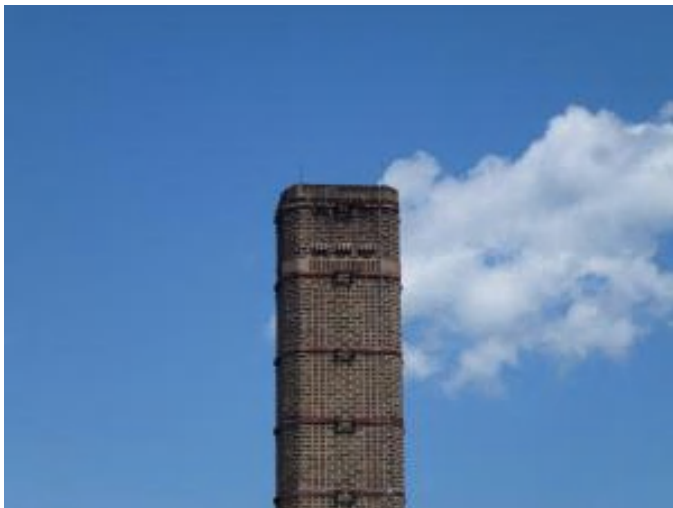
**System: D5090 - Other Electrical Systems**

**Location:** Roof  
**Distress:** Life Safety / NFPA / PFD  
**Category:** 1 - Health & Safety  
**Priority:** 1 - Response Time (< 2 yr)  
**Correction:** Repair Lightning Protection System  
**Qty:** 1.00  
**Unit of Measure:** Job  
**Estimate:** \$27,227.96  
**Assessor Name:** System  
**Date Created:** 08/13/2015

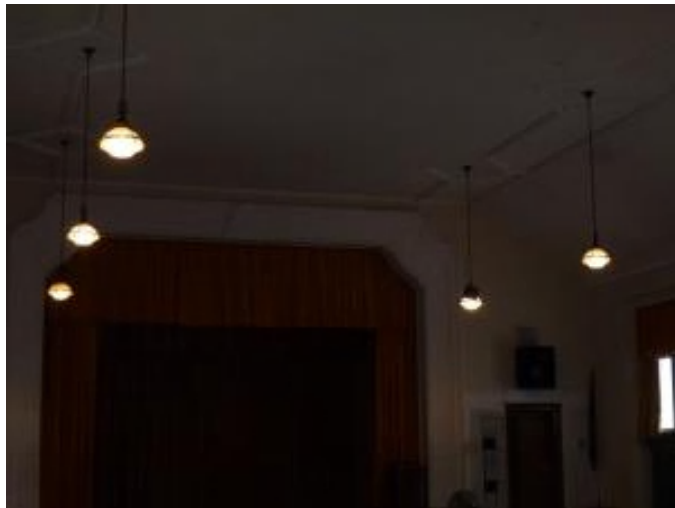
**System: E1020 - Institutional Equipment**

**Location:** Auditorium

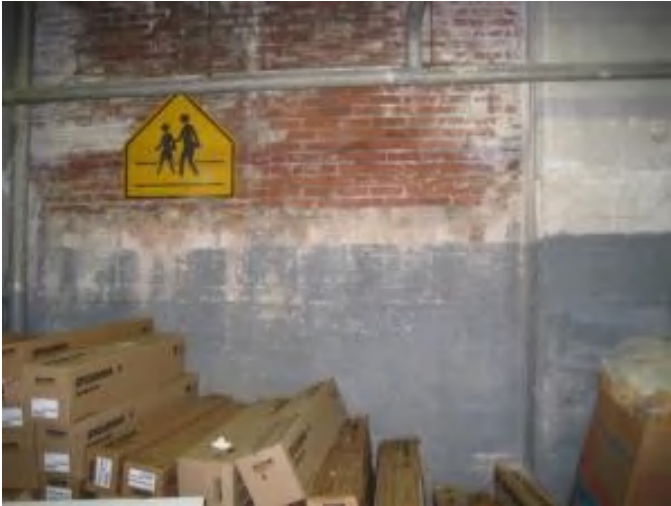
**System: A2020 - Basement Walls**

**Location:** basement

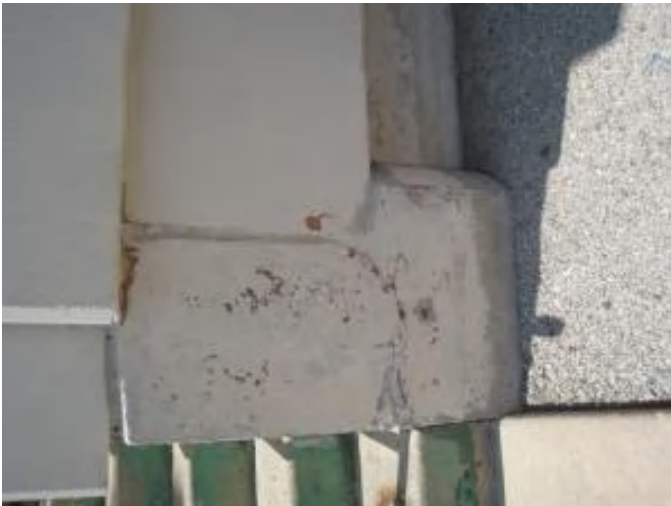
**System: A2020 - Basement Walls**

**Location:** portable building

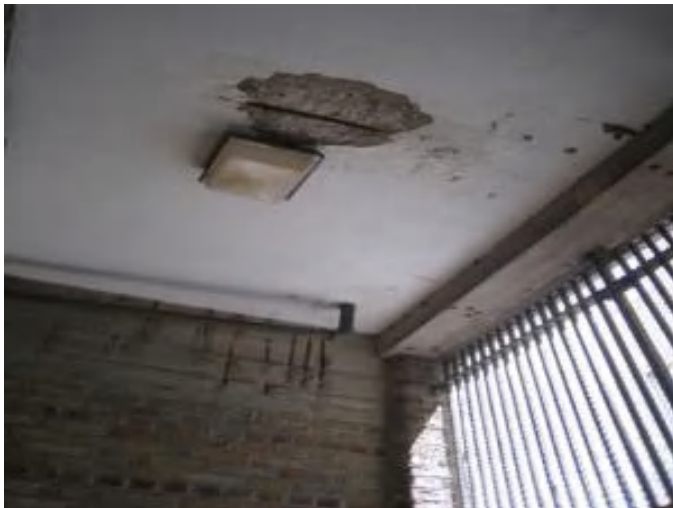
**System: B1010 - Floor Construction**

**Location:** exterior stair towers

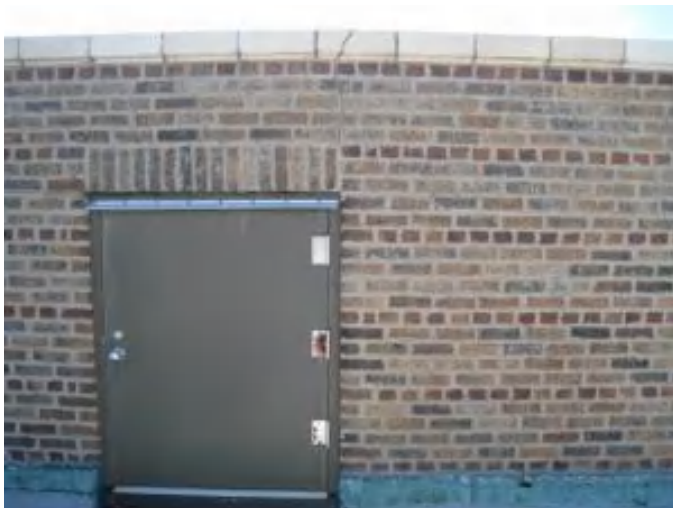
**System: B2010 - Exterior Walls**

**Location:** basement windows and doorways

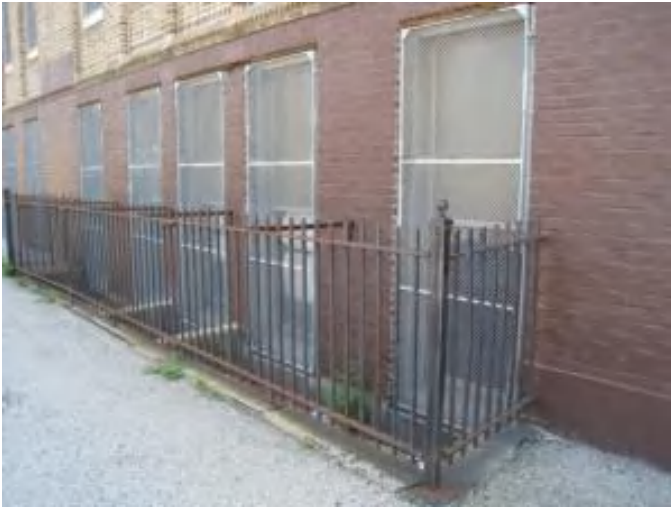
**System: B2020 - Exterior Windows**

**Location:** exterior walls

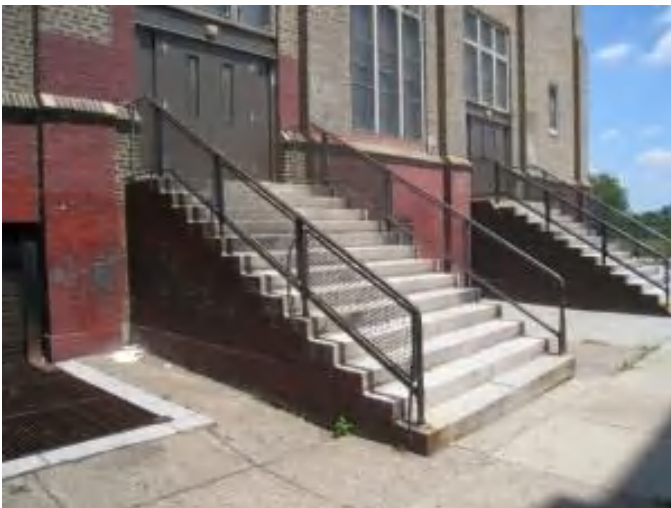
**System: B2030 - Exterior Doors**

**Location:** exterior walls

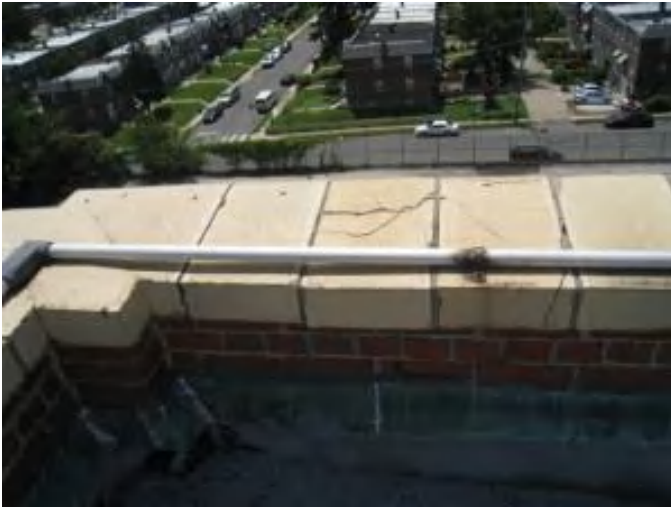
**System: B3010105 - Built-Up**

**Location:** building roof - coping

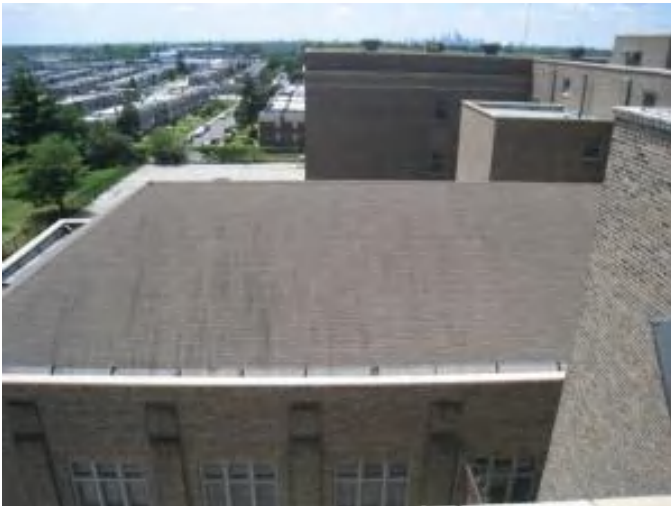
**System: B3010140 - Shingle & Tile**

**Location:** auditorium roof

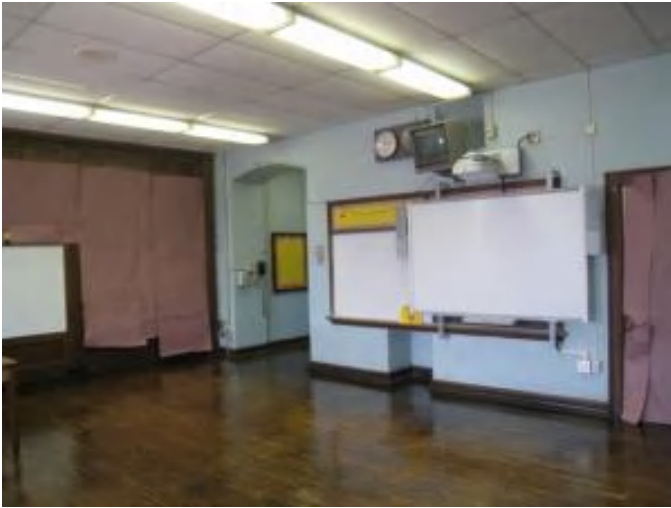
**System: C1010 - Partitions**

**Location:** classrooms

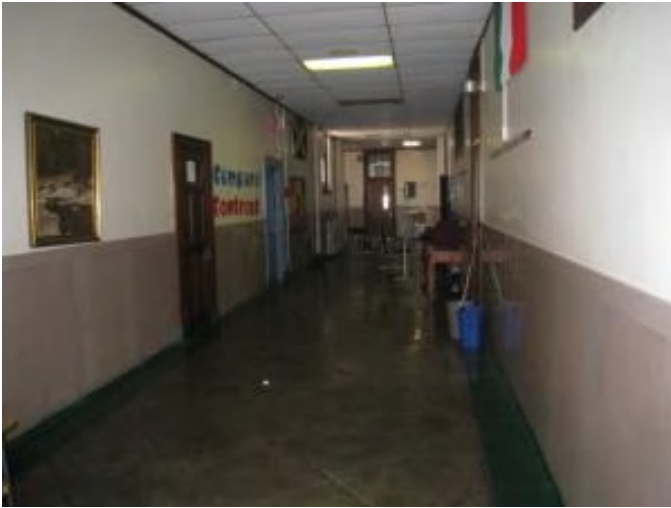
**System: C1020 - Interior Doors**

**Location:** classrooms and offices

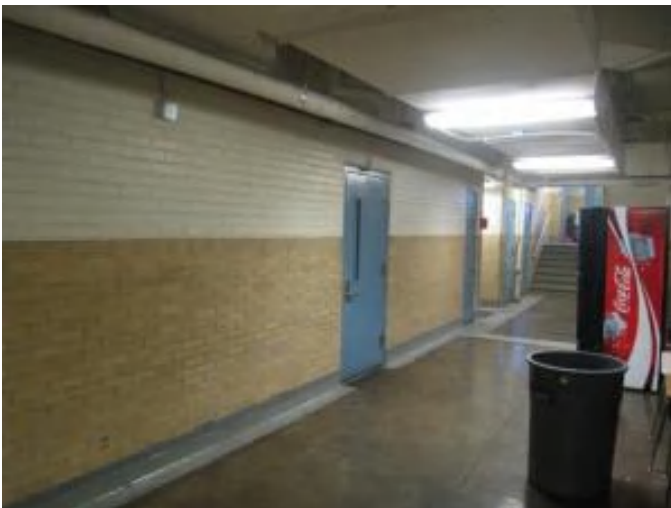
**System: C1020 - Interior Doors**

**Location:** basement

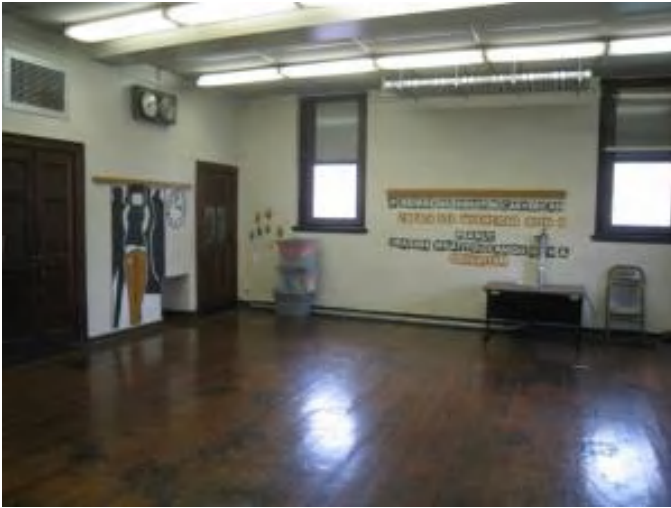
**System: C1020 - Interior Doors**

**Location:** interior rooms

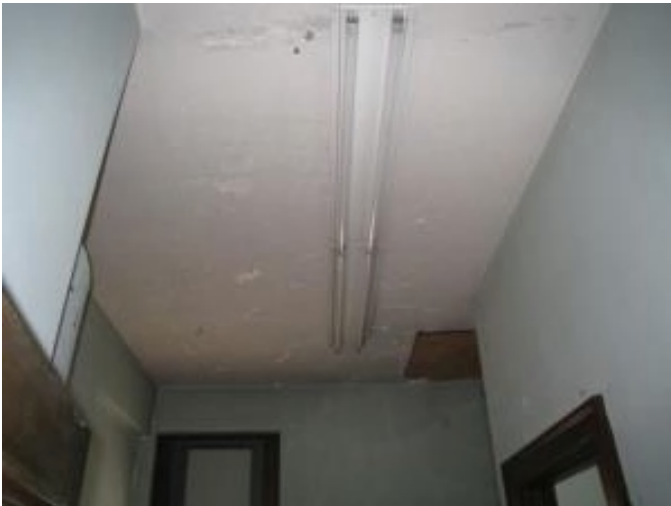
**System: C3010230 - Paint & Covering**

**Location:** interior walls

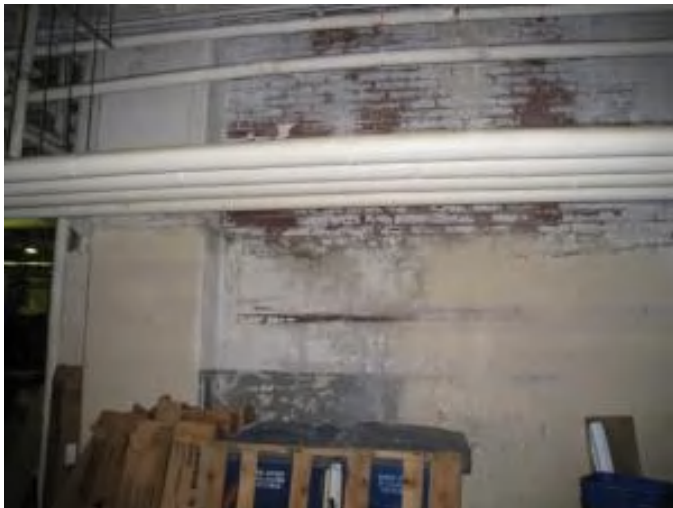
**System: C3010230 - Paint & Covering**

**Location:** basement - boiler room

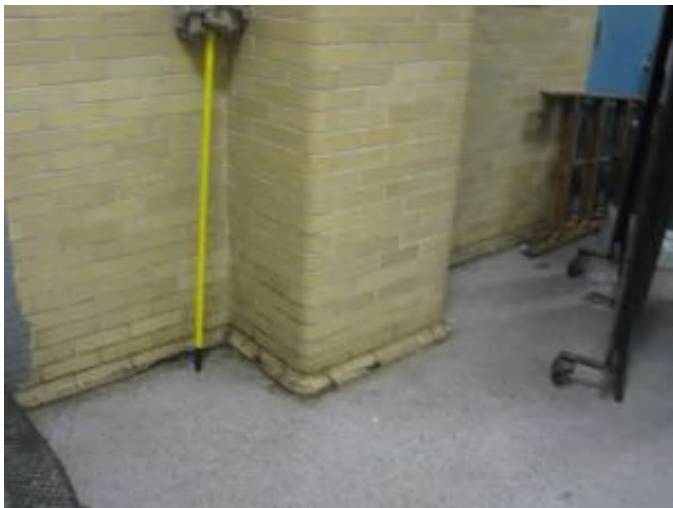
**System: C3020413 - Vinyl Flooring**

**Location:** misc rooms and gym

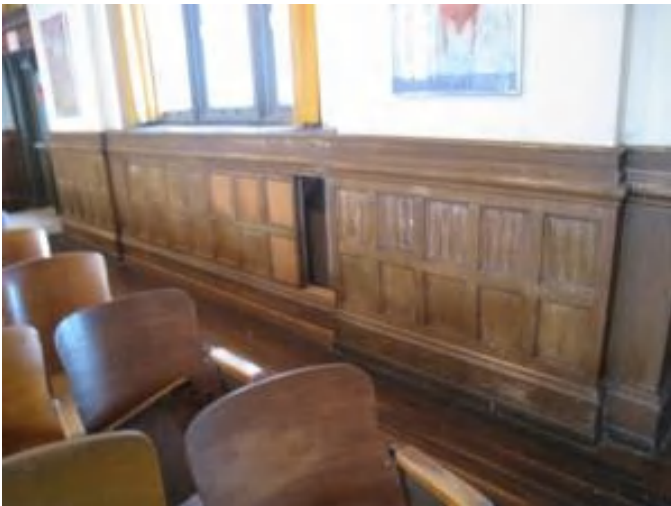
**System: C3020414 - Wood Flooring**

**Location:** auditorium walls

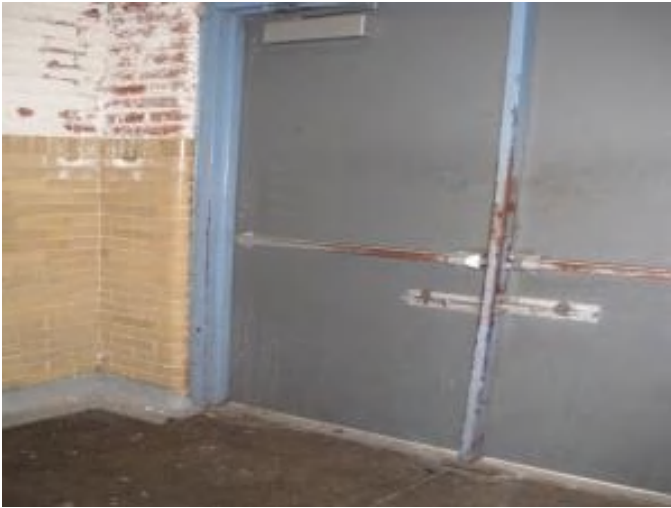
**System: C3020415 - Concrete Floor Finishes**

**Location:** all floors

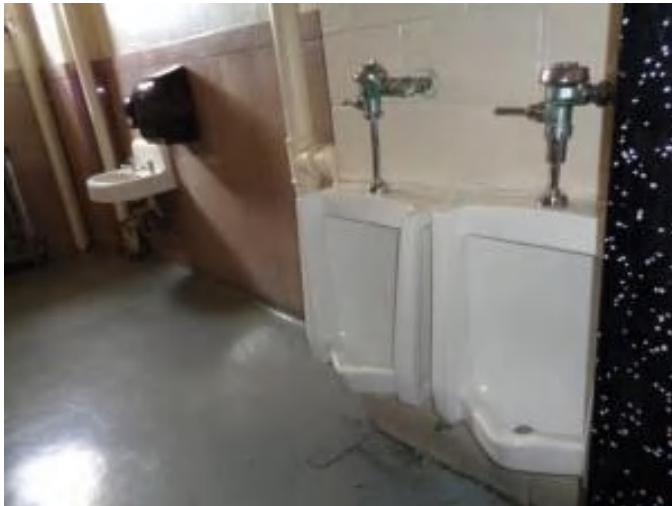
**System: D2010 - Plumbing Fixtures**

**Location:** Throughout the building

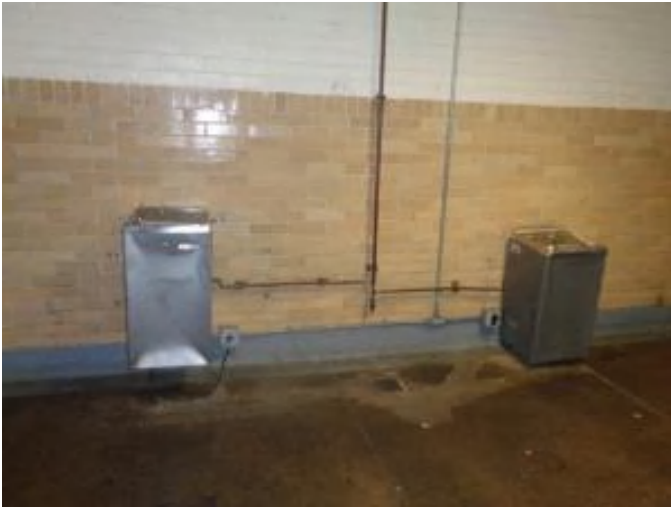
**System: D2010 - Plumbing Fixtures**

**Location:** Throughout the building

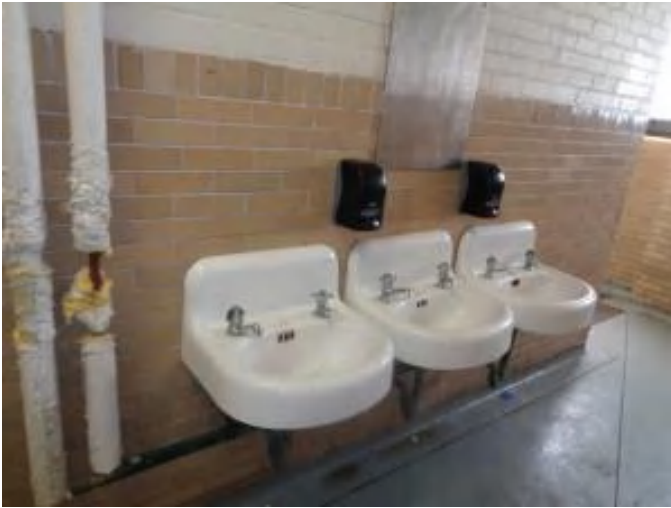
**System: D2010 - Plumbing Fixtures**

**Location:** Throughout the building

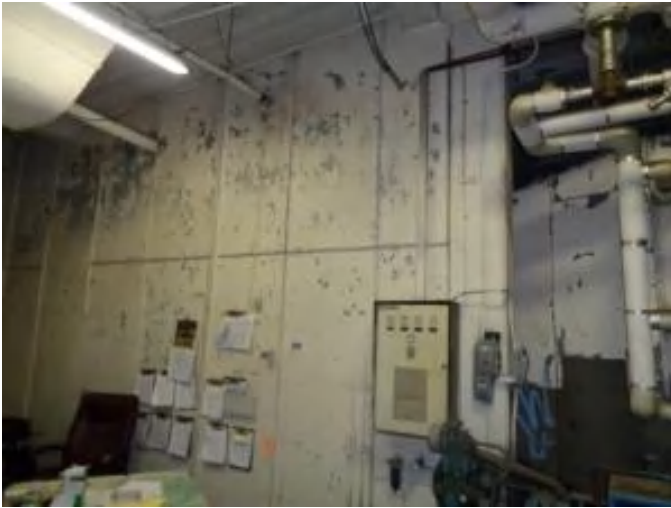
**System: D3060 - Controls & Instrumentation**

**Location:** Throughout the building

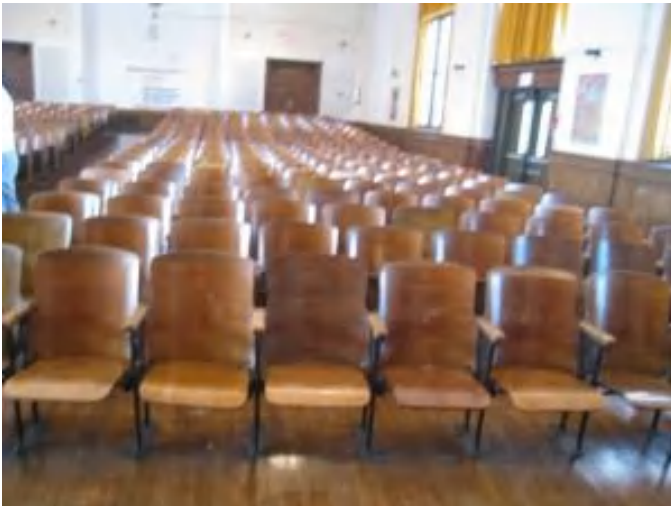
**System: E2010 - Fixed Furnishings**

**Location:** auditorium

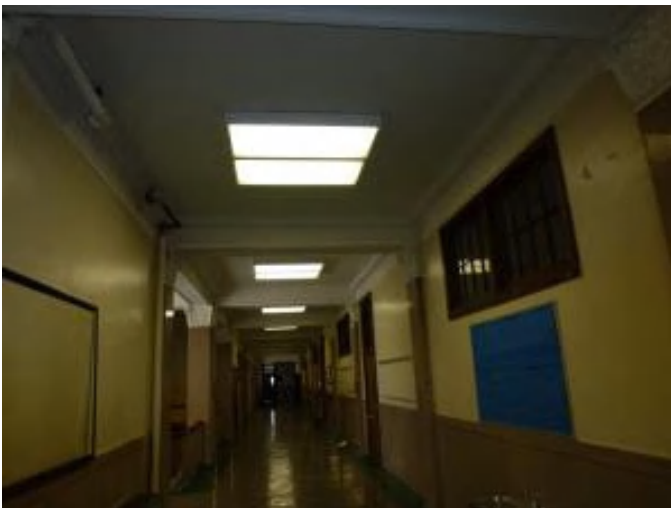
**System: D5020 - Lighting and Branch Wiring**

**Location:** Entire Building

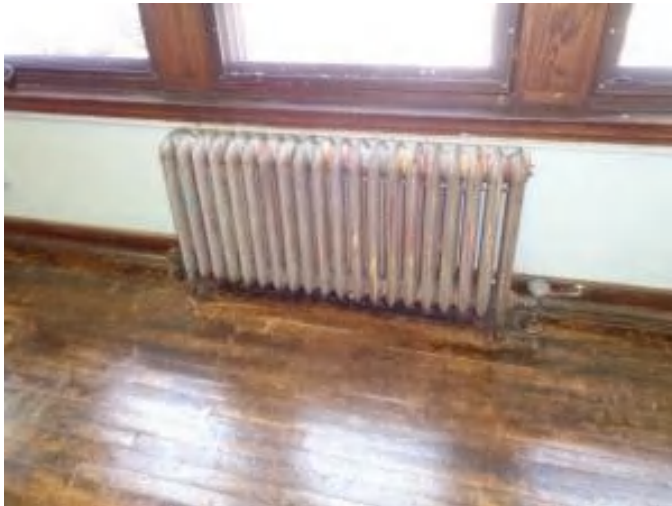
**System: D3040 - Distribution Systems**

**Location:** Throughout the building

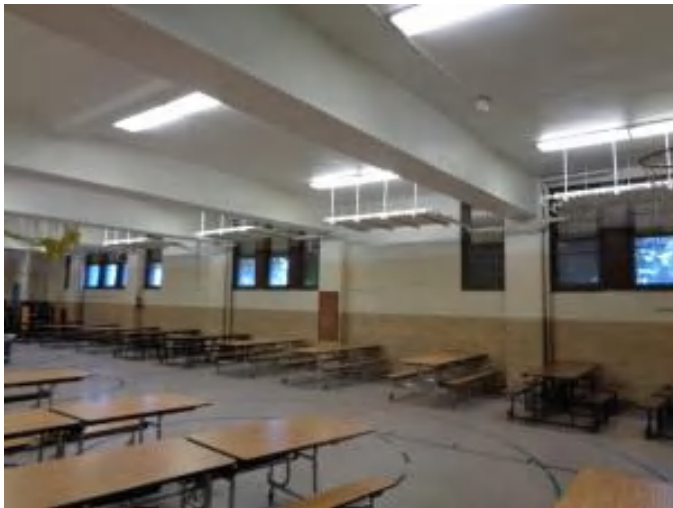
**System: D3040 - Distribution Systems**

**Location:** Cafeteria

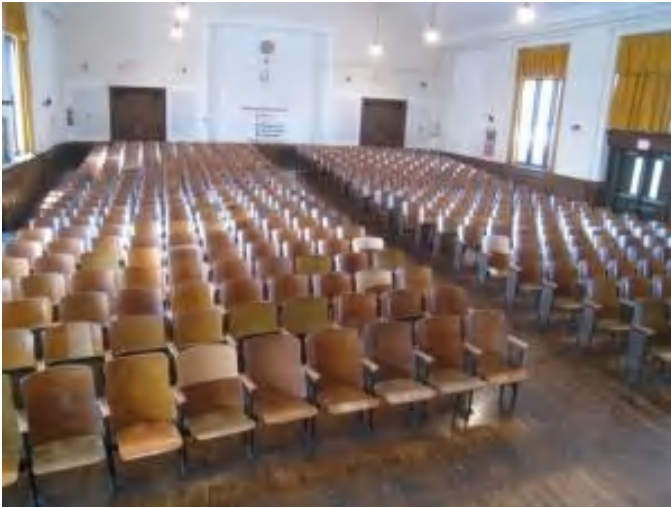
**System: D3040 - Distribution Systems**

**Location:** Auditorium

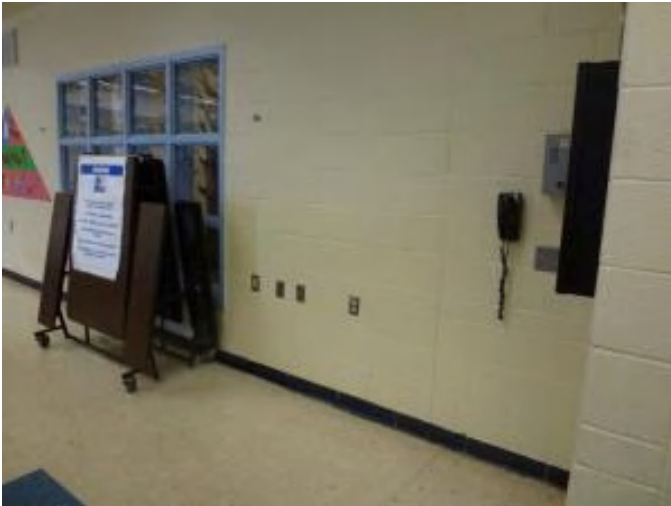
#### System: D5020 - Lighting and Branch Wiring

**Location:** LSH - Classrooms

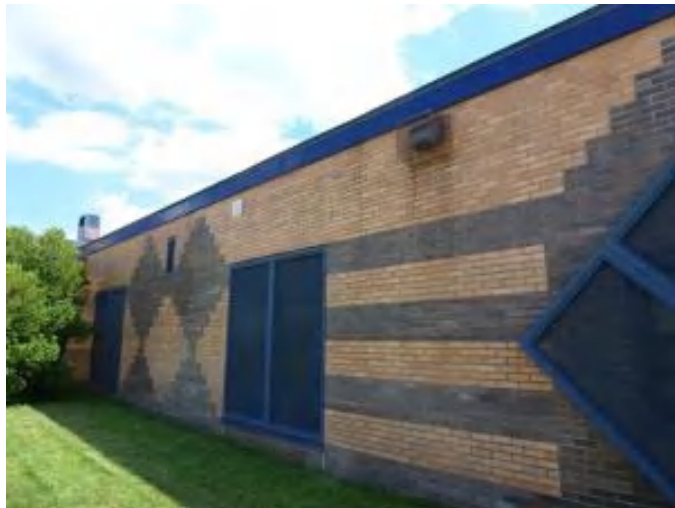
**System: D5030 - Communications and Security**

**Location:** LSH - Exterior Building

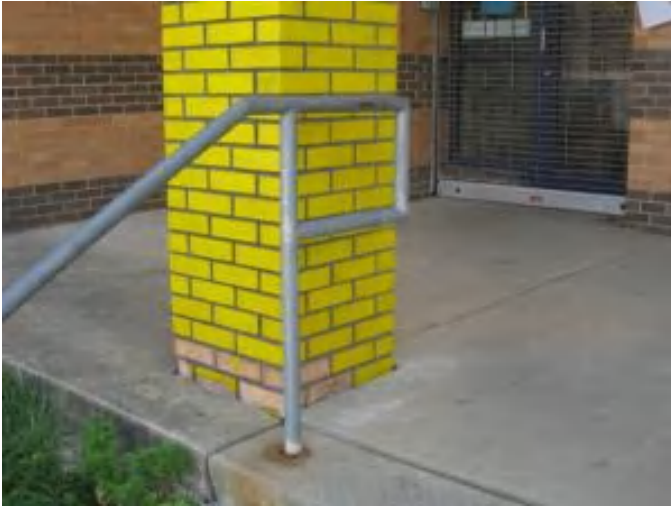
**System: B2010 - Exterior Walls**

**Location:** LSH - Godfrey St entrance

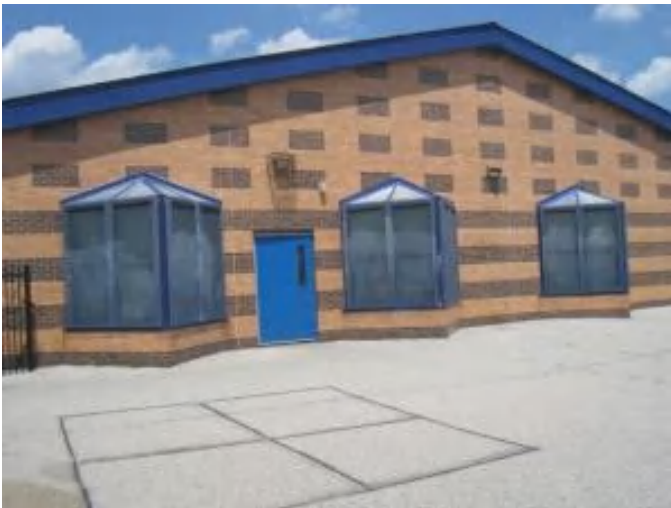
**System: B2020 - Exterior Windows**

**Location:** LSH - exterior windows

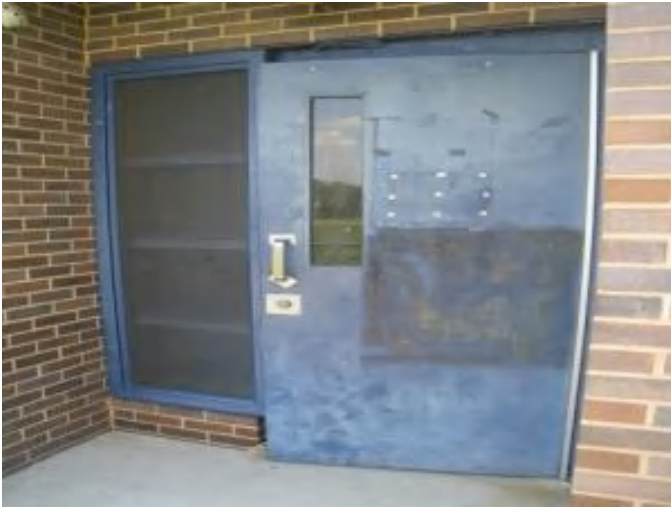
**System: B2030 - Exterior Doors**

**Location:** LSH - exterior  
**Distress:** Damaged  
**Category:** 3 - Operations / Maint.  
**Priority:** 2 - Response Time (2-3 yrs)  
**Correction:** Refinish and repaint exterior doors - per leaf  
**Qty:** 7.00  
**Unit of Measure:** Ea.  
**Estimate:** \$4,180.79  
**Assessor Name:** Craig Anding  
**Date Created:** 09/03/2015

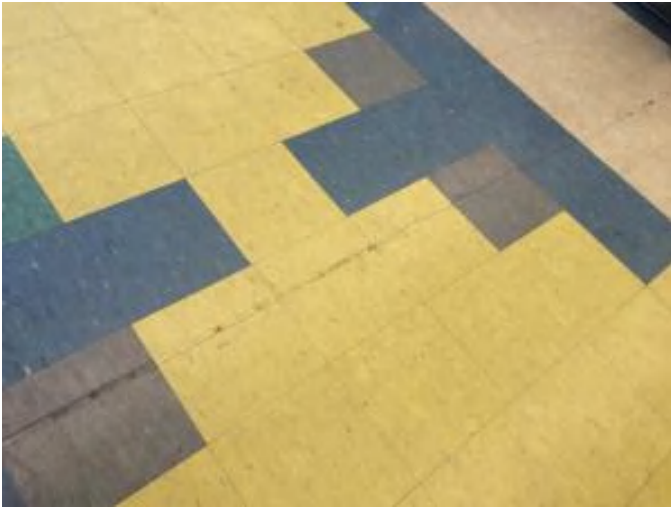
**System: C3020413 - Vinyl Flooring**

**Location:** LSH - corridors and multipurpose rm

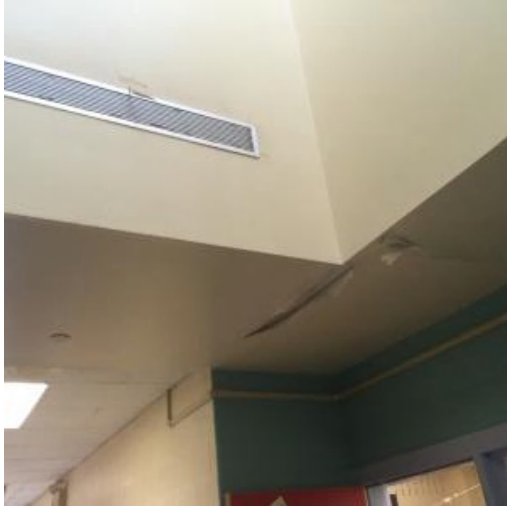
**System: C3030 - Ceiling Finishes**

**Location:** LSH - clerestory interior

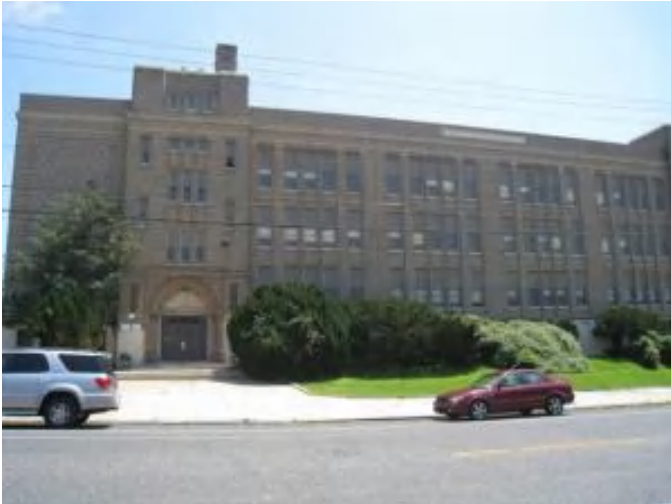
**System: G2030 - Pedestrian Paving**

**Location:** Front Street (front door)

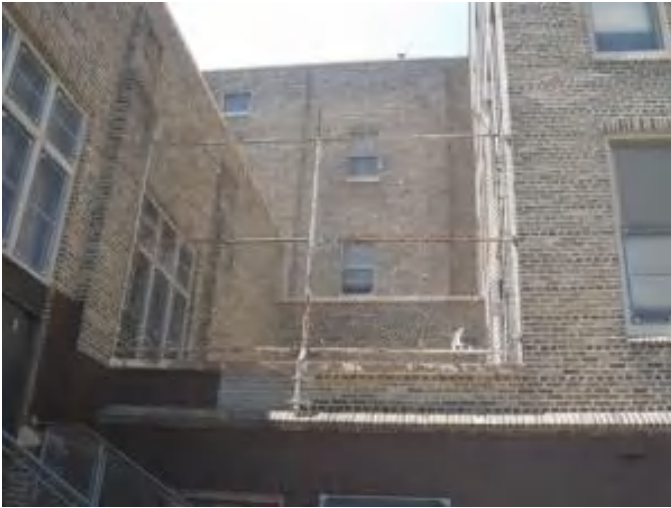
**System: G2040 - Site Development**

**Location:** low roof over boiler room
