Facility Condition Assessment Summary Report

Fitler School

S623001;Fidler

Site Assessment Report

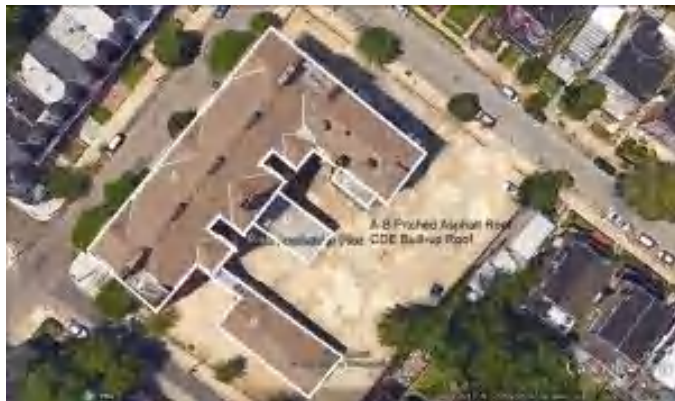
System: B3010105 - Built-Up

Location: Roof

Distress: Damaged

Notes: The built up roof was installed within the past ten years as reported by the school. The roof is in good condition with few exceptions. Currently there is an active leak that if not repaired soon will start to deteriorate the insulation and the integrity of the classroom finishes. This deficiency provides a budgetary consideration for built up roof repair for this section.

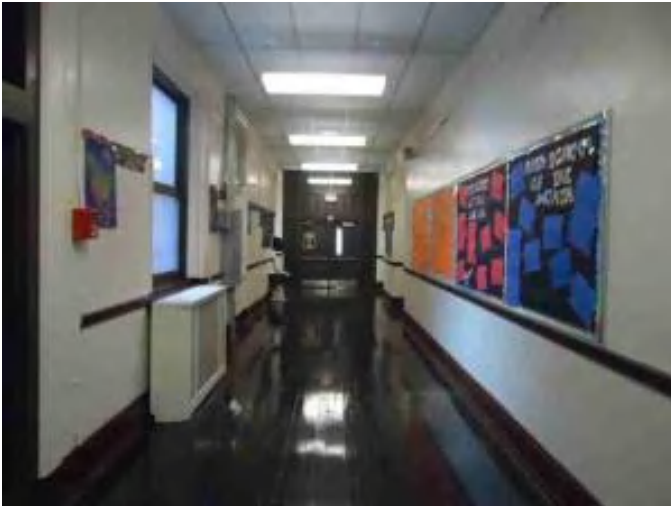
System: C1010 - Partitions

Location: Stairs

Distress: Life Safety / NFPA / PFD

Notes: The fire stair, corridor and general access stair doors are a mix of complaint and non-compliant applications. As indicated in the photo one wooden door is failing at the hinge. The interior corridor, exit stair doors are not considered to be code compliant as the usual fire rating tags that indicate the proper installation could not be found. The doors are generally in fair condition considering the age of the application. To restore the door finishes and provide fire rated door systems universal upgrades are required. Also, remove and replace original corridor door that separates the cafeteria from the main building with new code compliant fire rated door system.

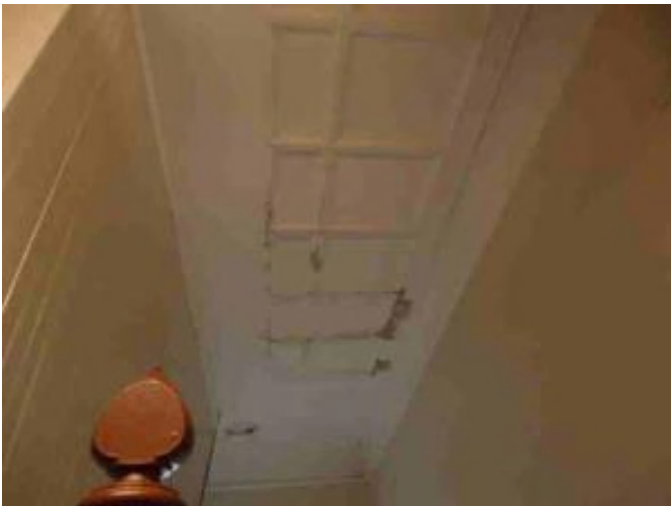
System: C1010 - Partitions

Location: Hallways and Stair

Distress: Life Safety / NFPA / PFD

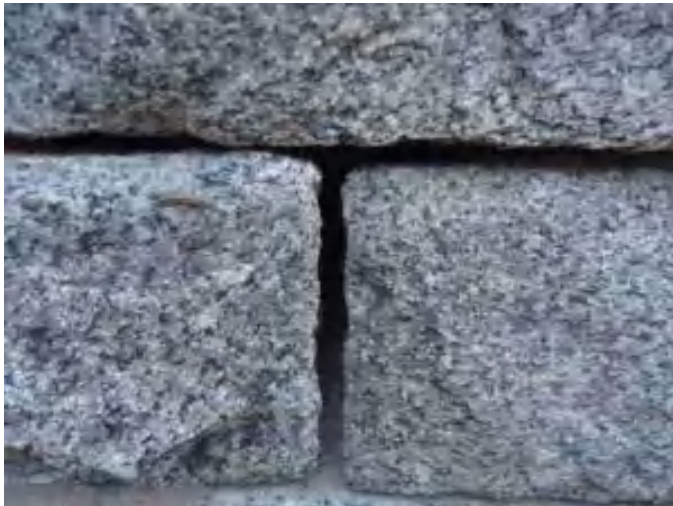
System: B2010 - Exterior Walls

Location: Exterior Elevation

Distress: Damaged

Notes: The exterior stone and brick surfaces are generally in fair condition for their age. In some locations, bricks have cracked or spalled and should be replaced. The stone work was reported to have been re-pointed within the past ten years. This effort appears to have been limited with additional work now being required. The repointing of deteriorated mortar joints is recommended, using mortar of a similar color and consistency as the original. Following the detailed examination of the stone and brick repair of mortar construction joints, the entire building should be pressure washed to remove stains and embedded pollutants. If moisture is found to be penetrating the masonry façade, the application of a spray sealant to the suspected exterior masonry surface is recommended.

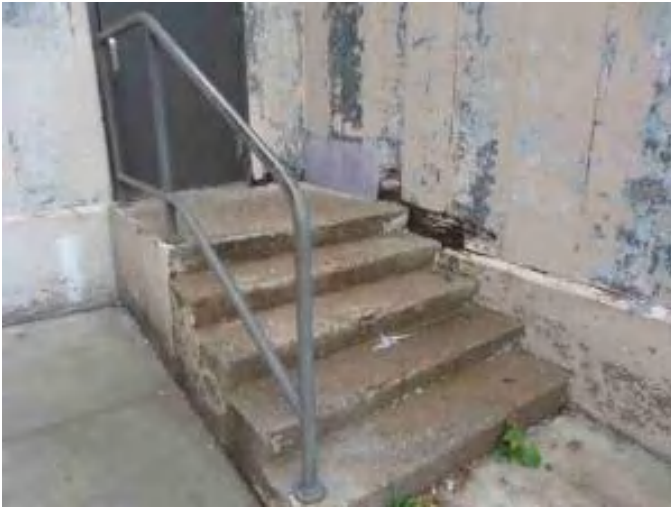
System: B2010 - Exterior Walls

Location: Cafeteria

Distress: Damaged

Notes: This schools exterior finish for the cafeteria is a metal siding finish. This finish was reported to have been completed in the late 1990's however, there were no records to indicate the date of installation. The painted finish is in very poor condition and peeling from the building in several areas. It is recommended that the exterior painted finish for this cafeteria be repaired and repainted. Special consideration to coordinate this project with the other exterior projects is required.

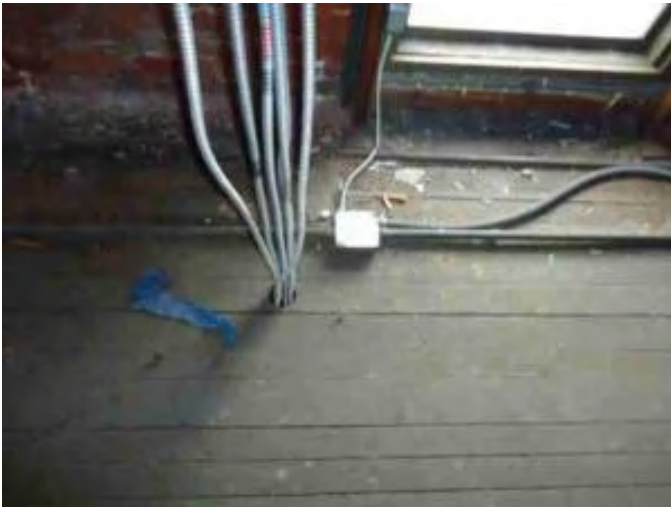
System: C1010 - Partitions

Location: Electrical Mechanical Spaces

Distress: Life Safety / NFPA / PFD

Notes: The mechanical room has several penetrations and as indicted in the photos an interior wall that has been compromised with several holes for equipment. Also, note the electrical modifications recently completed at this school has left several closet penetrations open. This deficiency provides a budgetary consideration to properly enclose the areas and to meet the current fire life safety requirements for mechanical spaces.

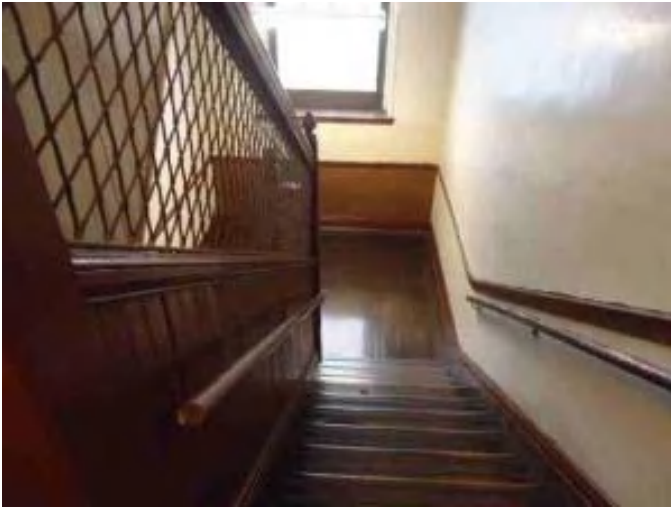
System: C2010 - Stair Construction

Location: Stairs

Distress: Life Safety / NFPA / PFD

Notes: Current requirements for stairs indicate that they have graspable handrails on both sides, that the rails have a specific end geometry, and that the handrails continue horizontally at the landings. In addition, guardrails must prevent the passage of a 4 inch diameter sphere (6 inches in the triangle formed by the lower rail and tread/riser angle). Although the stairs are compliant with the code enforced at the time of construction until a major renovation occurs, they are deficient in handrail and guardrail design relative to current standards. Future efforts should include comprehensive stair railing removal and replacement upgrades.

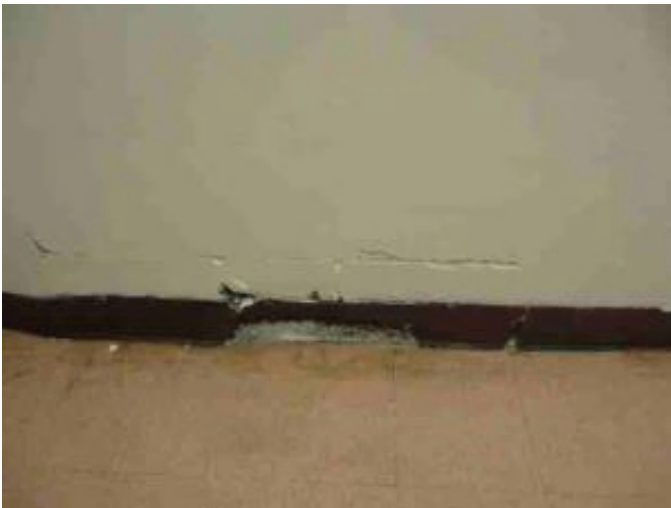
System: C3020413 - Vinyl Flooring

Location: Building Wide

Distress: Health Hazard / Risk

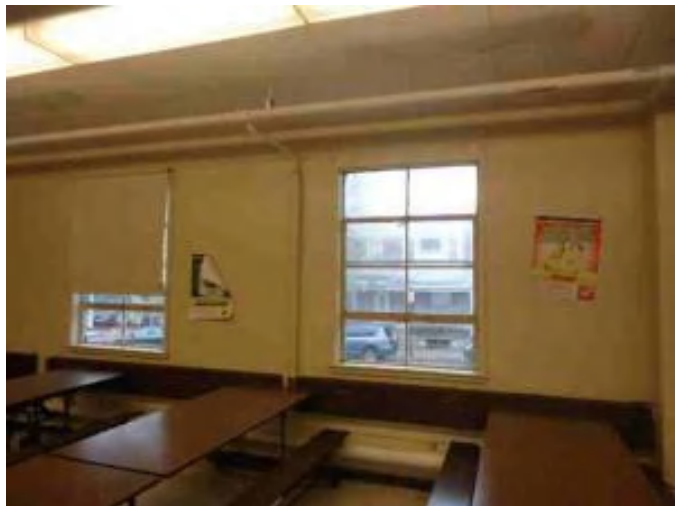
System: B2020 - Exterior Windows

Location: Exterior Elevation

Distress: Damaged

Notes: The exterior windows have been upgraded from the original applications. The window system is estimated to have been installed in the 1990's. Several of the windows are no longer functional and will require attention prior to an overall effort. Overall, the windows are in fair condition based on the year of installation or last renovation. The entire exterior window system is recommended to be replaced with units that retain their dimensions and profiles, but that incorporate updated energy-efficient features.

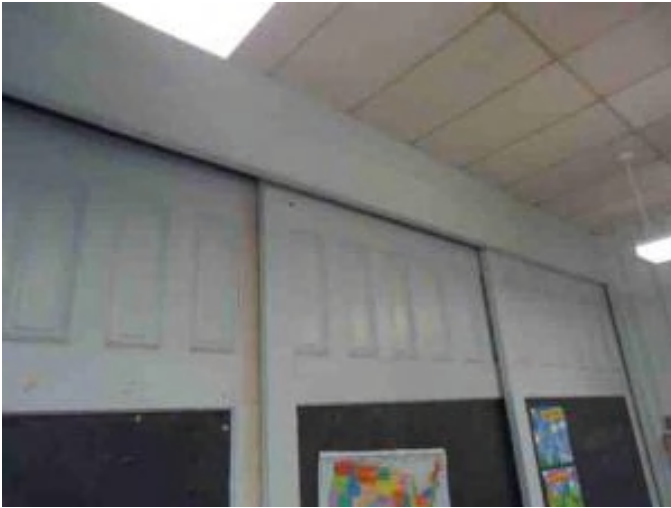
System: C1010 - Partitions

Location: Classroom

Distress: Damaged

Notes: There are several movable partitions that remain in classrooms. These wall systems are no longer used and in most cases cannot be used due to damage or wall modifications to support classroom needs. This deficiency provides a budgetary consideration to remove and replace the wall systems with universal removal of the existing movable partitions and upgrades to a permeate wall systems.

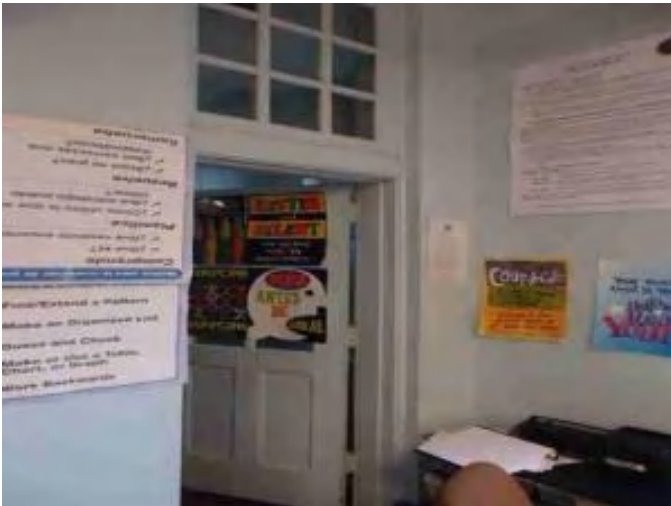
System: C1020 - Interior Doors

Location: Building Wide

Distress: Damaged

Notes: Interior doors are typically wood in wood frames with transom lites, sidelights, wired glass glazing. Other interior doors include solid wooden glass pane doors with original wooden pane frames, hollow metal in hollow metal frames at some of the stairwells and exit ways. Doors are generally in fair condition and are not ADA compliant. The deficiency provides a budgetary consideration to correct the hallway, transoms, wood doors and frames.

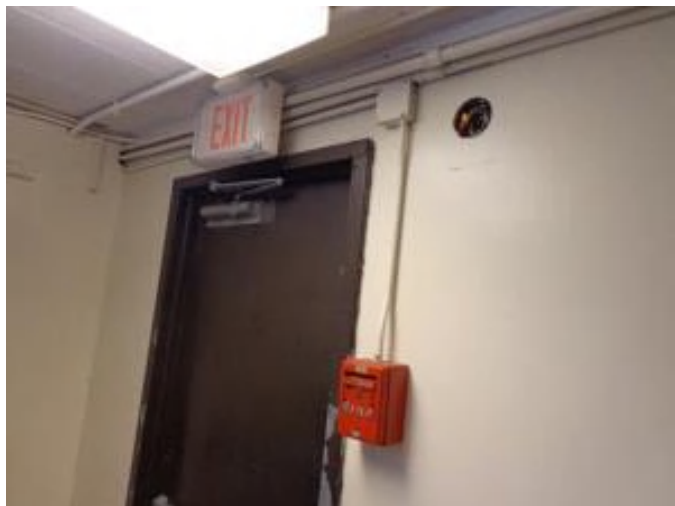
System: D5030 - Communications and Security

Location: Building wide

Distress: Life Safety / NFPA / PFD

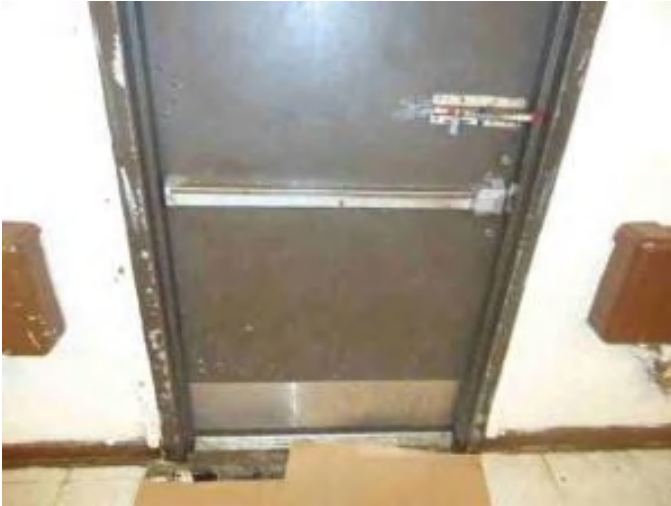
System: B2030 - Exterior Doors

Location: Exterior Elevation

Distress: Damaged

Notes: The exterior doors are metal applications with metal frames. The exterior door system for this school is a very high traffic system. The doors are in fair condition but are aging at a faster rate than expected based on traffic and condition. The exterior door system and service doors are recommended for upgrade. The new doors are expected to retain their dimensions and profiles, but that incorporate updated energy-efficient features.

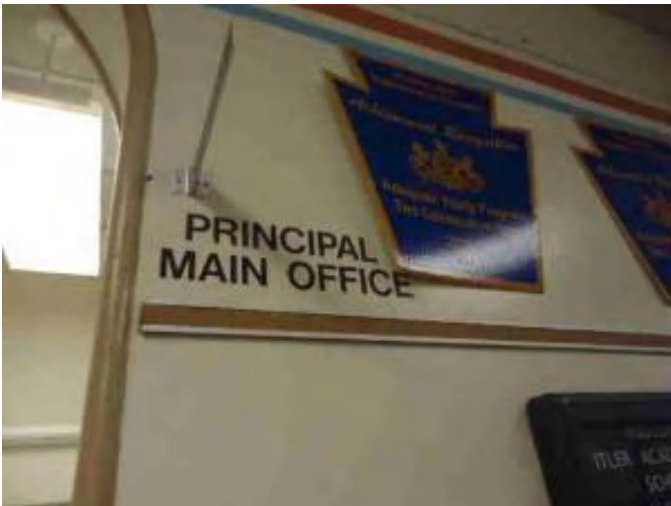
System: C1030 - Fittings

Location: Building Wide

Distress: Damaged

Notes: There is no directional signage and room signage is a custom design in places and scarce or painted with no consistency in others. Accessibility signage criteria have been established for the physically challenged. These include mounting heights, contrast and finish, raised and Braille characters and pictograms, and character proportions and heights. It is recommended that compliant signage be installed throughout the building.

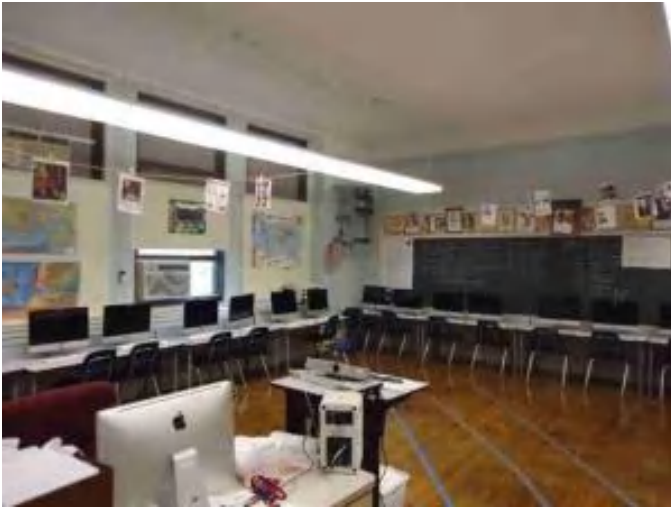
System: C1030 - Fittings

Location: Classrooms

Distress: Damaged

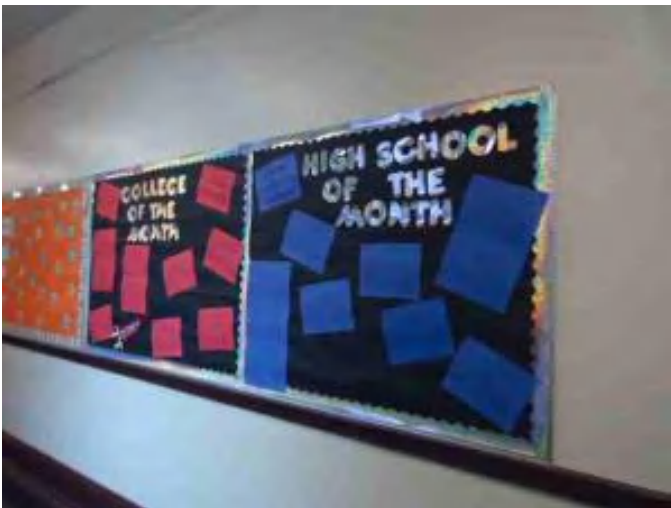
System: C1030 - Fittings

Location: Hallways

Distress: Damaged

Notes: There are several tack boards in the hallways for student displays. The systems are damaged and beyond the expected service life for this application. Remove and replace tack boards is recommended.

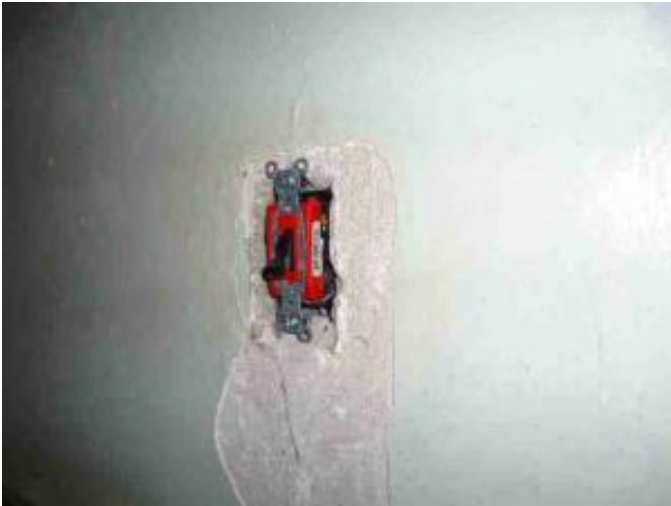
System: C3010230 - Paint & Covering

Location: Building Wide

Distress: Damaged

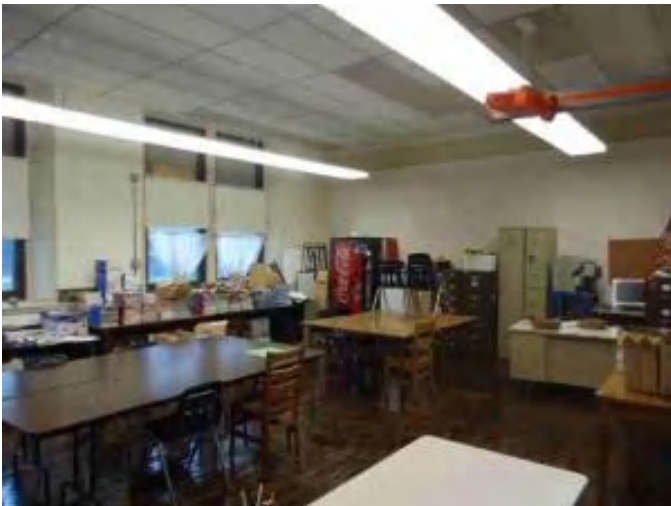
System: C3030 - Ceiling Finishes

Location: Building Wide

Distress: Damaged

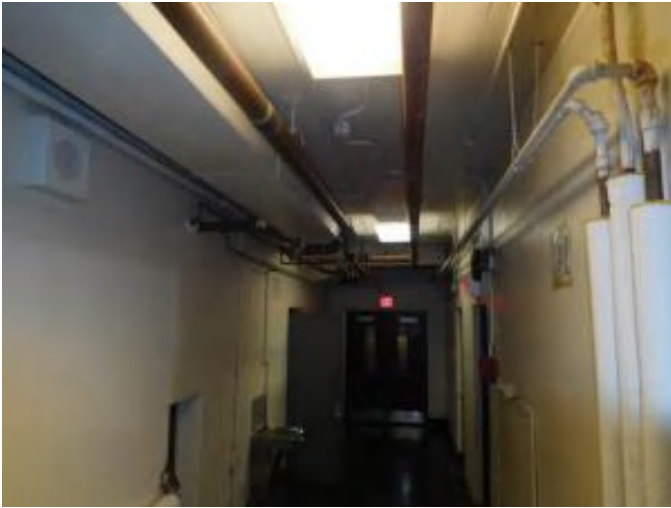
System: D2020 - Domestic Water Distribution

Location: entire building

Distress: Beyond Service Life

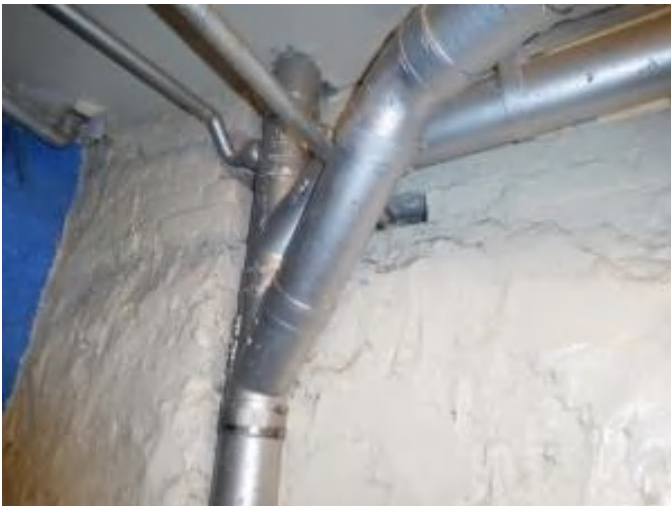
System: D2030 - Sanitary Waste

Location: entire building

Distress: Beyond Service Life

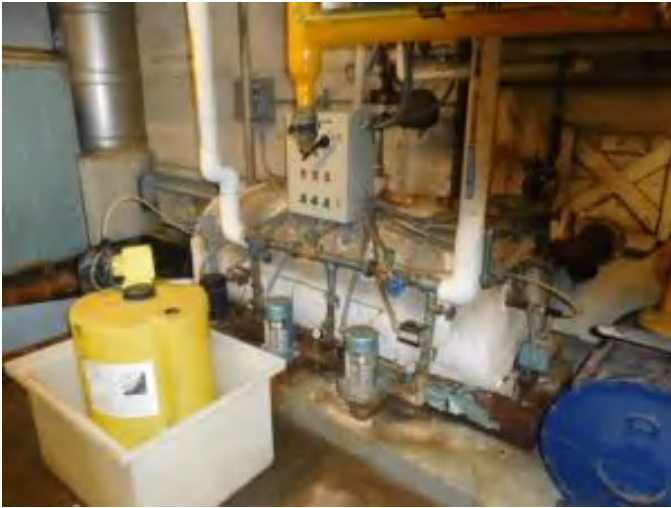
System: D3020 - Heat Generating Systems

Location: mechanical room

Distress: Beyond Service Life

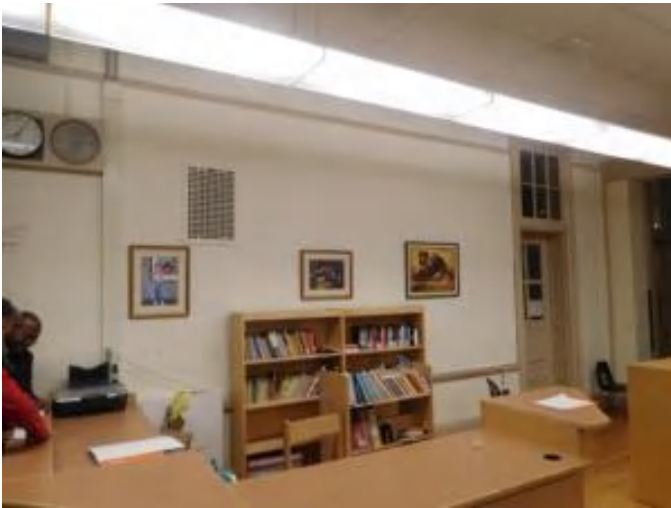
System: D3040 - Distribution Systems

Location: entire building

Distress: Building / MEP Codes

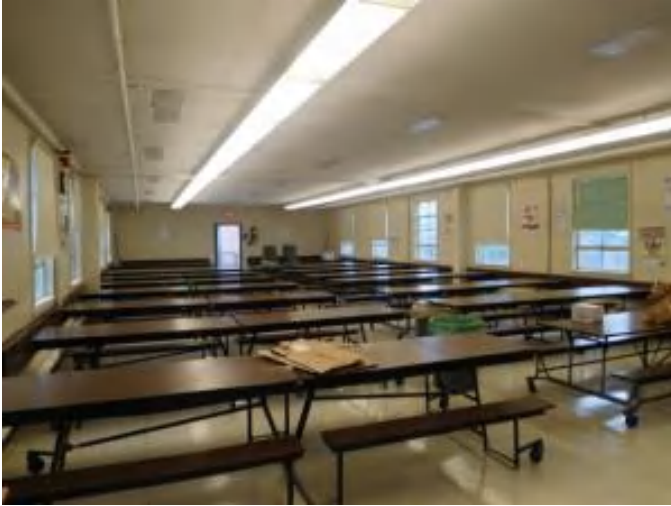
System: D3040 - Distribution Systems

Location: cafeteria

Distress: Building / MEP Codes

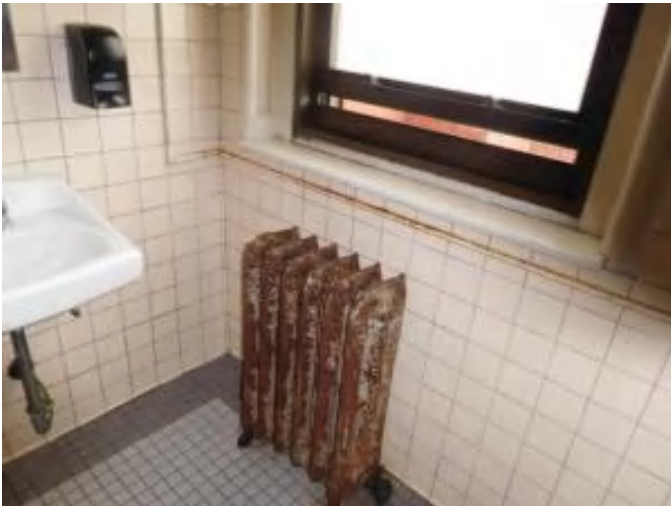
System: D3040 - Distribution Systems

Location: toilet rooms

Distress: Building / MEP Codes

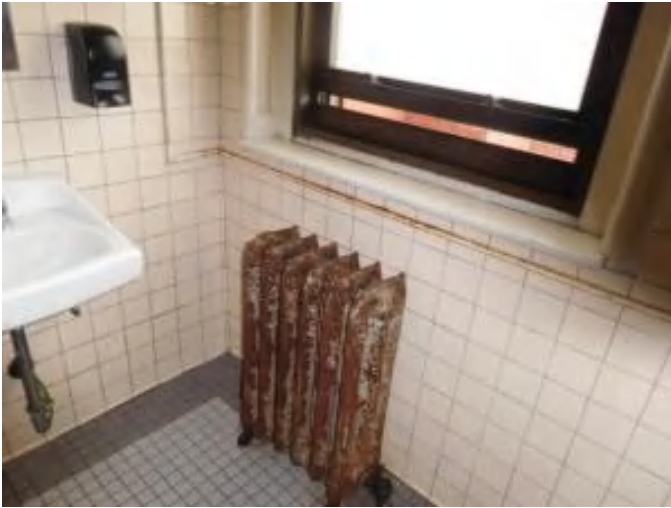
System: D3040 - Distribution Systems

Location: toilet rooms

Distress: Building / MEP Codes

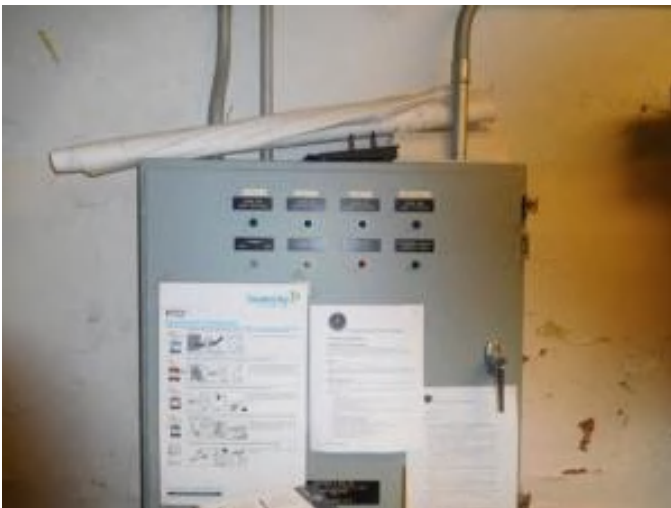
System: D3060 - Controls & Instrumentation

Location: entire building

Distress: Inadequate

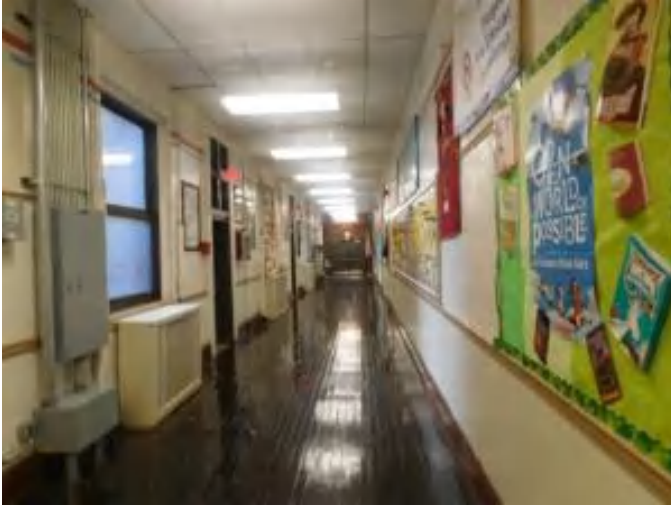
System: D4010 - Sprinklers

Location: entire building

Distress: Life Safety / NFPA / PFD

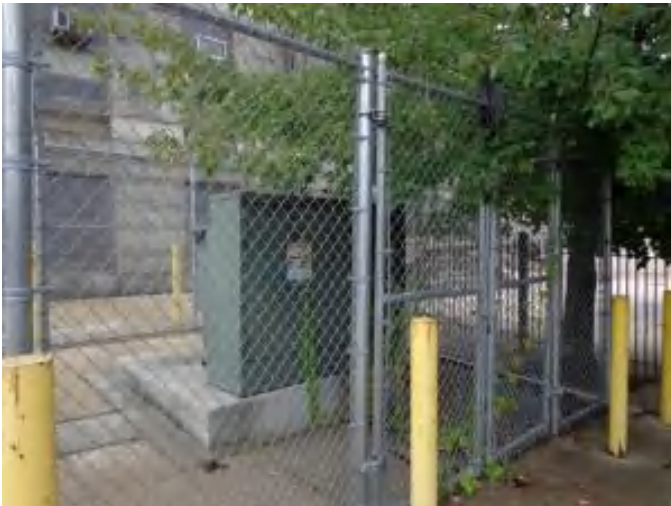
System: D5010 - Electrical Service/Distribution

Location: Main Electrical Room

Distress: Inadequate

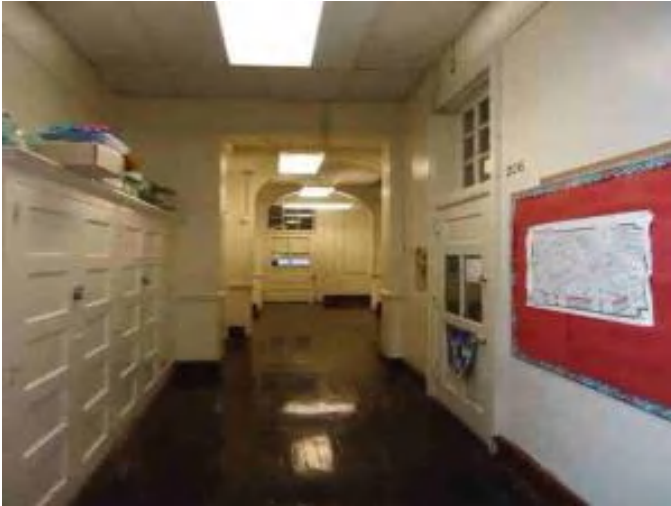
System: C3020414 - Wood Flooring

Location: Building Wide

Distress: Damaged

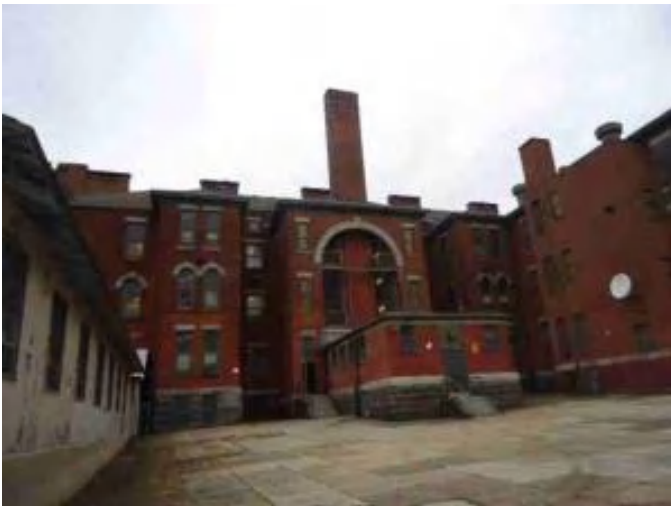
System: D1010 - Elevators and Lifts

Location: Building Wide

Distress: Inadequate

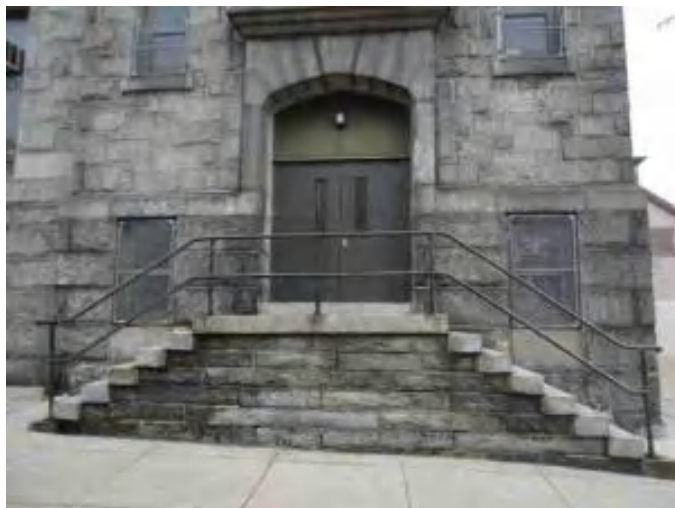
System: G2040 - Site Development

Location: Exterior Stairs

Distress: Life Safety / NFPA / PFD

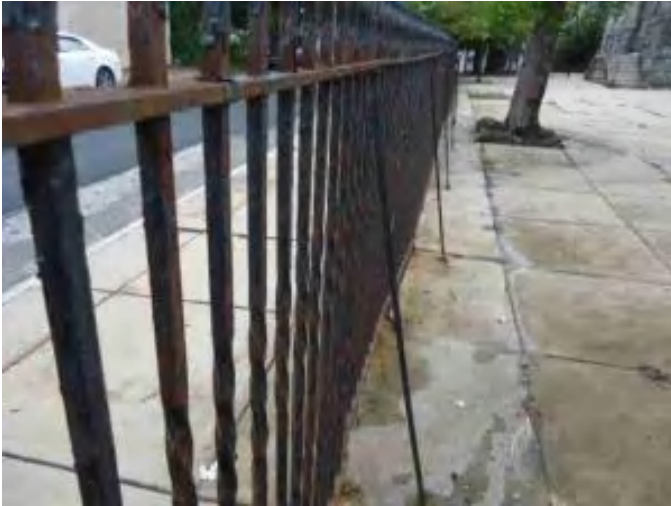
System: G2040 - Site Development

Location: Site

Distress: Damaged

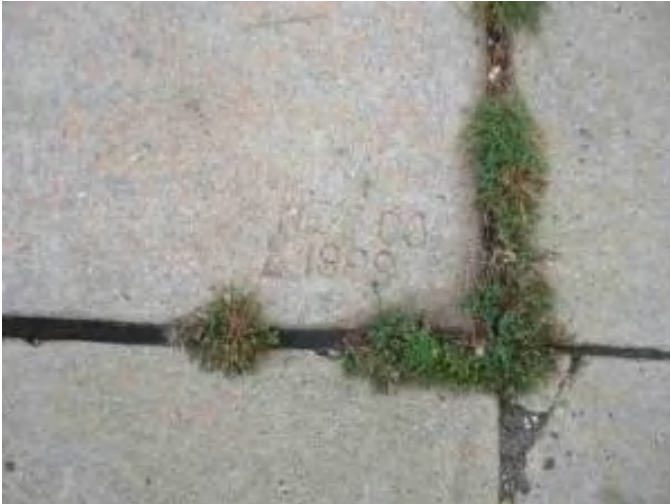
System: G2030 - Pedestrian Paving

Location: Site

Distress: Damaged

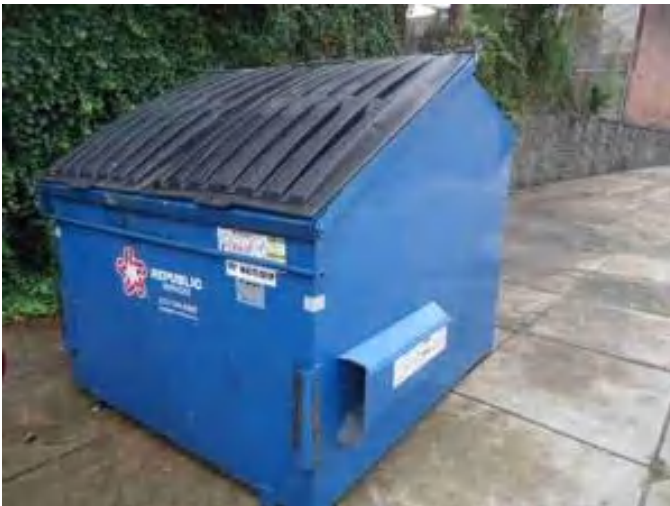
System: G2040 - Site Development

Location: Site

Distress: Health Hazard / Risk
