## Facility Condition Assessment Summary Report

### Fitzpatrick School

### Fitzpatrick (Annex) School

January 31, 2017

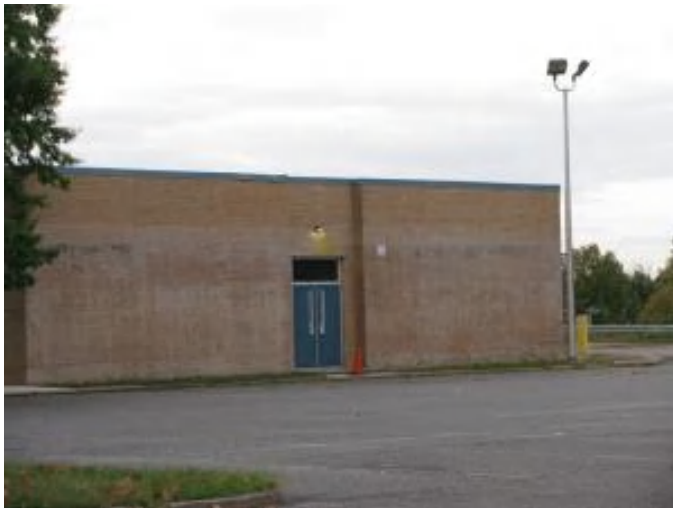
**System: D5030 - Communications and Security**

**Location:** Rush - Exterior Walls  
**Distress:** Inadequate  
**Category:** 4 - Capital Improvement  
**Priority:** 1 - Response Time (< 2 yr)  
**Correction:** Add/Replace Paging System  
**Qty:** 1.00  
**Unit of Measure:** Ea.  
**Estimate:** \$18,772.62  
**Assessor Name:** Craig Anding  
**Date Created:** 10/22/2015

**Notes:** Provide outdoor speakers to cover the school yard. Estimated 10 each.

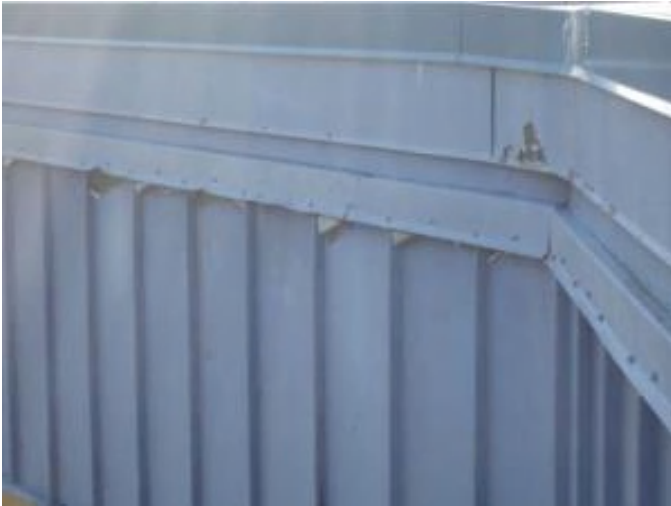
**System: B2010 - Exterior Walls**

**Location:** Rush - exterior mansard panels

**Distress:** Failing

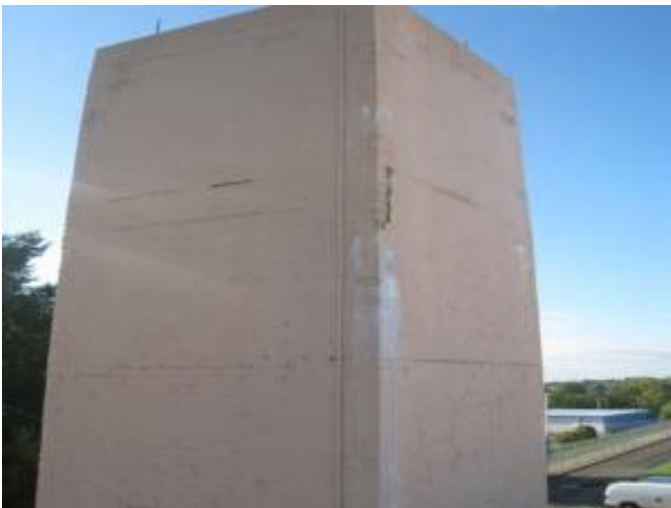
**System: B2010 - Exterior Walls**

**Location:** Rush - flue

**Distress:** Failing

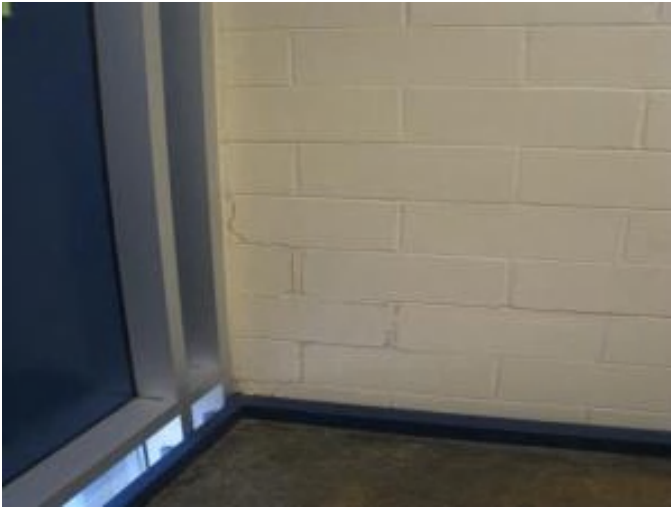
**System: B2010 - Exterior Walls**

**Location:** Rush - interior masonry cracks

**Distress:** Failing

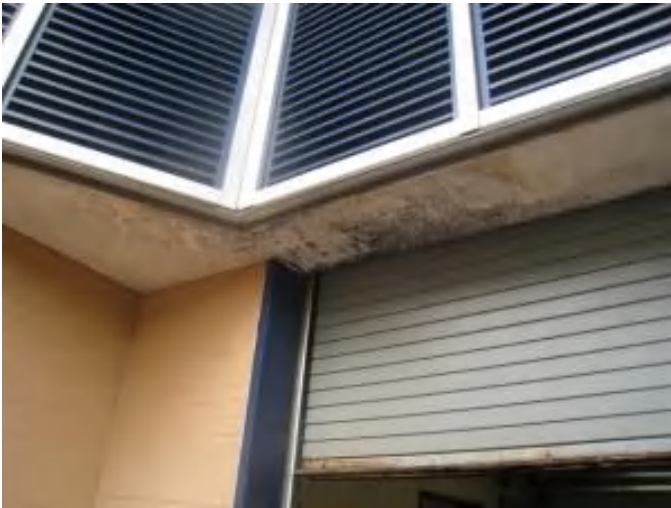
**System: B2030 - Exterior Doors**

**Location:** Rush - loading dock

**Distress:** Damaged

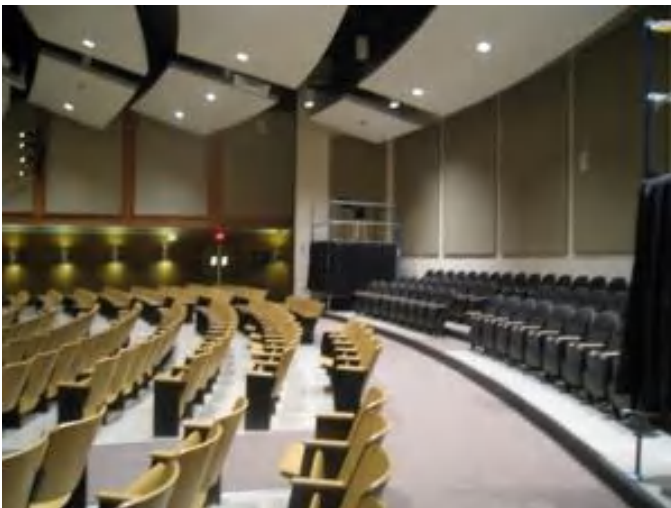
**System: C3020411 - Carpet**

**Location:** Rush - auditorium

**Distress:** Failing

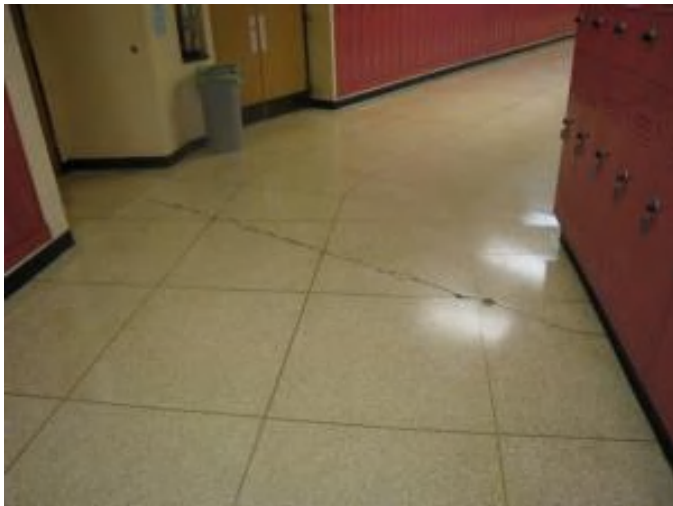
**System: C3020412 - Terrazzo & Tile**

**Location:** Rush - terrazzo floors - first floor

**Distress:** Failing

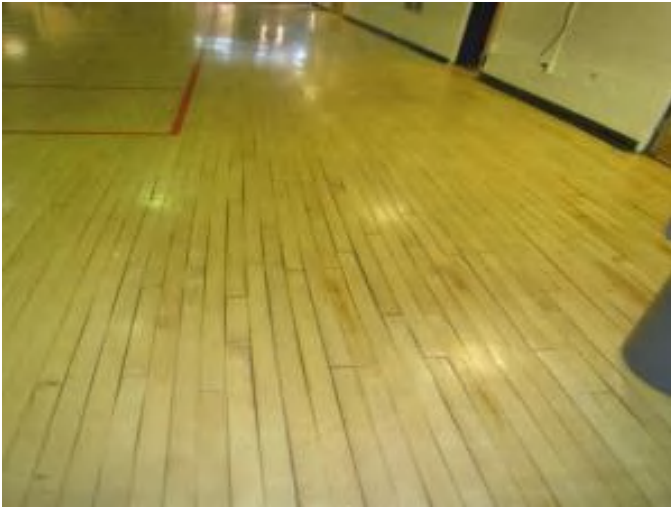
**System: C3020414 - Wood Flooring**

**Location:** Rush - gym floor

**Distress:** Damaged

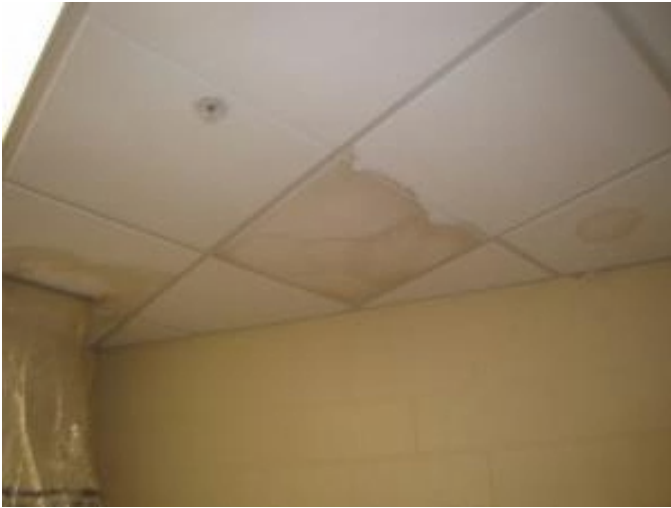
**System: C3030 - Ceiling Finishes**

**Location:** Rush - ceiling tiles

**Distress:** Damaged

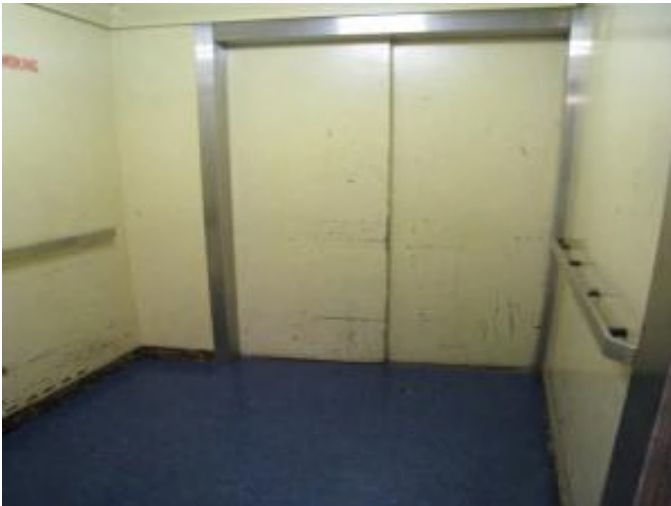
**System: D1010 - Elevators and Lifts**

**Location:** Rush - elevator

**Distress:** Failing

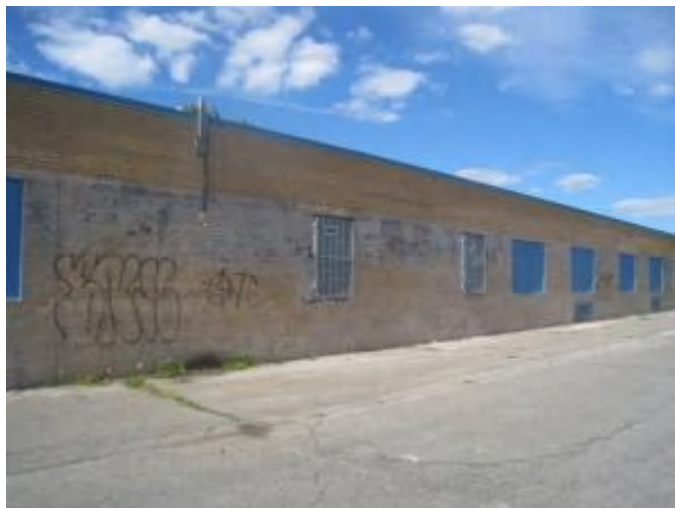
#### System: B2010 - Exterior Walls

**Location:** Rush Annex - exterior walls

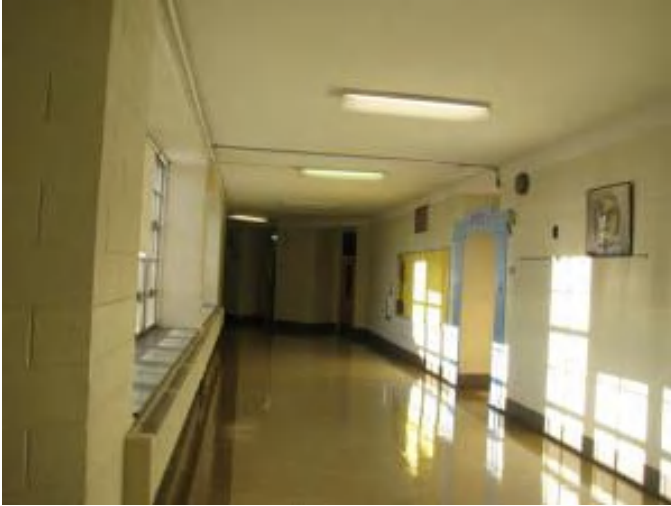
**System: D5020 - Lighting and Branch Wiring**

**Location:** Fitzpatrick- Entire Building

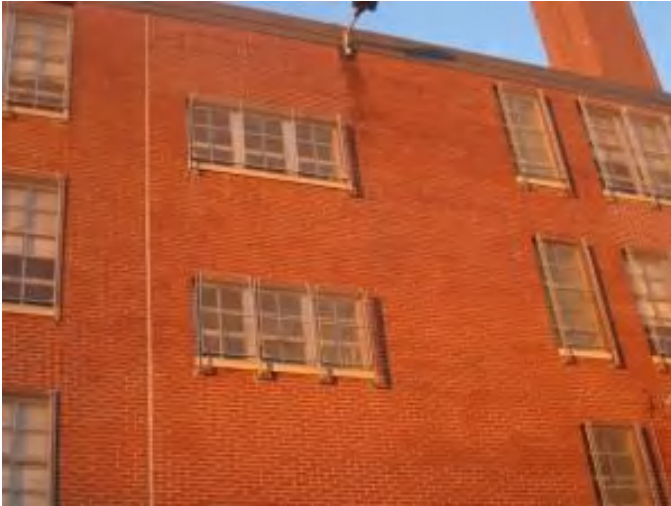
**System: B2010 - Exterior Walls**

**Location:** Fitzpatrick - exterior walls

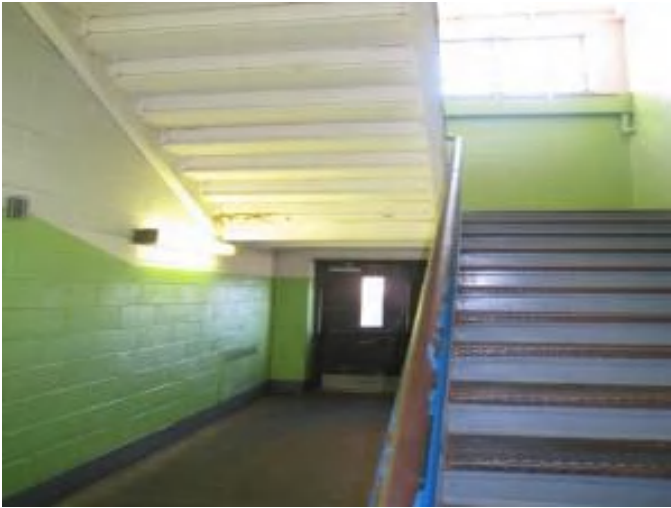
**System: B2010 - Exterior Walls**

**Location:** Fitzpatrick - stairway rust

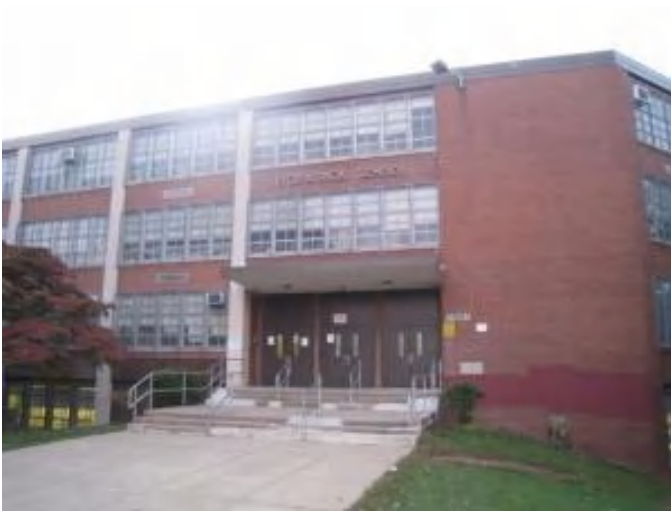
**System: B2020 - Exterior Windows**

**Location:** Fitzpatrick - windows

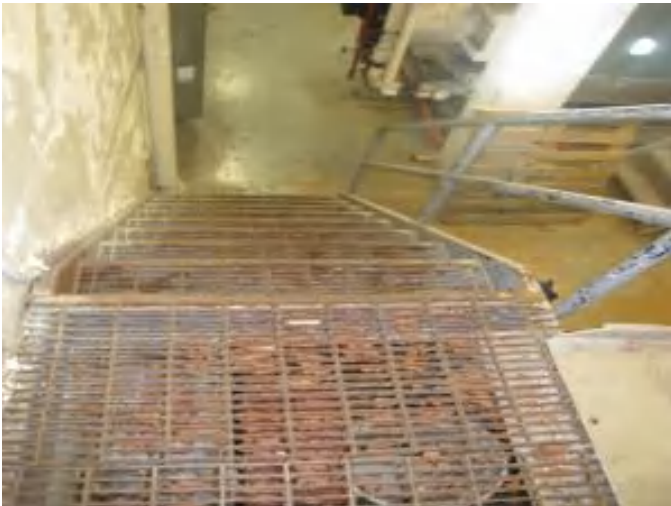
**System: C2010 - Stair Construction**

**Location:** Fitzpatrick - boiler room stairs

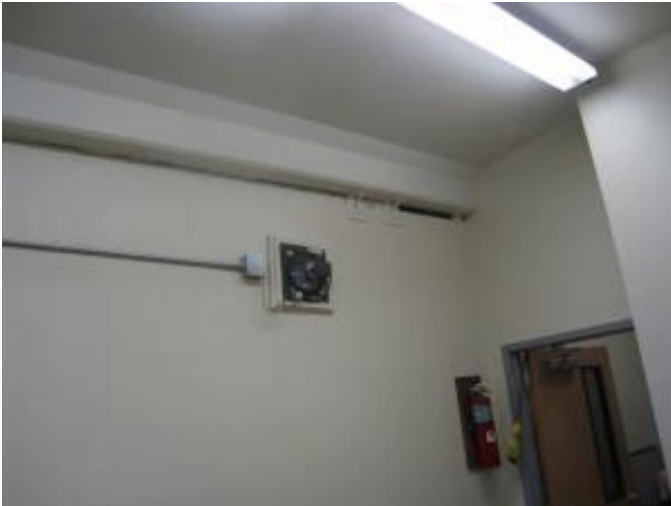
#### System: B2010 - Exterior Walls

**Location:** Fitzpatrick Annex - wall panels

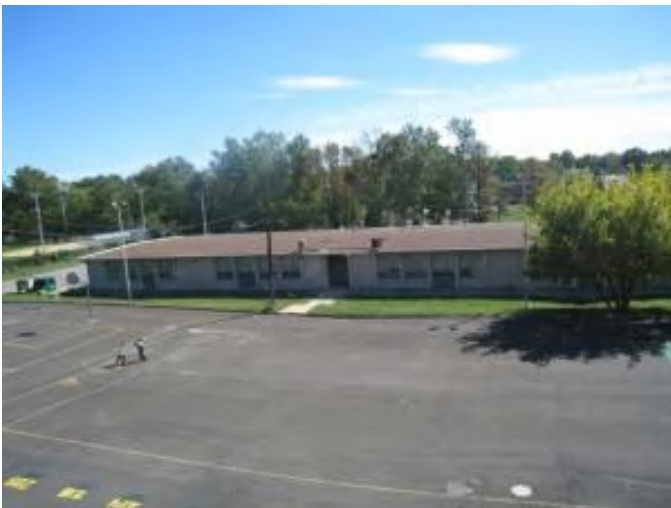
#### System: B3010105 - Built-Up

**Location:** Fitzpatrick Annex - roof

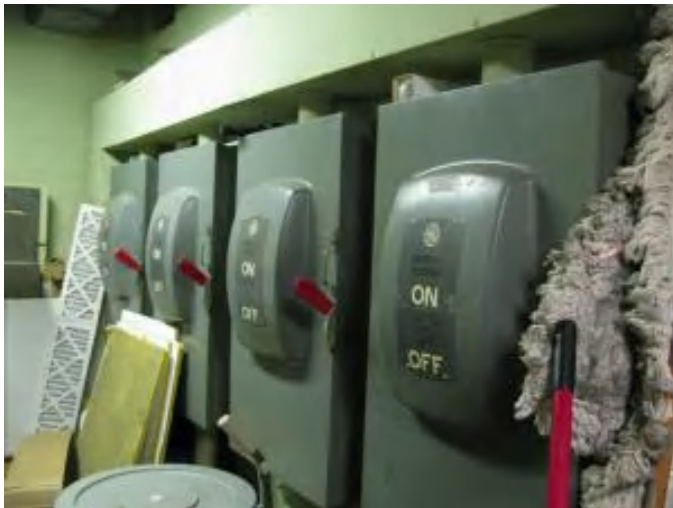
**System: D5010 - Electrical Service/Distribution**

**Location:** Fitzpatrick Annex - Electrical Room

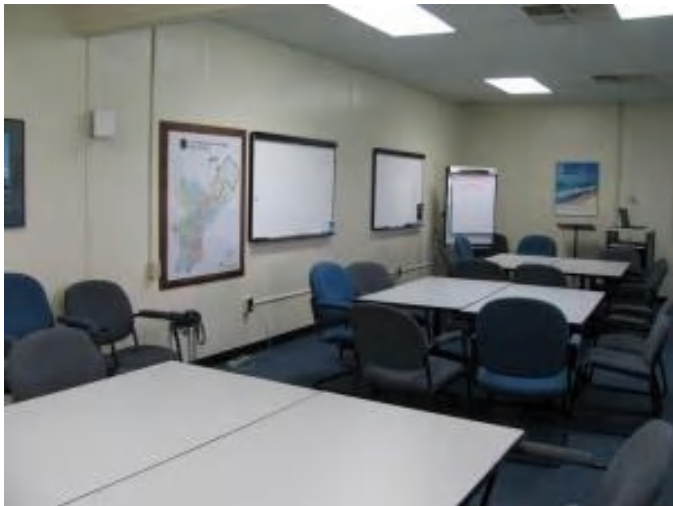
**System: D5020 - Lighting and Branch Wiring**

**Location:** Fitzpatrick Annex - Entire Building

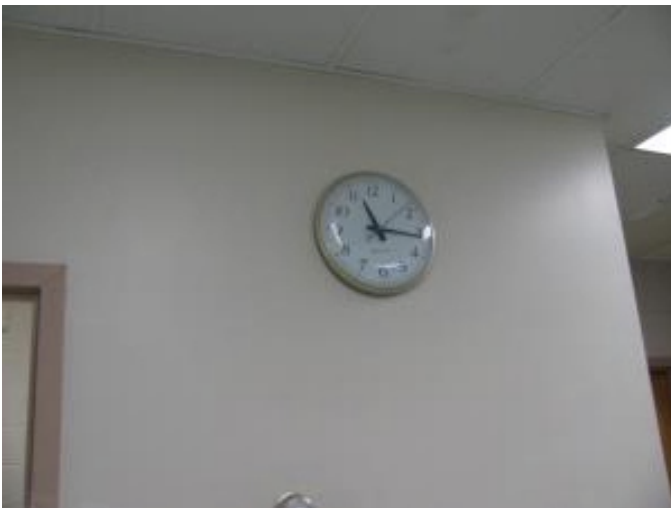
**System: D5030 - Communications and Security**

**Location:** Fitzpatrick Annex - Entire Building

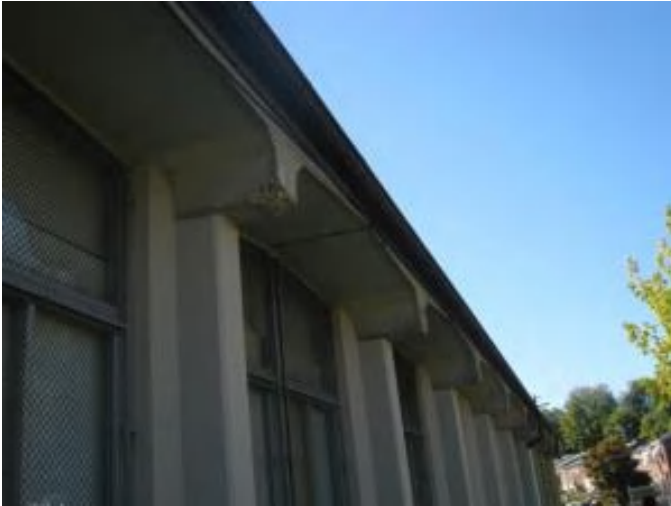
**System: B1020 - Roof Construction**

**Location:** Fitzpatrick Annex - exterior T section ends

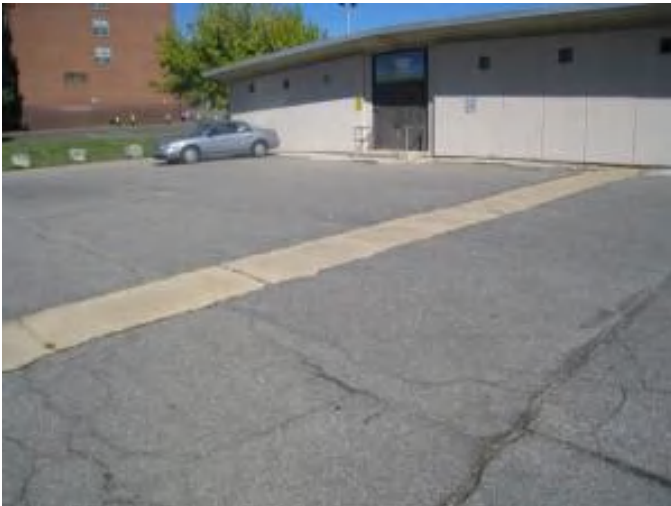
**System: B2010 - Exterior Walls**

**Location:** Fitzpatrick Annex - exterior wall panels

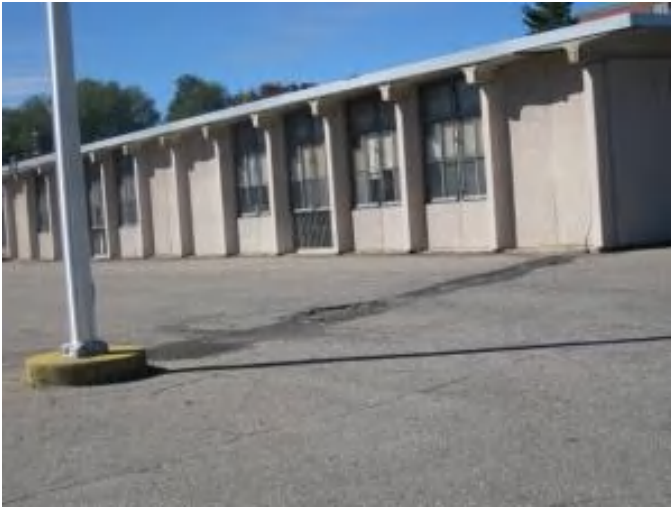
**System: B2010 - Exterior Walls**

**Location:** Fitzpatrick Annex - univent louvers

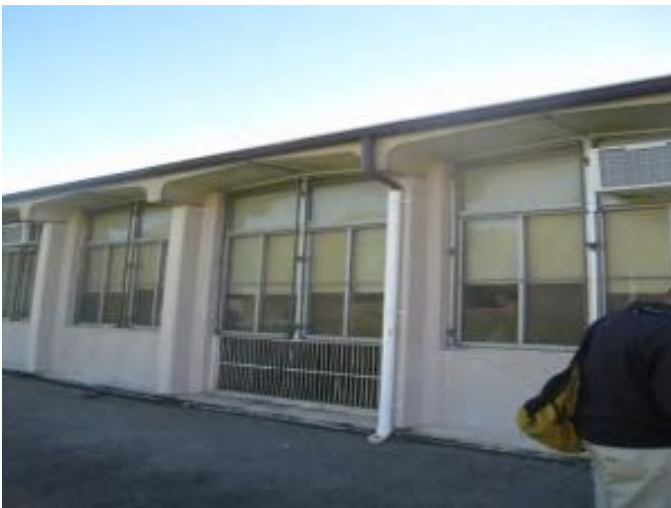
**System: B2020 - Exterior Windows**

**Location:** Fitzpatrick Annex - windows

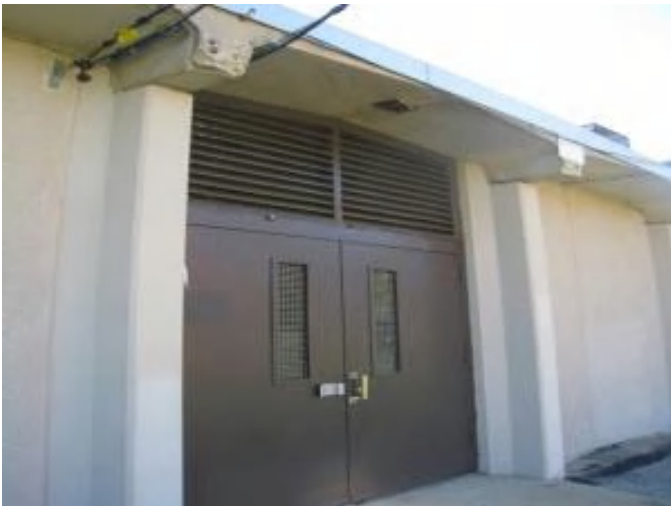
**System: B3010140 - Shingle & Tile**

**Location:** Fitzpatrick Annex - roof

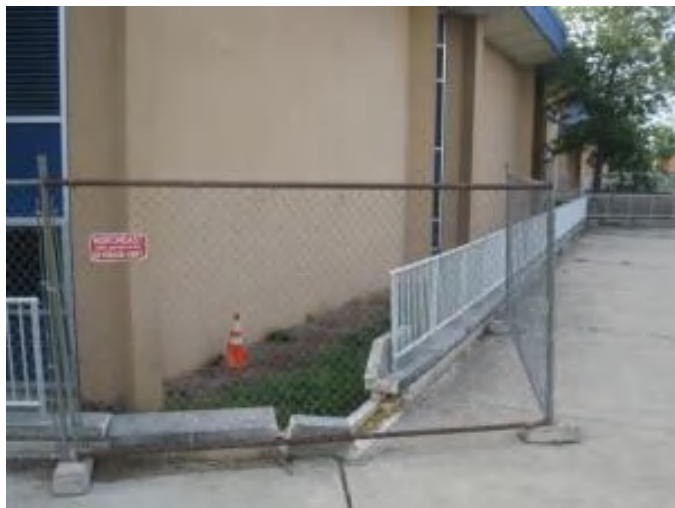
#### System: G2030 - Pedestrian Paving

**Location:** Rush - northwest corner of building

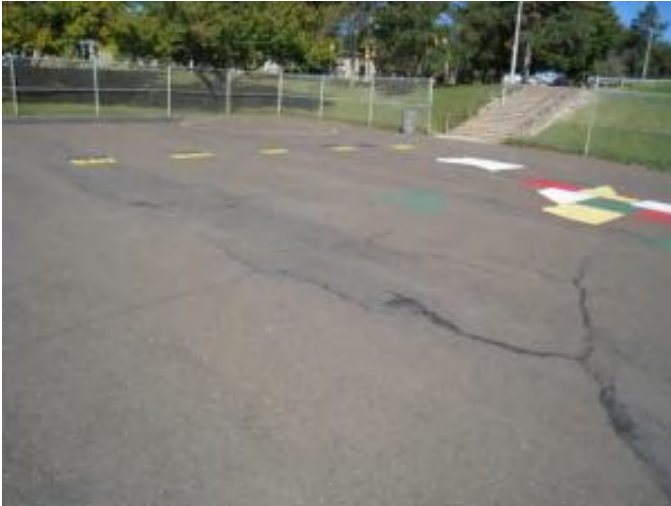
**System: G2020 - Parking Lots**

**Location:** Fitzpatrick - play area

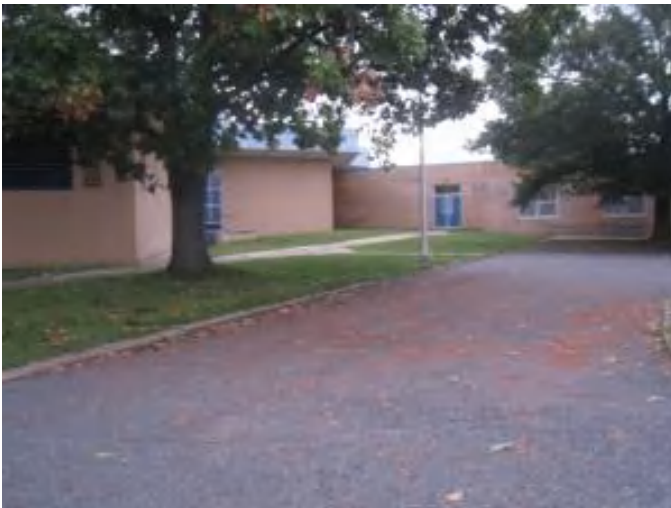
**System: G2020 - Parking Lots**

**Location:** Rush - parking lots

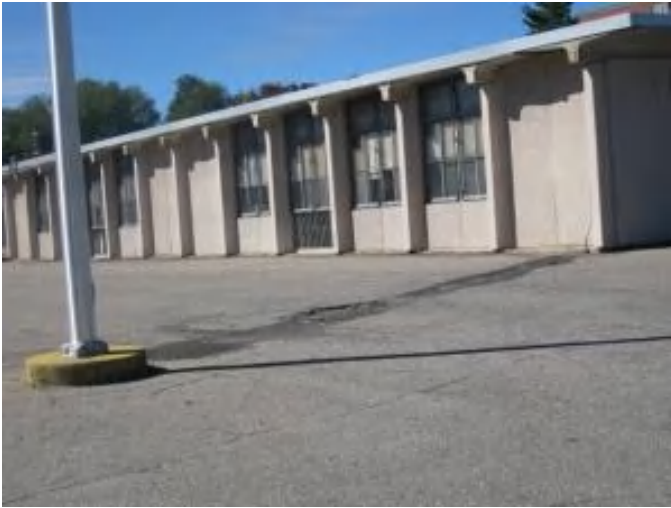
**System: G2020 - Parking Lots**

**Location:** Fitzpatrick Annex - parking lot

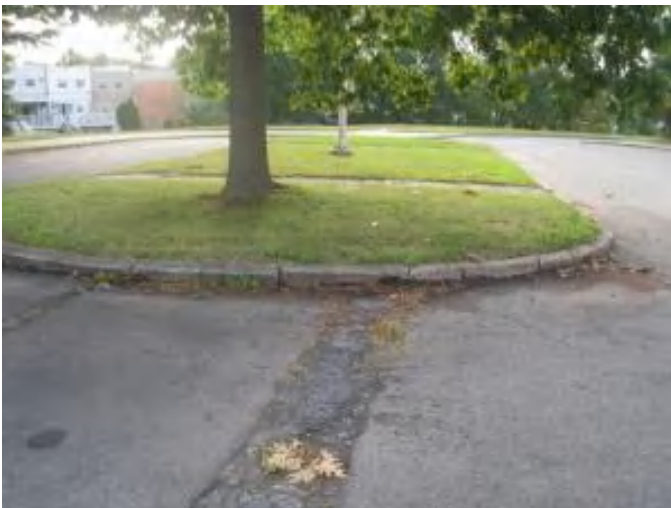
**System: G2020 - Parking Lots**

**Location:** Rush - roadways

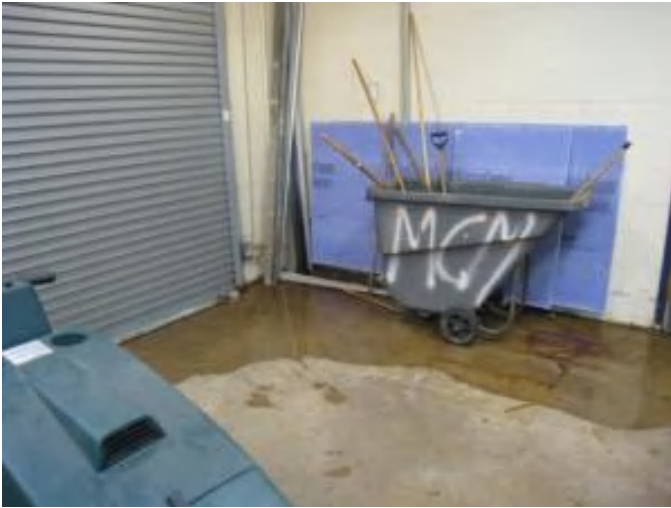
**System: G2020 - Parking Lots**

**Location:** Rush - loading dock

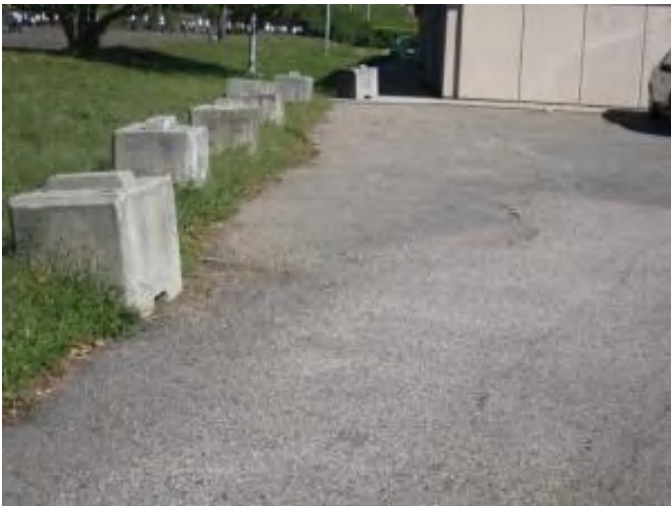
**System: G2020 - Parking Lots**

**Location:** Fitzpatrick Annex - parking lot entrance

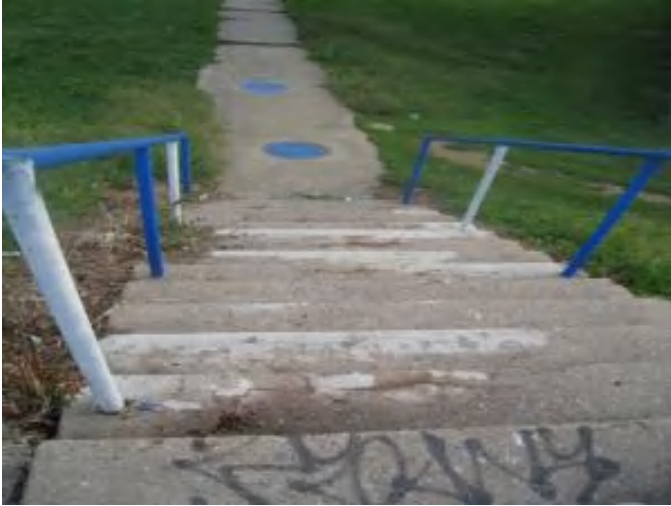
**System: G2030 - Pedestrian Paving**

**Location:** Rush - stair down from Library parking lot

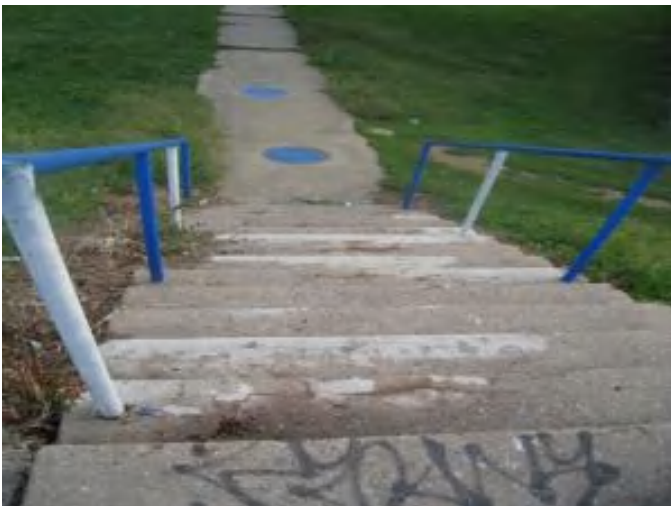
**System: G2030 - Pedestrian Paving**

**Location:** Rush - stair down from Library parking lot

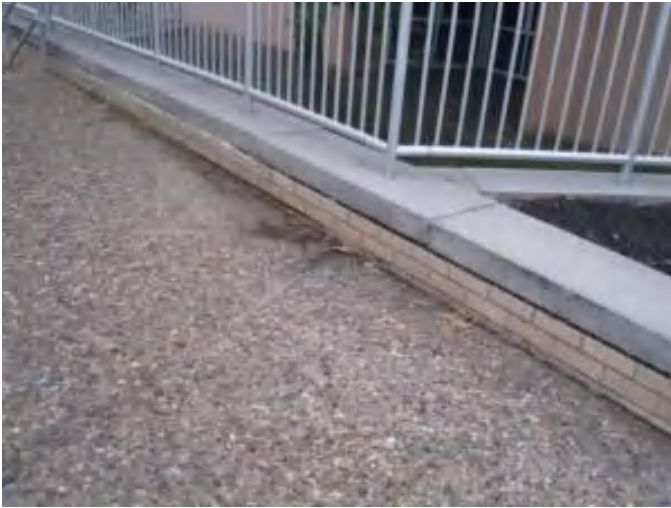
**System: G2040 - Site Development**

**Location:** Rush - front walks and walls

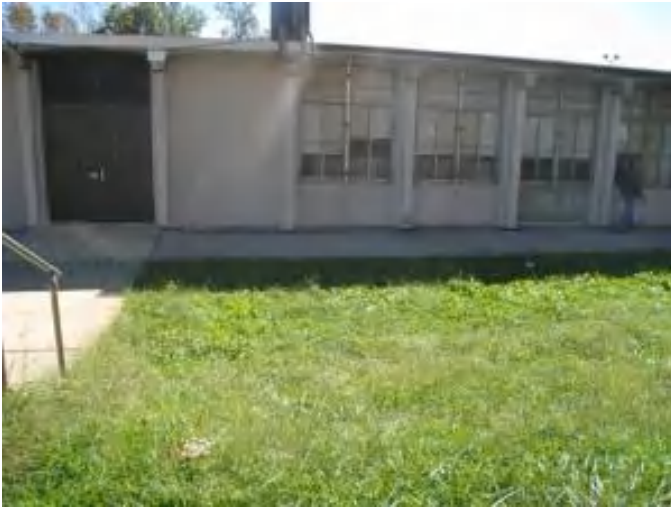
**System: G2040 - Site Development**

**Location:** Fitzpatrick Annex - regrading

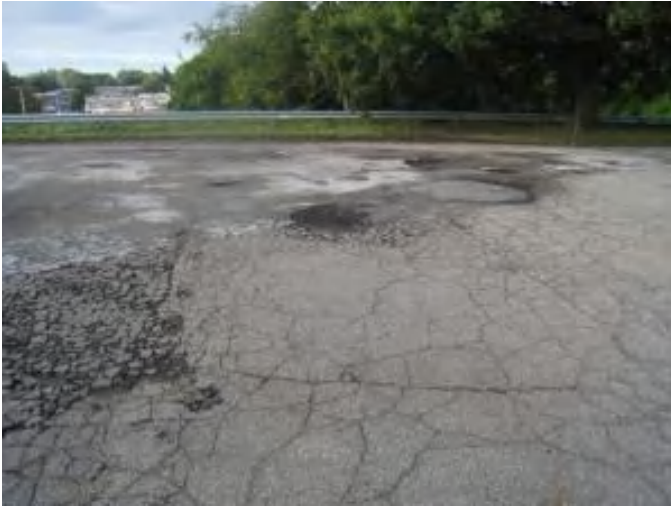
**System: G2020 - Parking Lots**

**Location:** Rush - roadways

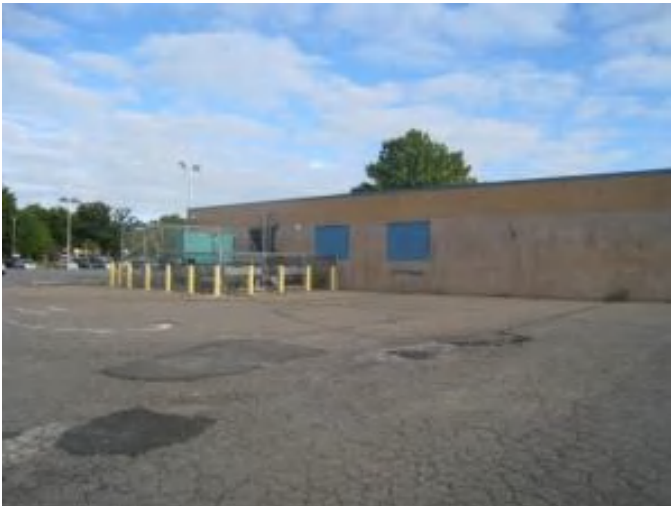
**System: G2020 - Parking Lots**

**Location:** Rush - parking lot

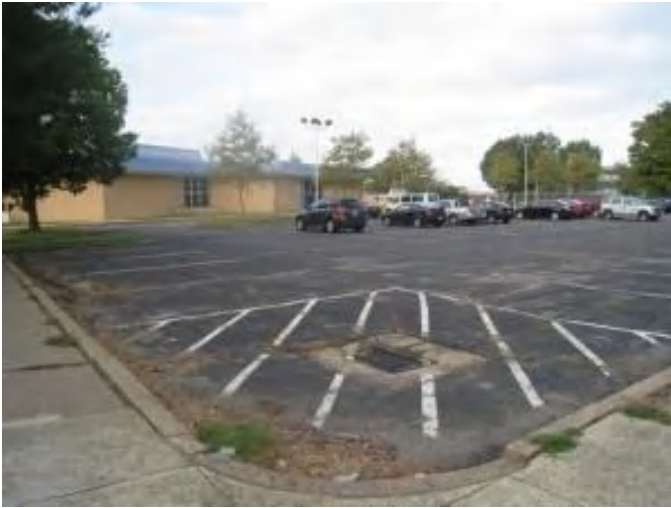
**System: G2020 - Parking Lots**

**Location:** Rush - parking lot

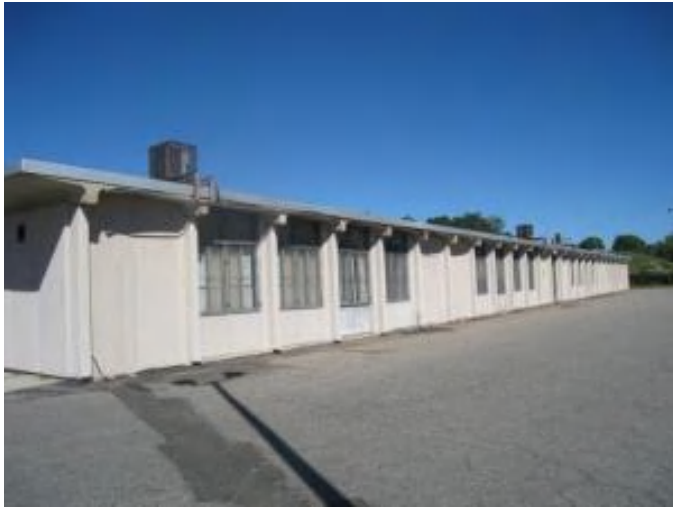
**System: G2020 - Parking Lots**

**Location:** Fitzpatrick Annex - repaving
