## Facility Condition Assessment Summary Report

### Forrest School

School District of Philadelphia  
**S825001;Forrest**  
Final  
**Site Assessment Report**  
January 31, 2017

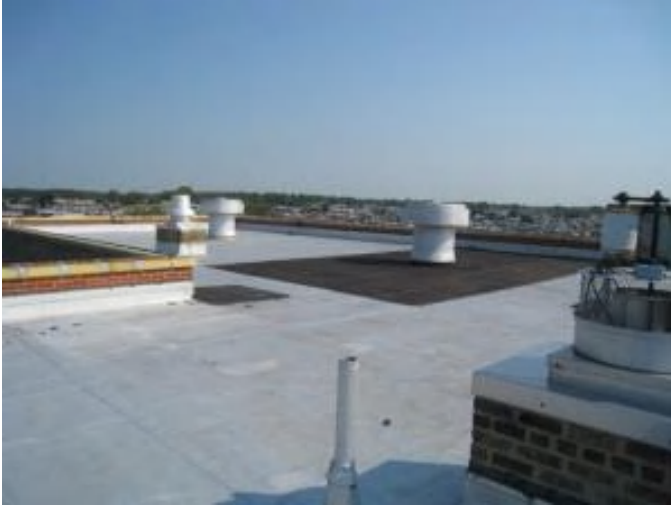
#### System: B3010105 - Built-Up

**Location:** roof

**Distress:** Failing

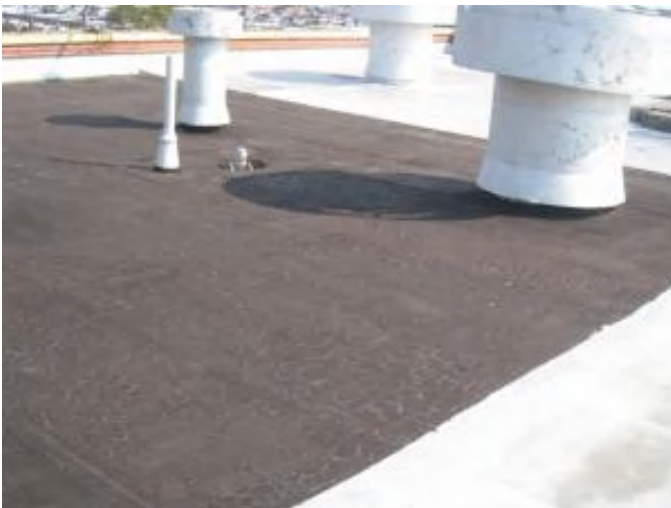
#### System: B3010105 - Built-Up

**Location:** roof

**Distress:** Failing

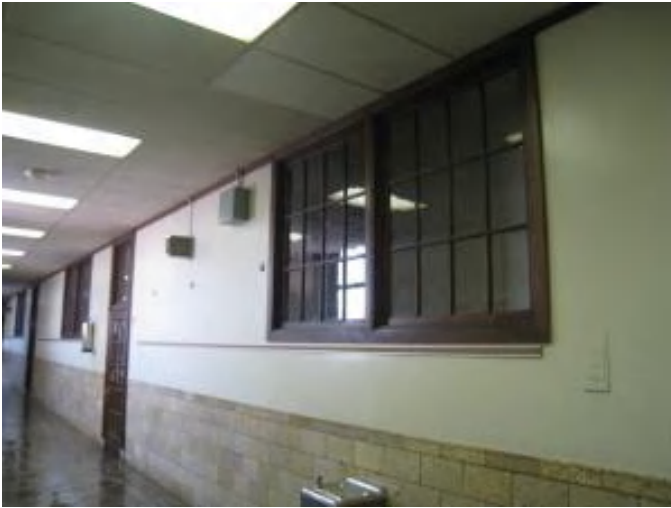
**System: C1010 - Partitions**

**Location:** corridor walls and stairway walls

**Distress:** Building / MEP Codes

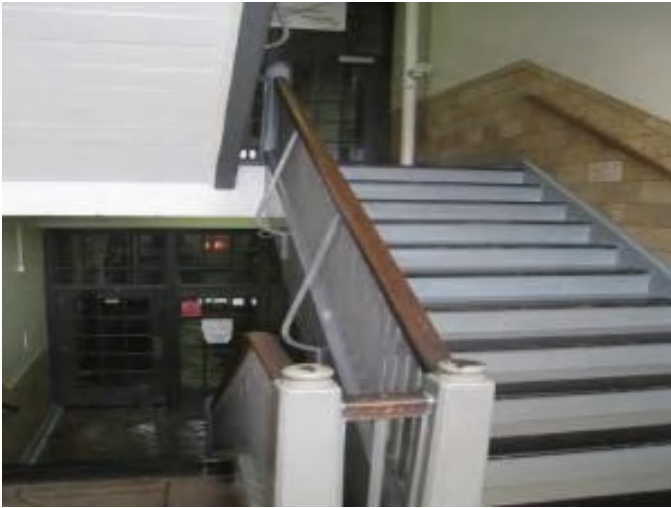
**System: C2010 - Stair Construction**

**Location:** stairs

**Distress:** Building / MEP Codes

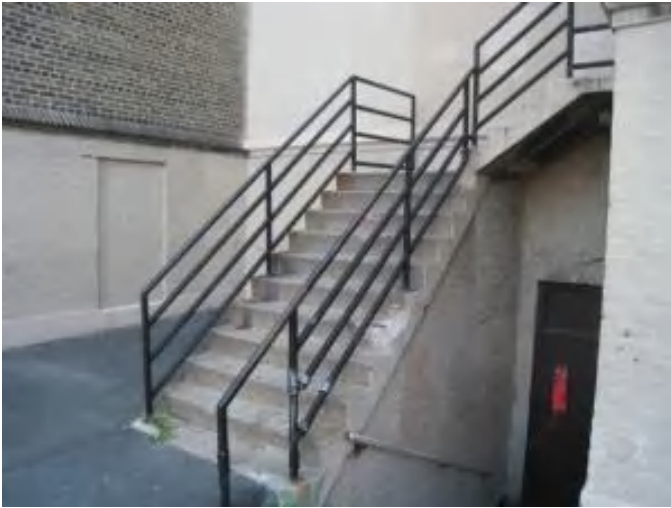
**System: C2010 - Stair Construction**

**Location:** exterior stairs

**Distress:** Building / MEP Codes

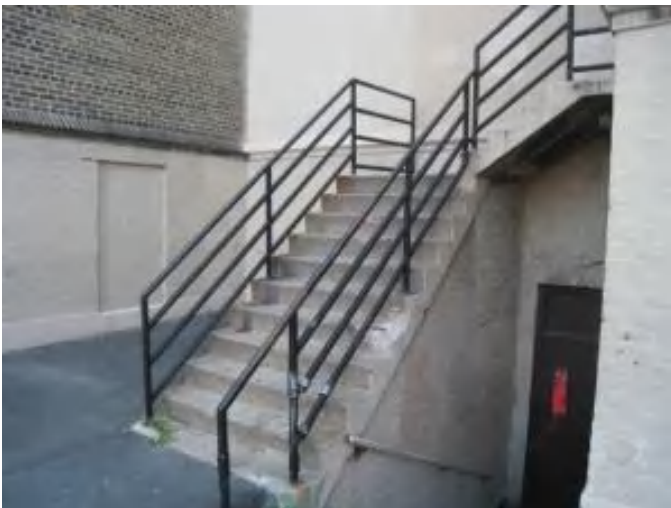
**System: C2010 - Stair Construction**

**Location:** exterior stair

**Distress:** Damaged

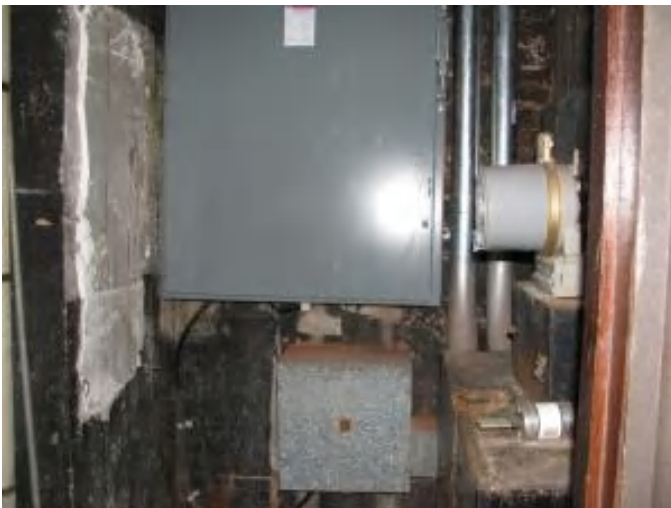
**System: D5010 - Electrical Service/Distribution**

**Location:** Boiler Room

**Distress:** Beyond Service Life

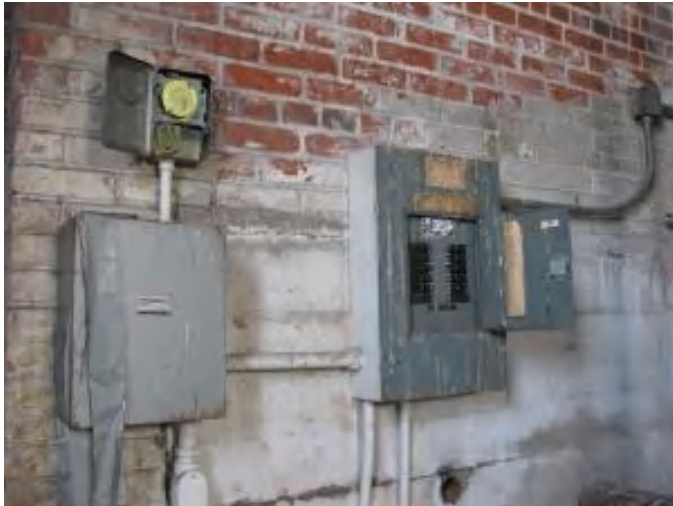
**System: D5010 - Electrical Service/Distribution**

**Location:** Boiler Room

**Distress:** Beyond Service Life

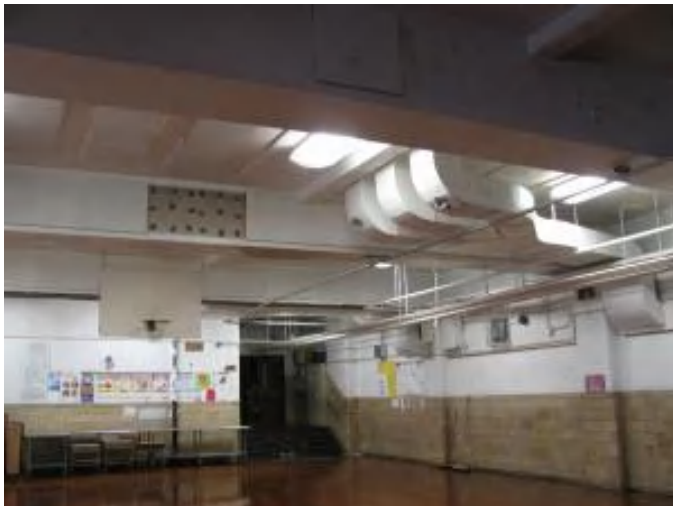
**System: D5020 - Lighting and Branch Wiring**

**Location:** Entire Building

**Distress:** Inadequate

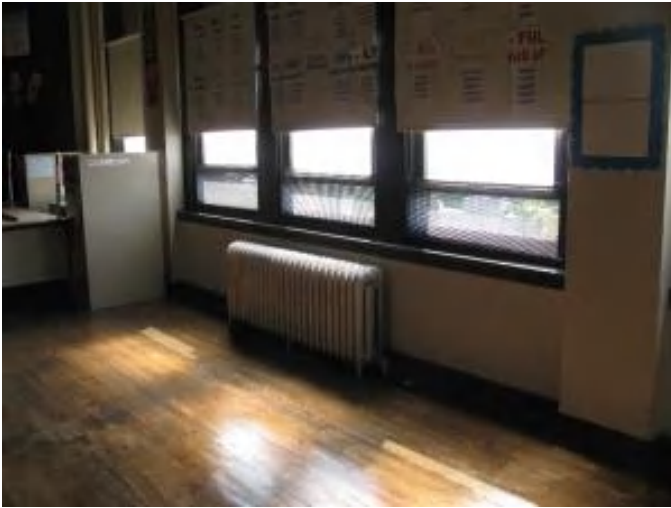
**System: D5020 - Lighting and Branch Wiring**

**Location:** Entire Building

**Distress:** Inadequate

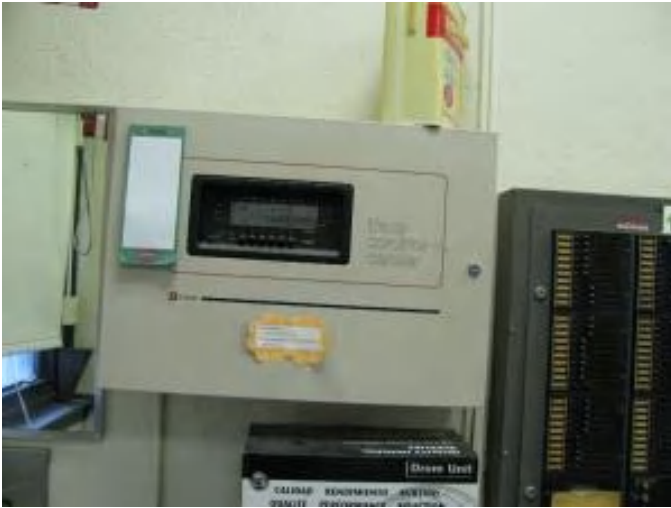
**System: D5030 - Communications and Security**

**Location:** Entire Building

**Distress:** Beyond Service Life

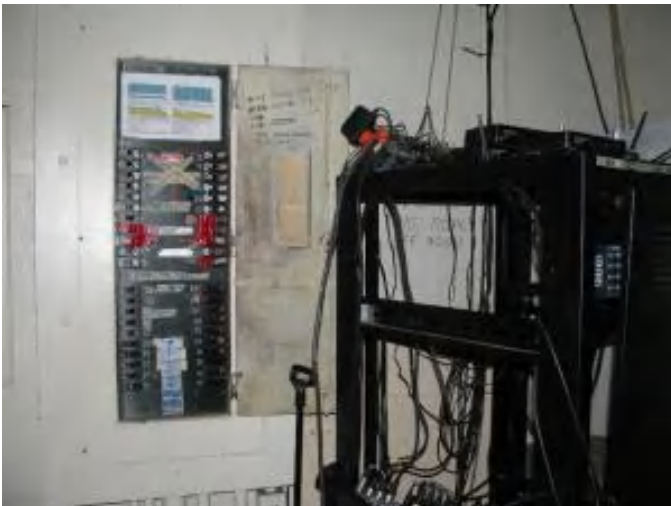
**System: D5030 - Communications and Security**

**Location:** Auditorium

**Distress:** Inadequate

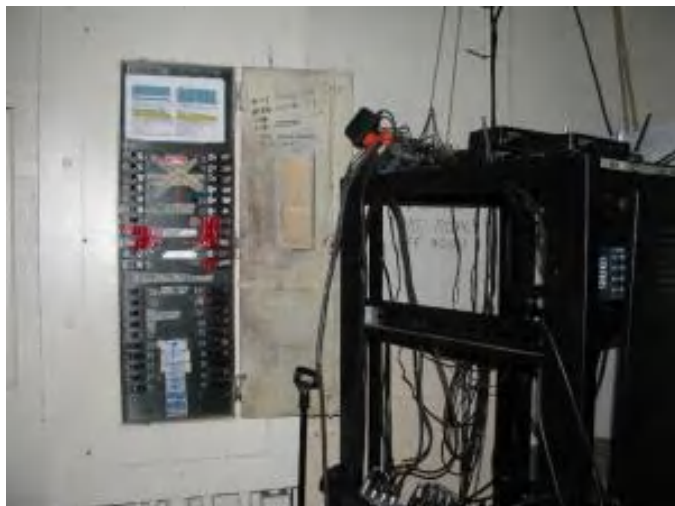
**System: E1020 - Institutional Equipment**

**Location:** Auditorium

**Distress:** Beyond Service Life

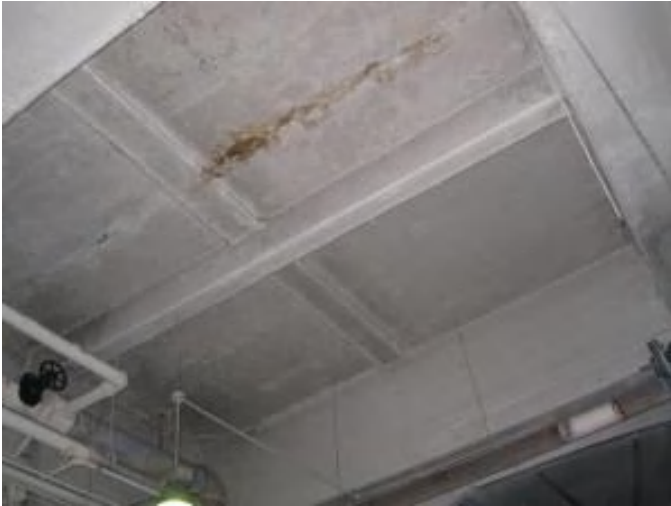
**System: B1010 - Floor Construction**

**Location:** underside 1st floor

**Distress:** Failing

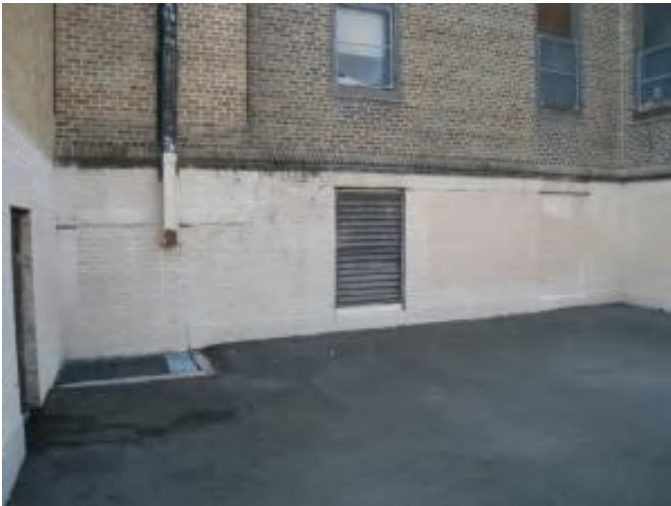
**System: B2010 - Exterior Walls**

**Location:** rear foundation walls

**Distress:** Appearance

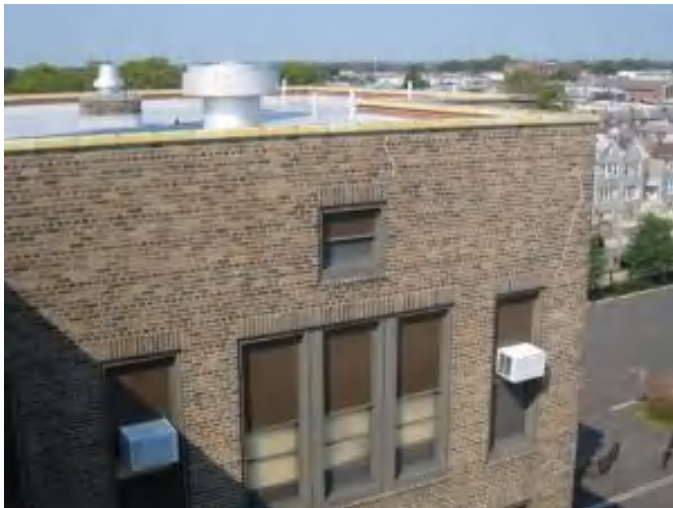
**System: B2010 - Exterior Walls**

**Location:** exterior walls near window and door lintels

**Distress:** Failing

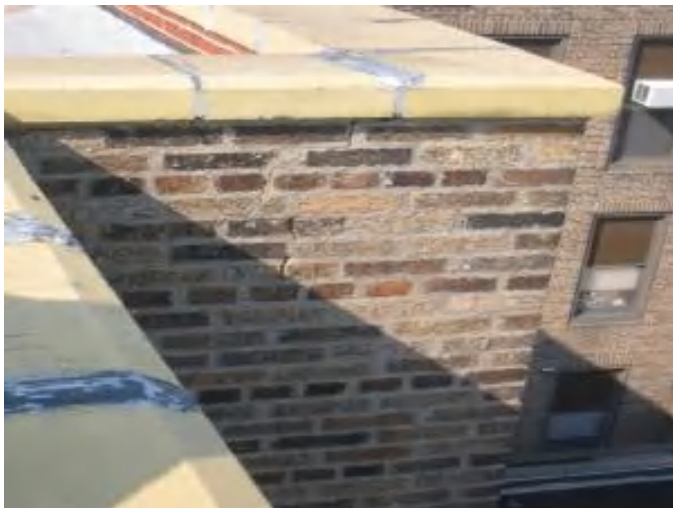
**System: B2010 - Exterior Walls**

**Location:** terra cotta parapet coping

**Distress:** Failing

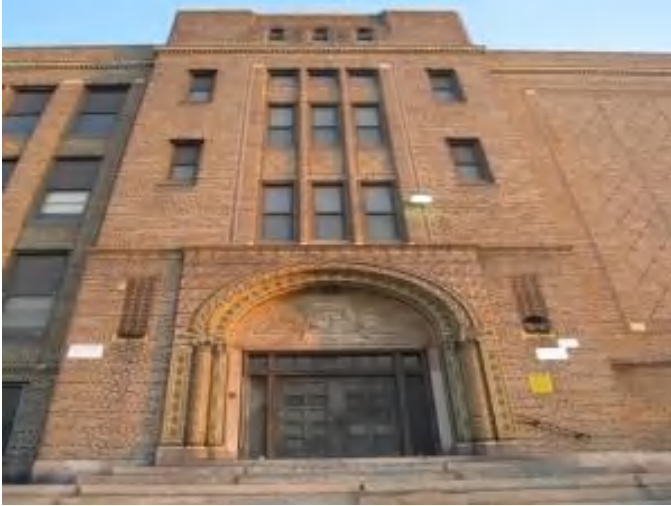
**System: B2010 - Exterior Walls**

**Location:** vents adjacent to entrance door

**Distress:** Damaged

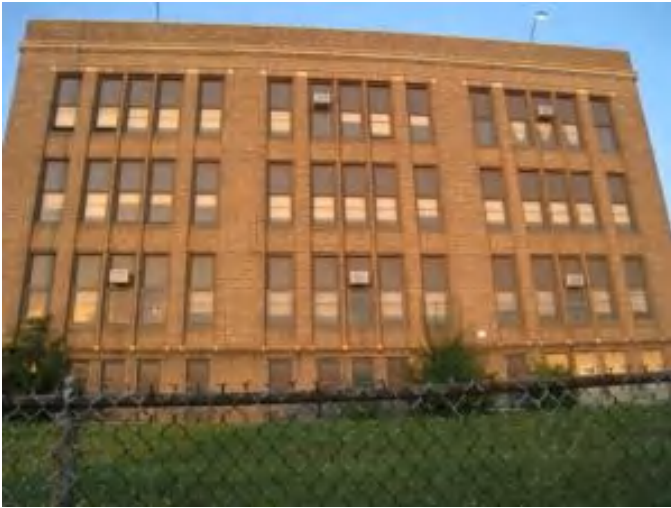
**System: B2020 - Exterior Windows**

**Location:** basement windows and louver

**Distress:** Failing

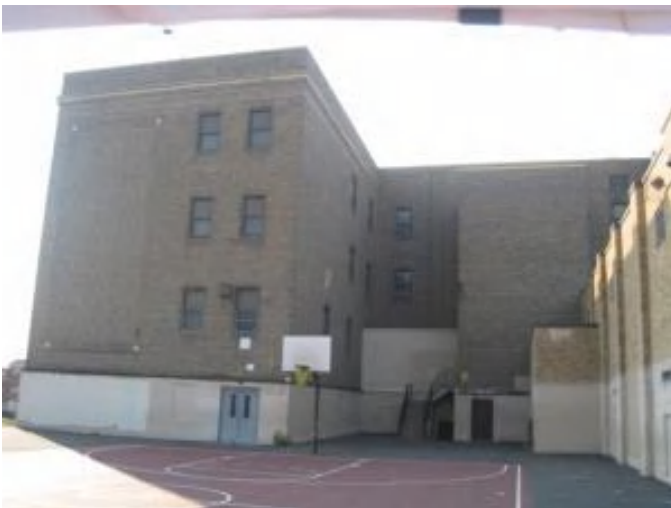
**System: B2030 - Exterior Doors**

**Location:** exterior metal doors

**Distress:** Failing

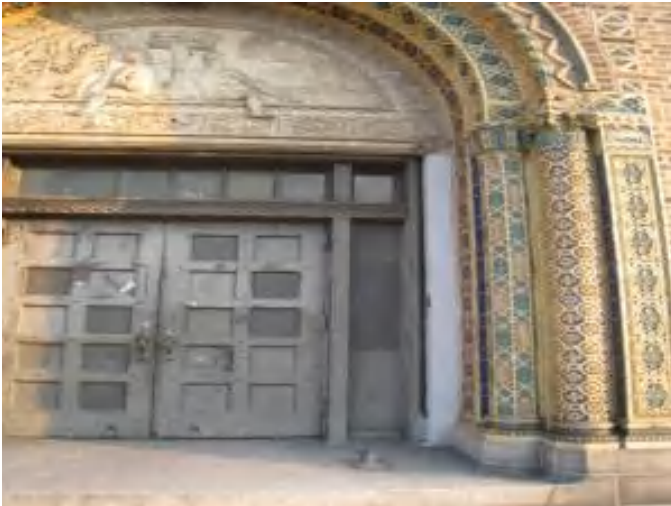
**System: B2030 - Exterior Doors**

**Location:** front doors

**Distress:** Damaged

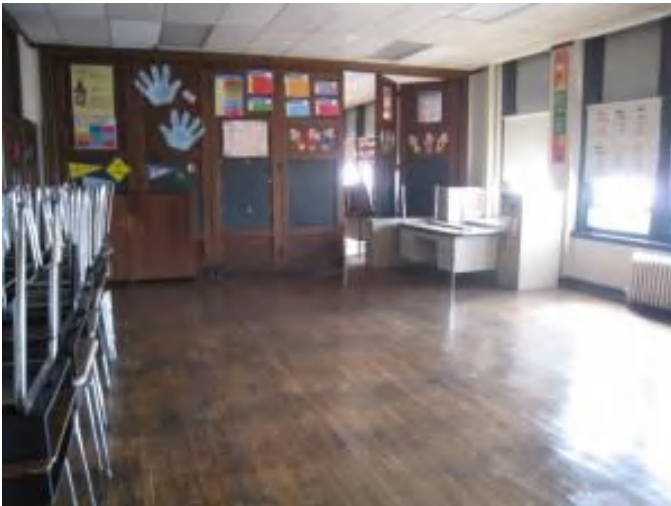
**System: C1010 - Partitions**

**Location:** partitions between classes

**Distress:** Failing

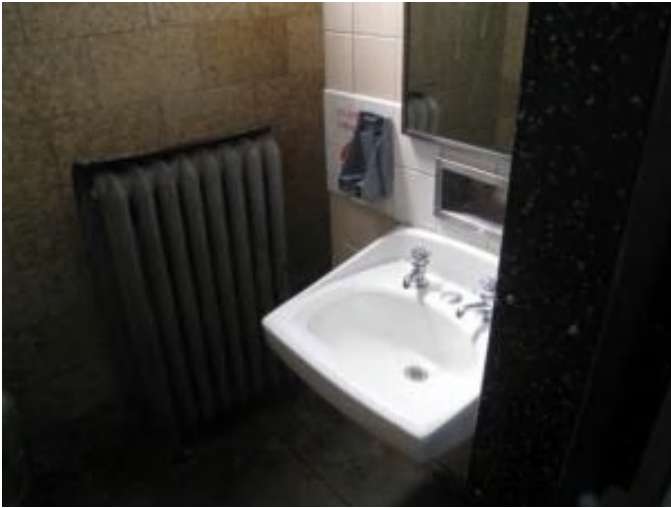
**System: C1010 - Partitions**

**Location:** toilet room

**Distress:** Accessibility

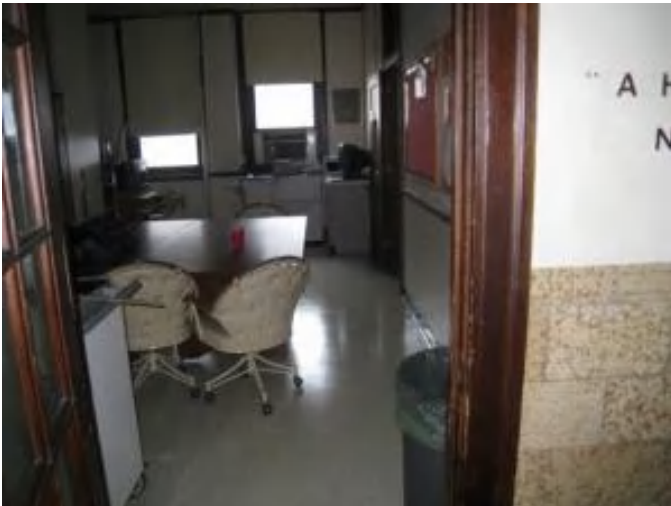
**System: C1020 - Interior Doors**

**Location:** corridors, classrooms, toilet rooms, offices

**Distress:** Damaged

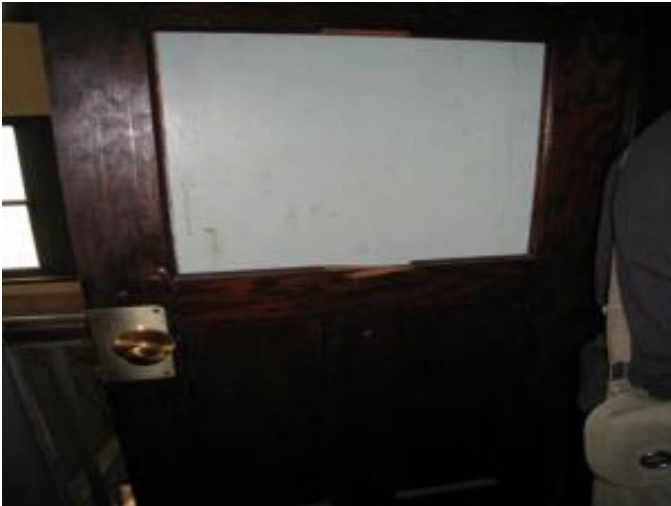
**System: C1020 - Interior Doors**

**Location:** interior doors inside classrooms

**Distress:** Damaged

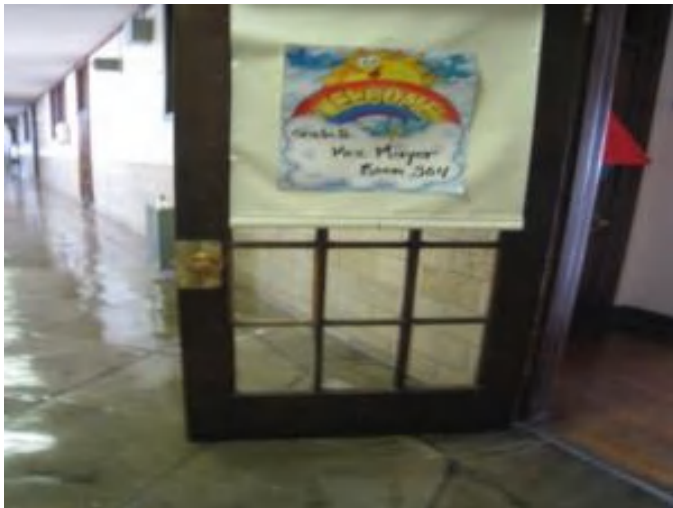
**System: C1020 - Interior Doors**

**Location:** classroom and office doors

**Distress:** Security Issue

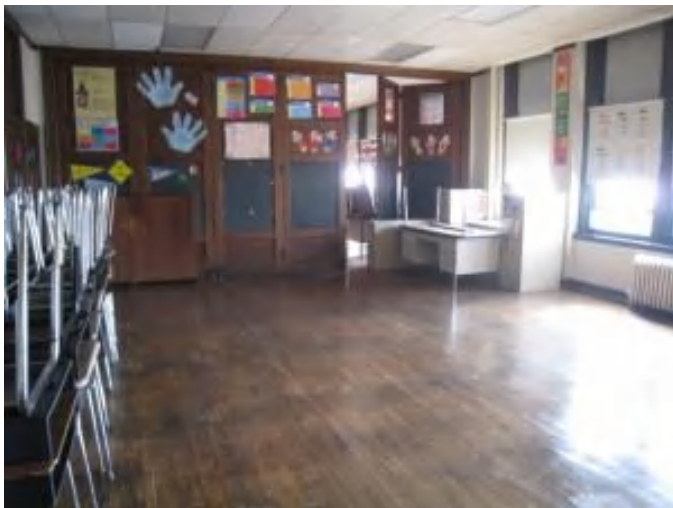
**System: C1030 - Fittings**

**Location:** classrooms

**Distress:** Inadequate

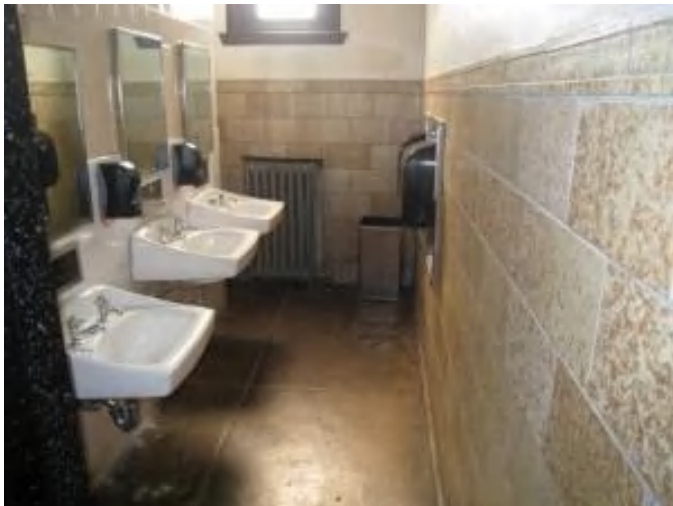
**System: C1030 - Fittings**

**Location:** toilet rooms

**Distress:** Damaged

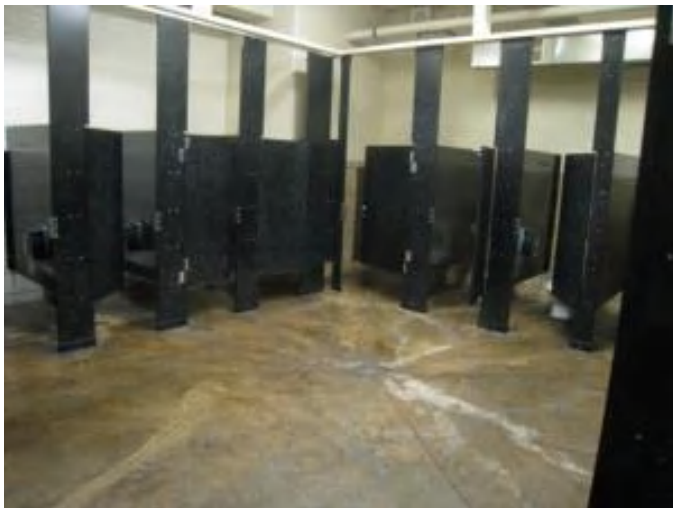
**System: C1030 - Fittings**

**Location:** toilet rooms

**Distress:** Damaged

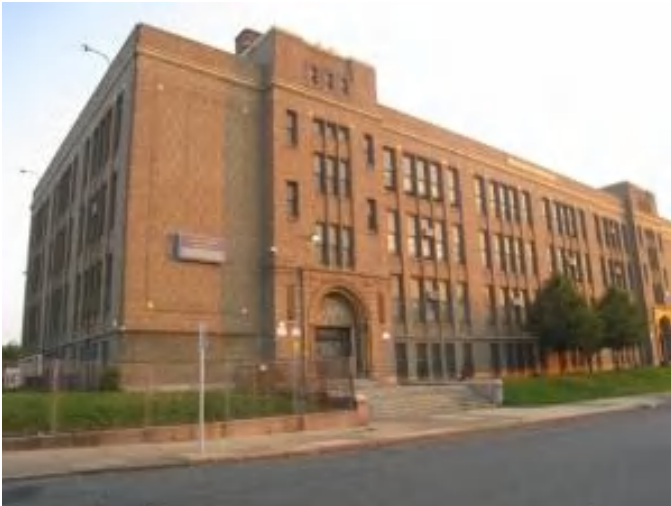
**System: C2010 - Stair Construction**

**Location:** exterior stairs

**Distress:** Damaged

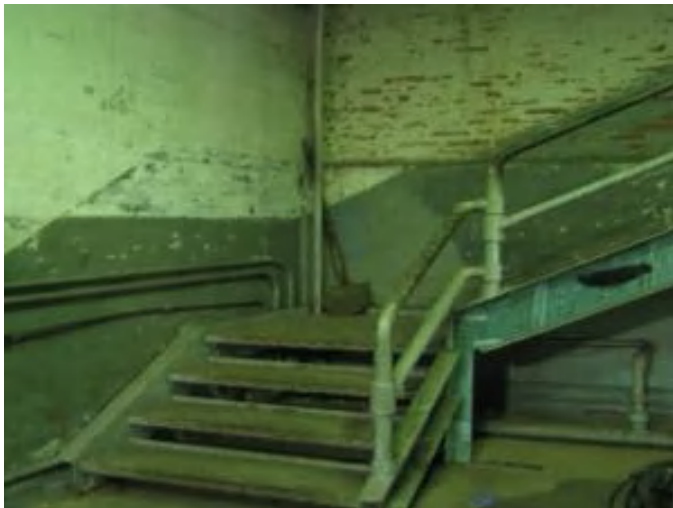
**System: C3010230 - Paint & Covering**

**Location:** basement mech rooms

**Distress:** Appearance

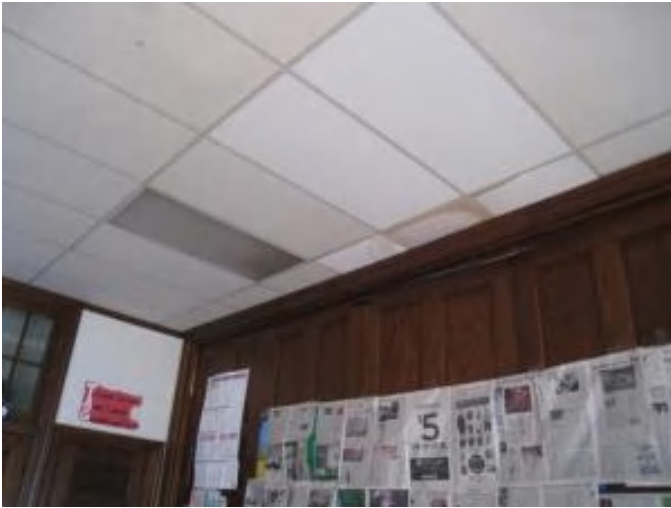
**System: C3030 - Ceiling Finishes**

**Location:** classrooms, corridors

**Distress:** Damaged

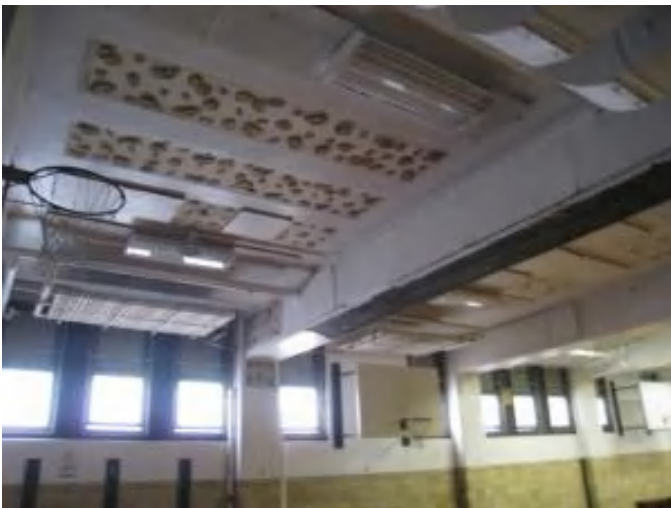
**System: C3030 - Ceiling Finishes**

**Location:** gymnasium

**Distress:** Failing

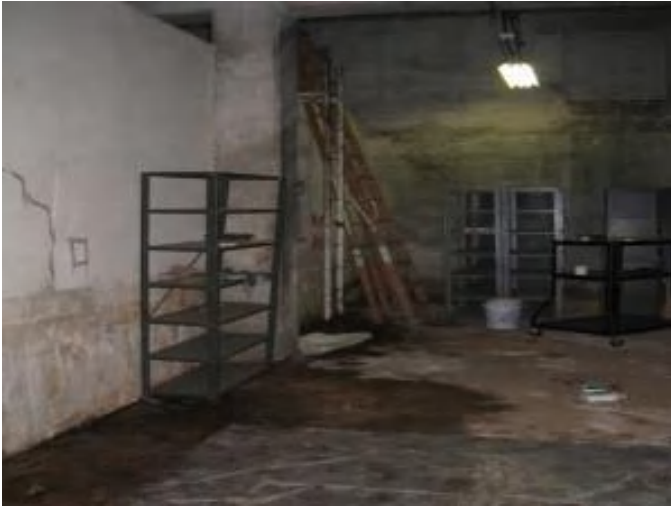
**System: C3030 - Ceiling Finishes**

**Location:** mech rooms, stairs, toilet rooms

**Distress:** Failing

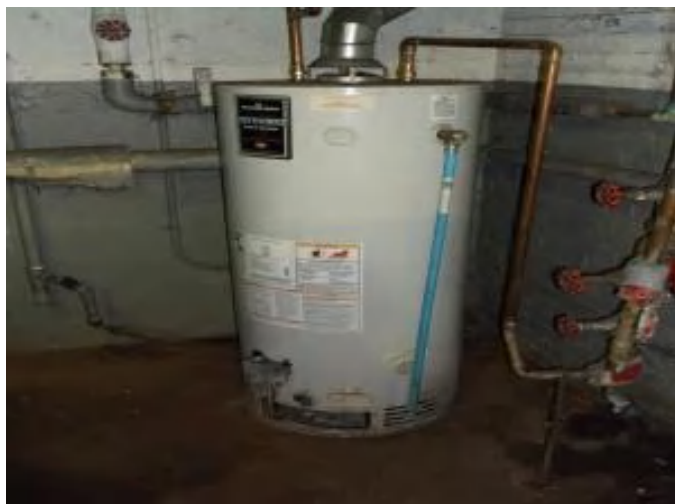
**System: D2020 - Domestic Water Distribution**

**Location:** Boiler Mechanical Equipment Room

**Distress:** Beyond Service Life

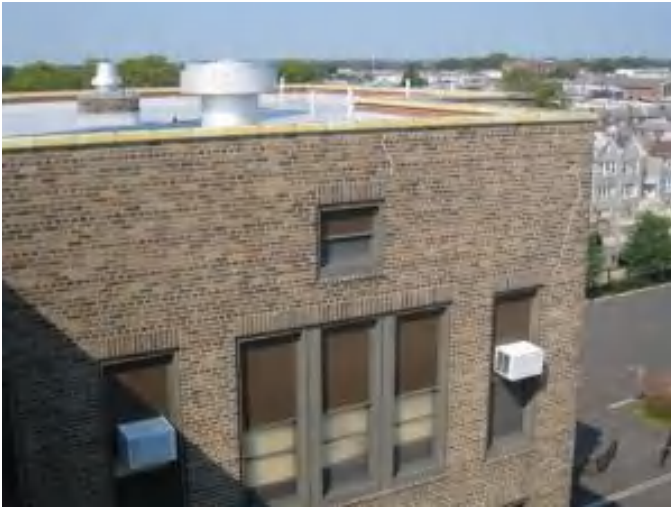
**System: D3030 - Cooling Generating Systems**

**Location:** Adjacent to the building

**Distress:** Inadequate

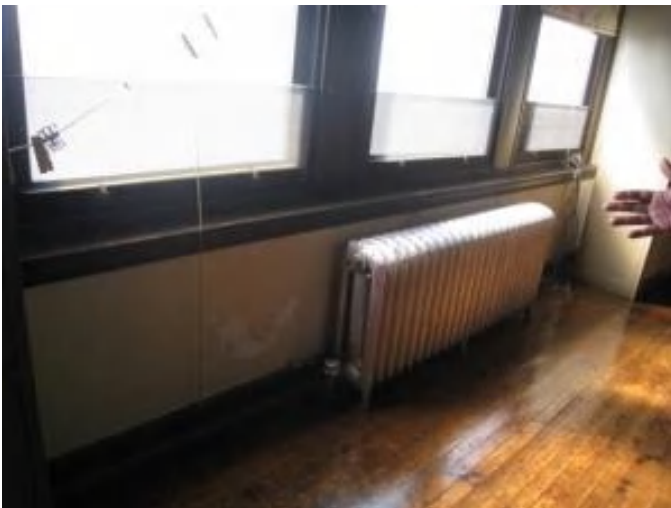
**System: D3040 - Distribution Systems**

**Location:** Throughout the building

**Distress:** Building / MEP Codes

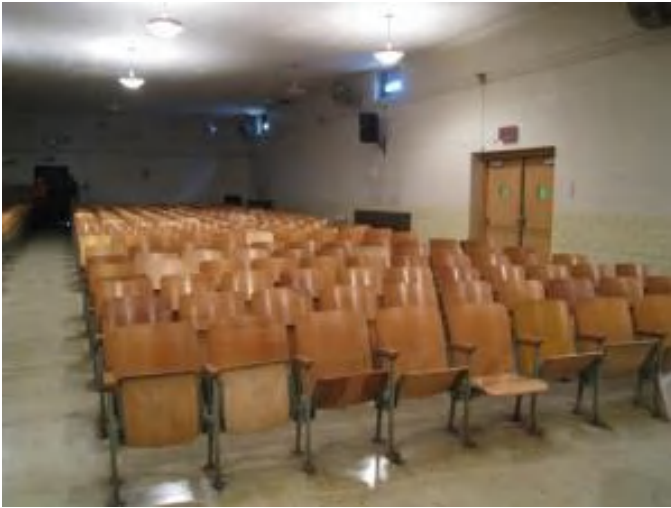
**System: D3040 - Distribution Systems**

**Location:** Auditorium

**Distress:** Building / MEP Codes

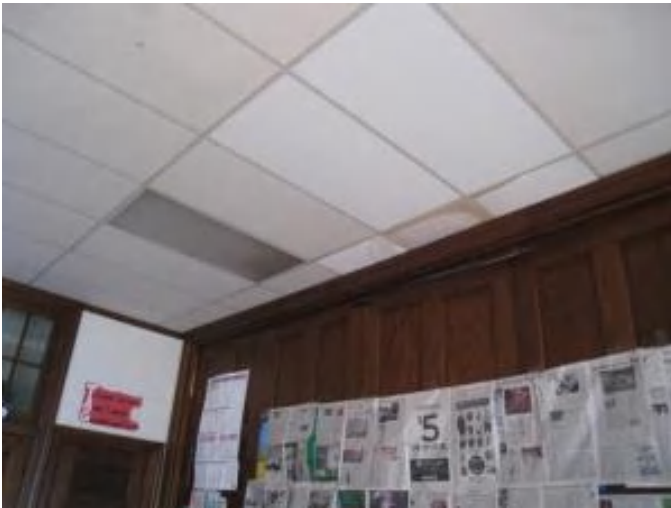
**System: D4010 - Sprinklers**

**Location:** Throughout the building

**Distress:** Life Safety / NFPA / PFD

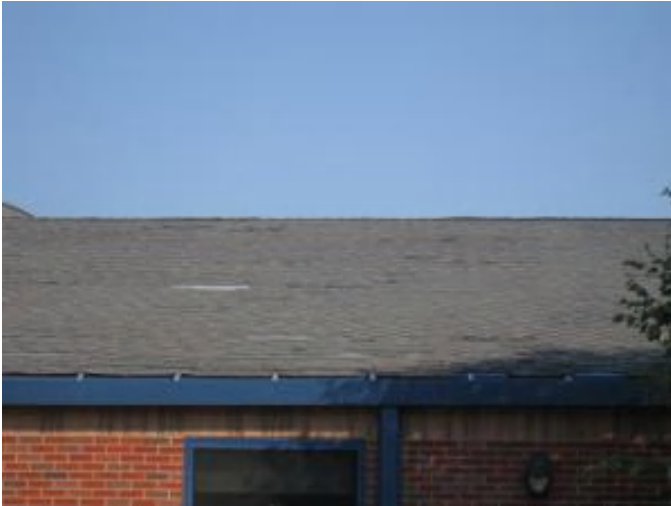
**System: B3010140 - Shingle & Tile**

**Location:** PEC roof

**Distress:** Damaged

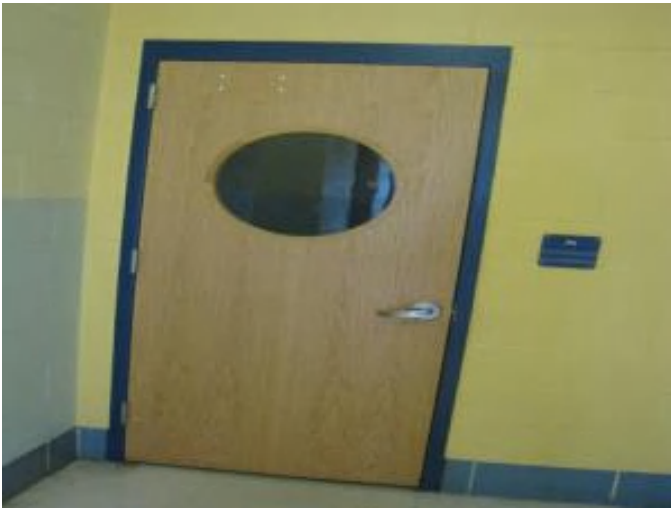
**System: C1020 - Interior Doors**

**Location:** PEC corridor door frames

**Distress:** Failing

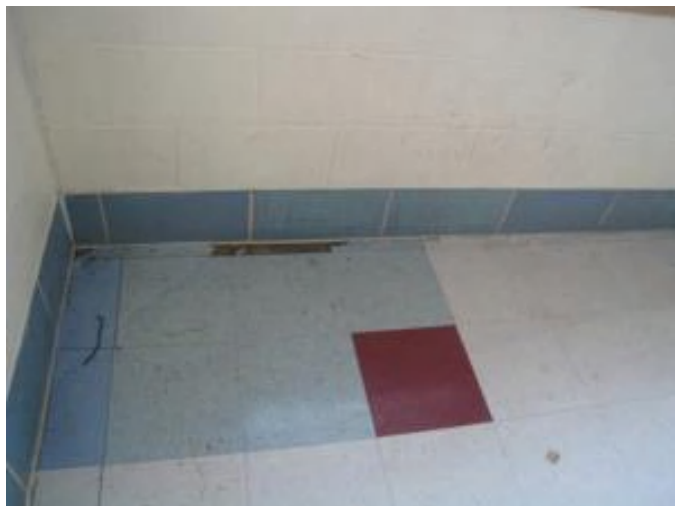
**System: C3020413 - Vinyl Flooring**

**Location:** PEC cafeteria

**Distress:** Damaged

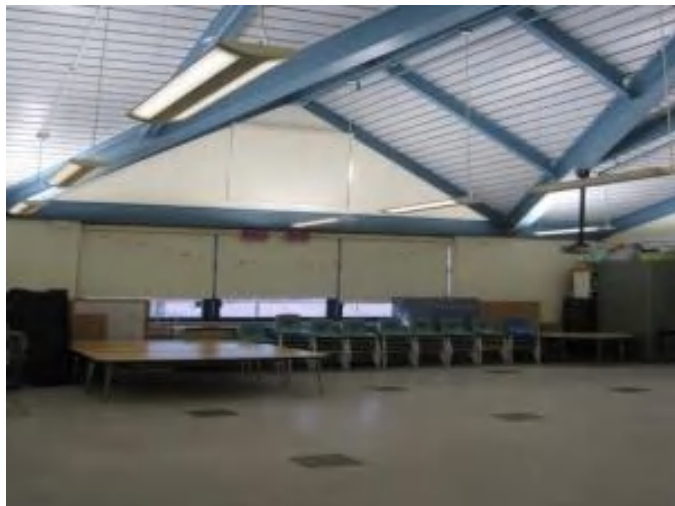
**System: C3030 - Ceiling Finishes**

**Location:** PEC ceilings

**Distress:** Damaged

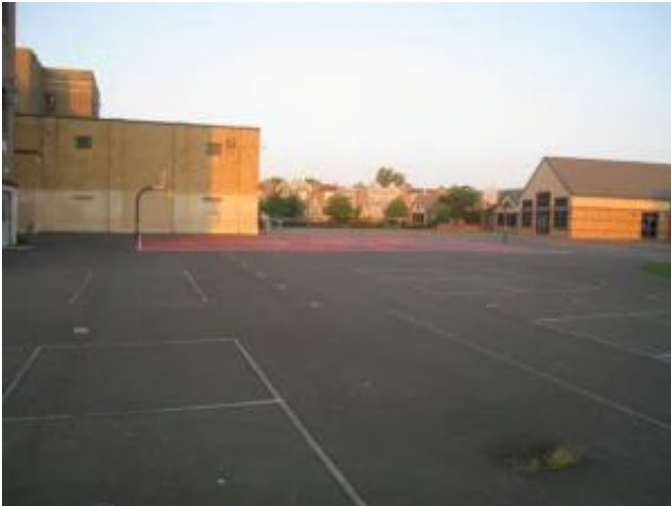
#### System: G2020 - Parking Lots

**Location:** parking lot

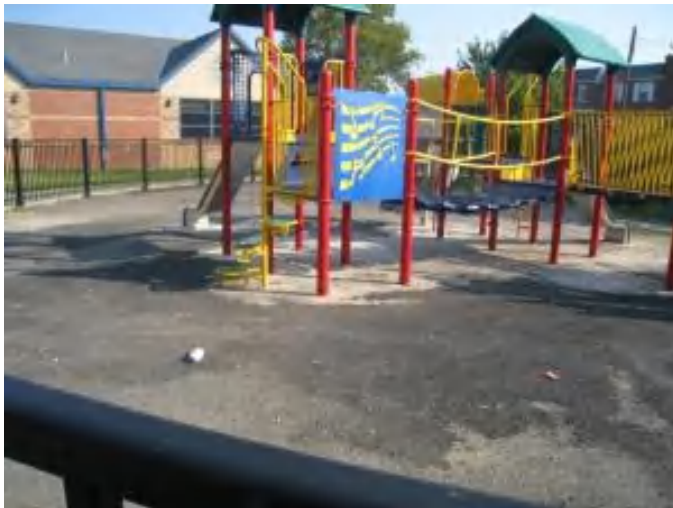
**System: G2030 - Pedestrian Paving**

**Location:** kiddie playground

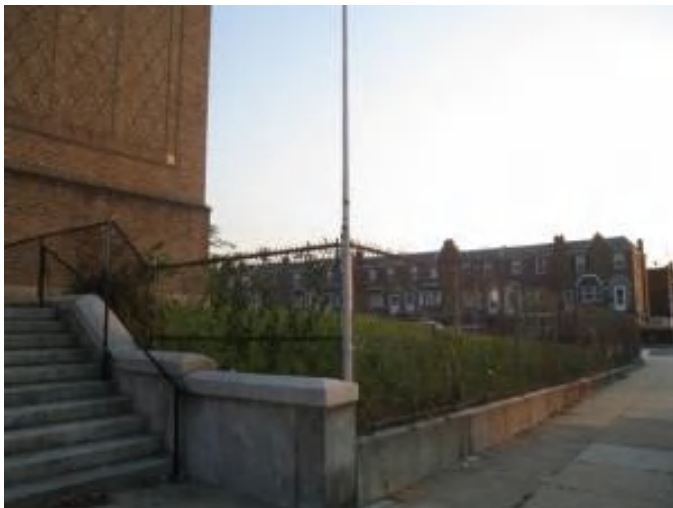
**System: G2040 - Site Development**

**Location:** site fence

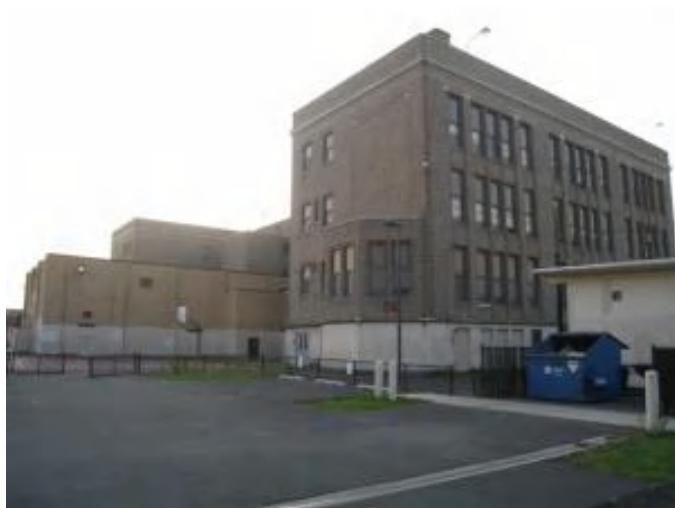
**System: G2040 - Site Development**

**Location:** parking area fence
