### Fox Chase School

# **S826001;Fox Chase**

## **Site Assessment Report**

January 31, 2017

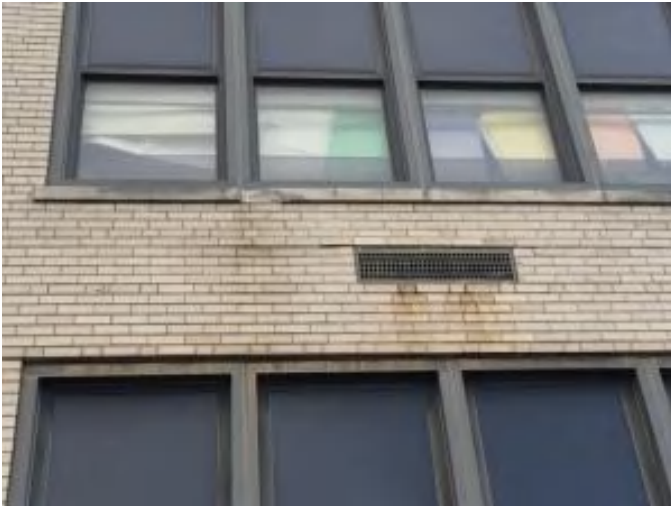
#### System: B2010 - Exterior Walls

**Location:** exterior walls - limestone sills and heads

**Distress:** Damaged

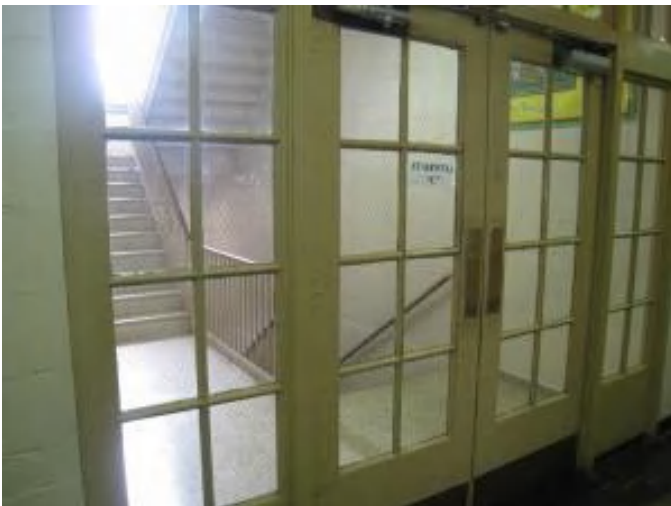
#### System: C1010 - Partitions

**Location:** stairways

**Distress:** Building / MEP Codes

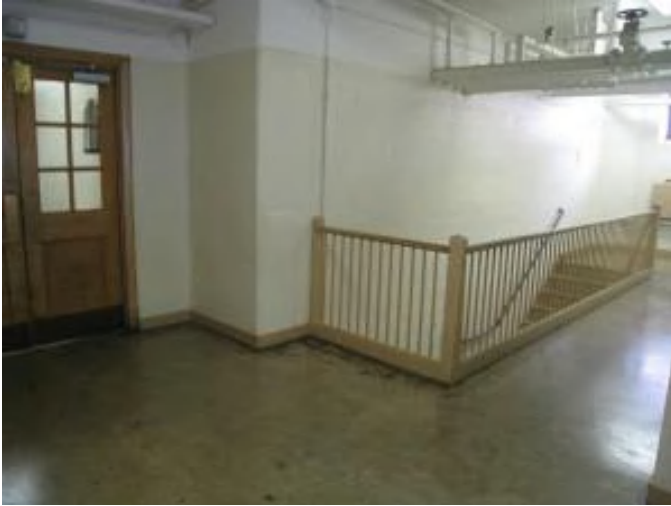
**System: C2010 - Stair Construction**

**Location:** stairways

**Distress:** Building / MEP Codes

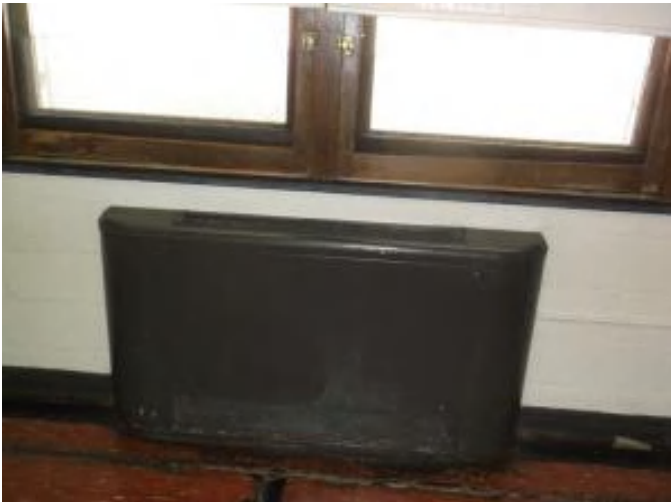
**System: D3040 - Distribution Systems**

**Location:** Throughout the building

**Distress:** Beyond Service Life

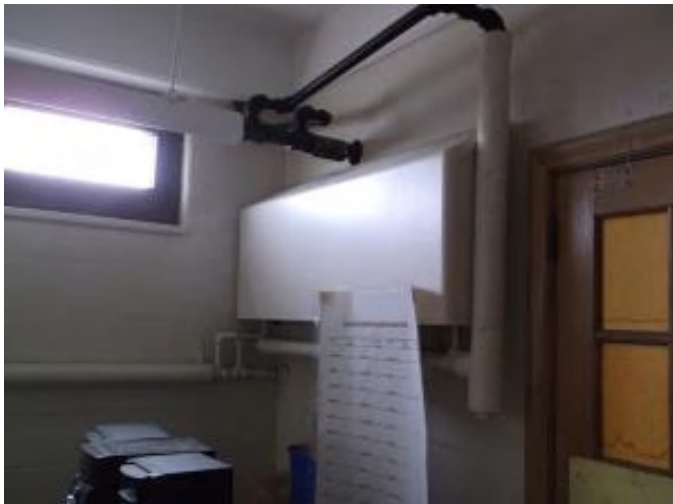
**System: D3040 - Distribution Systems**

**Location:** Throughout the building

**Distress:** Beyond Service Life

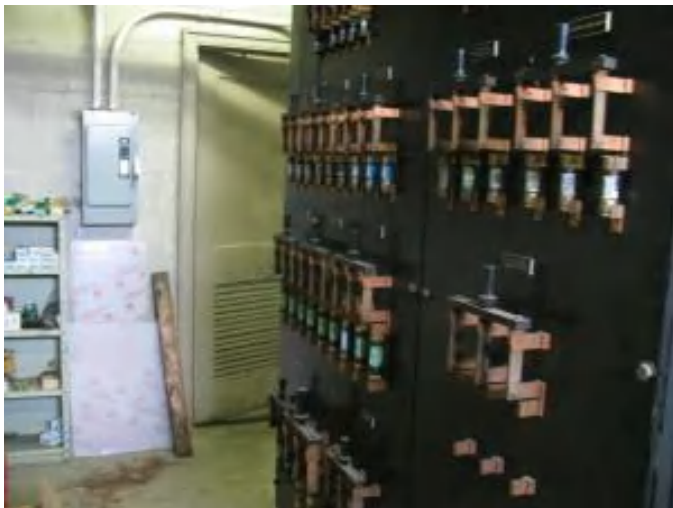
**System: D5010 - Electrical Service/Distribution**

**Location:** Electrical Room

**Distress:** Beyond Service Life

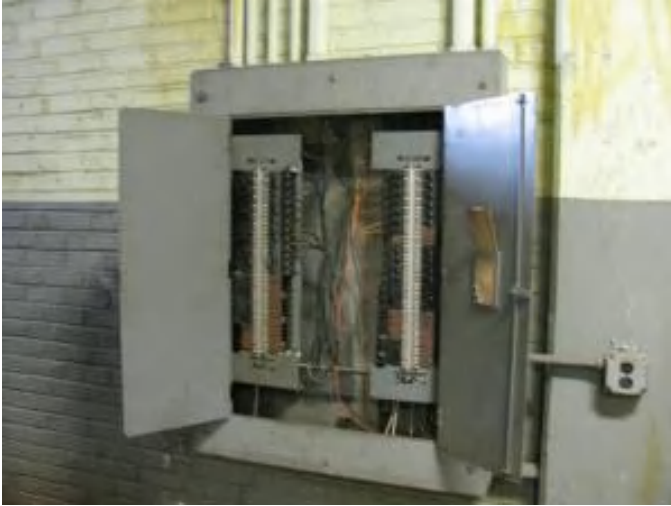
**System: D5010 - Electrical Service/Distribution**

**Location:** Entire Building

**Distress:** Beyond Service Life

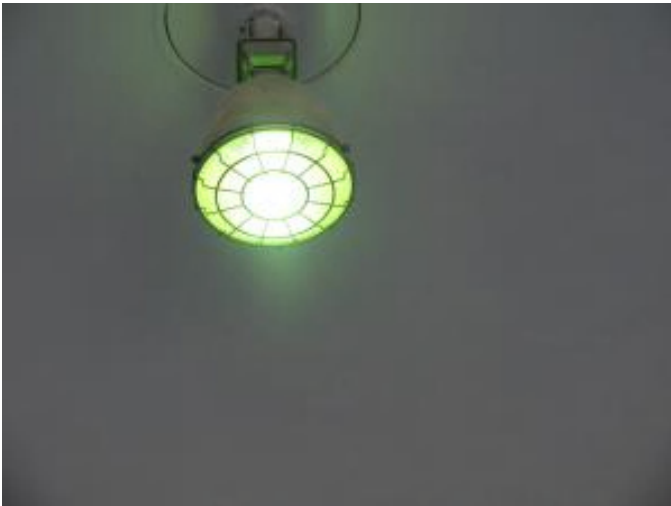
**System: D5020 - Lighting and Branch Wiring**

**Location:** Entire Building

**Distress:** Beyond Service Life

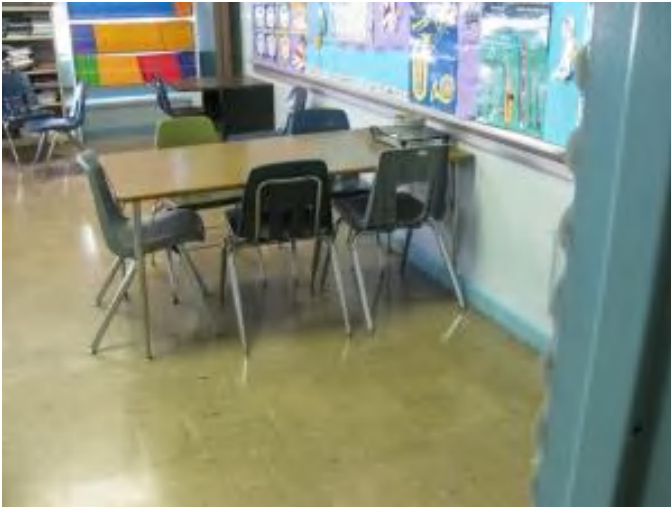
**System: D5020 - Lighting and Branch Wiring**

**Location:** Entire Building

**Distress:** Inadequate

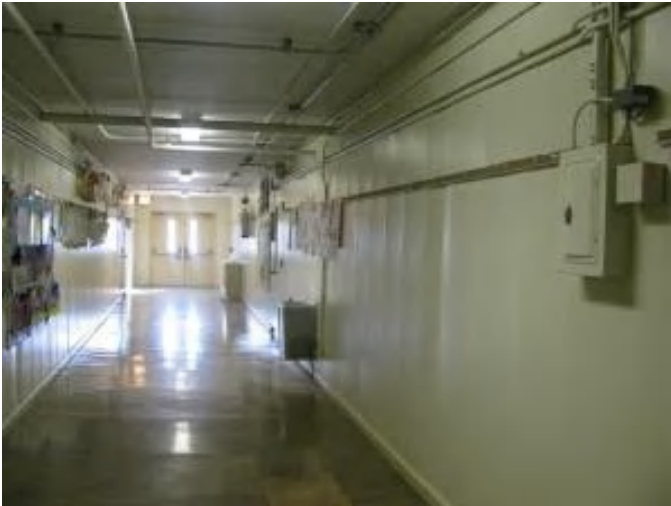
**System: D5030 - Communications and Security**

**Location:** Entire building

**Distress:** Security Issue

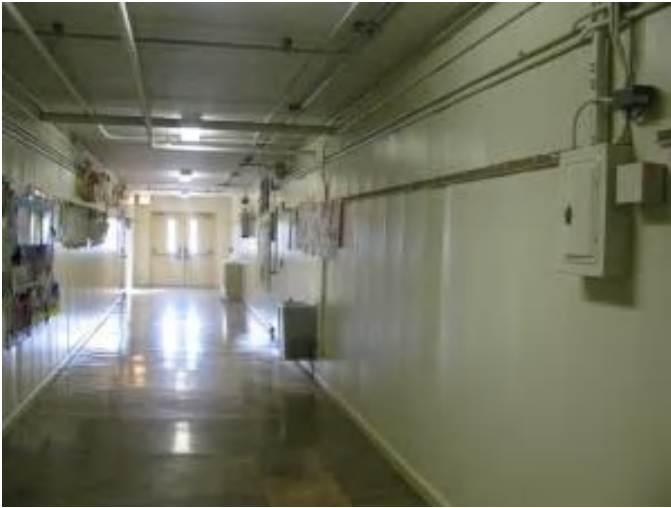
**System: D5030 - Communications and Security**

**Location:** Entire Building

**Distress:** Beyond Service Life

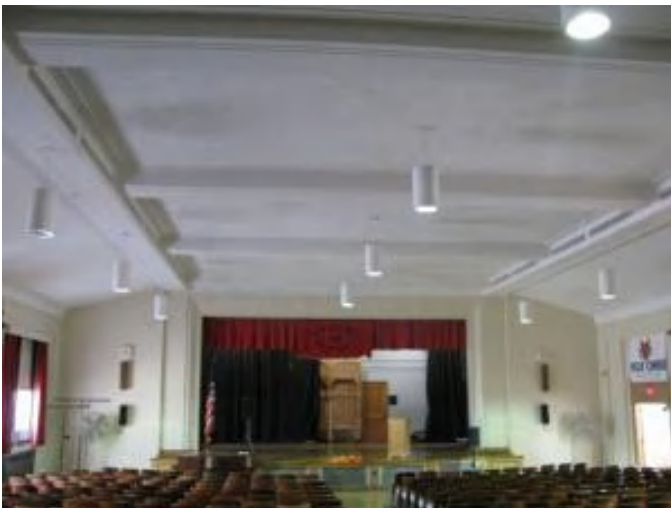
**System: D5030 - Communications and Security**

**Location:** Auditorium

**Distress:** Beyond Service Life

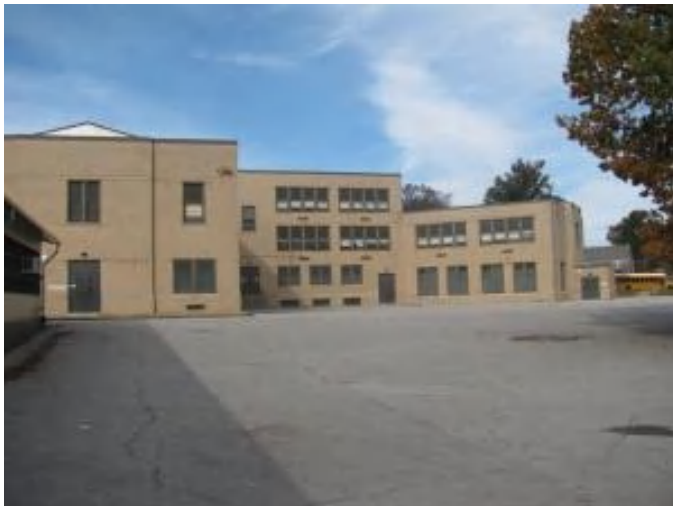
**System: D5030 - Communications and Security**

**Location:** B826001;Fox Chase

**Distress:** Security Issue

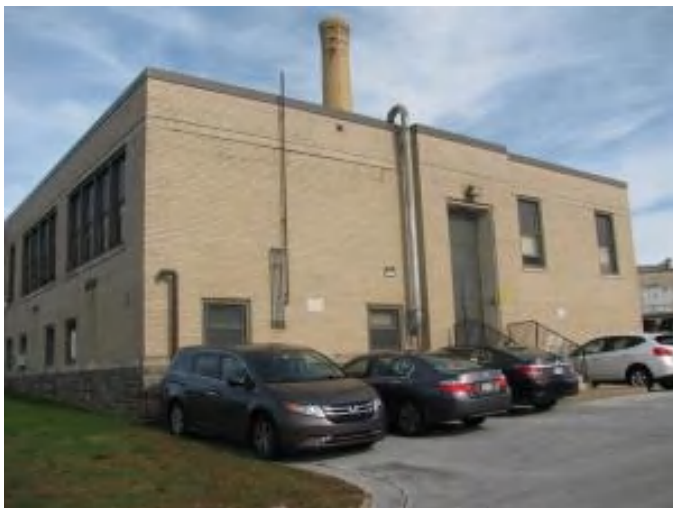
**System: D5090 - Other Electrical Systems**

**Location:** Roof

**Distress:** Life Safety / NFPA / PFD

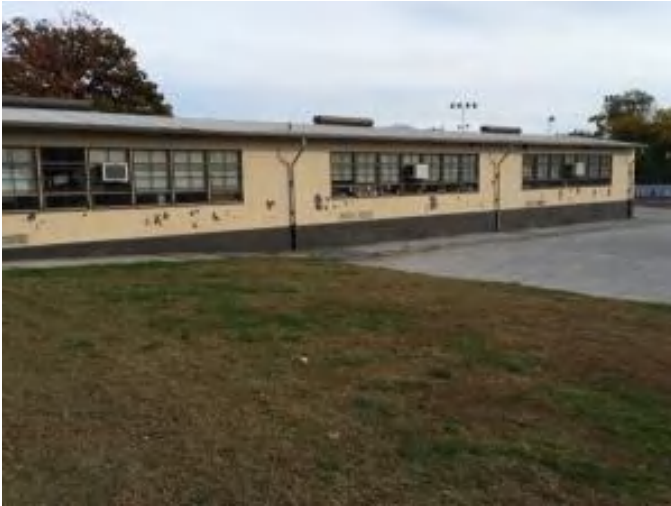
**System: B2010 - Exterior Walls**

**Location:** exterior Element 3 ("A" Wing)

**Distress:** Damaged

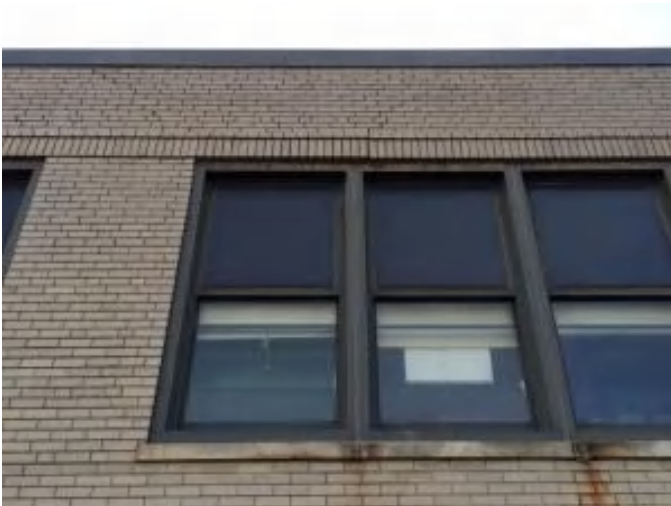
**System: B2010 - Exterior Walls**

**Location:** exterior wall lintels

**Distress:** Failing

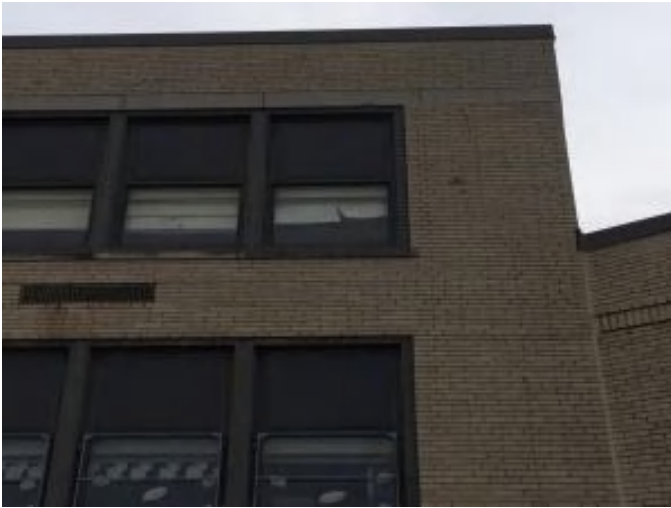
**System: B2010 - Exterior Walls**

**Location:** exterior walls

**Distress:** Failing

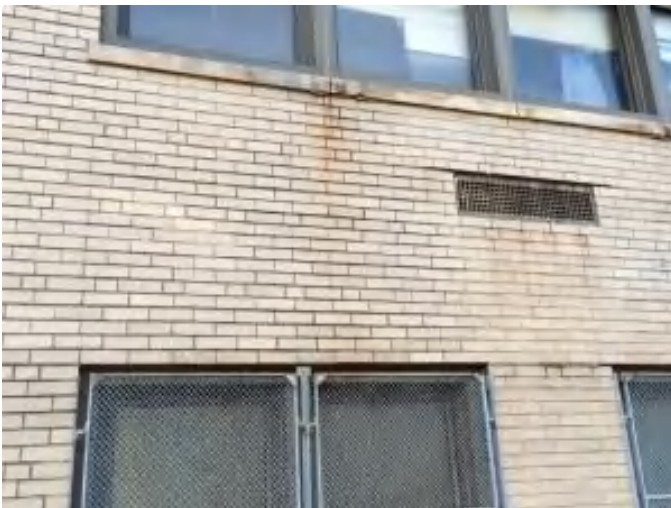
**System: B2010 - Exterior Walls**

**Location:** exterior walls - univents

**Distress:** Damaged

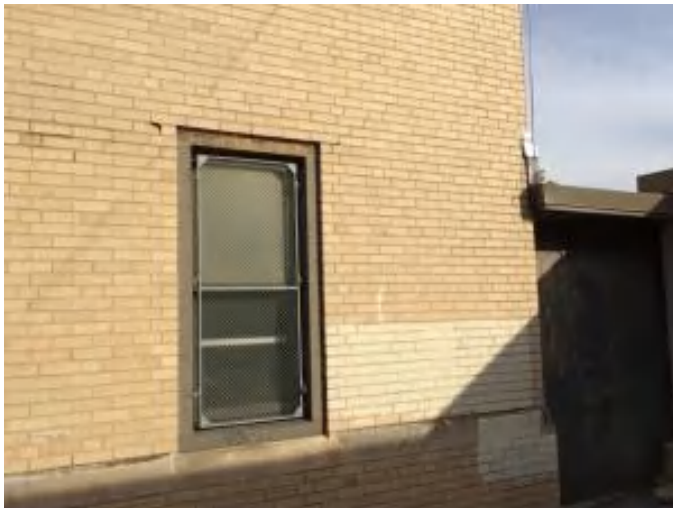
**System: B2010 - Exterior Walls**

**Location:** walls at lintels and sills

**Distress:** Failing

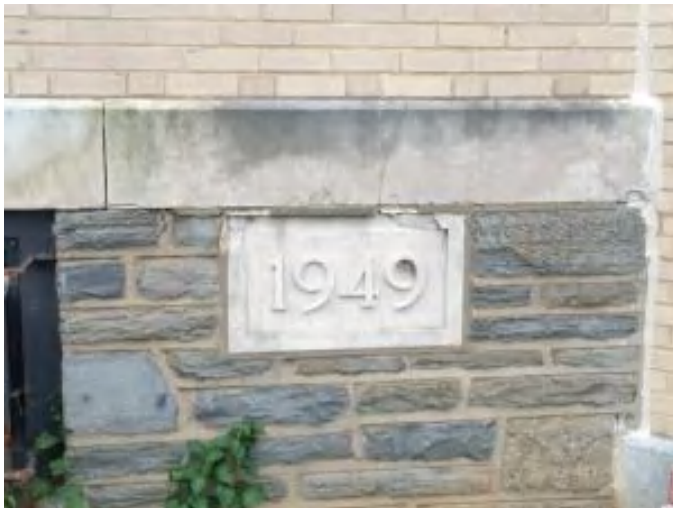
**System: B2010 - Exterior Walls**

**Location:** exterior walls - limestone sills and heads

**Distress:** Damaged

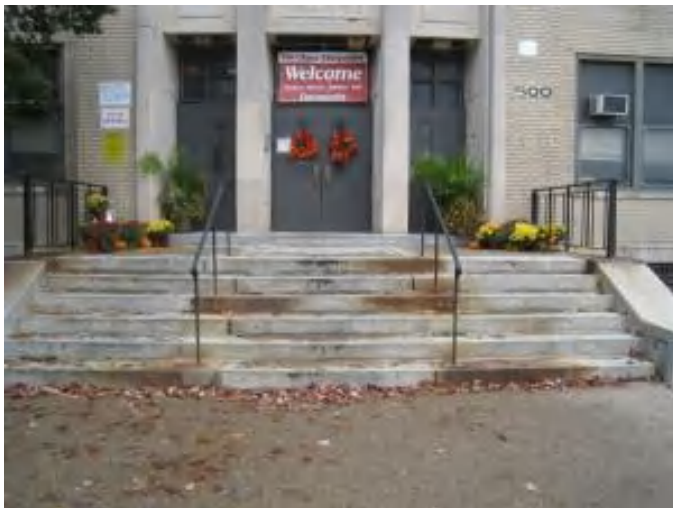
**System: B2010 - Exterior Walls**

**Location:** front stairs

**Distress:** Appearance

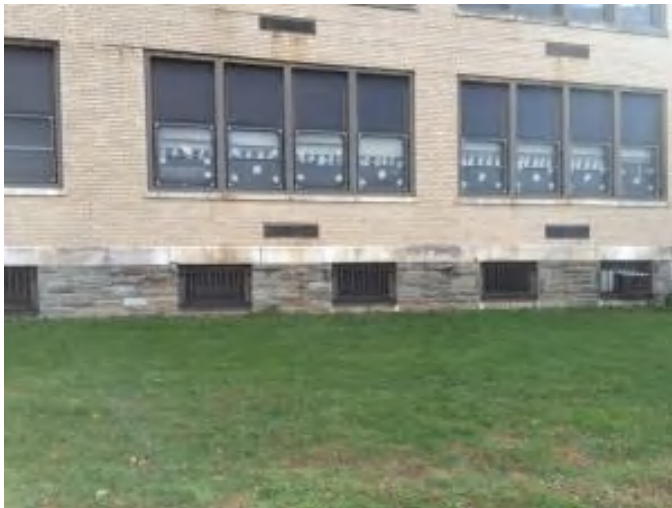
**System: B2020 - Exterior Windows**

Exterior windows in the main building and Element 3 are bronze anodized, aluminum framed, single hung, single glazed plexiglass units that may have been installed in the 1990's. They are now faded, cloudy, scratched and leaking; gymnasium windows are hopper-style. Element 4 has clear anodized aluminum, hopper-style, single glazed plexi glass systems, also in poor condition. Galvanized security screens are used on ground floor and first floor windows to protect against vandalism and playground accidents. Most windows do not open and close easily, do not seal tightly, and provide little insulation value during cold winter months. All windows should be replaced with aluminum framed, insulated glass systems.

**Location:** exterior windows

**Distress:** Beyond Service Life

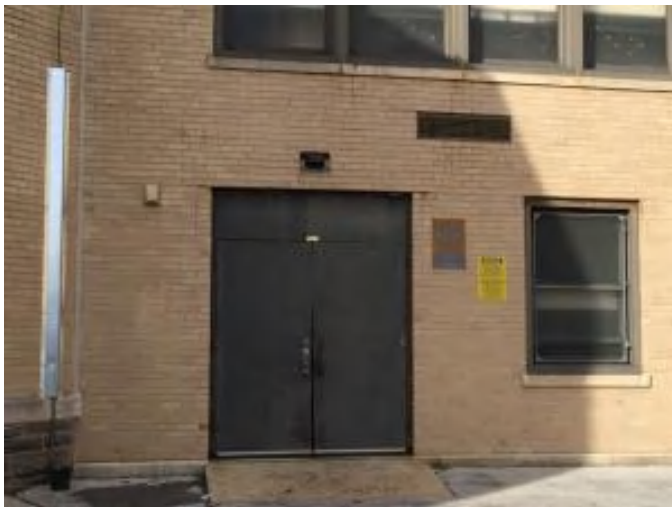
**System: B2030 - Exterior Doors**

**Location:** exterior doors

**Distress:** Damaged

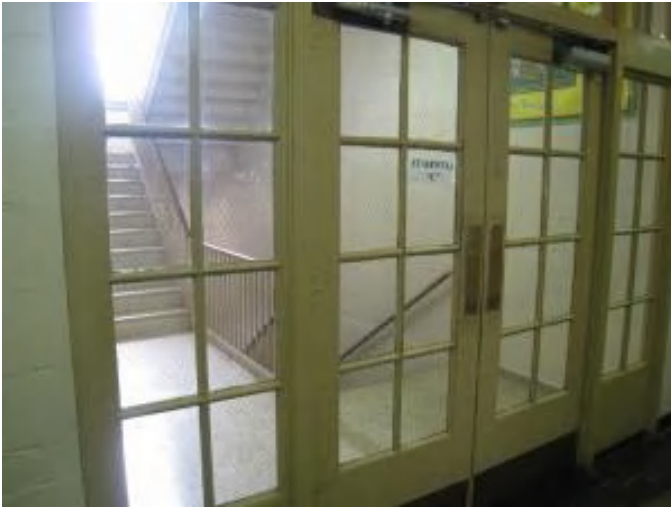
**System: C1010 - Partitions**

**Location:** stairway enclosures

**Distress:** Building / MEP Codes

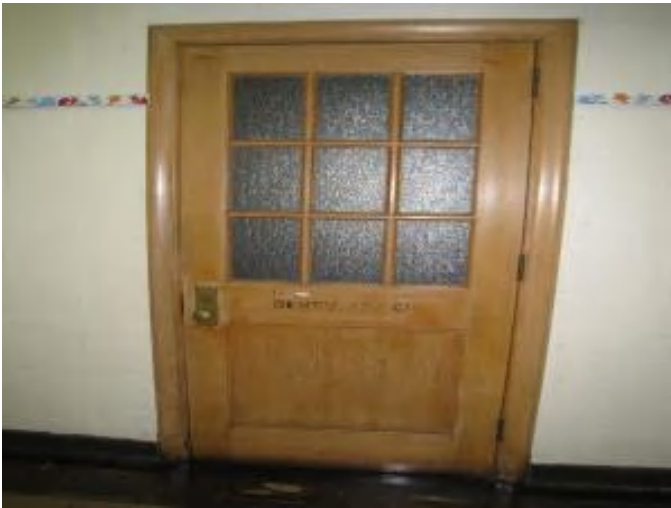
**System: C1020 - Interior Doors**

**Location:** interior wood doors on corridors

**Distress:** Building / MEP Codes

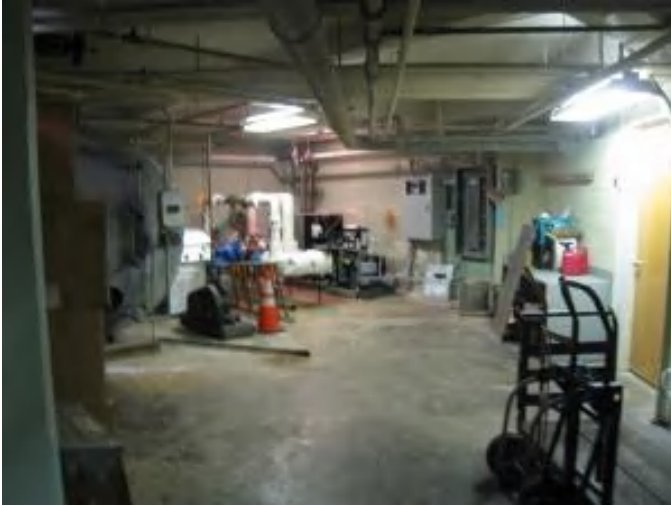
**System: C1020 - Interior Doors**

**Location:** interior doors

**Distress:** Damaged

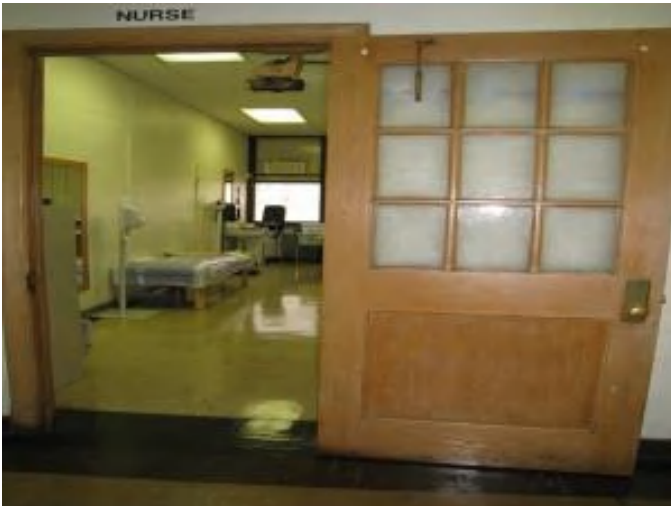
**System: C1020 - Interior Doors**

**Location:** corridor doors

**Distress:** Security Issue

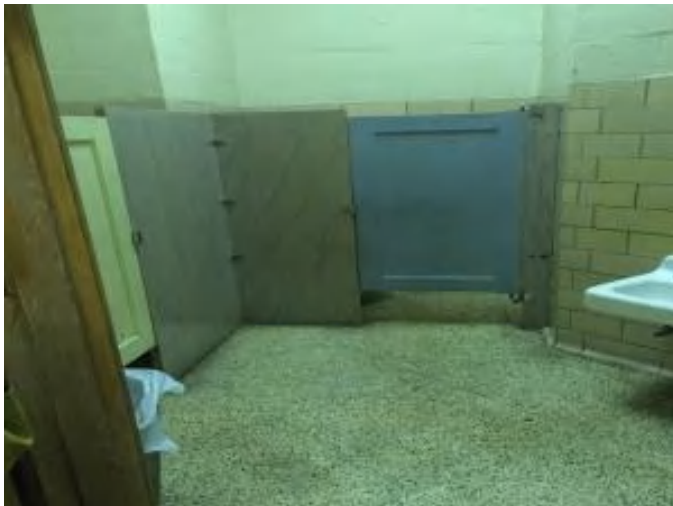
**System: C1030 - Fittings**

**Location:** toilet rooms

**Distress:** Damaged

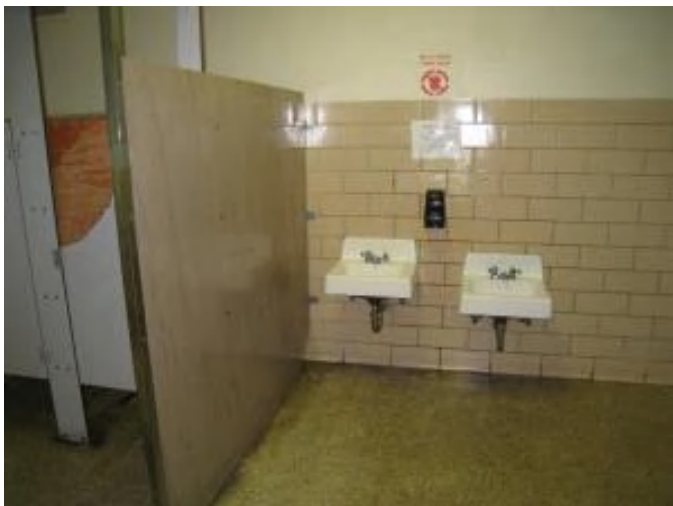
**System: C1030 - Fittings**

**Location:** toilet rooms

**Distress:** Damaged

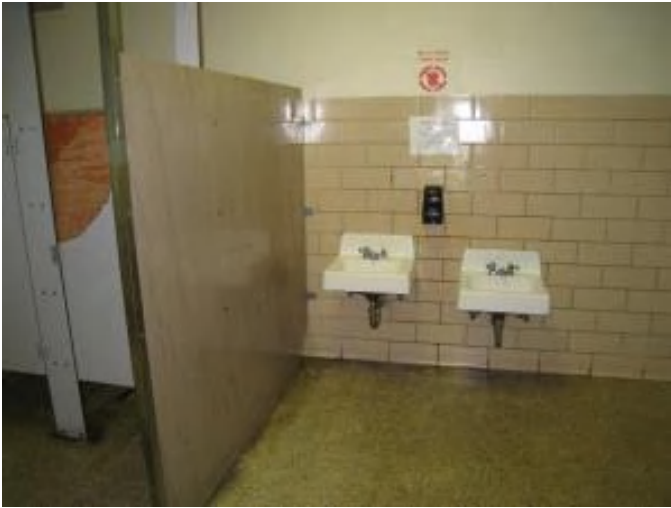
**System: C1030 - Fittings**

**Location:** toilet rooms

**Distress:** Inadequate

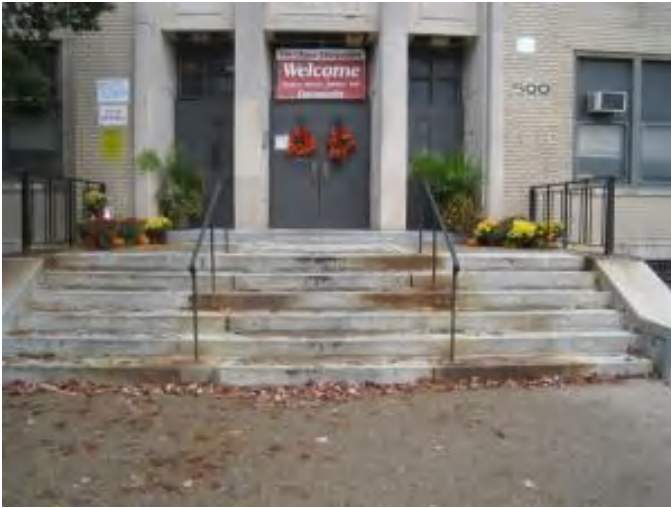
**System: C2010 - Stair Construction**

**Location:** front stairs

**Distress:** Damaged

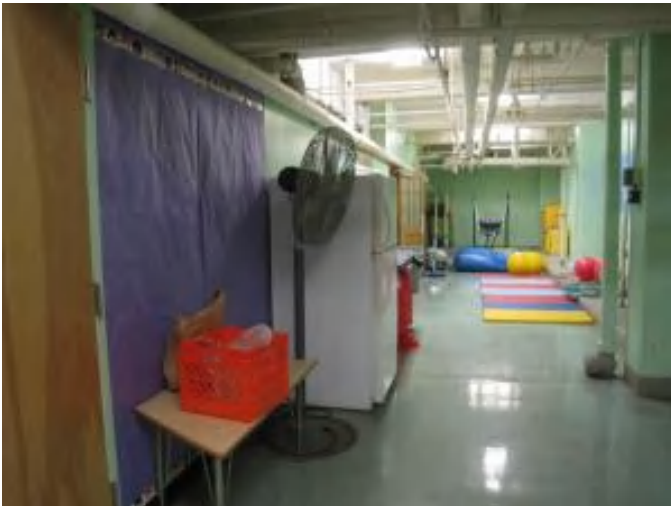
**System: C3010230 - Paint & Covering**

**Location:** interior walls

**Distress:** Appearance

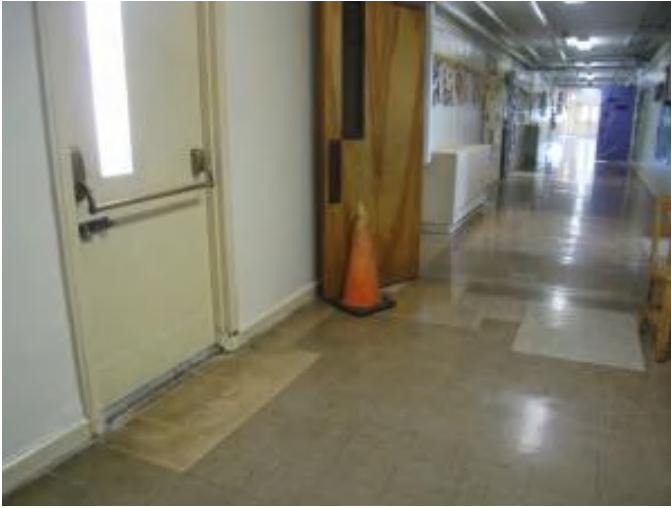
**System: C3020413 - Vinyl Flooring**

**Location:** classroom, office, auditorium, and corridor floors

**Distress:** Health Hazard / Risk

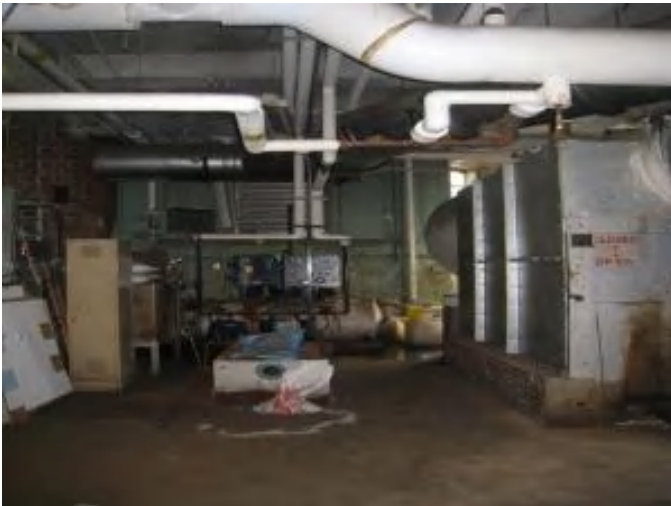
**System: C3020415 - Concrete Floor Finishes**

**Location:** ground level

**Distress:** Appearance

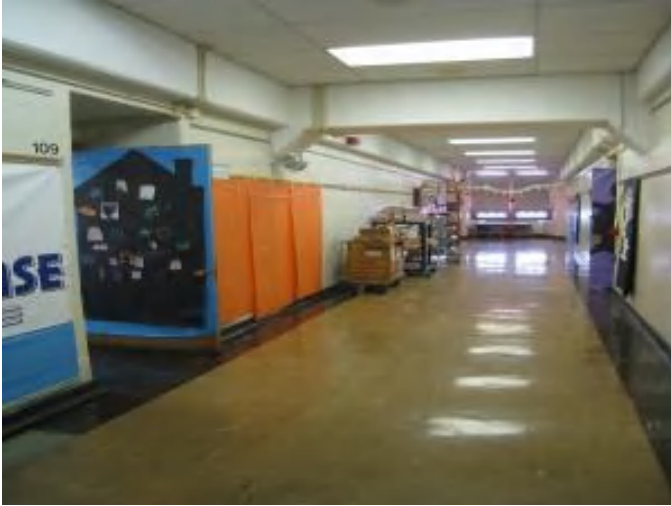
**System: C3030 - Ceiling Finishes**

**Location:** ceilings

**Distress:** Damaged

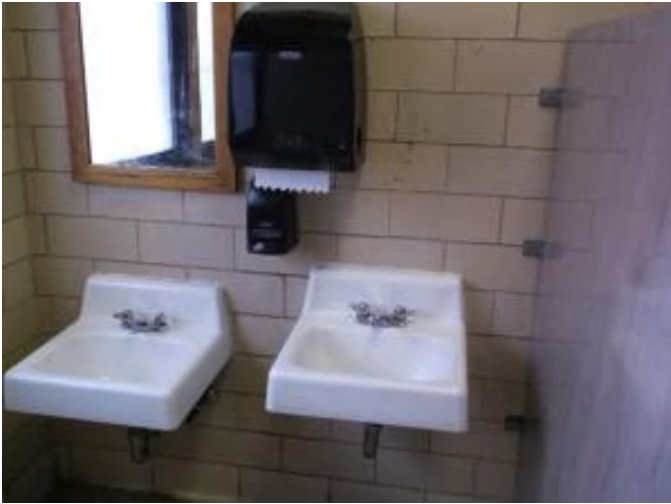
**System: D2010 - Plumbing Fixtures**

**Location:** Throughout the building

**Distress:** Beyond Service Life

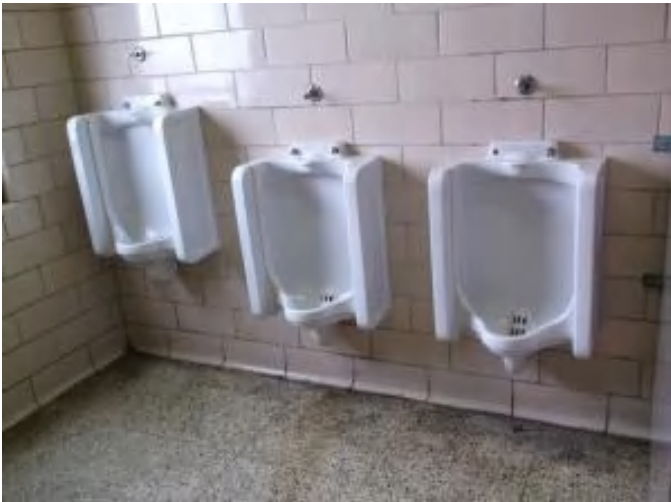
**System: D2010 - Plumbing Fixtures**

**Location:** Throughout the building

**Distress:** Beyond Service Life

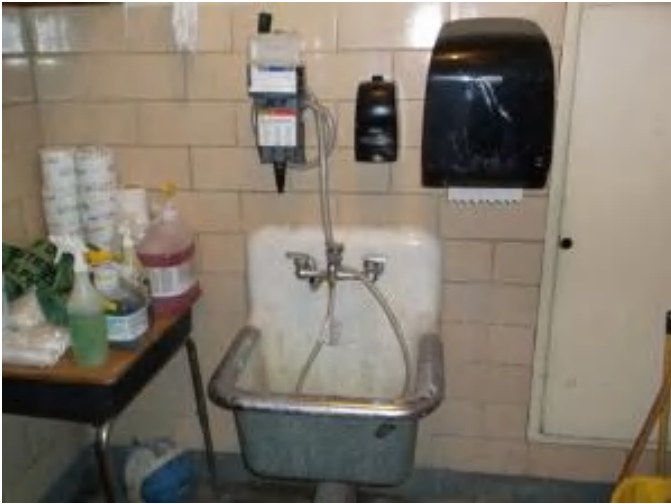
**System: D2010 - Plumbing Fixtures**

**Location:** Throughout the building

**Distress:** Beyond Service Life

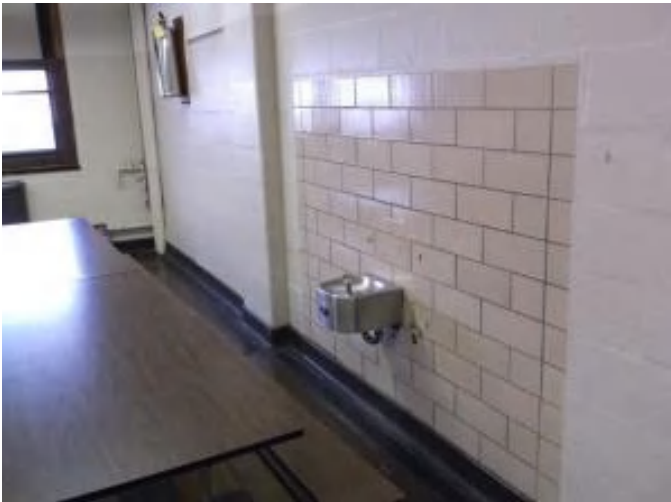
**System: D2010 - Plumbing Fixtures**

**Location:** Throughout the building

**Distress:** Beyond Service Life

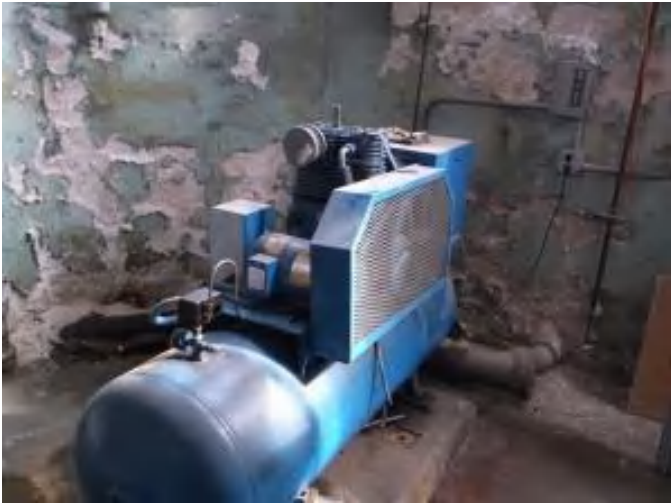
**System: D3060 - Controls & Instrumentation**

**Location:** Throughout the school

**Distress:** Beyond Service Life

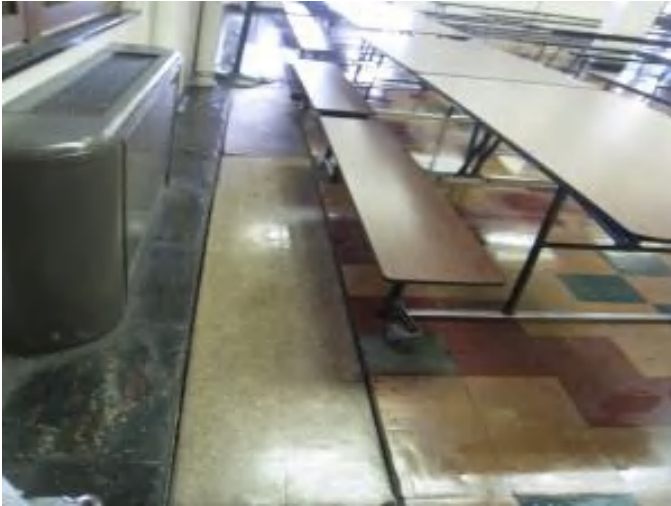
**System: B1010 - Floor Construction**

**Location:** cafeteria

**Distress:** Damaged

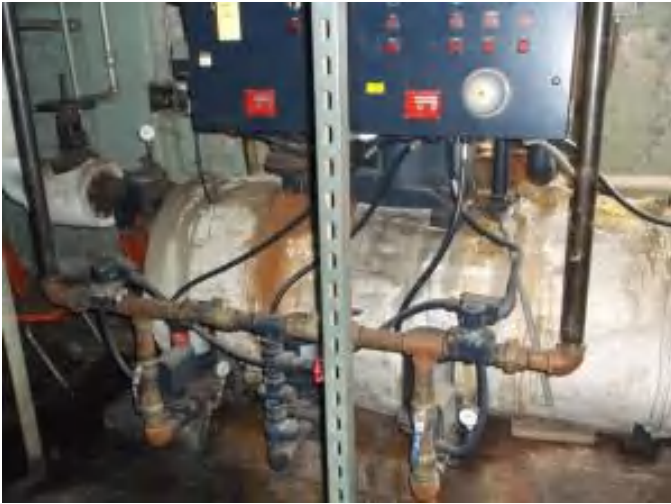
**System: D3040 - Distribution Systems**

**Location:** Throughout the building

**Distress:** Beyond Service Life

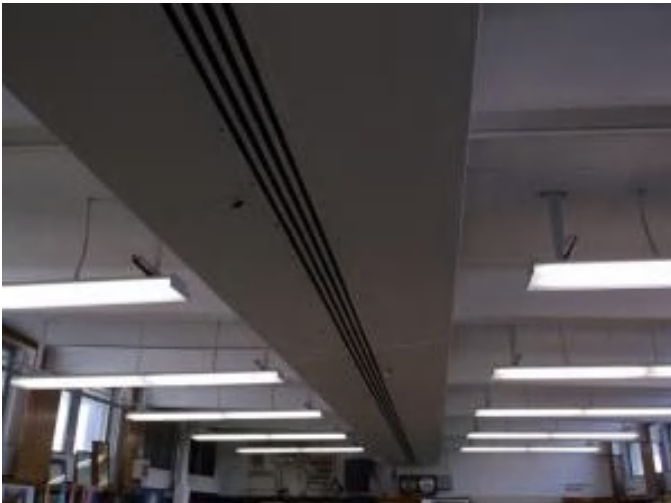
**System: D3040 - Distribution Systems**

**Location:** Roof

**Distress:** Beyond Service Life

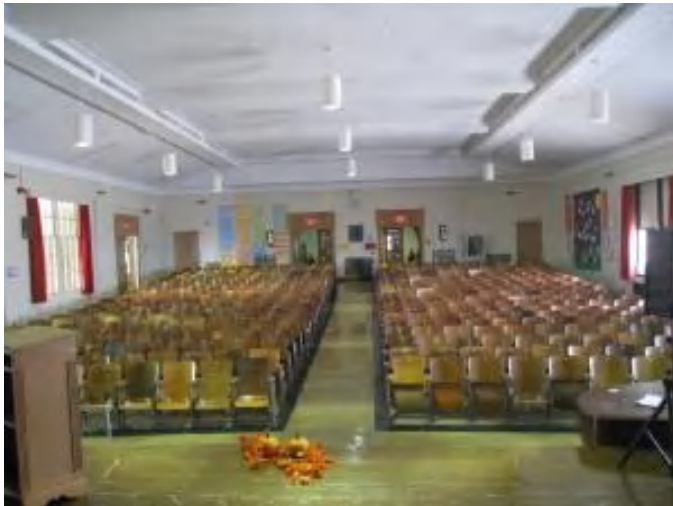
**System: E2010 - Fixed Furnishings**

Fixed furnishings include wood seating in the auditorium which has signs of wear on almost all seating surfaces. Seat should be refinished to improve the appearance. The cafeteria has folding tables for serving students. The kitchen area has stainless steel service counters and food preparation tables.

**Location:** auditorium

**Distress:** Damaged

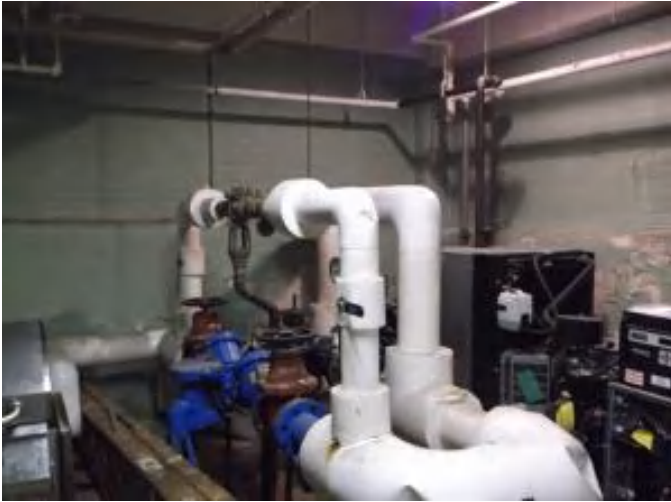
**System: D2020 - Domestic Water Distribution**

**Location:** Throughout the building

**Distress:** Beyond Service Life

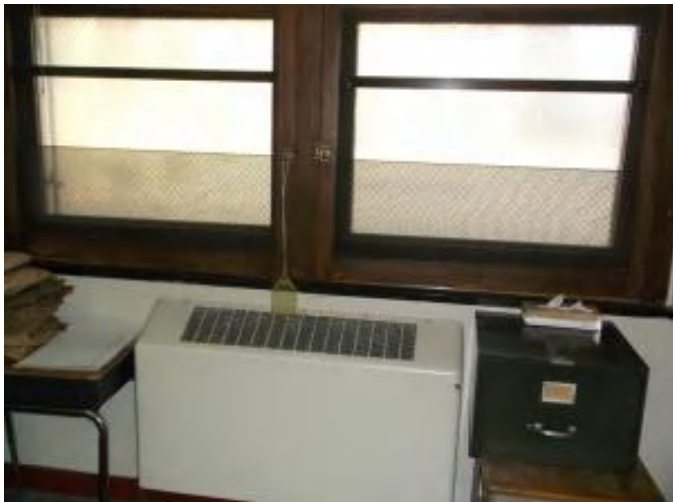
**System: D3040 - Distribution Systems**

**Location:** Throughout the building

**Distress:** Beyond Service Life

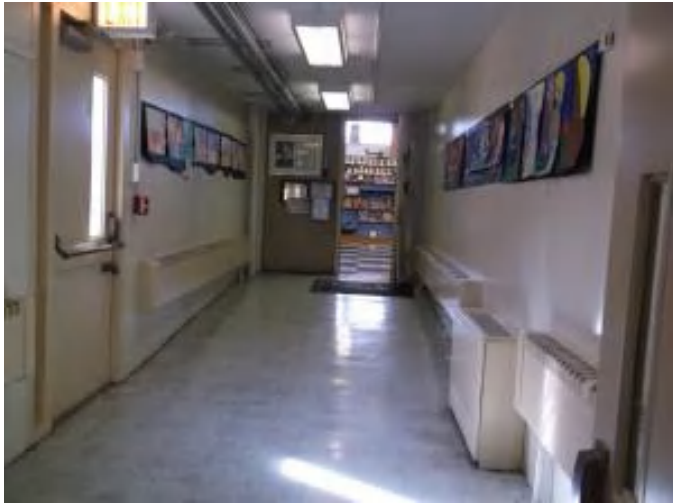
**System: D4010 - Sprinklers**

**Location:** Throughout the building

**Distress:** Life Safety / NFPA / PFD

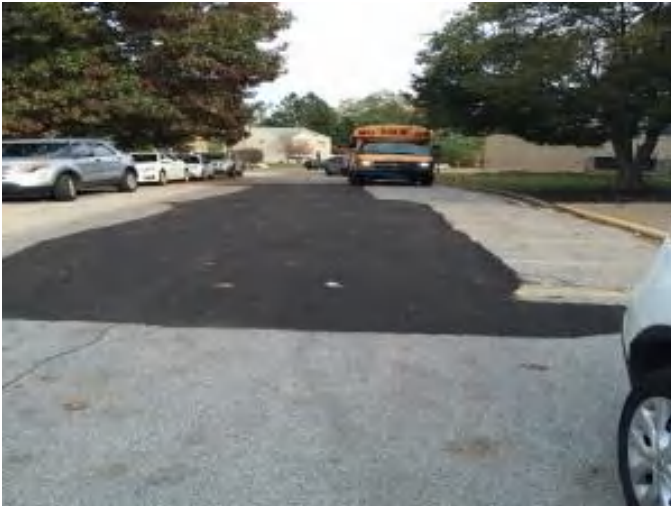
#### System: G2020 - Parking Lots

**Location:** circular front driveway

**Distress:** Damaged

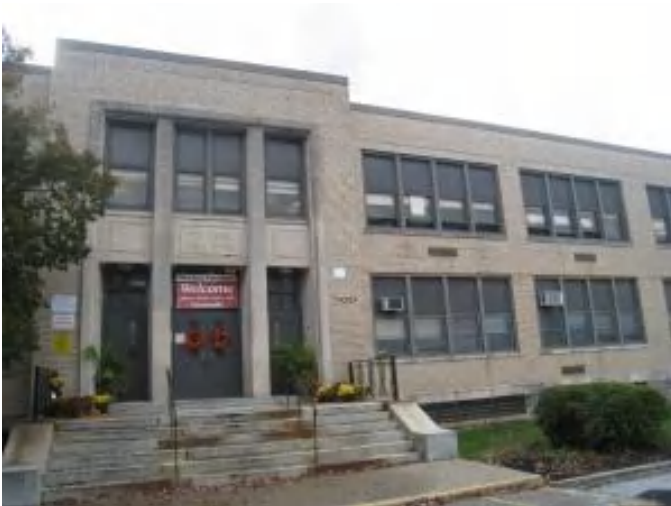
#### System: G2030 - Pedestrian Paving

**Location:** front entrance

**Distress:** Accessibility

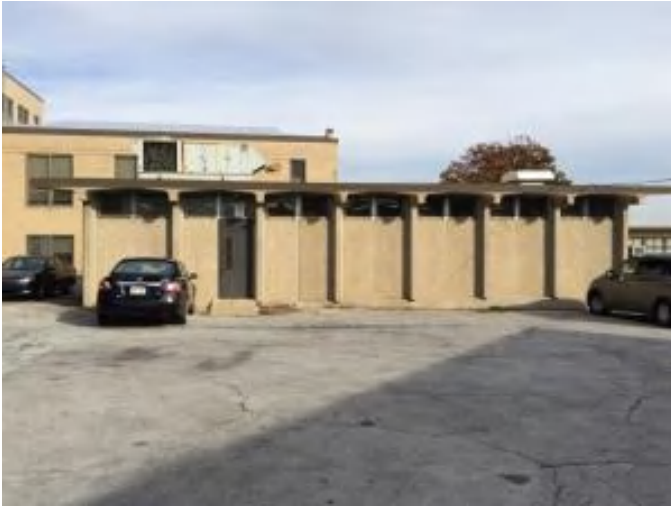
**System: G2020 - Parking Lots**

**Location:** parking lot and play area

**Distress:** Failing

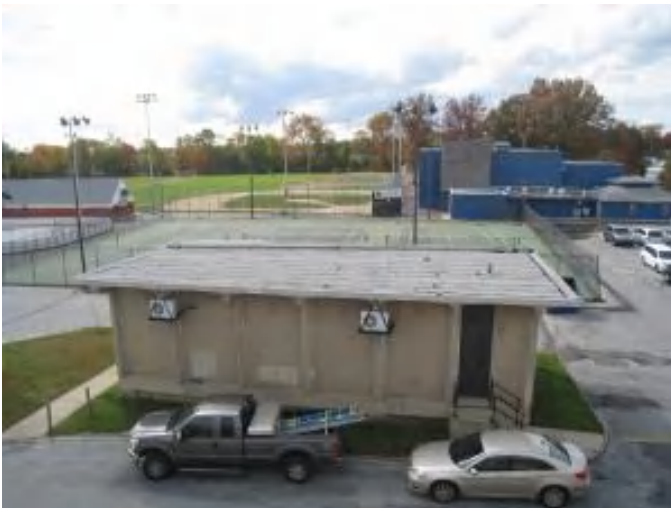
**System: G2040 - Site Development**

**Location:** driveway entrances

**Distress:** Security Issue
