Facility Condition Assessment Summary Report

Frank School

School District of Philadelphia

January 31, 2017

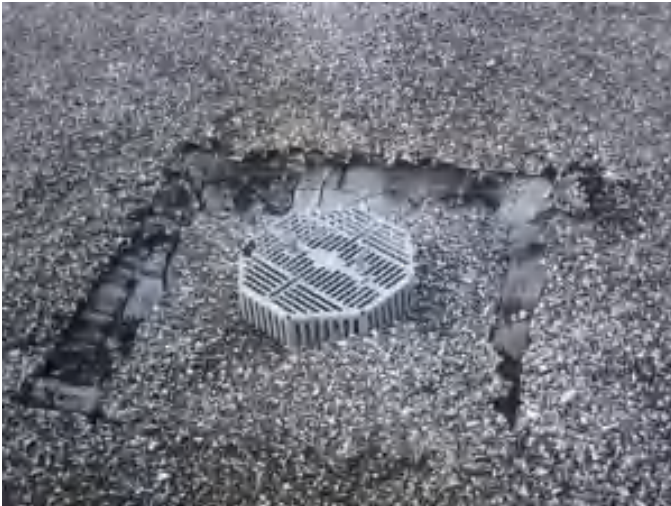
System: B3010105 - Built-Up

Location: Main Building - roof

Distress: Failing

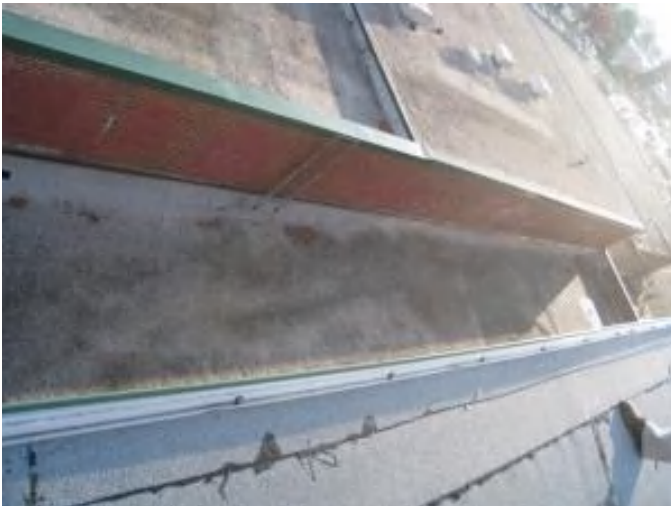
System: B3010105 - Built-Up

Location: Main Building - brick roof structures

Distress: Failing

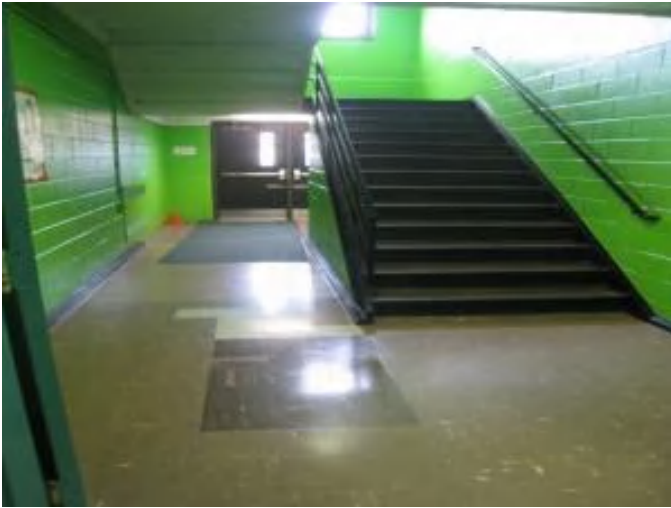
System: C2010 - Stair Construction

Location: Main Building - stairways

Distress: Building / MEP Codes

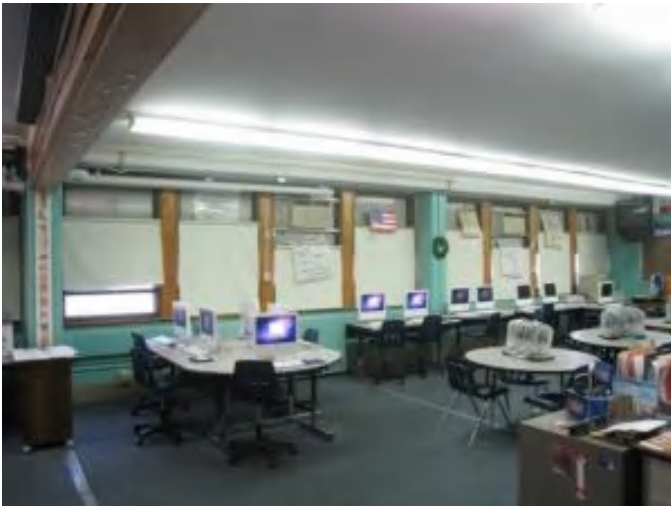
System: D3040 - Distribution Systems

Location: Main Building - throughout the building

Distress: Beyond Service Life

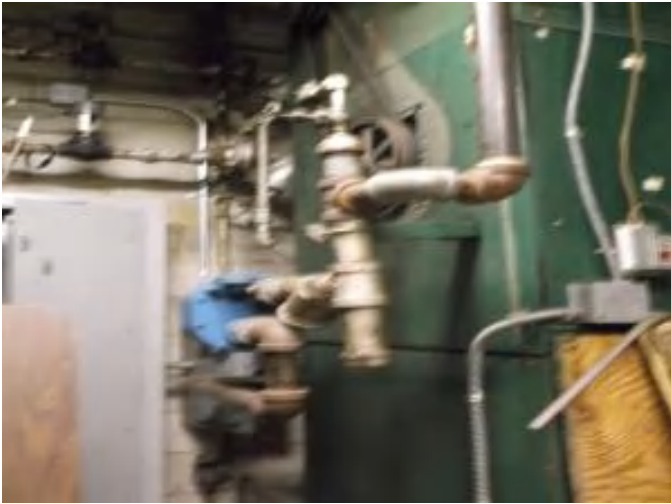
System: D3040 - Distribution Systems

Location: Main Building - throughout the building

Distress: Beyond Service Life

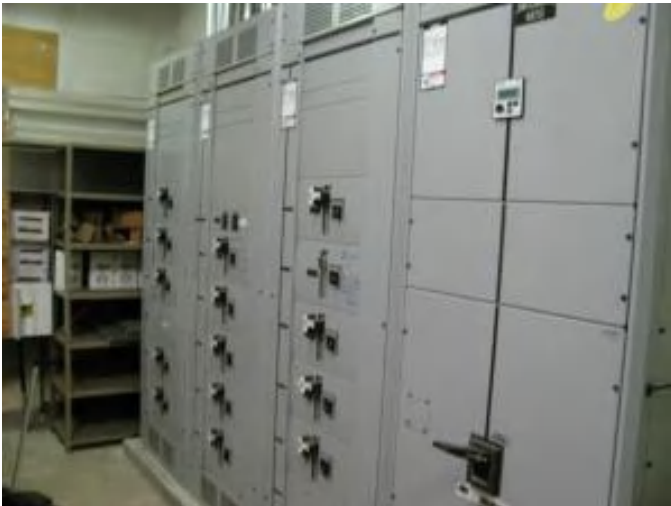
System: D5010 - Electrical Service/Distribution

Location: Main Building - Electrical Room

Distress: Inadequate

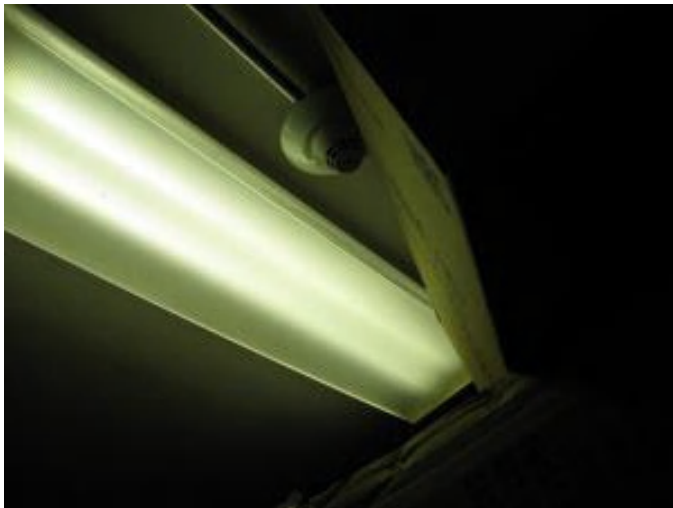
System: D5020 - Lighting and Branch Wiring

Location: Main Building - Entire Building

Distress: Beyond Service Life

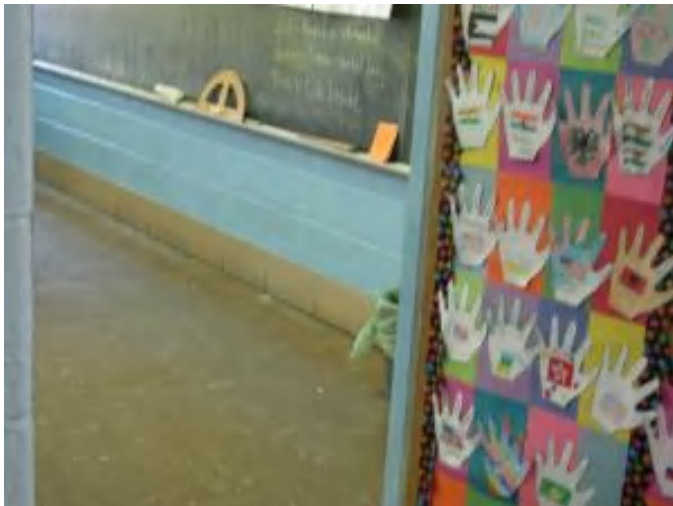
System: D5020 - Lighting and Branch Wiring

Location: Main Building - Classrooms

Distress: Inadequate

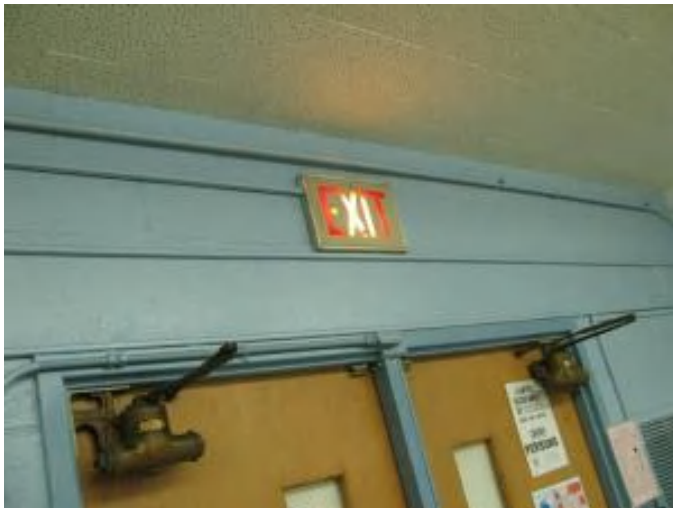
System: D5020 - Lighting and Branch Wiring

Location: Main Building - Corridors

Distress: Inadequate

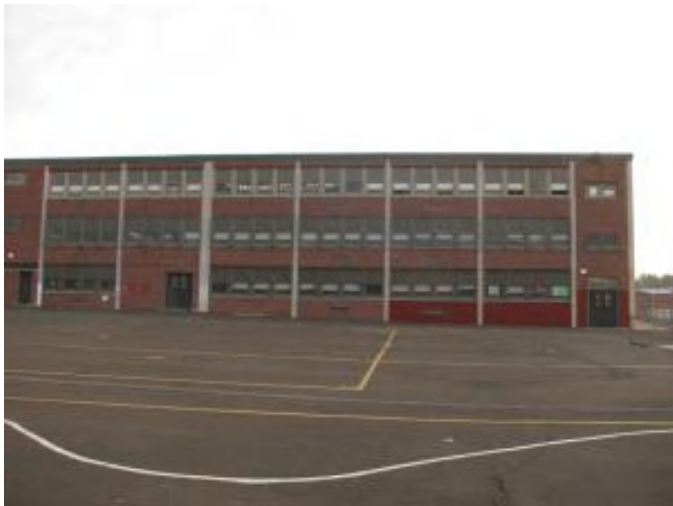
System: D5030 - Communications and Security

Location: Main Building - Entire Building

Distress: Security Issue

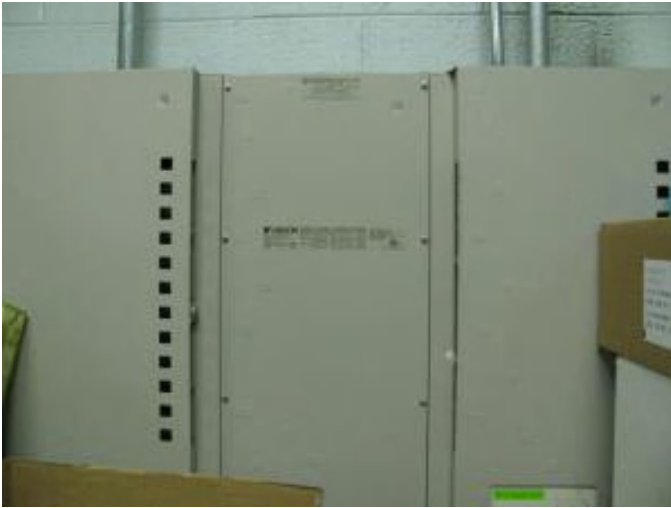
System: D5030 - Communications and Security

Location: Main Building - Auditorium

Distress: Inadequate

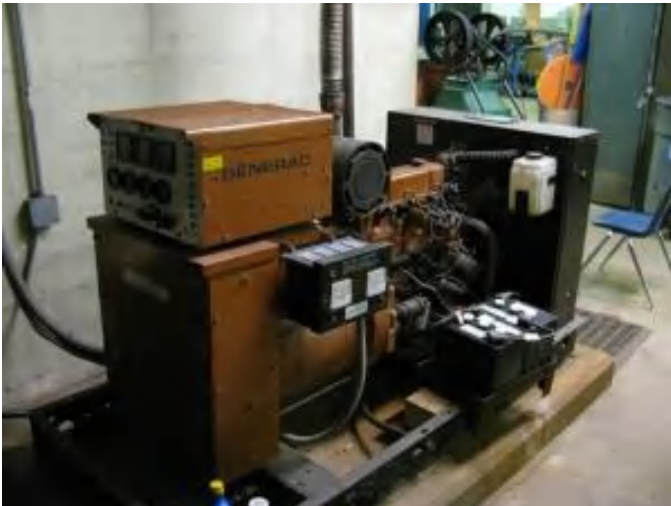
System: D5090 - Other Electrical Systems

Location: Main Building - Boiler Room

Distress: Inadequate

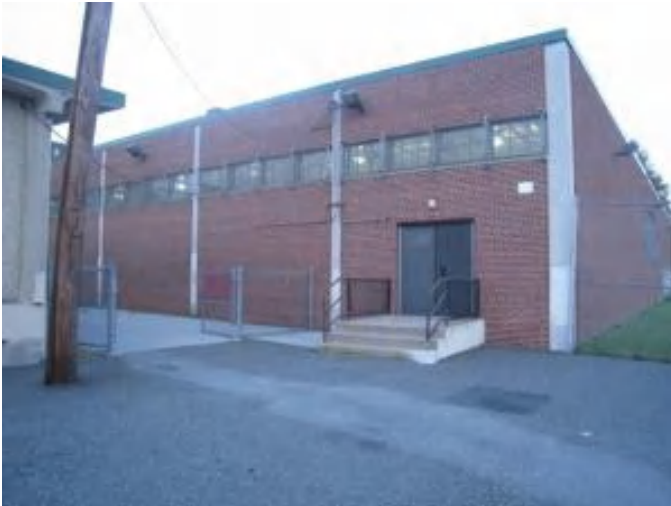
System: B2030 - Exterior Doors

Location: Main Building - exterior doors

Distress: Damaged

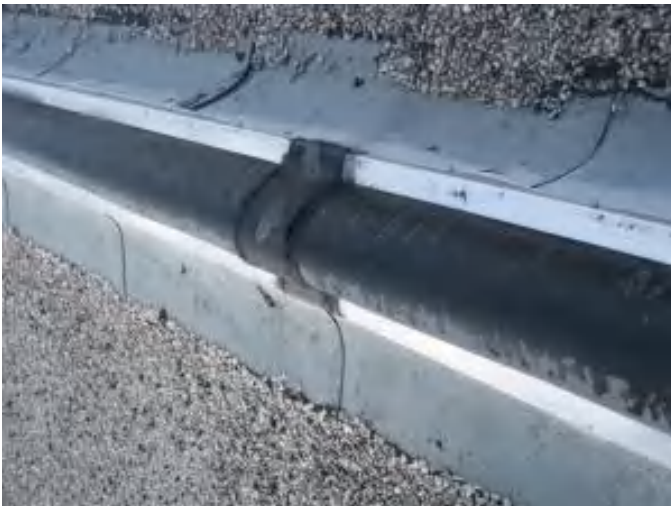
System: B3010105 - Built-Up

Location: Main Building - main roof expansion joint

Distress: Building Envelope Integrity

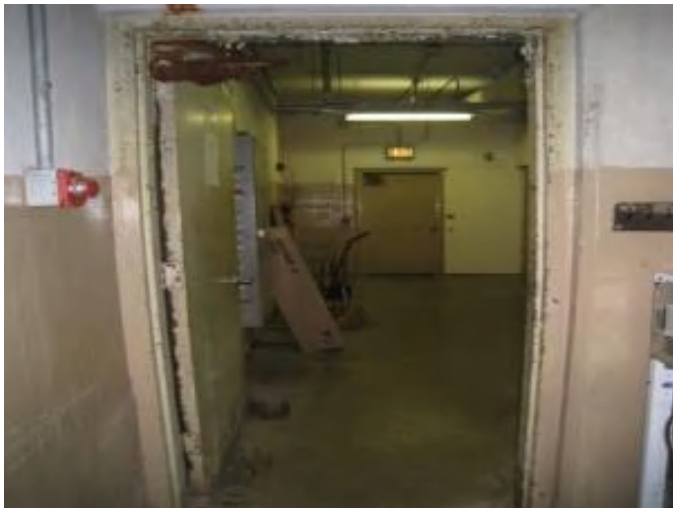
System: C1020 - Interior Doors

Location: Main Building - stairways; mechanical rooms

Distress: Damaged

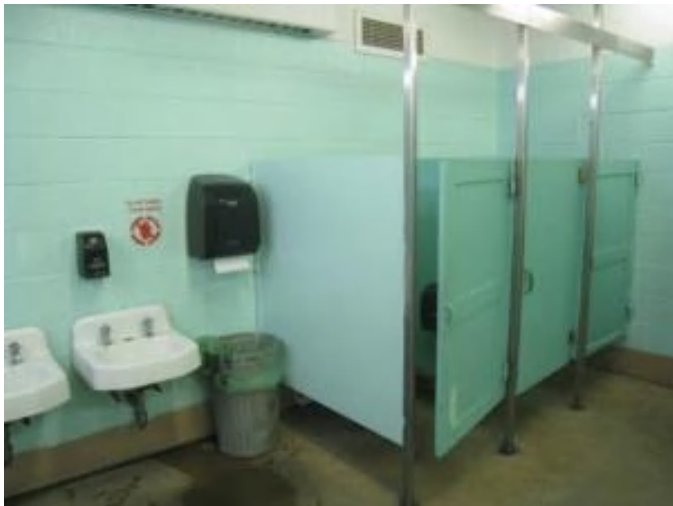
System: C1030 - Fittings

Location: Main Building - toilet rooms

Distress: Inadequate

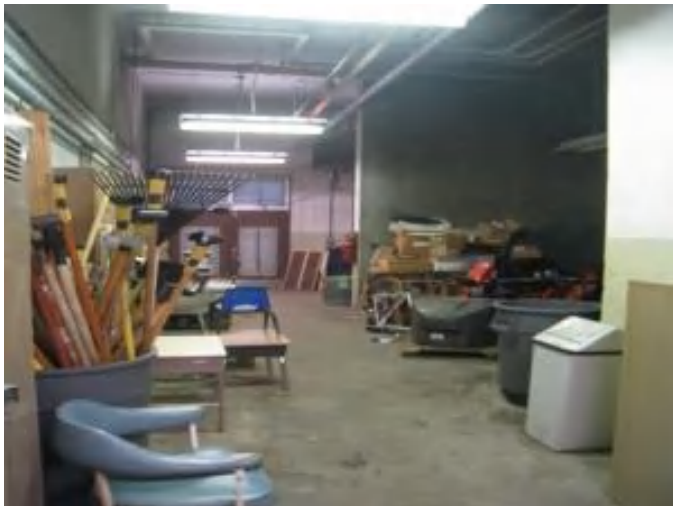
System: C3010230 - Paint & Covering

Location: Main Building - mechanical room walls

Distress: Appearance

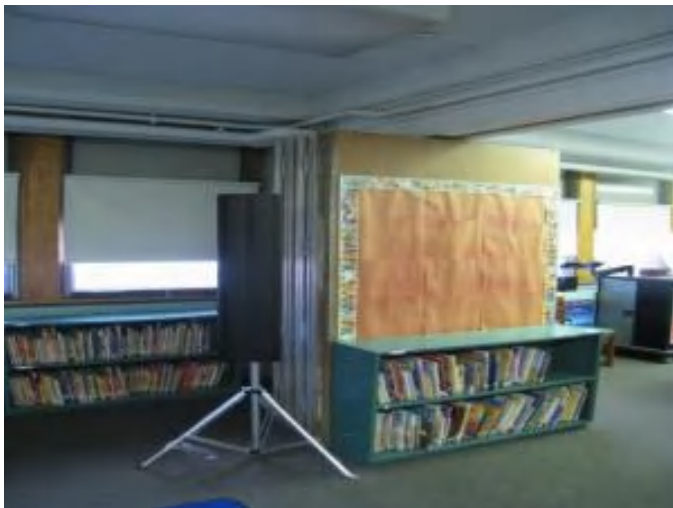
System: C3020411 - Carpet

Location: Main Building - library

Distress: Failing

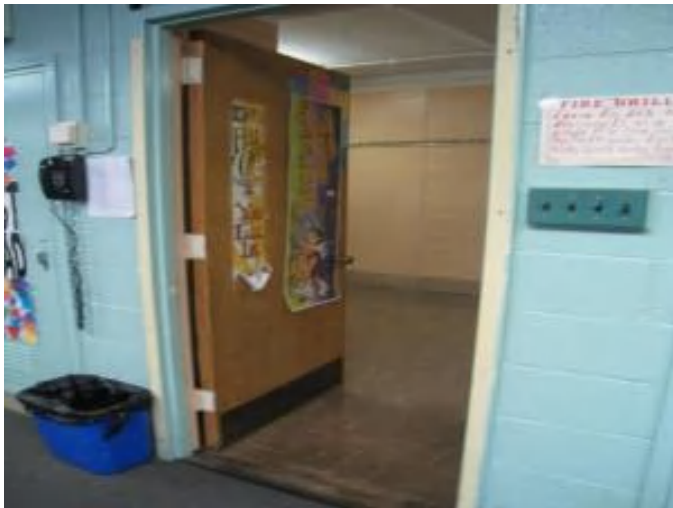
System: C3020413 - Vinyl Flooring

Location: Main Building - floors

Distress: Health Hazard / Risk

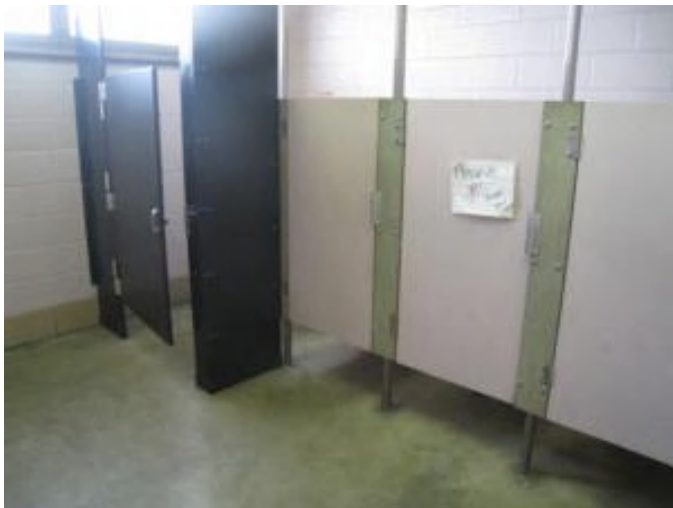
System: C3020415 - Concrete Floor Finishes

Location: Main Building - basement, stairways, toilet rooms

Distress: Appearance

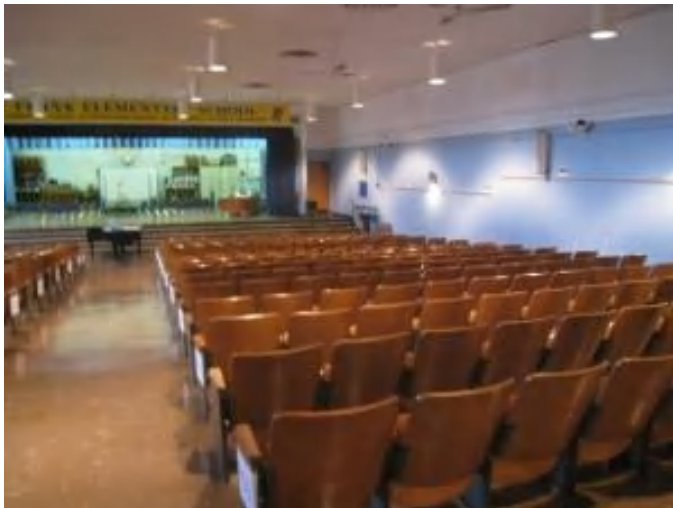
System: C3030 - Ceiling Finishes

Location: Main Building - auditorium and cafeteria

Distress: Failing

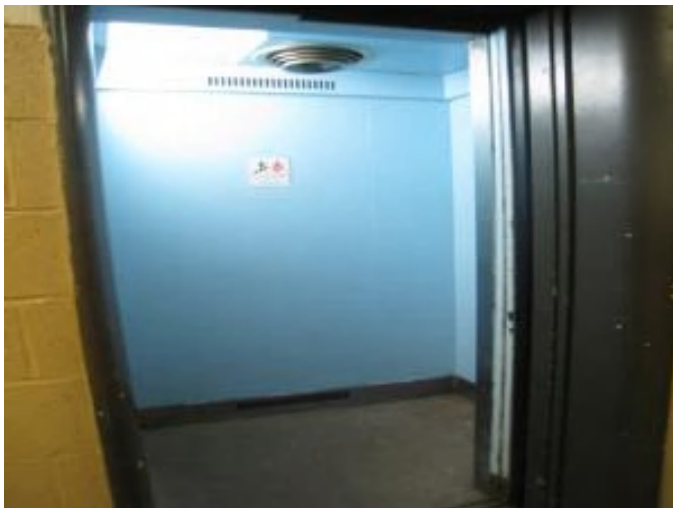
System: D1010 - Elevators and Lifts

Location: Main Building - elevator

Distress: Beyond Service Life

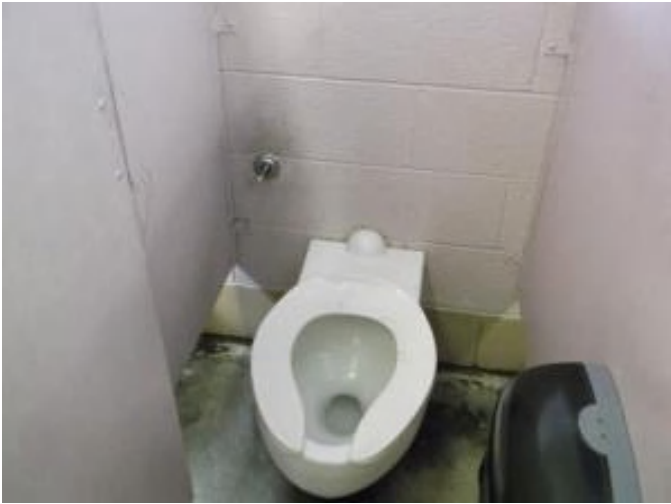
System: D2010 - Plumbing Fixtures

Location: Main Building - throughout the building

Distress: Beyond Service Life

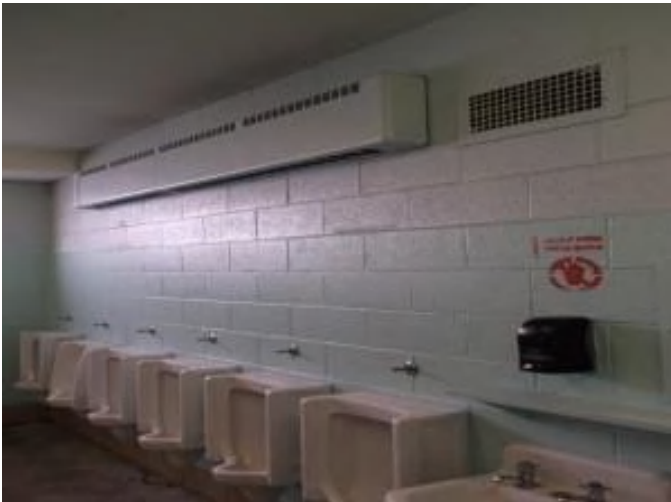
System: D2010 - Plumbing Fixtures

Location: Main Building - throughout the building

Distress: Beyond Service Life

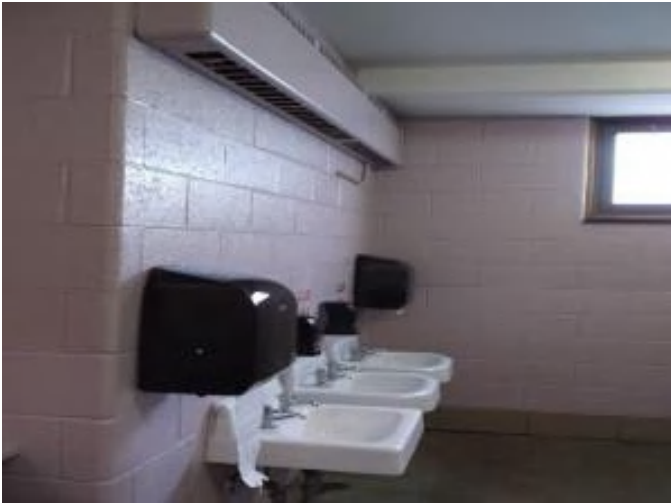
System: D2010 - Plumbing Fixtures

Location: Main Building - throughout the building

Distress: Beyond Service Life

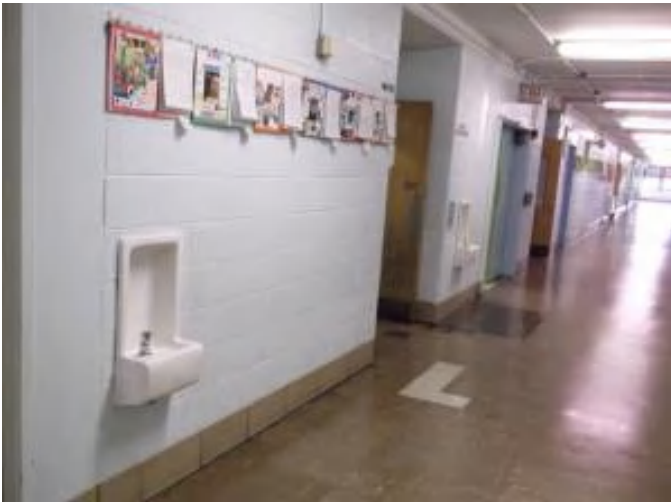
System: D2010 - Plumbing Fixtures

Location: Main Building - throughout the building

Distress: Beyond Service Life

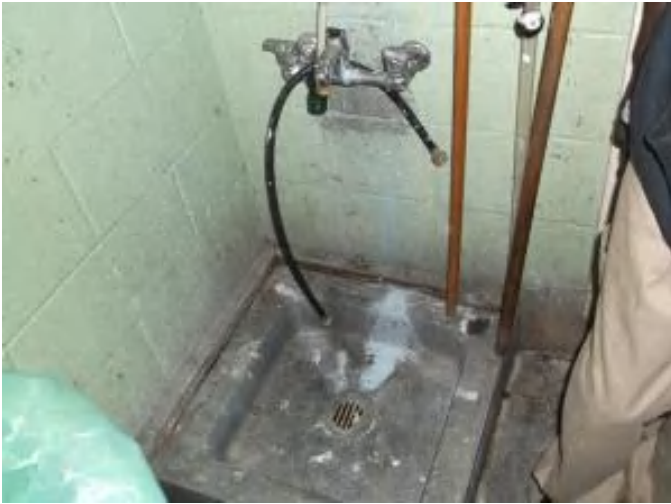
System: D2010 - Plumbing Fixtures

Location: Main Building - throughout the building

Distress: Beyond Service Life

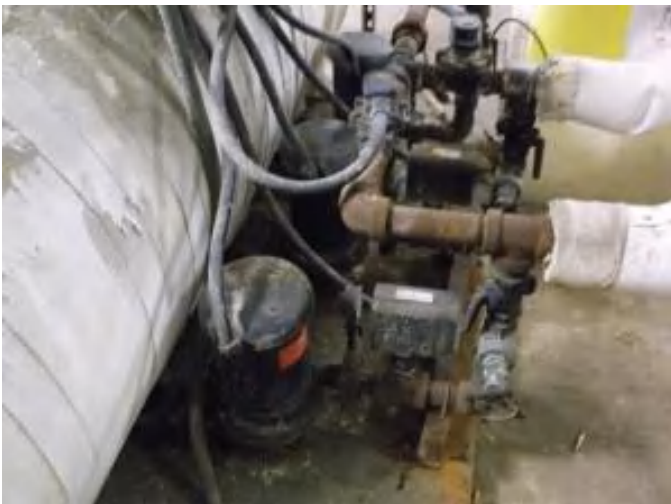
System: D3020 - Heat Generating Systems

Location: Main Building - main boiler mechanical equipment room

Distress: Beyond Service Life

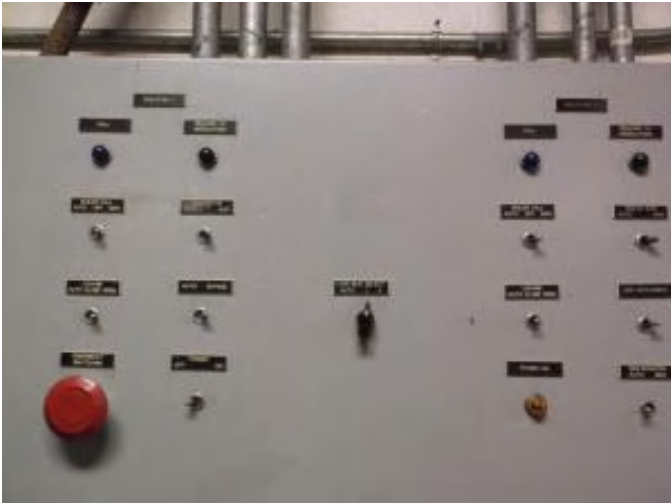
System: D3060 - Controls & Instrumentation

Location: Main Building - throughout the building

Distress: Beyond Service Life

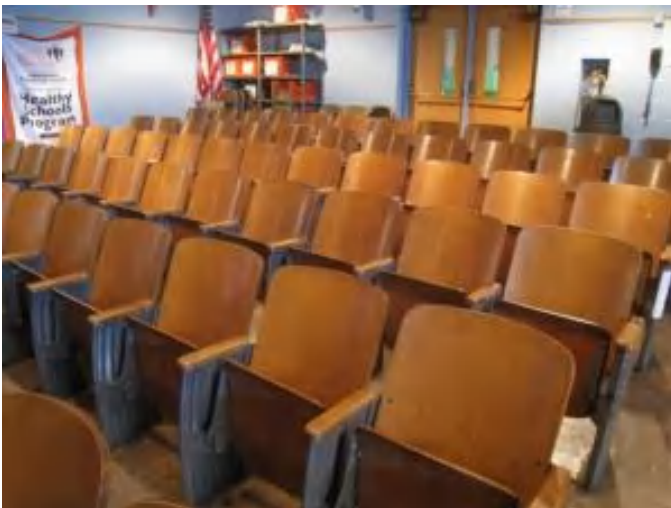
System: E2010 - Fixed Furnishings

Location: Main Building - auditorium

Distress: Damaged

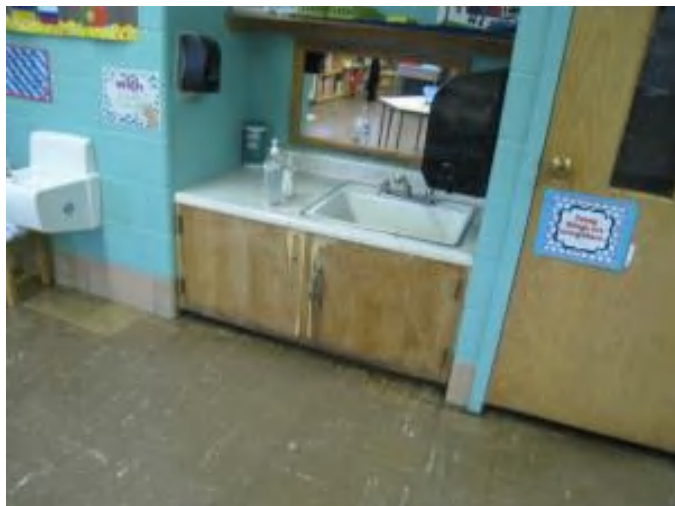
System: E2010 - Fixed Furnishings

Location: Main Building - kindergartens' kitchenettes

Distress: Failing

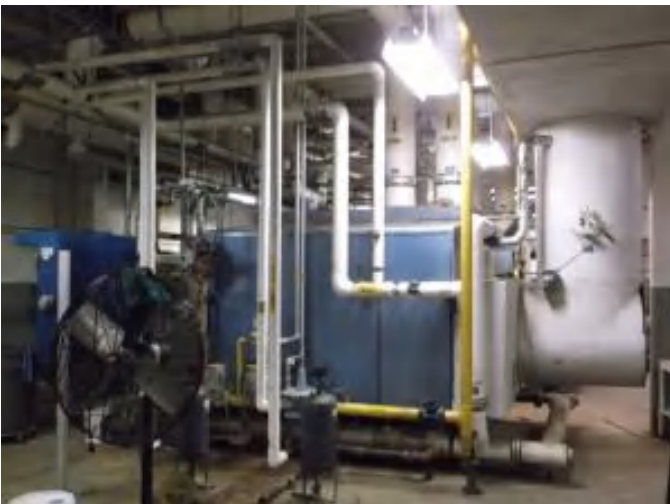
System: D3040 - Distribution Systems

Location: Main Building - throughout the building

Distress: Beyond Service Life

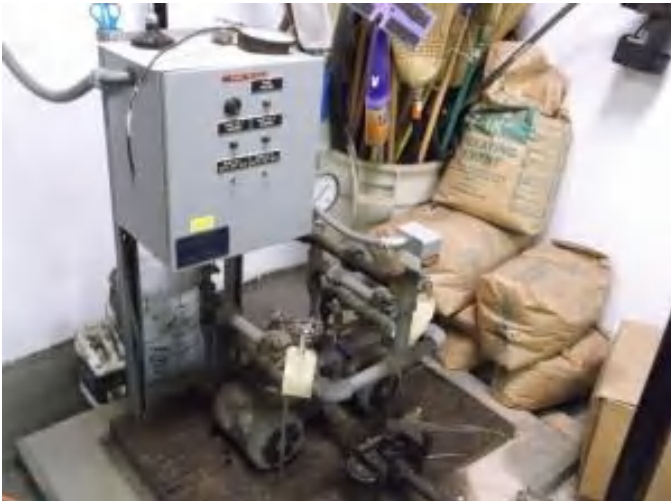
System: D3020 - Heat Generating Systems

Location: Main Building - main boiler mechanical equipment room

Distress: Beyond Service Life

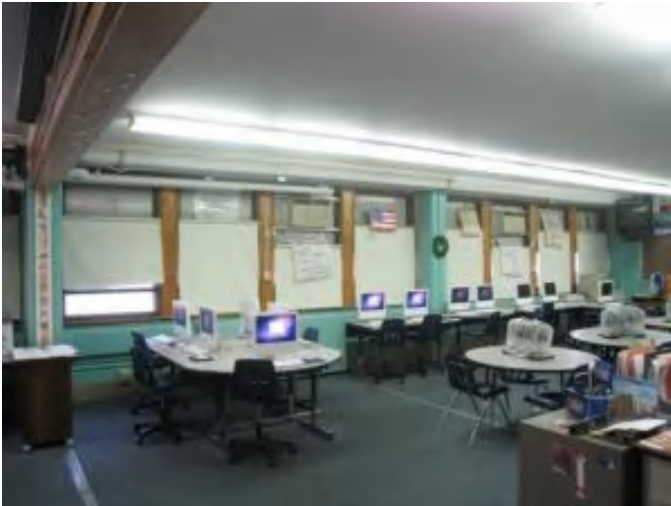
System: D3030 - Cooling Generating Systems

Location: Main Building - adjacent to the building

Distress: Inadequate

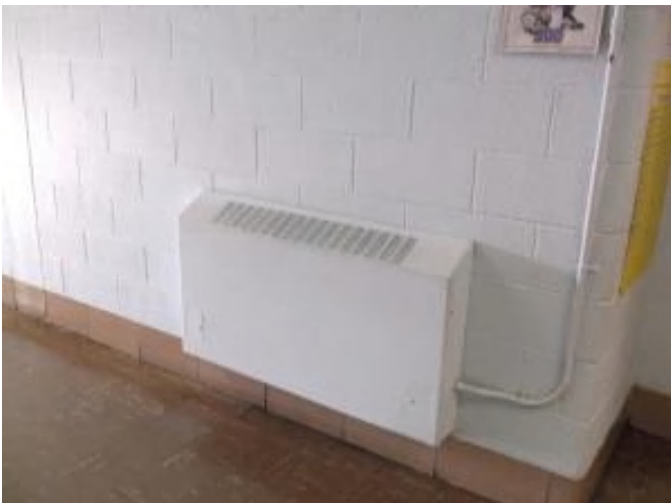
System: D3040 - Distribution Systems

Location: Main Building - throughout the building

Distress: Beyond Service Life

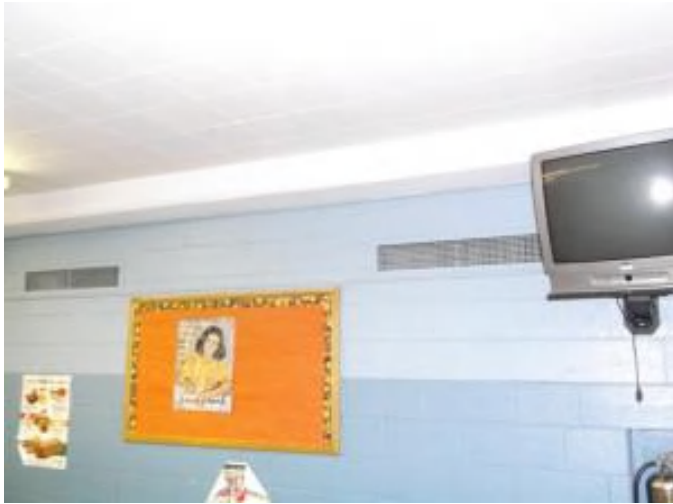
System: D4010 - Sprinklers

Location: Main Building - throughout the building

Distress: Life Safety / NFPA / PFD

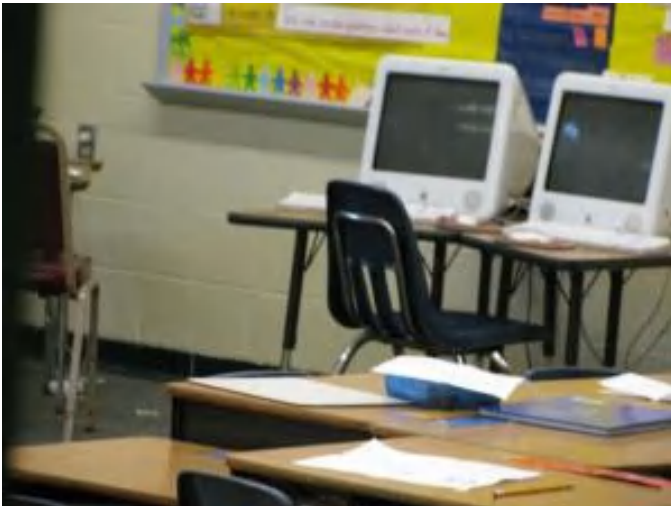
System: D5020 - Lighting and Branch Wiring

Location: LSH - all rooms

Distress: Life Safety / NFPA / PFD

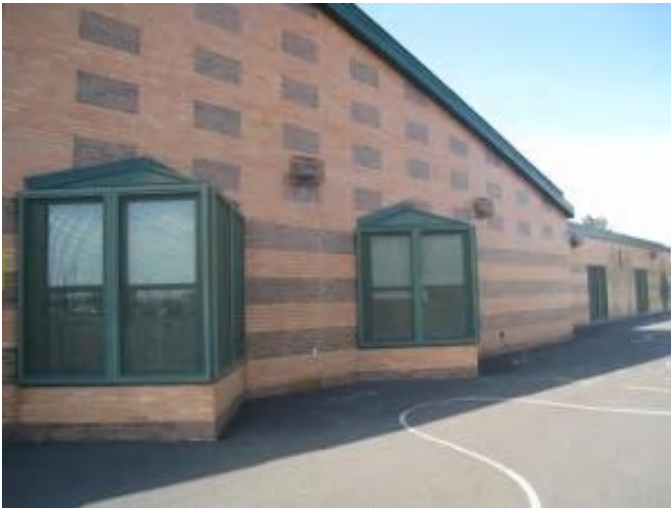
System: B2020 - Exterior Windows

Location: LSH - security screens

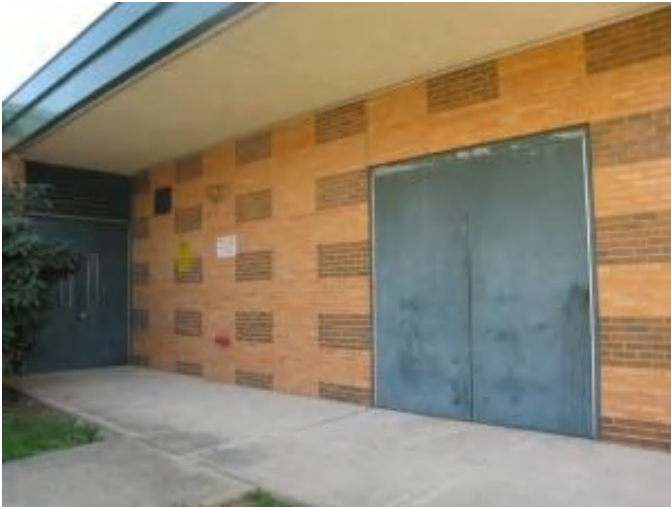
System: B2030 - Exterior Doors

Location: LSH - exterior doors

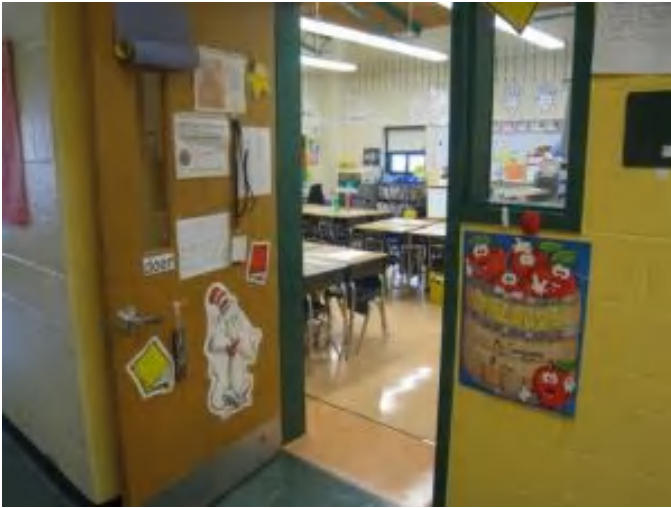
System: C1020 - Interior Doors

Location: LSH - corridor classroom doors

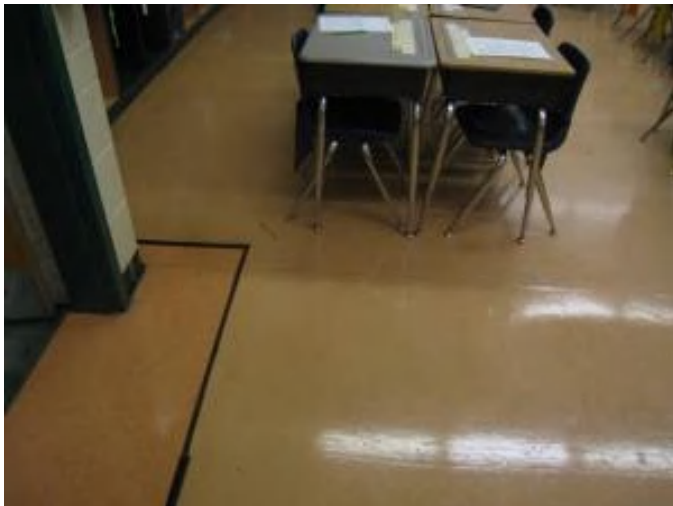
System: C3020413 - Vinyl Flooring

Location: LSH - classrooms

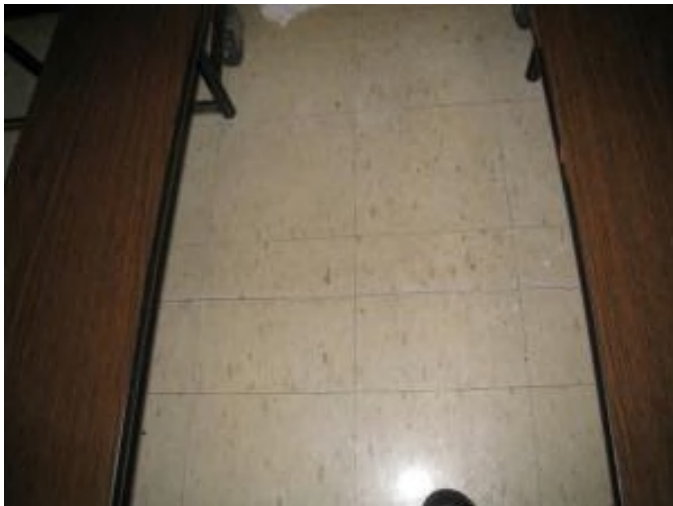
System: C3020413 - Vinyl Flooring

Location: LSH - corridors and multipurpose room

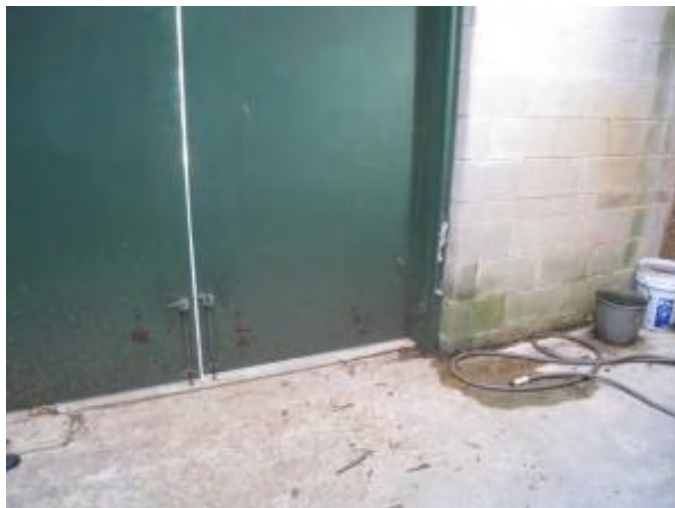
System: C3020415 - Concrete Floor Finishes

Location: LSH - mech room floors

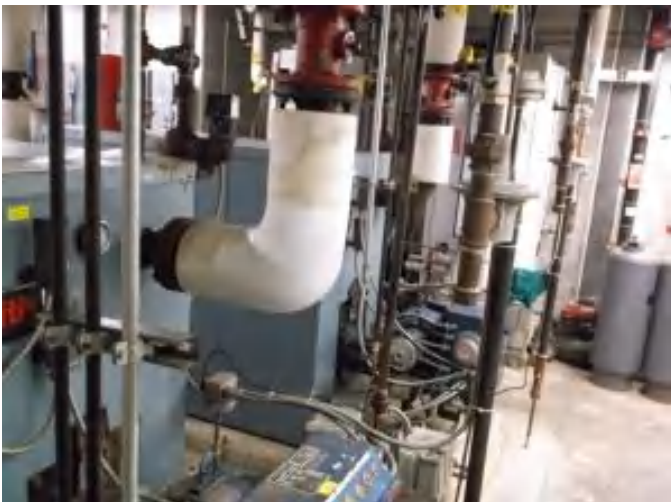
System: D3040 - Distribution Systems

Location: LSH - Main boiler mechanical equipment room

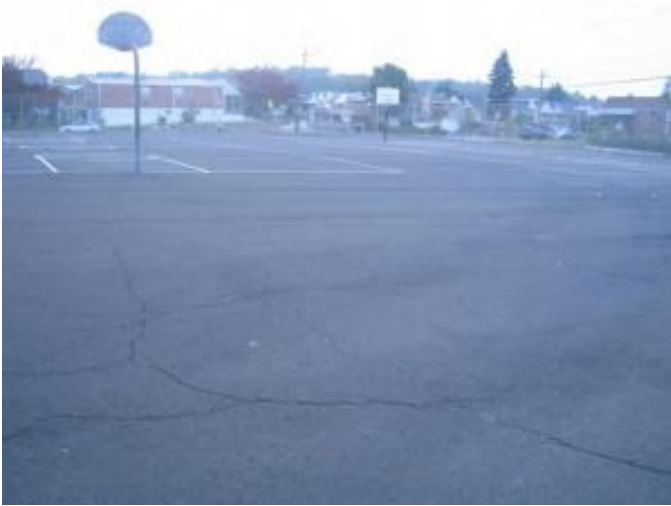
System: G2020 - Parking Lots

Location: asphalt parking and playground

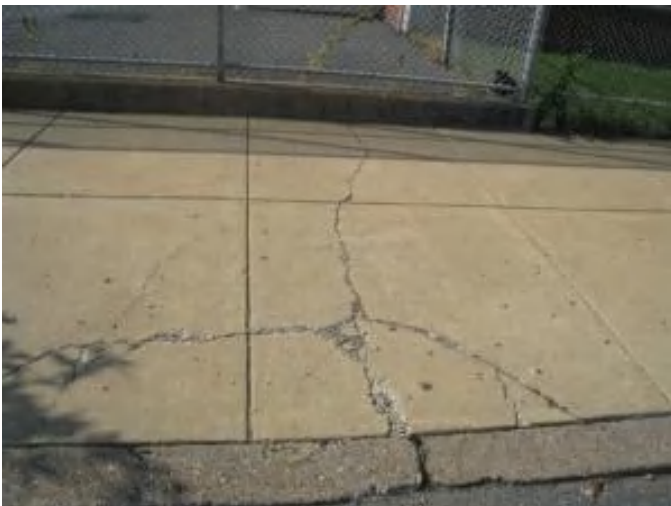
System: G2030 - Pedestrian Paving

Location: sidewalk around site

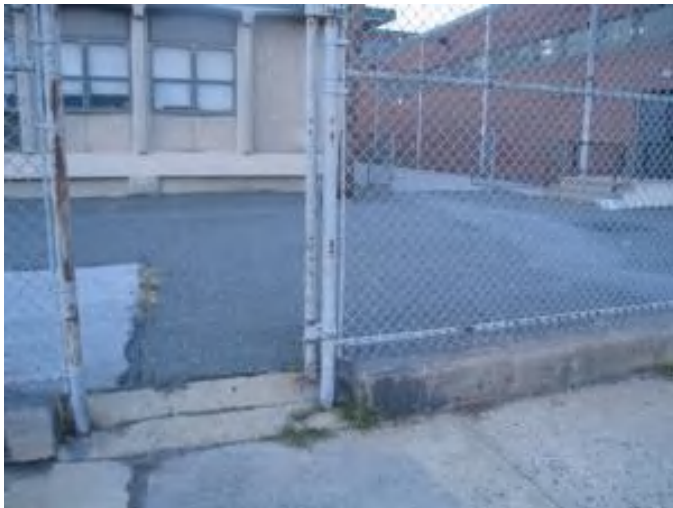
System: G2040 - Site Development

Location: chain link site fence

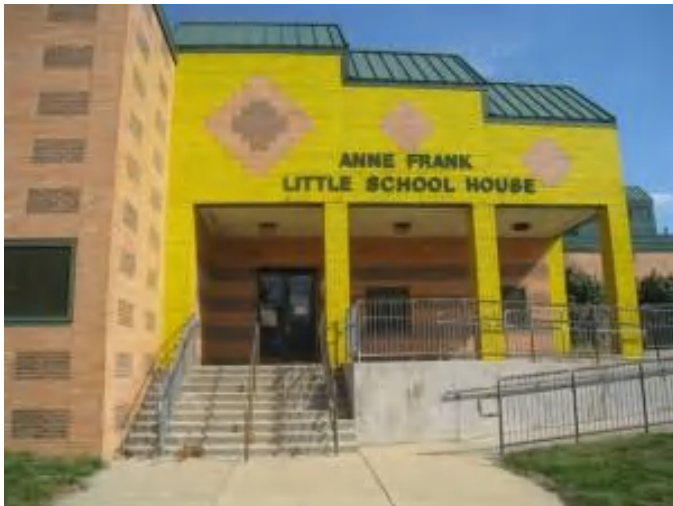
System: G2040 - Site Development

Location: ramp handrails and guards

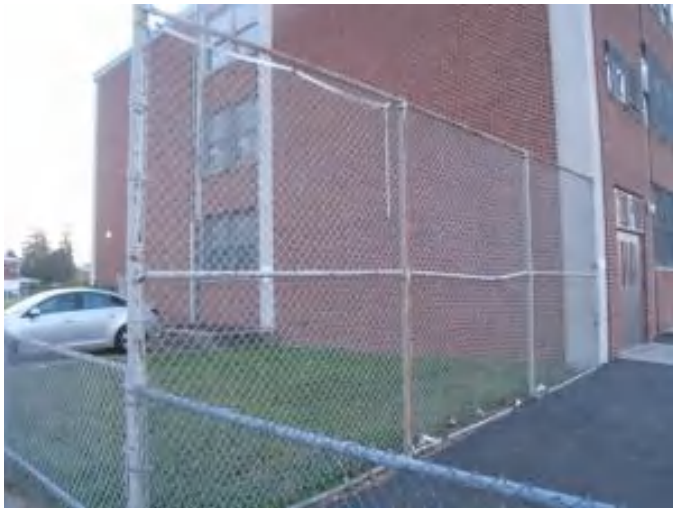
System: G2040 - Site Development

Location: chain link site fence
