## Facility Condition Assessment Summary Report

### Frankford School

School District of Philadelphia  
**S701001;Frankford**  
Final  
**Site Assessment Report**  
January 31, 2017

Facility Condition Assessment  
December 2015

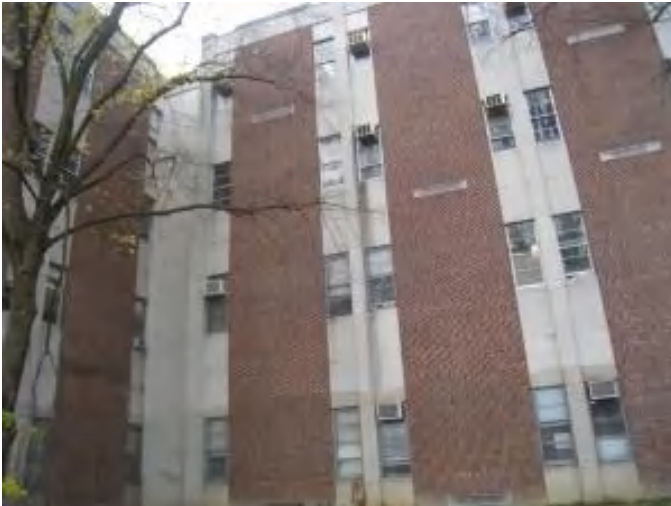
**Location:** exterior wall - element 4

#### System: B2010 - Exterior Walls

**Distress:** Failing

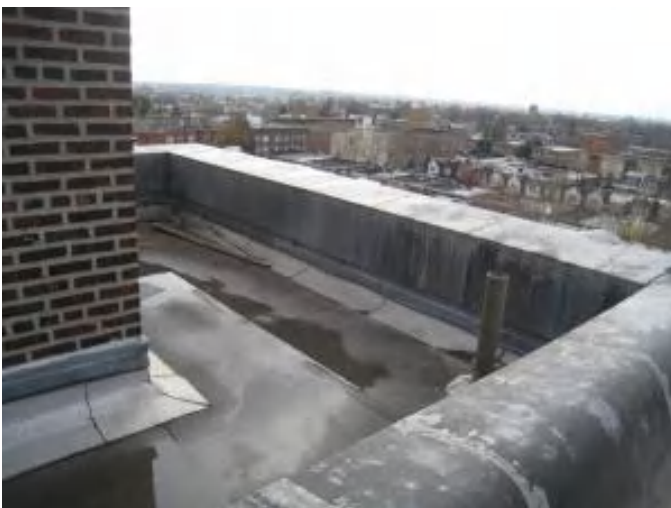
**Location:** roof

#### System: B3010105 - Built-Up

**Distress:** Inadequate

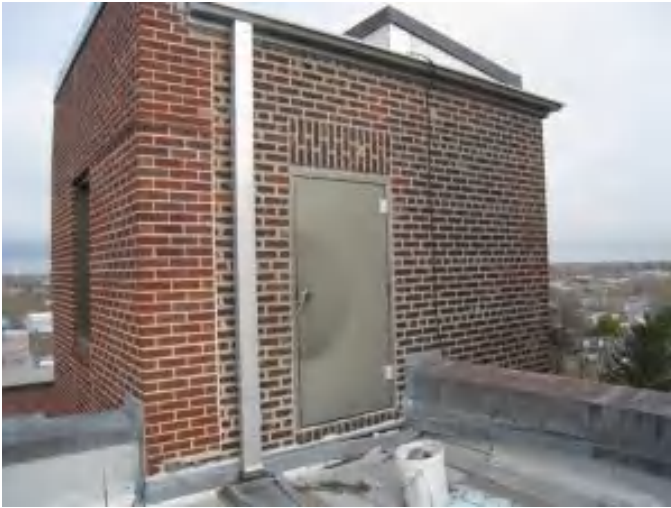
**Location:** roof - brick wall flashing

**System: B3010105 - Built-Up**

**Distress:** Damaged

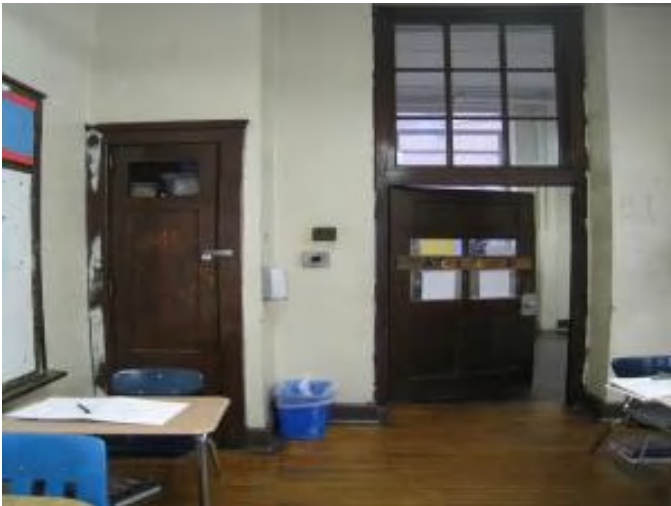
**Location:** corridor walls

**System: C1010 - Partitions**

**Distress:** Building / MEP Codes

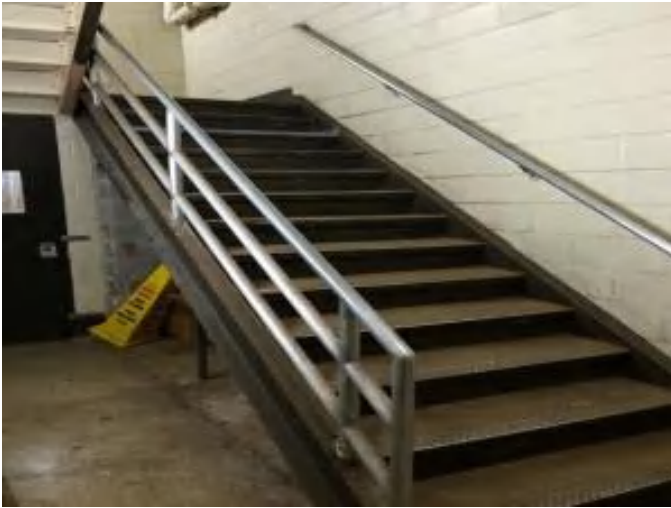
**Location:** stairways - element 4

**System: C2010 - Stair Construction**

**Distress:** Building / MEP Codes

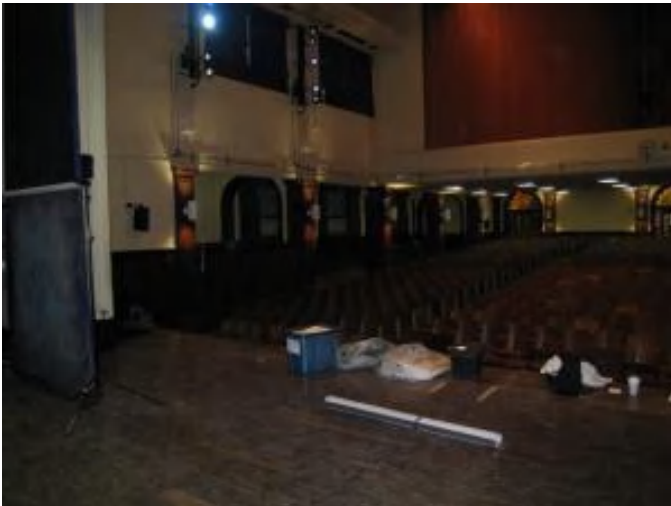
**Location:** balcony in auditorium

**System: C2010 - Stair Construction**

**Distress:** Health Hazard / Risk

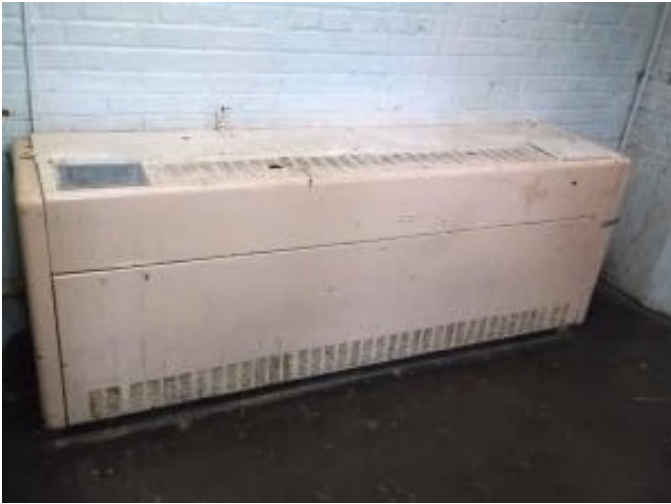
**Location:** Throughout the building

**System: D3040 - Distribution Systems**

**Distress:** Beyond Service Life

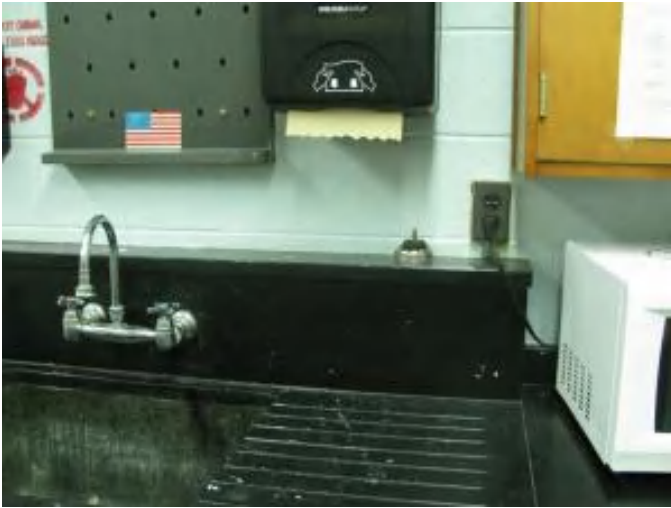
**Location:** Computer and Science Rooms

**System: D5020 - Lighting and Branch Wiring**

**Distress:** Inadequate

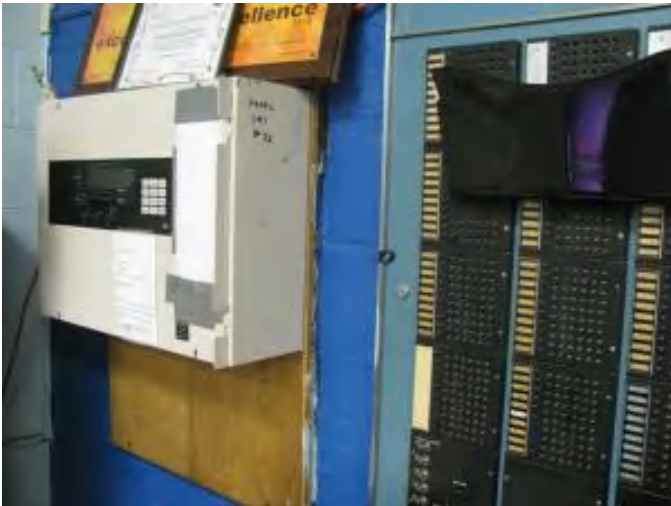
**Location:** entire building

**System: D5030 - Communications and Security**

**Distress:** Beyond Service Life

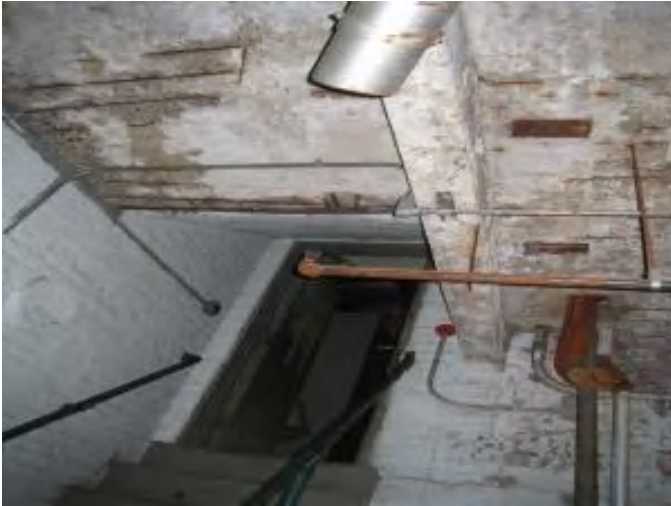
**Location:** basement - bottom of 1st floor

**System: B1010 - Floor Construction**

**Distress:** Failing

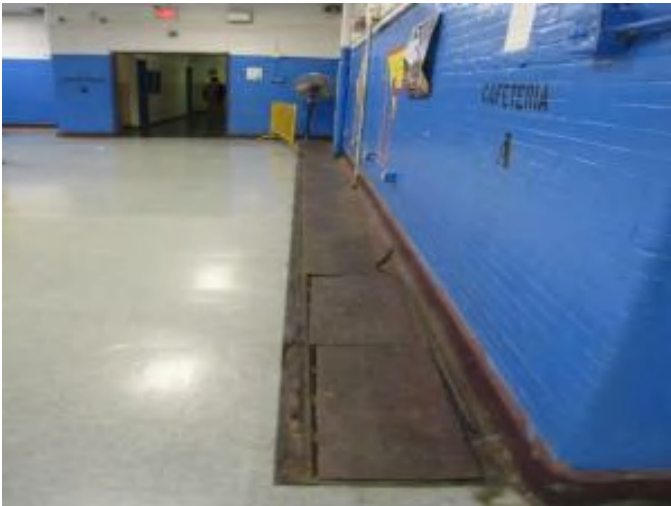
**Location:** cafeteria

**System: B1010 - Floor Construction**

**Distress:** Damaged

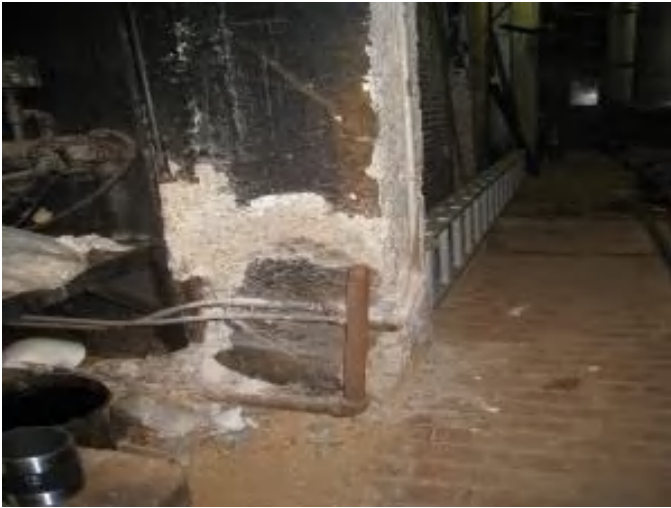
**Location:** basement

**System: B2010 - Exterior Walls**

**Distress:** Damaged

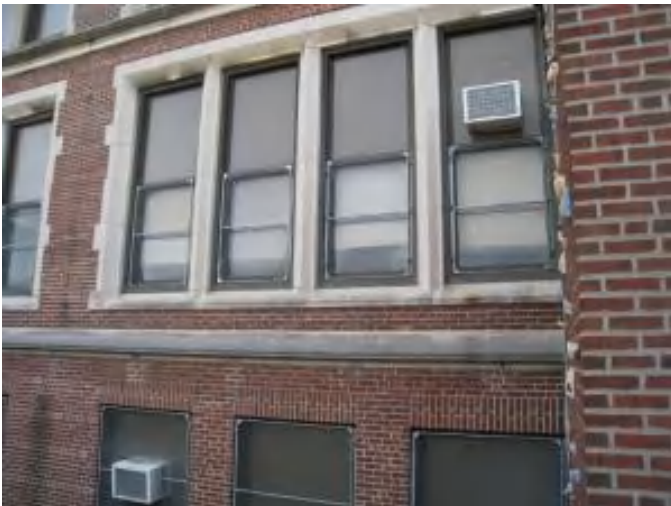
**Location:** exterior limestone

**System: B2010 - Exterior Walls**

**Distress:** Appearance

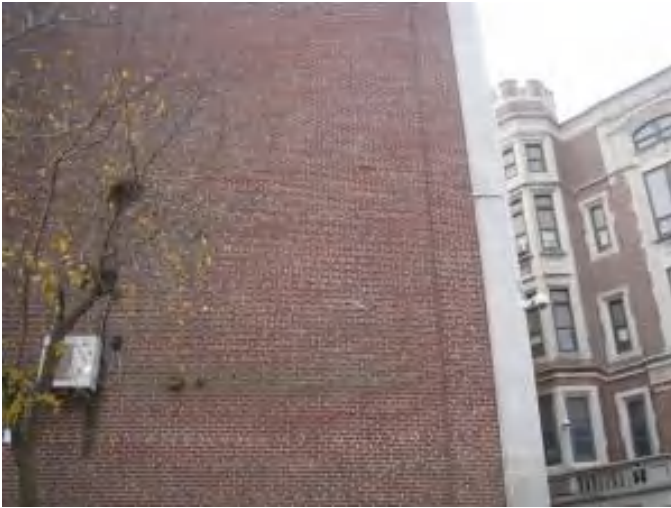
**Location:** exterior walls - chimney, element 2, element 4

**System: B2010 - Exterior Walls**

**Distress:** Failing

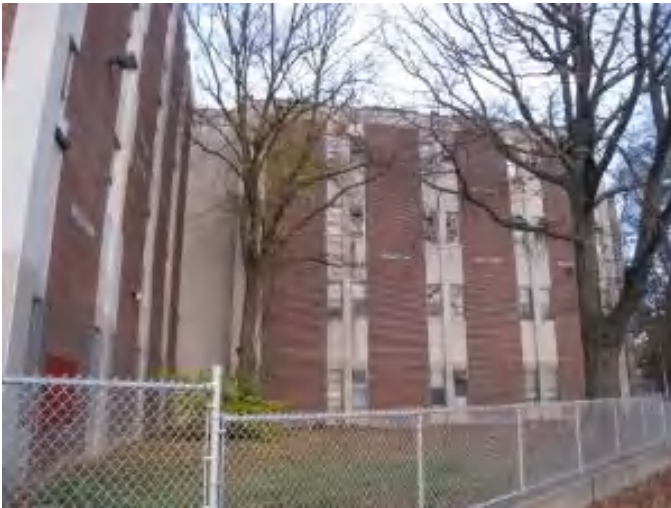
**Location:** windows

**System: B2020 - Exterior Windows**

**Distress:** Failing

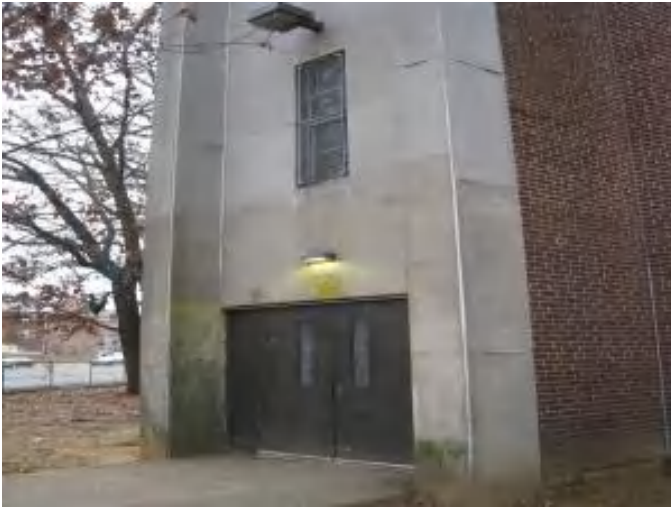
**System: B2030 - Exterior Doors**

**Location:** exterior doors  
**Distress:** Damaged  
**Category:** 3 - Operations / Maint.  
**Priority:** 2 - Response Time (2-3 yrs)  
**Correction:** Remove and replace exterior doors - per leaf  
**Qty:** 34.00  
**Unit of Measure:** Ea.  
**Estimate:** \$263,020.31  
**Assessor Name:** System  
**Date Created:** 02/24/2016

**Notes:** Replace all exterior doors and frames; also provide new exit hardware. (34)3x7

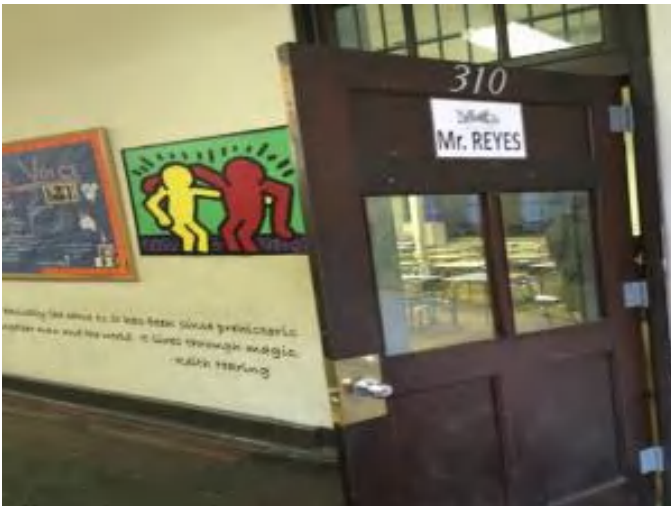
**System: C1020 - Interior Doors**

**Location:** corridor doors  
**Distress:** Building / MEP Codes  
**Category:** 3 - Operations / Maint.  
**Priority:** 2 - Response Time (2-3 yrs)  
**Correction:** Remove and replace interior doors - wood doors with hollow metal frames - per leaf  
**Qty:** 250.00  
**Unit of Measure:** Ea.  
**Estimate:** \$1,192,646.78  
**Assessor Name:** System  
**Date Created:** 02/25/2016

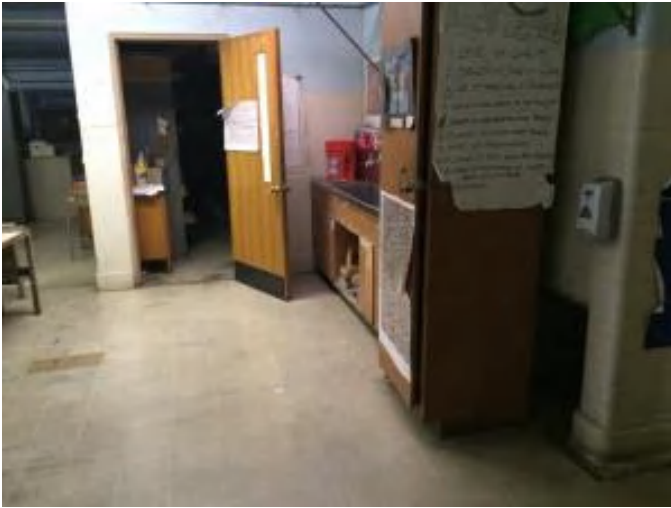
**System: C1020 - Interior Doors**

**Location:** interior non-rated doors  
**Distress:** Appearance  
**Category:** 3 - Operations / Maint.  
**Priority:** 2 - Response Time (2-3 yrs)  
**Correction:** Refinish interior doors  
**Qty:** 72.00  
**Unit of Measure:** Ea.  
**Estimate:** \$59,629.17  
**Assessor Name:** System  
**Date Created:** 02/25/2016

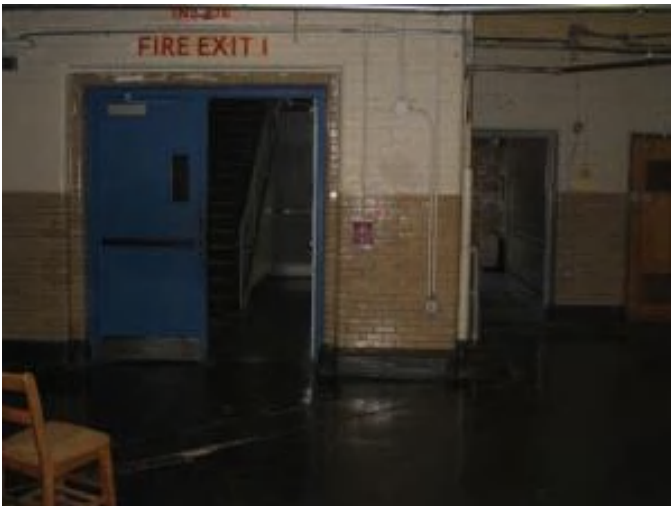
**System: C1020 - Interior Doors**

**Location:** stairway doors  
**Distress:** Appearance  
**Category:** 3 - Operations / Maint.  
**Priority:** 2 - Response Time (2-3 yrs)  
**Correction:** Refinish interior doors  
**Qty:** 70.00  
**Unit of Measure:** Ea.  
**Estimate:** \$57,972.81  
**Assessor Name:** System  
**Date Created:** 02/25/2016

**Notes:** Refinish fire rated steel stairway doors (70)

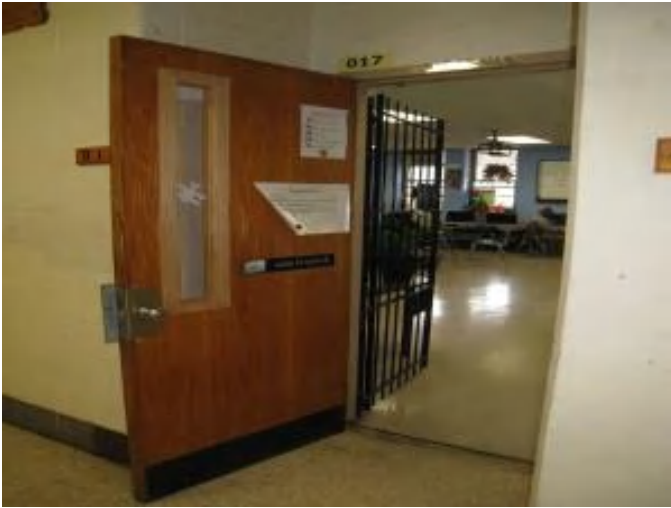
**Location:** corridor doors

**System: C1020 - Interior Doors**

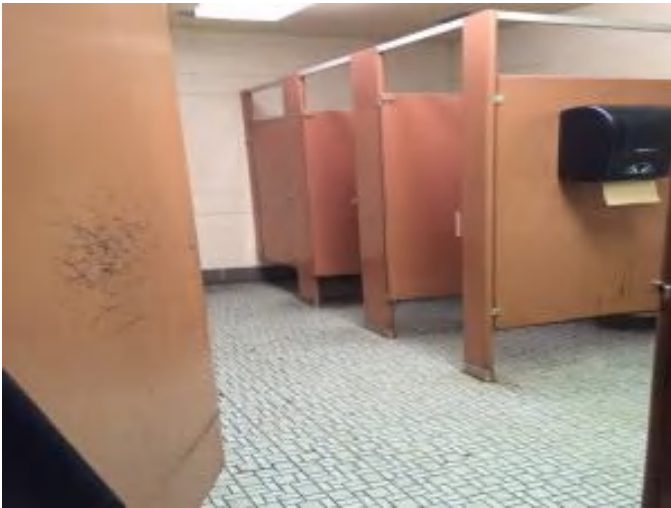
**Location:** toilet rooms - element 4

**System: C1030 - Fittings**

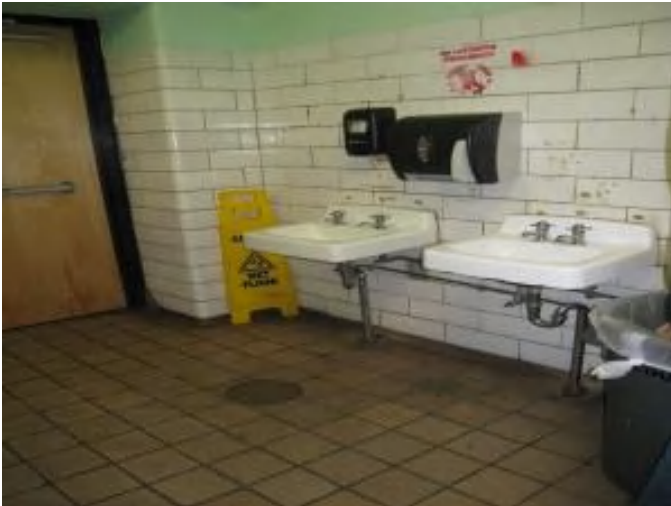
**System: C1030 - Fittings**

**Location:** toilet rooms  
**Distress:** Damaged  
**Category:** 3 - Operations / Maint.  
**Priority:** 2 - Response Time (2-3 yrs)  
**Correction:** Replace toilet accessories - select accessories and quantity  
**Qty:** 6.00  
**Unit of Measure:** Ea.  
**Estimate:** \$7,290.34  
**Assessor Name:** System  
**Date Created:** 02/25/2016

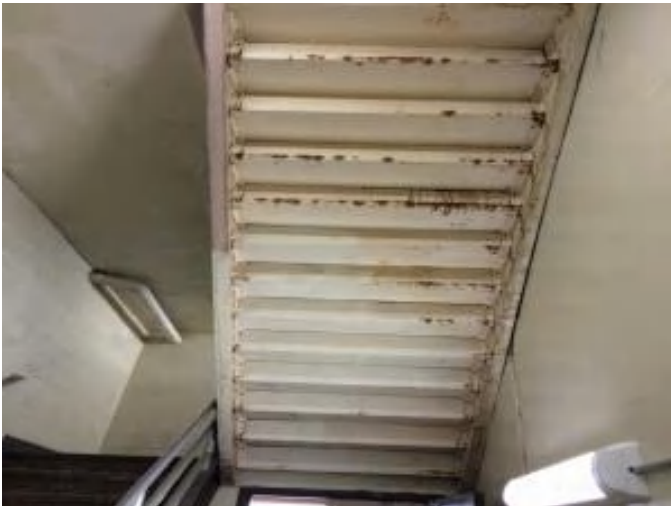
**System: C2010 - Stair Construction**

**Location:** stairways - element 4  
**Distress:** Failing  
**Category:** 3 - Operations / Maint.  
**Priority:** 2 - Response Time (2-3 yrs)  
**Correction:** Replace exterior enclosed stair tower egress stairs - per flight of stairs - stairs only  
**Qty:** 2.00  
**Unit of Measure:** Flight  
**Estimate:** \$107,550.65  
**Assessor Name:** System  
**Date Created:** 02/25/2016

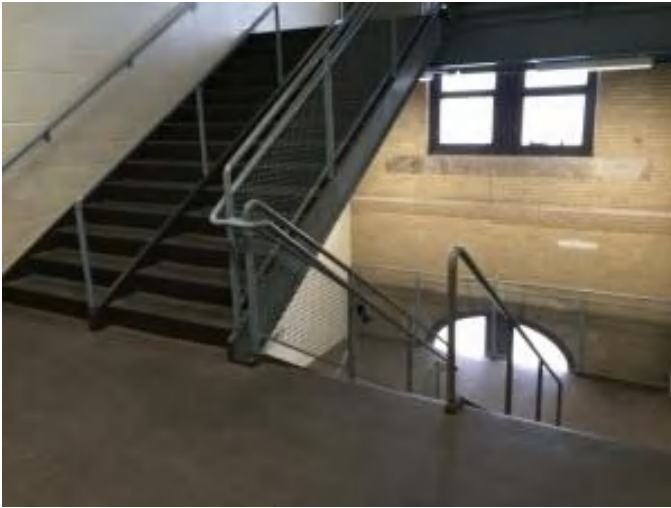
**Location:** stairways - element 1

**System: C2010 - Stair Construction**

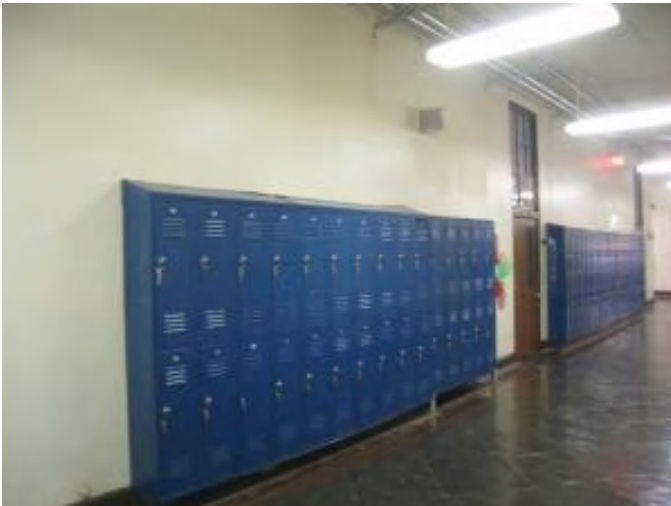
**Location:** corridors - lockers

**System: C3010230 - Paint & Covering**

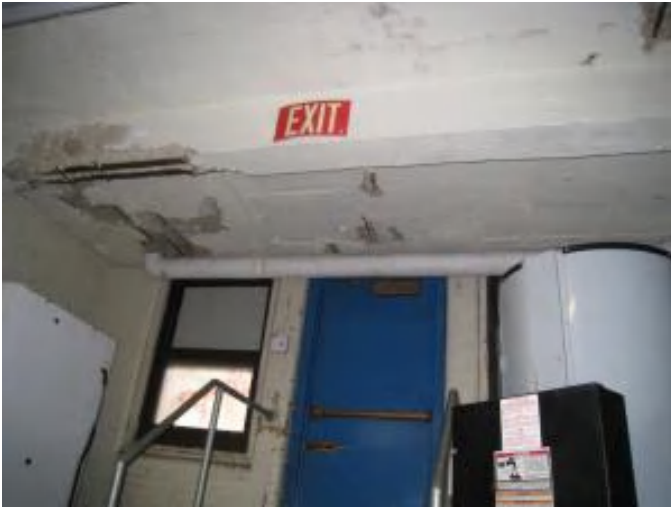
**Location:** interior walls - spalling plaster

**System: C3010230 - Paint & Covering**

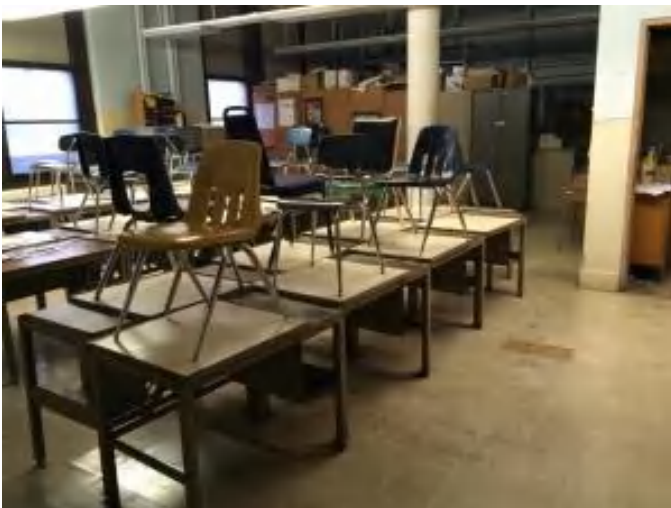
**Location:** corridors, cafeteria, classrooms

**System: C3020413 - Vinyl Flooring**

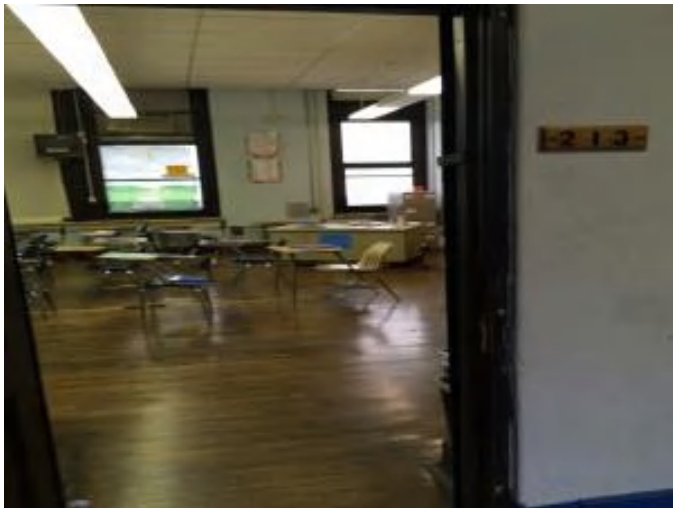
**Location:** classrooms, offices, cafeteria

**System: C3020413 - Vinyl Flooring**

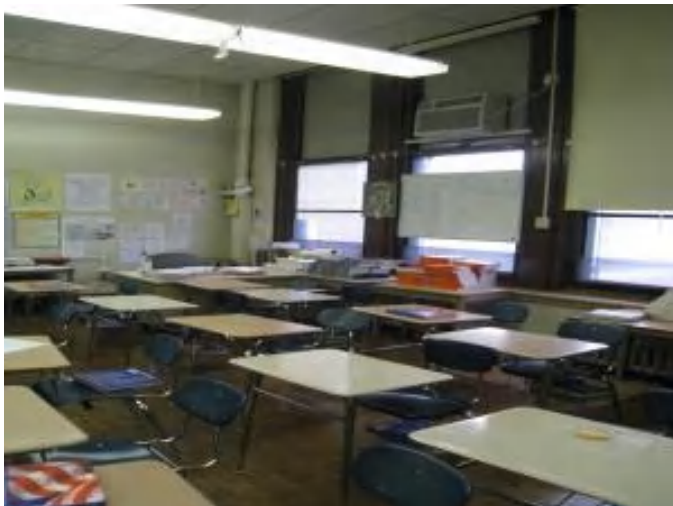
**Location:** classrooms, gym, auditorium wood floors

**System: C3020414 - Wood Flooring**

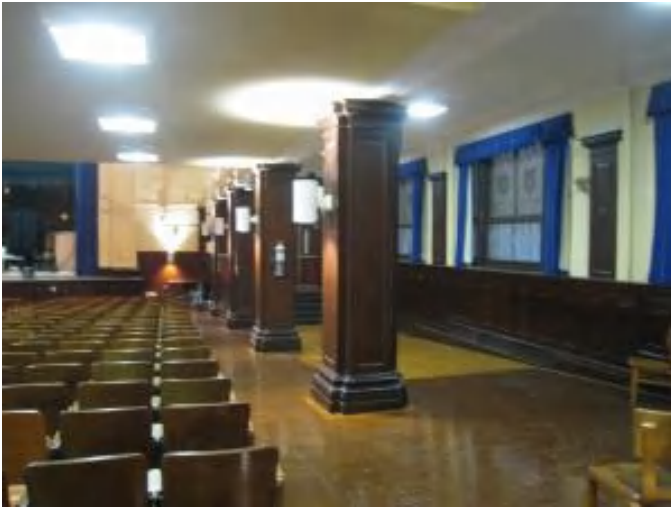
**Location:** wood wainscot on wall in auditorium

**System: C3020414 - Wood Flooring**

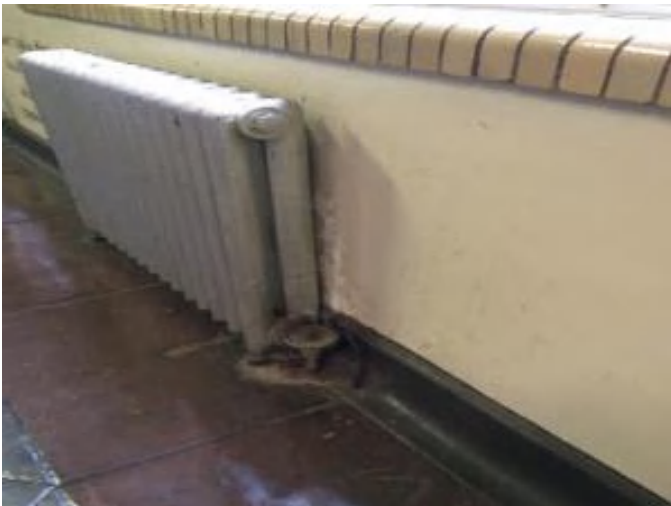
**Location:** corridors and mech rooms

**System: C3020415 - Concrete Floor Finishes**

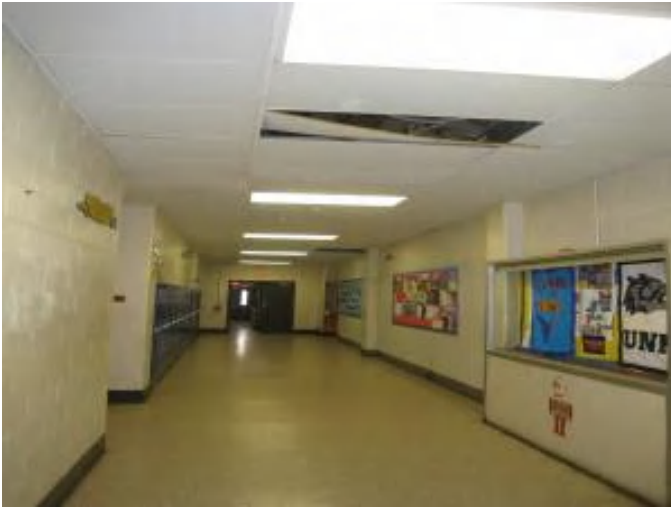
**Location:** classrooms, corridors

**System: C3030 - Ceiling Finishes**

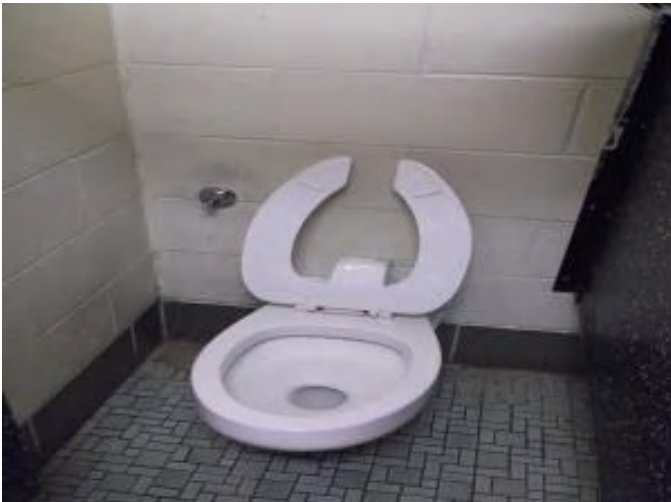
**Location:** Throughout the building

**System: D2010 - Plumbing Fixtures**

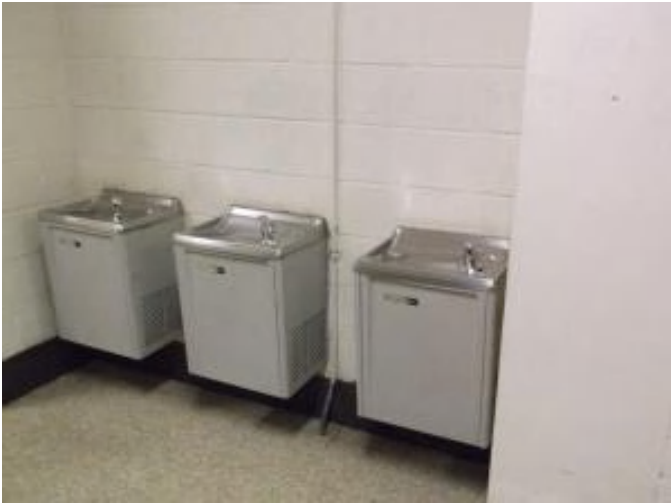
**Location:** Throughout the building

**System: D2010 - Plumbing Fixtures**

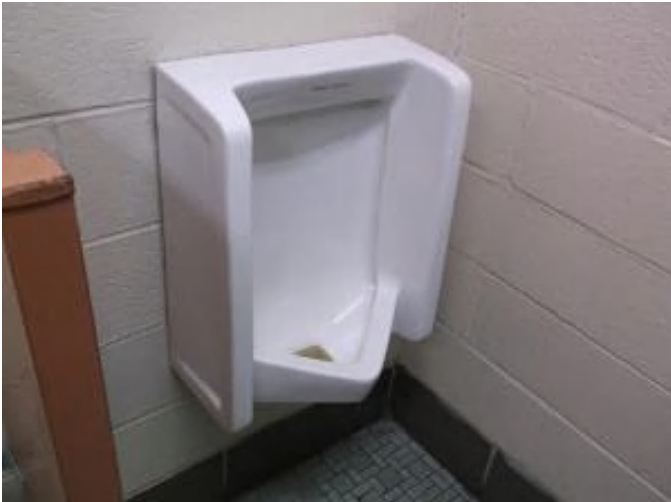
**Location:** Throughout the building

**System: D2010 - Plumbing Fixtures**

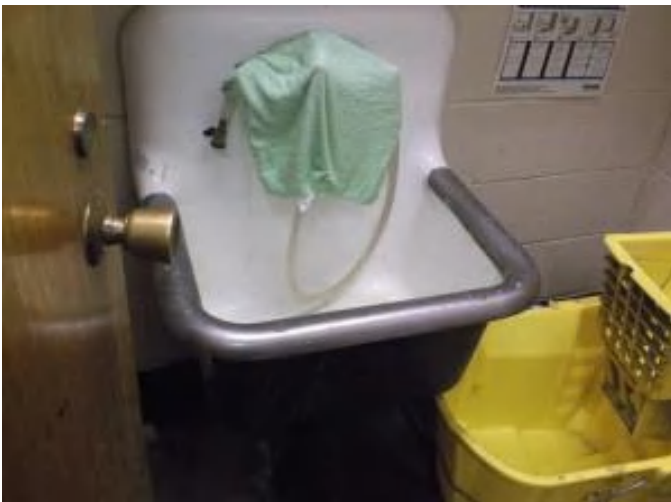
**Location:** Throughout the building

**System: D2010 - Plumbing Fixtures**

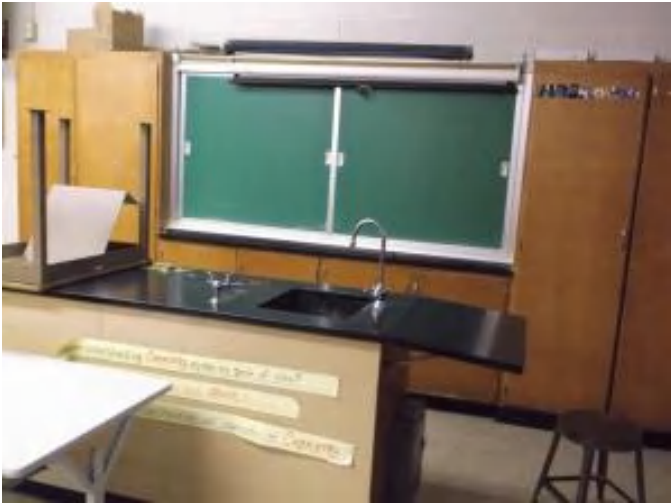
**Location:** Throughout the building

**System: D2010 - Plumbing Fixtures**

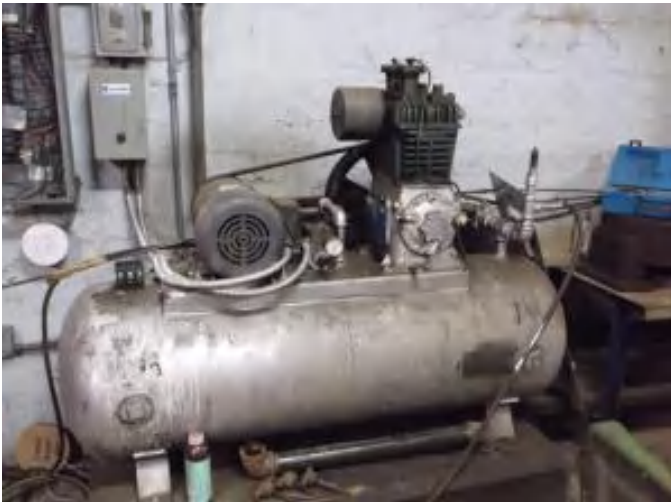
**Location:** throughout the building

**System: D3060 - Controls & Instrumentation**

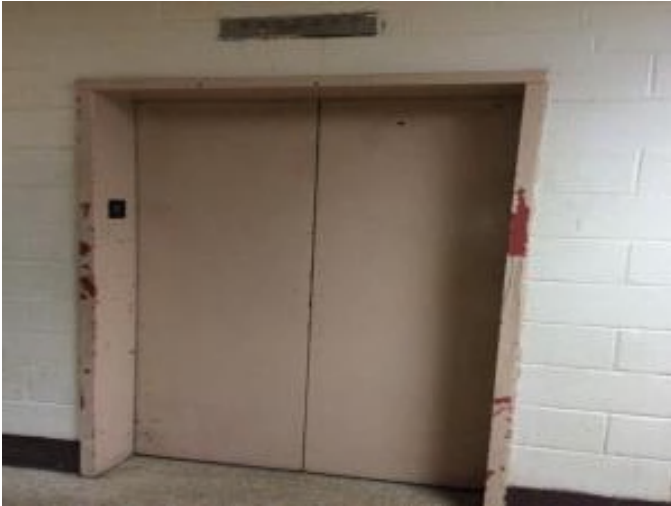
**Location:** corridors

**System: D1010 - Elevators and Lifts**

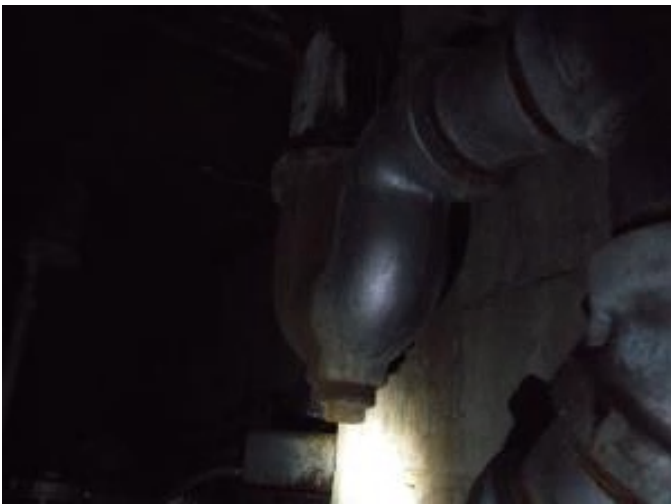
**Location:** Throughout the building

**System: D2030 - Sanitary Waste**

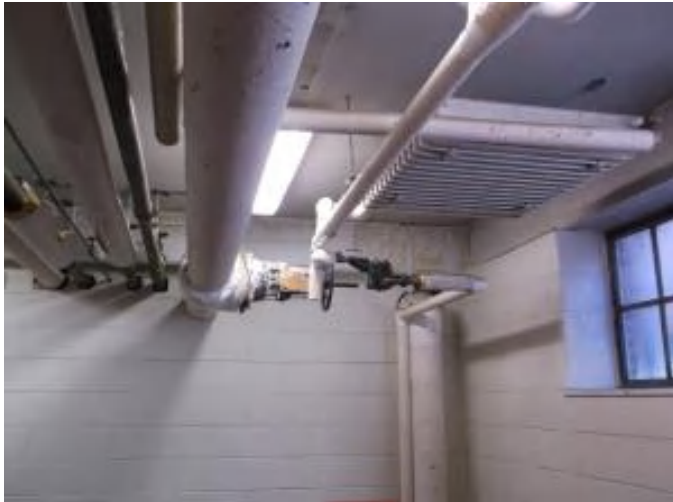
**System: D3040 - Distribution Systems**

**Location:** Throughout the building  
**Distress:** Beyond Service Life  
**Category:** 3 - Operations / Maint.  
**Priority:** 3 - Response Time (3-4 yrs)  
**Correction:** Perform testing to identify and replace damaged steam and condensate piping.  
**Qty:** 313,000.00  
**Unit of Measure:** S.F.  
**Estimate:** \$2,961,096.69  
**Assessor Name:** System  
**Date Created:** 03/02/2016

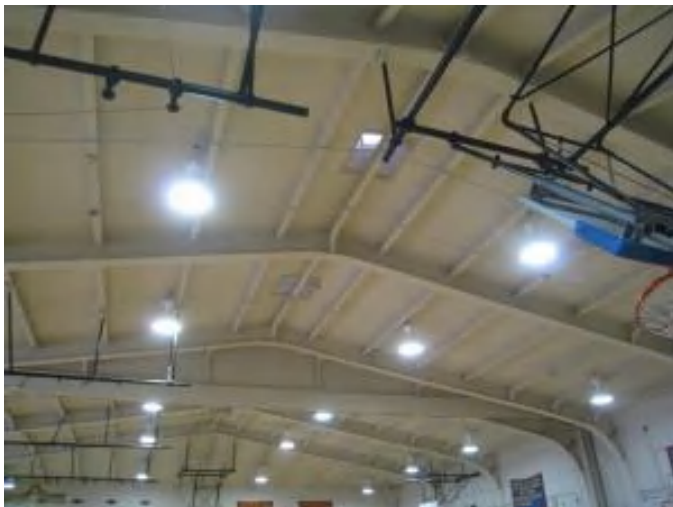
**System: D3040 - Distribution Systems**

**Location:** Roof  
**Distress:** Beyond Service Life  
**Category:** 3 - Operations / Maint.  
**Priority:** 3 - Response Time (3-4 yrs)  
**Correction:** Replace HVAC unit for Gymnasium (single station)  
**Qty:** 12,000.00  
**Unit of Measure:** S.F.  
**Estimate:** \$454,950.74  
**Assessor Name:** System  
**Date Created:** 03/02/2016

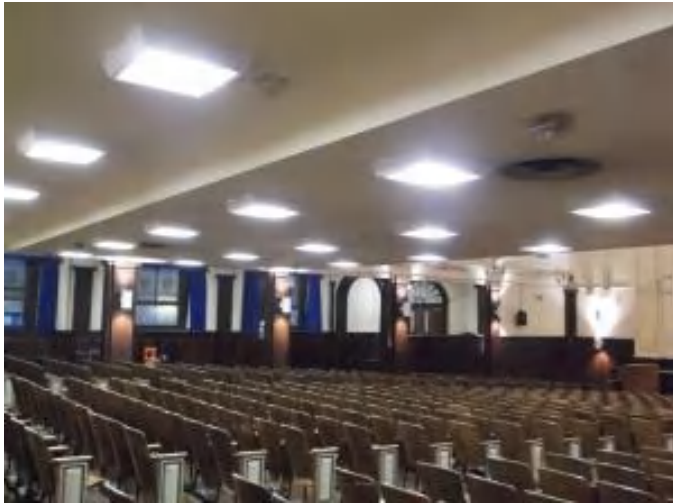
**Location:** Roof

**System: D3040 - Distribution Systems**

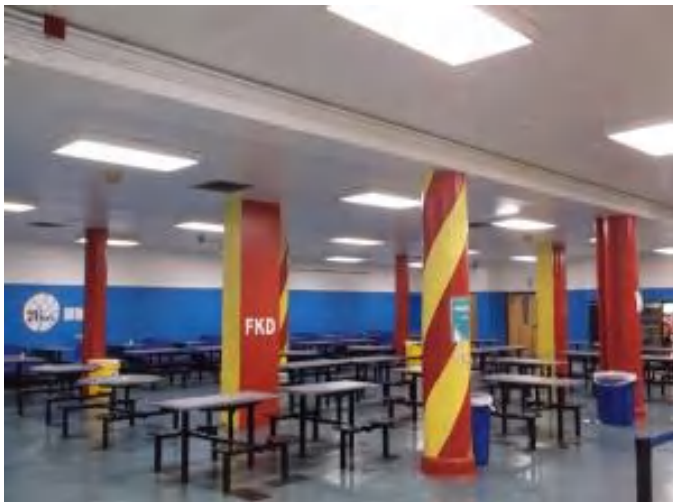
**Location:** Roof

**System: D3040 - Distribution Systems**

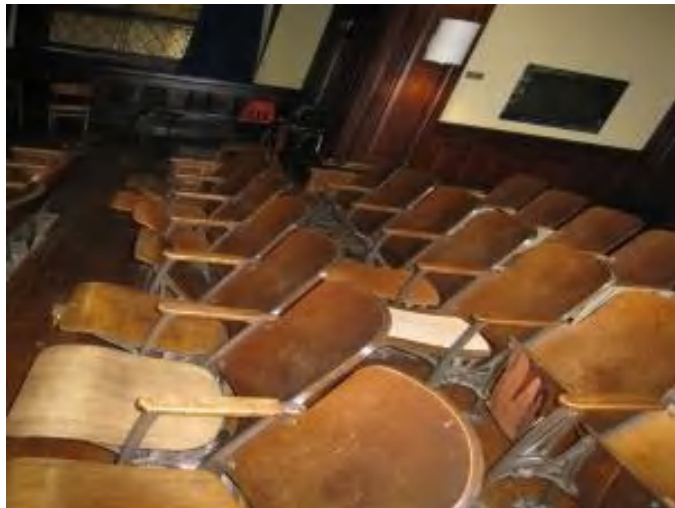
**Location:** auditorium seating

**System: E2010 - Fixed Furnishings**

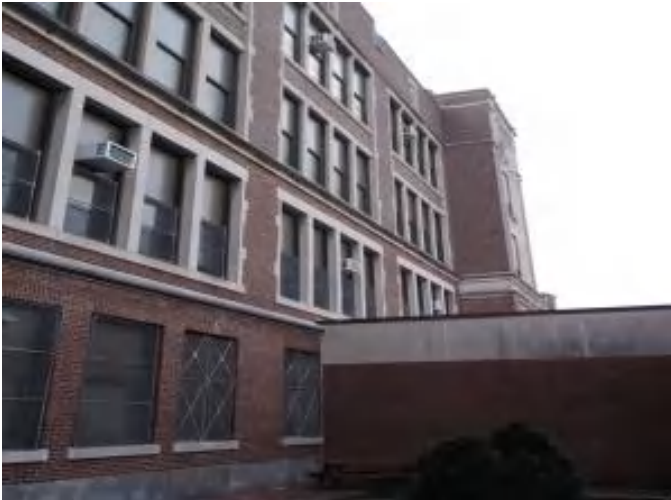
**Location:** Throughout the building

**System: D3030 - Cooling Generating Systems**

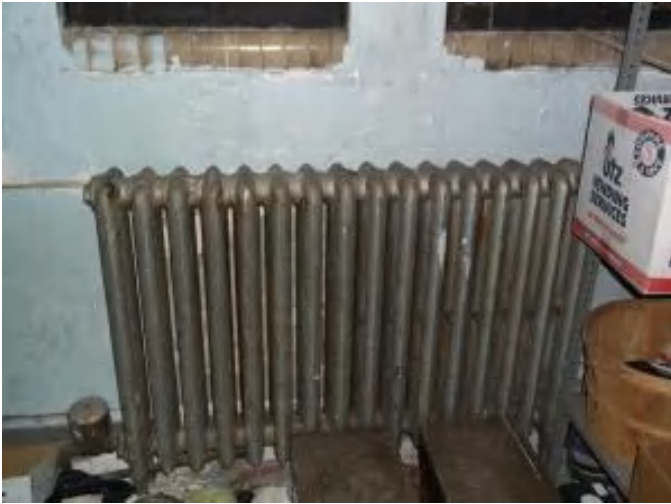
**System: D3040 - Distribution Systems**

**Location:** Throughout the building  
**Distress:** Beyond Service Life  
**Category:** 3 - Operations / Maint.  
**Priority:** 5 - Response Time (> 5 yrs)  
**Correction:** Replace finned tube radiation terminals (per 100 LF)  
**Qty:** 500.00  
**Unit of Measure:** L.F.  
**Estimate:** \$201,770.71  
**Assessor Name:** System  
**Date Created:** 03/02/2016

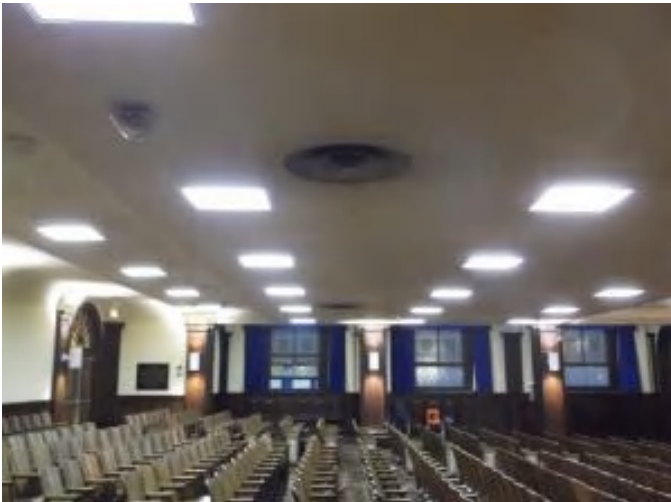
**System: D4010 - Sprinklers**

**Location:** throughout the building  
**Distress:** Beyond Service Life  
**Category:** 3 - Operations / Maint.  
**Priority:** 5 - Response Time (> 5 yrs)  
**Correction:** Install a fire protection sprinkler system  
**Qty:** 313,000.00  
**Unit of Measure:** S.F.  
**Estimate:** \$4,477,606.15  
**Assessor Name:** System  
**Date Created:** 03/02/2016

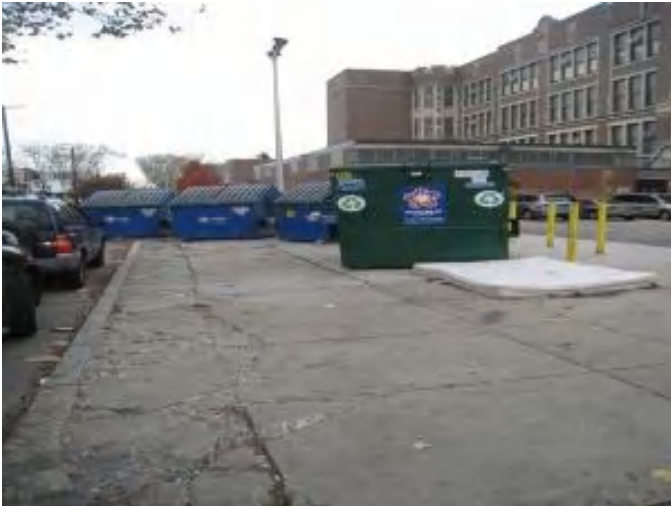
**Location:** dumpster area - Oakland St.

#### System: G2030 - Pedestrian Paving

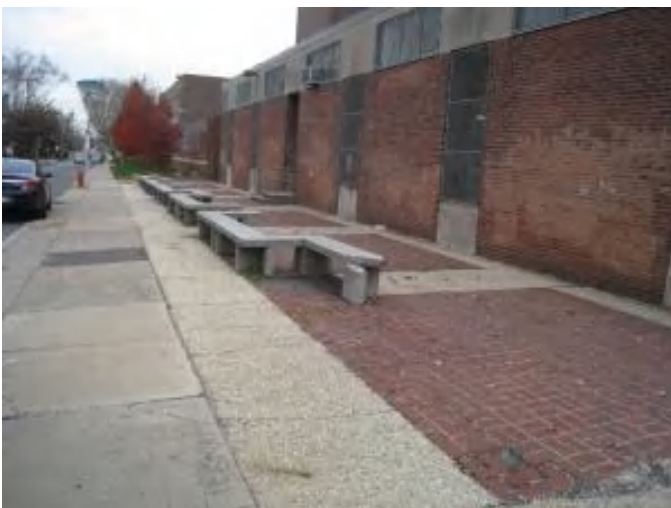
**Location:** sidewalks

#### System: G2030 - Pedestrian Paving

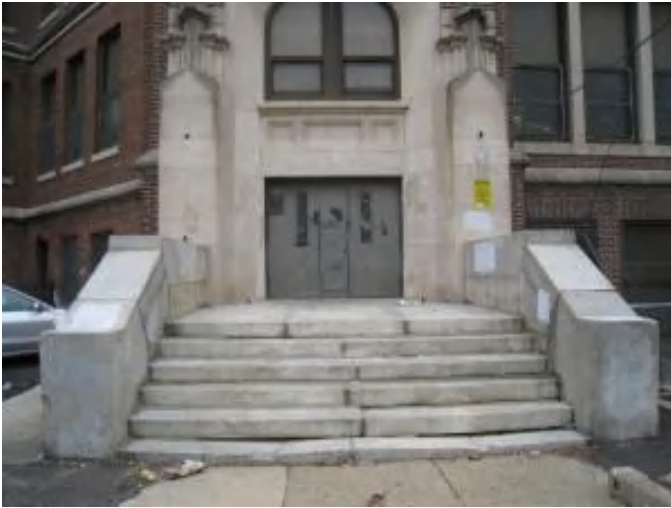
**Location:** exterior stairs

**System: G2030 - Pedestrian Paving**

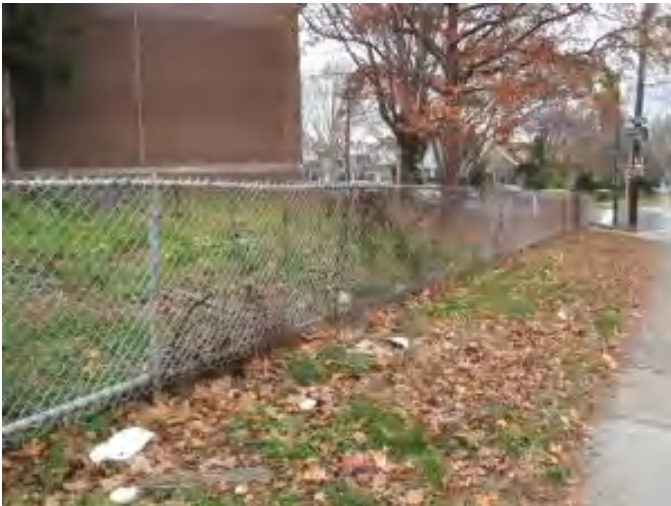
**Location:** site fence

**System: G2040 - Site Development**

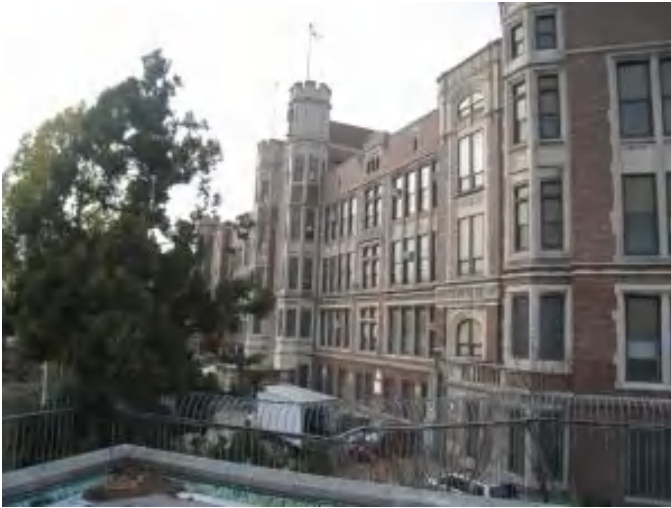
**Location:** roof and ground fencing

**System: G2040 - Site Development**

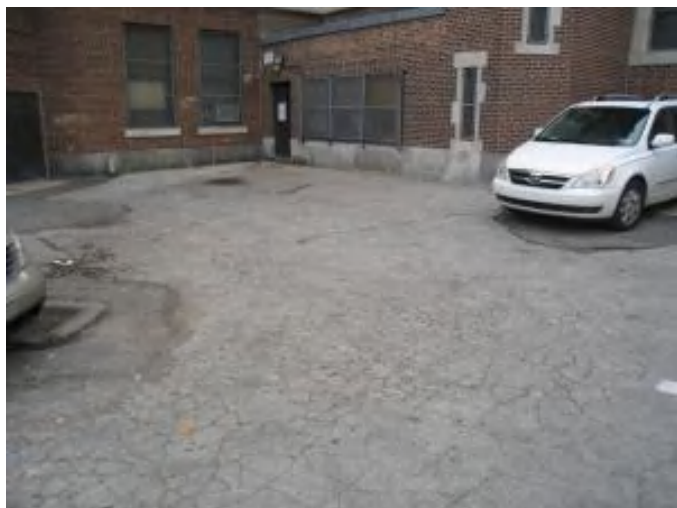
**Location:** parking lots around building

**System: G2020 - Parking Lots**
