## Facility Condition Assessment Summary Report

### Franklin Elementary School

School District of Philadelphia  
**S728001;Franklin ES**  
Final  
**Site Assessment Report**  
January 31, 2017

## Site Assessment Report

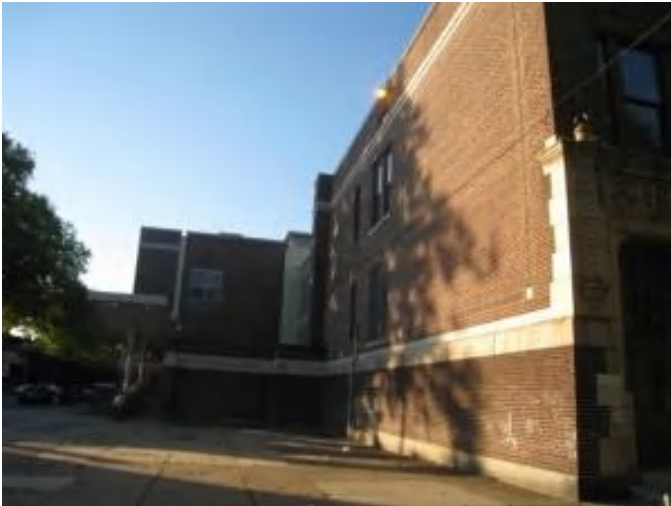
#### System: B2010 - Exterior Walls

**Location:** exterior basement - at grade

**Distress:** Appearance

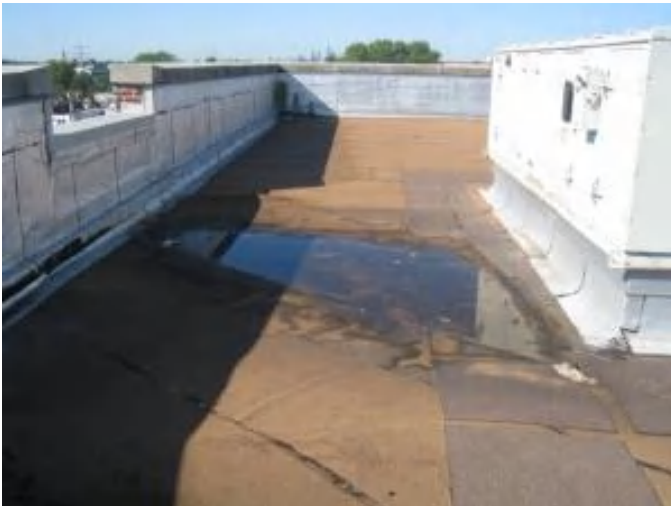
#### System: B3010105 - Built-Up

**Location:** roof

**Distress:** Failing

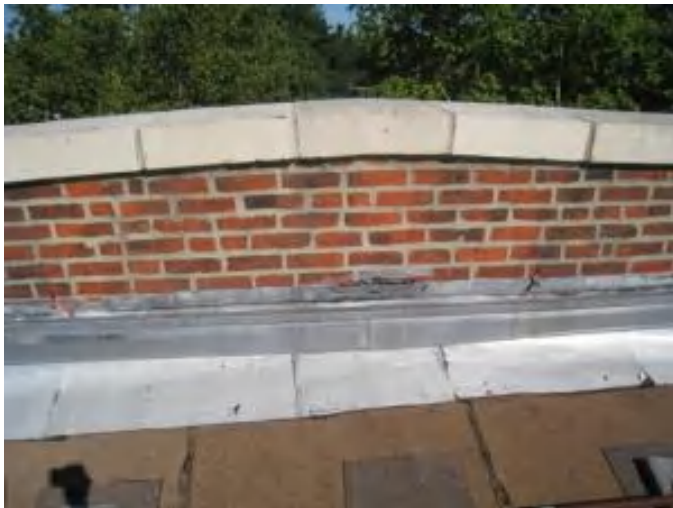
**System: B3010105 - Built-Up**

**Location:** roof

**Distress:** Failing

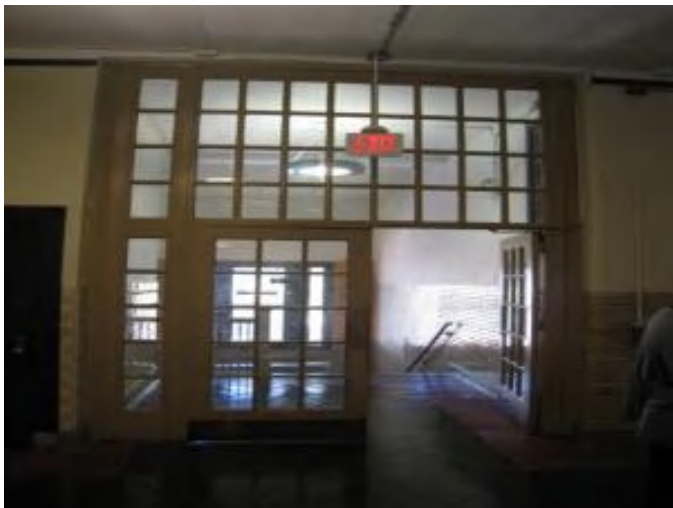
**System: C1010 - Partitions**

**Location:** stairs / corridors

**Distress:** Building / MEP Codes

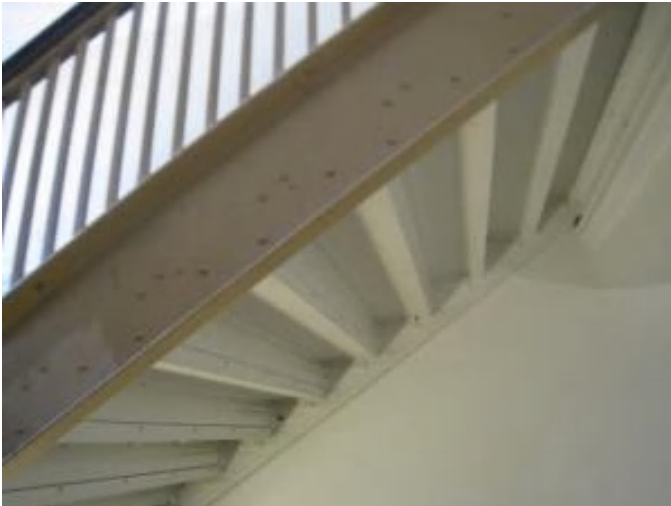
**System: C2010 - Stair Construction**

**Location:** orig bldg stairways  
**Distress:** Building / MEP Codes  
**Category:** 2 - Code Compliance  
**Priority:** 1 - Response Time (< 2 yr)  
**Correction:** Replace inadequate or install proper stair railing - select appropriate material  
**Qty:** 200.00  
**Unit of Measure:** L.F.  
**Estimate:** \$93,618.16  
**Assessor Name:** Craig Anding  
**Date Created:** 09/07/2015

**Notes:** Remove and replace stairway handrails and guards with code compliant systems (2) 3 story + (2) 1 story;=25x8=200lf handrails wall mounted and 200 lf railings with balustrade centremounted

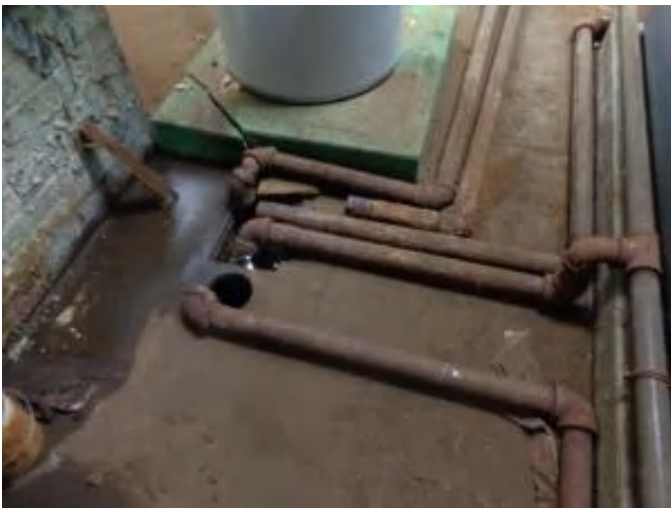
**System: D2030 - Sanitary Waste**

**Location:** Throughout the building  
**Distress:** Beyond Service Life  
**Category:** 3 - Operations / Maint.  
**Priority:** 1 - Response Time (< 2 yr)  
**Correction:** Replace damaged sanitary piping (per LF)  
**Qty:** 500.00  
**Unit of Measure:** L.F.  
**Estimate:** \$118,494.44  
**Assessor Name:** Craig Anding  
**Date Created:** 10/23/2015

**Notes:** Replace as needed the sanitary system throughout the original building.

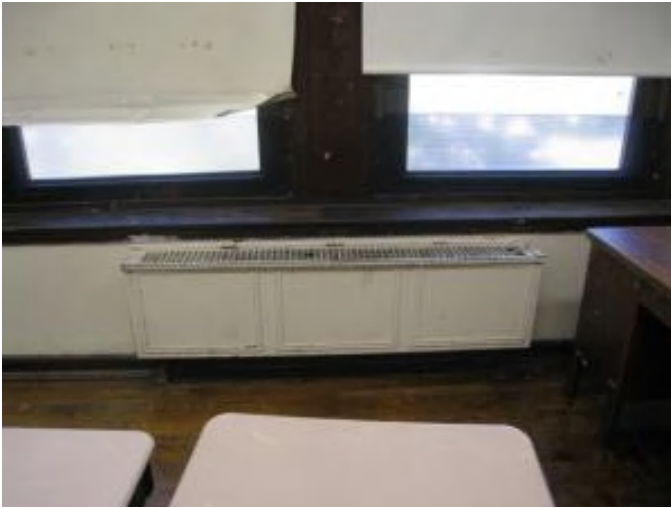
**System: D3040 - Distribution Systems**

**Location:** Throughout the building

**Distress:** Beyond Service Life

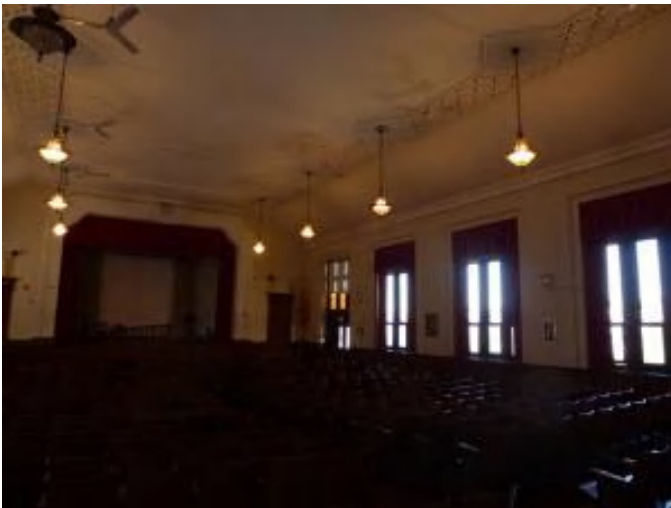
**System: D5020 - Lighting and Branch Wiring**

**Location:** entire building

**Distress:** Damaged

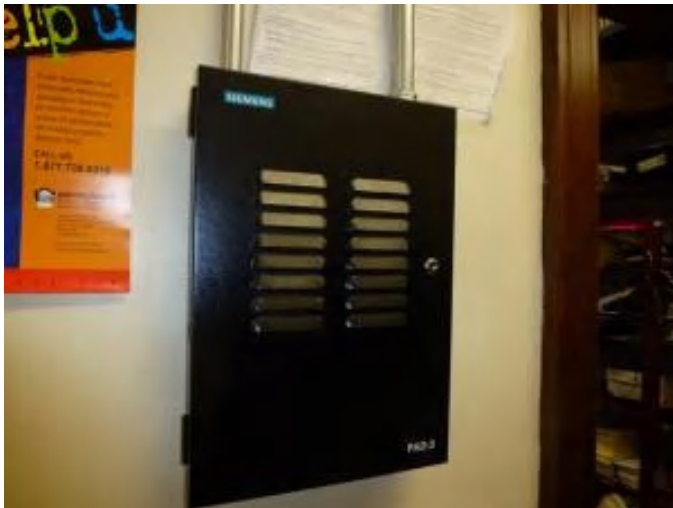
**System: D5030 - Communications and Security**

**Location:** Entire Building  
**Distress:** Beyond Service Life  
**Category:** 3 - Operations / Maint.  
**Priority:** 1 - Response Time (< 2 yr)  
**Correction:** Replace fire alarm system  
**Qty:** 1.00  
**Unit of Measure:** S.F.  
**Estimate:** \$382,784.60  
**Assessor Name:** Craig Anding  
**Date Created:** 08/12/2015

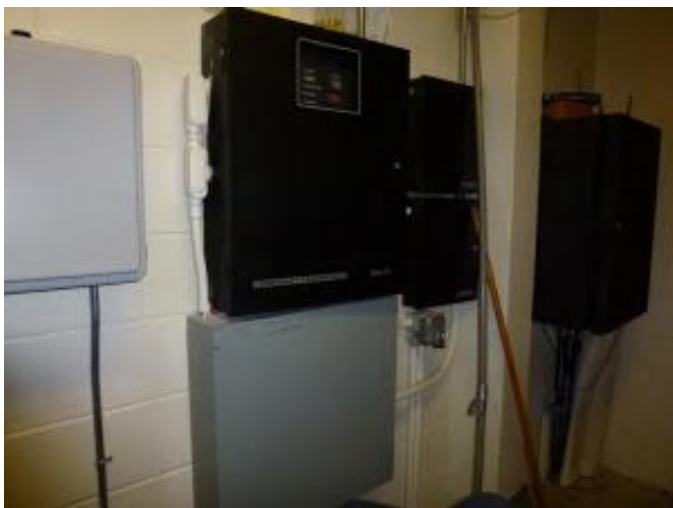
**System: D5030 - Communications and Security**

**Location:** entire building  
**Distress:** Damaged  
**Category:** 3 - Operations / Maint.  
**Priority:** 1 - Response Time (< 2 yr)  
**Correction:** Add/Replace Clock System or Components  
**Qty:** 1.00  
**Unit of Measure:** Ea.  
**Estimate:** \$203,719.03  
**Assessor Name:** Craig Anding  
**Date Created:** 08/12/2015

**Notes:** Replace existing wireless clock system with new wireless clock system.

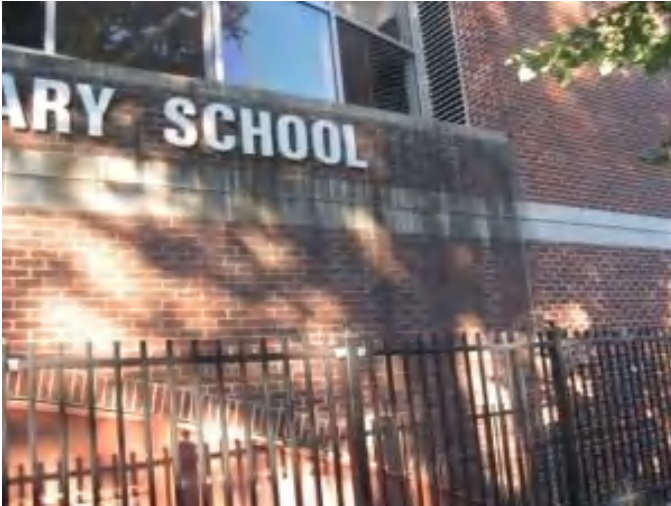
**System: B2010 - Exterior Walls**

**Location:** exterior

**Distress:** Appearance

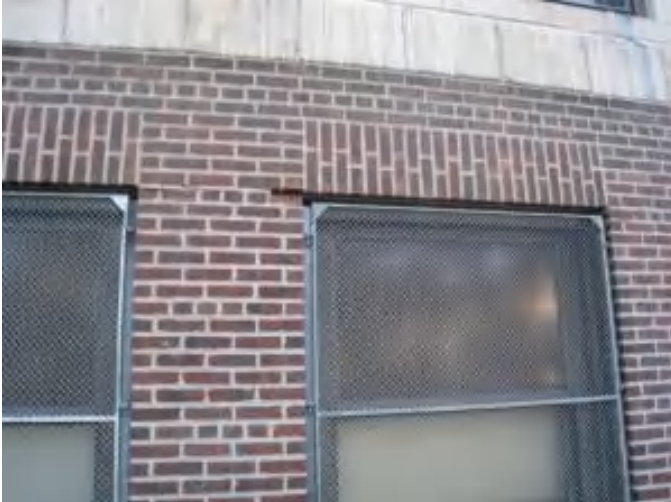
**System: B2010 - Exterior Walls**

**Location:** exterior

**Distress:** Failing

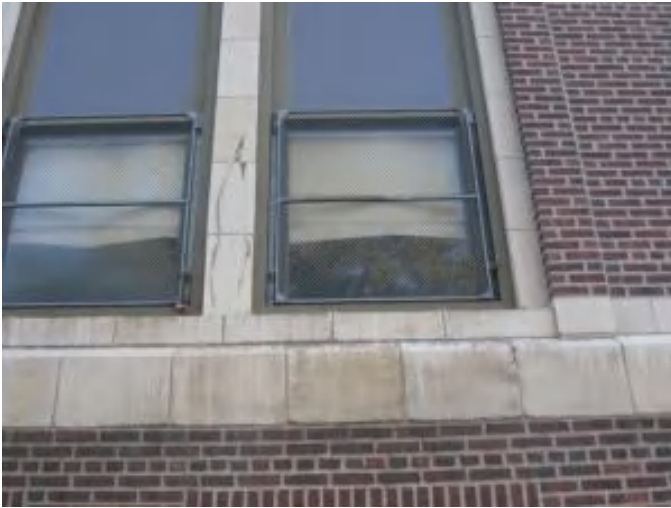
**System: B2010 - Exterior Walls**

**Location:** exterior  
**Distress:** Failing  
**Category:** 3 - Operations / Maint.  
**Priority:** 2 - Response Time (2-3 yrs)  
**Correction:** Repoint horizontal or vertical joints at limestone coping  
**Qty:** 200.00  
**Unit of Measure:** L.F.  
**Estimate:** \$3,412.69  
**Assessor Name:** Craig Anding  
**Date Created:** 09/06/2015

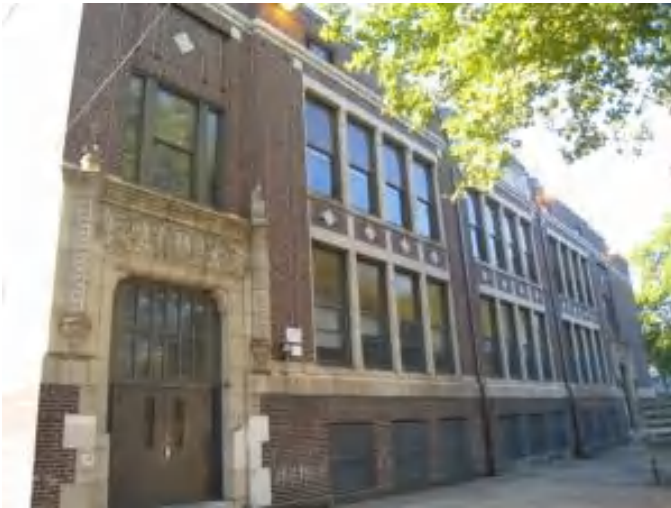
**System: B2020 - Exterior Windows**

**Location:** exterior  
**Distress:** Beyond Service Life  
**Category:** 3 - Operations / Maint.  
**Priority:** 2 - Response Time (2-3 yrs)  
**Correction:** Remove and replace aluminum windows - pick the appropriate size and style and insert the number of units  
**Qty:** 1.00  
**Unit of Measure:** Ea.  
**Estimate:** \$1,002,415.22  
**Assessor Name:** Craig Anding  
**Date Created:** 09/06/2015

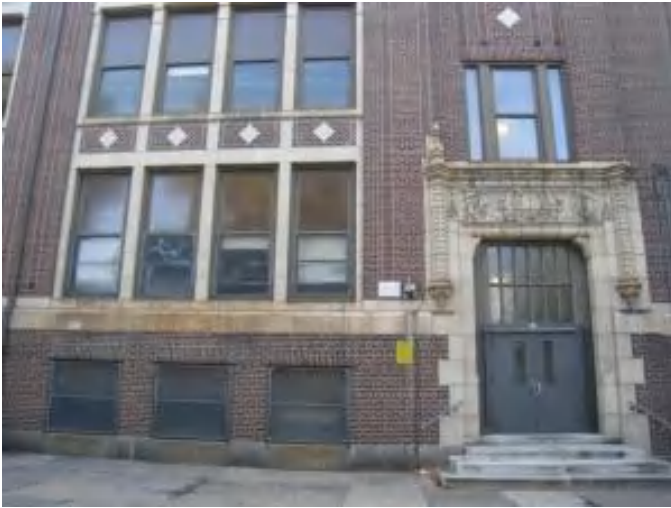
**System: B2030 - Exterior Doors**

**Location:** exterior  
**Distress:** Appearance  
**Category:** 3 - Operations / Maint.  
**Priority:** 2 - Response Time (2-3 yrs)  
**Correction:** Refinish and repaint exterior doors - per leaf  
**Qty:** 16.00  
**Unit of Measure:** Ea.  
**Estimate:** \$9,556.09  
**Assessor Name:** Craig Anding  
**Date Created:** 09/06/2015

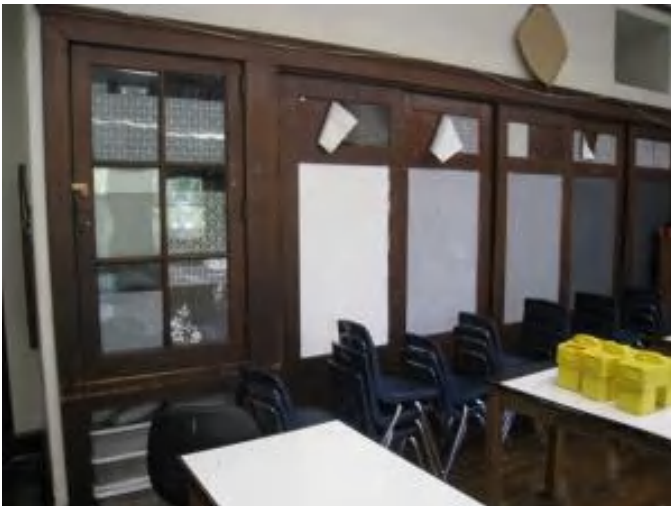
**System: C1010 - Partitions**

**Location:** classrooms  
**Distress:** Failing  
**Category:** 3 - Operations / Maint.  
**Priority:** 2 - Response Time (2-3 yrs)  
**Correction:** Folding partition inoperable - remove and replace - select quality  
**Qty:** 1,800.00  
**Unit of Measure:** S.F.  
**Estimate:** \$28,547.88  
**Assessor Name:** Craig Anding  
**Date Created:** 09/07/2015

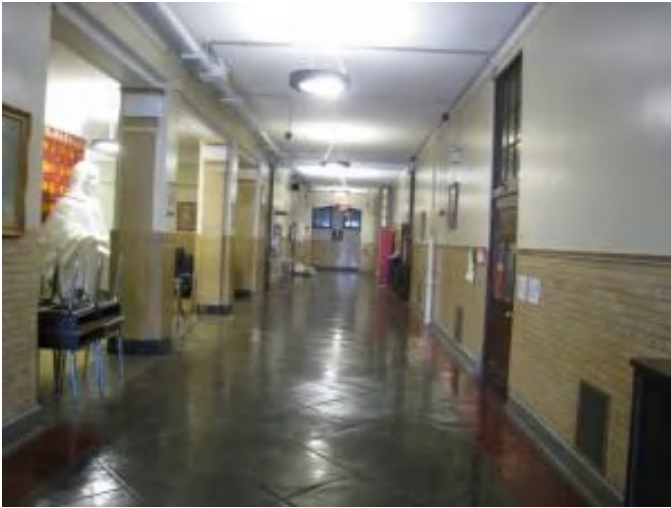
**System: C1010 - Partitions**

**Location:** corridors and stairs

**Distress:** Building / MEP Codes

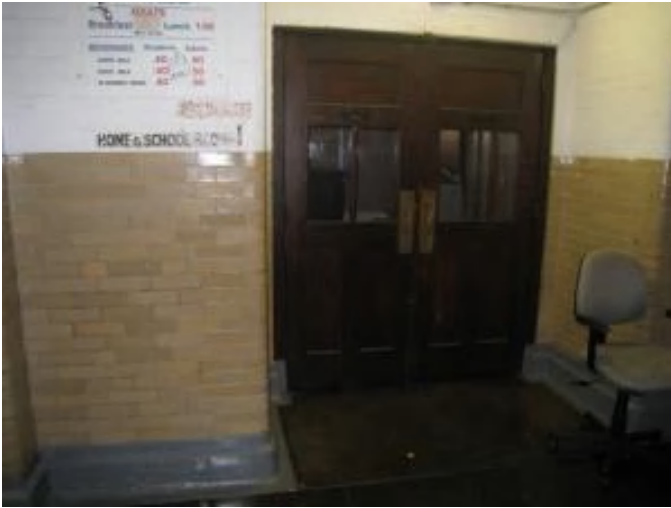
**System: C1020 - Interior Doors**

**Location:** basement  
**Distress:** Beyond Service Life  
**Category:** 3 - Operations / Maint.  
**Priority:** 2 - Response Time (2-3 yrs)  
**Correction:** Remove and replace hollow metal frames and doors  
**Qty:** 18.00  
**Unit of Measure:** Ea.  
**Estimate:** \$91,403.77  
**Assessor Name:** Craig Anding  
**Date Created:** 09/07/2015

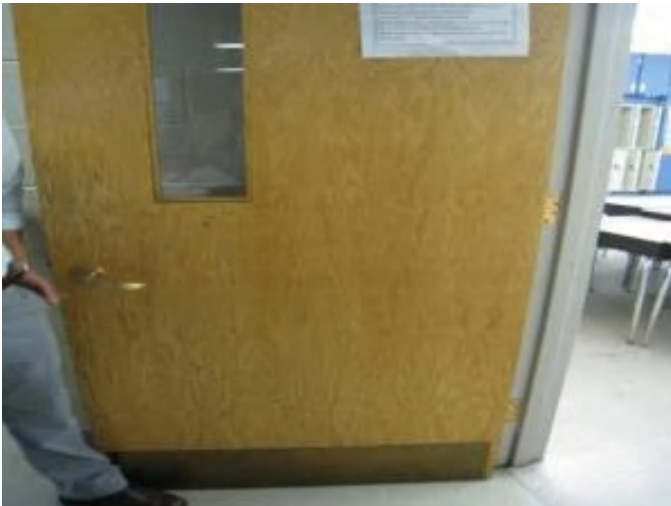
**System: C1020 - Interior Doors**

**Location:** classrooms in addition  
**Distress:** Appearance  
**Category:** 3 - Operations / Maint.  
**Priority:** 2 - Response Time (2-3 yrs)  
**Correction:** Refinish interior doors  
**Qty:** 50.00  
**Unit of Measure:** Ea.  
**Estimate:** \$41,409.15  
**Assessor Name:** Craig Anding  
**Date Created:** 09/07/2015

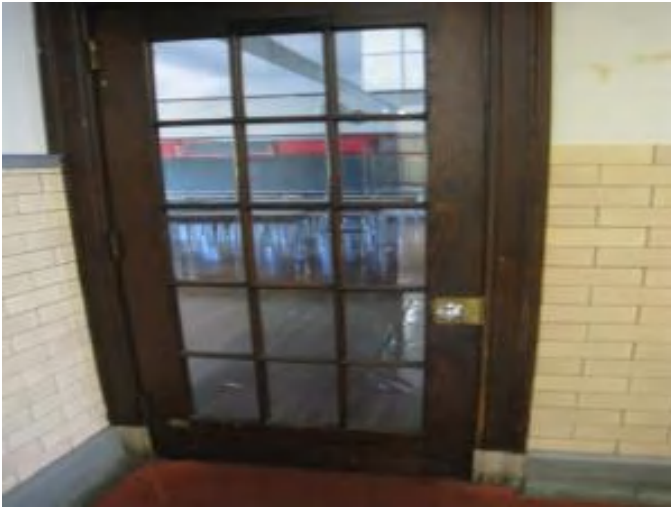
**System: C1020 - Interior Doors**

**Location:** all classrooms and offices  
**Distress:** Building / MEP Codes  
**Category:** 2 - Code Compliance  
**Priority:** 2 - Response Time (2-3 yrs)  
**Correction:** Provide security hardware for classroom and office doors  
**Qty:** 50.00  
**Unit of Measure:** Ea.  
**Estimate:** \$11,471.83  
**Assessor Name:** Craig Anding  
**Date Created:** 09/07/2015

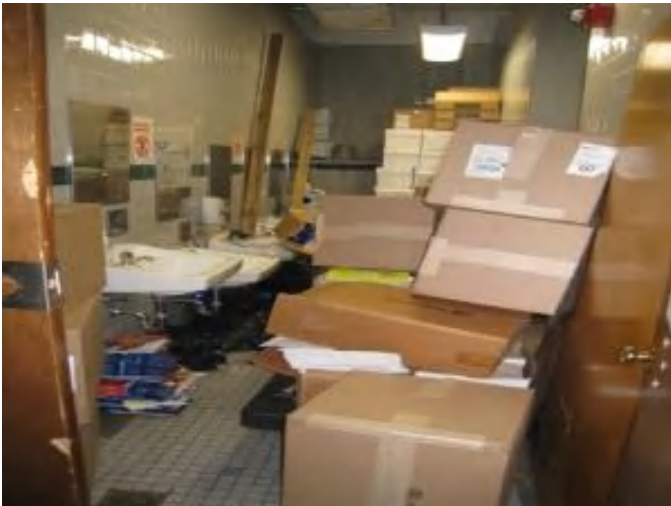
**System: C1030 - Fittings**

**Location:** toilet rooms  
**Distress:** Damaged  
**Category:** 3 - Operations / Maint.  
**Priority:** 2 - Response Time (2-3 yrs)  
**Correction:** Replace toilet accessories - select accessories and quantity  
**Qty:** 6.00  
**Unit of Measure:** Ea.  
**Estimate:** \$17,078.88  
**Assessor Name:** Craig Anding  
**Date Created:** 09/07/2015

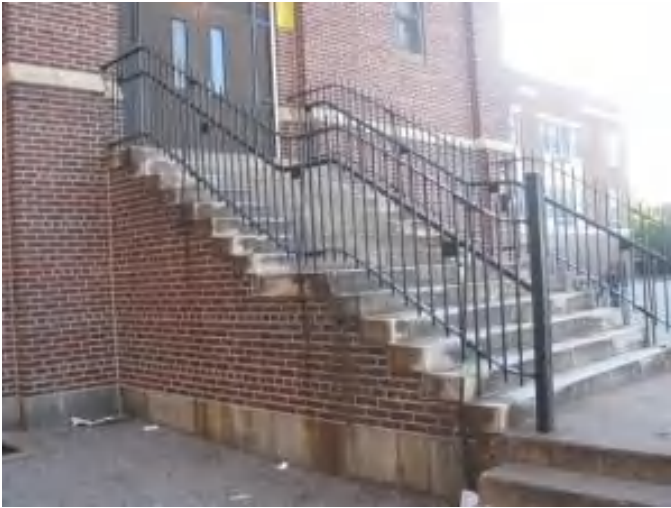
**System: C2010 - Stair Construction**

**Location:** exterior stairs

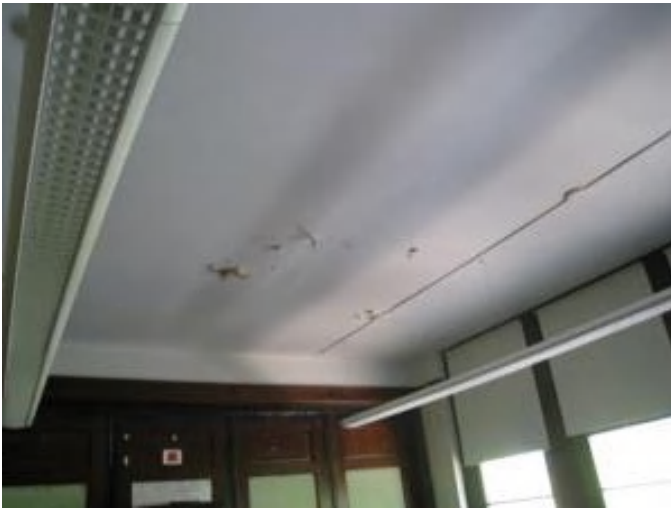
**System: C3010230 - Paint & Covering**

**Location:** interior walls

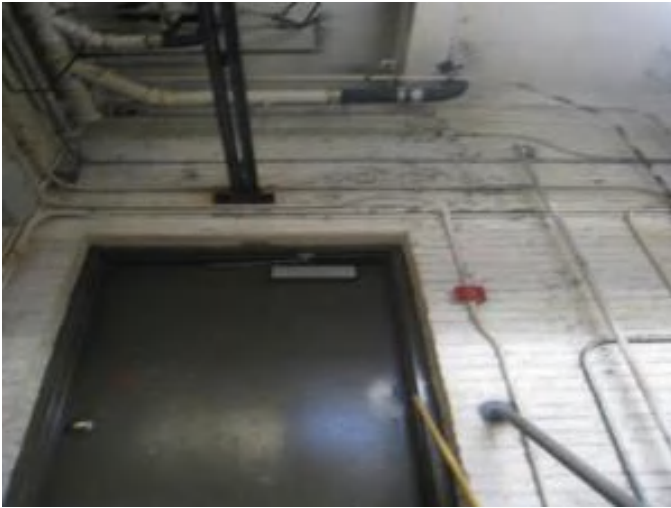
**System: C3010230 - Paint & Covering**

**Location:** basement

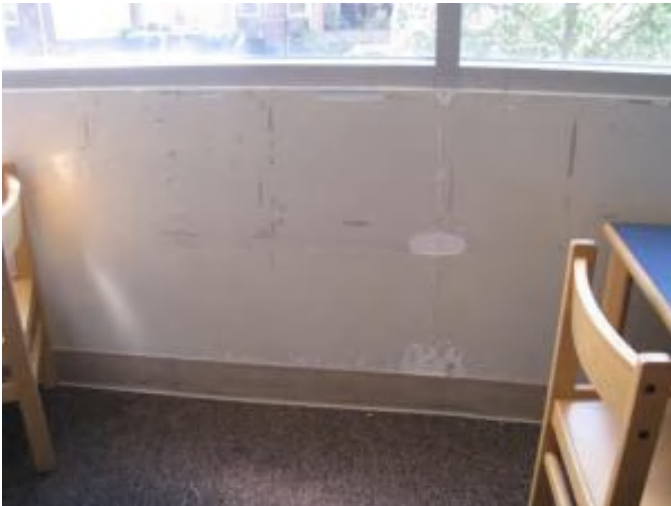
**System: C3010230 - Paint & Covering**

**Location:** library

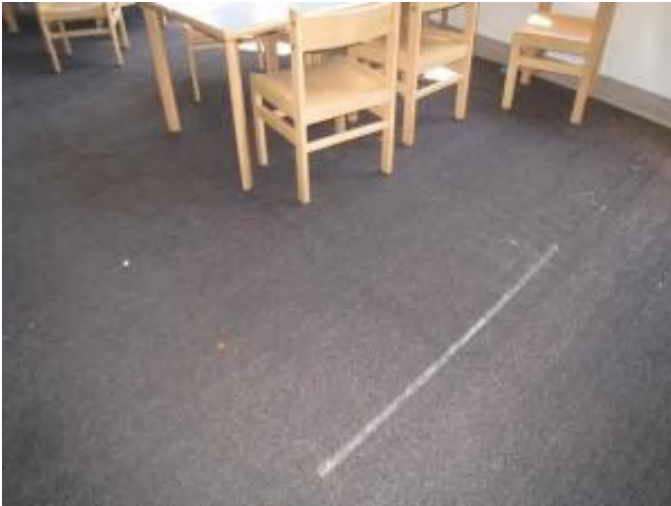
**System: C3020411 - Carpet**

**Location:** office; library

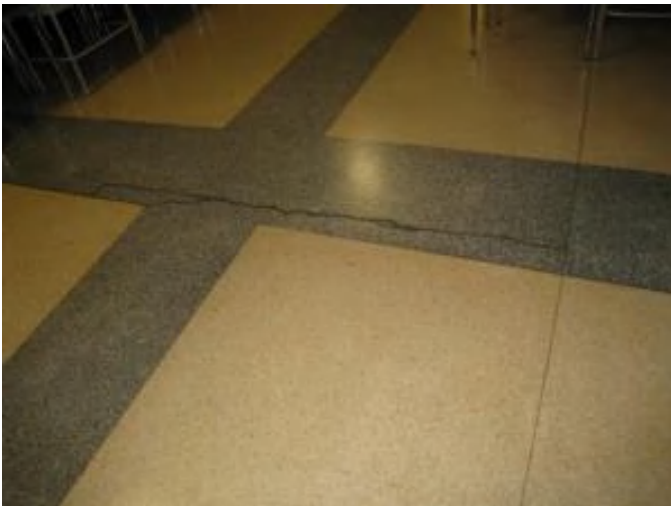
**System: C3020413 - Vinyl Flooring**

**Location:** cafeteria; auditorium lobby

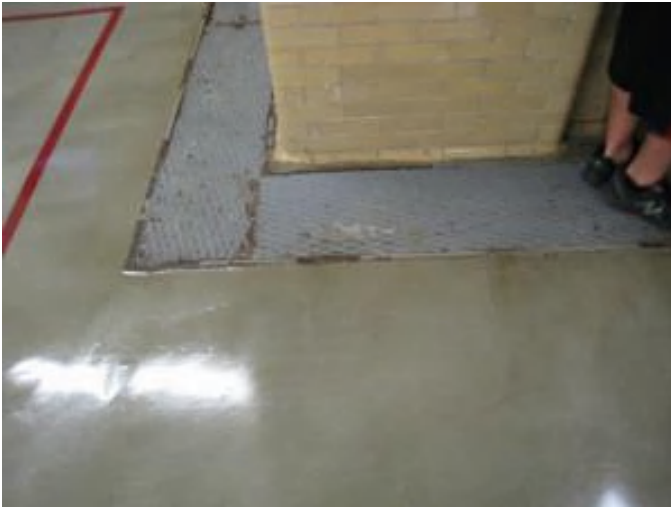
**System: C3020413 - Vinyl Flooring**

**Location:** offices, gym

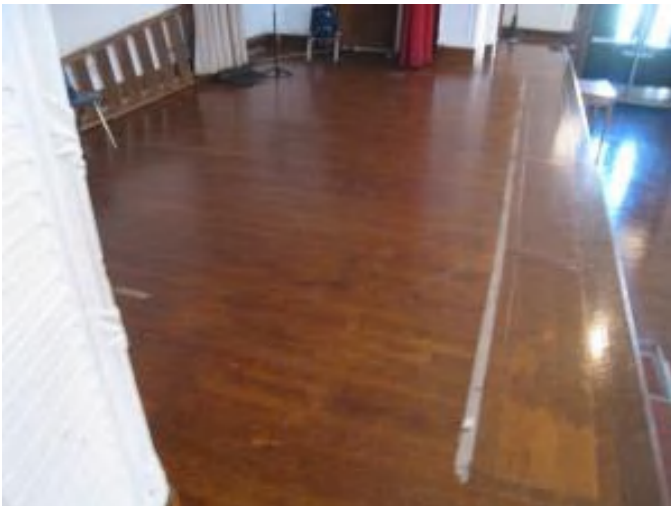
**System: C3020414 - Wood Flooring**

**Location:** classrooms, auditorium, offices

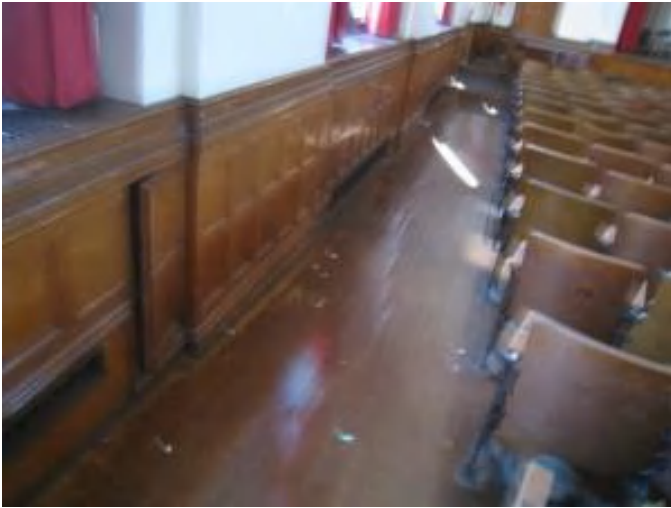
**System: C3020414 - Wood Flooring**

**Location:** auditorium walls

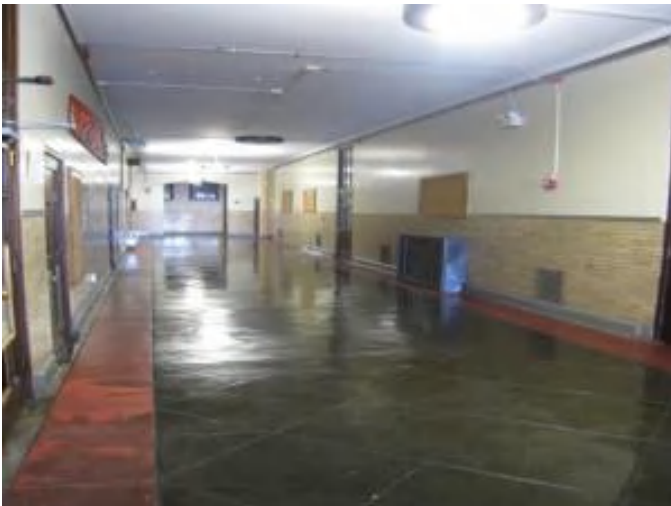
**System: C3020415 - Concrete Floor Finishes**

**Location:** all floors

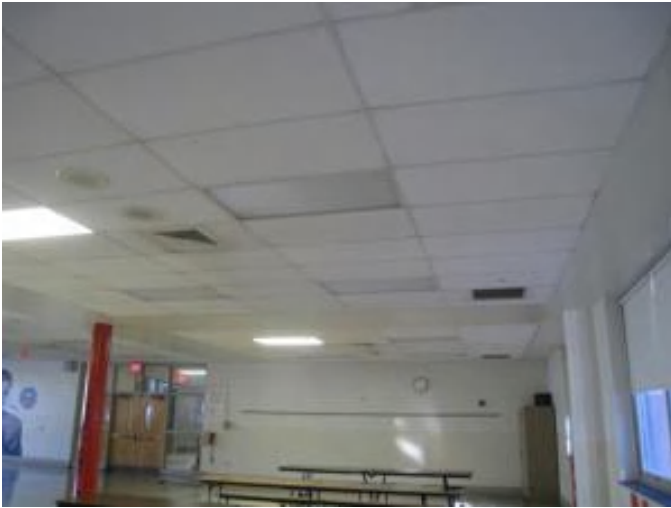
**System: C3030 - Ceiling Finishes**

**Location:** interior  
**Distress:** Damaged  
**Category:** 3 - Operations / Maint.  
**Priority:** 2 - Response Time (2-3 yrs)  
**Correction:** Remove and replace ceiling tiles only in suspended ceiling - pick the proper material  
**Qty:** 6,000.00  
**Unit of Measure:** S.F.  
**Estimate:** \$63,486.22  
**Assessor Name:** Craig Anding  
**Date Created:** 09/07/2015

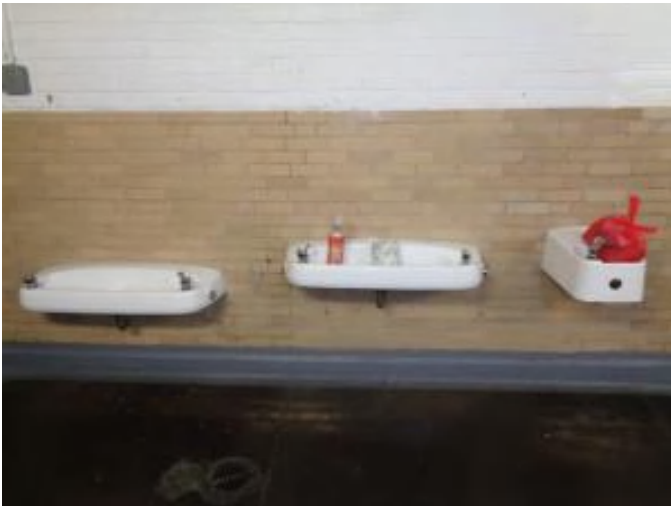
**System: D2010 - Plumbing Fixtures**

**Location:** Throughout the building  
**Distress:** Beyond Service Life  
**Category:** 3 - Operations / Maint.  
**Priority:** 2 - Response Time (2-3 yrs)  
**Correction:** Remove and replace water fountains to meet ADA - includes high and low fountains and new recessed alcove  
**Qty:** 1.00  
**Unit of Measure:** Ea.  
**Estimate:** \$15,692.89  
**Assessor Name:** Craig Anding  
**Date Created:** 10/23/2015

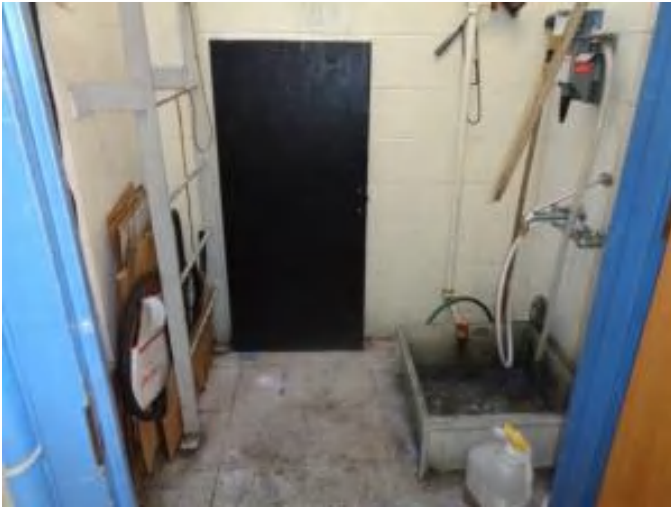
**System: D2010 - Plumbing Fixtures**

**Location:** Throughout the building

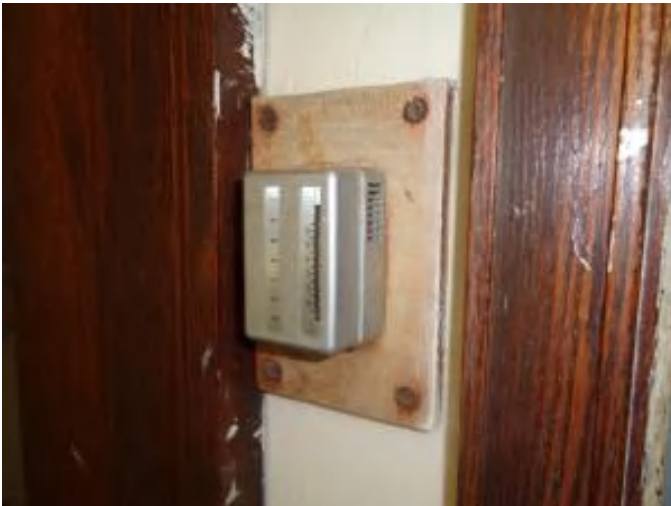
**System: D3060 - Controls & Instrumentation**

**Location:** Throughout the building

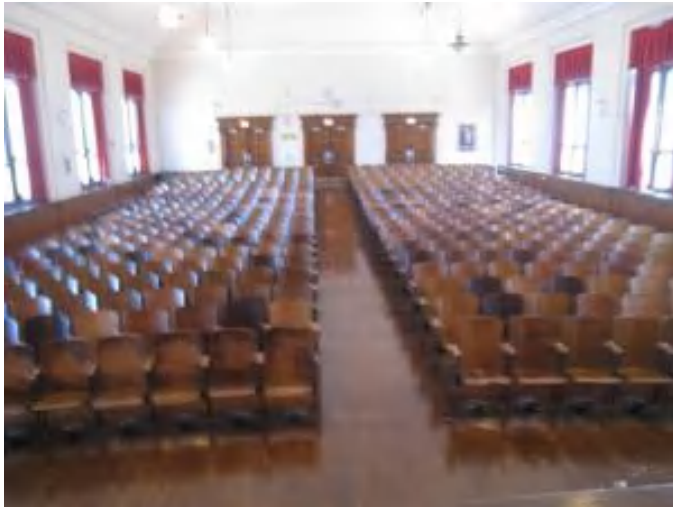
**System: E2010 - Fixed Furnishings**

**Location:** auditorium

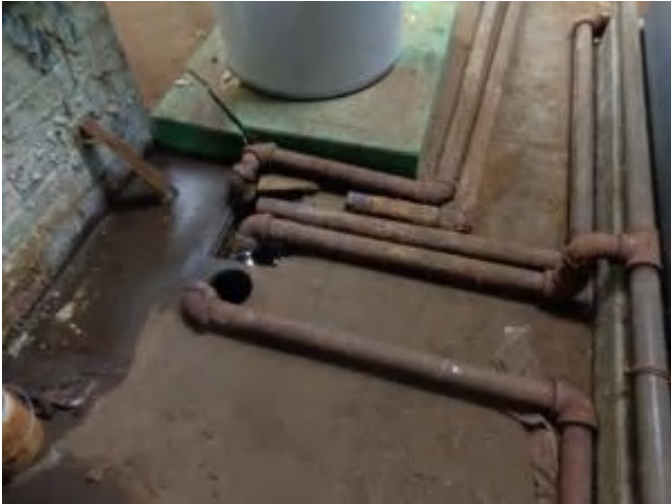
**System: D2030 - Sanitary Waste**

**Location:** Throughout the building

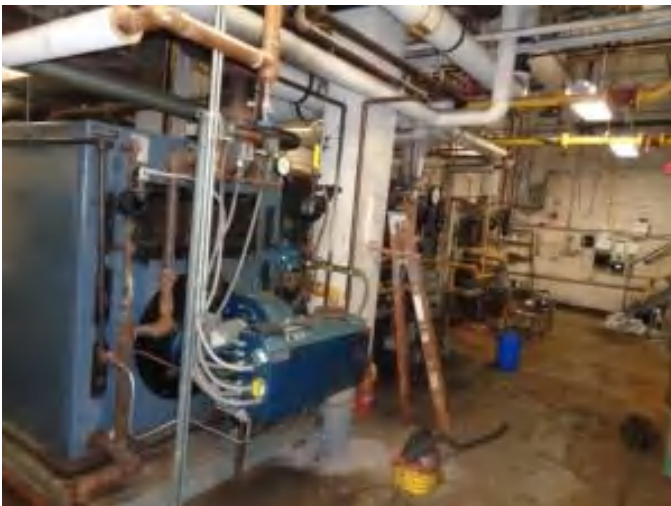
**System: D3020 - Heat Generating Systems**

**Location:** Boiler Mechanical Equipment Room

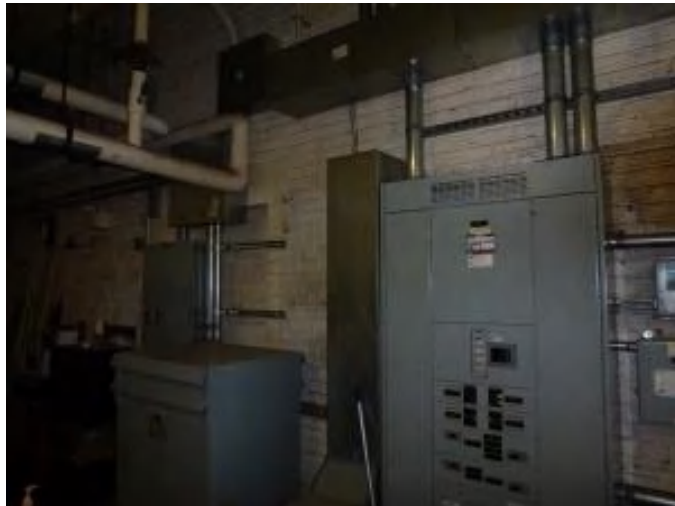
**System: D5010 - Electrical Service/Distribution**

**Location:** Electrical Room

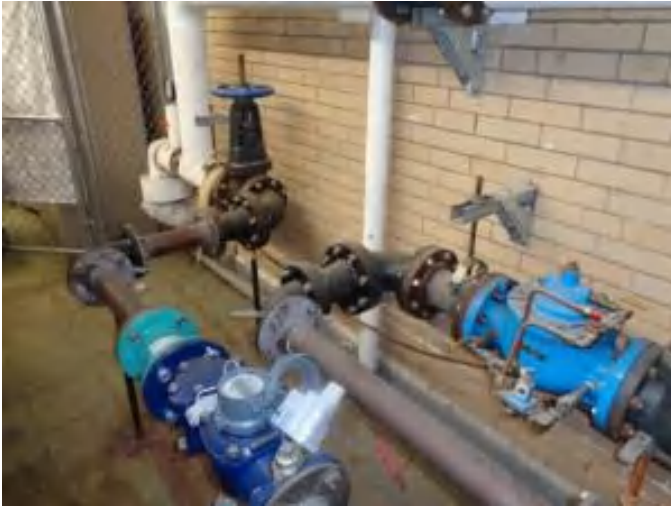
**System: D2020 - Domestic Water Distribution**

**Location:** Throughout the building

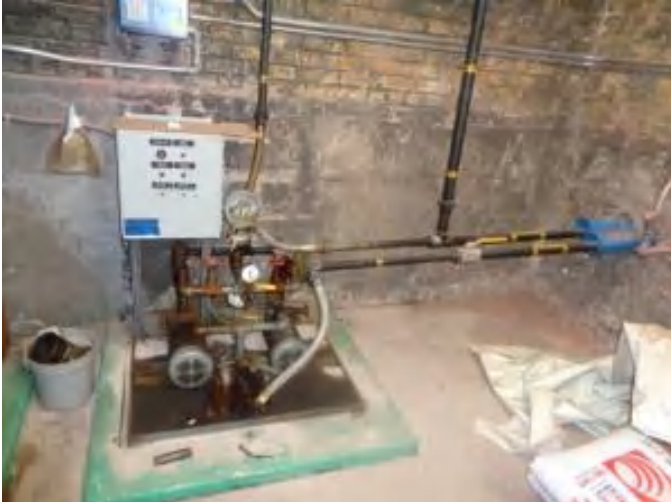
**System: D3020 - Heat Generating Systems**

**Location:** Boiler Mechanical Equipment Room

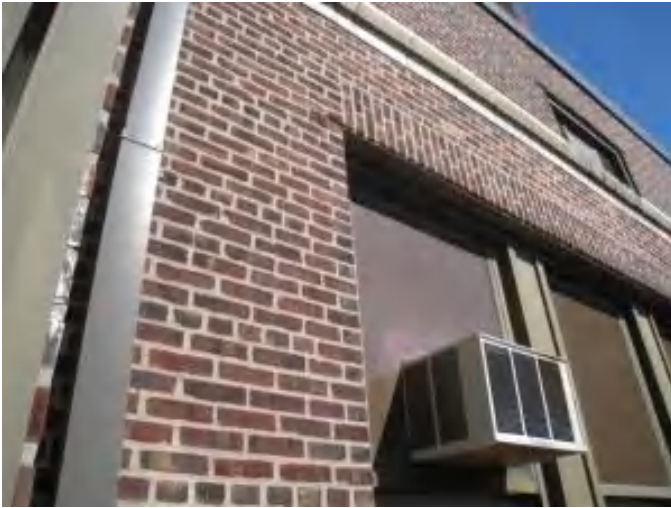
**System: D3030 - Cooling Generating Systems**

**Location:** Adjacent to building

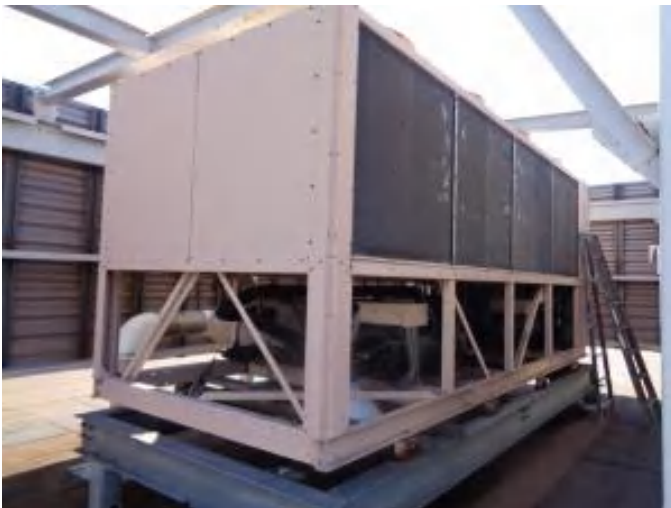
**System: D3030 - Cooling Generating Systems**

**Location:** Adjacent to building

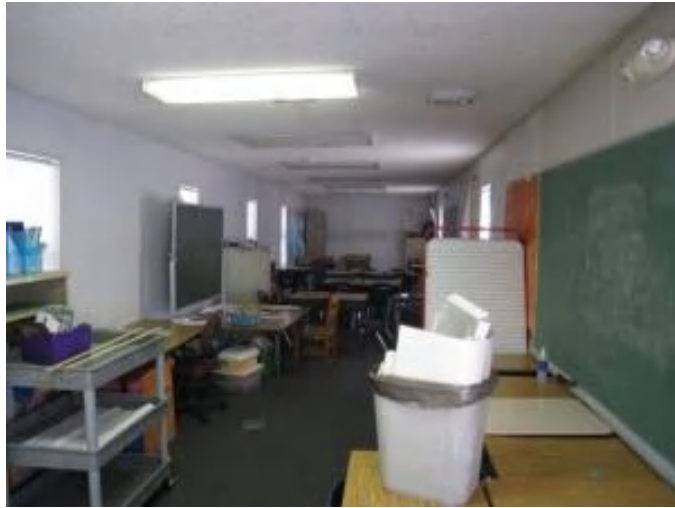
**System: D4010 - Sprinklers**

**Location:** Throughout the building

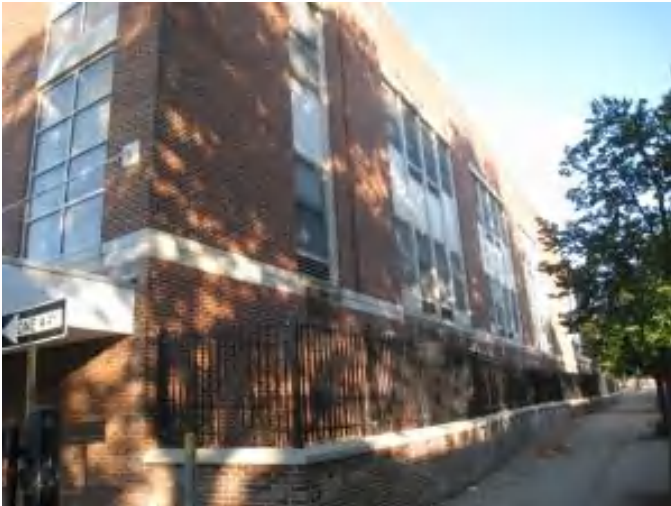
#### System: G2030 - Pedestrian Paving

**Location:** front and side walkways

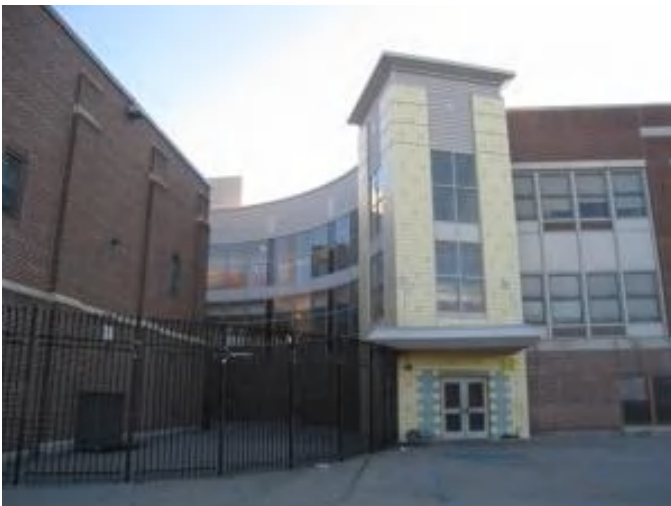
#### System: G2040 - Site Development

**Location:** site fence

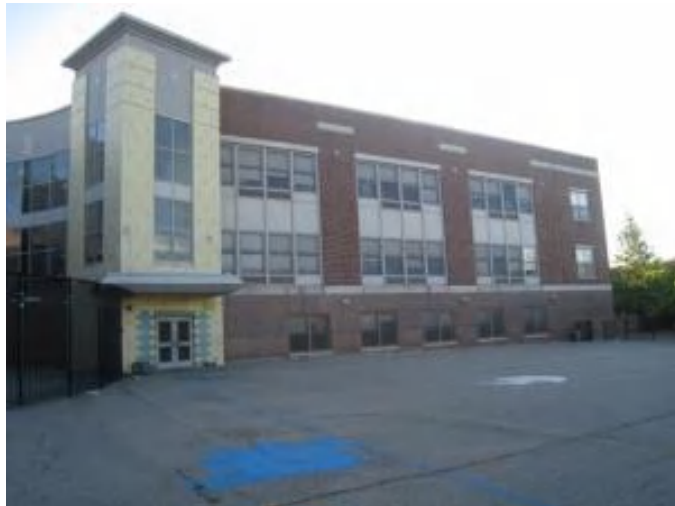
**System: G2020 - Parking Lots**

**Location:** asphalt playground
