Facility Condition Assessment Summary Report

Franklin High School

Site Assessment Report

January 31, 2017

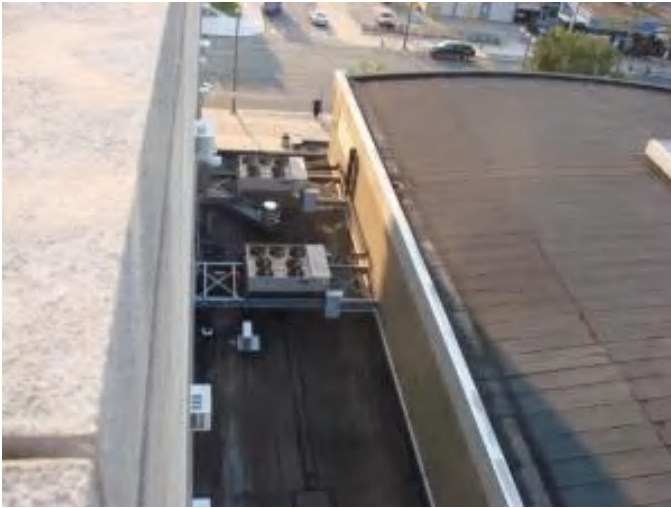
System: B3010105 - Built-Up

Roofing system is a built-up system approximately 20 years old; all roofing and flashing is typically in poor condition with deterioration of the built-up system; leaks have been reported.

Distress: Building Envelope Integrity

Notes: Install all new roofing system including insulation within next 5 to 10 years; tear-down existing roofing; install flashing, and counter flashing

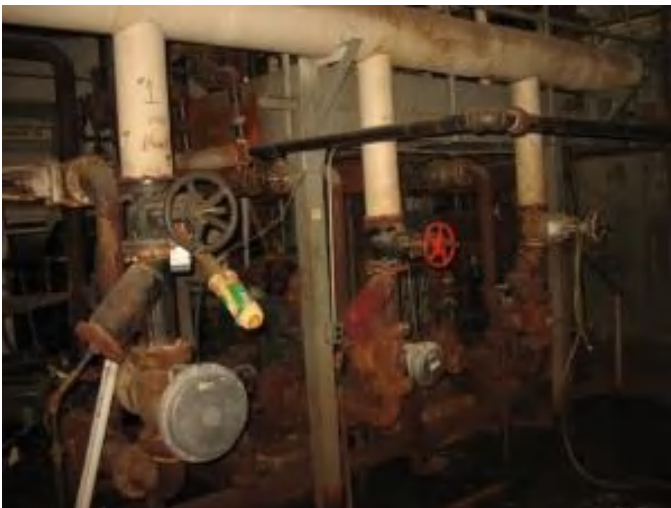
System: D3020 - Heat Generating Systems

Distress: Failing

Notes: Replace four (4) existing hot water distribution pumps and associated valves in the sub-basement.

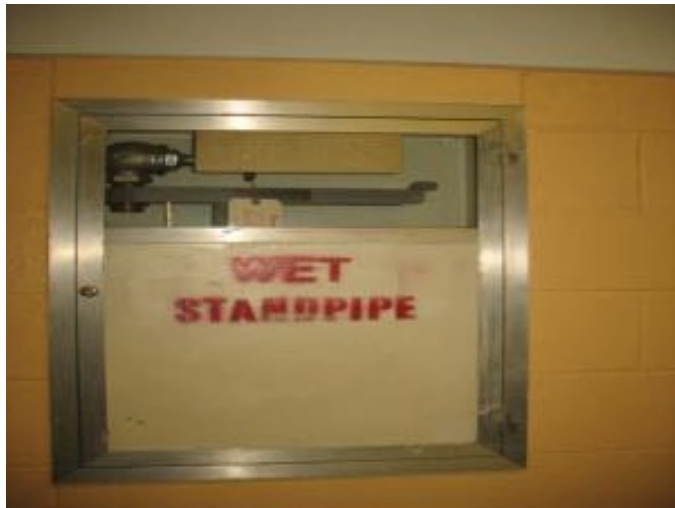
System: D4010 - Sprinklers

Distress: Life Safety / NFPA / PFD

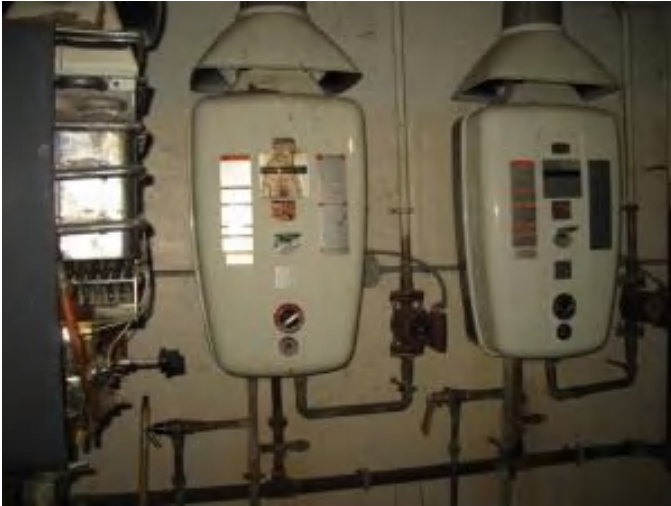
System: D2020 - Domestic Water Distribution

Distress: Beyond Service Life

Notes: Remove and replace the hot two water storage tanks and the three instantaneous water heaters should with a single 400 gallon vertical storage tank supplied by two gas-fired hot water heaters within the next 1-3 years.

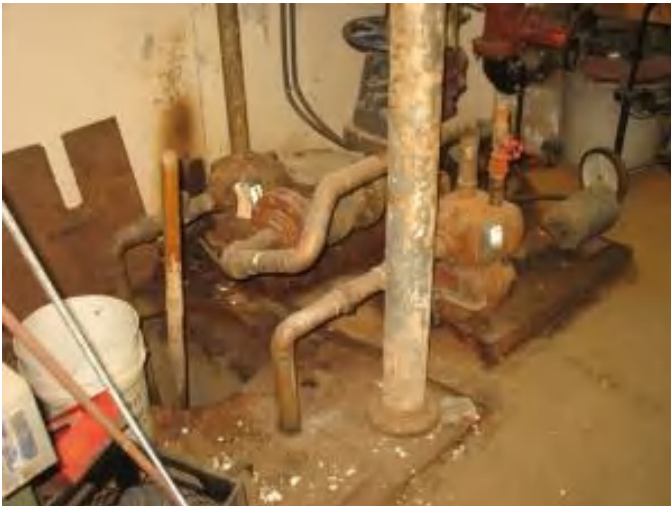
System: D2030 - Sanitary Waste

A sewage ejector pit located in sub-basement receives water from the sub-basement area. It has two 3HP self priming pumps. Significant amounts of rust can be seen on the pump system and it should be replaced to prevent flooding of the sub-basement. The pit is not sealed tightly, but should be.

Distress: Beyond Service Life

Notes: Replace existing sewage ejector system and piping in the basement as it appears beyond its useful service life.

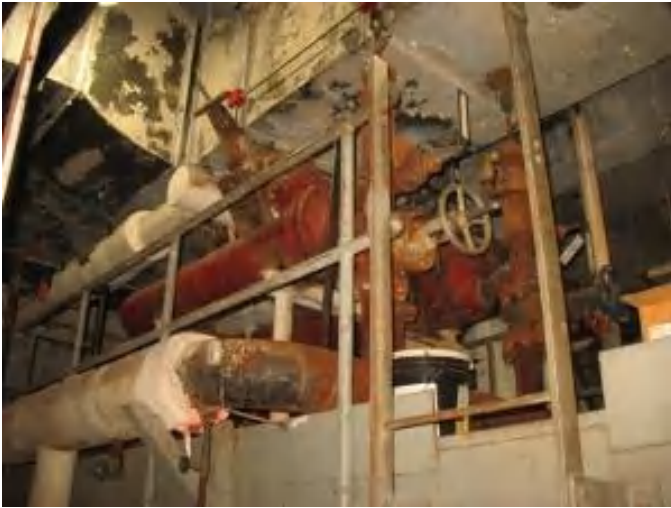
System: D3040 - Distribution Systems

Distress: Beyond Service Life

Notes: Replace the two (2) steam to water shell and tube heat exchangers serving the building heating water system.

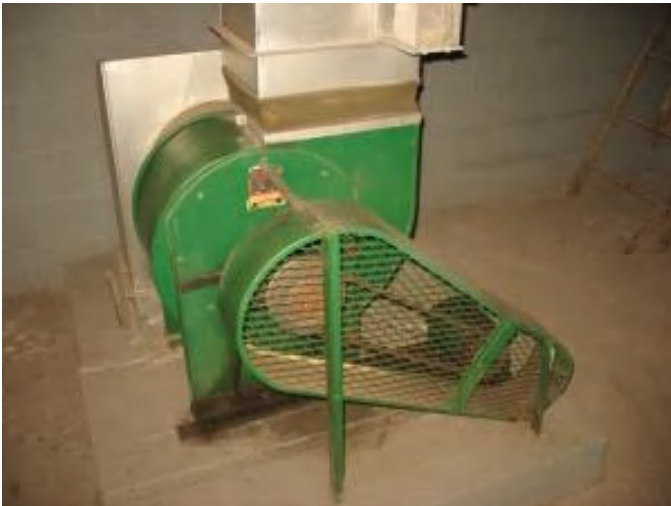
System: D3040 - Distribution Systems

Distress: Beyond Service Life

Notes: Replace four (4) existing exhaust fans in the penthouse and sub-basement serving the bathrooms and kitchen. Utilize the existing ductwork.

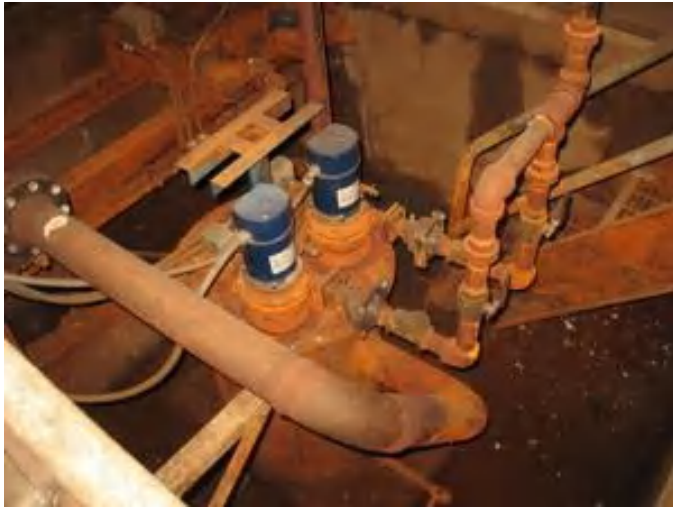
System: D3040 - Distribution Systems

Distress: Damaged

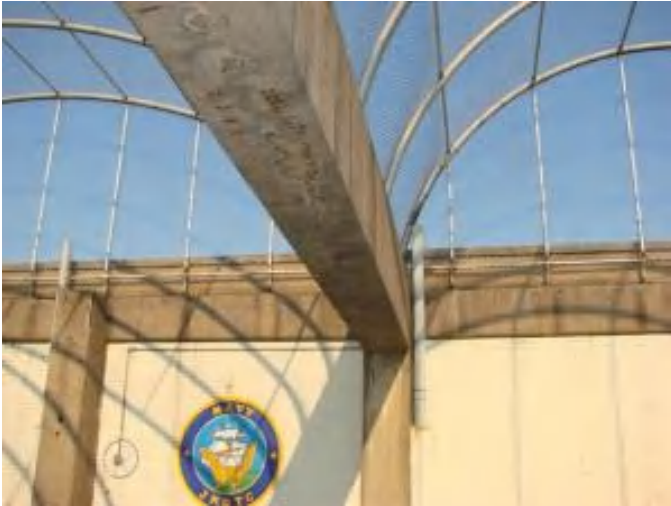
System: B1010 - Floor Construction

The main structure consists typically of combination of cast-in-place concrete columns, beams and concrete slabs in the basement; and structural steel framing, columns and bar joists supporting concrete floor and roof slabs in the original building. The roof structure of the addition consists of steel trusses and purlins supporting precast roof deck panels. The superstructure is in good condition with the exception of fifth floor open play area columns and girders which show some concrete spalling and exposed rusting reinforcement.

Distress: Damaged

Notes: Epoxy patch spalled concrete columns and girders (5th floor play court)

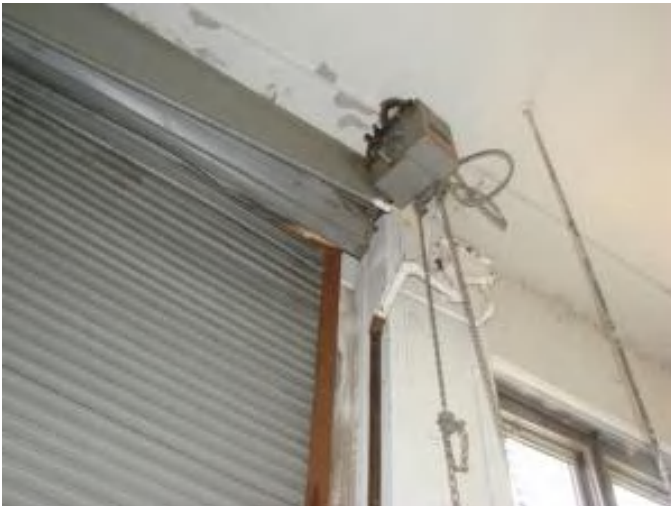
System: B2030 - Exterior Doors

The exterior service and egress doors are typically hollow metal doors and frames, painted. The doors are generally in poor condition with rusting leafs and frames in poor condition. Some doors have vision glazing with security screens. The loading dock has 2 overhead roll-up and 2 overhead sectional doors in very poor condition. Both sectional and one roll-up doors are not operational.

Distress: Failing

Notes: Replace all overhead doors

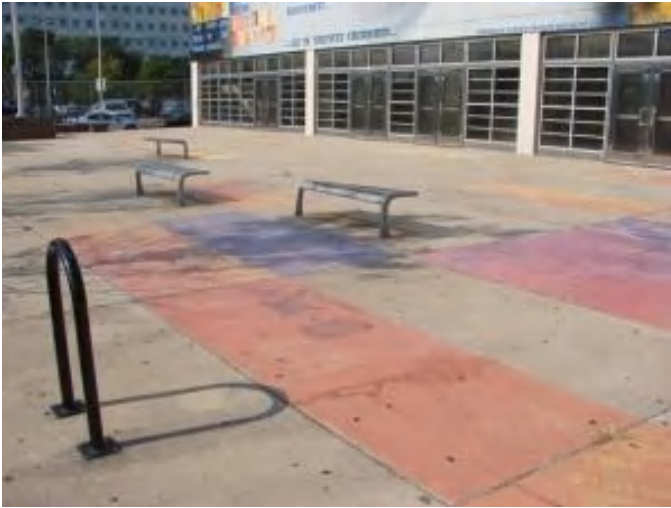
System: B3010120 - Single Ply Membrane

Distress: Beyond Service Life

Notes: Replace waterproofing membrane under exterior plaza paving
NOTE: paving replacement deficiency covered under G201001;Grounds

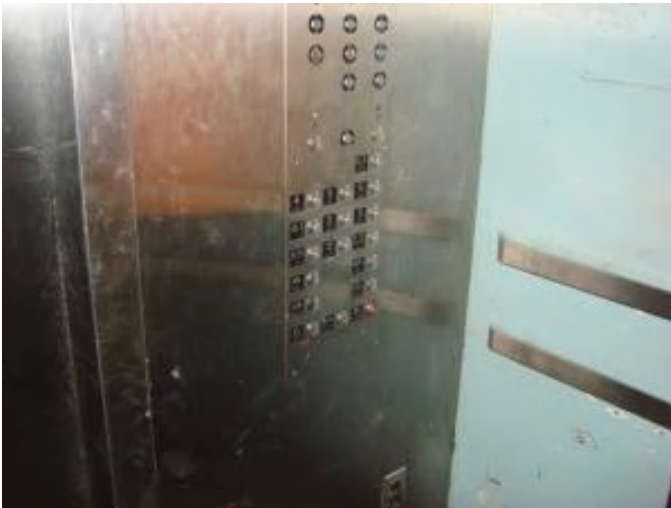
System: D1010 - Elevators and Lifts

The building has two original, 14,600 lb traction elevators serving all floors; generally in fair condition; however, elevator cabins show signs of distress. The controls are functioning properly.

Distress: Beyond Service Life

Notes: Refurbish elevator cabins

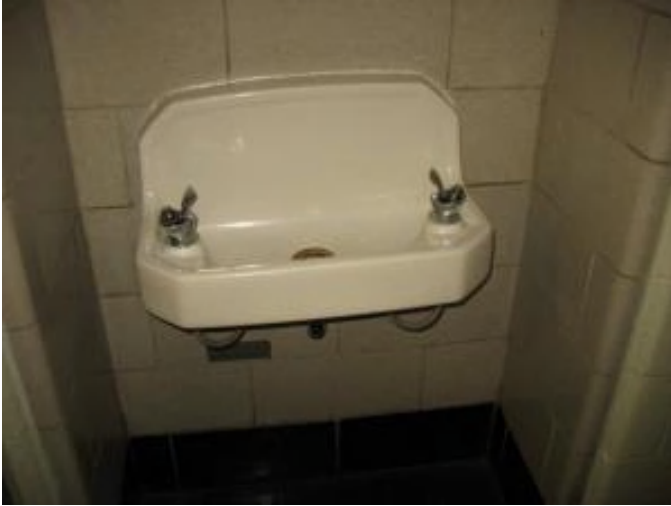
System: D2010 - Plumbing Fixtures

Drinking fountains in the corridors and at the restrooms are a mixture of stainless steel and porcelain wall hung units. The units are beyond their service life and should be replaced; most are accessible type.

Distress: Beyond Service Life

Notes: Replace the wall hung drinking fountains in the corridors and at the restrooms. These units are beyond their service life and most are accessible type.

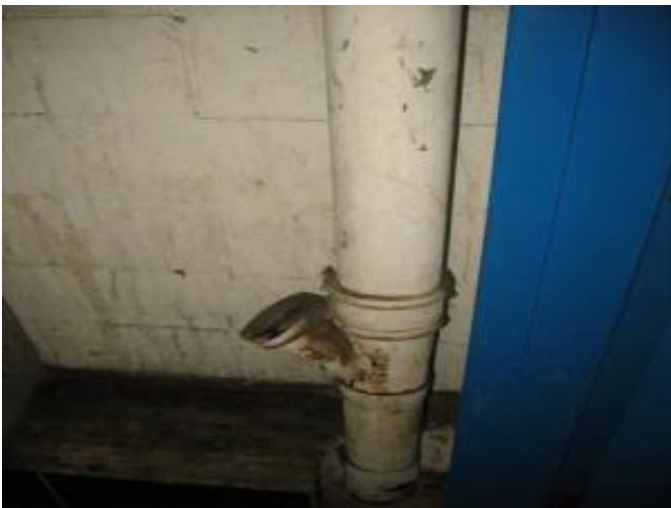
System: D2030 - Sanitary Waste

The maintenance staff reported mostly minor problems with the sanitary waste piping systems. However, the sewer piping has been in service for nearly 60 years and will require more frequent attention from the maintenance staff as time passes. The District should hire a qualified contractor to examine the sanitary waste piping using video cameras to locate and replace any damaged piping and to further quantify the extent of potential failures.

Distress: Beyond Service Life

Notes: Hire a qualified contractor to perform a detailed examination of the sanitary waste piping using visual inspection and video cameras to locate and replace any damaged piping and to further quantify the extent of potential failures.

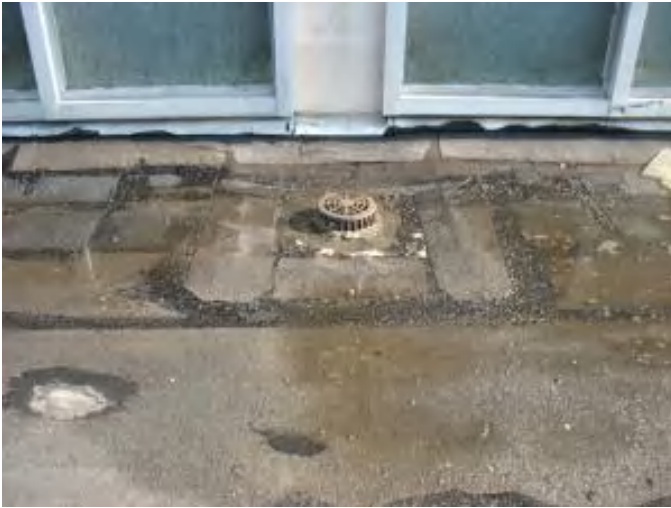
System: D2040 - Rain Water Drainage

Rain Water Drainage - The rain water drains from the roof are routed through mechanical chases in the building, connect to the storm sewer system in the sub-basement, and appear to be original. Some of the original galvanized piping has been repaired with HDPE piping and no-hub fittings. The drain piping should be inspected and repaired as necessary.

Distress: Beyond Service Life

Notes: Hire a qualified contractor to perform a detailed examination of the rain water drainage piping using visual inspection and video cameras to locate and replace any damaged piping and to further quantify the extent of potential failures.

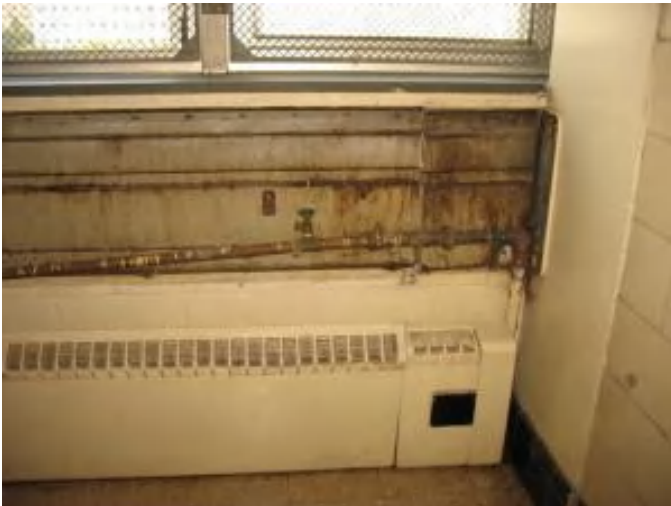
System: D3040 - Distribution Systems

Building water distribution piping is black steel with threaded fittings. The distribution piping is in poor condition. The piping has been in use beyond its service life and will require more frequent attention from the maintenance staff to address pipe/valve failures as time passes. The District should hire a qualified contractor to examine the distribution piping and perform additional testing to locate and replace any damaged piping and to further quantify the extent of potential failures. The District should budget for replacing this piping over the next 5 years.

Distress: Beyond Service Life

Notes: Hire a qualified contractor to examine the distribution piping, in service for almost 60 years and damaged, and perform additional testing to locate and replace any damaged piping and to further quantify the extent of potential failures.

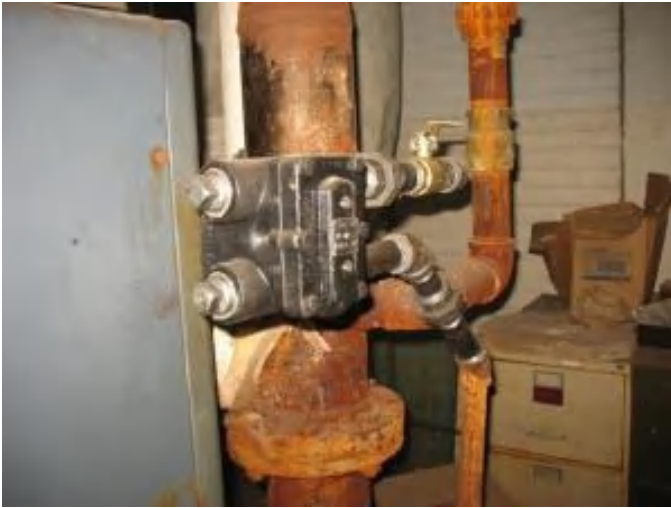
System: D3040 - Distribution Systems

A steam trap survey for this building has not been conducted recently and traps are not serviced on a regular schedule. The District should conduct a steam trap survey to identify and replace failed traps passing live steam into the condensate piping system.

Distress: Failing

Notes: Conduct a steam trap survey to identify and replace failed traps passing live steam into the condensate piping system.

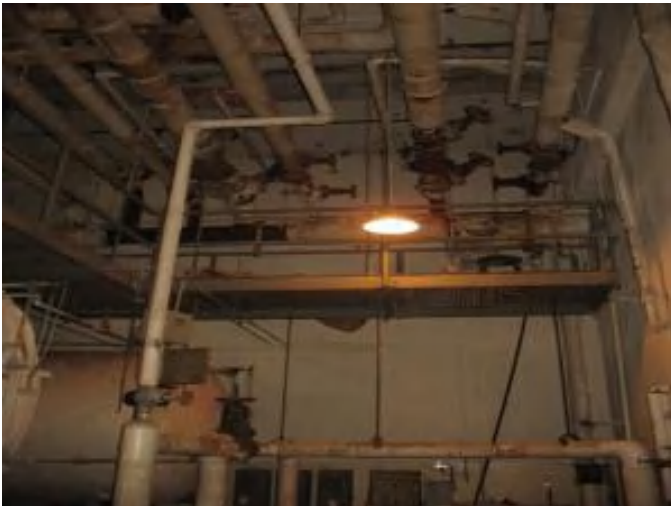
System: D3040 - Distribution Systems

Distress: Beyond Service Life

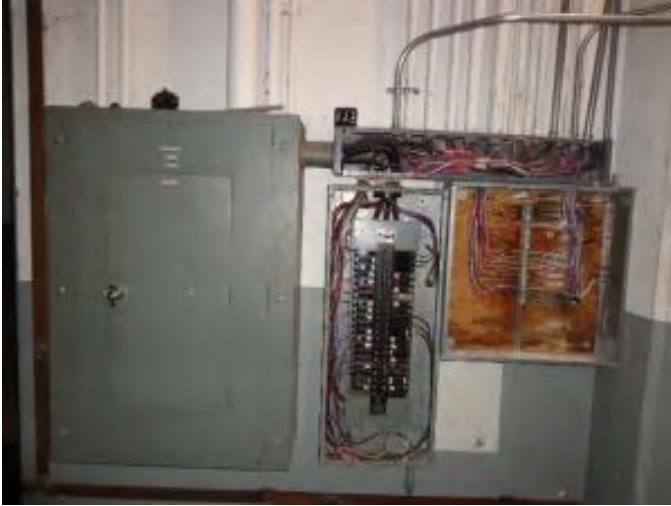
System: D5010 - Electrical Service/Distribution

Distress: Beyond Service Life

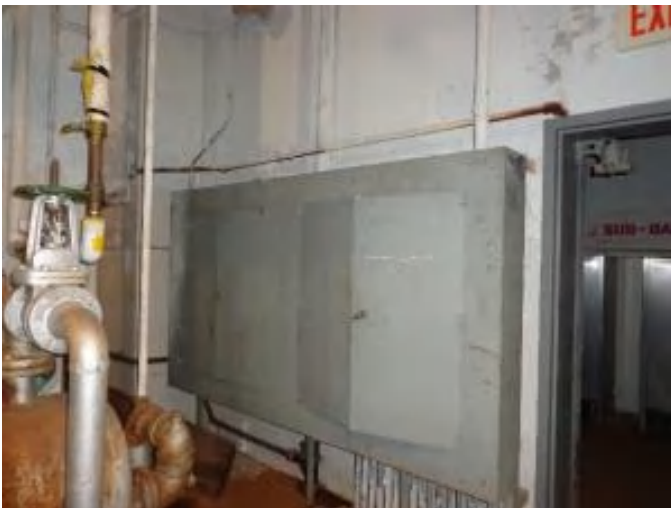
System: D5010 - Electrical Service/Distribution

Distress: Failing

Notes: Replace 600A Panelboard PP-10 and 400A Panelboard PP-11, both rated at 208/120 volt, 3 phas3, 4 wire located in the Boiler Room and in the Sub-Basement.

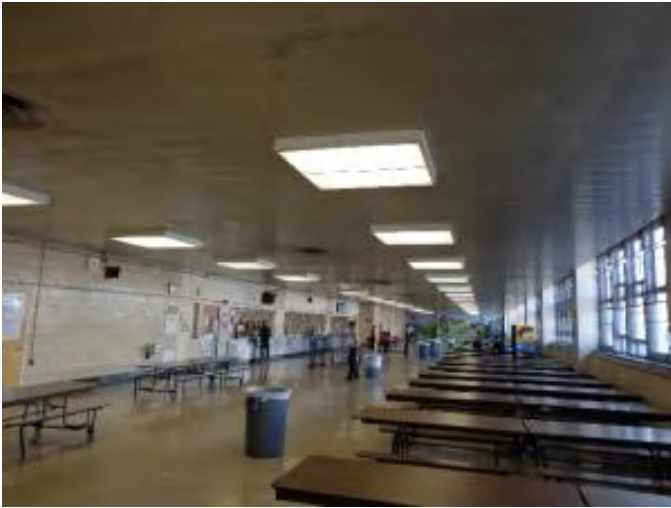
System: D5020 - Lighting and Branch Wiring

Distress: Beyond Service Life

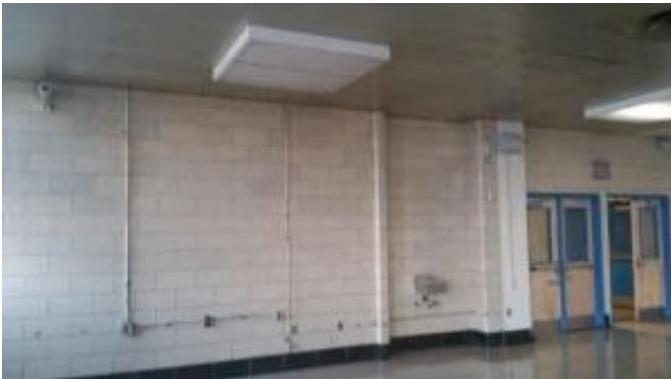
System: D5020 - Lighting and Branch Wiring

Distress: Building / MEP Codes

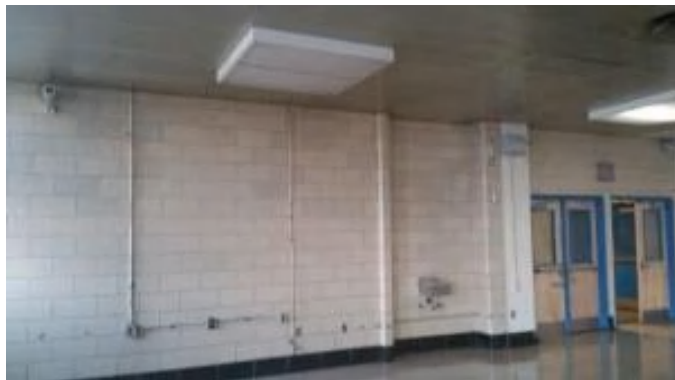
System: D5020 - Lighting and Branch Wiring

Distress: Building / MEP Codes

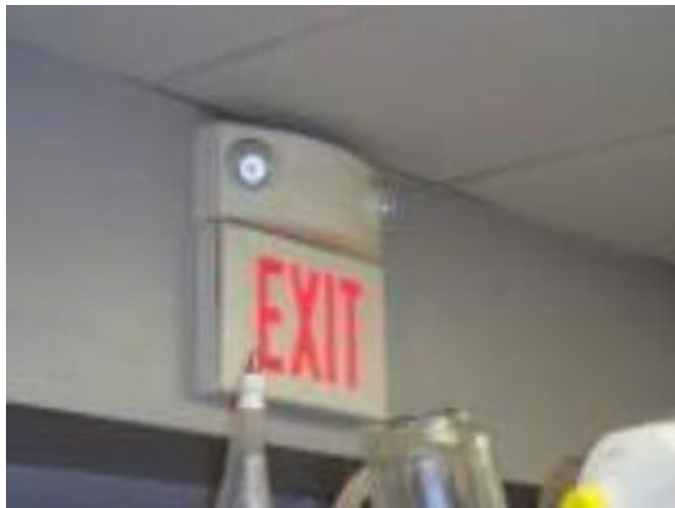
System: D5090 - Other Electrical Systems

Distress: Beyond Service Life

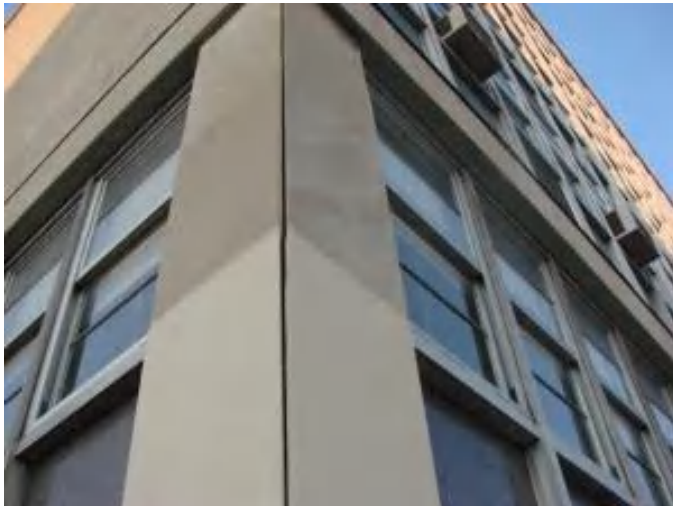
System: B2010 - Exterior Walls

Distress: Building Envelope Integrity

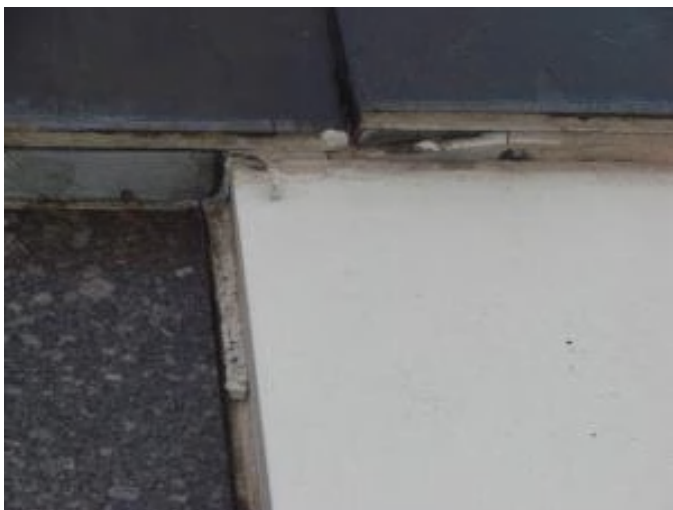
System: B2020 - Exterior Windows

Distress: Beyond Service Life

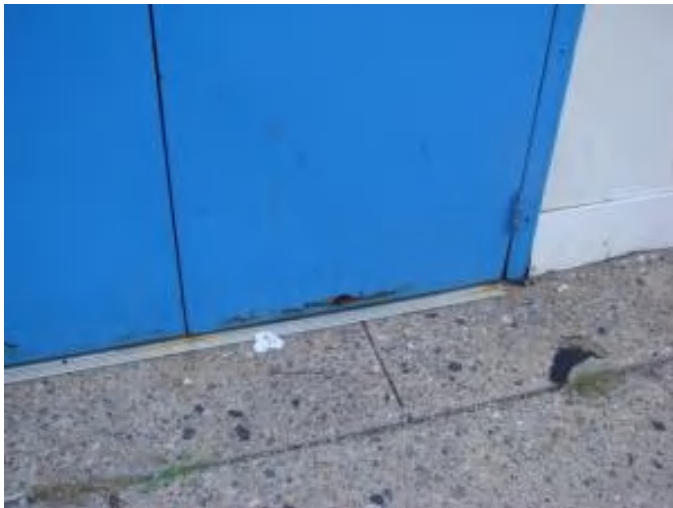
System: B2030 - Exterior Doors

Distress: Beyond Service Life

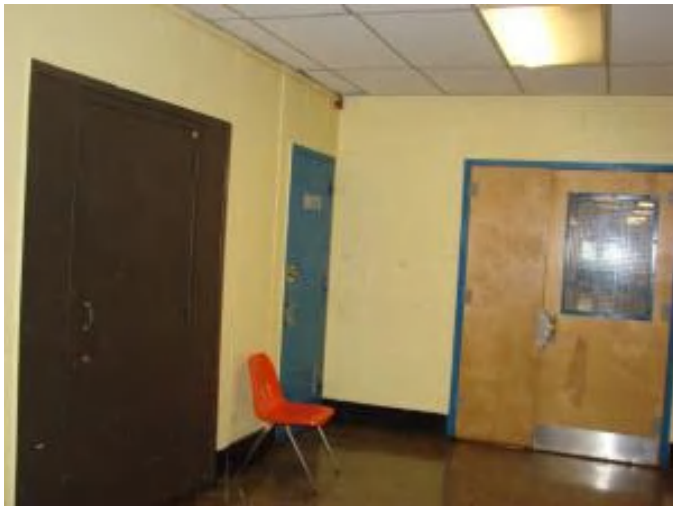
System: C1020 - Interior Doors

Interior doors are generally solid core wood doors, some glazed, with hollow metal frames, some doors are missing closers. Most doors do not have accessible handles. The doors leading to exit stairways and some toilets are hollow metal doors and frames in good condition.

Distress: Accessibility

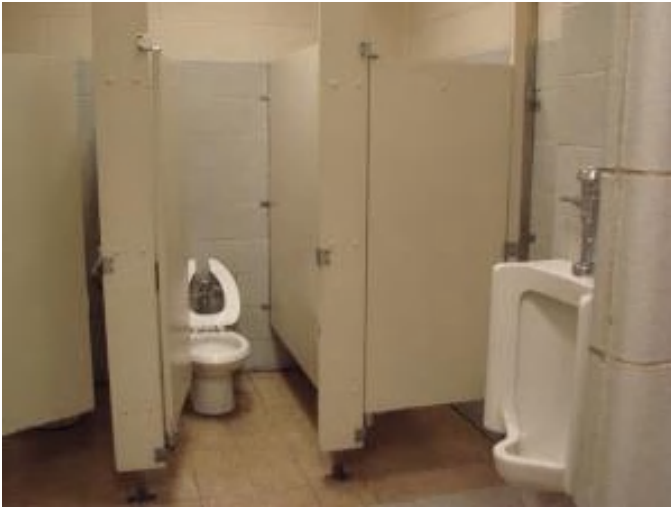
System: C1030 - Fittings

Fittings include toilet accessories and toilet partitions, generally in poor condition, installed approximately in 1990, no accessible compartments; chalkboards in good condition. Handrails and ornamental metals are generally in good condition. Built-in cabinets and lockers are steel in fair condition. Interior identifying signage is typically directly painted on wall or door surfaces generally in poor condition with some signage missing.

Distress: Accessibility

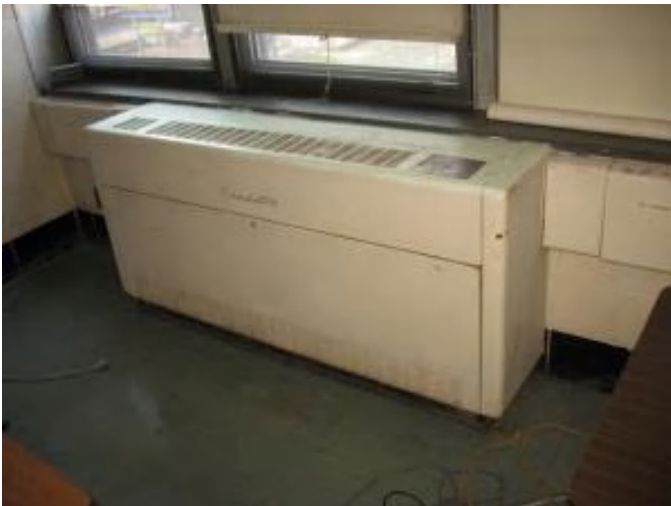
System: D3040 - Distribution Systems

Distress: Beyond Service Life

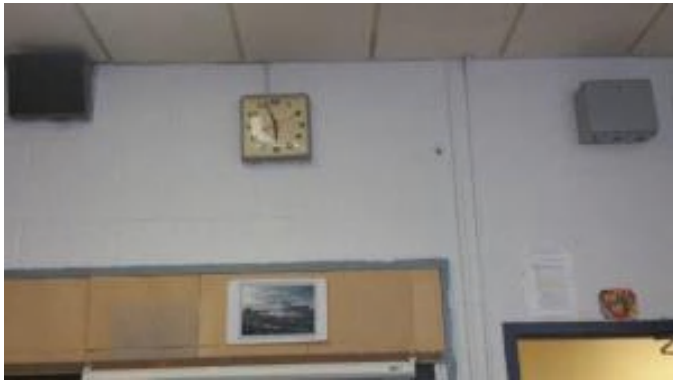
System: D5030 - Communications and Security

Distress: Beyond Service Life

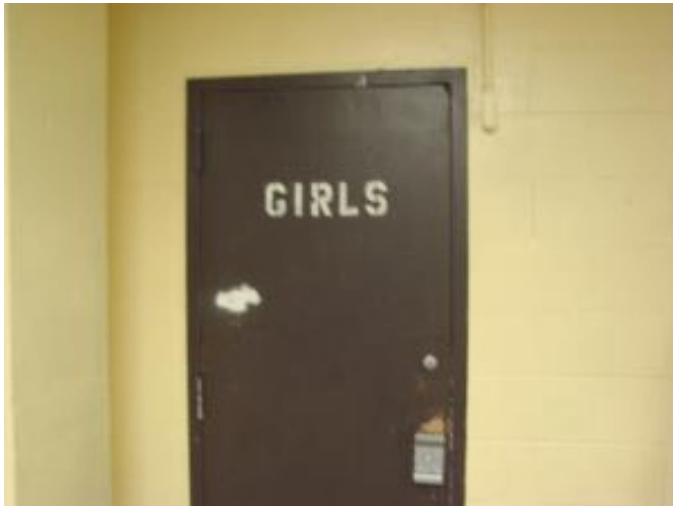
System: C1030 - Fittings

Distress: Inadequate

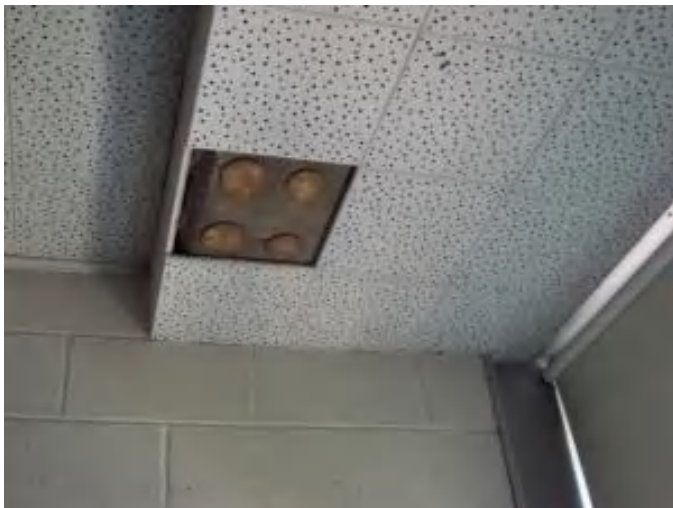
System: C3030 - Ceiling Finishes

Distress: Beyond Service Life

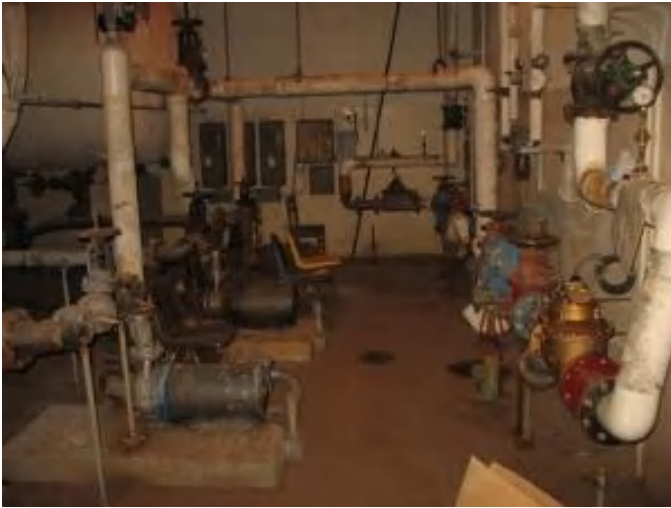
System: D2020 - Domestic Water Distribution

Distress: Obsolete

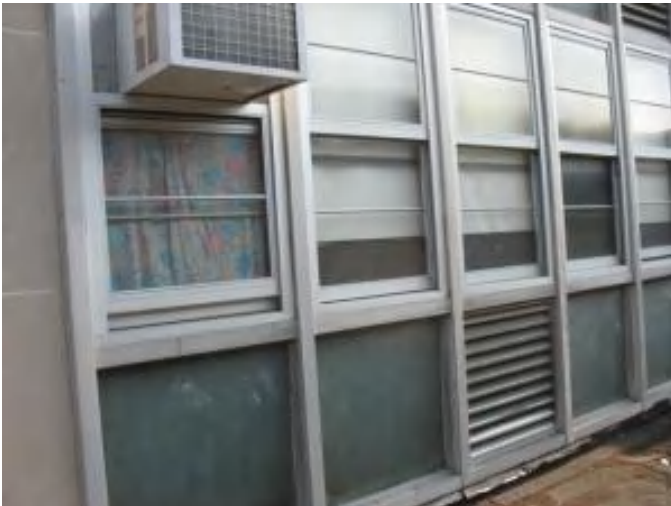
System: D3030 - Cooling Generating Systems

Distress: Inadequate

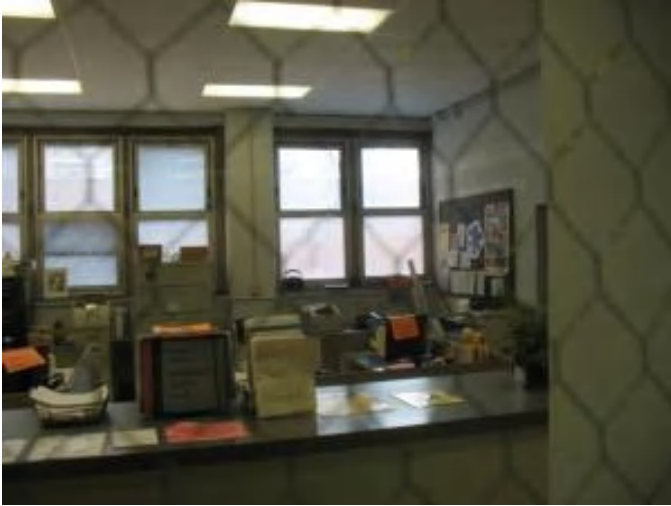
System: D3040 - Distribution Systems

Distress: Building / MEP Codes

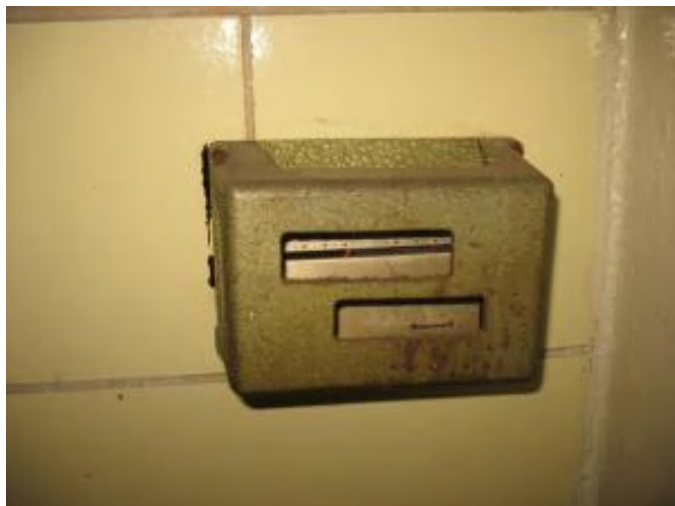
System: D3060 - Controls & Instrumentation

Distress: Inadequate

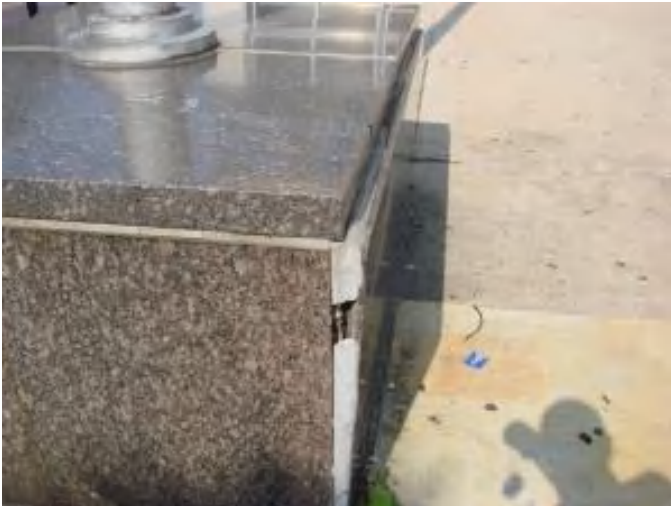
System: G2040 - Site Development

Distress: Damaged

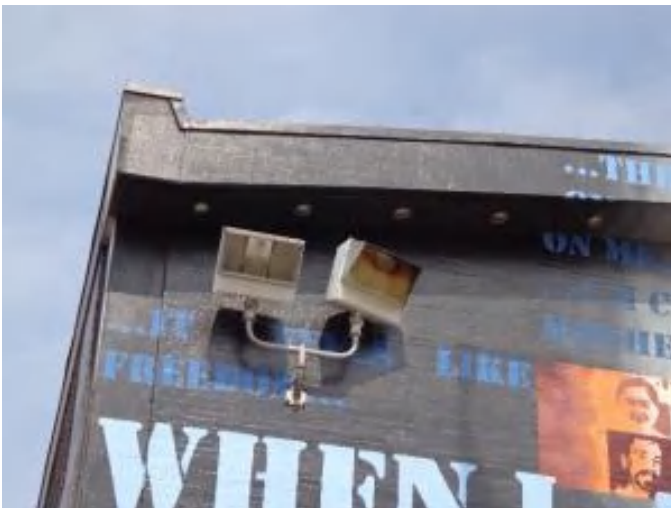
System: G4020 - Site Lighting

Distress: Building / MEP Codes

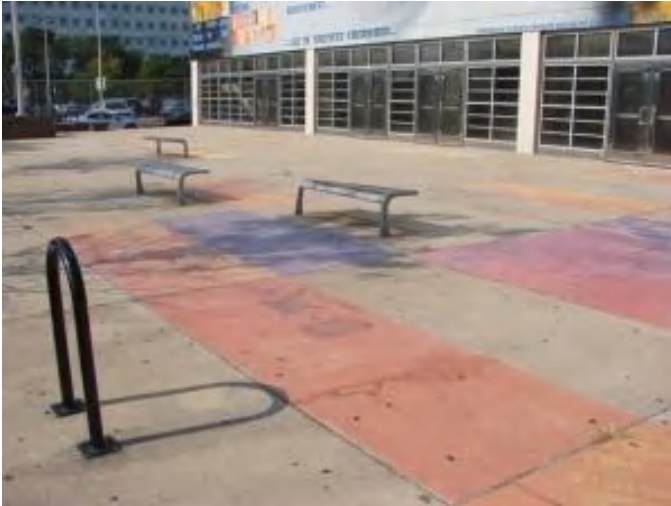
System: G2030 - Pedestrian Paving

Distress: Beyond Service Life

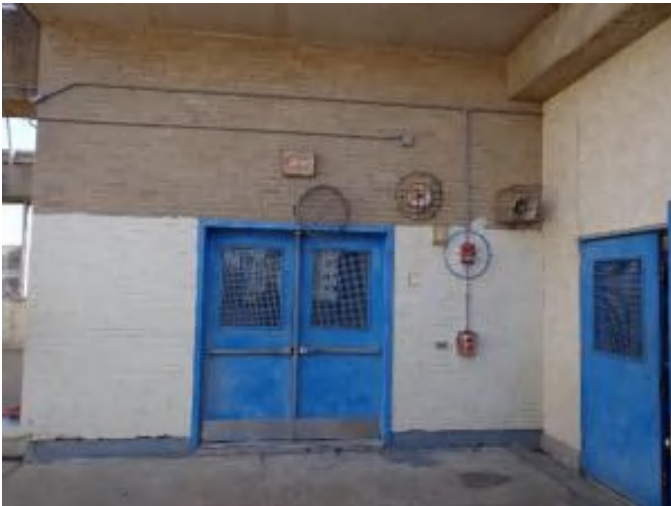
System: G4030 - Site Communications & Security

Distress: Security Issue
