Facility Condition Assessment Summary Report

Furness High School

School District of Philadelphia
S216001;Furness
Final
Site Assessment Report
January 31, 2017

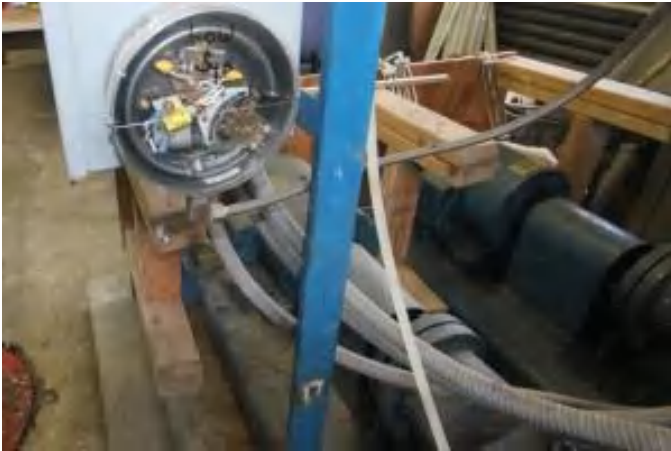
System: D2020 - Domestic Water Distribution

Location: Basement

Distress: Inadequate

Notes: Install hydro-pneumatic storage tank for domestic water pressure booster system.

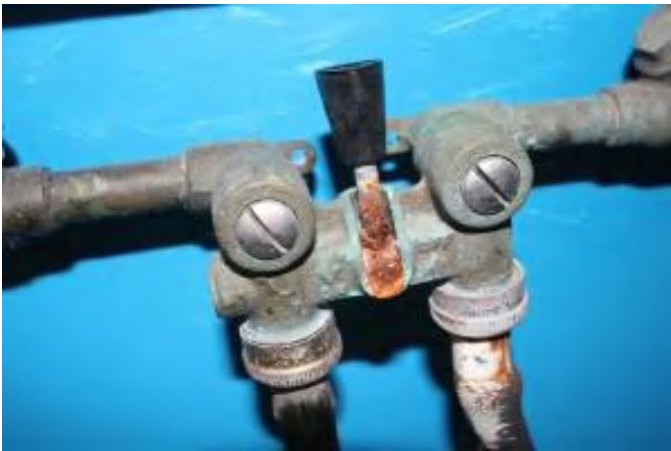
System: D2020 - Domestic Water Distribution

Life skills room has a stainless steel, rim mounted residential kitchen sink. It has a single lever controlled mixing faucet, and it is functional with at least 5 years useful life remaining. There is also a clothes washing machine and dryer. The washer has hot and cold water supply lines with a duplex shut off valve. The valve is severely rusted and failing with moisture present on the exterior. The valve needs replacement.

Location: Life skills classroom

Distress: Failing

Notes: Replace duplex shut-off valve on water supply to clothes washer.

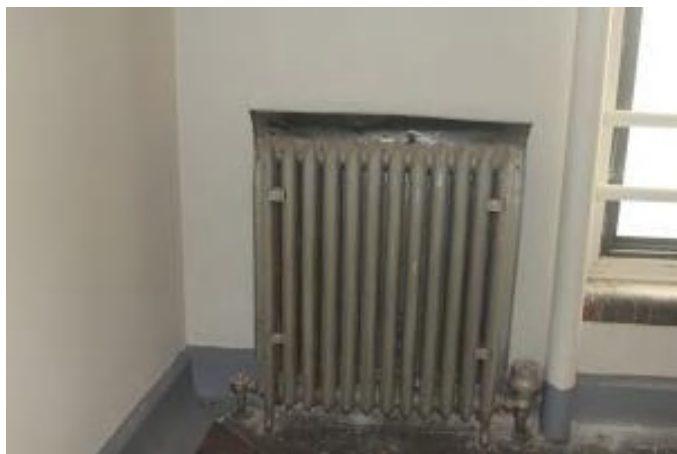
System: D3040 - Distribution Systems

Steam and condensate piping is threaded steel throughout the building. Its age is unknown, but likely dates to the 1964 renovation. The building engineer stated there is a massive underground condensate leak. The basement hallway shows signs of subsidence, likely due to scouring. The steam and condensate system piping should be replaced.

Location: Entire building

Distress: Failing

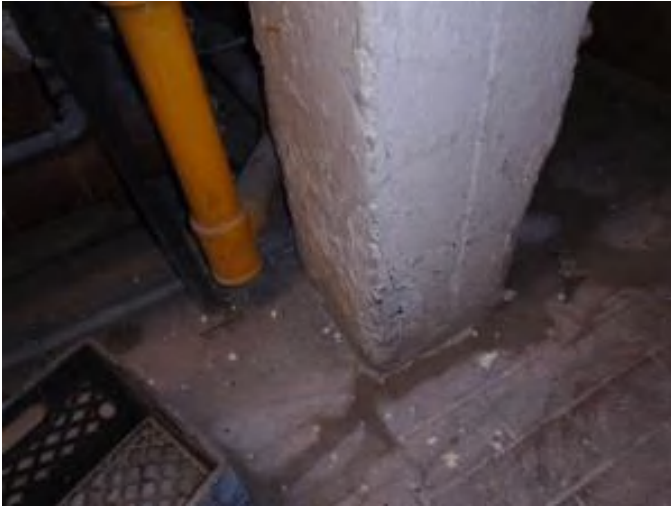
System: A2020 - Basement Walls

The building typically rests on concrete foundations and bearing walls that are showing signs of settlement damage with cracked concrete and exposed steel reinforcement. The main structure typically consists of cast-in-place concrete columns, beams, and concrete, one way ribbed slab. The main roof structures consist of concrete one-way slab and steel truss supported by main structural frame. Roof structure in basement service area is failing with one major collapse reported. Main roofing is single ply application and metal roof both in poor condition with complete replacement project underway. The building envelope is typically masonry and concrete with face brick in fair condition with structural cracks in need of repair. Elevations are greatly enhanced with decorative stonework around entrances with multiple failing points currently undergoing repair. The windows were replaced in the early 1990s with extruded aluminum, double hung sliding windows, Lexan Plexiglas with insect/security screens. All windows are generally in poor condition with heavy hazing. Exterior doors are typically hollow metal in fair condition and nearing the end of service life. The building is accessible from the public sidewalk via access ramp at southeast entrance.

Location: Basement

Distress: Damaged

Notes: Repair damaged structural columns and foundation walls in basement

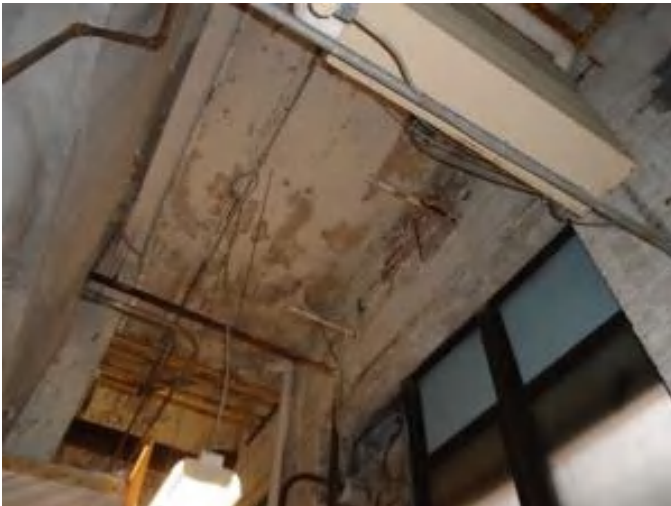
System: B1020 - Roof Construction

Location: Boiler/Mechanical

Distress: Failing

Notes: Repair failing structural roof in basement

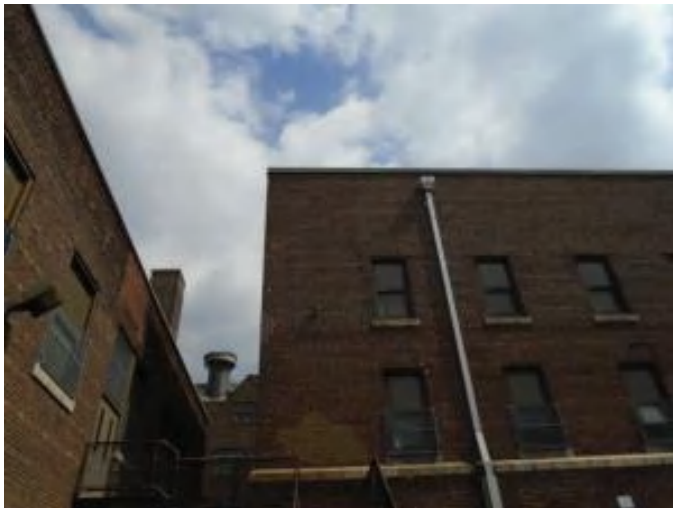
System: B2010 - Exterior Walls

Location: Various exterior

Distress: Damaged

Notes: Repair exterior wall cracks

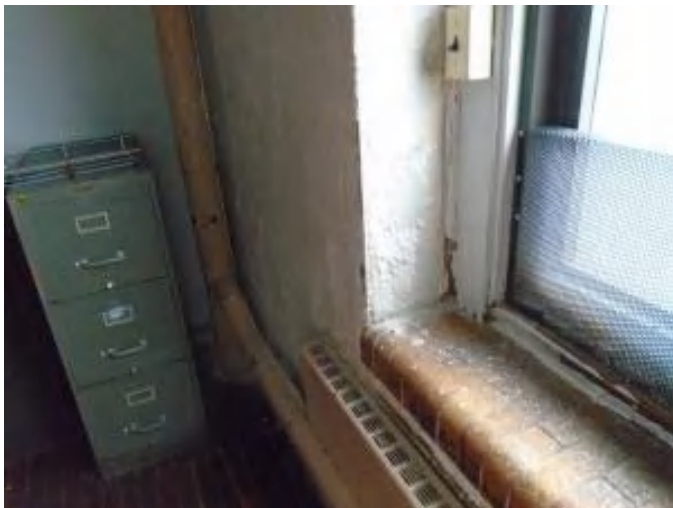
System: C3010230 - Paint & Covering

Location: Throughout

Distress: Damaged

Notes: Repair and paint interior plaster walls – damaged (15% of plaster area)

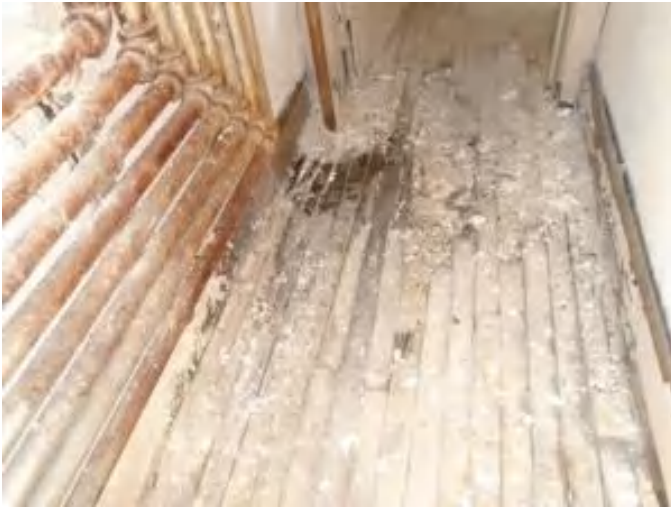
System: C3020414 - Wood Flooring

Location: Various

Distress: Damaged

Notes: Replace wood floor – 10% of wood floor area

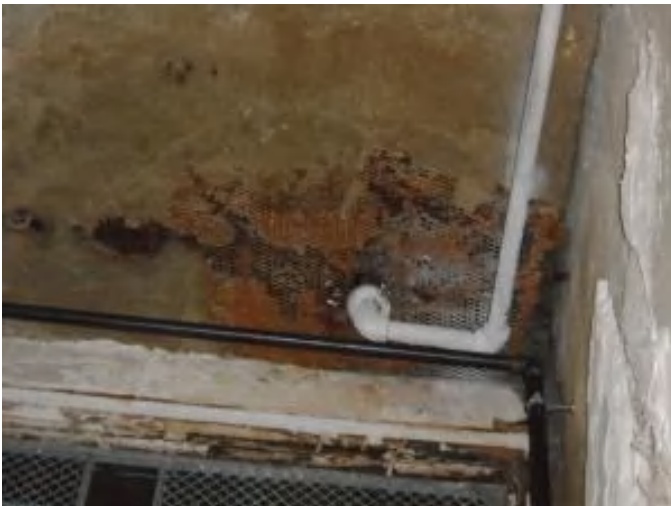
System: C3030 - Ceiling Finishes

Location: Gym balconies

Distress: Damaged

Notes: Replace plaster ceilings – damaged (gym balconies)

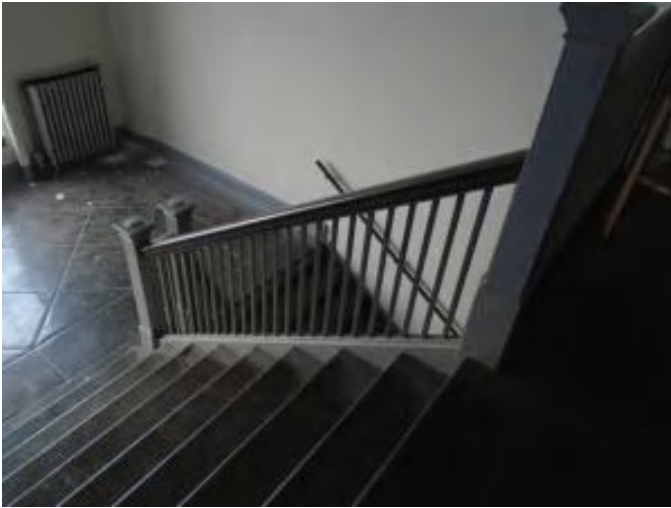
System: D1010 - Elevators and Lifts

Location: TBD

Distress: Accessibility

Notes: Install elevator for accessibility

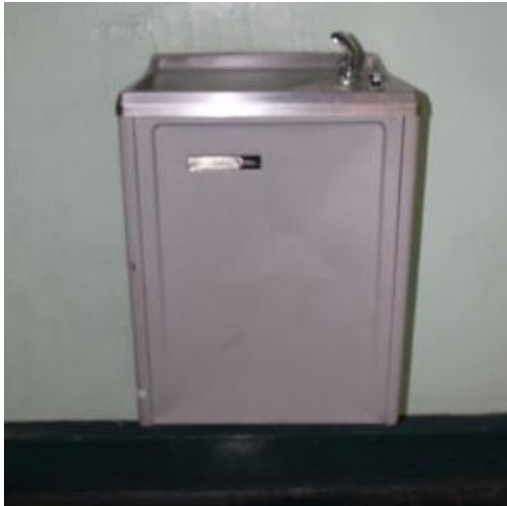
System: D2010 - Plumbing Fixtures

Drinking fountains are painted sheet metal and stainless steel located in hallways on each floor. They are beyond their service life and not ADA compliant. Fountains throughout the building should be replaced with accessible fountains with integral coolers.

Location: Hallways

Distress: Beyond Service Life

Notes: Replace drinking fountains with ADA compliant fountains including integral coolers, 9 pairs.

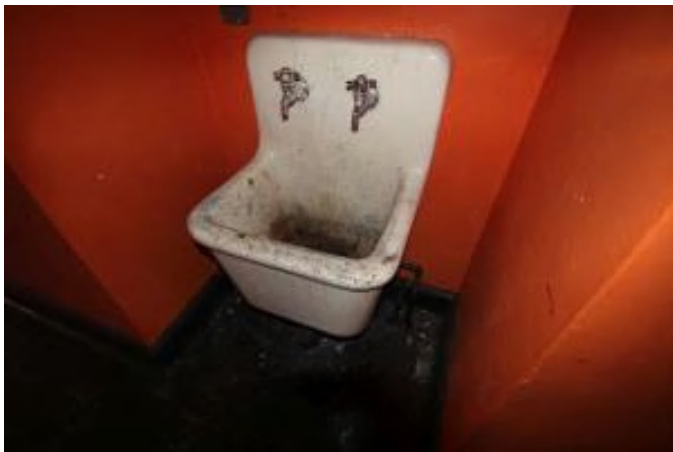
System: D2010 - Plumbing Fixtures

Service sinks in hallway alcoves are enameled cast iron with integral backsplash and trap. They have non-mixing faucets. Mop closet sinks are floor level plastic sinks with long neck mixing faucets with vacuum breakers. Sinks are heavily worn with crazed enamel and rust or stained plastic. They should all be replaced due to age and accumulated wear and tear.

Location: Corridors

Distress: Beyond Service Life

Notes: Replace 9 service sinks due to age, wear, and rust.

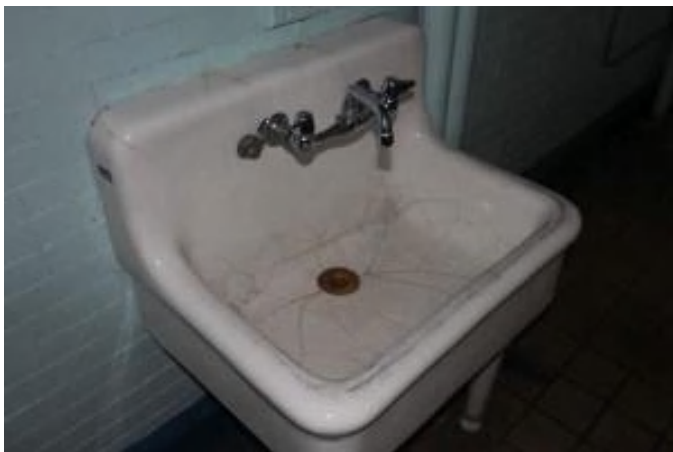
System: D2010 - Plumbing Fixtures

The cafeteria kitchen includes a commercial, floor standing, stainless steel, four basin wash sink with grease trap and chemical sanitation system. One of its faucets leaks steadily. The sink is rusted and should be replaced. The kitchen also has a single basin, enameled cast iron, cook sink. It has exceeded its service life and the enamel is worn through in multiple areas, so the sink should be replaced. There is an enameled cast iron lavatory and the enamel is crazed and wearing through in areas, so it should be replaced as well.

Location: Kitchen

Distress: Failing

Notes: Replace rusting and aged sinks and lavatory.

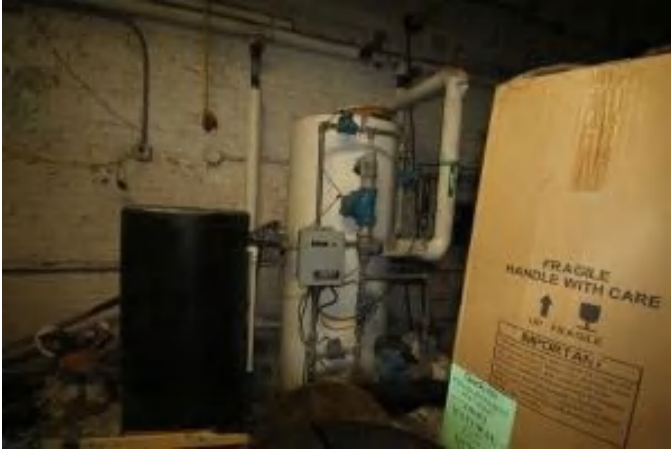
System: D2020 - Domestic Water Distribution

Location: Boiler room

Distress: Building / MEP Codes

Notes: Install code compliant double back flow prevention valve on steam system makeup water line.

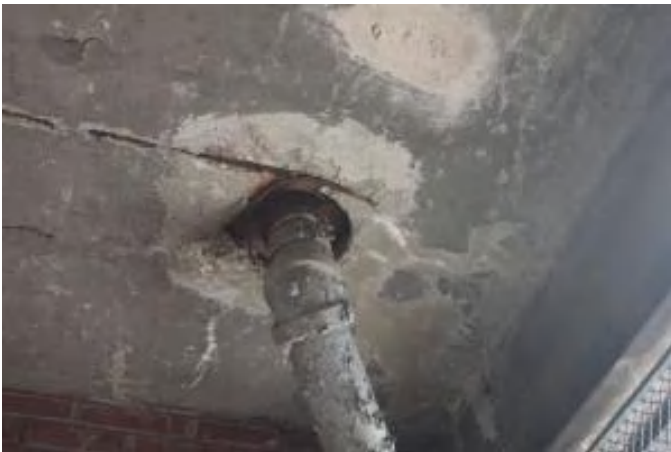
System: D2040 - Rain Water Drainage

Rain water drainage runs externally in sheet metal drain pipes and internally in galvanized threaded pipe. Visible areas of the internal pipe show rust, peeling paint, and extensive repairs with cast iron hubless pipe with banded connections. There is extensive water damage to interior finishes. The rain water drainage system should be more thoroughly examined and repaired as needed. There are no ground water sumps.

Location: Entire building

Distress: Beyond Service Life

Notes: Inspect rain water drain pipe and repair as needed.

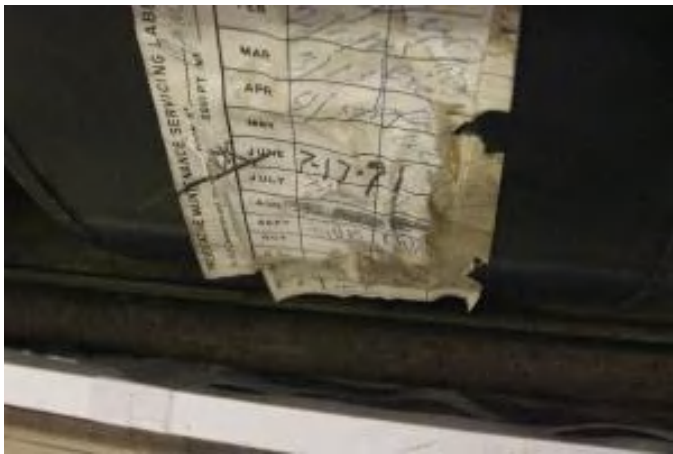
System: D3040 - Distribution Systems

All hallways and small rooms in the building are heated by radiators. Most radiators are a mix of cast iron, threaded steel pipe, or finned tube units. They are equipped with pneumatic controlled steam valves and thermostatic steam traps. Radiators are beyond their expected service life and many are missing guards. They should all be replaced with modern units.

Location: Classrooms

Distress: Beyond Service Life

Notes: Replace radiators throughout building due to age.

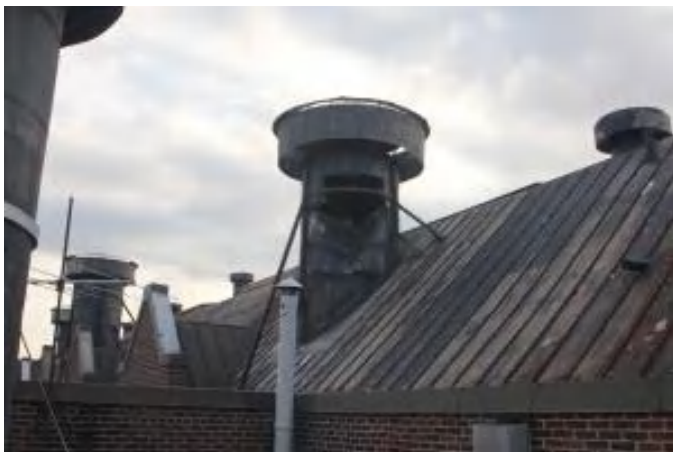
System: D3040 - Distribution Systems

The original ventilation system in the building has been blocked off where the supply ducts entered the classrooms. In 1964 the building was converted from central forced air to individual unit ventilators in the classrooms. The original air handlers, including primary heating coils, air washers, fans, and secondary heating coils, are located below the auditorium stage at the back of the building. Heating coils are cast iron, approximately 9 feet tall and 11 feet wide. Fans are belt drive with 15 HP, 8 pole, 3 phase electric motors. They are all entirely obsolete and should be replaced with new HVAC systems supplying the auditorium and both gymnasiums. Classroom exhaust ducts are plaster over clay tile block construction and lead from floor level up to the attic where sheet metal ducts connect them to roof top gravity vents. The attic was asbestos abated in 2013. There are pneumatic controlled dampers to adjust duct flow in the attic. Attic plenums have return ducts to the basement AHU intakes, but all room exhaust air exits the building through ducts to gravity vents in the roof. Gravity vents are damaged and allow water infiltration, and should be replaced.

Location: Roof top

Distress: Damaged

Notes: Replace roof top gravity vents to prevent water infiltration.

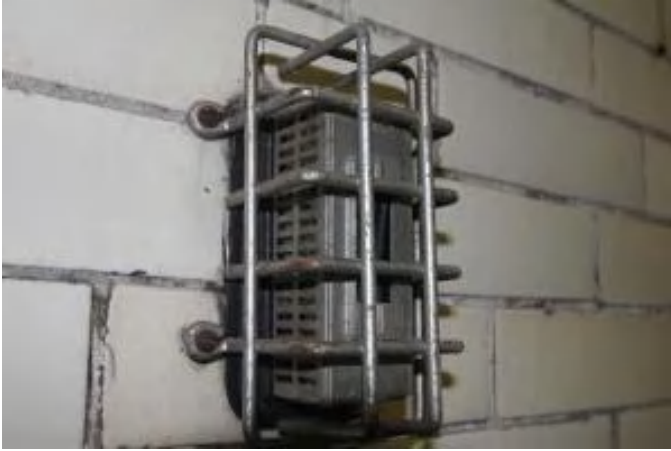
System: D3060 - Controls & Instrumentation

The building is equipped with pneumatic controls throughout, including wall thermostats, radiators, unit ventilators, attic exhaust ducts, and basement air handlers. The principal stated some rooms are too cold in winter. The pneumatic system is damaged and obsolete. A building automation system should be installed as part of overall system upgrades to integrate all new components.

Location: Entire building

Distress: Failing

Notes: Replace pneumatic control with digital and provide a new building automation system (BAS).

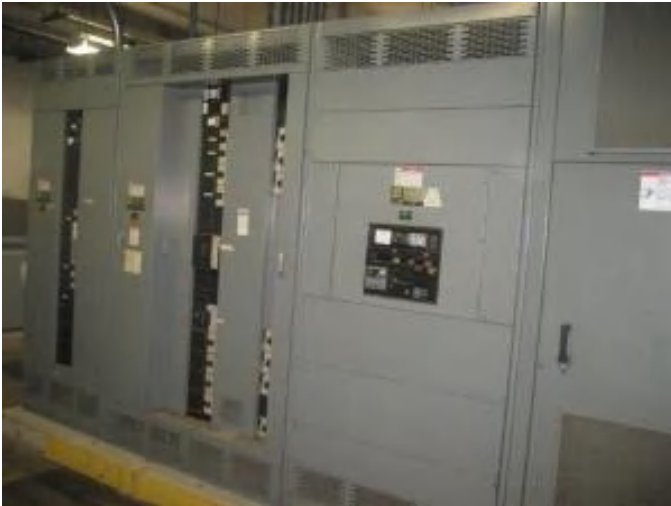
System: D5010 - Electrical Service/Distribution

Location: Basement electrical room

Distress: Inadequate

Notes: Provide a new electrical service to carries the HVAC load. Approximate 1500KVA Unit Substation

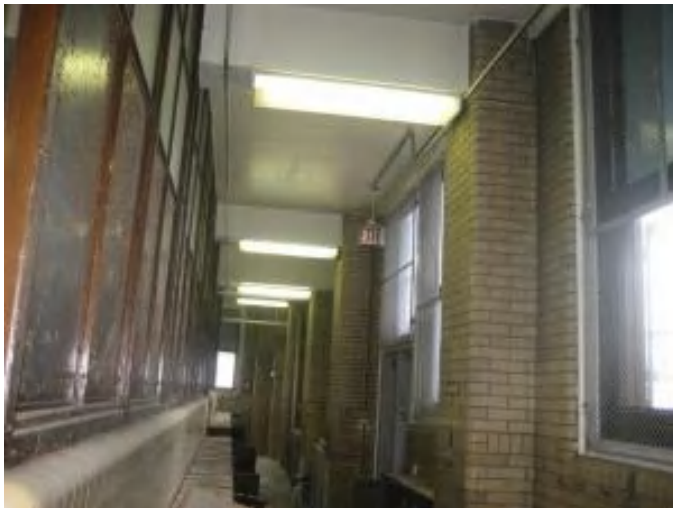
System: D5020 - Lighting and Branch Wiring

Location: Entire Building

Distress: Energy Efficiency

Notes: Provide to the 90% of the school with lighting fixtures with T-8 lamps. Approximate 1800

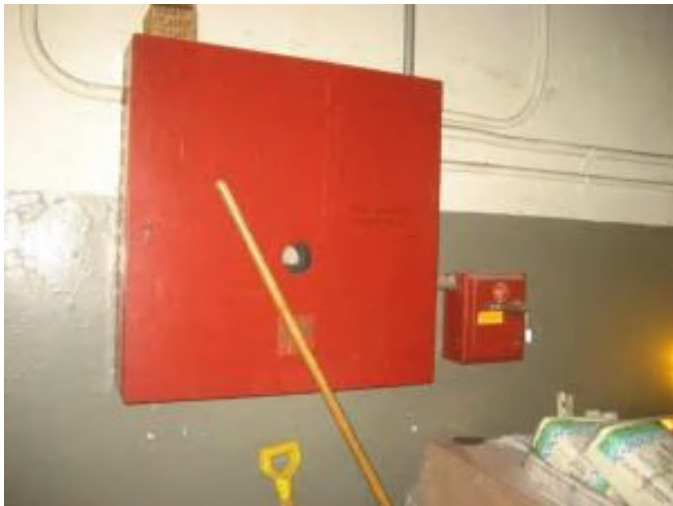
System: D5030 - Communications and Security

The Fire Alarm system is manufactured by S.H. Couch. The system is approximately 30 years old. The present Fire Alarm system does not meet current code and needs to be replaced. Fire alarm system is tested every day in the morning.

Location: Entire Building

Distress: Building / MEP Codes

Notes: Provide new fire alarm system. Approximate 200 devices

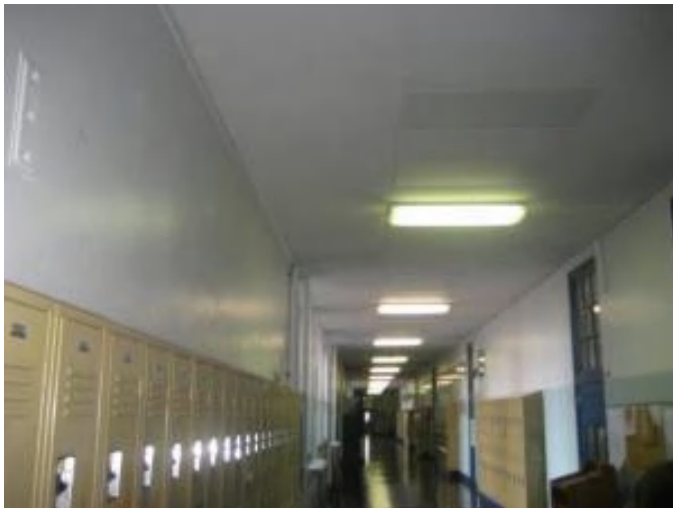
System: D5030 - Communications and Security

Location: Entire Building

Distress: Security Issue

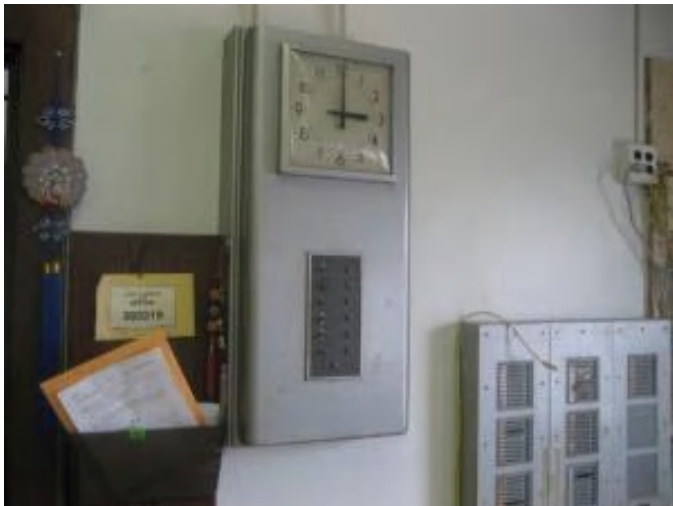
System: D5030 - Communications and Security

The school is provided with an inoperative central clock system. Replace clock system with wireless, battery operated, type system.

Location: Entire Building

Distress: Obsolete

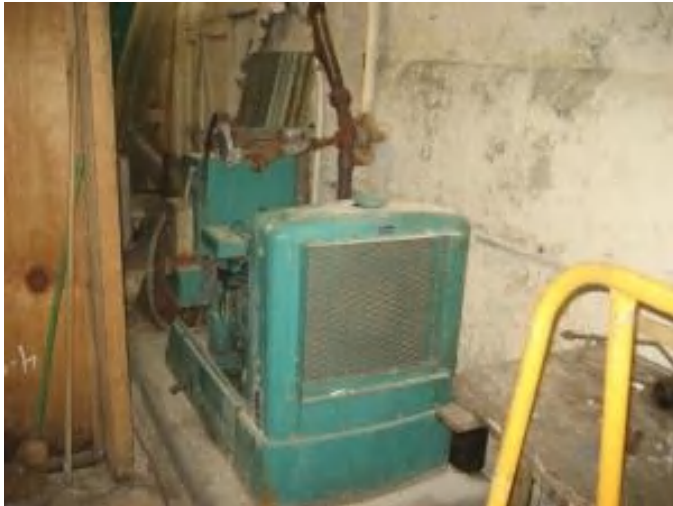
System: D5090 - Other Electrical Systems

Location: Outdoor

Distress: Inadequate

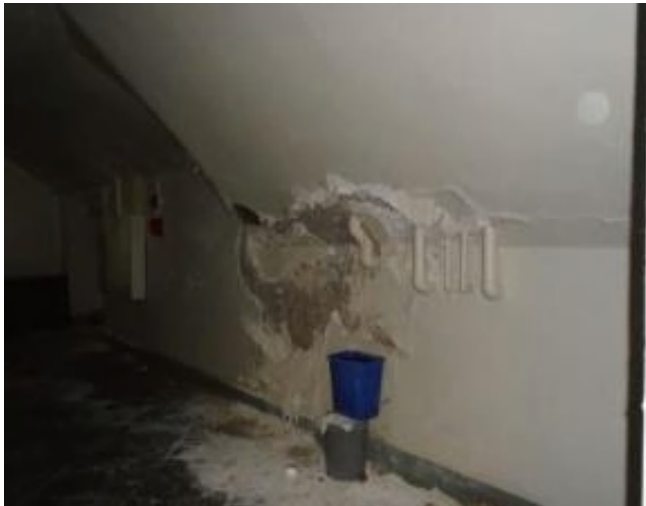
System: B1010 - Floor Construction

Location: 4th floor

Distress: Damaged

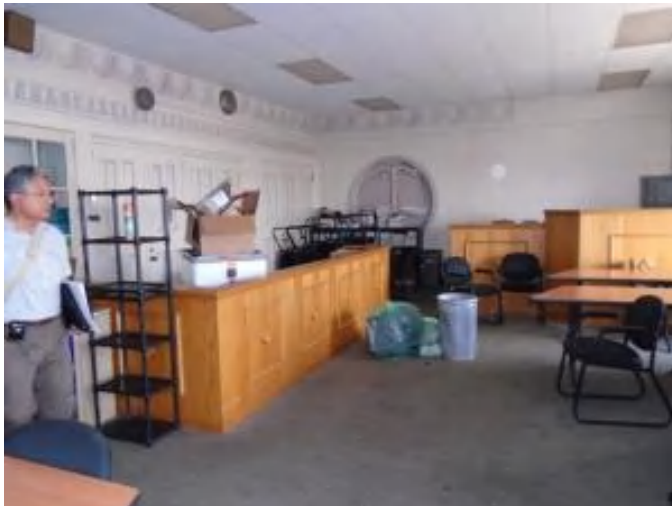
System: C3020411 - Carpet

Location: Classroom/office

Distress: Beyond Service Life

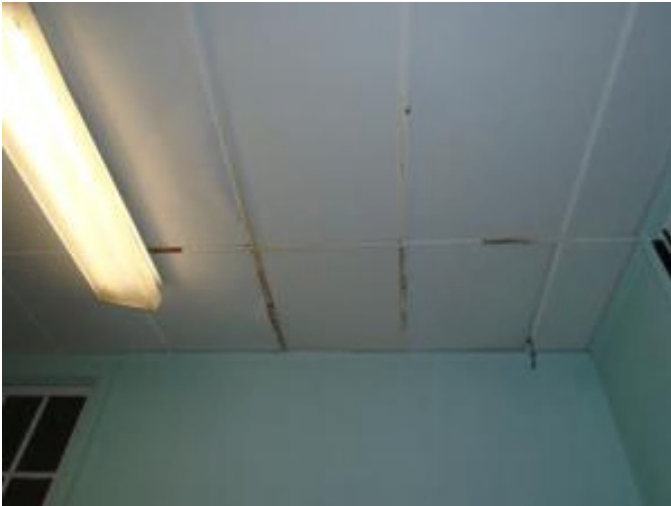
System: C3030 - Ceiling Finishes

Location: Throughout

Distress: Beyond Service Life

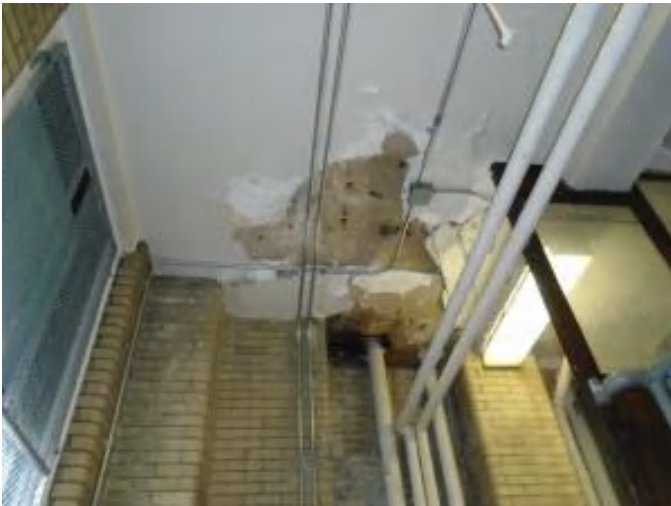
System: C3030 - Ceiling Finishes

Location: Throughout

Distress: Damaged

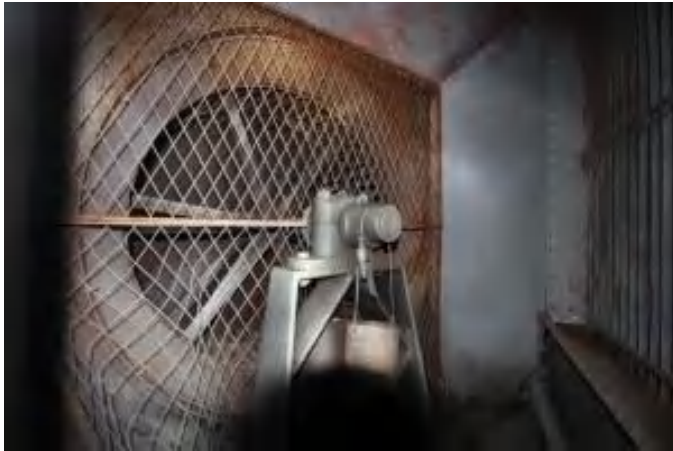
System: D3040 - Distribution Systems

Location: Auditorium

Distress: Inadequate

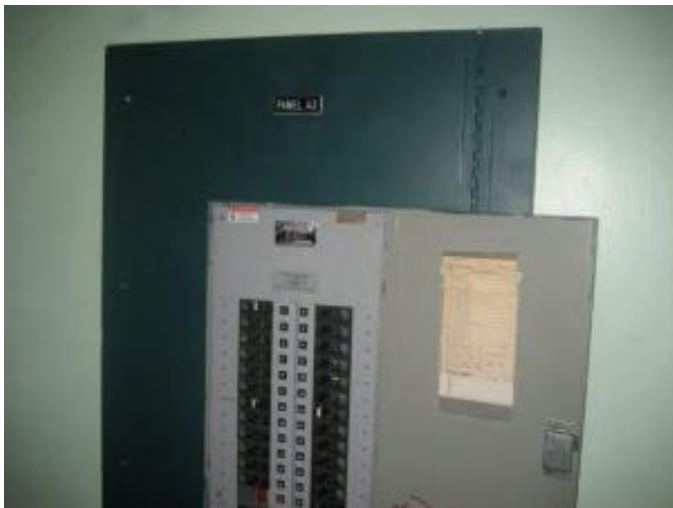
System: D5010 - Electrical Service/Distribution

The electrical distribution is obtained using, original and new 120/208V panel-boards located at each corridor floor. The original panel boards are for lighting and receptacles and the new panel-boards are for window type AC units. The panel boards are manufactured by Penn Panel & Box Co. The original panel-boards and associated wiring have exceeded their useful service life. Replace original panel boards.

Location: Entire Building

Distress: Not Reliable

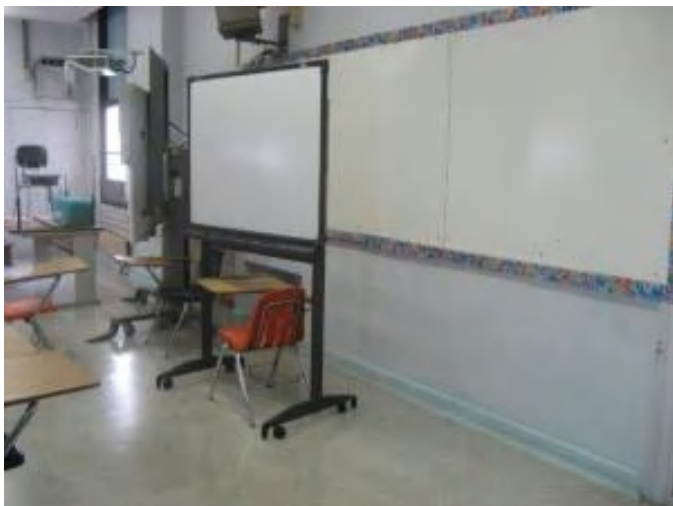
System: D5020 - Lighting and Branch Wiring

There number of receptacles in classrooms varies, approximate 20% of the classrooms have been remodeled and provided with the proper amount of receptacles but 80% of them the quantity of receptacles are inadequate. The 80% of the classrooms need to be provided with the teacher's whiteboard wall and the opposite of it with double compartment surface raceways, the other two walls with minimum two duplex outlets each, when feasible.

Location: Classrooms

Distress: Inadequate

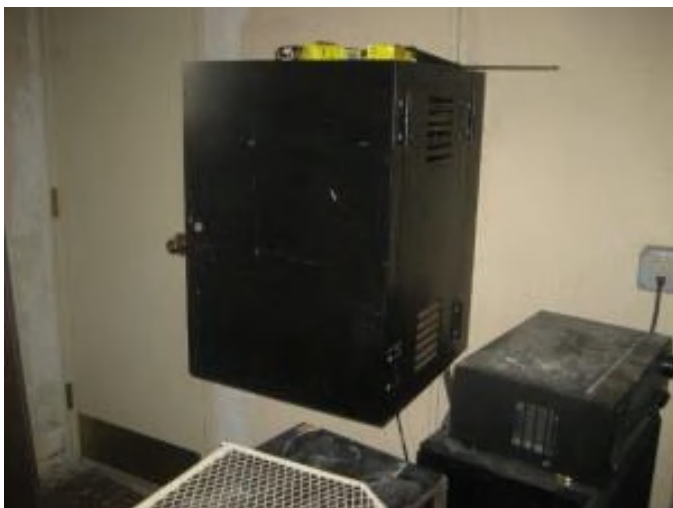
System: D5030 - Communications and Security

Location: Auditorium

Distress: Obsolete

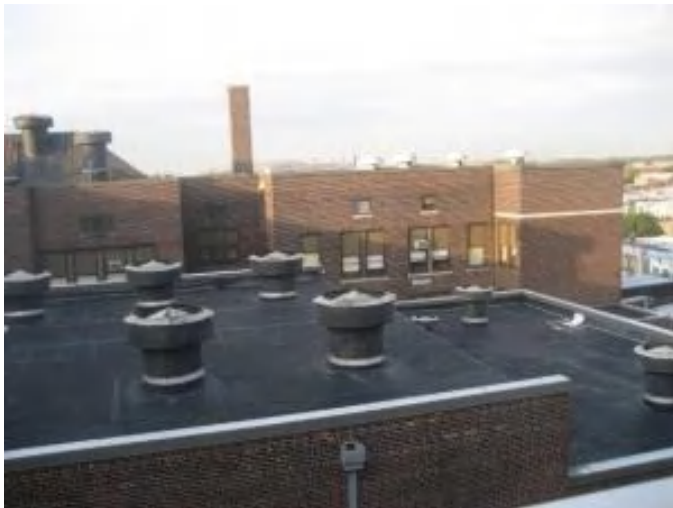
System: D5090 - Other Electrical Systems

Location: Roof

Distress: Building / MEP Codes

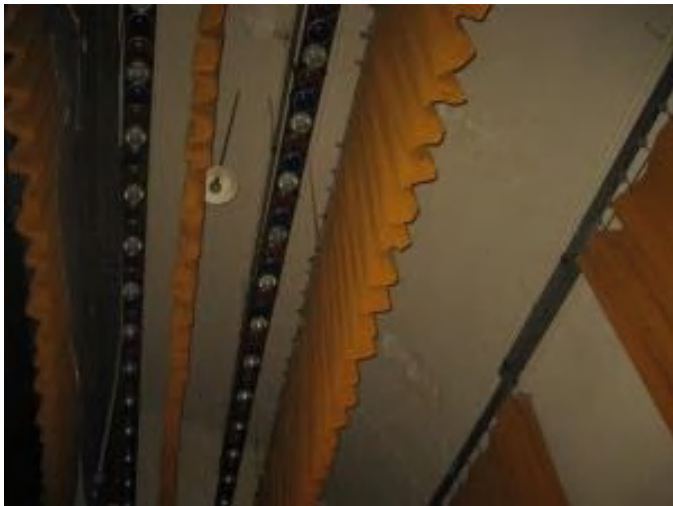
System: E1020 - Institutional Equipment

Location: Auditorium

Distress: Obsolete

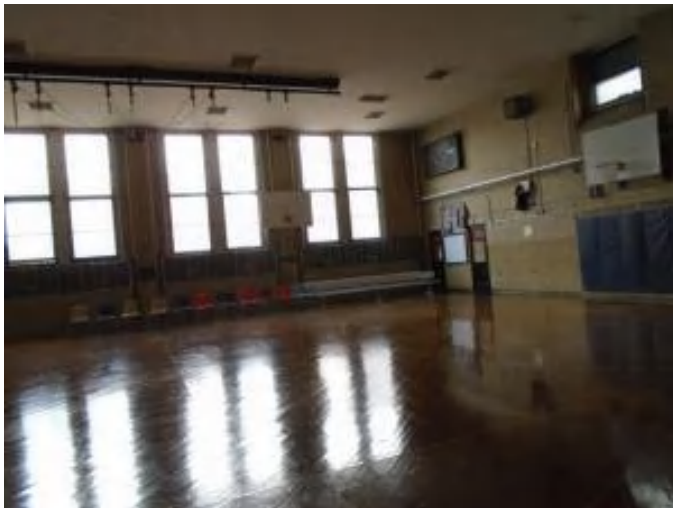
System: E1020 - Institutional Equipment

Commercial and Institutional equipment includes: security equipment, theatre and stage equipment, and exercise equipment in good condition, and gym equipment in poor condition. Other equipment includes: food service equipment in good condition.

Location: Gym

Distress: Failing

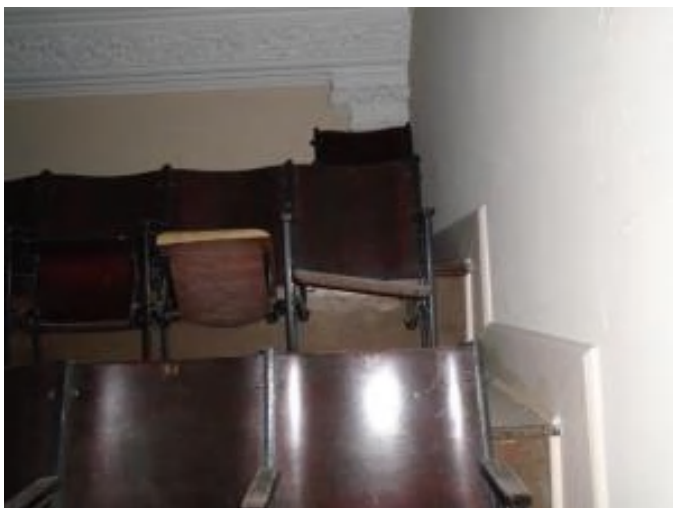
System: E2010 - Fixed Furnishings

Fixed furnishings include: fixed casework in classrooms, corridors and library, blinds and window shades, fixed table desks, and fixed locker room bench seats all generally in fair to good condition. Fixed auditorium seating for 675 is in fair condition and balcony seating for 230 is in poor condition and failing.

Location: Auditorium balcony

Distress: Failing

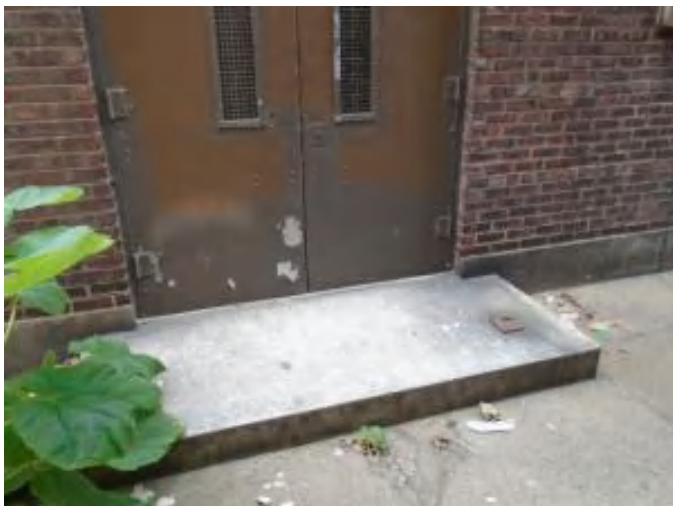
System: B2030 - Exterior Doors

Location: Ext. Doors

Distress: Beyond Service Life

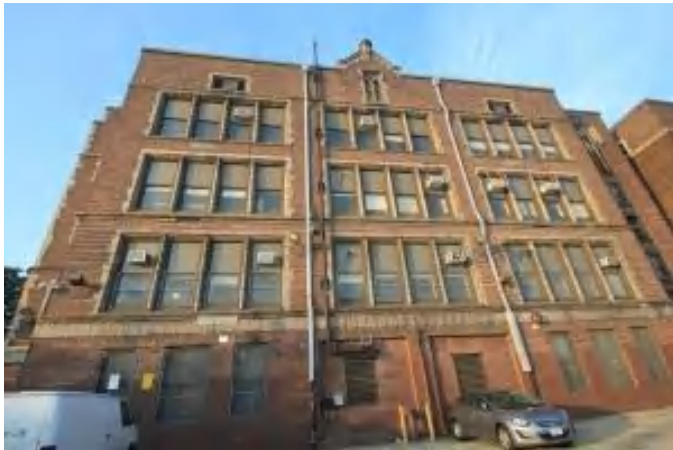
System: D3030 - Cooling Generating Systems

The building does not have any central cooling generation. There are 58 window unit air-conditioners for offices, IMC, and some classrooms. Two mini-split systems provide cooling for the computer network equipment rooms. In total, the building currently has approximately 120 tons cooling capacity. A chiller system should be installed with 400 ton capacity for the entire building.

Location: Entire building

Distress: Inadequate

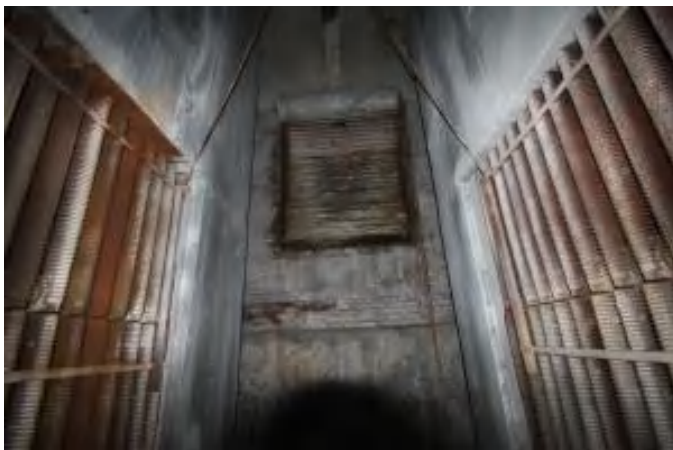
System: D3040 - Distribution Systems

Location: Gymnasiums

Distress: Inadequate

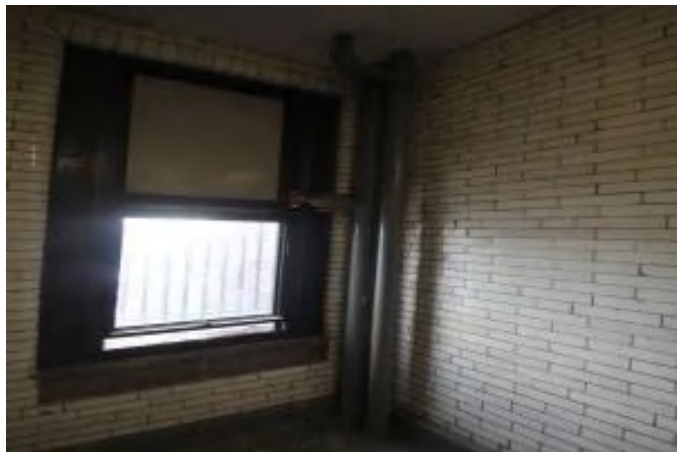
System: D4010 - Sprinklers

Location: Entire building

Distress: Life Safety / NFPA / PFD

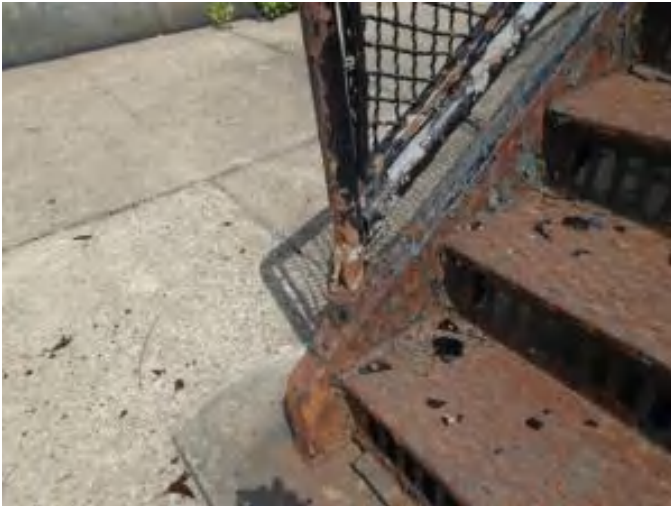
System: G2030 - Pedestrian Paving

Location: Fire exits

Distress: Health Hazard / Risk

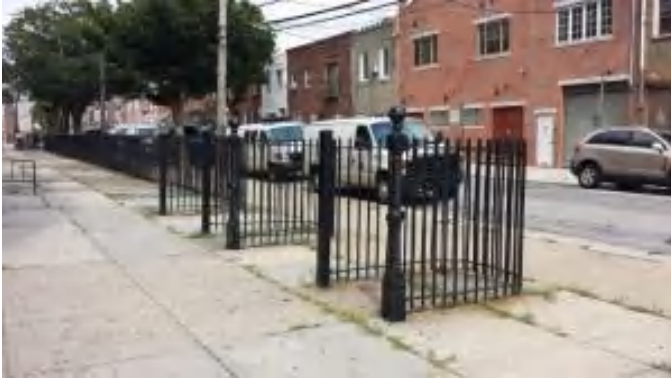
System: G2040 - Site Development

Location: Parking

Distress: Security Issue

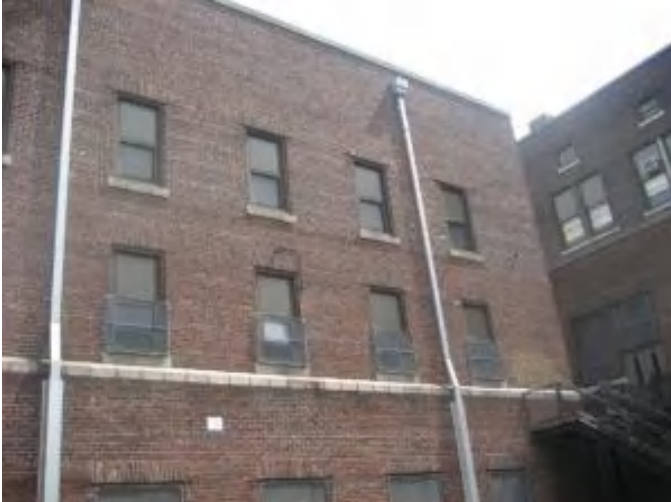
System: G4030 - Site Communications & Security

Location: Outdoor

Distress: Security Issue
