Facility Condition Assessment Summary Report

Gideon School

School District of Philadelphia
S453001;Gideon
Final
Site Assessment Report

January 30, 2017

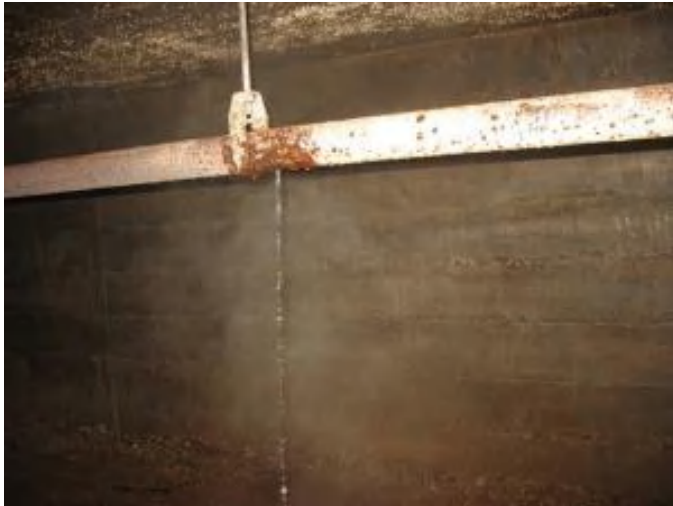
System: D3040 - Distribution Systems

Location: Throughout building

Distress: Failing

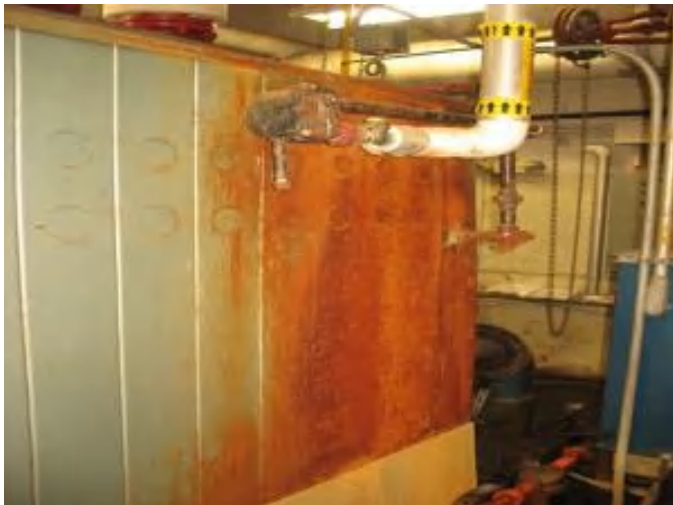
System: D3040 - Distribution Systems

Location: Throughout building

Distress: Failing

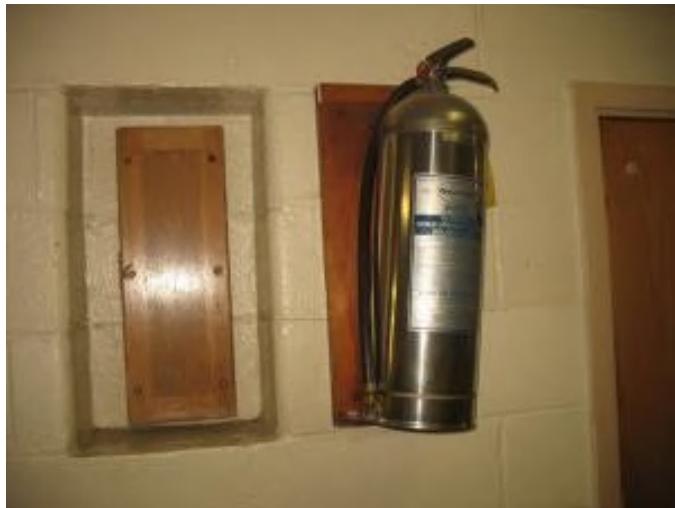
System: D4010 - Sprinklers

Location: Throughout building

Distress: Life Safety / NFPA / PFD

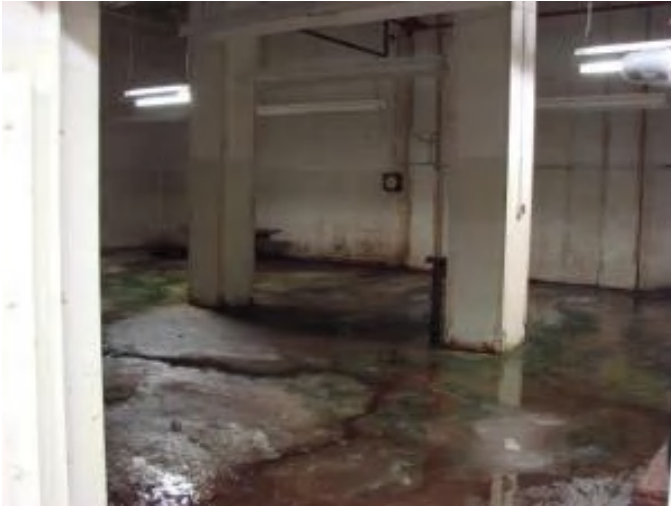
System: A1030 - Slab on Grade

The building typically rests on concrete foundations and bearing walls that are not showing signs of settlement. There is major water seepage through basement walls during rain in boiler and coal storage rooms on the north side of the building. Foundation walls do not show signs of deterioration. Microbial growth and rust is heavy in basement areas. The basement slab does not show signs of heaving.

Location: Basement

Distress: Building Envelope Integrity

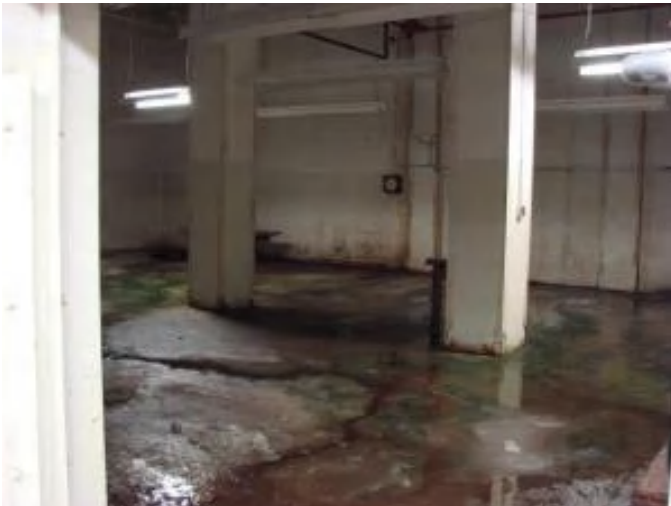
System: A2020 - Basement Walls

Location: Basement

Distress: Health Hazard / Risk

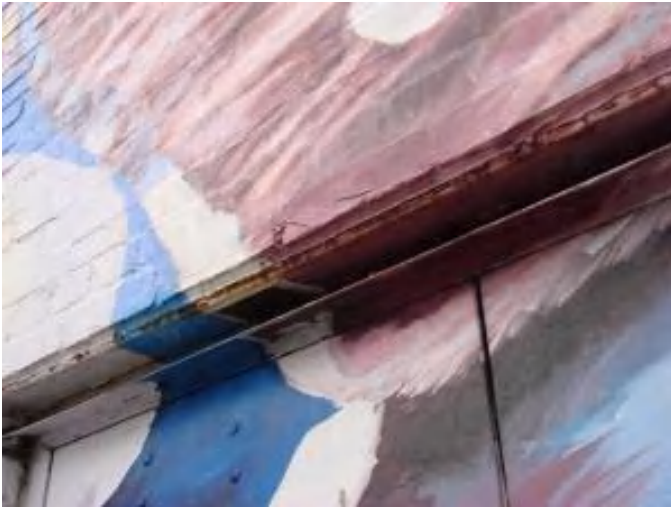
System: B2010 - Exterior Walls

The building envelope is typically masonry with face brick over CMU or SGFT. In general, masonry is in fair condition with some small cracks and missing mortar.

Location: Exterior

Distress: Maintenance Required

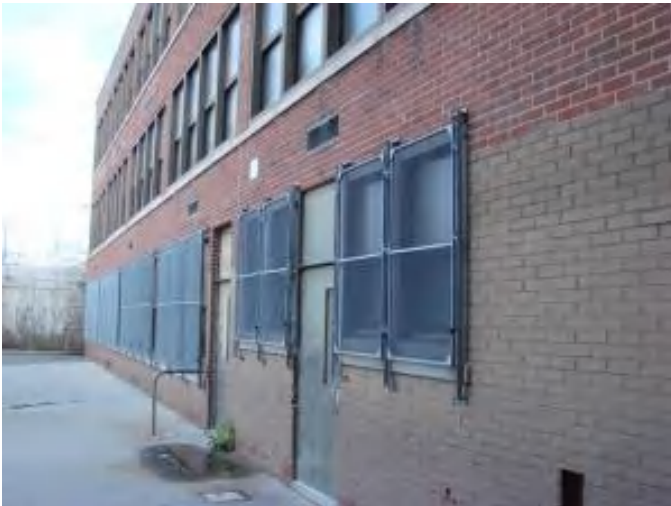
System: B2030 - Exterior Doors

Location: Throughout

Distress: Beyond Service Life

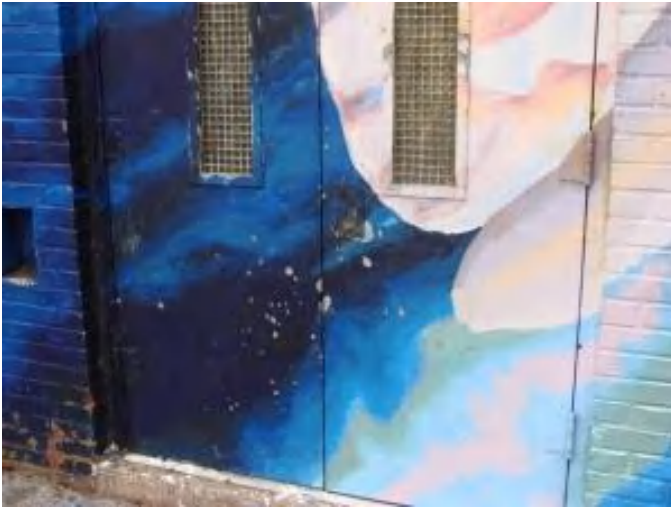
System: B2030 - Exterior Doors

Location: Entrance
Distress: Accessibility
Category: 2 - Code Compliance
Priority: 2 - Response Time (2-3 yrs)
Correction: Replace hardware with compliant hardware, paint and weatherstrip - per leaf
Qty: 2.00
Unit of Measure: Ea.
Estimate: \$6,987.28
Assessor Name: System
Date Created: 02/11/2016

Notes: Install accessible door hardware on at least one entrance

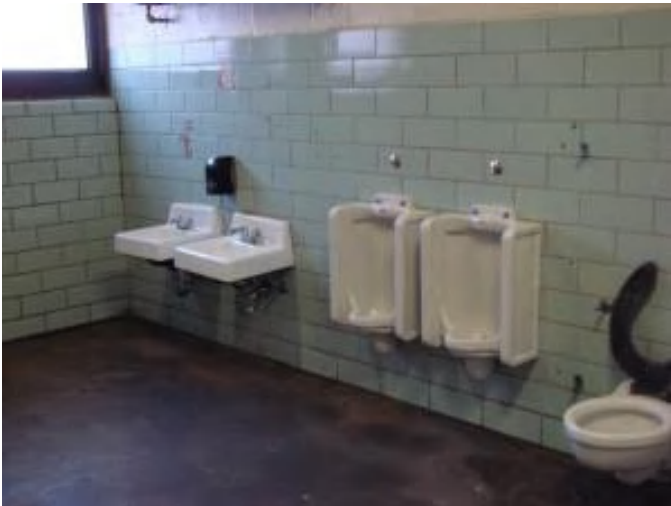
System: C1030 - Fittings

Fittings include original chalk boards, generally in fair condition. Toilet partitions and accessories in are in very poor condition, mostly original to the building, some missing. Interior identifying signage is typically directly painted on wall or door surfaces generally in poor condition.

Location: Toilets
Distress: Failing
Category: 3 - Operations / Maint.
Priority: 2 - Response Time (2-3 yrs)
Correction: Remove and replace toilet partitions
Qty: 20.00
Unit of Measure: Ea.
Estimate: \$51,328.09
Assessor Name: System
Date Created: 02/11/2016

Notes: Replace toilet partitions – missing and damaged

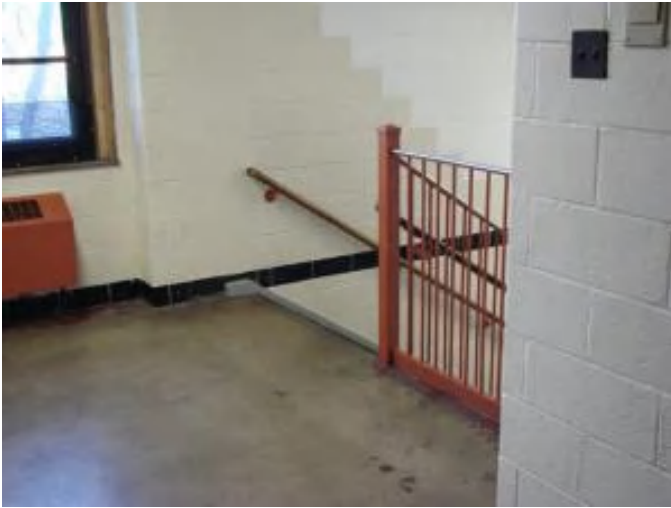
System: C3010230 - Paint & Covering

Partition wall types typically include painted CMU. The interior wall finishes are generally painted CMU and plaster. Walls in some toilets are SGFT. Generally, paint is in poor condition, applied in approximately 2003. Approximately 80% of ceilings are exposed, plastered and painted. 2x4 suspended acoustical panels are installed in some classrooms and office spaces in good condition.

Location: Throughout

Distress: Appearance

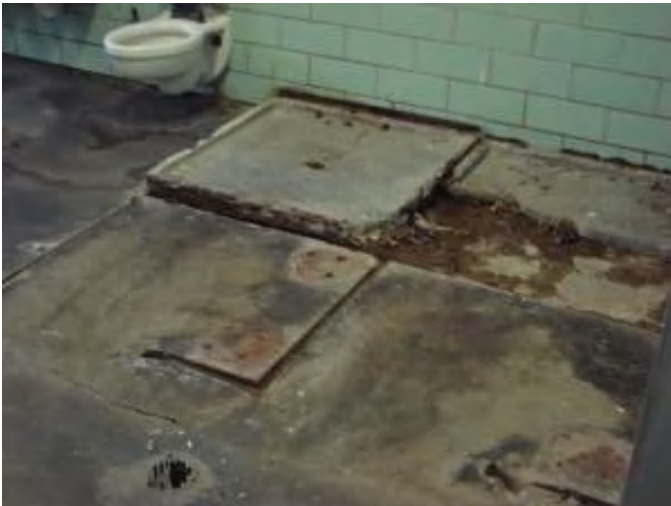
System: C3020415 - Concrete Floor Finishes

Flooring throughout is generally VAT and VCT with concrete in toilets, stairways, and mechanical spaces. Flooring in some toilets are heavily damaged.

Location: Toilet

Distress: Damaged

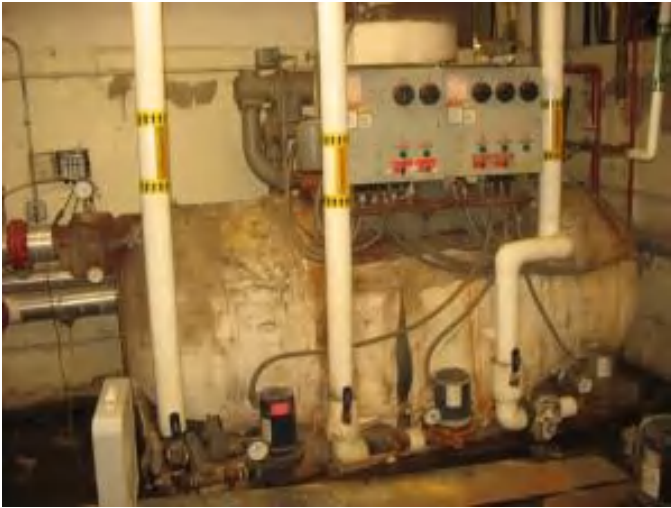
System: D3040 - Distribution Systems

A vacuum condensate receiver tank and boiler feed pump assembly are installed in the boiler room. The receiver tank provides treated make-up water to the boilers. The unit has three (3) 2HP pumps headered together and mounted on the tank. The unit appears to be in poor condition with rust forming on many parts due to leaking steam. The condensate receiver and associated pumps are damaged from rust and should be replaced.

Location: Boiler room
Distress: Damaged
Category: 3 - Operations / Maint.
Priority: 2 - Response Time (2-3 yrs)
Correction: Replace vacuum condensate pump set (duplex)
Qty: 1.00
Unit of Measure: Ea.
Estimate: \$85,863.15
Assessor Name: System
Date Created: 02/04/2016

Notes: Replace the vacuum condensate receiver tank and three (3) associated 2HP boiler feed pumps which are damaged from rust.

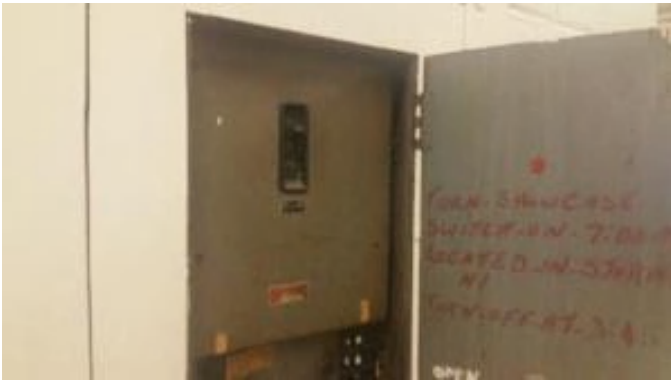
System: D5010 - Electrical Service/Distribution

Location: throughout the building
Distress: Beyond Service Life
Category: 3 - Operations / Maint.
Priority: 2 - Response Time (2-3 yrs)
Correction: Remove and Replace Panelboard - 400 amp
Qty: 1.00
Unit of Measure: Ea.
Estimate: \$411,758.77
Assessor Name: System
Date Created: 02/17/2016

Notes: Install new 120V lighting and receptacle panels throughout the building (total of 10)

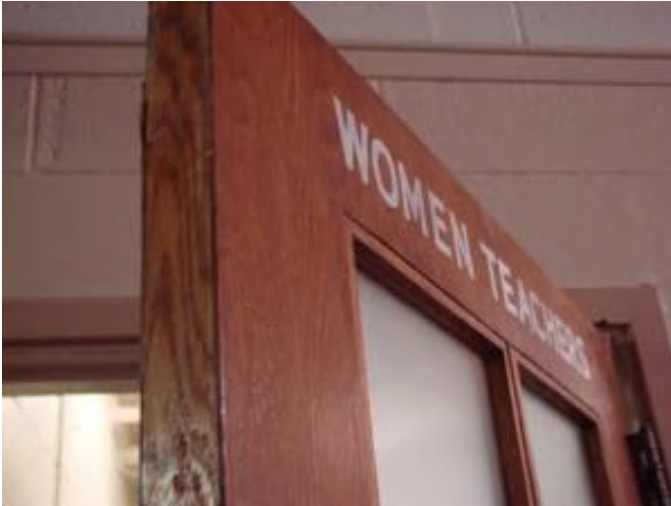
System: C1020 - Interior Doors

Location: Throughout

Distress: Beyond Service Life

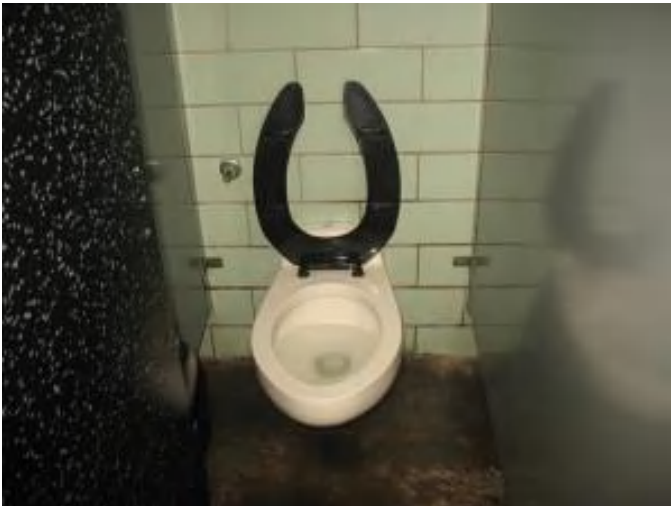
System: D2010 - Plumbing Fixtures

Many of the original plumbing fixtures remain in service. Fixtures in the restrooms on each floor consist of wall mounted push button flush valve water closets, wall hung urinals, and lavatories with wheel handle faucets. Many of the units appear to be in poor condition, are beyond their useful service lives, and should be replaced.

Location: Restrooms

Distress: Beyond Service Life

- Replace sixteen (16) urinals, in use beyond their service life, with new low flow fixtures.
- Replace twenty-seven (27) water closets, in use beyond their service life, with new code compliant fixtures.

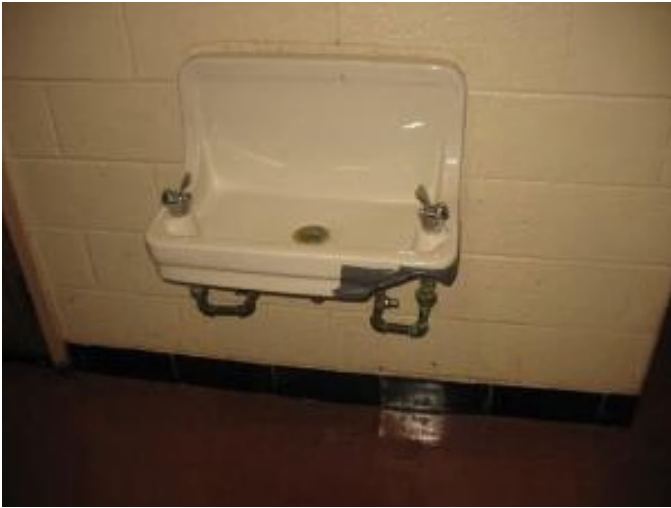
System: D2010 - Plumbing Fixtures

Drinking fountains in the corridors are a mixture of wall hung porcelain and floor mounted fountains with integral refrigerated coolers. They are beyond their service life and should be replaced; most are NOT accessible type.

Location: Corridors

Distress: Beyond Service Life

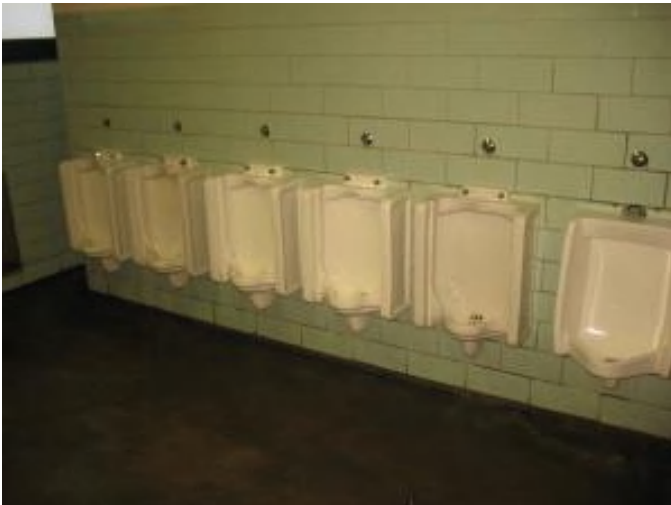
System: D2010 - Plumbing Fixtures

Location: Restrooms

Distress: Beyond Service Life

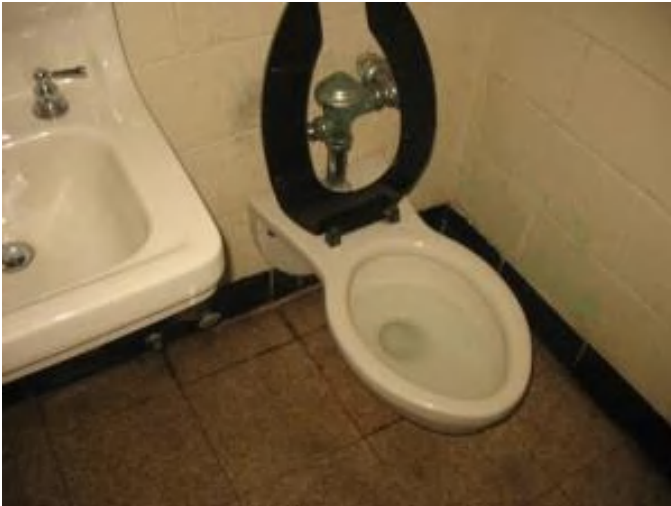
System: D2010 - Plumbing Fixtures

Location: Restrooms

Distress: Beyond Service Life

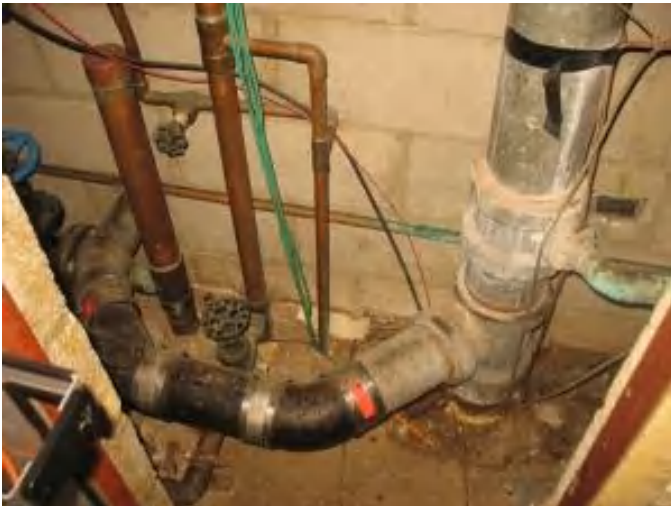
System: D2030 - Sanitary Waste

The maintenance staff reported mostly minor problems with the sanitary waste piping systems. However, the sewer piping has been in service for almost 65 years and will require more frequent attention from the maintenance staff as time passes. The District should hire a qualified contractor to examine the sanitary waste piping using video cameras to locate and replace any damaged piping and to further quantify the extent of potential failures.

Location: Throughout building

Distress: Beyond Service Life

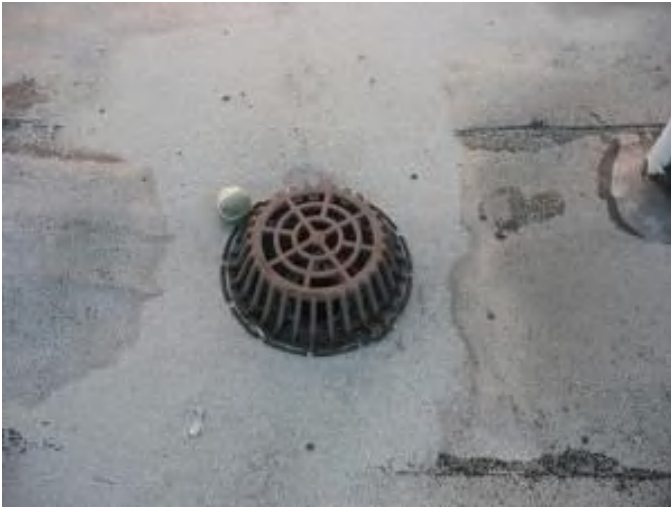
System: D2040 - Rain Water Drainage

Rain water drains from the roof are routed through mechanical chases in the building and appear to be original. The piping is threaded galvanized and has been in use well beyond its service life. The District should hire a qualified contractor to examine the rain water drainage piping using video cameras to locate and replace any damaged piping and to further quantify the extent of potential failures.

Location: Throughout building

Distress: Beyond Service Life

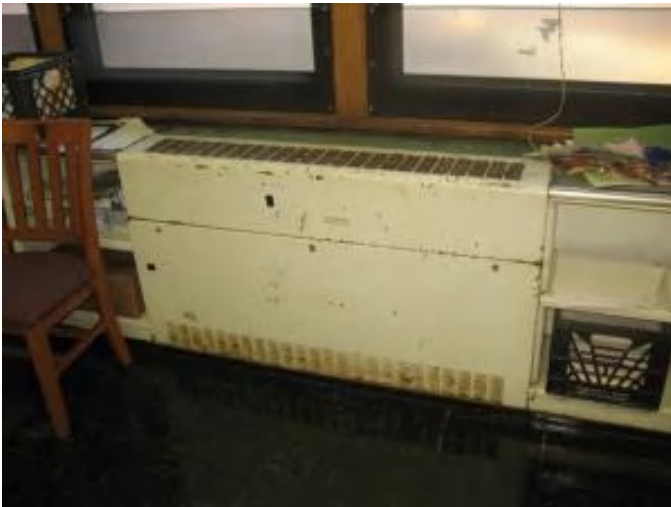
System: D3040 - Distribution Systems

Location: Classrooms

Distress: Beyond Service Life

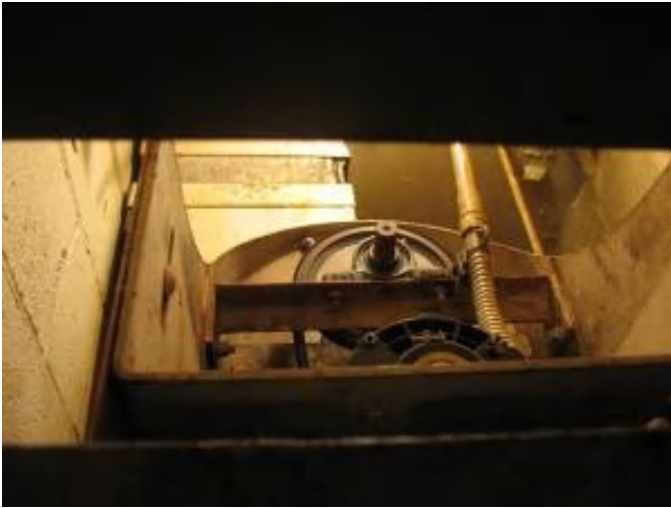
System: D3040 - Distribution Systems

Exhaust for the restrooms and janitor closets is provided by five (5) exhaust fans located in closets on the first and third floors. The exhaust fans are in poor condition, well beyond their service lives, and all should be replaced. Thirteen (13) small roof mounted gravity ventilators provide relief air for the corridors and are in poor condition. All gravity ventilators are beyond their service lives and should be replaced.

Location: Mechanical closet

Distress: Beyond Service Life

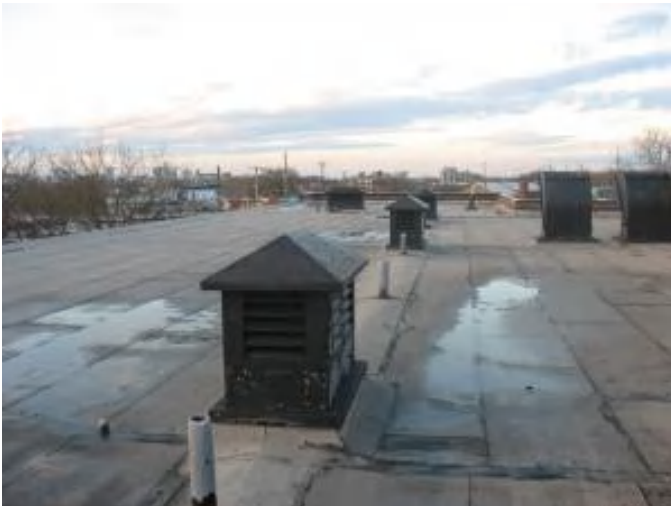
System: D3040 - Distribution Systems

Location: Roof

Distress: Beyond Service Life

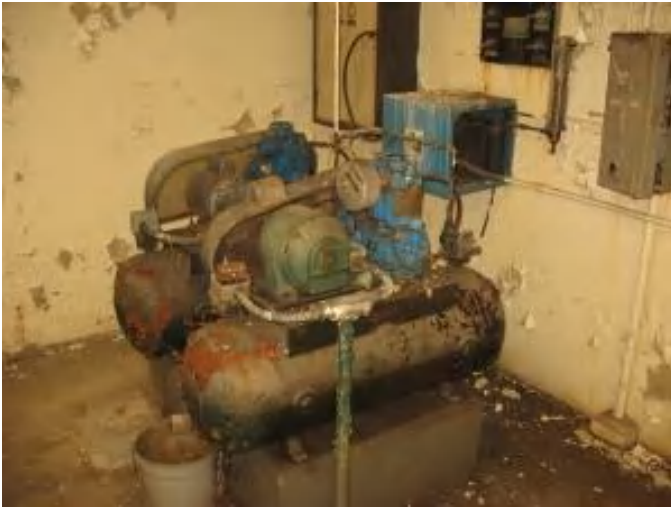
System: D3060 - Controls & Instrumentation

The original pneumatic systems no longer provide basic control functions. Pneumatic room thermostats are intended to control the unit ventilator control valves. In reality the unit ventilator control valves are wide open and heating is controlled via the boilers. Pneumatic control air is no longer supplied as the two (2) air compressors are defunct. The pneumatic systems are beyond their service life, no longer functional, and require too much attention from the maintenance staff. The original control valves and pneumatic actuators are beyond their service life and should be rebuilt or replaced. These controls should be converted to DDC.

Location: Throughout building

Distress: Failing

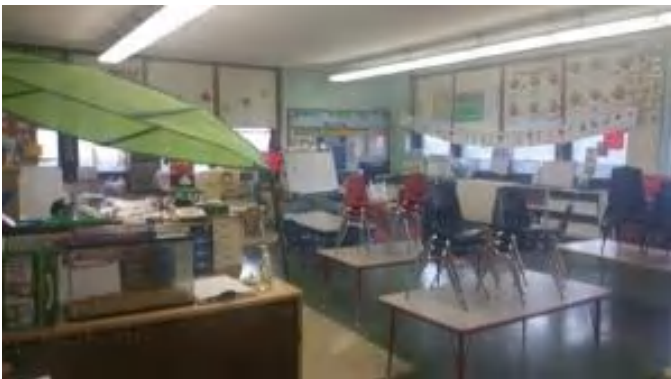
System: D5020 - Lighting and Branch Wiring

Location: throughout the building

Distress: Beyond Service Life

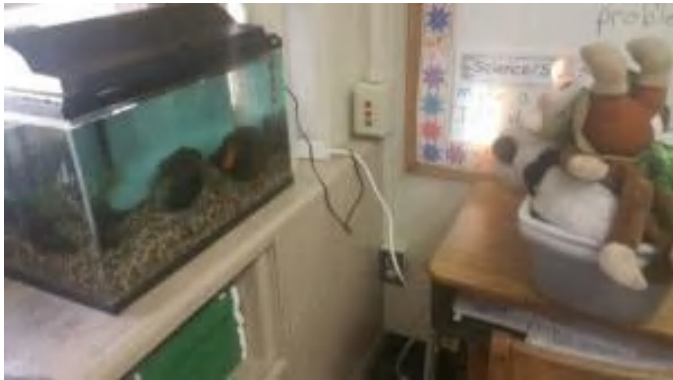
System: D5020 - Lighting and Branch Wiring

Location: throughout the building

Distress: Inadequate

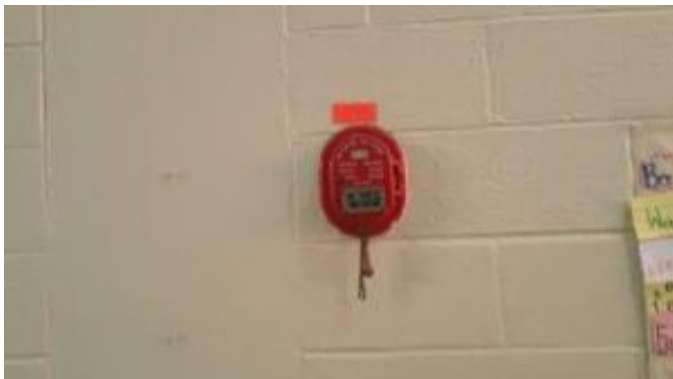
System: D5030 - Communications and Security

Location: throughout the building

Distress: Health Hazard / Risk

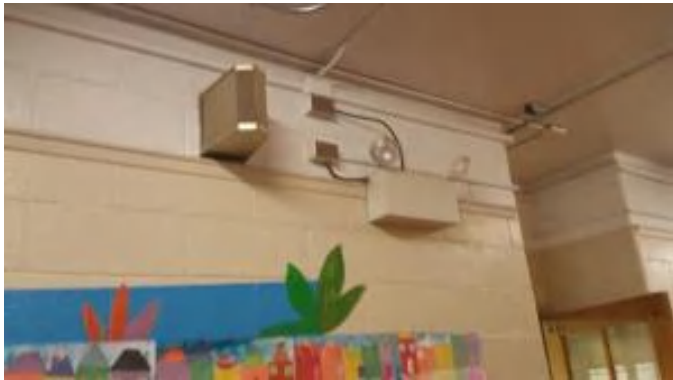
System: D5090 - Other Electrical Systems

Location: throughout the building
Distress: Beyond Service Life
Category: 3 - Operations / Maint.
Priority: 3 - Response Time (3-4 yrs)
Correction: Replace Emergency/Exit Lighting
Qty: 1.00
Unit of Measure: Ea.
Estimate: \$247,633.42
Assessor Name: System
Date Created: 02/17/2016

Notes: Install new exit lights and emergency lights.

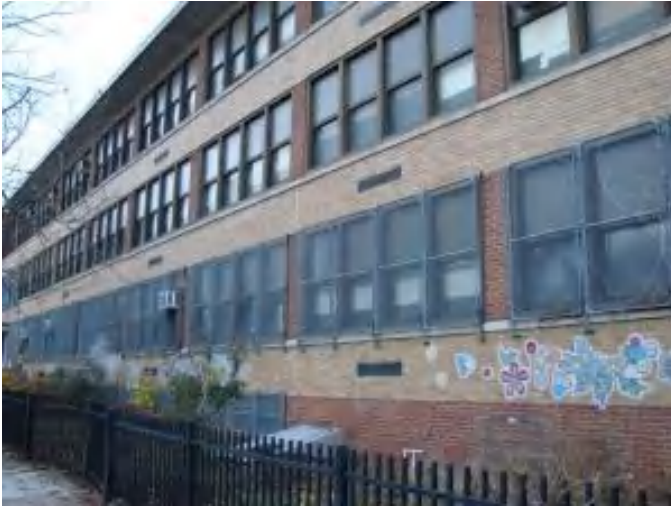
System: B2020 - Exterior Windows

The original windows were replaced in 1990 with extruded aluminum single hung windows, Lexan Plexiglas in poor condition with heavy hazing and not energy efficient. First floor windows are fitted with integral security screens in good condition. Exterior doors are typically hollow metal in poor condition; they are beyond their service life. Generally, the building is not accessible per ADA requirements due to first floor-grade separation, with no ramps or lifts.

Location: Throughout

Distress: Energy Efficiency

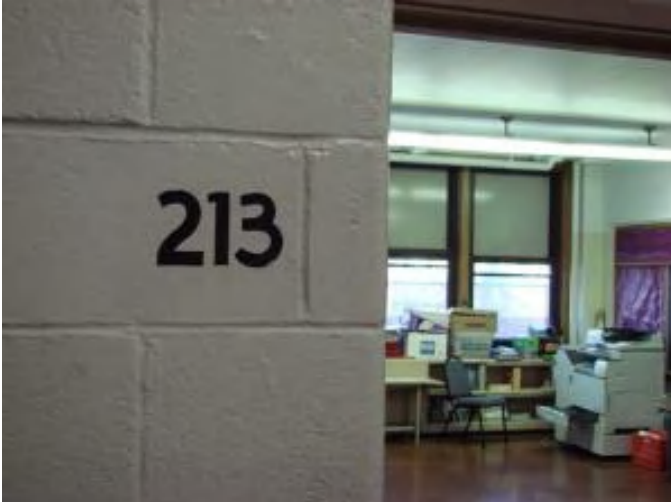
System: C1030 - Fittings

Location: Throughout

Distress: Inadequate

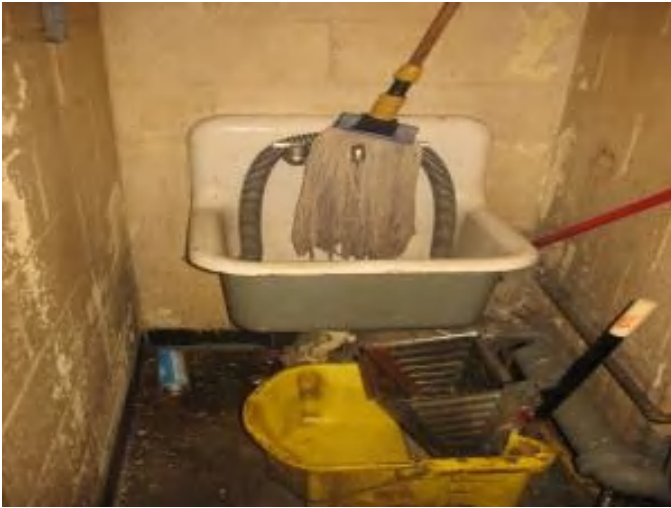
System: D2010 - Plumbing Fixtures

A service sink is available in a janitor closet in the corridor on each floor for use by the janitorial staff. The sinks are original to the building, in poor condition, and should be replaced.

Location: Corridors
Distress: Beyond Service Life
Category: 3 - Operations / Maint.
Priority: 4 - Response Time (4-5 yrs)
Correction: Remove and replace wall janitor or mop sink - insert the quantity
Qty: 3.00
Unit of Measure: Ea.
Estimate: \$23,594.12
Assessor Name: System
Date Created: 02/04/2016

Notes: Replace three (3) service sinks, located in janitor closets on each floor, which are beyond their service lives.

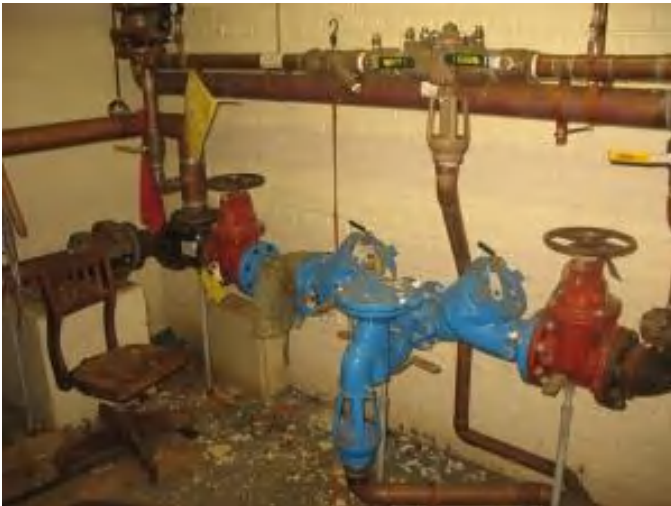
System: D2020 - Domestic Water Distribution

Location: Throughout building
Distress: Beyond Service Life
Category: 3 - Operations / Maint.
Priority: 4 - Response Time (4-5 yrs)
Correction: Replace domestic water piping (75 KSF)
Qty: 67,000.00
Unit of Measure: S.F.
Estimate: \$339,512.78
Assessor Name: System
Date Created: 02/04/2016

Notes: Hire a qualified contractor to perform a detailed inspection of the domestic water piping, in use for an unknown amount of time, and replace any damaged piping.

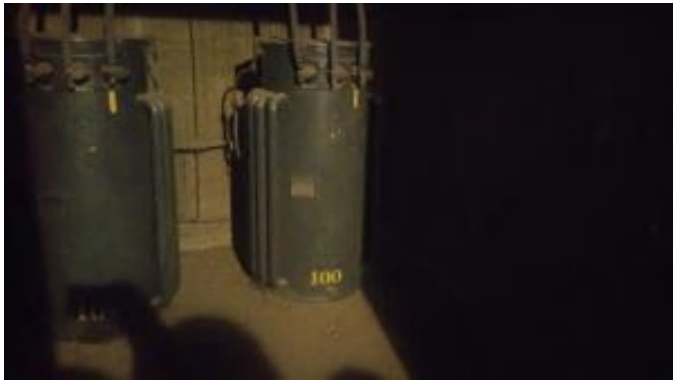
System: D5010 - Electrical Service/Distribution

Location: electrical room

Distress: Beyond Service Life

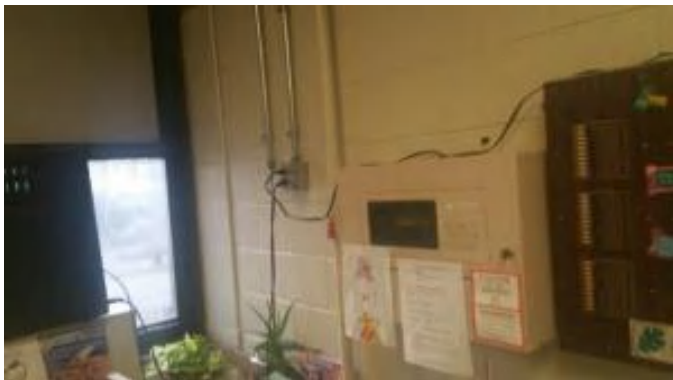
System: D5030 - Communications and Security

Location: throughout the building

Distress: Beyond Service Life

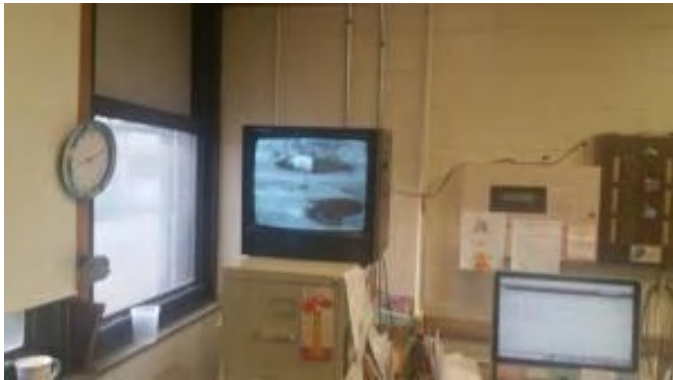
System: D5030 - Communications and Security

Location: throughout the building

Distress: Health Hazard / Risk

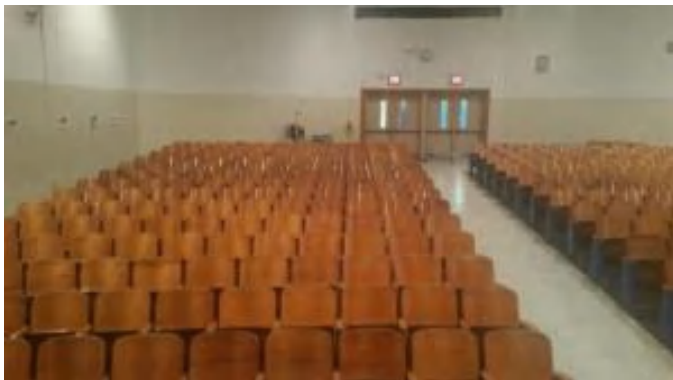
System: E1020 - Institutional Equipment

Location: Auditorium

Distress: Beyond Service Life

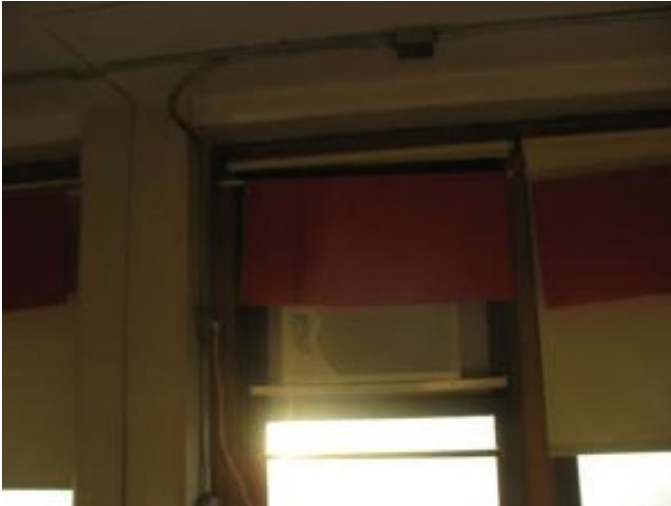
System: D3030 - Cooling Generating Systems

Several of the classrooms in the school building have window air conditioning units that have an anticipated service life of only 10 years. Installing a 190 ton air-cooled chiller, with pumps located in a mechanical room, and chilled water distribution piping would supply more reliable air conditioning for the building with a much longer service life.

Location: Throughout building

Distress: Inadequate

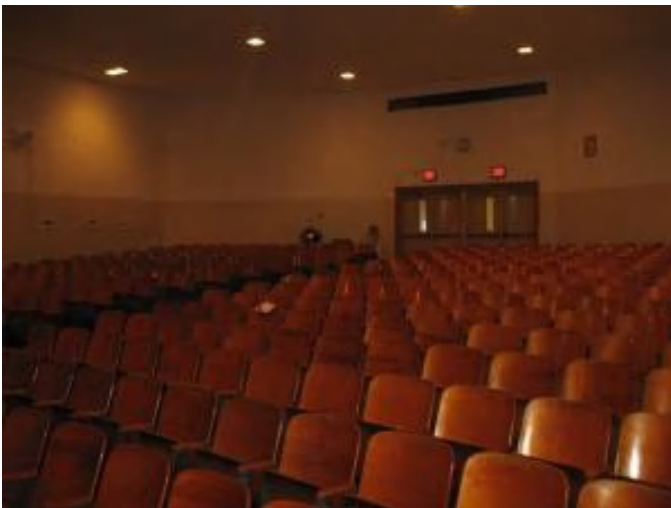
System: D3040 - Distribution Systems

Location: Auditorium

Distress: Building / MEP Codes

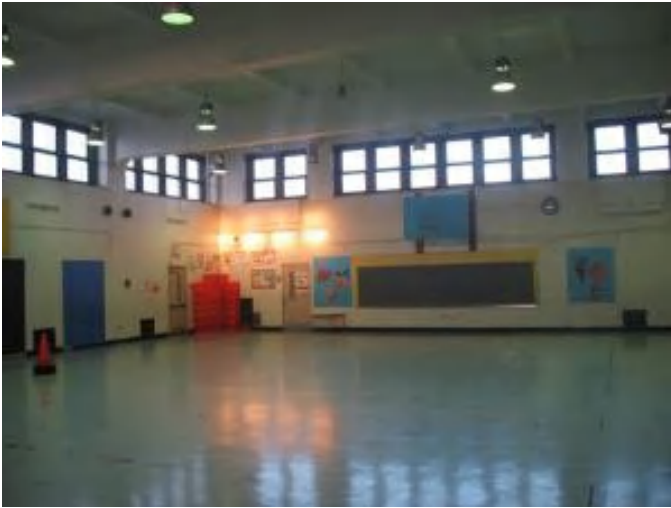
System: D3040 - Distribution Systems

Location: Gymnasium/Cafeteria
Distress: Building / MEP Codes
Category: 2 - Code Compliance
Priority: 5 - Response Time (> 5 yrs)
Correction: Install HVAC unit for Gymnasium (single station).
Qty: 6,000.00
Unit of Measure: S.F.
Estimate: \$344,860.27
Assessor Name: System
Date Created: 02/04/2016

Notes: Provide ventilation for the Gymnasium/Cafeteria by installing a fan coil air handling unit hung from the structure with outdoor air ducted to the unit from louvers in the window openings.

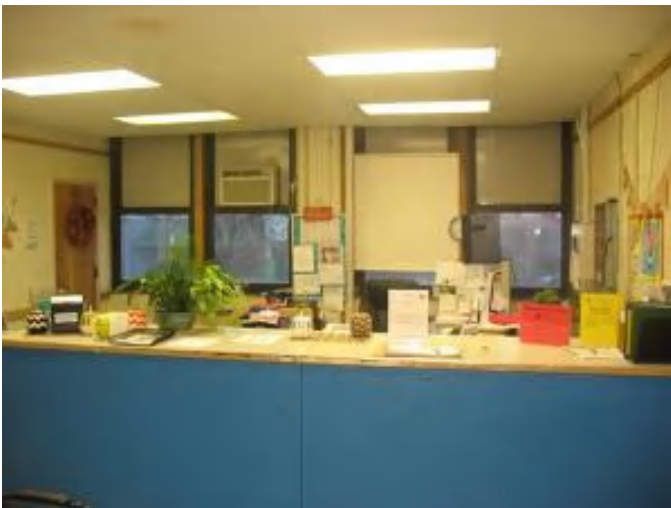
System: D3040 - Distribution Systems

Location: Administration offices
Distress: Building / MEP Codes
Category: 2 - Code Compliance
Priority: 5 - Response Time (> 5 yrs)
Correction: Install HVAC unit for Administration (2000 students).
Qty: 596.00
Unit of Measure: Student
Estimate: \$257,962.91
Assessor Name: System
Date Created: 02/04/2016

Notes: Provide ventilation for the administration offices by installing a fan coil air handling unit hung from the structure with outdoor air ducted to the unit from louvers in window openings.

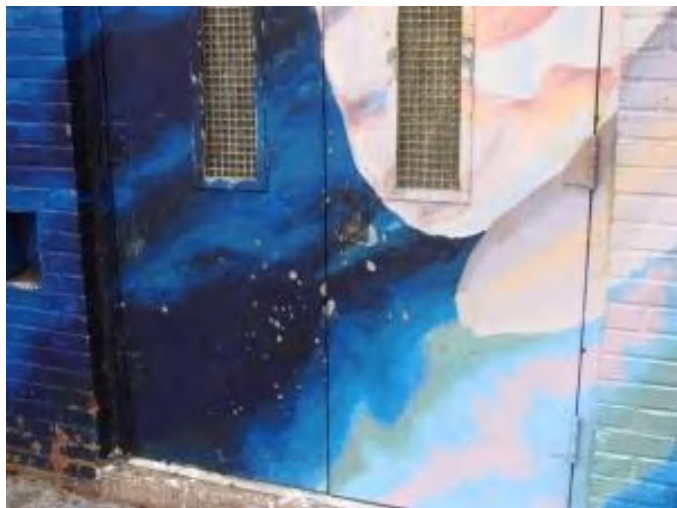
System: G2030 - Pedestrian Paving

Location: Entrance

Distress: Accessibility

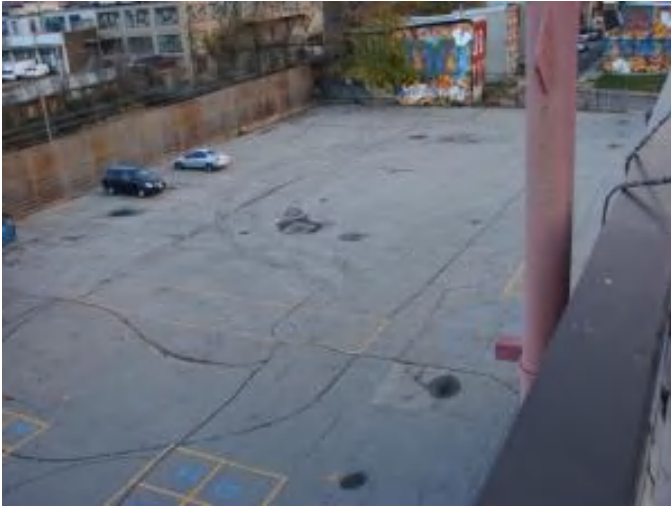
System: G2030 - Pedestrian Paving

Location: Play yard

Distress: Damaged

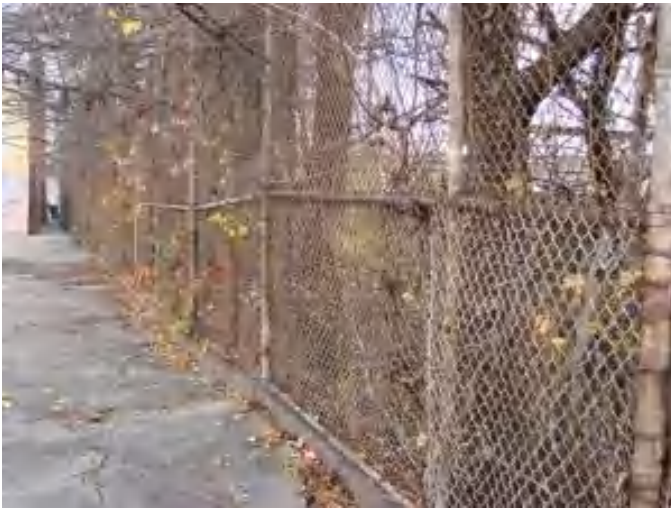
System: G2040 - Site Development

Location: Yard

Distress: Beyond Service Life

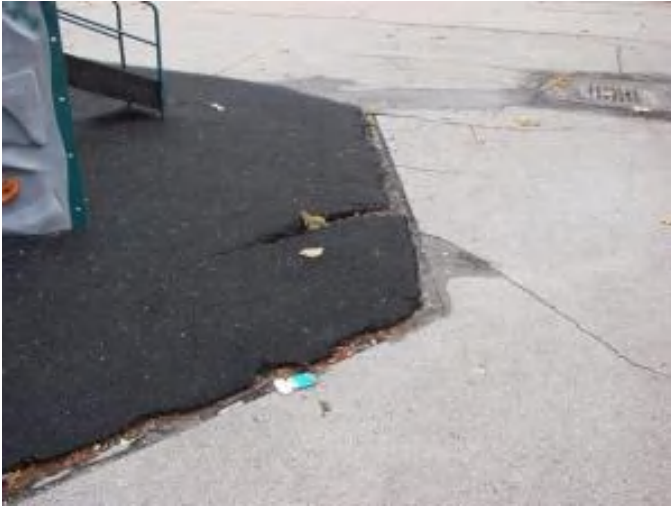
System: G2030 - Pedestrian Paving

Location: Playground

Distress: Failing

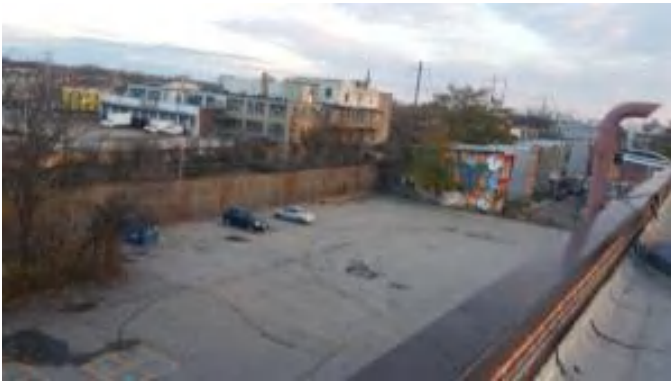
System: G4020 - Site Lighting

Location: grounds

Distress: Inadequate

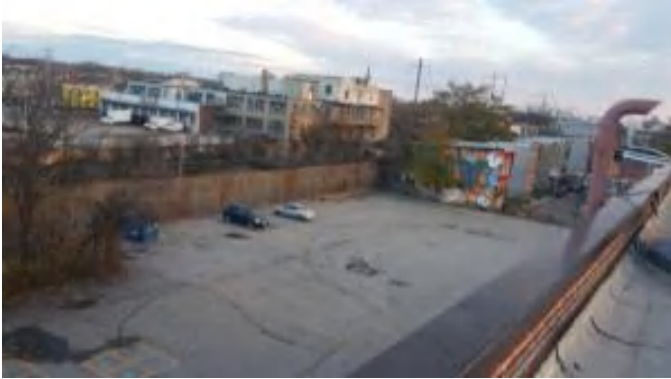
System: G4030 - Site Communications & Security

Location: grounds

Distress: Inadequate
