Facility Condition Assessment Summary Report

Girard School

School District of Philadelphia
S232001;Girard
Final
Site Assessment Report

January 30, 2017

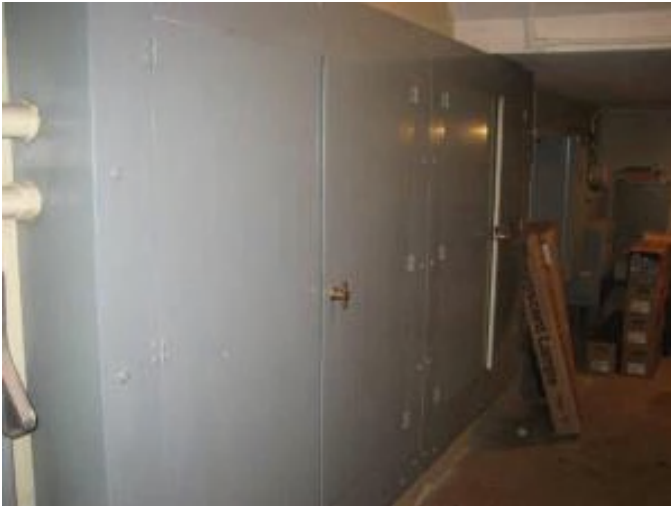
System: D5010 - Electrical Service/Distribution

Location: Basement electrical room

Distress: Inadequate

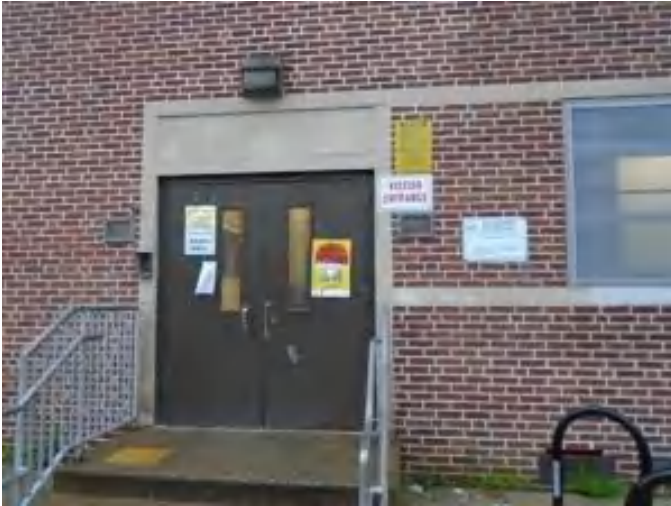
System: B2030 - Exterior Doors

Location: Entrance

Distress: Accessibility

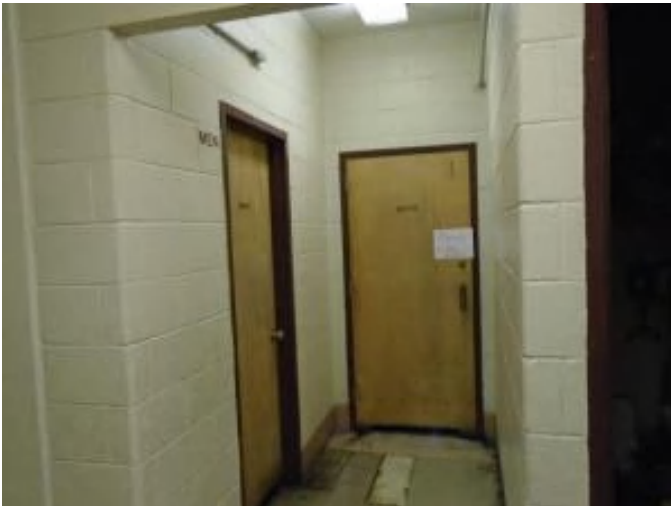
System: C1020 - Interior Doors

Location: Throughout

Distress: Accessibility

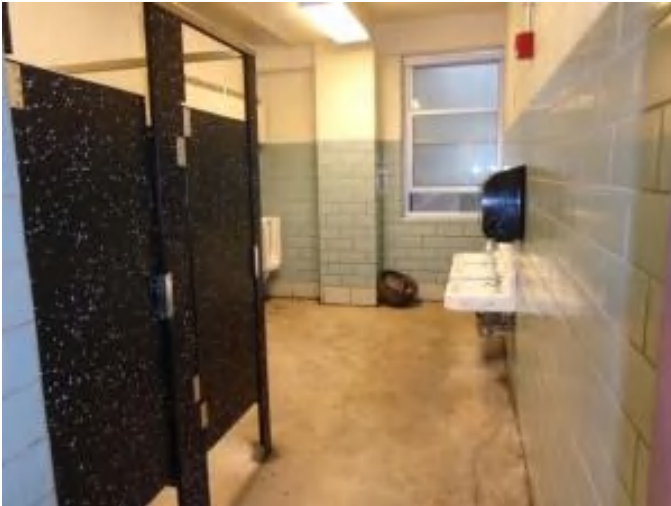
System: C1030 - Fittings

Location: Toilets
Distress: Accessibility
Category: 2 - Code Compliance
Priority: 2 - Response Time (2-3 yrs)
Correction: Remove and replace damaged toilet partitions - handicap units
Qty: 8.00
Unit of Measure: Ea.
Estimate: \$7,822.84
Assessor Name: System
Date Created: 08/11/2015

Notes: Provide new toilet partitions and toilet accessories including grab bars for accessibility

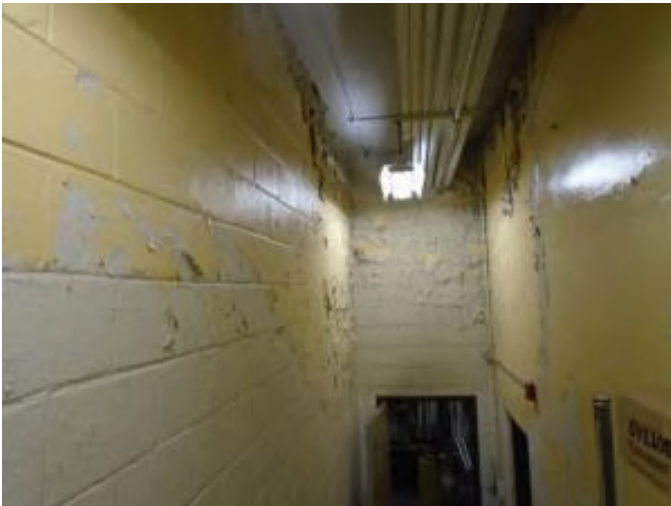
System: C3010230 - Paint & Covering

Location: Basement
Distress: Appearance
Category: 3 - Operations / Maint.
Priority: 2 - Response Time (2-3 yrs)
Correction: Repair and repaint all interior walls - SF of wall surface
Qty: 25,000.00
Unit of Measure: S.F.
Estimate: \$169,346.93
Assessor Name: System
Date Created: 08/11/2015

Notes: Repaint walls in basement

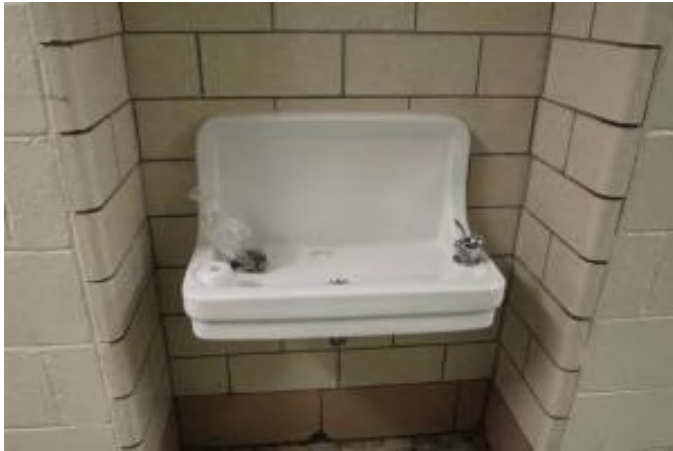
System: D2010 - Plumbing Fixtures

Location: Corridors

Distress: Accessibility

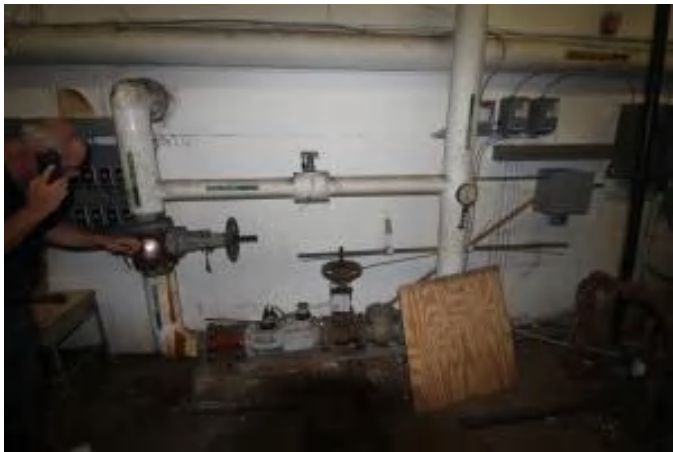
System: D2020 - Domestic Water Distribution

City water supply enters the building in the boiler room in a 4" line. There is a heavily rusted gate valve before the meter. It is dripping constantly from the valve body and failure is imminent. It should be replaced immediately. The water meter line and meter-bypass line do not have backflow preventers and those should be installed. Domestic hot and cold water distribution piping is insulated soldered copper of unknown age, and should be inspected more thoroughly to determine condition and remaining lifespan.

Location: Boiler room

Distress: Building / MEP Codes

- Provide ADA compliant ramp at one entrance (location TBD)
- Replace drinking fountains with accessible fountains with integral coolers.
- Replace failed 4" gate valve on city water entrance line, and install double backflow preventers on water meter and meter-bypass lines.

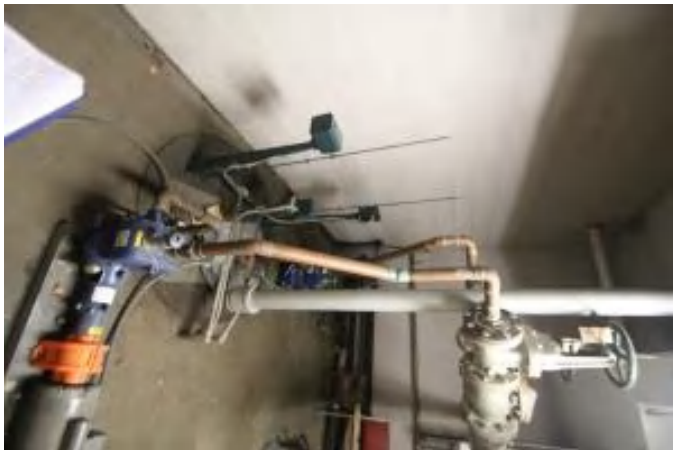
System: D3040 - Distribution Systems

Location: Sanitary sewer sump room

Distress: Building / MEP Codes

- Install exhaust fan in sewage sump room and seal sump pit cover.
- Inspect rain water drainage pipes.
- Repair inoperable boiler.
- Replace rusted and corroded boiler feedwater supply lines.

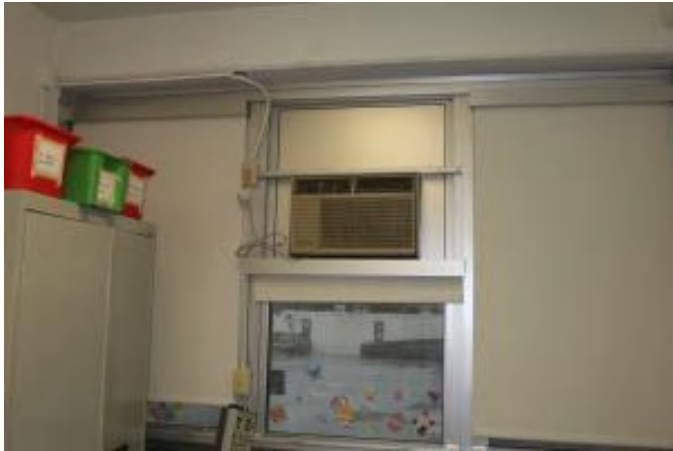
System: D3050 - Terminal & Package Units

The teacher lounge, nurse's office, and principal's office have window unit air conditioners. They are outdated and should be removed. The second floor network equipment room is cooled by a split unit air conditioner with a dedicated sump pump for condensate discharge. A 165 ton capacity roof top air-cooled chiller should be installed to cool the entire building.

Location: Offices

Distress: Obsolete

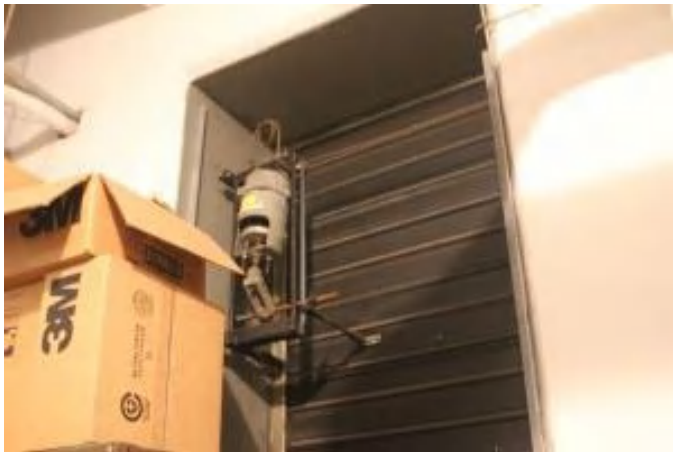
System: D3060 - Controls & Instrumentation

The building HVAC controls are pneumatic. Some controls malfunction, resulting in pressurization of the auditorium when the fans run. All building controls should be replaced by DDC when unit ventilators and air handlers are replaced and a building automation system installed to integrate all building HVAC systems.

Location: Entire building

Distress: Energy Efficiency

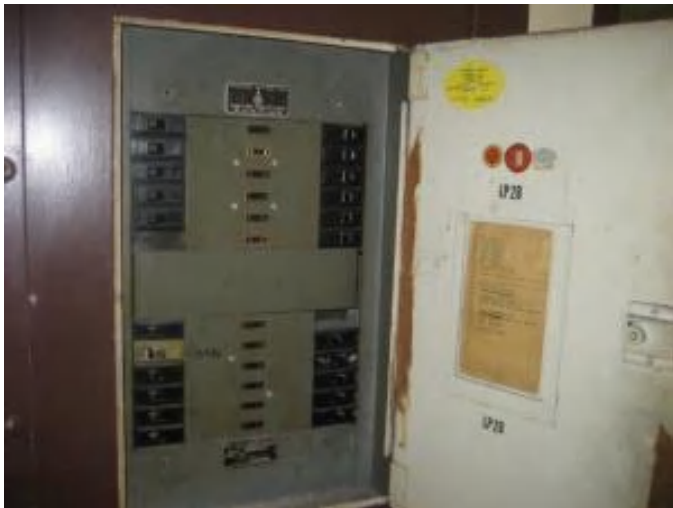
System: D5010 - Electrical Service/Distribution

There are 120/240V panel-boards in each floor for lighting and receptacles. These panelboards and associated wiring have exceeded the end of their useful life and are undersized to absorb new loads. The entire distribution system needs to be replaced with new 208/120 volt, 3 phase panelboards and new wiring. The raceway is mainly conduits run above the ceiling. Panel-board's doors are corridor are not locked and represent a potential hazard for students. As a safety issue all panel-boards at corridor on in areas where students are present must be provided with lockable devices.

Location: Entire Building

Distress: Inadequate

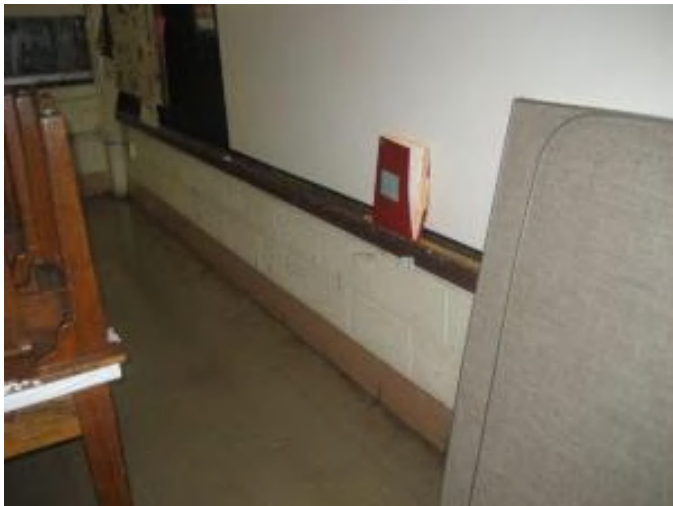
System: D5020 - Lighting and Branch Wiring

Except the IMC room the majority of the classrooms are provided with inadequate number the receptacles. Teachers use extension cords. The teacher's whiteboard wall and the opposite of it need to be provided with double compartment surface raceways, the other two walls with minimum two duplex outlets each, when feasible.

Location: Classrooms

Distress: Inadequate

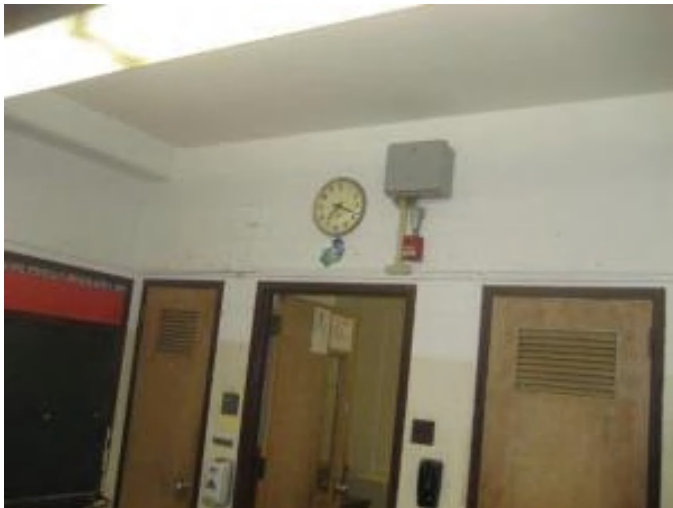
System: D5030 - Communications and Security

Location: Entire Building

Distress: Inadequate

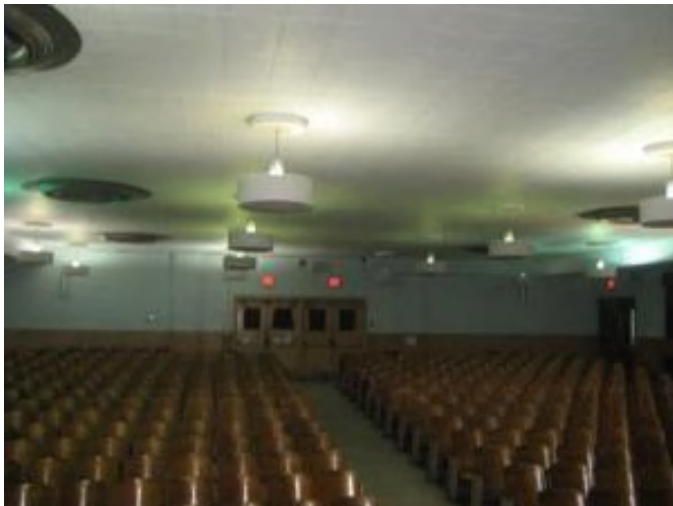
System: D5030 - Communications and Security

Location: Auditorium

Distress: Inadequate

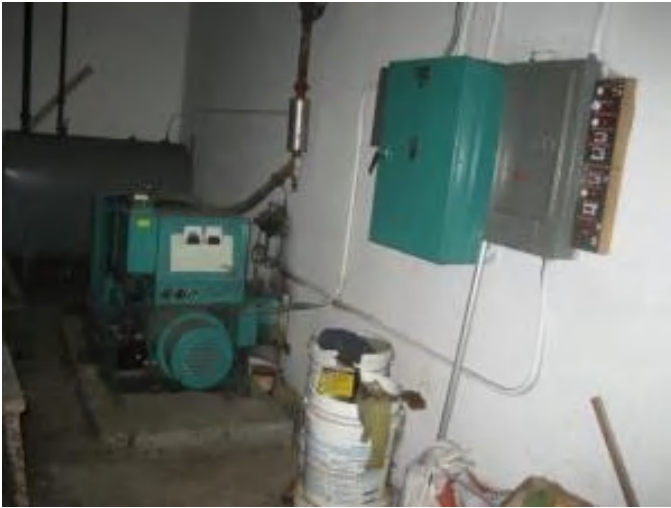
System: D5090 - Other Electrical Systems

The emergency power system consists of a gas powered generator, manufactured by Onan. The present emergency power system serves selected lighting fixtures at the corridor, stairways, auditorium and the gymnasium, it serves the exit signs too. The gas powered generator, already exceeds its useful service life and should be replaced with an outdoor diesel powered generator.

Location: Outdoor
Distress: Inadequate
Category: 4 - Capital Improvement
Priority: 2 - Response Time (2-3 yrs)
Correction: Add Standby Generator System
Qty: 1.00
Unit of Measure: Ea.
Estimate: \$122,127.83
Assessor Name: System
Date Created: 07/31/2015

Notes: Provide an outdoor diesel powered generator. Approximate 75KW

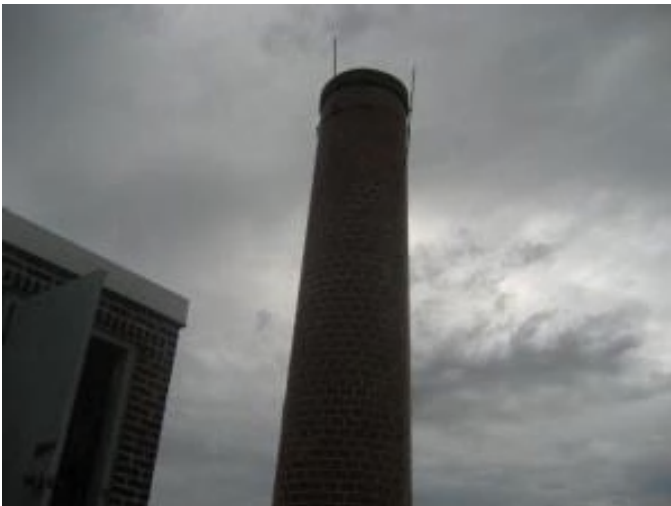
System: D5090 - Other Electrical Systems

Location: Roof
Distress: Building / MEP Codes
Category: 2 - Code Compliance
Priority: 2 - Response Time (2-3 yrs)
Correction: Repair Lightning Protection System
Qty: 1.00
Unit of Measure: Job
Estimate: \$24,249.82
Assessor Name: System
Date Created: 07/31/2015

Notes: Prepare a study to determine if the air terminals installed in the chimney provide the proper coverage to the school.

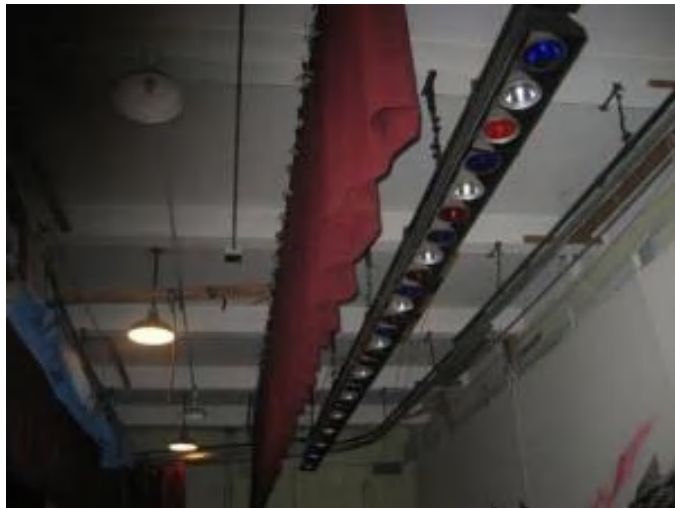
System: E1020 - Institutional Equipment

Location: Auditorium

Distress: Obsolete

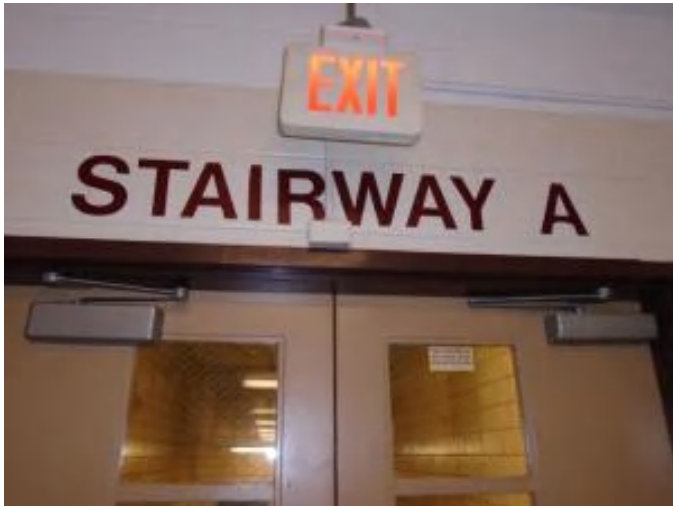
System: C1030 - Fittings

Location: Throughout
Distress: Inadequate
Category: 4 - Capital Improvement
Priority: 3 - Response Time (3-4 yrs)
Correction: Replace missing or damaged signage - insert the number of rooms
Qty: 100.00
Unit of Measure: Ea.
Estimate: \$14,376.19
Assessor Name: System
Date Created: 08/11/2015

Notes: Install new ID signage

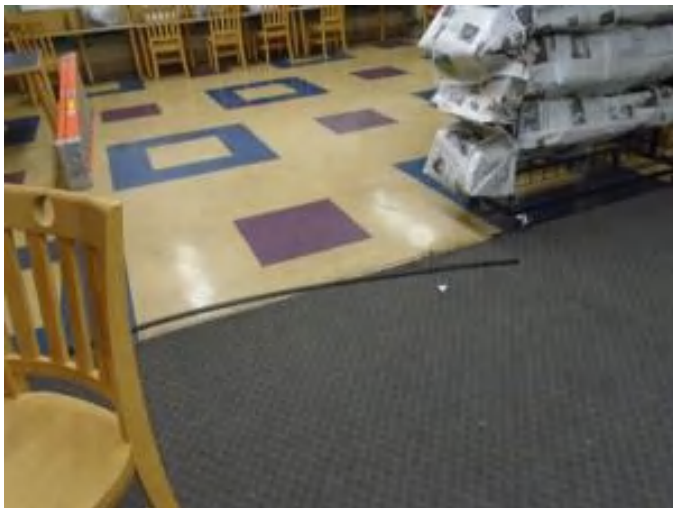
System: C3020411 - Carpet

Location: IMC, office
Distress: Beyond Service Life
Category: 3 - Operations / Maint.
Priority: 3 - Response Time (3-4 yrs)
Correction: Remove and replace carpet
Qty: 1,334.00
Unit of Measure: S.F.
Estimate: \$14,928.50
Assessor Name: System
Date Created: 08/12/2015

Notes: Replace stained and worn carpet (100% of carpeted area)

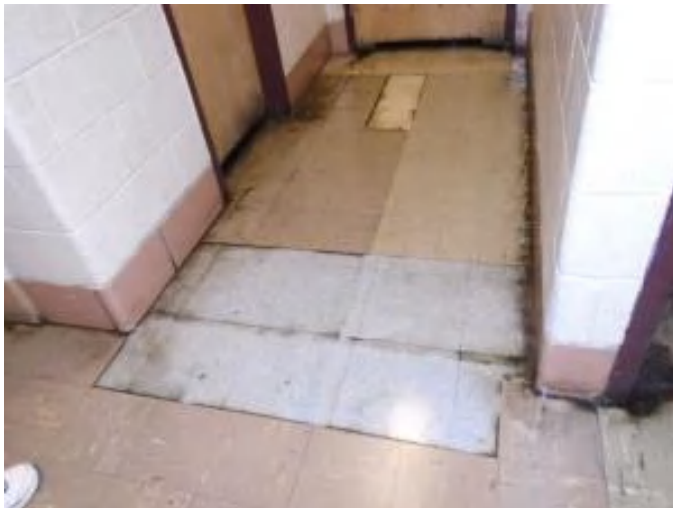
System: C3020413 - Vinyl Flooring

Location: Throughout
Distress: Damaged
Category: 3 - Operations / Maint.
Priority: 3 - Response Time (3-4 yrs)
Correction: Remove and replace VCT
Qty: 6,000.00
Unit of Measure: S.F.
Estimate: \$72,105.19
Assessor Name: System
Date Created: 08/12/2015

Notes: Replace damaged and mismatched VCT floor tiles (10% of VCT areas)

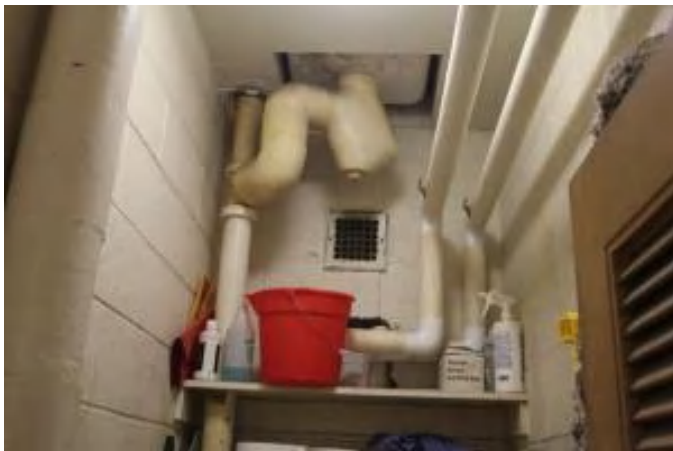
System: D2030 - Sanitary Waste

Sanitary waste pipe is mostly threaded galvanized pipe which appears to be original to the building but also includes some sections of iron pipe with banded couplers. The building engineer did not report any problems with it, but due to age it should be inspected internally and externally to determine repair requirements. The building has a sewage ejector system with dual pumps. The sump cover is not sealed and the sump room is not ventilated. A slight odor was present. The sump room should have an exhaust fan installed.

Location: Entire building
Distress: Beyond Service Life
Category: 3 - Operations / Maint.
Priority: 3 - Response Time (3-4 yrs)
Correction: Inspect sanitary waste piping and replace damaged sections. (+100KSF)
Qty: 66,685.00
Unit of Measure: S.F.
Estimate: \$283,185.05
Assessor Name: System
Date Created: 08/10/2015

Notes: Inspect sanitary waste piping to determine condition and repair as needed.

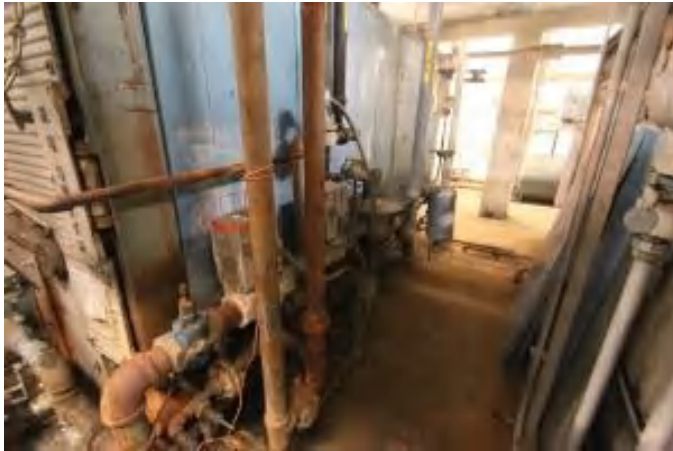
System: D3020 - Heat Generating Systems

Location: Boiler room
Distress: Beyond Service Life
Category: 3 - Operations / Maint.
Priority: 3 - Response Time (3-4 yrs)
Correction: Repair boiler
Qty: 2.00
Unit of Measure: Ea.
Estimate: \$9,111.04
Assessor Name: System
Date Created: 08/10/2015

Notes: Replace rusted and corroded boiler feedwater supply lines.

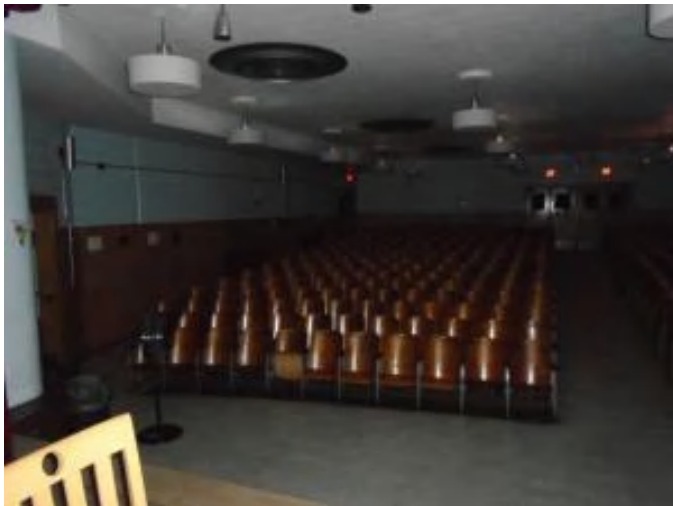
System: E2010 - Fixed Furnishings

Fixed furnishings include: fixed casework in classrooms generally in good condition; window shades/blinds, generally in good condition; fixed auditorium seating is original, generally in good condition with some damaged and missing seats.

Location: Auditorium
Distress: Damaged
Category: 3 - Operations / Maint.
Priority: 3 - Response Time (3-4 yrs)
Correction: Replace auditorium seating - add tablet arms if required. Veneer seating is an option.
Qty: 80.00
Unit of Measure: Ea.
Estimate: \$70,538.17
Assessor Name: System
Date Created: 08/12/2015

Notes: Replace broken/missing auditorium seats (20% of capacity)

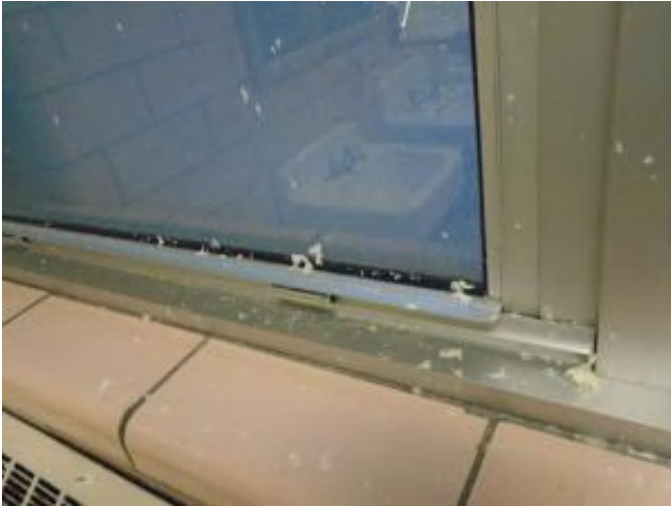
System: B2020 - Exterior Windows

Location: Throughout

Distress: Energy Efficiency

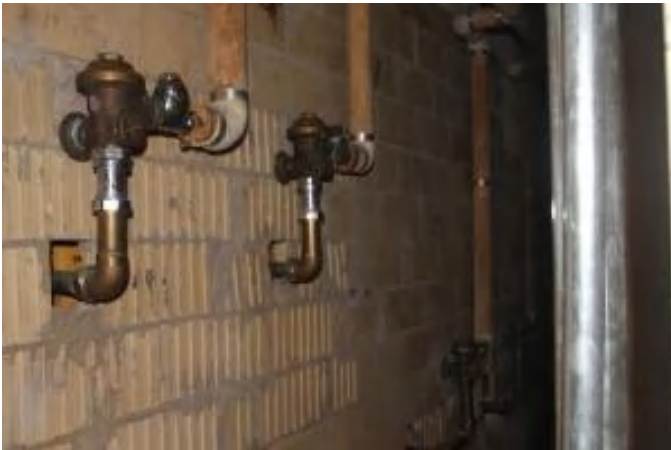
System: D2020 - Domestic Water Distribution

Location: Entire building

Distress: Beyond Service Life

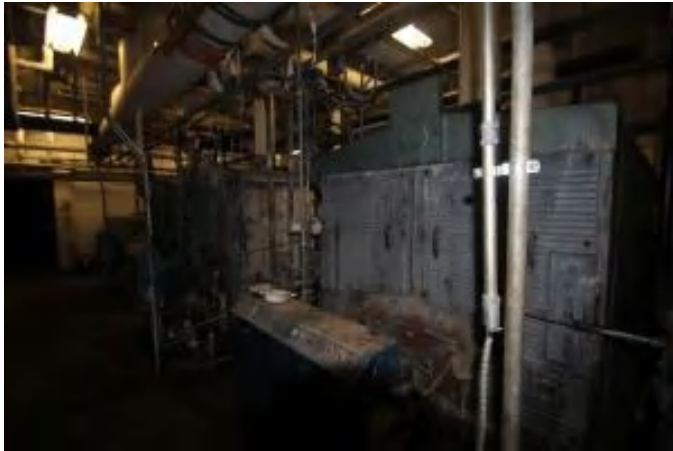
System: D3020 - Heat Generating Systems

Location: Boiler room
Distress: Failing
Category: 3 - Operations / Maint.
Priority: 4 - Response Time (4-5 yrs)
Correction: Repair boiler
Qty: 1.00
Unit of Measure: Ea.
Estimate: \$24,388.63
Assessor Name: System
Date Created: 08/10/2015

Notes: Repair inoperable boiler.

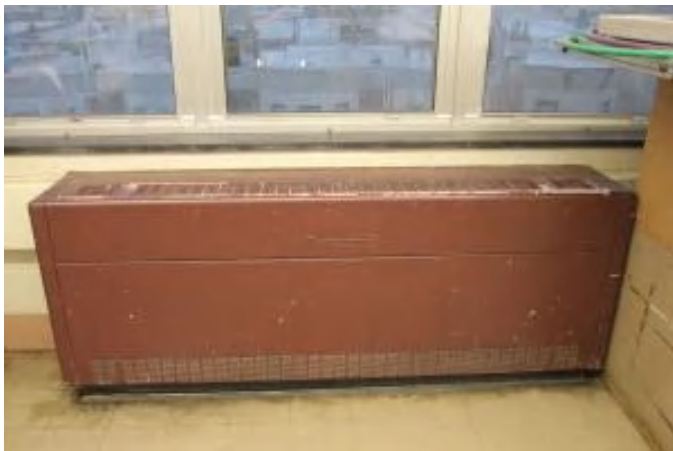
System: D3040 - Distribution Systems

The classrooms receive fresh air and heat from unit ventilators and discharge excess air through transfer ducts into the hallways. Unit ventilators include finned tube steam coils. Toilet rooms, hallways, and other rooms are heated by finned tube, natural convection, steam units. They appear to be original to the school, are beyond their expected lifespan, and many are cosmetically damaged. They should be replaced, and new ventilators should include cooling coils.

Location: Classrooms
Distress: Damaged
Category: 3 - Operations / Maint.
Priority: 4 - Response Time (4-5 yrs)
Correction: Replace the existing unit ventilators with new units designed to provide adequate ventilation per ASHRAE Std 62 - insert the SF of bldg. in the qty.
Qty: 66,685.00
Unit of Measure: S.F.
Estimate: \$3,245,349.39
Assessor Name: System
Date Created: 08/10/2015

Notes: Replace unit ventilators and radiators due to age, damage, and lack of cooling coils.

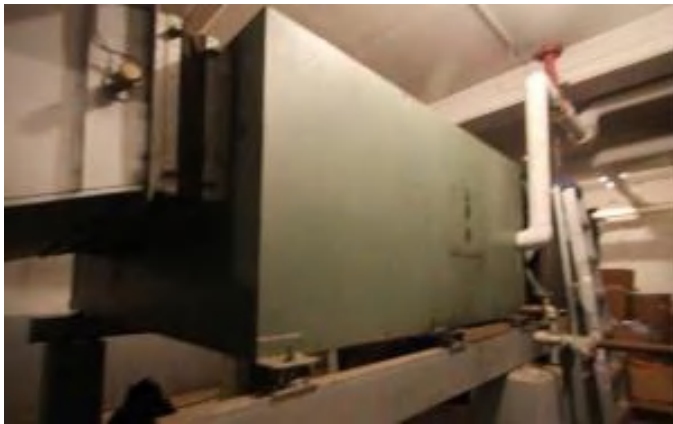
System: D3040 - Distribution Systems

There are three air handlers which serve the auditorium and gym/lunch room. They were installed before 1978 and should be replaced due to age by new air handlers with heating, cooling, humidification, and dehumidification sections.

Location: Gym and auditorium.

Distress: Inadequate

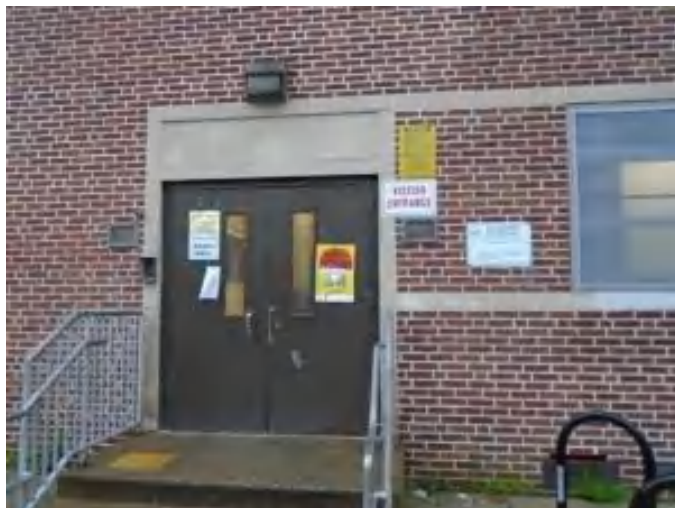
System: G2030 - Pedestrian Paving

Location: Entrance

Distress: Accessibility

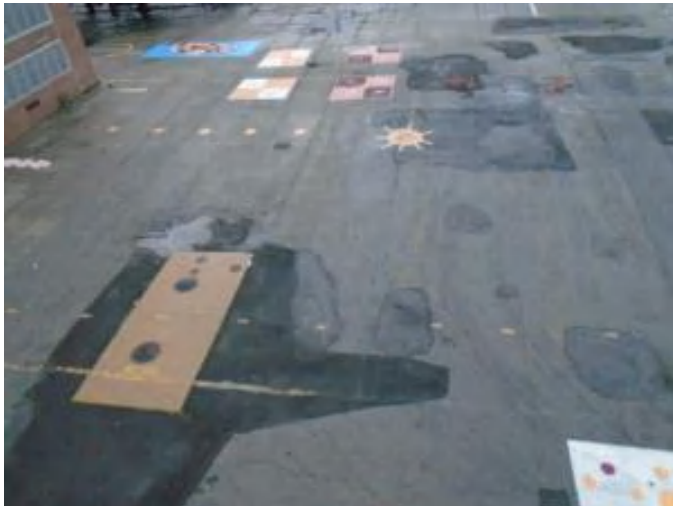
System: G2030 - Pedestrian Paving

The site surrounds the building on all four sides which is set back from the street. Play yard on North side is asphalt paving in poor condition with cracks and large depressions in need of resurfacing. Parking is street side on West side of building in good condition. Chain link fence surrounding play yard is in fair condition. Landscaping covers about 20% of the site and is mature and in good condition.

Location: Play yard

Distress: Health Hazard / Risk

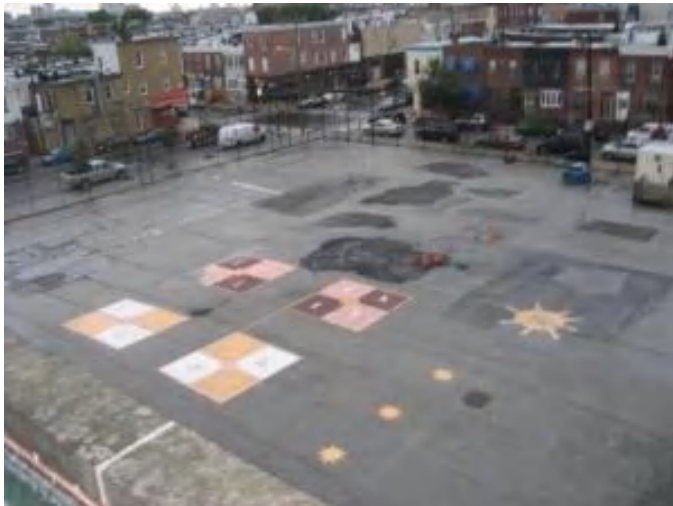
System: G4020 - Site Lighting

Location: Outdoor

Distress: Security Issue

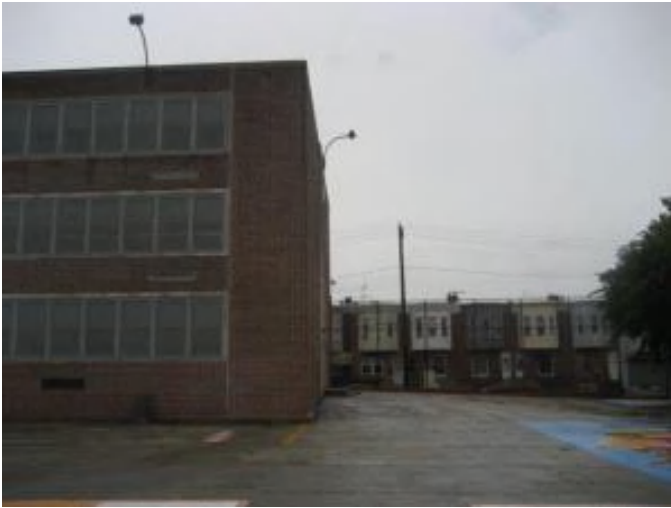
System: G4030 - Site Communications & Security

Location: Outdoor
Distress: Inadequate
Category: 4 - Capital Improvement
Priority: 2 - Response Time (2-3 yrs)
Correction: Add Video Surveillance System
Qty: 3.00
Unit of Measure: Ea.
Estimate: \$38,663.62
Assessor Name: Ben Nixon
Date Created: 07/31/2015

Notes: Additional (3) CCTV cameras should be provided to provide complete coverage around the building perimeter and parking lot.

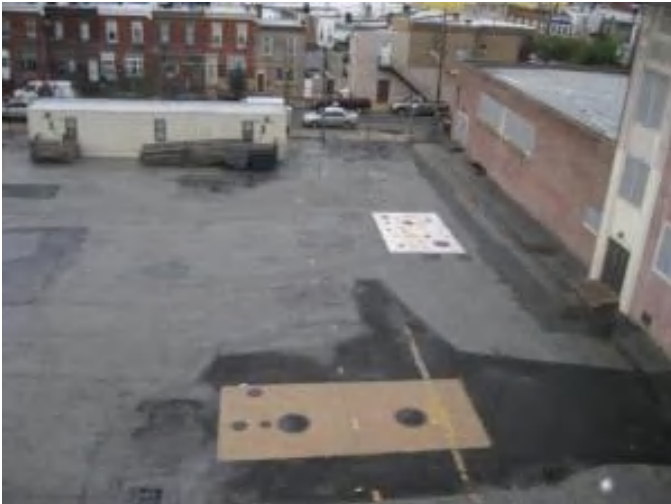
System: G4030 - Site Communications & Security

Location: Outdoor
Distress: Inadequate
Category: 4 - Capital Improvement
Priority: 2 - Response Time (2-3 yrs)
Correction: Add Site Paging System
Qty: 2.00
Unit of Measure: Ea.
Estimate: \$13,425.79
Assessor Name: Ben Nixon
Date Created: 07/31/2015

Notes: Two loud speakers should be added to cover the parking lot and playground
