## Facility Condition Assessment Summary Report

### Girls High School

| Address | 1400 W. Olney Ave.<br>Philadelphia, Pa 19141 | Enrollment | 1005 |

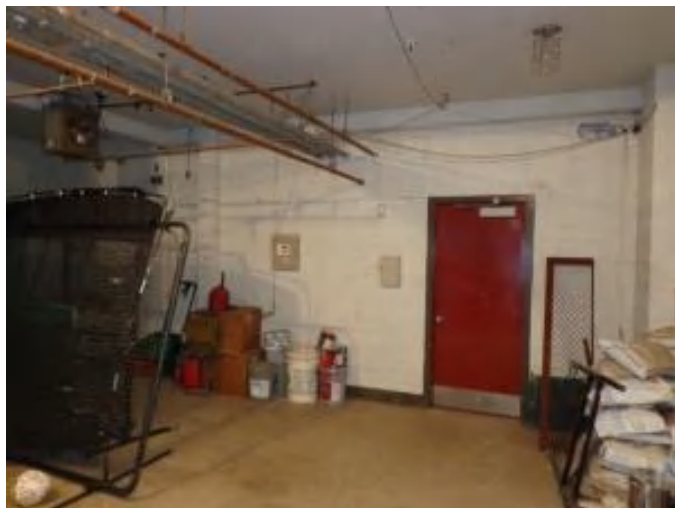
**System: D5090 - Other Electrical Systems**

**Location:** Entire Building

**Distress:** Health Hazard / Risk

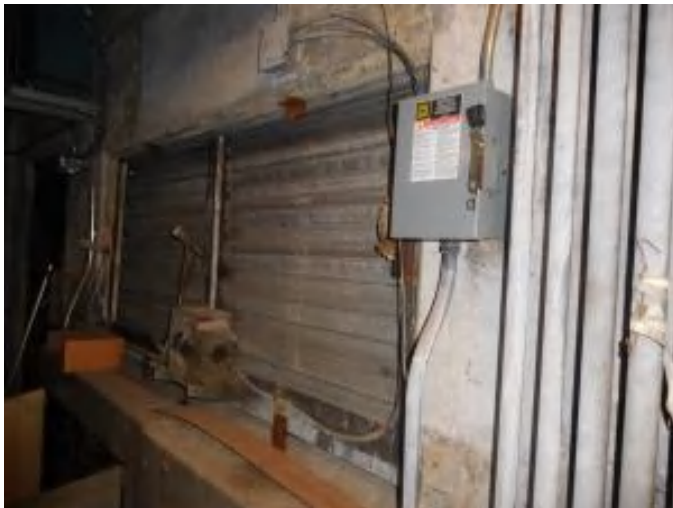
**System: D3060 - Controls & Instrumentation**

**Location:** entire building

**Distress:** Inadequate

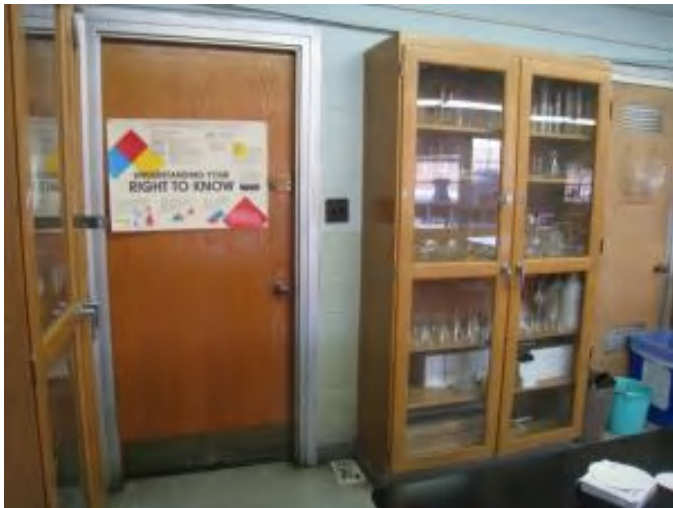
**System: C1020 - Interior Doors**

**Location:** Girls HS - interior doors

**Distress:** Failing

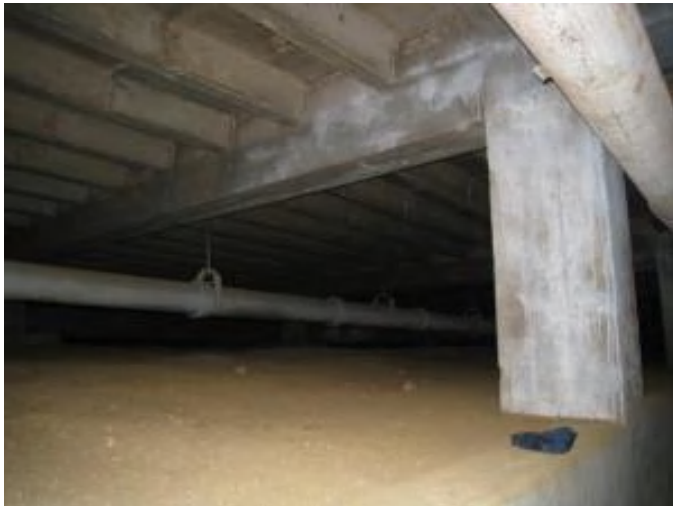
**System: B1010 - Floor Construction**

**Location:** Widener - crawl space

**Distress:** Failing

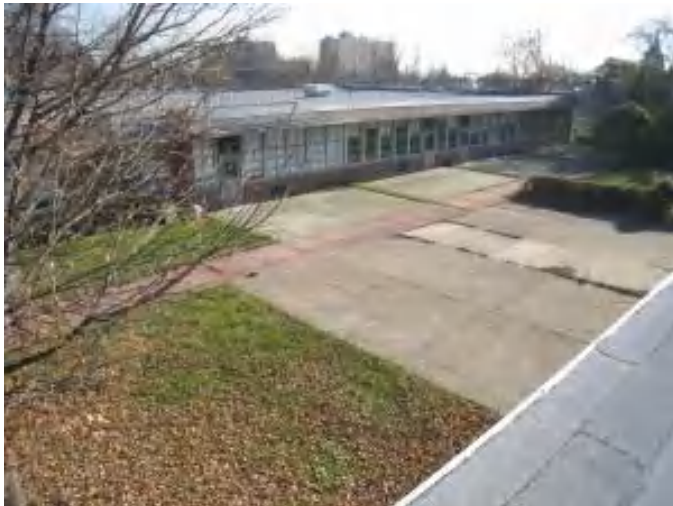
**System: B1020 - Roof Construction**

**Location:** Widener - roof overhangs

**Distress:** Damaged

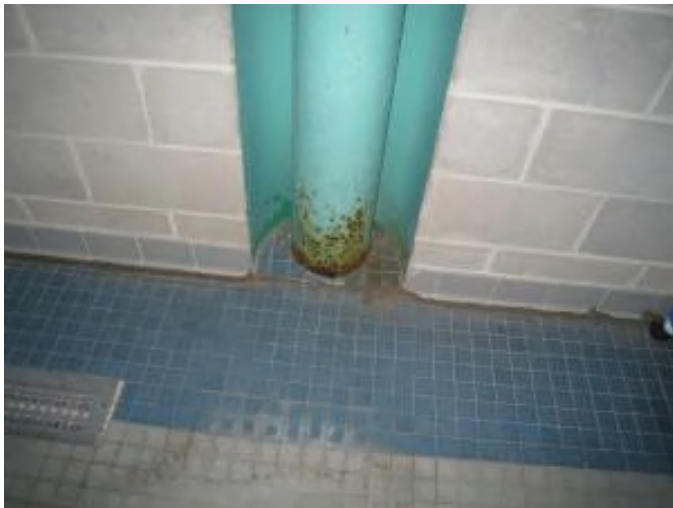
**System: B2010 - Exterior Walls**

**Location:** Widener - steel columns

**Distress:** Damaged

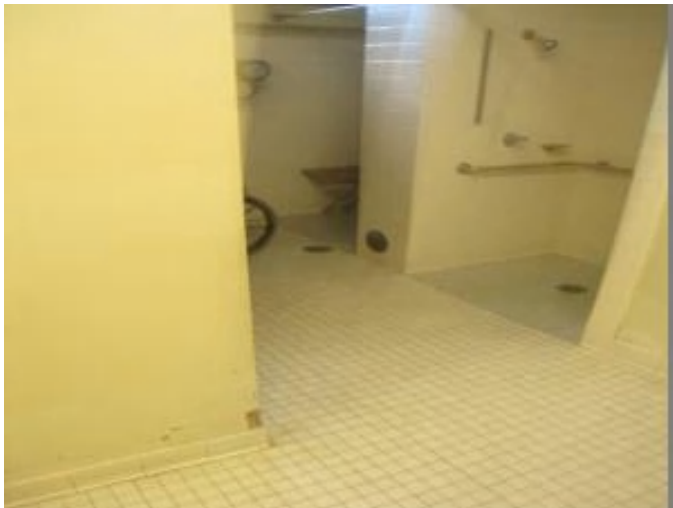
**System: C1030 - Fittings**

**Location:** Widener - interior walls

**Distress:** Inadequate

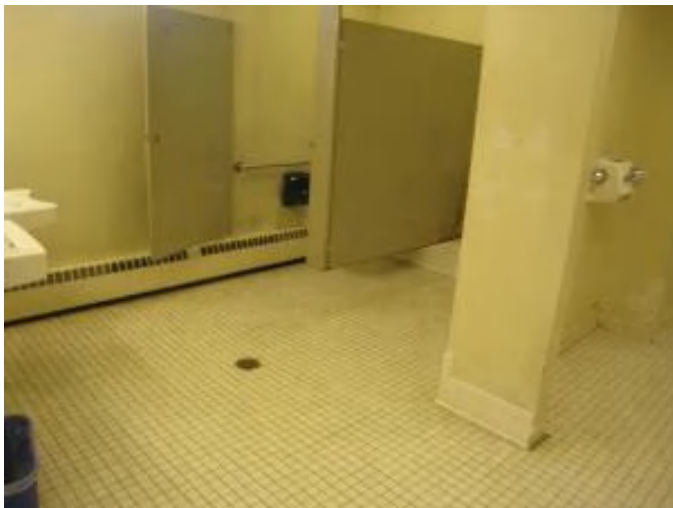
**System: C1030 - Fittings**

**Location:** Widener - toilet rooms

**Distress:** Failing
