Facility Condition Assessment Summary Report

Gompers School

School District of Philadelphia
S428001;Gompers
Final
Site Assessment Report

January 30, 2017

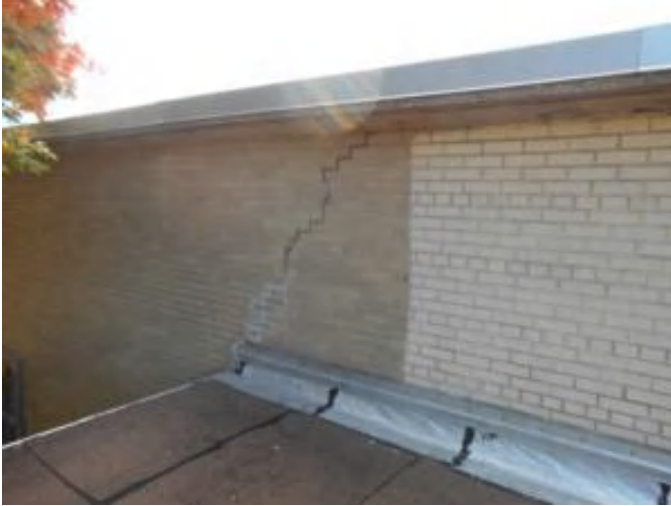
System: B2010 - Exterior Walls

Location: Exterior Walls

Distress: Building Envelope Integrity

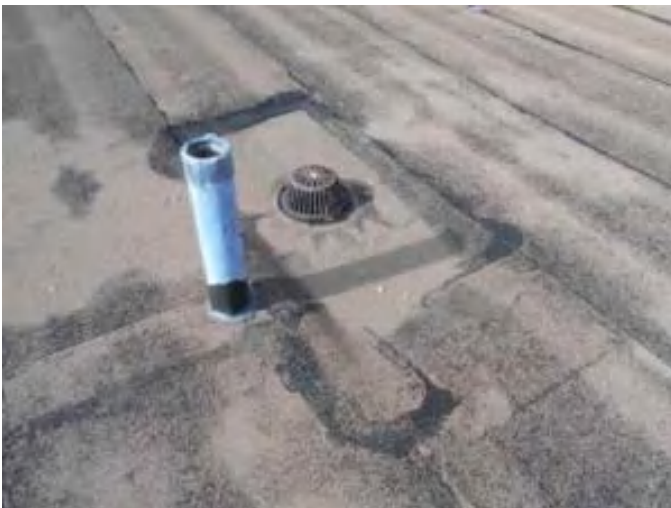
System: B3010105 - Built-Up

Location: Roofs

Distress: Building Envelope Integrity

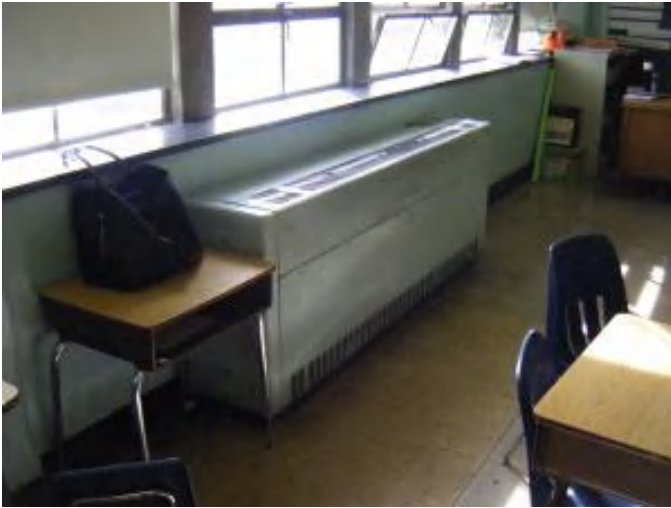
System: D3040 - Distribution Systems

Location: Throughout Building

Distress: Health Hazard / Risk

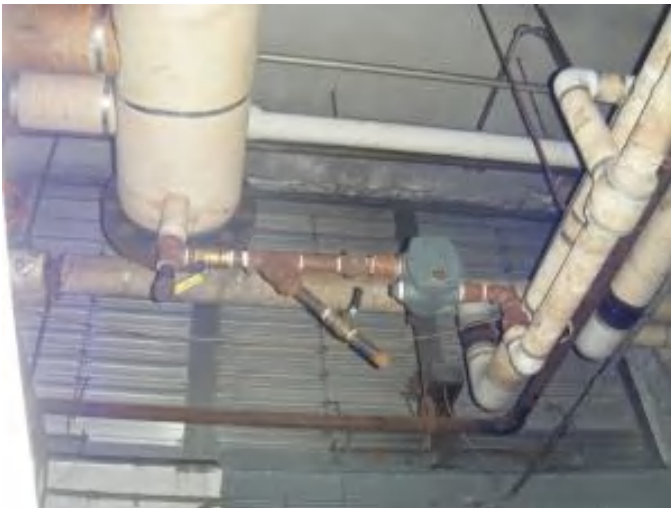
System: D3040 - Distribution Systems

Location: Throughout Building

Distress: Beyond Service Life

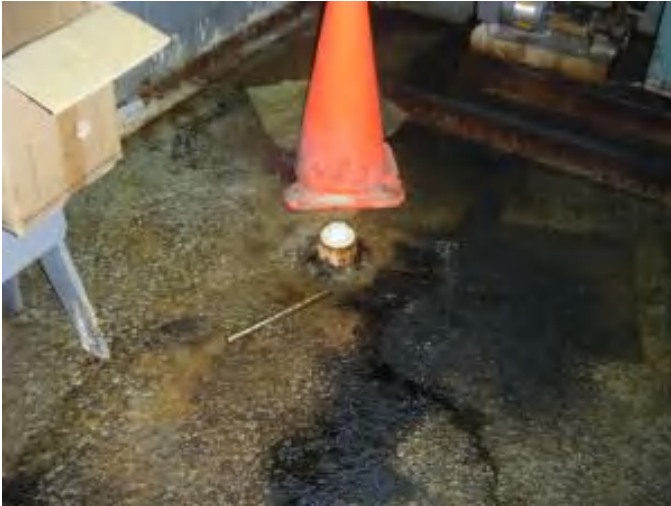
System: A1030 - Slab on Grade

Location: Boiler Room

Distress: Health Hazard / Risk

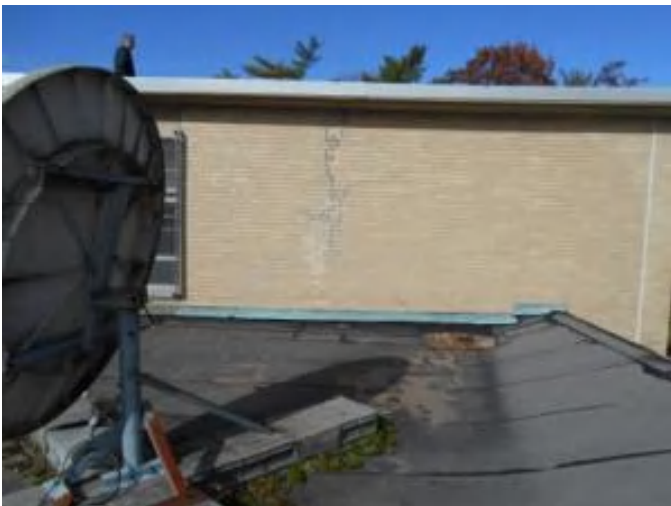
System: B2010 - Exterior Walls

Location: Exterior walls

Distress: Building Envelope Integrity

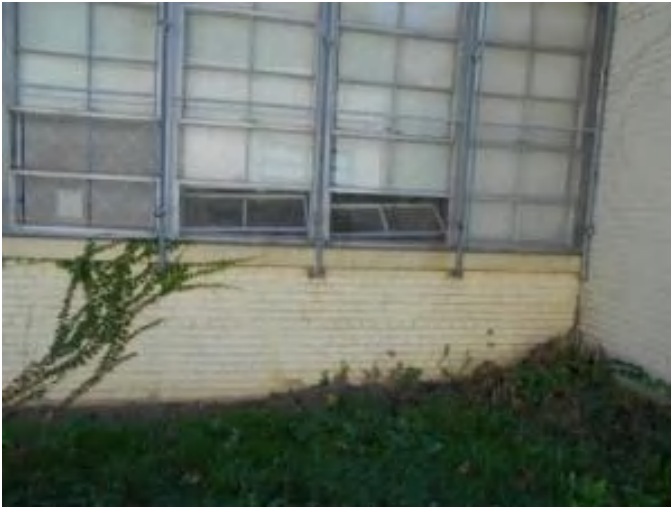
System: B2020 - Exterior Windows

Location: Exterior Windows

Distress: Beyond Service Life

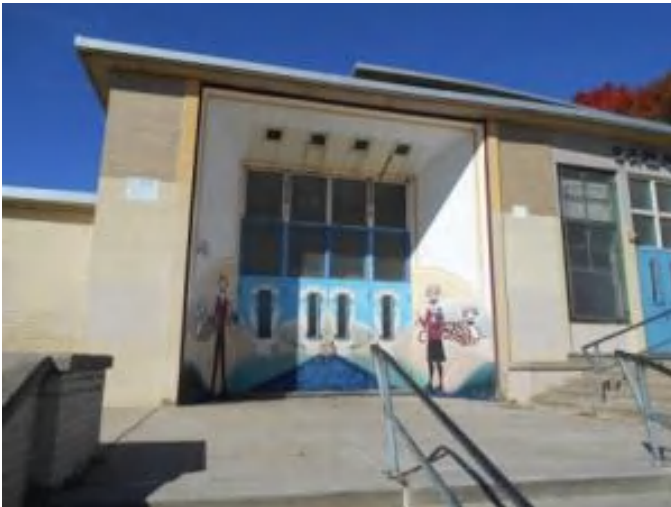
System: B2030 - Exterior Doors

Location: Exterior Doors

Distress: Beyond Service Life

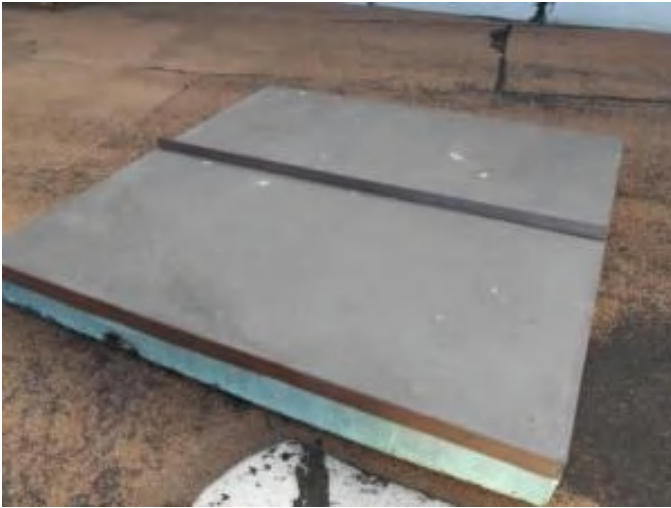
System: B3020 - Roof Openings

Location: Roofs
Distress: OSHA
Category: 2 - Code Compliance
Priority: 2 - Response Time (2-3 yrs)
Correction: Replace roof hatch - pick the closest size
Qty: 2.00
Unit of Measure: Ea.
Estimate: \$7,358.66
Assessor Name: System
Date Created: 01/20/2016

Notes: Existing roof hatches are "home-made" constructed of plywood and covered with metal roofing. They are extremely heavy, are not hinged, and are unsafe. Provide new roof hatches to facilitate safe maintenance of roofs and roof mounted systems.

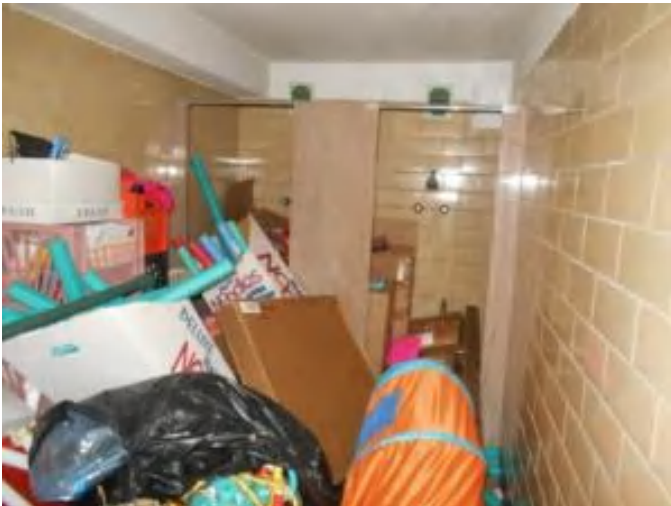
System: C1010 - Partitions

Location: TBD
Distress: Accessibility
Category: 2 - Code Compliance
Priority: 2 - Response Time (2-3 yrs)
Correction: Build new gang restroom to meet code or occupant needs - select type and number of fixtures and toilet partitions for mens or womens
Qty: 2.00
Unit of Measure: Ea.
Estimate: \$421,508.00
Assessor Name: System
Date Created: 01/21/2016

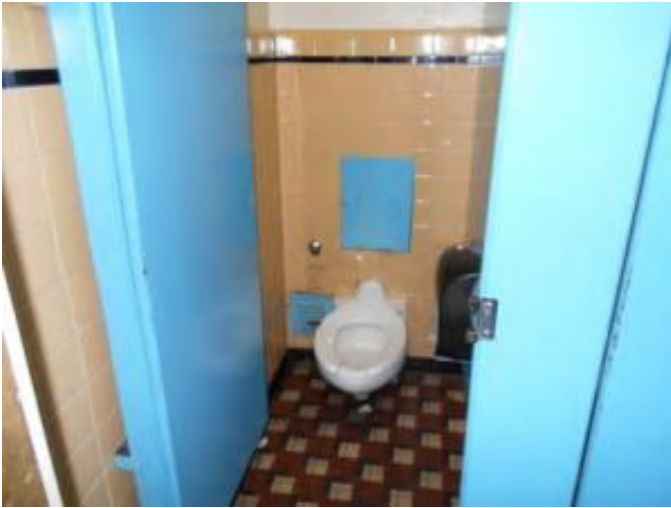
System: C1010 - Partitions

Location: One each floor
Distress: Accessibility
Category: 2 - Code Compliance
Priority: 2 - Response Time (2-3 yrs)
Correction: Build new single restroom to meet code requirements
Qty: 2.00
Unit of Measure: Ea.
Estimate: \$140,651.95
Assessor Name: System
Date Created: 01/21/2016

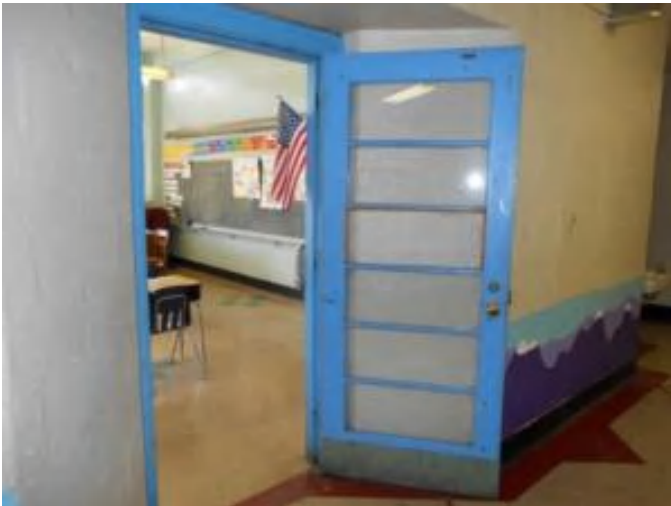
System: C1020 - Interior Doors

Location: Interior doors
Distress: Beyond Service Life
Category: 3 - Operations / Maint.
Priority: 2 - Response Time (2-3 yrs)
Correction: Remove and replace interior doors - wood doors with hollow metal frames - per leaf
Qty: 100.00
Unit of Measure: Ea.
Estimate: \$477,058.71
Assessor Name: System
Date Created: 01/20/2016

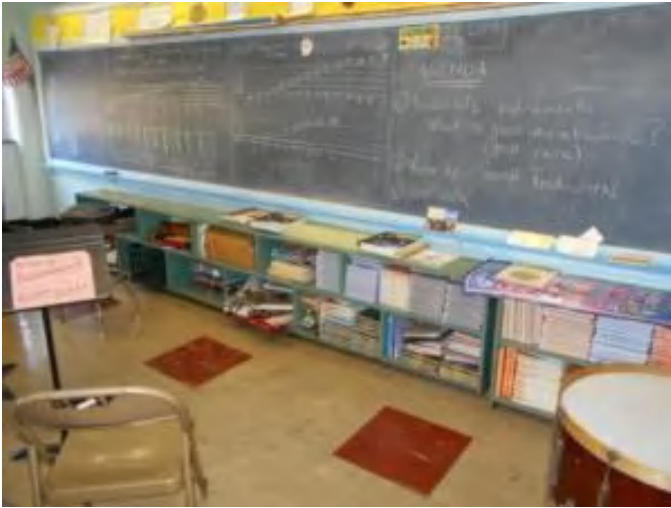
System: C1030 - Fittings

Location: Classrooms
Distress: Obsolete
Category: 3 - Operations / Maint.
Priority: 2 - Response Time (2-3 yrs)
Correction: Replace blackboards with marker boards - pick the appropriate size and insert the quantities
Qty: 40.00
Unit of Measure: Ea.
Estimate: \$55,133.39
Assessor Name: System
Date Created: 01/20/2016

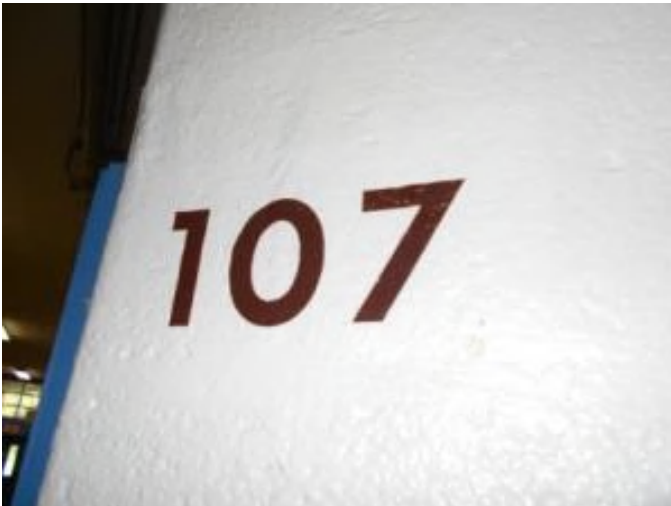
System: C1030 - Fittings

Location: Interiors building wide
Distress: Building / MEP Codes
Category: 2 - Code Compliance
Priority: 2 - Response Time (2-3 yrs)
Correction: Replace missing or damaged signage - insert the number of rooms
Qty: 60.00
Unit of Measure: Ea.
Estimate: \$16,254.75
Assessor Name: System
Date Created: 01/20/2016

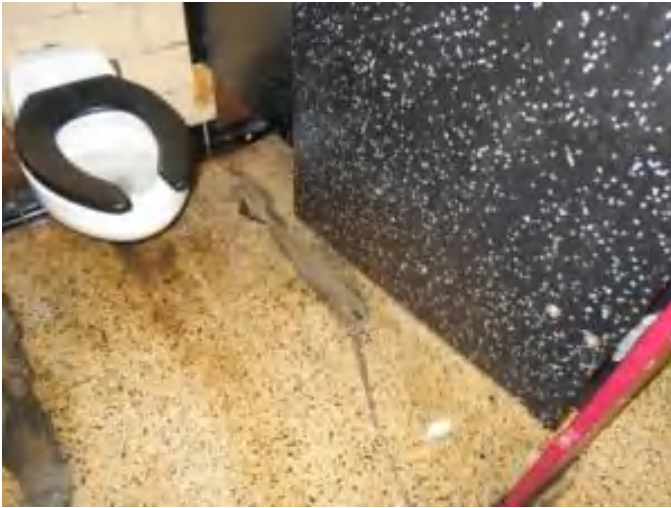
System: C3020412 - Terrazzo & Tile

Location: Student Restrooms

Distress: Health Hazard / Risk

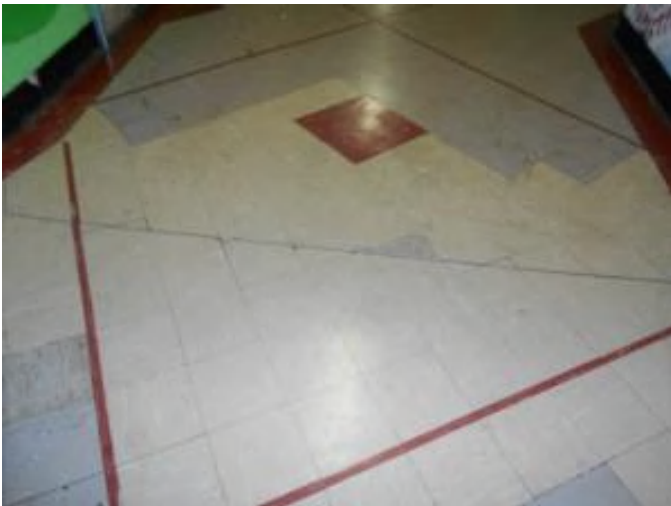
System: C3020413 - Vinyl Flooring

Location: Throughout the building

Distress: Health Hazard / Risk

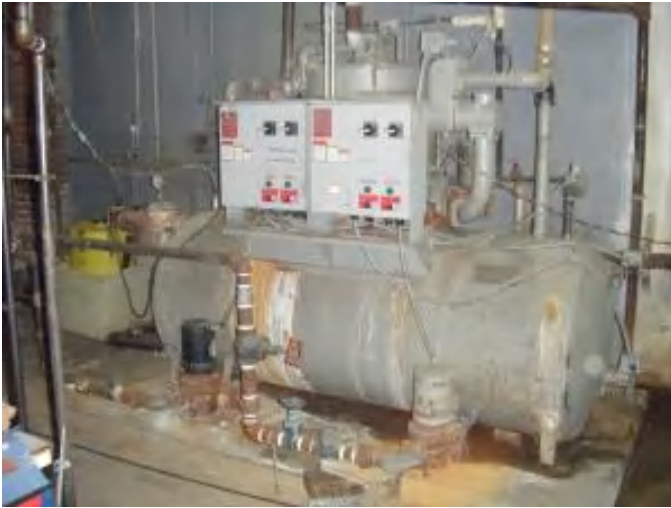
System: D3040 - Distribution Systems

The vacuum condensate receiver tank and boiler feed pump assembly was installed in the boiler room in 1976 and should be replaced as it is beyond the anticipated service life. A serious problem was reported with failed steam traps. Live steam passes into the condensate piping system from the failed traps. The District has not conducted a recent steam trap survey for this building and traps are not serviced on a regular schedule.

Location: Boiler Room
Distress: Beyond Service Life
Category: 3 - Operations / Maint.
Priority: 2 - Response Time (2-3 yrs)
Correction: Replace duplex vacuum and condensate receiver
Qty: 1.00
Unit of Measure: Ea.
Estimate: \$135,756.55
Assessor Name: System
Date Created: 01/29/2016

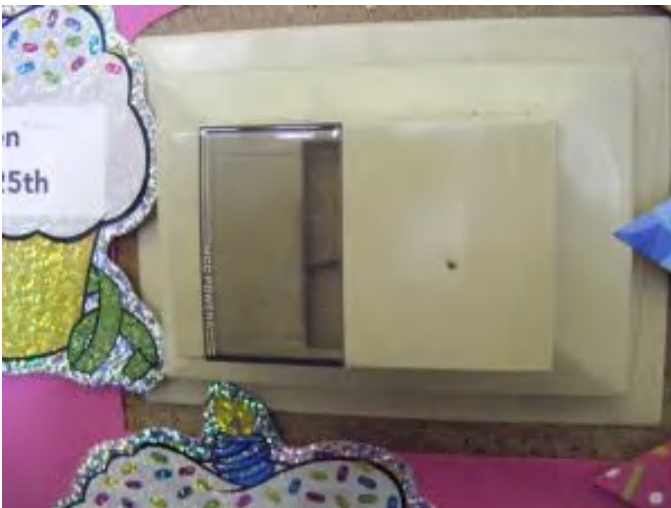
System: D3060 - Controls & Instrumentation

The original pneumatic systems still provide basic control functions. Pneumatic room thermostats drive the unit ventilators, the damper actuators and control valves. Pneumatic control air is supplied from a compressor and dryer located in the boiler room. The maintenance staff reports temperature control is poor due to significant problems with oil, moisture and dirt in the pneumatic supply lines and failed copper tubing buried in the walls and floor slabs. The older pneumatic controls have small rubber gaskets and tubing connections at devices that have become brittle and fail regularly. The Building Engineer is forced to turn the boilers on/off to regulate temperature in the building during the heating season. The pneumatic systems are beyond their service life and require too much attention from the maintenance staff. The original control valves, dampers and pneumatic actuators are over 35 years old and should be rebuilt or replaced. These controls should be converted to DDC.

Location: Throughout Building
Distress: Energy Efficiency
Category: 4 - Capital Improvement
Priority: 2 - Response Time (2-3 yrs)
Correction: Replace pneumatic controls with DDC (75KSF)
Qty: 56,000.00
Unit of Measure: S.F.
Estimate: \$1,201,319.59
Assessor Name: System
Date Created: 01/29/2016

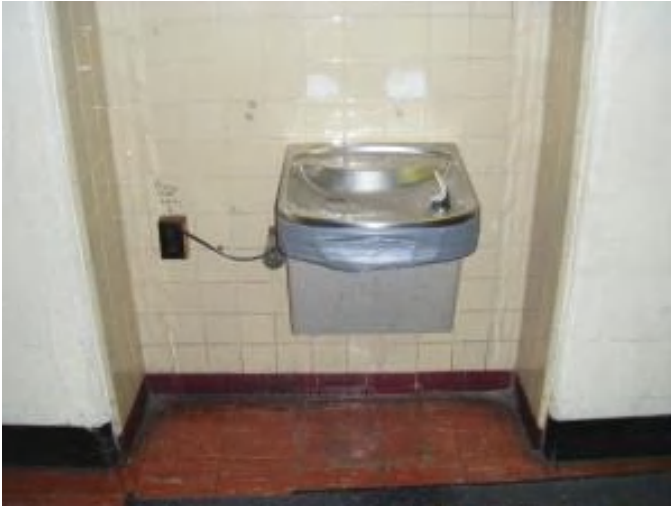
System: D2010 - Plumbing Fixtures

Drinking fountains in the corridors and at the restrooms are either the original wall hung china fixtures or replacement units with refrigerated coolers that are typically badly damaged. They are well beyond their service life and should be replaced; the original units are NOT accessible type.

Location: Corridors

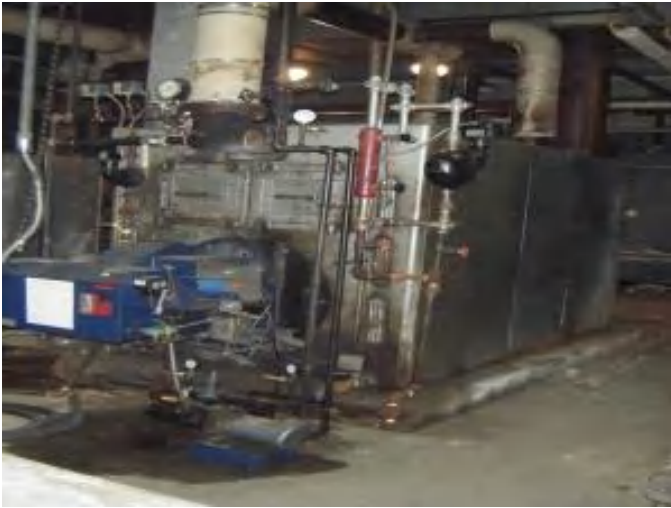
System: D3020 - Heat Generating Systems

Low pressure steam is generated at 15 lbs. /sq. in. or less by two 120 HP Weil McLain cast iron sectional boilers installed in 1976. One unit can handle the load in all weather conditions. A third smaller original boiler and the incinerator are abandoned in place. Each boiler is equipped with a Power Flame burner designed to operate on natural gas or fuel oil. Combustion air makeup is supplied by louvers equipped with motorized dampers. Burner controls provide full modulation with digital flame sensing, pressure atomization on oil and natural gas pilot ignition. Burner oil pumps are loose and not driven by the fan motor. The oil supply to the burner is equipped with dual solenoid valves and strainer, but does not have a disposable media filter. The breeching for each boiler is equipped with a barometric flue damper intended to maintain positive draft; these controls have failed. Cast iron sectional boilers have an anticipated service life of 35 years or more; these units have been in service over 40 years. The boilers appear well maintained, but the District should budget to replace them in the next 5-10 years. The new units should be equipped with gas/oil burners that incorporate

Location: Boiler Room
Distress: Beyond Service Life
Category: 3 - Operations / Maint.
Priority: 3 - Response Time (3-4 yrs)
Correction: Replace boiler, cast iron sectional (150 HP)
Qty: 2.00
Unit of Measure: Ea.
Estimate: \$1,012,205.26
Assessor Name: System
Date Created: 01/29/2016

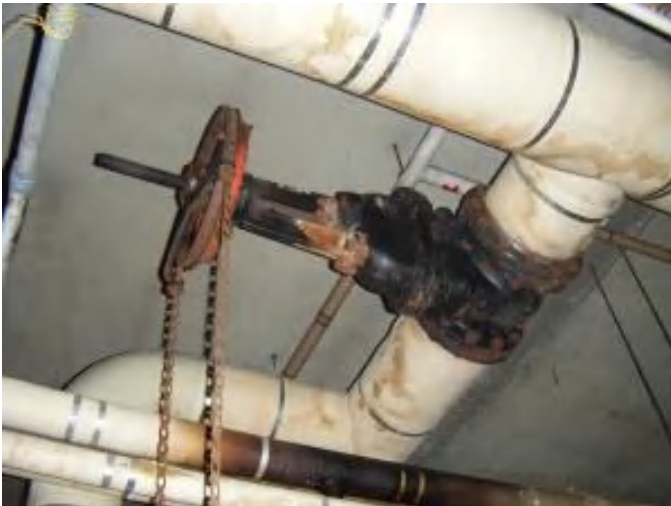
System: D3020 - Heat Generating Systems

Packing leaks were observed at the bonnets of the OS&Y gate valves at the steam header above the boilers. The boilers are equipped with steam pressure relief valves.

Location: Boiler Room
Distress: Damaged
Category: 3 - Operations / Maint.
Priority: 3 - Response Time (3-4 yrs)
Correction: Replace OSY valves (4" thru 8") - edit quantities
Qty: 1.00
Unit of Measure: Ea.
Estimate: \$109,564.96
Assessor Name: System
Date Created: 01/29/2016

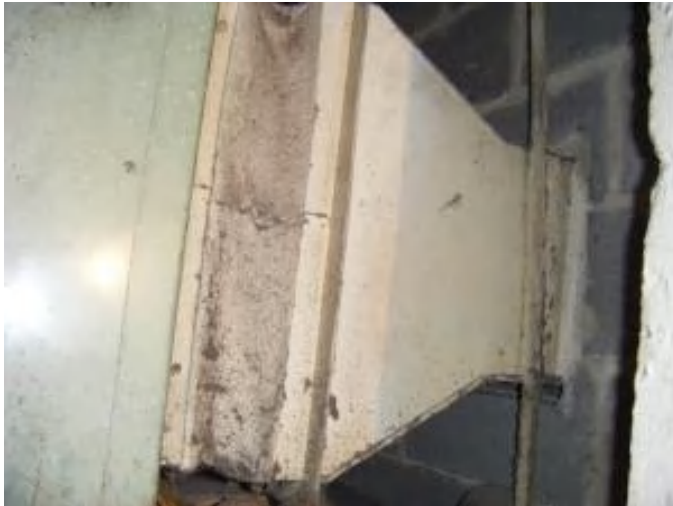
System: D3040 - Distribution Systems

Two fan coil air handling units mounted in the ceiling space above the locker rooms supply heating and ventilation for the Gymnasium. The blades of the wall supply diffusers are badly damaged and should be replaced with vandal resistant type. Similarly, two fan coil units hung from the structure of the stage supply heating and ventilation for the Auditorium. Return air for these units is drawn through the plenum space below the stage. These fan coil units are equipped with steam heating coils and mixing dampers, but do not have air conditioning coils. The fan coil units should be replaced as they are beyond their anticipated service life. Steam finned tube radiation terminals provide supplemental heat for many of the spaces including the classrooms, offices, lunchroom, and at the high windows in the auditorium and gym.

Location: Gymnasium

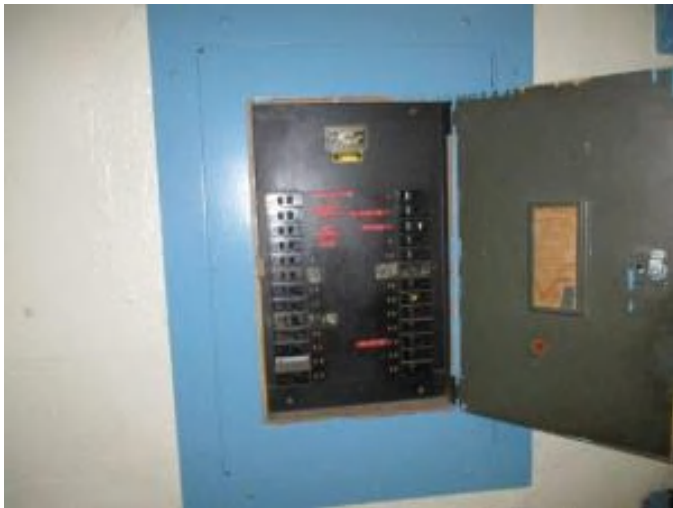
System: D5010 - Electrical Service/Distribution

On each floor, there are original 120/240V recessed, panel-boards for lighting and receptacles. The original panelboards and associated wiring have exceeded their useful life and they need to be replaced. There is (1) 45KVA phase converters from 240V to 120/208V which normally feeds newest mechanical equipment.

Location: Entire Building
Distress: Beyond Service Life
Category: 3 - Operations / Maint.
Priority: 3 - Response Time (3-4 yrs)
Correction: Replace Electrical Distribution System (U)
Qty: 1.00
Unit of Measure: Ea.
Estimate: \$269,530.20
Assessor Name: System
Date Created: 01/18/2016

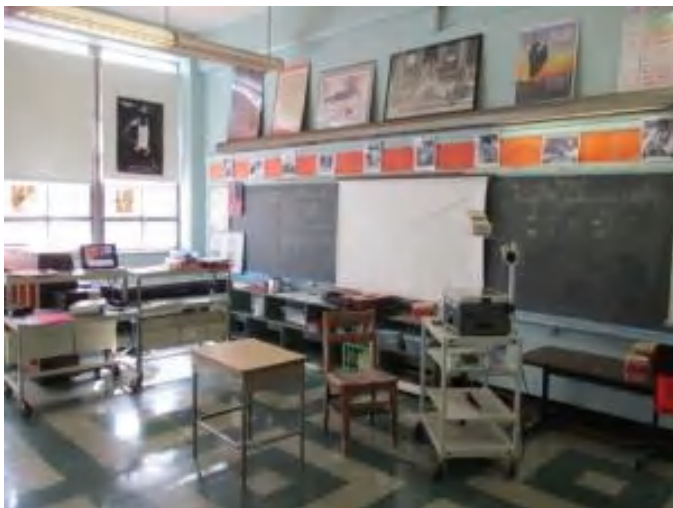
System: D5020 - Lighting and Branch Wiring

There number of receptacles in all of the classrooms is inadequate. Teachers use extension cords. The teacher's whiteboard wall and the opposite of it need to be provided with double compartment surface raceways, the other two walls with minimum two-duplex outlets each, when feasible.

Location: Entire Building
Distress: Inadequate
Category: 4 - Capital Improvement
Priority: 3 - Response Time (3-4 yrs)
Correction: Add wiring device
Qty: 320.00
Unit of Measure: Ea.
Estimate: \$117,558.72
Assessor Name: System
Date Created: 01/18/2016

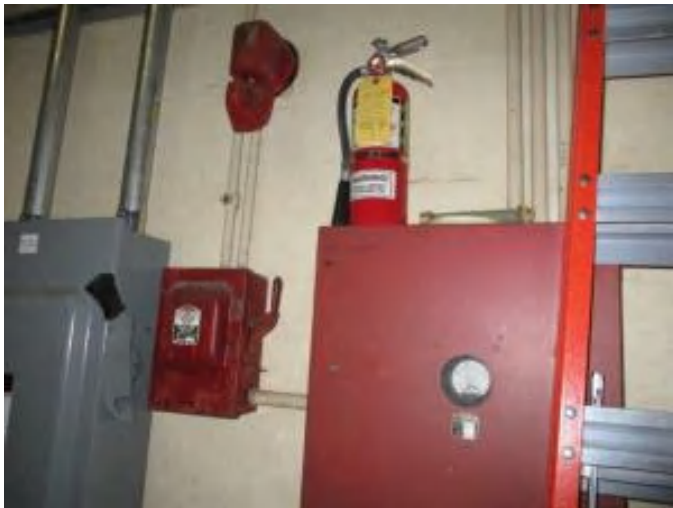
System: D5030 - Communications and Security

Location: Entire Building
Distress: Life Safety / NFPA / PFD
Category: 1 - Health & Safety
Priority: 3 - Response Time (3-4 yrs)
Correction: Replace fire alarm system
Qty: 1.00
Unit of Measure: S.F.
Estimate: \$145,423.00
Assessor Name: System
Date Created: 01/18/2016

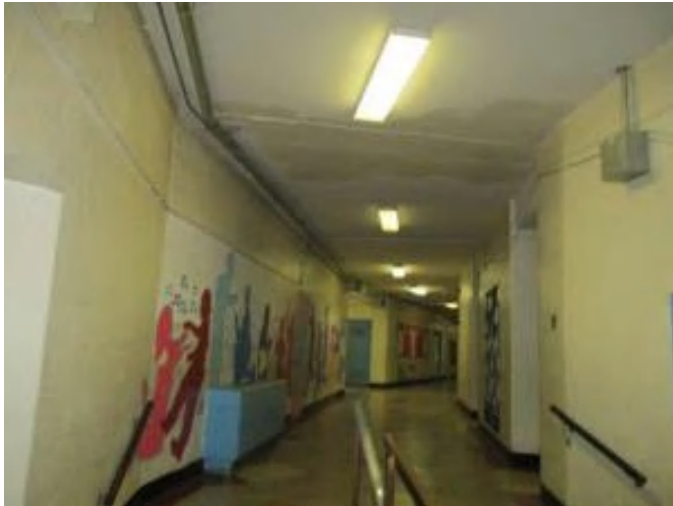
System: D5090 - Other Electrical Systems

Location: Entire Building
Distress: Life Safety / NFPA / PFD
Category: 1 - Health & Safety
Priority: 3 - Response Time (3-4 yrs)
Correction: Add Emergency/Exit Lighting
Qty: 16.00
Unit of Measure: Ea.
Estimate: \$28,720.62
Assessor Name: System
Date Created: 01/18/2016

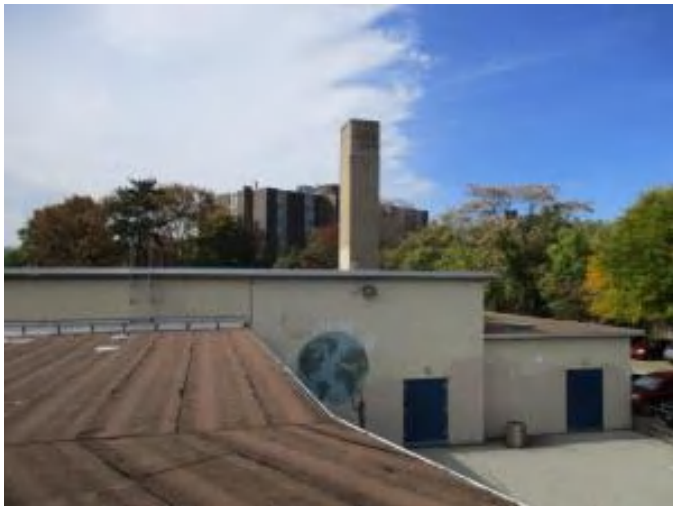
System: D5090 - Other Electrical Systems

Location: Roof
Distress: Building / MEP Codes
Category: 2 - Code Compliance
Priority: 3 - Response Time (3-4 yrs)
Correction: Repair Lightning Protection System
Qty: 1.00
Unit of Measure: Job
Estimate: \$24,249.82
Assessor Name: System
Date Created: 01/18/2016

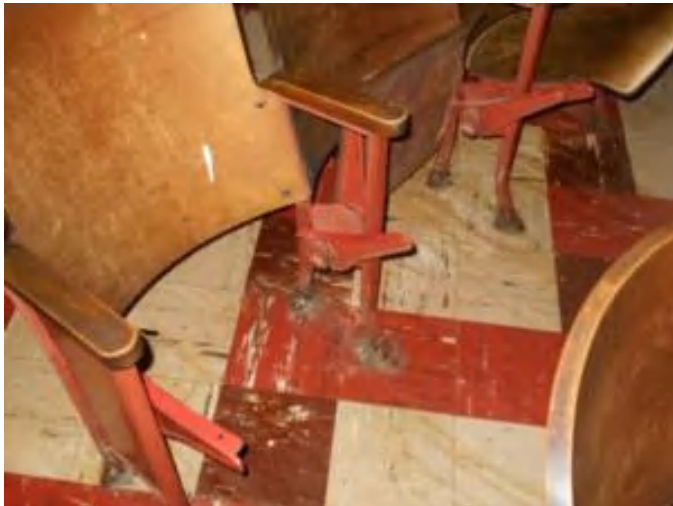
System: E2010 - Fixed Furnishings

Furnishings include: auditorium seating in poor condition; fixed wood casework aged condition; recessed display cases in corridors; window shades in poor condition.

Location: Auditorium

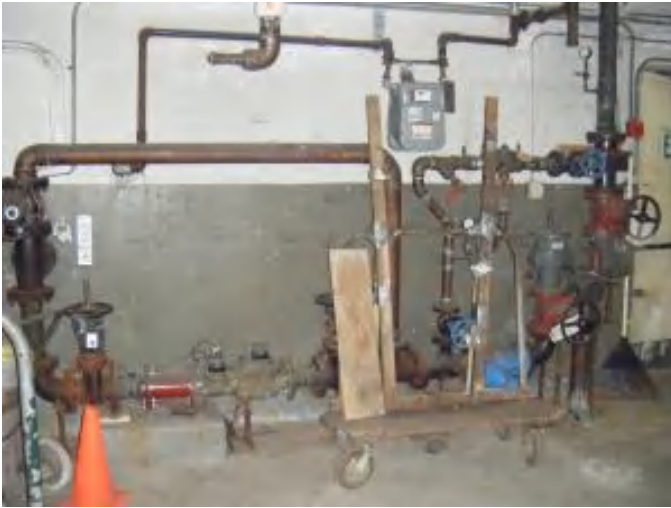
System: D3020 - Heat Generating Systems

A 1-1/4" natural gas service enters the building from Wynnefield Avenue near the intersection with Cardinal Avenue. The meter and valves are located in the boiler room near the stair. This service should be improved to provide sufficient capacity and pressure to support burning natural gas as the primary fuel. Cooking equipment is also powered by electricity.

Location: Site
Distress: Inadequate
Category: 4 - Capital Improvement
Priority: 5 - Response Time (> 5 yrs)
Correction: Improve service to support burning natural gas as the primary fuel (75KSF)
Qty: 150.00
Unit of Measure: L.F.
Estimate: \$331,742.55
Assessor Name: System
Date Created: 01/30/2016

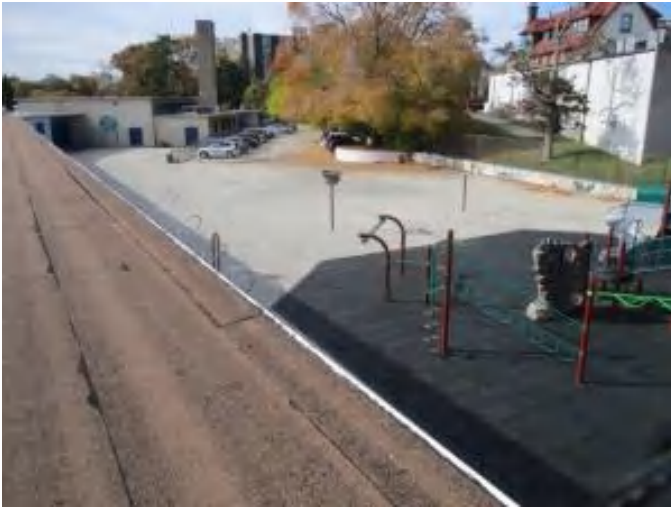
System: G4020 - Site Lighting

Location: Outdoor
Distress: Security Issue
Category: 1 - Health & Safety
Priority: 3 - Response Time (3-4 yrs)
Correction: Add Site Lighting - pole mounted - select the proper light and pole
Qty: 4.00
Unit of Measure: Ea.
Estimate: \$119,740.34
Assessor Name: Ann Buerger Linden
Date Created: 01/18/2016

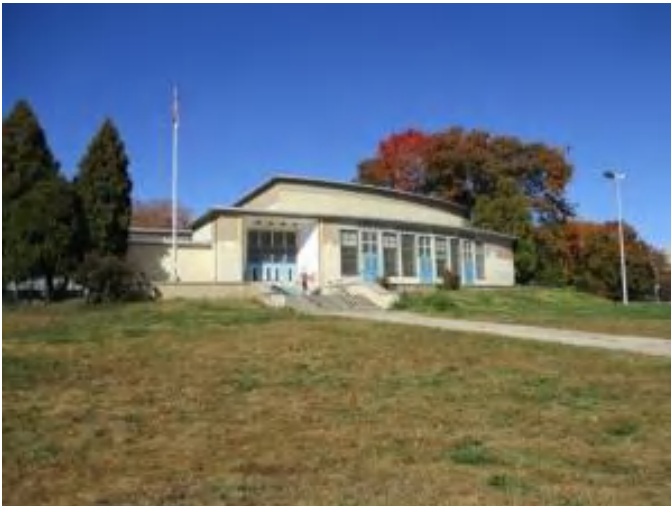
System: G4030 - Site Communications & Security

Location: Outdoor
Distress: Security Issue
Category: 1 - Health & Safety
Priority: 3 - Response Time (3-4 yrs)
Correction: Add Video Surveillance System
Qty: 20.00
Unit of Measure: Ea.
Estimate: \$231,923.76
Assessor Name: Ann Buerger Linden
Date Created: 01/18/2016
