## Facility Condition Assessment Summary Report

### Gratz School

**S401001;Gratz**

**Site Assessment Report**

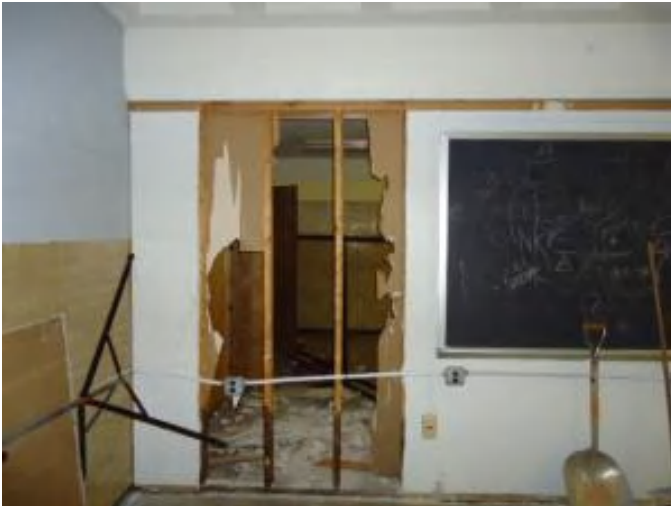
**Location:** Basement R.O.T.C. Storage Room

The basement level storage area of the R.O.T.C. section is damaged. As indicted in the photos the wall failure has exposed electrical wires and metal studs. This deficiency provides a budgetary consideration to build a fire rated wall to replace this section. This deficiency is expected to be coordinated with other interior efforts.

#### System: C1010 - Partitions

**Distress:** Damaged

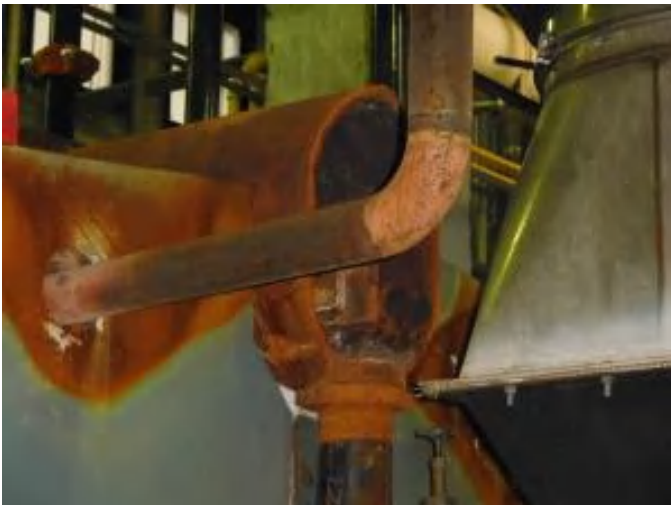
**Location:** mechanical room

#### System: D3020 - Heat Generating Systems

**Distress:** Damaged

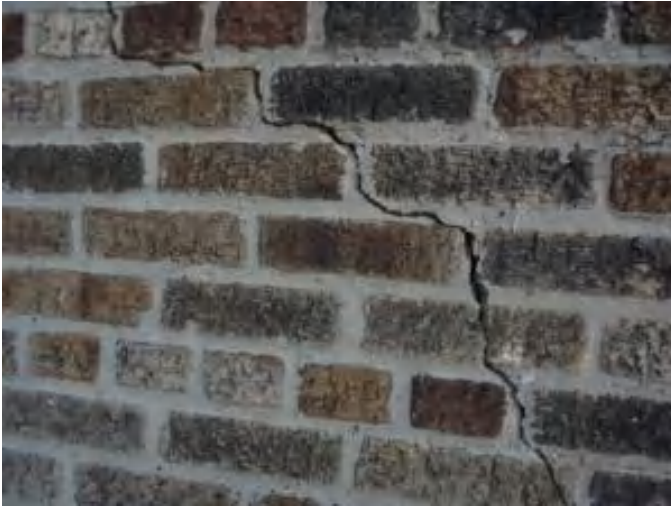
**Location:** Exterior Elevation

The exterior brick surfaces are generally in fair to good condition for their age. In some locations, bricks have cracked or spalled and should be replaced. The repointing of deteriorated mortar joints is also recommended, using mortar of a similar color and consistency as the original. Following the detailed examination of the brick and repair of mortar construction joints, the entire building should be pressure washed to remove stains and embedded pollutants. If moisture is found to be penetrating the masonry facade, the application of a spray sealant to the suspected exterior masonry surface is recommended.

**System: B2010 - Exterior Walls**

**Distress:** Damaged

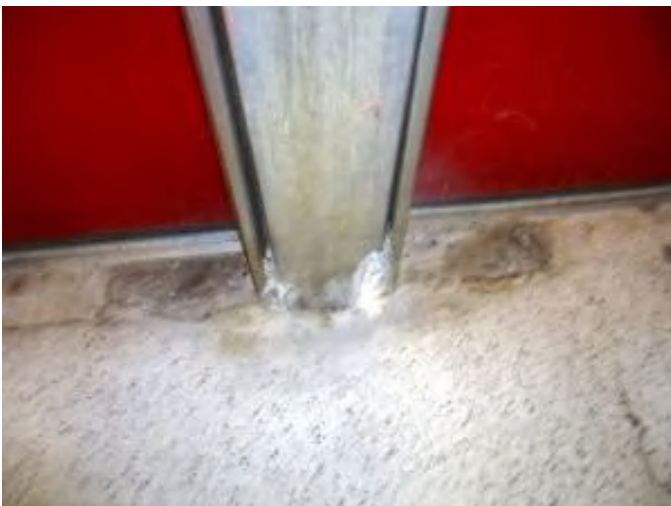
**Location:** Exterior Elevation

The exterior doors are metal applications with metal frames. The exterior door system for this school is a very high traffic system. Most of the doors are in fair condition but are aging at a faster rate than expected based on traffic and condition. The service doors on the roof have expired and failed compromising access to elevator rooms and tower rooms. The exterior door system, store front and service doors are recommended for upgrade.

**System: B2030 - Exterior Doors**

**Distress:** Damaged

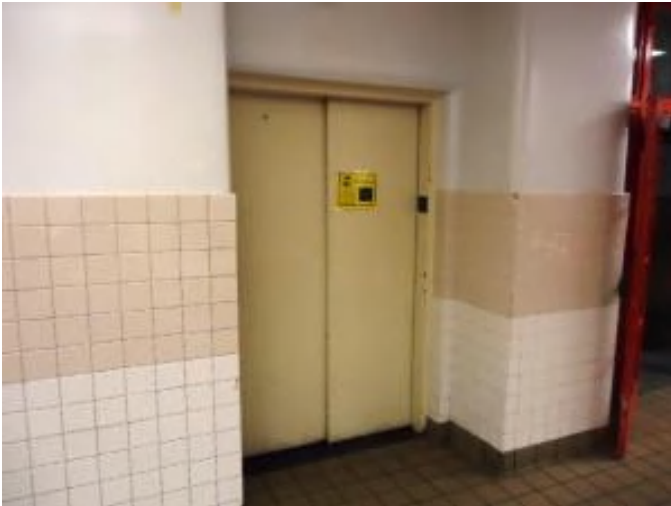
**Location:** Elevator

The present floor plan arrangement has the elevator lobbies opening up into the existing hall corridors. IBC 2000 states that elevators opening into a fire resistant corridor shall be provided with an elevator lobby at each floor containing such a corridor. The lobby should completely separate the elevators from the corridor with rated partitions. Elevator lobbies need to have at least one means of egress and contain smoke detectors. This deficiency recommends the construction of fire resistant barrier with automatically closing fire doors to be installed between the elevator lobbies and the corridors to provide the required separation and protection.

**System: C1010 - Partitions**

**Distress:** Life Safety / NFPA / PFD

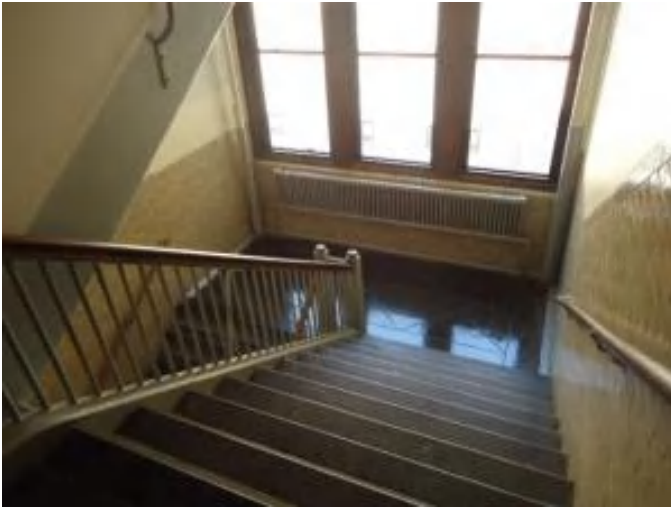
**Location:** Stairs

A large portion of the interior corridor, exit stair doors are not code compliant. Several doors are typically wood or metal in metal frames with transom lites or sidelights, glass glazing. The older doors are generally in good condition considering the age of the application. To restore the door finishes, universal upgrades are required for the older door applications. Remove and replace original door systems with new code compliant fire rated door system.

**System: C2010 - Stair Construction**

**Distress:** Life Safety / NFPA / PFD

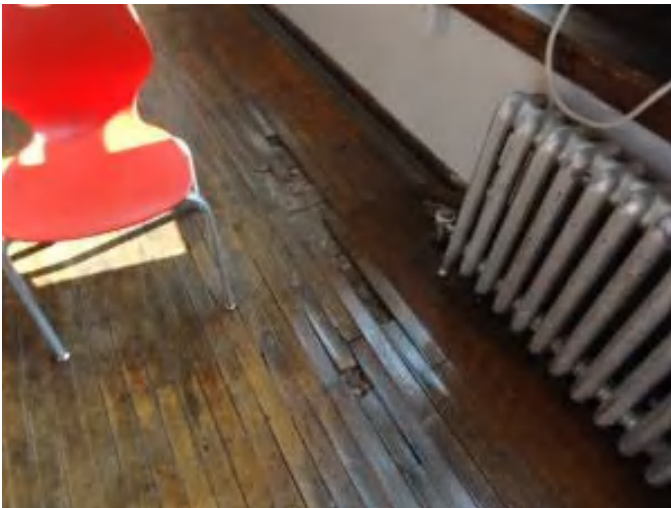
**Location:** Building Wide

The classrooms and auditorium in this school have a wooden floor finish that appears to be from original construction. As indicated in the photos the floors in the basement level were under water during the time of the inspection as a result of a water line leak discovered during the inspection. Also, on the third floor the wooden floor under the 12x12 tile floor was saturated with water as a result of a backed up condensation line. Other sections of wooden flooring are showing signs of age such as the effects of sanding and refinishing with yearly cleaning and waxing with some repairs. Most of the floor finish is in fair condition however, the finish is beyond its expected life cycle. It is recommended that the wooden floor finish be removed and replaced with an in kind finish.

**System: C3020414 - Wood Flooring**

**Distress:** Damaged

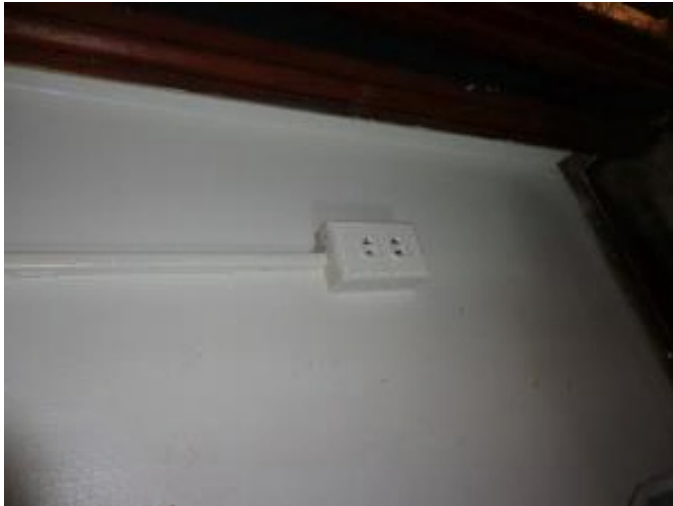
**Location:** Classrooms

**System: D5020 - Lighting and Branch Wiring**

**Distress:** Beyond Service Life

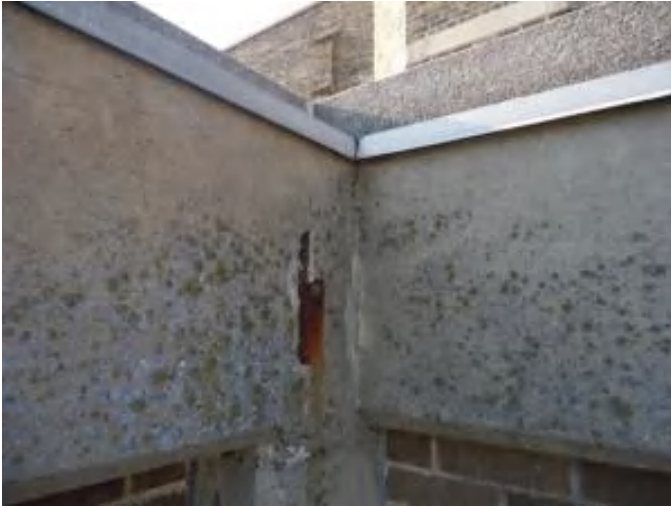
**Location:** Exterior Elevation

The exterior concrete finish is spalling as indicated in the photos. Thus far the damage is limited to the interior sections of the roof on the addition. This deficiency provides a budgetary consideration for repairs to the concrete sections that are damaged. This work should be coordinated with the recommended exterior point and tuck work.

**System: B2010 - Exterior Walls**

**Distress:** Damaged

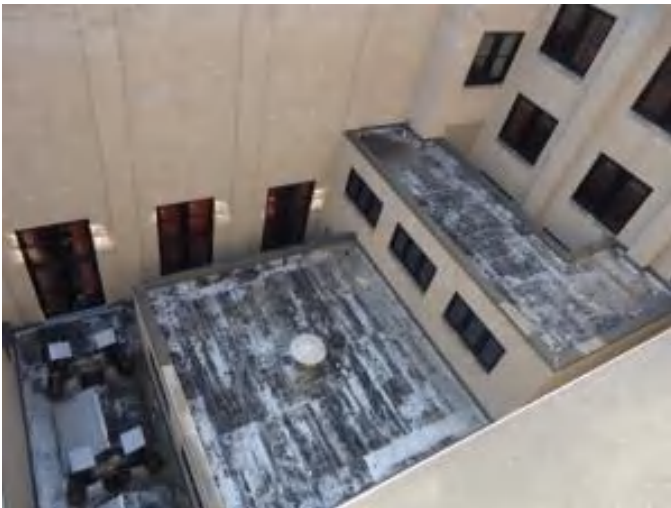
**Location:** Roof

to extend the life cycle of the application. During the time of the inspection it was reported that several leaks are active and a consistent repair program is consuming efforts to maintain the roof. Considering the age and condition of the roofing systems, universal upgrades are recommended. Remove and replace all roof sections. This deficiency is expected to be completed as part of an exterior effort coordinated with other recommendations included in this report.

**System: B3010105 - Built-Up**

**Distress:** Damaged

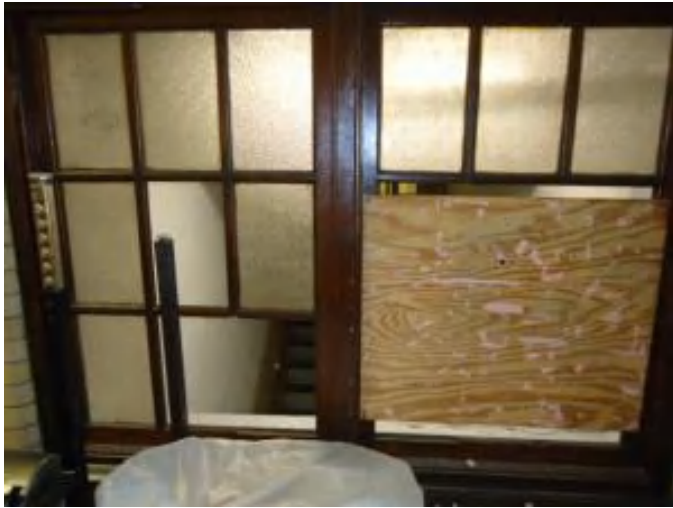
**Location:** Hallways

There are several transom lites and sidelights constructed into hallway wall systems. It is recommended that the lites and sidelights be removed and replaced with a fire rated wall construction. The deficiency provides a budgetary consideration to correct the hallway, transoms, lites and sidelights.

**System: C1010 - Partitions**

**Distress:** Life Safety / NFPA / PFD

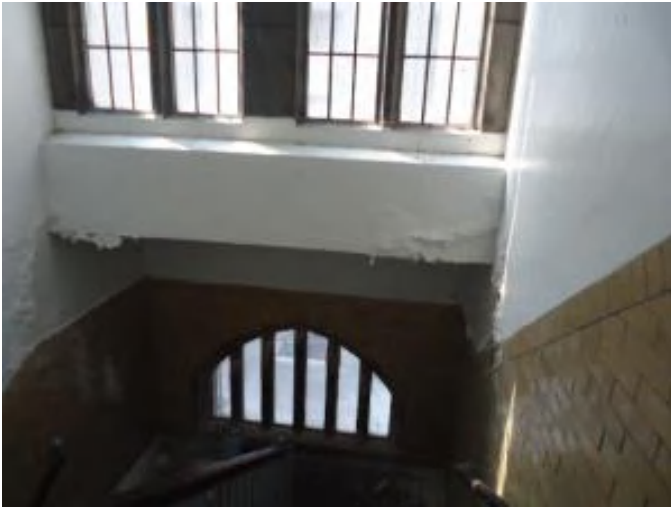
**Location:** Building Wide

There are painted walls, trim, and some painted ceilings in this building. Sections of the building, some textured concrete surfaces have been painted as well. The interior finishes are in fair to poor condition depending on the location of the finish. For example due to recent roof leaks over the auditorium several areas will require repair and repainting. Also, sections of the fifth floor are damaged

**System: C3010230 - Paint & Covering**

**Distress:** Damaged

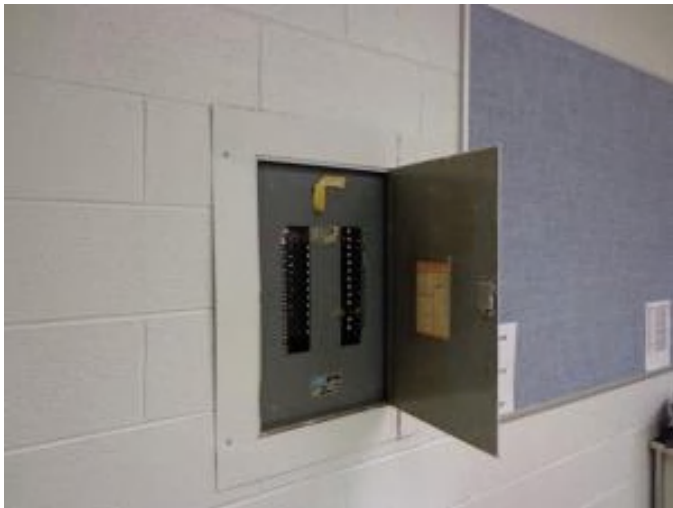
**Location:** Gymnasium Offices

**System: D5010 - Electrical Service/Distribution**

**Distress:** Beyond Service Life

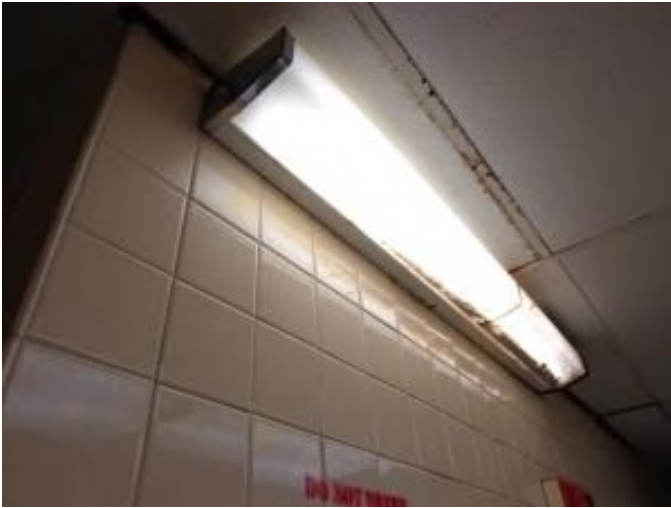
**Location:** Various rooms

**System: D5020 - Lighting and Branch Wiring**

**Distress:** Beyond Service Life

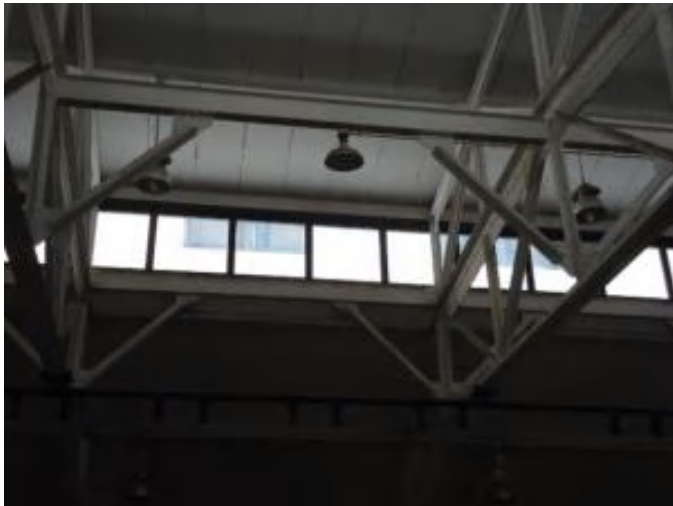
**Location:** Exterior Elevation

Most of the exterior windows have been upgraded from the original applications. As indicated in the photos several of the windows appear to be original. A majority of the window system is estimated to have been installed in the 1990's. Several of the windows no longer work and will require attention prior to an overall effort. Overall, the windows are in fair condition based on the year of installation or last renovation. The entire exterior window system is recommended to be replaced with units that retain their dimensions and profiles, but that incorporate updated energy-efficient features.

**System: B2020 - Exterior Windows**

**Distress:** Damaged

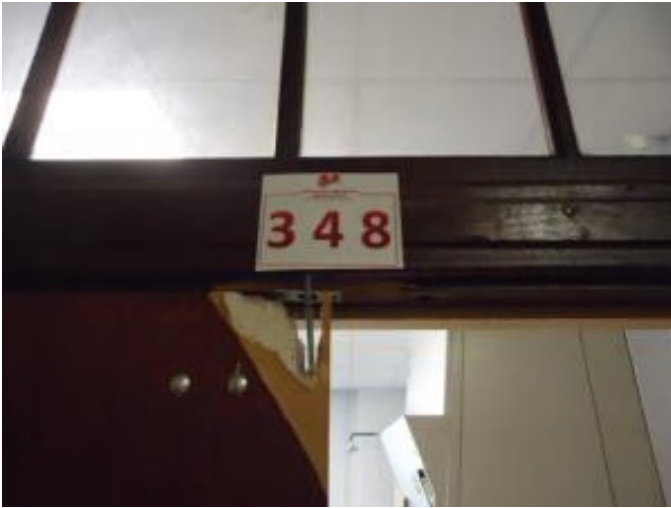
**Location:** Building Wide

Interior doors are typically wood in wood frames with transom lites, sidelights, wired glass glazing. Other interior doors include wooden glass pane doors with original wooden pane frames, hollow metal in hollow metal frames at stairwells and exit ways. Doors are generally in good condition considering the age of the application. Universal upgrades are required for the interior door systems it is recommended that the interior doors system be removed and replaced with a new modern metal framed hollow metal door system with consideration for ADA compliance.

**System: C1020 - Interior Doors**

**Distress:** Damaged

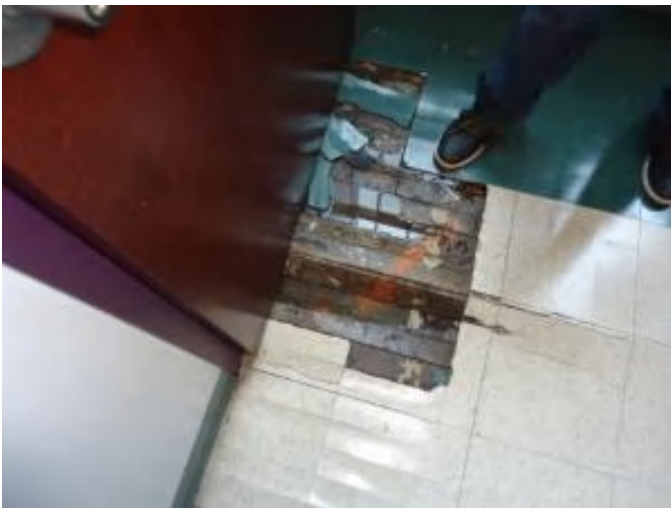
**Location:** Building Wide

**System: C3020413 - Vinyl Flooring**

**Distress:** Health Hazard / Risk

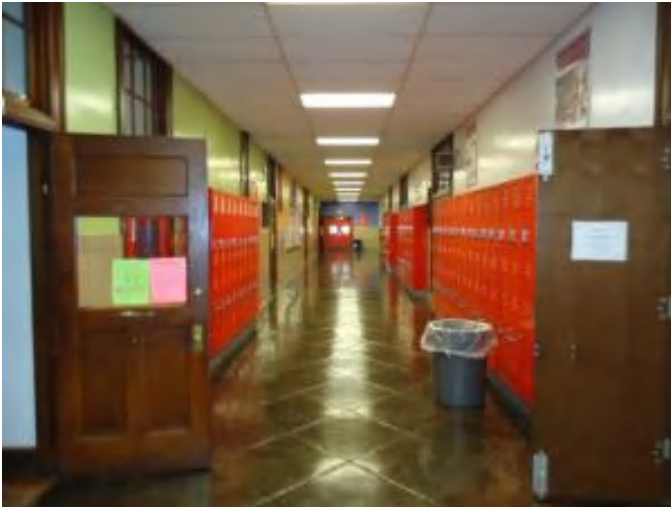
**Location:** Hallways

The hallways, stair landings and mechanical spaces have a sealed concrete finish. The hallway concrete finish is diamond cut and placed as 24x24 inch sections. As indication in the photos most of the finish is in good condition. However what is not apparent in the photos is that several of the sections are loose and require re-grouting and in some places replacement. This deficiency provides a budgetary consideration for section by section repairs to the concrete floors and consideration for refinishing work once repairs are complete.

**System: C3020415 - Concrete Floor Finishes**

**Distress:** Damaged

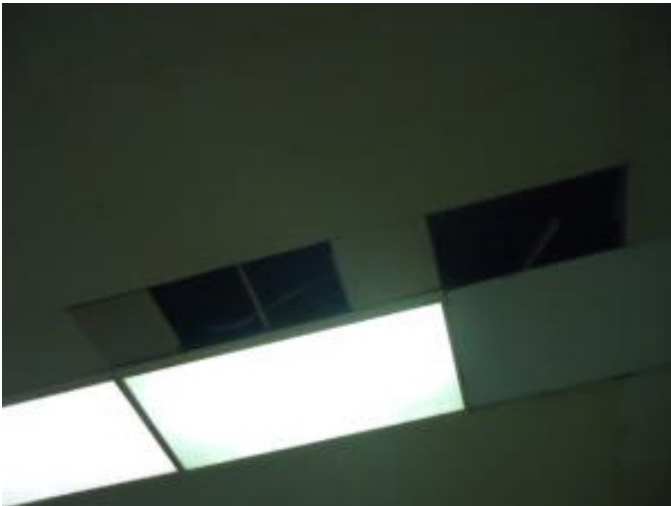
**Location:** Building Wide

The ceiling finish is a mix of 12 x 12 ceiling grid, painted and 2 x 4 Acoustical tile finish. Ceilings have been repaired in several areas and are in good condition considering the age of the application and the current condition of the school. The ceiling finish is expected to require upgrades to support the recommended mechanical electrical efforts in this report. This deficiency provides a budgetary consideration for removal and replacement of the current ceiling finish to a new acoustical tile finish. Considering the recommended mechanical and electrical upgrades this effort should be completed as part of an overall renewal program for the school. No work should be considered until after the recommended exterior efforts are complete.

**System: C3030 - Ceiling Finishes**

**Distress:** Damaged

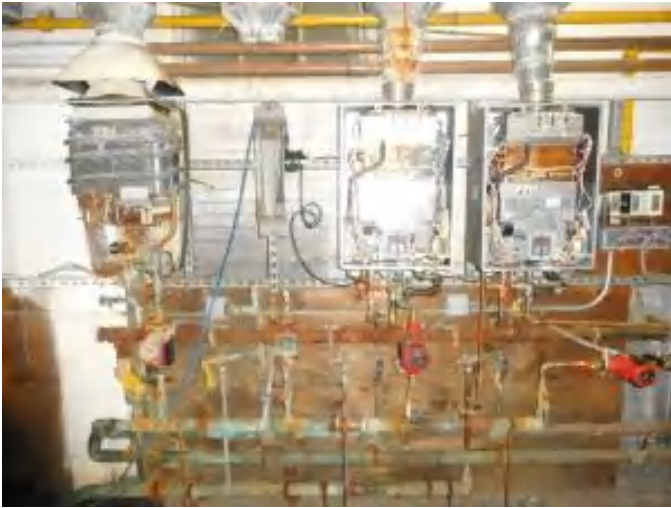
**Location:** entire building

**System: D2020 - Domestic Water Distribution**

**Distress:** Beyond Service Life

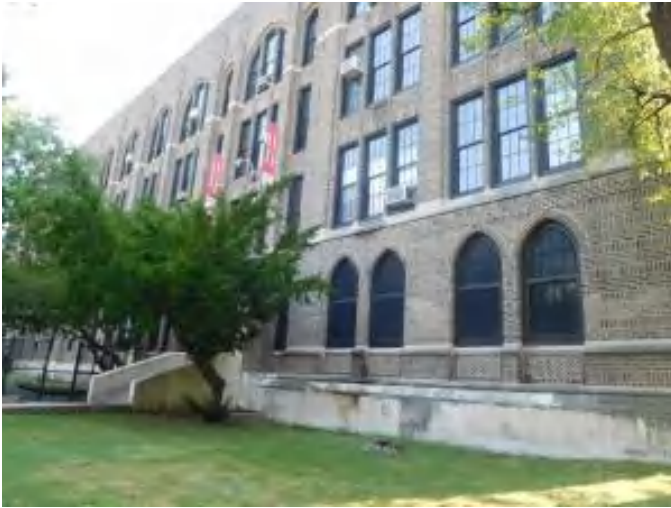
**Location:** roof, mechanical room

**System: D3030 - Cooling Generating Systems**

**Distress:** Inadequate

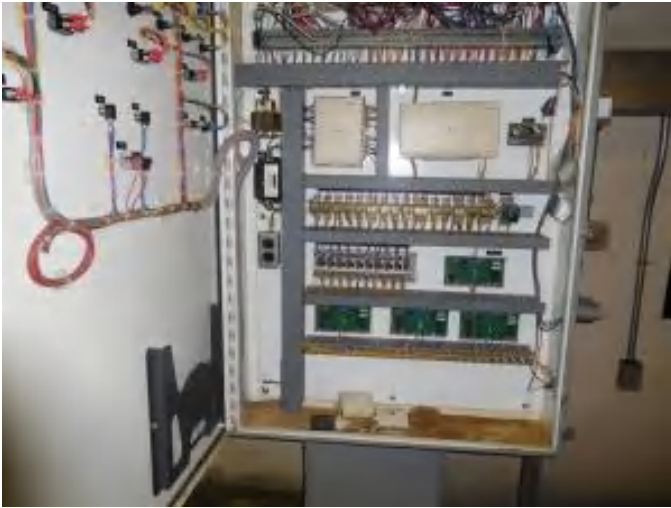
**Location:** entire building

**System: D3060 - Controls & Instrumentation**

**Distress:** Inadequate

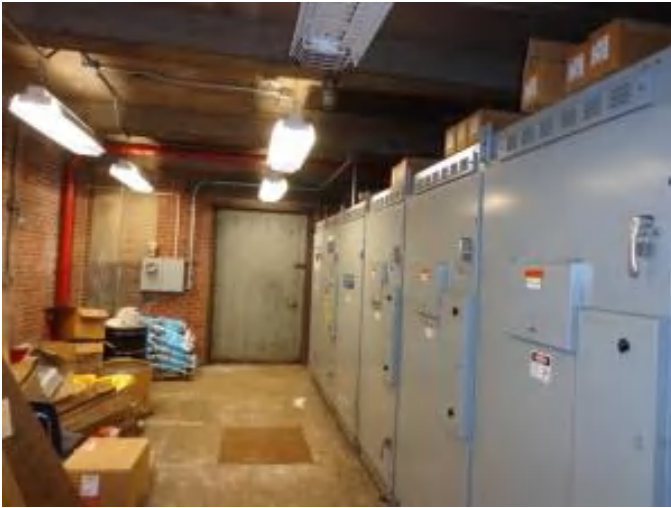
**Location:** Main Electrical Room

**System: D5010 - Electrical Service/Distribution**

**Distress:** Inadequate

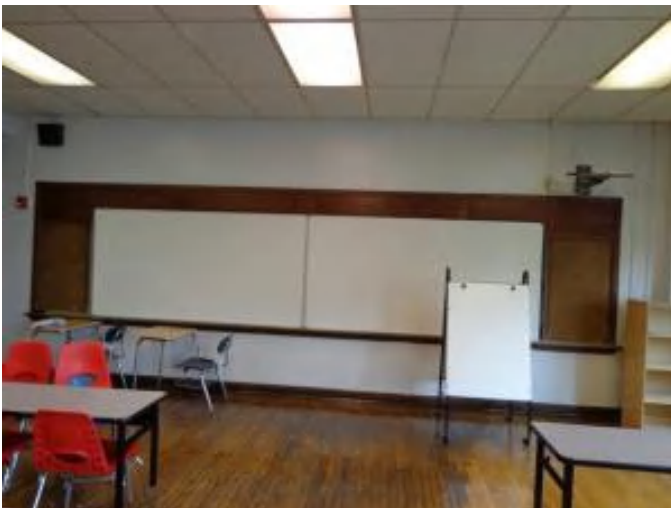
**Location:** Classrooms

**System: D5020 - Lighting and Branch Wiring**

**Distress:** Inadequate

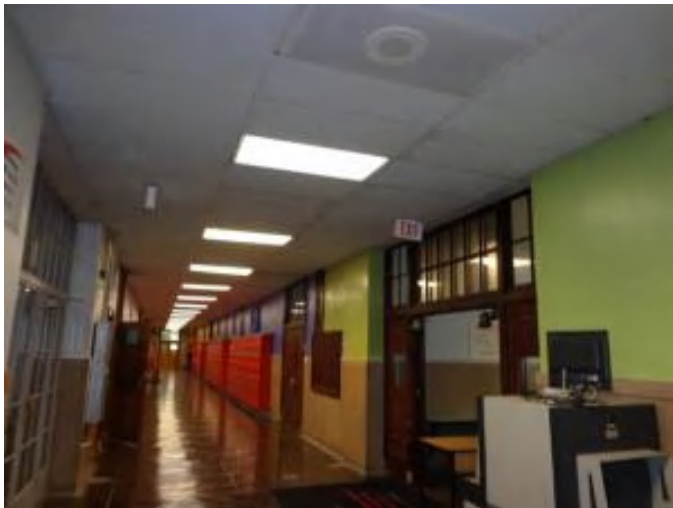
**Location:** Corridors

**System: D5020 - Lighting and Branch Wiring**

**Distress:** Damaged

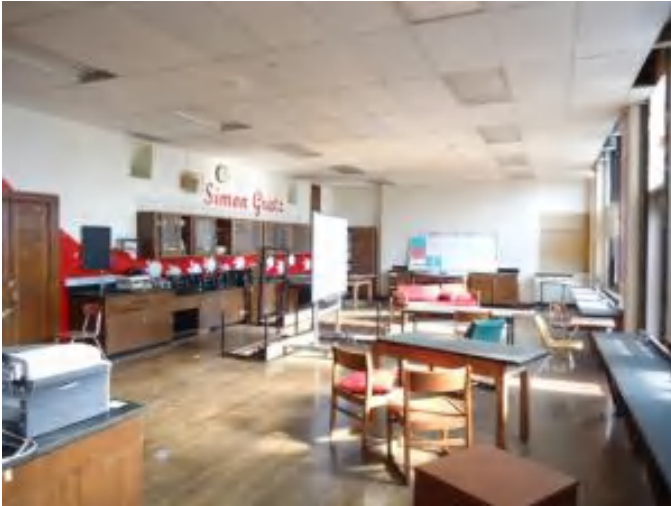
**Location:** Science Labs

Lab casework and countertops are located in the science classrooms on the fifth floor of this school. They vary in design, age, and degree of deterioration. Selective replacement of both base cabinets and countertops should be anticipated within ten years. The new cabinetry should be designed in accordance with current requirements and include utility upgrades.

**System: C1010 - Partitions**

**Distress:** Damaged

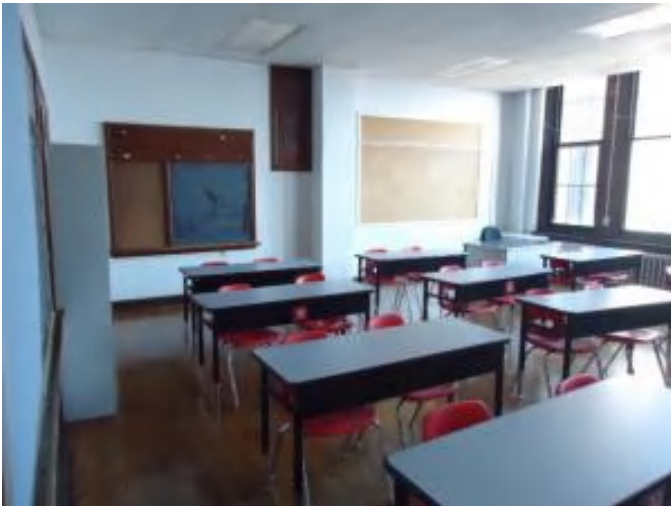
**Location:** Building Wide

There are several tack boards in the hallways for student displays. The systems are beyond the expected service life for this application. Remove and replace tack boards is recommended.

**System: C1030 - Fittings**

**Distress:** Damaged

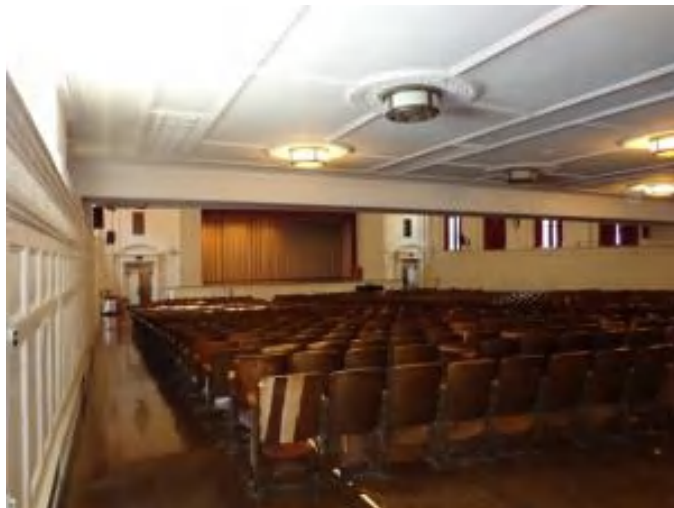
**Location:** Auditorium

**System: D5020 - Lighting and Branch Wiring**

**Distress:** Energy Efficiency

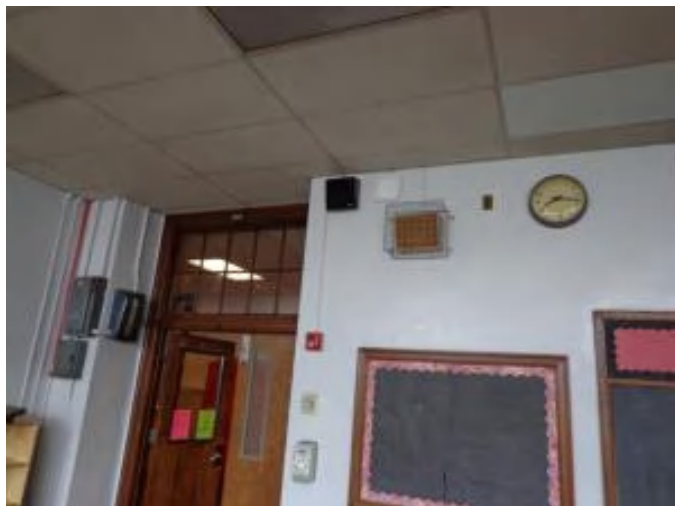
**Location:** Building wide

**System: D5030 - Communications and Security**

**Distress:** Inadequate

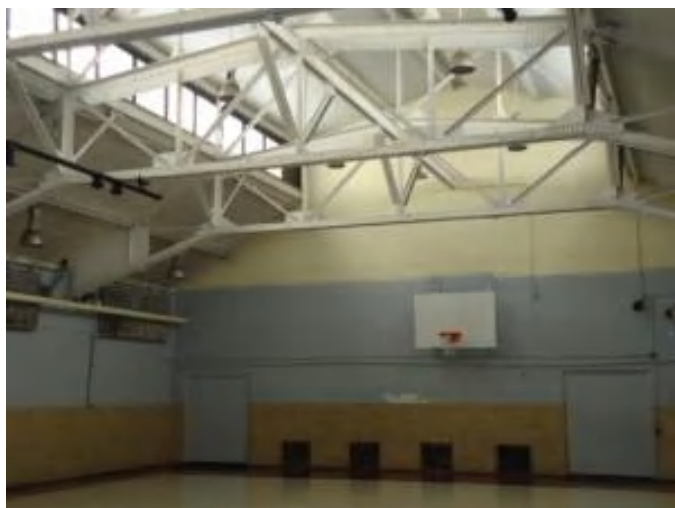
**Location:** Old Gyms

The practice Gyms or Boy's and Girl's Gyms each have a single scoreboard that appears to be from the early 1950's. This deficiency provides a budgetary consideration for the removal and replacement of each scoreboard.

**System: E1020 - Institutional Equipment**

**Distress:** Beyond Service Life

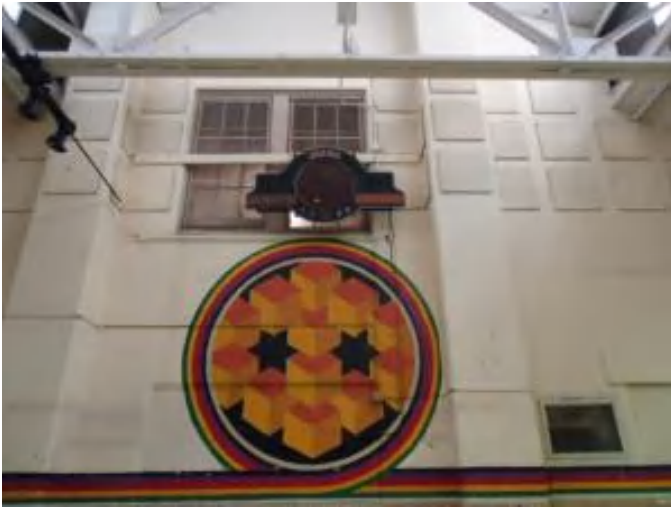
**Location:** Boys Gym

The boys and girls Gyms are no longer the main areas as this school had a new Gym addition constructed within the past ten years. This new Gym is in like new condition with modern backstops and sports safety barriers. However the old Gyms are still used as either a student common area or practice court. The interior backboards and support equipment is beyond its service life. Damaged boards are recommended for removal and replacement.

**System: E1020 - Institutional Equipment**

**Distress:** Damaged

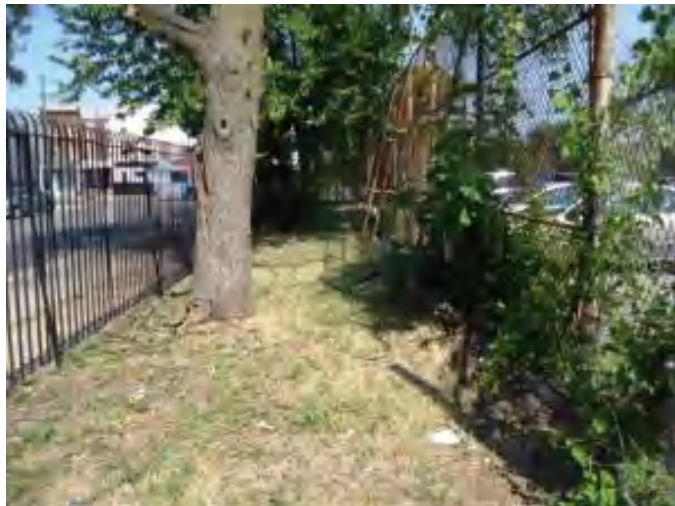
**Location:** Parking Lot

#### System: G2040 - Site Development

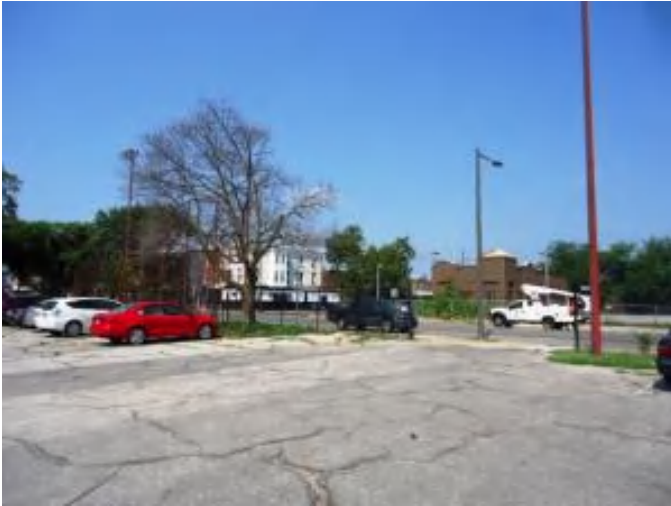
**Location:** Parking Lot

**System: G2020 - Parking Lots**

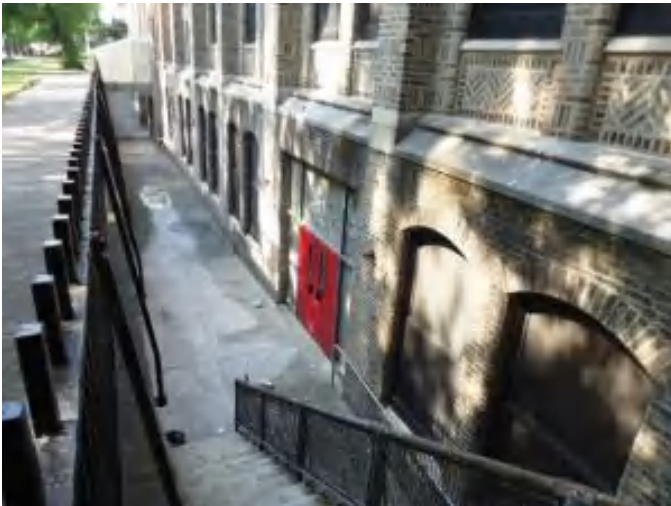
**Location:** Site

**System: G2040 - Site Development**

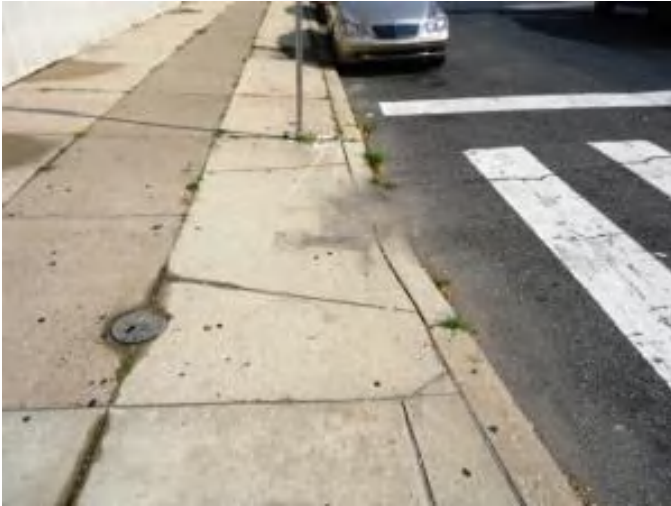
**Location:** Sidewalk

**System: G2030 - Pedestrian Paving**

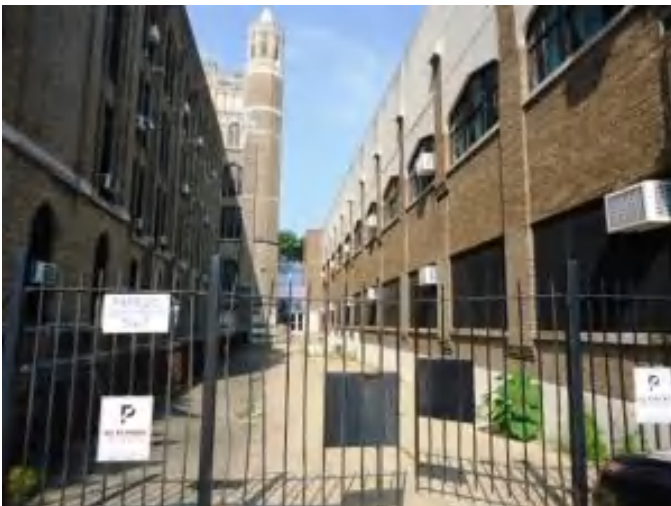
**Location:** Site

**System: G2040 - Site Development**

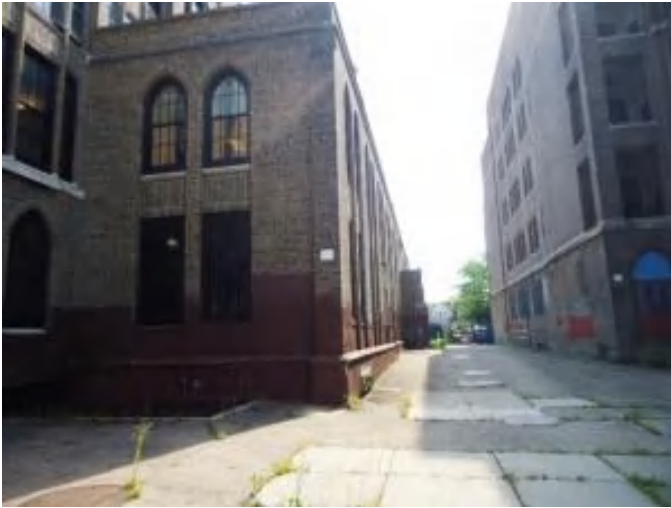
**Location:** Site

**System: G2040 - Site Development**

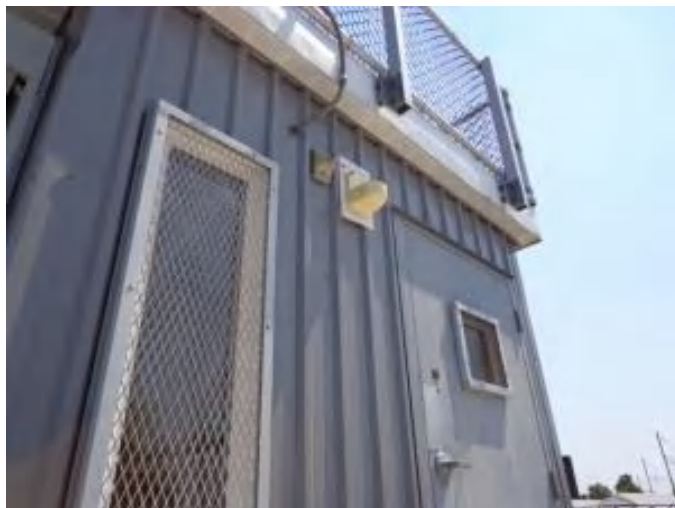
**Location:** Grandstands

#### System: D5090 - Other Electrical Systems
