## Facility Condition Assessment Summary Report

### Greenberg School

School District of Philadelphia  
**S843001;Greenberg**  
Final  
**Site Assessment Report**  
January 31, 2017

## Site Assessment Report

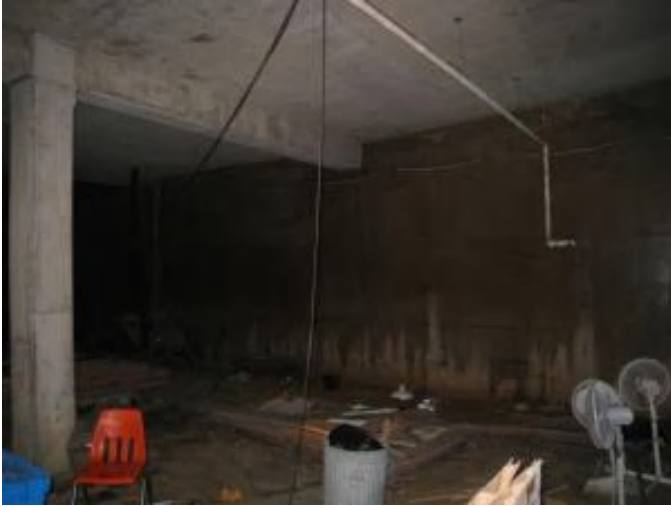
**Location:** foundation wall in Bomb Shelter Room

#### System: A1010 - Standard Foundations

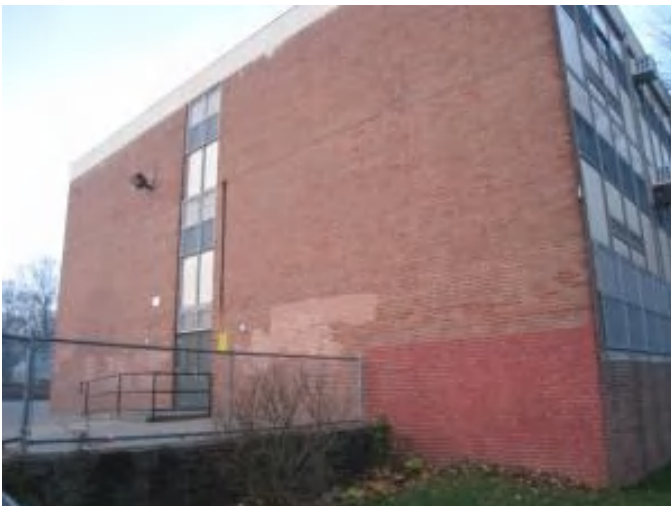
**Location:** exterior walls

#### System: B2010 - Exterior Walls

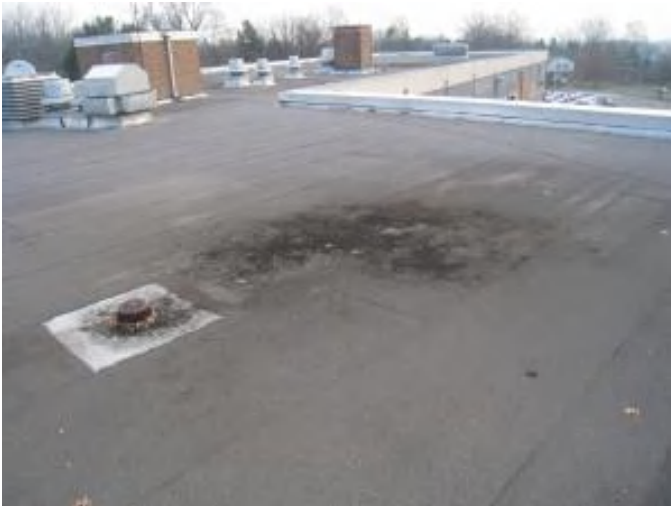
**Location:** roof

**System: B3010105 - Built-Up**

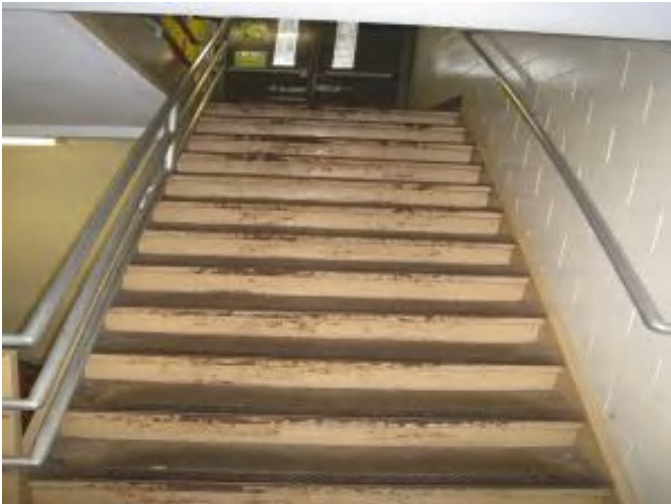
**Location:** stairways

**System: C2010 - Stair Construction**

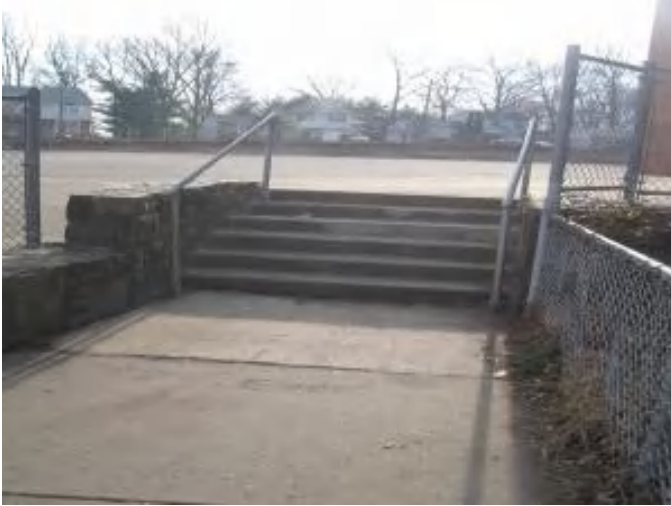
**Location:** exterior stairways  
**Distress:** Building / MEP Codes  
**Category:** 2 - Code Compliance  
**Priority:** 1 - Response Time (< 2 yr)  
**Correction:** Replace inadequate or install proper stair railing - select appropriate material  
**Qty:** 100.00  
**Unit of Measure:** L.F.  
**Estimate:** \$15,217.02  
**Assessor Name:** Craig Anding  
**Date Created:** 02/09/2016

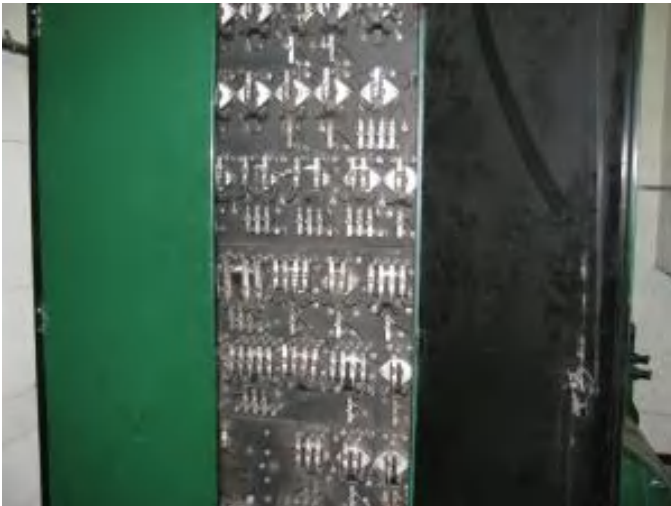
**Location:** Interior Building  
**Distress:** Beyond Service Life  
**Category:** 4 - Capital Improvement  
**Priority:** 1 - Response Time (< 2 yr)  
**Correction:** Replace Elevator - 2 to 3 stop hydraulic - add to the estimate for the number of stops over 2 up to 3 stops total - for 4 stops and up use traction elevator  
**Qty:** 1.00  
**Unit of Measure:** Ea.  
**Estimate:** \$199,133.78  
**Assessor Name:** Craig Anding  
**Date Created:** 01/07/2016

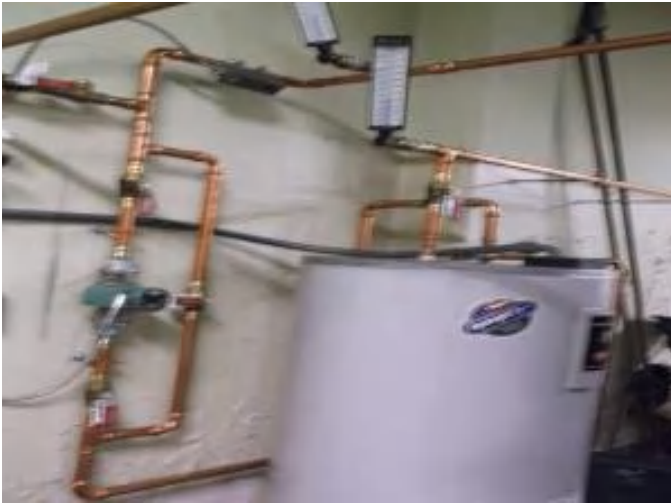
**Location:** Boiler Room

**System: D2020 - Domestic Water Distribution**

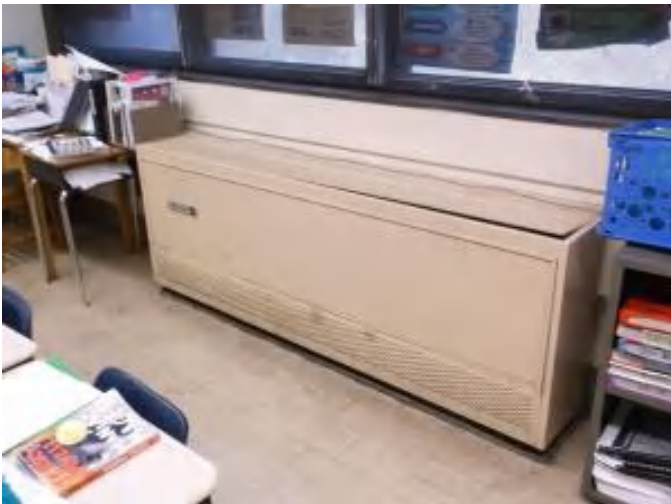
**Location:** Classrooms

**System: D3040 - Distribution Systems**

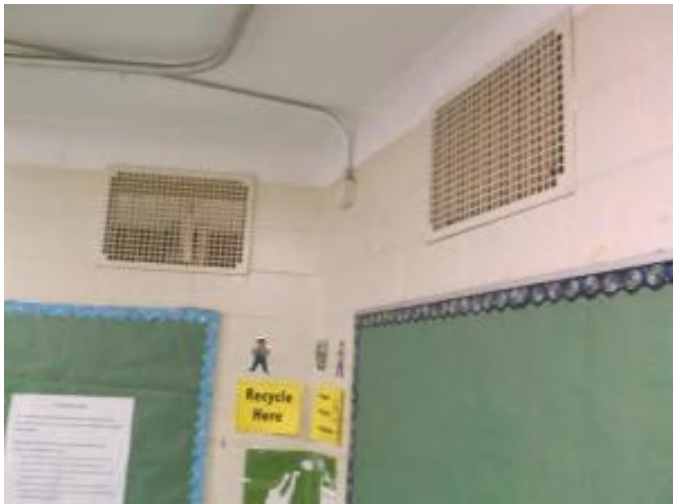
**Location:** Corridors  
**Distress:** Health Hazard / Risk  
**Category:** 1 - Health & Safety  
**Priority:** 1 - Response Time (< 2 yr)  
**Correction:** Install indoor AHU, CV, DT (15T)  
**Qty:** 75.00  
**Unit of Measure:** TonAC  
**Estimate:** \$1,276,700.27  
**Assessor Name:** Craig Anding  
**Date Created:** 03/01/2016

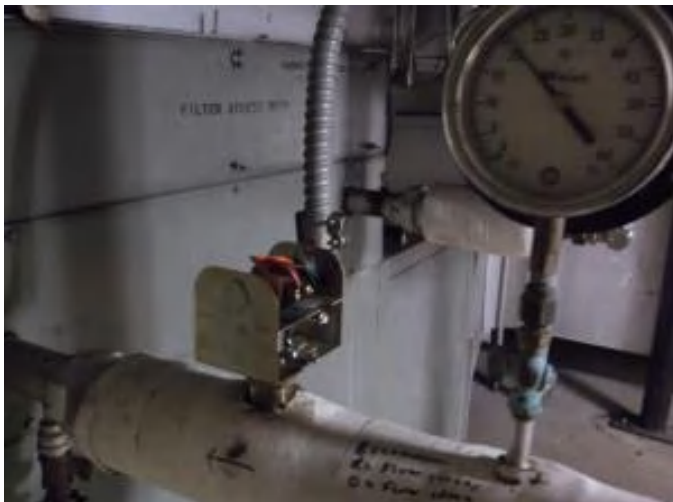
**Location:** Mezzanine Mechanical  
**Distress:** Health Hazard / Risk  
**Category:** 1 - Health & Safety  
**Priority:** 1 - Response Time (< 2 yr)  
**Correction:** Replace HVAC unit for Auditorium (800 seat).  
**Qty:** 600.00  
**Unit of Measure:** Seat  
**Estimate:** \$306,762.03  
**Assessor Name:** Craig Anding  
**Date Created:** 03/01/2016

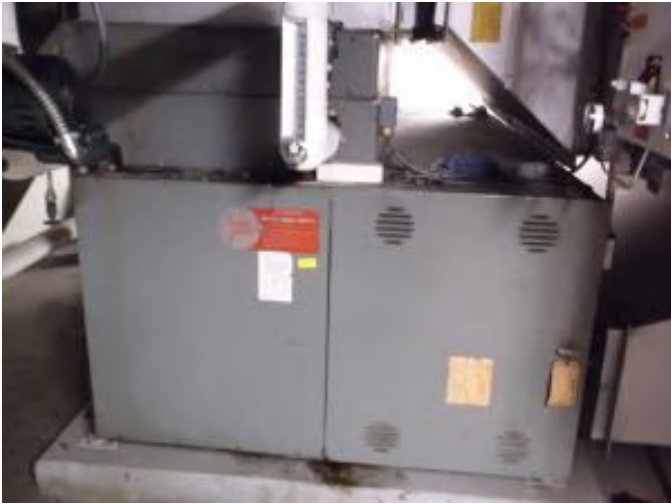
**Location:** Mezzanine Mechanical  
**Distress:** Health Hazard / Risk  
**Category:** 1 - Health & Safety  
**Priority:** 1 - Response Time (< 2 yr)  
**Correction:** Replace HVAC unit for Cafeteria (850)  
**Qty:** 850.00  
**Unit of Measure:** Student  
**Estimate:** \$231,369.13  
**Assessor Name:** Craig Anding  
**Date Created:** 03/01/2016

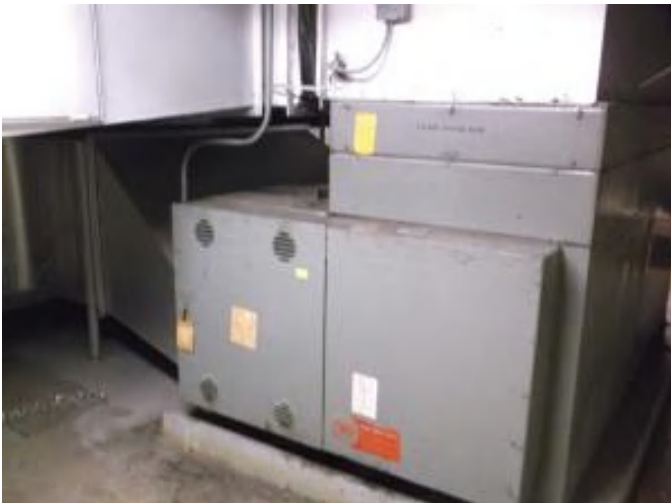
**Location:** Mezzanine Mechanical  
**Distress:** Health Hazard / Risk  
**Category:** 1 - Health & Safety  
**Priority:** 1 - Response Time (< 2 yr)  
**Correction:** Replace HVAC unit for Gymnasium (single station)  
**Qty:** 6,000.00  
**Unit of Measure:** S.F.  
**Estimate:** \$227,475.37  
**Assessor Name:** Craig Anding  
**Date Created:** 03/01/2016

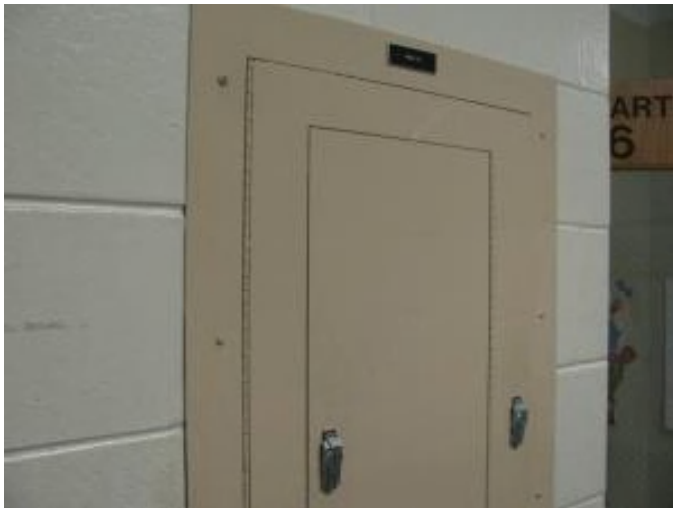
**Location:** Entire Building  
**Distress:** Beyond Service Life  
**Category:** 3 - Operations / Maint.  
**Priority:** 1 - Response Time (< 2 yr)  
**Correction:** Replace Electrical Distribution System (U)  
**Qty:** 1.00  
**Unit of Measure:** Ea.  
**Estimate:** \$264,420.28  
**Assessor Name:** Craig Anding  
**Date Created:** 01/07/2016

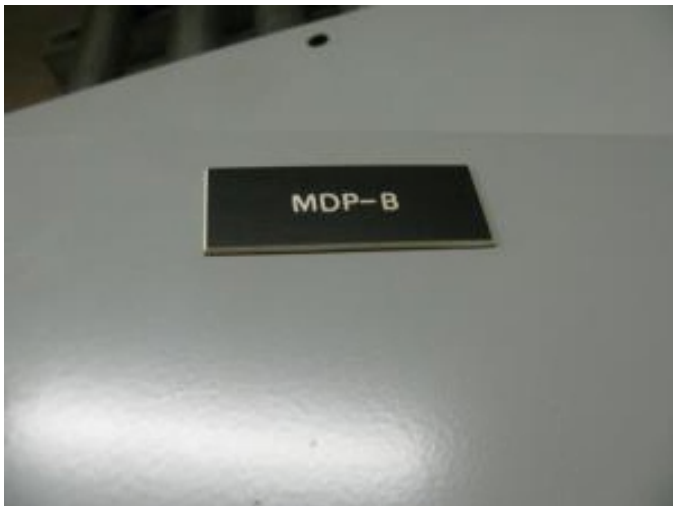
**Location:** Electrical Room  
**Distress:** Beyond Service Life  
**Category:** 3 - Operations / Maint.  
**Priority:** 1 - Response Time (< 2 yr)  
**Correction:** Add Electrical Switchgear and Distribution System  
**Qty:** 1.00  
**Unit of Measure:** Ea.  
**Estimate:** \$78,347.21  
**Assessor Name:** Craig Anding  
**Date Created:** 01/07/2016

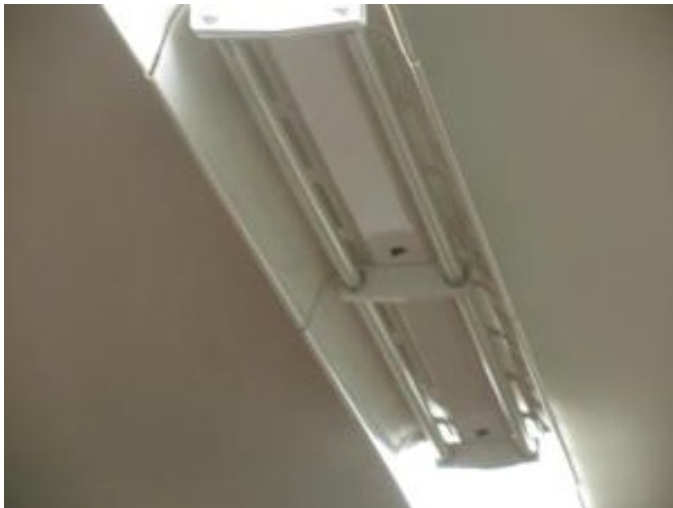
**Location:** Kitchen and Gymnasium  
**Distress:** Inadequate  
**Category:** 3 - Operations / Maint.  
**Priority:** 1 - Response Time (< 2 yr)  
**Correction:** Replace lighting fixtures  
**Qty:** 1.00  
**Unit of Measure:** Ea.  
**Estimate:** \$72,322.27  
**Assessor Name:** Craig Anding  
**Date Created:** 01/07/2016

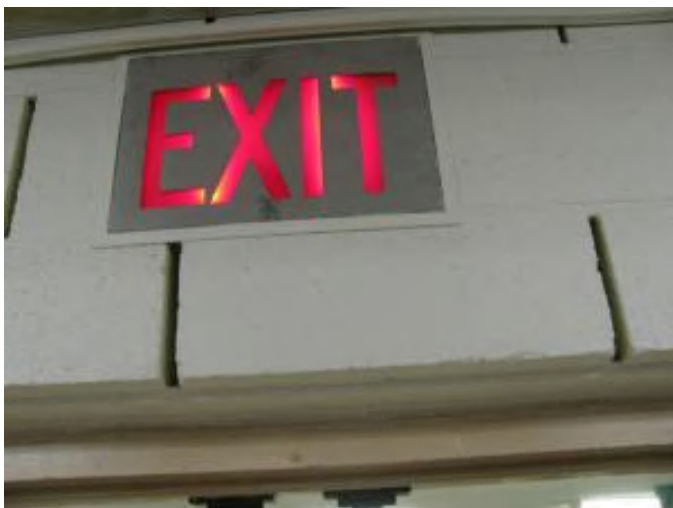
**Location:** Entire Building  
**Distress:** Life Safety / NFPA / PFD  
**Category:** 1 - Health & Safety  
**Priority:** 1 - Response Time (< 2 yr)  
**Correction:** Replace lighting fixtures  
**Qty:** 1.00  
**Unit of Measure:** Ea.  
**Estimate:** \$23,450.05  
**Assessor Name:** Craig Anding  
**Date Created:** 01/07/2016

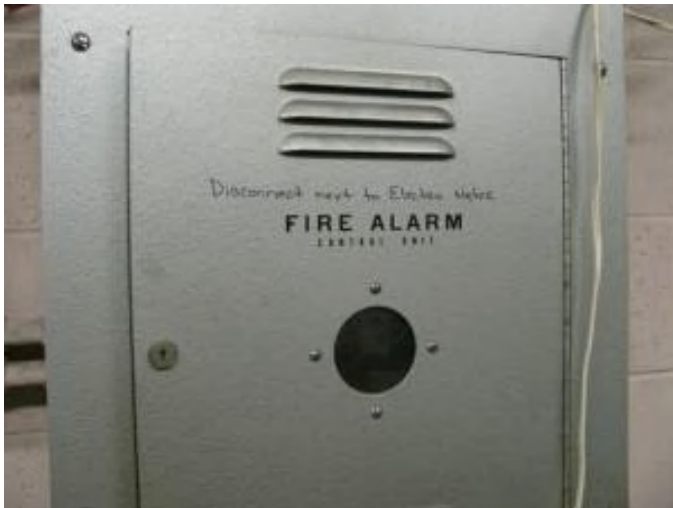
**Location:** Entire Building  
**Distress:** Life Safety / NFPA / PFD  
**Category:** 1 - Health & Safety  
**Priority:** 1 - Response Time (< 2 yr)  
**Correction:** Replace fire alarm system  
**Qty:** 1.00  
**Unit of Measure:** S.F.  
**Estimate:** \$322,184.99  
**Assessor Name:** Craig Anding  
**Date Created:** 01/07/2016

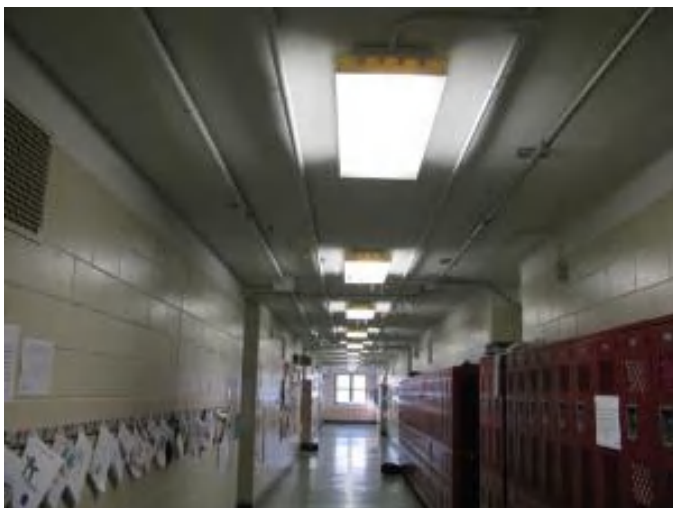
**Location:** Entire Building  
**Distress:** Security Issue  
**Category:** 1 - Health & Safety  
**Priority:** 1 - Response Time (< 2 yr)  
**Correction:** Add/Replace Video Surveillance System  
**Qty:** 1.00  
**Unit of Measure:** Ea.  
**Estimate:** \$265,290.24  
**Assessor Name:** Craig Anding  
**Date Created:** 01/07/2016

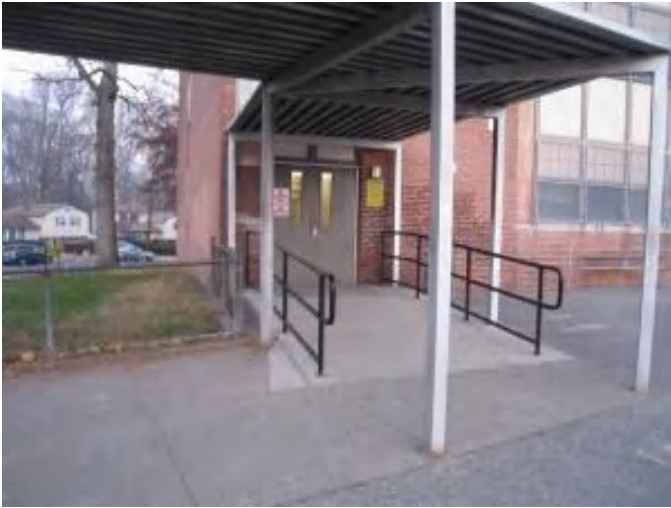
**Location:** exterior doors  
**Distress:** Failing  
**Category:** 3 - Operations / Maint.  
**Priority:** 2 - Response Time (2-3 yrs)  
**Correction:** Remove and replace exterior doors - per leaf  
**Qty:** 15.00  
**Unit of Measure:** Ea.  
**Estimate:** \$116,038.37  
**Assessor Name:** Craig Anding  
**Date Created:** 02/09/2016

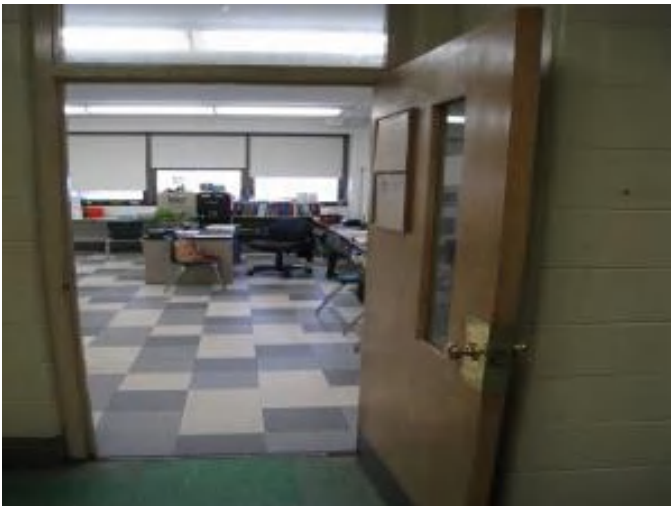
**Location:** interior doors  
**Distress:** Damaged  
**Category:** 3 - Operations / Maint.  
**Priority:** 2 - Response Time (2-3 yrs)  
**Correction:** Remove and replace interior doors - wood doors with hollow metal frames - per leaf  
**Qty:** 80.00  
**Unit of Measure:** Ea.  
**Estimate:** \$381,646.97  
**Assessor Name:** Craig Anding  
**Date Created:** 02/09/2016

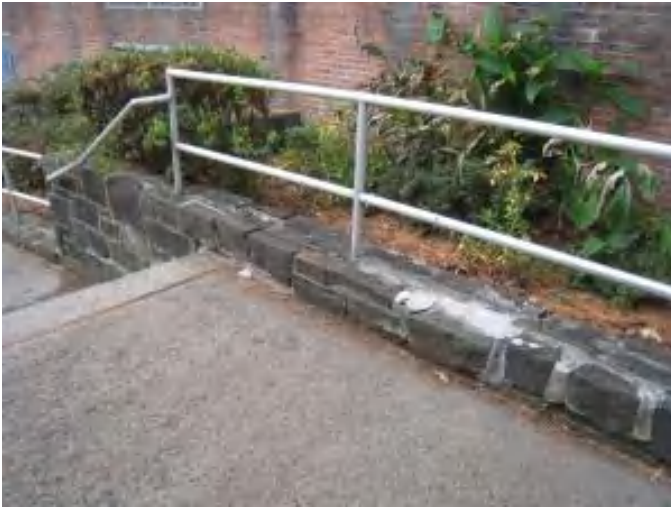
**Location:** exterior ramp handrails/guards  
**Distress:** Appearance  
**Category:** 3 - Operations / Maint.  
**Priority:** 2 - Response Time (2-3 yrs)  
**Correction:** Re-paint stairway handrails - per LF of handrail pipe  
**Qty:** 300.00  
**Unit of Measure:** L.F.  
**Estimate:** \$1,644.09  
**Assessor Name:** Craig Anding  
**Date Created:** 02/09/2016

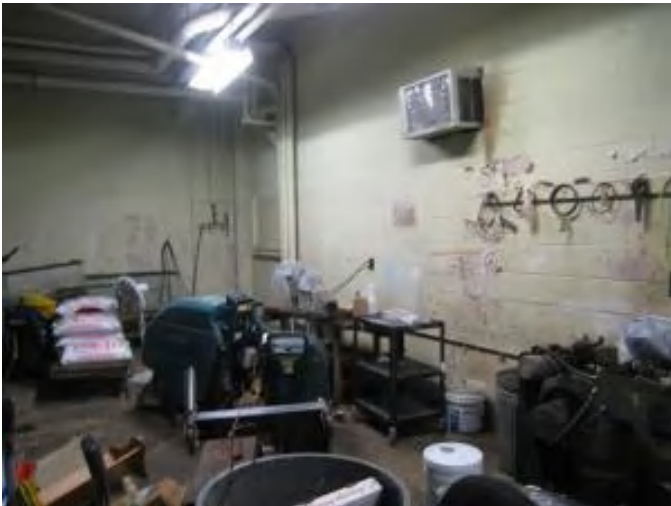
**Location:** basement and corridor walls  
**Distress:** Appearance  
**Category:** 3 - Operations / Maint.  
**Priority:** 2 - Response Time (2-3 yrs)  
**Correction:** Repair substrate and repaint interior concrete or CMU walls - SF of wall surface  
**Qty:** 8,000.00  
**Unit of Measure:** S.F.  
**Estimate:** \$60,016.01  
**Assessor Name:** Craig Anding  
**Date Created:** 02/09/2016

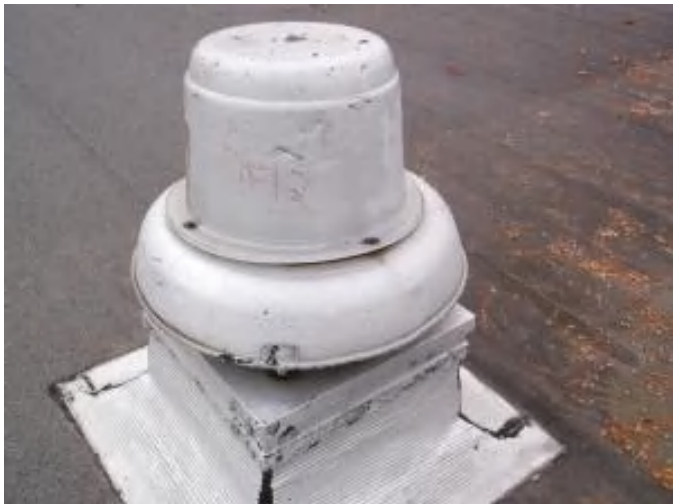
**Location:** Roof  
**Distress:** Beyond Service Life  
**Category:** 3 - Operations / Maint.  
**Priority:** 3 - Response Time (3-4 yrs)  
**Correction:** Replace power roof ventilator (24" dia.)  
**Qty:** 8.00  
**Unit of Measure:** Ea.  
**Estimate:** \$354,467.11  
**Assessor Name:** Craig Anding  
**Date Created:** 03/01/2016

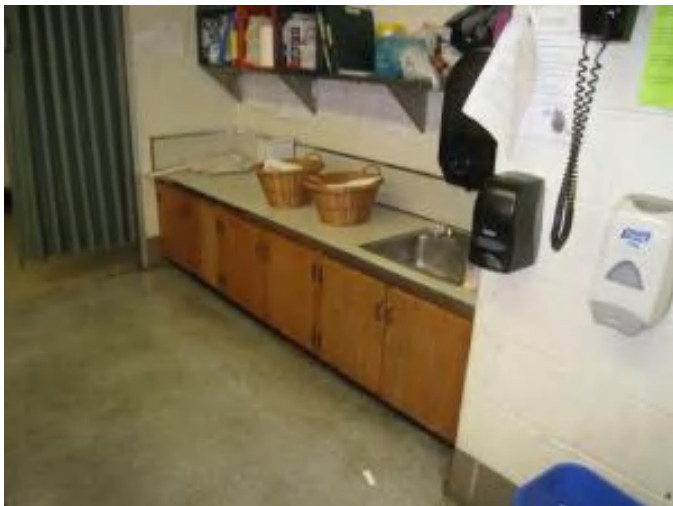
**Location:** classrooms  
**Distress:** Damaged  
**Category:** 3 - Operations / Maint.  
**Priority:** 3 - Response Time (3-4 yrs)  
**Correction:** Remove and replace base cabinets and countertops  
**Qty:** 40.00  
**Unit of Measure:** L.F.  
**Estimate:** \$33,246.61  
**Assessor Name:** Craig Anding  
**Date Created:** 02/09/2016

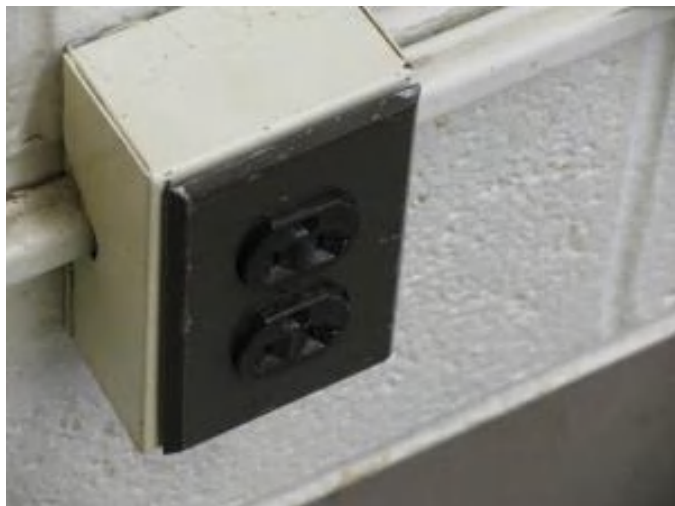
**Location:** Entire Building  
**Distress:** Inadequate  
**Category:** 3 - Operations / Maint.  
**Priority:** 4 - Response Time (4-5 yrs)  
**Correction:** Replace Wiring Device  
**Qty:** 0.00  
**Unit of Measure:** Ea.  
**Estimate:** \$4,942.72  
**Assessor Name:** Craig Anding  
**Date Created:** 01/07/2016

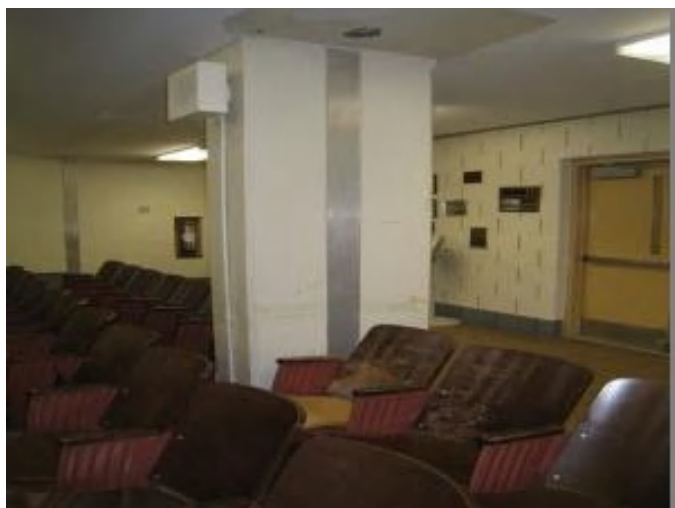
**Location:** auditorium  
**Distress:** Damaged  
**Category:** 3 - Operations / Maint.  
**Priority:** 4 - Response Time (4-5 yrs)  
**Correction:** Refinish auditorium seating  
**Qty:** 20.00  
**Unit of Measure:** Ea.  
**Estimate:** \$17,117.89  
**Assessor Name:** Craig Anding  
**Date Created:** 02/09/2016

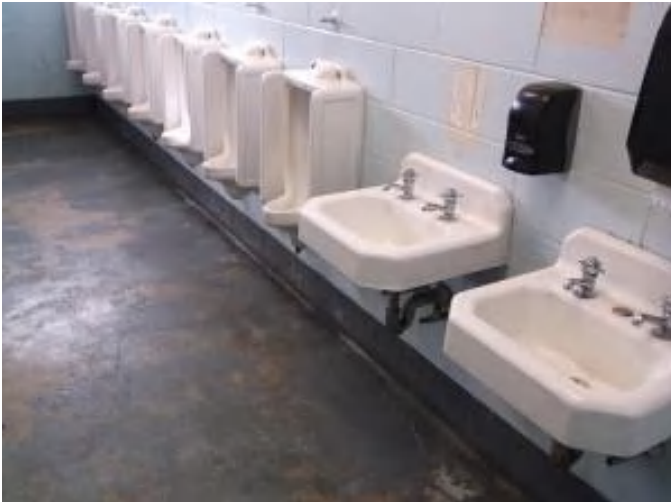
**Location:** Restrooms  
**Distress:** Beyond Service Life  
**Category:** 3 - Operations / Maint.  
**Priority:** 5 - Response Time (> 5 yrs)  
**Correction:** Remove and replace or replace wall hung urinals  
**Qty:** 12.00  
**Unit of Measure:** Ea.  
**Estimate:** \$44,472.65  
**Assessor Name:** Craig Anding  
**Date Created:** 03/01/2016

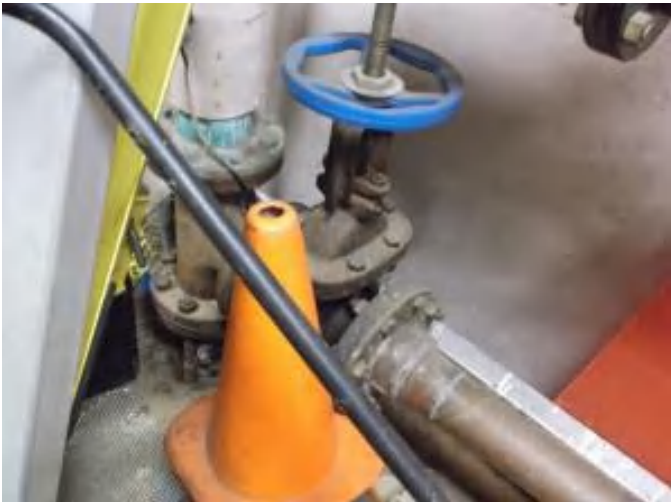
**Location:** Throughout Building  
**Distress:** Beyond Service Life  
**Category:** 3 - Operations / Maint.  
**Priority:** 5 - Response Time (> 5 yrs)  
**Correction:** Replace domestic water piping (75 KSF)  
**Qty:** 90,000.00  
**Unit of Measure:** S.F.  
**Estimate:** \$456,062.42  
**Assessor Name:** Craig Anding  
**Date Created:** 03/01/2016

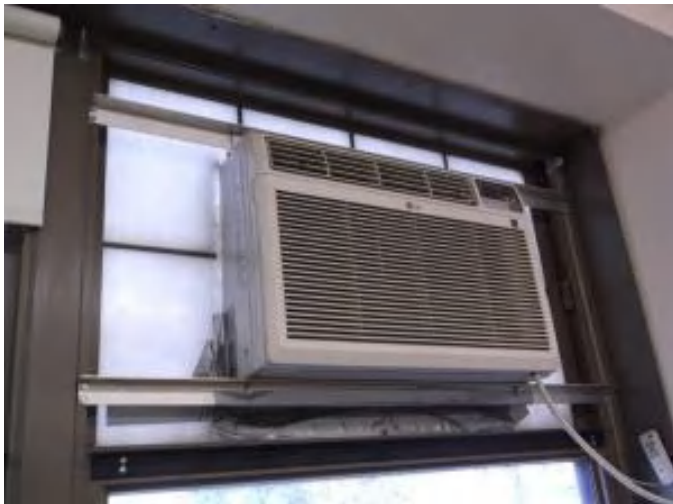
**Location:** Throughout Building  
**Distress:** Inadequate  
**Category:** 4 - Capital Improvement  
**Priority:** 5 - Response Time (> 5 yrs)  
**Correction:** Install chilled water system with distribution piping and pumps. (+75KSF)  
**Qty:** 90,000.00  
**Unit of Measure:** S.F.  
**Estimate:** \$1,445,345.43  
**Assessor Name:** Craig Anding  
**Date Created:** 03/01/2016

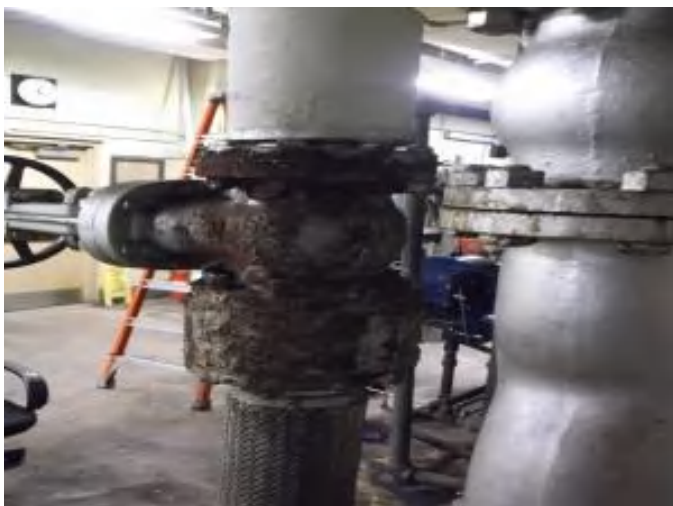
**Location:** Throughout Building  
**Distress:** Beyond Service Life  
**Category:** 3 - Operations / Maint.  
**Priority:** 5 - Response Time (> 5 yrs)  
**Correction:** Replace hydronic heating piping (75KSF)  
**Qty:** 90,000.00  
**Unit of Measure:** S.F.  
**Estimate:** \$885,997.14  
**Assessor Name:** Craig Anding  
**Date Created:** 03/01/2016

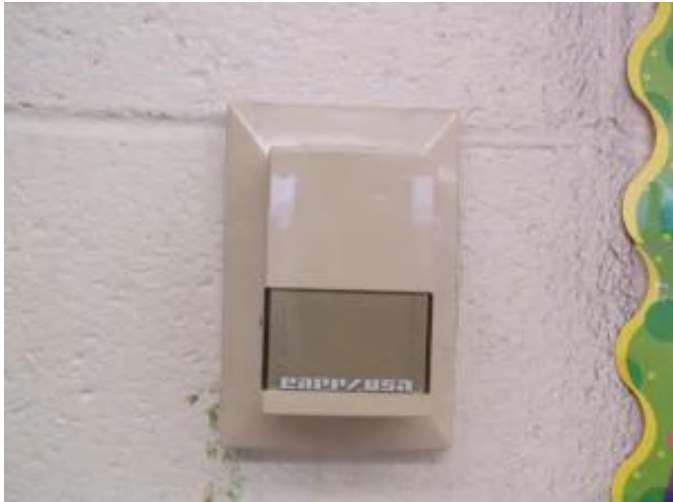
**Location:** Throughout Building  
**Distress:** Energy Efficiency  
**Category:** 4 - Capital Improvement  
**Priority:** 5 - Response Time (> 5 yrs)  
**Correction:** Replace pneumatic controls with DDC (75KSF)  
**Qty:** 90,000.00  
**Unit of Measure:** S.F.  
**Estimate:** \$1,930,688.21  
**Assessor Name:** Craig Anding  
**Date Created:** 03/01/2016

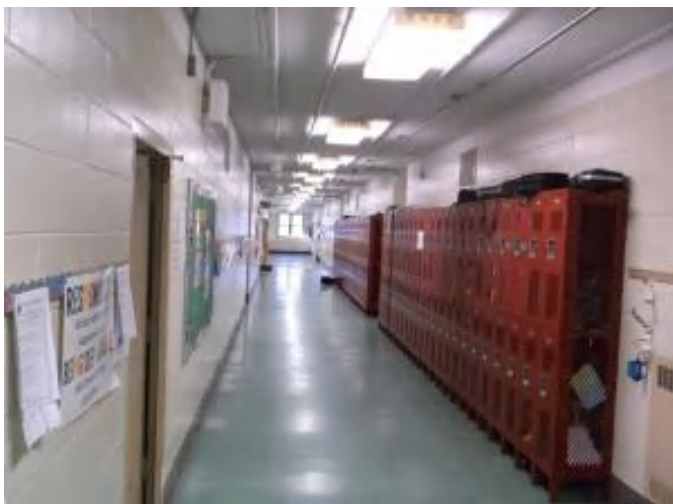
**Location:** Throughout Building  
**Distress:** Life Safety / NFPA / PFD  
**Category:** 2 - Code Compliance  
**Priority:** 5 - Response Time (> 5 yrs)  
**Correction:** Install a fire protection sprinkler system  
**Qty:** 90,000.00  
**Unit of Measure:** S.F.  
**Estimate:** \$1,287,490.18  
**Assessor Name:** Craig Anding  
**Date Created:** 03/01/2016
