## Facility Condition Assessment Summary Report

### Greenfield School

School District of Philadelphia  
**S247001;Greenfield**  
Final  
**Site Assessment Report**  
January 31, 2017

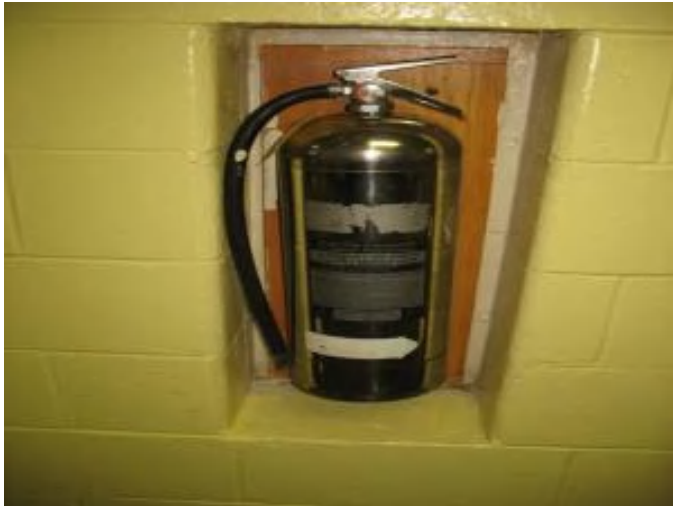
#### System: D4010 - Sprinklers

**Location:** Throughout building

**Distress:** Life Safety / NFPA / PFD

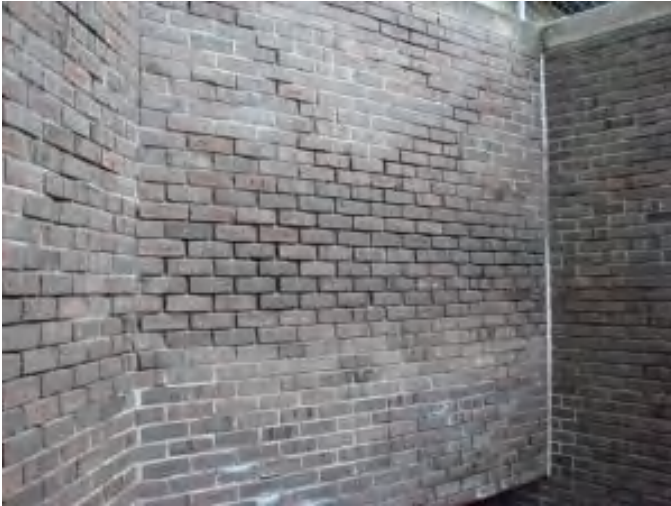
**System: B1010 - Floor Construction**

**Location:** Exterior

**Distress:** Damaged

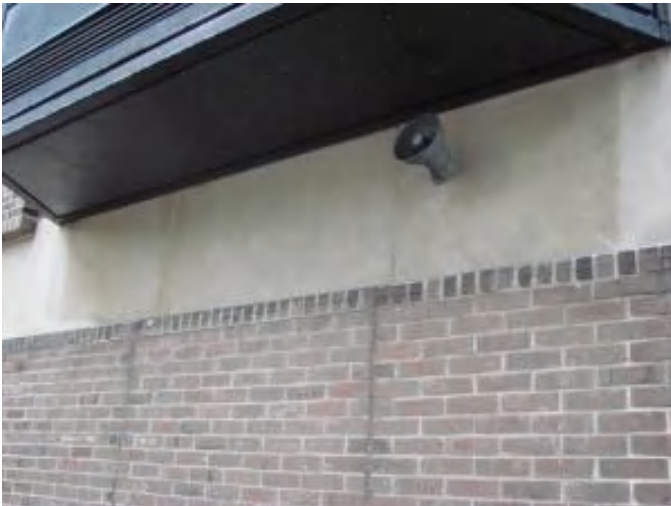
**System: B2010 - Exterior Walls**

**Location:** Exterior

**Distress:** Building Envelope Integrity

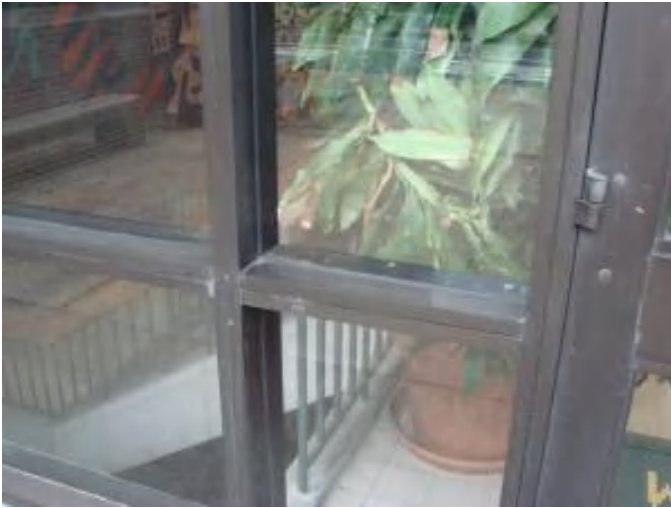
**System: B2020 - Exterior Windows**

**Location:** Exterior

**Distress:** Building Envelope Integrity

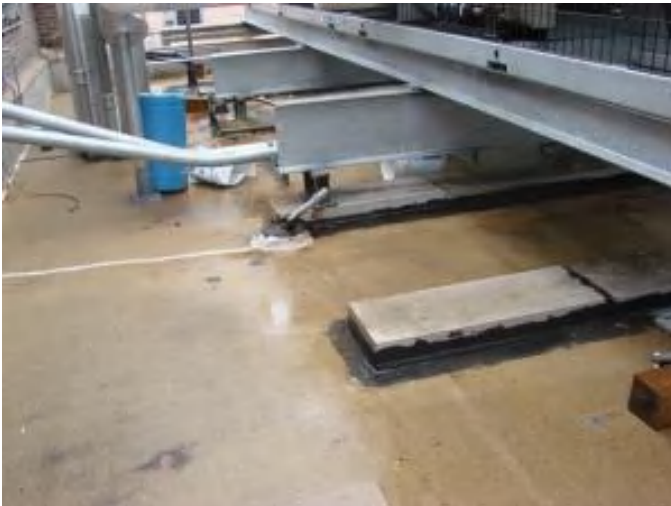
**System: B3010105 - Built-Up**

**Location:** Exterior

**Distress:** Building Envelope Integrity

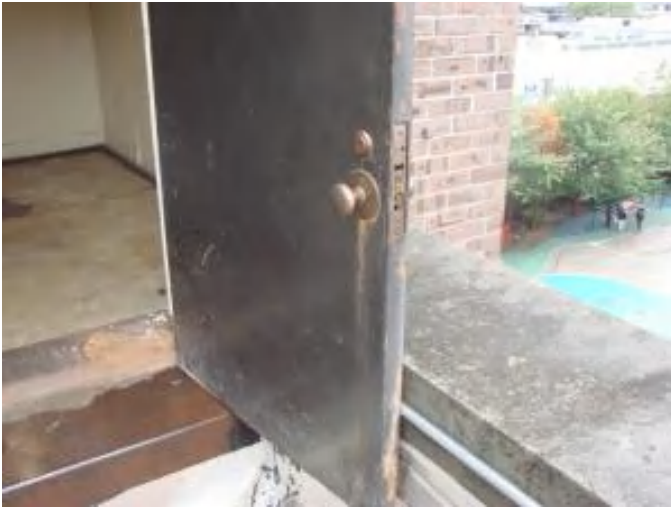
**System: B3020 - Roof Openings**

**Location:** Exterior

**Distress:** OSHA

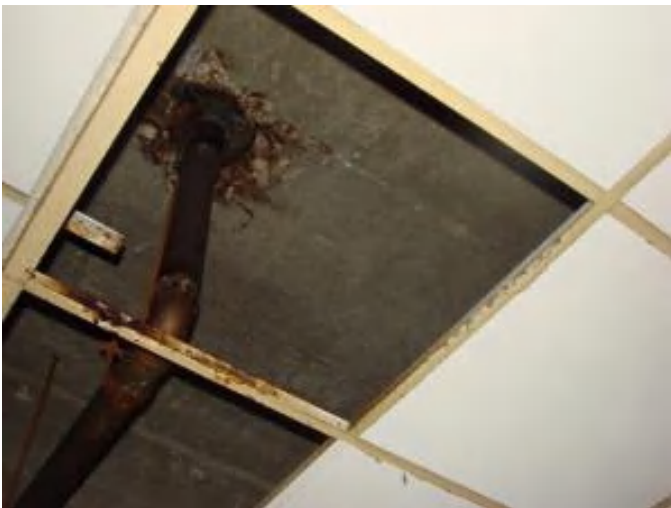
**System: C3030 - Ceiling Finishes**

**Location:** Interior

**Distress:** Life Safety / NFPA / PFD

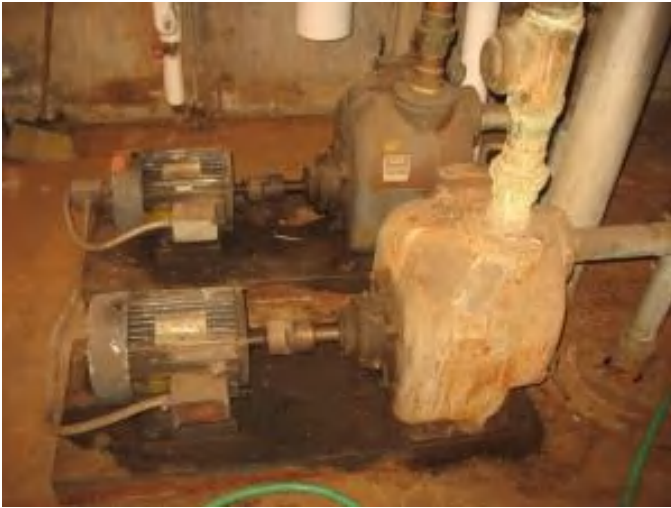
**System: D2030 - Sanitary Waste**

**Location:** Basement mechanical room

**Distress:** Failing

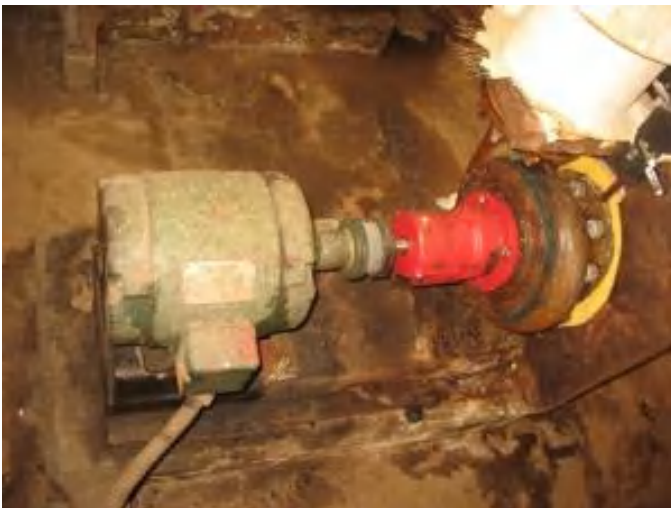
**System: D3020 - Heat Generating Systems**

**Location:** Basement mechanical room

**Distress:** Damaged

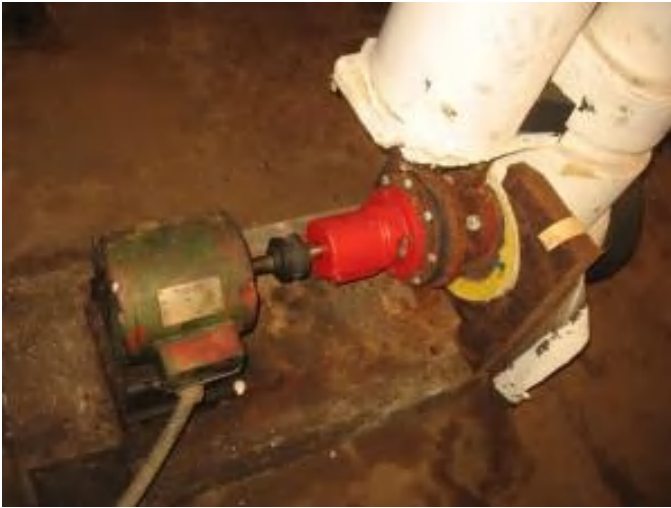
**System: D3020 - Heat Generating Systems**

**Location:** Basement mechanical room

**Distress:** Damaged

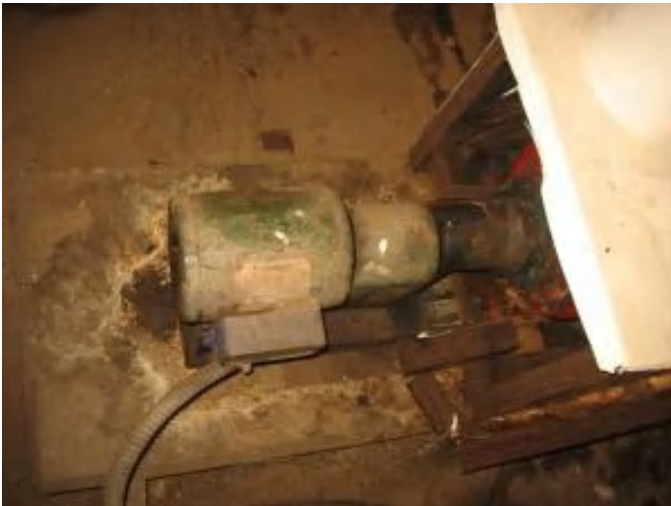
**System: D3030 - Cooling Generating Systems**

**Location:** Basement mechanical room

**Distress:** Damaged

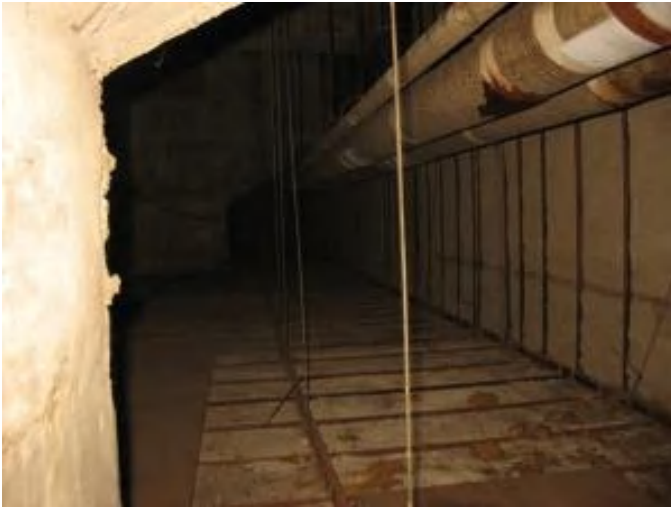
**System: D3040 - Distribution Systems**

**Location:** Throughout building

**Distress:** Damaged

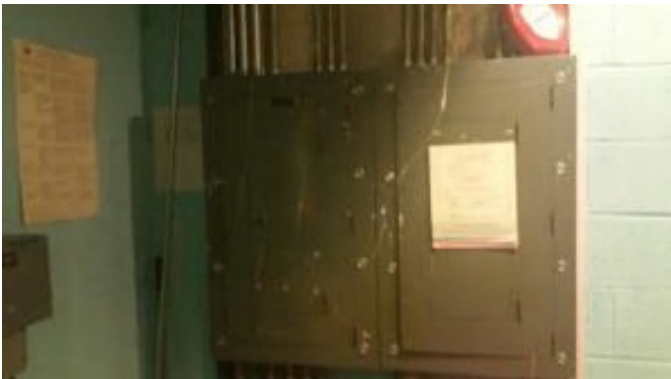
**System: D5010 - Electrical Service/Distribution**

**Location:** throughout the building

**Distress:** Beyond Service Life

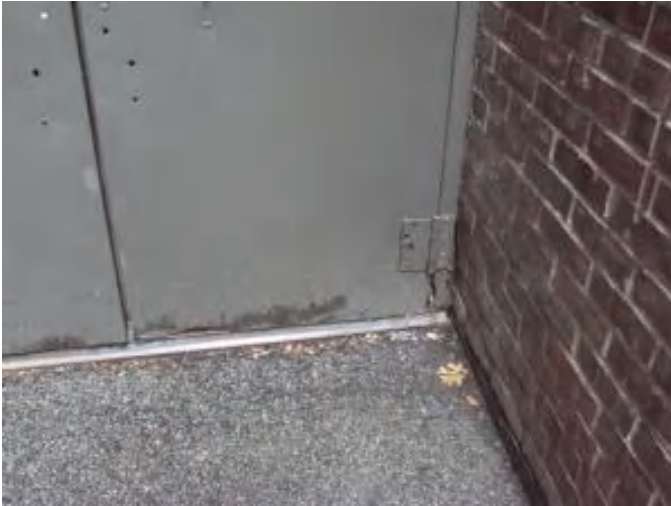
**System: B2030 - Exterior Doors**

**Location:** Exterior

**Distress:** Beyond Service Life

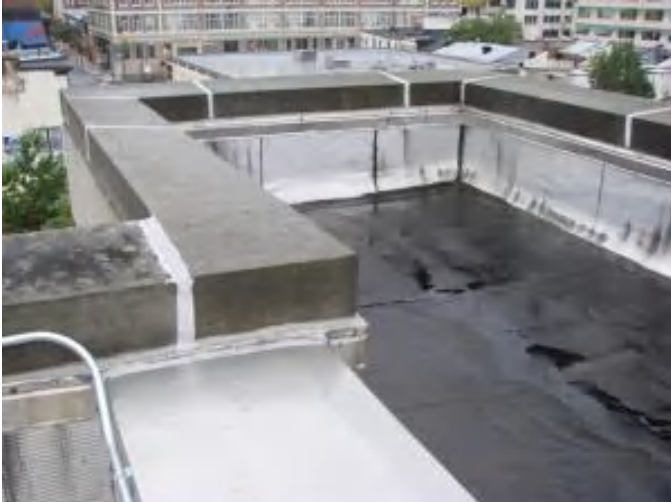
**System: B3010105 - Built-Up**

**Location:** Exterior

**Distress:** Building Envelope Integrity

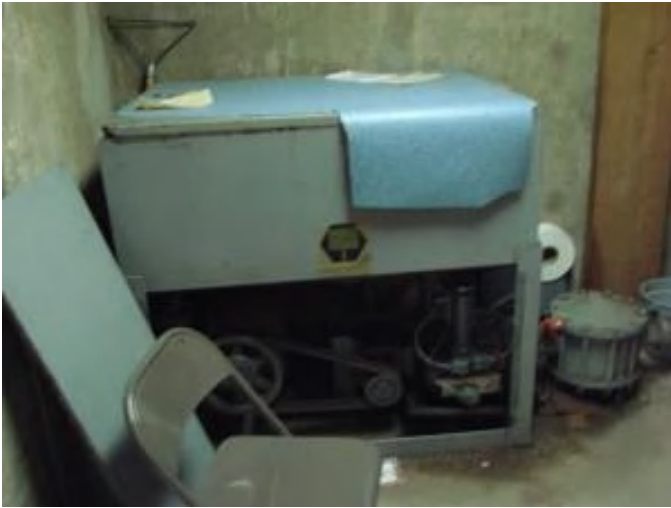
**System: D1010 - Elevators and Lifts**

**Location:** Interior  
**Distress:** Accessibility  
**Category:** 2 - Code Compliance  
**Priority:** 3 - Response Time (3-4 yrs)  
**Correction:** Replace elevator - 4 stop electric traction  
**Qty:** 1.00  
**Unit of Measure:** Ea.  
**Estimate:** \$323,144.32  
**Assessor Name:** Craig Anding  
**Date Created:** 01/06/2016

**Notes:** Replace existing elevator with an ADA compliant 2500 lb elevator serving all floors

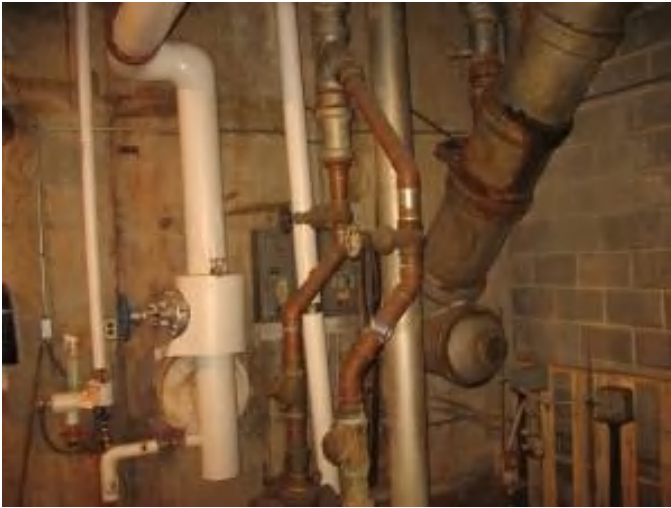
**System: D2030 - Sanitary Waste**

**Location:** Throughout building

**Distress:** Beyond Service Life

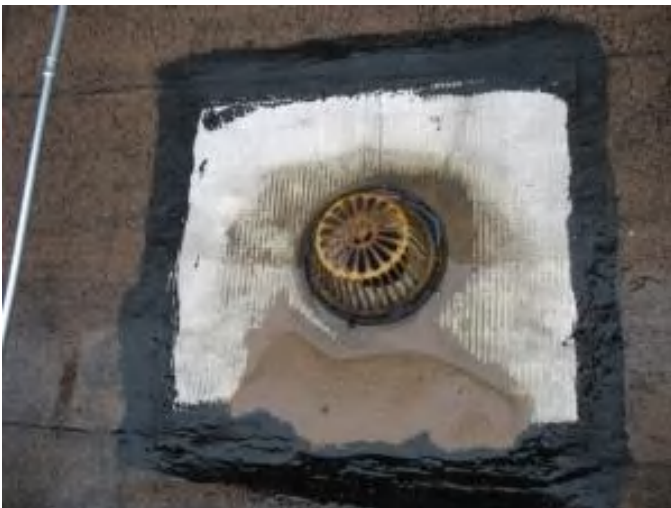
**System: D2040 - Rain Water Drainage**

**Location:** Throughout building

**Distress:** Beyond Service Life

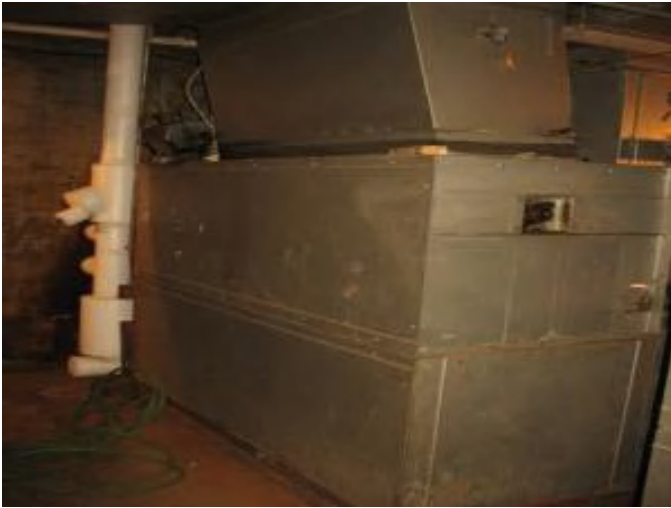
**System: D3040 - Distribution Systems**

**Location:** Auditorium

**Distress:** Beyond Service Life

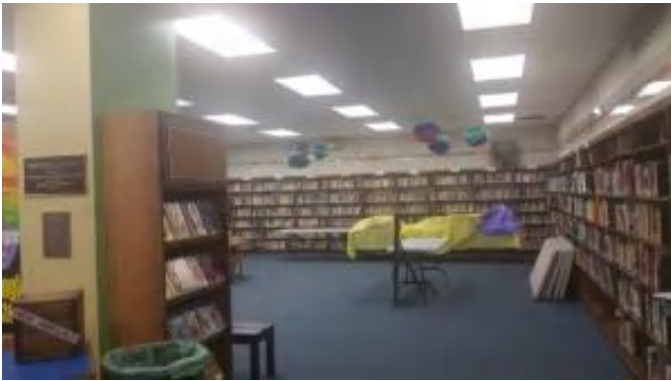
**System: D5020 - Lighting and Branch Wiring**

**Location:** throughout the building

**Distress:** Beyond Service Life

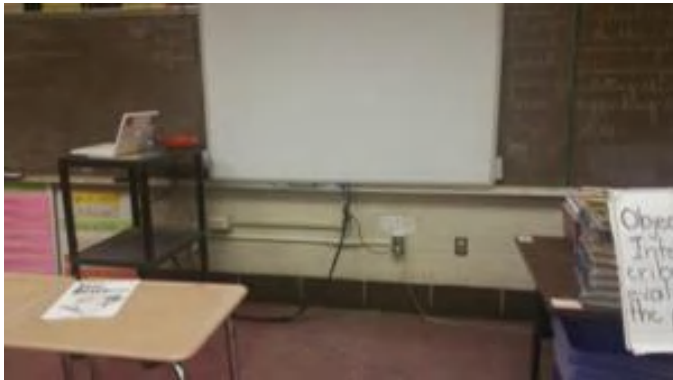
**System: D5020 - Lighting and Branch Wiring**

**Location:** throughout the building

**Distress:** Beyond Service Life

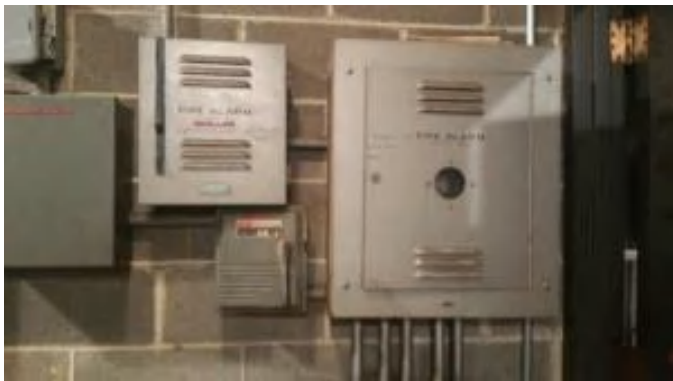
**System: D5030 - Communications and Security**

**Location:** throughout the building

**Distress:** Health Hazard / Risk

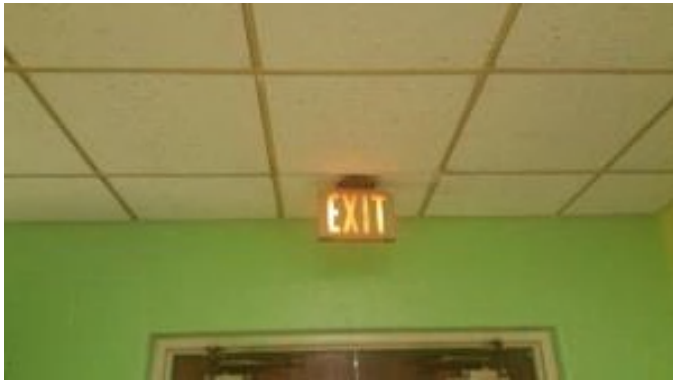
**System: D5090 - Other Electrical Systems**

**Location:** throuout the building  
**Distress:** Beyond Service Life  
**Category:** 3 - Operations / Maint.  
**Priority:** 3 - Response Time (3-4 yrs)  
**Correction:** Replace Emergency/Exit Lighting  
**Qty:** 1.00  
**Unit of Measure:** Ea.  
**Estimate:** \$296,433.61  
**Assessor Name:** Craig Anding  
**Date Created:** 01/05/2016

**Notes:** Install new emergency exit signs emergency lights.

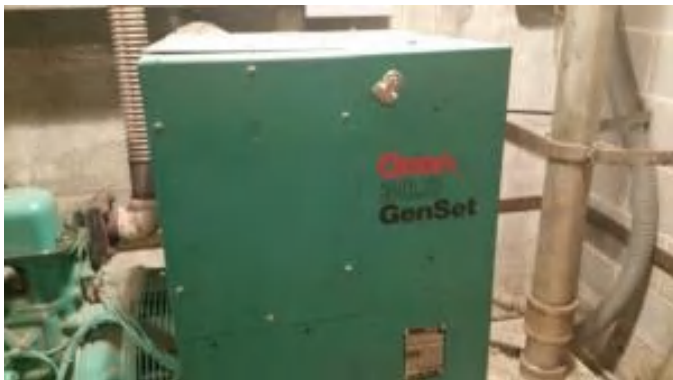
**System: D5090 - Other Electrical Systems**

**Location:** electrical room  
**Distress:** Beyond Service Life  
**Category:** 3 - Operations / Maint.  
**Priority:** 3 - Response Time (3-4 yrs)  
**Correction:** Replace standby generator system  
**Qty:** 1.00  
**Unit of Measure:** Ea.  
**Estimate:** \$140,583.63  
**Assessor Name:** Craig Anding  
**Date Created:** 01/05/2016

**Notes:** Install a new 100KW Emergency Generator.

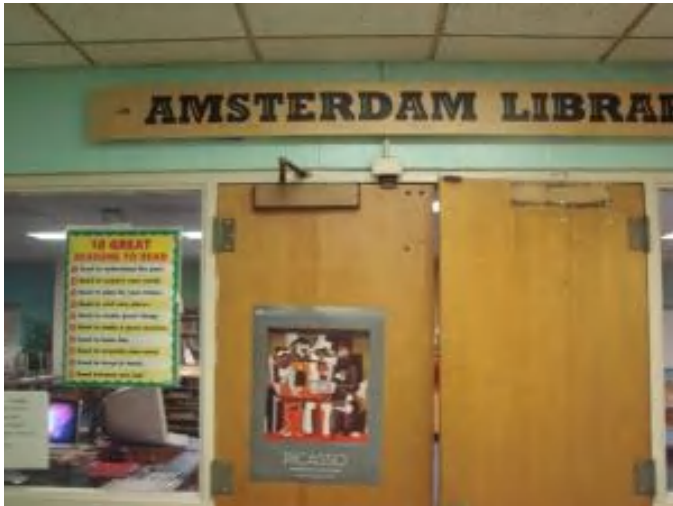
**System: C1020 - Interior Doors**

**Location:** Interiors

**Distress:** Beyond Service Life

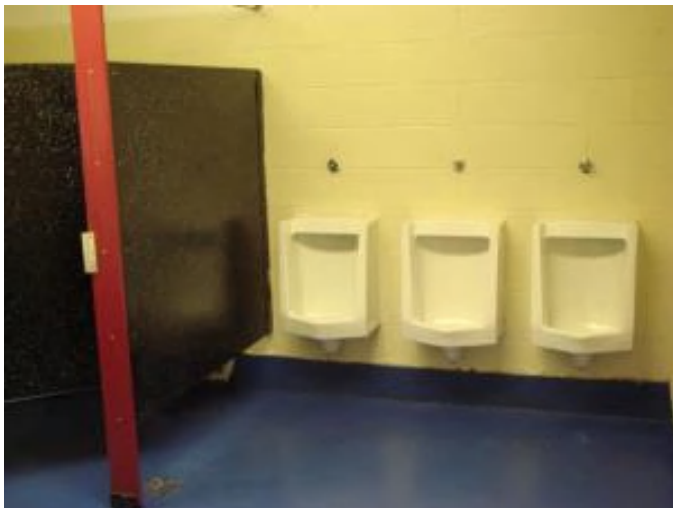
**System: C1030 - Fittings**

**Location:** Interior

**Distress:** Accessibility

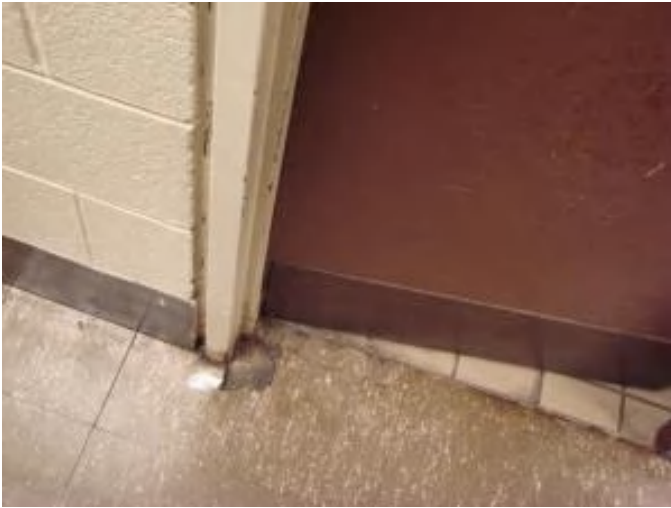
**System: C3020413 - Vinyl Flooring**

**Location:** Interior

**Distress:** Beyond Service Life

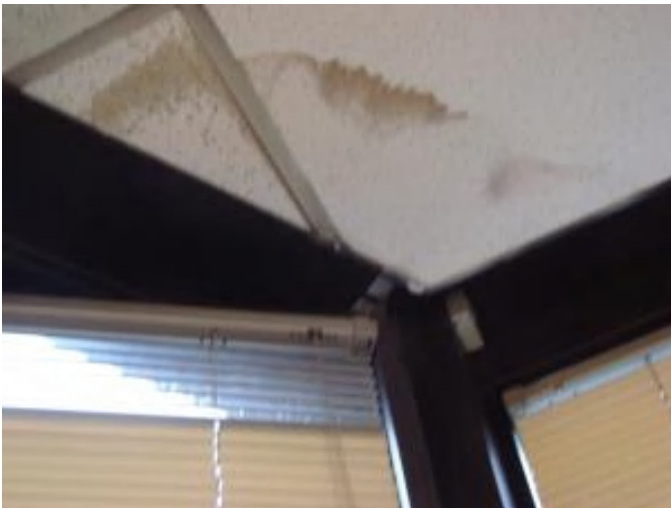
**System: C3030 - Ceiling Finishes**

**Location:** Interior

**Distress:** Beyond Service Life

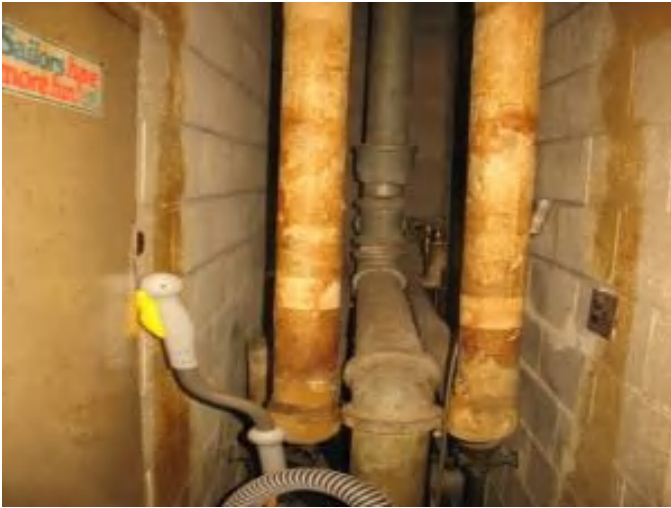
**System: D2020 - Domestic Water Distribution**

**Location:** Throughout building

**Distress:** Beyond Service Life

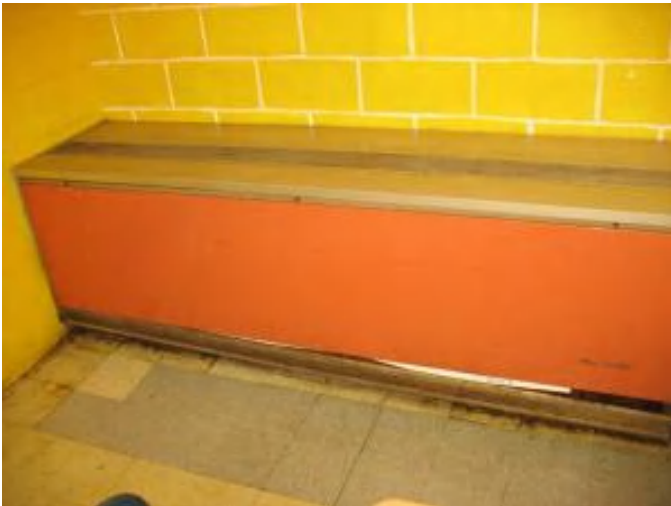
**System: D3040 - Distribution Systems**

**Location:** Throughout building

**Distress:** Beyond Service Life

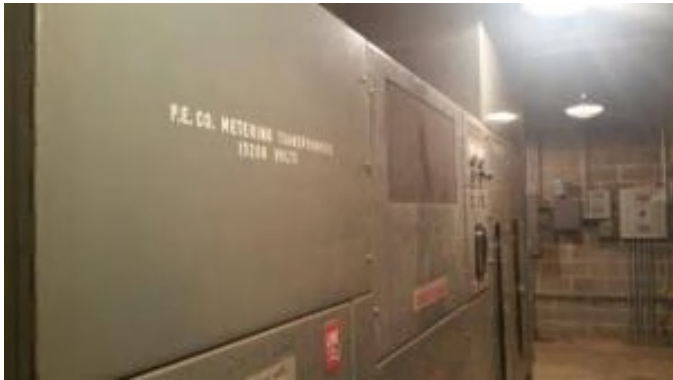
**System: D5010 - Electrical Service/Distribution**

**Location:** electrical room

**Distress:** Beyond Service Life

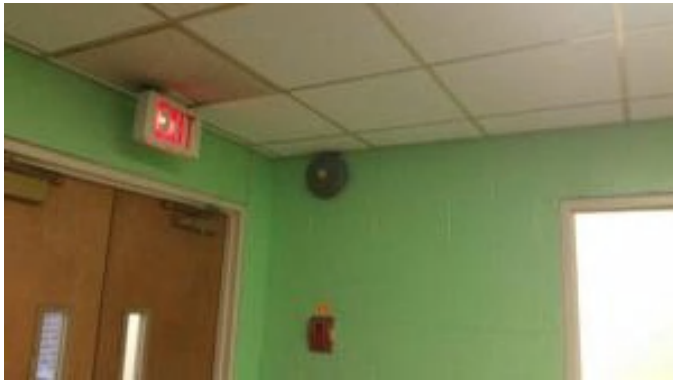
**System: D5030 - Communications and Security**

**Location:** throughout the building

**Distress:** Inadequate

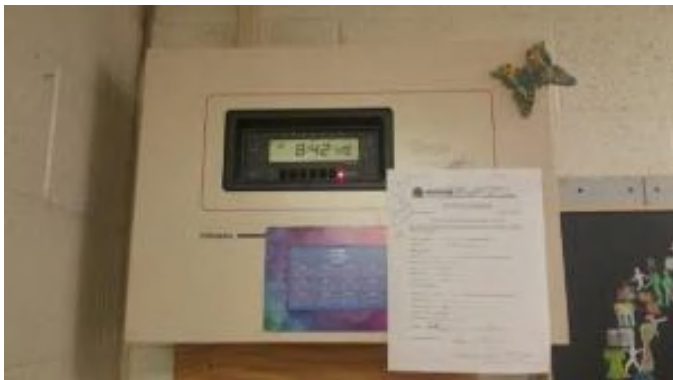
**System: D5030 - Communications and Security**

**Location:** Classrooms

**Distress:** Beyond Service Life

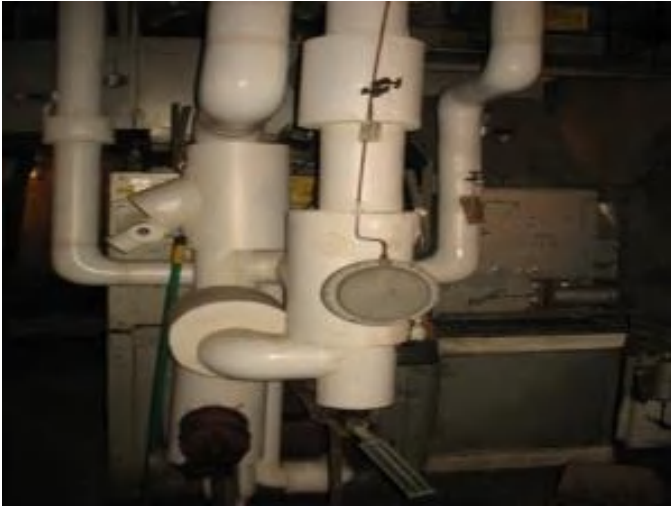
**System: D3040 - Distribution Systems**

**Location:** Cafeteria

**Distress:** Beyond Service Life

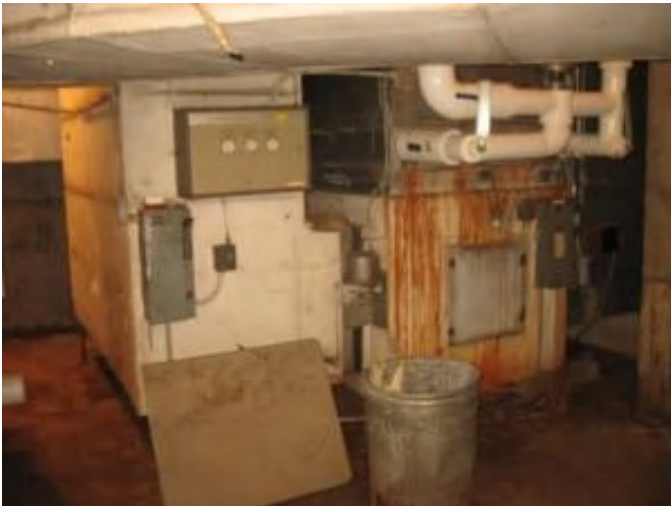
**System: D3040 - Distribution Systems**

**Location:** Gymnasium

**Distress:** Energy Efficiency

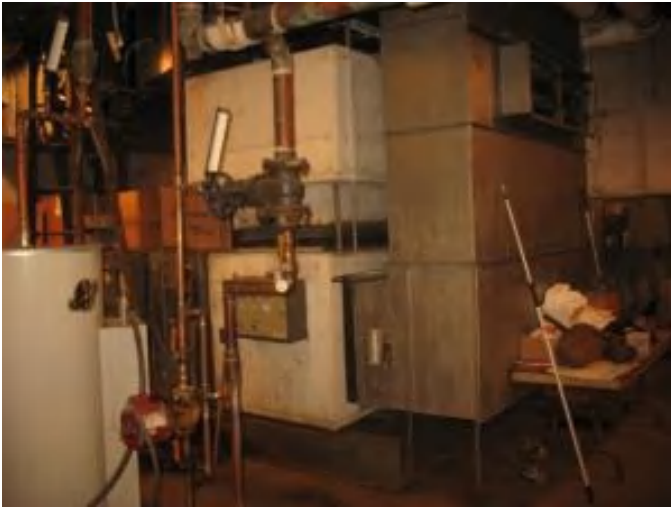
**System: D3040 - Distribution Systems**

**Location:** Administration  
**Distress:** Energy Efficiency  
**Category:** 4 - Capital Improvement  
**Priority:** 5 - Response Time (> 5 yrs)  
**Correction:** Install HVAC unit for Administration (2000 students).  
**Qty:** 676.00  
**Unit of Measure:** Pr.  
**Estimate:** \$292,588.81  
**Assessor Name:** Craig Anding  
**Date Created:** 11/10/2015

**Notes:** Replace the air handling unit, located in the basement mechanical room, serving the Administration office which is beyond its service life, with a new more efficient unit.

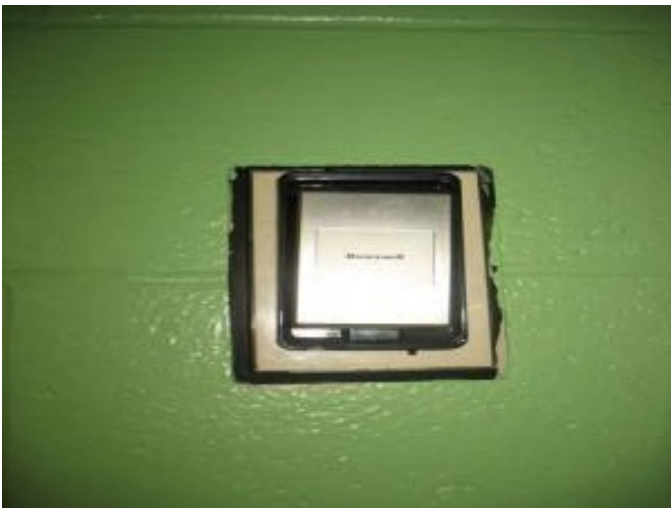
**System: D3060 - Controls & Instrumentation**

**Location:** Throughout building  
**Distress:** Failing  
**Category:** 3 - Operations / Maint.  
**Priority:** 5 - Response Time (> 5 yrs)  
**Correction:** Replace pneumatic controls with DDC (75KSF)  
**Qty:** 96,000.00  
**Unit of Measure:** S.F.  
**Estimate:** \$2,059,400.75  
**Assessor Name:** Craig Anding  
**Date Created:** 11/10/2015

**Notes:** Replace the pneumatic controls for the HVAC systems with modern DDC modules, valves and actuators to improve reliability and energy efficiency. Provide a new building automation system (BAS) with communication interface to the preferred system in use throughout the District.

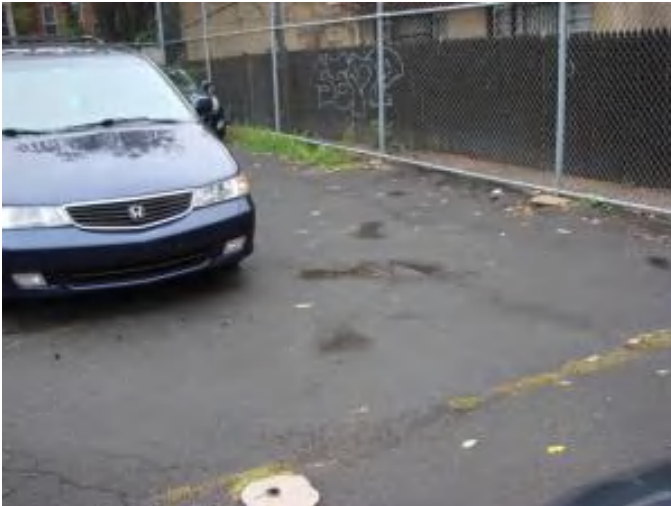
#### System: G2020 - Parking Lots

**Location:** Grounds

**Distress:** Beyond Service Life

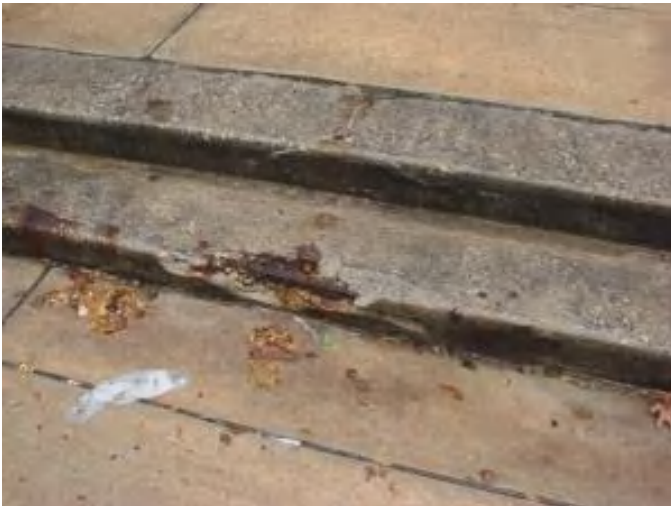
#### System: G2040 - Site Development

**Location:** Grounds

**Distress:** Beyond Service Life

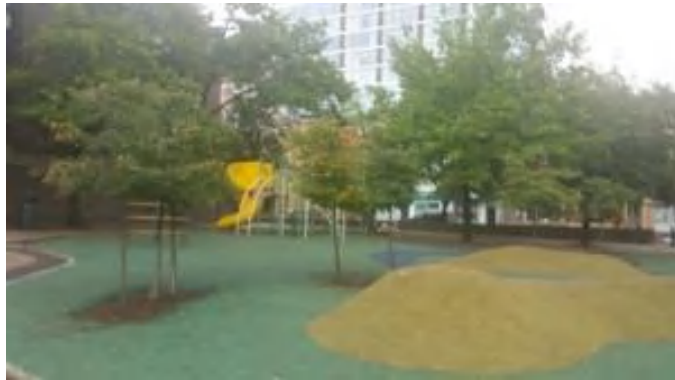
**System: G4020 - Site Lighting**

**Location:** Grounds

**Distress:** Inadequate

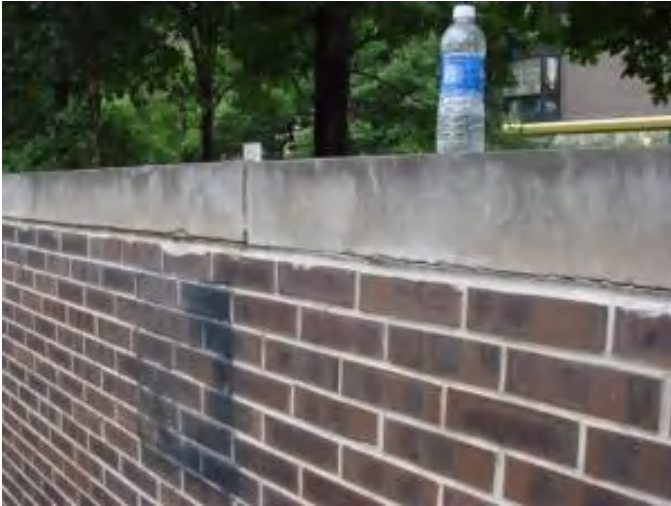
**System: G2040 - Site Development**

**Location:** Grounds

**Distress:** Beyond Service Life

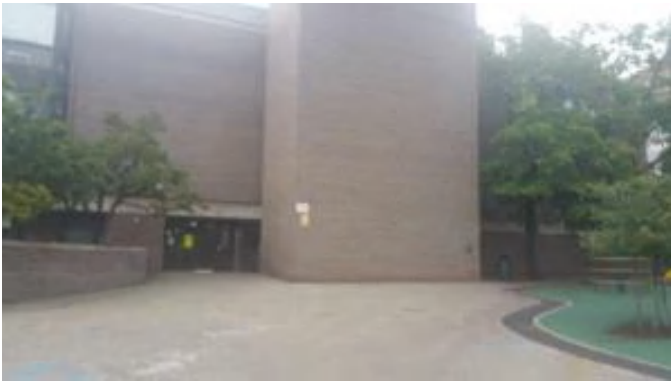
**System: G4030 - Site Communications & Security**

**Location:** Grounds

**Distress:** Inadequate

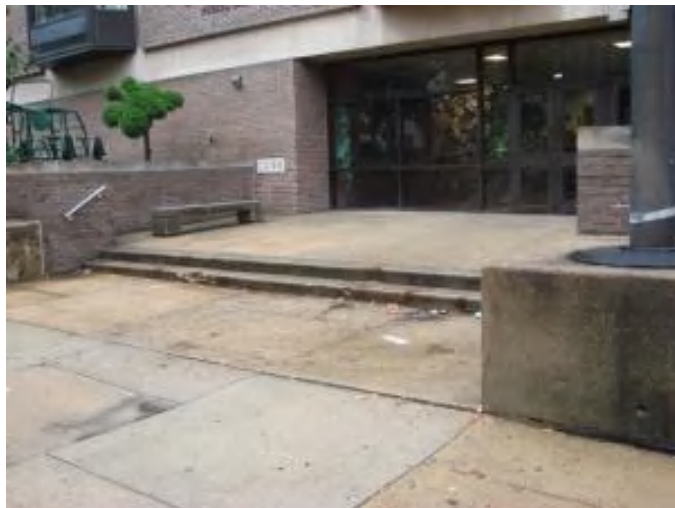
**System: G2030 - Pedestrian Paving**

**Location:** Grounds

**Distress:** Beyond Service Life
