Facility Condition Assessment Summary Report

Hackett School

School District of Philadelphia
S530001;Hackett
Final
Site Assessment Report
January 31, 2017

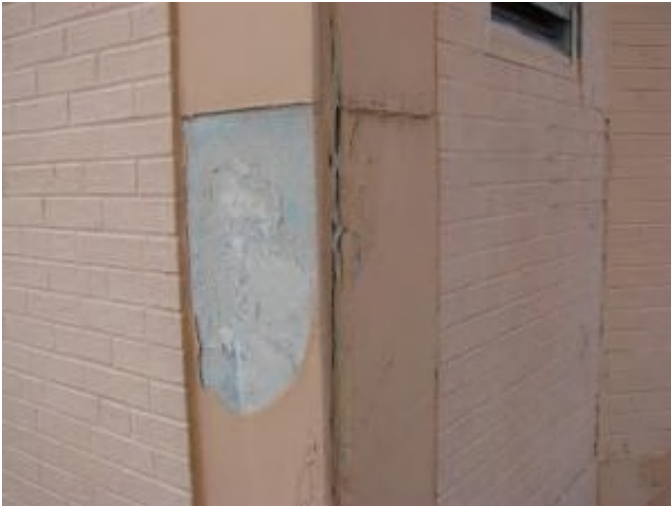
Location: Exterior

The building envelope is typically face brick masonry with CMU backup. In general, masonry is in fair to good condition with some minor cracks and missing mortar. The exterior columns are clad with cementitious panels to accentuate the structural grid. These panels are sealed to adjacent brick with sealant where mortar was missing; joints at panels' perimeter show substantial deterioration. Water penetration through walls has not been reported. First floor walls are covered with anti-graffiti coating which is deteriorated and in some places peeling off the face brick.

System: B2010 - Exterior Walls

Distress: Building Envelope Integrity

Notes: Repair cracks in panels covering exterior columns

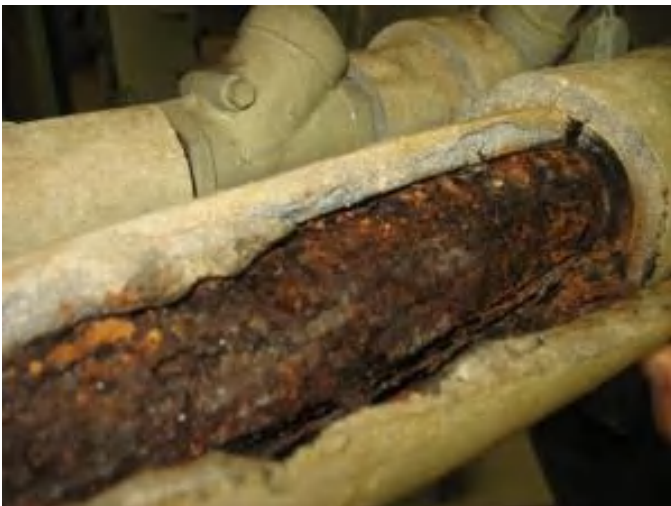
Location: Throughout building

Distribution Systems - Building water distribution piping is black steel with threaded fittings. The distribution piping has been damaged by condensation and has significant rust damage. The piping has been in use beyond its service life and will require more frequent attention from the maintenance staff to address pipe/valve failures as time passes. The District should hire a qualified contractor to examine the distribution piping and perform additional testing to locate and replace any damaged piping and to further quantify the extent of potential failures. The District should budget for replacing this piping over the next 5 years.

System: D3040 - Distribution Systems

Distress: Failing

Notes: Hire a qualified contractor to examine the distribution piping, in service for 45 years and damaged, and perform additional testing to locate and replace any damaged piping and to further quantify the extent of potential failures.

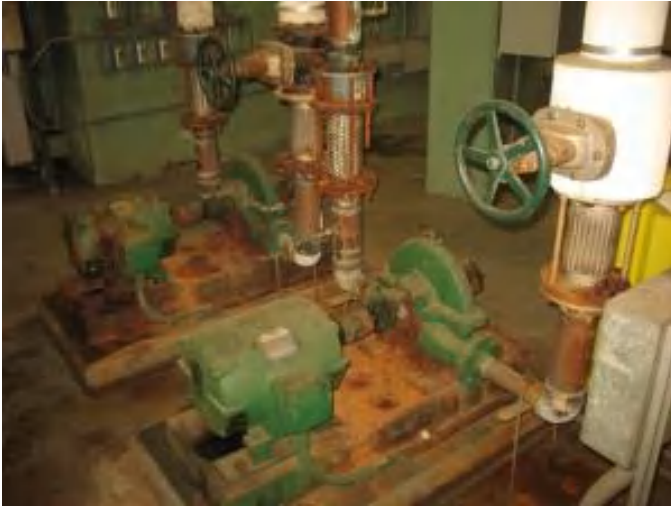
Location: Boiler room

System: D2020 - Domestic Water Distribution

Distress: Damaged

Notes: Replace building water distribution system in the boiler room with new distribution and condenser loop pumps, piping, and controls.

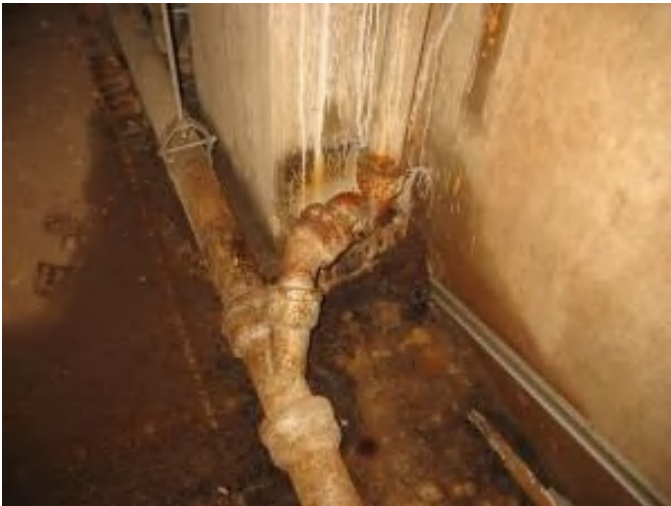
Location: Throughout building

The maintenance staff reported mostly minor problems with the sanitary waste piping systems. However, the sewer piping has been in service for 46 years and will require more frequent attention from the maintenance staff as time passes. The District should hire a qualified contractor to examine the sanitary waste piping using video cameras to locate and replace any damaged piping and to further quantify the extent of potential failures.

System: D2030 - Sanitary Waste

Distress: Health Hazard / Risk

Notes: Hire a qualified contractor to perform a detailed examination of the sanitary waste piping using visual inspection and video cameras to locate and replace any damaged piping and to further quantify the extent of potential failures.

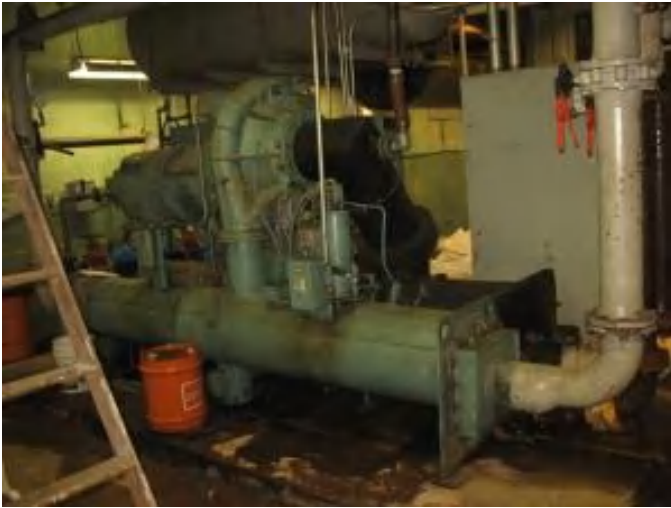
Location: Boiler room

Cooling Generating Systems - Chilled water is generated by one York water cooled chiller located in the boiler room with heat rejected by one Evapco LSTA galvanized cooling tower located in the boiler room. Centrifugal chillers have an anticipated service life of 28 years; this unit has been in service approximately 45 years and needs to be replaced. Galvanized cooling tower have an anticipated service life of 18 years; this unit has been in service over 20 years. The existing centrifugal chiller and cooling tower are well beyond their service life and should be replaced with a new packaged air cooled chiller fitted with modern controls.

System: D3030 - Cooling Generating Systems

Distress: Beyond Service Life

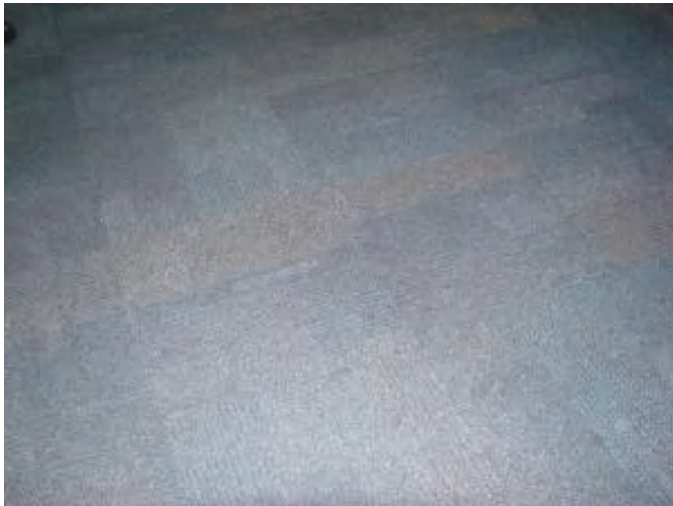
Location: Interior/ Library

Flooring in classrooms and auditorium/ cafeteria and gymnasium is VCT (approximately 70% of floor area); and painted concrete in toilets. Flooring in the kitchen is quarry tile in good condition. Most flooring is in fair to good condition. Library has carpet in poor condition.

System: C3020411 - Carpet

Distress: Beyond Service Life

Notes: Replace existing carpet

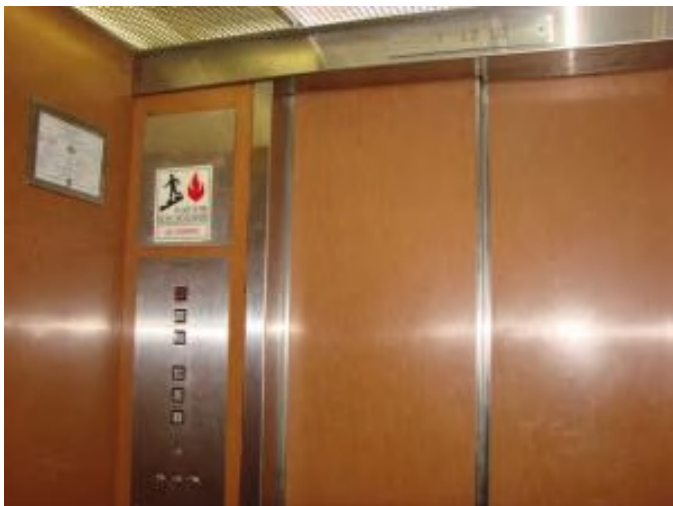
Location: Interior

The building has a 2,000 lb traction elevator serving all floors; generally in good condition, however, the cabin size and configuration does not meet ADA standards.

System: D1010 - Elevators and Lifts

Distress: Accessibility

Notes: Replace 2000 lb elevator with ADA compliant 2500 lb elevator

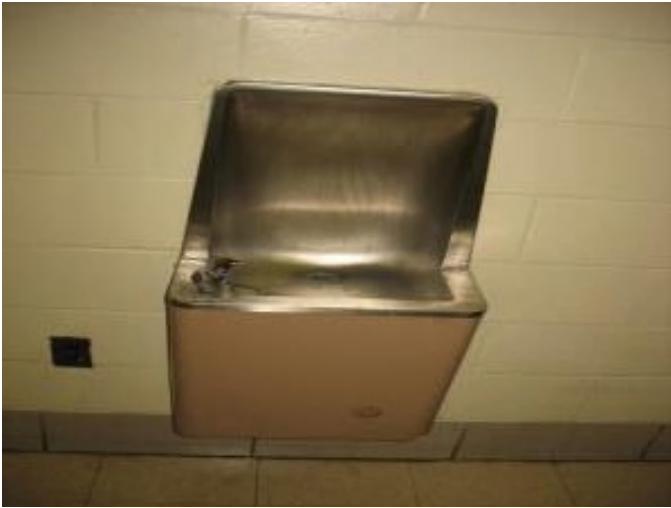
Location: Corridors

Drinking fountains in the corridors and at the restrooms consist of wall hung fixtures with integral refrigerated coolers. They are beyond their service life and should be replaced; most are NOT accessible type.

System: D2010 - Plumbing Fixtures

Distress: Beyond Service Life

Notes: Replace the wall hung drinking fountains and integral refrigerated coolers in the corridors and at the restrooms. These units are well beyond their service life and most are NOT accessible type.

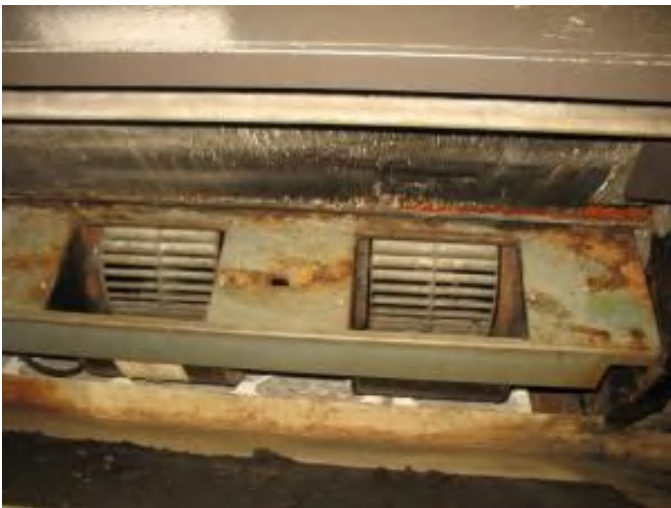
Location: Throughout building

Unit ventilators provide heating and cooling for the majority of classrooms, offices, and indirectly to the hallways. The unit ventilators are original to the building, beyond their service life, and have rust on their interiors. The existing unit ventilators should be removed and new units installed.

System: D3040 - Distribution Systems

Distress: Beyond Service Life

Notes: Replace the existing unit ventilators with two pipe units that have integral heat exchangers to introduce outdoor air to the building.

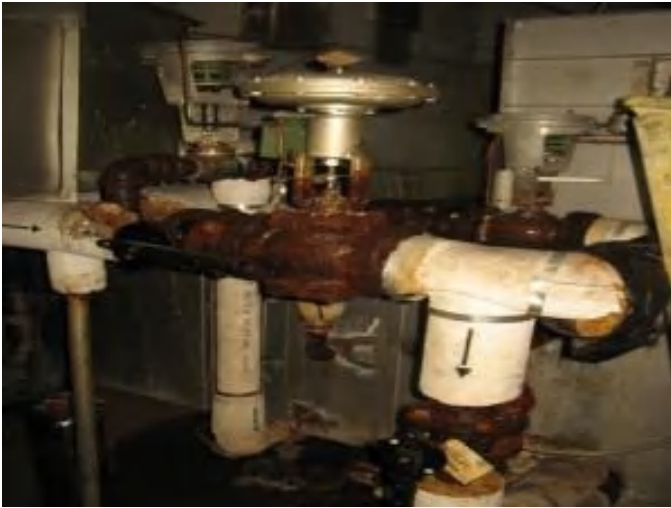
Location: Fan Room 2

System: D3040 - Distribution Systems

Distress: Beyond Service Life

Notes: Replace AHU-3, located in Fan Room 2, which serves the Cafeteria/Auditorium.

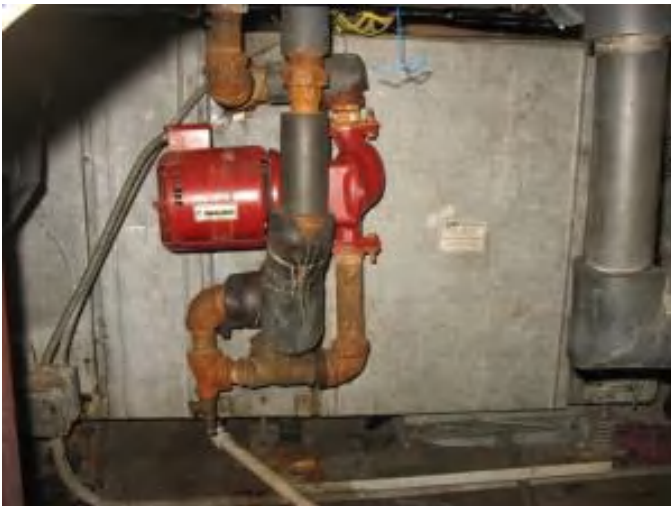
Location: Crawl Space

System: D3040 - Distribution Systems

Distress: Beyond Service Life

Notes: Replace AHU-2, located in the second floor crawl space, which serves rooms 215-219.

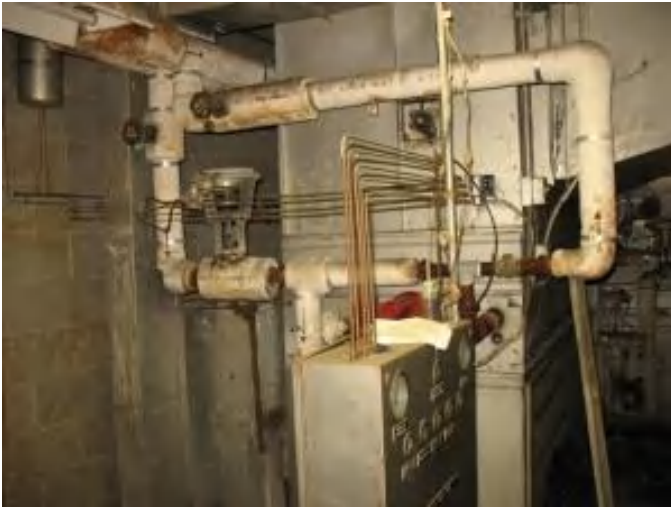
Location: Mechanical room

System: D3040 - Distribution Systems

Distress: Beyond Service Life

Notes: Replace AHU-5, located in the mechanical room behind the gymnasium, which serves the Gymnasium.

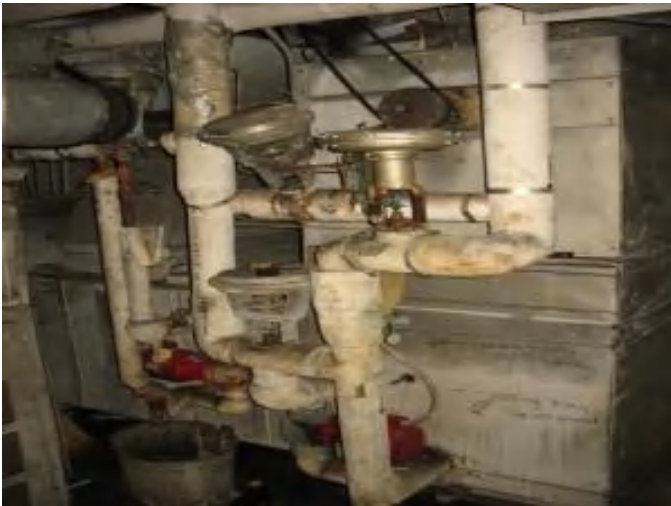
Location: Mechanical room

Conditioned air is provided to several spaces in the building by air handling units. Heating and ventilation unit HV-1, located in the mechanical room behind the gymnasium, serves Room 106. Heating and ventilation unit HV-2, located in the mechanical room behind the gymnasium, serves Room 107. AHU-2, located in the second floor crawl space, serves rooms 215-219. AHU-3, located in Fan Room 2, serves the Cafeteria/Auditorium. AHU-5, located in the mechanical room behind the gymnasium, serves the Gymnasium. AHU-6, located in Fan Room 1, serves the Kitchen and is for heating only. These units are beyond their service life, show signs of damage from rust, and should be replaced.

System: D3040 - Distribution Systems

Distress: Damaged

Notes: Replace heating and ventilation unit HV-1, located in the mechanical room behind the gymnasium, which serves Room 106.

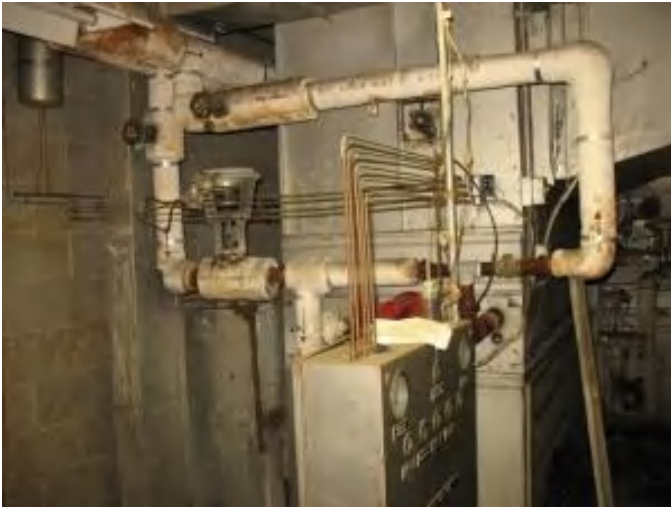
Location: Mechanical room

System: D3040 - Distribution Systems

Distress: Damaged

Notes: Replace heating and ventilation unit HV-2, located in the mechanical room behind the gymnasium, which serves Room 107.

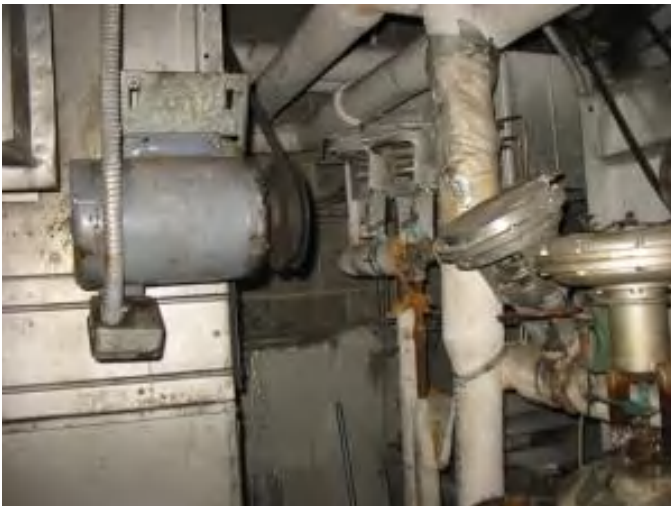
Location: Fan Room 1

System: D3040 - Distribution Systems

Distress: Beyond Service Life

Notes: Replace AHU-6, located in Fan Room 1, which serves the Kitchen.

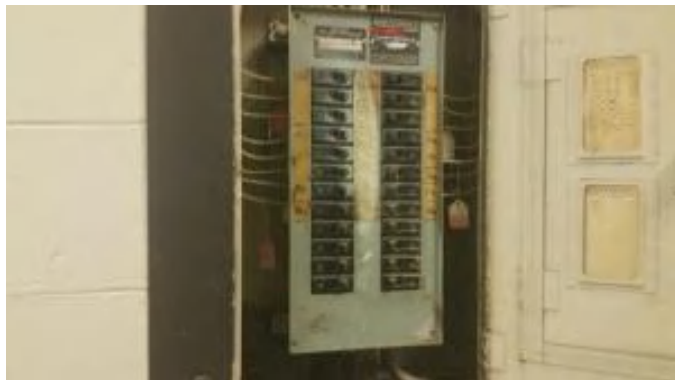
Location: Throughout the building

System: D5010 - Electrical Service/Distribution

Distress: Beyond Service Life

Notes: Install 8 120V/208V panels to replace the existing panels (two in each floor). Also replace the power feeders, conduit wire to the four panels from the new 120V/208V three phase main Panel Board.

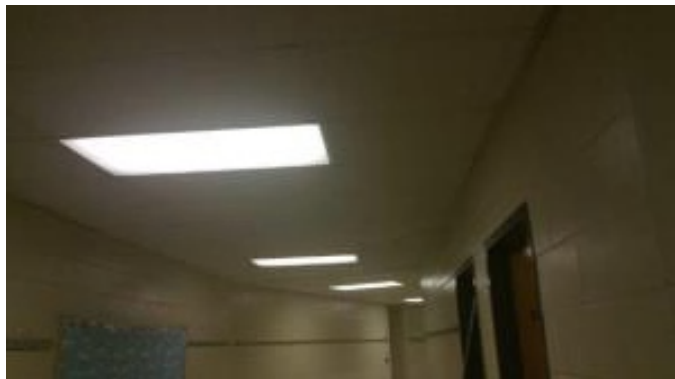
Location: Throughout the building

System: D5020 - Lighting and Branch Wiring

Distress: Beyond Service Life

Notes: Install new lighting fixtures for all the class rooms, and other rooms. New fluorescent lighting (T-5) will be adequate, however, using the state-of-the-art LED lighting will improve the energy usage.

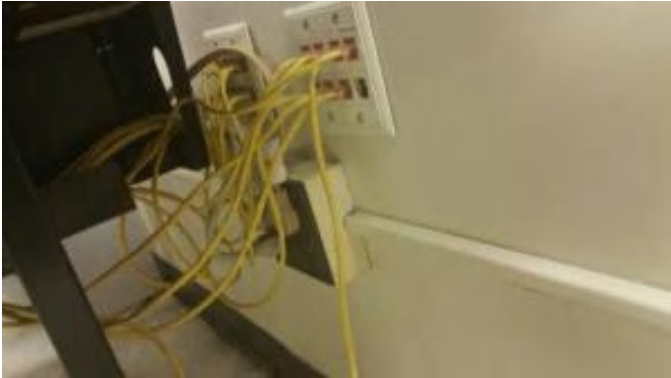
Location: throughout the building

Receptacles - There is inadequate receptacles in classrooms, multi-purpose room, computer room, etc. We recommend two receptacles in each wall of class rooms and other purpose rooms. Also, we recommend adding a wire-mold system with receptacles on every 3' for the computer room.

System: D5020 - Lighting and Branch Wiring

Distress: Beyond Service Life

Notes: Install two receptacles in all of class rooms and other purpose rooms. Add a wire-mold system with receptacles on every 3' for the computer room.

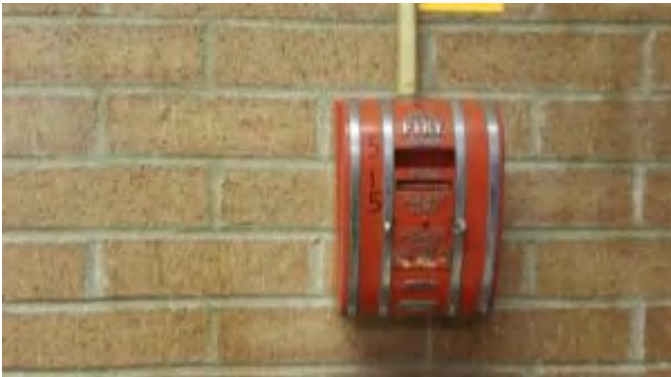
Location: Throughout the building

Fire Alarm System – The present Fire Alarm system is inadequate and is not addressable. A new Automated Fire Alarm System is needed.

System: D5030 - Communications and Security

Distress: Building / MEP Codes

Notes: Install a new Automated Fire Alarm System to be located in the new Electrical Room.

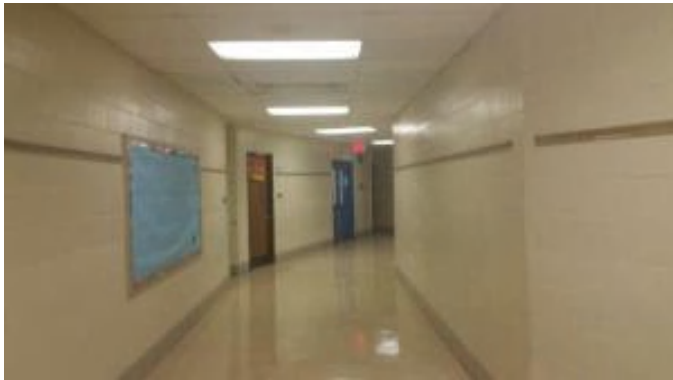
Location: throughout the building

Emergency Lighting System / Exit Lighting- The emergency lighting and exit lighting is inadequate throughout each floor and stairways.

System: D5090 - Other Electrical Systems

Distress: Life Safety / NFPA / PFD

Notes: Install new battery packed emergency lights and exit lights in all the hallways, stairways, and in each class room or other purpose rooms.

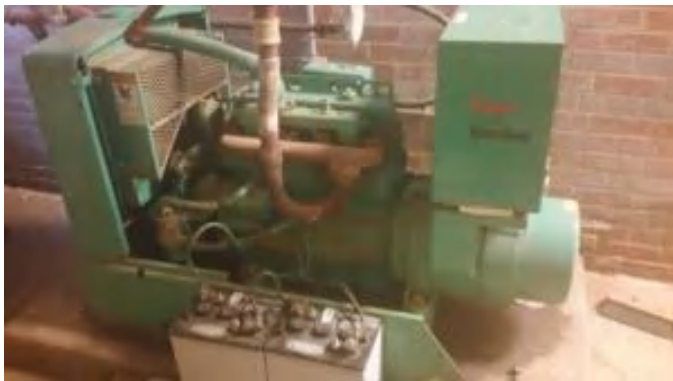
Location: Electrical room in the basement.

Emergency Power System – The present emergency power system is inadequate, old and undersized. A larger emergency power system (30 KVA) is needed.

System: D5090 - Other Electrical Systems

Distress: Beyond Service Life

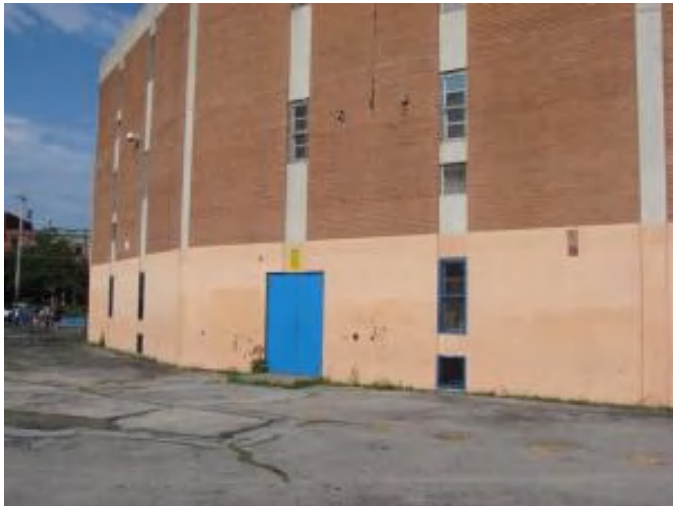
Location: Exterior

System: B2010 - Exterior Walls

Distress: Appearance

Notes: Provide new anti-graffiti coating first floor ext. walls (remove old coating)

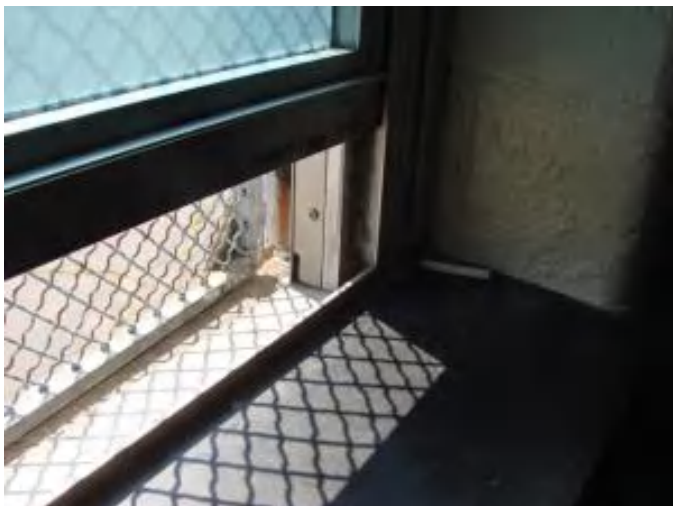
Location: Exterior/ walls

The building windows appear to be extruded aluminum double hung windows single acrylic glazed. All windows are generally in poor condition with some of the windows inoperable; most of the windows have security screens in fair to poor condition. The leaks around the windows perimeters have not been reported and are not evident.

System: B2020 - Exterior Windows

Distress: Building Envelope Integrity

Notes: Replace all windows within next 4 to 5 years

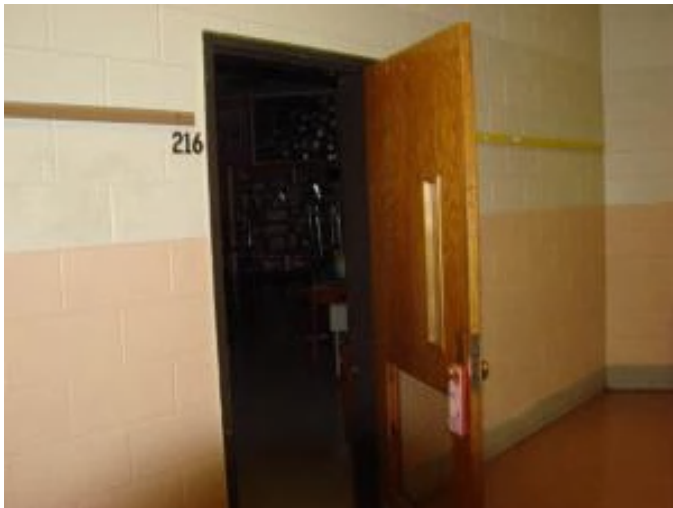
Location: Interior

System: C1020 - Interior Doors

Distress: Accessibility

Notes: Replace interior doors hardware for ADA accessibility

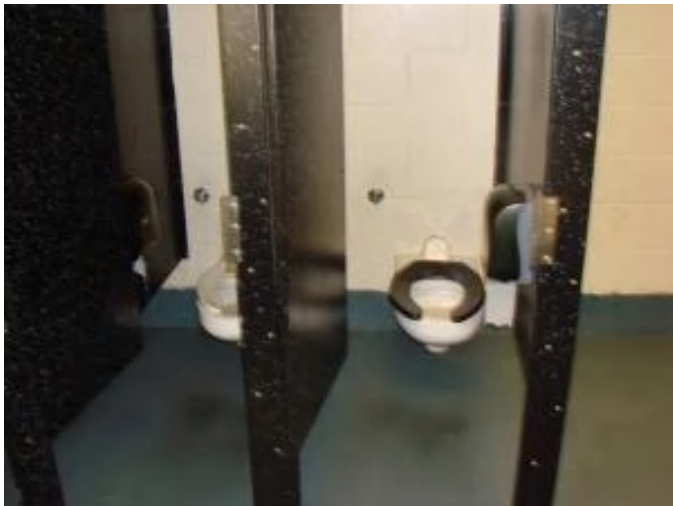
Location: Interiors

System: C1030 - Fittings

Distress: Accessibility

Notes: Replace non-ADA compliant toilet partitions; reconfigure remaining toilet partitions

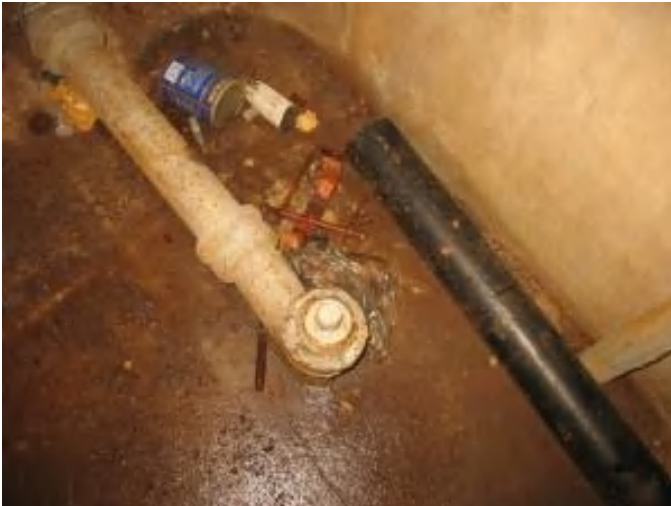
Location: Throughout building

Rain Water Drainage - The rain water drains from the roof are routed through mechanical chases in the building and appear to be original. The drain piping should be inspected by a qualified contractor and repaired as necessary.

System: D2040 - Rain Water Drainage

Distress: Beyond Service Life

Notes: Hire a qualified contractor to perform a detailed examination of the rain water drainage piping using visual inspection and video cameras to locate and replace any damaged piping and to further quantify the extent of potential failures.

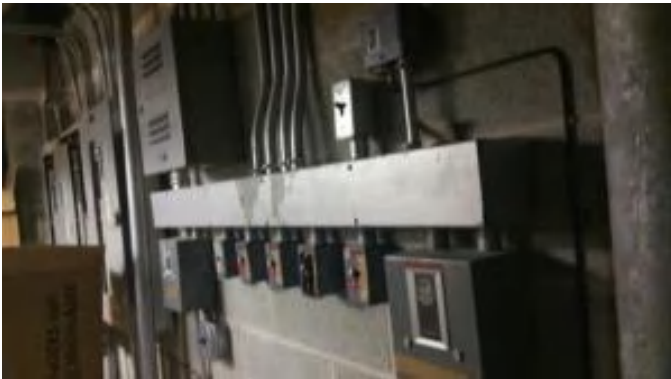
Location: Electrical room in the basement

System: D5010 - Electrical Service/Distribution

Distress: Beyond Service Life

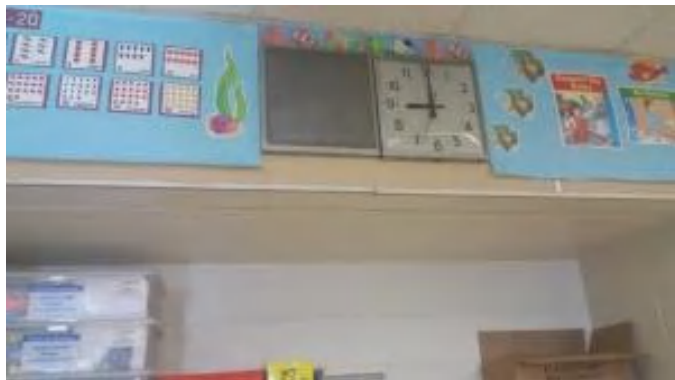
Location: Throughout the building

Site Video Surveillance - The present Site Video Surveillance System is inadequate with no existing cameras.

System: D5030 - Communications and Security

Distress: Beyond Service Life

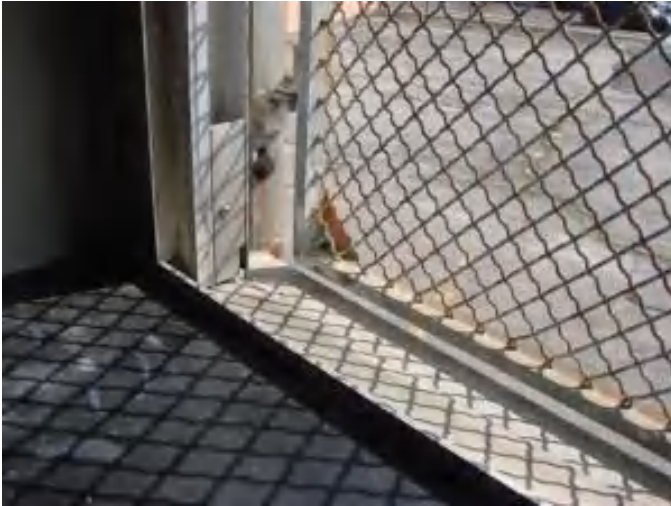
Location: Exterior

System: B2020 - Exterior Windows

Distress: Beyond Service Life

Notes: Replace security screens on 1st and 2nd floor windows

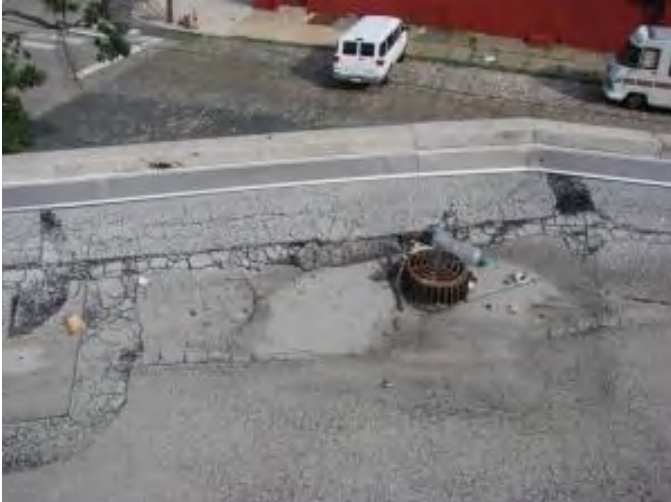
Location: Exterior/ roof

Roofing system is a built-up system approximately 15 to 20 years old and in fair condition; all roofing and flashing is typically in fair condition with some deterioration of the built-up system and flashing sealant; leaks have not been reported.

System: B3010105 - Built-Up

Distress: Beyond Service Life

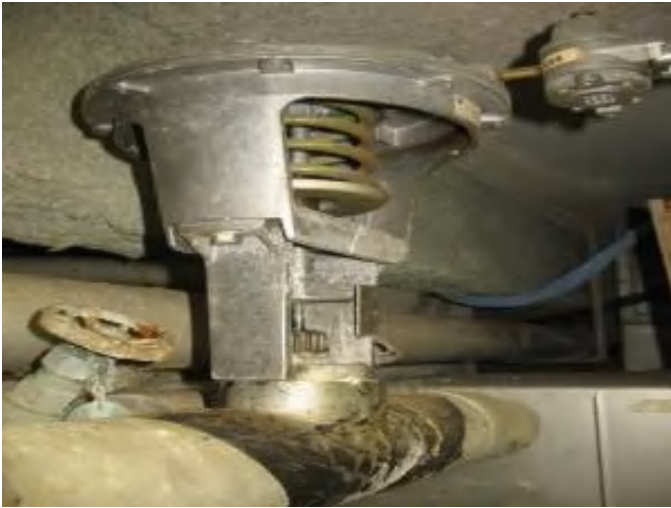
Location: Throughout building

System: D3060 - Controls & Instrumentation

Distress: Inadequate

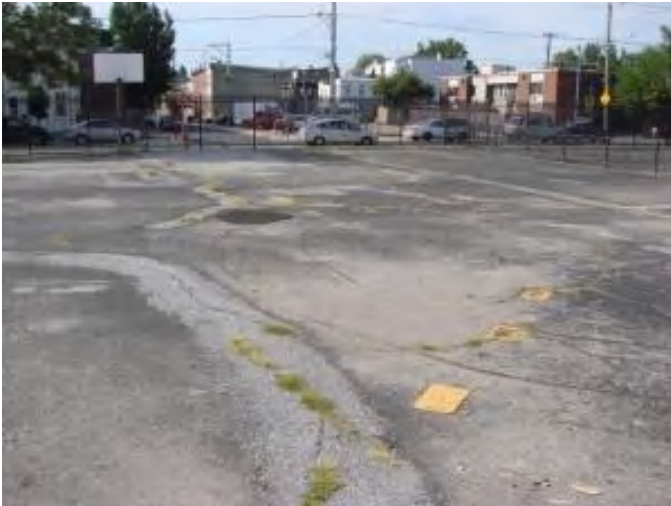
Location: Grounds/ site

There is no parking lot at the site. Playground pavement adjacent to the building is in poor condition, paving is cracked and deteriorated; there is no playground equipment. Perimeter picket fence separating the playground from the street is generally in good condition. There is minimal landscaping at the North West corner of the site, generally in good condition.

System: G2030 - Pedestrian Paving

Distress: Beyond Service Life

- Resurface playground paving.
- Replace 2000 lb elevator with ADA compliant 2500 lb elevator
- Replace the wall hung drinking fountains and integral refrigerated coolers in the corridors and at the restrooms. These units are well beyond their service life and most are NOT accessible type.
