## Facility Condition Assessment Summary Report

### Hancock School

School District of Philadelphia  
**S818001;Hancock**  
Final  
**Site Assessment Report**  
January 31, 2017

School District of Philadelphia  
**S832001;LaBrum**  
Final  
**Site Assessment Report**  
January 31, 2017

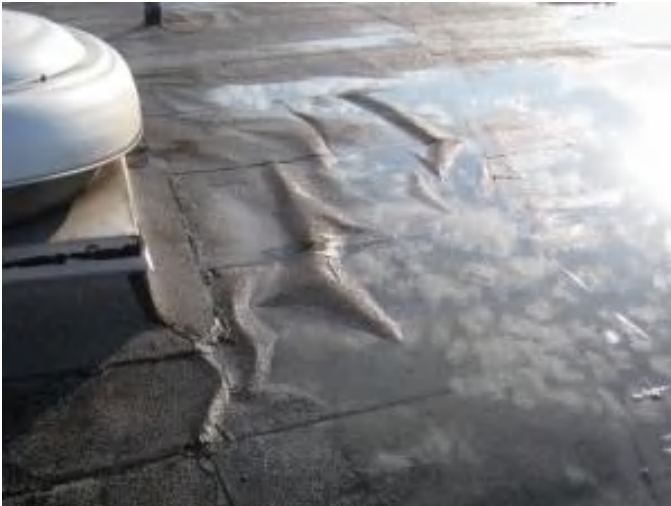
#### System: B3010105 - Built-Up

**Location:** roof

**Distress:** Failing

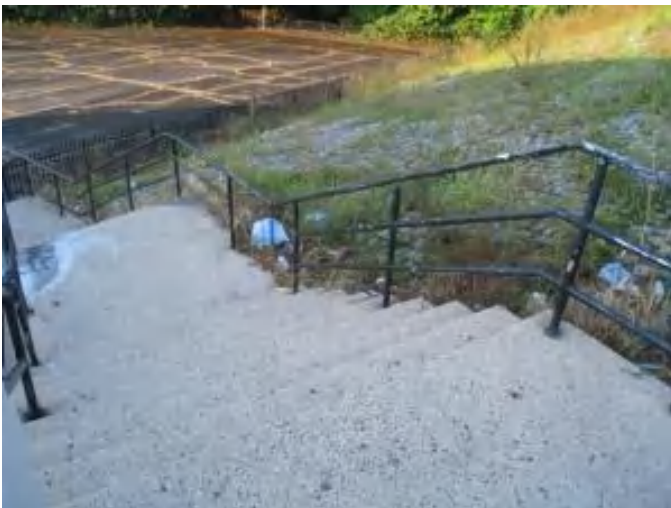
**System: C2010 - Stair Construction**

**Location:** exterior stair - play area

**Distress:** Failing

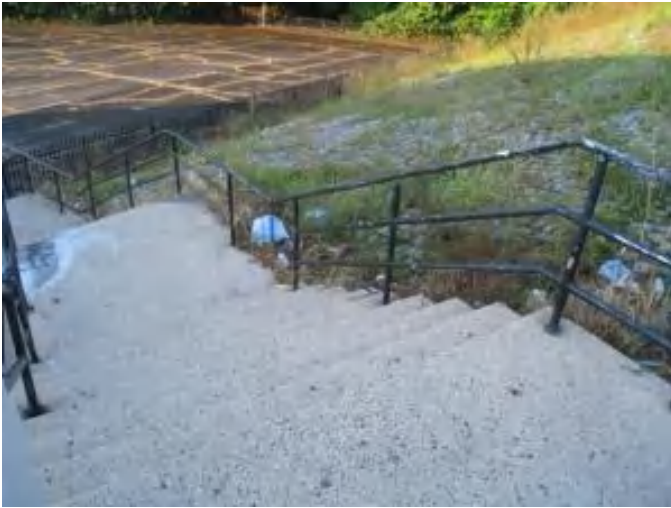
**System: C2010 - Stair Construction**

**Location:** exterior stair - play area

**Distress:** Failing

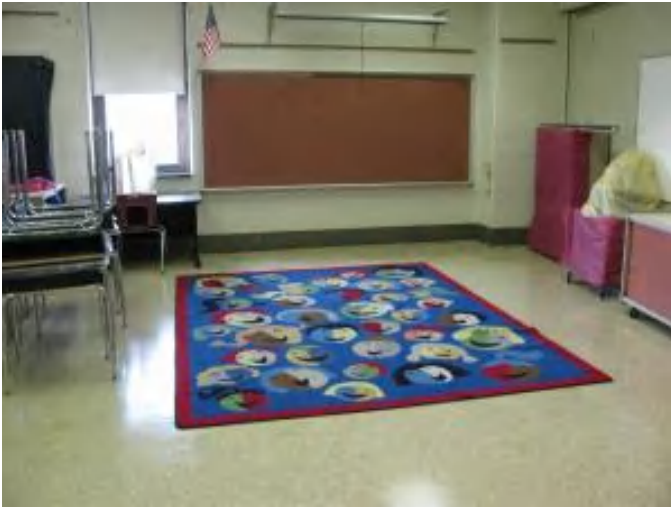
**System: D5020 - Lighting and Branch Wiring**

**Location:** Entire Building

**Distress:** Inadequate

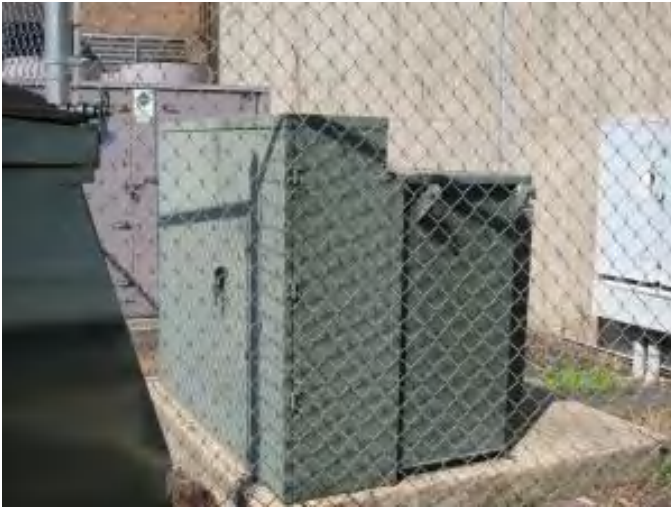
**System: D5020 - Lighting and Branch Wiring**

**Location:** Chiller area  
**Distress:** Inadequate  
**Category:** 4 - Capital Improvement  
**Priority:** 1 - Response Time (< 2 yr)  
**Correction:** Add Exterior Lighting  
**Qty:** 1.00  
**Unit of Measure:** Ea.  
**Estimate:** \$3,858.38  
**Assessor Name:** Carlton Ross  
**Date Created:** 09/10/2015

**Notes:** Provide one lighting fixture in chiller area.

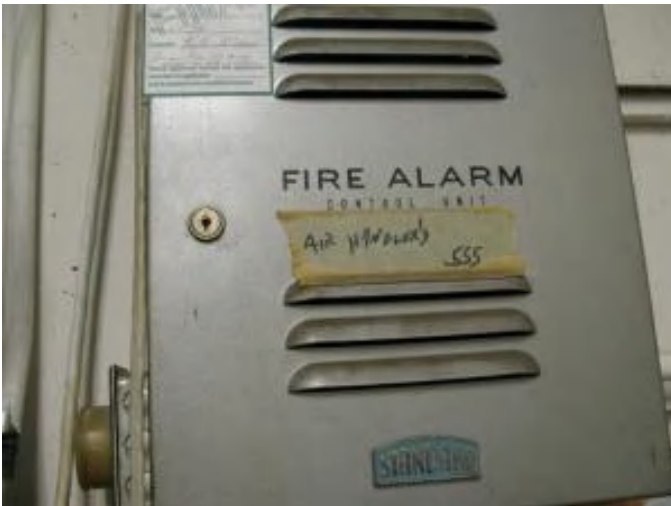
**System: D5030 - Communications and Security**

**Location:** Entire building  
**Distress:** Beyond Service Life  
**Category:** 3 - Operations / Maint.  
**Priority:** 1 - Response Time (< 2 yr)  
**Correction:** Replace fire alarm system  
**Qty:** 1.00  
**Unit of Measure:** S.F.  
**Estimate:** \$339,713.26  
**Assessor Name:** Carlton Ross  
**Date Created:** 09/09/2015

**Notes:** Replace existing fire alarm system with an automatic fire alarm system including smoke detectors in corridors and other recommended areas per NEC. Install horn/strobes in class rooms, corridors, offices, toilets, library and other recommended areas per codes.

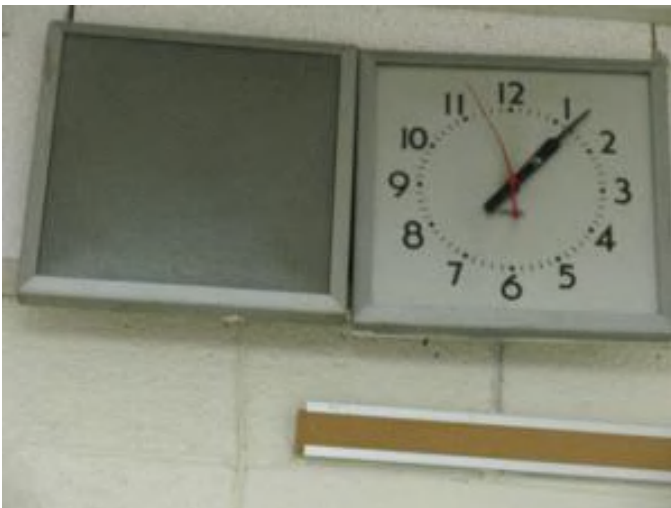
**System: D5030 - Communications and Security**

**Location:** Entire Building

**Distress:** Inadequate

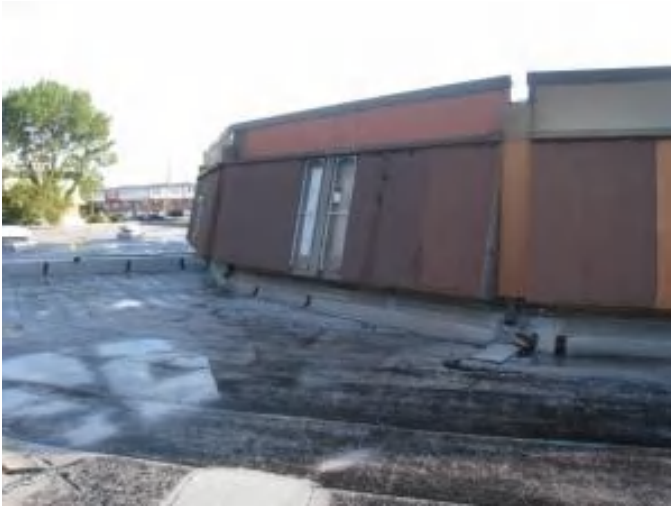
**System: B2010 - Exterior Walls**

**Location:** clerestory wall (roof)

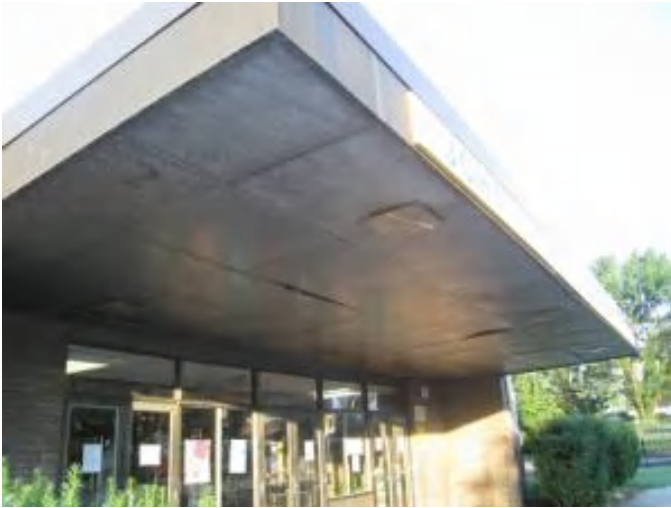
**System: B2010 - Exterior Walls**

**Location:** soffit over main entrance

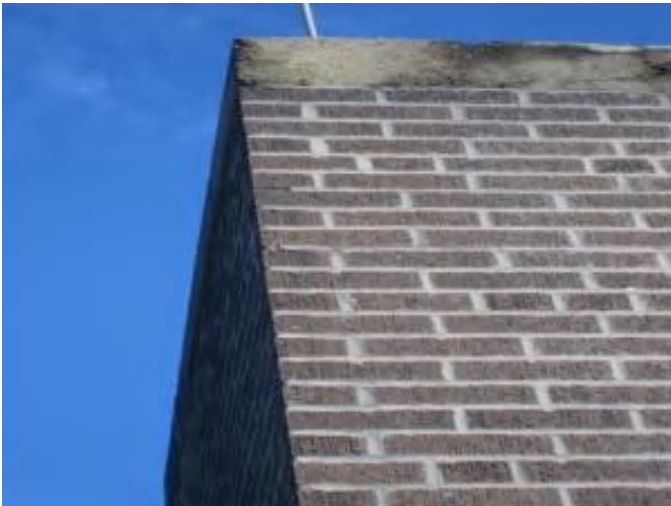
**System: B2010 - Exterior Walls**

**Location:** boiler flue - chimney

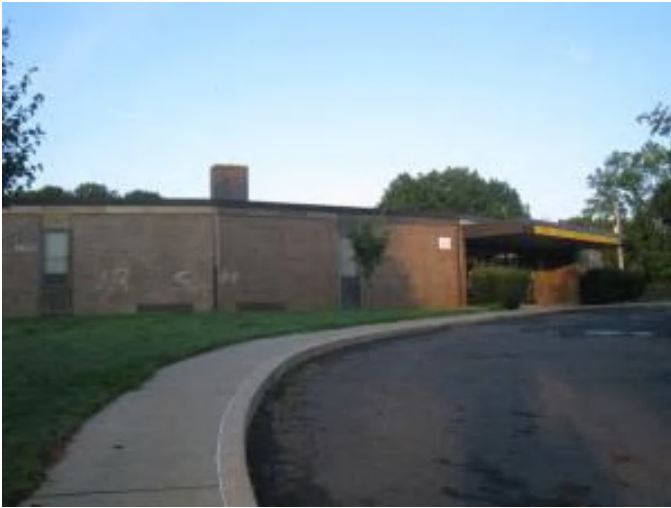
**System: B2020 - Exterior Windows**

**Location:** exterior windows

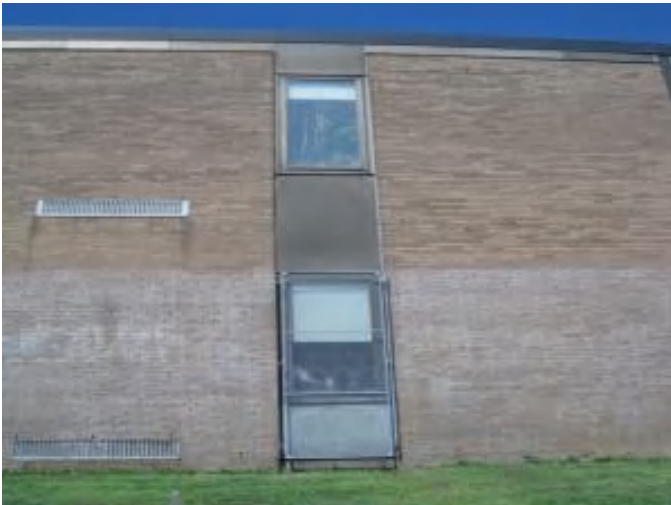
**System: B2020 - Exterior Windows**

**Location:** exterior windows

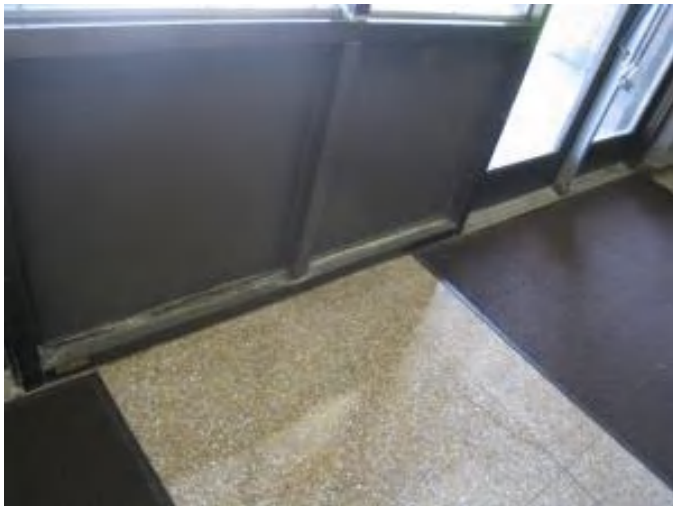
**System: B2030 - Exterior Doors**

**Location:** exterior doors

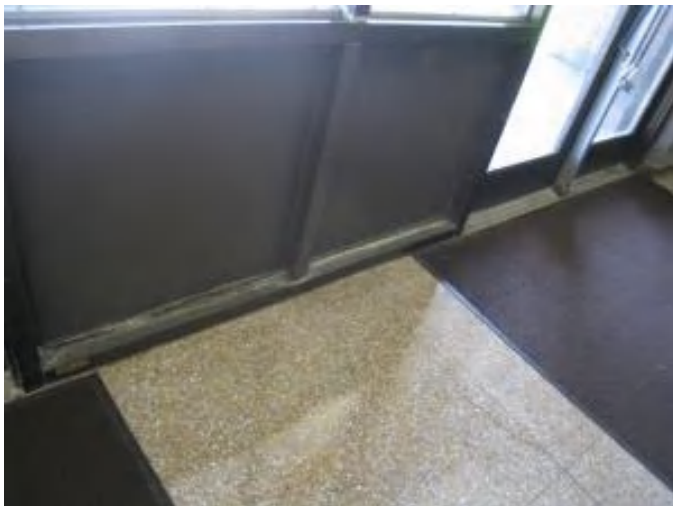
**System: C3020412 - Terrazzo & Tile**

**Location:** upper level corridors

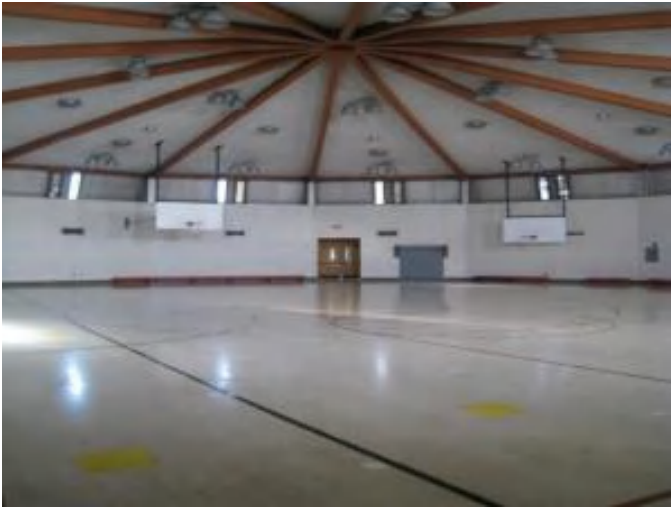
**System: C3020413 - Vinyl Flooring**

**Location:** gym, auditorium, offices, classrooms

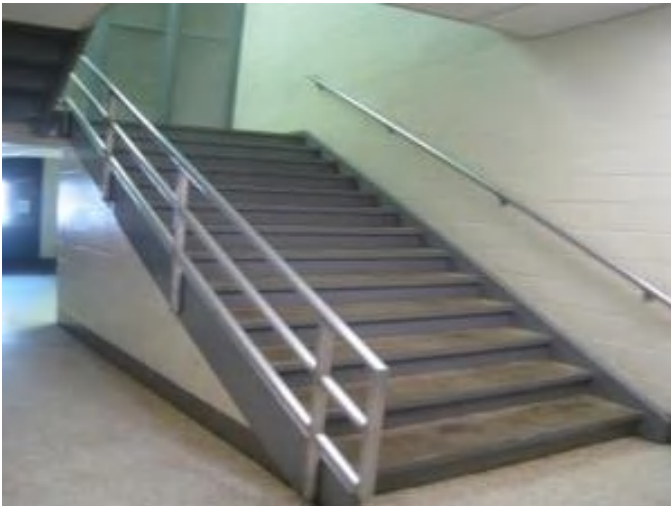
**System: C3020413 - Vinyl Flooring**

**Location:** interior rooms

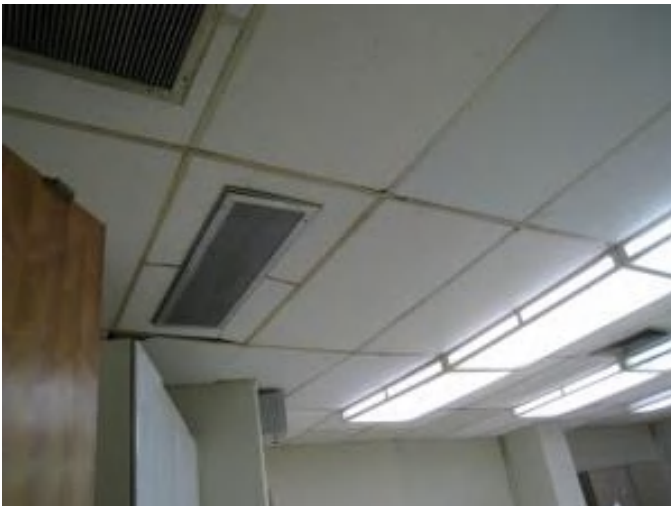
**System: C3030 - Ceiling Finishes**

**Location:** corridors and most rooms

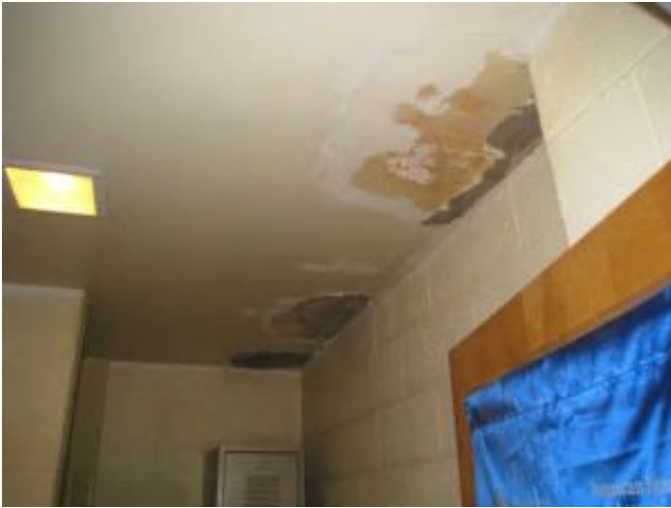
**System: C3030 - Ceiling Finishes**

**Location:** toilet room ceiling

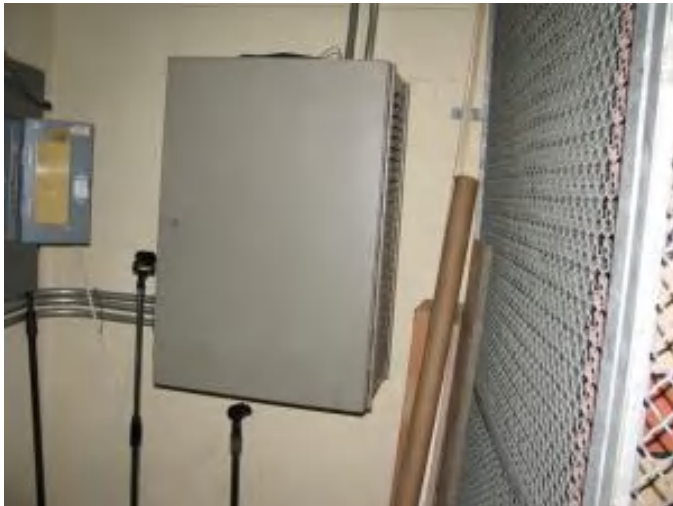
**System: D5030 - Communications and Security**

**Location:** Auditorium

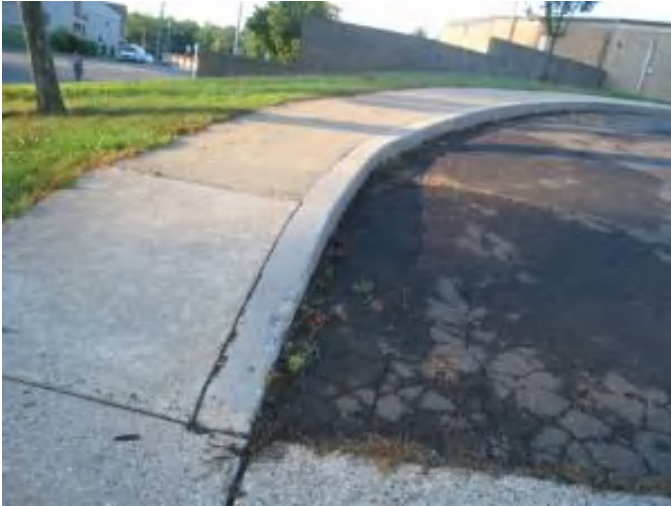
**System: G2030 - Pedestrian Paving**

**Location:** entrance area walkway

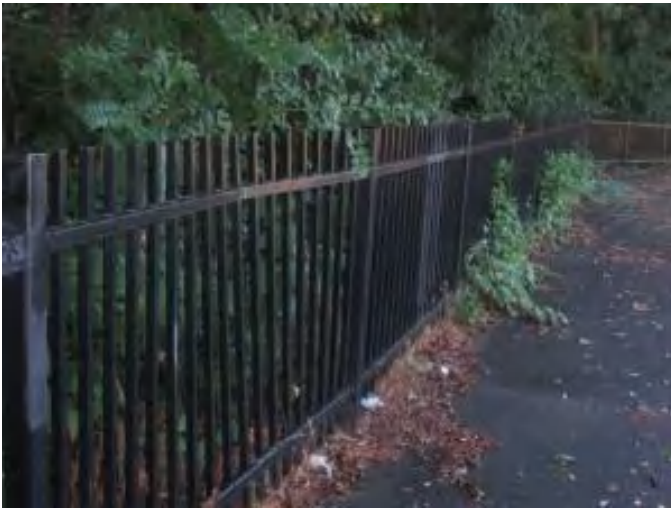
**System: G2040 - Site Development**

**Location:** site fence

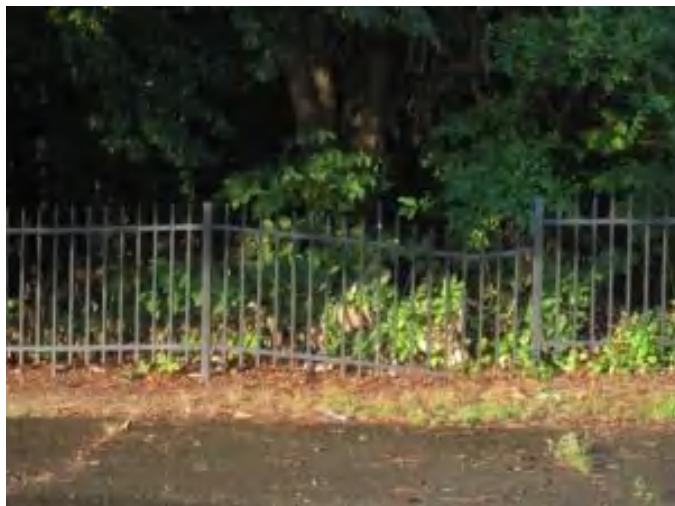
**System: G2040 - Site Development**

**Location:** site fence

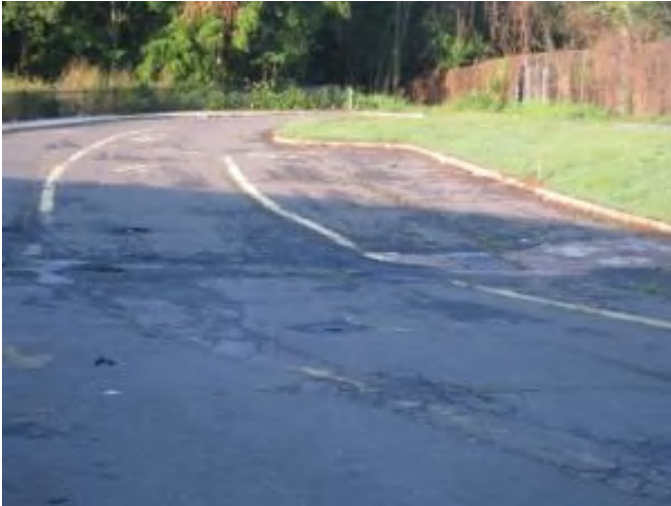
**System: G2020 - Parking Lots**

**Location:** parking lot, drop off driveway, play area

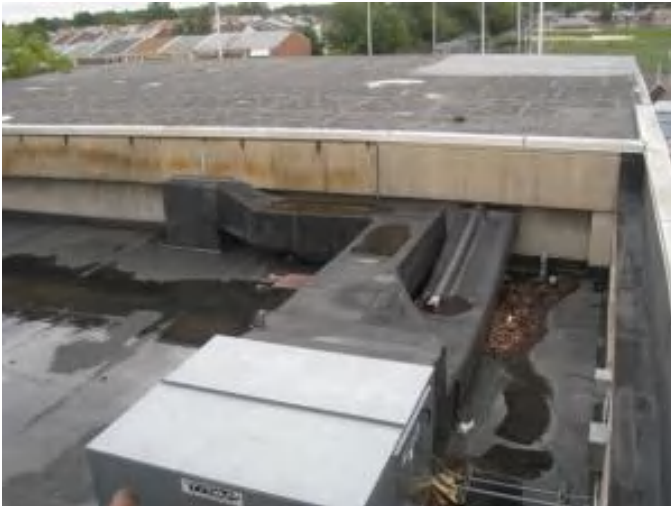
#### System: B2010 - Exterior Walls

**Location:** Low Roof

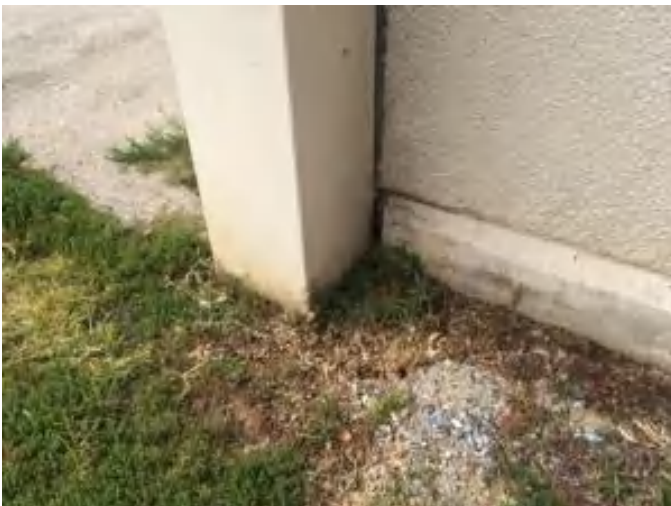
#### System: B2010 - Exterior Walls

**Location:** exterior gaps between columns and conc panels

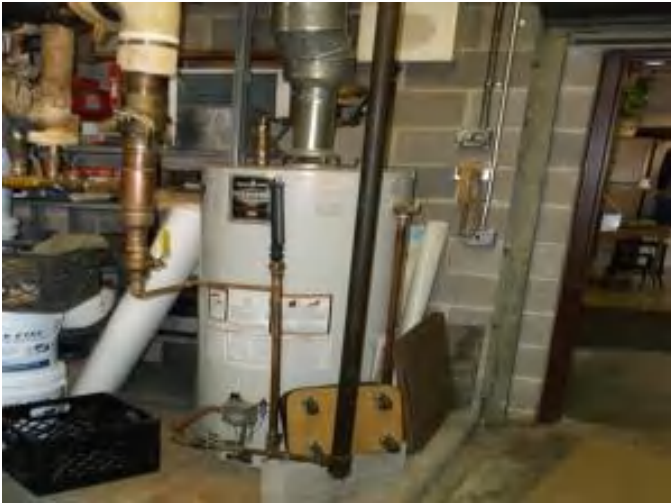
**System: D2020 - Domestic Water Distribution**

**Location:** Boiler Room

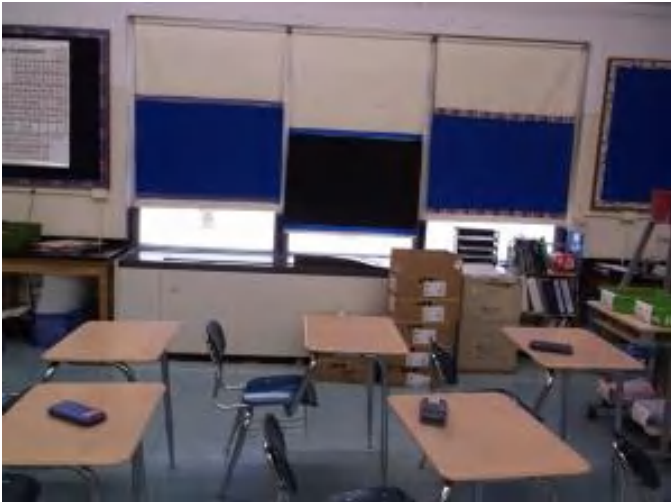
**System: D3040 - Distribution Systems**

**Location:** Classrooms

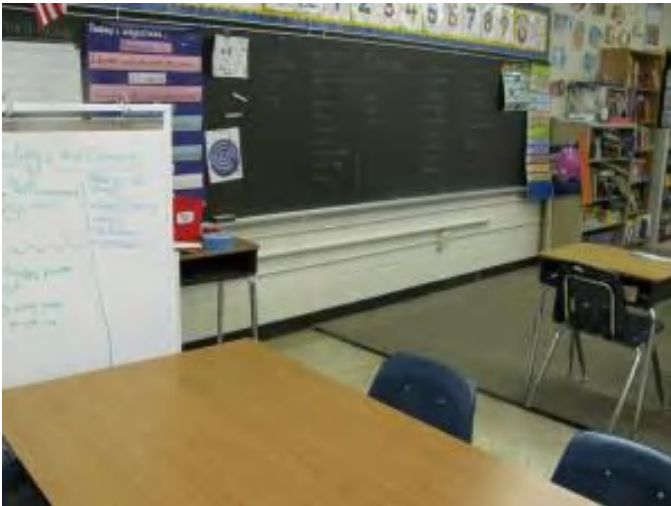
**System: D5020 - Lighting and Branch Wiring**

**Location:** Entire Building

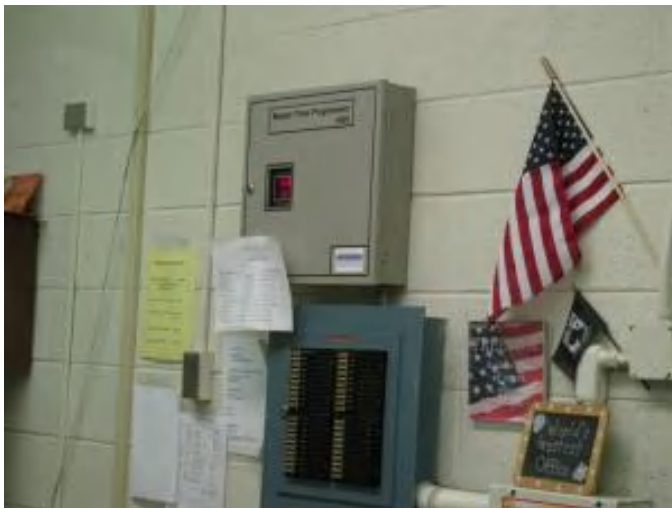
**System: D5030 - Communications and Security**

**Location:** Entire Building

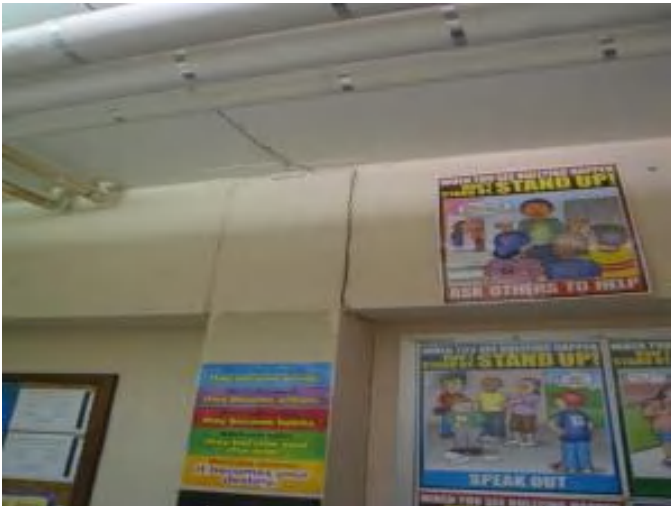
**System: B2010 - Exterior Walls**

**Location:** Interior block walls

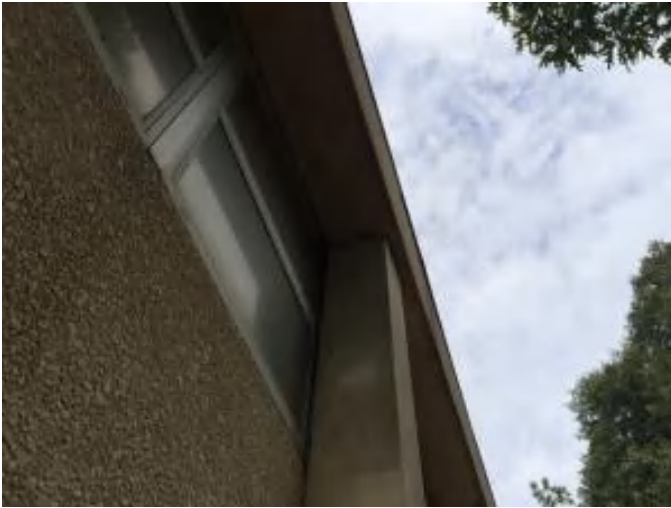
**System: B2010 - Exterior Walls**

**Location:** Exterior walls

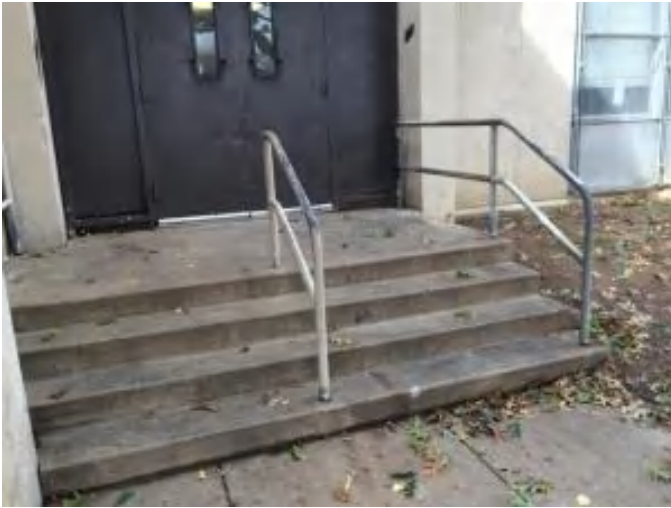
**System: B2030 - Exterior Doors**

**Location:** Exterior doors

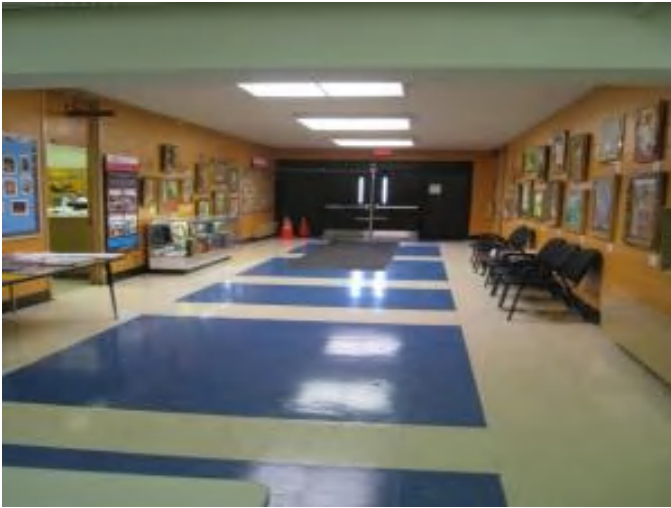
**System: C1010 - Partitions**

**Location:** Entrance lobby

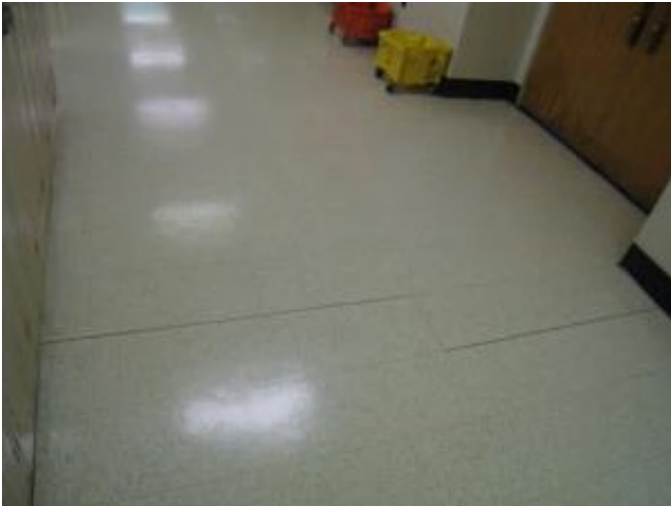
**System: C3020413 - Vinyl Flooring**

**Location:** Interiors - floors

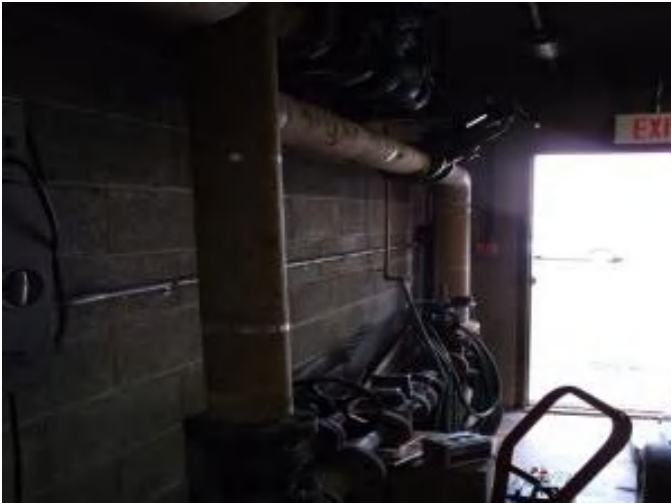
**System: D2020 - Domestic Water Distribution**

**Location:** Boiler Room

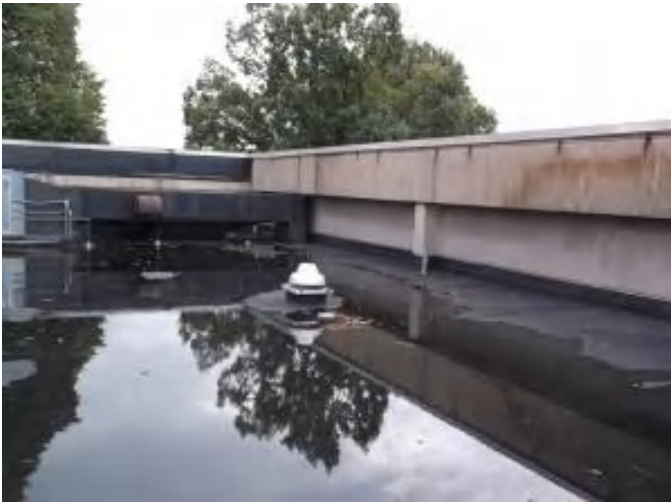
**System: D2040 - Rain Water Drainage**

**Location:** Throughout Building

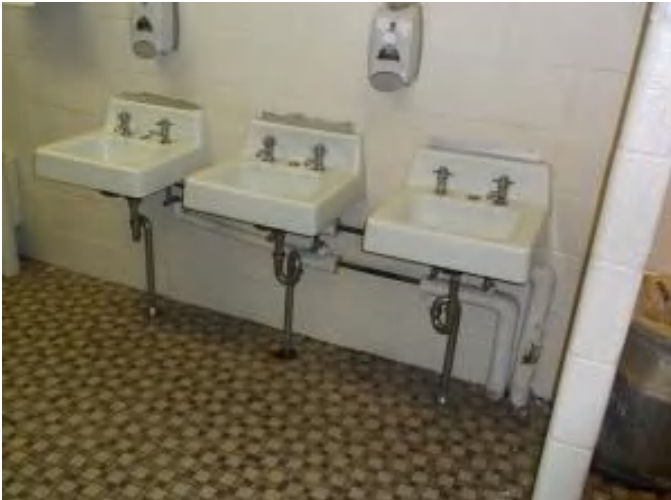
**System: D3040 - Distribution Systems**

**Location:** Gymnasium

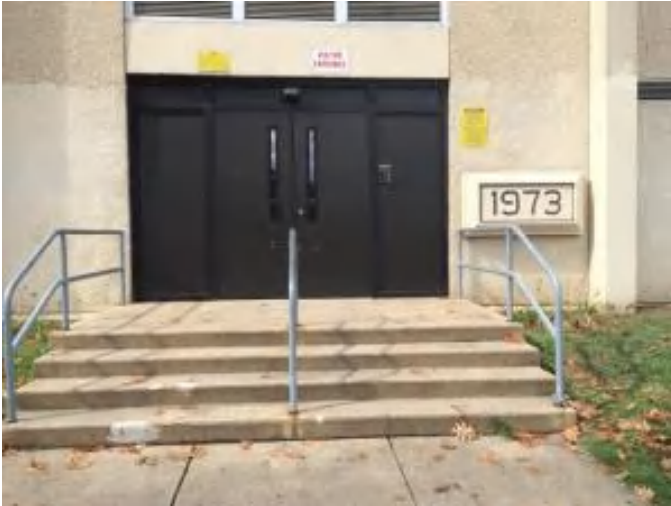
**System: G2030 - Pedestrian Paving**

**Location:** sidewalk - front of building

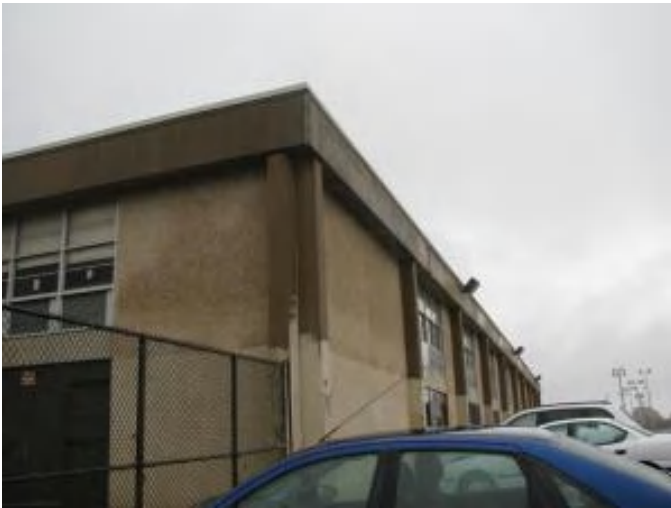
**System: G2040 - Site Development**

**Location:** site fence

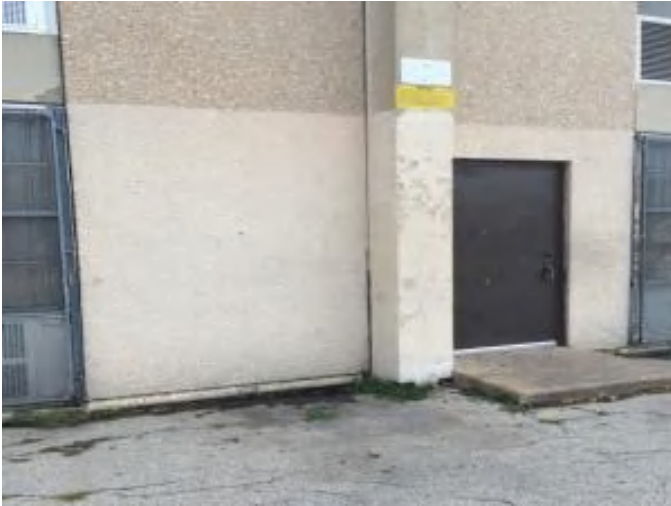
**System: G2020 - Parking Lots**

**Location:** parking lot
