Facility Condition Assessment Summary Report

Harding Middle School

School District of Philadelphia
S711001;Harding
Final
Site Assessment Report

January 31, 2017

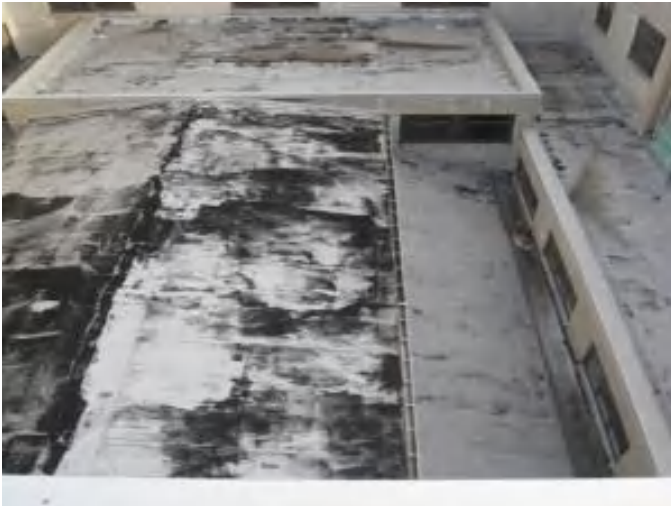
System: B3010105 - Built-Up

Location: roof

Distress: Failing

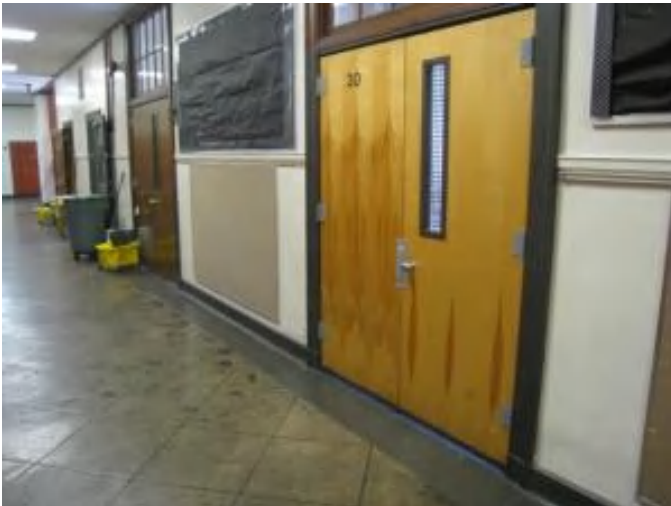
System: C1010 - Partitions

Location: corridor walls

Distress: Building / MEP Codes

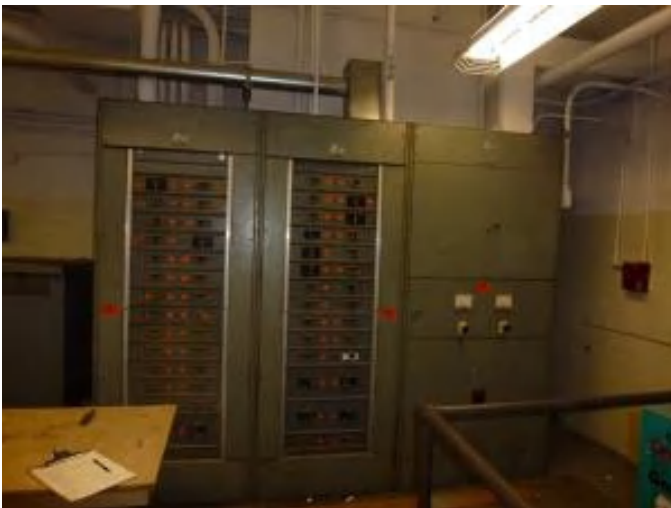
System: D5010 - Electrical Service/Distribution

Location: Boiler Room

Distress: Beyond Service Life

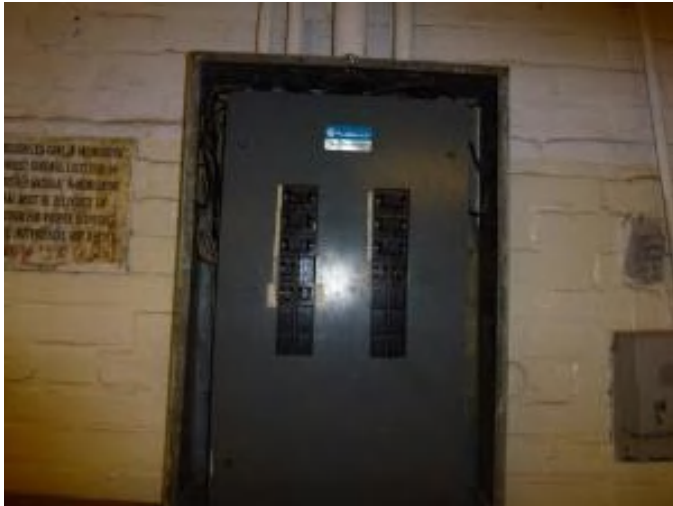
System: D5010 - Electrical Service/Distribution

Location: Throughout the building

Distress: Beyond Service Life

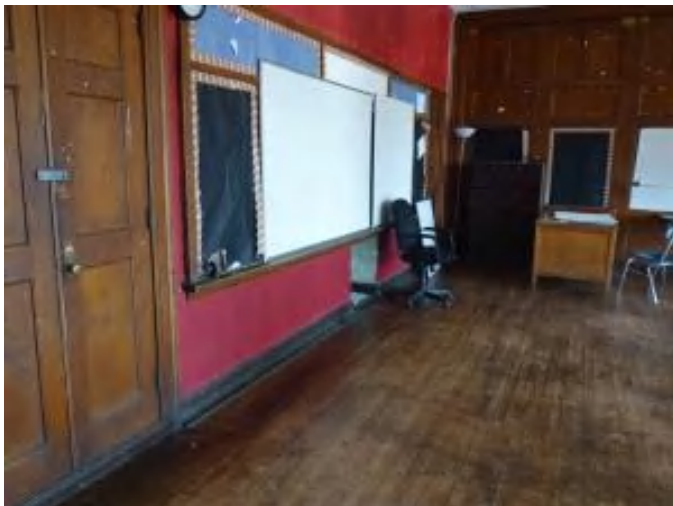
System: D5020 - Lighting and Branch Wiring

Location: Classrooms

Distress: Inadequate

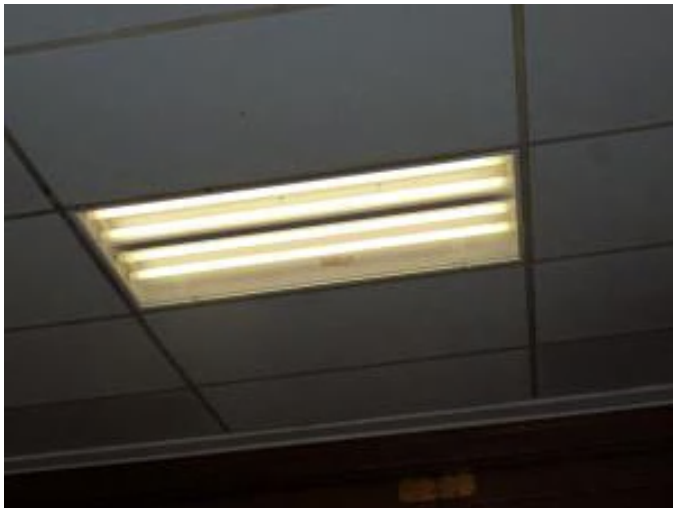
System: D5020 - Lighting and Branch Wiring

Location: Gymnasium, kitchen,dining room, access to roof

Distress: Beyond Service Life

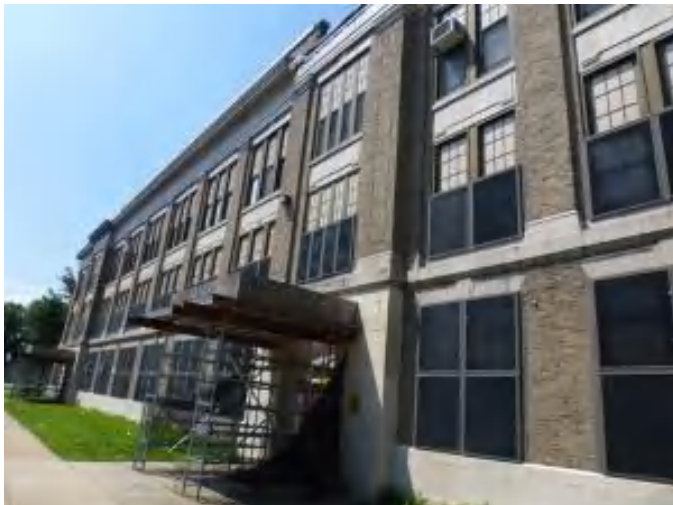
System: D5020 - Lighting and Branch Wiring

Location: Exterior walls

Distress: Damaged

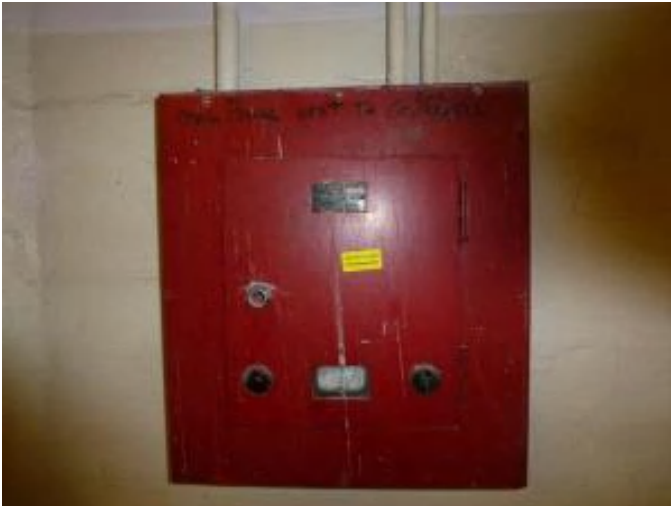
System: D5030 - Communications and Security

Location: Entire Building
Distress: Beyond Service Life
Category: 3 - Operations / Maint.
Priority: 1 - Response Time (< 2 yr)
Correction: Replace fire alarm system
Qty: 1.00
Unit of Measure: S.F.
Estimate: \$598,669.83
Assessor Name: System
Date Created: 08/10/2015

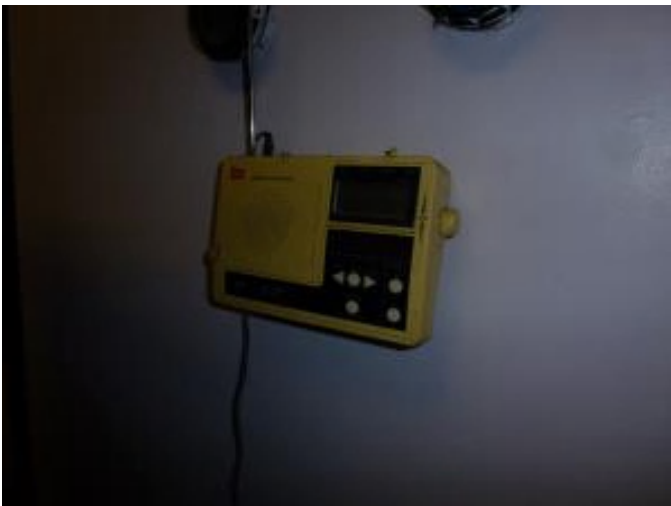
System: D5030 - Communications and Security

Location: Main Office
Distress: Damaged
Category: 3 - Operations / Maint.
Priority: 1 - Response Time (< 2 yr)
Correction: Add/Replace Clock System or Components
Qty: 0.00
Unit of Measure: Ea.
Estimate: \$164,874.77
Assessor Name: System
Date Created: 08/10/2015

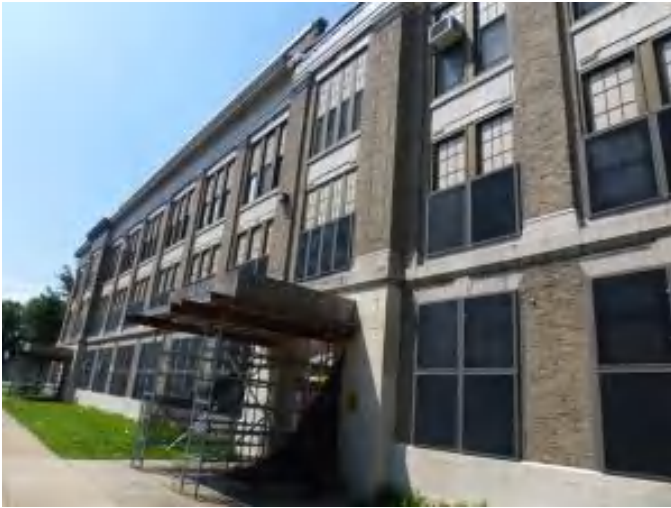
System: D5030 - Communications and Security

Location: Exterior walls
Distress: Life Safety / NFPA / PFD
Category: 1 - Health & Safety
Priority: 1 - Response Time (< 2 yr)
Correction: Add/Replace Video Surveillance System
Qty: 1.00
Unit of Measure: Ea.
Estimate: \$63,082.05
Assessor Name: System
Date Created: 08/10/2015

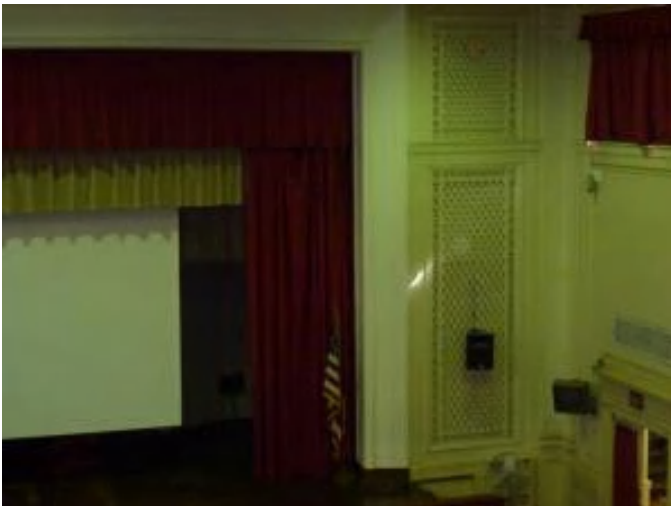
System: D5030 - Communications and Security

Location: Auditorium
Distress: Beyond Service Life
Category: 3 - Operations / Maint.
Priority: 1 - Response Time (< 2 yr)
Correction: Add/Replace Sound System
Qty: 1.00
Unit of Measure: LS
Estimate: \$41,427.54
Assessor Name: System
Date Created: 08/10/2015

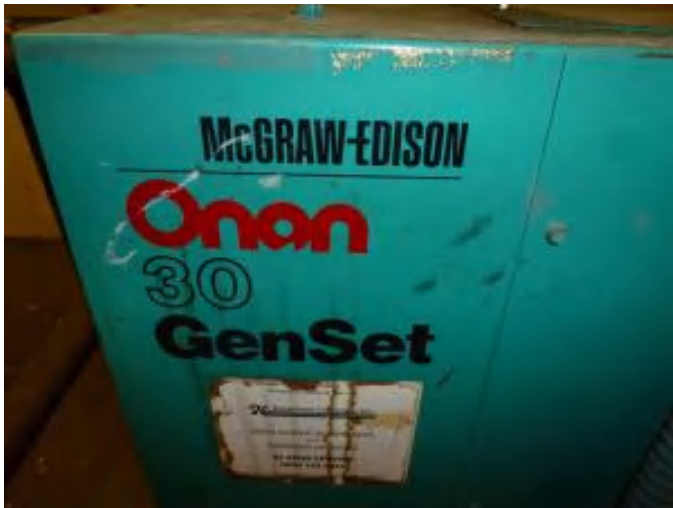
System: D5090 - Other Electrical Systems

Location: Basement
Distress: Life Safety / NFPA / PFD
Category: 1 - Health & Safety
Priority: 1 - Response Time (< 2 yr)
Correction: Replace standby generator system
Qty: 1.00
Unit of Measure: Ea.
Estimate: \$250,093.28
Assessor Name: System
Date Created: 08/10/2015

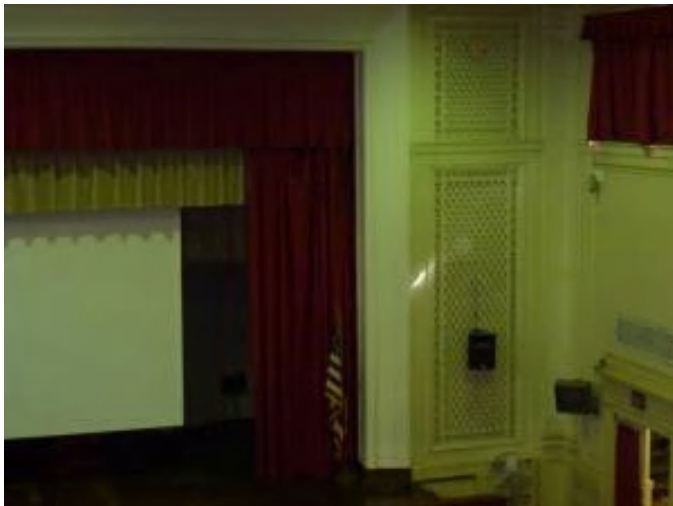
System: E1020 - Institutional Equipment

Location: Auditorium
Distress: Beyond Service Life
Category: 3 - Operations / Maint.
Priority: 1 - Response Time (< 2 yr)
Correction: Add/Replace Stage Theatrical Lighting System
Qty: 1.00
Unit of Measure: Ea.
Estimate: \$90,802.49
Assessor Name: System
Date Created: 08/10/2015

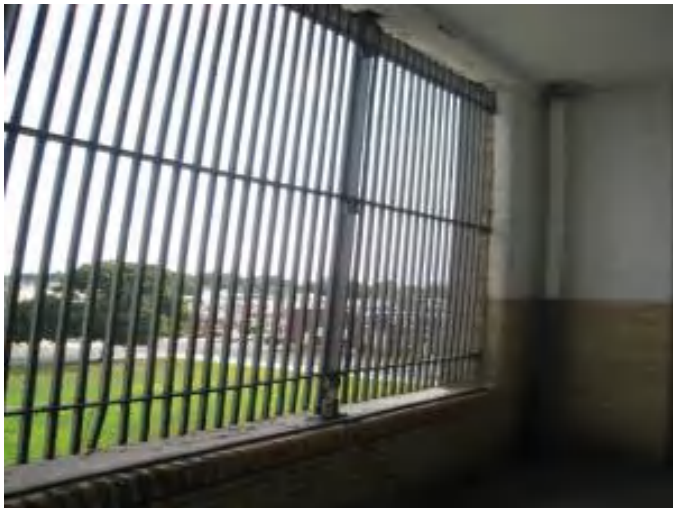
System: B2020 - Exterior Windows

Location: fire stairs exterior grating
Distress: Damaged
Category: 3 - Operations / Maint.
Priority: 2 - Response Time (2-3 yrs)
Correction: Replace security screens
Qty: 300.00
Unit of Measure: S.F.
Estimate: \$46,051.91
Assessor Name: System
Date Created: 08/14/2015

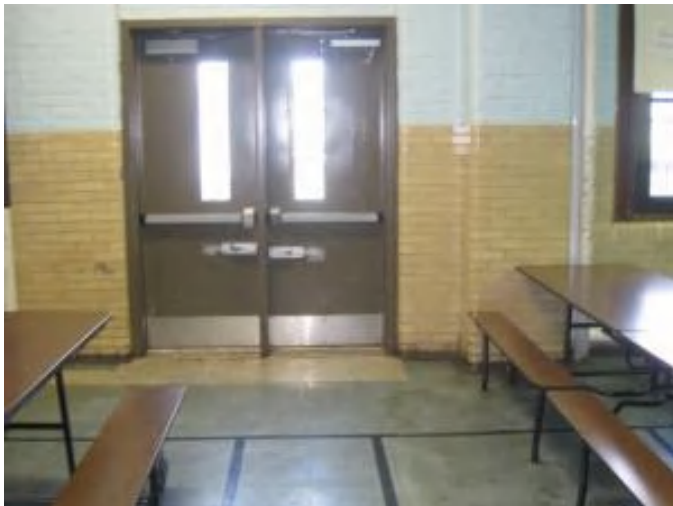
System: B2030 - Exterior Doors

Location: exterior doors
Distress: Beyond Service Life
Category: 3 - Operations / Maint.
Priority: 2 - Response Time (2-3 yrs)
Correction: Remove and replace exterior doors - per leaf
Qty: 20.00
Unit of Measure: Ea.
Estimate: \$138,000.02
Assessor Name: System
Date Created: 08/14/2015

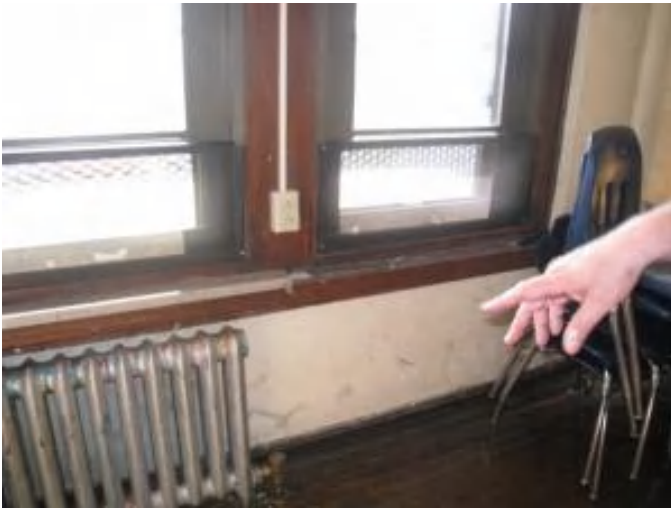
System: C3010230 - Paint & Covering

Location: interior plaster walls
Distress: Damaged
Category: 3 - Operations / Maint.
Priority: 2 - Response Time (2-3 yrs)
Correction: Repair substrate and repaint interior walls - SF of wall surface
Qty: 20,000.00
Unit of Measure: S.F.
Estimate: \$161,659.02
Assessor Name: System
Date Created: 08/14/2015

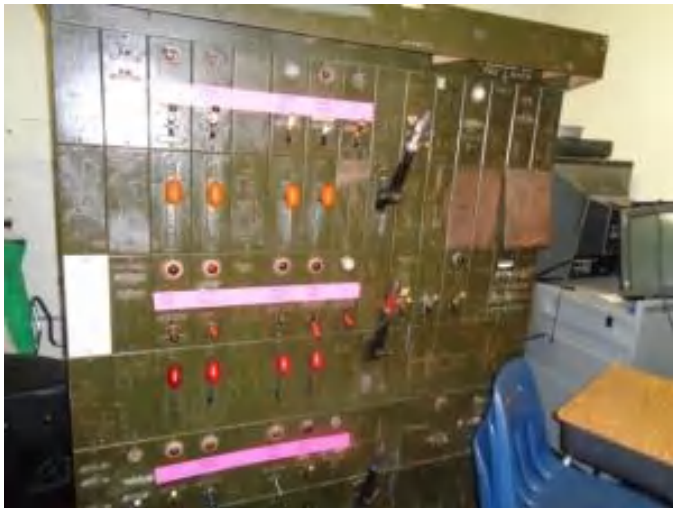
System: D3060 - Controls & Instrumentation

Location: Throughout the building
Distress: Beyond Service Life
Category: 3 - Operations / Maint.
Priority: 2 - Response Time (2-3 yrs)
Correction: Replace pneumatic controls with DDC (150KSF)
Qty: 150,000.00
Unit of Measure: S.F.
Estimate: \$2,686,710.32
Assessor Name: System
Date Created: 10/12/2015

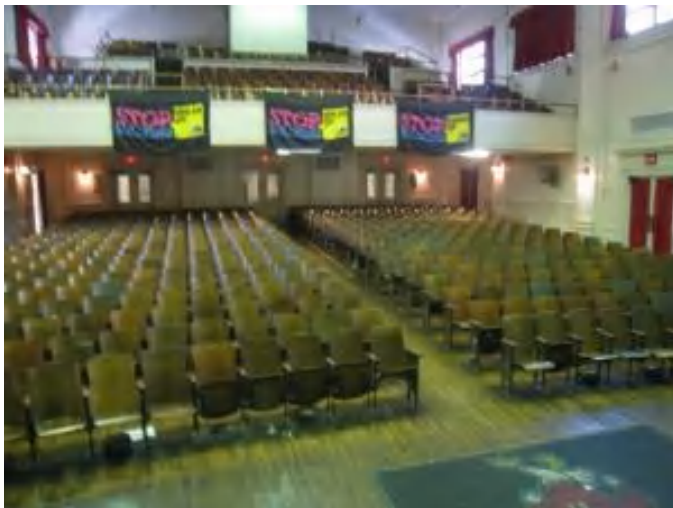
System: E2010 - Fixed Furnishings

Location: auditorium
Distress: Failing
Category: 3 - Operations / Maint.
Priority: 2 - Response Time (2-3 yrs)
Correction: Replace auditorium seating - add tablet arms if required. Veneer seating is an option.
Qty: 300.00
Unit of Measure: Ea.
Estimate: \$264,518.15
Assessor Name: System
Date Created: 08/14/2015

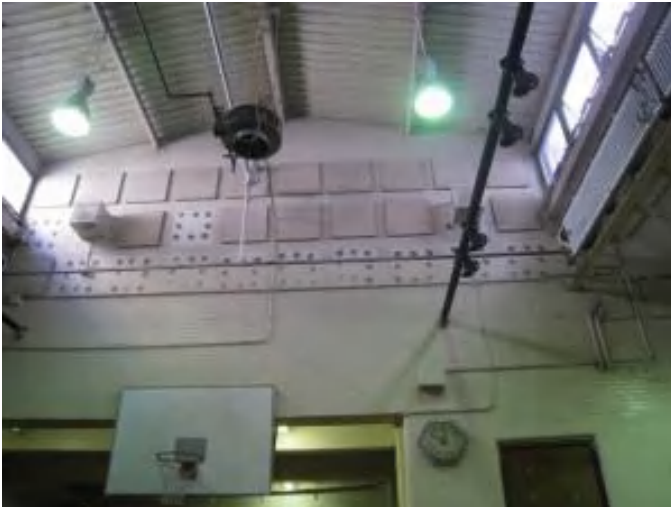
System: C3030 - Ceiling Finishes

Location: gym ceilings
Distress: Appearance
Category: 3 - Operations / Maint.
Priority: 3 - Response Time (3-4 yrs)
Correction: Re-paint ceilings - SF of ceilings
Qty: 6,000.00
Unit of Measure: S.F.
Estimate: \$28,722.17
Assessor Name: System
Date Created: 08/14/2015

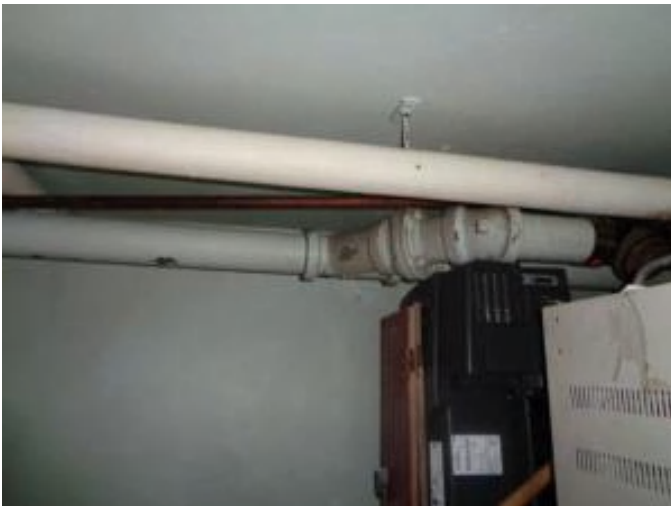
System: D2030 - Sanitary Waste

Location: Throughout the building
Distress: Beyond Service Life
Category: 3 - Operations / Maint.
Priority: 3 - Response Time (3-4 yrs)
Correction: Inspect sanitary waste piping and replace damaged sections. (+100KSF)
Qty: 120,300.00
Unit of Measure: S.F.
Estimate: \$510,866.81
Assessor Name: System
Date Created: 10/12/2015

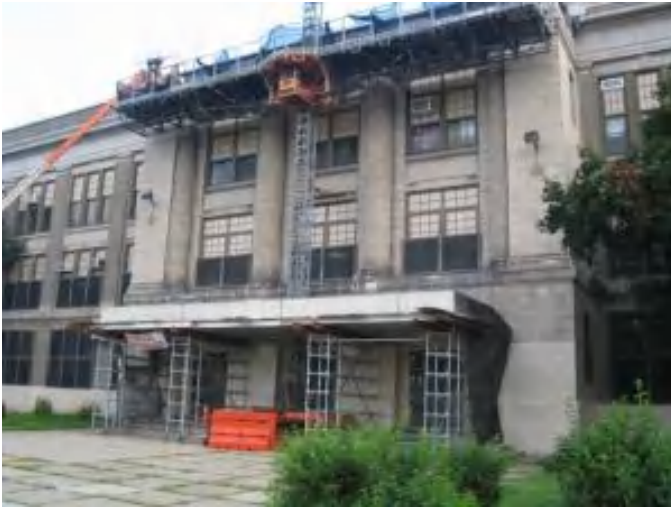
System: G2030 - Pedestrian Paving

Location: sidewalk
Distress: Damaged
Category: 3 - Operations / Maint.
Priority: 2 - Response Time (2-3 yrs)
Correction: Remove and replace concrete sidewalk or concrete paving - 4" concrete thickness
Qty: 5,000.00
Unit of Measure: S.F.
Estimate: \$71,914.25
Assessor Name: Craig Anding
Date Created: 08/14/2015

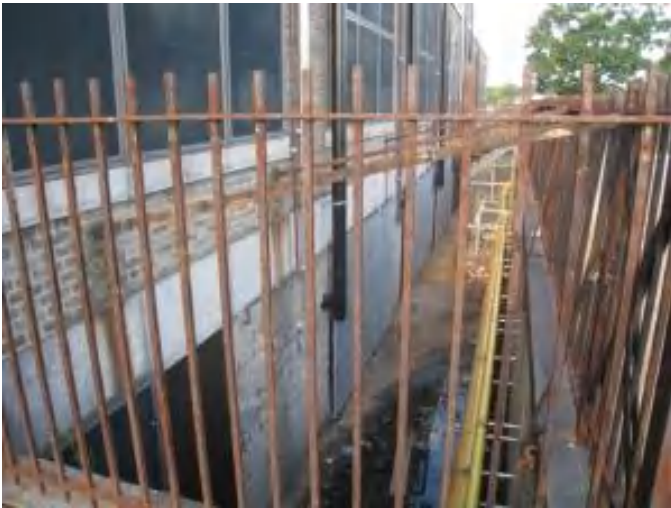
System: G2040 - Site Development

Location: site fence
Distress: Damaged
Category: 3 - Operations / Maint.
Priority: 2 - Response Time (2-3 yrs)
Correction: Remove and replace metal picket fence - input number of gates
Qty: 300.00
Unit of Measure: L.F.
Estimate: \$50,513.60
Assessor Name: Craig Anding
Date Created: 08/14/2015
