Facility Condition Assessment Summary Report

Harrington School

Harrington Annex School

January 30, 2017

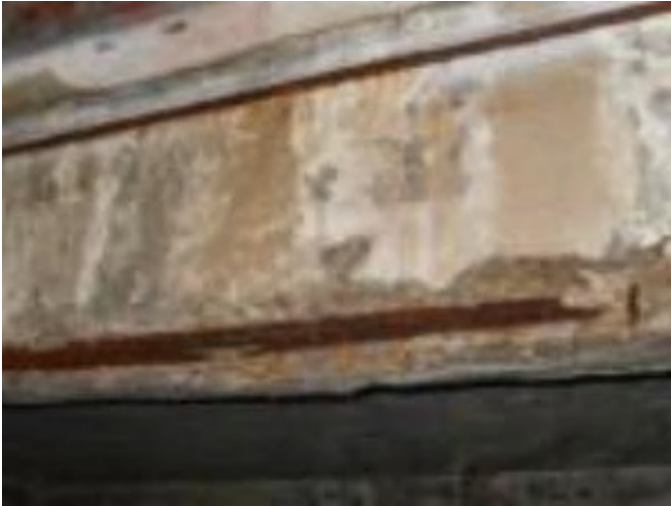
Location: Boiler and coal rooms

System: B1020 - Roof Construction

Distress: Failing

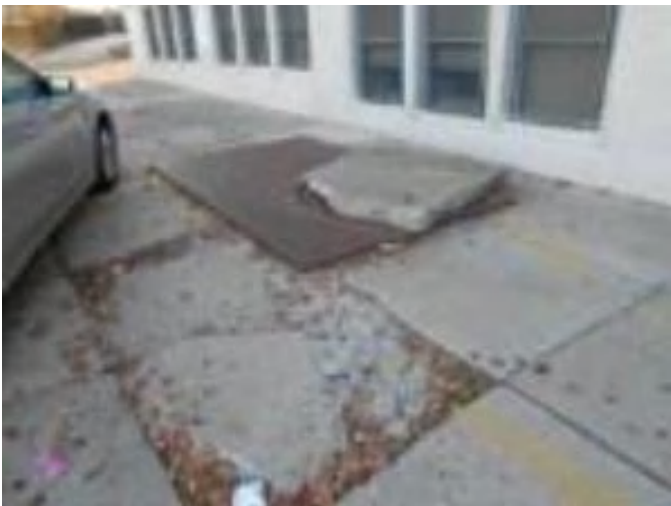
Location: Above boiler and coal rooms

System: B1020 - Roof Construction

Distress: Failing

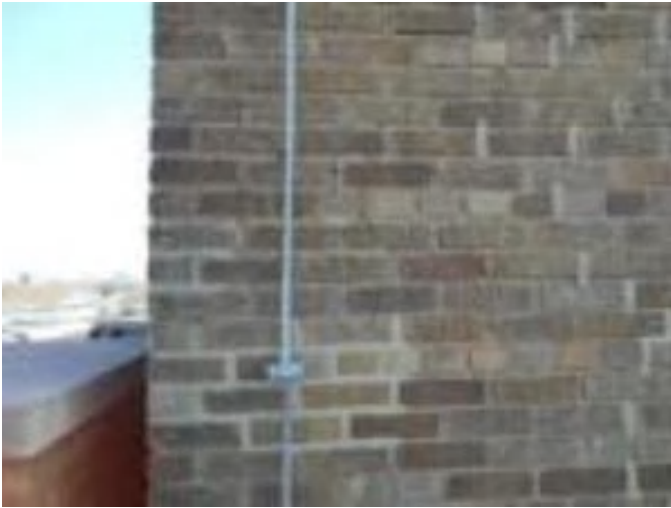
Location: Exterior walls

System: B2010 - Exterior Walls

Distress: Failing

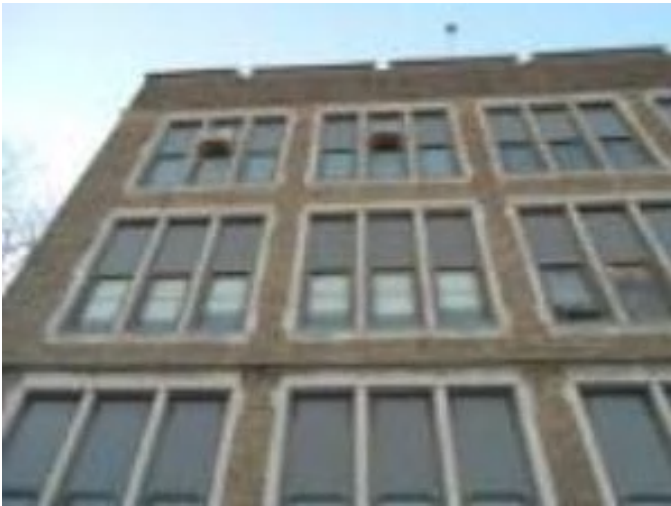
Location: Exterior walls

System: B2020 - Exterior Windows

Distress: Failing

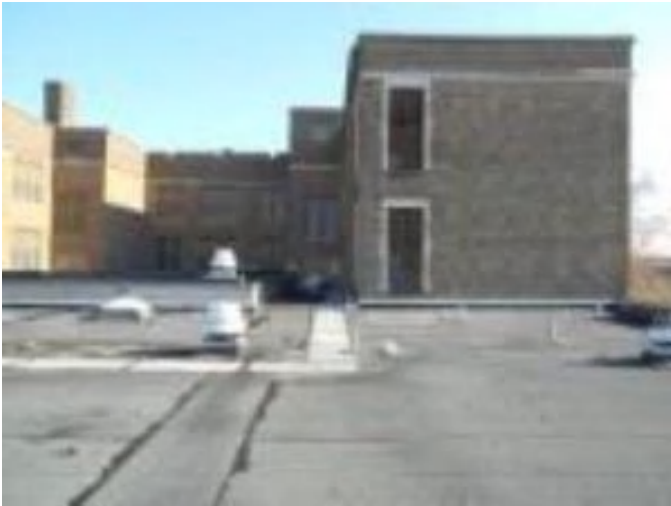
Location: Second floor

System: B2030 - Exterior Doors

Distress: Accessibility

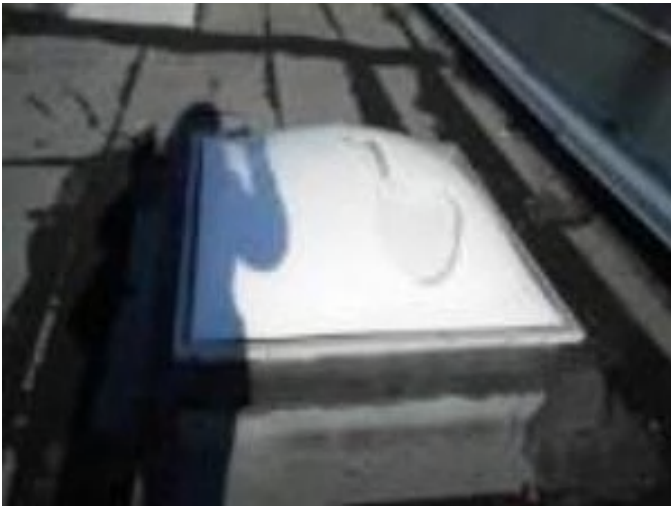
Location: Roof

System: B3020 - Roof Openings

Distress: Damaged

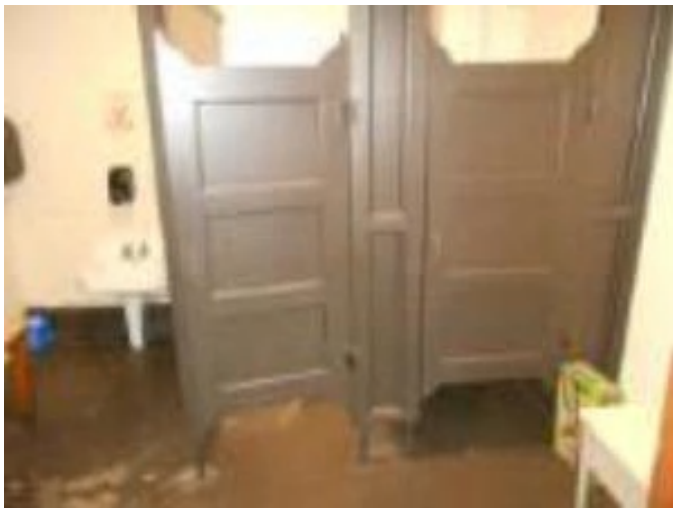
Location: Restrooms

System: C1030 - Fittings

Distress: Damaged

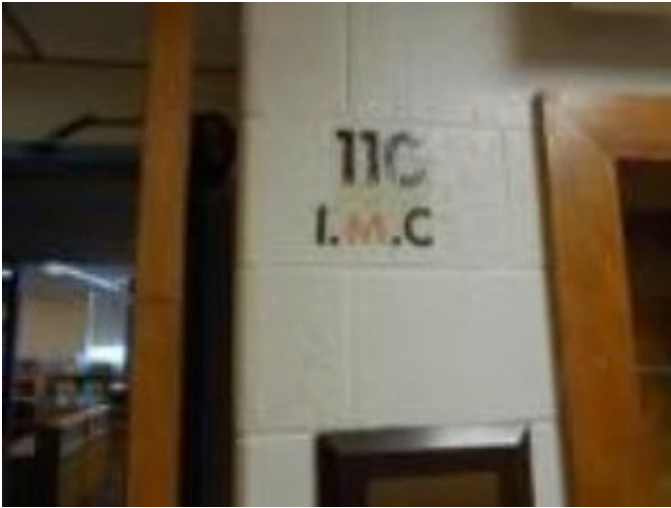
Location: Throughout the building

System: C1030 - Fittings

Distress: Accessibility

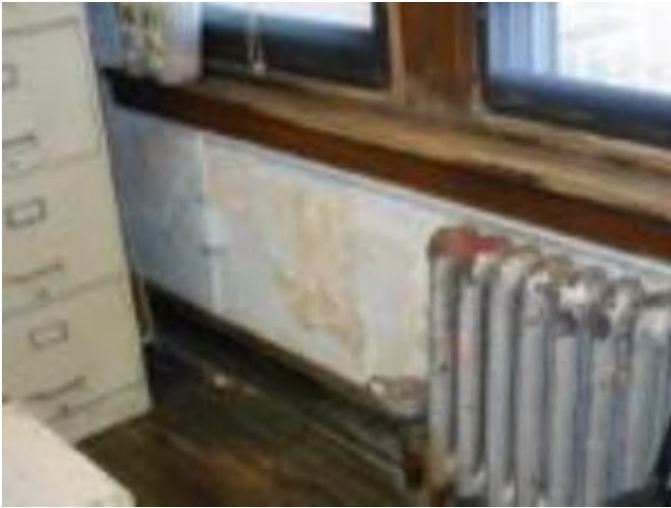
Location: N and E walls 1st and 2nd floors

System: C3010230 - Paint & Covering

Distress: Damaged

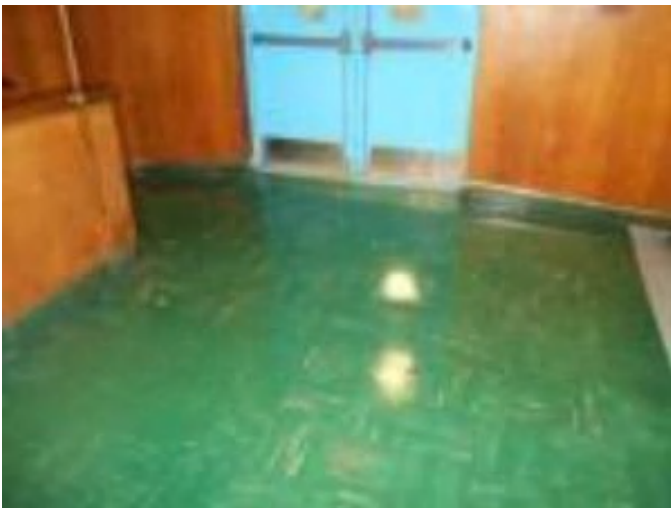
Location: Basement, auditorium and kindergarten

System: C3020413 - Vinyl Flooring

Distress: Damaged

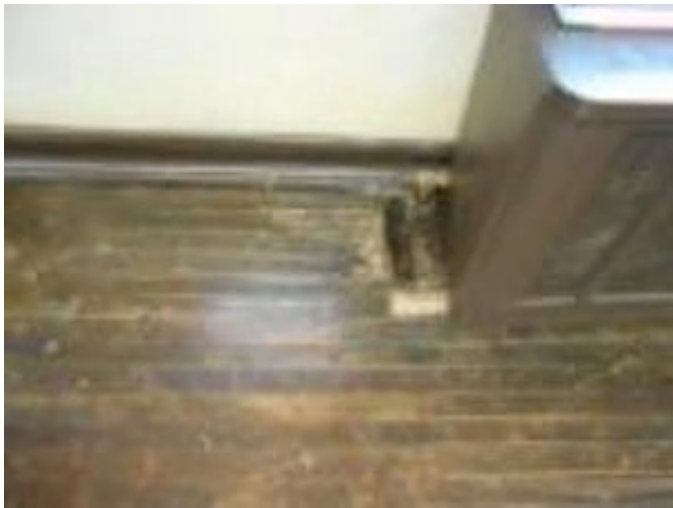
Location: Classroom 208

System: C3020414 - Wood Flooring

Distress: Damaged

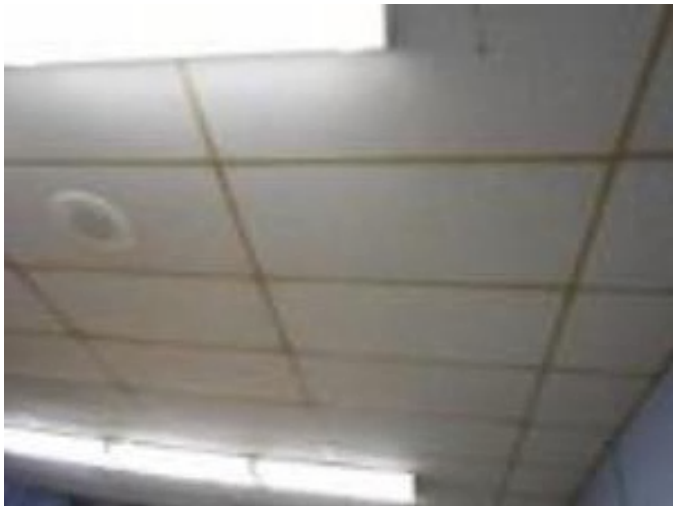
Location: Throughout the building

System: C3030 - Ceiling Finishes

Distress: Appearance

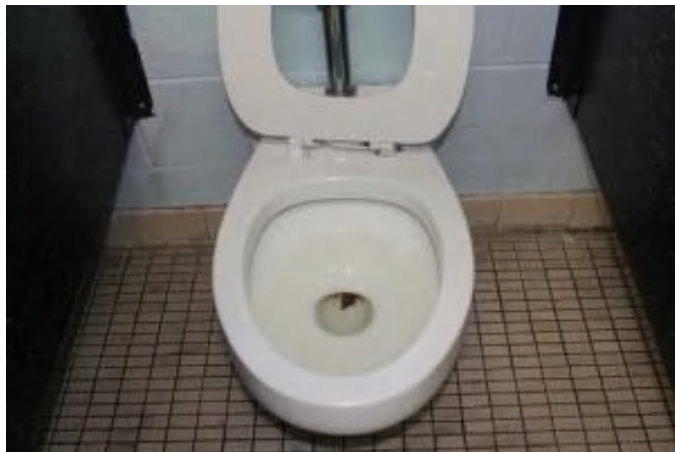
Location: Toilet rooms

System: D2010 - Plumbing Fixtures

Distress: Beyond Service Life

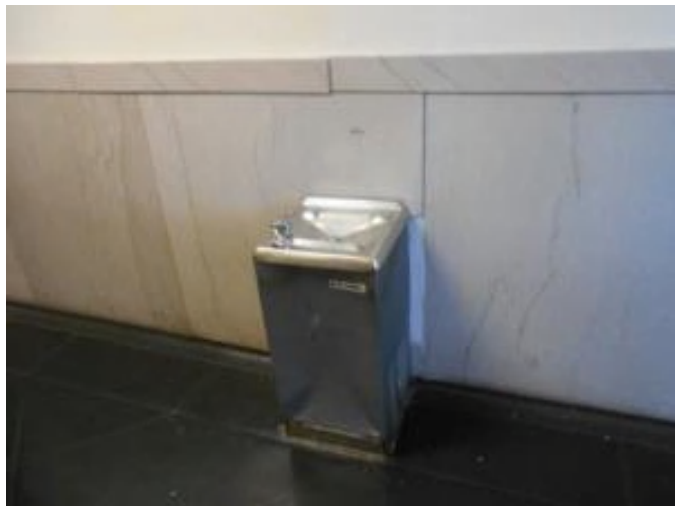
Location: Corridors

System: D2010 - Plumbing Fixtures

Distress: Accessibility

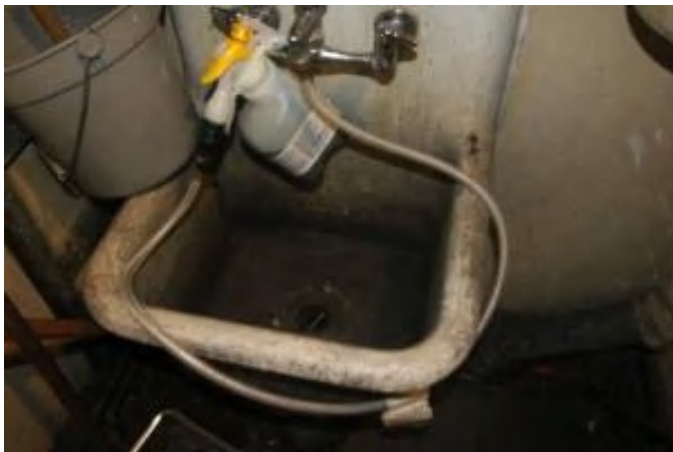
Location: Cleaning closets

System: D2010 - Plumbing Fixtures

Distress: Beyond Service Life

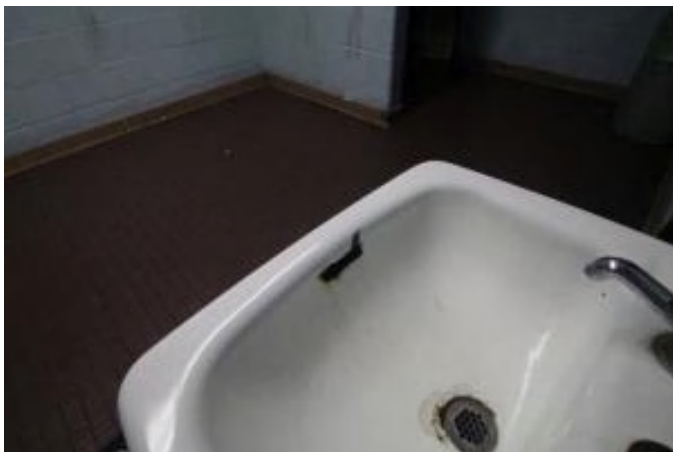
Location: Toilet rooms

System: D2010 - Plumbing Fixtures

Distress: Beyond Service Life

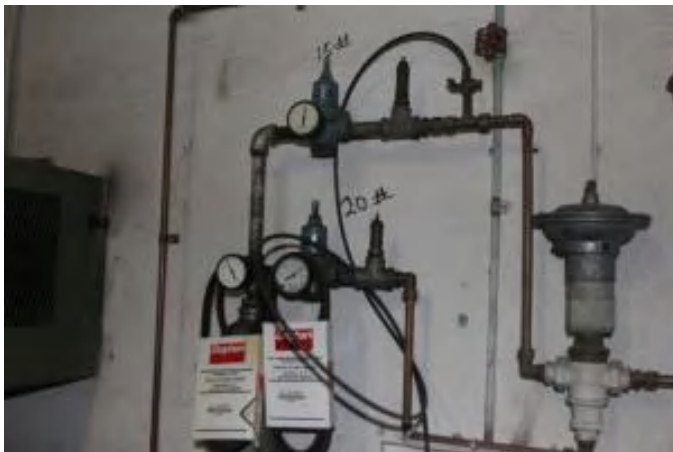
Location: Entire building

System: D3060 - Controls & Instrumentation

Distress: Obsolete

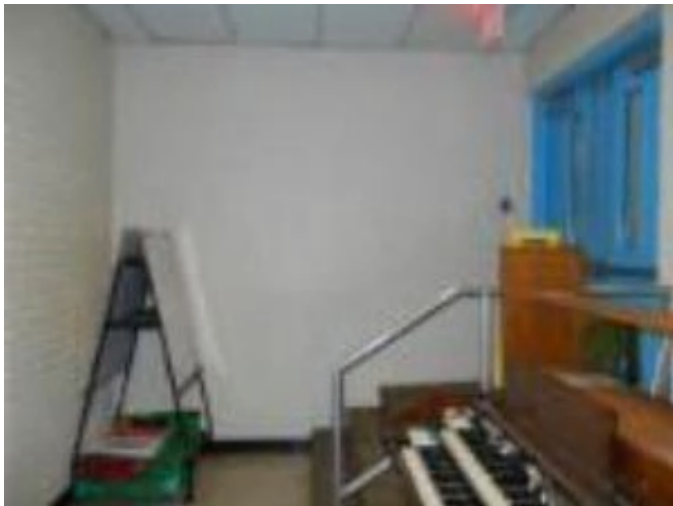
Location: Room 106

System: E2010 - Fixed Furnishings

Distress: Inadequate

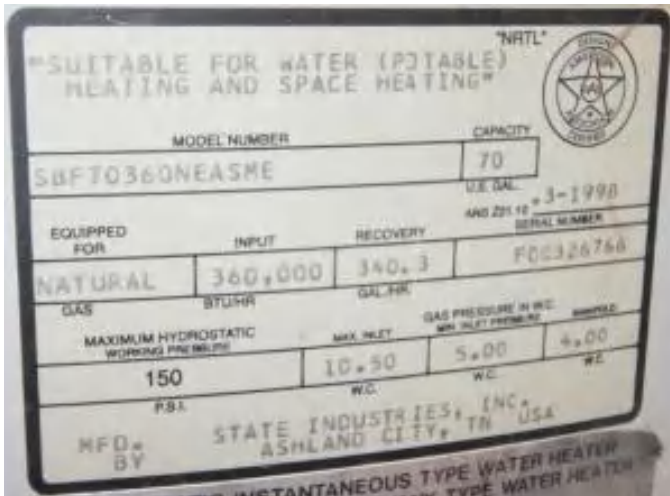
Location: Entire building

System: D2020 - Domestic Water Distribution

Distress: Beyond Service Life

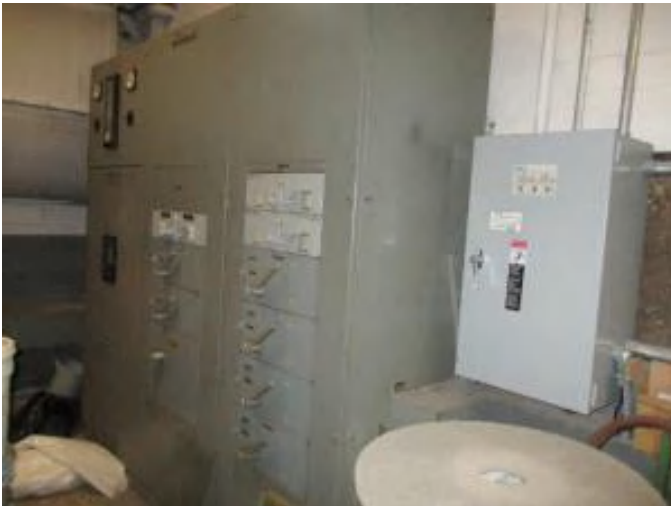
Location: Basement

System: D5010 - Electrical Service/Distribution

Distress: Beyond Service Life

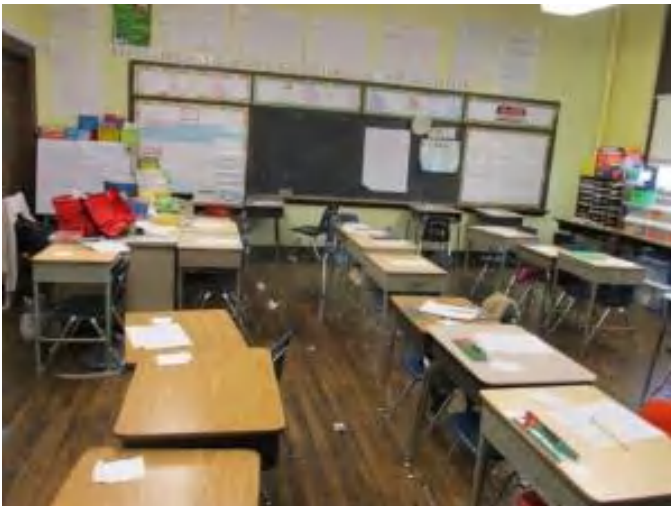
Location: Entire Building

System: D5020 - Lighting and Branch Wiring

Distress: Inadequate

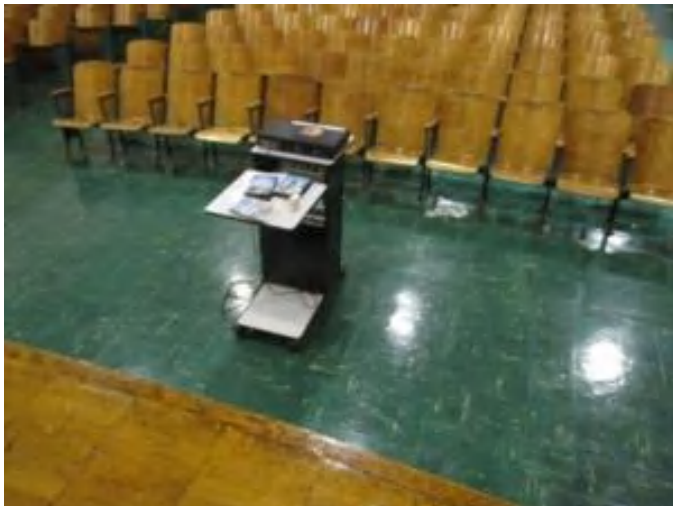
Location: Auditorium

System: D5030 - Communications and Security

Distress: Inadequate

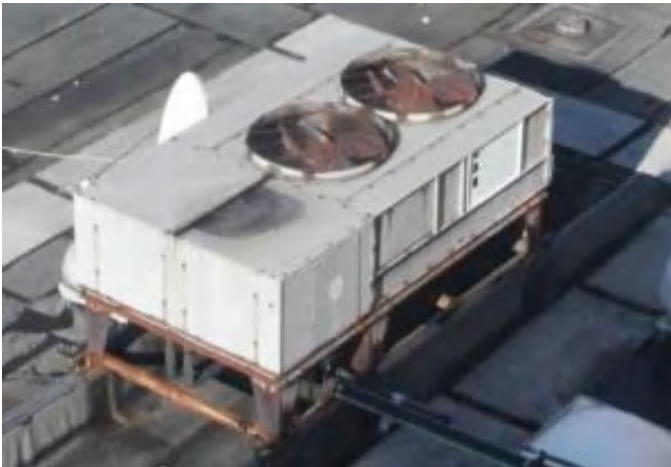
Location: Entire building

System: D3030 - Cooling Generating Systems

Distress: Inadequate

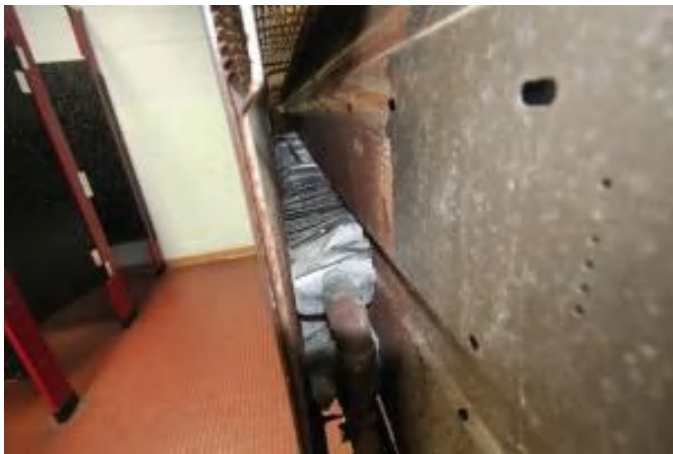
Location: Entire building

System: D3040 - Distribution Systems

Distress: Beyond Service Life

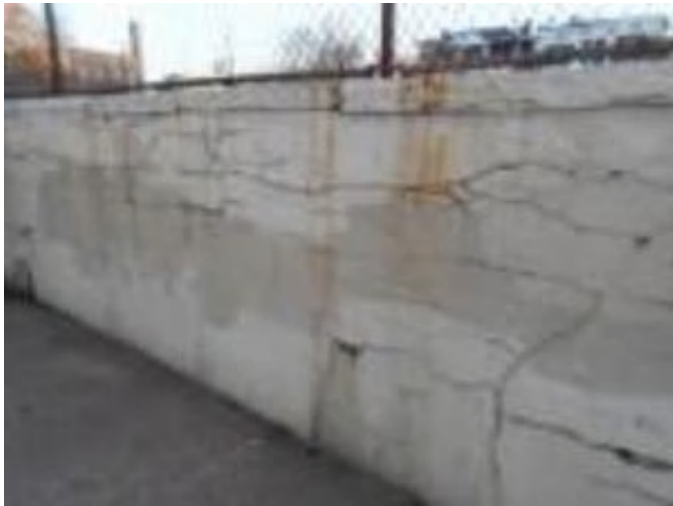
Location: Site retaining walls

System: G2040 - Site Development

Distress: Failing

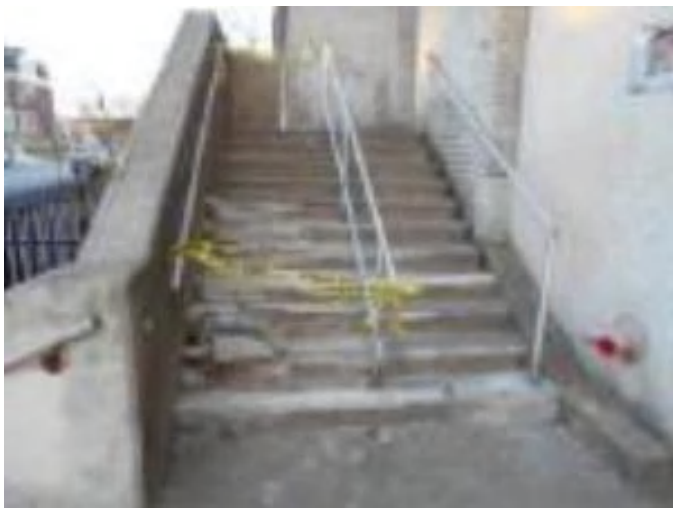
Location: Site stairs

System: G2040 - Site Development

Distress: Damaged

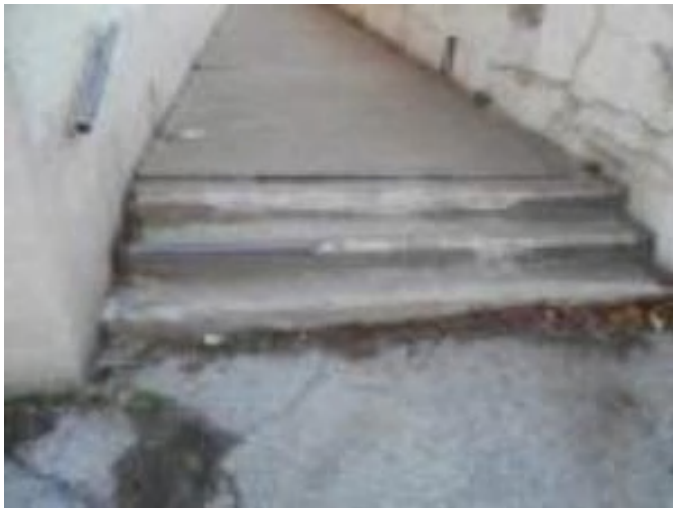
Location: Site stairs

System: G2040 - Site Development

Distress: Damaged

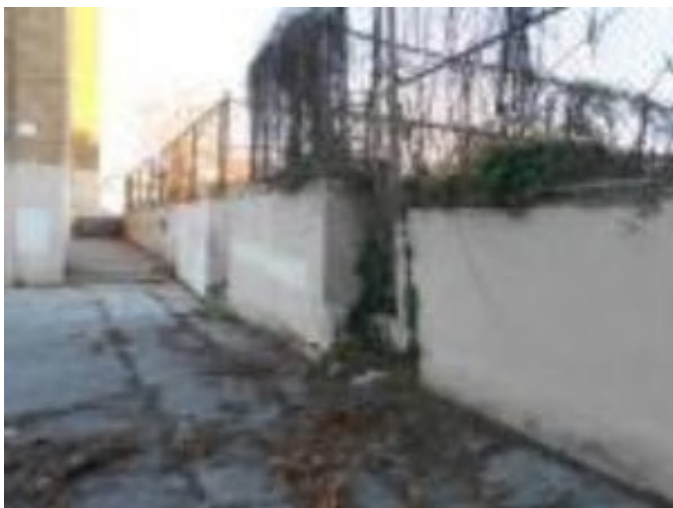
Location: Playground

System: G2040 - Site Development

Distress: Failing

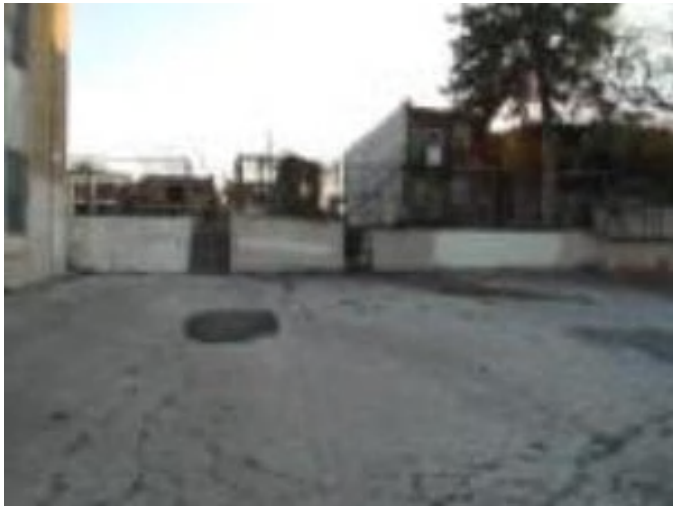
Location: Playgrounds

System: G2030 - Pedestrian Paving

Distress: Failing

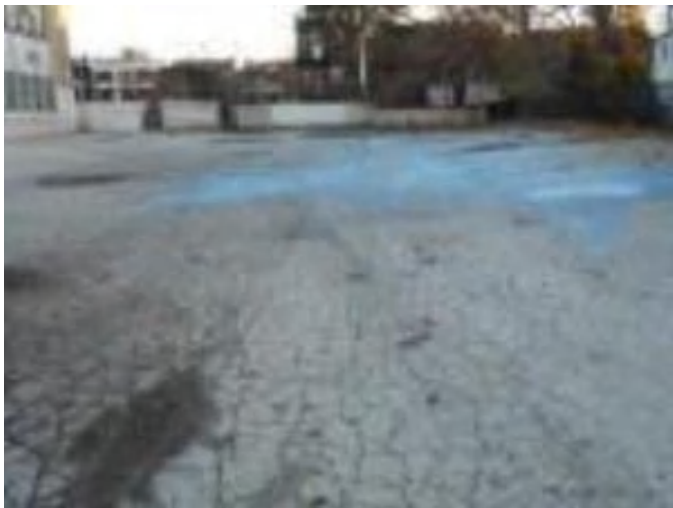
Location: Site

System: G2040 - Site Development

Distress: Inadequate

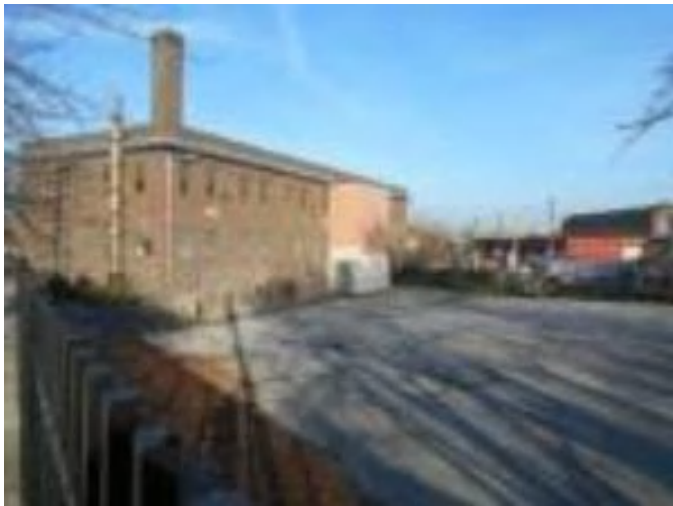
Location: Roof

System: B3020 - Roof Openings

Distress: Accessibility

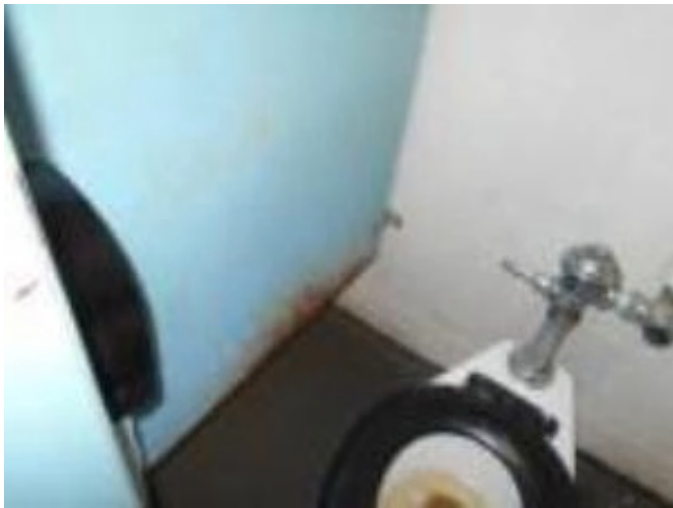
Location: Restrooms

System: C1030 - Fittings

Distress: Damaged

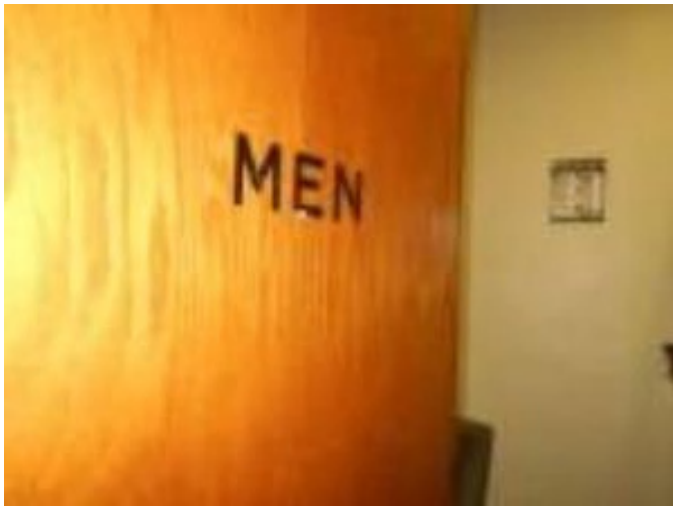
Location: Throughout the building

System: C1030 - Fittings

Distress: Accessibility

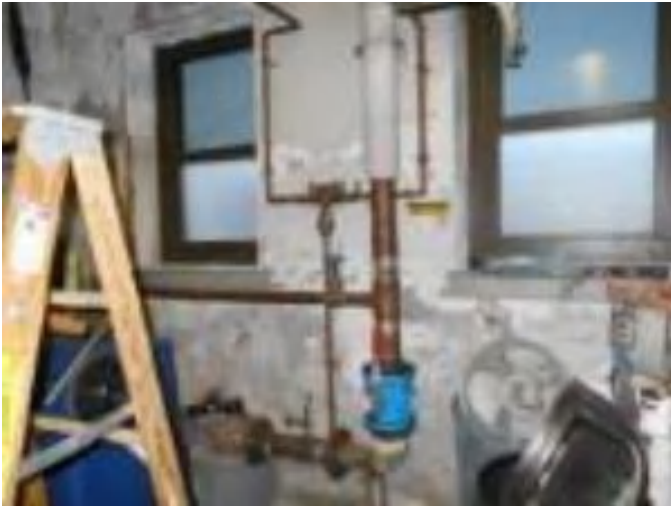
Location: First floor and boiler room

System: C3010230 - Paint & Covering

Distress: Damaged

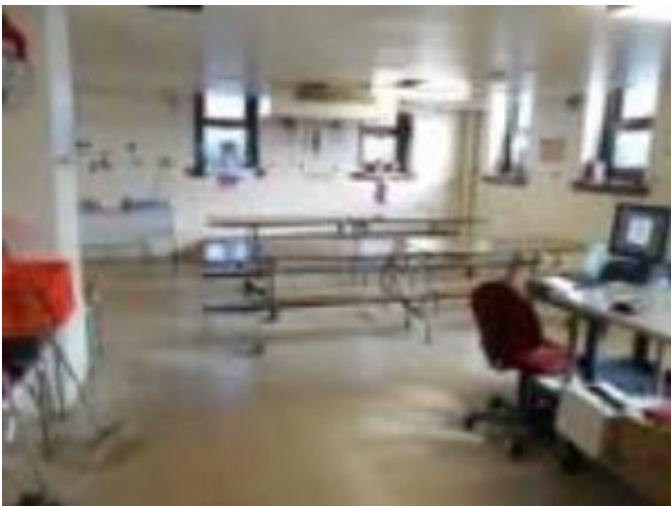
Location: Throughout the building

System: C3020413 - Vinyl Flooring

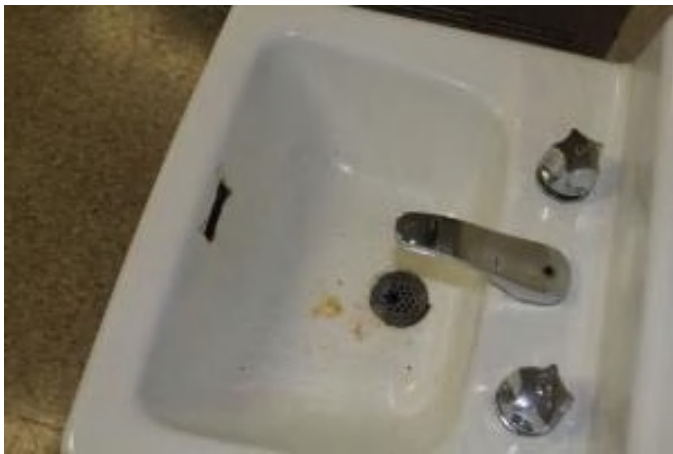
Location: Toilet rooms

System: D2010 - Plumbing Fixtures

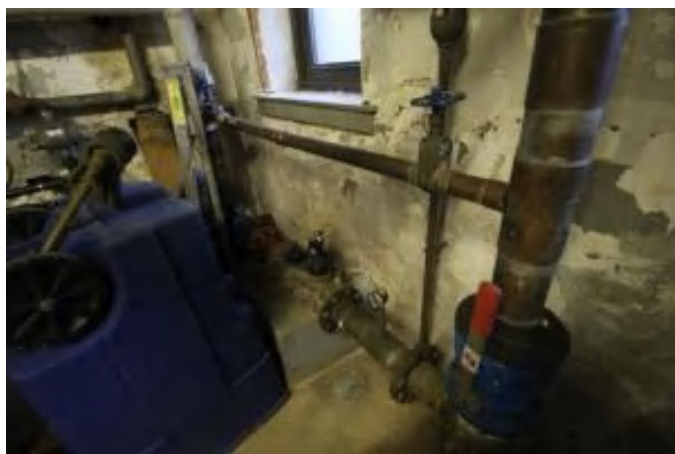
Location: Boiler room

System: D2020 - Domestic Water Distribution

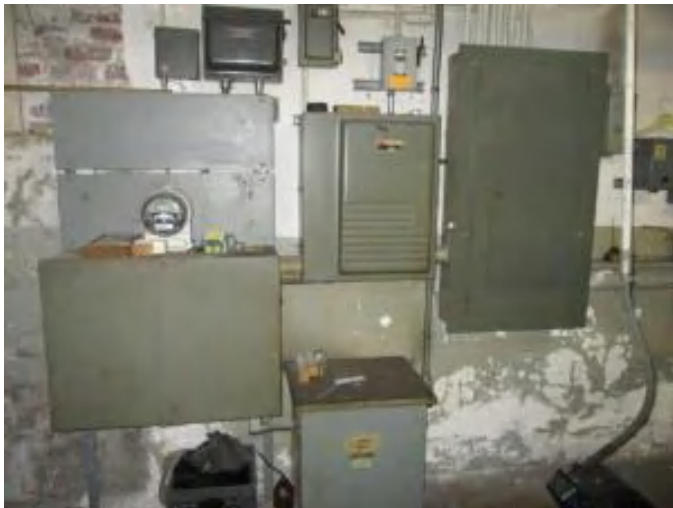
Location: Basement

System: D5010 - Electrical Service/Distribution

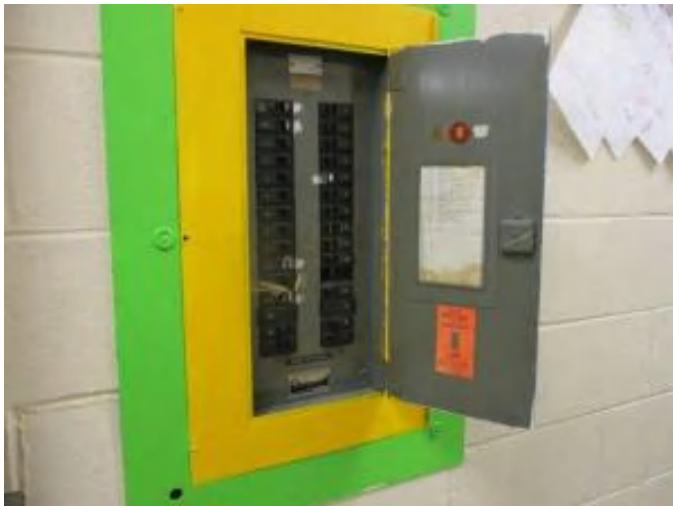
Location: Entire Building

System: D5010 - Electrical Service/Distribution

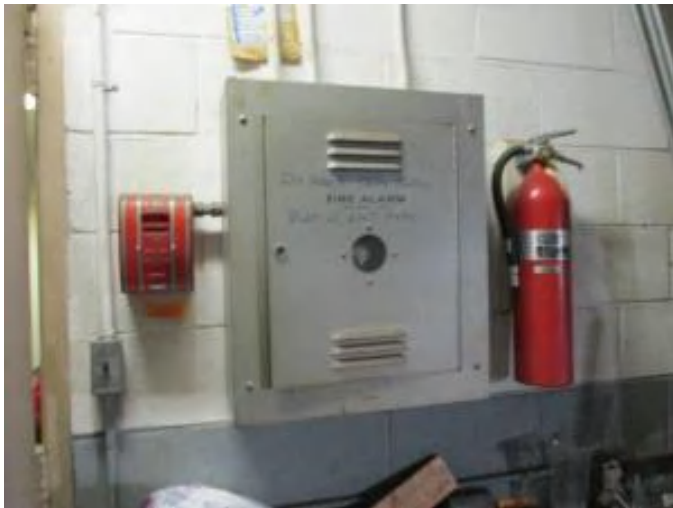
Location: Entire Building

System: D5030 - Communications and Security

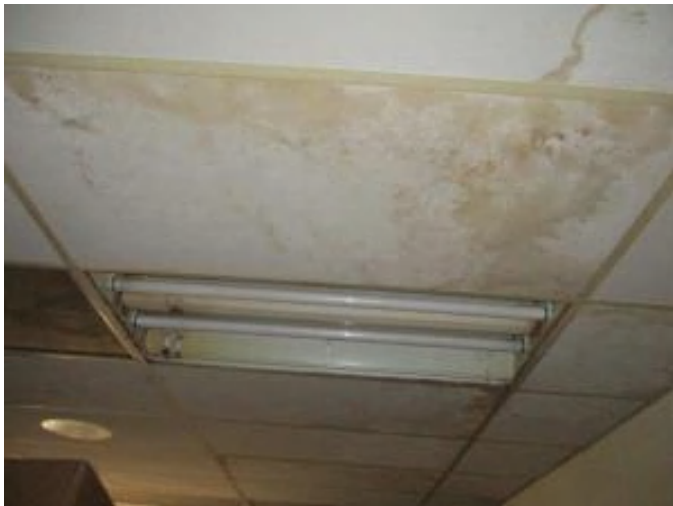
Location: Entire Building

System: D5020 - Lighting and Branch Wiring

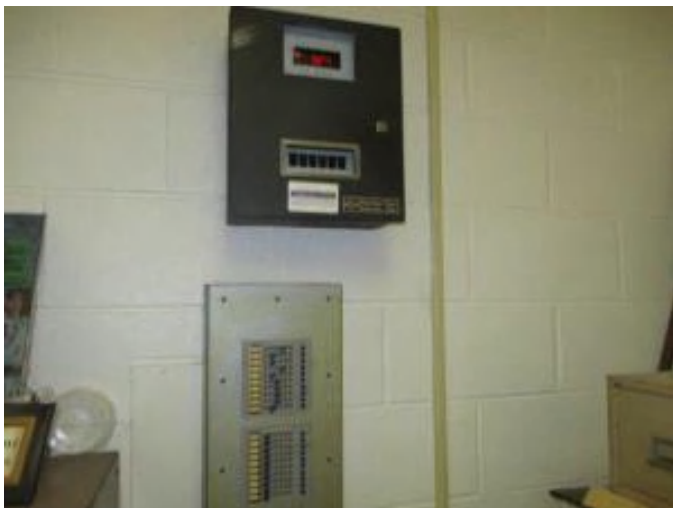
Location: Entire Building

System: D5030 - Communications and Security

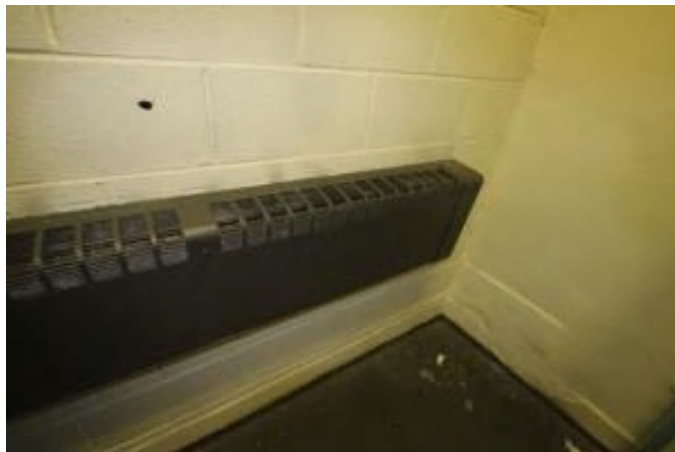
Location: Toilet rooms, storage areas

System: D3040 - Distribution Systems

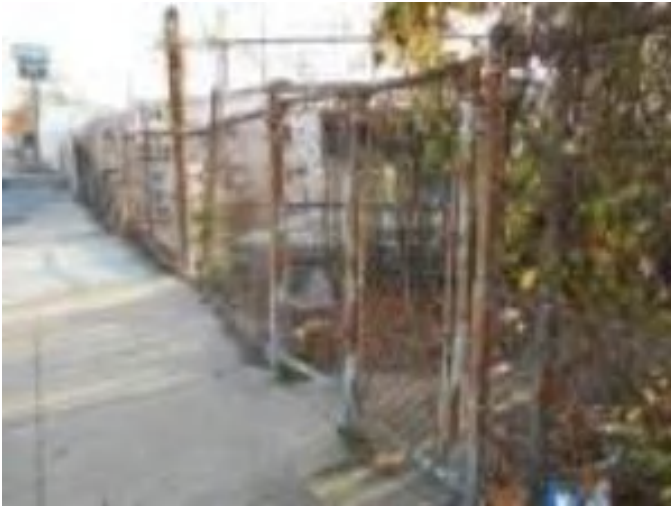
Location: Playground fence

System: G2040 - Site Development

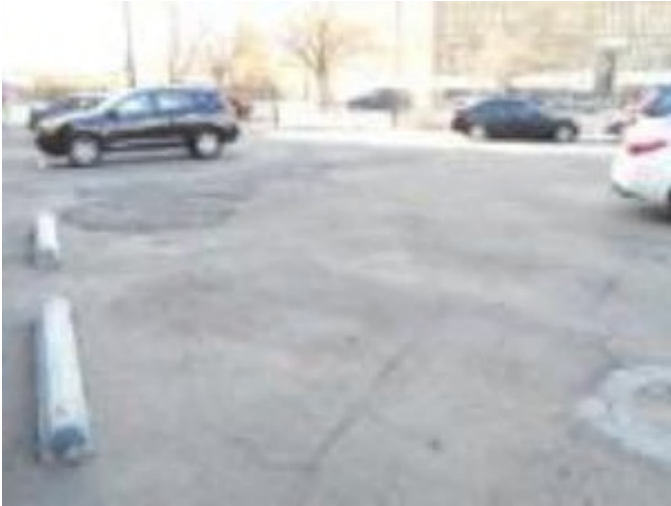
Location: Parking Lot

System: G2020 - Parking Lots
