Facility Condition Assessment Summary Report

Harrity School

School District of Philadelphia
S131001;Harrity
Final
Site Assessment Report

February 1, 2017

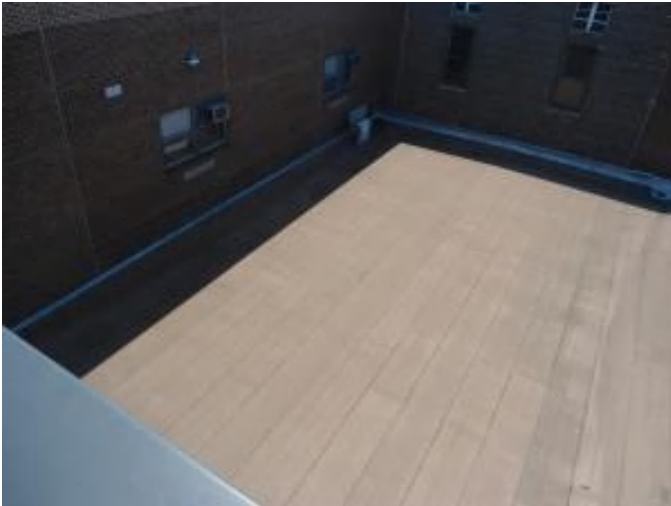
System: B3010105 - Built-Up

The built up roof was installed within the past ten years as reported by the school. The roof is in very good condition with one exception. Currently, there is an active leak over room 411 that, if not repaired soon, will start to deteriorate the insulation and the integrity of the classroom finishes. This deficiency provides a budgetary consideration for built up roof repair for this section.

Location: Roof

Distress: Damaged

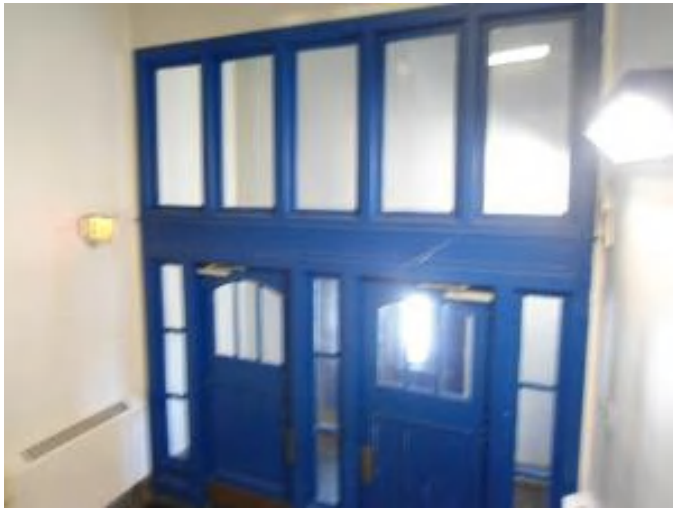
System: C1010 - Partitions

Location: Exit Stairs

Distress: Life Safety / NFPA / PFD

Notes: A large portion of the interior corridor, exit stair doors are code compliant with both ADA and are fire rated. However, several interior doors are typically wood in wood frames with transom lites or sidelights, glass glazing. The entrance doors to the lobby from the main entrance and the stair entrance to the common area are good examples of the interior system needs. The older doors are generally in good condition considering the age of the application. To restore the door finishes, universal upgrades are required for the older door applications. Remove and replace original door systems.

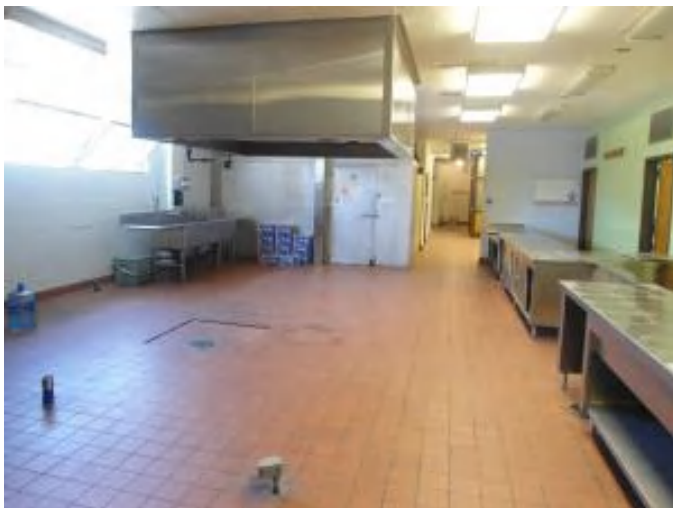
System: C3020412 - Terrazzo & Tile

Location: Kitchen

Distress: Damaged

Notes: The tile application in the kitchen area is damaged in several places. As indicated in the photo some of the finish has been removed revealing the deck finish only. This deficiency provides a budgetary consideration for the repairs and replacement of the damaged kitchen tile finish.

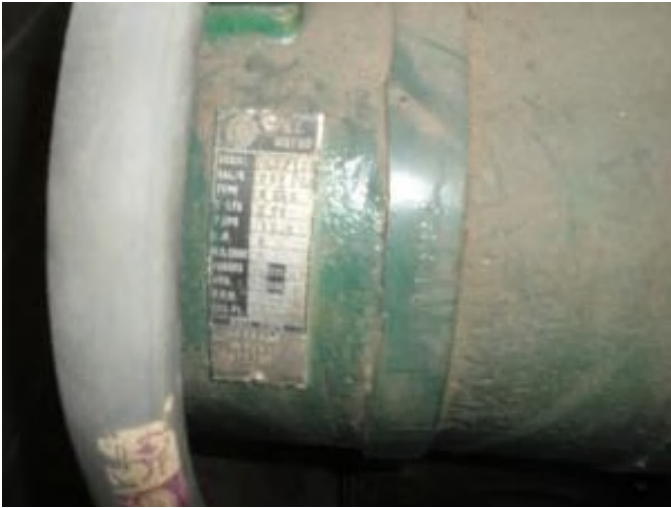
System: D1010 - Elevators and Lifts

Location: Northwest Elevator

Distress: Beyond Service Life

Notes: Provide upgrade and modernization of elevator cab, controls and machine room for freight elevator.

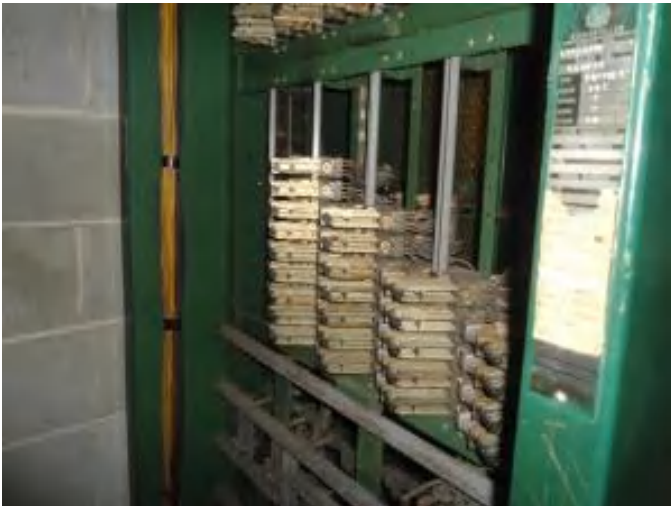
System: D1010 - Elevators and Lifts

Location: Southwest Elevator

Distress: Beyond Service Life

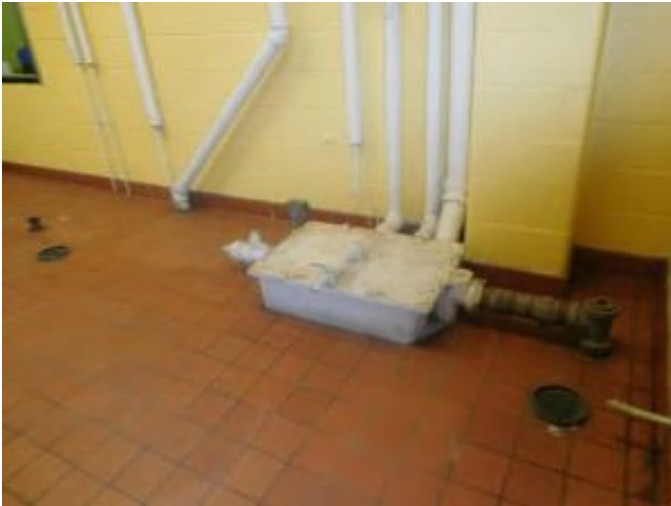
System: D2020 - Domestic Water Distribution

Location: entire building

Distress: Beyond Service Life

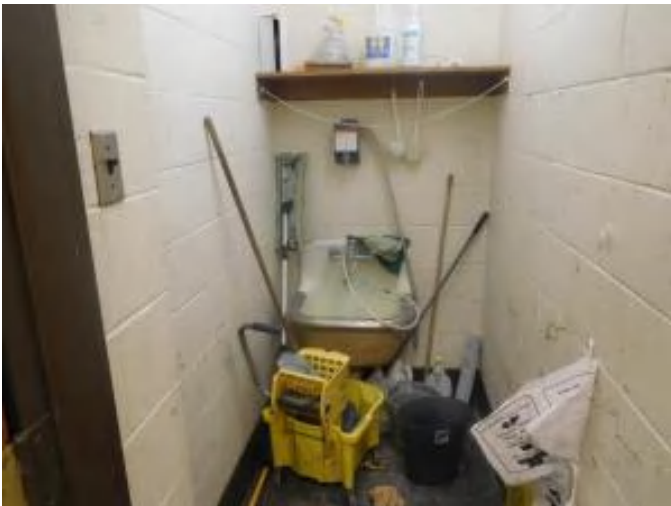
System: D2030 - Sanitary Waste

Location: entire building

Distress: Beyond Service Life

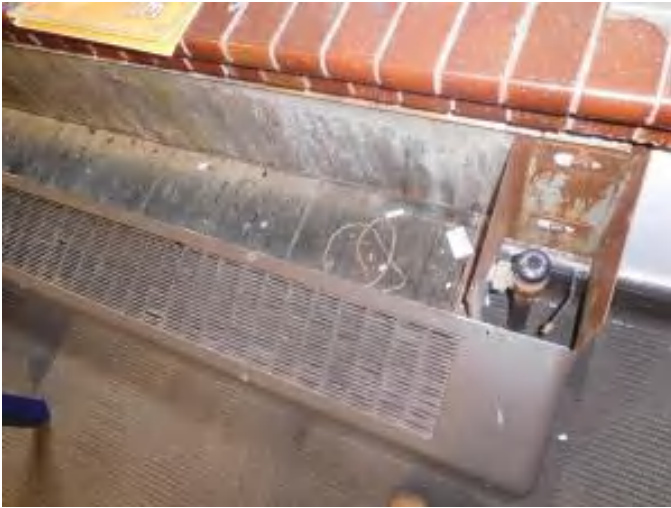
System: D3040 - Distribution Systems

Location: entire building
Distress: Inadequate
Category: 4 - Capital Improvement
Priority: 3 - Response Time (3-4 yrs)
Correction: Provide classroom FC units and dedicated OA ventilation system. (20 clsrms)
Qty: 45.00
Unit of Measure: C
Estimate: \$3,737,744.54
Assessor Name: System
Date Created: 09/01/2015

Notes: Provide a four pipe fan coil system with roof mounted outside air system ducted to each fan coil unit. Provide a fan coil unit for each classroom and separate area. Include new heat exchanger and pump for hot water, piping, control valves and controls.

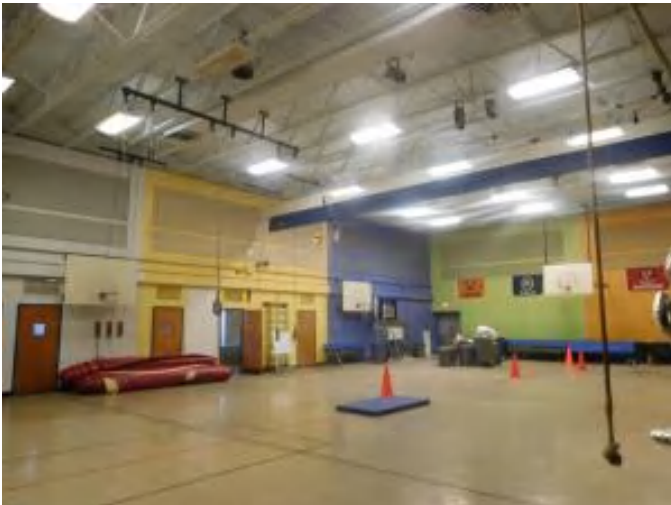
System: D3040 - Distribution Systems

Location: multipurpose room
Distress: Inadequate
Category: 4 - Capital Improvement
Priority: 3 - Response Time (3-4 yrs)
Correction: Install HVAC unit for Cafeteria (850 students).
Qty: 500.00
Unit of Measure: Pr.
Estimate: \$233,767.42
Assessor Name: System
Date Created: 09/01/2015

Notes: Provide a new central station air handling unit for the multipurpose room with hot and chilled water coils, filters, outside and return air dampers, hydronic valves and controls, blower and motor. Connect to hot and chilled water systems.

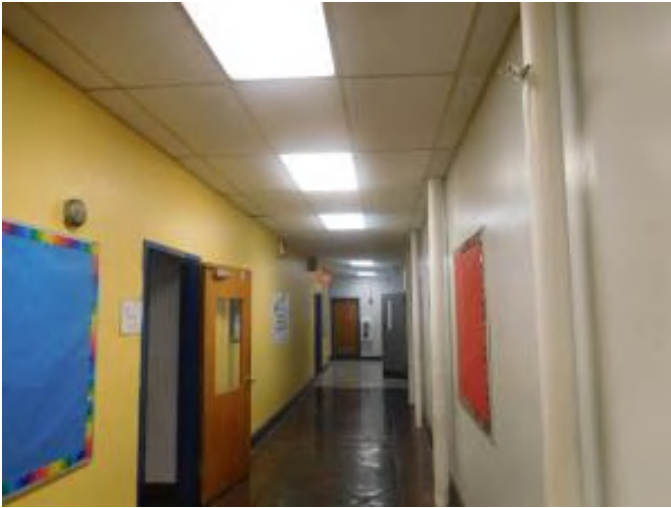
System: D4010 - Sprinklers

Location: entire building

Distress: Life Safety / NFPA / PFD

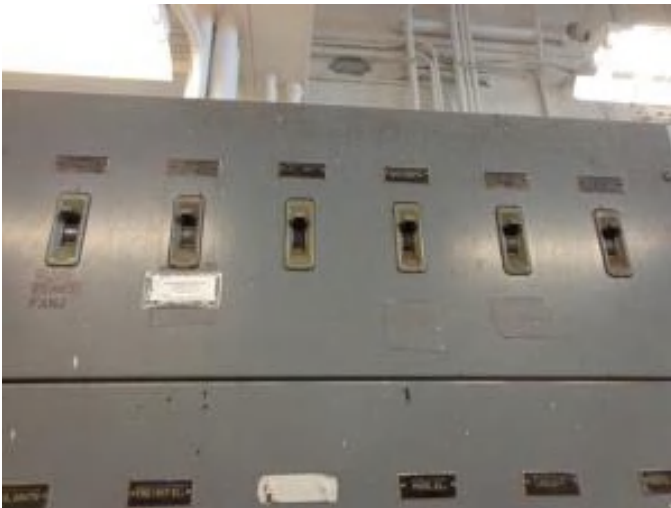
System: D5010 - Electrical Service/Distribution

Location: Boiler Room

Distress: Beyond Service Life

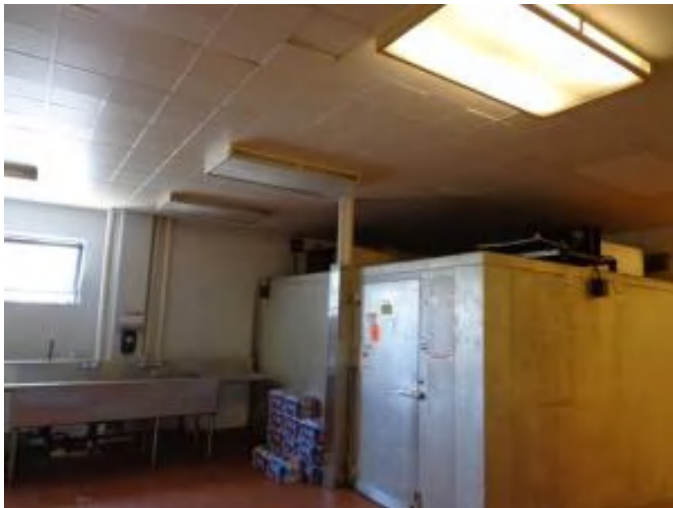
System: D5020 - Lighting and Branch Wiring

Location: Various rooms
Distress: Beyond Service Life
Category: 3 - Operations / Maint.
Priority: 3 - Response Time (3-4 yrs)
Correction: Replace Lighting Fixtures (SF)
Qty: 1,500.00
Unit of Measure: S.F.
Estimate: \$31,941.41
Assessor Name: System
Date Created: 08/12/2015

Notes: Provide an allowance for lighting fixture replacement for approximately 1500 SF, mainly in the Floor 1 teachers lounge, kitchen area, platform in the Multi-Purpose Room, and some storage areas.

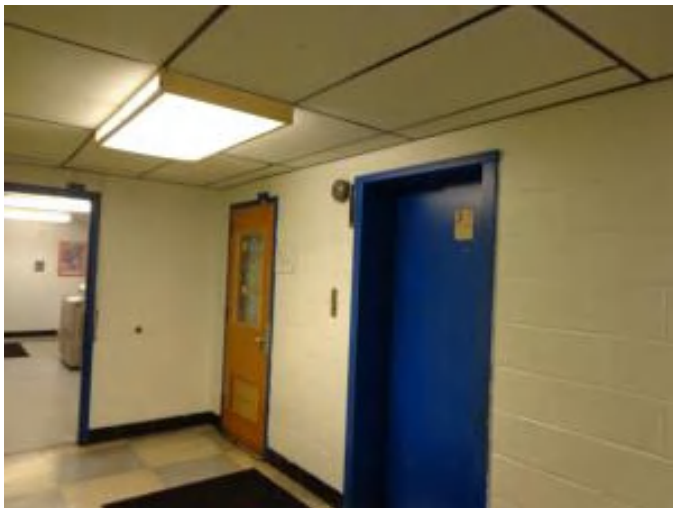
System: D5030 - Communications and Security

Location: Entire Building
Distress: Life Safety / NFPA / PFD
Category: 1 - Health & Safety
Priority: 3 - Response Time (3-4 yrs)
Correction: Add fire alarm device
Qty: 1.00
Unit of Measure: Ea.
Estimate: \$94,823.74
Assessor Name: System
Date Created: 08/12/2015

Notes: Replace fire alarm control panel and provide notification appliances in all classrooms, secondary dining Room 118, Teachers' Dining Room 243, kitchen, and infirmary. Provide smoke detectors in elevator lobbies, and smoke and heat detectors in elevator machine rooms for elevator recall.

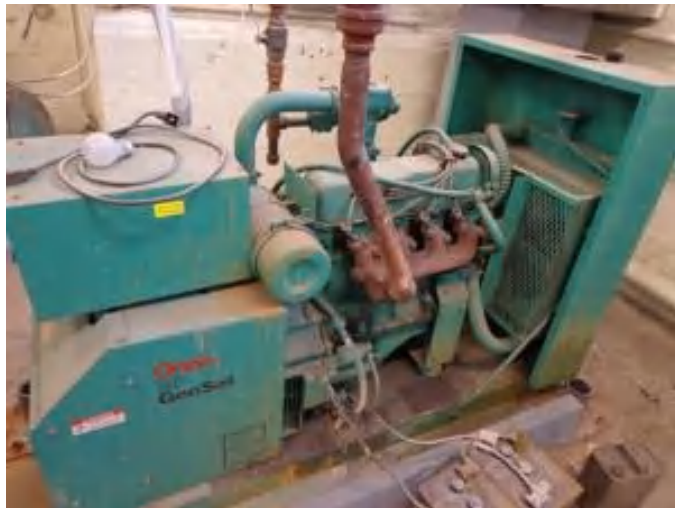
System: D5090 - Other Electrical Systems

Location: Boiler Room

Distress: Beyond Service Life

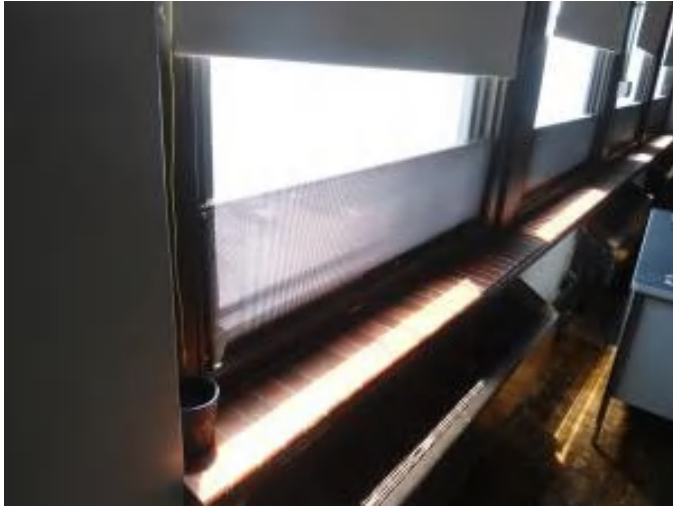
System: B2020 - Exterior Windows

Exterior windows have been upgraded from the original applications with the exception of the roof mechanical windows. The current aluminum framed system is estimated to have been installed in the 1990's; however, several of the original wooden windows are still present. Several windows no longer work and will require attention prior to an overall effort. Windows are in fair condition based on the year of installation or last renovation. It is recommended that the exterior window system be replaced with units that retain their dimensions and profiles, but that incorporate updated energy-efficient features.

Location: Exterior Elevation

Distress: Damaged

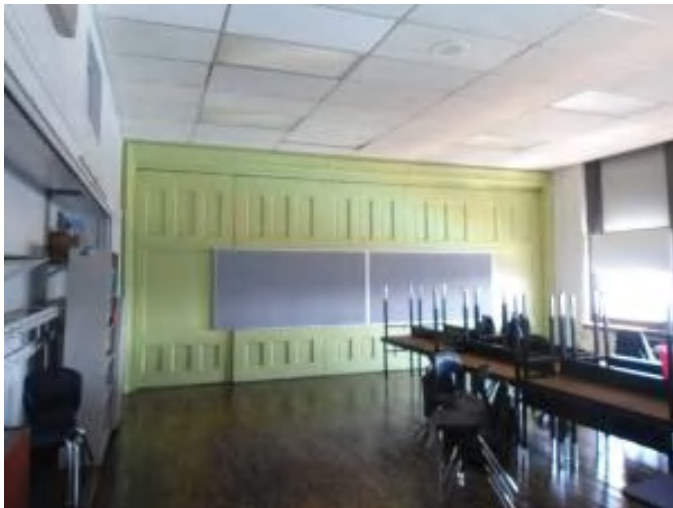
System: C1010 - Partitions

There are several movable partitions that remain in classrooms. These wall systems are no longer used and in most cases cannot be used due to damage or wall modifications to support classroom needs. This deficiency provides a budgetary consideration to remove and replace the wall systems with universal removal of the existing movable partitions and upgrades to a permeate wall systems.

Location: Classrooms

Distress: Damaged

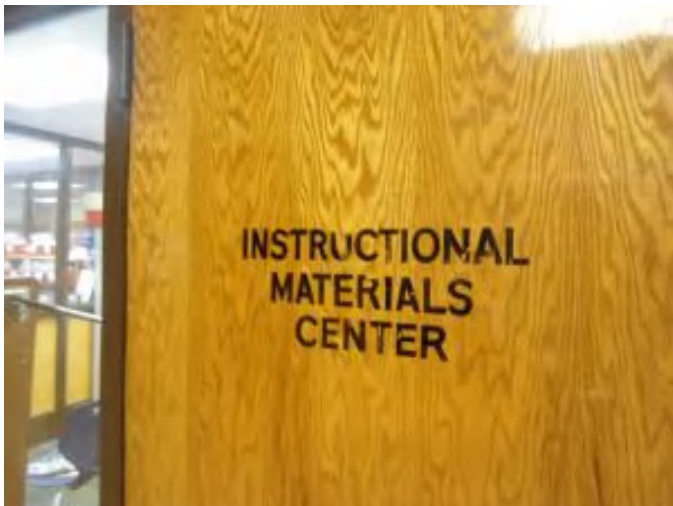
System: C1030 - Fittings

There is no directional signage and room signage is a combination of either printed paper or painted with no consistency. Accessibility signage criteria have been established for the physically challenged. These include mounting heights, contrast and finish, raised and Braille characters and pictograms, and character proportions and heights. It is recommended that compliant signage be installed throughout the building.

Location: Building Wide Signage

Distress: Damaged

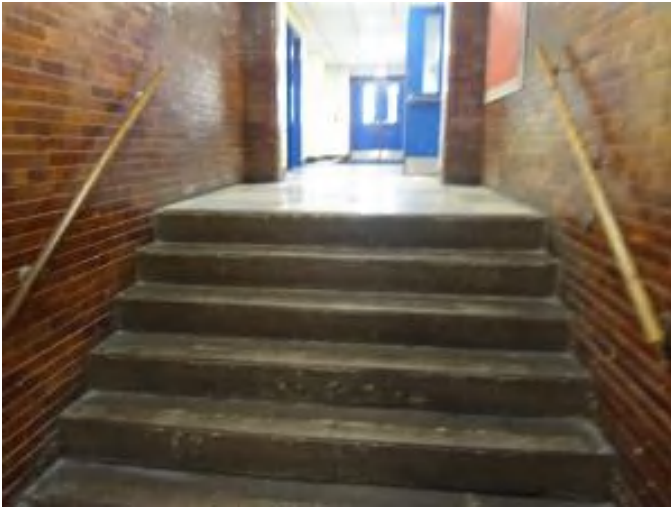
System: C2010 - Stair Construction

Current requirements for stairs indicate that they have graspable handrails on both sides, that the rails have a specific end geometry, and that the handrails continue horizontally at the landings. In addition, guardrails must prevent the passage of a 4 inch diameter sphere (6 inches in the triangle formed by the lower rail and tread/riser angle). Although the stairs are compliant with the code enforced at the time of construction until a major renovation occurs, they are deficient in handrail and guardrail design relative to current standards. Future efforts should include comprehensive stair railing removal and replacement upgrades.

Location: Stairs

Distress: Life Safety / NFPA / PFD

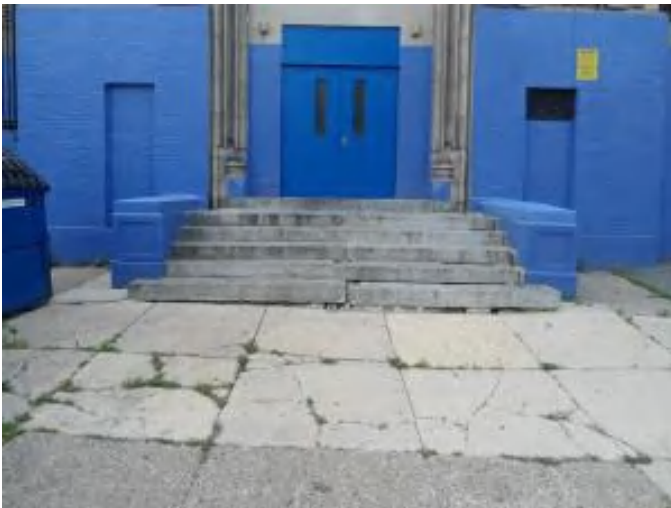
System: C2010 - Stair Construction

The exterior stair at the western exterior elevation is broken and missing sections of concrete. Considering the limited access to the school by those that may be physically challenged, this stair is recommended for universal upgrade. Current legislation related to accessibility requires that building entrances be wheelchair accessible. To comply with the intent of this legislation, it is recommended that a wheelchair ramp be installed at this entrance. This work should include the installation of a powered door operator and steel handrails at all entrances as required.

Location: Exterior Elevation

Distress: Damaged

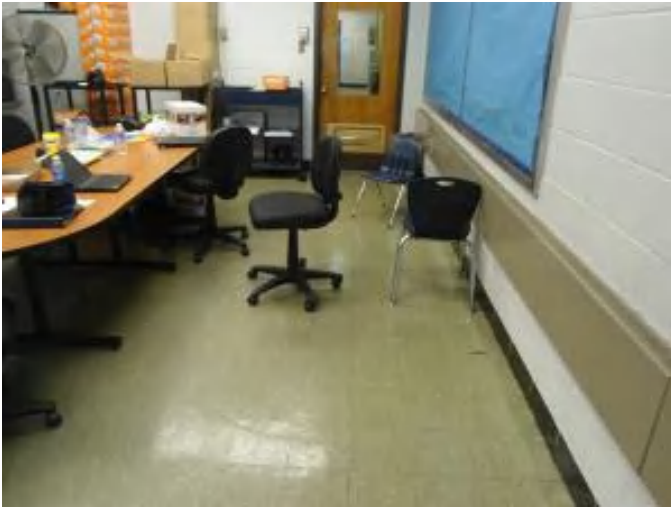
System: C3020413 - Vinyl Flooring

The vinyl floor finish in most of this school is in very good condition and appears to have part of an isolated upgrade. Some of the original flooring that was not a part of that effort consists of a 9x9 finish. This finish is suspect to contain asbestos and is recommended for upgrade. Remove and replace with a 12x12 vinyl tile application.

Location: Building Wide

Distress: Health Hazard / Risk

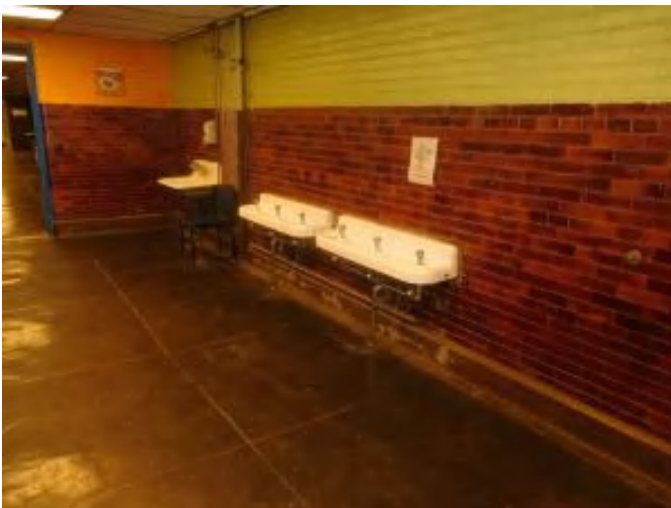
System: D2010 - Plumbing Fixtures

Location: basement corridor

Distress: Beyond Service Life

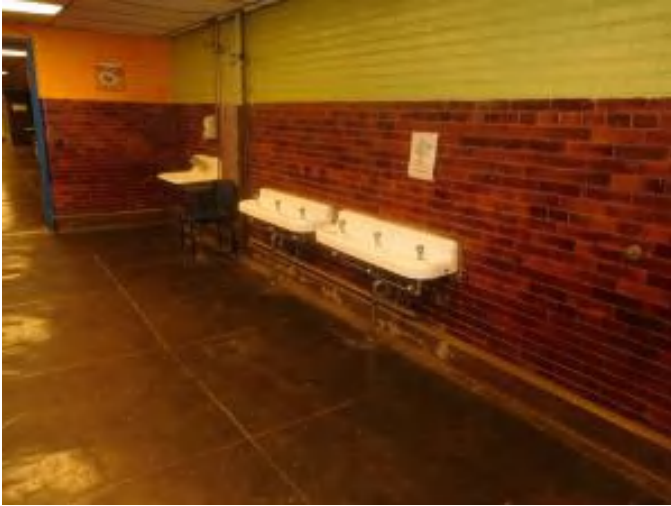
System: D2010 - Plumbing Fixtures

Location: basement

Distress: Beyond Service Life

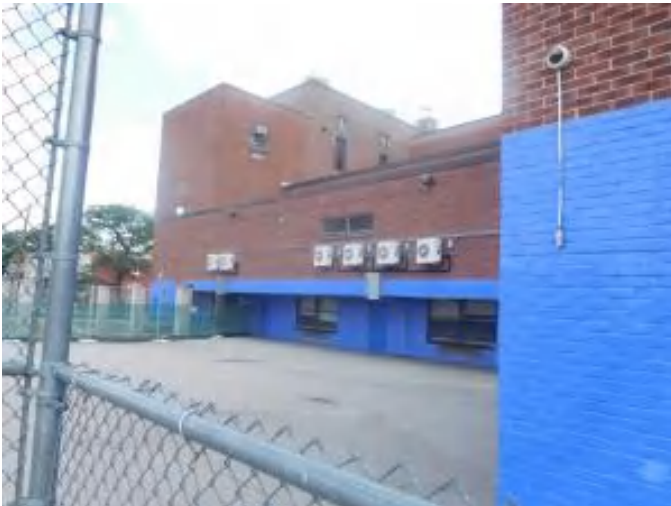
System: D3030 - Cooling Generating Systems

Location: roof,mechanical room

Distress: Inadequate

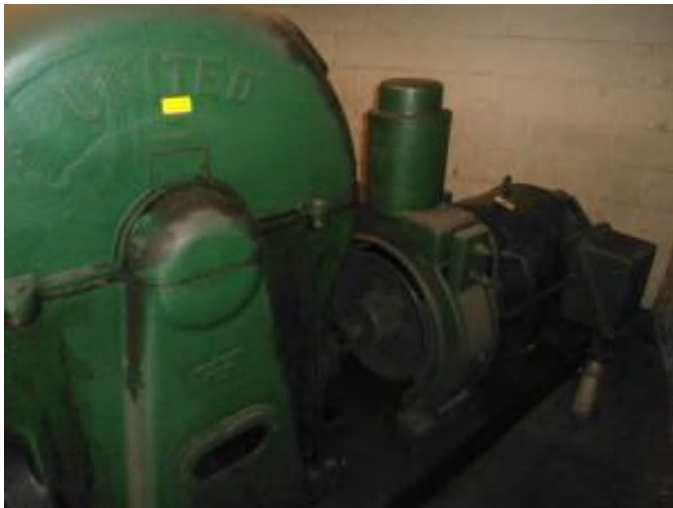
System: D3050 - Terminal & Package Units

Location: roof

Distress: Inadequate

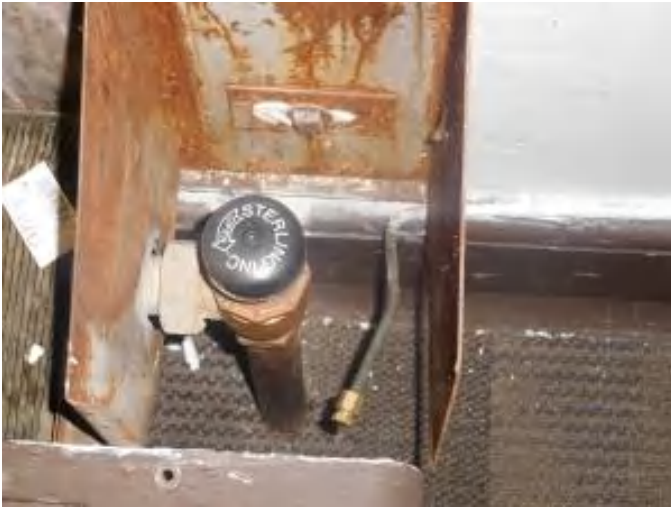
System: D3060 - Controls & Instrumentation

Location: entire building

Distress: Inadequate

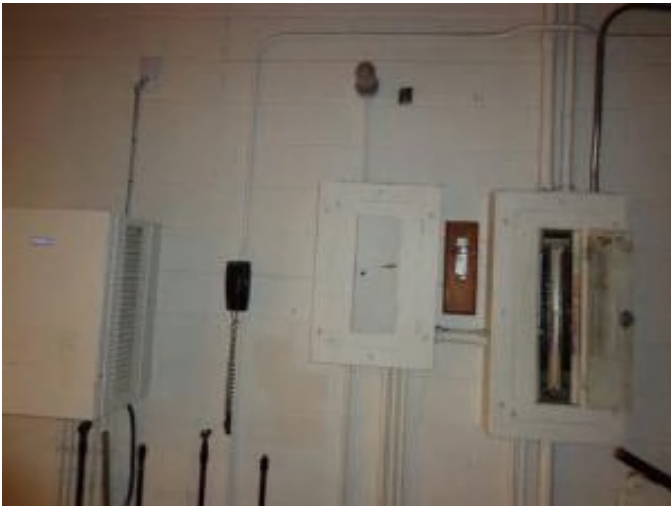
System: D5010 - Electrical Service/Distribution

Location: Corridors - all floors

Distress: Beyond Service Life

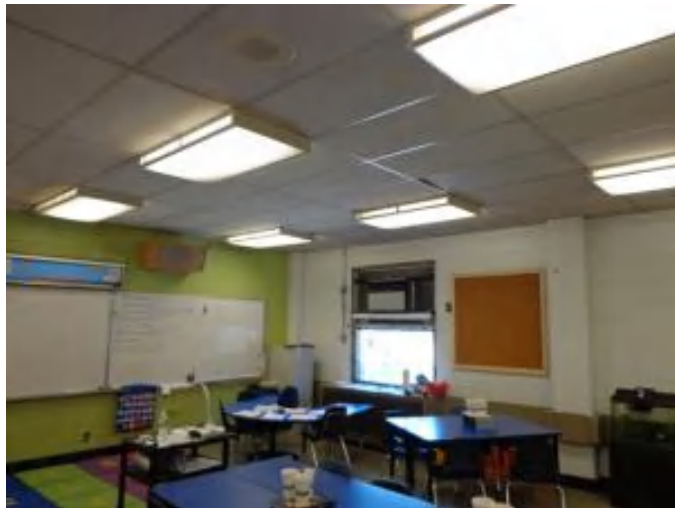
System: D5020 - Lighting and Branch Wiring

Location: Classrooms

Distress: Inadequate

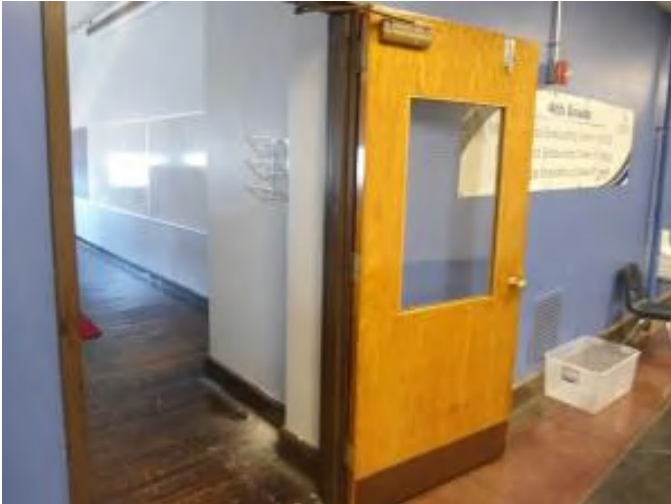
System: C1020 - Interior Doors

Location: Building Wide
Distress: Beyond Service Life
Category: 3 - Operations / Maint.
Priority: 5 - Response Time (> 5 yrs)
Correction: Remove and replace interior doors - wood doors with hollow metal frames - per leaf
Qty: 200.00
Unit of Measure: Ea.
Estimate: \$954,117.42
Assessor Name: System
Date Created: 09/02/2015

Notes: Interior doors include wooden glass pane doors with original wooden pane frames or hollow metal frames. Doors are generally in good condition considering the age of the application. Doors swing in the direction of exit and do not obstruct hallways. Universal upgrades are required for the interior door systems, it is recommended that the interior doors system be removed and replaced with a new modern metal framed hollow metal door system with consideration for ADA compliance.

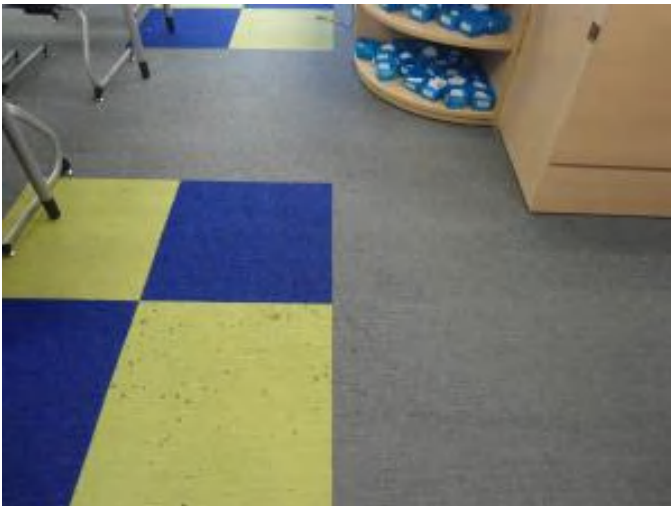
System: C3020411 - Carpet

Location: Classrooms / Library
Distress: Appearance
Category: 3 - Operations / Maint.
Priority: 5 - Response Time (> 5 yrs)
Correction: Remove and replace carpet
Qty: 3,000.00
Unit of Measure: S.F.
Estimate: \$33,572.29
Assessor Name: System
Date Created: 09/02/2015

Notes: The interior carpet finish was installed approximately in 2000 and is in fair condition considering the age and high traffic conditions. This finish will exceeded its expected life within the next five years and is recommended for removal and replacement.

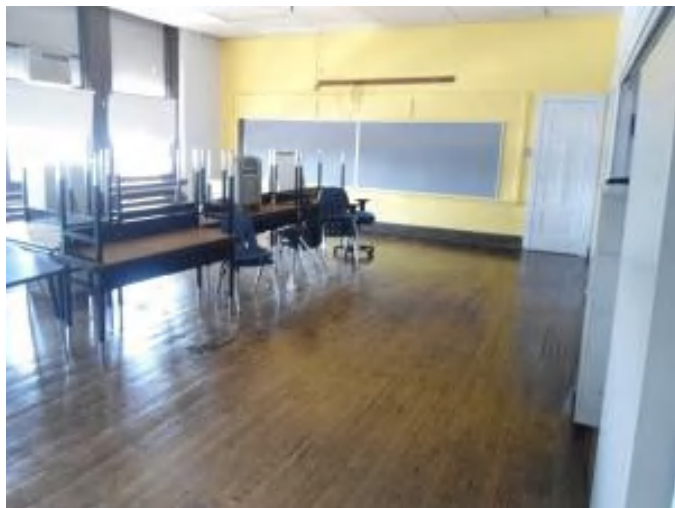
System: C3020414 - Wood Flooring

The classrooms in this school have a wooden floor finish that appears to be from original construction. The system is showing signs of age such as the effects of sanding and refinishing with yearly cleaning and waxing with some repairs. The floor finish is in fair condition however, the finish is beyond its expected life cycle. It is recommended that the wooden floor finish be removed and replaced with an in kind finish.

Location: Building Wide

Distress: Beyond Service Life

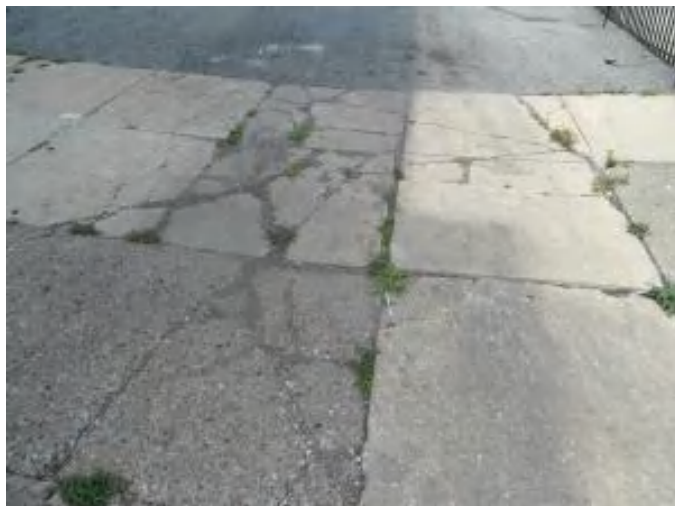
System: G2030 - Pedestrian Paving

Location: Site

Distress: Damaged

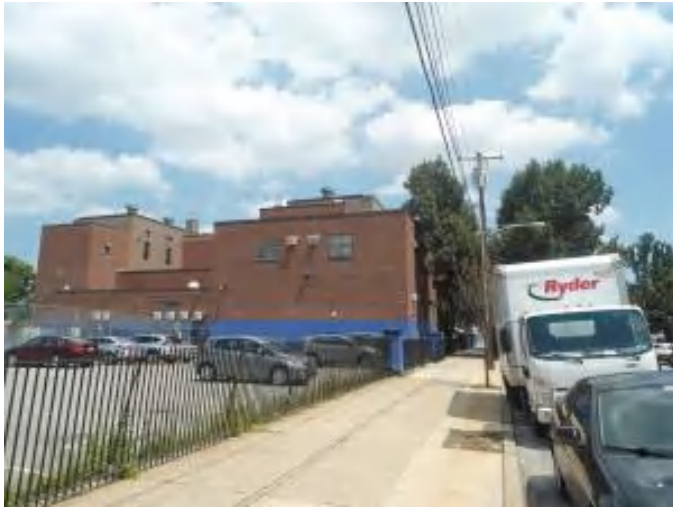
System: G2040 - Site Development

Location: Site

Distress: Damaged

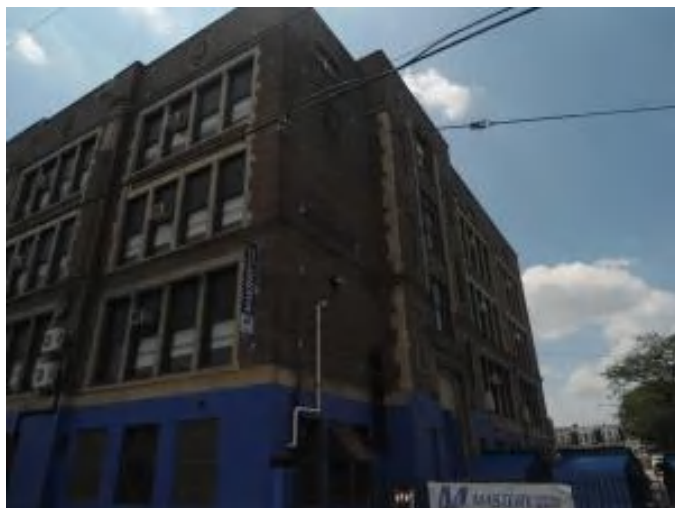
System: G2040 - Site Development

Location: Site

Distress: Health Hazard / Risk
