Facility Condition Assessment Summary Report

Hartranft School

School District of Philadelphia
S532001; Hartranft
Final
Site Assessment Report
January 31, 2017

Site Assessment Report

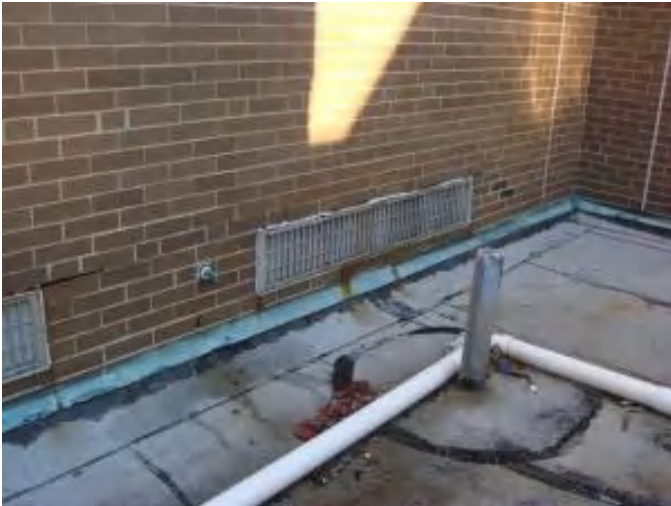
System: B3010105 - Built-Up

Location: Exterior

Distress: Building Envelope Integrity

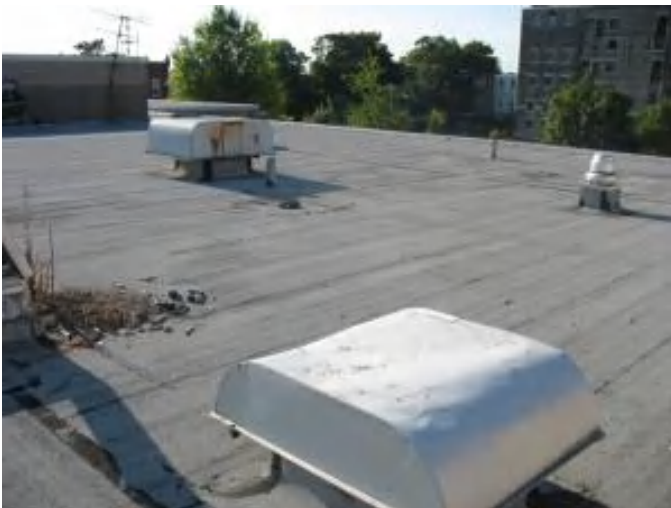
System: D3040 - Distribution Systems

Location: Roof

Distress: Failing

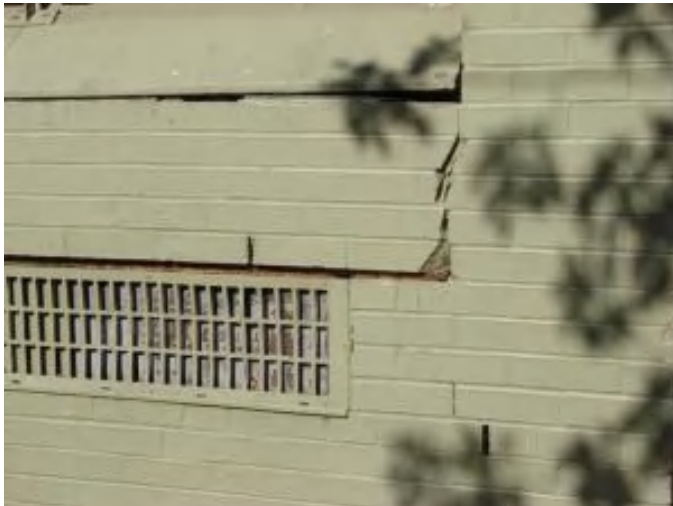
System: B2010 - Exterior Walls

Location: Exterior

Distress: Building Envelope Integrity

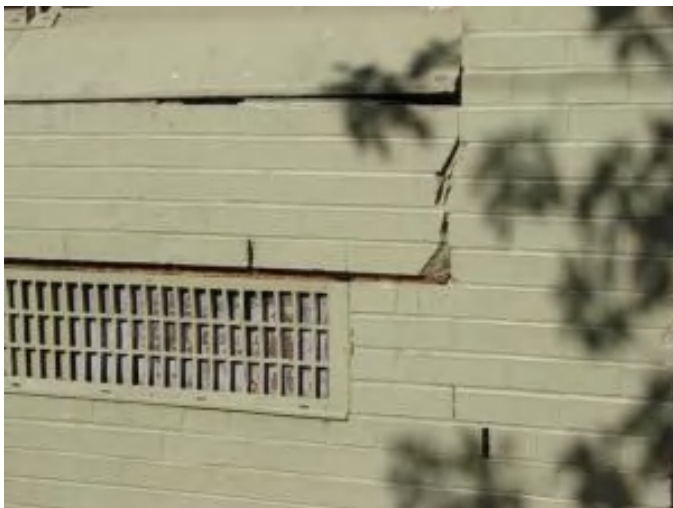
System: B2010 - Exterior Walls

Location: Exterior

Distress: Building Envelope Integrity

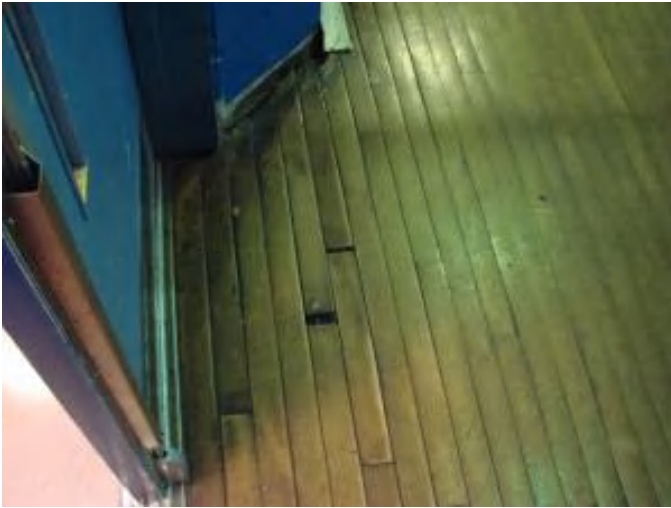
System: C3020414 - Wood Flooring

Location: Interior
Distress: Damaged
Category: 3 - Operations / Maint.
Priority: 2 - Response Time (2-3 yrs)
Correction: Remove and replace wood flooring
Qty: 6,400.00
Unit of Measure: S.F.
Estimate: \$186,573.25
Assessor Name: Craig Anding
Date Created: 12/17/2015

Notes: Repair and refinish hardwood flooring in gym

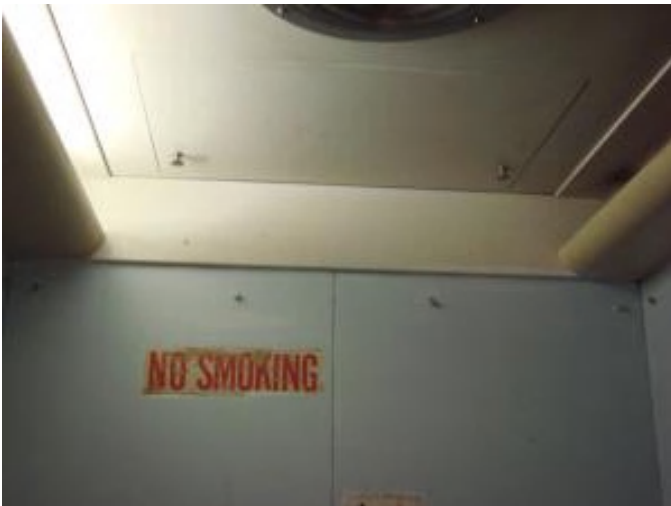
System: D1010 - Elevators and Lifts

Location: Interior
Distress: Accessibility
Category: 2 - Code Compliance
Priority: 2 - Response Time (2-3 yrs)
Correction: Add interior elevator - 4 floors - adjust the electrical run lengths to hook up the elevator
Qty: 1.00
Unit of Measure: Ea.
Estimate: \$670,322.07
Assessor Name: Craig Anding
Date Created: 12/17/2015

Notes: Replace existing 1200# traction elevator with new 2500# elevator

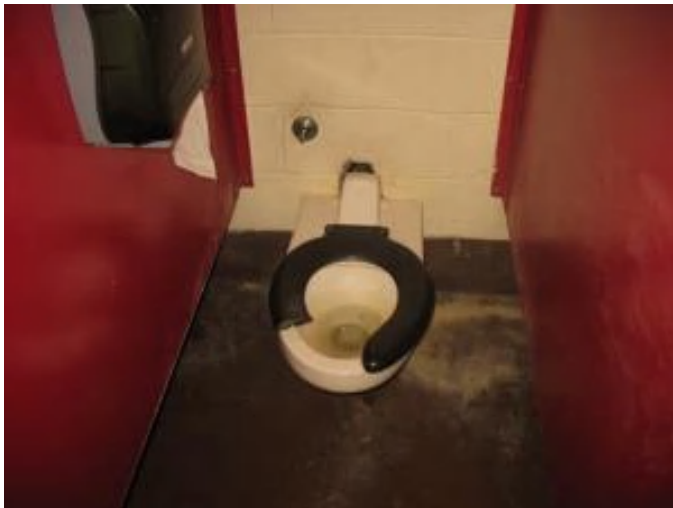
System: D2010 - Plumbing Fixtures

Location: Restrooms
Distress: Beyond Service Life
Category: 3 - Operations / Maint.
Priority: 2 - Response Time (2-3 yrs)
Correction: Remove and replace or replace water closet - quantify additional units
Qty: 15.00
Unit of Measure: Ea.
Estimate: \$111,932.22
Assessor Name: Craig Anding
Date Created: 09/29/2015

Notes: Replace fifteen (15) water closets, in use beyond their service life, with new code compliant fixtures.

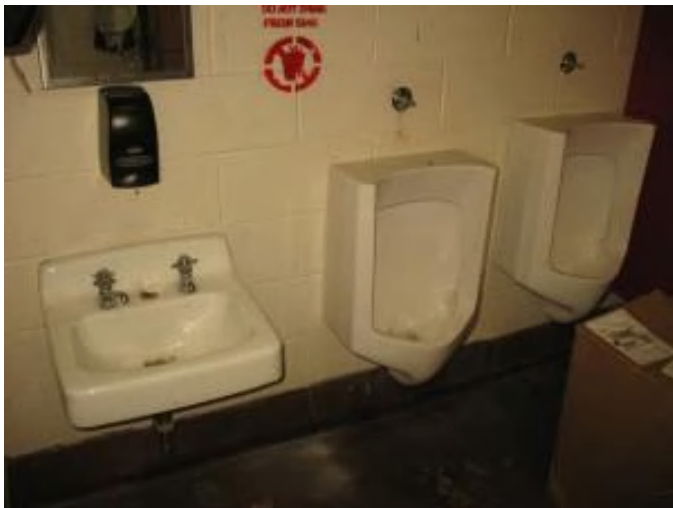
System: D2010 - Plumbing Fixtures

Location: Restrooms
Distress: Beyond Service Life
Category: 3 - Operations / Maint.
Priority: 2 - Response Time (2-3 yrs)
Correction: Remove and replace or replace wall hung urinals
Qty: 10.00
Unit of Measure: Ea.
Estimate: \$33,424.38
Assessor Name: Craig Anding
Date Created: 09/29/2015

Notes: Replace ten (10) urinals, in use beyond their service life, with new low flow fixtures.

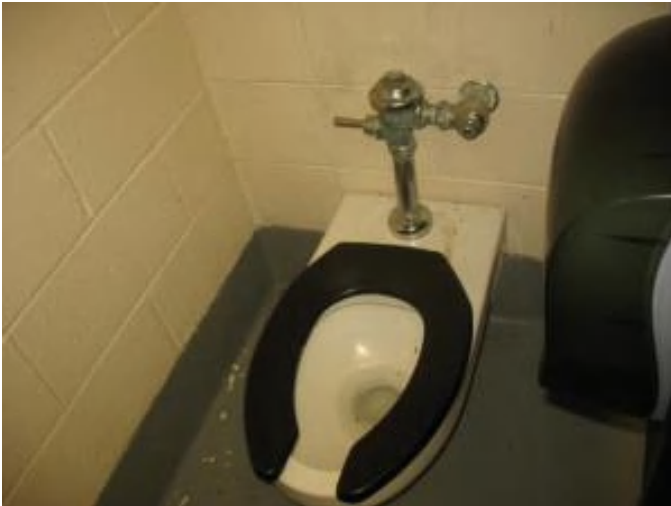
System: D2010 - Plumbing Fixtures

Location: Restrooms

Distress: Beyond Service Life

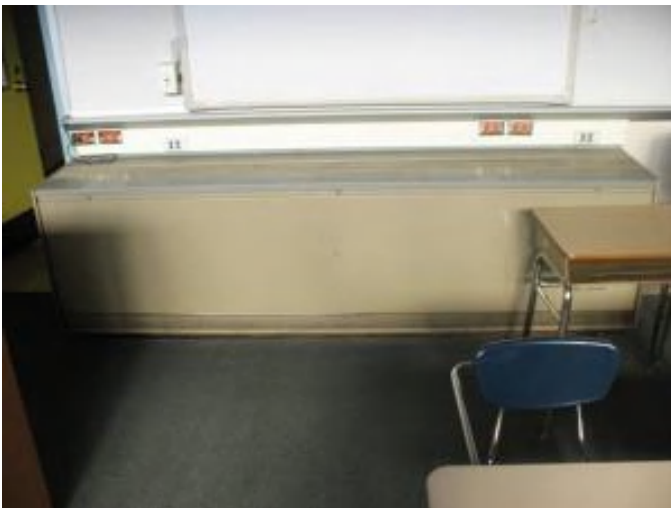
System: D3040 - Distribution Systems

Location: Classrooms

Distress: Beyond Service Life

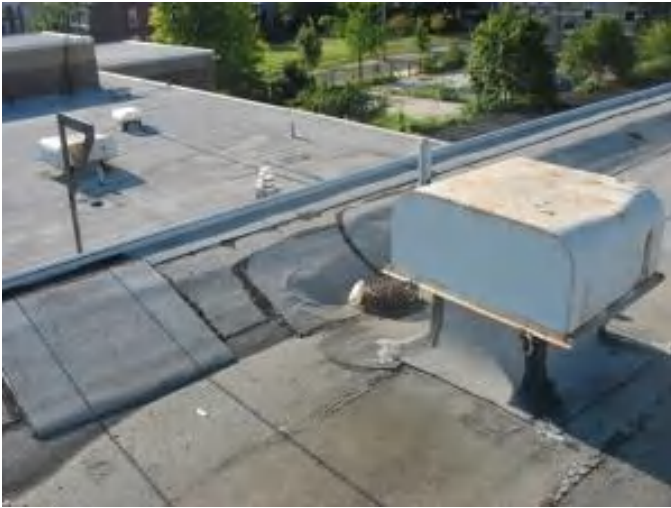
System: D3040 - Distribution Systems

Location: Roof
Distress: Damaged
Category: 3 - Operations / Maint.
Priority: 2 - Response Time (2-3 yrs)
Correction: Replace power roof ventilator (24" dia.)
Qty: 20.00
Unit of Measure: Ea.
Estimate: \$606,572.03
Assessor Name: Craig Anding
Date Created: 09/29/2015

Notes: Replace the twenty (20) existing roof mounted power ventilators, many of which are damaged, and utilize the existing ductwork.

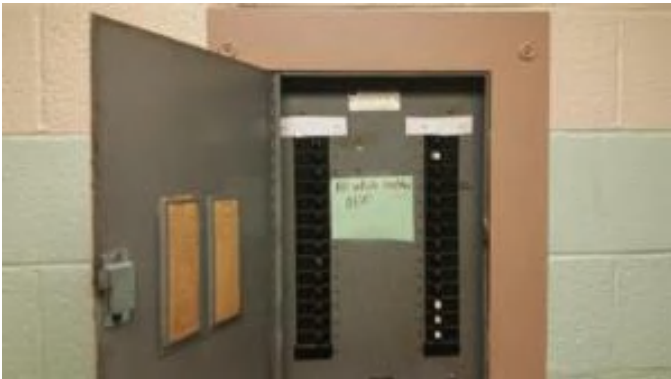
System: D5010 - Electrical Service/Distribution

Location: throughout the building
Distress: Beyond Service Life
Category: 3 - Operations / Maint.
Priority: 2 - Response Time (2-3 yrs)
Correction: Remove and Replace Panelboard - 400 amp
Qty: 1.00
Unit of Measure: Ea.
Estimate: \$329,407.02
Assessor Name: Craig Anding
Date Created: 09/29/2015

Notes: Replace existing old 120V panel-boards

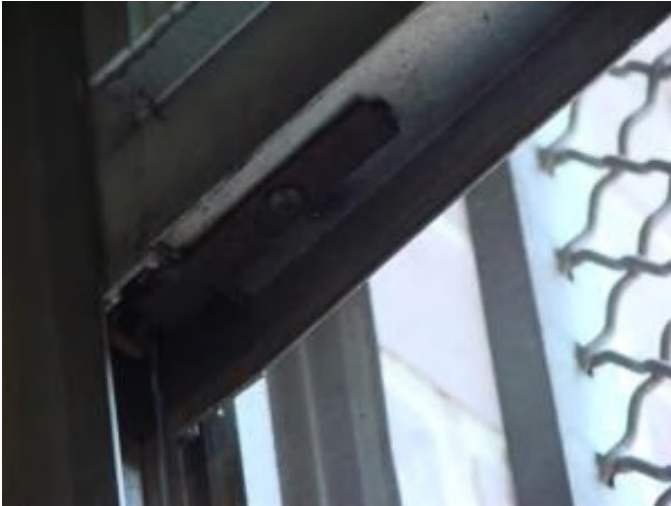
System: B2020 - Exterior Windows

Location: Exterior

Distress: Beyond Service Life

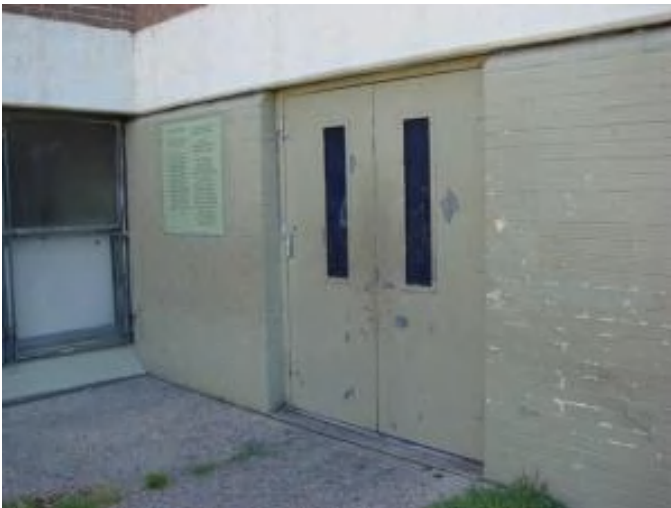
System: B2030 - Exterior Doors

Location: Exterior

Distress: Beyond Service Life

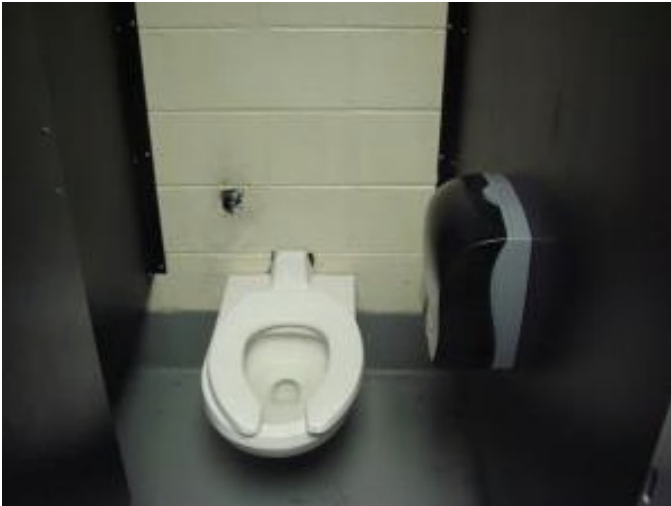
System: C1030 - Fittings

Location: Interior
Distress: Building / MEP Codes
Category: 2 - Code Compliance
Priority: 3 - Response Time (3-4 yrs)
Correction: Remove and replace damaged toilet partitions - handicap units
Qty: 25.00
Unit of Measure: Ea.
Estimate: \$81,197.93
Assessor Name: Craig Anding
Date Created: 12/17/2015

Notes: Replace non-ADA compliant toilet partitions; reconfigure remaining toilet partitions

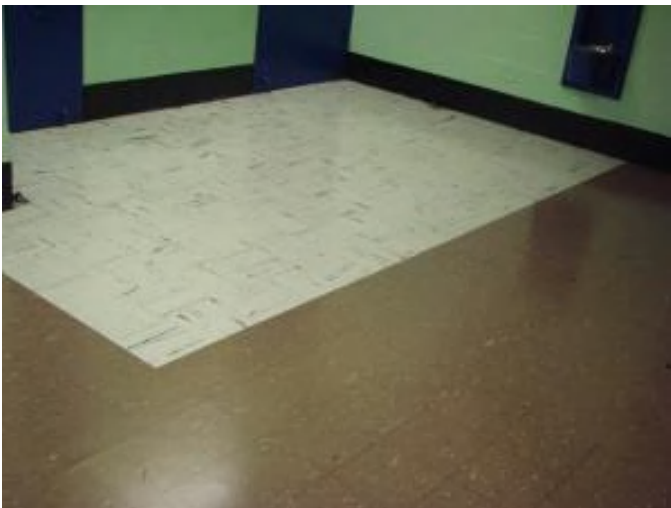
System: C3020413 - Vinyl Flooring

Location: Interior
Distress: Health Hazard / Risk
Category: 1 - Health & Safety
Priority: 3 - Response Time (3-4 yrs)
Correction: Remove VAT and replace with VCT - SF of area
Qty: 49,200.00
Unit of Measure: S.F.
Estimate: \$746,200.07
Assessor Name: Craig Anding
Date Created: 12/17/2015

Notes: Replace VCT/VAT tile throughout the building

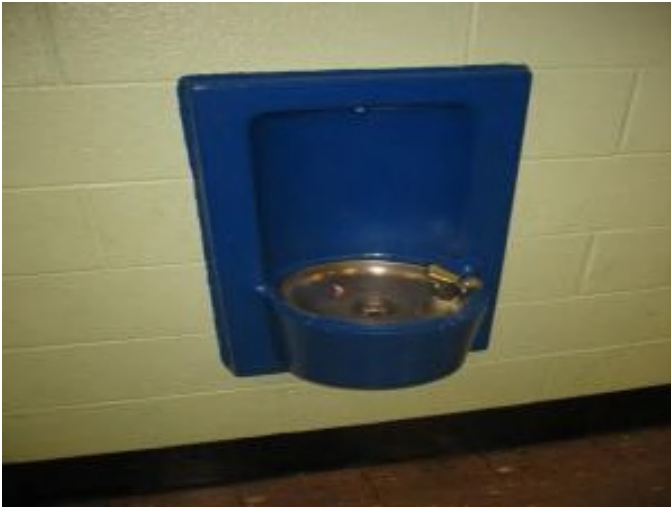
System: D2010 - Plumbing Fixtures

Location: Corridors
Distress: Beyond Service Life
Category: 3 - Operations / Maint.
Priority: 3 - Response Time (3-4 yrs)
Correction: Remove and Replace Water Fountains - without ADA new recessed alcove
Qty: 6.00
Unit of Measure: Ea.
Estimate: \$45,475.14
Assessor Name: Craig Anding
Date Created: 09/29/2015

Notes: Replace six (6) wall hung drinking fountains and integral refrigerated coolers in the corridors. These units are well beyond their service life and most are NOT accessible type.

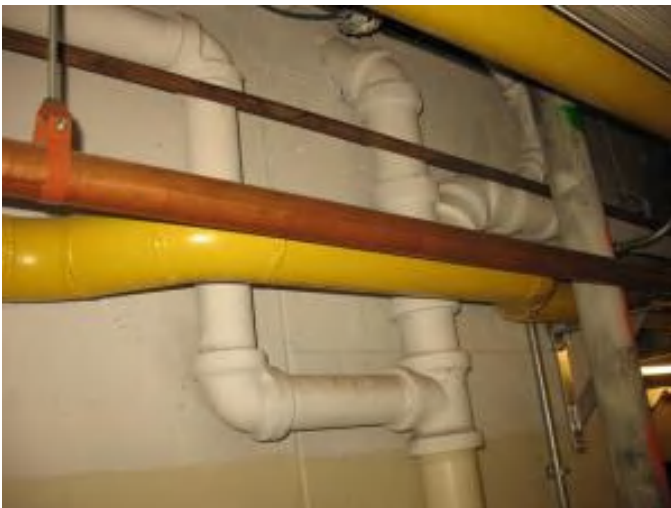
System: D2030 - Sanitary Waste

Location: Throughout building
Distress: Beyond Service Life
Category: 3 - Operations / Maint.
Priority: 3 - Response Time (3-4 yrs)
Correction: Inspect sanitary waste piping and replace damaged sections. (+50KSF)
Qty: 85,000.00
Unit of Measure: S.F.
Estimate: \$416,988.77
Assessor Name: Craig Anding
Date Created: 09/29/2015

Notes: Hire a qualified contractor to perform a detailed examination of the sanitary waste piping using visual inspection and video cameras to locate and replace any damaged piping and to further quantify the extent of potential failures.

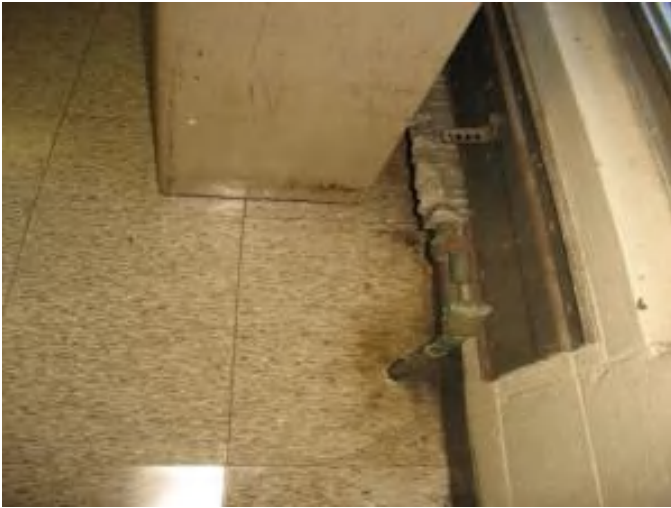
System: D3040 - Distribution Systems

Location: Throughout building

Distress: Beyond Service Life

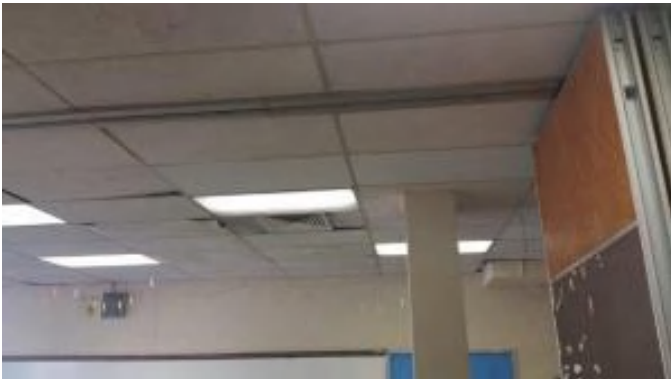
System: D5020 - Lighting and Branch Wiring

Location: throughout the building

Distress: Beyond Service Life

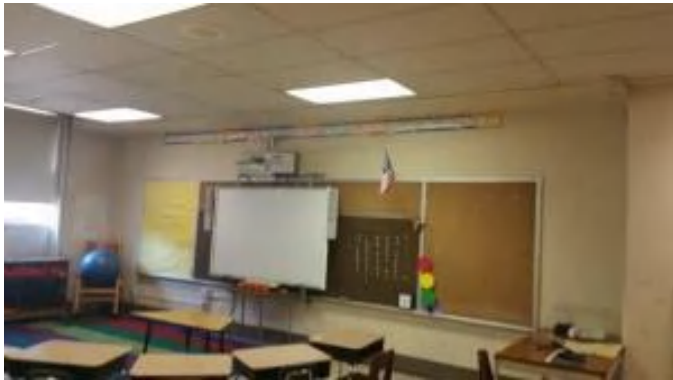
System: D5020 - Lighting and Branch Wiring

Location: throughout the building

Distress: Beyond Service Life

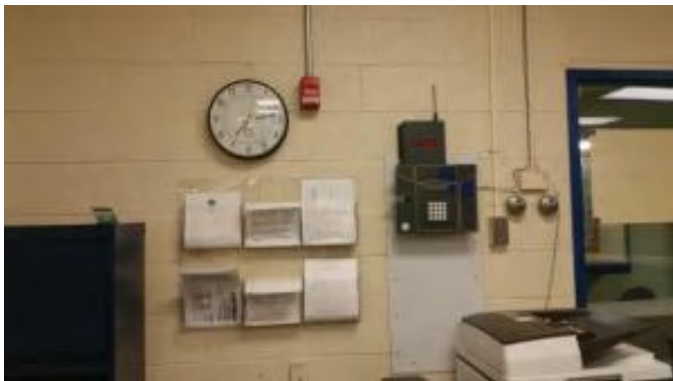
System: D5030 - Communications and Security

Location: throughout the building

Distress: Building / MEP Codes

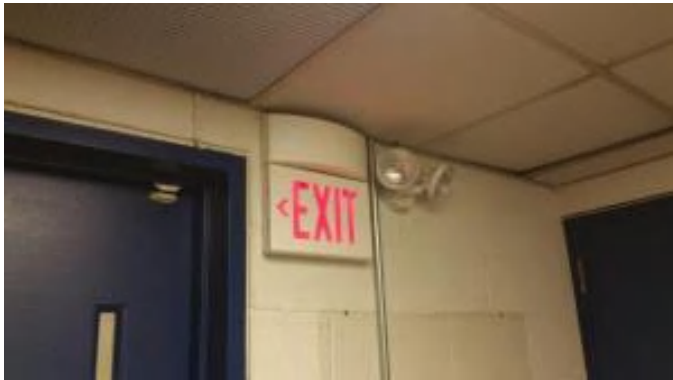
System: D5090 - Other Electrical Systems

Location: throughout the building
Distress: Life Safety / NFPA / PFD
Category: 1 - Health & Safety
Priority: 3 - Response Time (3-4 yrs)
Correction: Add Emergency/Exit Lighting
Qty: 1.00
Unit of Measure: Ea.
Estimate: \$222,869.85
Assessor Name: Craig Anding
Date Created: 09/29/2015

Notes: New emergency exit signs emergency lights

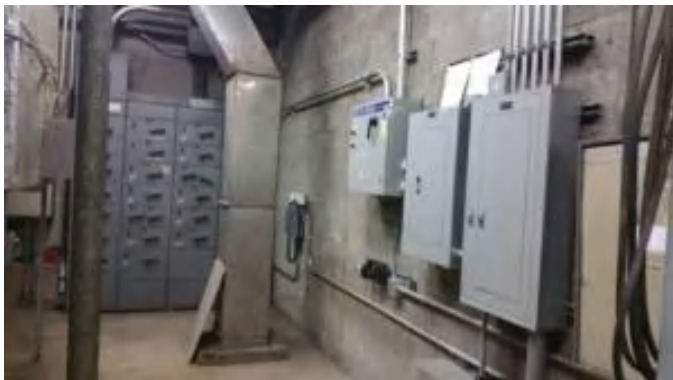
System: D5090 - Other Electrical Systems

Location: electrical room
Distress: Building / MEP Codes
Category: 2 - Code Compliance
Priority: 3 - Response Time (3-4 yrs)
Correction: Replace standby generator system
Qty: 1.00
Unit of Measure: Ea.
Estimate: \$152,774.44
Assessor Name: Craig Anding
Date Created: 09/29/2015

Notes: New 100 KW emergency generator. Notes: a). used 1.2 instead of 1.0 to cover the installation cost for other things. b). since there is no existing generator, I used the picture of the location it can be installed.

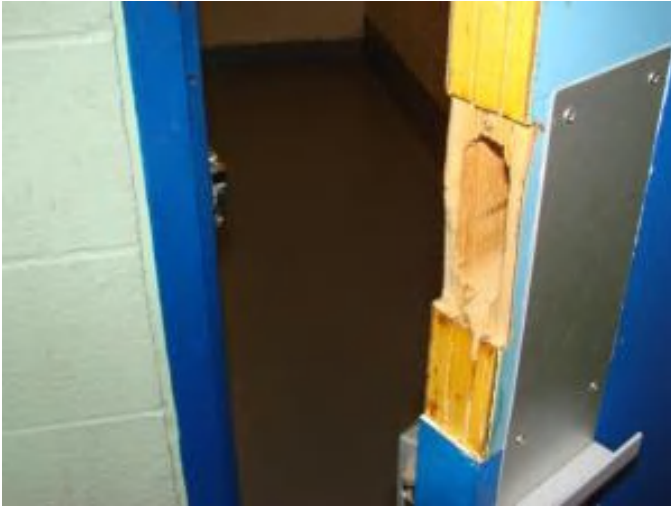
System: C1020 - Interior Doors

Location: Interior

Distress: Beyond Service Life

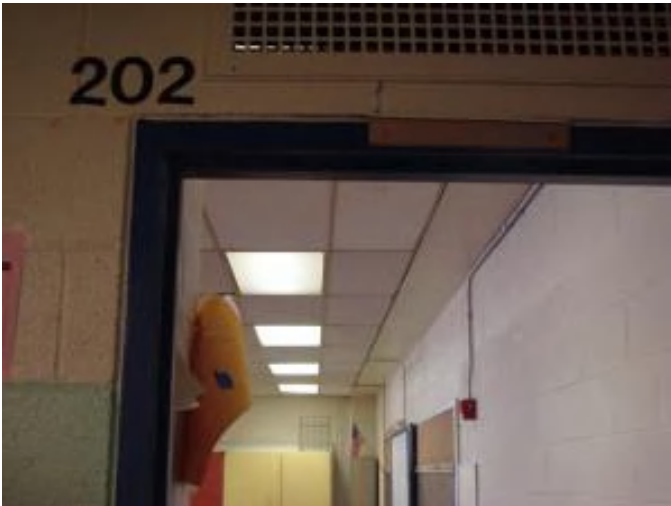
System: C1030 - Fittings

Location: Interior

Distress: Beyond Service Life

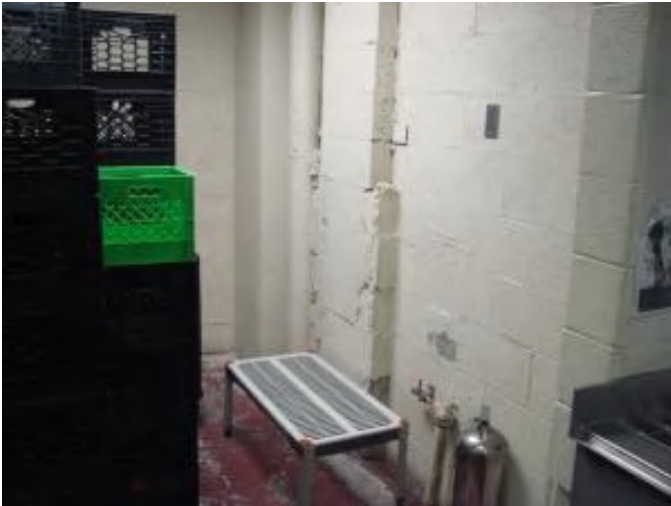
System: C3010230 - Paint & Covering

Location: Interior

Distress: Beyond Service Life

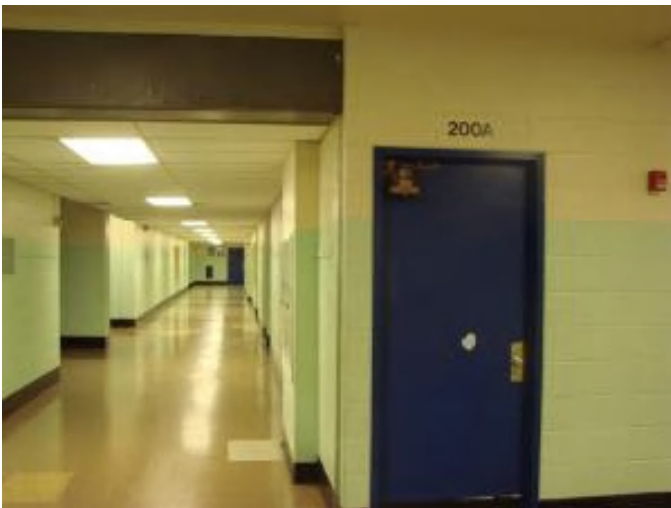
System: C3030 - Ceiling Finishes

Location: Interior

Distress: Beyond Service Life

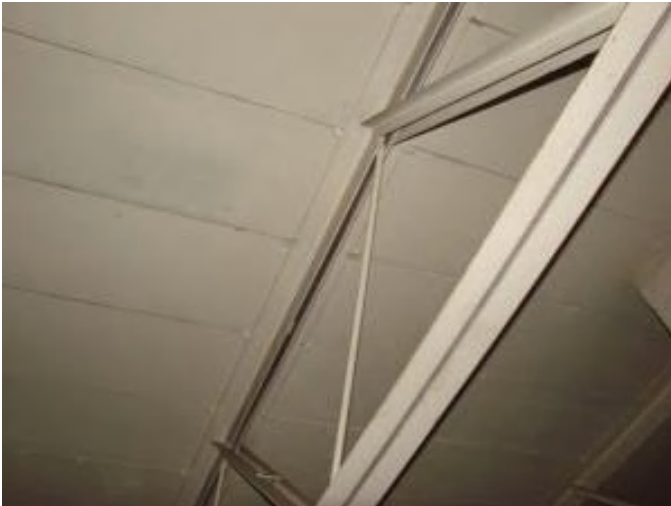
System: C3030 - Ceiling Finishes

Location: Interior

Distress: Beyond Service Life

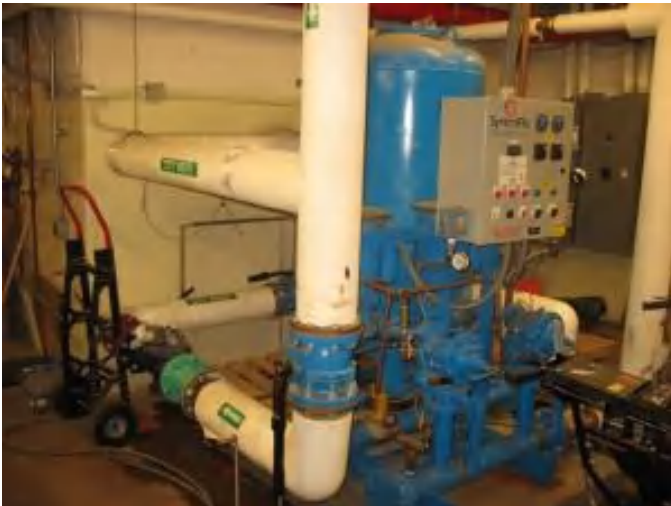
System: D2020 - Domestic Water Distribution

Location: Throughout building

Distress: Beyond Service Life

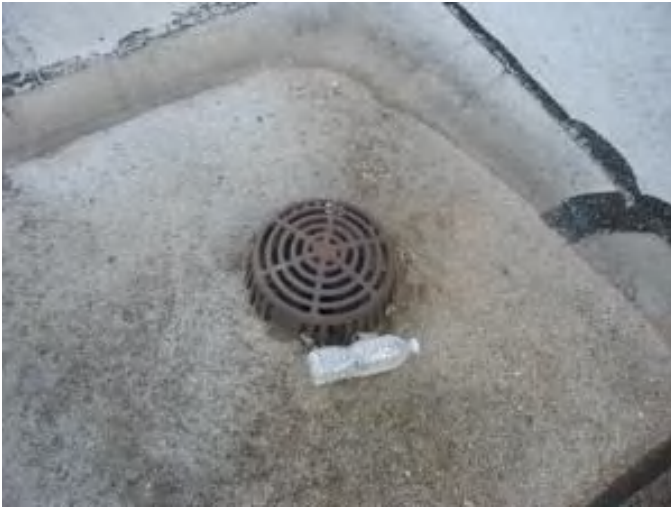
System: D2040 - Rain Water Drainage

Location: Throughout building

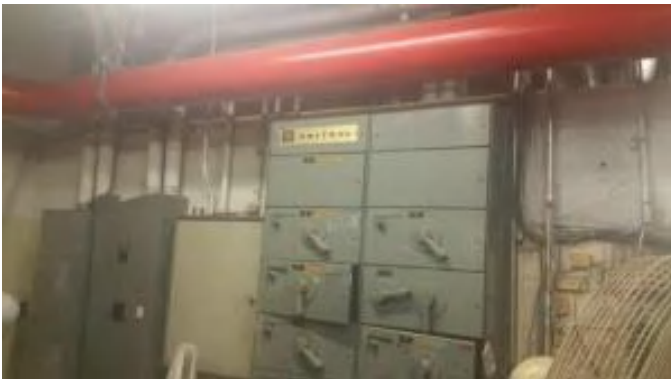
System: D5010 - Electrical Service/Distribution

Location: electrical room

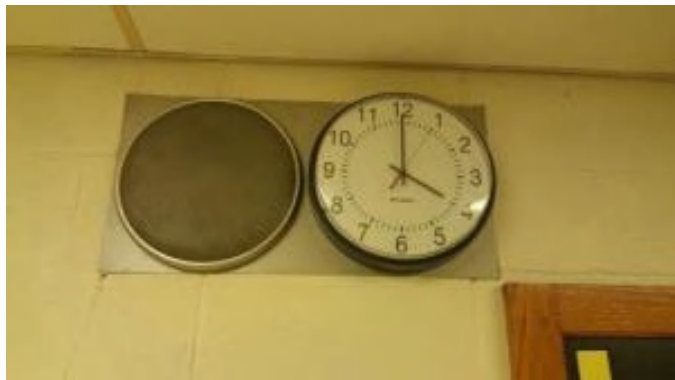
System: D5030 - Communications and Security

Location: throughout the building

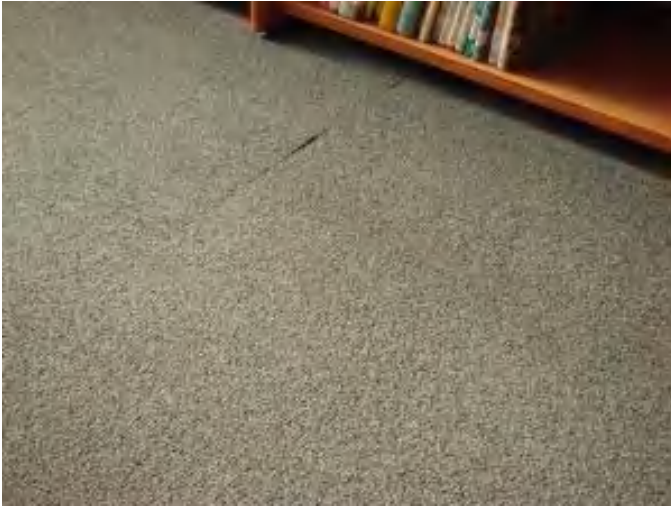
System: C3020411 - Carpet

Location: Interior
Distress: Beyond Service Life
Category: 3 - Operations / Maint.
Priority: 5 - Response Time (> 5 yrs)
Correction: Remove and replace carpet
Qty: 2,100.00
Unit of Measure: S.F.
Estimate: \$23,500.61
Assessor Name: Craig Anding
Date Created: 12/17/2015

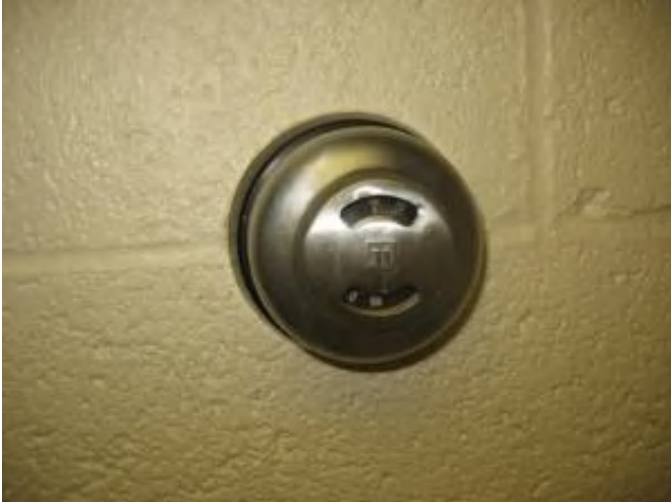
System: D3060 - Controls & Instrumentation

Location: Throughout building
Distress: Energy Efficiency
Category: 4 - Capital Improvement
Priority: 5 - Response Time (> 5 yrs)
Correction: Replace pneumatic controls with DDC (75KSF)
Qty: 85,000.00
Unit of Measure: S.F.
Estimate: \$1,823,425.29
Assessor Name: Craig Anding
Date Created: 09/29/2015

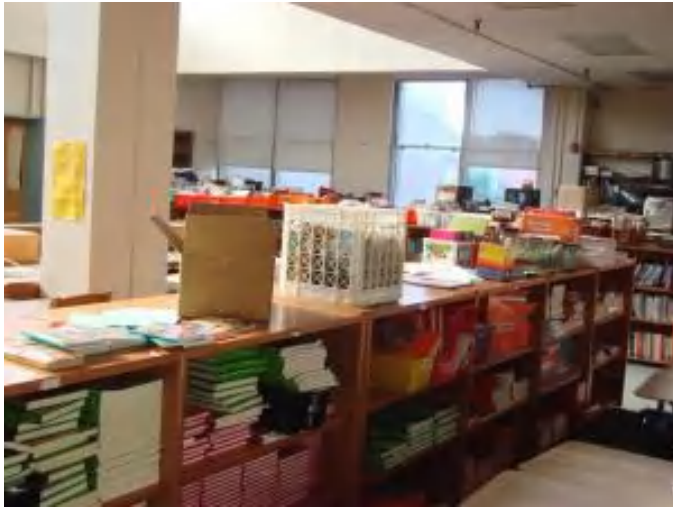
System: E2010 - Fixed Furnishings

Location: Interior

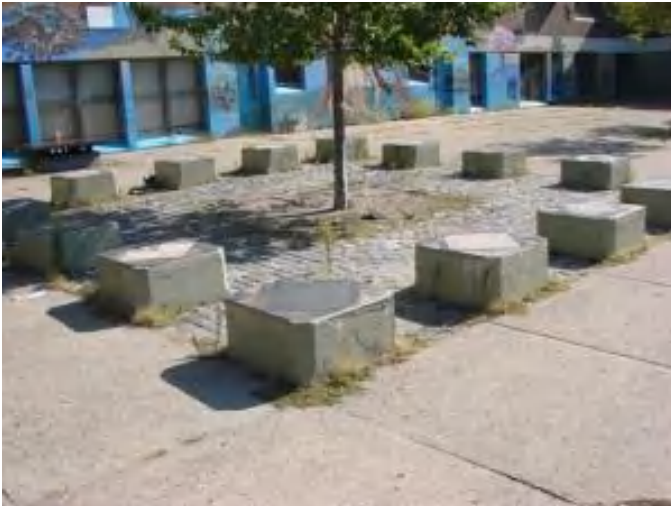
System: G2030 - Pedestrian Paving

Location: Grounds/ site

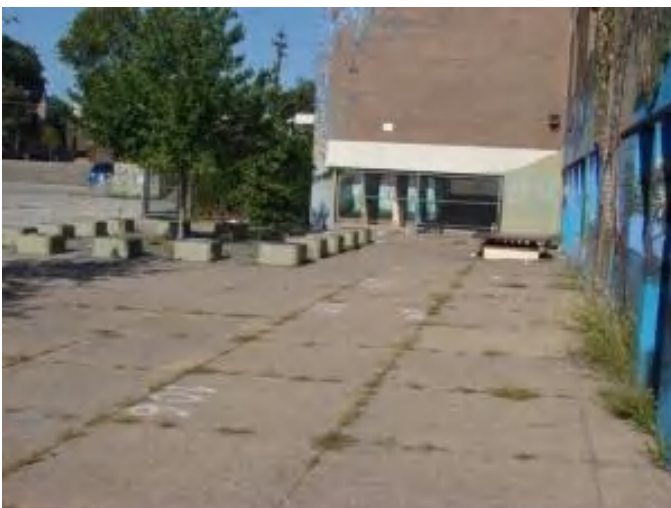
System: G4020 - Site Lighting

Location: grounds

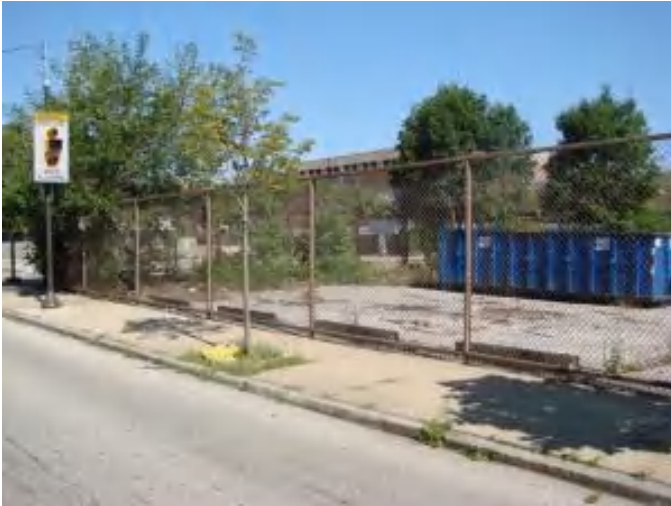
System: G2020 - Parking Lots

Location: G532001;Grounds

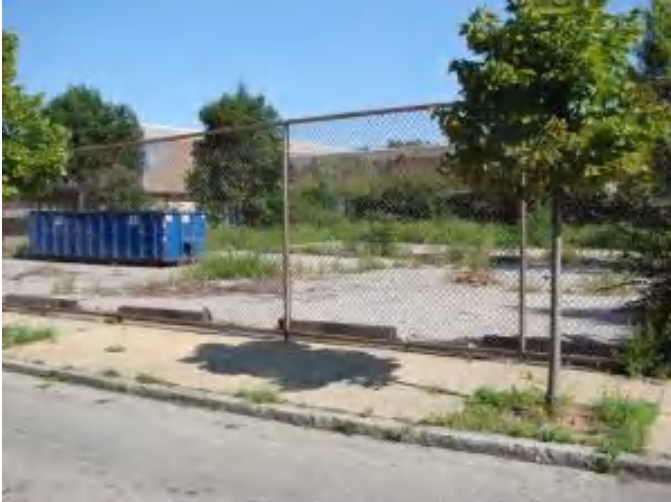
System: G2020 - Parking Lots

Location: Grounds/ site

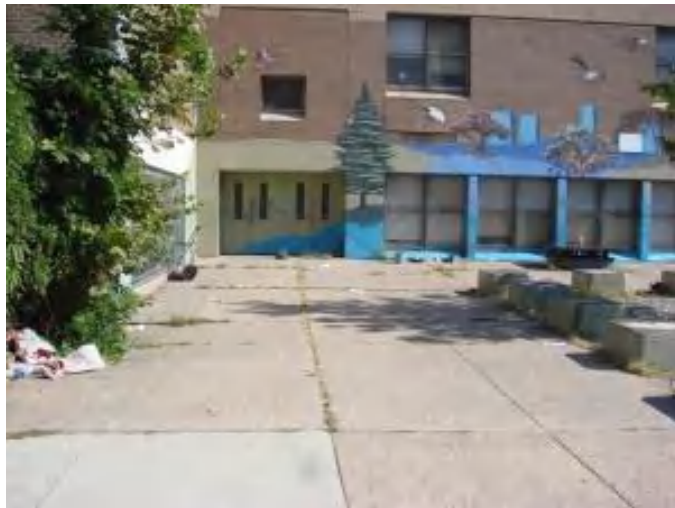
System: G4030 - Site Communications & Security

Location: grounds
