Facility Condition Assessment Summary Report

Heston School

School District of Philadelphia
S430001; Heston
Final
Site Assessment Report

January 30, 2017

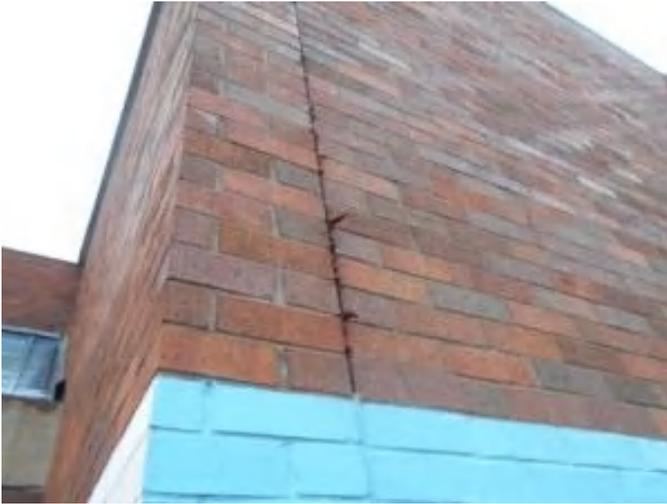
System: B2010 - Exterior Walls

Location: Exterior walls

Distress: Building Envelope Integrity

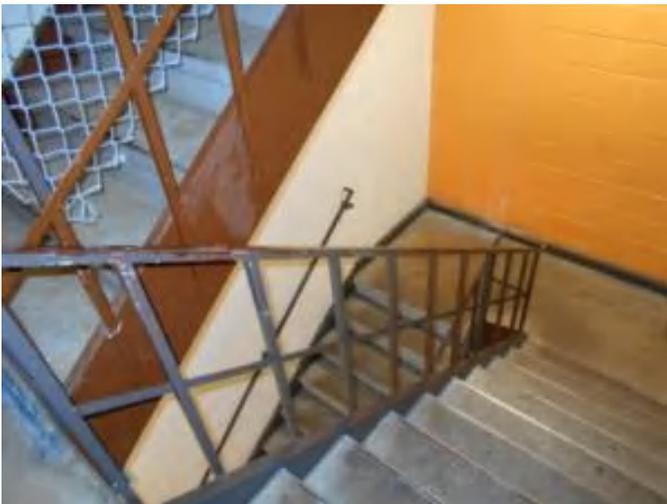
System: C2010 - Stair Construction

Location: Stairwells

Distress: Building / MEP Codes

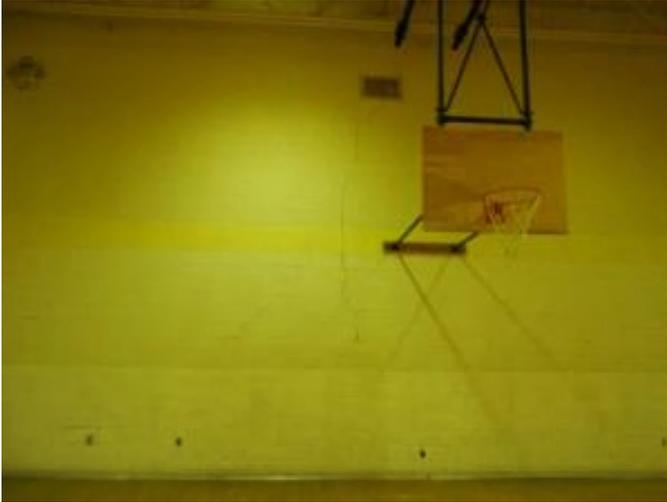
System: B2010 - Exterior Walls

Location: Exterior walls

Distress: Building Envelope Integrity

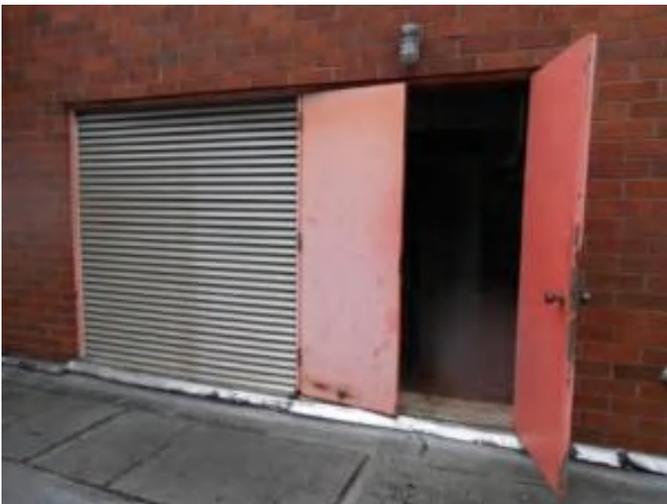
System: B2030 - Exterior Doors

Location: Exterior doors

Distress: Beyond Service Life

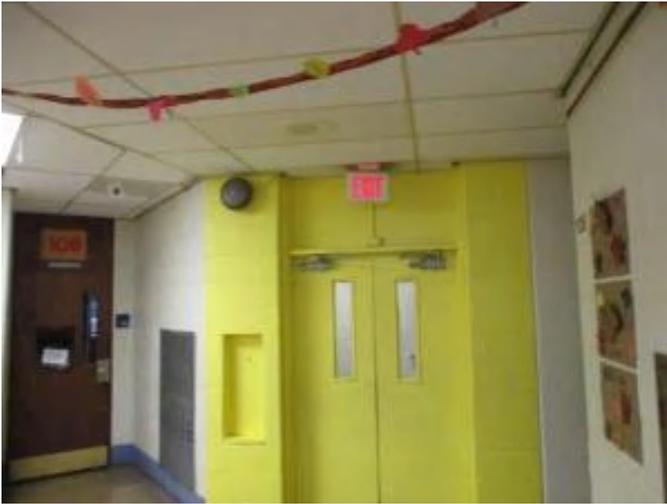
System: C1020 - Interior Doors

Location: Stairwells

Distress: Building / MEP Codes

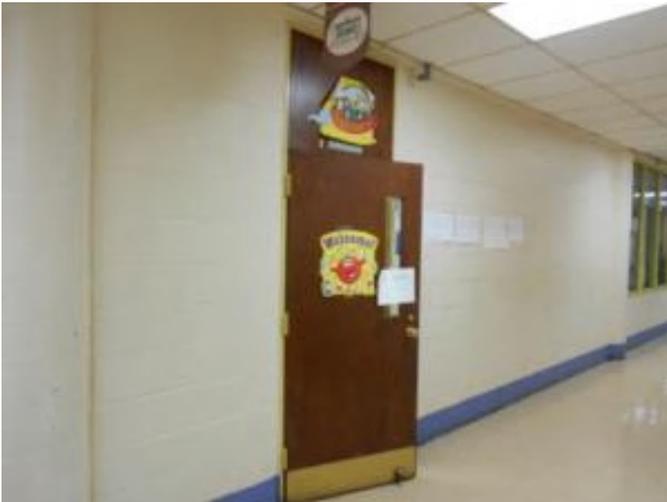
System: C1020 - Interior Doors

Location: Interiors

Distress: Accessibility

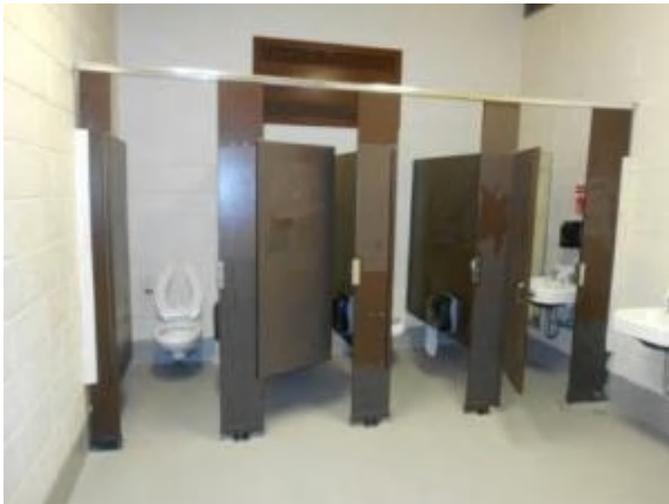
System: C1030 - Fittings

Location: Toilet rooms

Distress: Beyond Service Life

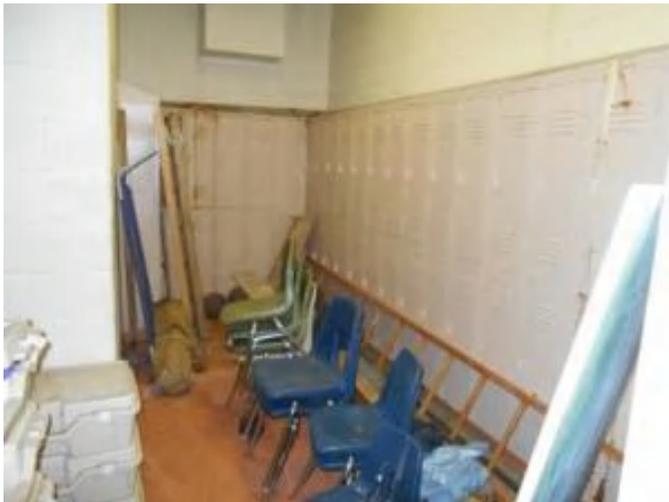
System: C1030 - Fittings

Location: Locker rooms

Distress: Beyond Service Life

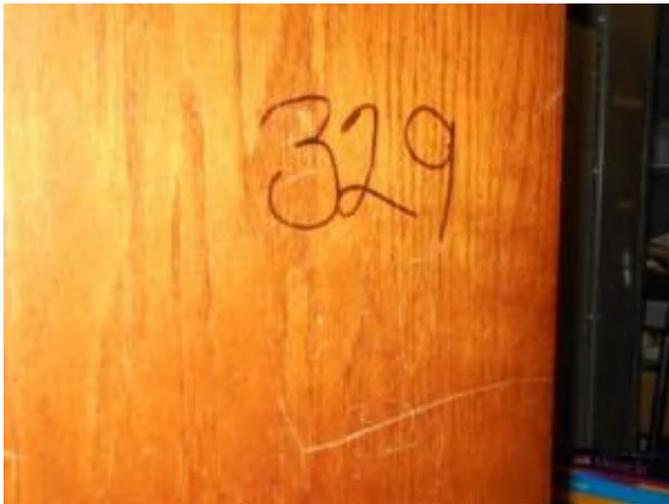
System: C1030 - Fittings

Location: Interiors throughout
Distress: Building / MEP Codes
Category: 2 - Code Compliance
Priority: 2 - Response Time (2-3 yrs)
Correction: Replace missing or damaged signage - insert the number of rooms
Qty: 160.00
Unit of Measure: Ea.
Estimate: \$43,346.00
Assessor Name: Craig Anding
Date Created: 02/23/2016

Notes: Replace/install interior signage.

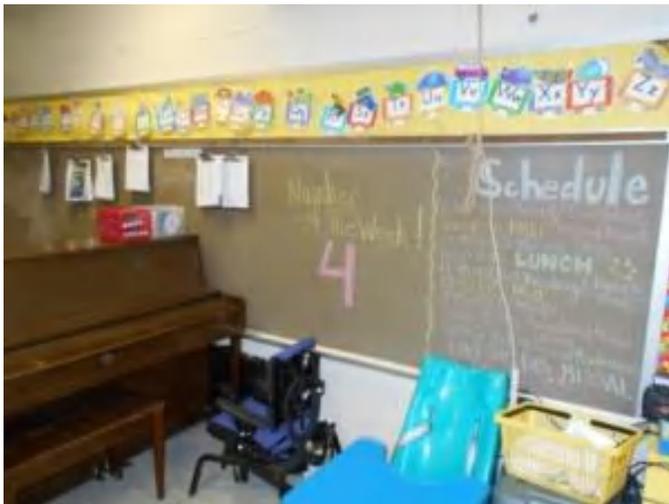
System: C1030 - Fittings

Location: Classrooms
Distress: Obsolete
Category: 3 - Operations / Maint.
Priority: 2 - Response Time (2-3 yrs)
Correction: Replace blackboards with marker boards - pick the appropriate size and insert the quantities
Qty: 20.00
Unit of Measure: Ea.
Estimate: \$24,822.44
Assessor Name: Craig Anding
Date Created: 02/24/2016

Notes: Replace chalkboards with white marker boards

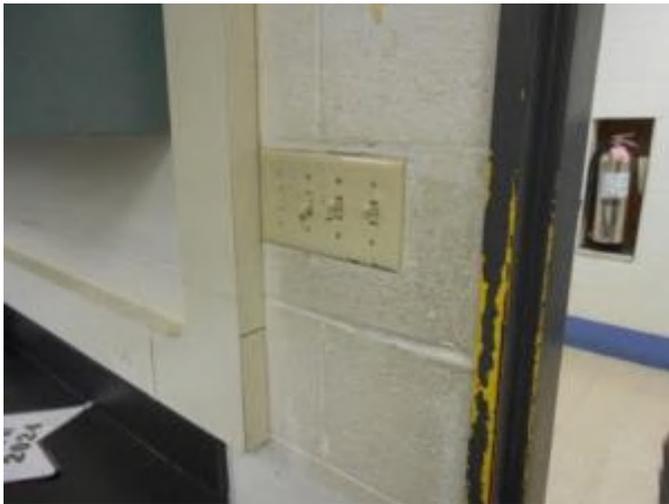
System: C3010230 - Paint & Covering

Location: Interiors

Distress: Beyond Service Life

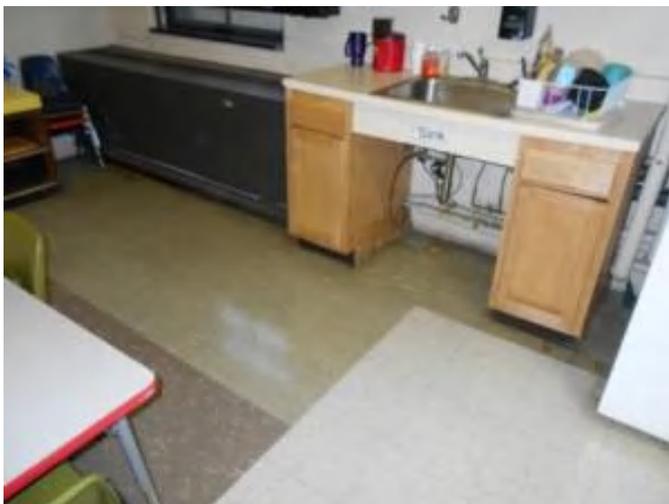
System: C3020413 - Vinyl Flooring

Location: Corridors, classrooms, auditorium

Distress: Health Hazard / Risk

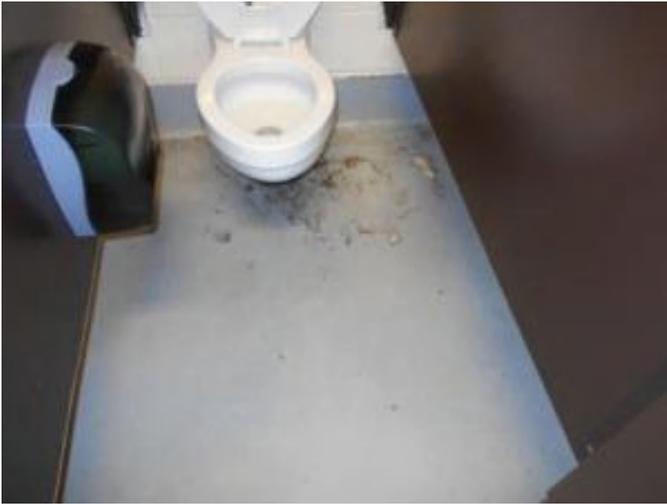
System: C3020415 - Concrete Floor Finishes

Location: Toilet rooms, kitchen
Distress: Maintenance Required
Category: 3 - Operations / Maint.
Priority: 2 - Response Time (2-3 yrs)
Correction: Prepare and repaint concrete floor
Qty: 4,500.00

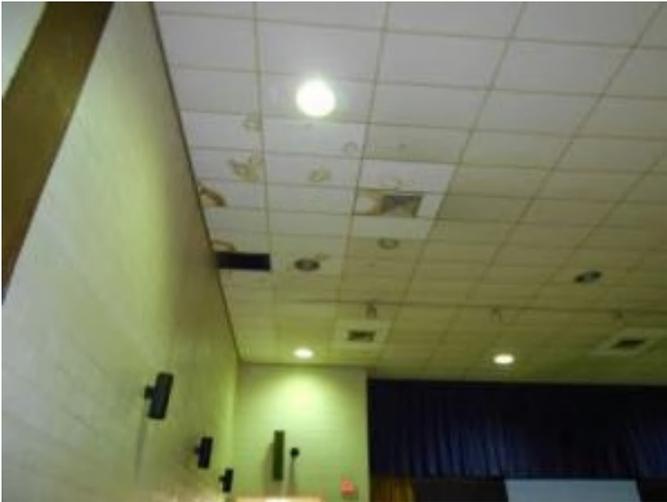
System: C3030 - Ceiling Finishes

Location: Corridors, auditorium, etc.
Distress: Beyond Service Life
Category: 3 - Operations / Maint.
Priority: 2 - Response Time (2-3 yrs)
Correction: Remove and replace suspended acoustic ceilings - lighting not included
Qty: 24,500.00

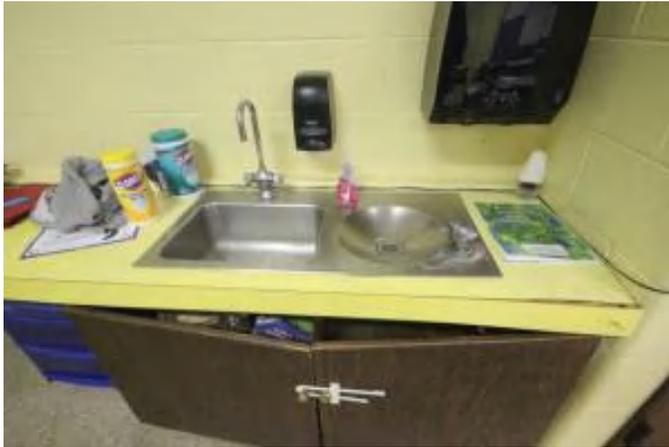
System: D2010 - Plumbing Fixtures

Location: Classrooms

Distress: Failing

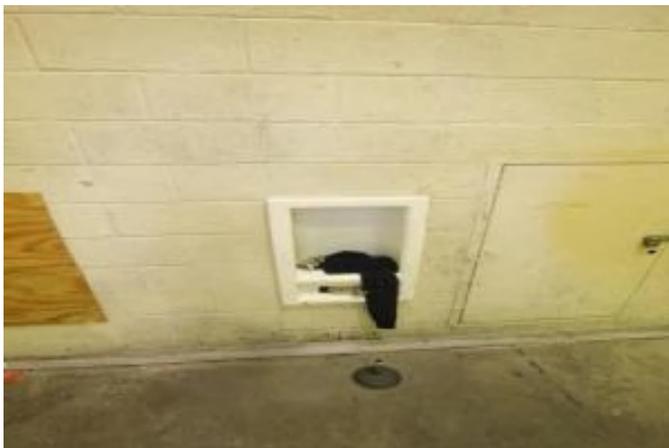
System: D2010 - Plumbing Fixtures

Location: Entire building

Distress: Accessibility

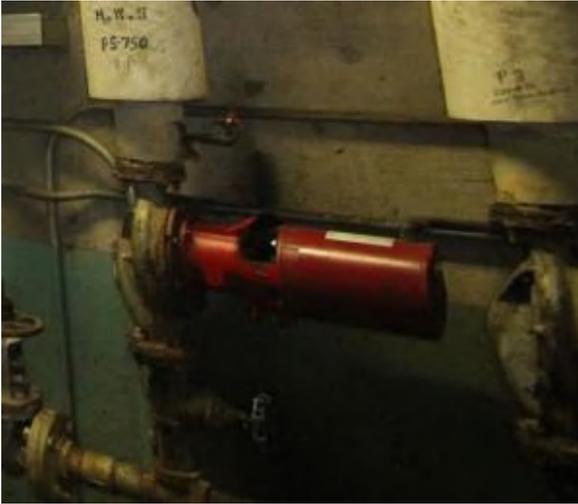
System: D2020 - Domestic Water Distribution

Location: Boiler room
Distress: Failing
Category: 3 - Operations / Maint.
Priority: 2 - Response Time (2-3 yrs)
Correction: Replace pipe and fittings
Qty: 2.00
Unit of Measure: L.F.
Estimate: \$1,200.71
Assessor Name: Craig Anding
Date Created: 01/29/2016

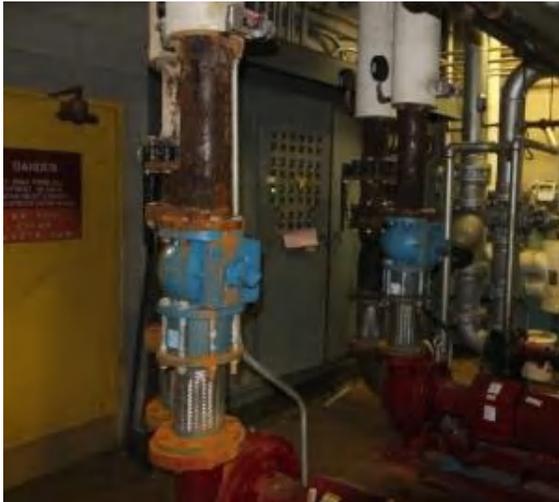
System: D3040 - Distribution Systems

Location: Boiler and mechanical rooms
Distress: Maintenance Required
Category: 3 - Operations / Maint.
Priority: 2 - Response Time (2-3 yrs)
Correction: Replace hydronic distribution piping insulation - 100 LF of piping
Qty: 500.00
Unit of Measure: L.F.
Estimate: \$17,457.06
Assessor Name: Craig Anding
Date Created: 01/29/2016

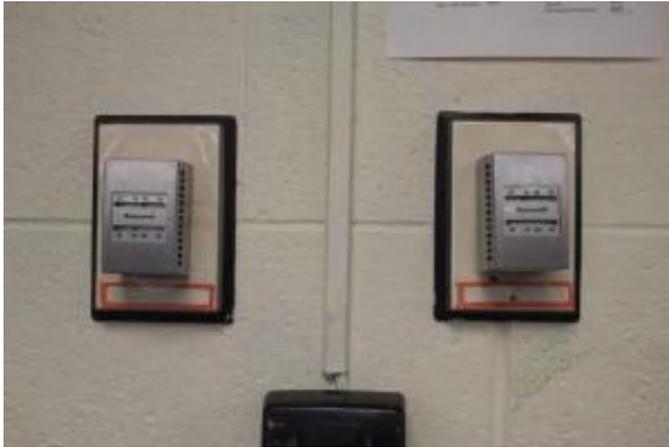
System: D3060 - Controls & Instrumentation

The building is equipped with pneumatic controls including day and night thermostats. The controls are inoperative according to the building engineer. The system is obsolete and should be replaced with a digital control system when other HVAC equipment is replaced. A duplex air compressor is in the boiler and it is fully operational.

Location: Entire building

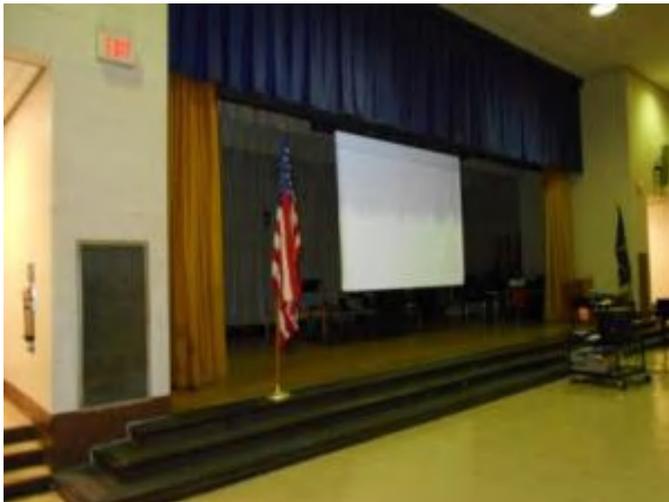
System: E2010 - Fixed Furnishings

Location: Stage

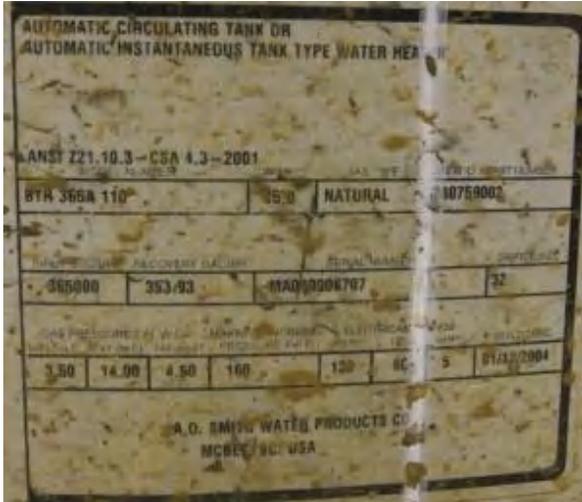
System: D2020 - Domestic Water Distribution

Location: Boiler room

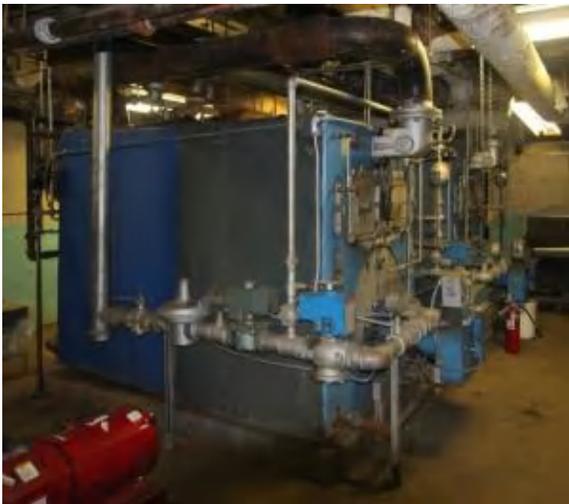
System: D3020 - Heat Generating Systems

Hot water is generated for the building by 2 Weil-McLain, 15 section, model 94, cast iron boilers. One boiler is needed to heat the school. Each boiler has a capacity of 2,539 MBH (106 HP) burning natural gas only in Gordon Piatt burners. They were all installed in 1976. Both boilers are operative. There is an 8 inch gas line without pressure booster. There is a water softener on the makeup water supply line which includes a backflow preventer. A chemical injection system is located next to the boilers. A hot water return tank is located next to the chiller in the boiler room. Boiler combustion makeup air enters the boiler room through automatically controlled louvers. The boilers are in fair condition but have exceeded their 35 year life expectancy by 5 years and should be replaced.

Location: Boiler room

- Replace hydronic boilers due to age (otherwise in fair condition)
- Replace chiller due to age and obsolete refrigerant (R-11 CFC)
- Replace cooling water circulation pump due to age, 1

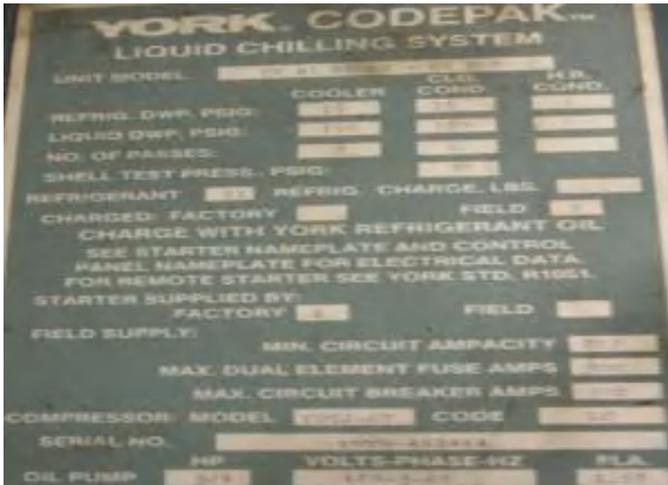
System: D3030 - Cooling Generating Systems

Location: Boiler room
Distress: Beyond Service Life
Category: 3 - Operations / Maint.
Priority: 3 - Response Time (3-4 yrs)
Correction: Replace chiller, air-cooled (200 tons)
Qty: 1.00
Unit of Measure: Ea.
Estimate: \$662,896.85
Assessor Name: Craig Anding
Date Created: 01/26/2016

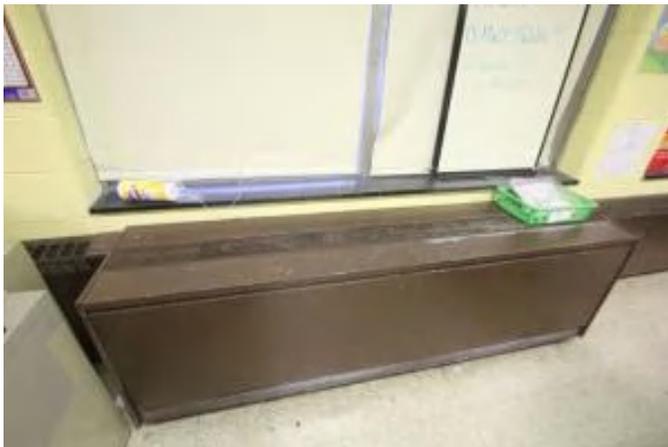
System: D3040 - Distribution Systems

Location: Classrooms
Distress: Beyond Service Life
Category: 3 - Operations / Maint.
Priority: 3 - Response Time (3-4 yrs)
Correction: Replace classroom unit ventilator (htg/clg coils, 5 tons, 2,000 CFM)
Qty: 35.00
Unit of Measure: Ea.
Estimate: \$1,745,753.55
Assessor Name: Craig Anding
Date Created: 01/29/2016

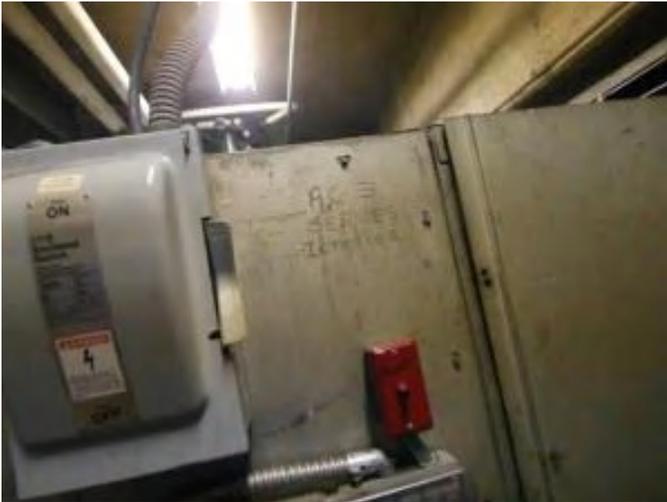
System: D3040 - Distribution Systems

Location: Mechanical room

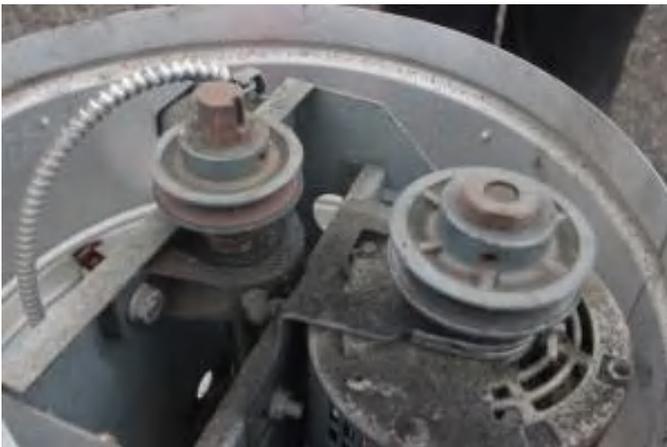
System: D3040 - Distribution Systems

Location: Roof top

- Repair or replace roof top exhaust fan with misaligned motor
- Install insulation on hydronic pipe to prevent condensation
- Replace leaking flange gaskets on hot water recirculation pumps

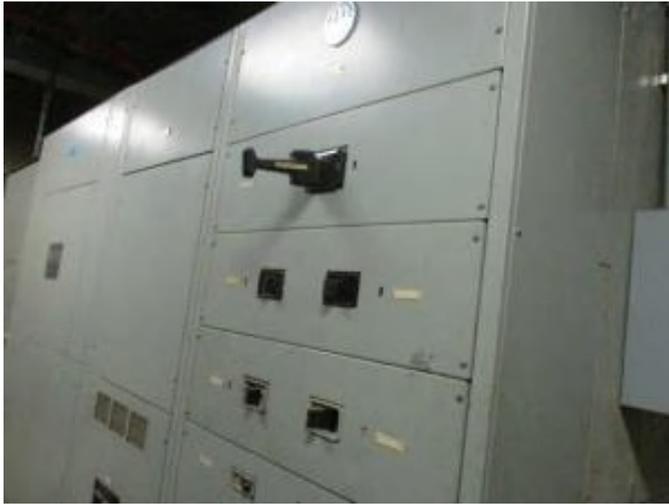
System: D5010 - Electrical Service/Distribution

Location: Basement
Distress: Inadequate
Category: 4 - Capital Improvement
Priority: 3 - Response Time (3-4 yrs)
Correction: Replace unit substation
Qty: 1.00
Unit of Measure: Ea.
Estimate: \$645,704.89
Assessor Name: Craig Anding
Date Created: 01/19/2016

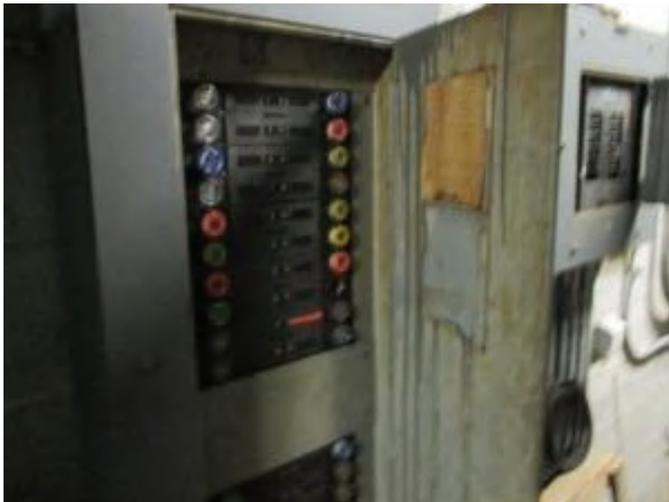
System: D5010 - Electrical Service/Distribution

Location: Entire Building
Distress: Obsolete
Category: 3 - Operations / Maint.
Priority: 3 - Response Time (3-4 yrs)
Correction: Replace Electrical Distribution System (U)
Qty: 8.00
Unit of Measure: Ea.
Estimate: \$215,624.16
Assessor Name: Craig Anding
Date Created: 01/19/2016

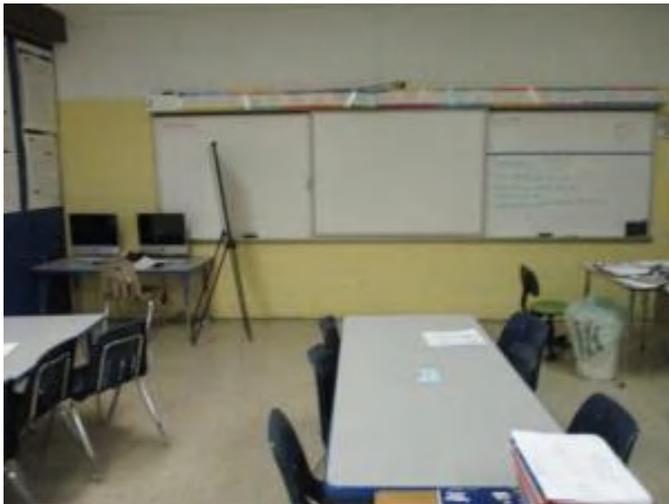
System: D5020 - Lighting and Branch Wiring

The number of receptacles in 70% of the classrooms is inadequate. Teachers use extension cords. The teacher's whiteboard wall and the opposite of it need to be provided with double compartment surface raceways, the other two walls with minimum two duplex outlets each, when feasible.

Location: Entire Building
Distress: Inadequate
Category: 4 - Capital Improvement
Priority: 3 - Response Time (3-4 yrs)
Correction: Add wiring device
Qty: 340.00
Unit of Measure: Ea.
Estimate: \$123,754.16
Assessor Name: Craig Anding
Date Created: 01/19/2016

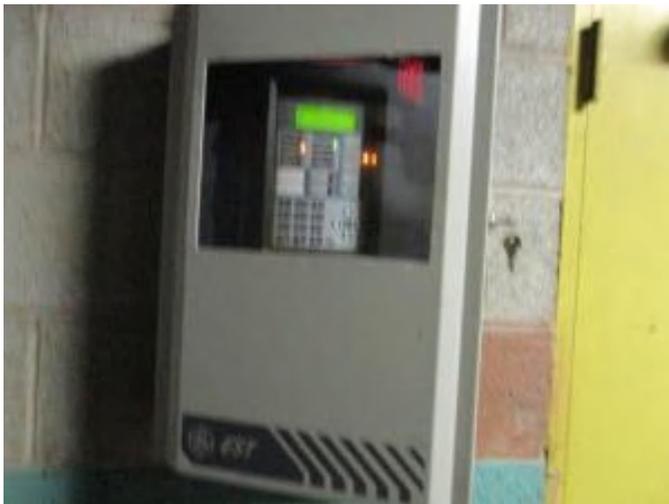
System: D5030 - Communications and Security

Location: Entire Building
Distress: Life Safety / NFPA / PFD
Category: 1 - Health & Safety
Priority: 3 - Response Time (3-4 yrs)
Correction: Replace fire alarm system
Qty: 1.00
Unit of Measure: S.F.
Estimate: \$116,086.98
Assessor Name: Craig Anding
Date Created: 01/19/2016

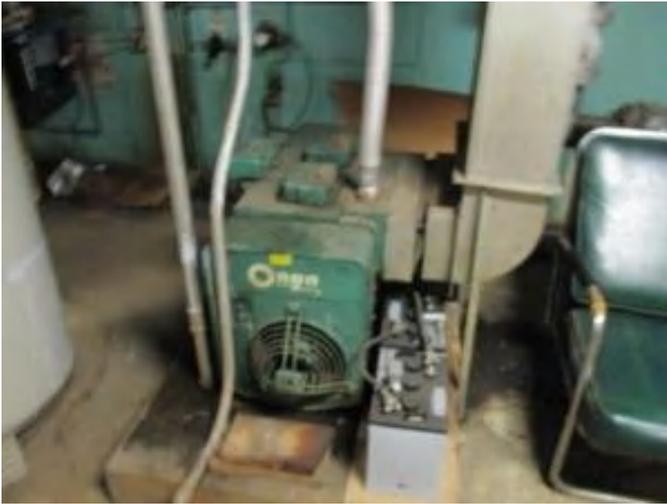
System: D5090 - Other Electrical Systems

Location: Outdoor
Distress: Beyond Service Life
Category: 3 - Operations / Maint.
Priority: 3 - Response Time (3-4 yrs)
Correction: Add Standby Generator System
Qty: 1.00
Unit of Measure: Ea.
Estimate: \$191,097.77
Assessor Name: Craig Anding
Date Created: 01/19/2016

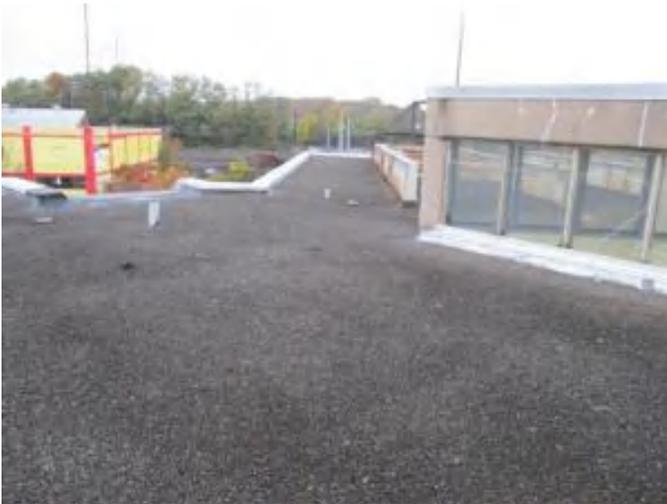
System: D5090 - Other Electrical Systems

Location: Roof
Distress: Building / MEP Codes
Category: 2 - Code Compliance
Priority: 3 - Response Time (3-4 yrs)
Correction: Repair Lightning Protection System
Qty: 1.00
Unit of Measure: Job
Estimate: \$24,249.82
Assessor Name: Craig Anding
Date Created: 01/19/2016

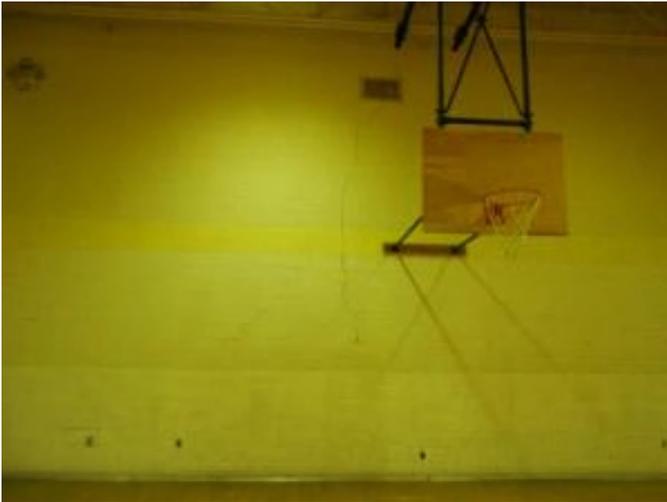
System: E1020 - Institutional Equipment

Location: Gym

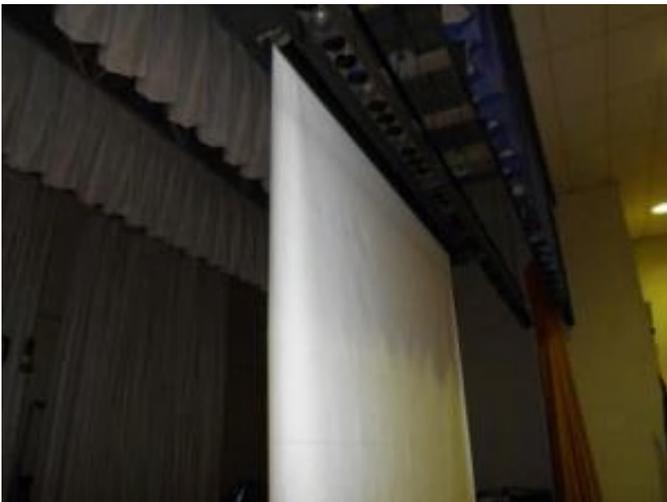
System: E1020 - Institutional Equipment

Location: Stage

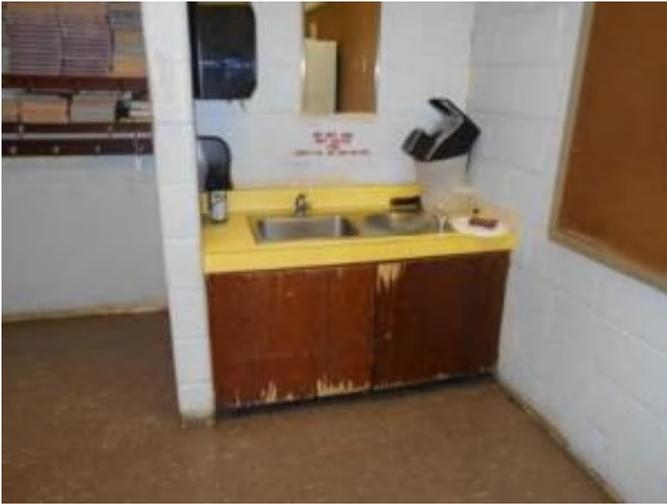
System: E2010 - Fixed Furnishings

Location: Classrooms
Distress: Beyond Service Life
Category: 3 - Operations / Maint.
Priority: 3 - Response Time (3-4 yrs)
Correction: Remove and replace casework - per LF - insert quantities for cabinets in the estimate
Qty: 400.00
Unit of Measure: L.F.
Estimate: \$419,837.07
Assessor Name: Craig Anding
Date Created: 02/23/2016

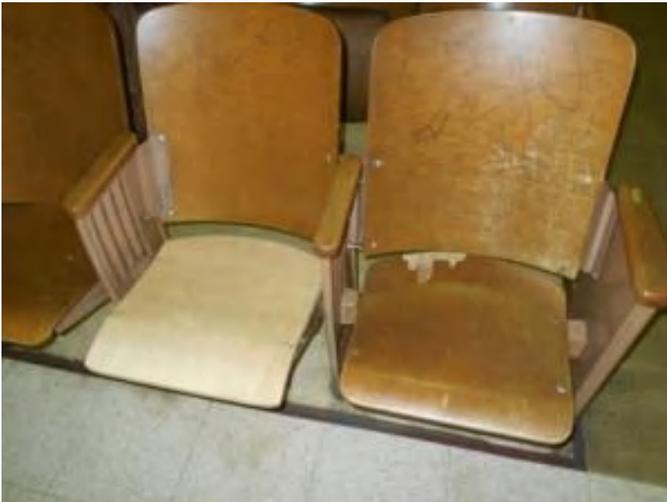
System: E2010 - Fixed Furnishings

Location: Auditorium
Distress: Damaged
Category: 3 - Operations / Maint.
Priority: 3 - Response Time (3-4 yrs)
Correction: Replace auditorium seating - add tablet arms if required. Veneer seating is an option.
Qty: 156.00
Unit of Measure: Ea.
Estimate: \$140,697.26
Assessor Name: Craig Anding
Date Created: 02/22/2016

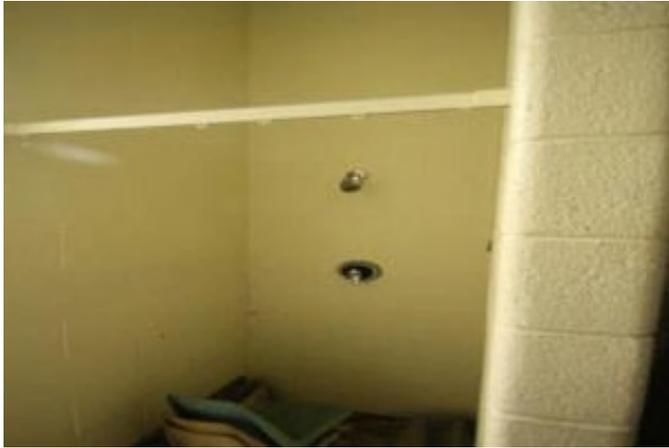
System: C1010 - Partitions

Location: Showers

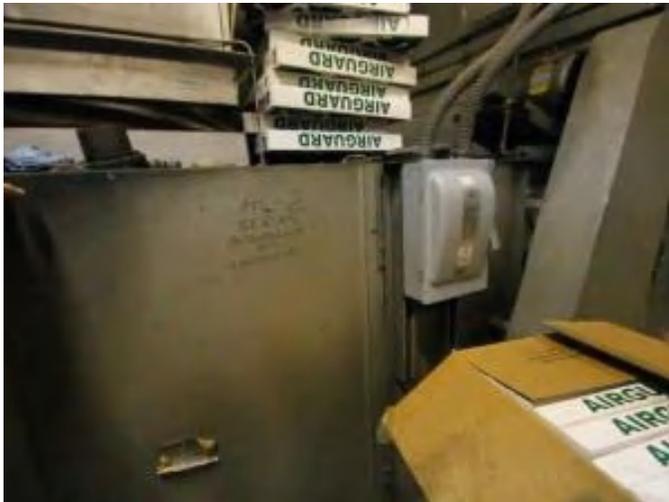
System: D3040 - Distribution Systems

Location: Mechanical room

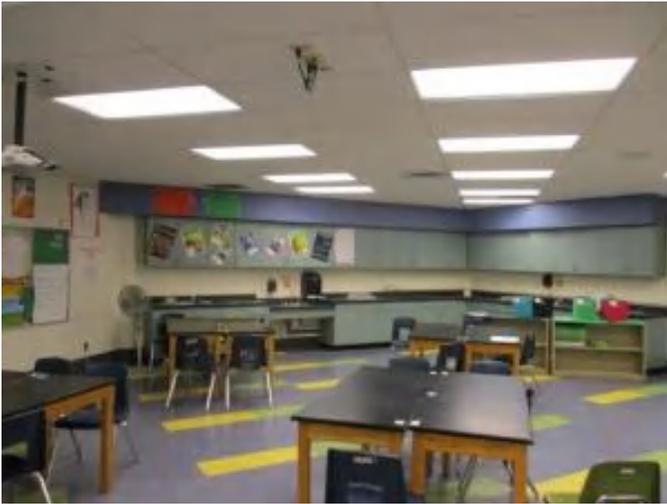
System: D5020 - Lighting and Branch Wiring

Location: Entire Building

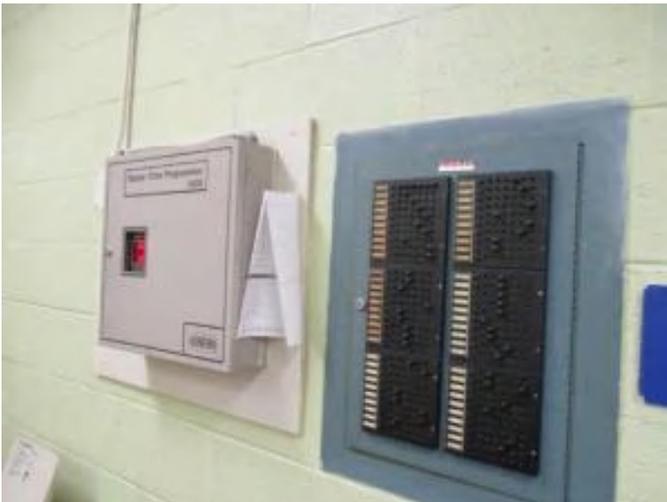
System: D5030 - Communications and Security

Location: Entire Building

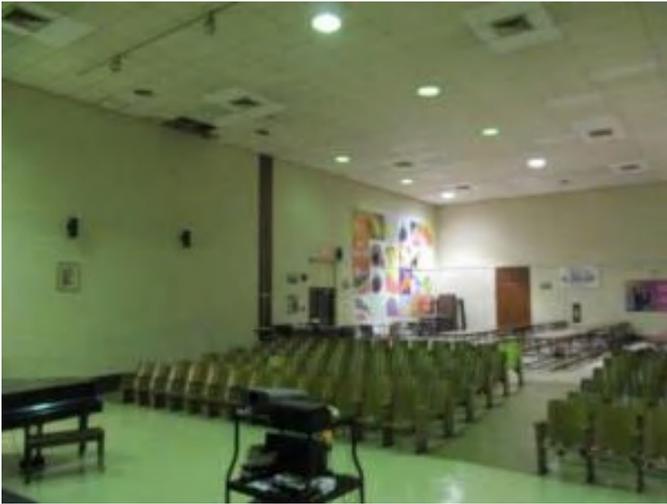
System: D5030 - Communications and Security

Location: Auditorium

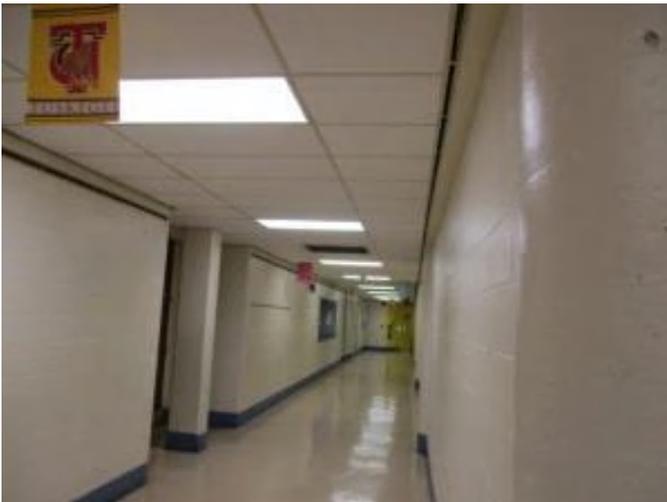
System: D5030 - Communications and Security

Location: Entire Building

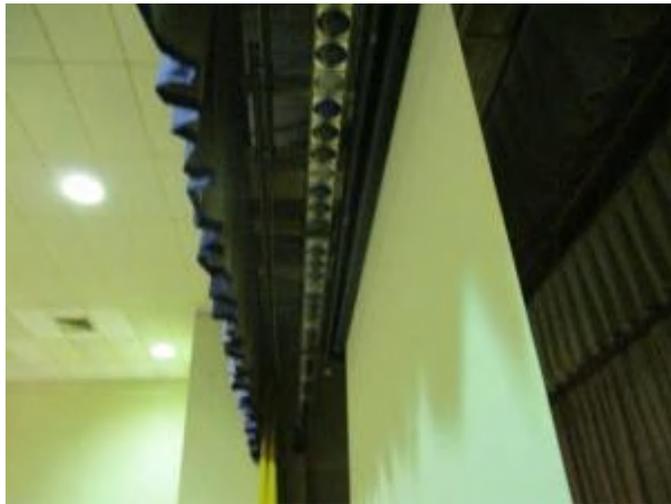
System: E1020 - Institutional Equipment

Location: Auditorium

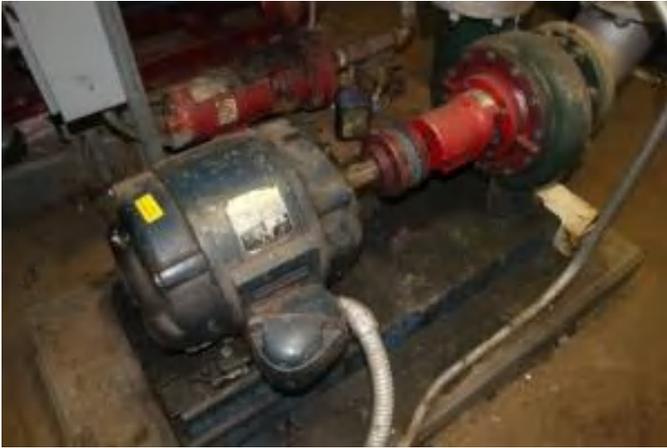
System: D3020 - Heat Generating Systems

Location: Boiler room

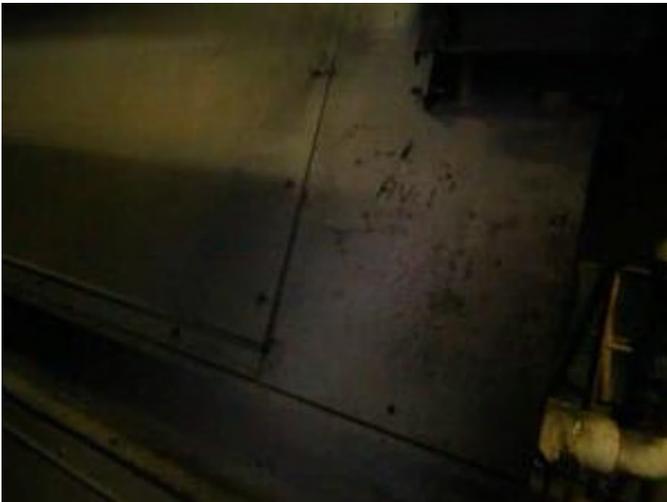
System: D3040 - Distribution Systems

Location: Mechanical room

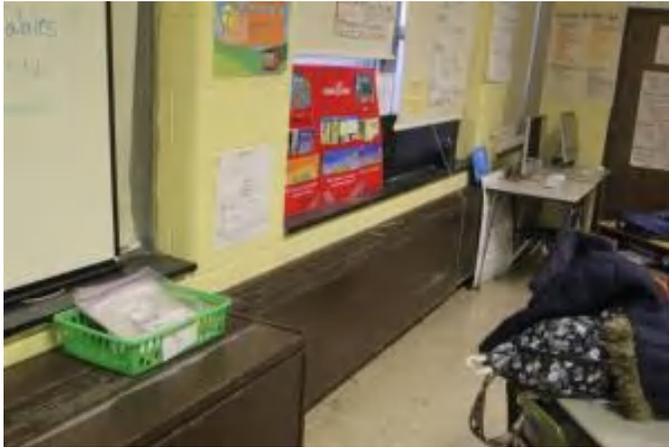
System: D3040 - Distribution Systems

Location: Classrooms

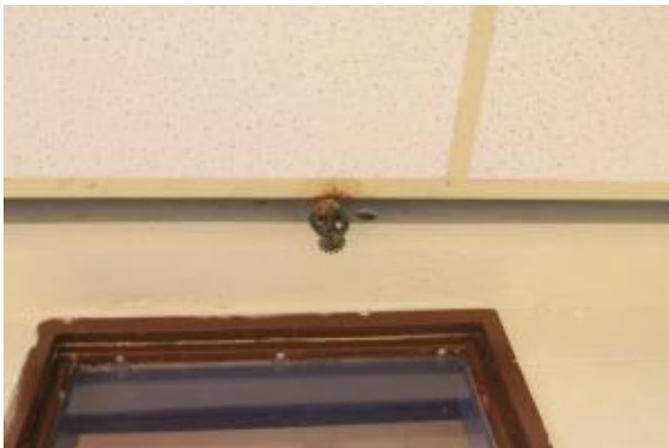
System: D4010 - Sprinklers

The school building has standpipes. There is a sprinkler system for the second and third floor corridors around the IMC. The sprinklers heads are lightly rusted and corroded, so they are probably the original nozzles. There are 4 manual valves in a store room beside the cafeteria that can block the flow of fire water to either second or third floor and east or west sides. These valves are sealed open. There is no fire pump. Sprinklers should be installed for the entire building with a fire pump if needed.

Location: Entire building

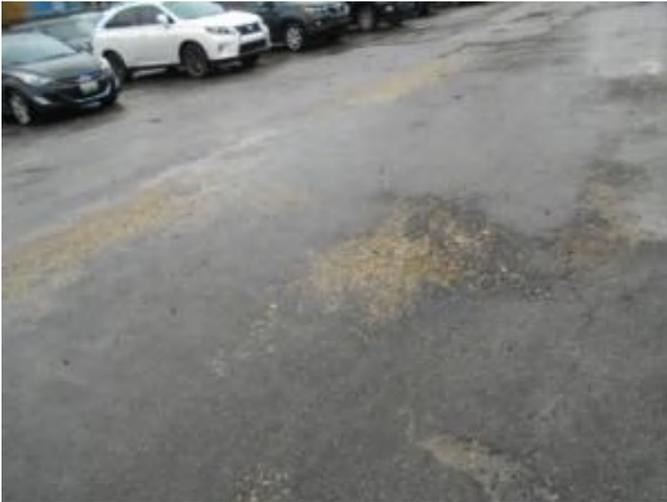
System: G2020 - Parking Lots

Location: Parking lot

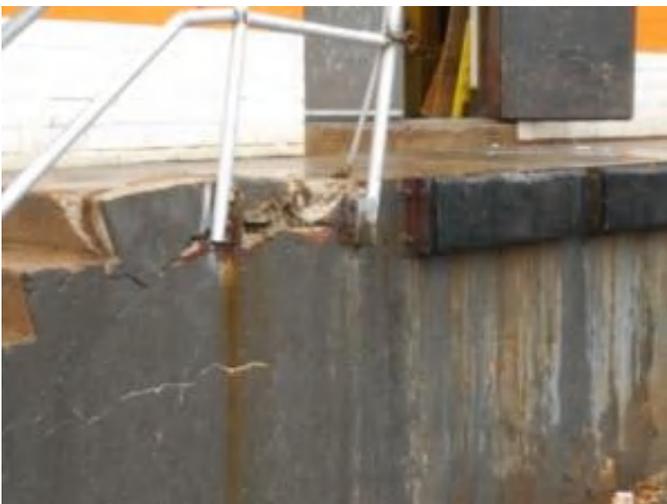
System: G2030 - Pedestrian Paving

Location: Exterior steps at dock and playground

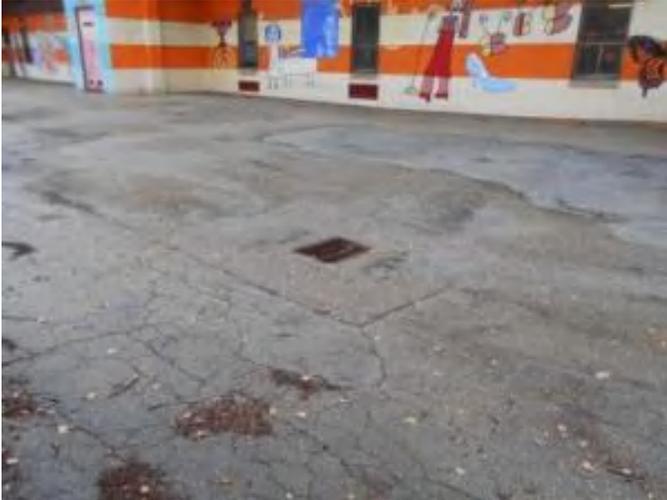
System: G2030 - Pedestrian Paving

Location: Asphalt playgrounds

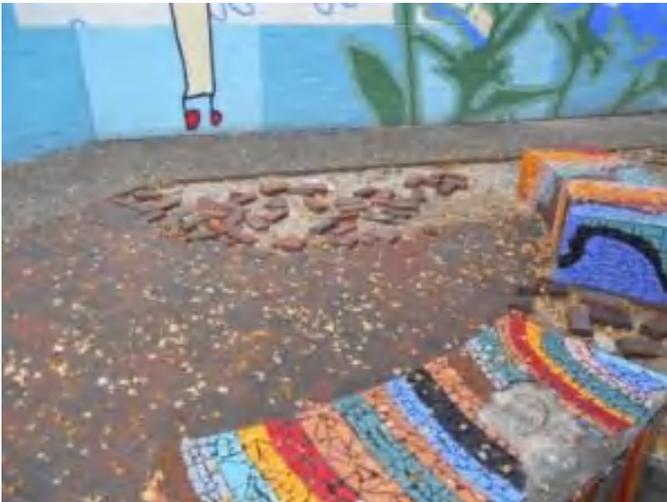
System: G2030 - Pedestrian Paving

Location: Front plaza

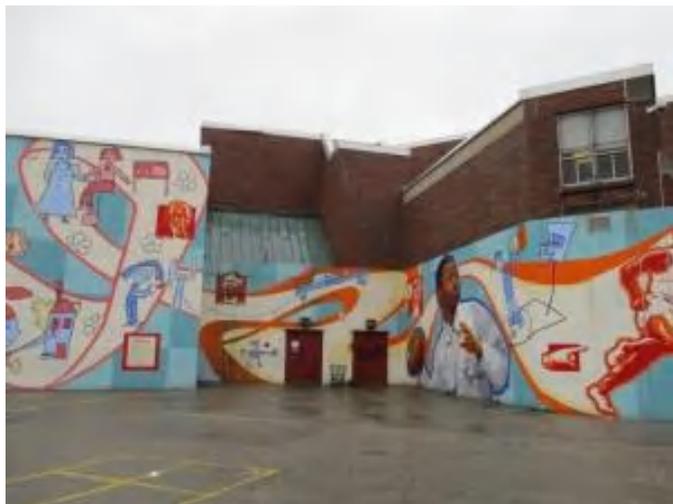
System: G4030 - Site Communications & Security

Location: Building Perimeter
