Hill-Freedman at Leeds School

School District of Philadelphia

S610001;Leeds

Site Assessment Report

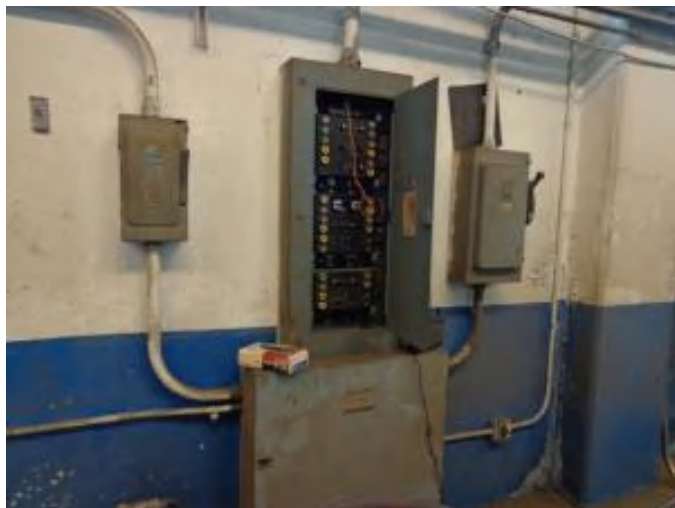
System: D5090 - Other Electrical Systems

Location: Boiler Room

Distress: Life Safety / NFPA / PFD

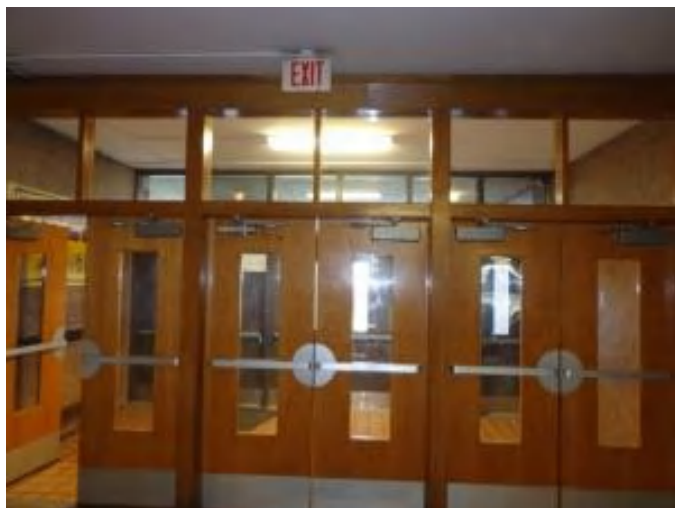
System: D5090 - Other Electrical Systems

Location: Building wide

Distress: Failing

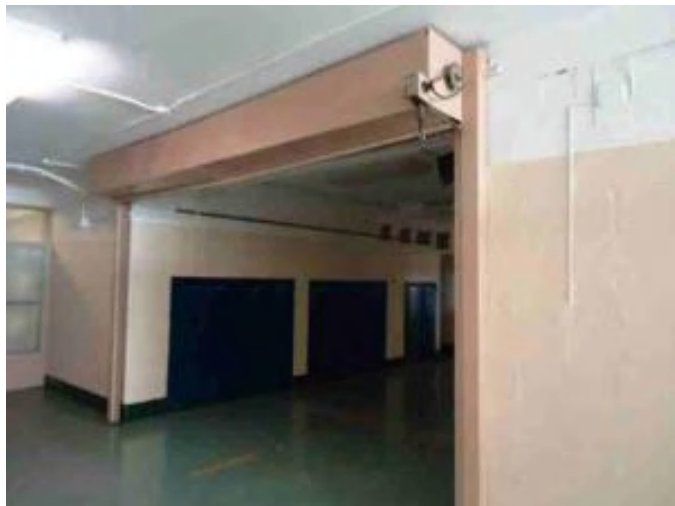
System: C1010 - Partitions

Location: Stairs

Distress: Damaged

Notes: This building has adequate exit pathways and no egress obstructions were noted during our building walk through. However the corridor doors on all floors are not fire rated and should be upgraded. Install new fire rated flush wood doors on all floor corridors. If the recommended lever hardware and room signage has not been implemented then these features should be incorporated into the work scope.

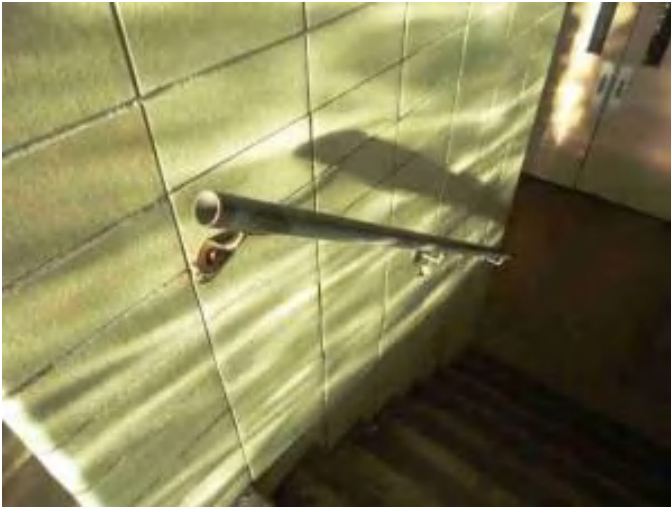
System: C2010 - Stair Construction

Location: Stairs

Distress: Damaged

Notes: Current requirements for stairs indicate that they have graspable handrails on both sides, that the rails have a specific end geometry, and that the handrails continue horizontally at the landings. In addition, guardrails must prevent the passage of a 4 inch diameter sphere (6 inches in the triangle formed by the lower rail and tread/riser angle). Although the stairs are compliant with the code enforced at the time of construction until a major renovation occurs, they are deficient in handrail and guardrail design relative to current standards. Future efforts should include comprehensive stair railing removal and replacement upgrades.

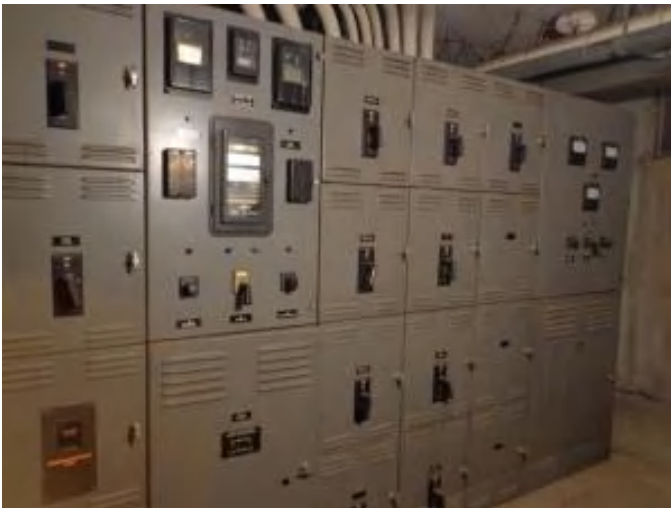
System: D5010 - Electrical Service/Distribution

Location: Transformer Vault

Distress: Beyond Service Life

Notes: Remove service entrance equipment, including utility medium voltage switchgear, six (6) 167 kVA transformers and the double-ended 1600A, 208/120V, 3 phase, 4wire Main Switchboard. Replace with new utility switchgear, a double-ended 750 kVA, 2500A, 208/120V, 3 phase, 4 wire substation, and a 750 kVA, 1200A, 480/277V, 3 phase, 4 wire substation for central air conditioning equipment and elevator loads.

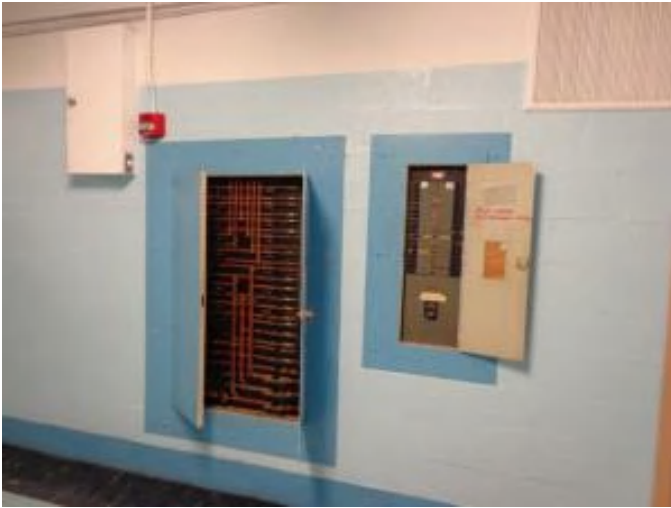
System: D5010 - Electrical Service/Distribution

Location: Building wide

Distress: Beyond Service Life

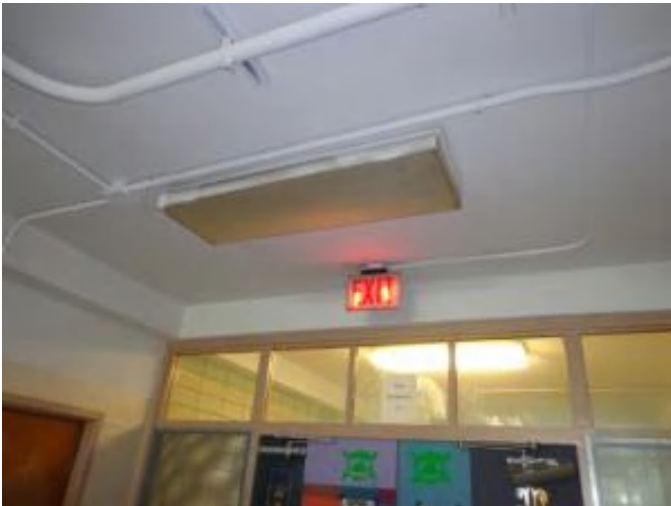
System: D5020 - Lighting and Branch Wiring

Location: Building wide

Distress: Beyond Service Life

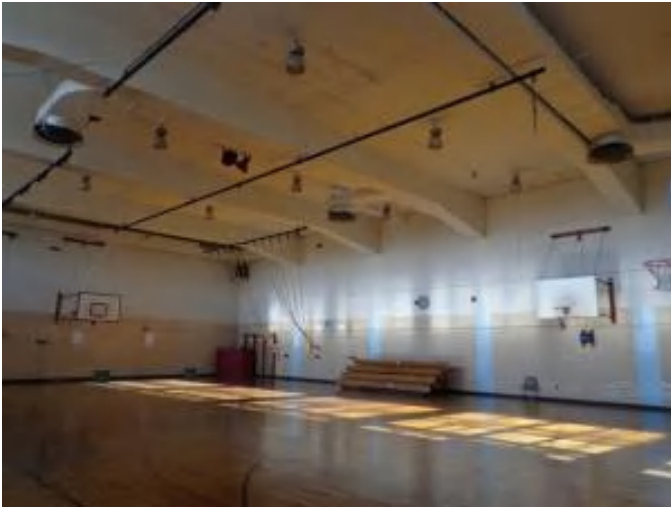
System: D5020 - Lighting and Branch Wiring

Location: Gymnasiums

Distress: Beyond Service Life

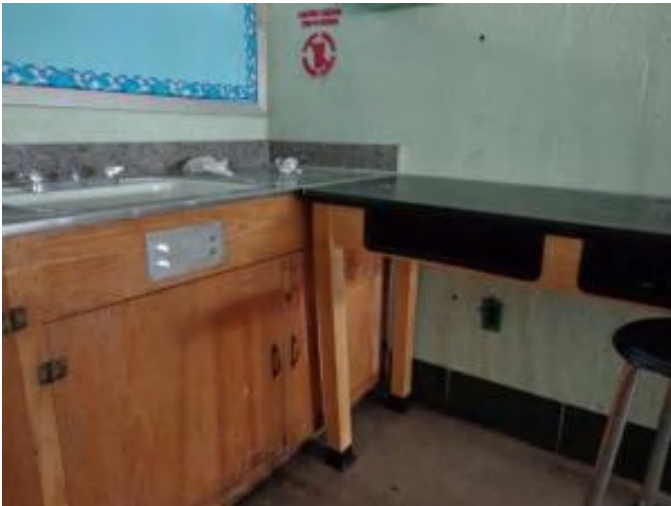
System: D5020 - Lighting and Branch Wiring

Location: Classrooms and building wide

Distress: Beyond Service Life

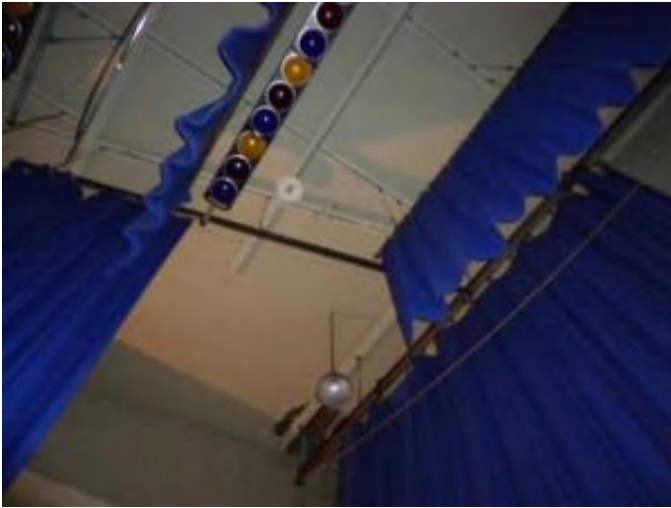
System: D5020 - Lighting and Branch Wiring

Location: Stage

Distress: Beyond Service Life

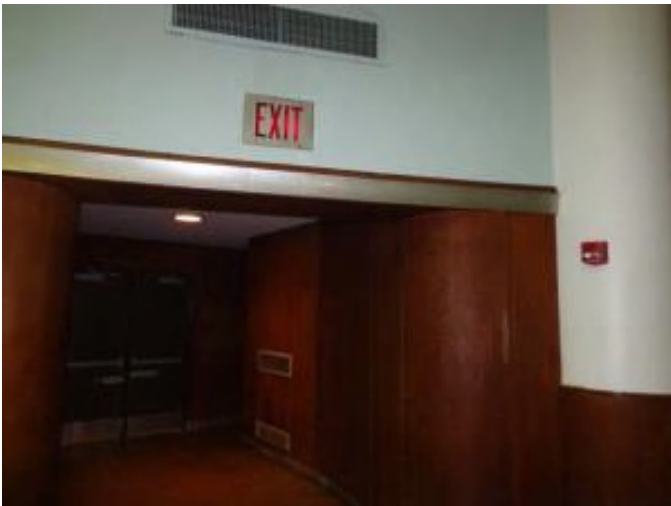
System: D5020 - Lighting and Branch Wiring

Location: Auditorium

Distress: Beyond Service Life

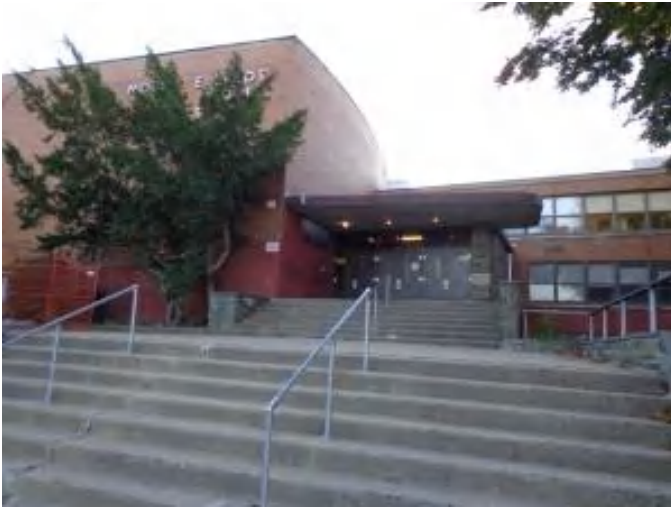
System: D5020 - Lighting and Branch Wiring

Location: Exit discharges

Distress: Beyond Service Life

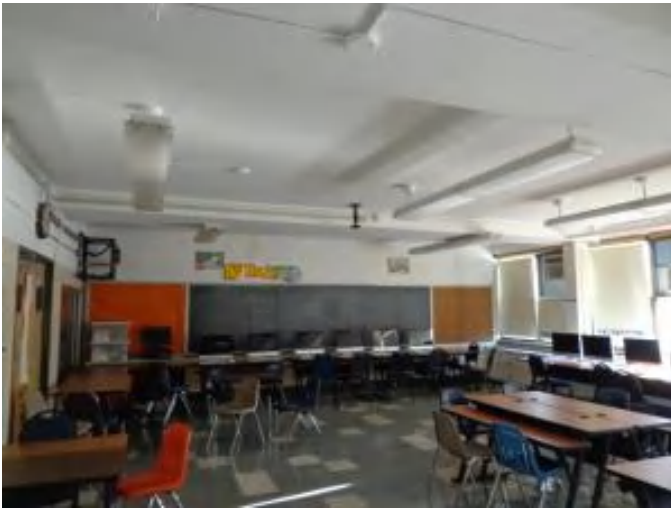
System: D5030 - Communications and Security

Location: Various rooms

Distress: Building / MEP Codes

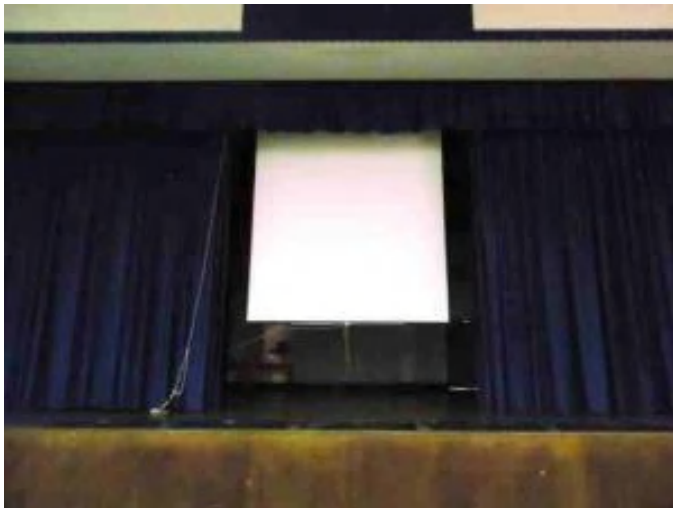
System: E2010 - Fixed Furnishings

Location: Stage

Distress: Life Safety / NFPA / PFD

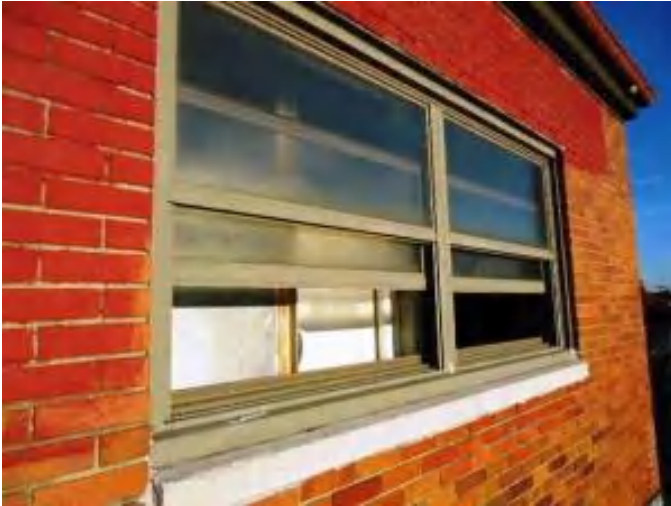
System: B2020 - Exterior Windows

Location: Exterior Elevation

Distress: Damaged

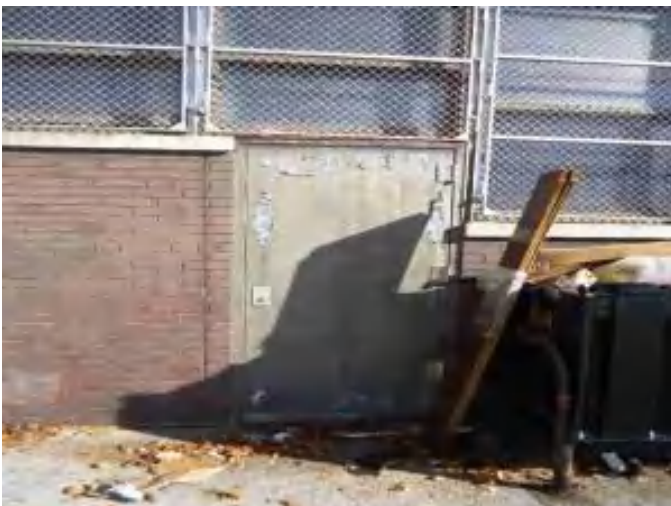
System: B2030 - Exterior Doors

Location: Exterior Elevation

Distress: Damaged

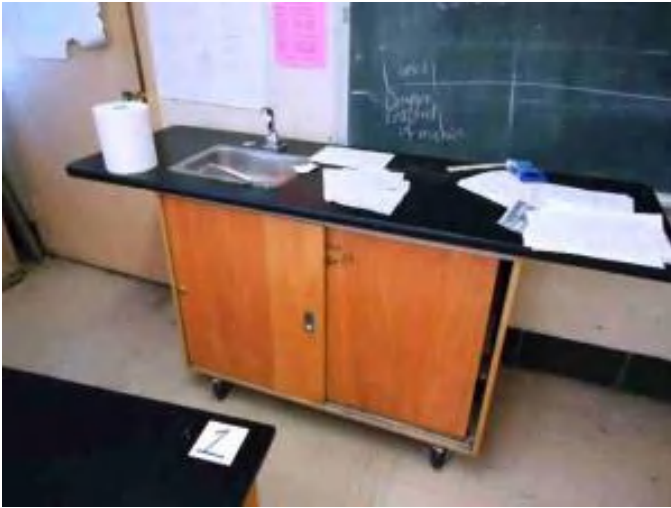
System: C1010 - Partitions

Location: Science Rooms

Distress: Damaged

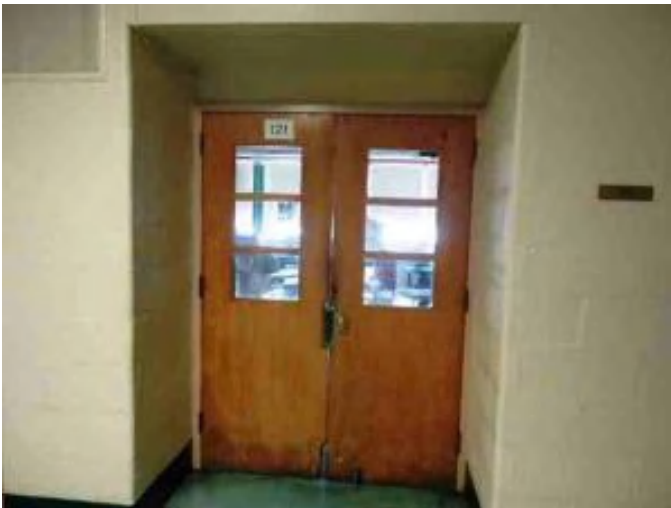
System: C1020 - Interior Doors

Location: Classrooms

Distress: Damaged

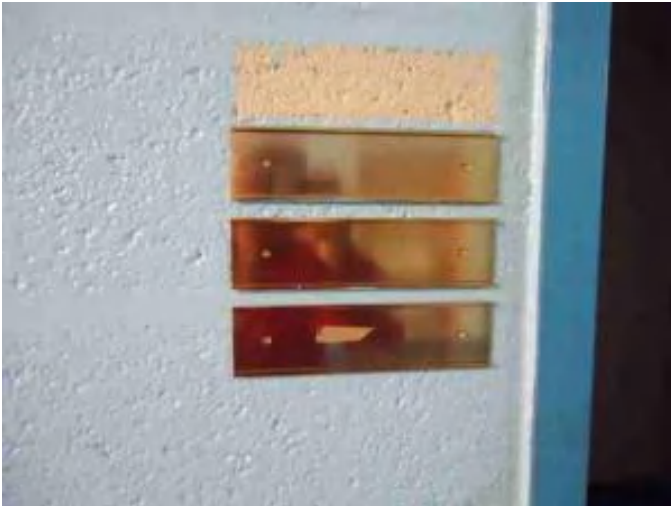
System: C1030 - Fittings

Location: Building Wide

Distress: Damaged

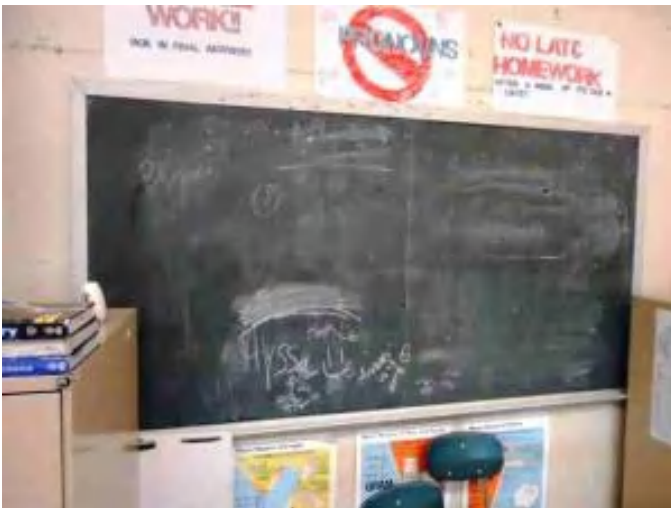
System: C1030 - Fittings

Location: Classrooms

Distress: Damaged

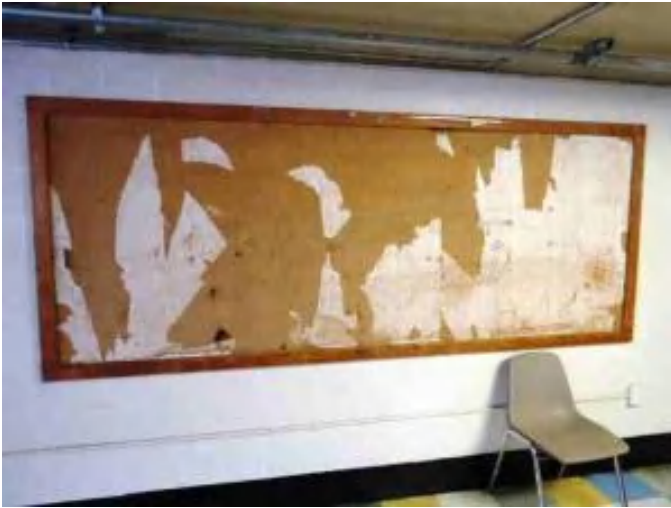
System: C1030 - Fittings

Location: Building Wide

Distress: Damaged

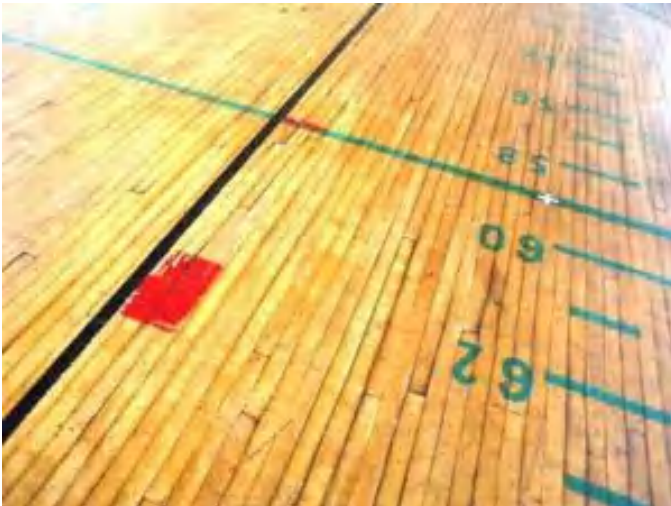
System: C3020414 - Wood Flooring

Location: Gym

Distress: Damaged

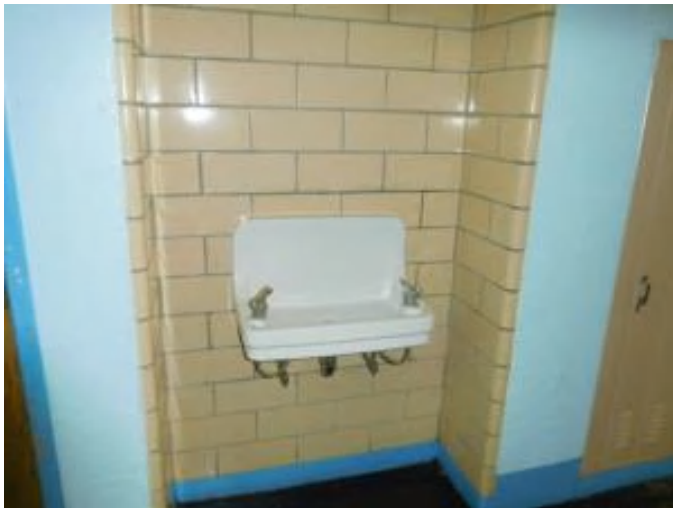
System: D2010 - Plumbing Fixtures

Location: corridors

Distress: Beyond Service Life

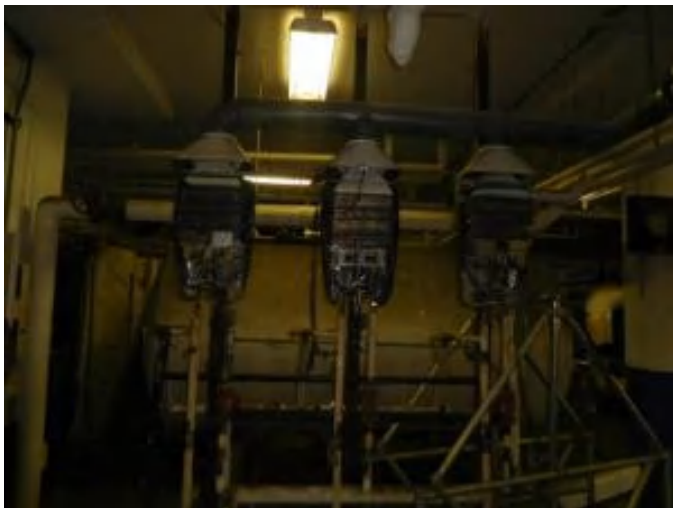
System: D2020 - Domestic Water Distribution

Location: entire building

Distress: Beyond Service Life

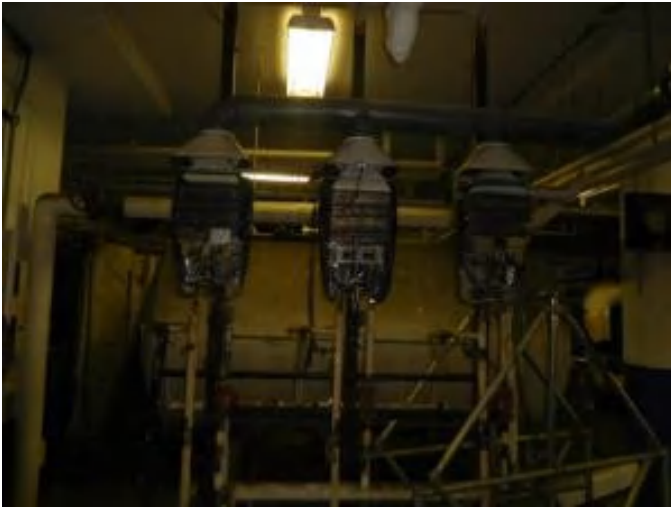
System: D2020 - Domestic Water Distribution

Location: mechanical room

Distress: Beyond Service Life

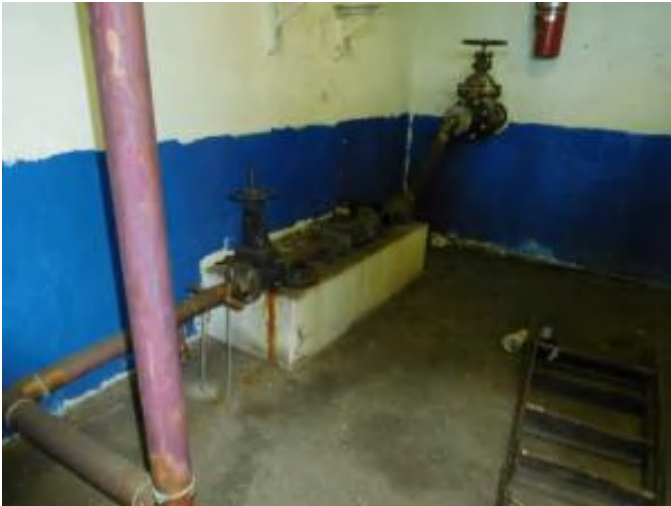
System: D2020 - Domestic Water Distribution

Location: mechanical room

Distress: Building / MEP Codes

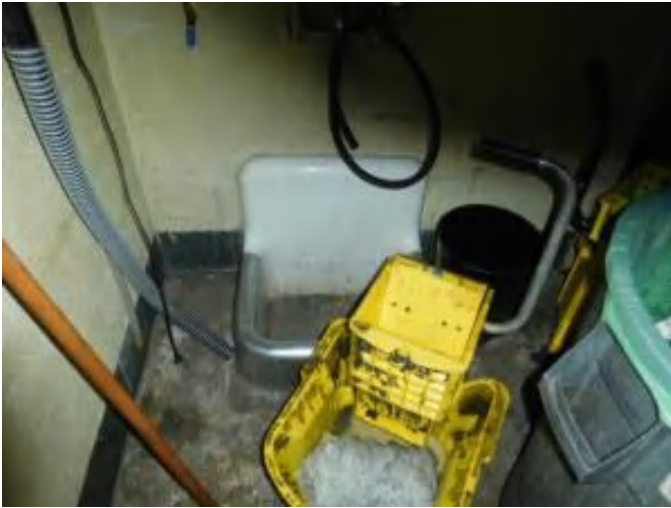
System: D2030 - Sanitary Waste

Location: entire building

Distress: Beyond Service Life

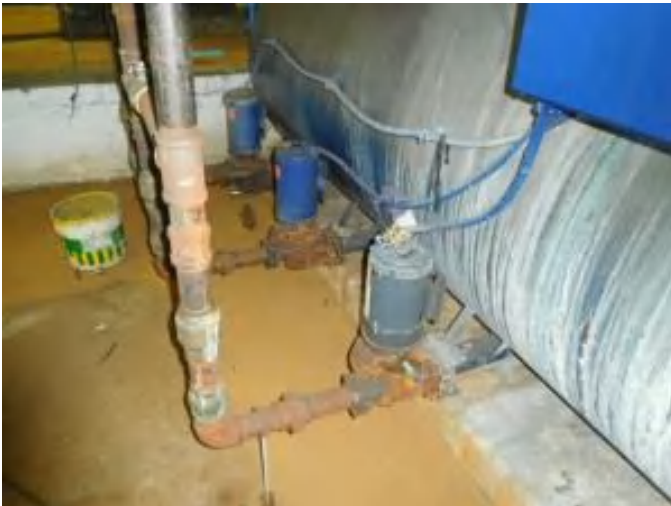
System: D3020 - Heat Generating Systems

Location: mechanical room

Distress: Beyond Service Life

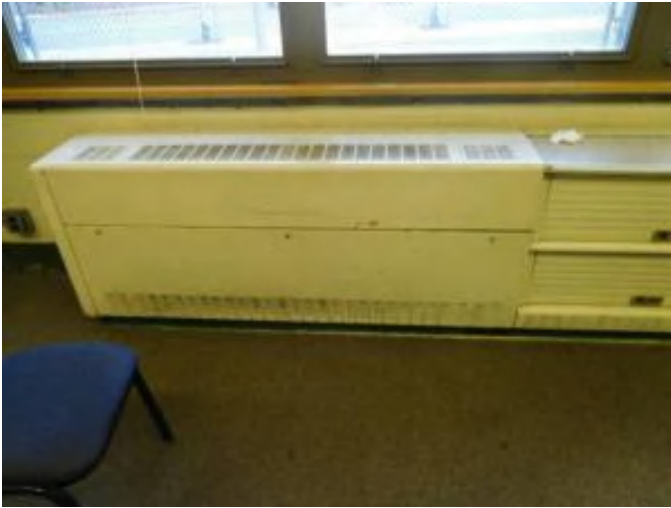
System: D3040 - Distribution Systems

Location: classrooms, offices, IMC

Distress: Building / MEP Codes

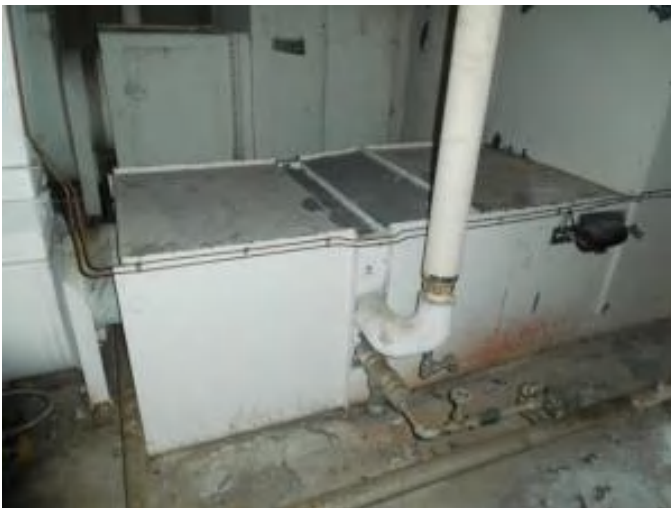
System: D3040 - Distribution Systems

Location: auditorium

Distress: Building / MEP Codes

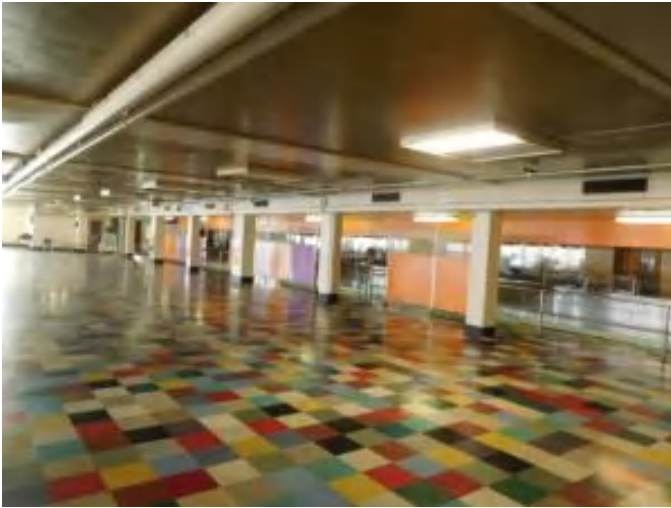
System: D3040 - Distribution Systems

Location: cafeteria

Distress: Building / MEP Codes

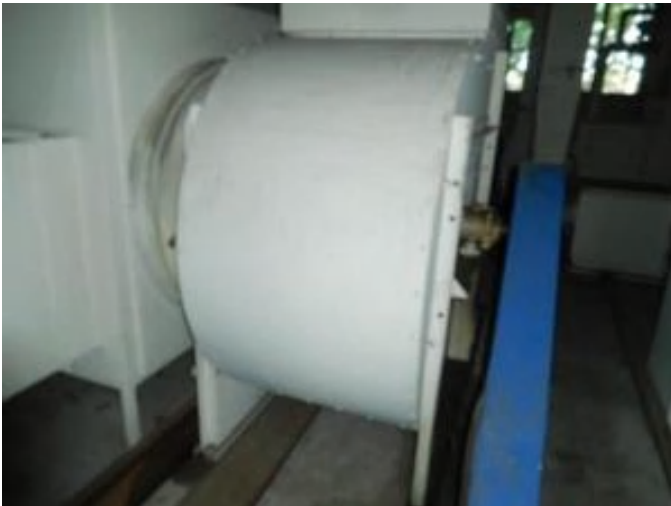
System: D3040 - Distribution Systems

Location: third floor mechanical

Distress: Beyond Service Life

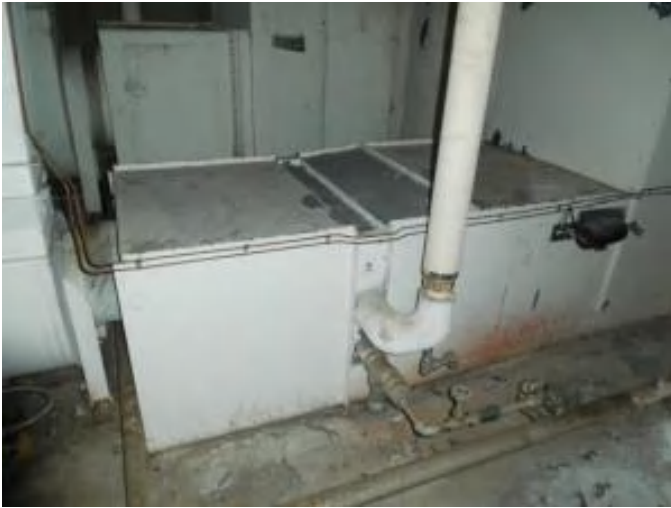
System: D3040 - Distribution Systems

Location: gymnasiums

Distress: Building / MEP Codes

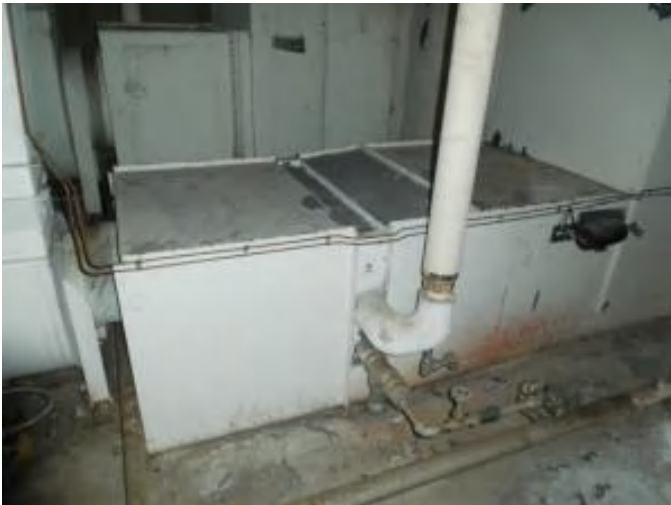
System: D3040 - Distribution Systems

Location: gymnasiums

Distress: Building / MEP Codes

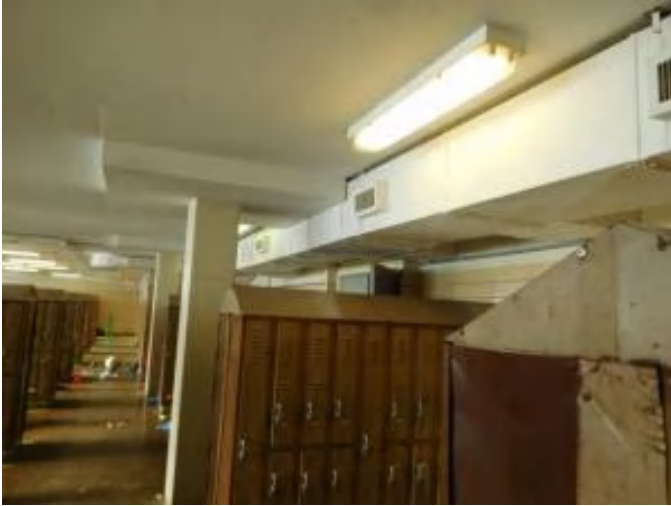
System: D3040 - Distribution Systems

Location: locker room

Distress: Building / MEP Codes

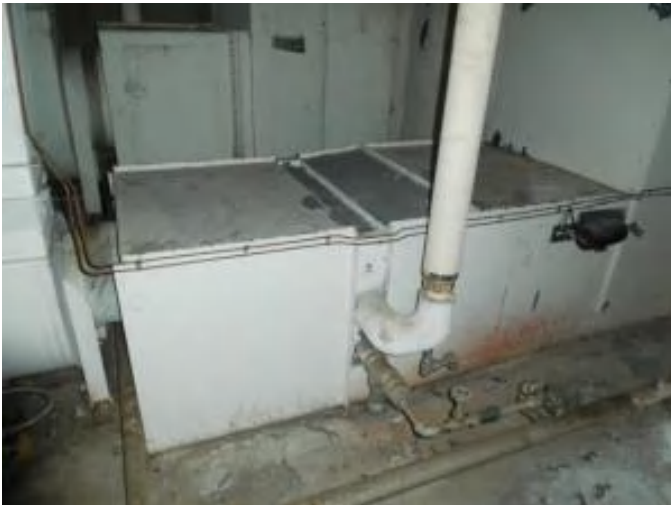
System: D3040 - Distribution Systems

Location: locker room

Distress: Building / MEP Codes

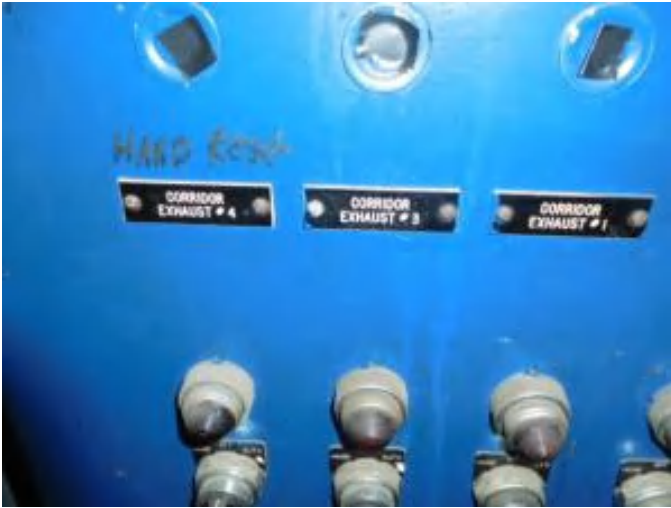
System: D3060 - Controls & Instrumentation

Location: entire building

Distress: Beyond Service Life

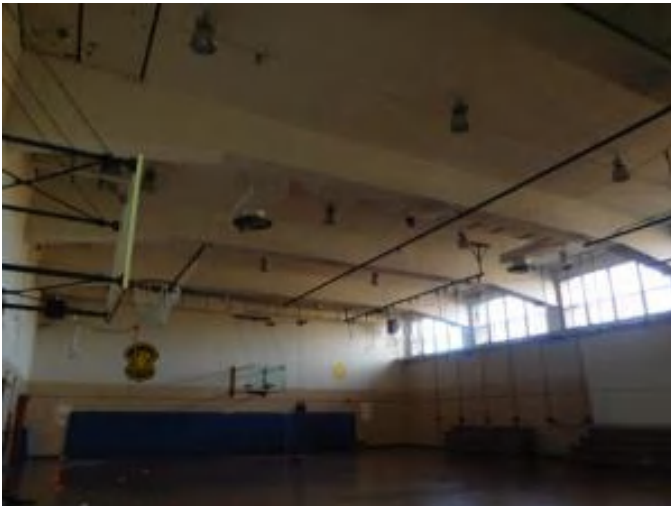
System: D4010 - Sprinklers

Location: entire building

Distress: Life Safety / NFPA / PFD

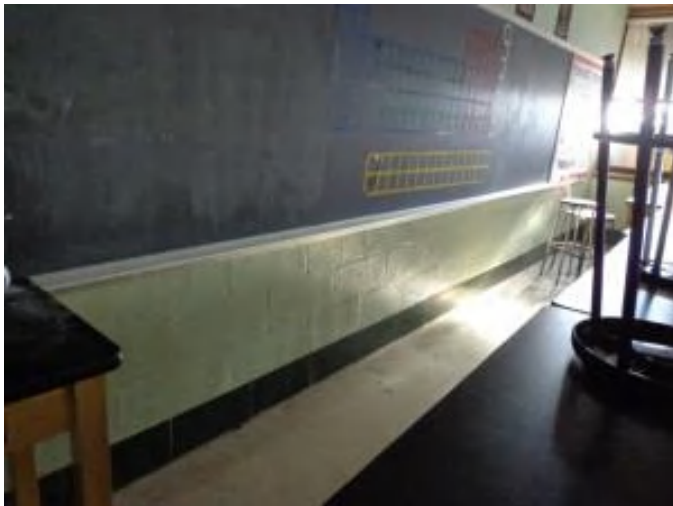
System: D5020 - Lighting and Branch Wiring

Location: Classrooms

Distress: Inadequate

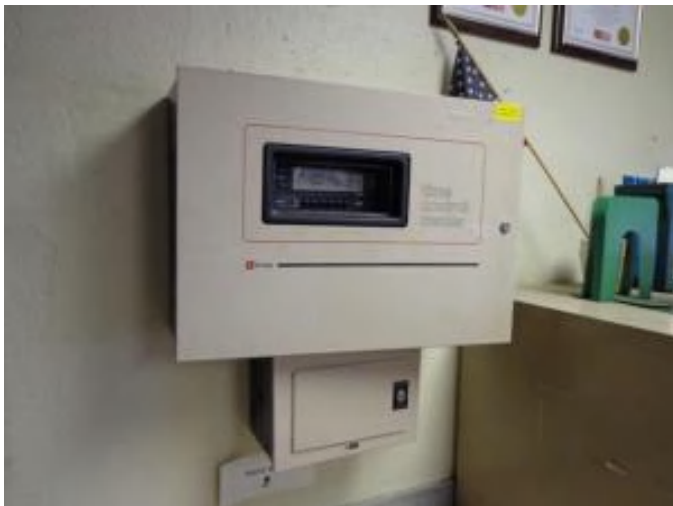
System: D5030 - Communications and Security

Location: Building wide

Distress: Damaged

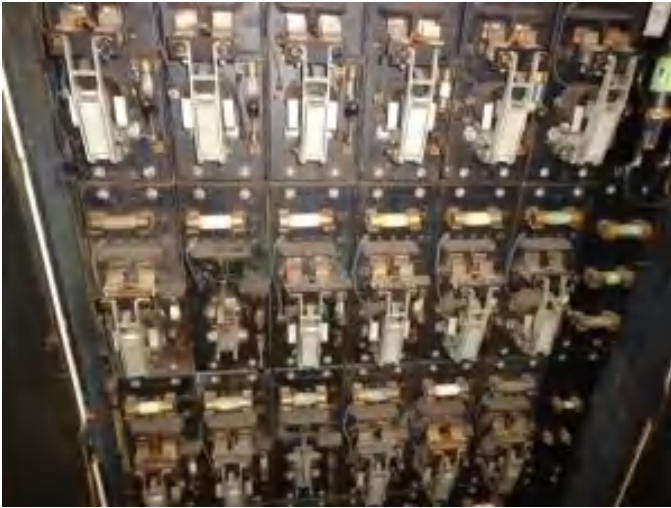
System: E1020 - Institutional Equipment

Location: Stage

Distress: Obsolete

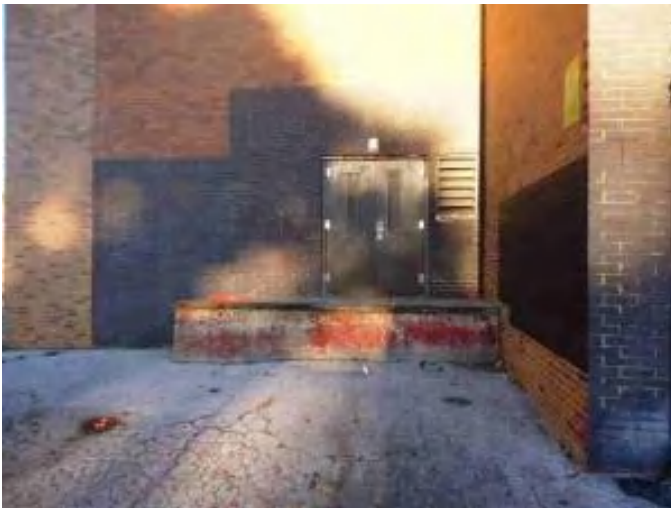
System: E1090 - Other Equipment

Location: Loading Dock

Distress: Damaged

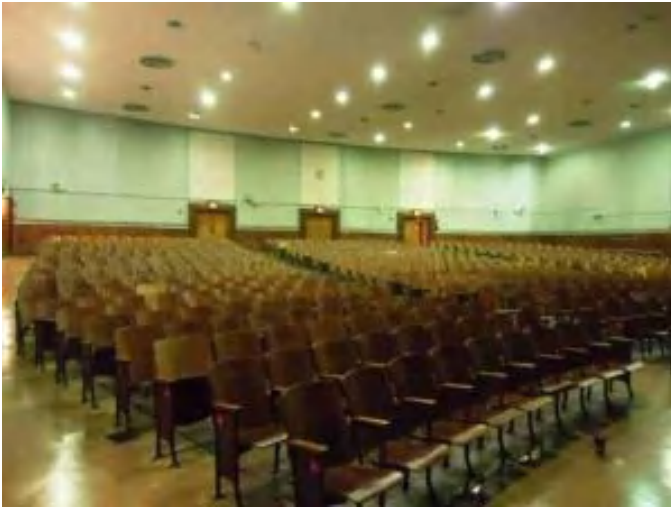
System: E2010 - Fixed Furnishings

Location: Auditorium

Distress: Damaged

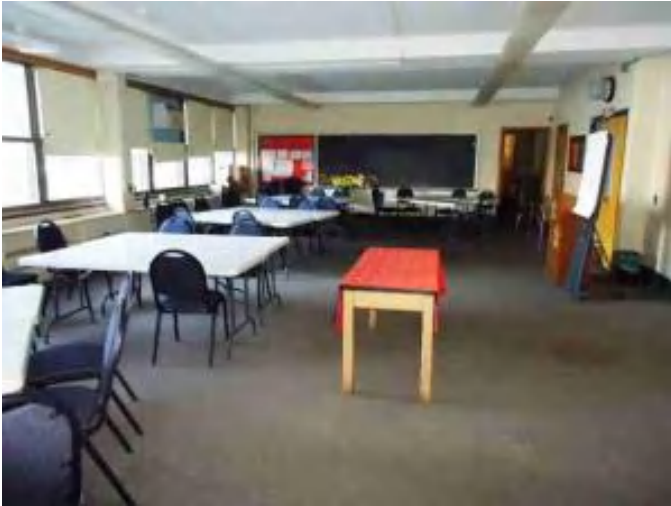
System: C3020411 - Carpet

Location: Conference Room and Admin Area

Distress: Damaged

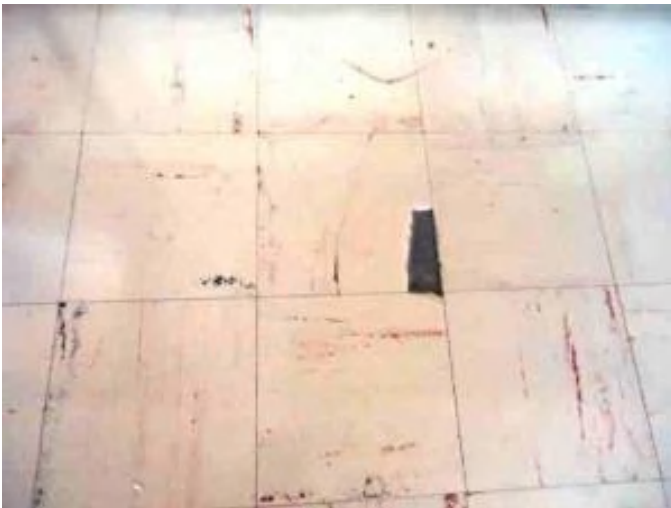
System: C3020413 - Vinyl Flooring

Location: Building Wide

Distress: Damaged

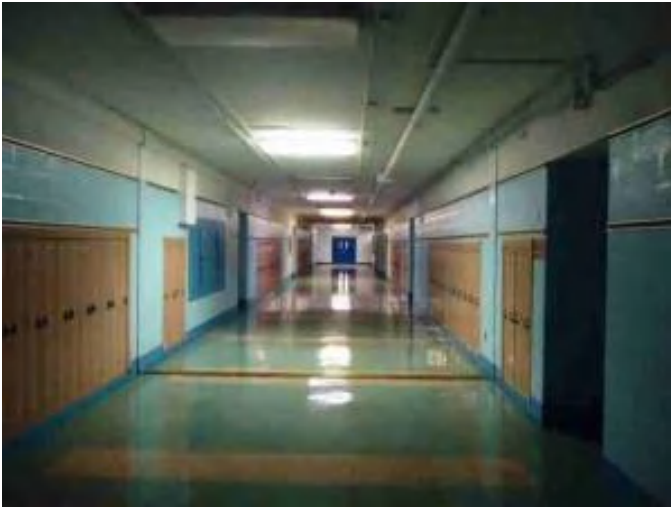
System: D1010 - Elevators and Lifts

Location: Building Wide

Distress: Accessibility

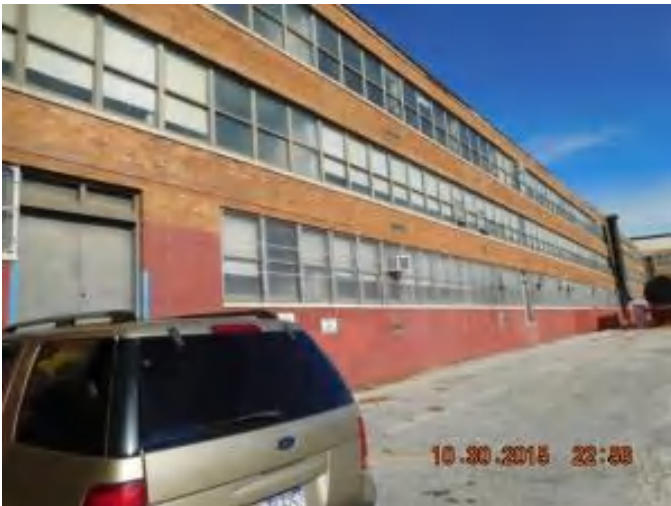
System: D3030 - Cooling Generating Systems

Location: roof, mechanical room

Distress: Inadequate

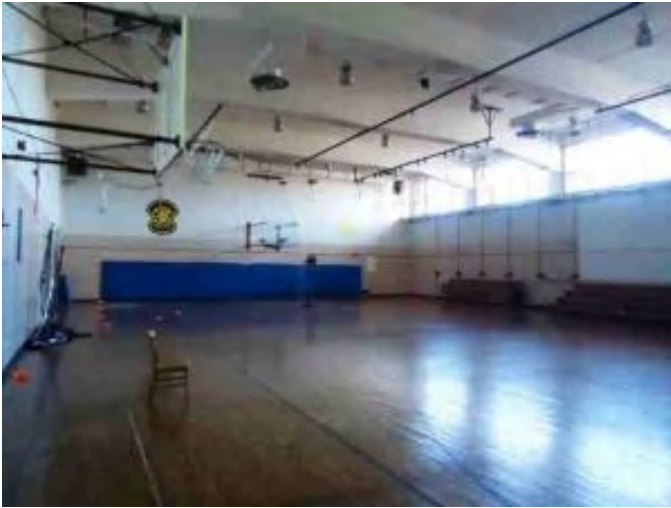
System: E1020 - Institutional Equipment

Location: Gym

Distress: Damaged

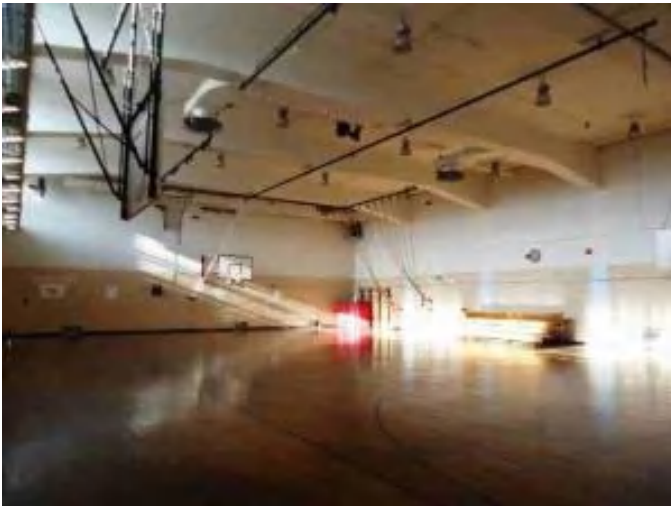
System: E1020 - Institutional Equipment

Location: Gym

Distress: Damaged

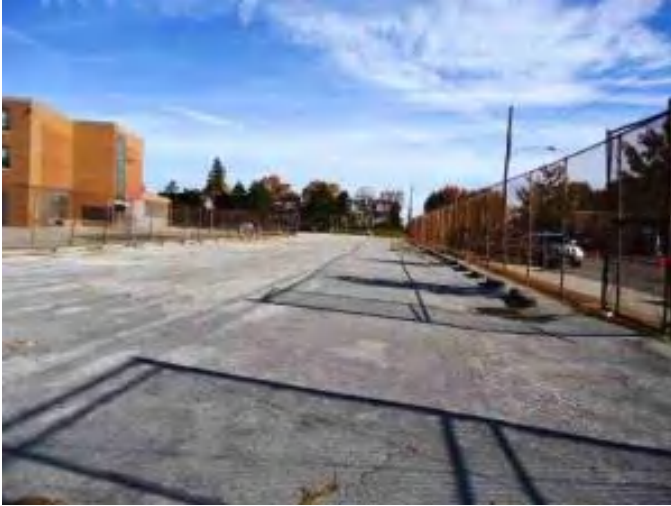
System: G2020 - Parking Lots

Location: Site

Distress: Damaged

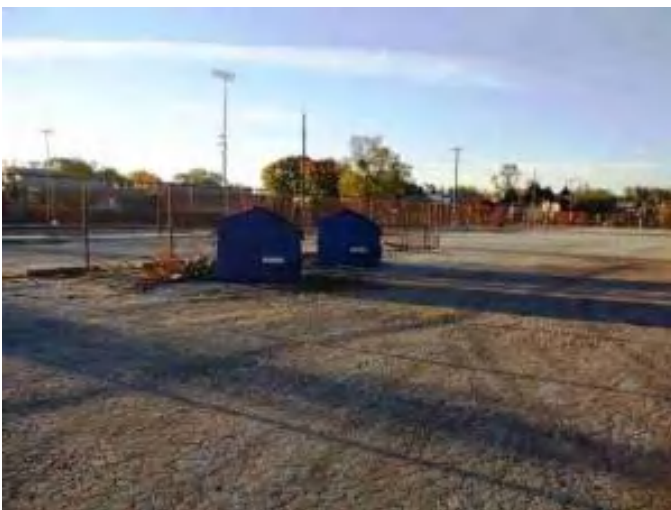
System: G2040 - Site Development

Location: Site

Distress: Health Hazard / Risk

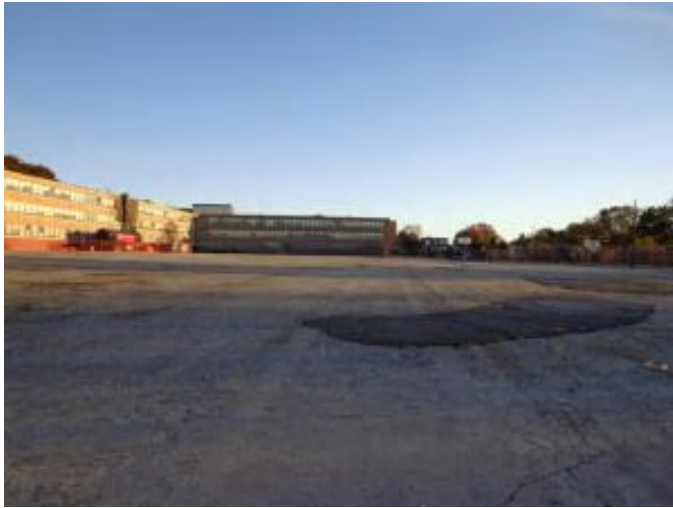
System: G4020 - Site Lighting

Location: Site

Distress: Security Issue

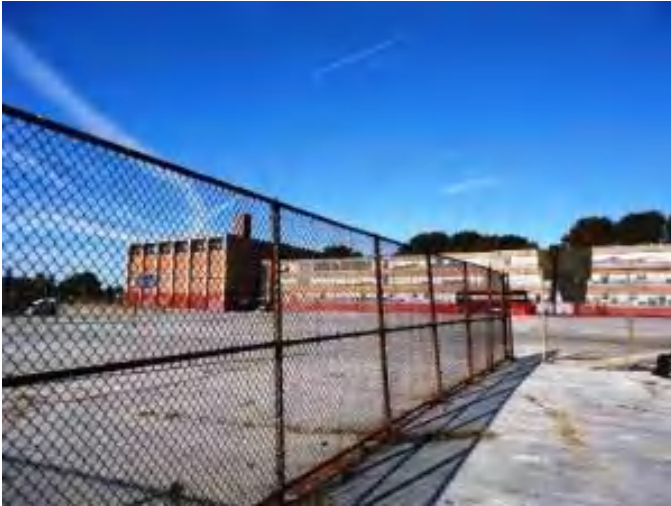
System: G2040 - Site Development

Location: Site

Distress: Damaged
