Facility Condition Assessment Summary Report

Holme School

School District of Philadelphia
S827001;Holme
Final
Site Assessment Report

January 31, 2017

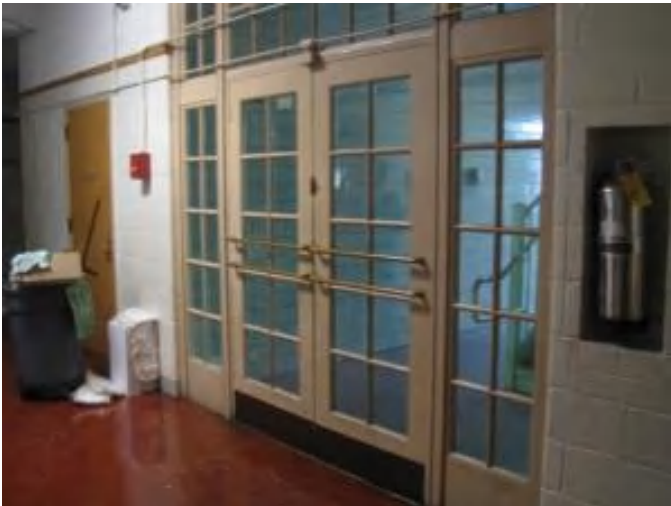
System: C1010 - Partitions

Location: stairway walls at corridors

Distress: Building / MEP Codes

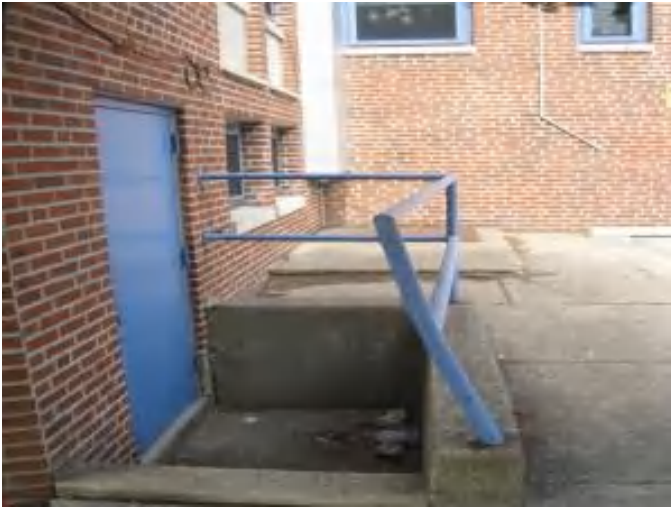
System: C2010 - Stair Construction

Location: basement stair in front of building

Distress: Failing

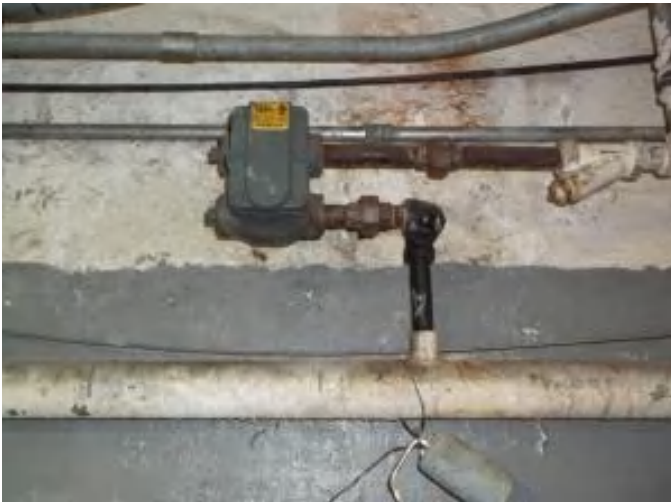
System: D3040 - Distribution Systems

Location: Throughout the building

Distress: Beyond Service Life

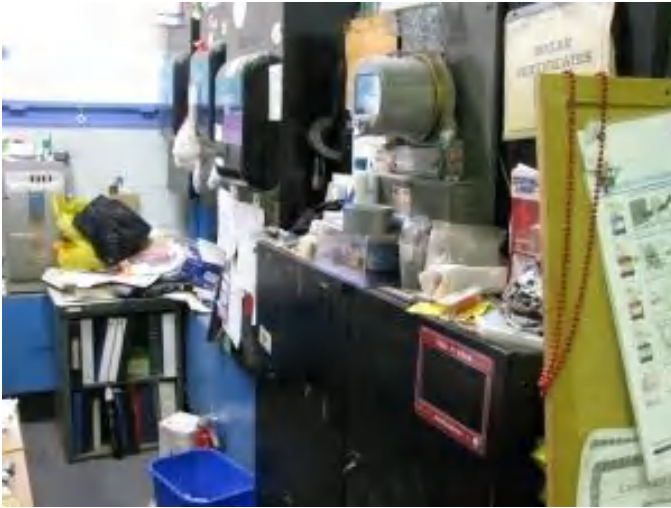
System: D5010 - Electrical Service/Distribution

Location: Basement
Distress: Beyond Service Life
Category: 3 - Operations / Maint.
Priority: 1 - Response Time (< 2 yr)
Correction: Add Electrical Switchgear and Distribution System
Qty: 1.00
Unit of Measure: Ea.
Estimate: \$1,093,290.83
Assessor Name: System
Date Created: 09/09/2015

Notes: Upgrade the existing electrical service with a new service. Replace the existing switchboard with new 1600A, 480/277, 3PH, 4 wire switchboard. Provide two 150KVA,480V to 120/208V step down transformer for providing power to Kitchen equipment, receptacles and other 208volts loads throughout the building.

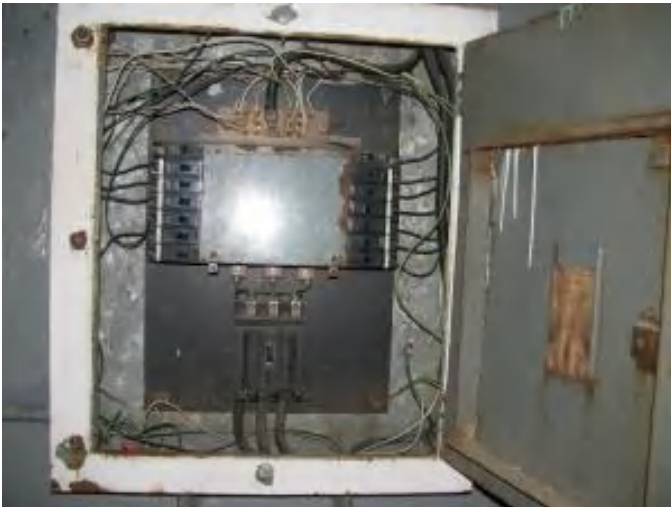
System: D5010 - Electrical Service/Distribution

Location: Entire Building
Distress: Beyond Service Life
Category: 3 - Operations / Maint.
Priority: 1 - Response Time (< 2 yr)
Correction: Replace Electrical Distribution System (U)
Qty: 1.00
Unit of Measure: Ea.
Estimate: \$405,399.54
Assessor Name: System
Date Created: 09/09/2015

Notes: Replace the entire distribution system with new panels and new wiring/conduits. Our recommendation is to replace existing conduits and wiring to new Junction boxes, receptacles, and lighting. Provide arc flash label on the electrical equipment. Estimated 16 panel boards.

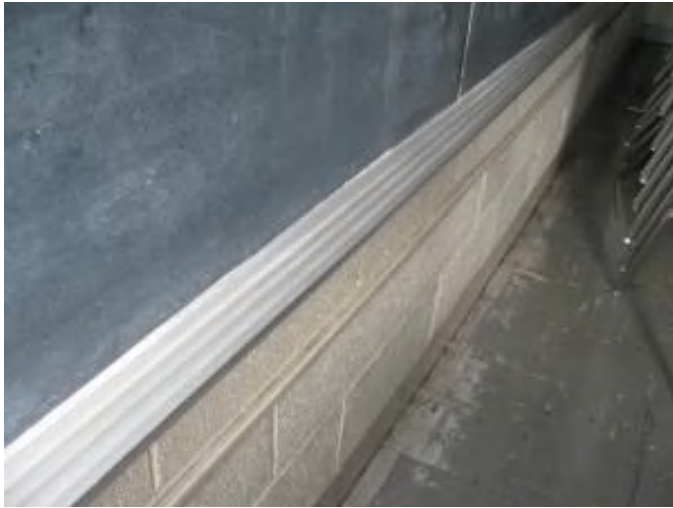
System: D5020 - Lighting and Branch Wiring

Location: Entire Building
Distress: Inadequate
Category: 4 - Capital Improvement
Priority: 1 - Response Time (< 2 yr)
Correction: Replace Wiring Devices (SF) - surface mounted conduit and boxes
Qty: 1.00
Unit of Measure: S.F.
Estimate: \$523,048.65
Assessor Name: System
Date Created: 09/09/2015

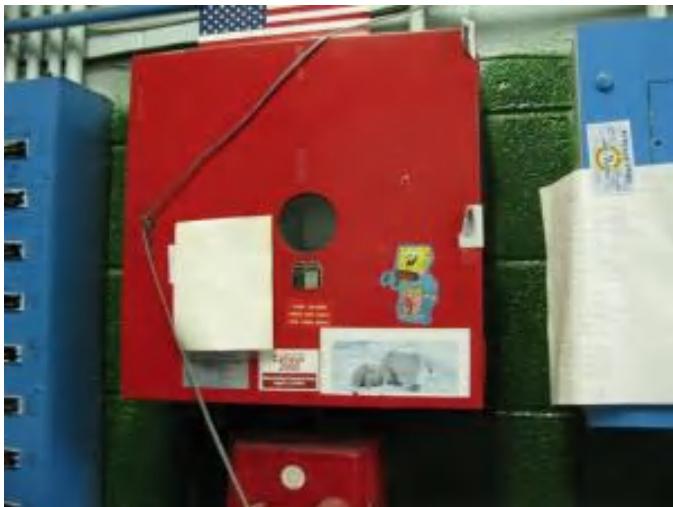
System: D5030 - Communications and Security

Fire Alarm System consists of a 120V manual fire alarm system. The system does not meet current fire alarm codes and should be replaced.

Location: Entire Building
Distress: Beyond Service Life
Category: 3 - Operations / Maint.
Priority: 1 - Response Time (< 2 yr)
Correction: Replace fire alarm system
Qty: 1.00
Unit of Measure: S.F.
Estimate: \$347,739.98
Assessor Name: System
Date Created: 09/09/2015

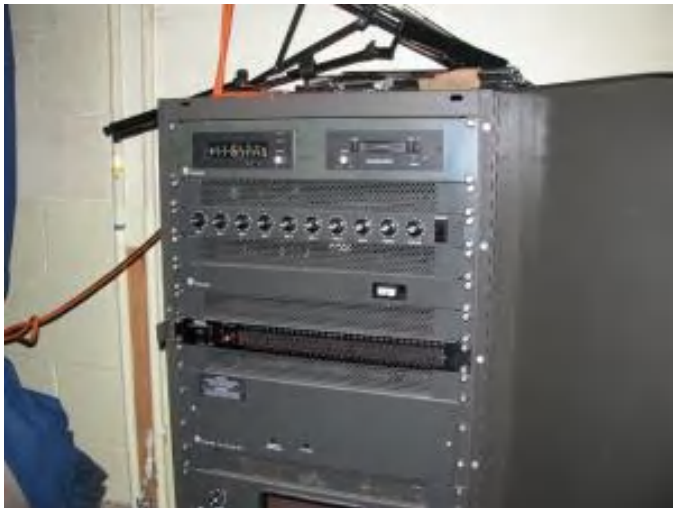
System: D5030 - Communications and Security

Location: Auditorium
Distress: Inadequate
Category: 4 - Capital Improvement
Priority: 1 - Response Time (< 2 yr)
Correction: Add/Replace Sound System
Qty: 1.00
Unit of Measure: LS
Estimate: \$39,453.05
Assessor Name: System
Date Created: 09/09/2015

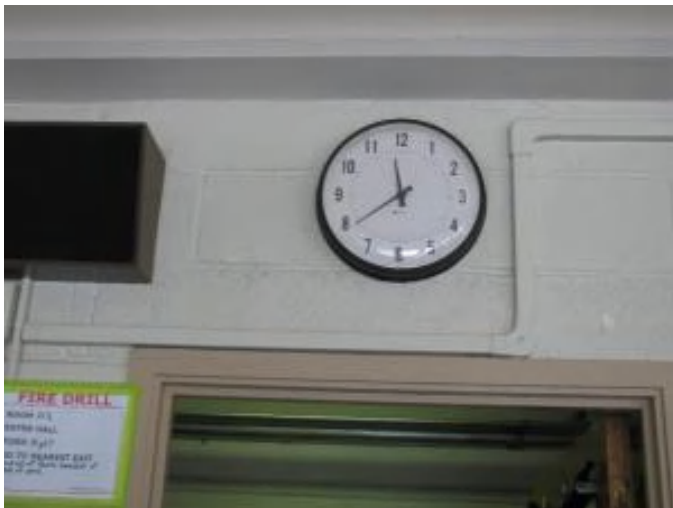
System: D5030 - Communications and Security

Location: Entire building
Distress: Inadequate
Category: 4 - Capital Improvement
Priority: 1 - Response Time (< 2 yr)
Correction: Add/Replace Clock System or Components
Qty: 1.00
Unit of Measure: Ea.
Estimate: \$27,297.87
Assessor Name: System
Date Created: 09/09/2015

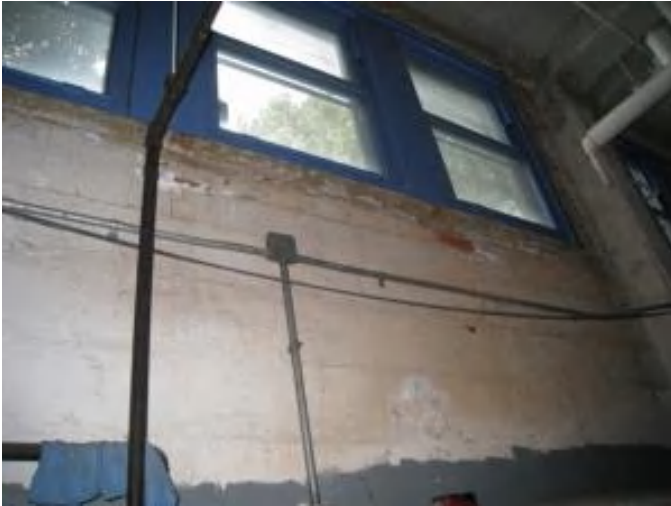
System: A2020 - Basement Walls

Location: mechanical room

Distress: Damaged

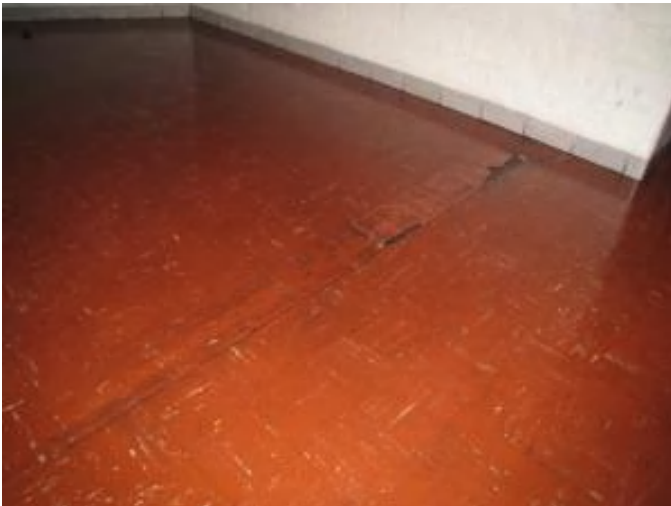
System: B1010 - Floor Construction

Location: basement

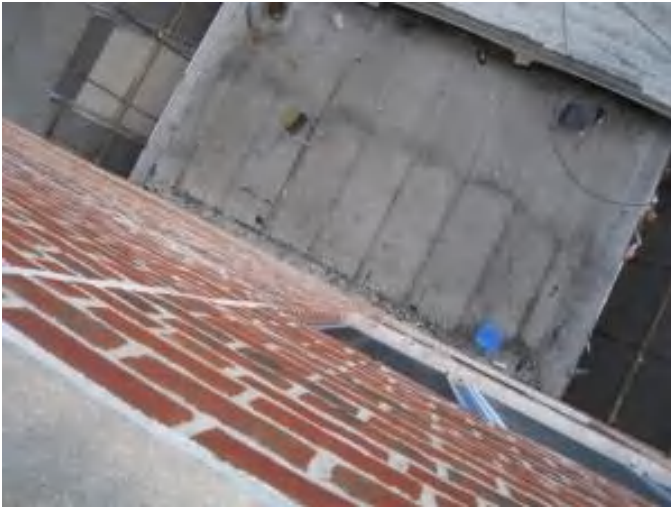
System: B2010 - Exterior Walls

Location: exterior walls

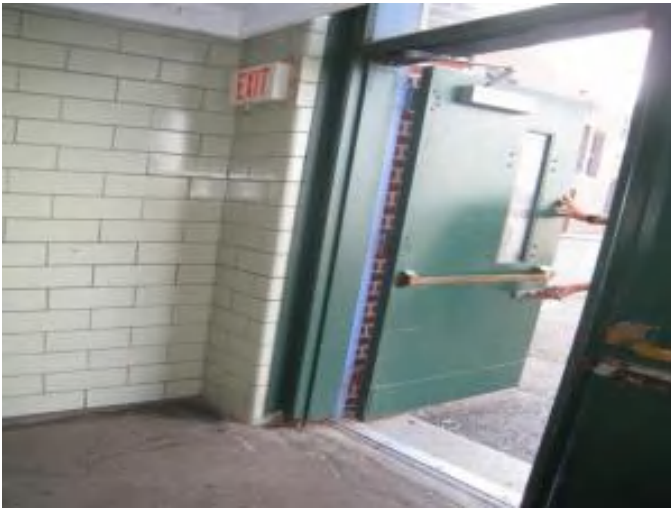
System: B2030 - Exterior Doors

Location: exterior doors

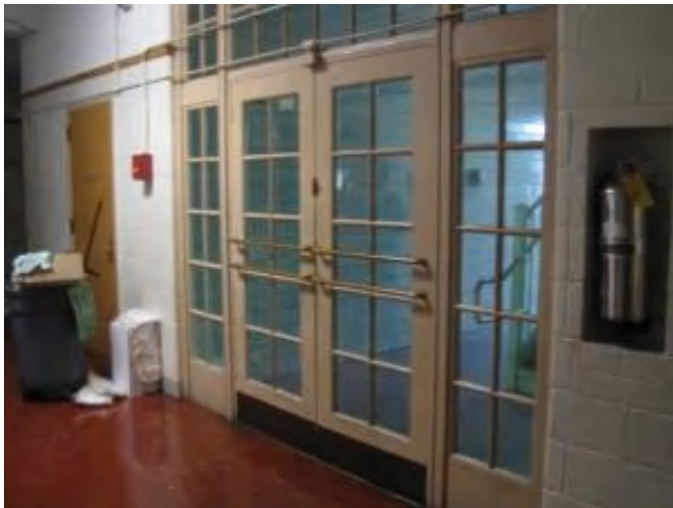
System: C1020 - Interior Doors

Location: interior rooms

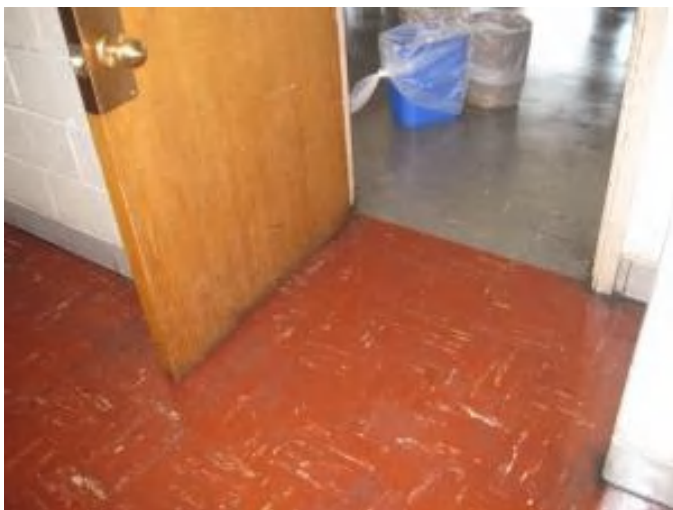
System: C1020 - Interior Doors

Location: classroom and office doors

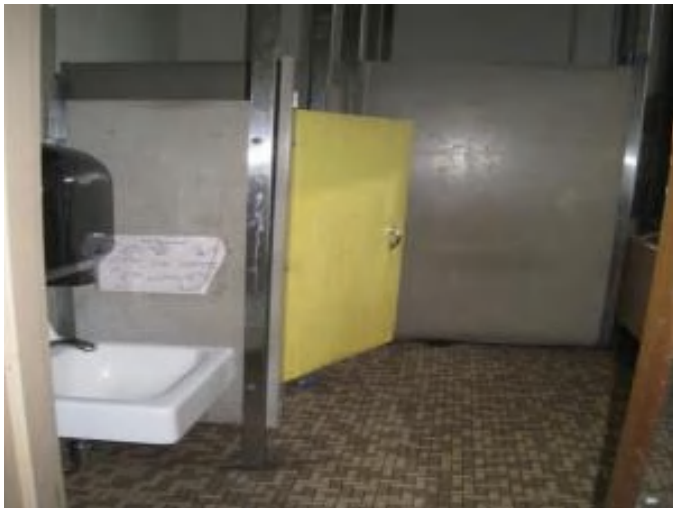
System: C1030 - Fittings

Location: toilet rooms

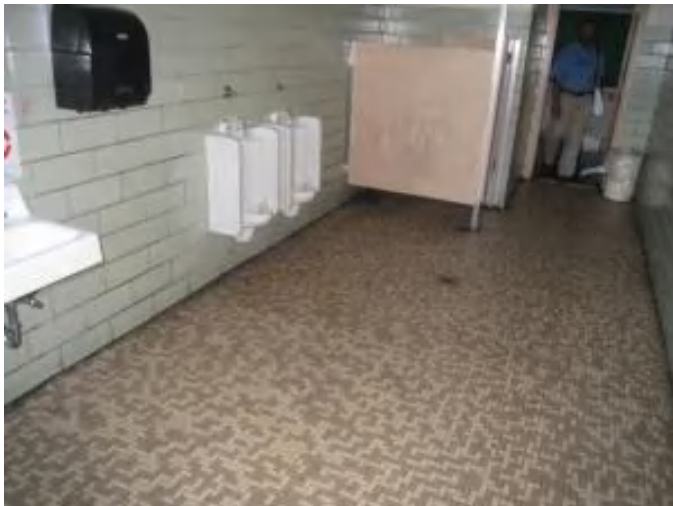
System: C1030 - Fittings

Location: toilet rooms

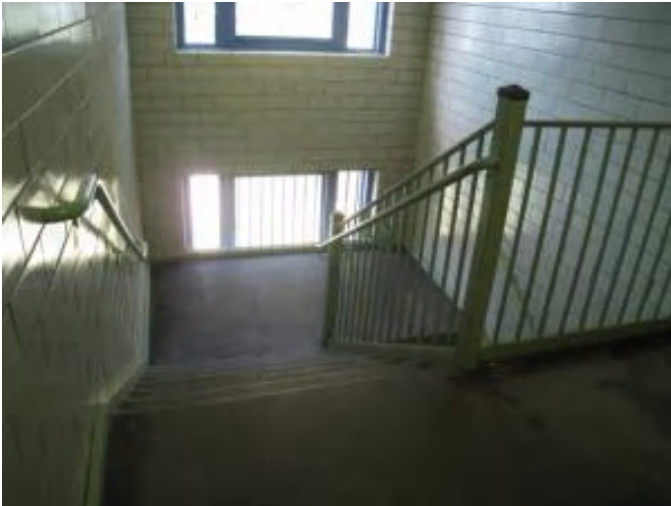
System: C2010 - Stair Construction

Location: stairways

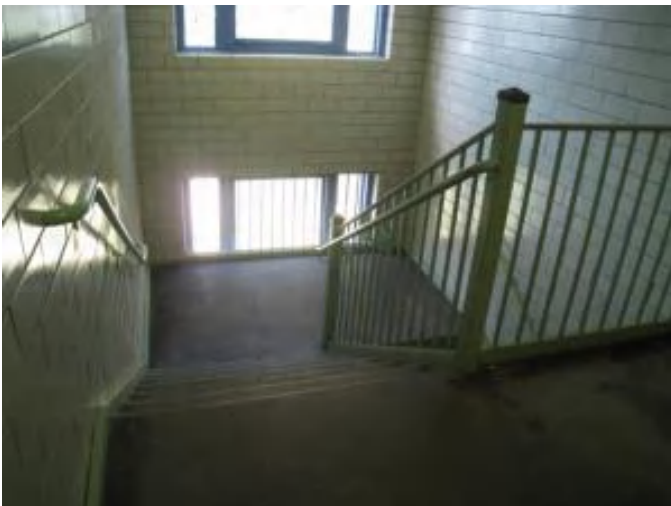
System: C2010 - Stair Construction

Location: stairs

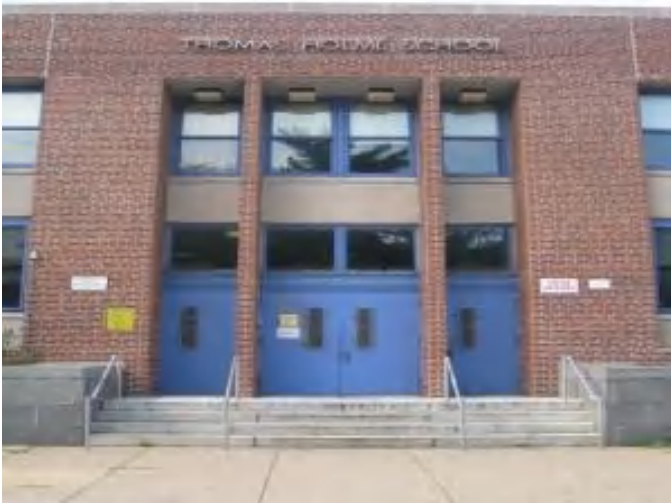
System: C2010 - Stair Construction

Location: exterior stairs

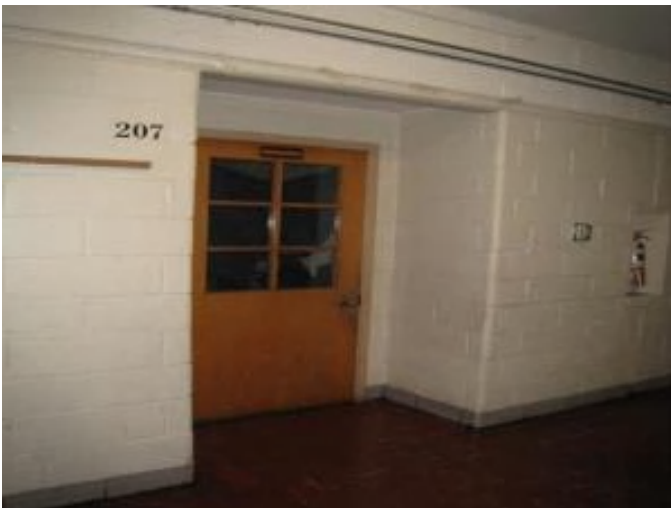
System: C3010230 - Paint & Covering

Location: classrooms and corridors

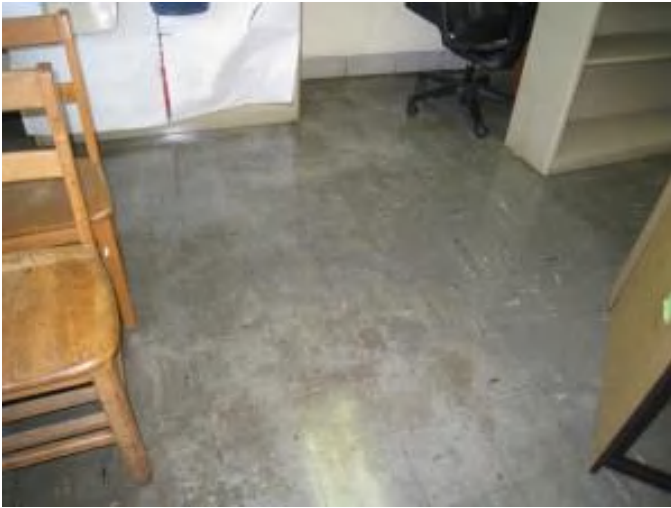
System: C3010230 - Paint & Covering

Location: classroom storage units adj to univents

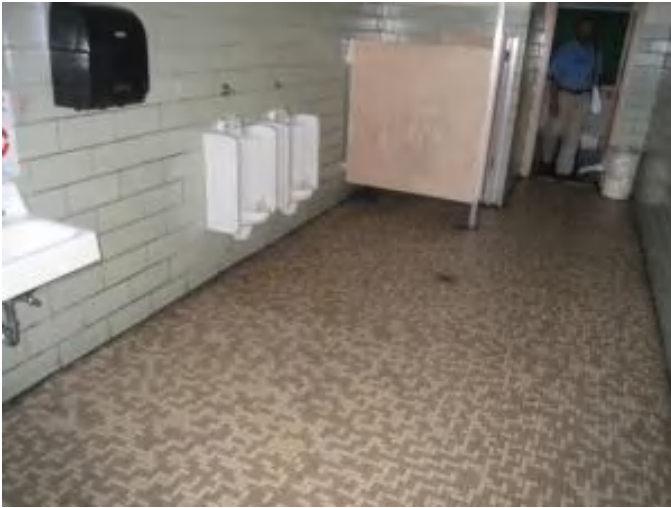
System: C3020412 - Terrazzo & Tile

Location: toilet rooms

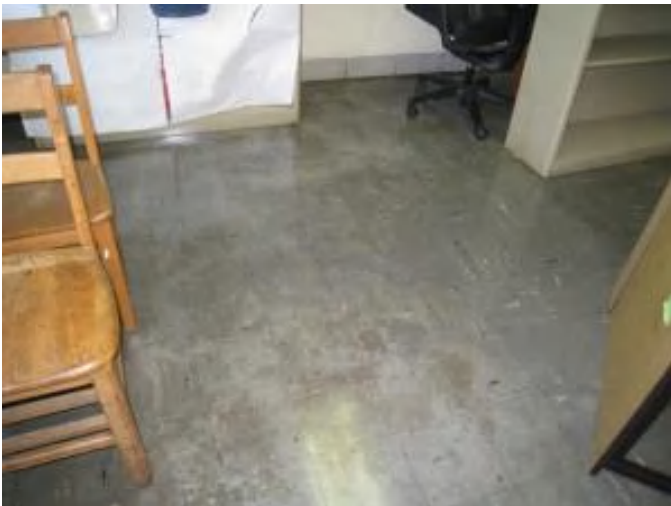
System: C3020413 - Vinyl Flooring

Location: all floors

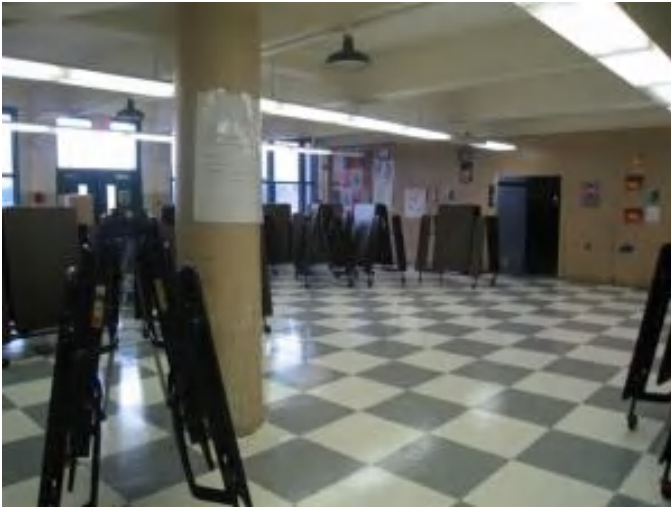
System: C3020413 - Vinyl Flooring

Location: cafeteria, gym, other rooms

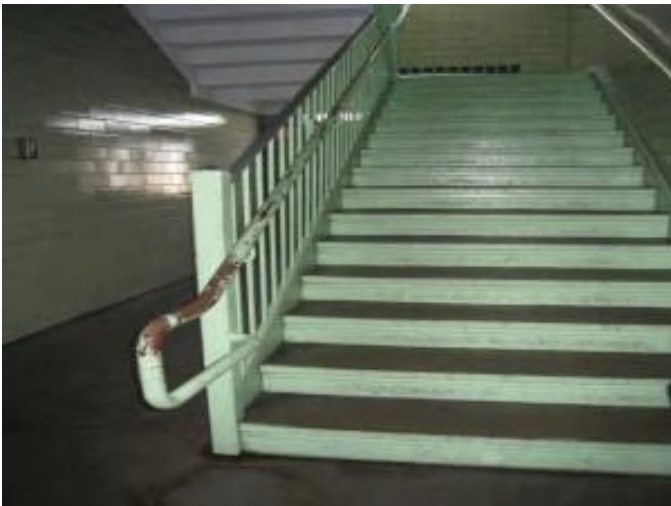
System: C3020415 - Concrete Floor Finishes

Location: mechanical area and stairs

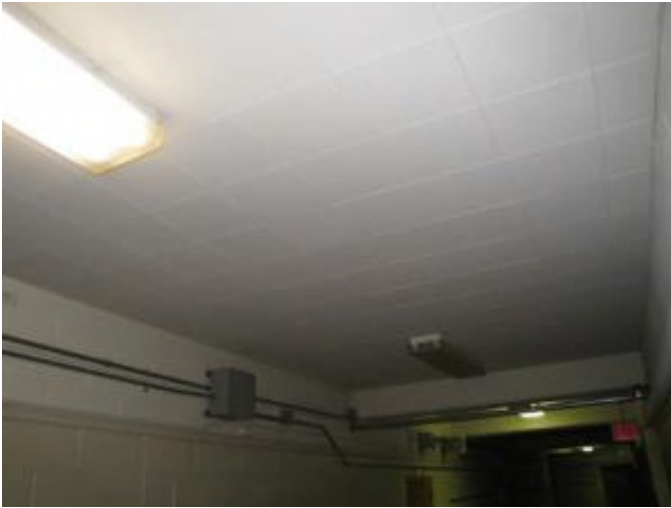
System: C3030 - Ceiling Finishes

Location: all rooms

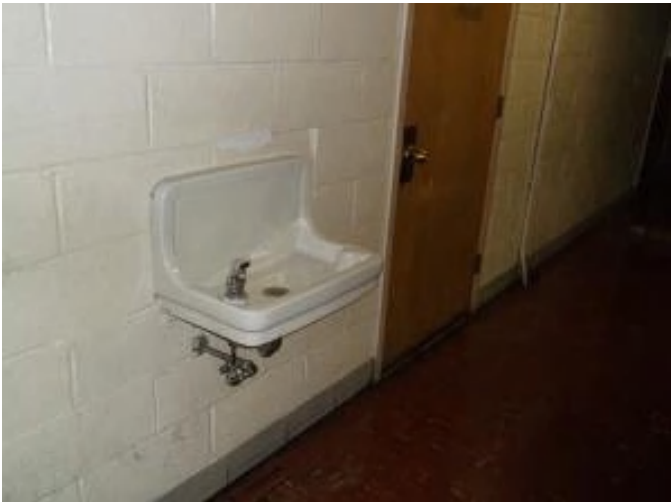
System: D2010 - Plumbing Fixtures

Location: Throughout the building

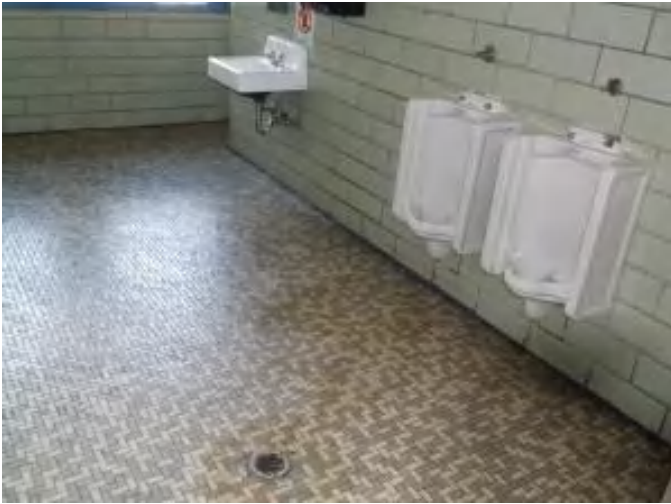
System: D2010 - Plumbing Fixtures

Location: Throughout the building

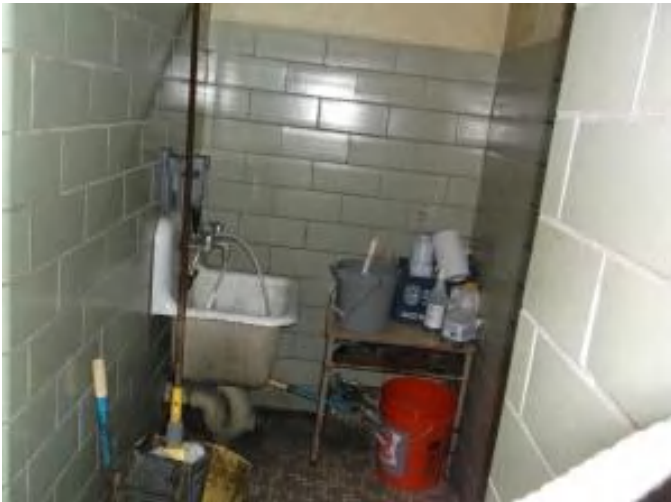
System: D2010 - Plumbing Fixtures

Location: Throughout the building

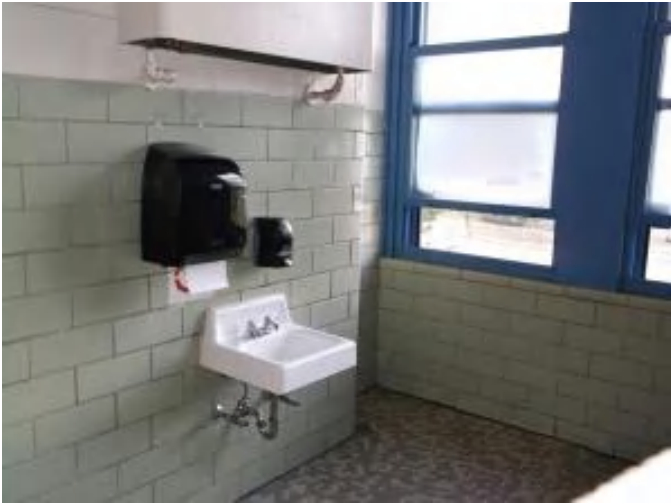
System: D2010 - Plumbing Fixtures

Location: Throughout the building
Distress: Beyond Service Life
Category: 3 - Operations / Maint.
Priority: 2 - Response Time (2-3 yrs)
Correction: Remove and replace or replace lavatory - quantify accessible if required
Qty: 9.00
Unit of Measure: Ea.
Estimate: \$1,537.19
Assessor Name: System
Date Created: 11/17/2015

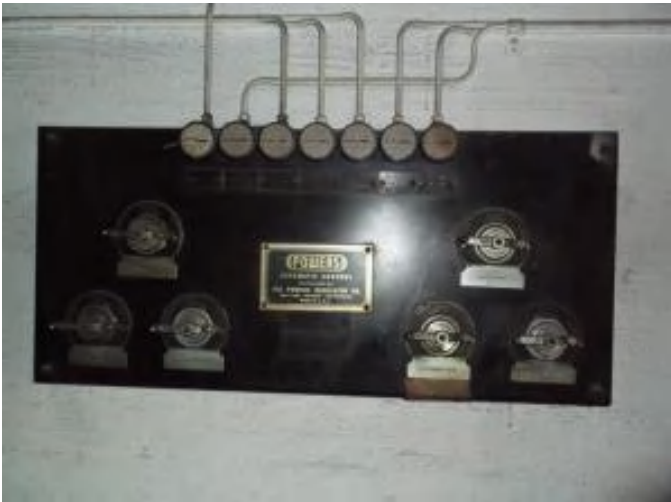
System: D3060 - Controls & Instrumentation

Location: Throughout the building
Distress: Beyond Service Life
Category: 3 - Operations / Maint.
Priority: 2 - Response Time (2-3 yrs)
Correction: Replace pneumatic controls with DDC (75KSF)
Qty: 73,000.00
Unit of Measure: S.F.
Estimate: \$1,566,000.16
Assessor Name: System
Date Created: 11/17/2015

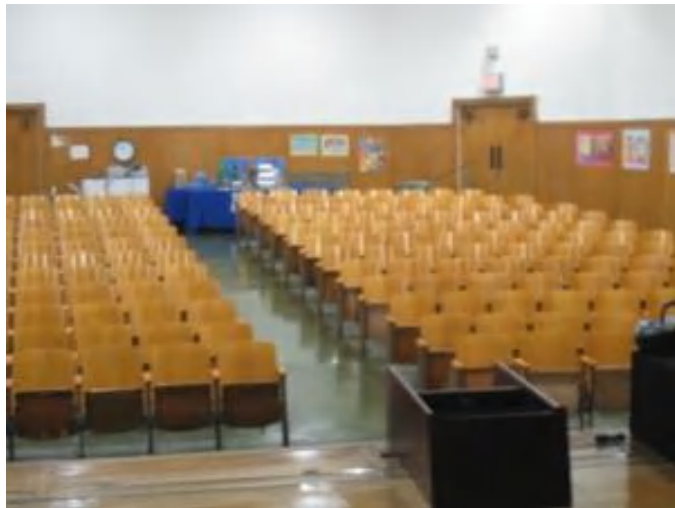
System: E2010 - Fixed Furnishings

Location: auditorium

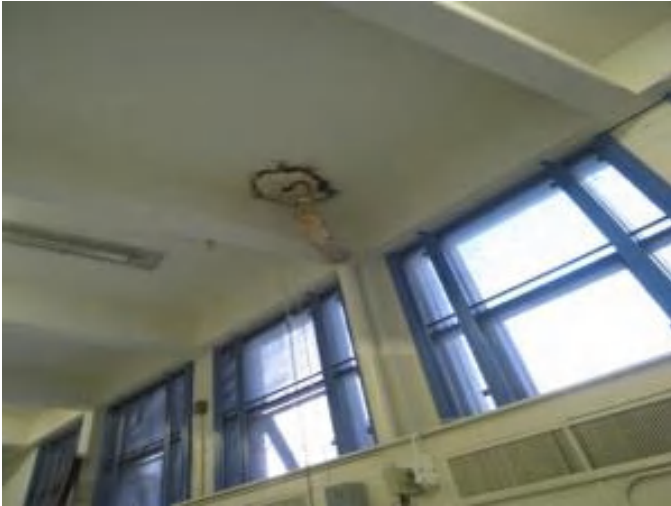
System: C3030 - Ceiling Finishes

Location: water damaged exposed ceilings

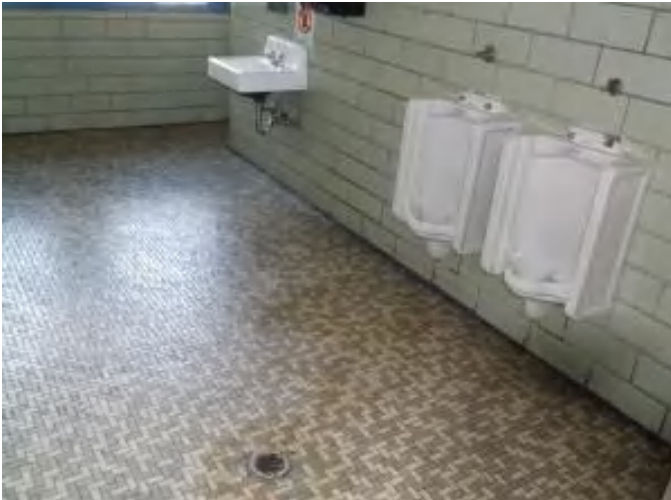
System: D2030 - Sanitary Waste

Sanitary Waste - The sanitary waste piping system in the original building is extra heavy cast iron with lead and oakum seals and appears to be the original piping installed in the building. It is therefore recommended to inspect this piping and repair or replace sections as needed. The sanitary system leaves the building by gravity flow.

Location: Throughout the building

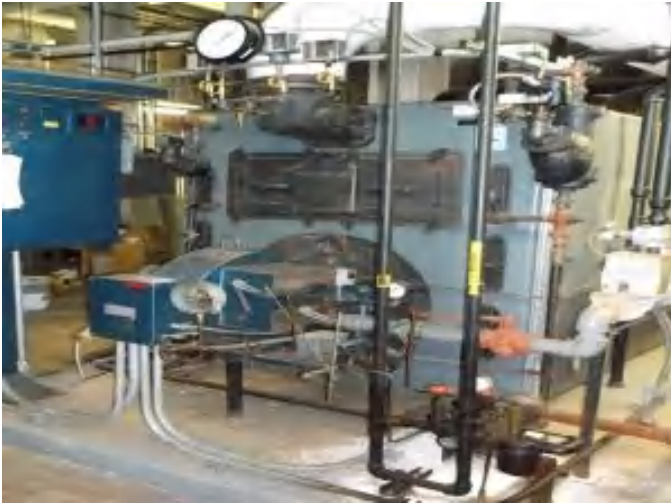
System: D3020 - Heat Generating Systems

Location: Boiler Mechanical Equipment Room
Distress: Beyond Service Life
Category: 3 - Operations / Maint.
Priority: 3 - Response Time (3-4 yrs)
Correction: Replace boiler, cast iron sectional (100 HP)
Qty: 2.00
Unit of Measure: Ea.
Estimate: \$655,796.89
Assessor Name: System
Date Created: 11/17/2015

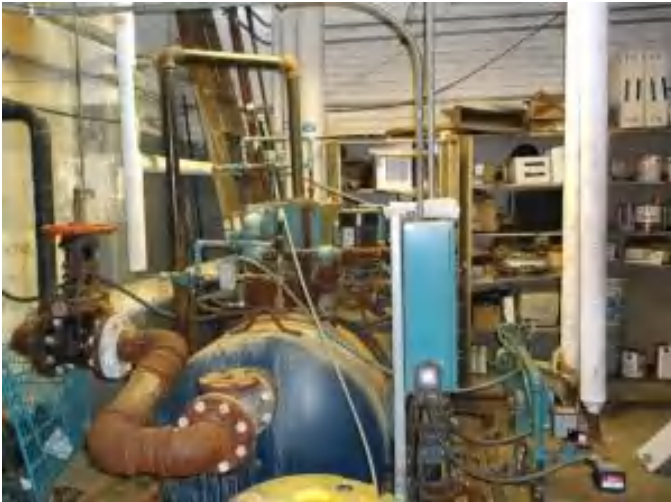
System: D3040 - Distribution Systems

Location: Throughout the building
Distress: Beyond Service Life
Category: 3 - Operations / Maint.
Priority: 3 - Response Time (3-4 yrs)
Correction: Perform testing to identify and replace damaged steam and condensate piping.
Qty: 73,000.00
Unit of Measure: S.F.
Estimate: \$690,607.29
Assessor Name: System
Date Created: 11/17/2015

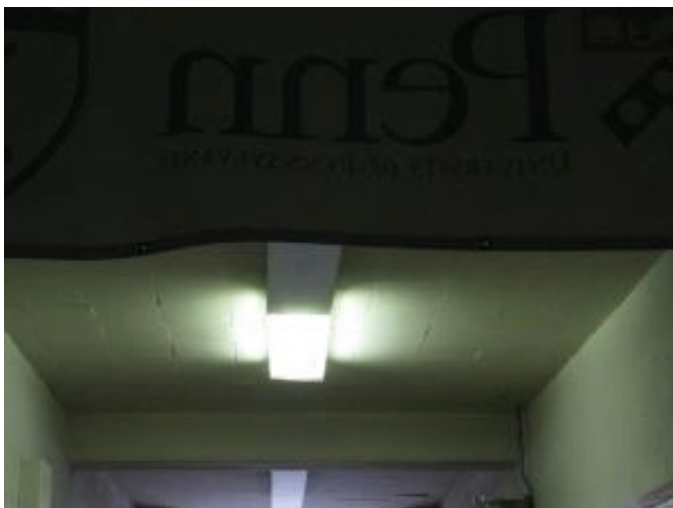
System: D5020 - Lighting and Branch Wiring

Location: Entire Building

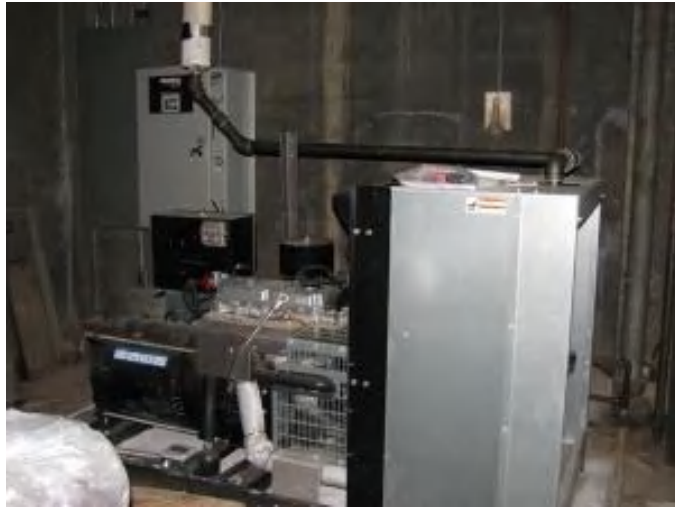
System: D5090 - Other Electrical Systems

Location: Basement

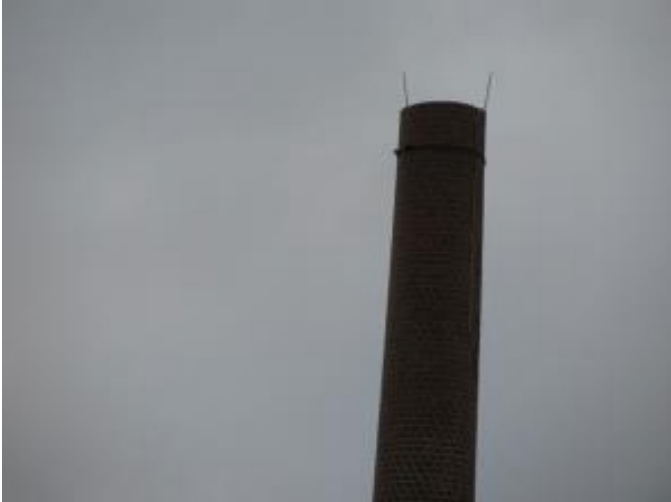
System: D5090 - Other Electrical Systems

Location: Roof

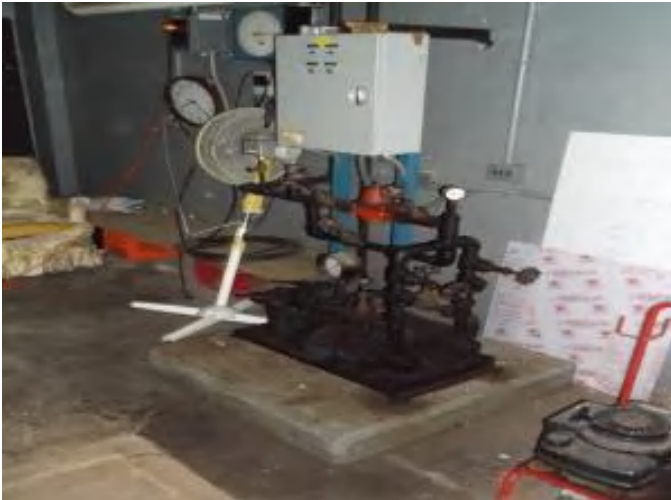
System: D3020 - Heat Generating Systems

Location: Boiler Mechanical Equipment Room

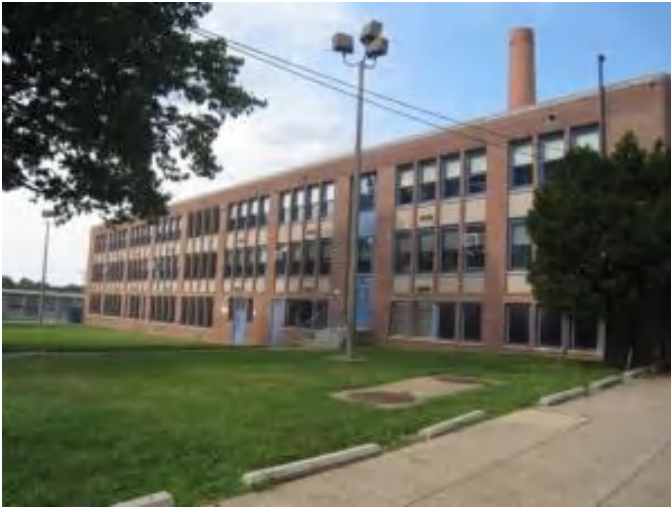
System: D3030 - Cooling Generating Systems

Location: Adjacent to building
Distress: Inadequate
Category: 4 - Capital Improvement
Priority: 5 - Response Time (> 5 yrs)
Correction: Install chilled water system with distribution piping and pumps. (+75KSF)
Qty: 73,000.00
Unit of Measure: S.F.
Estimate: \$1,172,321.97
Assessor Name: System
Date Created: 11/17/2015

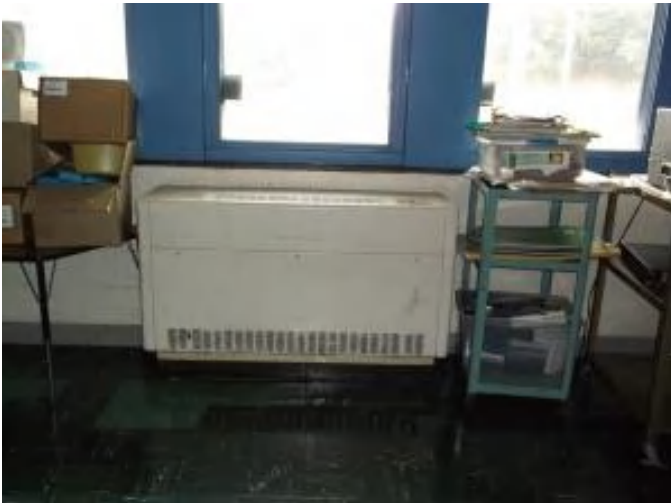
System: D3040 - Distribution Systems

Location: Throughout the building
Distress: Beyond Service Life
Category: 3 - Operations / Maint.
Priority: 5 - Response Time (> 5 yrs)
Correction: Provide classroom FC units and dedicated OA ventilation system. (20 clsrms)
Qty: 20.00
Unit of Measure: C
Estimate: \$1,661,219.77
Assessor Name: System
Date Created: 11/17/2015

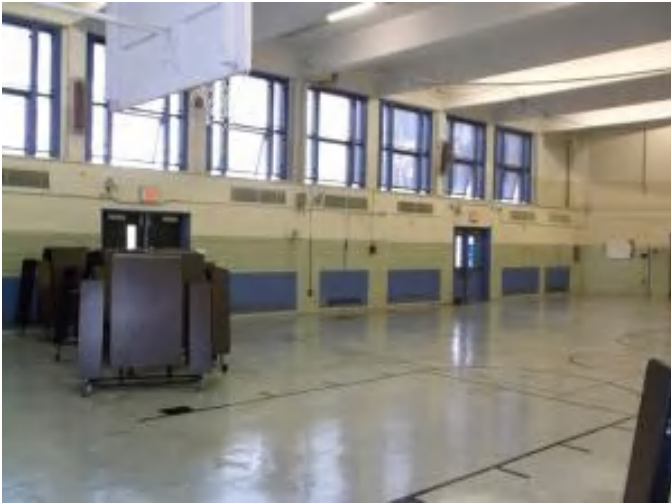
System: D3040 - Distribution Systems

Location: Gym
Distress: Beyond Service Life
Category: 3 - Operations / Maint.
Priority: 5 - Response Time (> 5 yrs)
Correction: Install HVAC unit for Gymnasium (single station).
Qty: 12,000.00
Unit of Measure: Ea.
Estimate: \$616,602.09
Assessor Name: System
Date Created: 11/17/2015

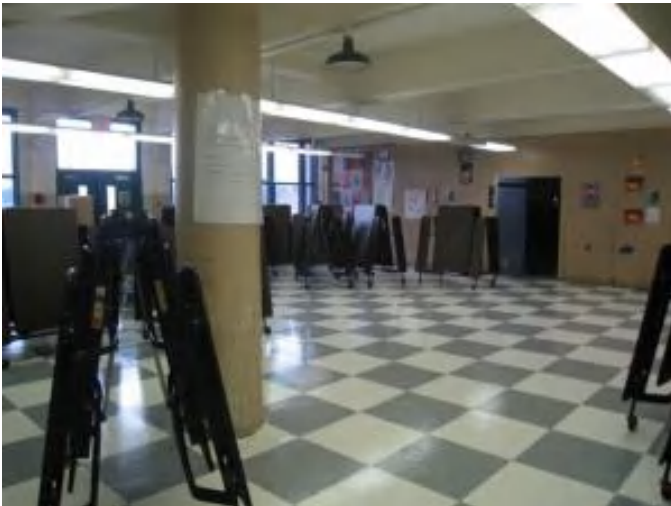
System: D3040 - Distribution Systems

Location: Cafeteria
Distress: Beyond Service Life
Category: 3 - Operations / Maint.
Priority: 5 - Response Time (> 5 yrs)
Correction: Install HVAC unit for Cafeteria (850 students).
Qty: 550.00
Unit of Measure: Pr.
Estimate: \$257,151.40
Assessor Name: System
Date Created: 11/17/2015

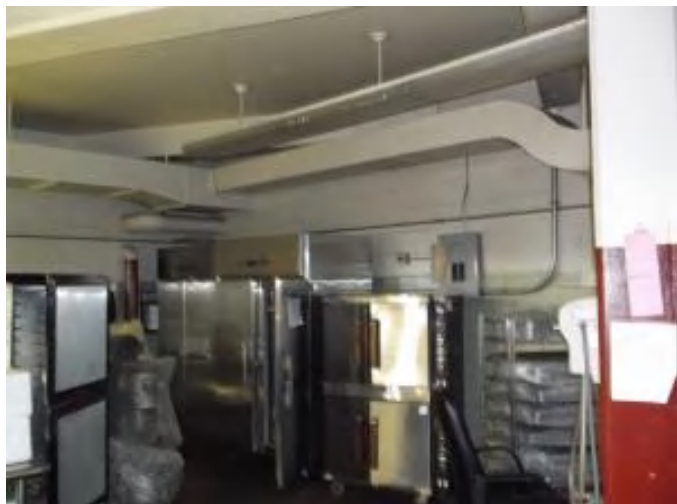
System: D4010 - Sprinklers

Location: Throughout the building

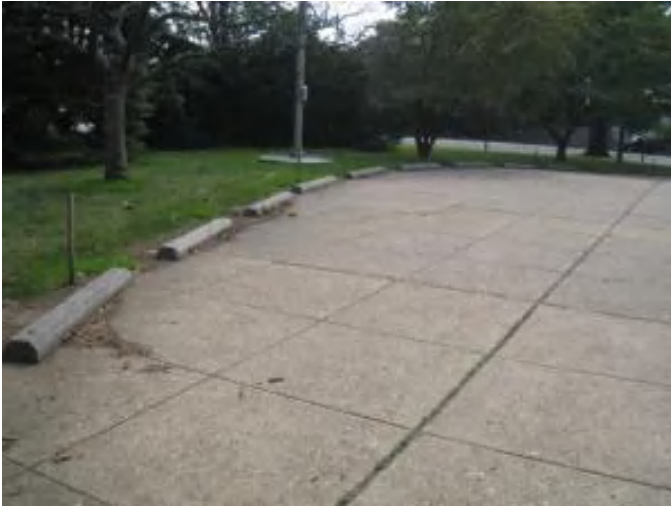
System: G2020 - Parking Lots

Location: front drop-off area

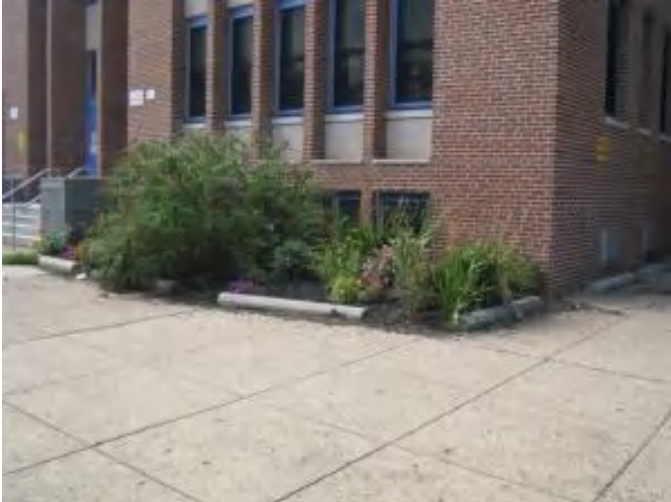
System: G2030 - Pedestrian Paving

Location: front drop-off area

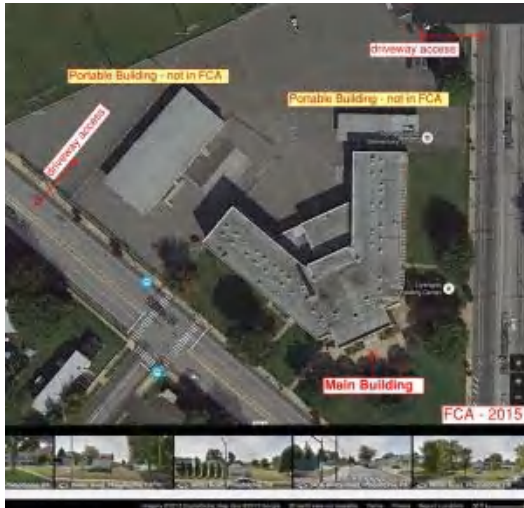
System: G2040 - Site Development

Location: Willits and Academy Roads

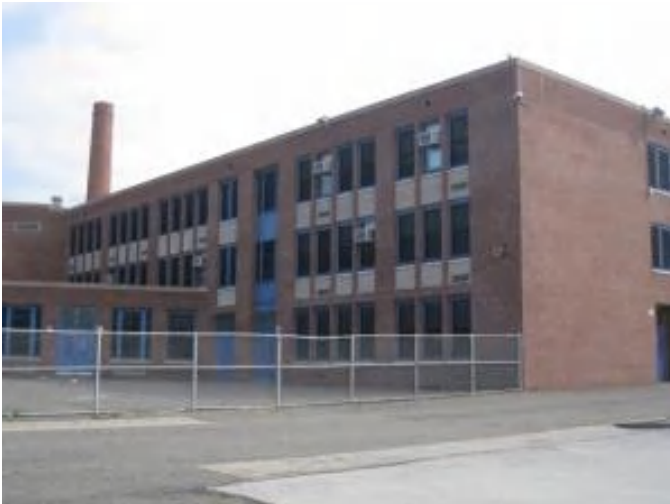
System: G2040 - Site Development

Location: rear parking lot area

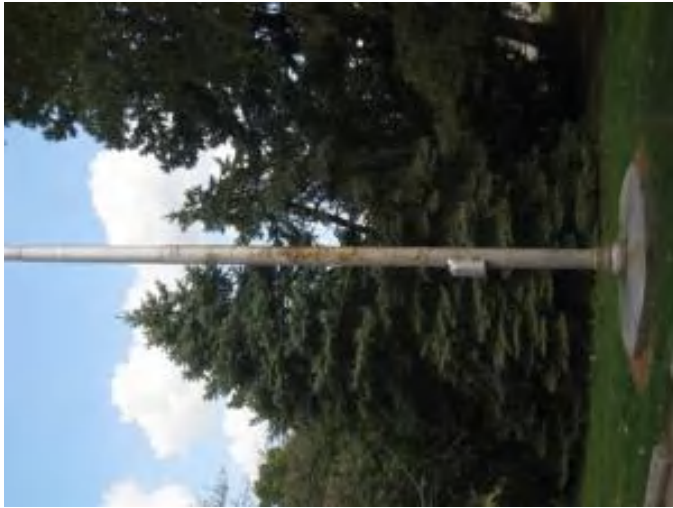
System: G2040 - Site Development

Notes: Paint rusted flagpole

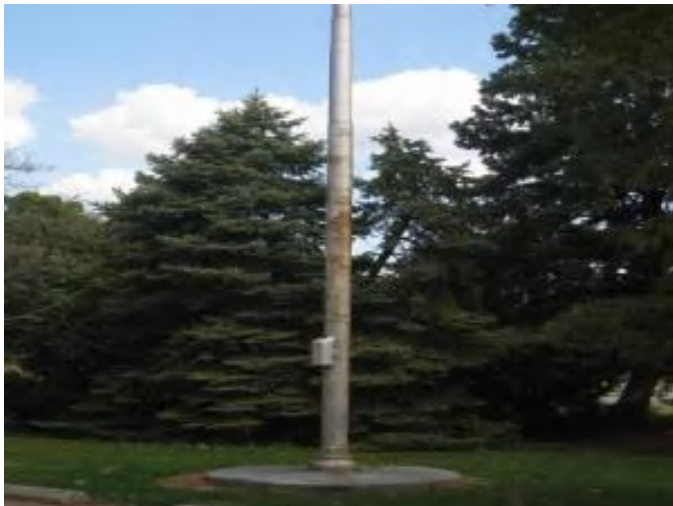
System: G2040 - Site Development

Notes: Paint rusted flagpole

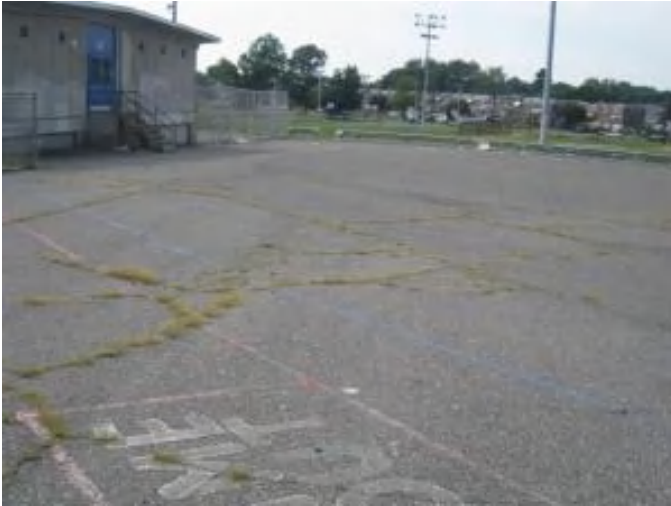
System: G2020 - Parking Lots

Location: rear parking / playground area
