Facility Condition Assessment Summary Report

Hopkinson School

School District of Philadelphia

January 31, 2017

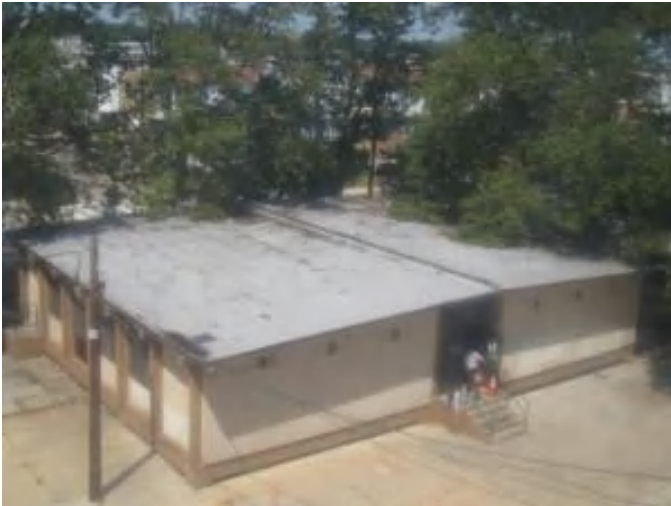
Location: portable building - roof

System: B3010105 - Built-Up

Distress: Failing

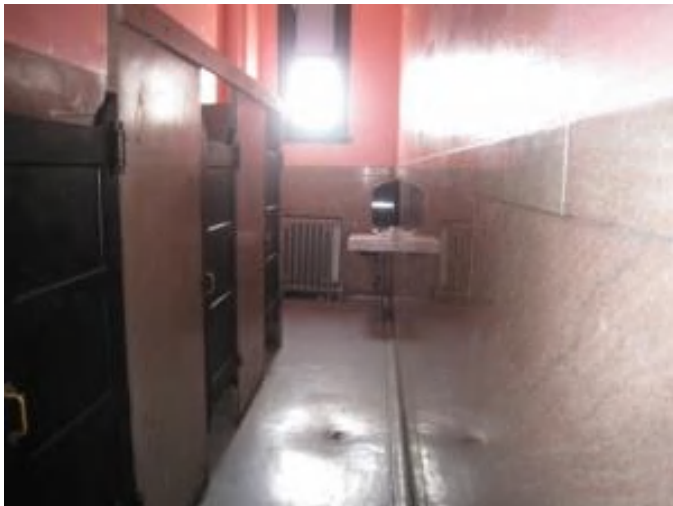
Location: main building - toilet rooms

System: C1030 - Fittings

Distress: Damaged

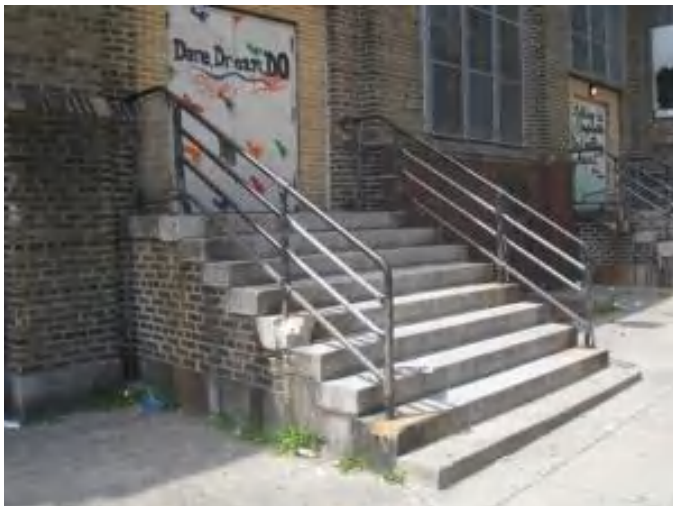
Location: main building - exterior stairs

System: C2010 - Stair Construction

Distress: Damaged

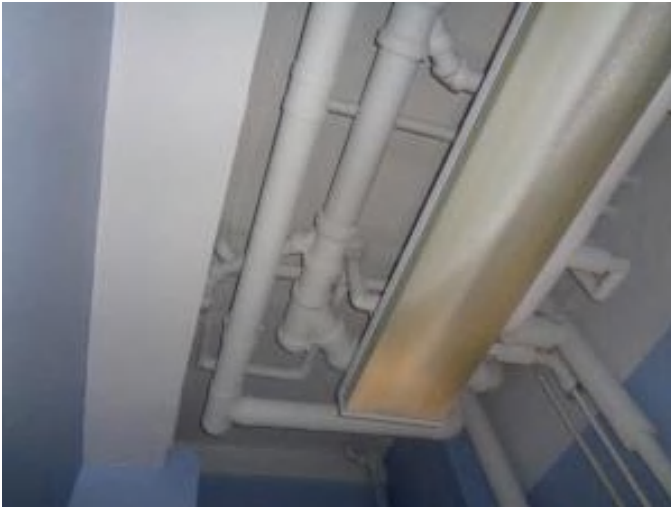
Location: main building - entire building

System: D2030 - Sanitary Waste

Distress: Health Hazard / Risk

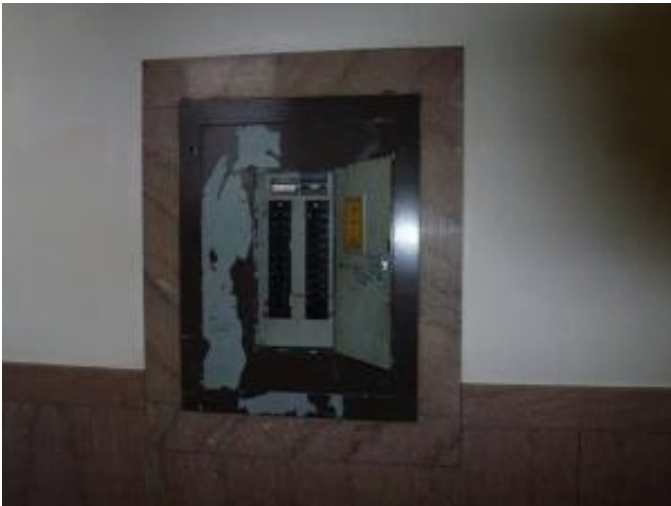
Location: main building - entire building

System: D5010 - Electrical Service/Distribution

Distress: Beyond Service Life

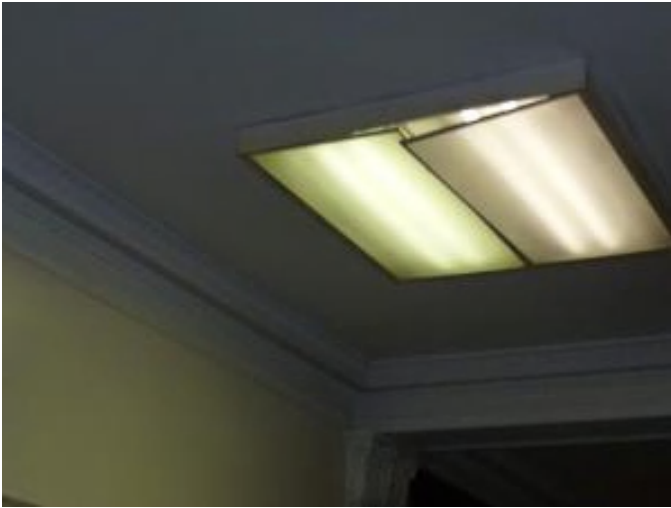
Location: main building - entire building

System: D5020 - Lighting and Branch Wiring

Distress: Beyond Service Life

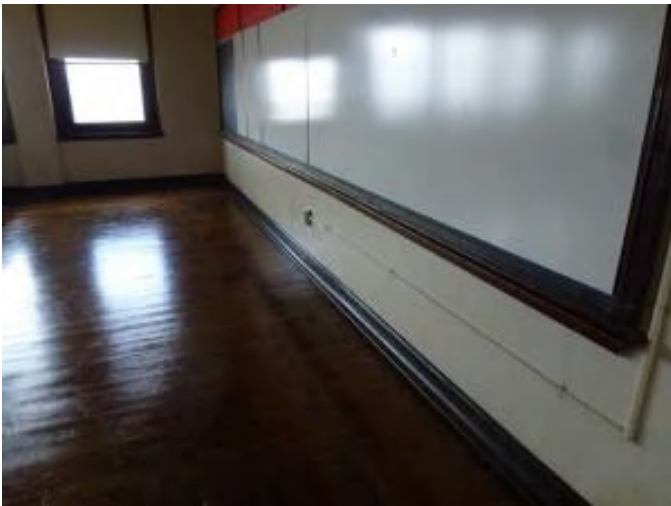
Location: main building - entire building

System: D5020 - Lighting and Branch Wiring

Distress: Beyond Service Life

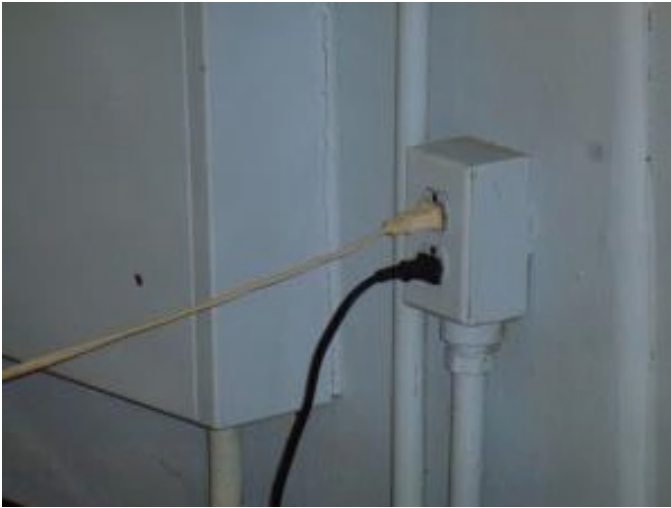
Location: main building - Kindergarten Classrooms

System: D5020 - Lighting and Branch Wiring

Distress: Inadequate

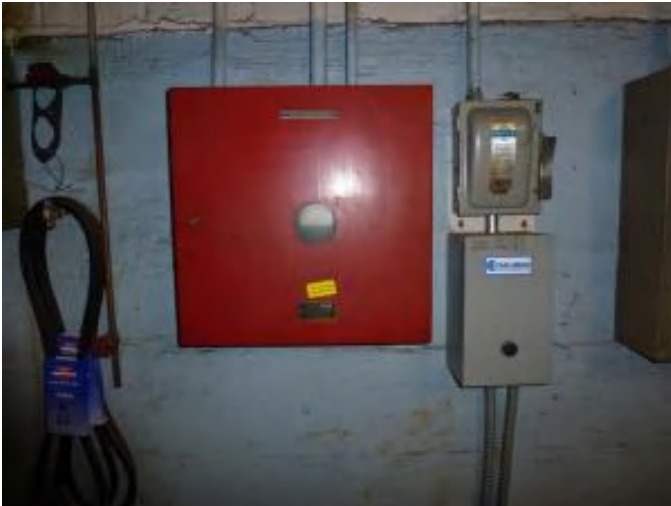
Location: main building - entire building

System: D5030 - Communications and Security

Distress: Beyond Service Life

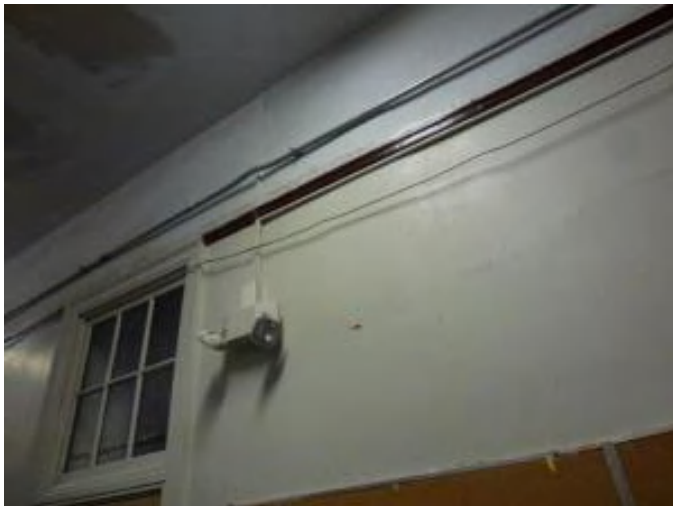
Location: Main building

System: D5030 - Communications and Security

Distress: Security Issue

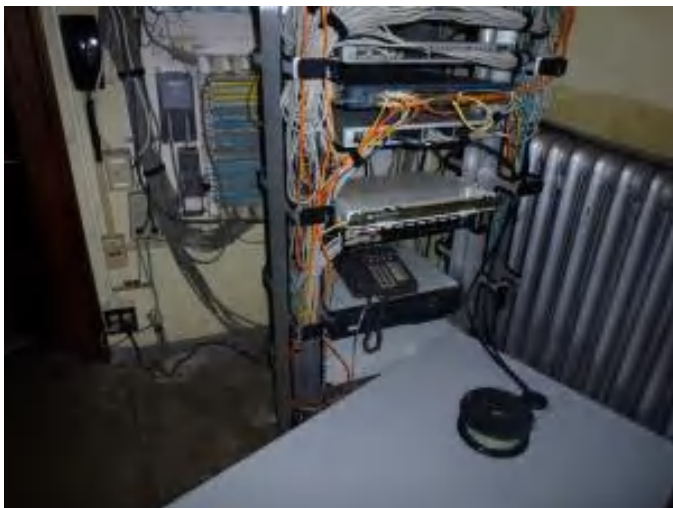
Location: main building - school office

System: D5030 - Communications and Security

Distress: Damaged

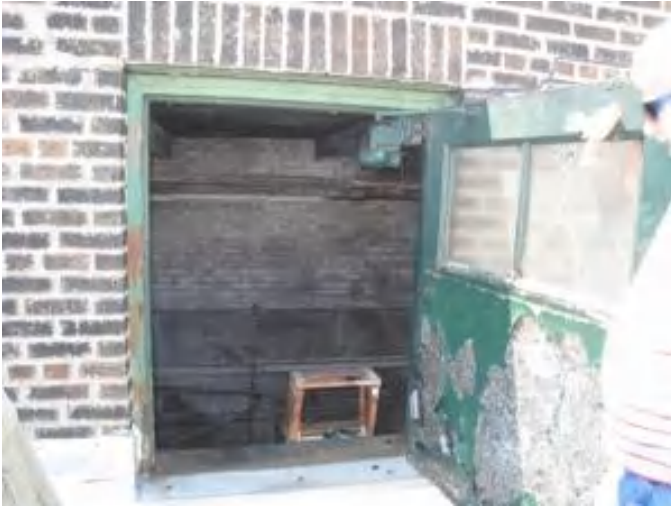
Location: main building - exterior walls

Exterior walls of the main building are generally in good condition, however the lintels above most basement windows, some upper windows, and some doors are rusted with brick joint cracks extending from the lintels into the brick joints in the walls. Lintels should be replaced when windows are replaced. Many brick roof-structure walls and parapets have been repointed or caulked (not a good solution) and continue to show signs of cracking and joint failure. A number of other horizontal masonry cracks were observed in exterior walls at below the level of the roof and above the foundation. A more detailed inspection of the masonry is required to determine if this cracking is related to structural failures and to assess the extent of failing joints for to ensure a watertight envelope. Exterior walls of the Little School House (LSH) are generally in good condition constructed of a cavity wall design with a brick veneer exterior and a concrete masonry unit (block) interior. Brick joints are in good condition. Lintels over windows are in good condition. Brick walls have cavity wall venting formed by a mortarless joint approximately 3 brick courses up from grade and over steel window lintels; joints appear to be clear of debris. The brick has a glossy finish and is in very good condition with minimal efflorescence or dirt buildup. A few years ago, the corner of the building at L Street and Luzerne Street, was hit by a vehicle which damaged the brickwork. Repairs from this accident have not aged well and the area requires some brick repair/replacement, once again. The exterior walls of the Portable Building form flat wall sections and pilasters under "T" bearing points and they are generally intact, despite an isolated area of surface spalling.

System: B2010 - Exterior Walls

Distress: Failing

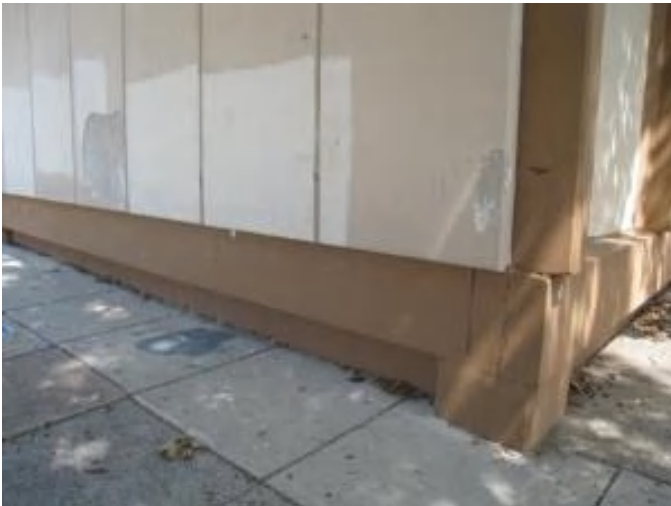
Location: portable building - foundations/walls

System: B2010 - Exterior Walls

Distress: Damaged

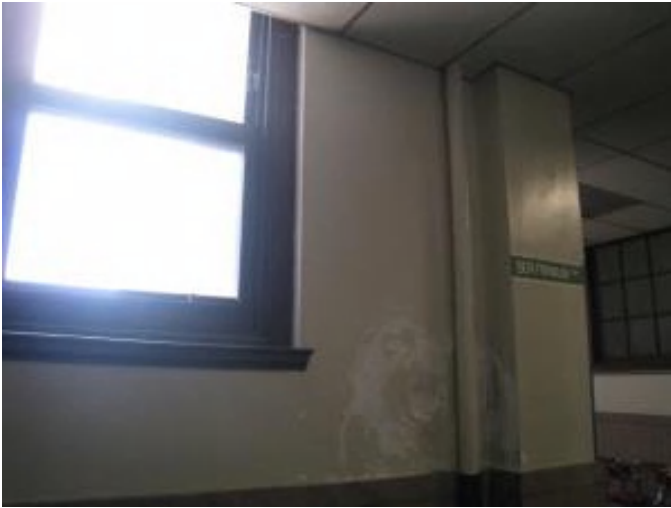
Location: main building - windows

Exterior windows in the main building were replaced in the 1990's with bronze anodized, aluminum frame, operable, single hung units with single thickness clear plexiglass acrylic vision panel glazing. Windows are in poor condition with oxidized frames and severely scratched plexiglass vision panels. Operable panes are difficult to move up and down; some do not stay open due to broken internal counterbalance weights. Single pane plexiglas units do not meet today's energy code requirements and are large sources of heat loss.

System: B2020 - Exterior Windows

Distress: Beyond Service Life

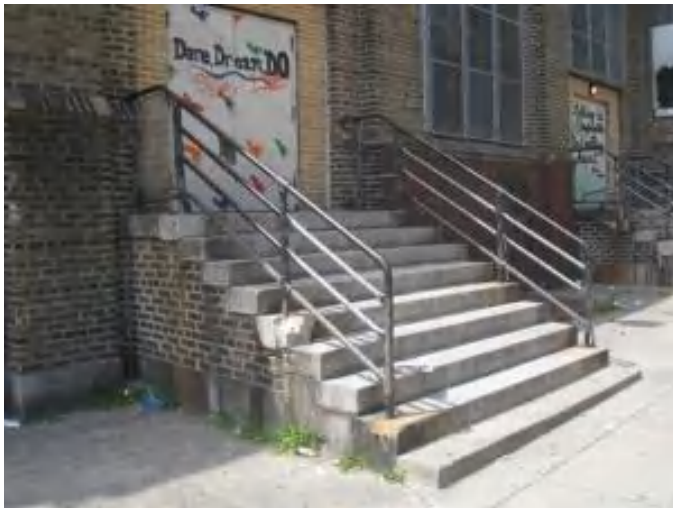
Location: main building - exterior doors

Exterior doors on the main building are painted steel framed flush hollow metal units with steel frames. Some doors have small glazing vision panels. The main entrance and secondary main entrance on L Street have decorative Romanesque-style tile arches around door openings. They should be cleaned to highlight their style and artistic technique. Most doors have pictures painted on them possibly by students. Doors are in generally poor condition, have broken or non-functioning panic hardware, rusted dented panels, rusted frames, and are not ADA compliant. There are no handicap entrances, no accessible ramps, and no elevators in the main building. All exterior steel doors, frames, and hardware systems need to be replaced. Exterior entrance doors in the LSH are painted aluminum tube frame system door units with plexiglass glazing and glass side lights. Plexiglass is scratched and needs replacing. Where plexiglass is also used for sidelights, it is scratched and needs to be replaced. There is a handicap accessible entrance into the Little School House. The steel frame of the hollow metal entrance door to the mechanical area is rusted and needs to be replaced. Portable Building has two sets of doors, both flush solid panel hollow metal doors and frames. They are in poor condition and need to be replaced.

System: B2030 - Exterior Doors

Distress: Damaged

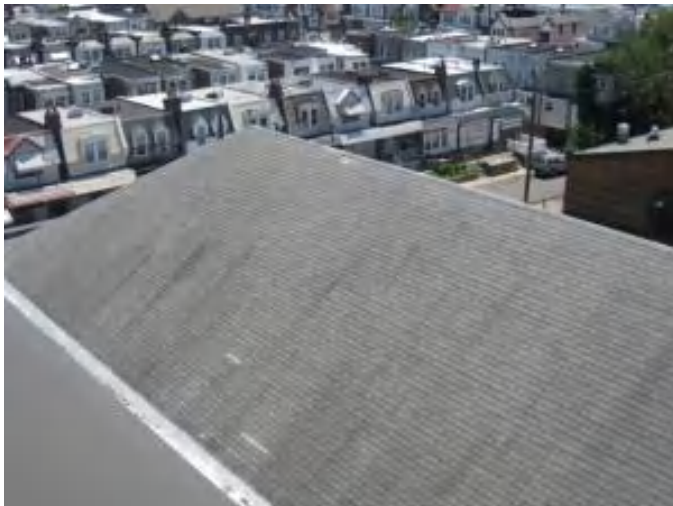
Location: main building - auditorium roof

System: B3010140 - Shingle & Tile

Distress: Beyond Service Life

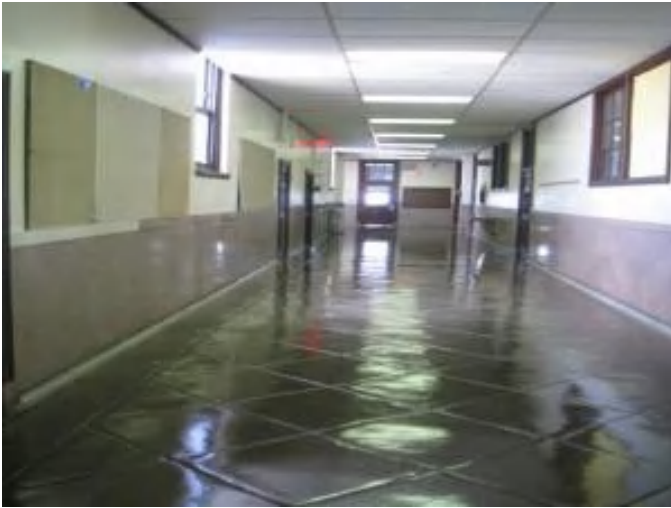
Location: main building - corridors

System: C1010 - Partitions

Distress: Building / MEP Codes

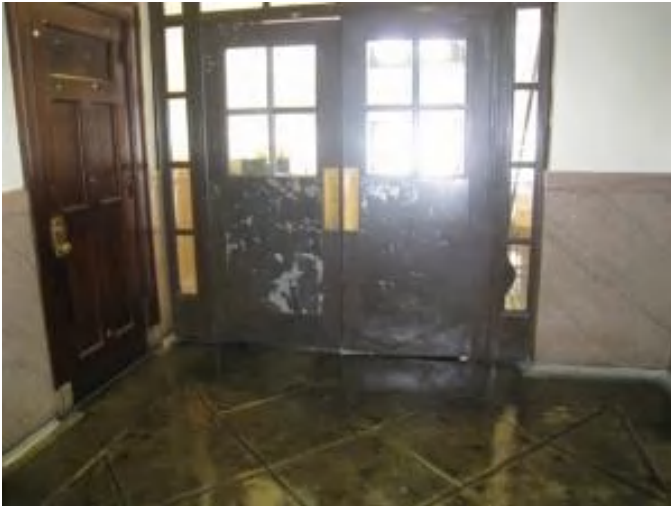
Location: main building - mechanical rooms and stairways

System: C1020 - Interior Doors

Distress: Damaged

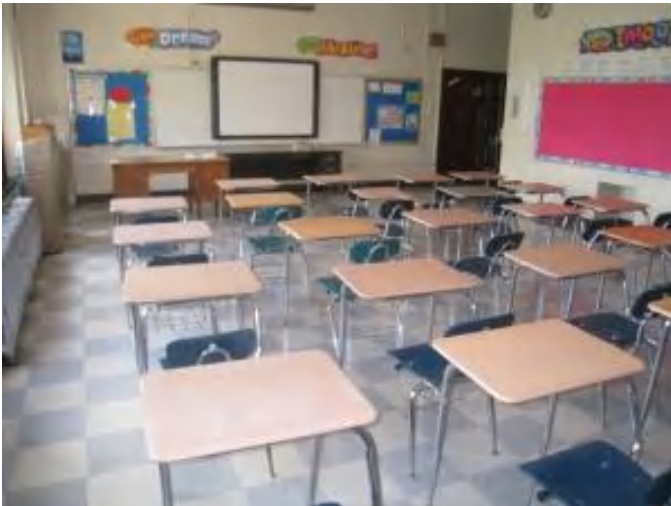
Location: interior rooms

System: C1020 - Interior Doors

Distress: Beyond Service Life

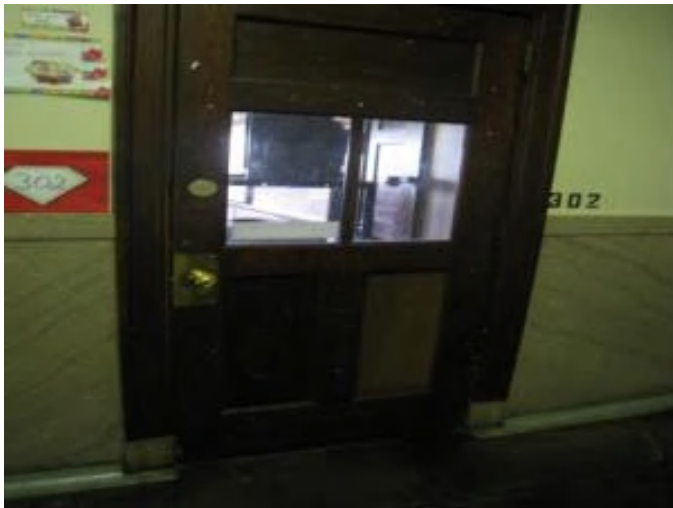
Location: main building - classrooms and offices

System: C1020 - Interior Doors

Distress: Security Issue

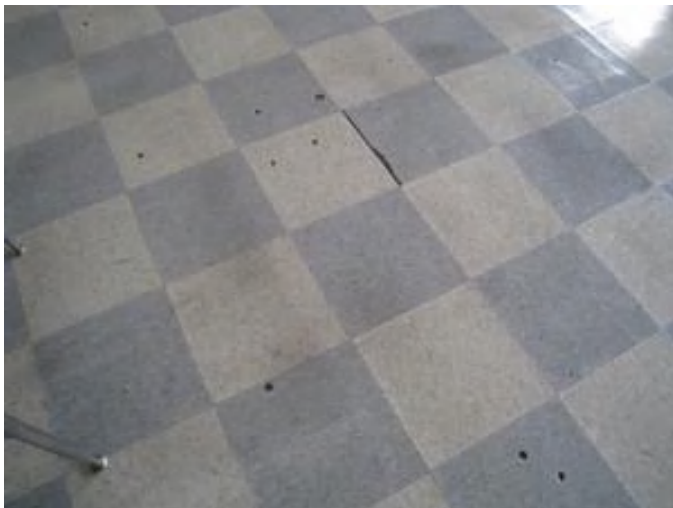
Location: main building - corridors and classrooms

System: C3020413 - Vinyl Flooring

Distress: Beyond Service Life

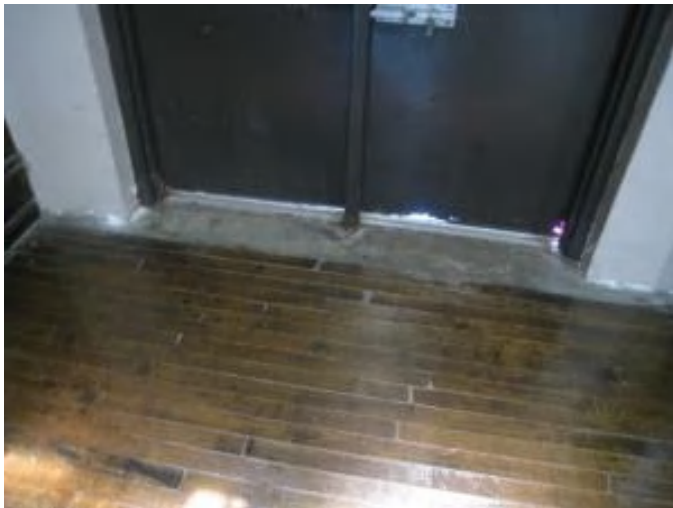
Location: main building - classrooms and auditorium

Floor finishes in the original building consist of dark stained oak floors in classrooms and the auditorium. Most are in good enough condition to be stripped, sanded, and refinished. There are some rooms (main office, faculty lounge, and some classrooms) with 12"x12" vinyl composition tile (VCT) over the wood. The gymnasium which also serves as the cafeteria is finished in VCT. All 12"x12" VCT floors need to be removed and replaced. Stair walking surfaces are finished in exposed concrete that have years of dirt ground into the surfaces; these should be stripped, cleaned and resealed. All corridor floors are finished with 4'x4' (nominal size) concrete tiles which appear to be a monolithic system and highly durable. There is a painted concrete cove base along corridor walls. These corridor floors have not recently been stripped and cleaned and have years of dirt sealed into the surface and corners, causing their color to be very dark and dingy. There is an especially large build-up of dirt at all corners. Basement toilet rooms have been recently refinished with new fixtures, plastic partitions and ceramic mosaic tile floors; a thorough cleaning of these rooms is required. The room in the basement originally designated as the cafeteria is now a food prep area finished with VCT. Floor finishes in LSH corridors and the Multi-Purpose Room are 12"x12" vinyl composition tile (VCT) which is generally in good enough condition to be stripped and rewaxed to rejuvenate the look. Repairs to the VCT are required along concrete expansion and control joints. Although probably not a structural problem, the concrete has shifted enough to cause cracking and buckling of the VCT installed over the concrete joint in the corridors and multi-purpose room. Tiles need to be removed and the concrete repaired before reinstalling new VCT. Other areas of VCT are cracked and broken, requiring replacement. The main office area in the LSH has glued-down tufted carpet. Classrooms are finished half in vinyl composition tile and half in glued-down tufted carpet. Mechanical areas are finished in exposed sealed concrete that should be stripped, cleaned and resealed. Toilet rooms have ceramic mosaic floor tiles with ceramic tile wall base. Entrance vestibules and side entrance doorway areas in the corridor have traffic mats which are worn and dirty; these should be replaced. The LSH kitchen has a

System: C3020414 - Wood Flooring

Distress: Damaged

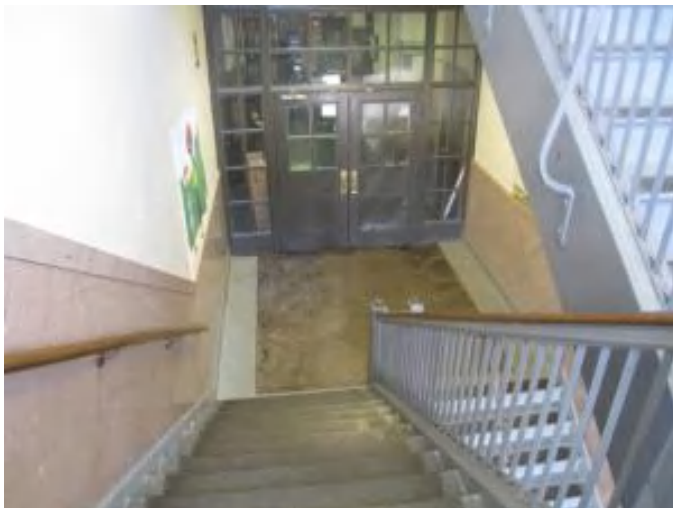
Location: main building - mechanical rooms, corridors, stairways

System: C3020415 - Concrete Floor Finishes

Distress: Appearance

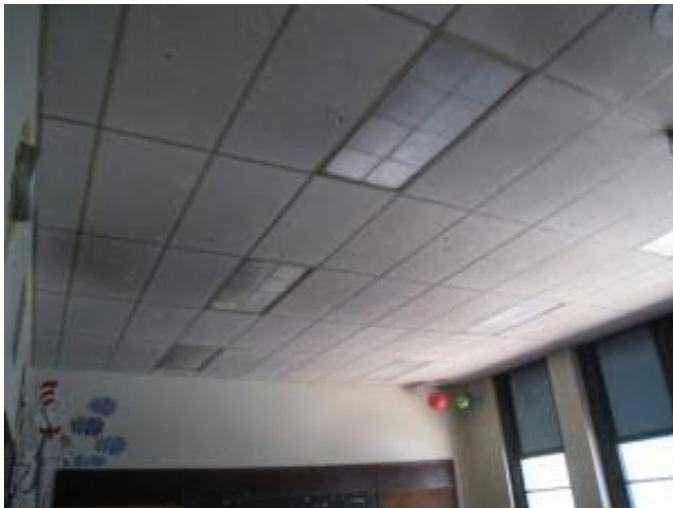
Location: main building - classrooms

System: C3030 - Ceiling Finishes

Distress: Damaged

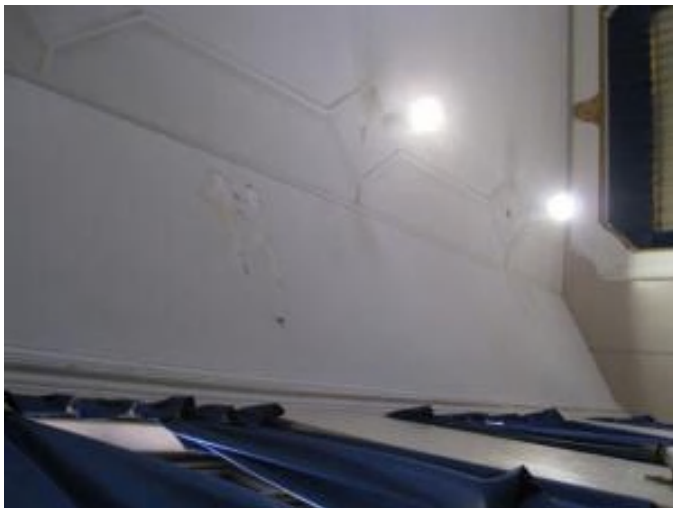
Location: main building - auditorium and cafeteria

System: C3030 - Ceiling Finishes

Distress: Damaged

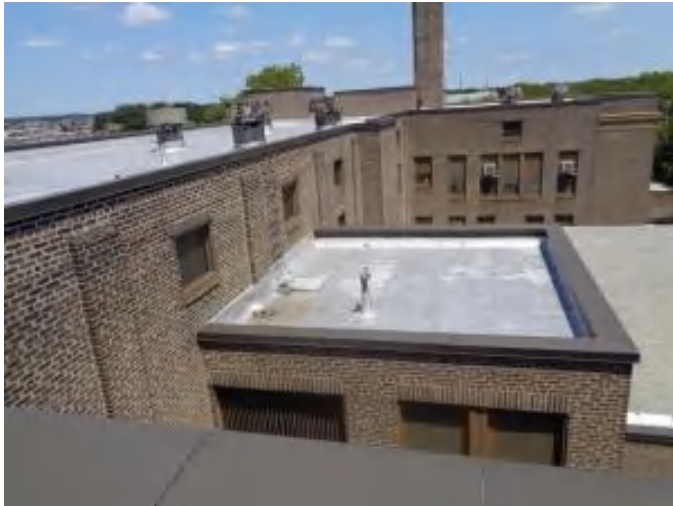
Location: main building - roof

System: D2040 - Rain Water Drainage

Distress: Building / MEP Codes

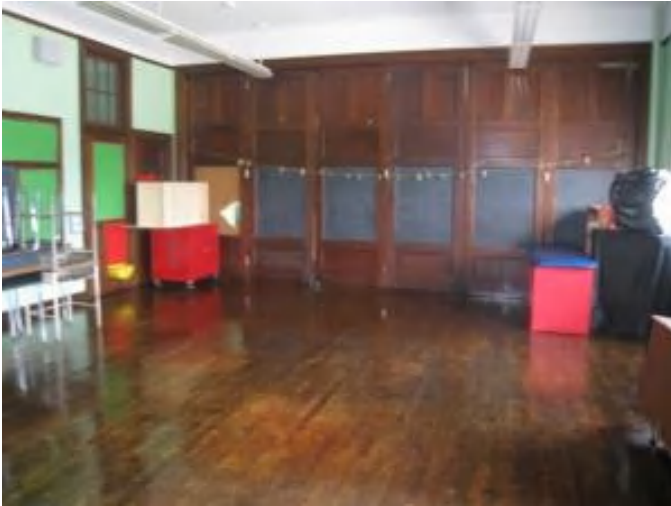
Location: main building - classrooms

System: C1010 - Partitions

Distress: Failing

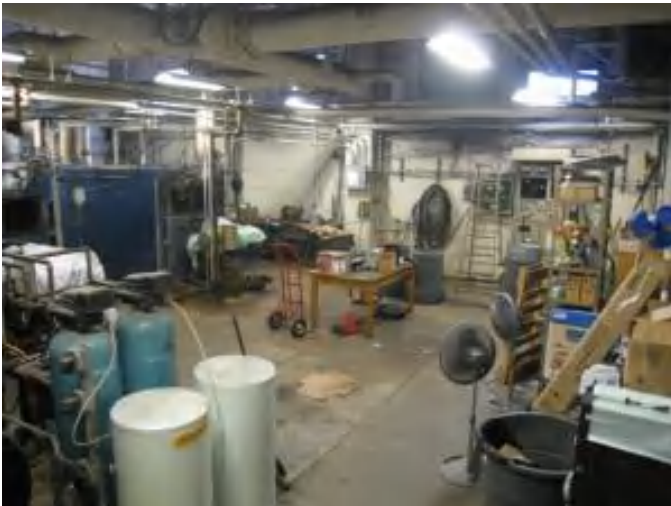
Location: main building - mechanical room

System: C3010230 - Paint & Covering

Distress: Appearance

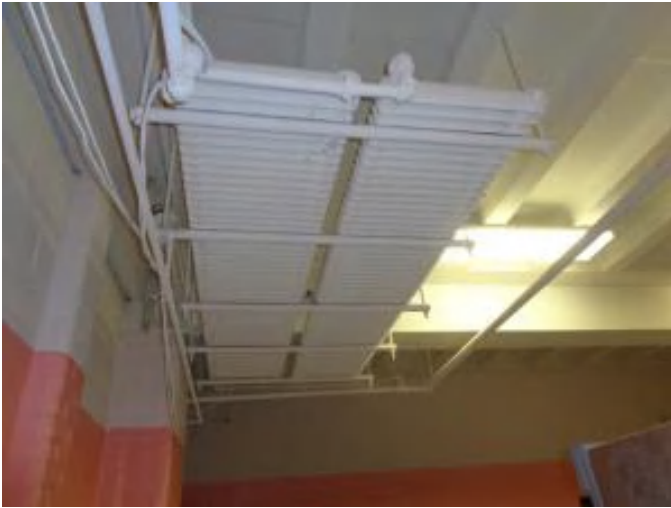
Location: Throughout the building

System: D3040 - Distribution Systems

Distress: Beyond Service Life

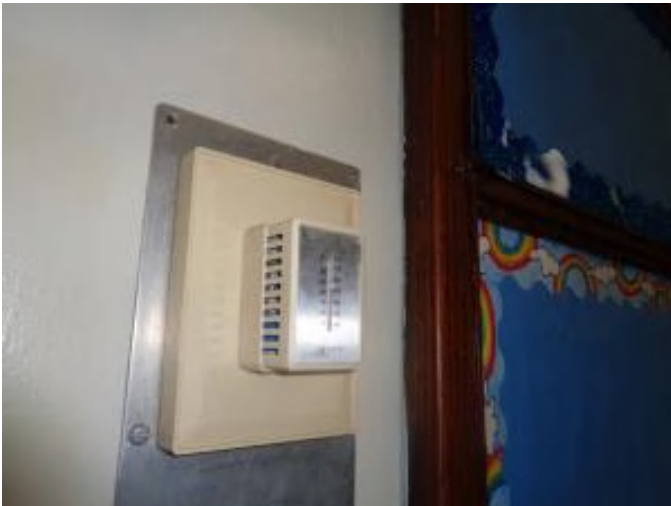
Location: main building - entire building

System: D3060 - Controls & Instrumentation

Distress: Failing

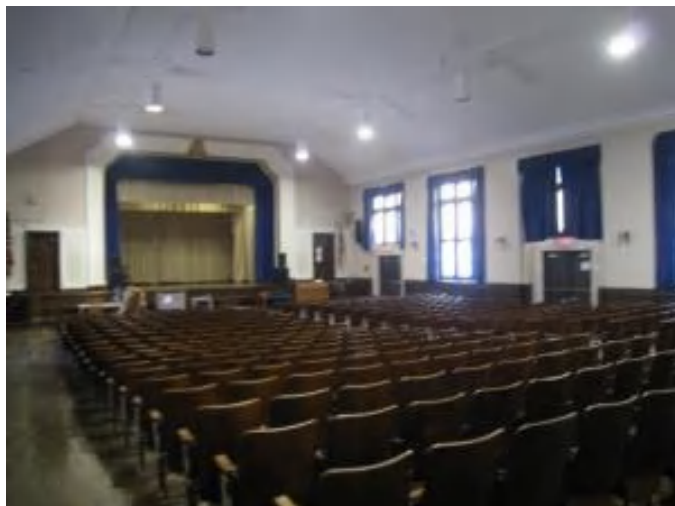
Location: main building - auditorium

Furnishings include the original folding wood seating in the auditorium is still in use; however many seats need to be repaired to operate properly and many are scratched; at least 50% are damaged. With the unavailability of parts for repair and the worn condition of the seating, full replacement is required. Casework and storage cabinets in the classrooms and the office is damaged, worn, and needs replacement.

System: E2010 - Fixed Furnishings

Distress: Damaged

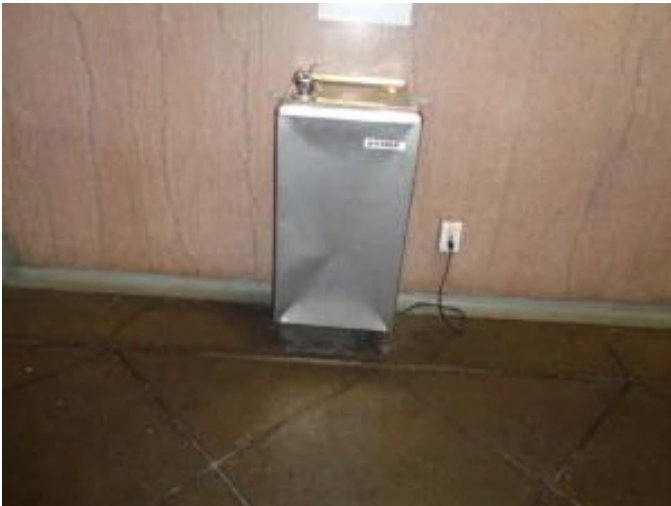
Location: main building - corridors

Drinking fountains in the corridors and at the restrooms are wall hung with integral refrigerated coolers. Most appear to be the original installed equipment or are beyond their service life. Recommend replacement of all drinking fountains in the Main building. The Little School House, constructed in 1998, the original wall hung drinking fountains and are in satisfactory condition and should not need replacement for 10 years.

System: D2010 - Plumbing Fixtures

Distress: Beyond Service Life

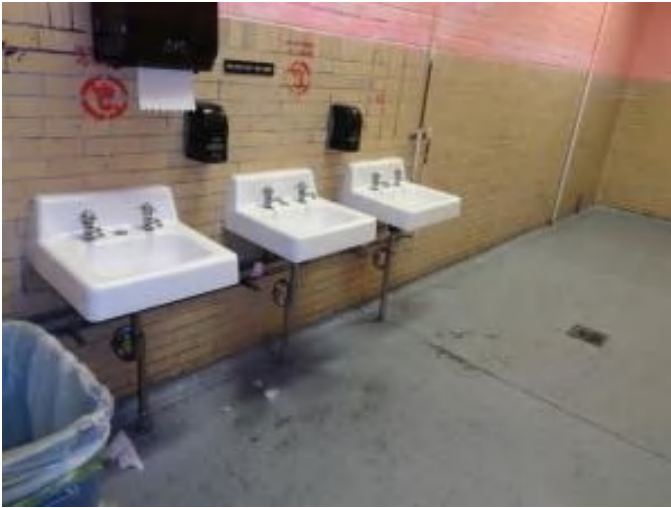
Location: main building - toilet rooms

System: D2010 - Plumbing Fixtures

Distress: Beyond Service Life

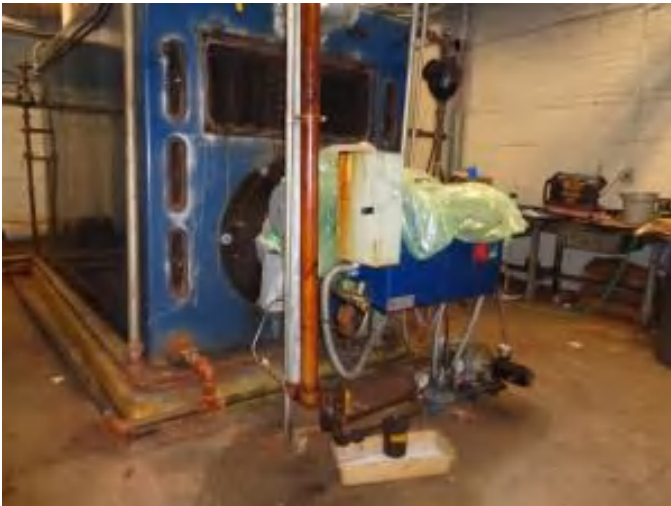
Location: main building - boiler room

System: D3020 - Heat Generating Systems

Distress: Beyond Service Life

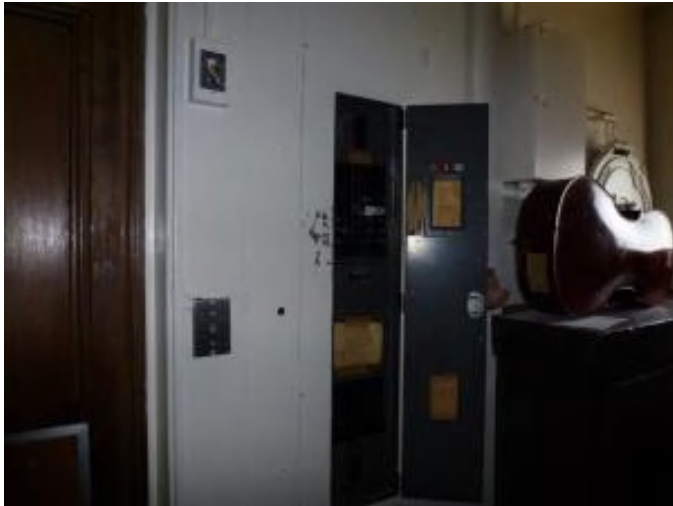
Location: main building - backstage

System: E1020 - Institutional Equipment

Distress: Inadequate

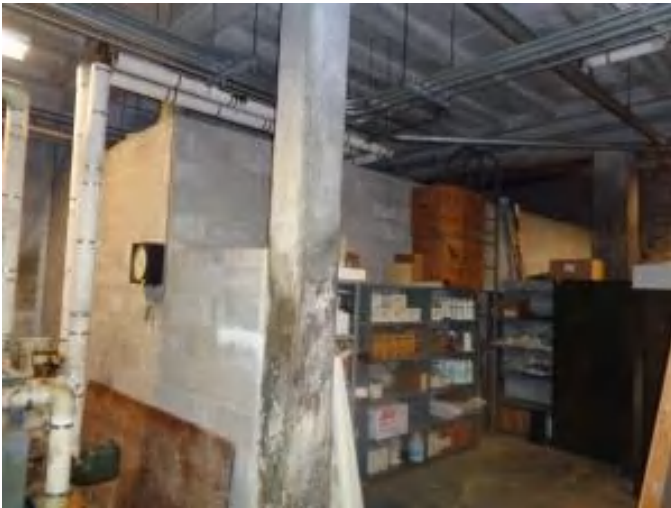
Location: main building - location to be determined

System: D3020 - Heat Generating Systems

Distress: Beyond Service Life

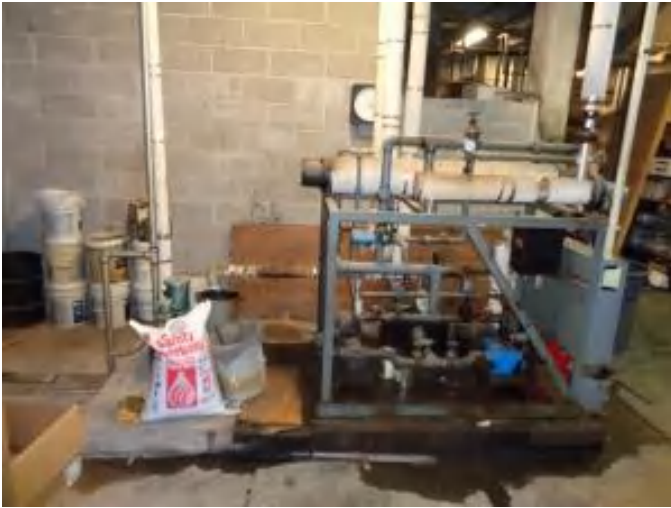
Location: main building - boiler room

System: D3020 - Heat Generating Systems

Distress: Beyond Service Life

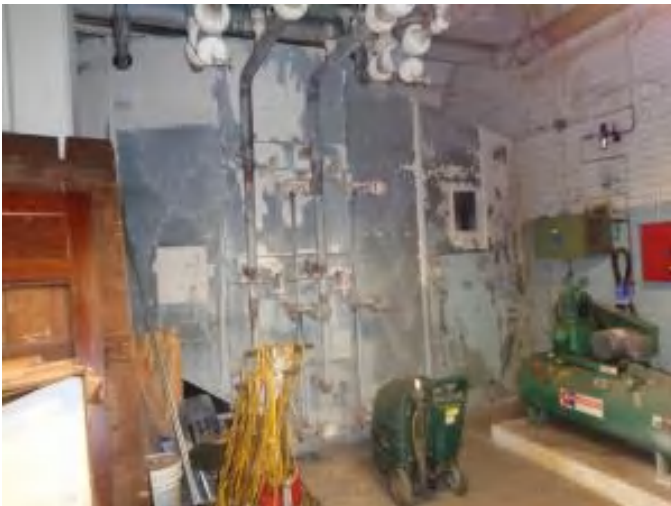
Location: main building - entire building

System: D3030 - Cooling Generating Systems

Distress: Inadequate

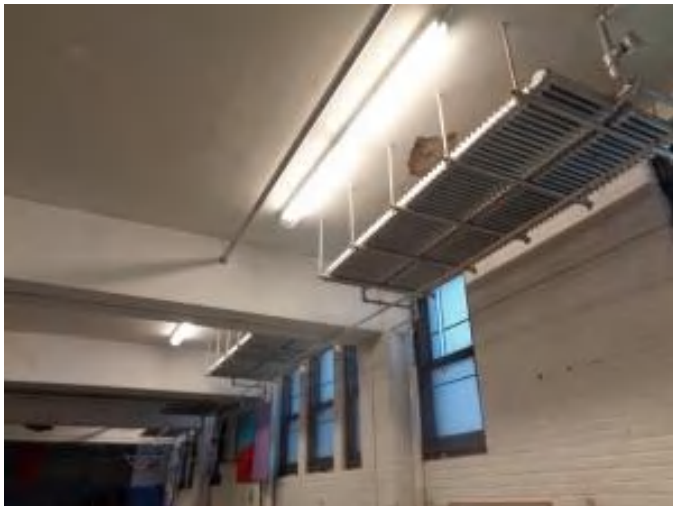
Location: main building - cafeteria/gymnasium

System: D3040 - Distribution Systems

Distress: Beyond Service Life

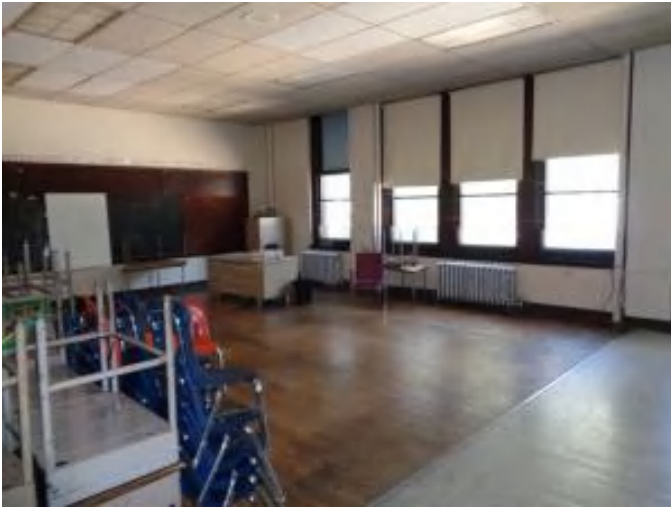
Location: main building - entire building

System: D4010 - Sprinklers

Distress: Life Safety / NFPA / PFD

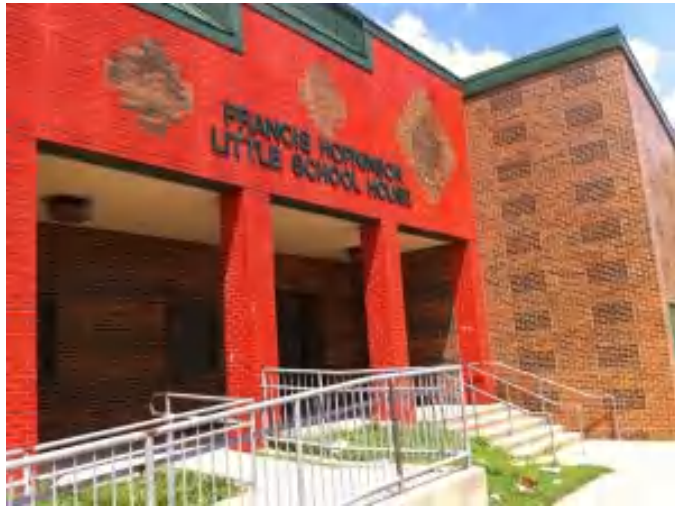
Location: LSH - exterior

System: D5030 - Communications and Security

Distress: Inadequate

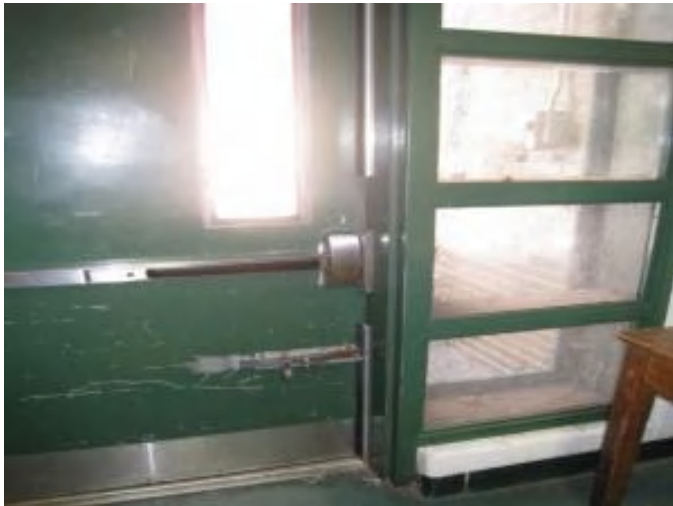
Location: LSH - exterior doors

System: B2030 - Exterior Doors

Distress: Damaged

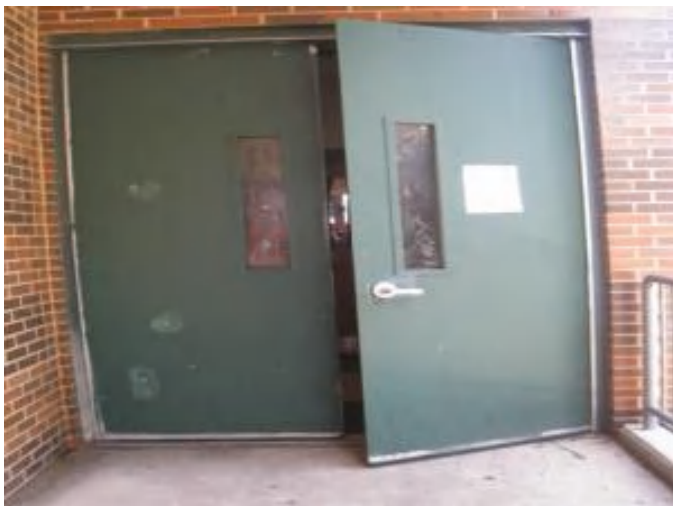
Location: LSH - exterior doors

System: B2030 - Exterior Doors

Distress: Appearance

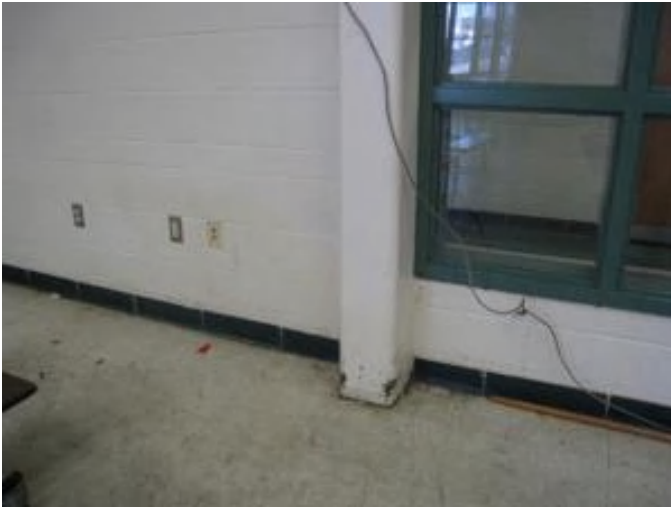
Location: LSH - floors

System: C3020413 - Vinyl Flooring

Distress: Failing

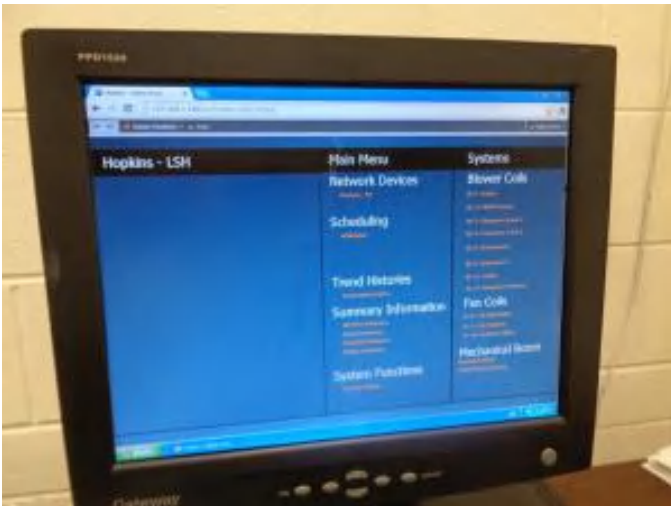
Location: LSH - entire building

System: D3060 - Controls & Instrumentation

Distress: Beyond Service Life

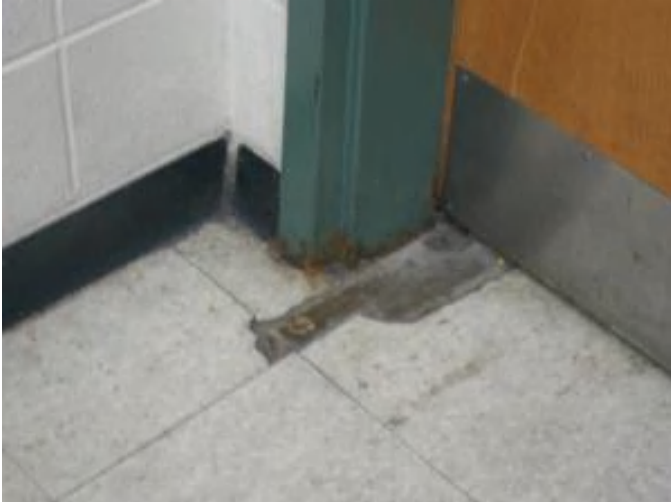
Location: LSH - interior doors

System: C1020 - Interior Doors

Distress: Appearance

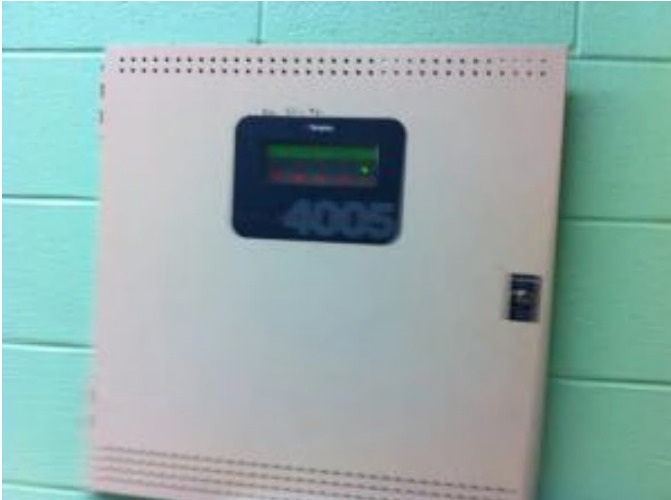
Location: LSH - school office

System: D5030 - Communications and Security

Distress: Inadequate

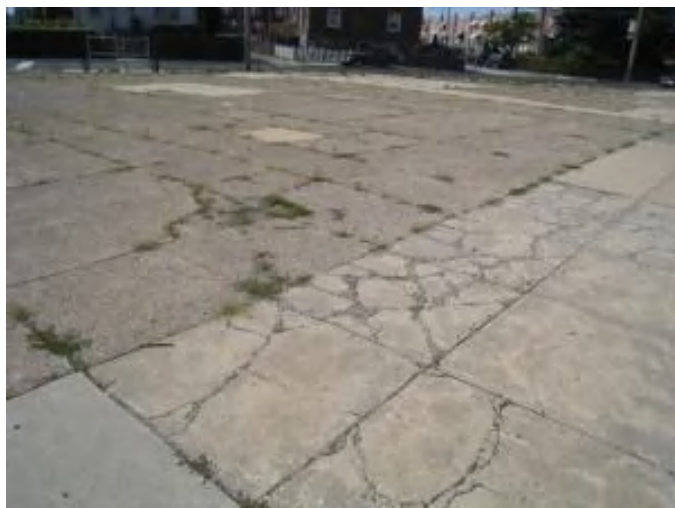
Location: site play area

System: G2030 - Pedestrian Paving

Distress: Failing
