## Facility Condition Assessment Summary Report

### Houston School

School District of Philadelphia  
**S626001;Houston**  
Final  
**Site Assessment Report**  
January 31, 2017

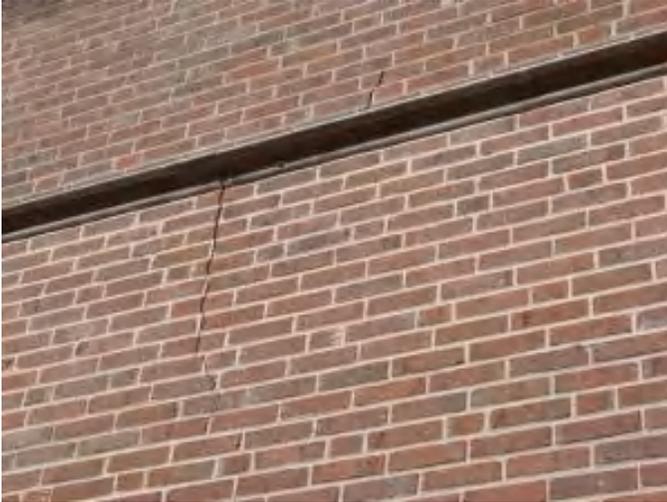
**System: B2010 - Exterior Walls**

The building envelope is typically masonry with face brick with decorative stone friezes and quoining. Main entrance is accentuated with stone columns and arch. In general, masonry is in good condition except on the second floor of the east elevation the window lintels are in poor condition.

**Location:** East elevation second floor; Element 2

**Distress:** Building Envelope Integrity

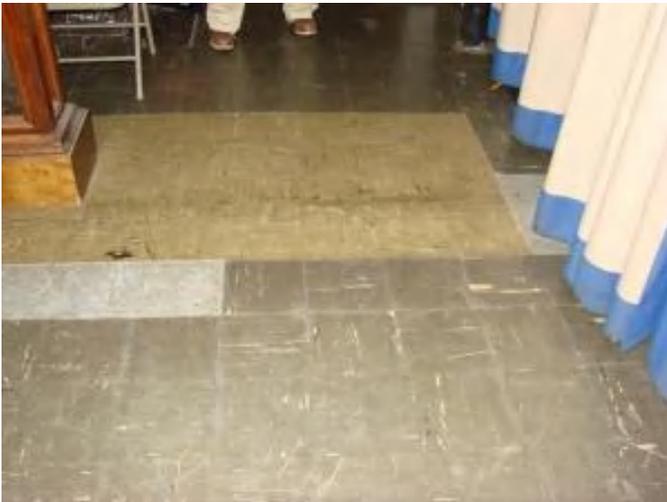
**System: C3020413 - Vinyl Flooring**

**Location:** Corridors; classrooms

**Distress:** Beyond Service Life

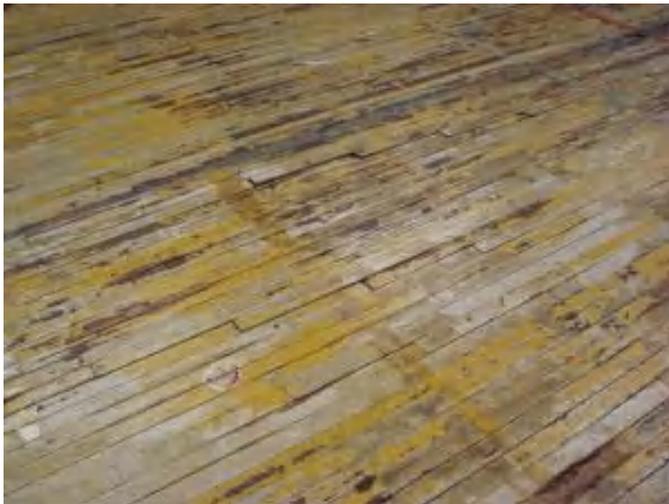
**System: C3020414 - Wood Flooring**

**Location:** Gym

**Distress:** Damaged

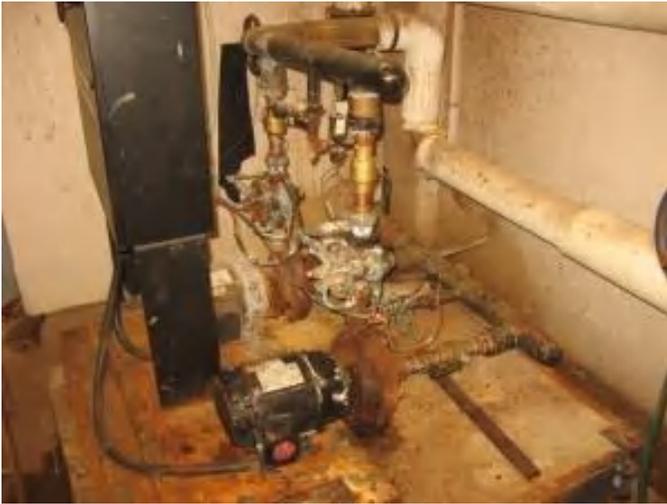
**System: D2020 - Domestic Water Distribution**

**Location:** Boiler room  
**Distress:** Damaged  
**Category:** 3 - Operations / Maint.  
**Priority:** 2 - Response Time (2-3 yrs)  
**Correction:** Replace duplex domestic booster pump set (5 HP)  
**Qty:** 1.00  
**Unit of Measure:** Ea.  
**Estimate:** \$50,533.86  
**Assessor Name:** System  
**Date Created:** 01/08/2016

**Notes:** Replace the duplex 5HP domestic water booster pumps and isolation valves on incoming domestic water line with a new skid mounted pressure booster system.

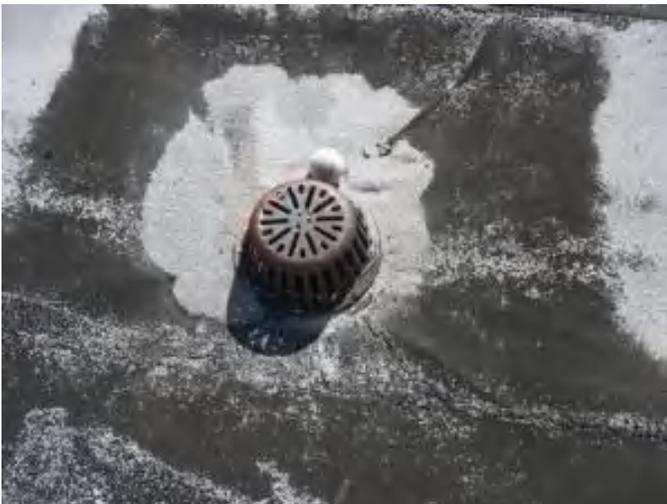
**System: D2040 - Rain Water Drainage**

Rain water drains from the roof are routed through mechanical chases in the building and appear to be original. The piping is galvanized piping with threaded fittings and has been in use well beyond its service life. The Building Engineer reported the rain leaders have backed up in the past. The District should hire a qualified contractor to examine the rain water drainage piping using video cameras to locate and replace any damaged piping and to further quantify the extent of potential failures.

**Location:** Throughout building  
**Distress:** Beyond Service Life  
**Category:** 3 - Operations / Maint.  
**Priority:** 2 - Response Time (2-3 yrs)  
**Correction:** Inspect internal rain water drainage piping and replace pipe - based on SF of multi-story building - insert SF of building  
**Qty:** 72,000.00  
**Unit of Measure:** S.F.  
**Estimate:** \$319,278.97  
**Assessor Name:** System  
**Date Created:** 01/08/2016

**Notes:** Hire a qualified contractor to perform a detailed examination of the rain water drainage piping using visual inspection and video cameras to locate and replace any damaged piping and to further quantify the extent of potential failures.

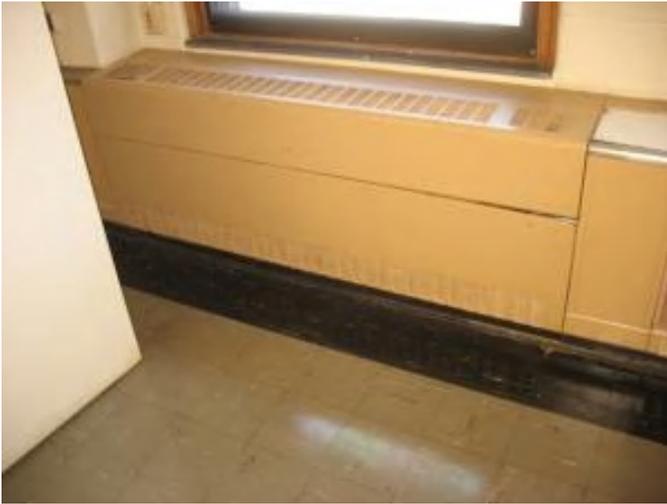
**System: D3040 - Distribution Systems**

**Location:** Element 2

**Distress:** Beyond Service Life

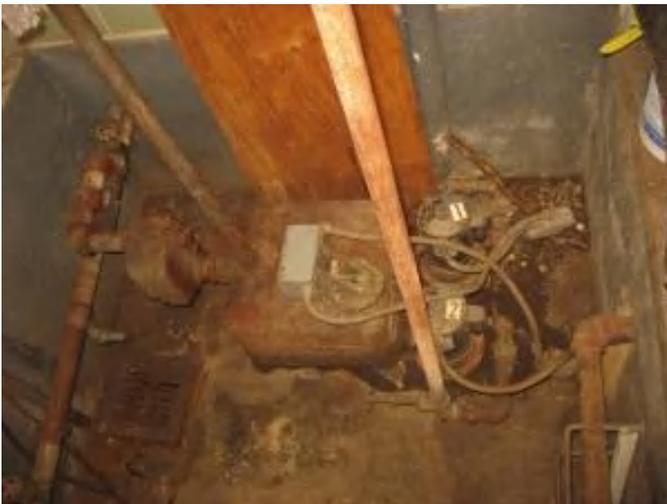
**System: D3040 - Distribution Systems**

A condensate receiver with duplex pumps, located in a pit in the Element 2 mechanical room, returns condensate to the boiler room in Element 1. This condensate receiver is covered in rust, looks to be in poor condition, and should be replaced. A second condensate receiver with duplex 3/4HP pumps and a boiler feed tank assembly with three (3) 3/4HP pumps headered together is installed in the boiler room. The condensate receiver was installed in 2006 when the boiler room was renovated and is in good condition. The soft water piping connection at the top of the boiler feed tank is leaking, which has caused rust to form on the tank. The Building Engineer said a work order is in to repair the pipe leak. Once the leak has been repaired the tank should be monitored closely as its service life has most likely been reduced. The feed pumps appeared to be in good condition. The Building Engineer reported no steam in the boiler room when he runs the boiler.

**Location:** Element 2 mechanical room

**Distress:** Damaged

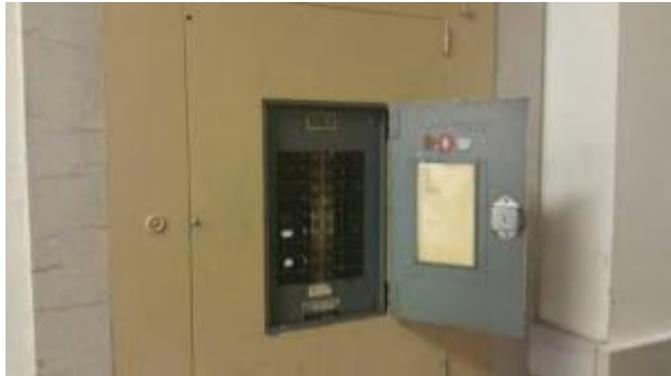
**System: D5010 - Electrical Service/Distribution**

**Location:** throughout the building

**Distress:** Beyond Service Life

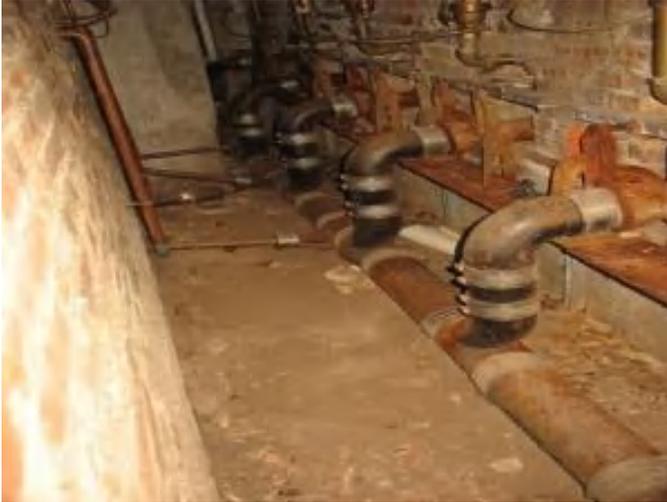
**System: D2030 - Sanitary Waste**

The maintenance staff reported mostly minor problems with the sanitary waste piping systems. The original sewer piping has been in service for 90 years and will require more frequent attention from the maintenance staff as time passes. The District should hire a qualified contractor to examine the sanitary waste piping using video cameras to locate and replace any damaged piping and to further quantify the extent of potential failures.

**Location:** Throughout building

**Distress:** Beyond Service Life

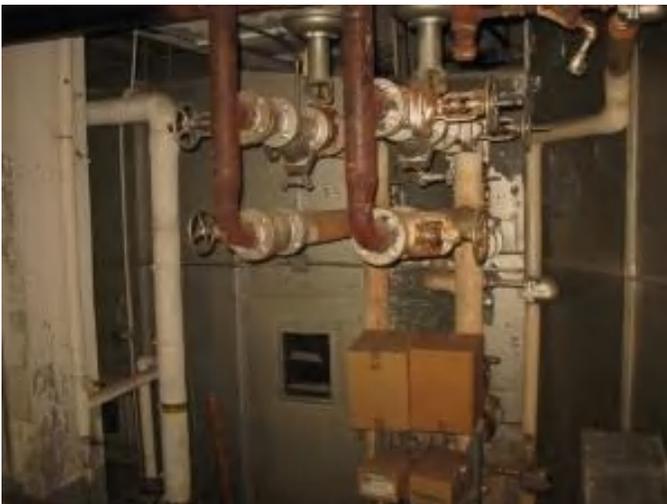
**System: D3040 - Distribution Systems**

**Location:** Throughout building

**Distress:** Beyond Service Life

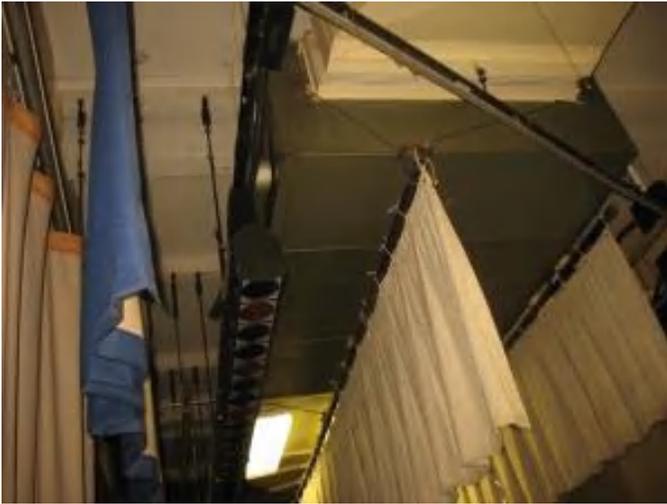
**System: D3040 - Distribution Systems**

**Location:** Auditorium

**Distress:** Beyond Service Life

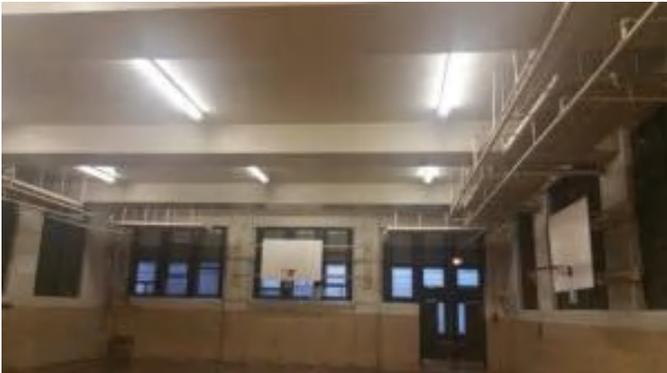
**System: D5020 - Lighting and Branch Wiring**

**Location:** throughout the building

**Distress:** Beyond Service Life

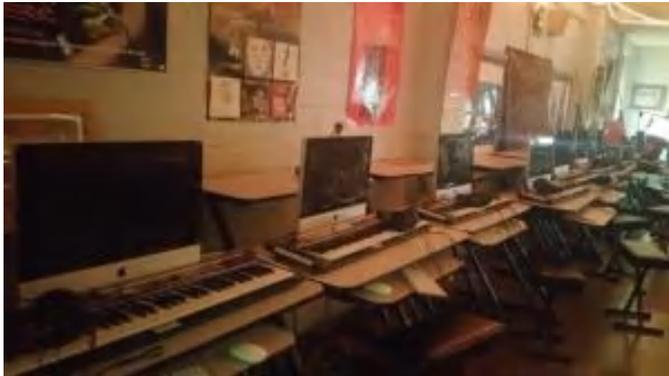
**System: D5020 - Lighting and Branch Wiring**

**Location:** throughout the building

**Distress:** Inadequate

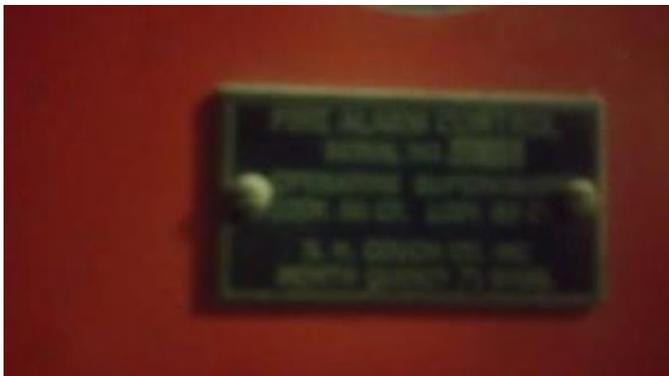
**System: D5030 - Communications and Security**

**Location:** throughout the building

**Distress:** Health Hazard / Risk

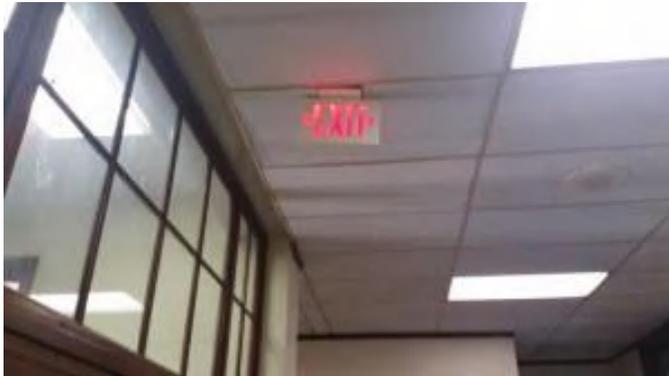
**System: D5090 - Other Electrical Systems**

**Location:** throughout the building

**Distress:** Beyond Service Life

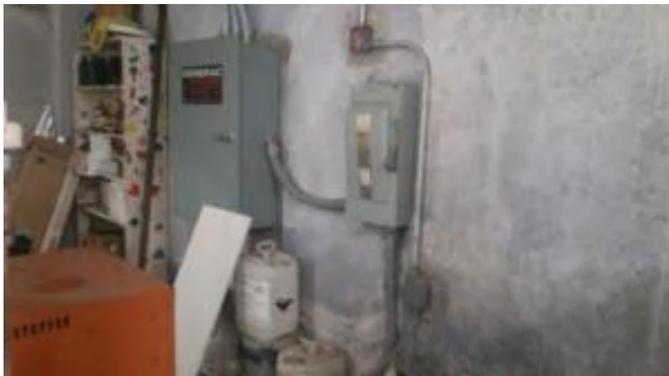
**System: D5090 - Other Electrical Systems**

**Location:** electrical room

**Distress:** Inadequate

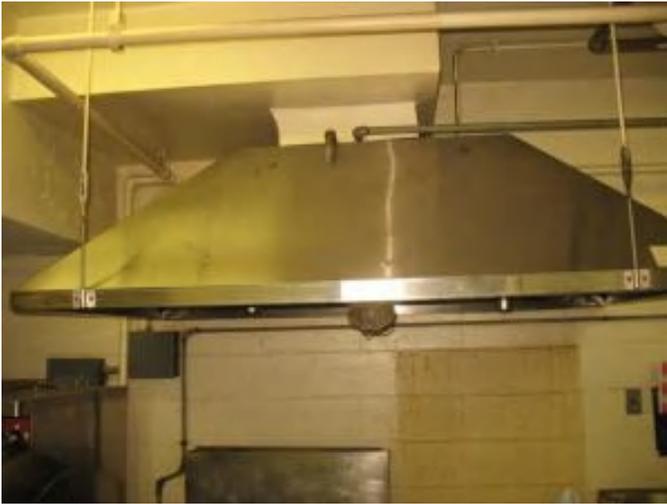
**System: E1090 - Other Equipment**

**Location:** Kitchen

**Distress:** Beyond Service Life

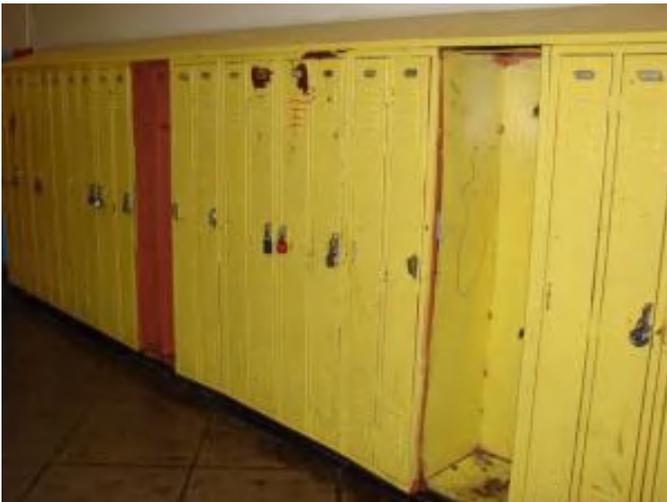
**System: E2010 - Fixed Furnishings**

**Location:** Main corridors

**Distress:** Beyond Service Life

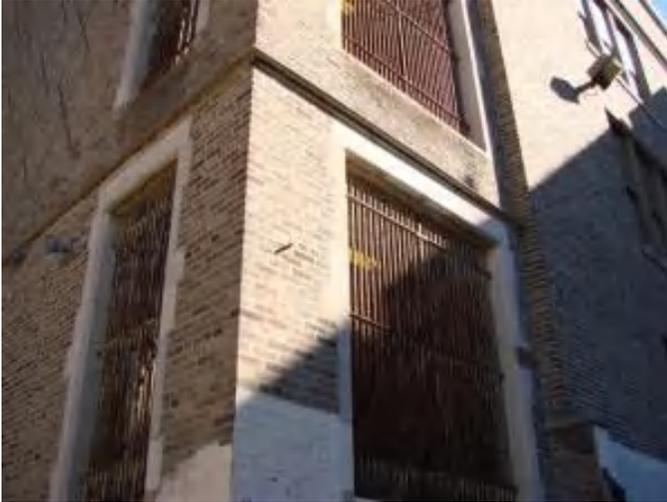
**System: B2020 - Exterior Windows**

**Location:** Stairwell window guards

**Distress:** Appearance

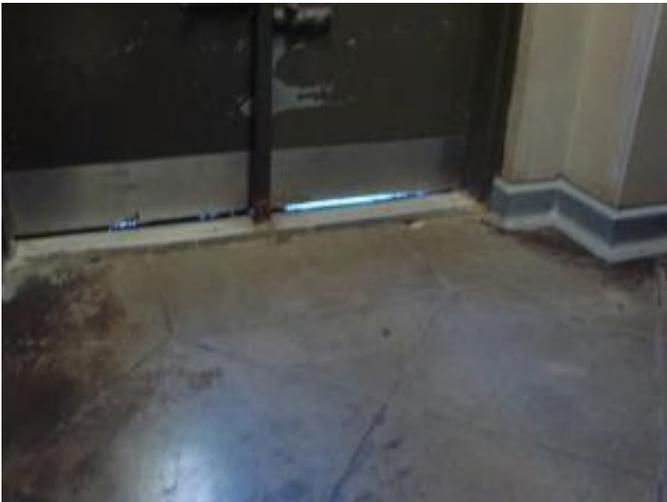
**System: B2030 - Exterior Doors**

**Location:** Exterior doors

**Distress:** Damaged

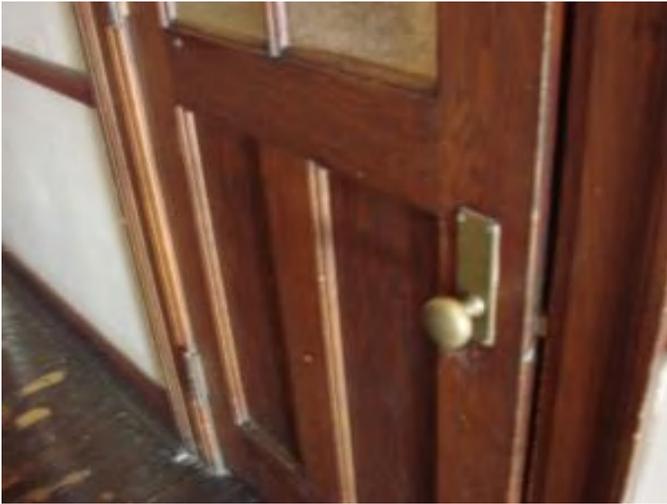
**System: C1020 - Interior Doors**

**Location:** Interior doors; corridors, classrooms, restrooms

**Distress:** Accessibility

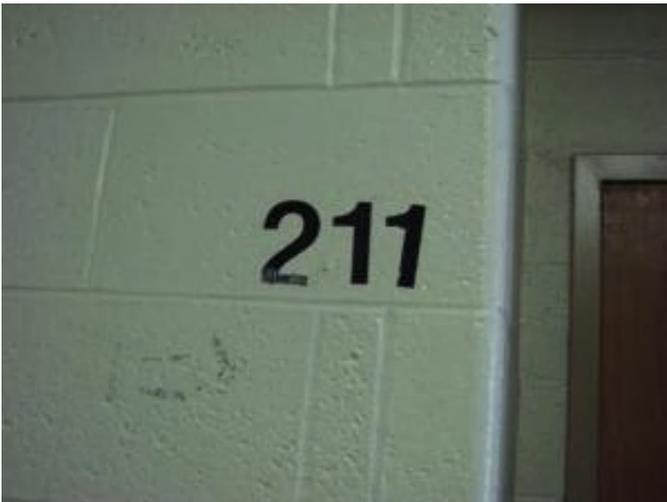
**System: C1030 - Fittings**

**Location:** Corridors

**Distress:** Inadequate

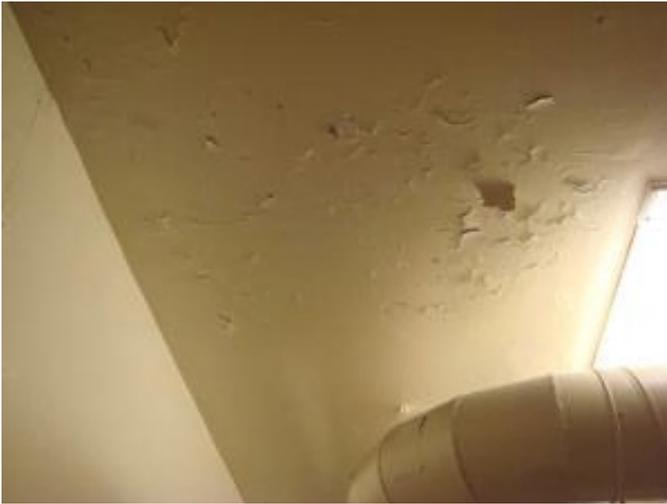
**System: C3010230 - Paint & Covering**

**Location:** Ceiling in corridors, classrooms

**Distress:** Appearance

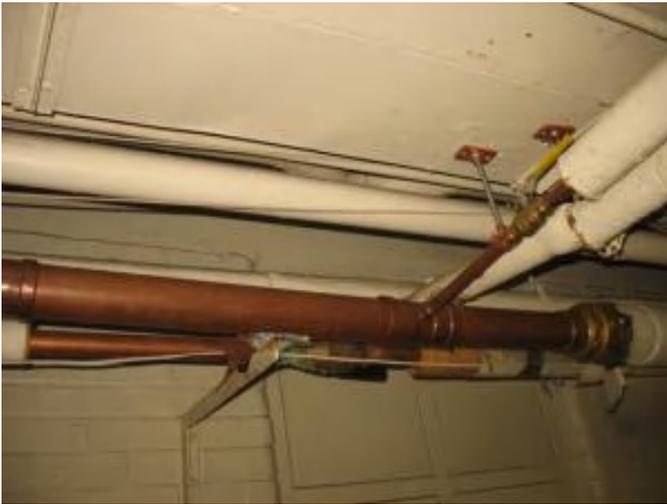
**System: D2020 - Domestic Water Distribution**

**Location:** Throughout building

**Distress:** Beyond Service Life

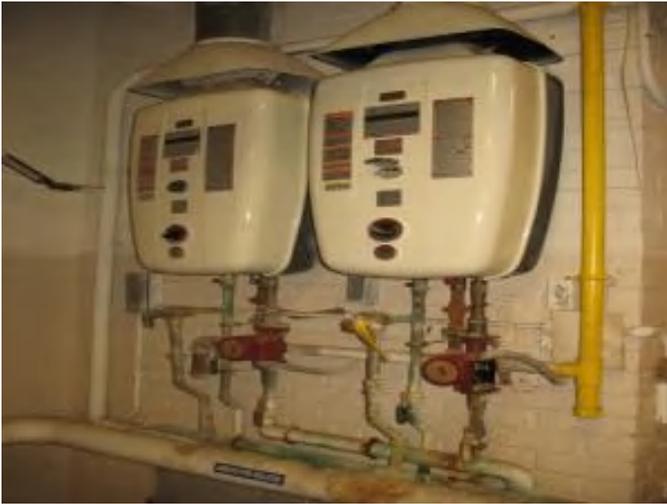
**System: D2020 - Domestic Water Distribution**

**Location:** Boiler room

**Distress:** Beyond Service Life

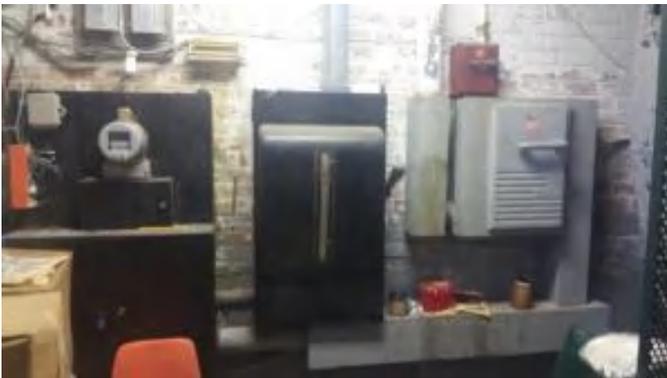
**System: D5010 - Electrical Service/Distribution**

**Location:** electrical room

**Distress:** Beyond Service Life

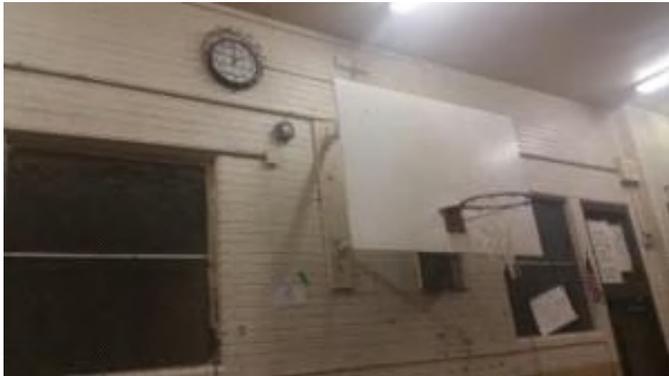
**System: D5030 - Communications and Security**

**Location:** throughout the building

**Distress:** Beyond Service Life

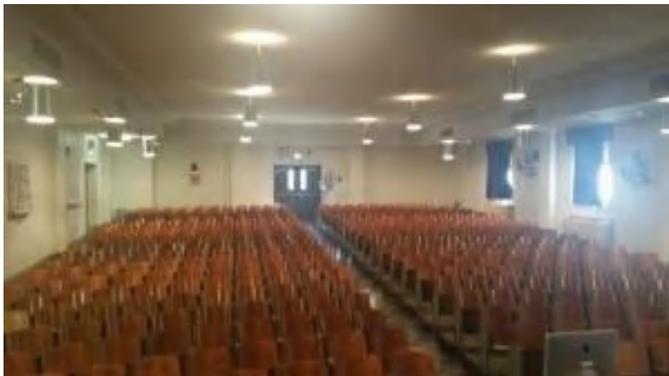
**System: D5030 - Communications and Security**

**Location:** auditorium

**Distress:** Beyond Service Life

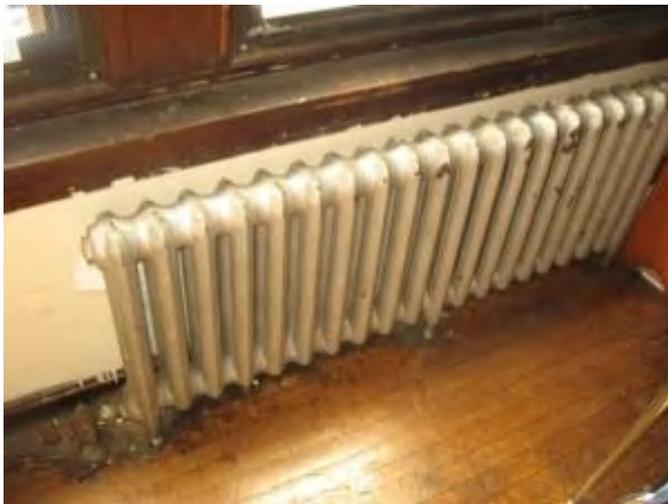
**System: D3040 - Distribution Systems**

**Location:** Element 1

**Distress:** Building / MEP Codes

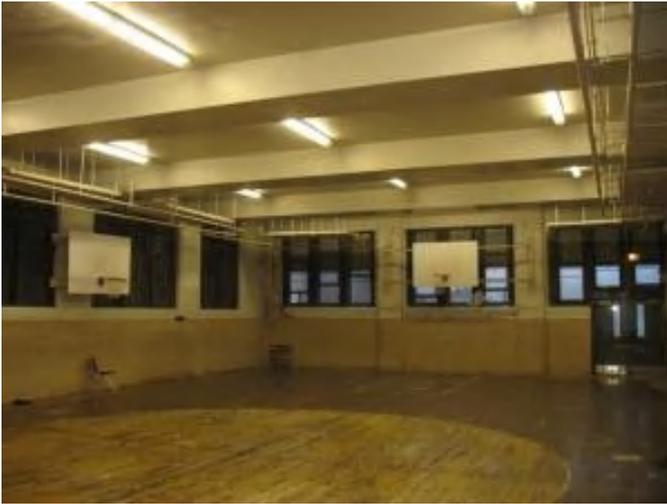
**System: D3040 - Distribution Systems**

**Location:** Gymnasium  
**Distress:** Building / MEP Codes  
**Category:** 2 - Code Compliance  
**Priority:** 5 - Response Time (> 5 yrs)  
**Correction:** Install HVAC unit for Gymnasium (single station).  
**Qty:** 6,000.00  
**Unit of Measure:** Ea.  
**Estimate:** \$344,860.27  
**Assessor Name:** System  
**Date Created:** 01/08/2016

**Notes:** Provide ventilation for the Gymnasium by installing a fan coil air handling unit hung from the structure with outdoor air ducted to the unit from louvers in the window openings.

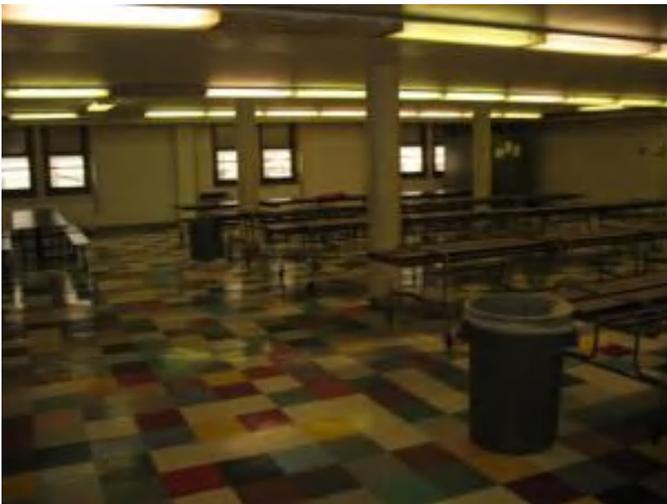
**System: D3040 - Distribution Systems**

**Location:** Cafeteria  
**Distress:** Building / MEP Codes  
**Category:** 2 - Code Compliance  
**Priority:** 5 - Response Time (> 5 yrs)  
**Correction:** Install HVAC unit for Cafeteria (850 students).  
**Qty:** 656.00  
**Unit of Measure:** Pr.  
**Estimate:** \$335,688.89  
**Assessor Name:** System  
**Date Created:** 01/08/2016

**Notes:** Provide ventilation for the Cafeteria by installing a fan coil air handling unit hung from the structure with outdoor air ducted to the unit from louvers in window openings.

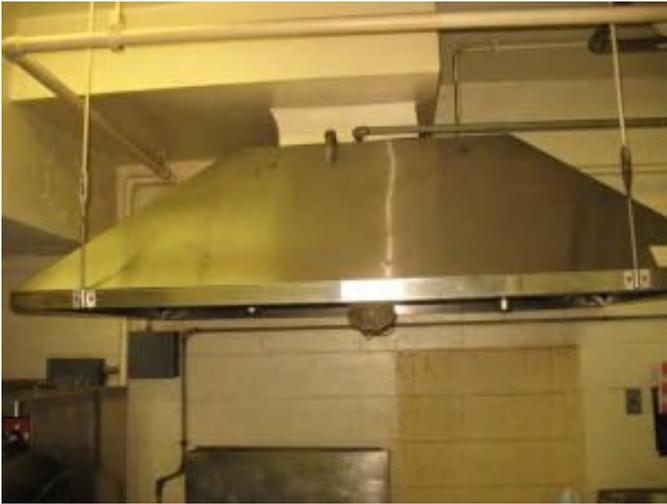
**System: D3040 - Distribution Systems**

**Location:** Kitchen

**Distress:** Inadequate

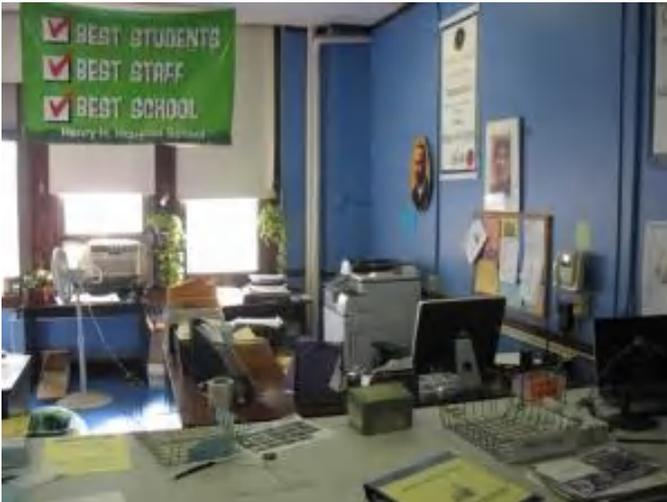
**System: D3040 - Distribution Systems**

**Location:** Administration

**Distress:** Building / MEP Codes

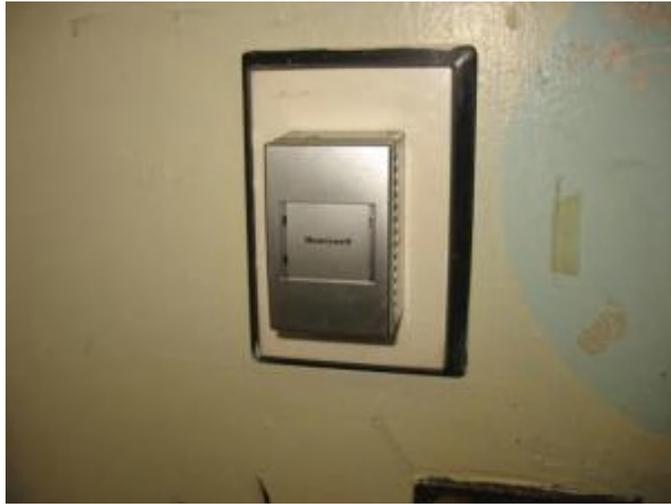
**System: D3060 - Controls & Instrumentation**

**Location:** Throughout building

**Distress:** Inadequate

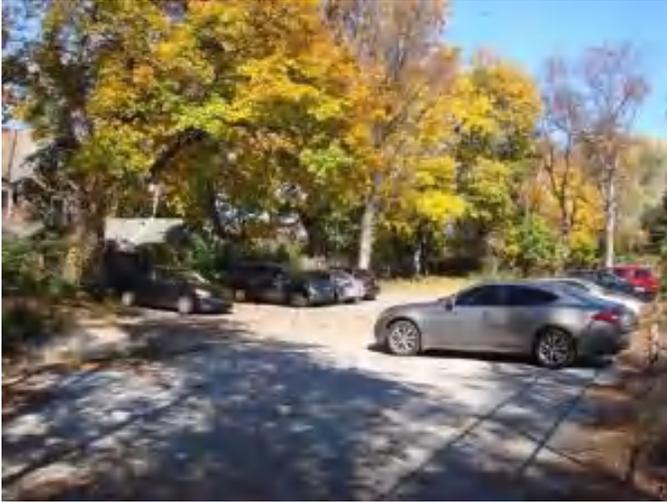
#### System: G2020 - Parking Lots

There are two staff parking locations on site. There's a fenced in lot on the northwest corner of the site accessible from Rural Lane and another area directly behind the Element-2 wing (1970). Pavement is in very poor condition, striping is deteriorated with no accessible stalls or signage.

**Location:** On site parking area

**Distress:** Beyond Service Life

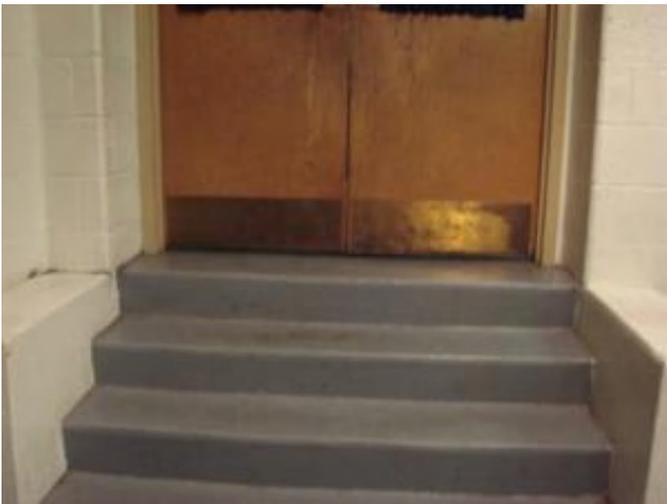
#### System: G2030 - Pedestrian Paving

**Location:** Along accessible route to elevator

**Distress:** Accessibility

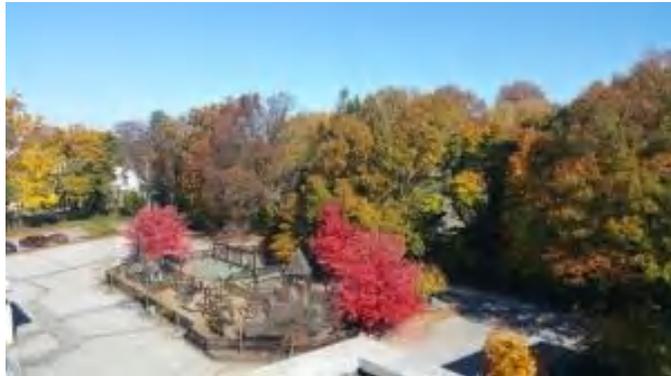
**System: G4020 - Site Lighting**

**Location:** grounds

**Distress:** Inadequate

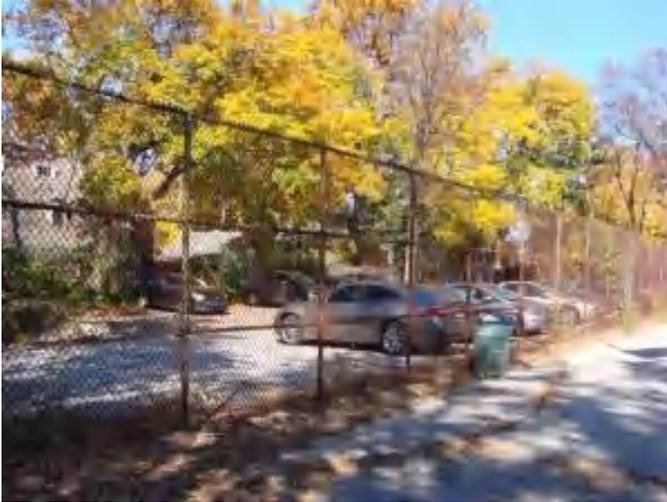
**System: G2020 - Parking Lots**

**Location:** On site parking area

**Distress:** Beyond Service Life

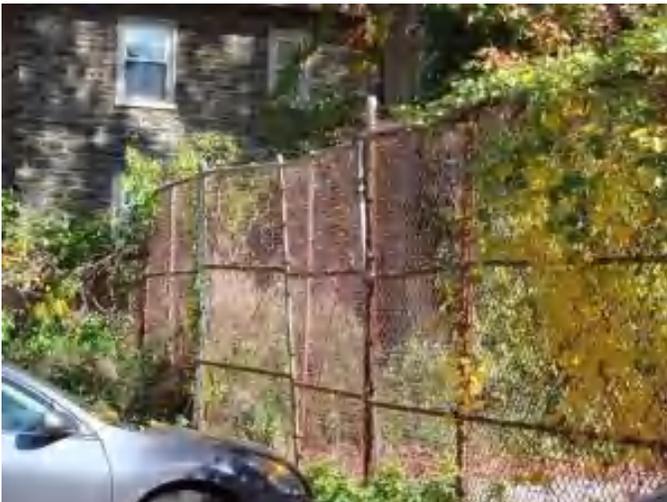
**System: G2040 - Site Development**

**Location:** Along on site parking area

**Distress:** Beyond Service Life

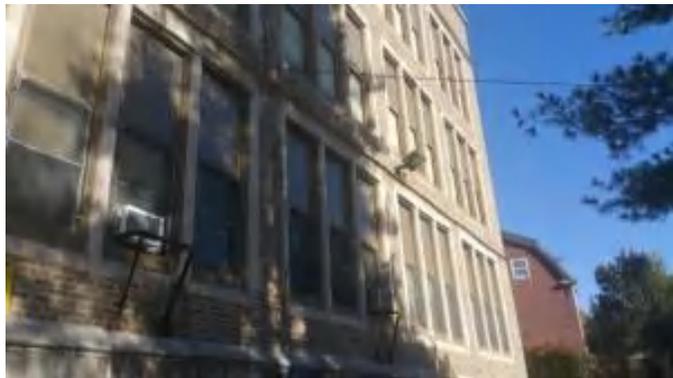
**System: G4030 - Site Communications & Security**

**Location:** grounds

**Distress:** Inadequate
