Facility Condition Assessment Summary Report

Howe School

S732001;Howe

Site Assessment Report

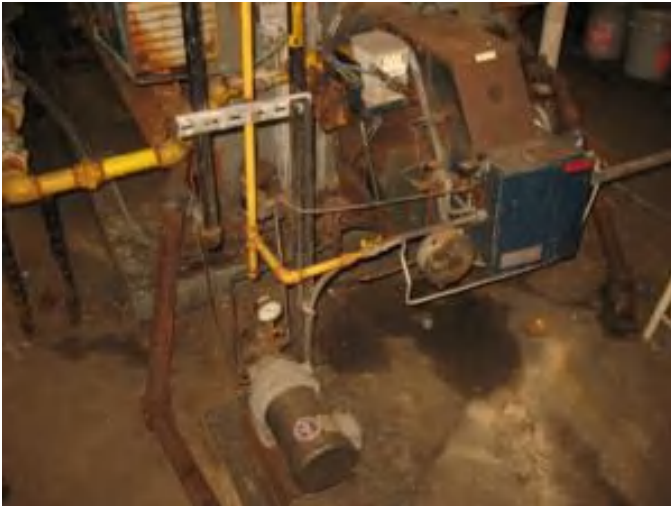
System: D3020 - Heat Generating Systems

Location: Boiler room

Distress: Beyond Service Life

Notes: Replace the two (2) 5800MBH dual fuel boiler burners, which are beyond their service lives, with new more efficient burners within the next 0-2 years.

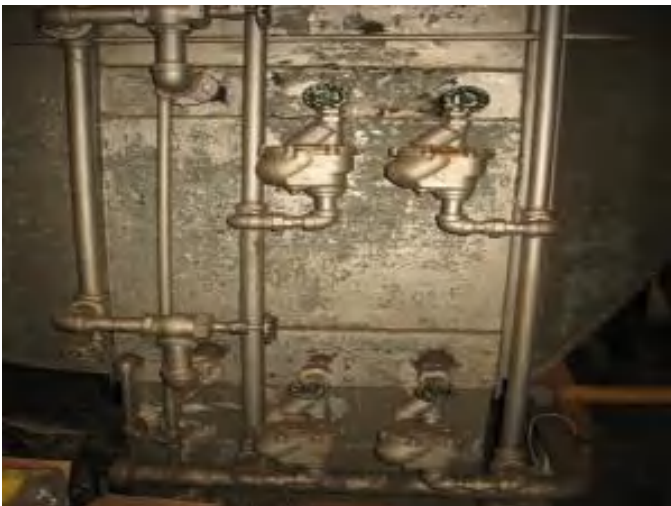
System: D3040 - Distribution Systems

The boiler feed tank assembly with three (3) 1/2HP pumps headered together is installed in the boiler room. A serious problem was reported with steam leaking into the system from failed steam traps and of the feed tank system leaking. The boiler feed tank and pumps should be replaced. A water chemical treatment system is connected to the feed tank.

Location: Throughout building

Distress: Failing

Notes: Conduct a steam trap survey to identify and replace failed traps passing live steam into the condensate piping system.

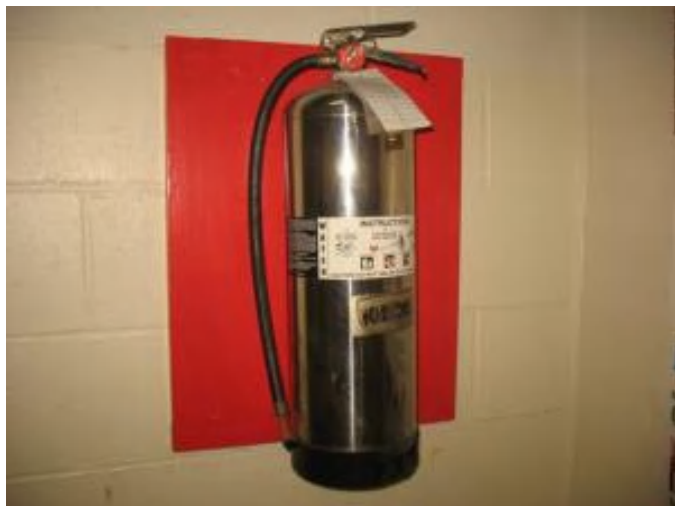
System: D4010 - Sprinklers

Location: Throughout building

Distress: Life Safety / NFPA / PFD

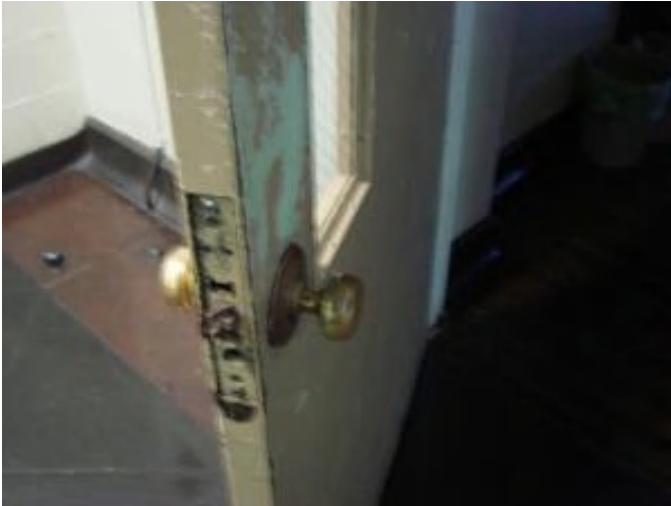
System: C1020 - Interior Doors

Interior doors are wood rail and stile wood glazed doors with transoms, generally in various stages of deterioration. Most doors are fitted with door knobs and are not ADA compliant. Doors leading to exit stairways are retrofitted with hollow metal doors and frames in good condition. Doors in 1970 addition are mostly solid core in hollow metal frames, generally in poor condition.

Location: Throughout building

Distress: Accessibility

Notes: Provide ADA compliant hardware on interior doors

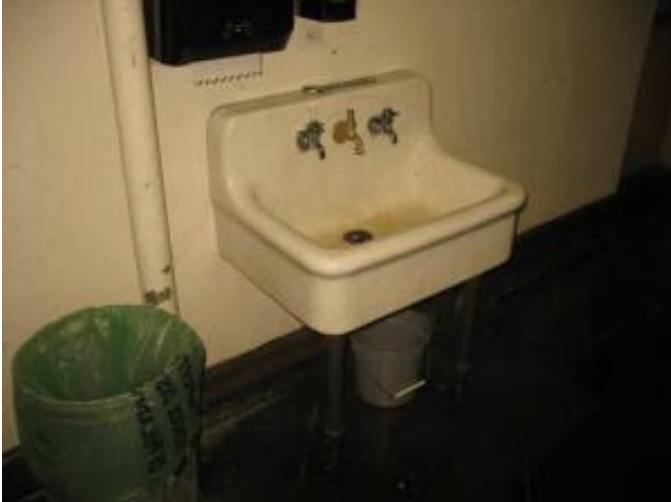
System: D2010 - Plumbing Fixtures

A sink is available in the corridor on each floor for use by the janitorial staff. These sinks are beyond their service lives, insufficient, and should be replaced with new service sinks.

Location: Corridors

Distress: Beyond Service Life

Notes: Replace four (4) service sinks in the corridors for use by the janitorial staff which are beyond their service lives.

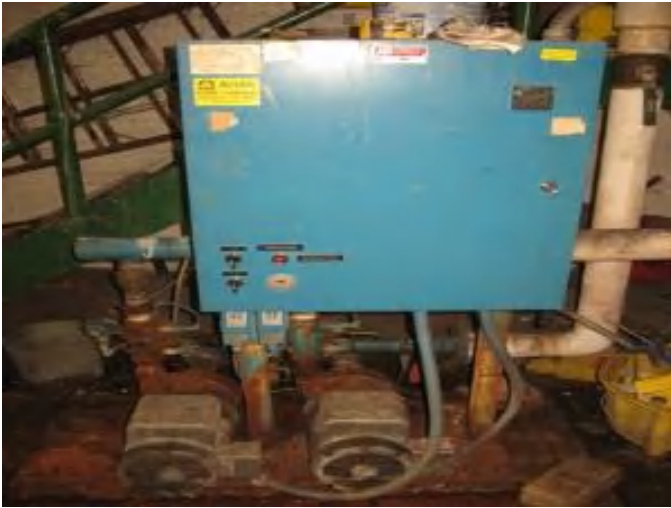
System: D2020 - Domestic Water Distribution

Location: Boiler room

Distress: Damaged

Notes: Replace the duplex 5HP domestic water booster pumps and isolation valves on the incoming domestic water line with a new skid mounted pressure booster system.

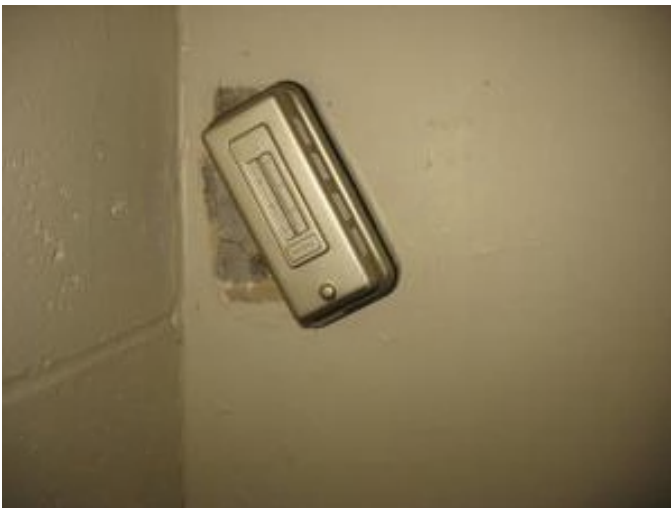
System: D3060 - Controls & Instrumentation

The original pneumatic systems provide no control functions. Pneumatic room thermostats are intended to control the steam radiator control valves. In reality the radiator control valves are wide open and heating control is achieved via the boilers and house fan. Pneumatic control air is no longer supplied as the air compressor has been removed. The pneumatic systems are beyond their service life and are no longer functional. The original control valves and pneumatic actuators are beyond their service life and should be rebuilt or replaced. These controls should be converted to DDC.

Location: Throughout building

Distress: Inadequate

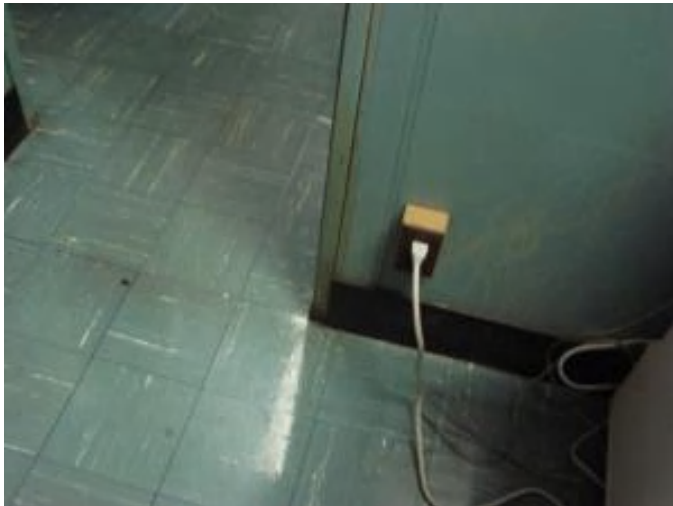
System: C3020413 - Vinyl Flooring

Location: First floor rooms 1050

Distress: Building Envelope Integrity

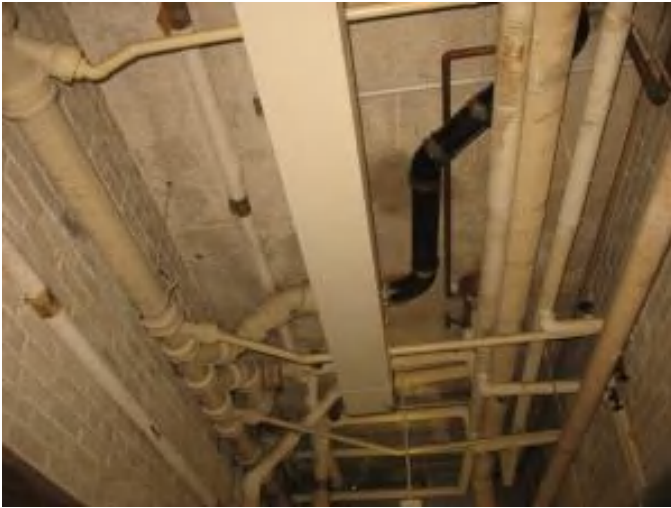
System: D2030 - Sanitary Waste

The maintenance staff reported mostly minor problems with the sanitary waste piping systems. The original sewer piping has been in service for over 100 years and will require more frequent attention from the maintenance staff as time passes. The District should hire a qualified contractor to examine the sanitary waste piping using video cameras to locate and replace any damaged piping and to further quantify the extent of potential failures.

Location: Throughout building

Distress: Beyond Service Life

Notes: Hire a qualified contractor to perform a detailed examination of the sanitary waste piping using visual inspection and video cameras to locate and replace any damaged piping and to further quantify the extent of potential failures.

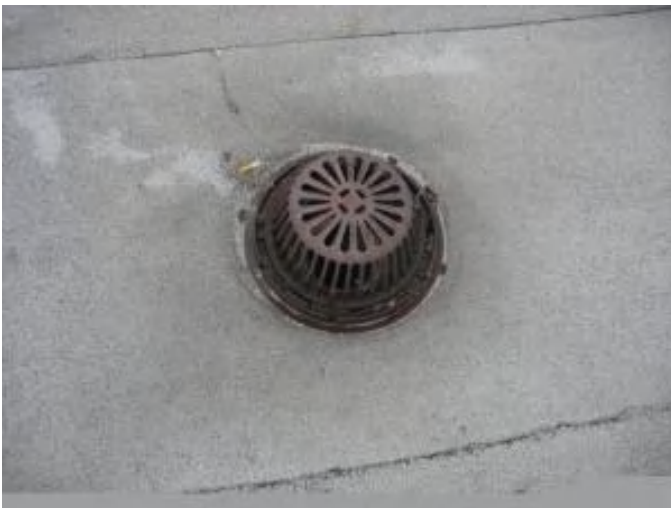
System: D2040 - Rain Water Drainage

Rain water drains from the roof are routed through mechanical chases in the building and appear to be original. The piping is cast iron piping with hub and spigot fittings and has been in use well beyond its service life. The District should hire a qualified contractor to examine the rain water drainage piping using video cameras to locate and replace any damaged piping and to further quantify the extent of potential failures.

Location: Throughout building

Distress: Beyond Service Life

Notes: Hire a qualified contractor to perform a detailed examination of the rain water drainage piping using visual inspection and video cameras to locate and replace any damaged piping and to further quantify the extent of potential failures.

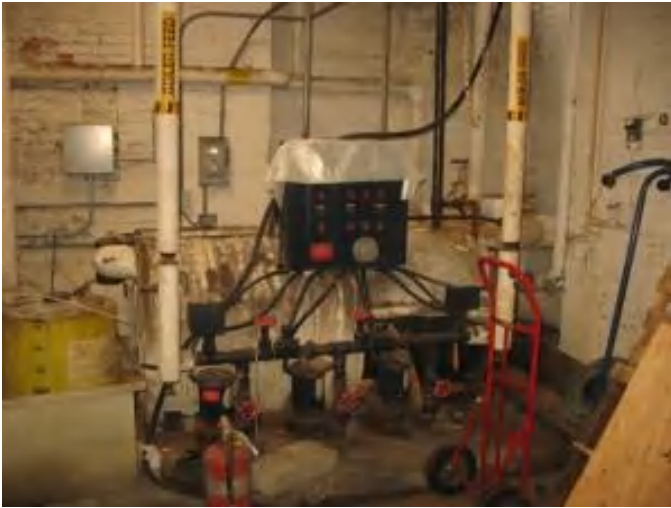
System: D3020 - Heat Generating Systems

Location: Boiler room

Distress: Beyond Service Life

Notes: Replace the existing boiler feed tank, which is estimated to be beyond its service life, and three (3) 1/2HP pumps in the boiler room.

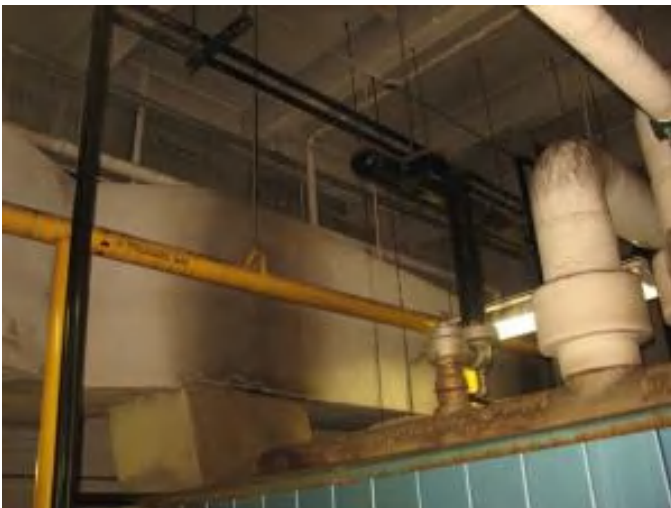
System: D3040 - Distribution Systems

Steam piping is black steel with welded fittings. The condensate piping is black steel with threaded fittings. Steam and condensate piping mains from the basement level run up through the building to the radiators on all three floors. The distribution piping has been in use well beyond its service life and will require more frequent attention from the maintenance staff to address pipe/valve failures as time passes. The District should hire a qualified contractor to examine the steam and condensate piping and perform additional testing to locate and replace any damaged piping and to further quantify the extent of potential failures. The District should budget for replacing this piping over the next 10 years.

Location: Throughout building

Distress: Beyond Service Life

Notes: Hire a qualified contractor to examine the steam piping, in service for over 100 years, and perform additional testing to locate and replace any damaged piping and to further quantify the extent of potential failures.

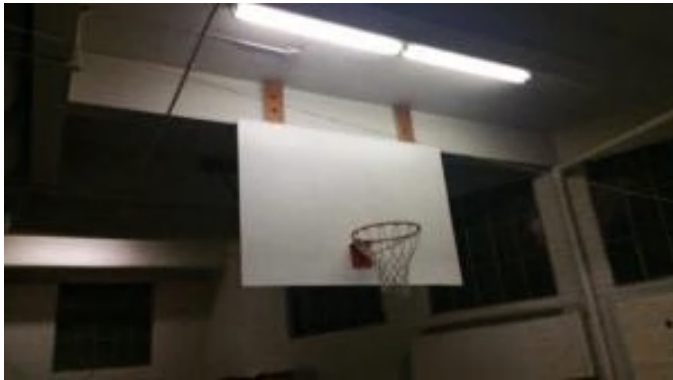
System: D5020 - Lighting and Branch Wiring

Lighting - Interior building is illuminated by various types of fixtures. They include fluorescent lighting (mostly T-8 & T-12 lamps) in majority of the areas, including; classrooms, corridors, offices, Library, cafeteria, Kitchen, etc. Surface or pendant mounted industrial fluorescent fixtures are used in mechanical and electrical rooms. About 30% of the school lighting was upgraded, however the majority of the building (70%) lacks adequate illumination level. The majority of interior lighting fixtures are not in good condition and have reached the end of their useful service life.

Location: throughout the building

Notes: Install new lighting system for 70% of the building.
40,500 SF x 70% =

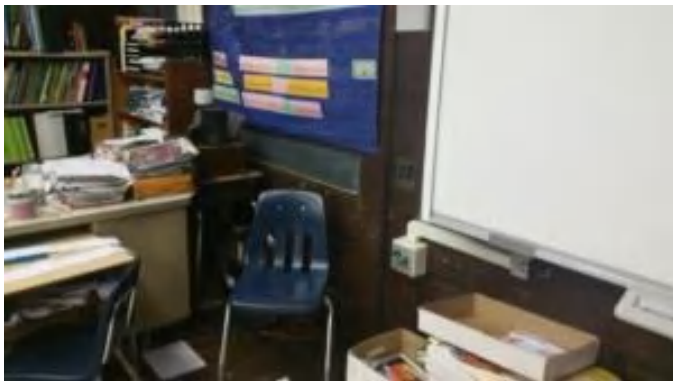
System: D5020 - Lighting and Branch Wiring

Location: throughout the building

Notes: Install new receptacles for 70% of the building
40,500 SF x 70% = 28,350 SF

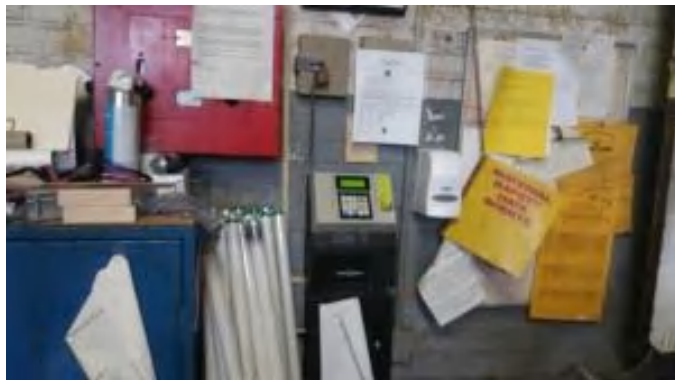
System: D5030 - Communications and Security

Location: throughout the building

Distress: Beyond Service Life

Notes: Install new Automated Fire alarm System.

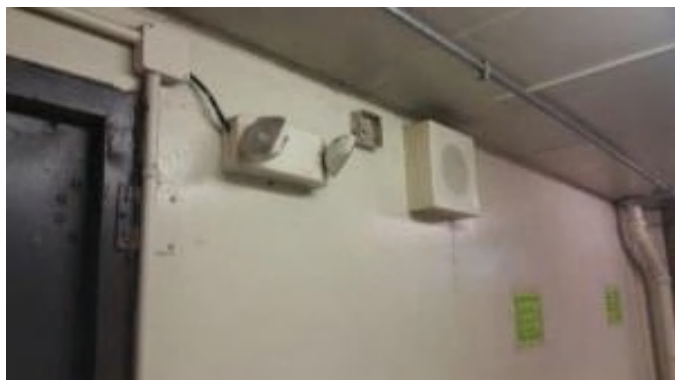
System: D5090 - Other Electrical Systems

Location: throughout the building

Distress: Beyond Service Life

Notes: Replace existing exit lights and emergency lights

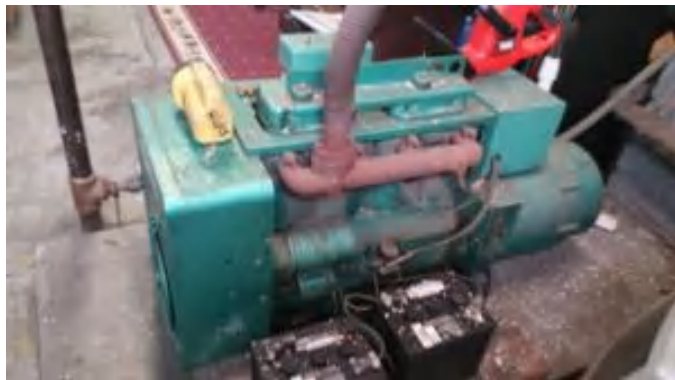
System: D5090 - Other Electrical Systems

Location: electrical room

Distress: Health Hazard / Risk

Notes: Install a new emergency generator.

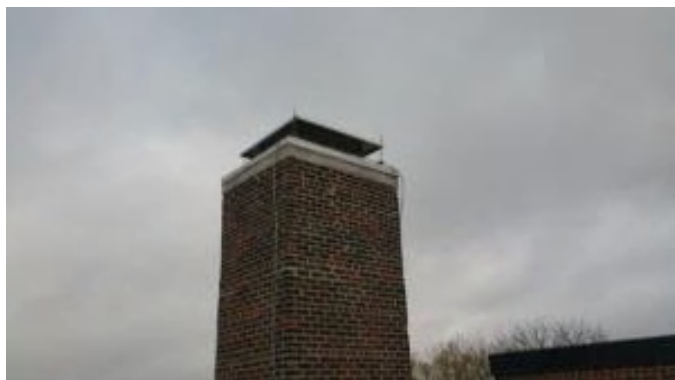
System: D5090 - Other Electrical Systems

Location: roof

Distress: Health Hazard / Risk

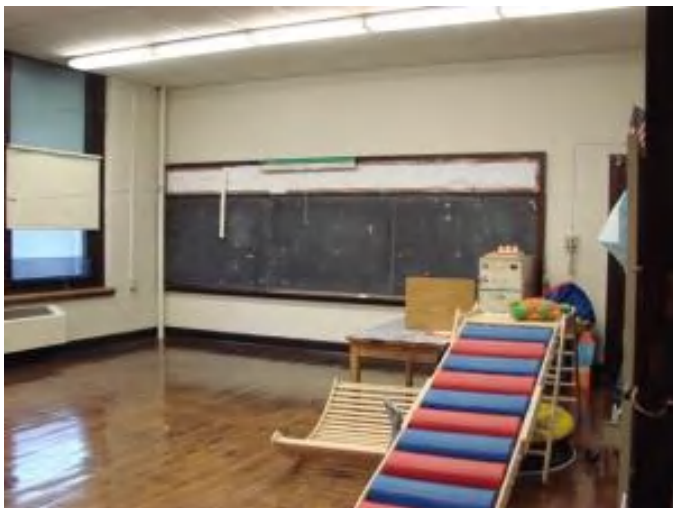
System: C1030 - Fittings

Location: Classrooms

Distress: Beyond Service Life

Notes: Replace original chalk boards

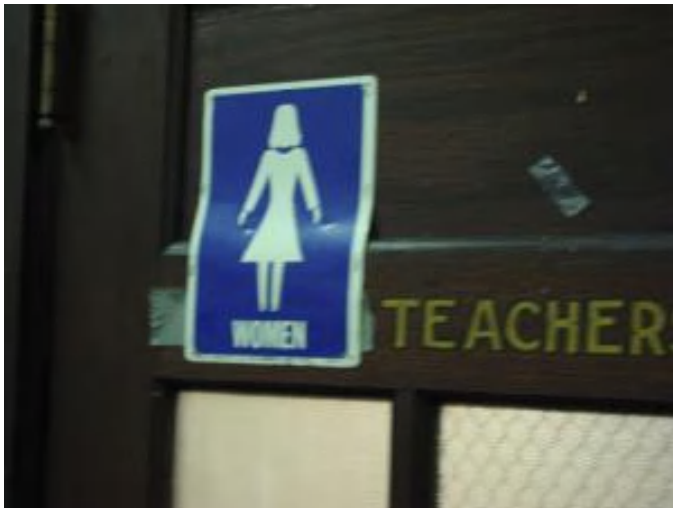
System: C1030 - Fittings

Location: Throughout building

Distress: Inadequate

Notes: Install new signage throughout the building

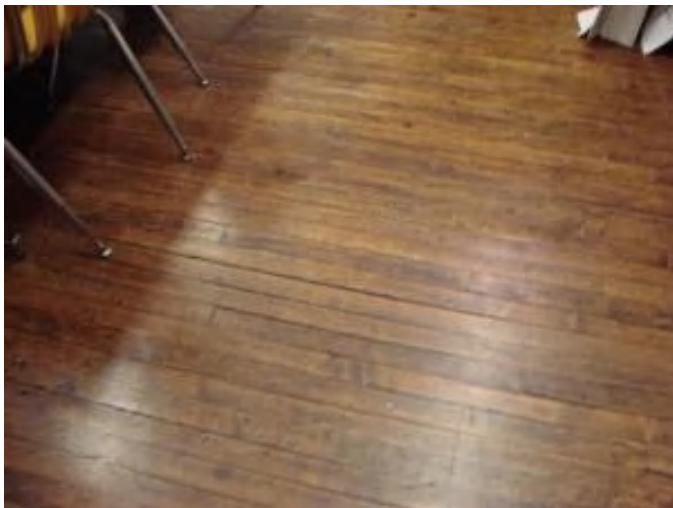
System: C3020414 - Wood Flooring

Location: Throughout building

Distress: Appearance

Notes: Repair refinish hardwood flooring

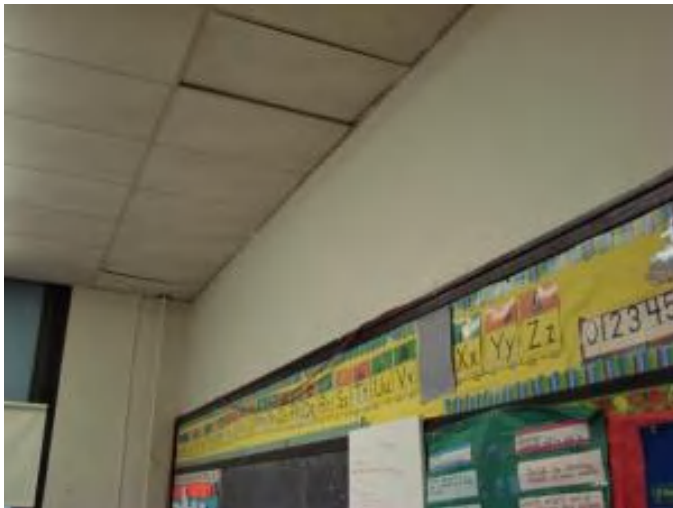
System: C3030 - Ceiling Finishes

Most ceilings are 2x4 suspended acoustical panels, 1x1 adhered to ceiling and exposed painted. The suspension system and tile are old and approaching the end of their useful life. Paint on exposed ceilings is in fair to poor condition.

Location: Throughout building

Distress: Beyond Service Life

Notes: Replace all suspended acoustical ceilings

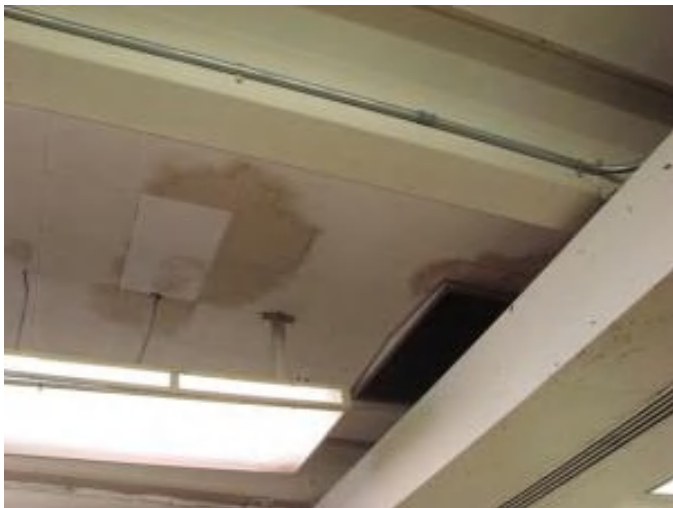
System: C3030 - Ceiling Finishes

Location: Throughout building

Distress: Damaged

Notes: Repair and repaint exposed ceilings

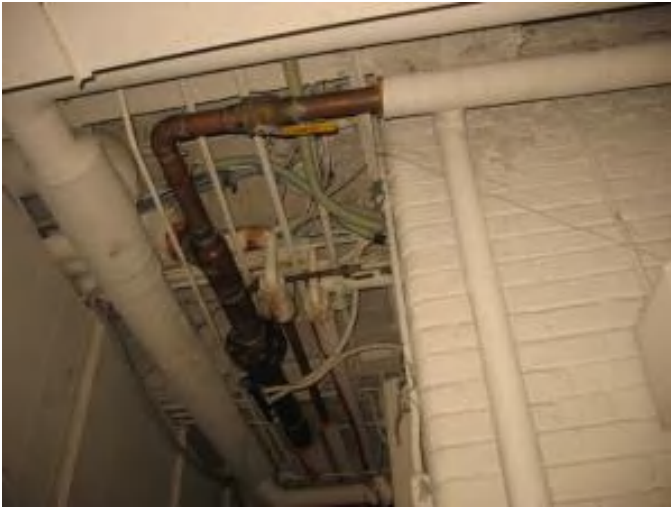
System: D2020 - Domestic Water Distribution

Location: Throughout building

Distress: Beyond Service Life

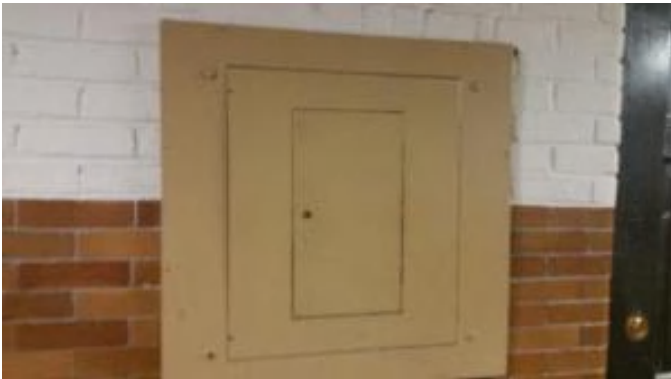
System: D5010 - Electrical Service/Distribution

Distribution system - The electrical distribution is accomplished by using the 400A switchboard distribution panel (located in the electrical room) and feeding several 120V lighting and receptacle panels throughout the building. These panels are in poor condition. They have reached the end of their useful service life.

Location: throughout the building

Distress: Beyond Service Life

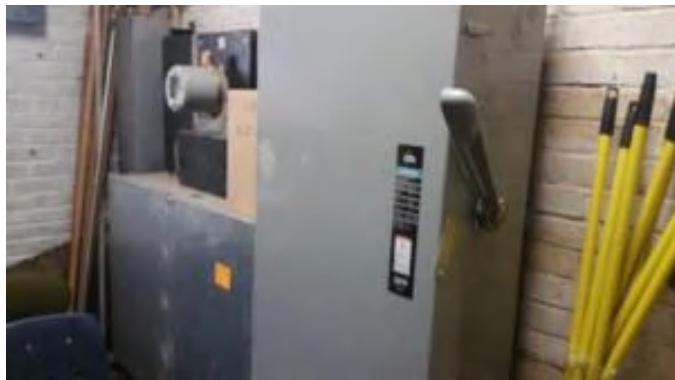
System: D5010 - Electrical Service/Distribution

Site electrical service - The primary power is at 13.2KV from the power poles feeding a pole-top transformer. The secondary power is brought into the school building overhead and down on the exterior of the building into the electrical room. It feeds an old 400A, 120V/240 V, 2 phase switchboard. The PECO (PECO 9U-4216273) meter is also located inside the new electrical room (basement). The switchboard is in a poor condition and has reached the end of its useful service life.

Location: electrical room

Distress: Beyond Service Life

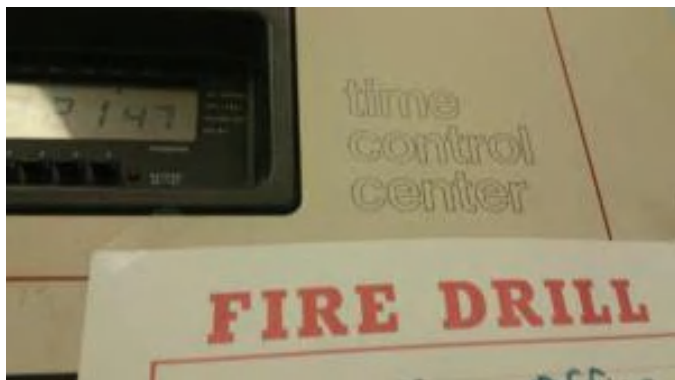
System: D5030 - Communications and Security

Location: throughout the building

Distress: Beyond Service Life

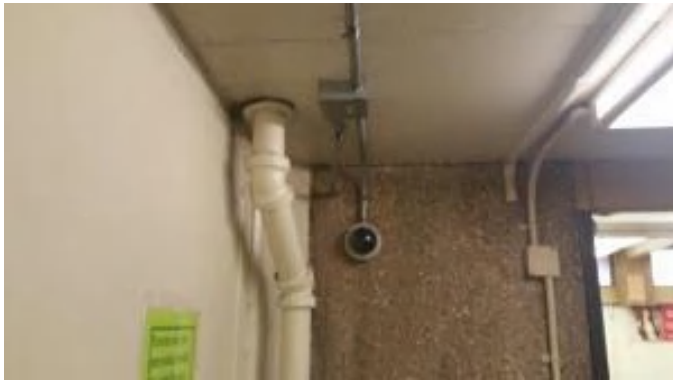
System: D5030 - Communications and Security

Location: throughout the building

Distress: Inadequate

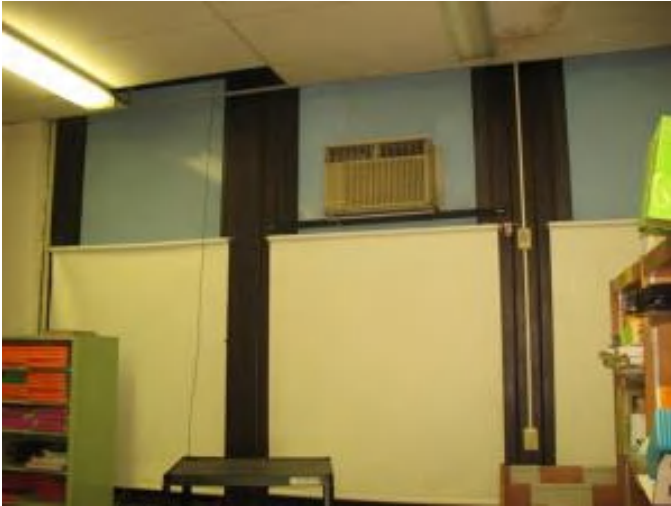
System: D3030 - Cooling Generating Systems

Several of the classrooms in the school building have window air conditioning units that have an anticipated service life of only 10 years. Installing a 110 ton air-cooled chiller with pumps located in a mechanical room and chilled water distribution piping would supply more reliable air conditioning for the building with a much longer service life.

Location: Throughout building

Distress: Inadequate

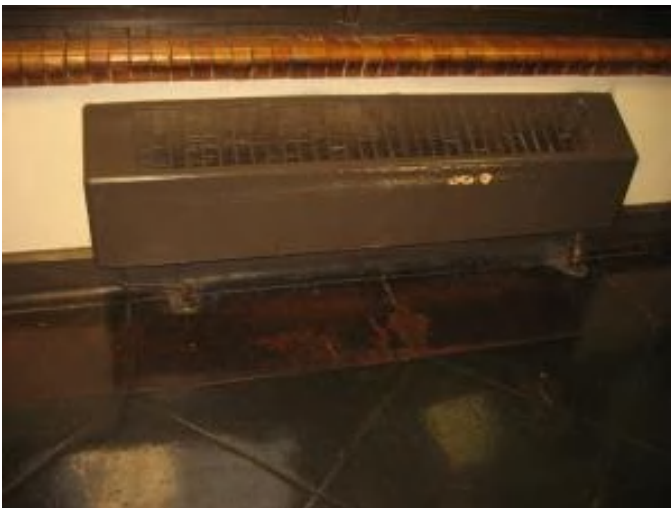
System: D3040 - Distribution Systems

Location: Classrooms

Distress: Building / MEP Codes

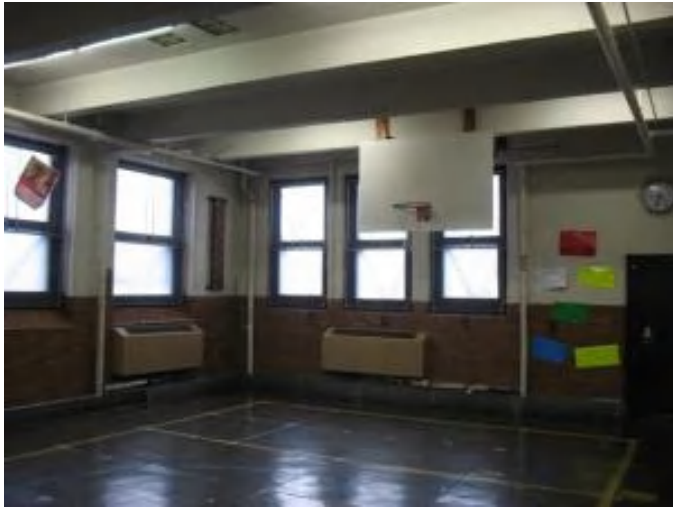
System: D3040 - Distribution Systems

Location: Gymnasium

Distress: Building / MEP Codes

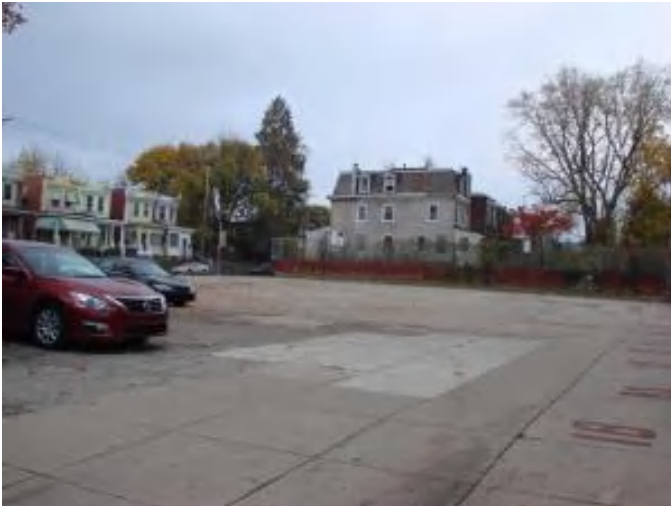
System: G2020 - Parking Lots

There is a parking lot at the west side of the site. There are no accessible spaces, aisles or signage. The pavement is concrete in good condition;

Location: Parking area

Distress: Accessibility

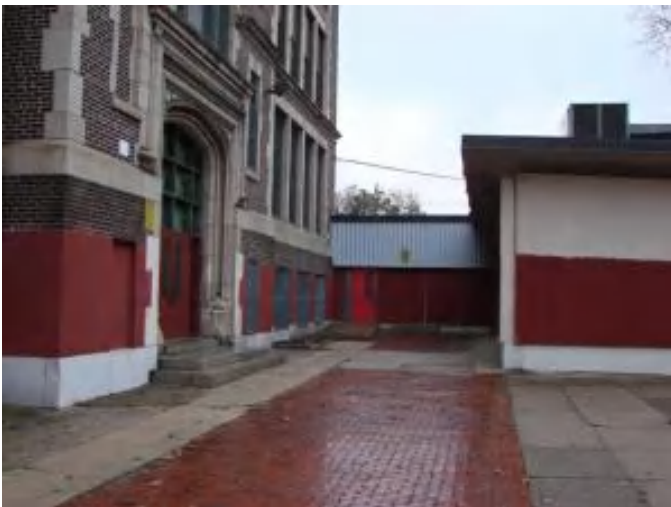
System: G2030 - Pedestrian Paving

Location: Side entrance north side

Distress: Accessibility

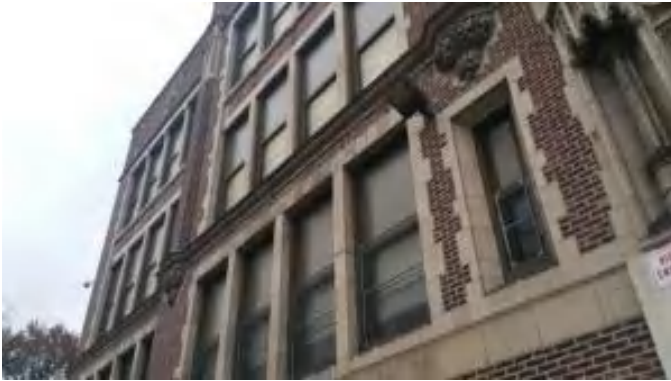
System: G4020 - Site Lighting

Location: grounds

Distress: Inadequate

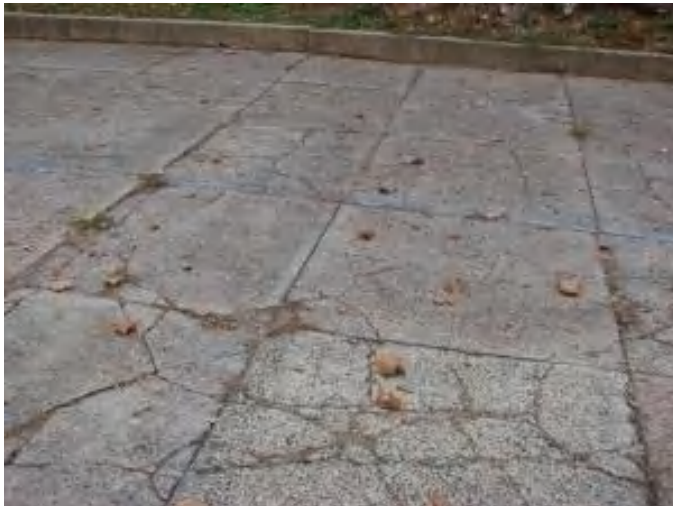
System: G2020 - Parking Lots

Location: Parking paving area

Distress: Beyond Service Life

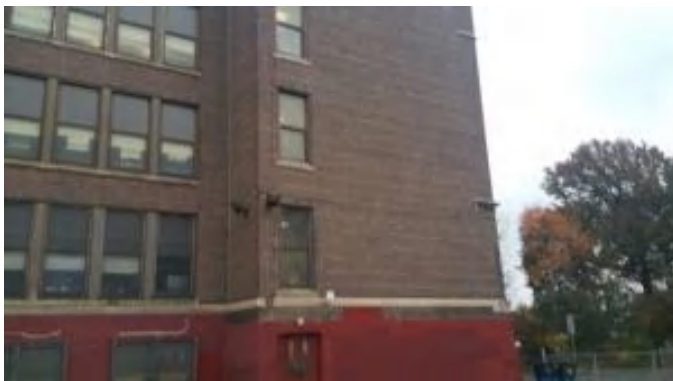
System: G4030 - Site Communications & Security

Location: grounds

Distress: Inadequate
