Facility Condition Assessment Summary Report

Hunter School

School District of Philadelphia
S533001; Hunter
Final
Site Assessment Report

January 31, 2017

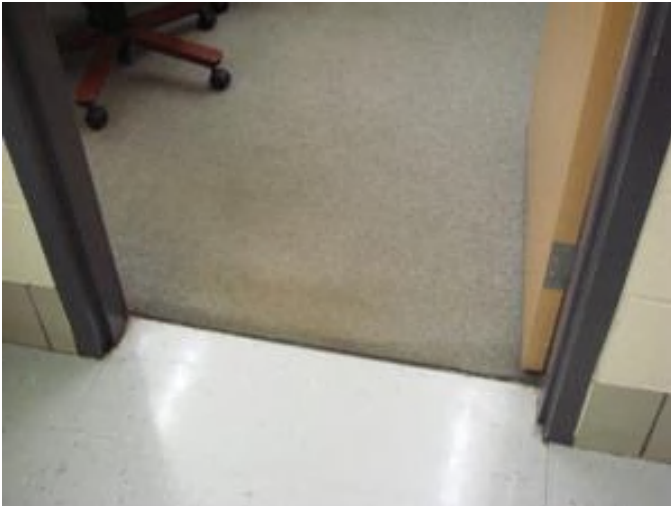
System: C3020411 - Carpet

Flooring in most areas is generally vinyl composition tile, in very good condition. Flooring in library and principal's office is carpet in poor condition. Gym has resilient sheet flooring in very good condition. Flooring in toilets and kitchen area is typically ceramic tiles in good condition. The ground floor corridors and main lobby are covered with epoxy terrazzo in very good condition.

Location: Interior

Distress: Beyond Service Life

Notes: Replace carpet in library and principal's office

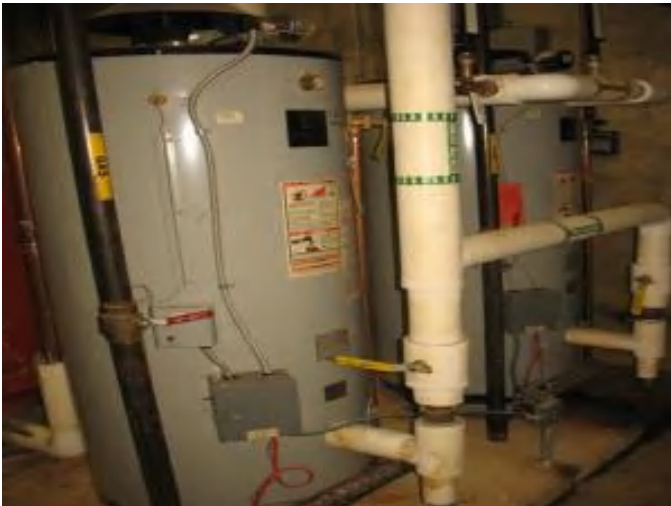
System: D2020 - Domestic Water Distribution

Two State Sandblaster 100 gallon vertical domestic hot water heaters with circulating pump and expansion tank provide domestic hot water for the building. Both units are original to the building, are gas fired, and are located in the basement mechanical room. The hot water heaters are equipped with T&P relief valves and an Amtrol expansion tank. The domestic hot water heaters are at the end of their service life and should be replaced in the next 1-3 years. A water softener was located in the basement mechanical room.

Location: Basement mechanical room

Distress: Beyond Service Life

Notes: Replace two 100 gallon, gas fired, vertical hot water heaters which are beyond their service life.

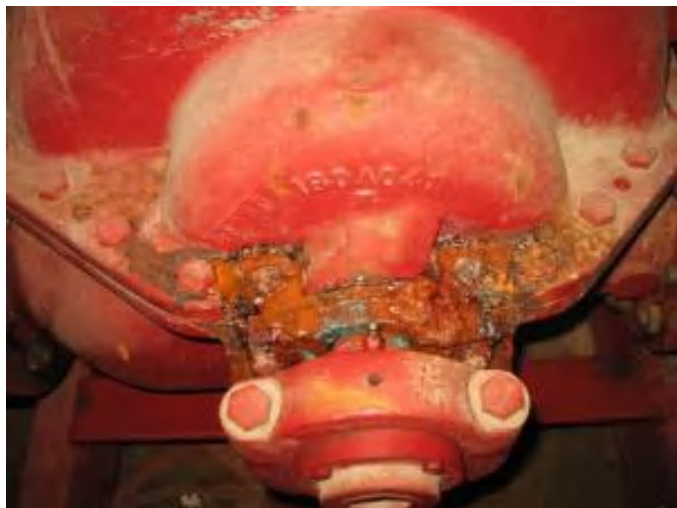
System: D4010 - Sprinklers

The building is equipped with a wet type sprinkler system. An 8" fire water line enters the building in the basement mechanical room along the same wall as the domestic water. A skid mounted 60-HP engine driven 750 gpm Aurora pump ensures adequate pressure throughout the system during a sprinkler discharge. A 50 gallon diesel tank is mounted adjacent to the engine. The fire suppression system is the originally installed equipment and should not need replacement within the next 10 years, but the fire pump is damaged from rust and should be inspected by a qualified contractor.

Location: Basement mechanical room

Distress: Maintenance Required

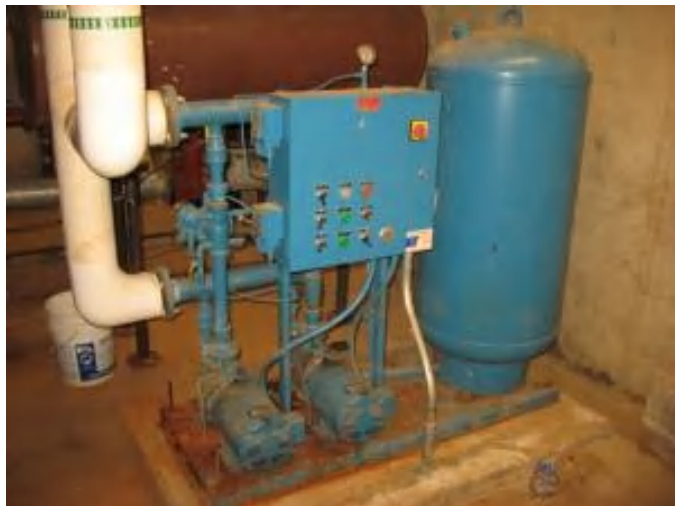
System: D2020 - Domestic Water Distribution

Location: Basement mechanical room

Distress: Damaged

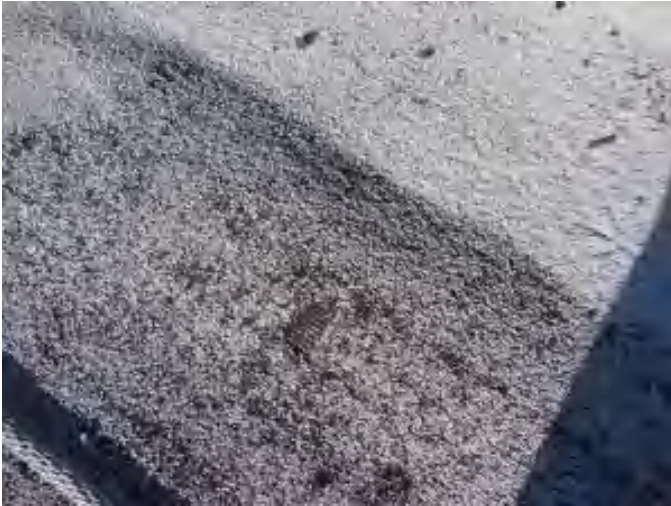
System: B3010105 - Built-Up

Roofing typically consists of 2 types: modified bitumen over rigid insulation on the flat roofs, and prefinished metal, standing seam roofing over sloped clerestories. All roofing is generally in good condition; however, a central portion of the main roof exhibits several large soft spots which will potentially deteriorate and cause leaks.

Location: Exterior

Distress: Beyond Service Life

Notes: Replace deteriorating portion of BUR on main roof (approximately 2000 SF)

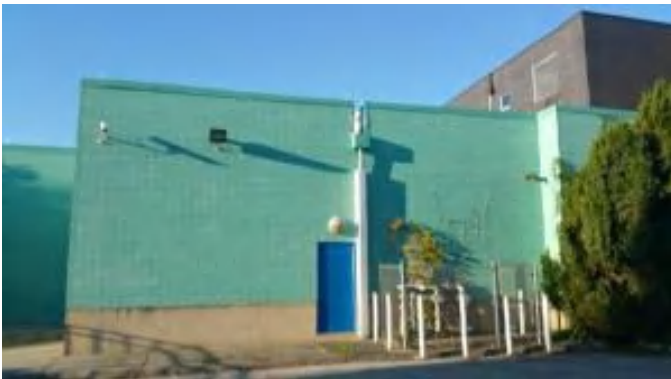
System: D5030 - Communications and Security

Location: Throughout the building

Distress: Inadequate

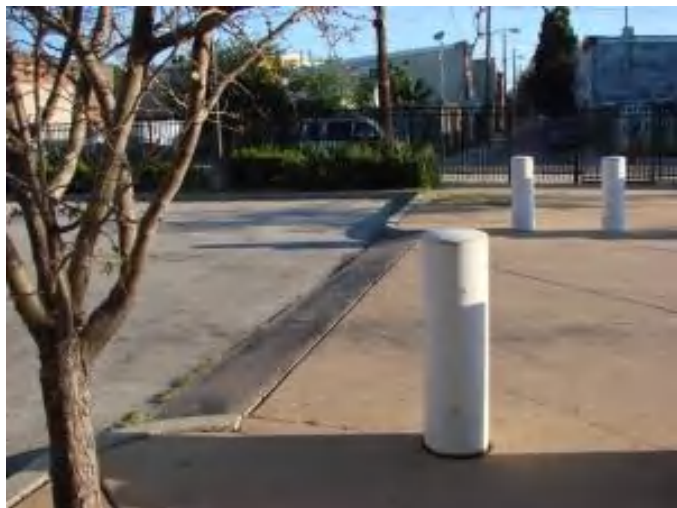
System: G2020 - Parking Lots

There are two parking lots at the site, in good condition. Public parking for 33 vehicles has 2 accessible spaces; staff parking for 44 vehicles has 2 spaces designated as accessible. Compliant accessible signage is in good condition. Stalls striping is faded.

Location: Grounds/ site

Distress: Accessibility

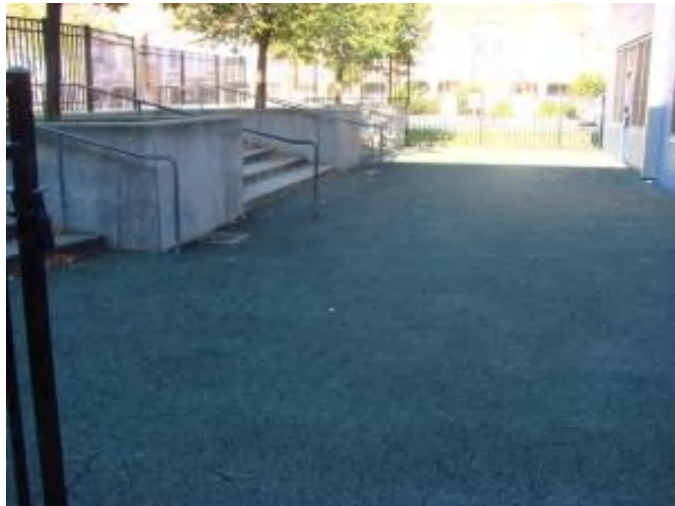
System: G2040 - Site Development

The playground paving on the west side of the building is in good condition; however, protective rubber matting in the kindergarten play area is deteriorated. Original perimeter chain link and picket fences are generally in good condition. The portion of the site is landscaped with trees, shrubs and grass areas, generally in good condition. The trees and shrubs are not fully mature.

Location: Grounds/ site

Distress: Beyond Service Life
