Facility Condition Assessment Summary Report

Jackson School

School District of Philadelphia
S251001; Jackson
Final
Site Assessment Report

January 31, 2017

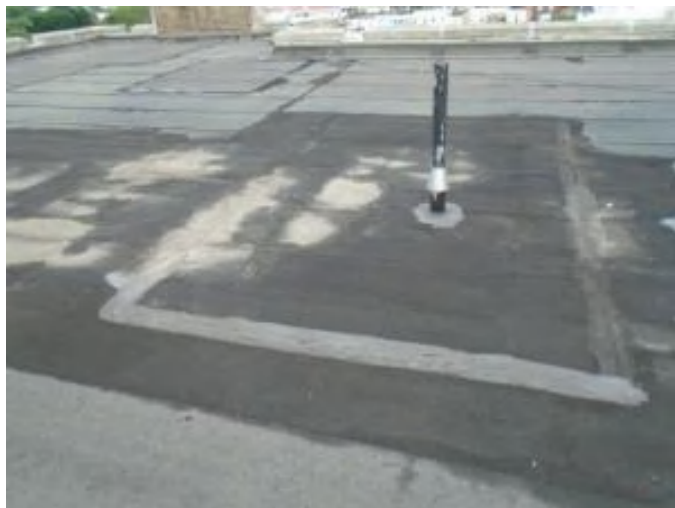
System: B3010105 - Built-Up

Location: Roof

Distress: Failing

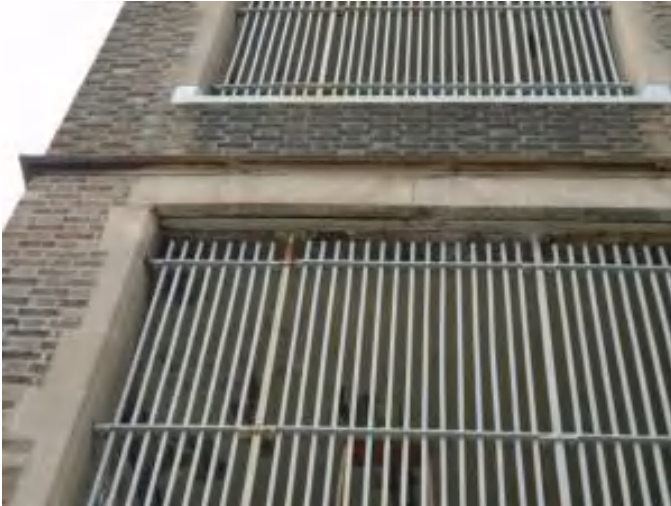
System: B2010 - Exterior Walls

Location: Fire towers

Distress: Failing

Notes: •Repair stonework on fire tower and replace metal grating – rusted and failing

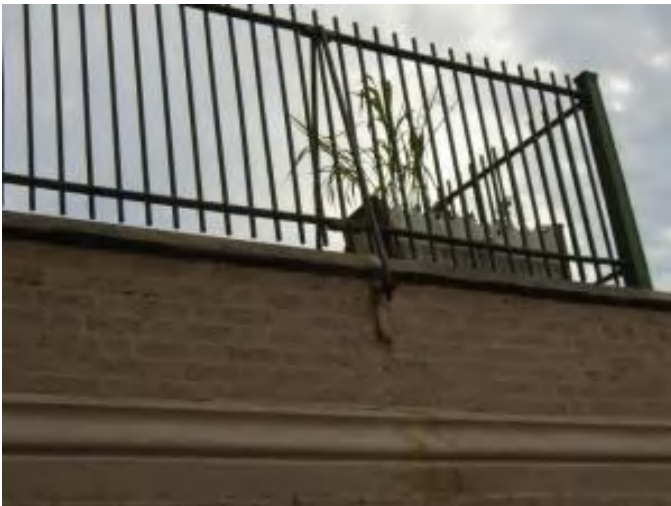
System: B2010 - Exterior Walls

Location: Kinder patio

Distress: Failing

Notes: Repair stonework on kinder rooftop area and replace fencing – rusted and failing

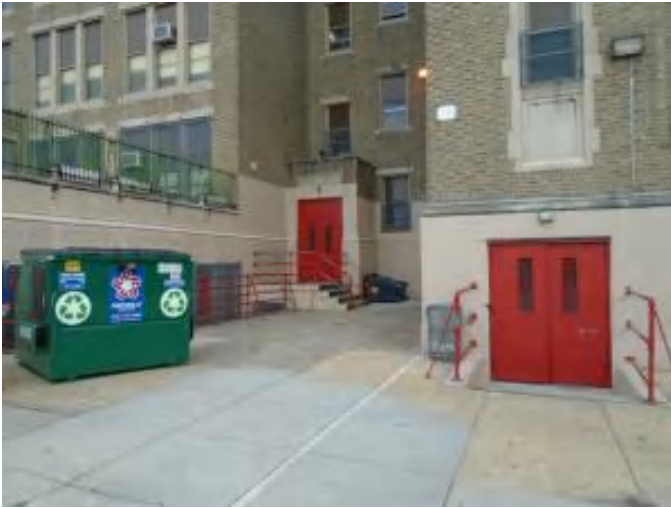
System: B2030 - Exterior Doors

Location: Entrance

Distress: Accessibility

Notes: Provide ADA compliant exterior door hardware at one entrance

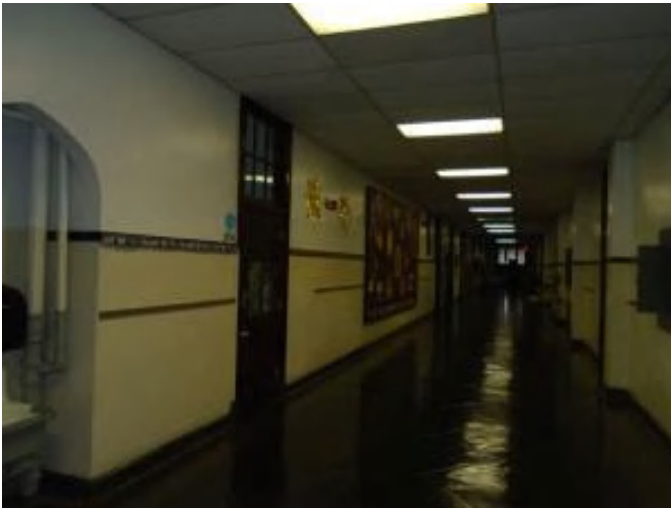
System: C1020 - Interior Doors

Location: Entire Building

Distress: Accessibility

Notes: Provide ADA lever handle lock/latchsets on interior doors

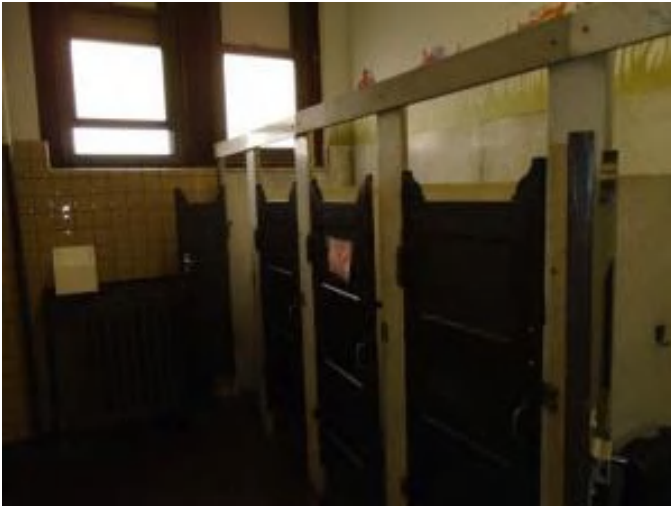
System: C1030 - Fittings

Location: Toilets

Distress: Accessibility

Notes: Provide new toilet partitions and toilet accessories including grab bars for accessibility

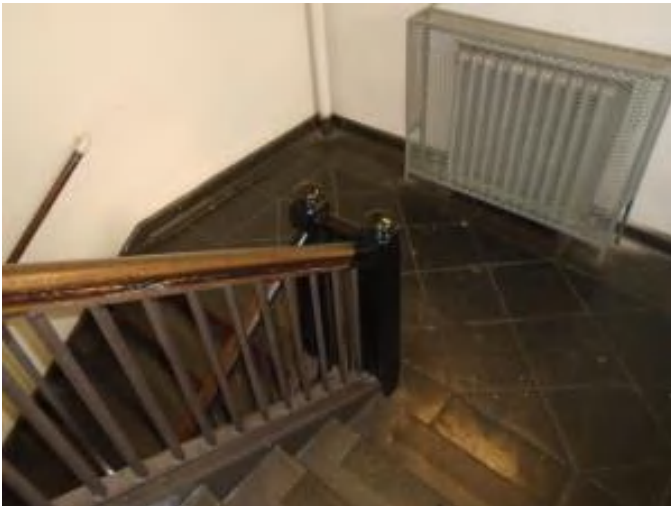
System: C2010 - Stair Construction

Location: Stairs

Distress: Building / MEP Codes

Notes: Replace railing in stairways with code compliant

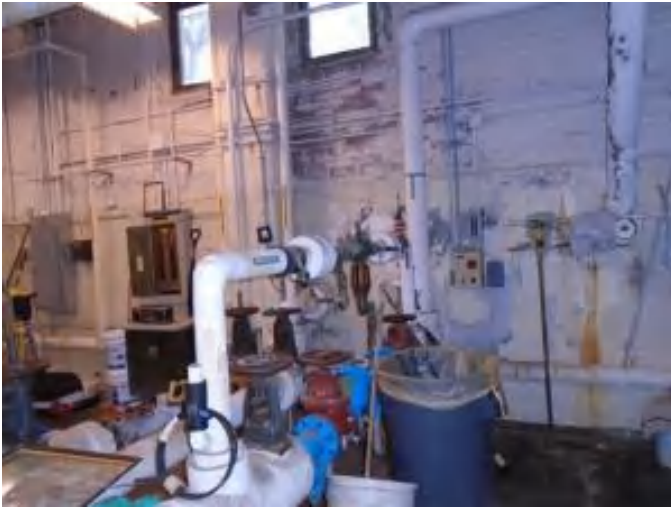
System: C3010230 - Paint & Covering

Location: Boiler room
Distress: Appearance
Category: 3 - Operations / Maint.
Priority: 2 - Response Time (2-3 yrs)
Correction: Repair and repaint all interior walls - SF of wall surface
Qty: 8,000.00
Unit of Measure: S.F.
Estimate: \$29,202.42
Assessor Name: System
Date Created: 09/01/2015

Notes: Strip and paint boiler room

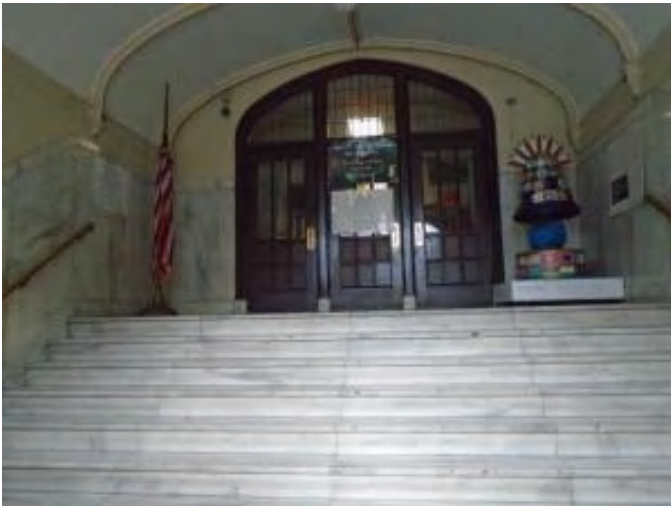
System: D1010 - Elevators and Lifts

Location: TBD
Distress: Accessibility
Category: 2 - Code Compliance
Priority: 2 - Response Time (2-3 yrs)
Correction: Add interior elevator - 4 floors - adjust the electrical run lengths to hook up the elevator
Qty: 1.00
Unit of Measure: Ea.
Estimate: \$594,735.94
Assessor Name: System
Date Created: 09/01/2015

Notes: Install elevator for accessibility (location TBD)

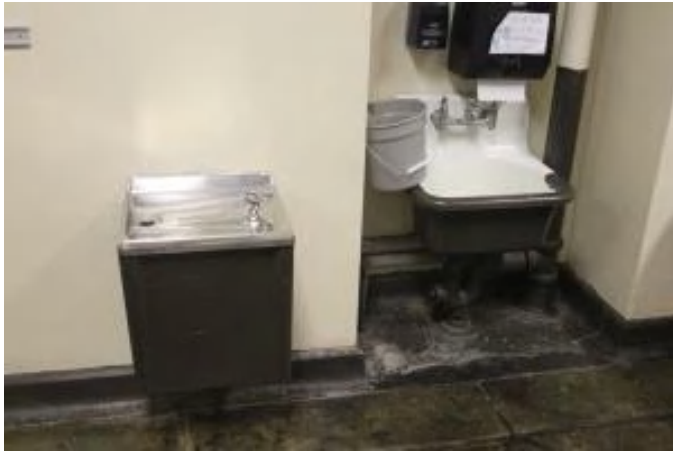
System: D2010 - Plumbing Fixtures

Drinking fountains in the corridors are mostly wall hung, non-accessible, with integral refrigerated coolers. They have exceeded their service life and should be replaced with accessible fountains.

Location: Entire building

Distress: Accessibility

Notes: Replace the aged drinking fountains throughout school with chilled, accessible models.

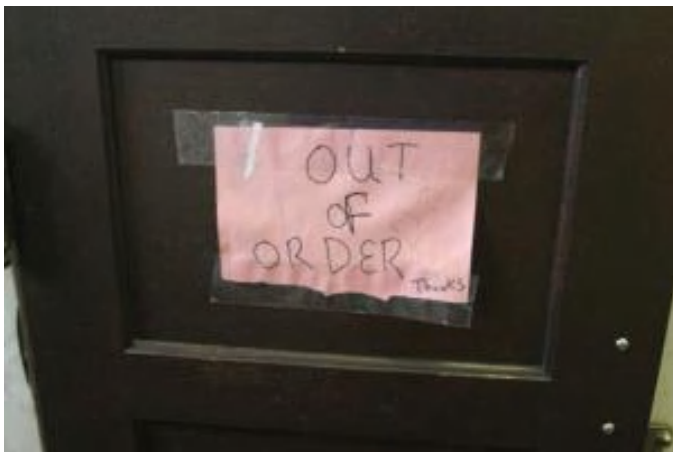
System: D2010 - Plumbing Fixtures

Location: Entire building

Distress: Damaged

Notes: Repair inoperative plumbing fixtures throughout the building.

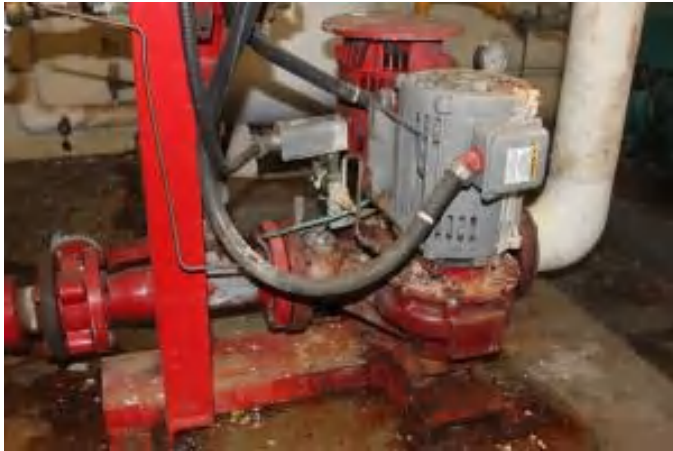
System: D2020 - Domestic Water Distribution

A 4" city water service enters the building in the boiler room along 12th Street. There is a duplex booster pump with expansion tank. The pump controller was not operating properly, and one pump was running constantly at full speed and this resulted in the surrounding pipe being too hot to touch. This must be repaired. The domestic hot and cold water distribution piping is copper piping and soldered connections. The engineer and housekeeping staff reported no significant problems with domestic piping and the supply is adequate to the fixtures.

Location: Fan Room
Distress: Damaged
Category: 3 - Operations / Maint.
Priority: 2 - Response Time (2-3 yrs)
Correction: Replace duplex domestic booster pump set (5 HP)
Qty: 0.50
Unit of Measure: Ea.
Estimate: \$22,093.53
Assessor Name: System
Date Created: 08/13/2015

Notes: Repair domestic water booster pump controller to stop pump from continuously running at full power.

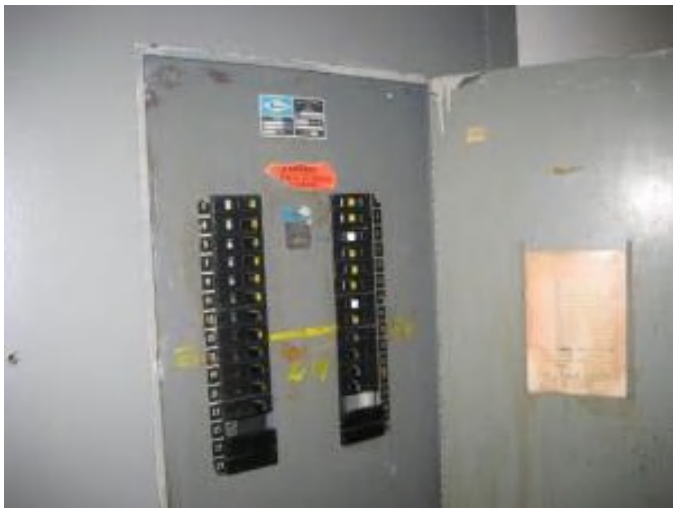
System: D5010 - Electrical Service/Distribution

There are 120/240V panel-boards in each floor for lighting and receptacles. These panel-boards and associated wiring have exceeded the end of their useful life and are undersized to absorb additional loads. The entire distribution system needs to be replaced with new 208/120 volt, 3 phase panelboards and new wiring. The raceway is mainly conduits run above the ceiling. There is a 75KVA phase converter from 240V to 120/208V which normally feeds newest mechanical equipment. Panel-board's doors at corridors are not locked and represent a potential hazard for students. As a safety issue all panel-boards at corridor or in areas where students are present must be provided with lockable devices.

Location: Entire Building
Distress: Beyond Service Life
Category: 3 - Operations / Maint.
Priority: 2 - Response Time (2-3 yrs)
Correction: Replace Electrical Distribution System (U)
Qty: 9.00
Unit of Measure: Ea.
Estimate: \$278,672.03
Assessor Name: System
Date Created: 08/07/2015

Notes: Replace the entire distribution system with new panels and new wiring/conduits. Approximate (9) 208/120V

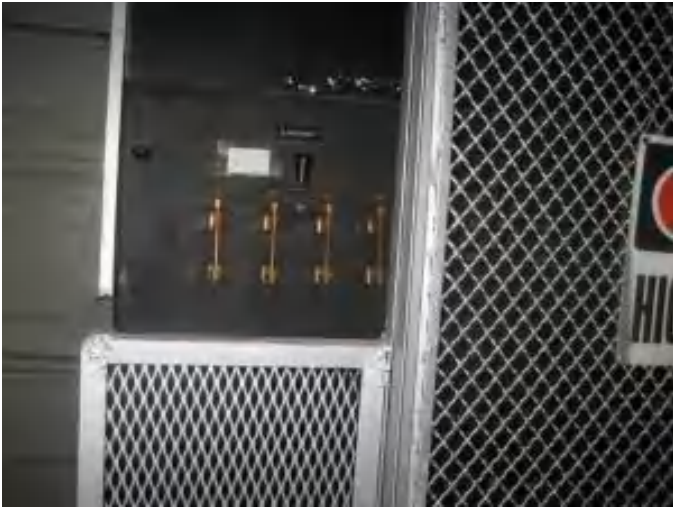
System: D5010 - Electrical Service/Distribution

distribution section consists in a gutter with safety switches. The original floor mounted distribution section is abandoned in place. The existing service has no extra capacity for expansion or new Heating, Ventilation, Air Conditioning (HVAC) system. The electrical service entrance should be upgraded. The new service will be 480V/277V, 3 phase power, approximate 1000 Amperes and will be located in the vicinity of the existing electrical service. The new electrical service would feed a 480V Motor Control Center (MCC) and HVAC (Heating, Ventilation and Air Conditioning) equipment, and a 480V 3 phase to 120V/208V 3 phase, 225KVA step-down transformer to feed receptacles, lighting fixtures and other smaller loads.

Location: Basement electrical room
Distress: Inadequate
Category: 4 - Capital Improvement
Priority: 2 - Response Time (2-3 yrs)
Correction: Replace Switchboard
Qty: 1.00
Unit of Measure: Ea.
Estimate: \$238,881.80
Assessor Name: System
Date Created: 08/07/2015

Notes: The new service will be 480V/277V, 3 phase power, approximate 1000 Amperes and will be located in the vicinity of the existing electrical service.

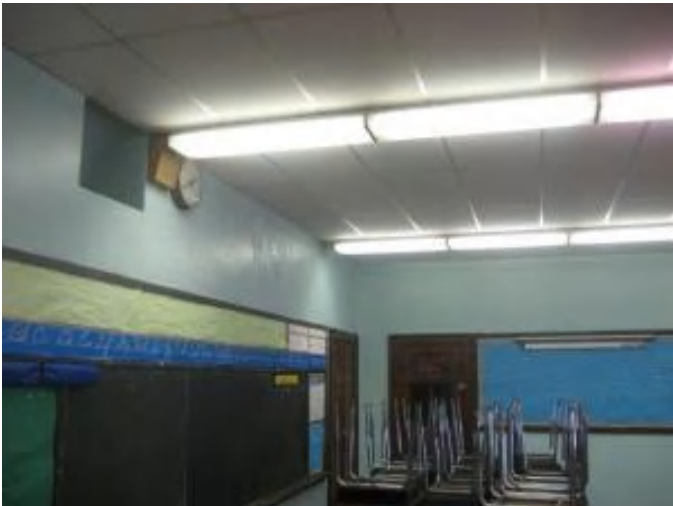
System: D5020 - Lighting and Branch Wiring

Location: Entire Building
Distress: Obsolete
Category: 3 - Operations / Maint.
Priority: 2 - Response Time (2-3 yrs)
Correction: Replace lighting fixtures
Qty: 633.00
Unit of Measure: Ea.
Estimate: \$550,631.38
Assessor Name: System
Date Created: 08/07/2015

Notes: Approximate 85% of the lighting fixtures are provided with T-12 lamps. Provide lighting fixtures with T-8 lamps. Approximate 633 fixtures.

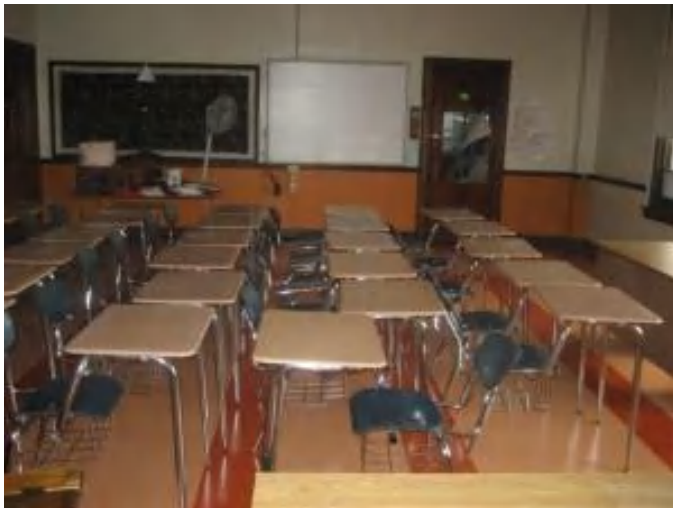
System: D5020 - Lighting and Branch Wiring

There number of receptacles in classrooms varies, approximate 15% of the classrooms have been remodeled and provided with the proper amount of receptacles but 85% of them the quantity of receptacles are inadequate. Teachers use extension cords. The teacher's whiteboard wall and the opposite of it need to be provided with double compartment surface raceways, the other two walls with minimum two duplex outlets each, when feasible.

Location: Classrooms
Distress: Inadequate
Category: 4 - Capital Improvement
Priority: 2 - Response Time (2-3 yrs)
Correction: Add wiring device
Qty: 432.00
Unit of Measure: Ea.
Estimate: \$127,811.90
Assessor Name: System
Date Created: 08/07/2015

Notes: Install minimum two receptacles in each wall of class rooms and other purpose rooms. Approximate 432 receptacles.

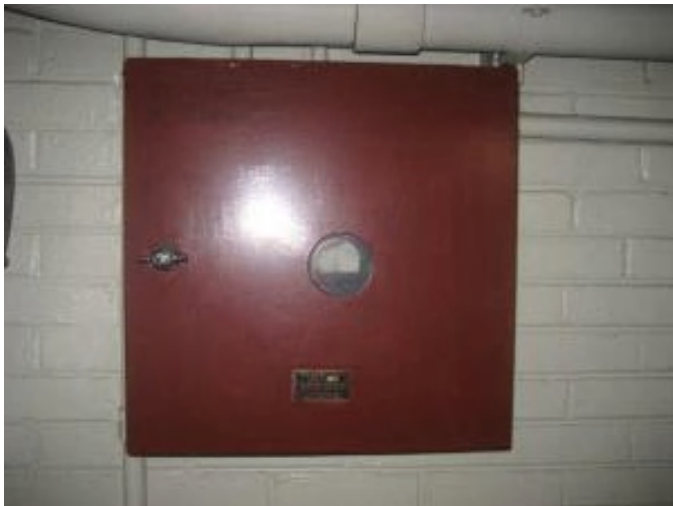
System: D5030 - Communications and Security

Location: Entire Building
Distress: Life Safety / NFPA / PFD
Category: 1 - Health & Safety
Priority: 2 - Response Time (2-3 yrs)
Correction: Add fire alarm device
Qty: 77.00
Unit of Measure: Ea.
Estimate: \$118,202.99
Assessor Name: System
Date Created: 08/07/2015

Notes: Provide a new fire alarm system Replace old fire alarm system with addressable type with audio/visual devices in the entire school. Approximate 77 devices

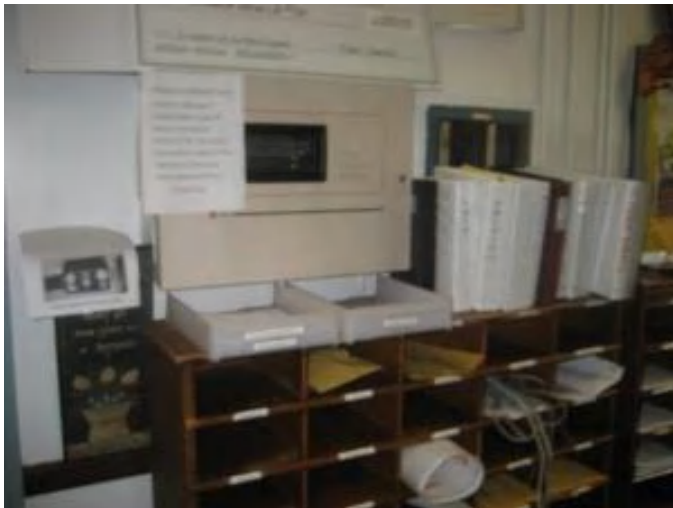
System: D5030 - Communications and Security

Location: Entire Building
Distress: Beyond Service Life
Category: 3 - Operations / Maint.
Priority: 2 - Response Time (2-3 yrs)
Correction: Add/Replace Clock System or Components
Qty: 40.00
Unit of Measure: Ea.
Estimate: \$90,628.20
Assessor Name: System
Date Created: 08/07/2015

Notes: Provide a new clock system, wireless battery operated. Approximate 40 clocks

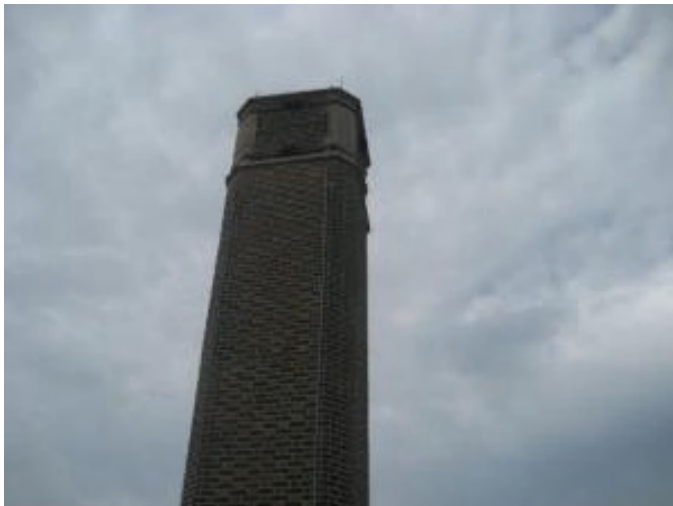
System: D5090 - Other Electrical Systems

Location: Roof
Distress: Building / MEP Codes
Category: 2 - Code Compliance
Priority: 2 - Response Time (2-3 yrs)
Correction: Repair Lightning Protection System
Qty: 1.00
Unit of Measure: Job
Estimate: \$19,519.92
Assessor Name: System
Date Created: 08/07/2015

Notes: Prepare a study to determine if existing lightning protection system provide the proper coverage to the school building.

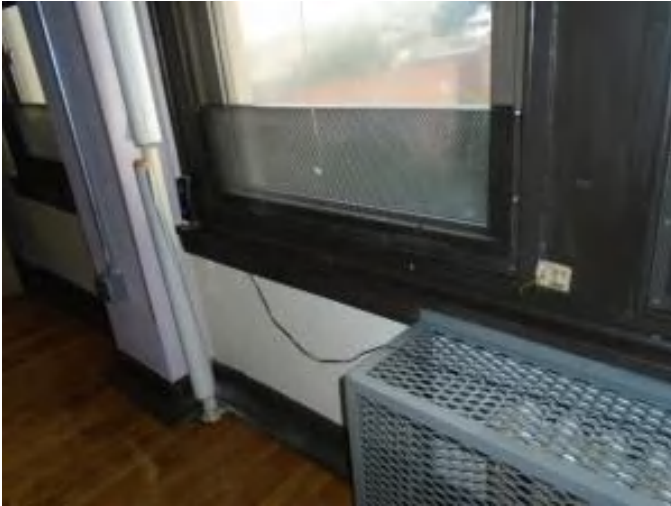
System: B2020 - Exterior Windows

Location: Entire Building

Distress: Energy Efficiency

Notes: Replace Plexiglas windows – hazed

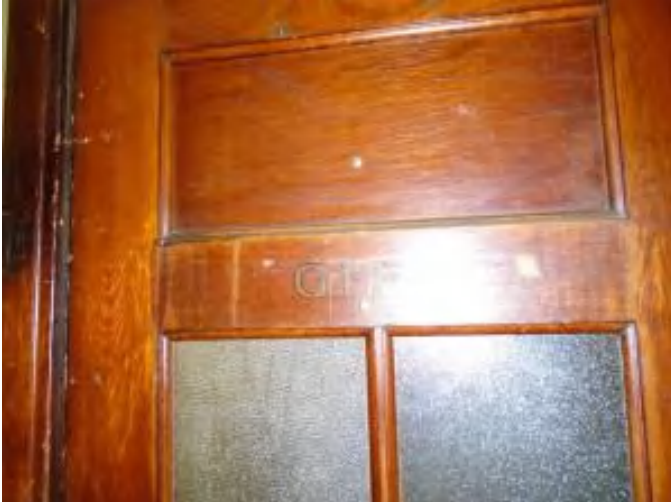
System: C1020 - Interior Doors

Location: Entire Building

Distress: Damaged

Notes: Repair or replace damaged doors and frames

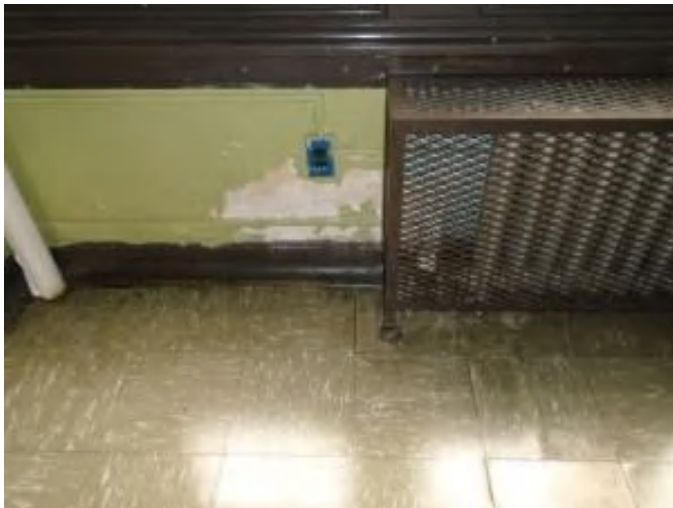
System: C3010230 - Paint & Covering

The interior wall finishes are generally painted plaster or brick with glazed brick or tile wainscot in toilets in good condition with a few areas of plaster deterioration. Major damage due to water intrusion has occurred to storage room on the north side of the gym and has not been addressed; continued neglect of this area may cause structural damage in the near future. Main entrance stairway and kinder toilets have marble wainscot in very good condition. Flooring includes: hardwood in classrooms in good condition; patterned and bare concrete in corridors, toilets, stairs and basement areas in good condition; vinyl in gym/auditorium, some classrooms, offices and kitchen in good condition; carpet tiles in computer room in very good condition; and terrazzo and marble in main entrance in very good condition. Wood base is typically in fair-good condition. Most ceilings suspended acoustic tile in good condition with painted plaster or structural concrete in stairways, toilets, gym, kitchen, and basement service areas in good condition with new paint needed in boiler room.

Location: Throughout

Distress: Damaged

Notes: Repair and repaint interior plaster walls (10% of wall surface)

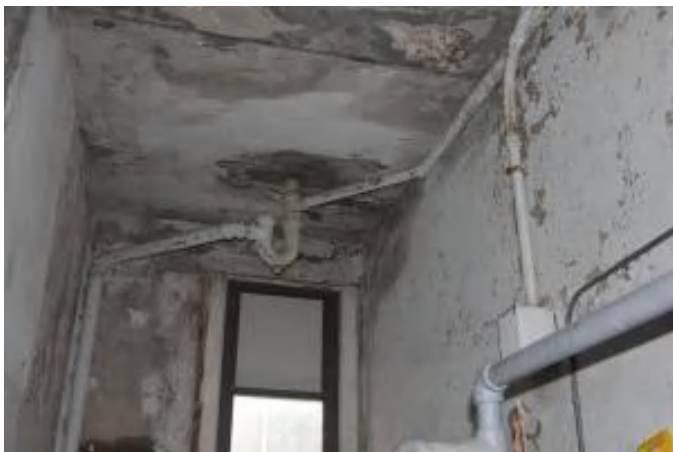
System: D2030 - Sanitary Waste

The sanitary sewer piping is threaded galvanized steel pipe and mostly original. There is no sewage ejector. The rain water drain pipes are threaded galvanized steel as well with cast iron with banded couplings for repairs in some areas. Due to age and known recent failures, the district should hire a qualified contractor to examine the rain water discharge piping using video cameras to locate and replace any damaged piping and to further quantify the extent of potential failures.

Location: Entire building

Distress: Beyond Service Life

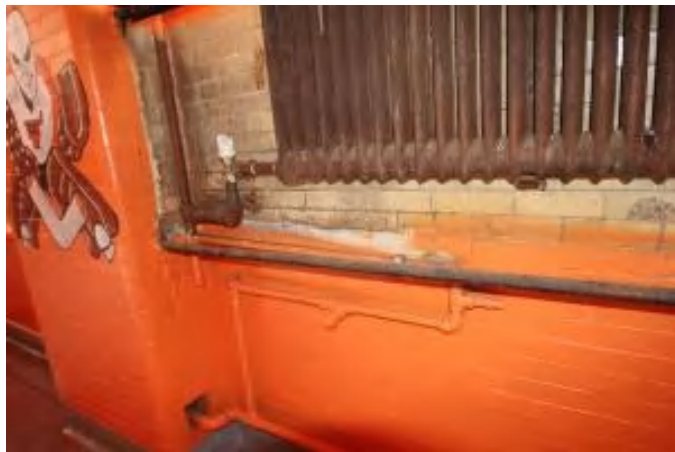
System: D3040 - Distribution Systems

Steam and condensate piping is steel with welded and threaded fittings. Steam mains from the basement level run up through the building to the radiators and also to two air handlers in the basement fan room. The piping appears to be original to the building. The steam and condensate piping should be replaced due to age and visible rust. Steam traps and manual thermostats were replaced in 2013.

Location: Entire building

Distress: Beyond Service Life

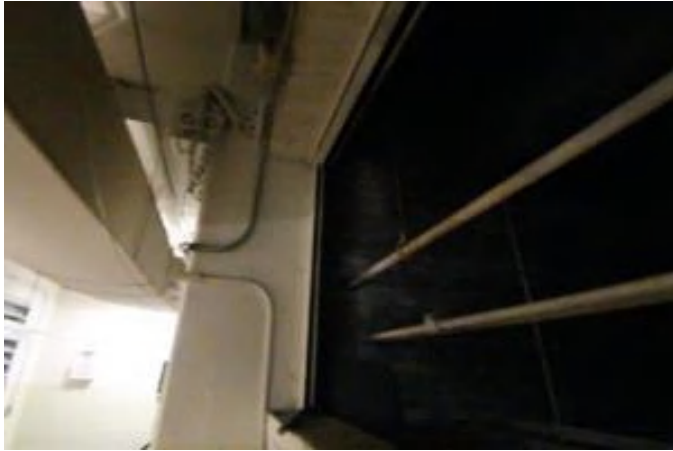
System: D3060 - Controls & Instrumentation

Radiators had thermostats replaced in 2013 with manual thermostats. These should be upgraded to DDC when the radiators are replaced with finned tube units. The basement air handlers have had controls upgraded during their recent rebuild. Duct upgrades should include automatic dampers when the building cooling system is installed, as part of a total building automation system (BAS) with modern DDC modules to improve reliability and energy efficiency. An interface should be provided with the preferred system in use throughout the District.

Location: Entire building

Distress: Energy Efficiency

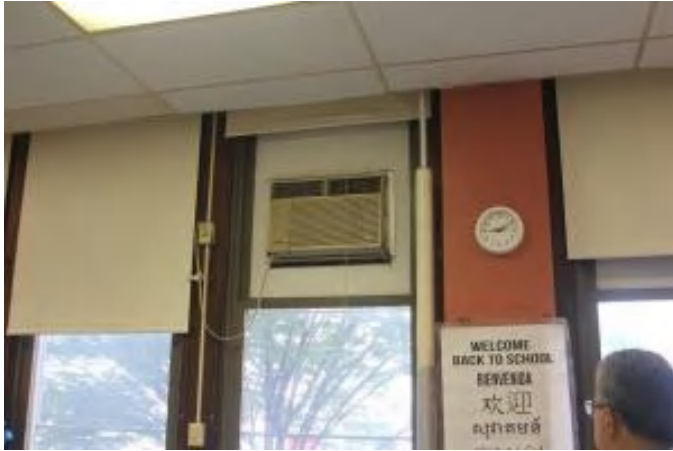
System: D3030 - Cooling Generating Systems

The building does not have any central cooling systems. A 145 ton total capacity cooling system should be installed to provide cooling to the entire building and replace approximately 20 aged, inefficient window unit air conditioners.

Location: Entire building

Distress: Inadequate

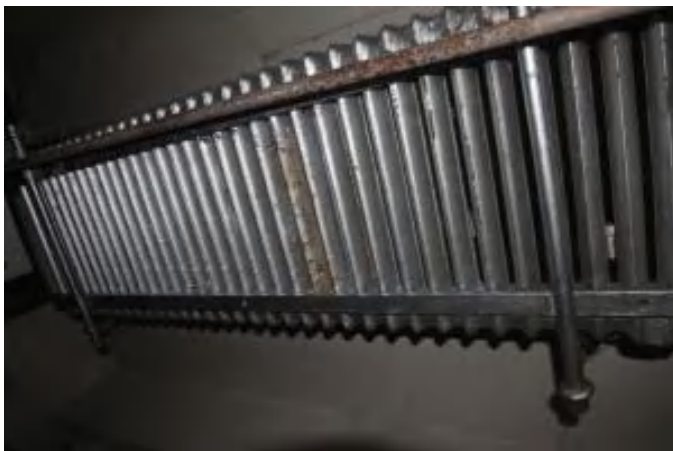
System: D3040 - Distribution Systems

Cast iron radiators supply heat for the entire building. They are original to the building and have new manually controlled steam valves. The radiators are well beyond their service life and should be replaced with finned tube unit heaters with electronic controls.

Location: Entire building

Distress: Beyond Service Life

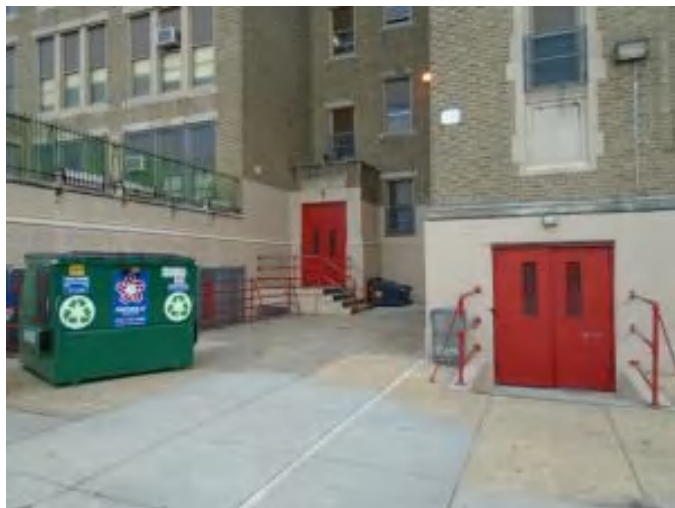
System: G2030 - Pedestrian Paving

Location: Entrance

Distress: Accessibility
