Facility Condition Assessment Summary Report

Jenks, Abram School

School District of Philadelphia
S252001;Jenks, Abram
Final
Site Assessment Report
January 30, 2017

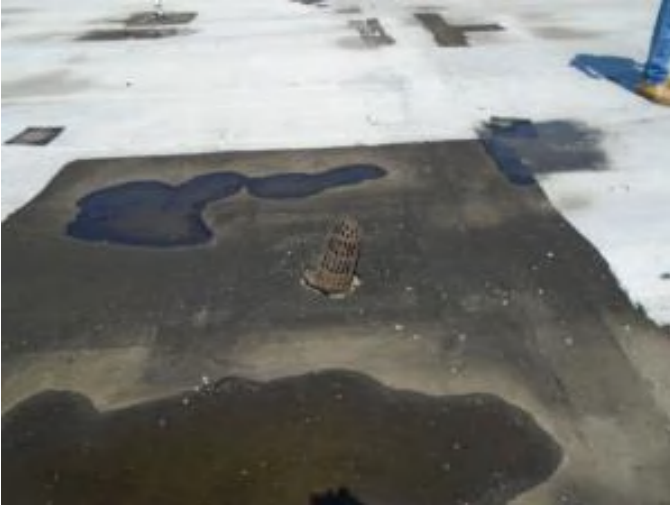
System: B3010105 - Built-Up

Location: Roof

Distress: Failing

- Repair foundation walls – deterioration
- Re-point and seal window lintels and sills
- Replace Plexiglas windows – hazed and energy inefficient
- Provide ADA compliant exterior door hardware at one entrance
- Replace built-up roofing system – leaking, failing, and beyond service life

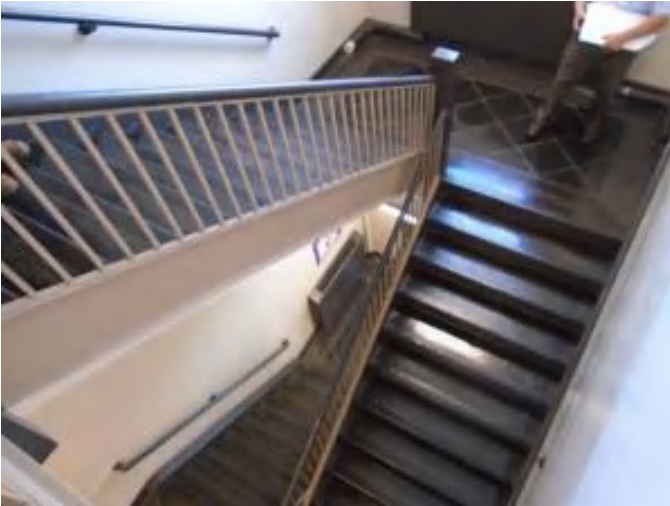
System: C2010 - Stair Construction

Location: Stairs

Distress: Building / MEP Codes

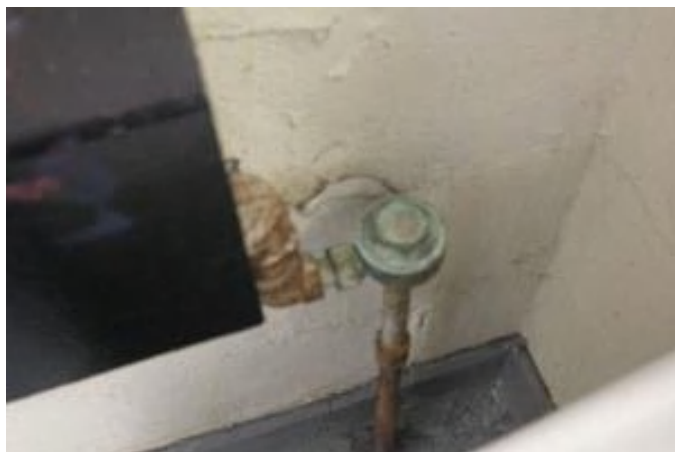
System: D3040 - Distribution Systems

Location: Entire building

Distress: Failing

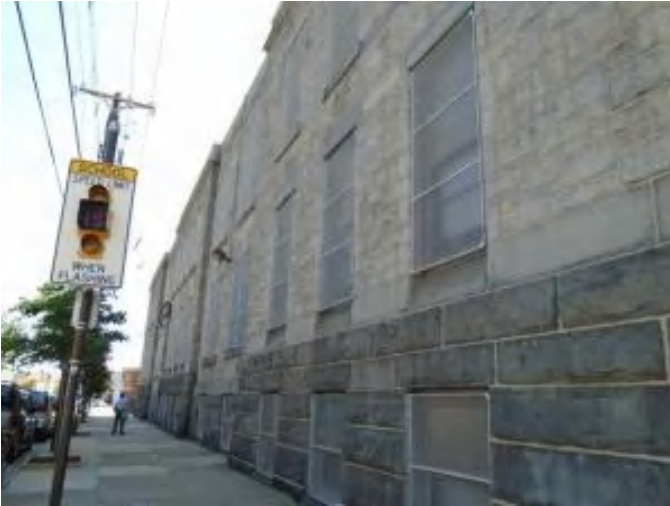
System: B2010 - Exterior Walls

Location: Ext. walls

Distress: Maintenance Required

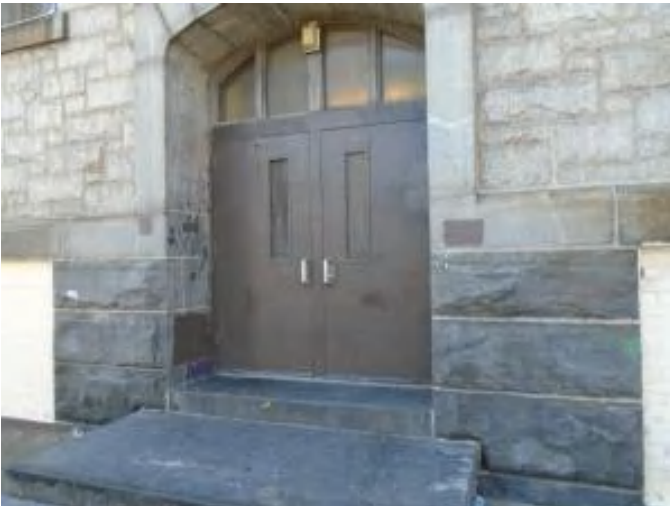
System: B2030 - Exterior Doors

Location: Entrance

Distress: Accessibility

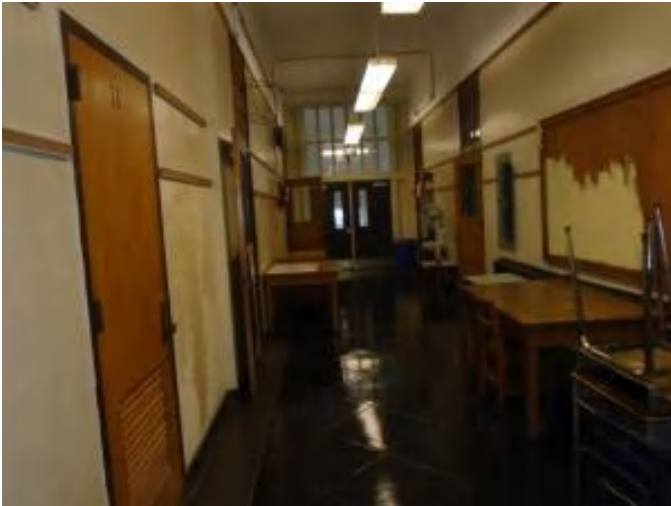
System: C1020 - Interior Doors

Location: Throughout
Distress: Accessibility
Category: 2 - Code Compliance
Priority: 2 - Response Time (2-3 yrs)
Correction: Replace door knobs with compliant lever type
Qty: 30.00
Unit of Measure: Ea.
Estimate: \$16,697.08
Assessor Name: System
Date Created: 10/21/2015

Notes: Provide ADA lever handle lock/latchsets on interior doors

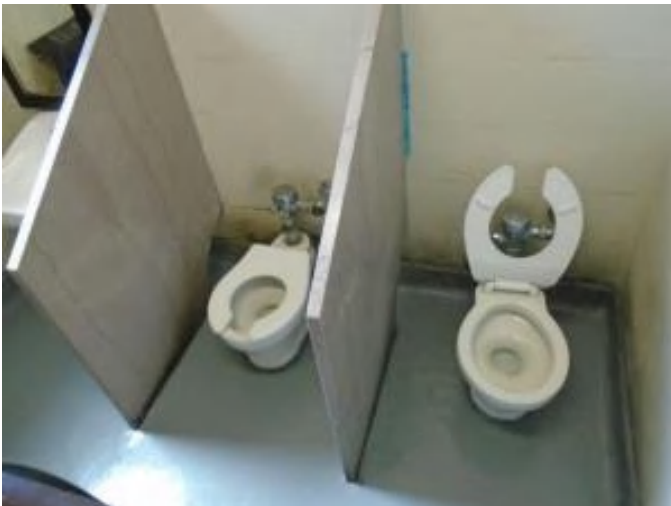
System: C1030 - Fittings

Location: Toilets
Distress: Beyond Service Life
Category: 3 - Operations / Maint.
Priority: 2 - Response Time (2-3 yrs)
Correction: Remove and replace toilet partitions
Qty: 17.00
Unit of Measure: Ea.
Estimate: \$43,628.88
Assessor Name: System
Date Created: 10/21/2015

Notes: Provide new toilet partitions and toilet accessories including grab bars for accessibility

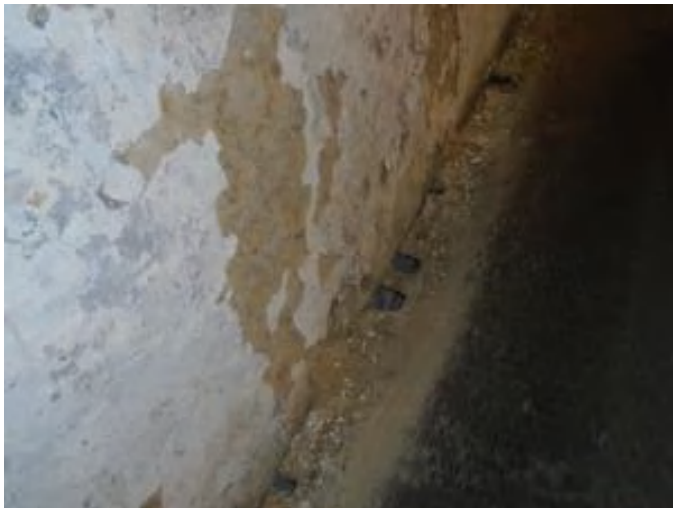
System: C3010230 - Paint & Covering

Location: Various
Distress: Damaged
Category: 3 - Operations / Maint.
Priority: 2 - Response Time (2-3 yrs)
Correction: Repair substrate and repaint interior walls - SF of wall surface
Qty: 6,200.00
Unit of Measure: S.F.
Estimate: \$53,115.87
Assessor Name: System
Date Created: 10/22/2015

Notes: Repair and repaint damaged wall areas (10% of plaster wall areas)

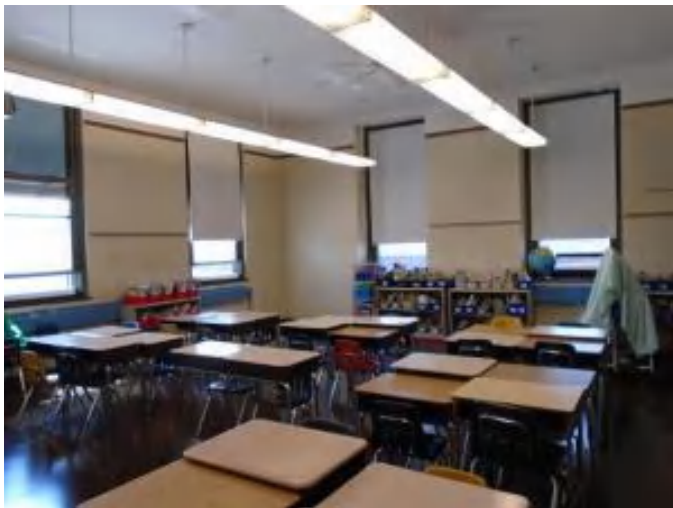
System: C3020413 - Vinyl Flooring

Location: Various
Distress: Damaged
Category: 3 - Operations / Maint.
Priority: 2 - Response Time (2-3 yrs)
Correction: Remove VAT and replace with VCT - SF of area
Qty: 2,014.00
Unit of Measure: S.F.
Estimate: \$26,060.55
Assessor Name: System
Date Created: 10/22/2015

Notes: Replaced damaged VAC tile with VCT (10% of vinyl floor area)

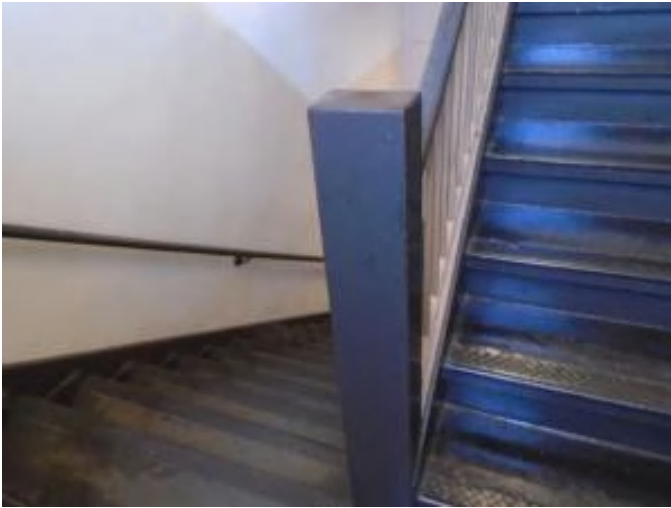
System: D1010 - Elevators and Lifts

Location: TBD

Distress: Accessibility

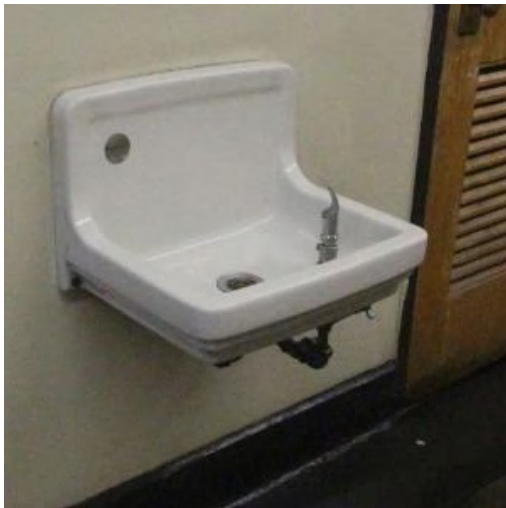
System: D2010 - Plumbing Fixtures

Location: Hallways

Distress: Accessibility

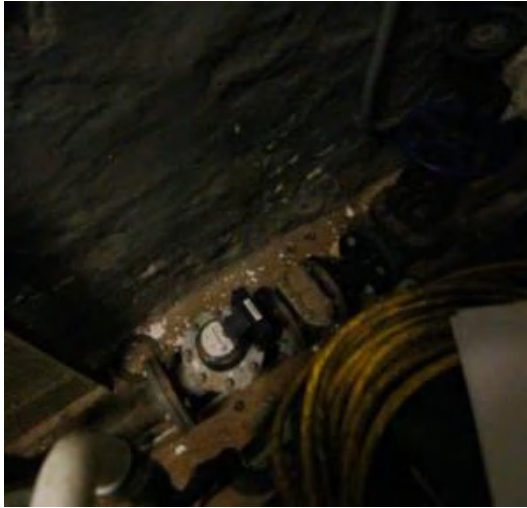
System: D2020 - Domestic Water Distribution

Location: Basement

Distress: Building / MEP Codes

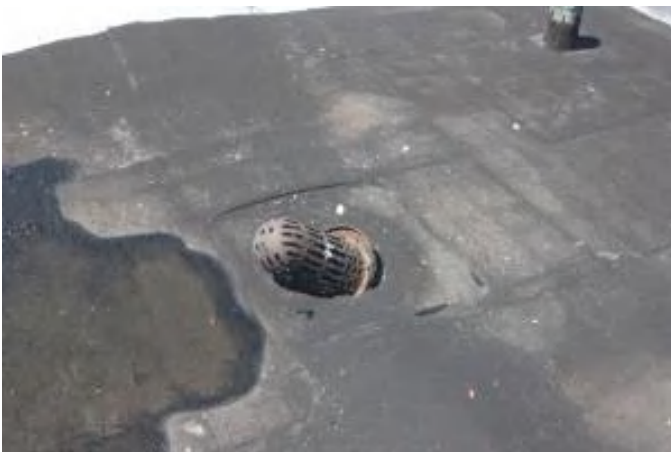
System: D2040 - Rain Water Drainage

Location: Entire building

Distress: Beyond Service Life

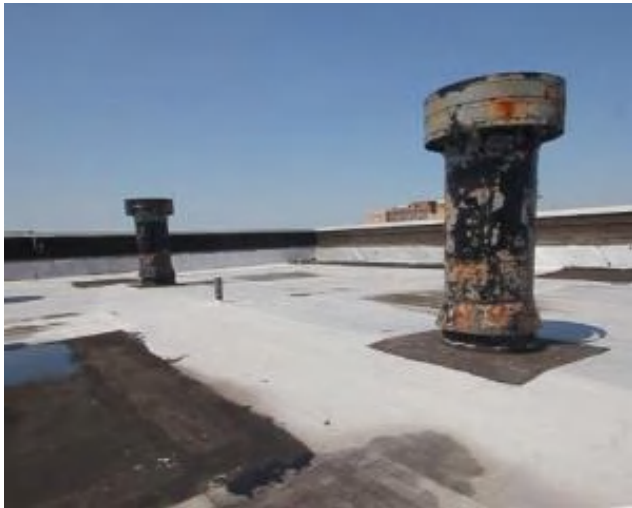
System: D3040 - Distribution Systems

Location: Rooftop
Distress: Damaged
Category: 3 - Operations / Maint.
Priority: 2 - Response Time (2-3 yrs)
Correction: Replace rooftop gravity ventilator units - select the proper type and size
Qty: 10.00
Unit of Measure: Ea.
Estimate: \$19,262.29
Assessor Name: System
Date Created: 11/28/2015

Notes: Replace rooftop gravity vents due to age and damage.

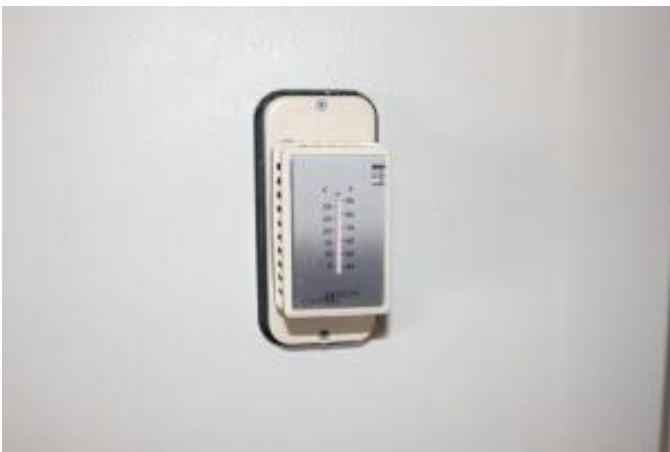
System: D3060 - Controls & Instrumentation

Location: Entire building
Distress: Obsolete
Category: 3 - Operations / Maint.
Priority: 2 - Response Time (2-3 yrs)
Correction: Replace pneumatic controls with DDC (75KSF)
Qty: 31,475.00
Unit of Measure: S.F.
Estimate: \$675,207.14
Assessor Name: System
Date Created: 11/28/2015

Notes: Replace obsolete pneumatic HVAC controls with DDC.

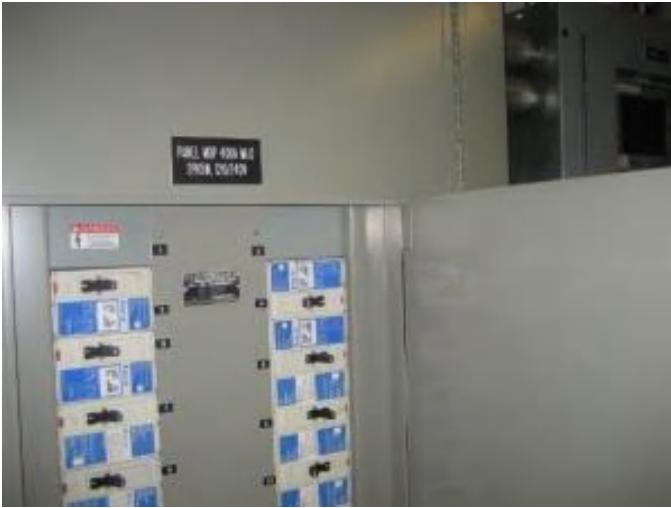
System: D5010 - Electrical Service/Distribution

Location: Basement
Distress: Inadequate
Category: 4 - Capital Improvement
Priority: 2 - Response Time (2-3 yrs)
Correction: Replace Switchboard
Qty: 1.00
Unit of Measure: Ea.
Estimate: \$239,422.66
Assessor Name: System
Date Created: 10/15/2015

Notes: Provide a new electrical service 1200 Amperes 120/208V, it will be located in the vicinity of the existing electrical service.

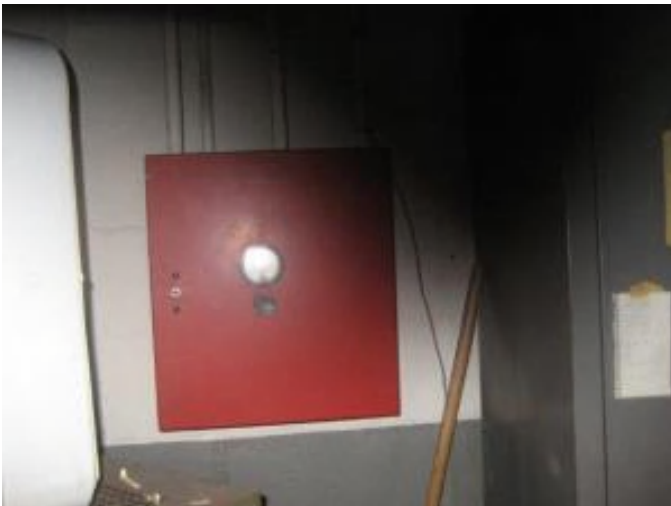
System: D5030 - Communications and Security

The Fire Alarm system is manufactured by S.H. COUCH INC. The system is approximately 30 years old. The present Fire Alarm system does not meet current code and needs to be replaced. Fire alarm system is tested every day in the morning.

Location: Entire Building
Distress: Life Safety / NFPA / PFD
Category: 1 - Health & Safety
Priority: 2 - Response Time (2-3 yrs)
Correction: Replace fire alarm system
Qty: 1.00
Unit of Measure: S.F.
Estimate: \$110,784.09
Assessor Name: System
Date Created: 10/15/2015

Notes: Replace old fire alarm system with addressable type with audio/visual devices at corridors and classrooms.

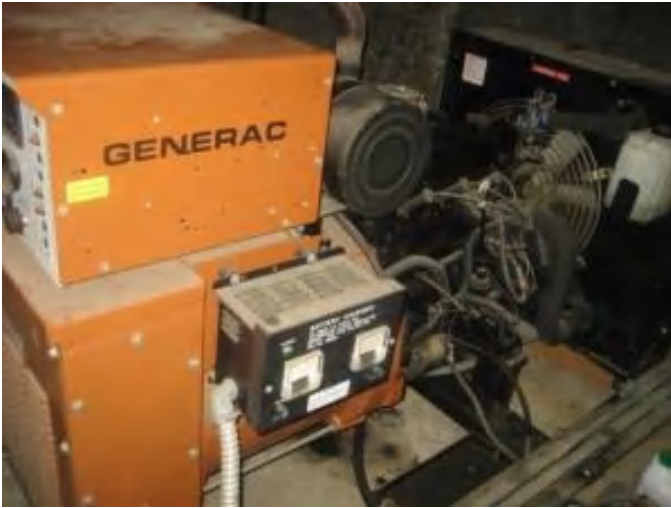
System: D5090 - Other Electrical Systems

Location: Outdoor
Distress: Inadequate
Category: 4 - Capital Improvement
Priority: 2 - Response Time (2-3 yrs)
Correction: Add Standby Generator System
Qty: 1.00
Unit of Measure: Ea.
Estimate: \$136,408.38
Assessor Name: System
Date Created: 10/15/2015

Notes: Provide 35KW, outdoor, diesel powered generator.

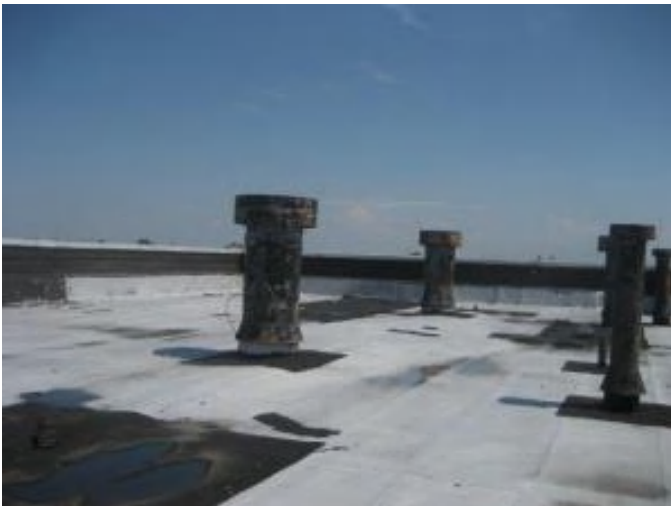
System: D5090 - Other Electrical Systems

Location: Roof
Distress: Building / MEP Codes
Category: 2 - Code Compliance
Priority: 2 - Response Time (2-3 yrs)
Correction: Provide Lightning Protection System
Qty: 1.00
Unit of Measure: LS
Estimate: \$21,472.30
Assessor Name: System
Date Created: 10/15/2015

Notes: Prepare a study to determine if a lightning protection system is required

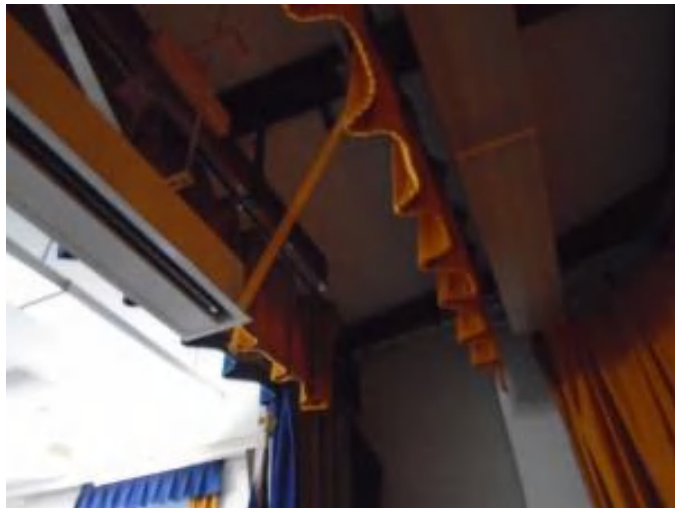
System: E2010 - Fixed Furnishings

Institutional and Commercial equipment includes: stage equipment, generally in poor condition with torn curtains. Other equipment includes kitchen equipment (heat and serve only), generally in good condition.

Location: Stage

Distress: Failing

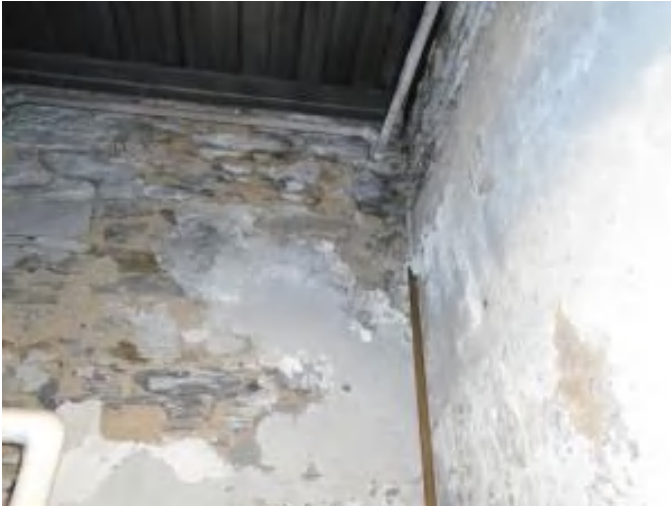
System: A2020 - Basement Walls

Location: Basement

Distress: Damaged

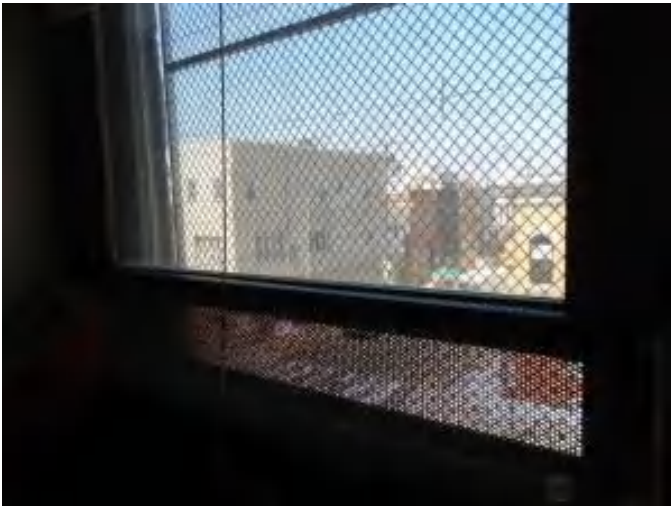
System: B2020 - Exterior Windows

Location: Windows

Distress: Energy Efficiency

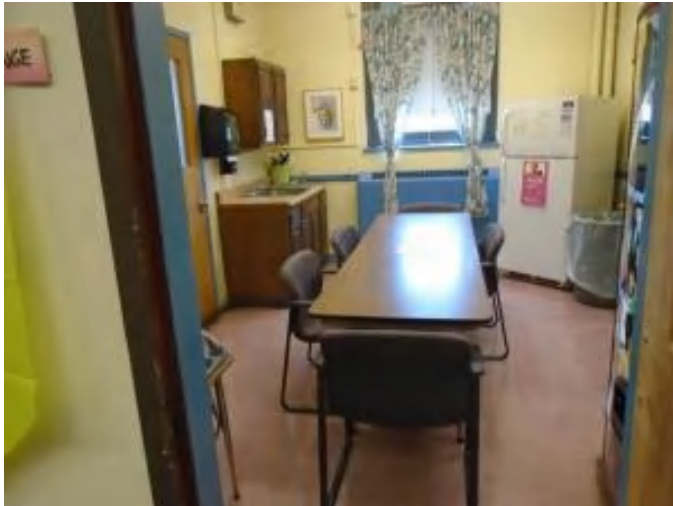
System: C1030 - Fittings

Location: Throughout

Distress: Inadequate

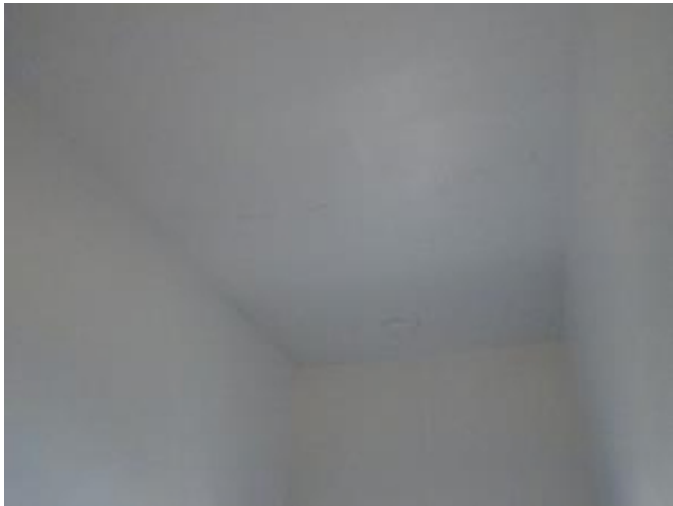
System: C3030 - Ceiling Finishes

Location: Various

Distress: Damaged

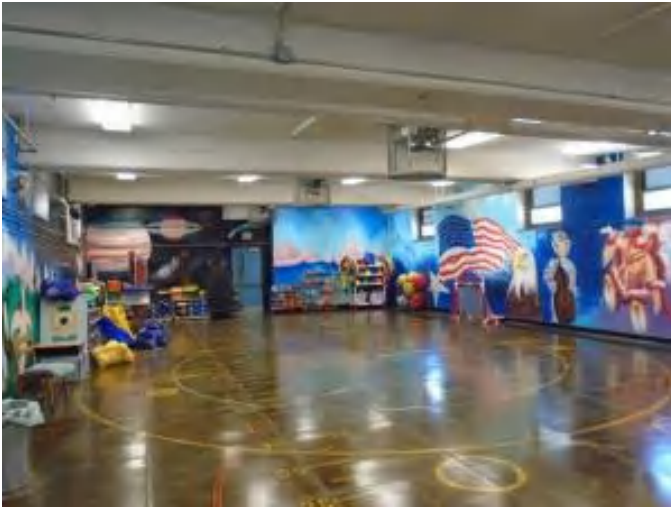
System: C3030 - Ceiling Finishes

Location: Gym
Distress: Inadequate
Category: 4 - Capital Improvement
Priority: 3 - Response Time (3-4 yrs)
Correction: Remove and replace glued on or mechanically attached acoustical ceiling tiles
Qty: 883.00
Unit of Measure: S.F.
Estimate: \$7,489.49
Assessor Name: System
Date Created: 10/22/2015

Notes: Install acoustic panels on gym ceiling for sound absorption

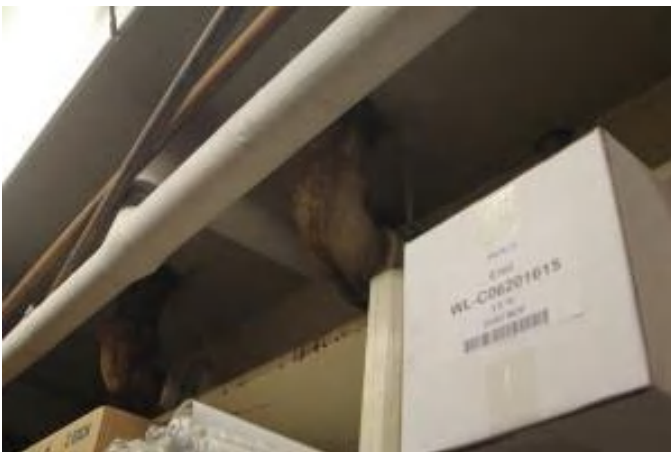
System: D2030 - Sanitary Waste

Location: Entire building
Distress: Beyond Service Life
Category: 3 - Operations / Maint.
Priority: 3 - Response Time (3-4 yrs)
Correction: Inspect sanitary waste piping and replace damaged sections. (+50KSF)
Qty: 31,475.00
Unit of Measure: S.F.
Estimate: \$154,408.49
Assessor Name: System
Date Created: 11/28/2015

Notes: Inspect and repair sanitary waste pipe due to age, 31,475 sq. ft.

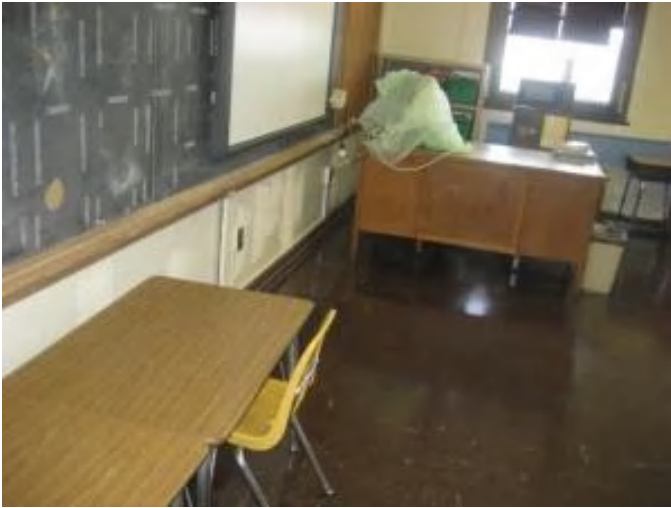
System: D5020 - Lighting and Branch Wiring

The number of receptacles in approximate 6 classrooms are inadequate. Teachers use extension cords. The teacher's whiteboard wall and the opposite of it need to be provided with double compartment surface raceways, the other two walls with minimum two duplex outlets each, when feasible.

Location: Entire Building
Distress: Inadequate
Category: 4 - Capital Improvement
Priority: 3 - Response Time (3-4 yrs)
Correction: Add wiring device
Qty: 96.00
Unit of Measure: Ea.
Estimate: \$226,864.93
Assessor Name: System
Date Created: 10/15/2015

Notes: Provide (2)25FT of surface raceways with 24" receptacles on center and two-duplex wall mount receptacles. Approximate 96

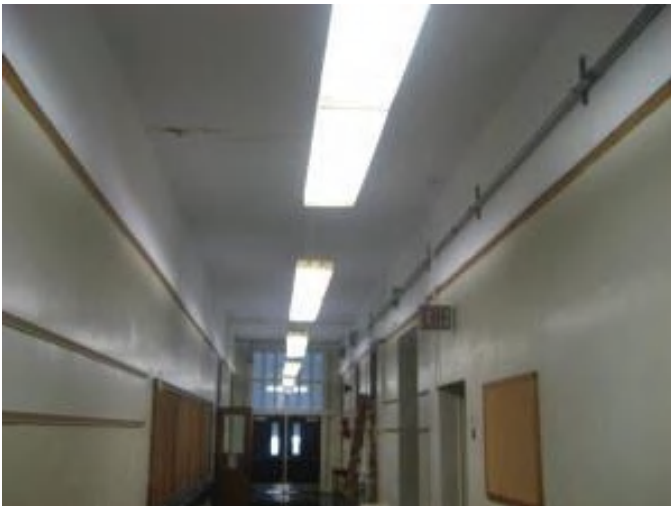
System: D5030 - Communications and Security

The security system consists of CCTV cameras at the basement and first floor stairways. There are missing CCTV cameras at the gym and corridors. Provide additional CCTV cameras.

Location: Entire Building
Distress: Security Issue
Category: 1 - Health & Safety
Priority: 3 - Response Time (3-4 yrs)
Correction: Add/Replace Video Surveillance System
Qty: 15.00
Unit of Measure: Ea.
Estimate: \$52,211.43
Assessor Name: System
Date Created: 10/15/2015

Notes: Add CCTV cameras to provide a full coverage of the building interior. Approximate 15 CCTV cameras

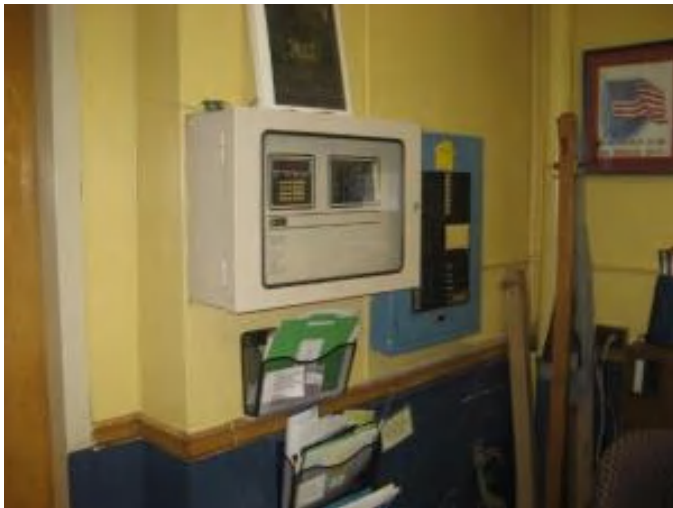
System: D5030 - Communications and Security

The present clocks are old and manufactured by Simplex 2350 Master Time System. The clocks are difficult to find parts and repair. Replace clock system with wireless, battery operated clock system.

Location: Entire Building
Distress: Obsolete
Category: 3 - Operations / Maint.
Priority: 3 - Response Time (3-4 yrs)
Correction: Add/Replace Clock System or Components
Qty: 25.00
Unit of Measure: Ea.
Estimate: \$47,862.15
Assessor Name: System
Date Created: 10/15/2015

Notes: Replace clock and bell system with wireless, battery operated, clock system. Approximate 25

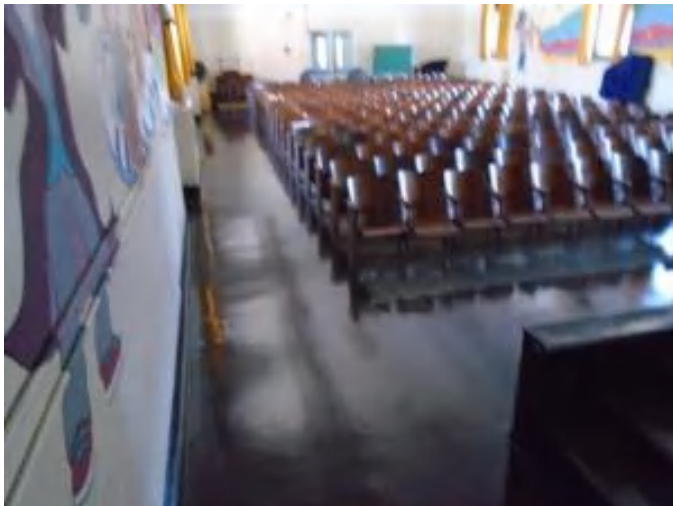
System: E2010 - Fixed Furnishings

Location: Auditorium
Distress: Damaged
Category: 3 - Operations / Maint.
Priority: 3 - Response Time (3-4 yrs)
Correction: Replace auditorium seating - add tablet arms if required. Veneer seating is an option.
Qty: 20.00
Unit of Measure: Ea.
Estimate: \$16,302.62
Assessor Name: System
Date Created: 10/22/2015

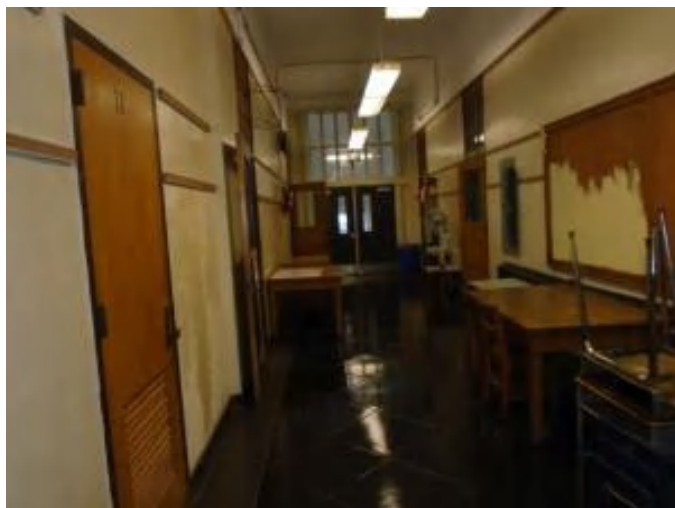
System: C3030 - Ceiling Finishes

Location: Corridors

Distress: Appearance

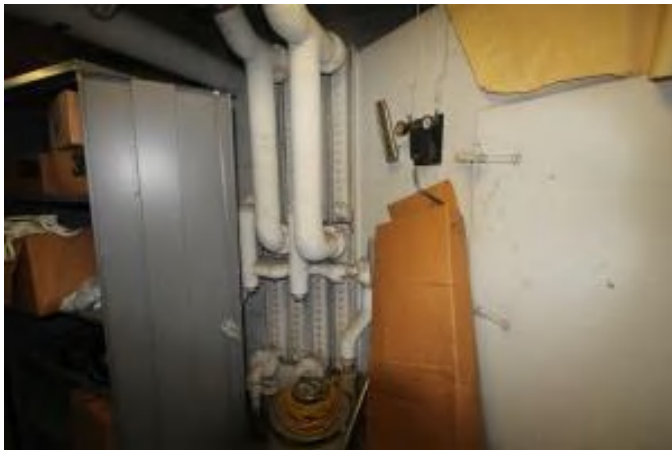
System: D3040 - Distribution Systems

Location: Basement Mechanical Room

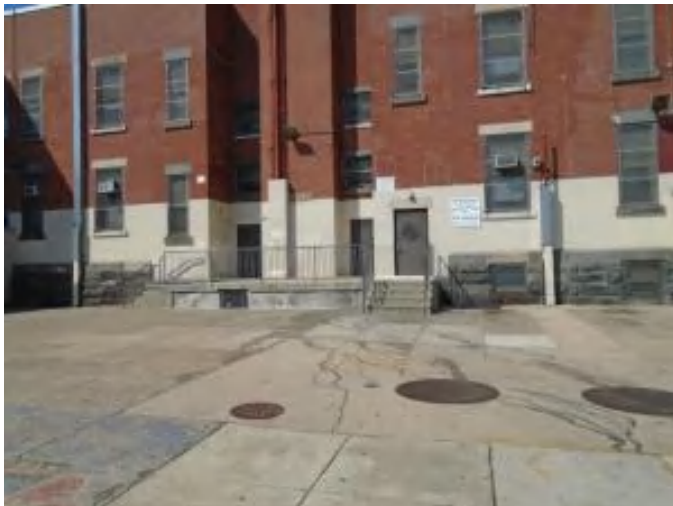
System: G2030 - Pedestrian Paving

Location: TBD

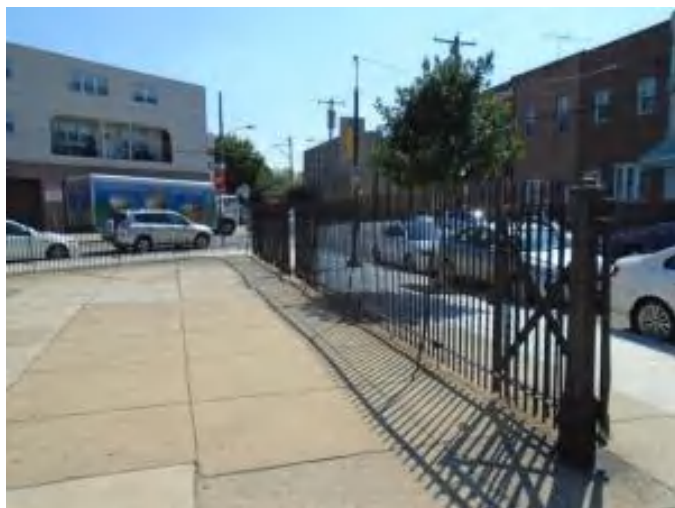
System: G2040 - Site Development

Location: Site

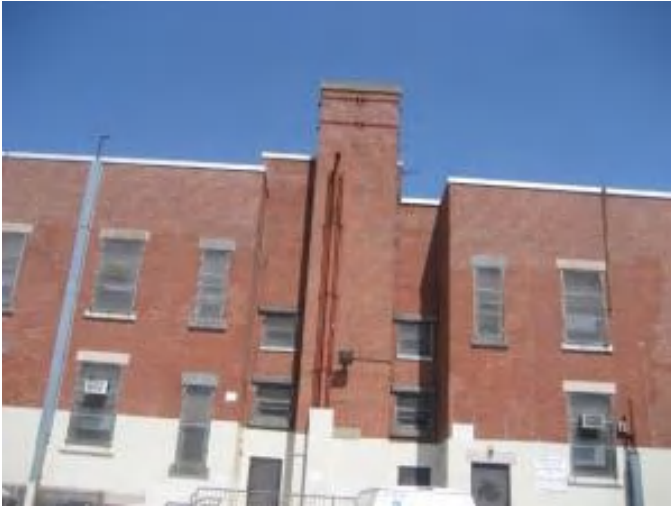
System: G4030 - Site Communications & Security

Location: outdoor

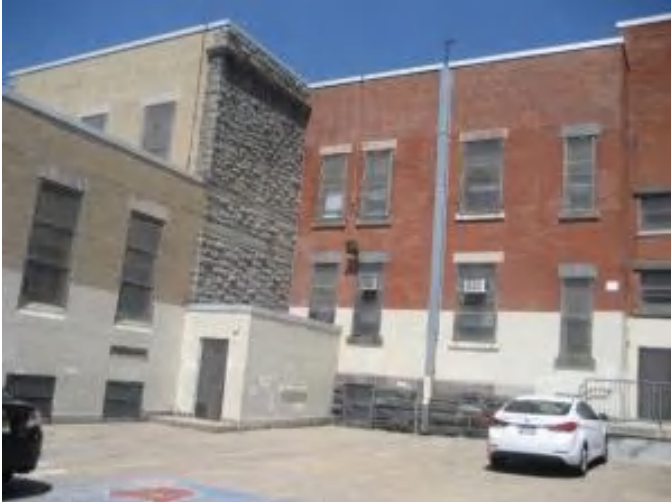
System: G4030 - Site Communications & Security

Location: Outdoor

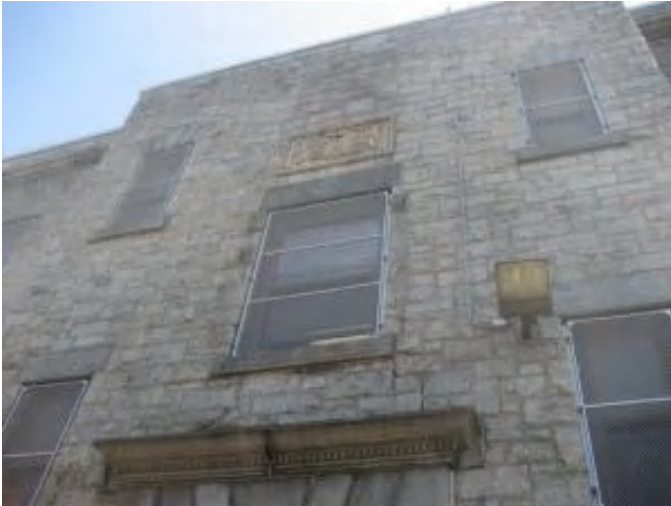
System: G4020 - Site Lighting

The school perimeter is illuminated with wall mounted lighting fixtures. Most of the lenses or lamps are damaged. Replace existing lighting fixtures.

Location: Outdoor
