## Facility Condition Assessment Summary Report

# **S627001; Jenks, John**

## **Site Assessment Report**

January 31, 2017

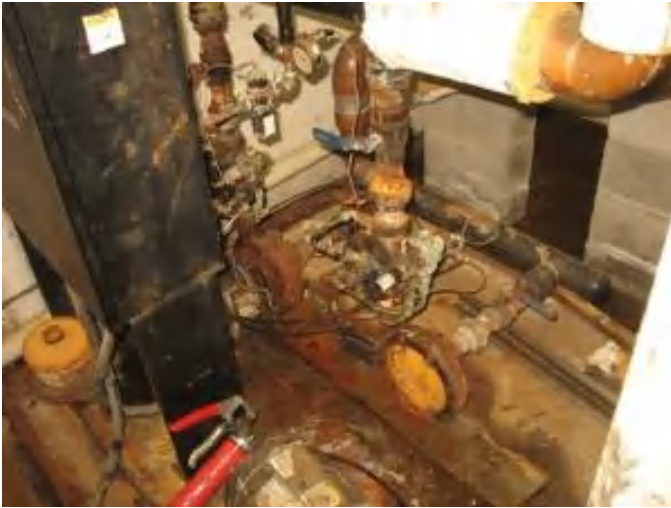
#### System: D2020 - Domestic Water Distribution

**Location:** Boiler room

**Distress:** Damaged

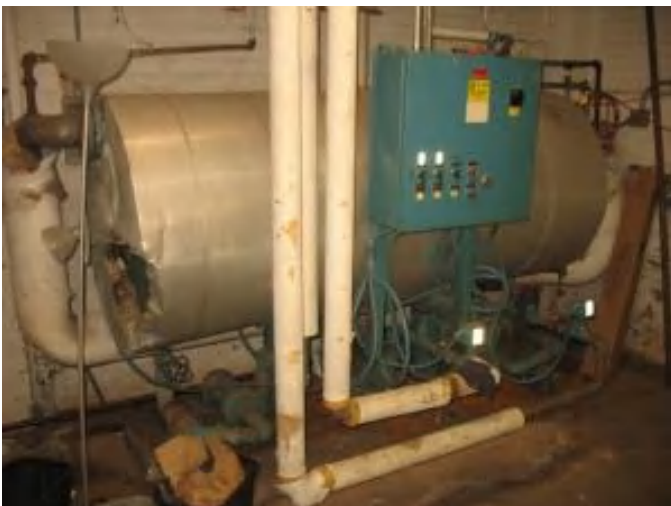
#### System: D3020 - Heat Generating Systems

**Location:** Boiler room

**Distress:** Damaged

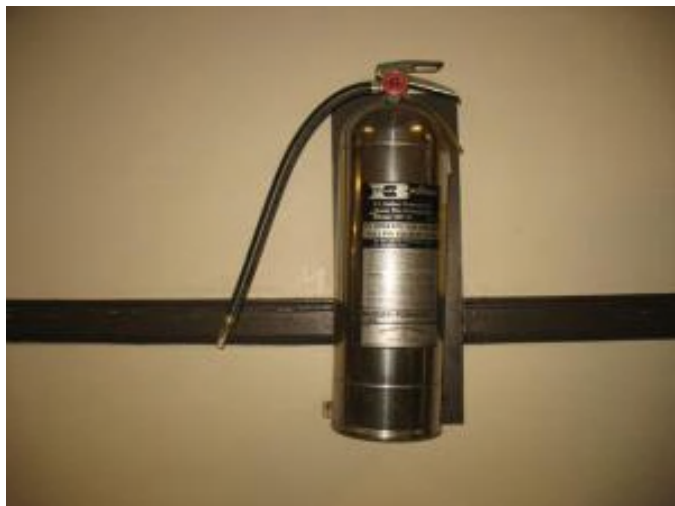
**System: D4010 - Sprinklers**

**Location:** Throughout building

**Distress:** Life Safety / NFPA / PFD

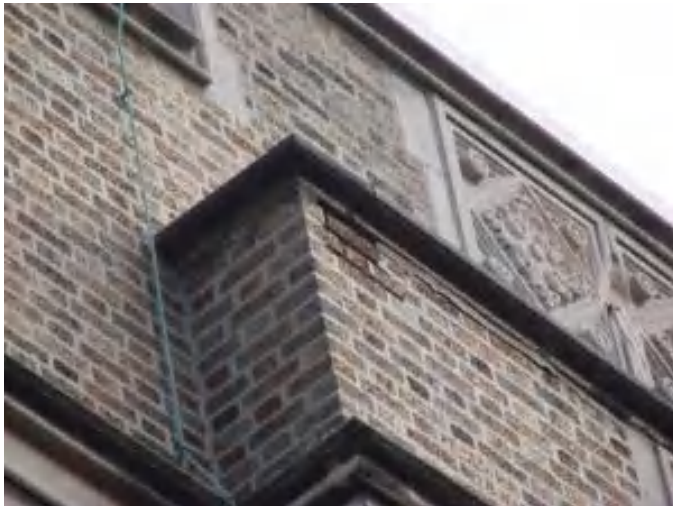
**System: B2010 - Exterior Walls**

**Location:** Front elevation above entry area

**Distress:** Building Envelope Integrity

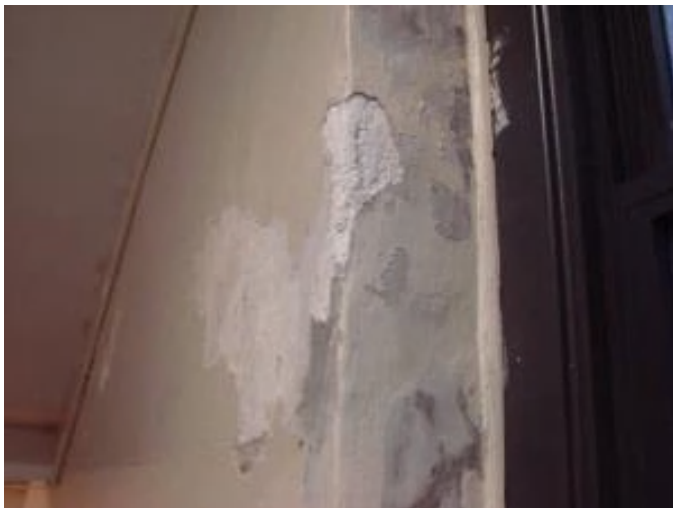
**System: C3010230 - Paint & Covering**

**Location:** Gym and basement corridor, stairwell

**Distress:** Damaged

**Notes:** Repair and repaint all walls.

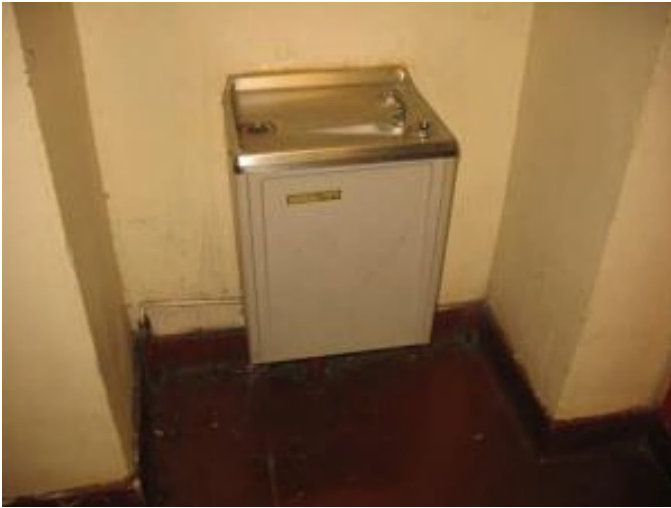
**System: D2010 - Plumbing Fixtures**

Drinking fountains in the corridors and at the restrooms are wall hung with integral refrigerated coolers. They are well beyond their service life and should be replaced; most are NOT accessible type.

**Location:** Corridors

**Distress:** Beyond Service Life

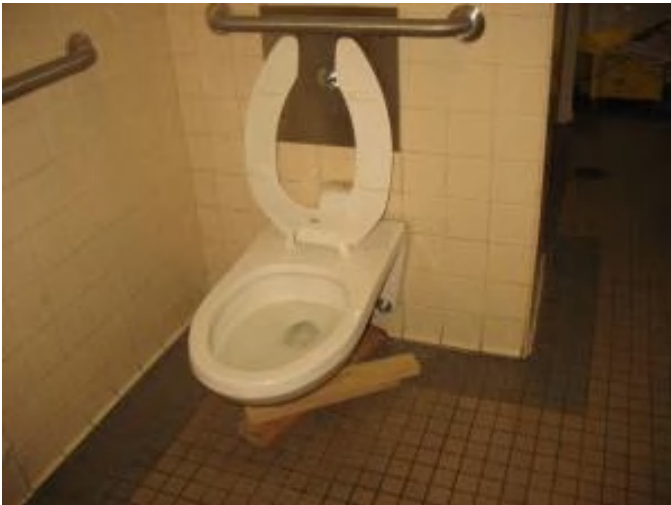
**System: D2010 - Plumbing Fixtures**

Many of the plumbing fixtures, updated around 2000, remain in service. Fixtures in the restrooms on each floor consist of wall mounted push button flush valve water closets, wall hung urinals and lavatories with wheel handle faucets. The units were replaced around 2000, according to the Principal, but are in poor condition. The water closets were not properly secured to the wall and thus are falling off the wall. The water closets that are falling off the wall should be repaired.

**Location:** Restrooms

**Distress:** Damaged

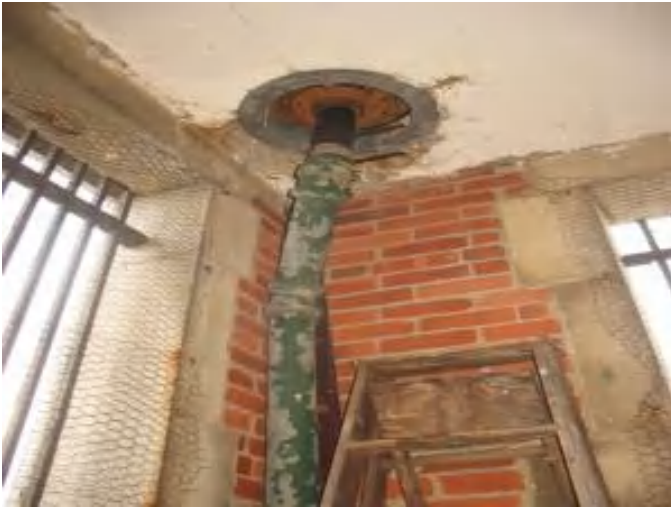
**System: D2040 - Rain Water Drainage**

**Location:** Throughout building

**Distress:** Beyond Service Life

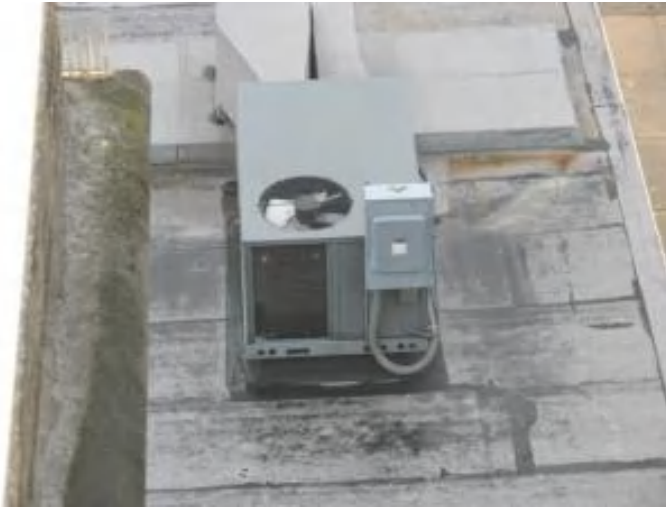
**System: D3050 - Terminal & Package Units**

A portable classroom located on the Northwest side of the main school building houses one (1) classroom. The portable has an independent conditioning system from the main building. A packaged rooftop unit provides heating and cooling to the classroom. According to the Building Engineer the packaged unit is over 10 years old and leaks into the classroom. The roof of the portable was not accessible during the site visit and further information on the packaged unit is not available. This unit should be replaced to provide reliable heating and cooling to the portable classroom.

**Location:** Portable

**Distress:** Beyond Service Life

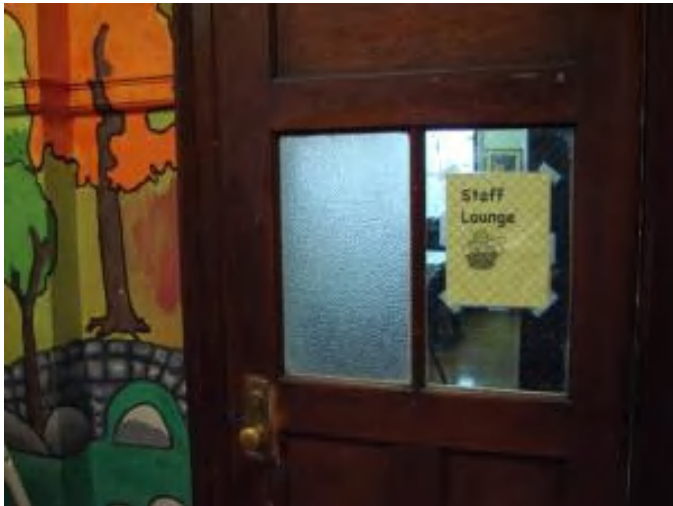
#### System: C1020 - Interior Doors

**Location:** Through out building

**Distress:** Accessibility

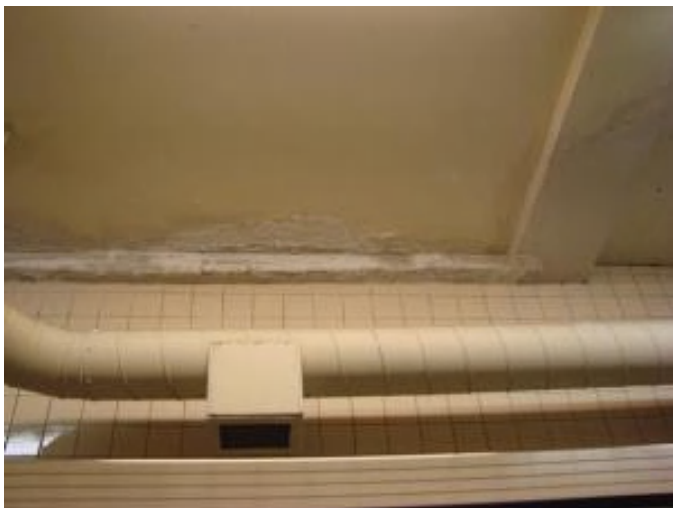
#### System: C3030 - Ceiling Finishes

**Location:** Ceilings in restrooms,

**Distress:** Damaged

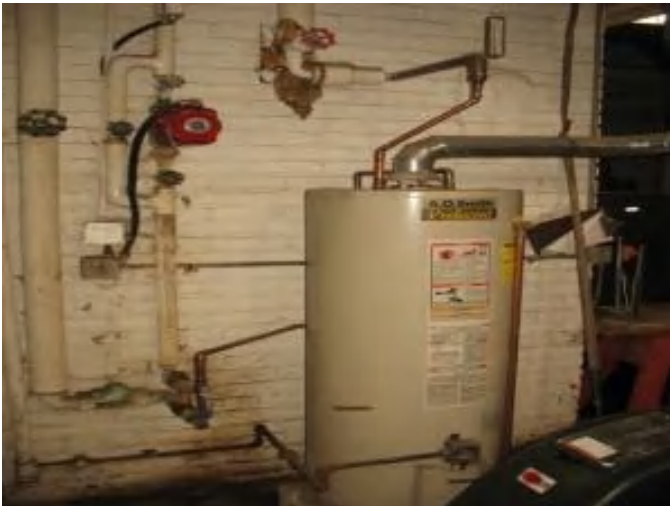
**System: D2020 - Domestic Water Distribution**

**Location:** Boiler room

**Distress:** Beyond Service Life

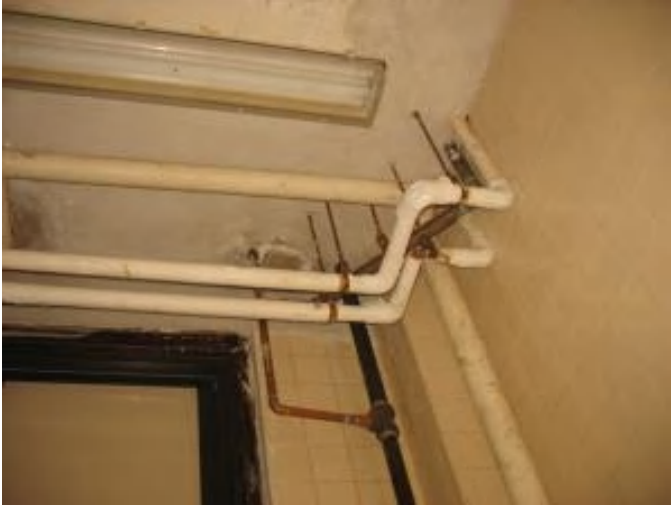
**System: D2030 - Sanitary Waste**

The maintenance staff reported mostly minor problems with the sanitary waste piping systems. The sewer piping has been in service for over 90 years and will require more frequent attention from the maintenance staff as time passes. The District should hire a qualified contractor to examine the sanitary waste piping using video cameras to locate and replace any damaged piping and to further quantify the extent of potential failures.

**Location:** Throughout building

**Distress:** Beyond Service Life

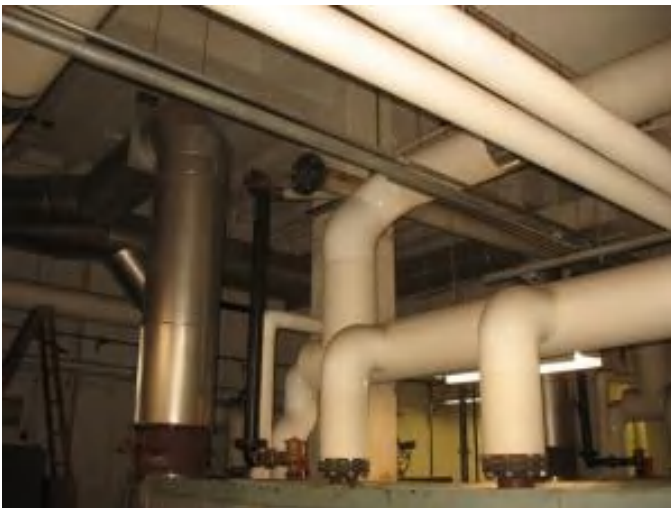
**System: D3040 - Distribution Systems**

**Location:** Throughout building

**Distress:** Beyond Service Life

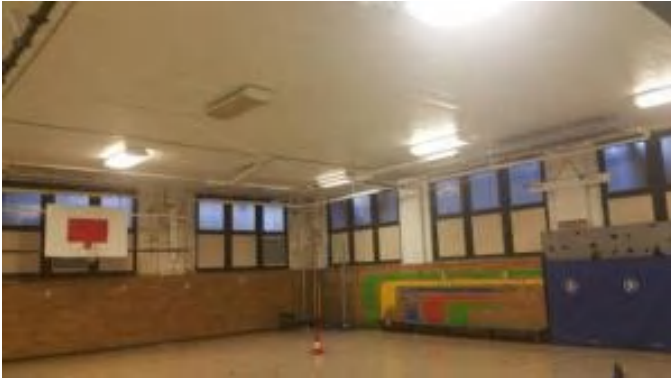
**System: D5020 - Lighting and Branch Wiring**

**Location:** throughout the building

**Notes:** Install new lighting system for 70% of the building.  
 $54,000 \text{ SF} \times 70\% = 37,800 \text{ SF}$

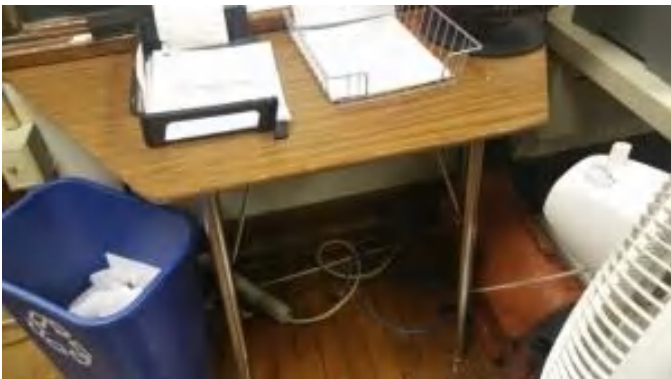
**System: D5020 - Lighting and Branch Wiring**

**Location:** throughout the building

**Notes:** Install new receptacles for 50% of the building  
 $54,000 \times 50\% = 27,000 \text{ SF}$

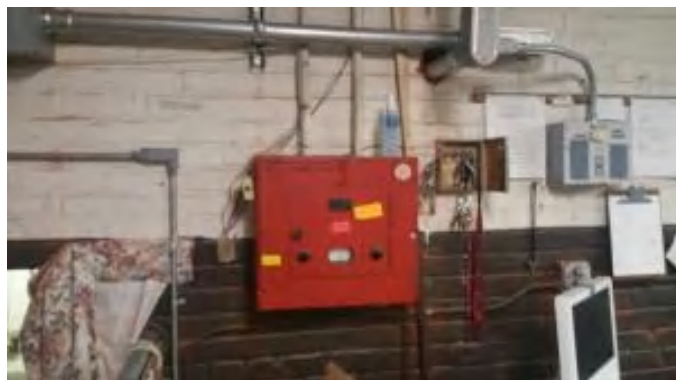
**System: D5030 - Communications and Security**

**Location:** throughout the building

**Distress:** Health Hazard / Risk

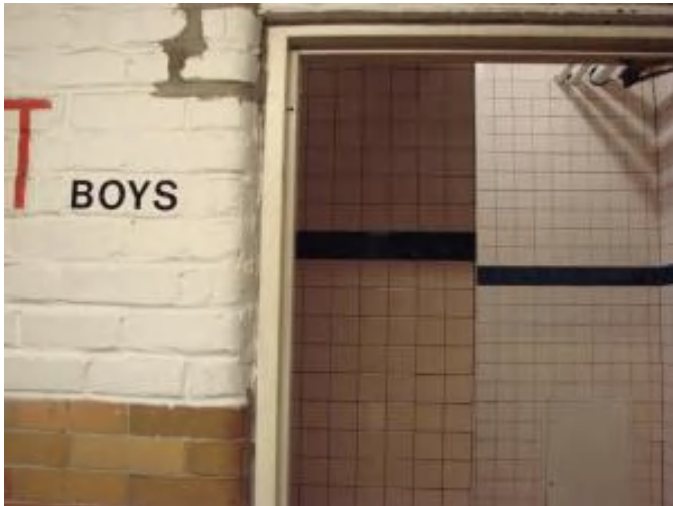
**System: C1030 - Fittings**

**Location:** Through out building

**Distress:** Obsolete

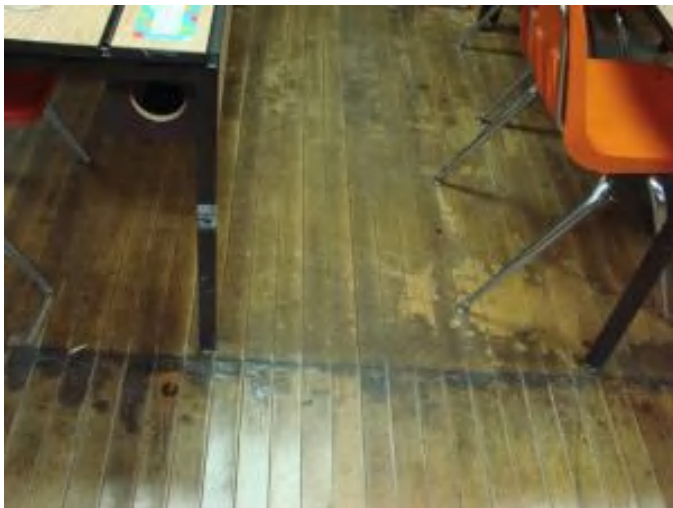
**System: C3020414 - Wood Flooring**

**Location:** B627001;Jenks, John

**Distress:** Appearance

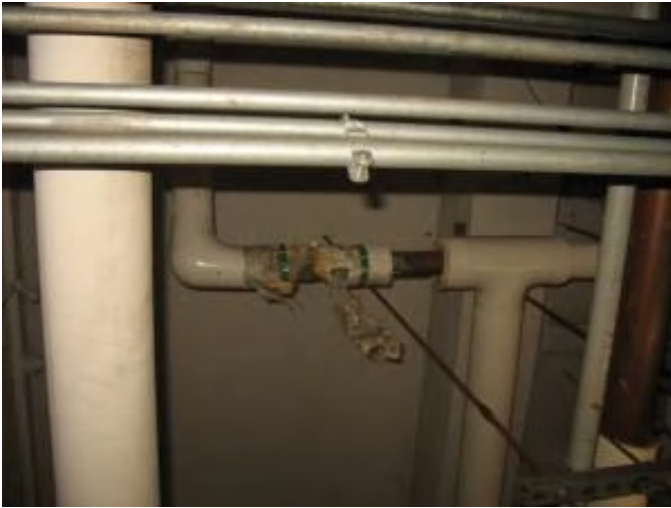
**System: D2020 - Domestic Water Distribution**

**Location:** Throughout building

**Distress:** Beyond Service Life

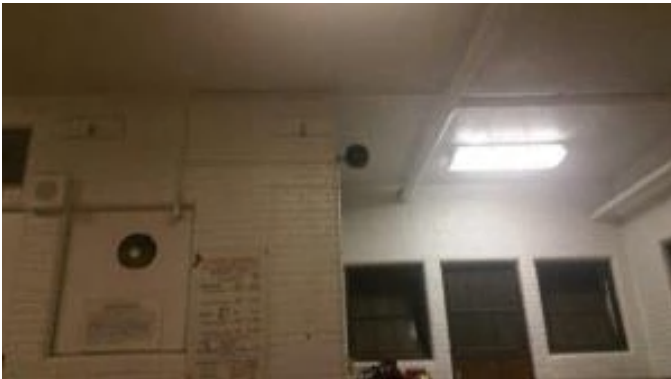
**System: D5010 - Electrical Service/Distribution**

**Location:** throughout the building

**Distress:** Beyond Service Life

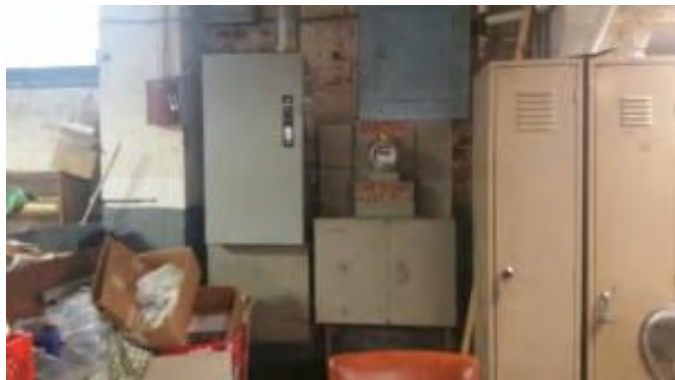
**System: D5010 - Electrical Service/Distribution**

**Location:** electrical room

**Distress:** Beyond Service Life

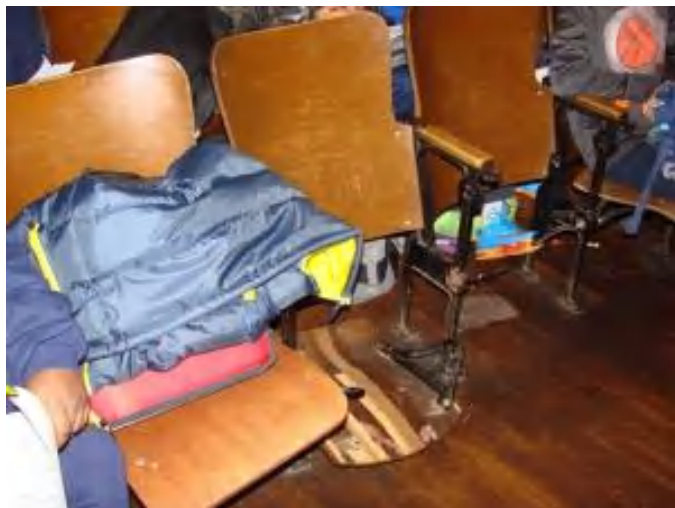
**System: E2010 - Fixed Furnishings**

**Location:** Auditorium

**Distress:** Damaged

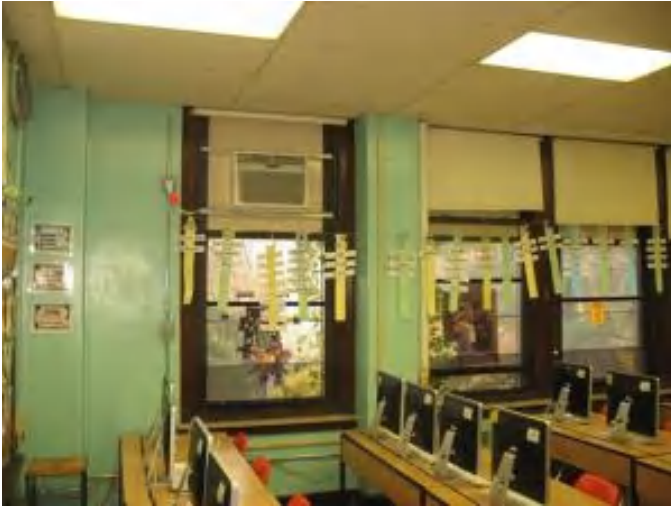
**System: D3030 - Cooling Generating Systems**

**Location:** Throughout building

**Distress:** Inadequate

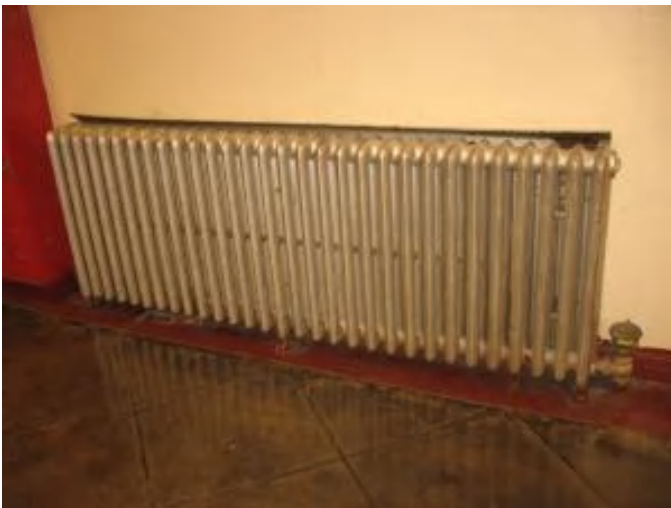
**System: D3040 - Distribution Systems**

**Location:** Classrooms

**Distress:** Beyond Service Life

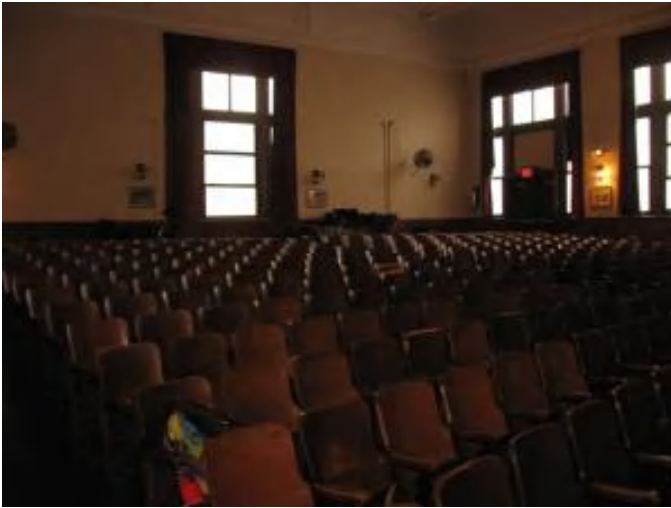
**System: D3040 - Distribution Systems**

**Location:** Auditorium

**Distress:** Building / MEP Codes

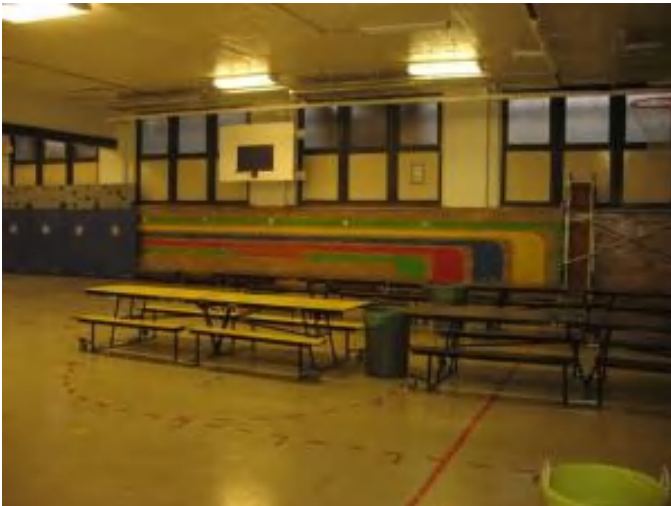
**System: D3040 - Distribution Systems**

**Location:** Cafeteria/Gymnasium

**Distress:** Building / MEP Codes

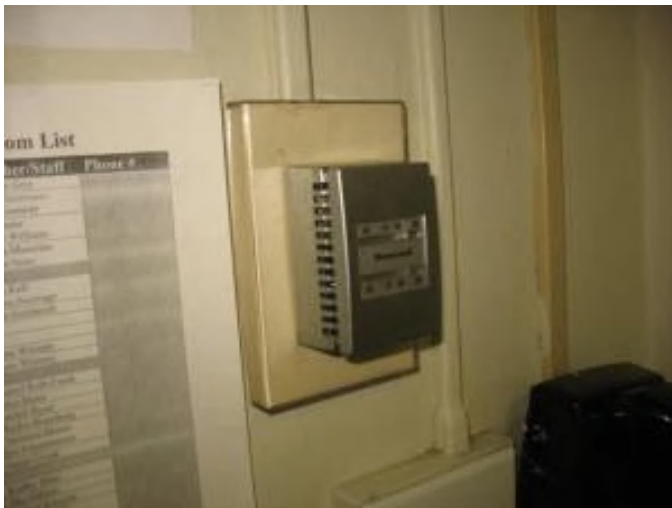
**System: D3060 - Controls & Instrumentation**

The original pneumatic systems no longer provide basic control functions. Pneumatic room thermostats are intended to control the steam radiator control valves. In reality the radiator control valves are wide open and heating control is achieved via the boilers. Pneumatic control air is no longer supplied, the compressor has been removed. The pneumatic controls systems are no longer functional. The original control valves and pneumatic actuators are beyond their service life and should be rebuilt or replaced. These controls should be converted to DDC.

**Location:** Throughout building

**Distress:** Inadequate

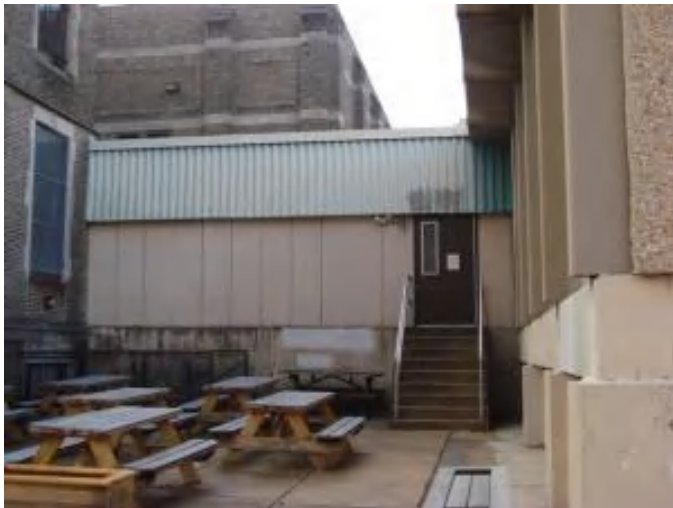
#### **System: G2030 - Pedestrian Paving**

**Location:** Exterior entry on rear of building

**Distress:** Accessibility

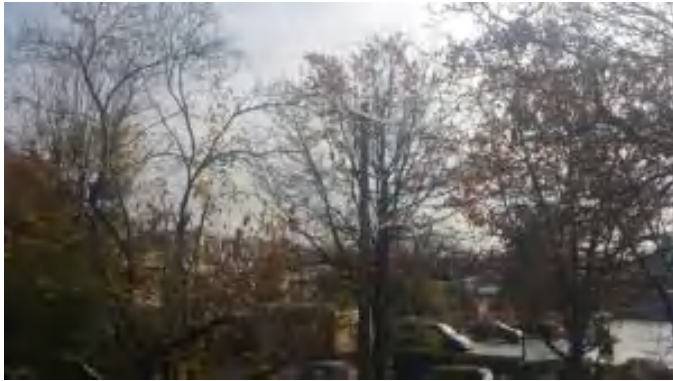
**System: G4020 - Site Lighting**

**Location:** grounds

**Distress:** Inadequate

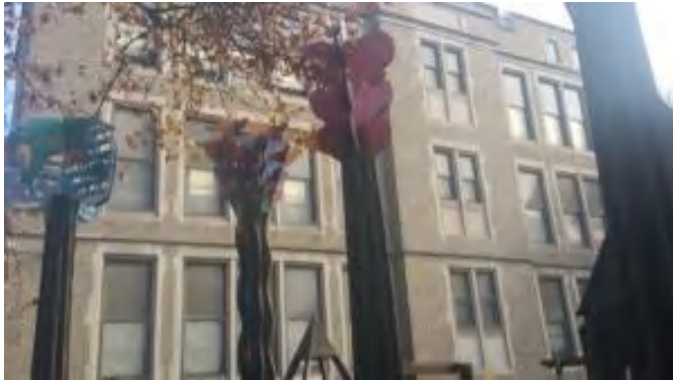
**System: G4030 - Site Communications & Security**

**Location:** grounds

**Distress:** Inadequate
