Facility Condition Assessment Summary Report

Juniata Academy School

S715001;Juniata Academy

Site Assessment Report

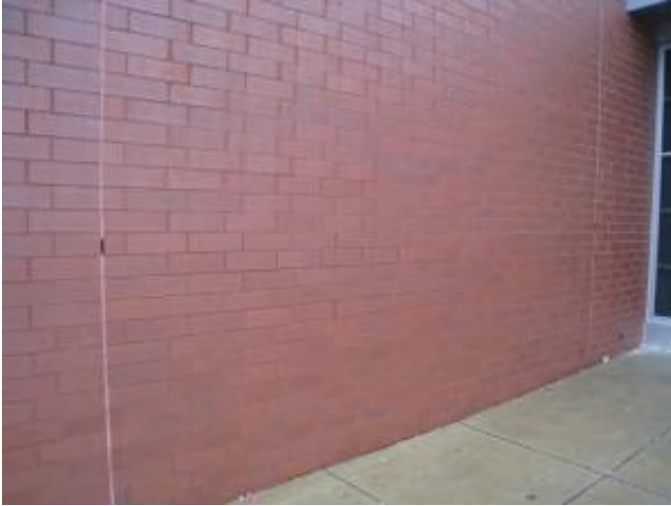
Location: brick walls near entrance

System: B2010 - Exterior Walls

Distress: Damaged

Notes: Repair vertical caulking in masonry expansion joints near entrance (20ft)

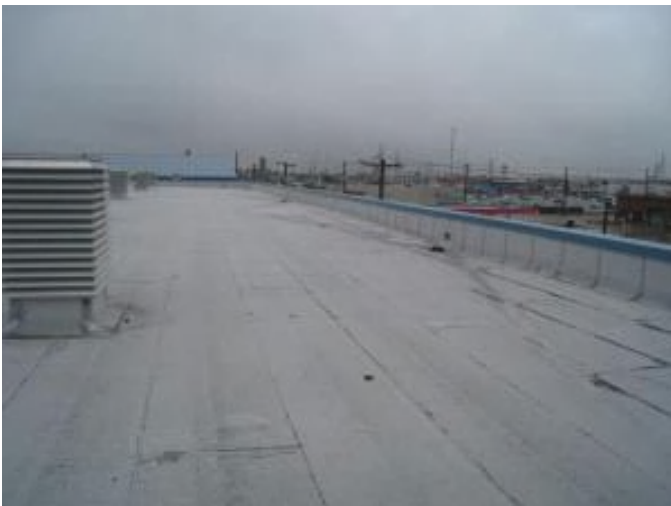
Location: roof

System: B3010105 - Built-Up

Distress: Inadequate

Notes: Repair (reinstall) flashing around rooftop equipment (100ft)

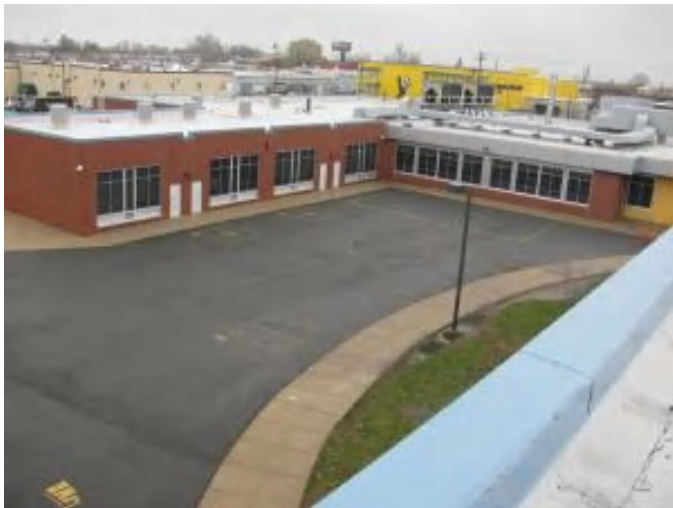
Location: Roof

System: D5090 - Other Electrical Systems

Distress: Life Safety / NFPA / PFD

Notes: Provide lightning protection studies to ascertain adequacy of existing systems.

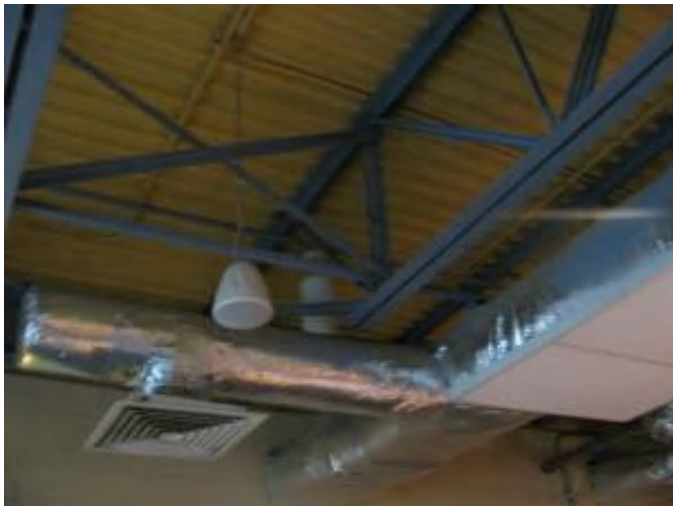
Location: Dining area platform

System: E1020 - Institutional Equipment

Distress: Inadequate

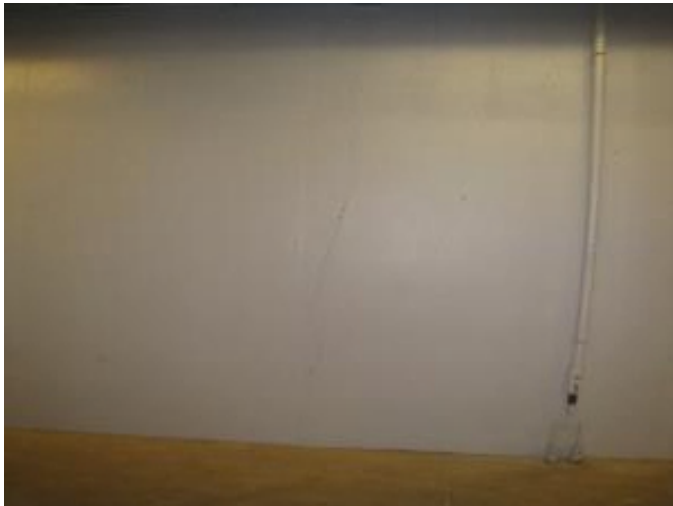
Location: basement

Foundations are constructed of concrete block and concrete. Wall surfaces are in good condition with no major settlement cracks observed. A hairline crack was observed in the concrete wall in the mechanical room. Footings were not seen and their construction type or condition could not be ascertained.

System: A2020 - Basement Walls

Distress: Damaged

Notes: Repair crack in basement wall (30ft)

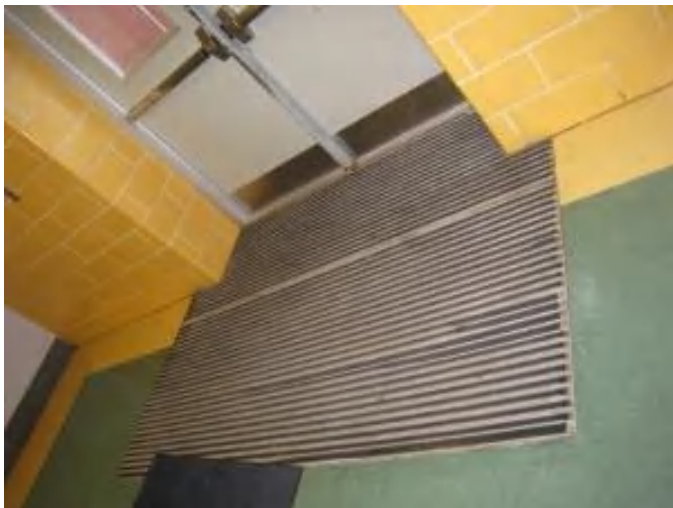
Location: entrance mats

System: B1010 - Floor Construction

Distress: Damaged

Notes: Replace traffic mats at main entrances and side entrance to playground (300sf)

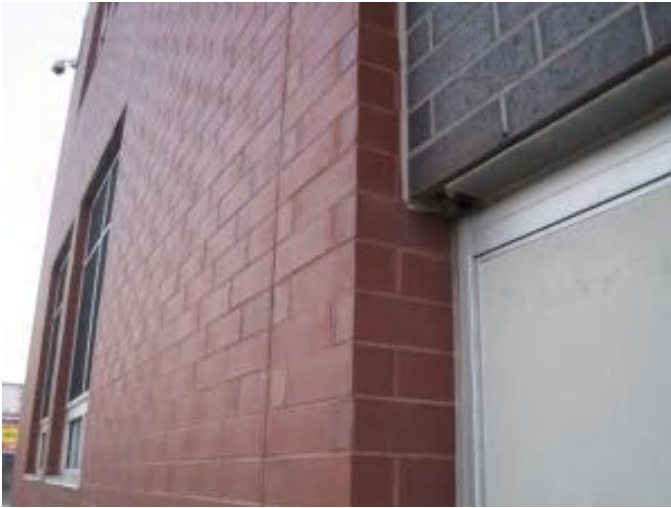
Location: exterior wall

System: B2010 - Exterior Walls

Distress: Inadequate

Notes: Replace short lintel over door on G Street (8ft)

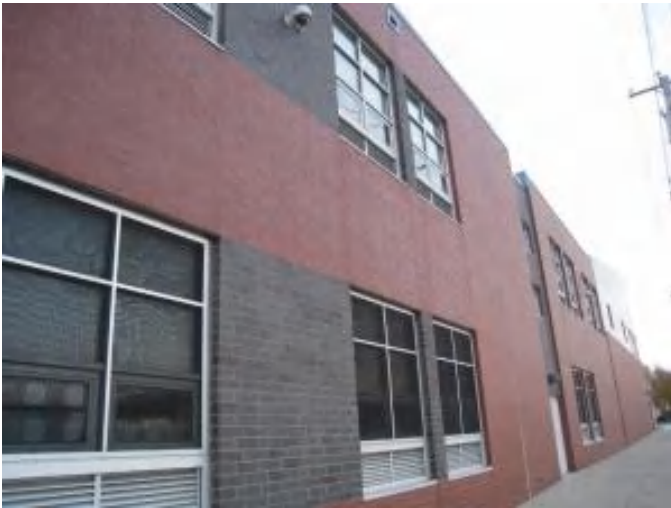
Location: exterior walls

System: B2010 - Exterior Walls

Distress: Damaged

Notes: Replace broken bricks on G Street elevation (100sf)

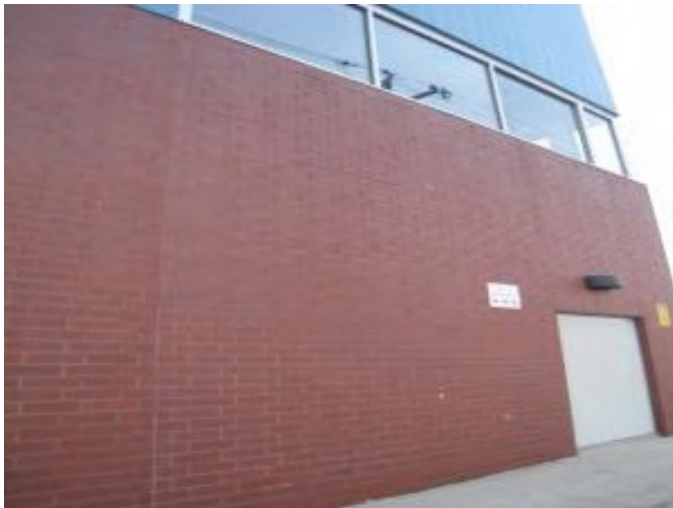
Location: exterior walls

System: B2010 - Exterior Walls

Distress: Appearance

Notes: Power wash efflorescence from brick (2,000sf)

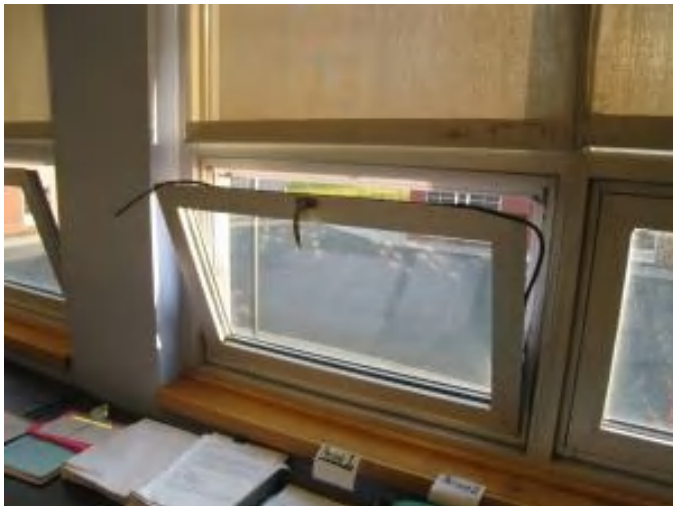
Location: windows

System: B2020 - Exterior Windows

Distress: Failing

Notes: Replace failing foam window gaskets – (10 windows)

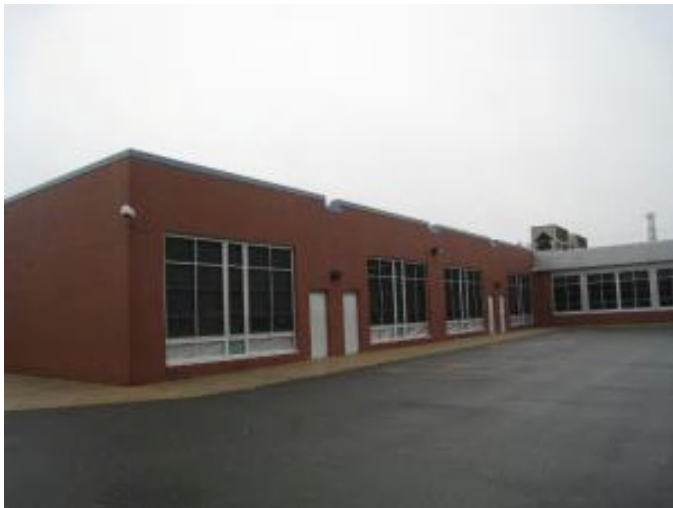
Location: exterior doors

System: B2030 - Exterior Doors

Distress: Appearance

Notes: Repaint hollow metal exterior doors opening from Kindergarten into playground (4)

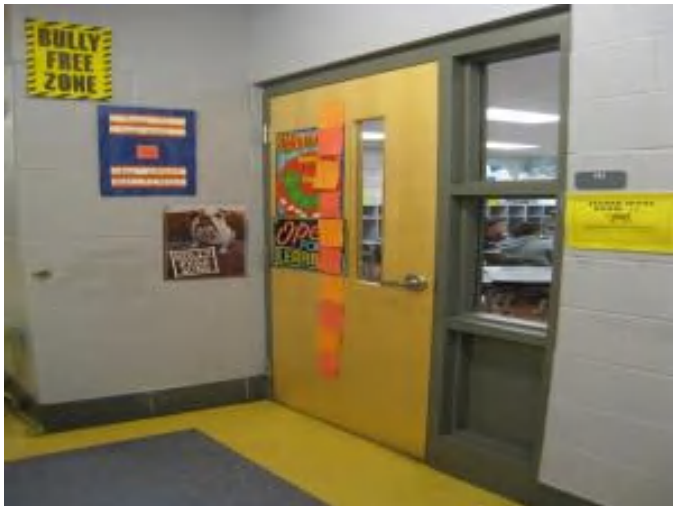
Location: interior door frames

System: C1020 - Interior Doors

Distress: Damaged

Notes: Repaint interior hollow metal door frames, especially at bottoms where rusting; refinish oak doors where damaged (20) 3'x7'

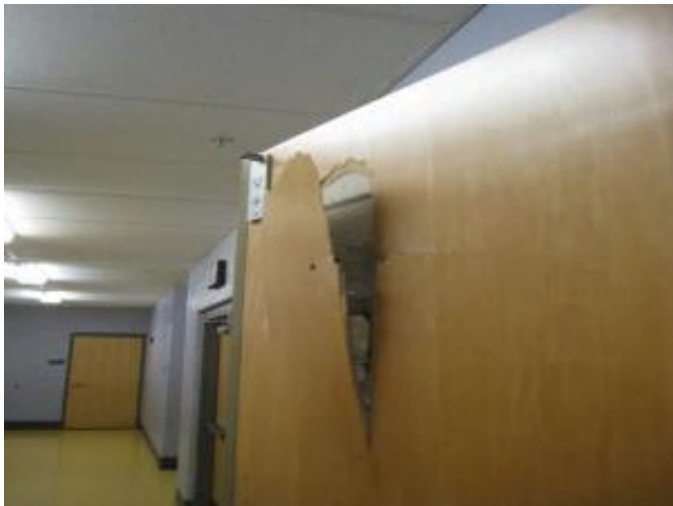
Location: corridor door

System: C1020 - Interior Doors

Distress: Damaged

Notes: Replace corridor door damaged by slamming into hold open; reuse hardware (1)

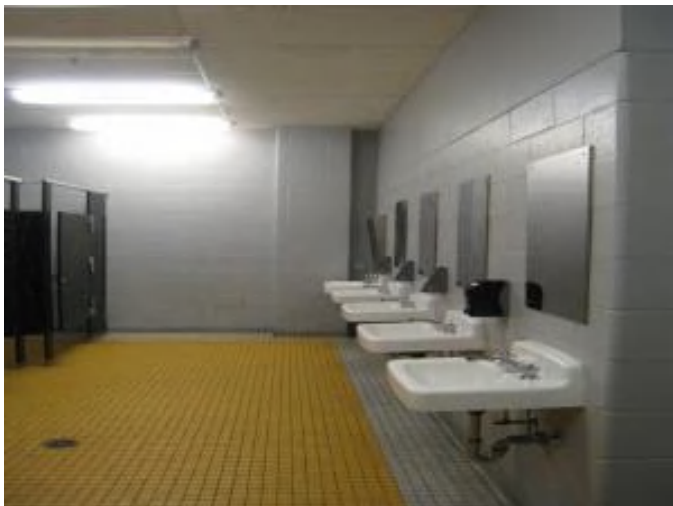
Location: toilet rooms

System: C1030 - Fittings

Distress: Damaged

Notes: Replace broken toilet room accessories (6)

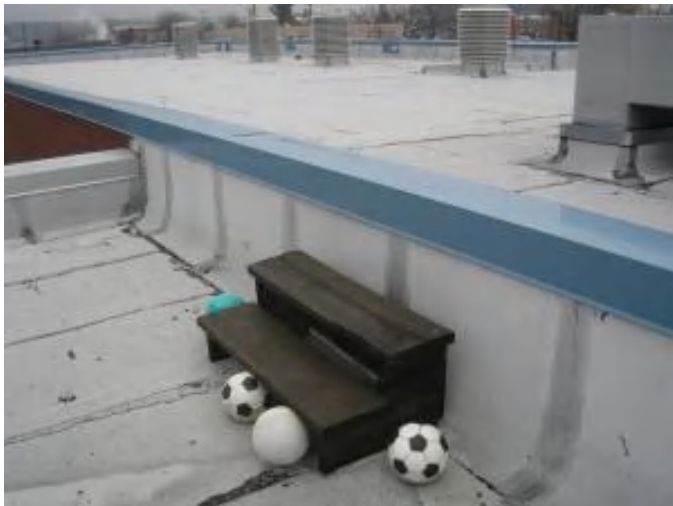
Location: roof

System: C2010 - Stair Construction

Distress: Building / MEP Codes

Notes: Provide 5 riser stair and handrail from roof over classrooms to roof over cafetorium (1 stairway, 32" h)

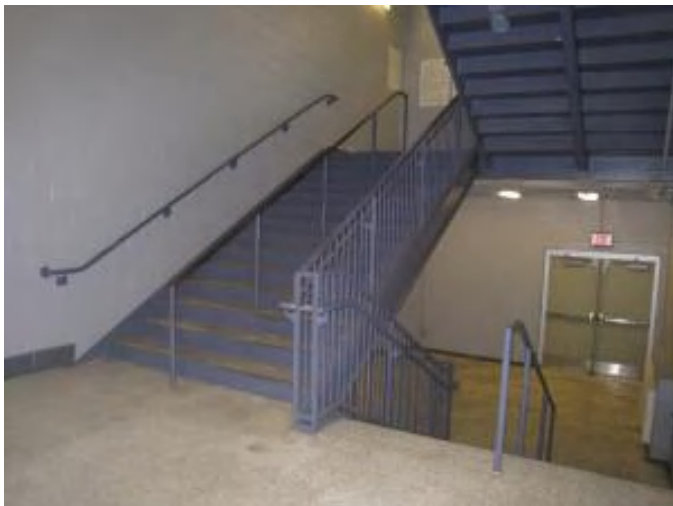
Location: stairways

System: C2010 - Stair Construction

Distress: Appearance

Notes: Repaint stair handrails (350ft)

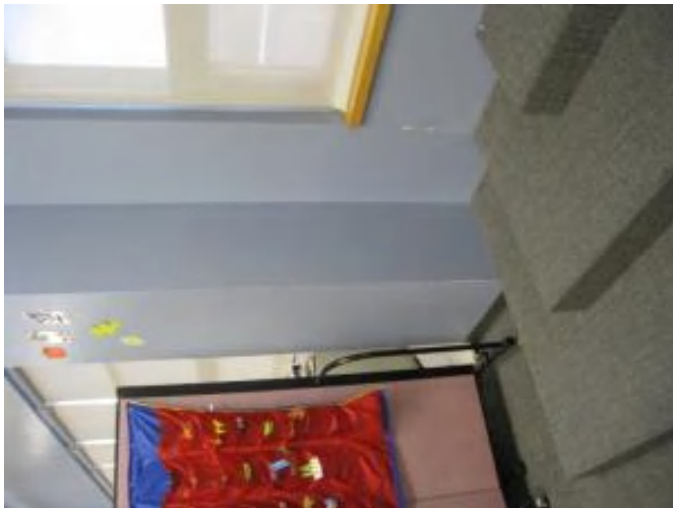
Location: IMC, offices, interior of exterior walls

System: C3010230 - Paint & Covering

Distress: Damaged

Notes: Repair and repaint damaged gypsum board from accidental impact in IMC and outside walls (1000sf)

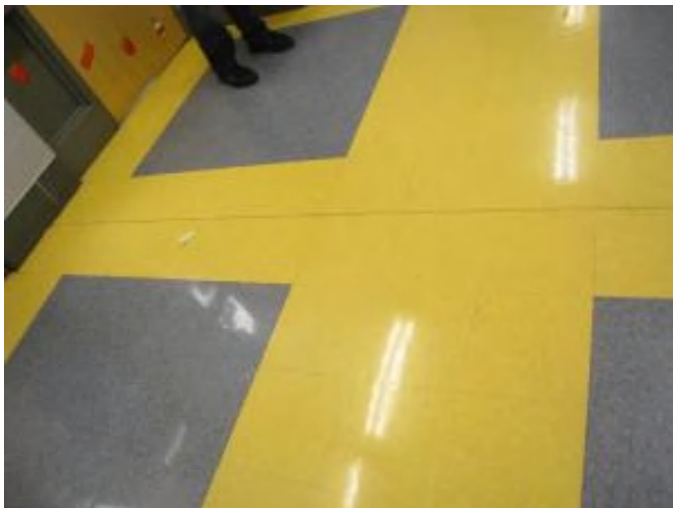
Location: corridor floors

Floor finishes in the building consist mostly of 12"x12" vinyl composition tile (VCT) in classrooms, offices, corridors, and cafetorium. There are some areas of joint separation in the VCT in ground floor corridors, probably due to the usual minimal settlement of the ground floor slab; these corridors should be watched to see if slab settlement increases. In removing these tiles for repair, the slab should be studied to ascertain if there is a settlement problem. The IMC (library), main school offices, and some other offices have glued-down carpet. The stage in the cafetorium is VCT and in good condition. The gymnasium floor is an oak plank floor. One section of the floor was damaged as a result of a heating pipe leak; the floor in that area should be replaced. The kitchen has quarry tile, which is in good condition. The main building entrance lobby is VCT, also in good condition. The main entrance and secondary entrance to the kindergarten corridor has recessed walk-off mats, in good condition. The walk-off mat at the courtyard door in the cafetorium is damaged and needs to be replaced.

System: C3020413 - Vinyl Flooring

Distress: Failing

Notes: Repair cracks in VCT floors in corridors - replace VCT (200sf)

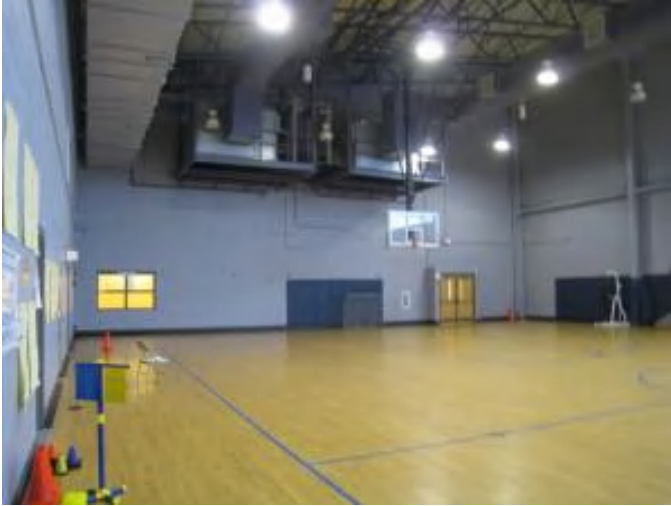
Location: gym floor

System: C3020414 - Wood Flooring

Distress: Damaged

Notes: Repair wood floor in gym, damaged by water from HVAC leaks (200sf)

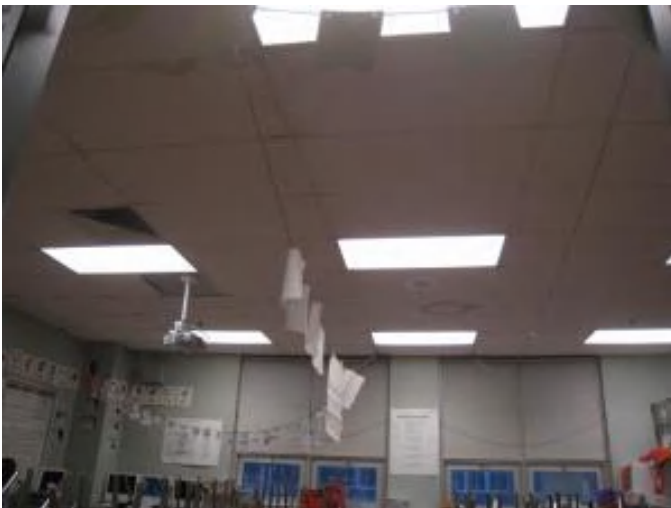
Location: ceilings

leaks or condensation leaks above the ceiling causing leaks into classrooms and staining of ceiling tile. The air-conditioning unit on the roof overheats and shuts off. Parking is inadequate for the 95 staff working in the school (there are 73 parking spaces in the on-site lot). There are 72 cameras at the school, including 8 outside cameras – all are working properly.

System: C3030 - Ceiling Finishes

Distress: Damaged

Notes: Replace water stained ceilings, damaged from HVAC leaks (3,000sf)

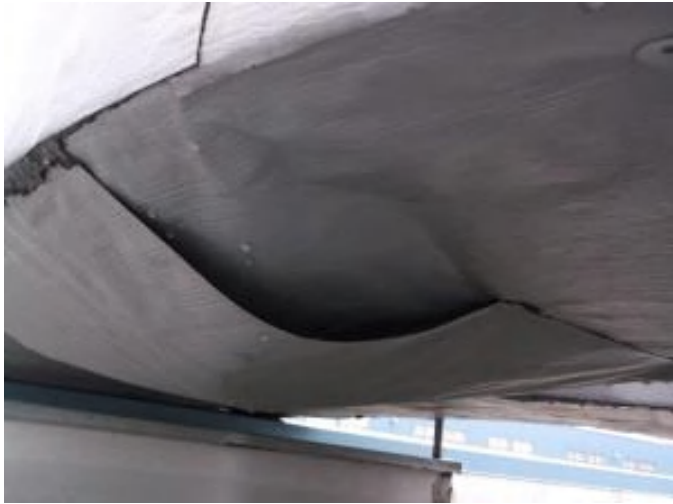
Location: Roof

System: D3040 - Distribution Systems

Distress: Damaged

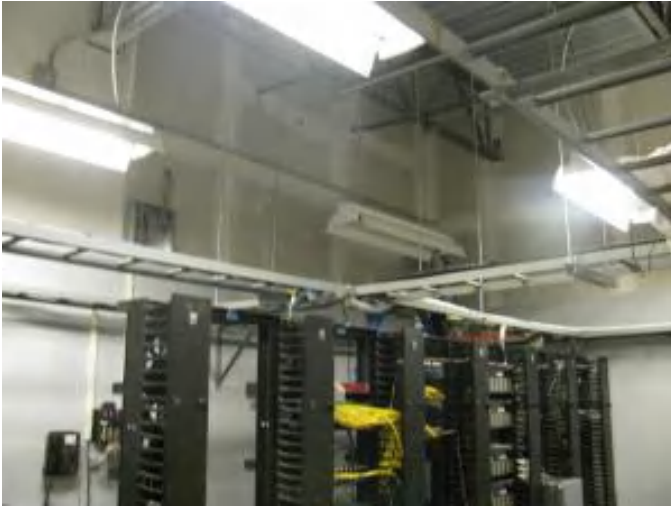
Location: Roof

System: D3040 - Distribution Systems

Distress: Inadequate

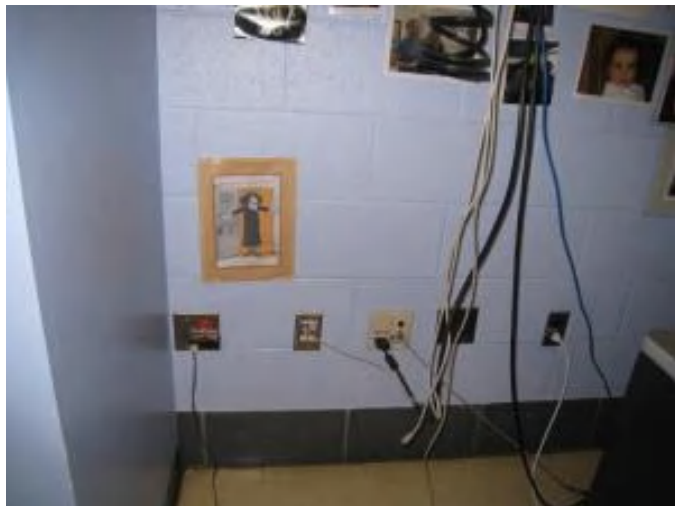
Location: classrooms

System: D5020 - Lighting and Branch Wiring

Distress: Damaged

Notes: Replace wall jacks and cable connections for smartboards in classrooms (60)

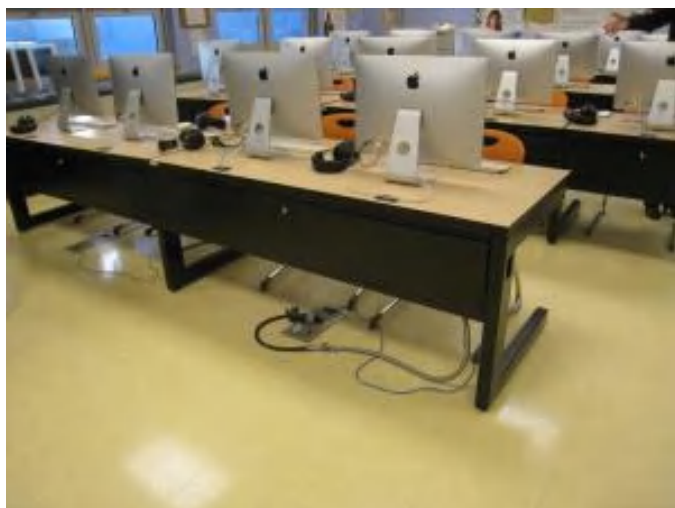
Location: computer lab

System: D5020 - Lighting and Branch Wiring

Distress: Damaged

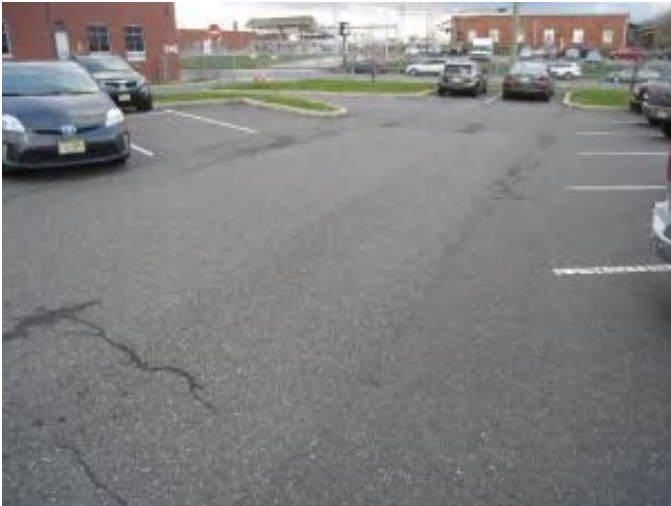
Location: staff parking lot

Asphalt parking area and the asphalt playground have some cracking which needs to be filled. ADA accessible parking spaces are provided in the parking lot to the north of the main drop off and curb cuts are provided. Entrances do not require ramps since they are grade level. Accessible route signage is needed. The number of required parking spaces for school staff and faculty is unknown, however the inspection team was told there is not enough parking for staff and parents.

System: G2020 - Parking Lots

Distress: Failing

Notes: Fill cracks in asphalt parking lot (2,000ft)

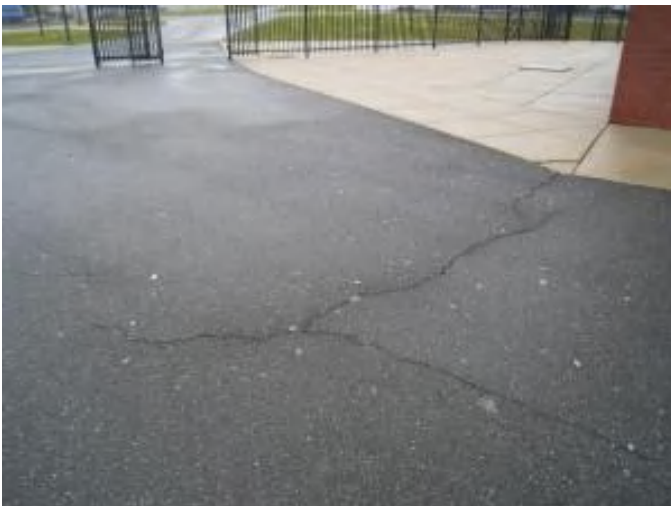
Location: sidewalks

Front, side and rear concrete walkways are generally in good condition with a some cracked concrete panels needing replacement.

System: G2030 - Pedestrian Paving

Distress: Damaged

Notes: Repave damaged sections of concrete walkway (200sf)

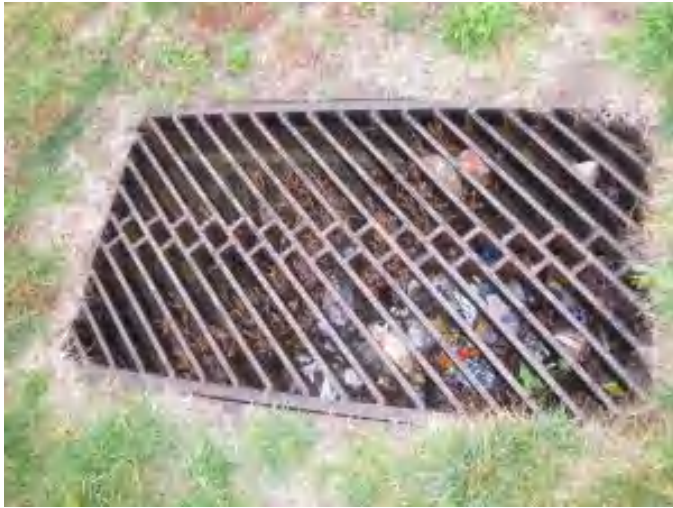
Location: front entrance area

System: G2050 - Landscaping & Irrigation

Distress: Failing
