## Facility Condition Assessment Summary Report

### Kearny School

School District of Philadelphia  
**S548001;Kearny**  
Final  
**Site Assessment Report**  
January 31, 2017

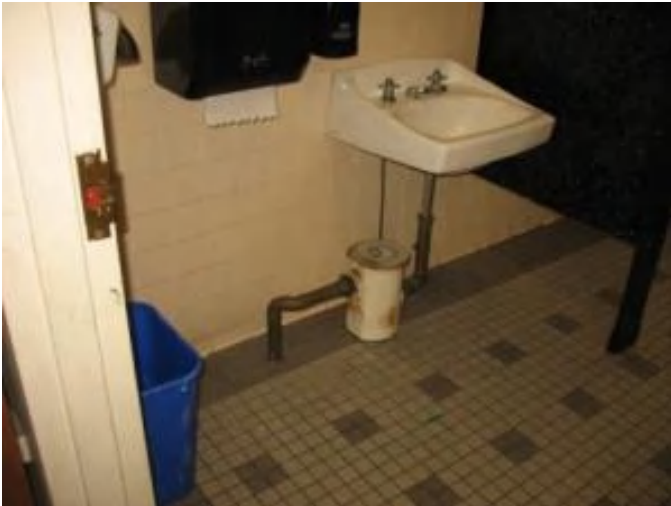
#### System: D2030 - Sanitary Waste

**Location:** Throughout building

**Distress:** Health Hazard / Risk

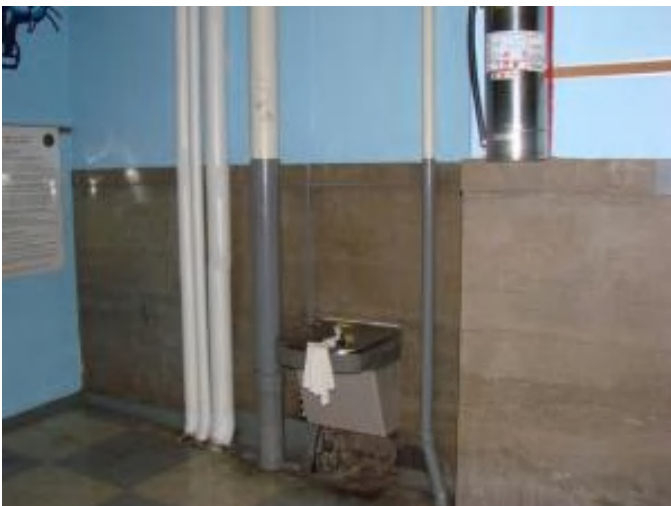
#### System: D4010 - Sprinklers

**Location:** Throughout building

**Distress:** Life Safety / NFPA / PFD

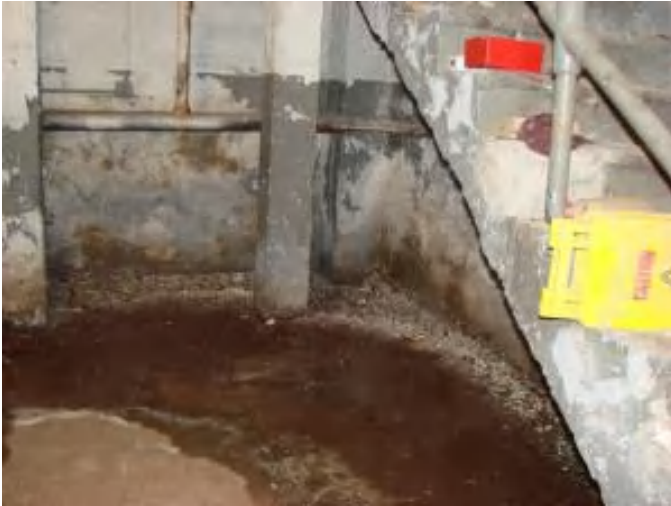
**System: A1010 - Standard Foundations**

**Location:** Basement/ exterior

**Distress:** Building Envelope Integrity

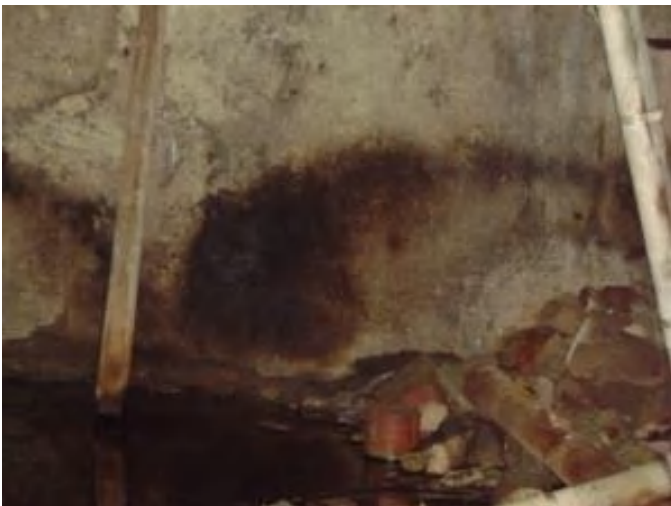
**System: A2020 - Basement Walls**

**Location:** Interior/ basement

**Distress:** Life Safety / NFPA / PFD

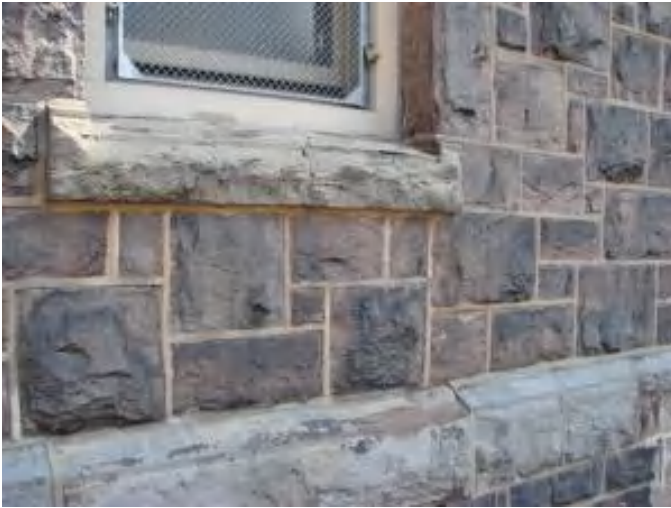
**System: B2010 - Exterior Walls**

**Location:** Exterior

**Distress:** Building Envelope Integrity

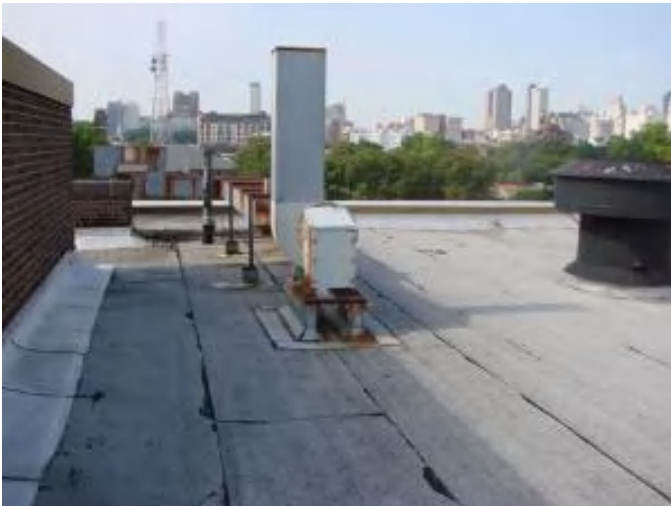
**System: B3010105 - Built-Up**

**Location:** Roof

**Distress:** Failing

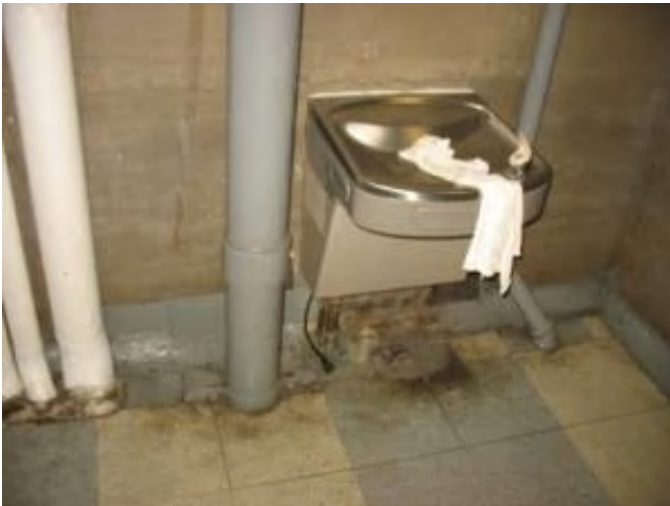
**System: D2010 - Plumbing Fixtures**

**Location:** Throughout building

**Distress:** Beyond Service Life

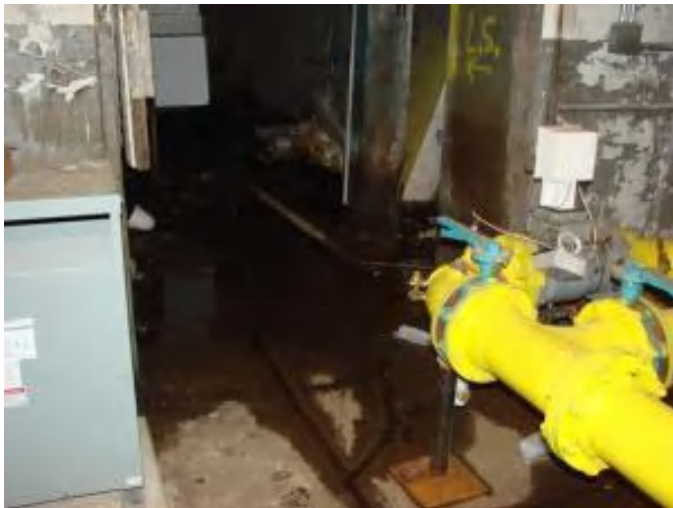
**System: D2030 - Sanitary Waste**

**Location:** Basement

**Distress:** Failing

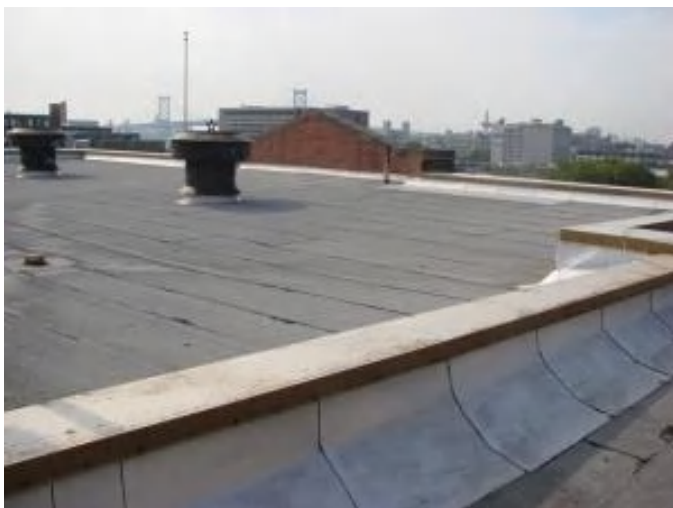
**System: D3040 - Distribution Systems**

**Location:** Roof

**Distress:** Beyond Service Life

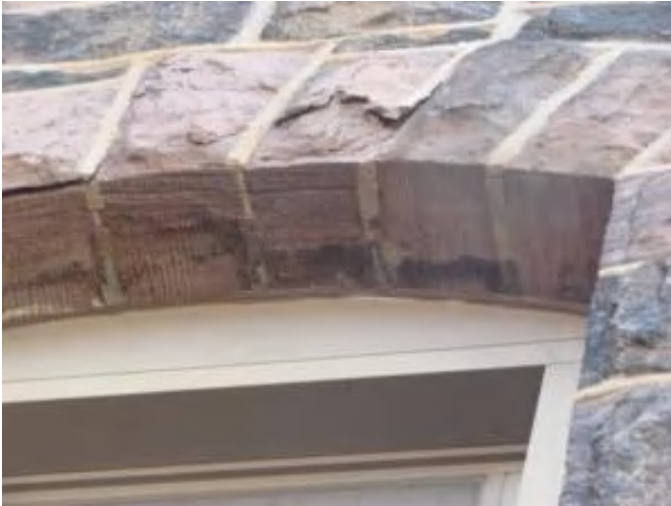
**System: B2020 - Exterior Windows**

**Location:** Exterior

**Distress:** Building Envelope Integrity

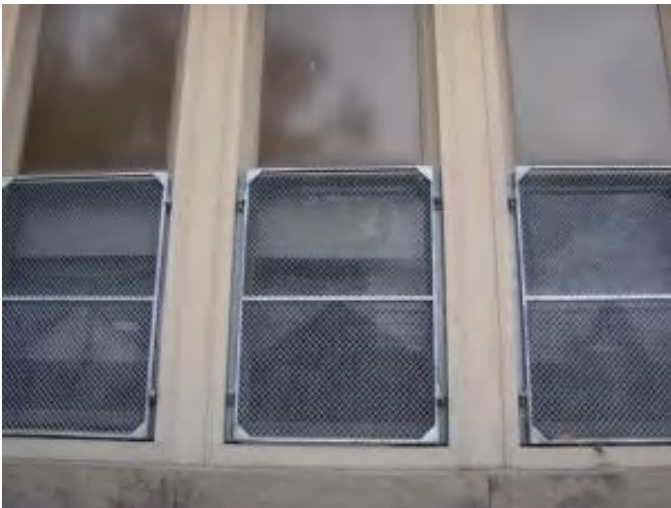
**System: B2020 - Exterior Windows**

**Location:** Exterior windows/ 1st floor

**Distress:** Security Issue

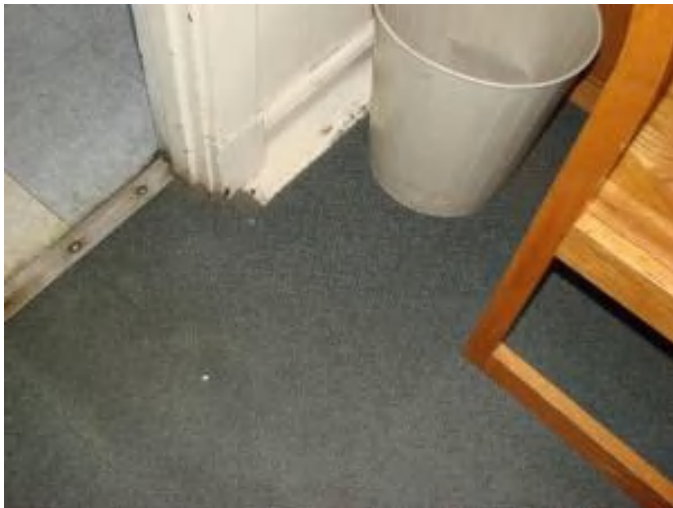
**System: C3020411 - Carpet**

**Location:** Library and (1)office

**Distress:** Beyond Service Life

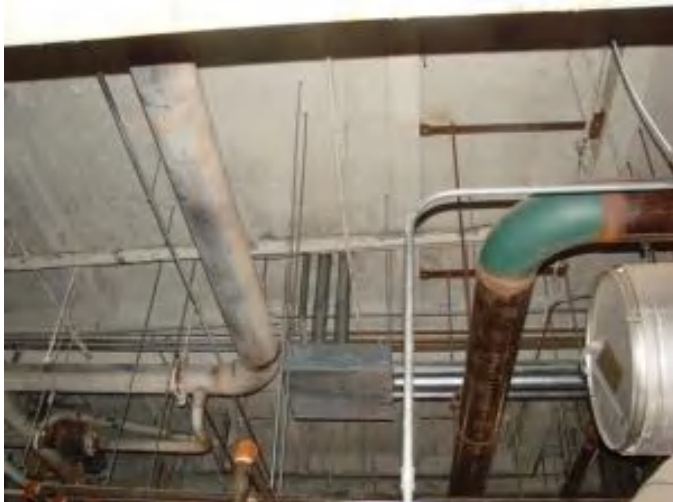
**System: C3030 - Ceiling Finishes**

**Location:** Interiors

**Distress:** Beyond Service Life

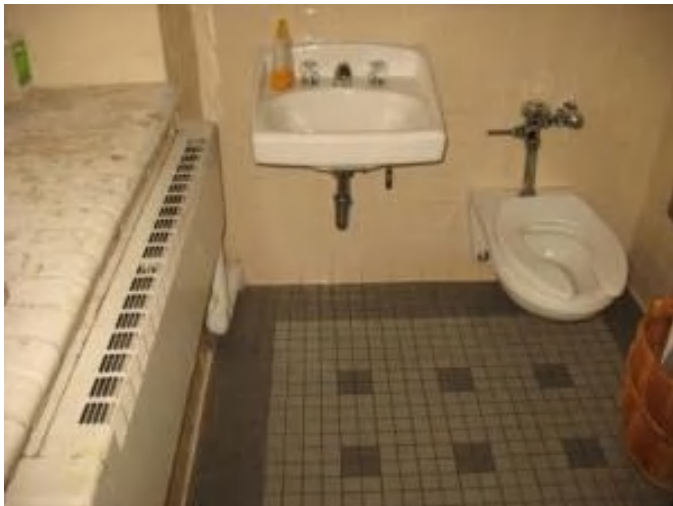
**System: D2010 - Plumbing Fixtures**

**Location:** Restrooms

**Distress:** Accessibility

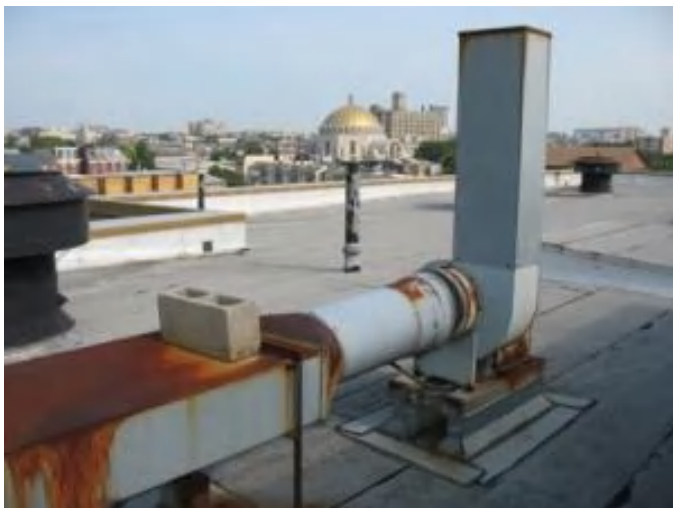
**System: D3040 - Distribution Systems**

**Location:** Roof

**Distress:** Beyond Service Life

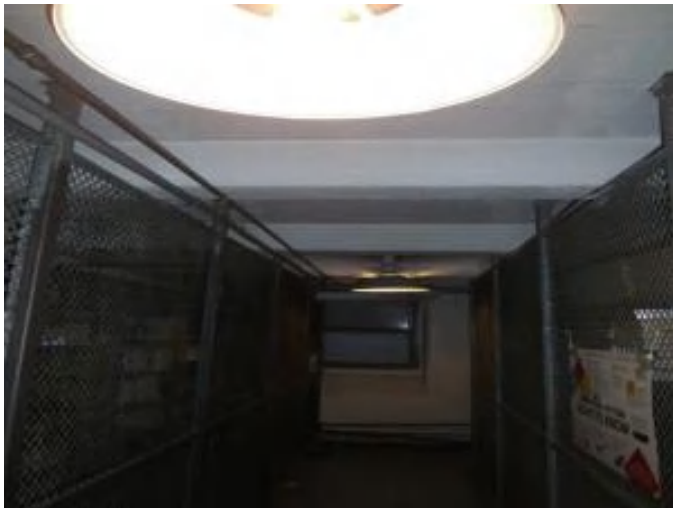
**System: D5020 - Lighting and Branch Wiring**

**Location:** Throughout Building

**Distress:** Inadequate

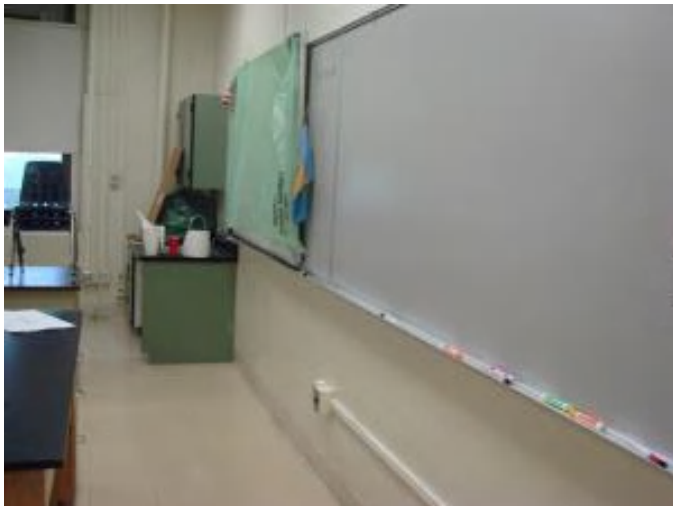
**System: D5020 - Lighting and Branch Wiring**

**Location:** Classrooms

**Distress:** Inadequate

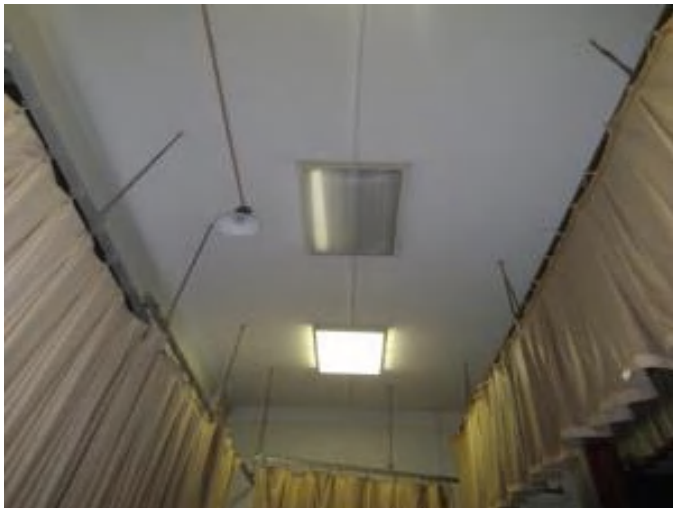
**System: D5020 - Lighting and Branch Wiring**

**Location:** Throughout Building

**Distress:** Inadequate

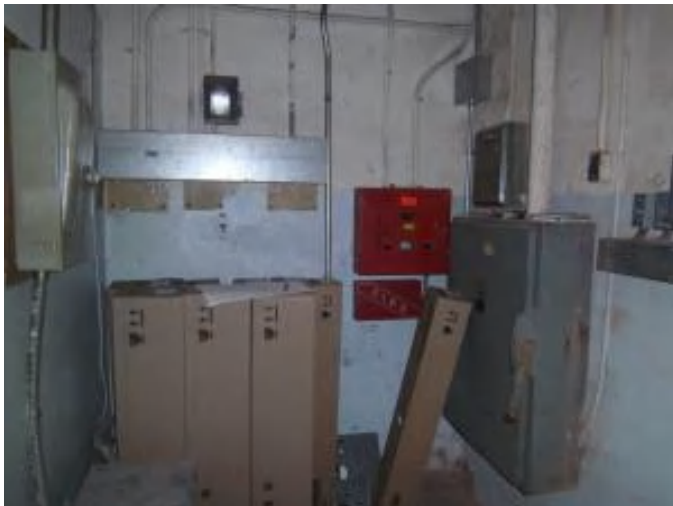
**System: D5030 - Communications and Security**

**Location:** Throughout Building

**Distress:** Building / MEP Codes

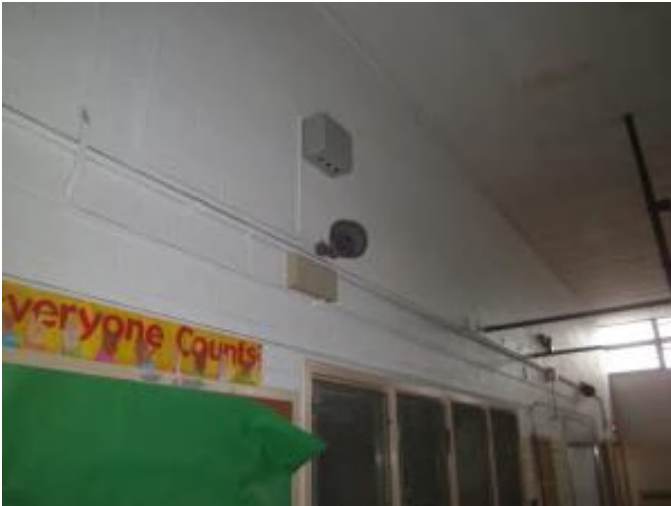
**System: D5090 - Other Electrical Systems**

**Location:** Basement

**Distress:** Inadequate

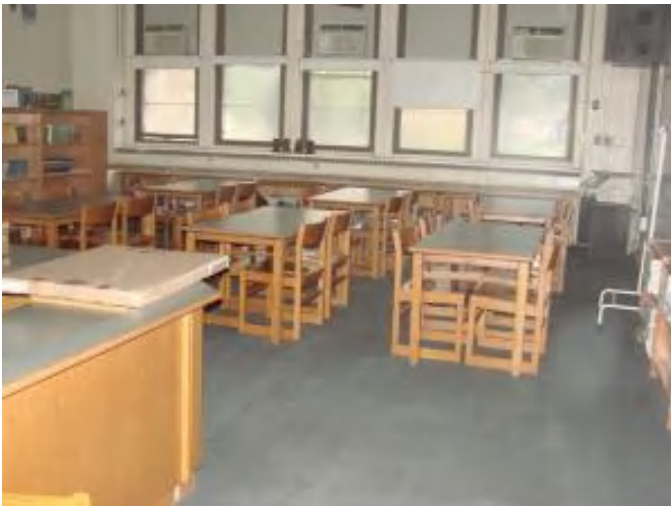
**System: E2010 - Fixed Furnishings**

**Location:** Interior

**Distress:** Beyond Service Life

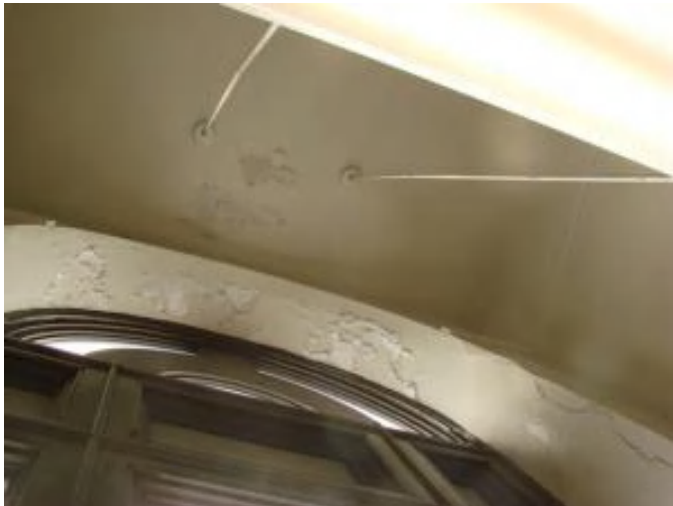
**System: C3010230 - Paint & Covering**

**Location:** Interior

**Distress:** Beyond Service Life

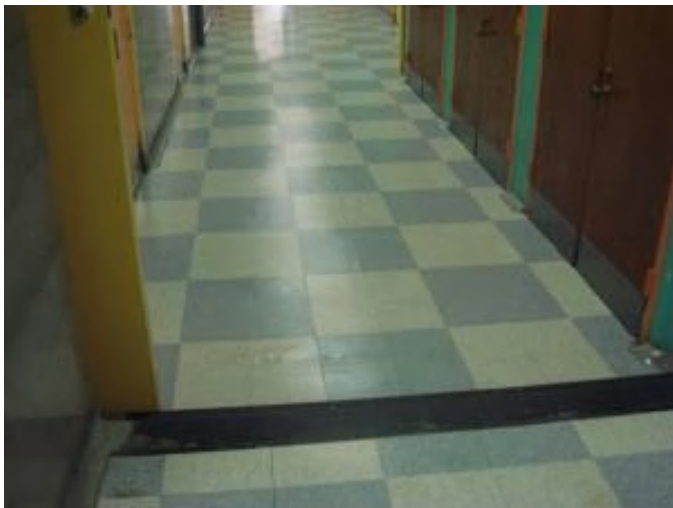
**System: C3020413 - Vinyl Flooring**

**Location:** Interior

**Distress:** Beyond Service Life

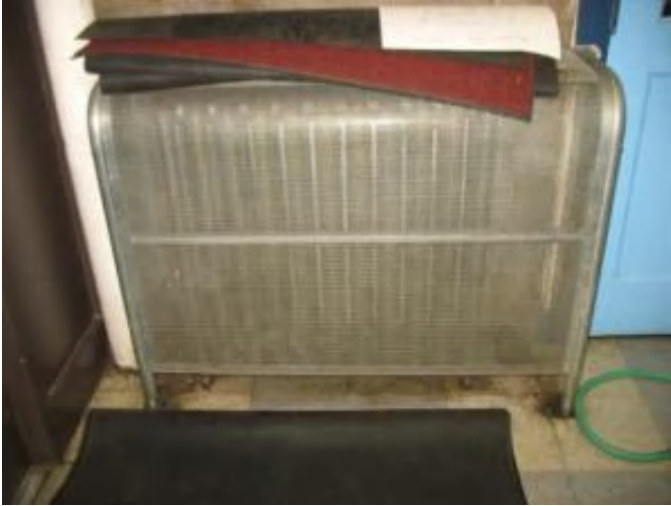
**System: D3040 - Distribution Systems**

**Location:** Throughout building

**Distress:** Beyond Service Life

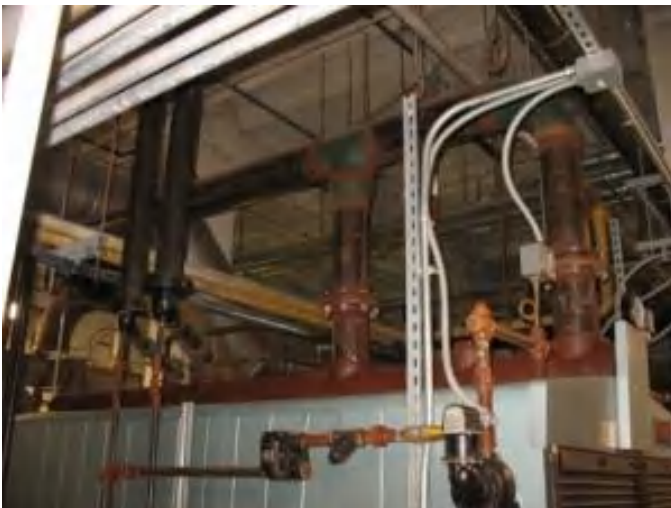
**System: D3040 - Distribution Systems**

**Location:** Basement

**Distress:** Energy Efficiency

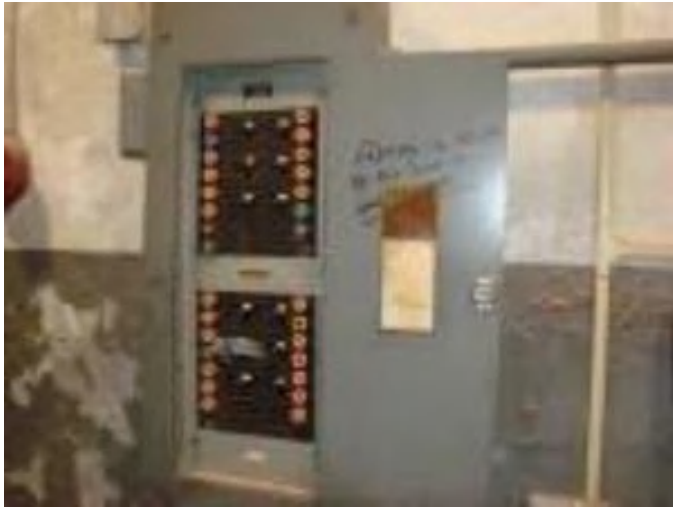
**System: D5010 - Electrical Service/Distribution**

**Location:** Throughout Building

**Distress:** Beyond Service Life

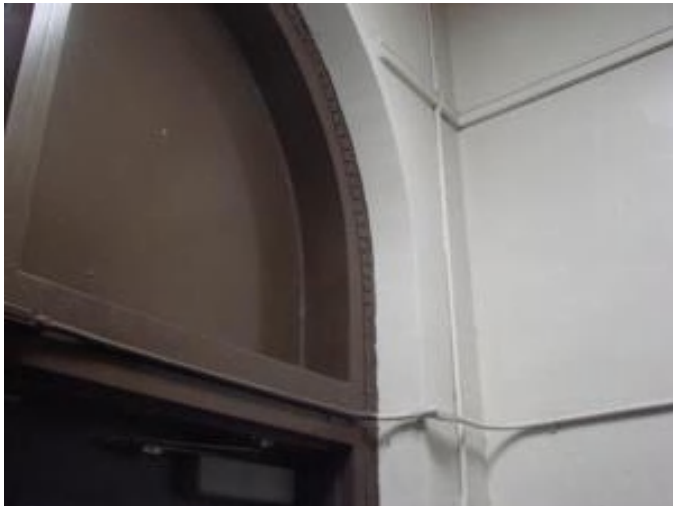
**System: B2030 - Exterior Doors**

**Location:** Exterior

**Distress:** Beyond Service Life

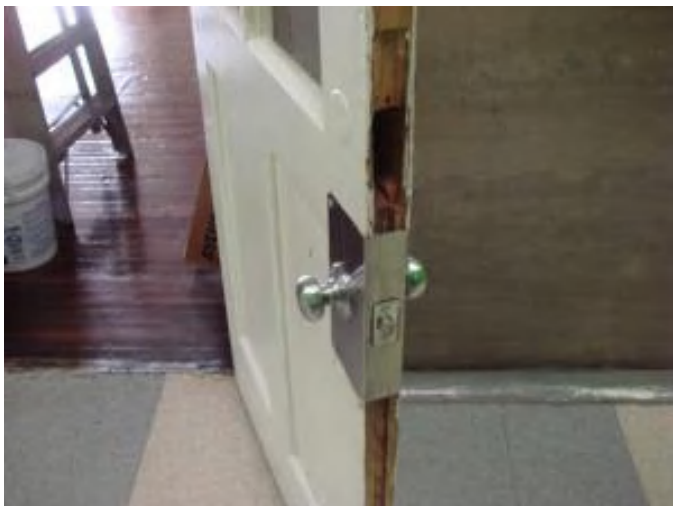
**System: C1020 - Interior Doors**

**Location:** Interior

**Distress:** Beyond Service Life

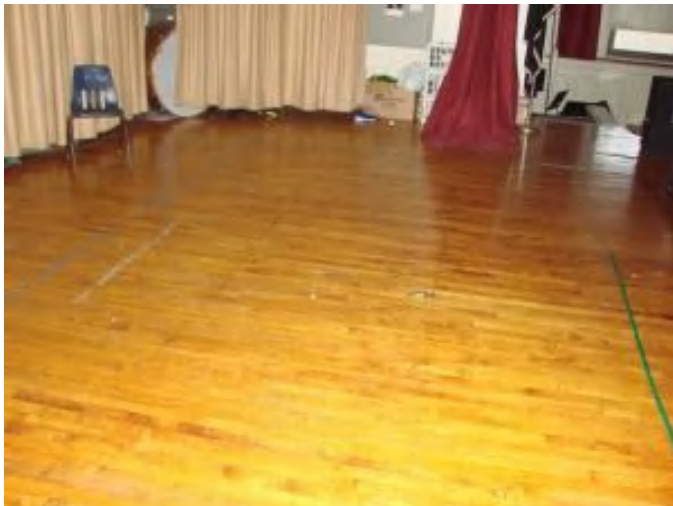
**System: C3020414 - Wood Flooring**

**Location:** Interior

**Distress:** Maintenance Required

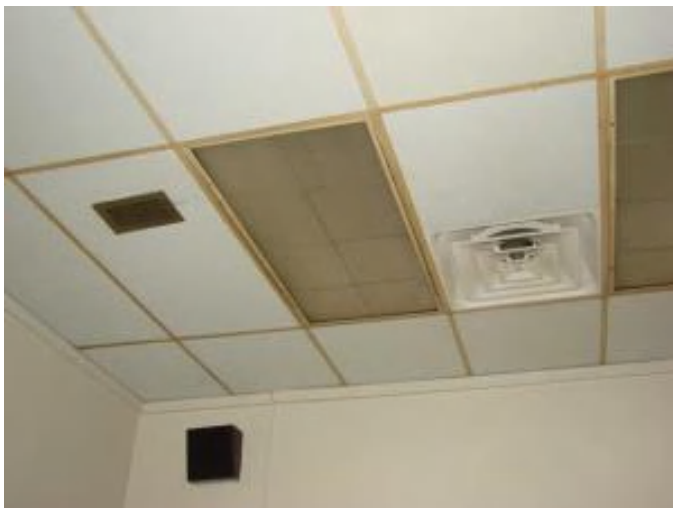
**System: C3030 - Ceiling Finishes**

**Location:** Interiors

**Distress:** Beyond Service Life

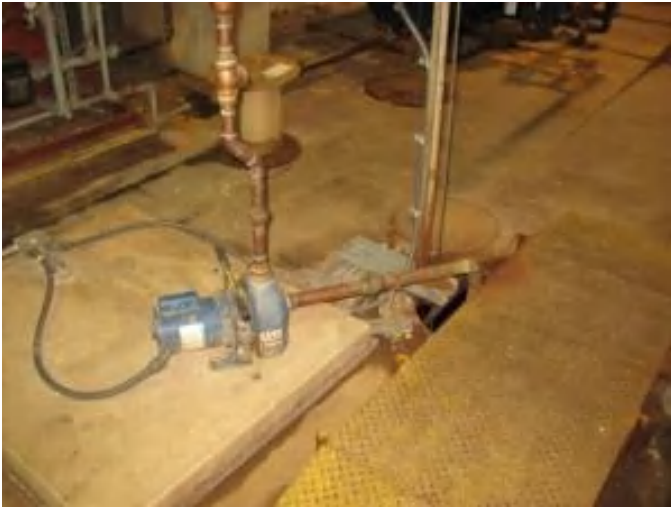
**System: D2030 - Sanitary Waste**

**Location:** Basement

**Distress:** Beyond Service Life

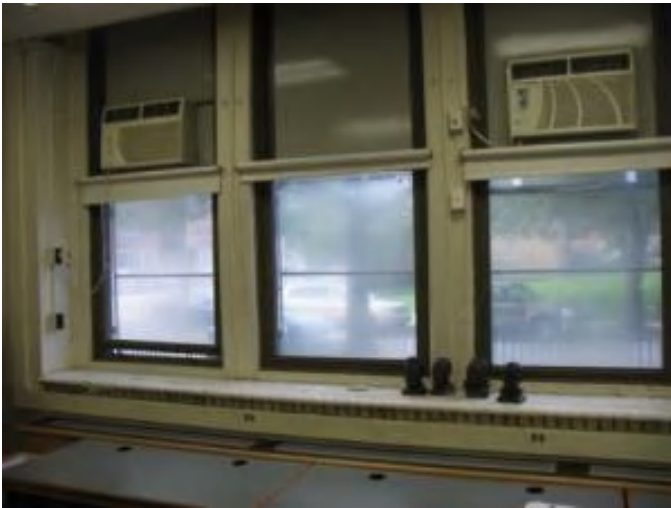
**System: D3030 - Cooling Generating Systems**

**Location:** Throughout building

**Distress:** Inadequate

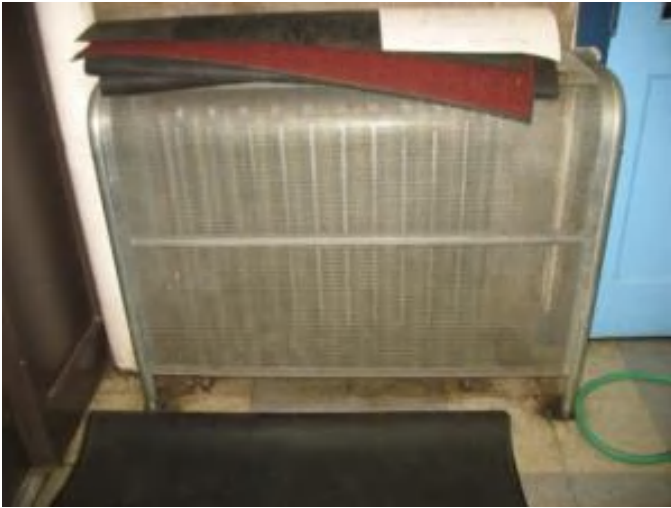
**System: D3040 - Distribution Systems**

**Location:** Throughout building

**Distress:** Health Hazard / Risk

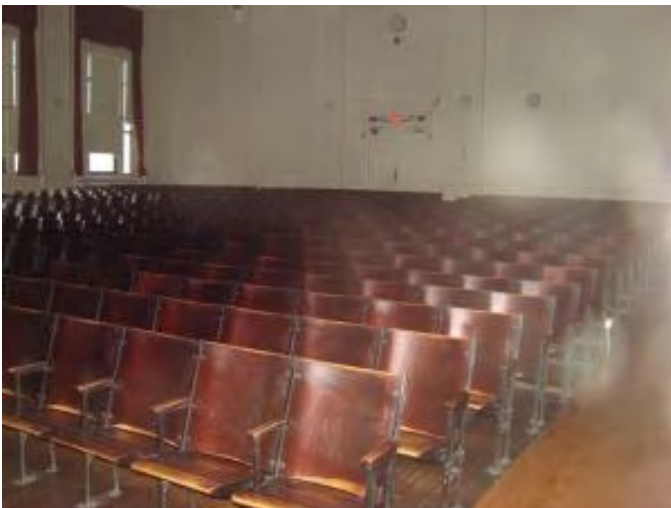
**System: D3040 - Distribution Systems**

**Location:** Auditorium

**Distress:** Building / MEP Codes

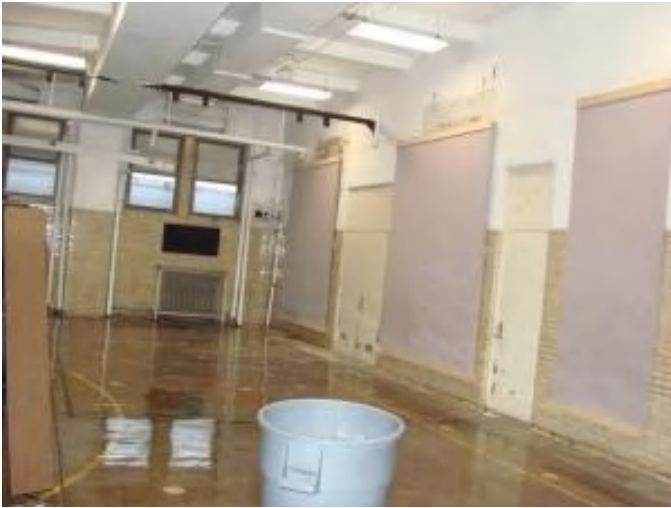
**System: D3040 - Distribution Systems**

**Location:** Cafeteria

**Distress:** Building / MEP Codes

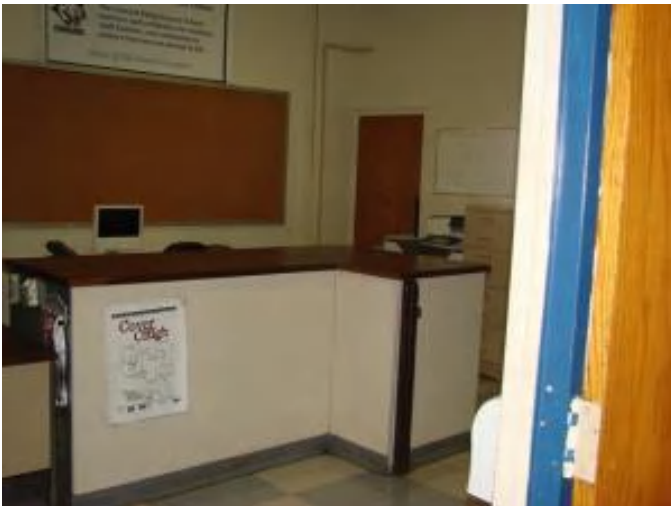
**System: D3040 - Distribution Systems**

**Location:** Administration

**Distress:** Building / MEP Codes

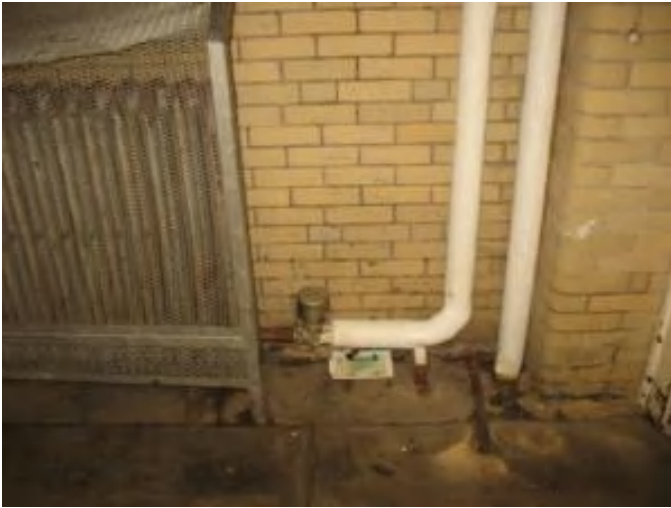
**System: D3060 - Controls & Instrumentation**

**Location:** Throughout building

**Distress:** Inadequate

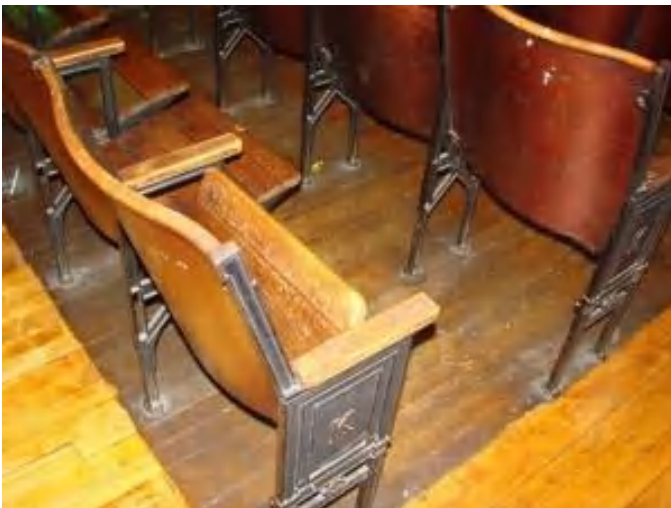
**System: E2010 - Fixed Furnishings**

**Location:** Auditorium

**Distress:** Appearance

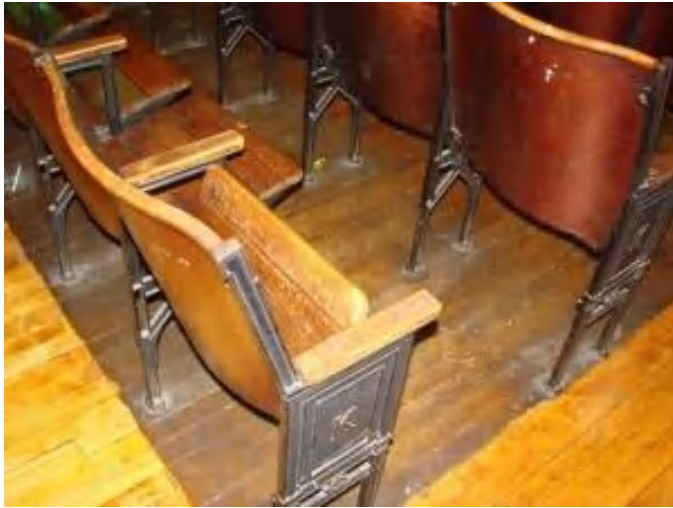
**System: E2010 - Fixed Furnishings**

**Location:** 1st Floor/Auditorium

**Distress:** Maintenance Required

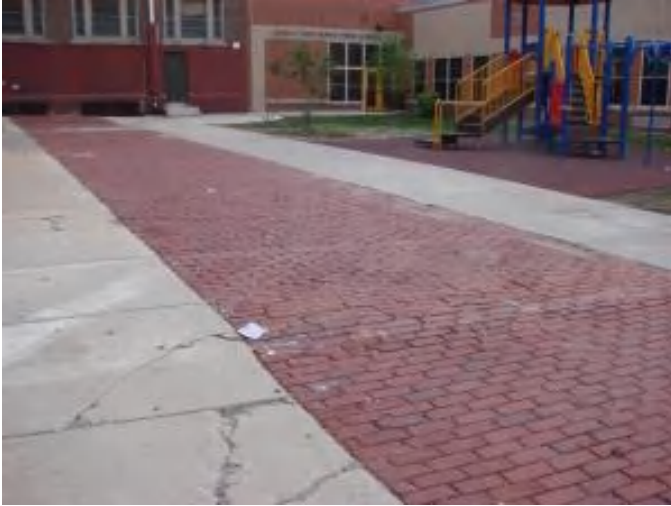
#### System: G2030 - Pedestrian Paving

**Location:** Site

**Distress:** Damaged

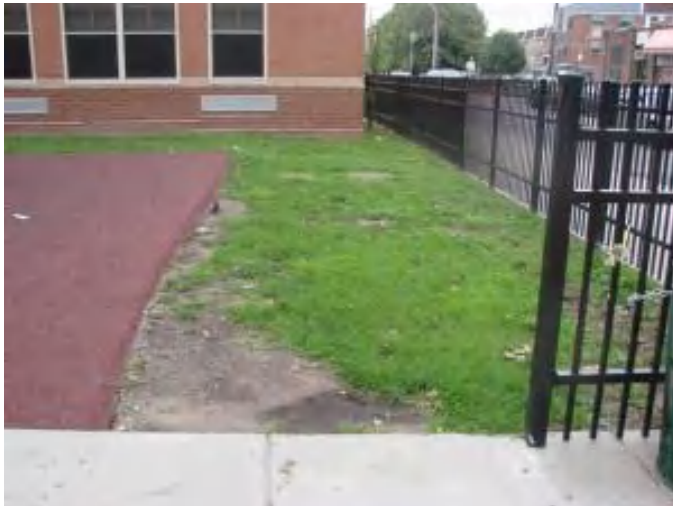
**System: G2050 - Landscaping & Irrigation**

**Location:** Site

**Distress:** Appearance

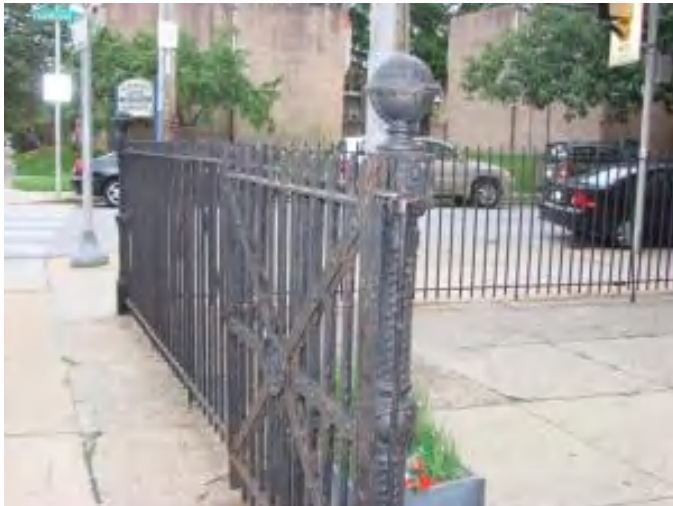
**System: G2040 - Site Development**

**Location:** Grounds

**Distress:** Security Issue
