Facility Condition Assessment Summary Report

Kelley, W D School

Site Assessment Report

January 30, 2017

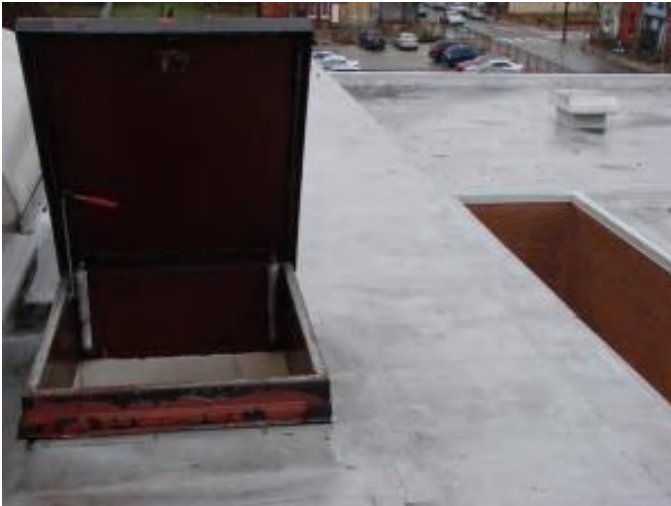
System: B3020 - Roof Openings

Location: Roof access

Distress: Building / MEP Codes

Notes: Install safety railing at roof access hatch near roof edge

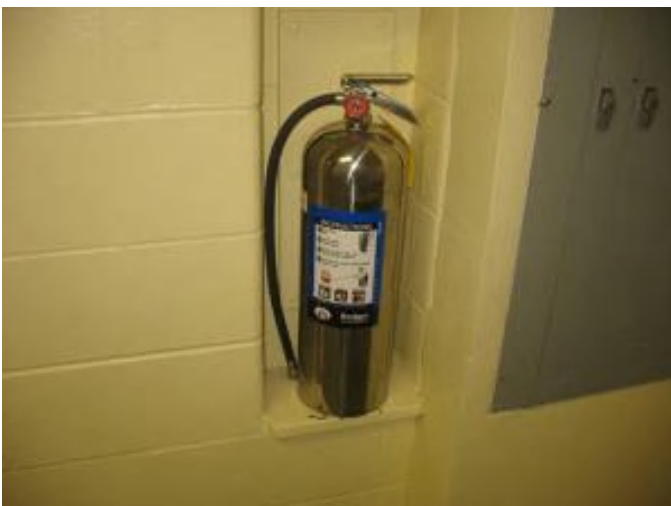
System: D4010 - Sprinklers

Location: Throughout building

Distress: Life Safety / NFPA / PFD

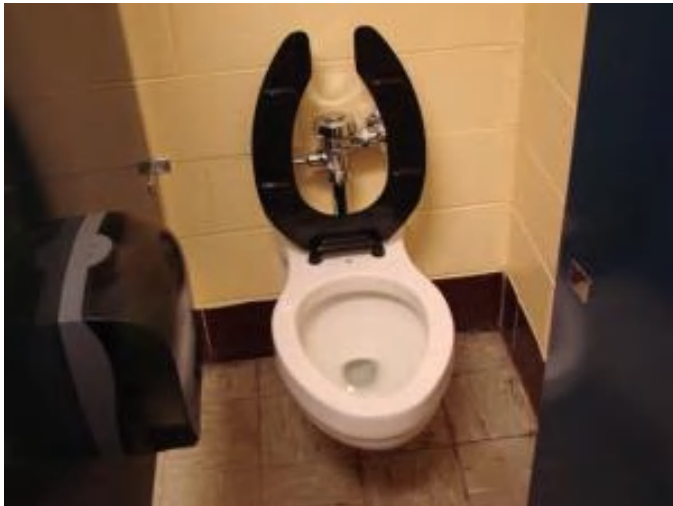
System: C1030 - Fittings

Location: Toilets

Distress: Accessibility

Notes: Replace non-ADA compliant toilet partitions; reconfigure remaining toilet partitions

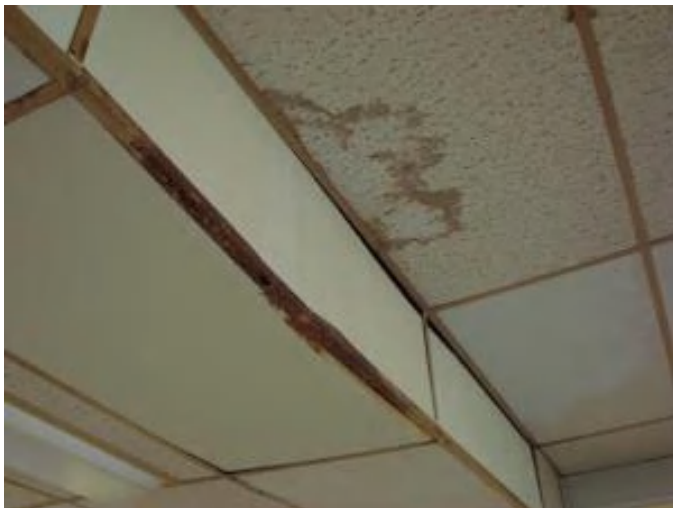
System: C3030 - Ceiling Finishes

Most ceilings are exposed structural painted concrete with 2x2 suspended acoustical panels installed in corridors, office and auditorium in various conditions. Ceilings in some corridors are damaged and beyond their service life. Ceiling in gymnasium is exposed painted metal structure in good condition.

Location: B456001;Kelley, William

Distress: Damaged

Notes: Replace suspended acoustic ceiling system – 25% of suspended ceiling damaged

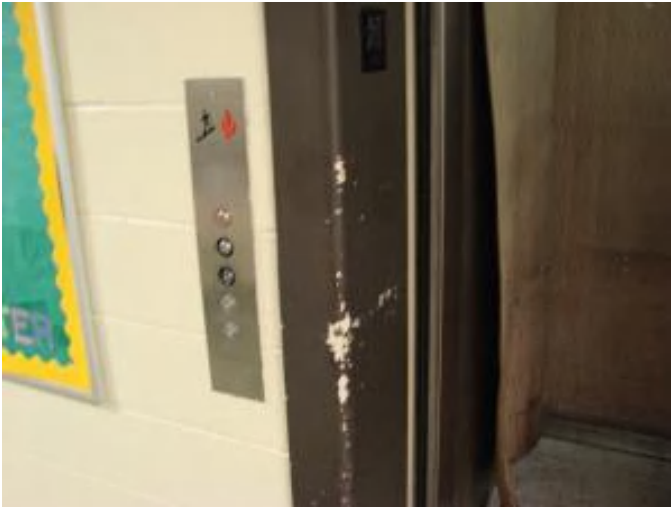
System: D1010 - Elevators and Lifts

The building has 1200 lb traction elevator, original to the building. Cabin size does not conform to ADA requirement and its finishes are old and deteriorating.

Location: Elevator

Distress: Accessibility

Notes: Replace existing elevator with an ADA compliant 2500 lb elevator serving all floors

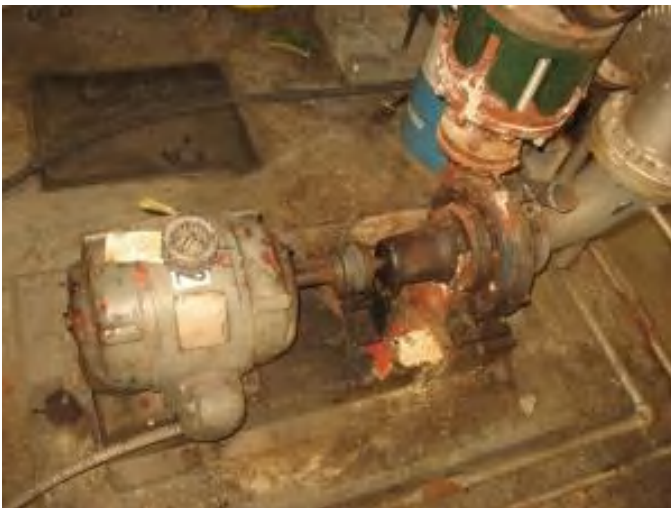
System: D3020 - Heat Generating Systems

Location: Boiler room

Distress: Beyond Service Life

Notes: Replace two (2) 7.5HP end-suction hot water supply pumps in the boiler room which are beyond their service lives and in poor condition.

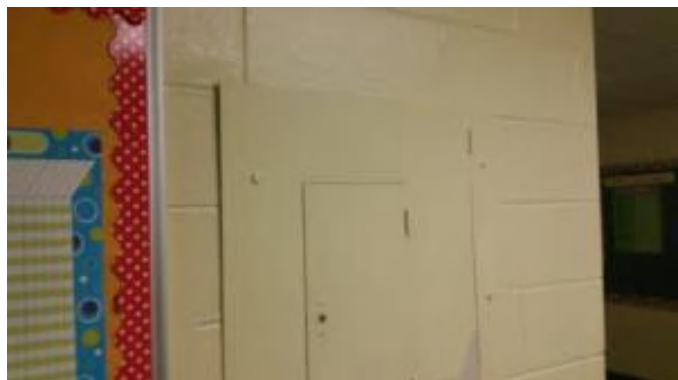
System: D5010 - Electrical Service/Distribution

Location: throughout the building

Distress: Beyond Service Life

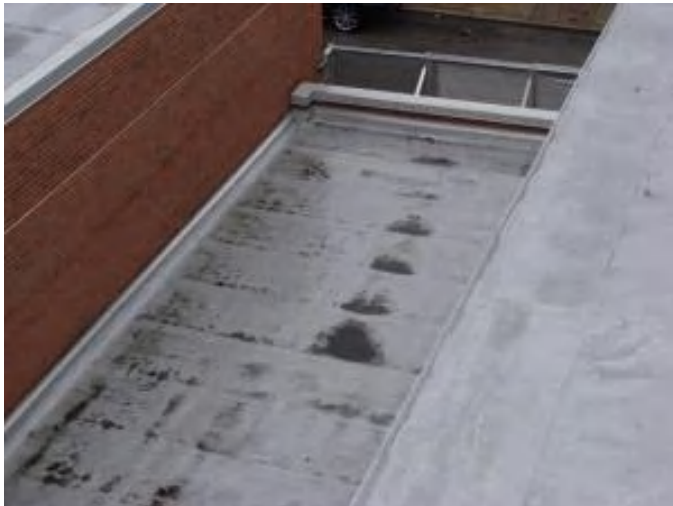
System: B2010 - Exterior Walls

Location: Lobby roof

Distress: Health Hazard / Risk

Notes: Install caged ladder to access lower roof over entry/lobby area

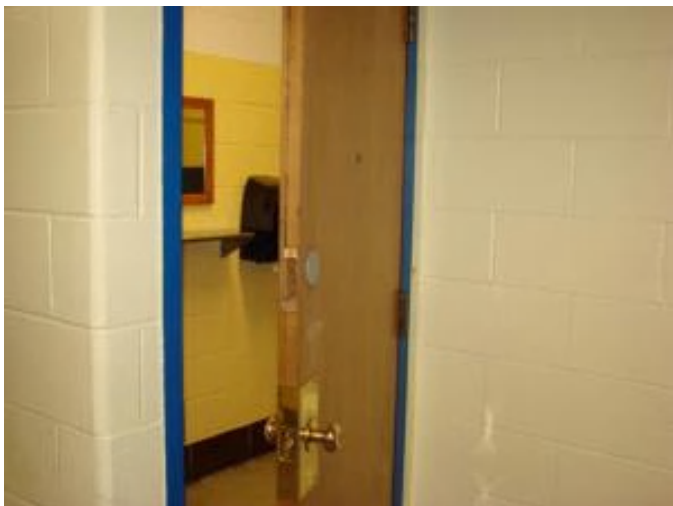
System: C1020 - Interior Doors

Location: Throughout

Distress: Accessibility

Notes: Replace interior doors hardware with lever type handles for accessibility

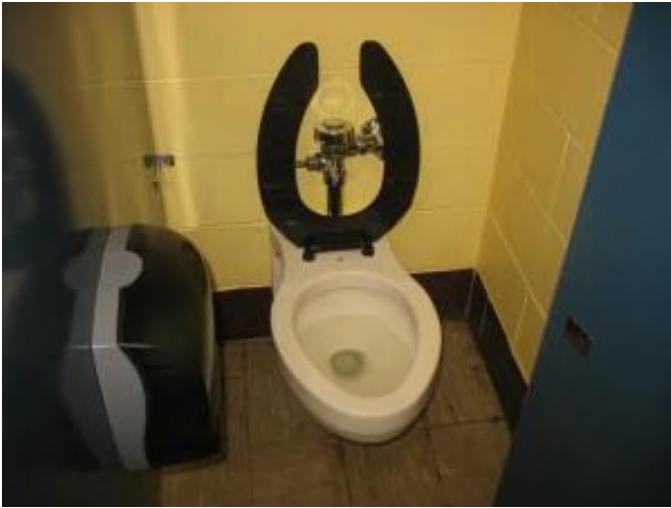
System: D2010 - Plumbing Fixtures

Location: Restrooms

Distress: Beyond Service Life

Notes: Replace thirty five (35) water closets, in use beyond their service life, in the restrooms with new code compliant fixtures.

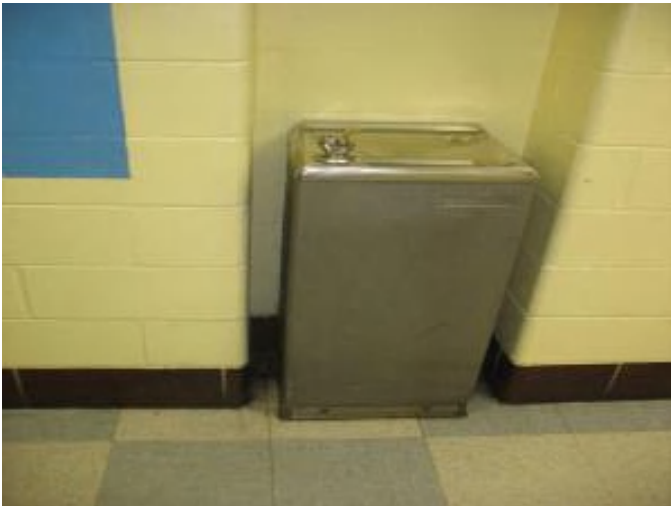
System: D2010 - Plumbing Fixtures

Drinking fountains in the corridors are a mixture of wall hung units and floor standing units with integral refrigerated coolers. Many are beyond their service life and should be replaced; most are NOT accessible type.

Location: Corridors

Distress: Beyond Service Life

Notes: Replace four (4) wall hung drinking fountains and integral refrigerated coolers in the corridors. These units are beyond their service life and most are NOT accessible type.

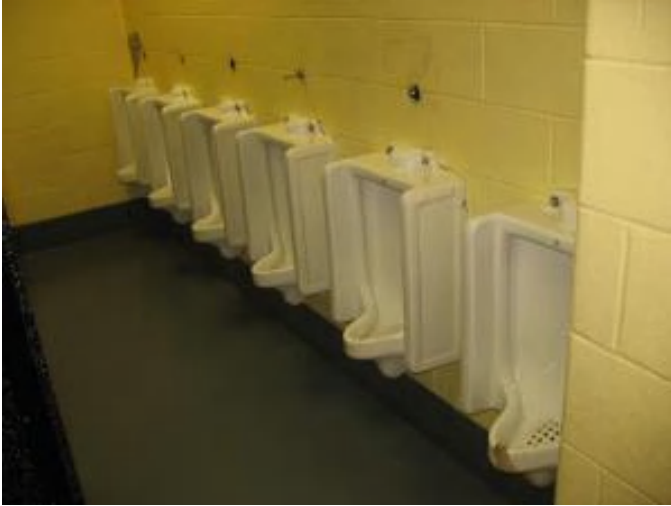
System: D2010 - Plumbing Fixtures

Location: Restrooms

Distress: Beyond Service Life

Notes: Replace eighteen (18) urinals, in use beyond their service life, in the restrooms with new low flow fixtures.

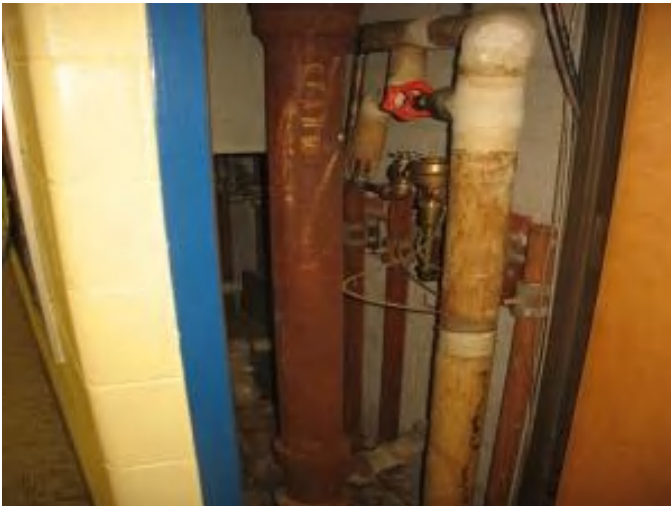
System: D2030 - Sanitary Waste

The maintenance staff reported mostly minor problems with the sanitary waste piping systems. However, the sewer piping has been in service for over 50 years and will require more frequent attention from the maintenance staff as time passes. The District should hire a qualified contractor to examine the sanitary waste piping using video cameras to locate and replace any damaged piping and to further quantify the extent of potential failures.

Location: Throughout building

Distress: Beyond Service Life

Notes: Hire a qualified contractor to perform a detailed examination of the sanitary waste piping using visual inspection and video cameras to locate and replace any damaged piping and to further quantify the extent of potential failures.

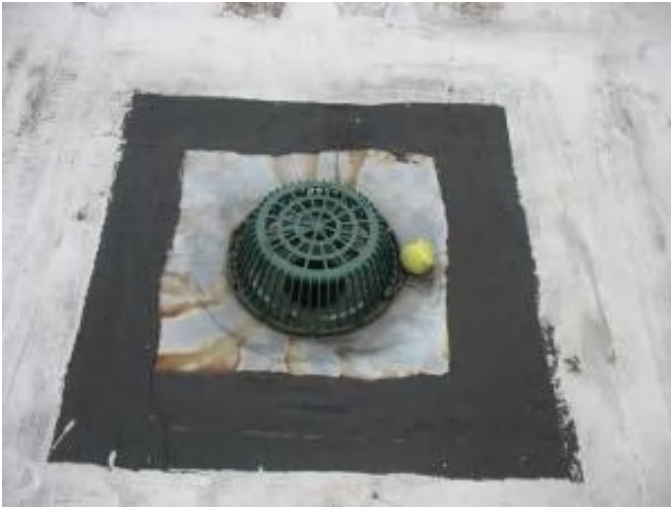
System: D2040 - Rain Water Drainage

The rain water drains from the roof are routed through mechanical chases in the building and appear to be original. The piping is cast iron with hub and spigot fittings and has been in use beyond its service life. The drain piping should be inspected by a qualified contractor and repaired as necessary.

Location: Throughout building

Distress: Beyond Service Life

Notes: Hire a qualified contractor to perform a detailed examination of the rain water drainage piping using visual inspection and video cameras to locate and replace any damaged piping and to further quantify the extent of potential failures.

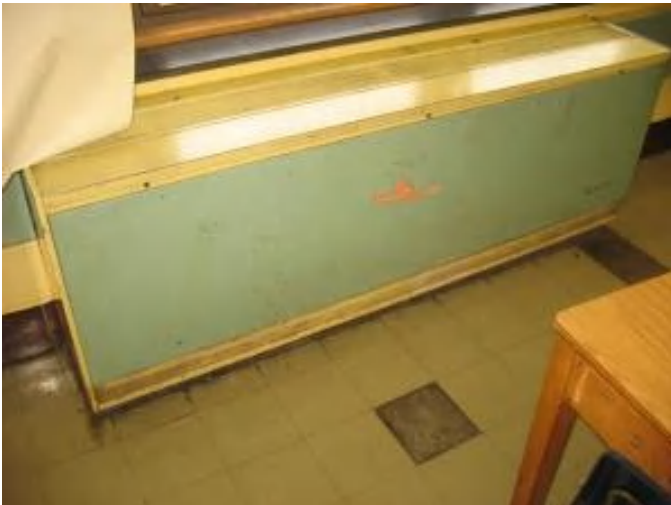
System: D3040 - Distribution Systems

Location: Classrooms

Distress: Beyond Service Life

Notes: Remove the existing unit ventilators and install units with hot and chilled water coils and integral heat exchangers to introduce outdoor air to the building.

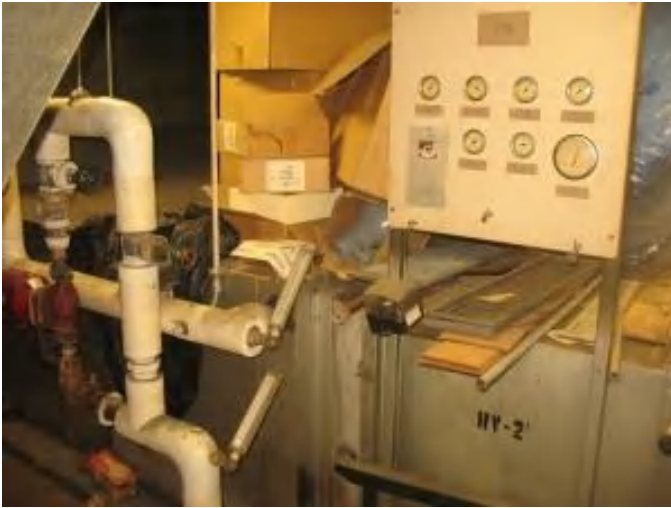
System: D3040 - Distribution Systems

Location: Gymnasium/Cafeteria

Distress: Beyond Service Life

Notes: Remove the existing heating and ventilation unit, which is beyond its service life, and provide ventilation for the Gymnasium/Cafeteria by installing a fan coil air handling unit hung from the structure with outdoor air ducted to the unit from louvers in the window openings.

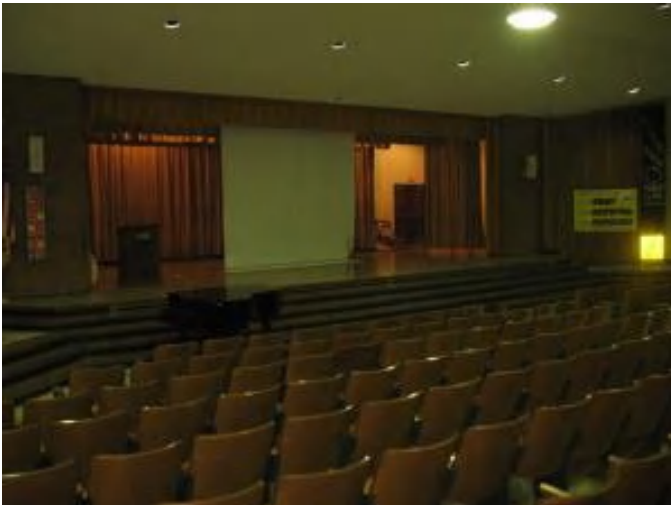
System: D3040 - Distribution Systems

Location: Auditorium

Distress: Building / MEP Codes

Notes: Provide ventilation for the Auditorium by installing a fan coil air handling unit installed in the basement boiler room with outdoor air ducted to the unit from existing louvers.

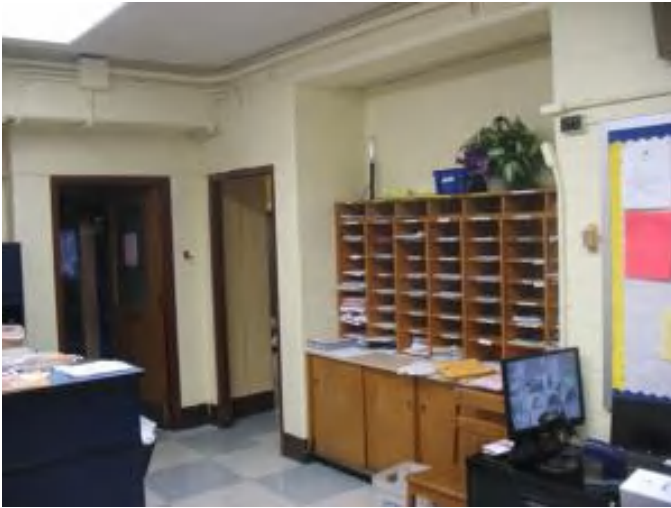
System: D3040 - Distribution Systems

Location: Administration offices

Distress: Beyond Service Life

Notes: Remove the existing heating and ventilation unit, which is beyond its service life, and provide ventilation for the administration offices by installing a fan coil air handling unit hung from the structure with outdoor air ducted to the unit from the existing louvers.

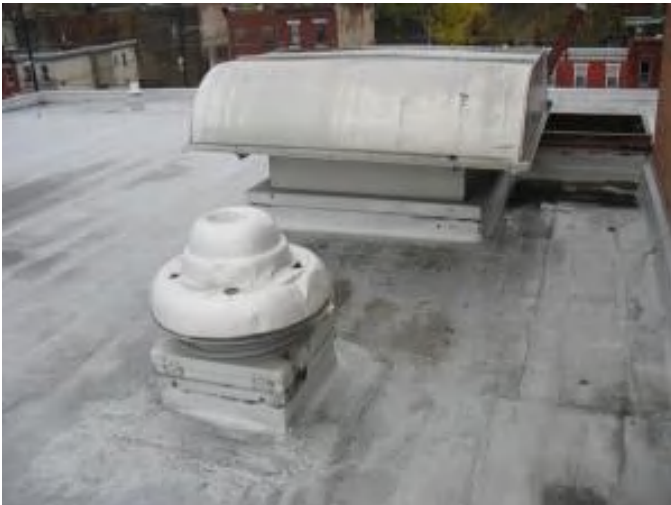
System: D3040 - Distribution Systems

Location: Roof

Distress: Beyond Service Life

Notes: Replace nine (9) roof mounted power ventilators allowing relief air to escape from the building which are in poor condition.

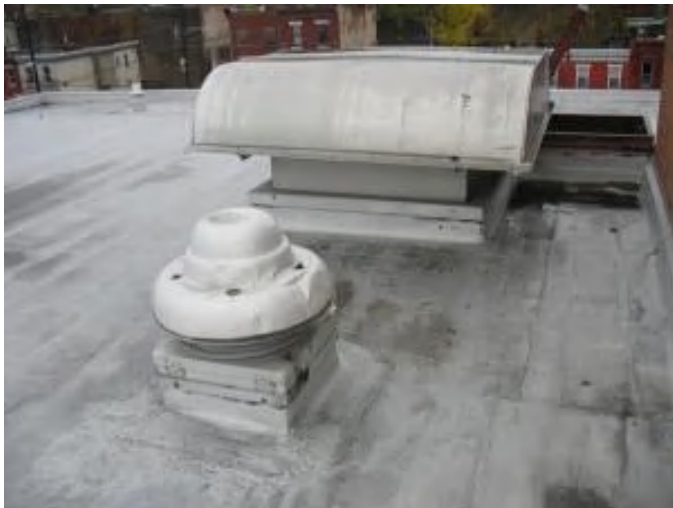
System: D3040 - Distribution Systems

Exhaust for the restrooms, art lab, and science lab is provided by four (4) roof mounted exhaust fans. One (1) exhaust fan serves the girls' restrooms, one (1) serves the boys' restrooms, and the other two (2) serve the science and art labs. The existing roof mounted exhaust fans are operational according to the Building Engineer but are in poor condition and should be replaced. Nine (9) roof mounted power ventilators provide relief air for the corridors, are in poor condition, and should be replaced.

Location: Roof

Distress: Beyond Service Life

Notes: Replace four (4) roof mounted exhaust fans serving the restrooms, science lab, and art lab which are in poor condition.

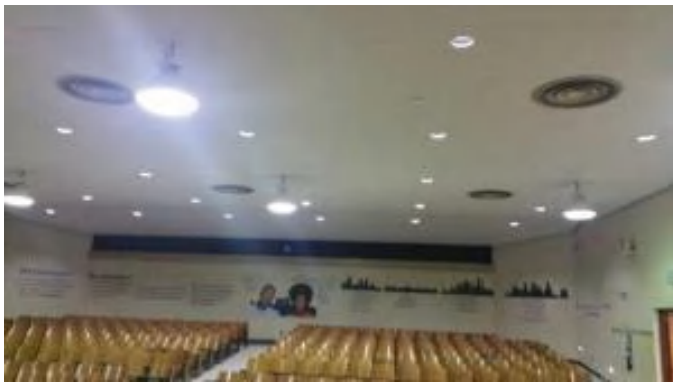
System: D5020 - Lighting and Branch Wiring

Location: throughout the building

Distress: Beyond Service Life

Notes: Install new lighting system for 80% of the building.
74,000 SF x 80% = 59,200 SF

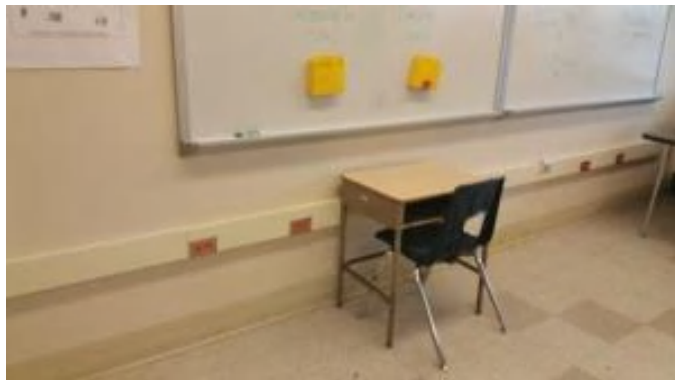
System: D5020 - Lighting and Branch Wiring

Location: throughout the building

Distress: Inadequate

Notes: Install new receptacles for the building (80% of the building)
 $74,000 \times 80\% = 59,200$ SF

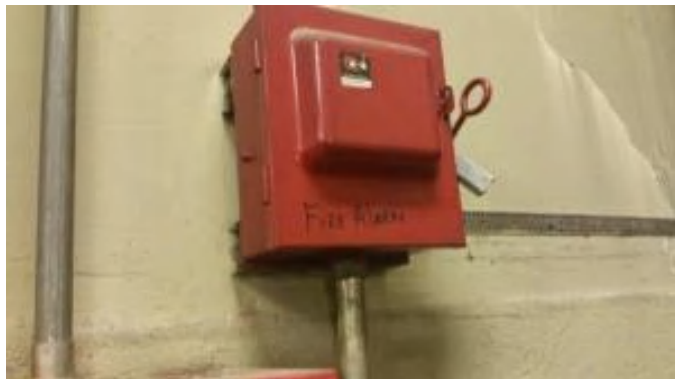
System: D5030 - Communications and Security

Location: throughout the building

Distress: Health Hazard / Risk

Notes: Install new automated/addressable FA system.

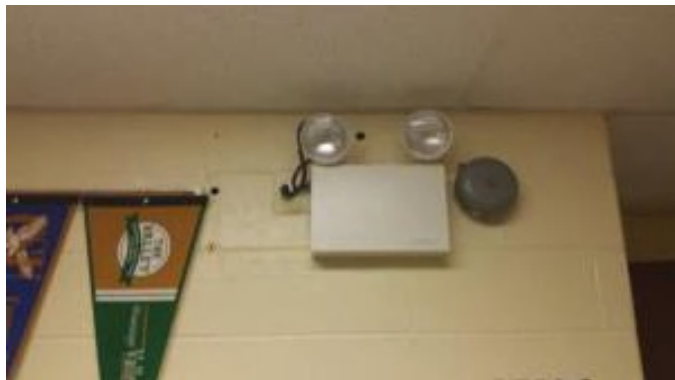
System: D5090 - Other Electrical Systems

Location: throughout the building

Distress: Beyond Service Life

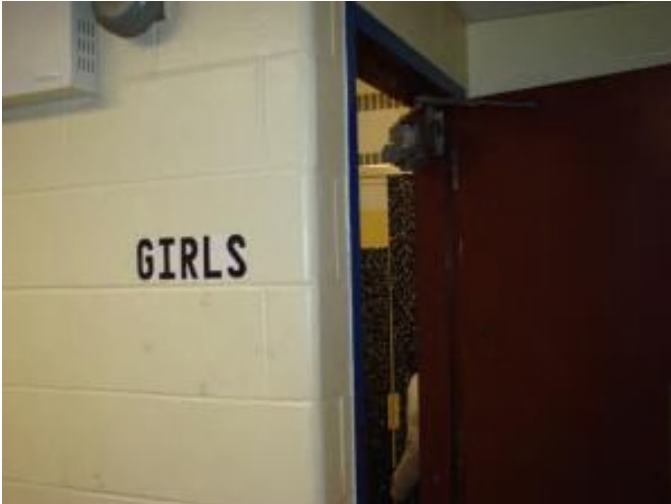
System: C1030 - Fittings

Location: Throughout

Distress: Inadequate

Notes: Install new signage throughout

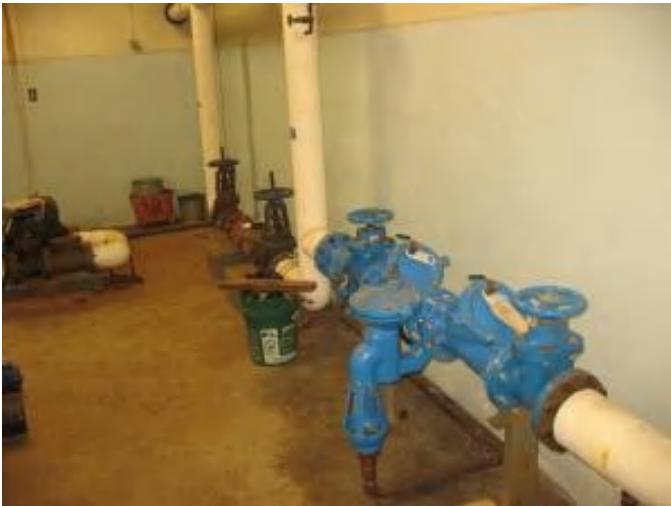
System: D2020 - Domestic Water Distribution

Location: Throughout building

Distress: Beyond Service Life

Notes: Hire a qualified contractor to perform a detailed inspection of the domestic water piping, in use beyond its service life, and replace any damaged piping.

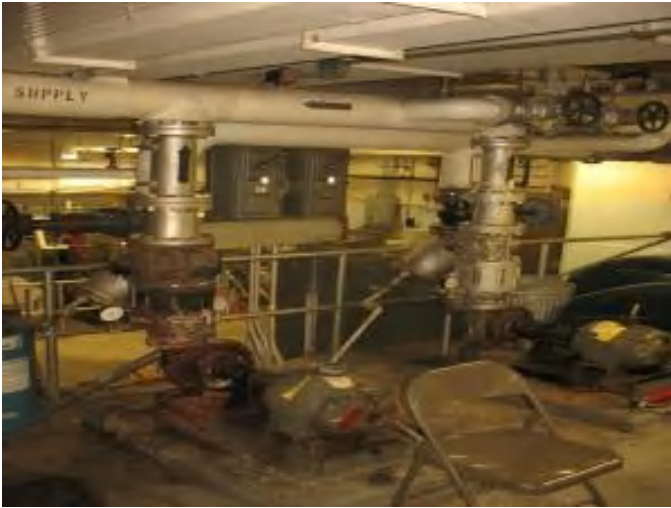
System: D3040 - Distribution Systems

Location: Throughout building

Distress: Beyond Service Life

Notes: Hire a qualified contractor to examine the distribution piping, in service for over 50 years, and replace any damaged piping and to further quantify the extent of potential failures.

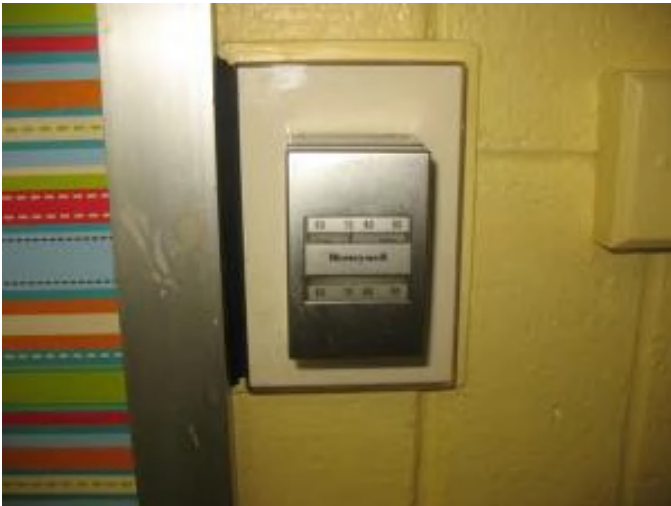
System: D3060 - Controls & Instrumentation

Location: Throughout building

Distress: Beyond Service Life

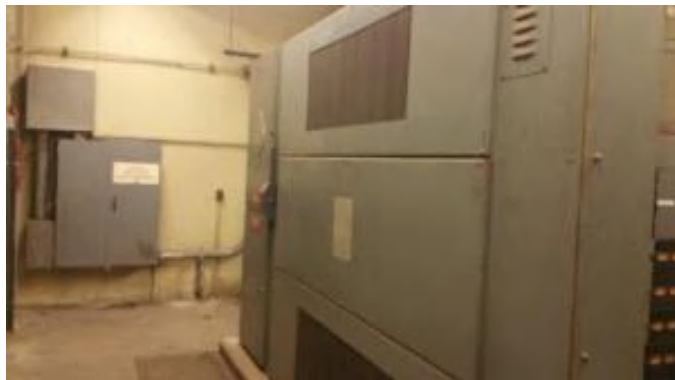
System: D5010 - Electrical Service/Distribution

Location: electrical room

Distress: Beyond Service Life

Notes: Install a new and upgraded electrical service for this school to handle existing loads plus any additional mechanical loads.

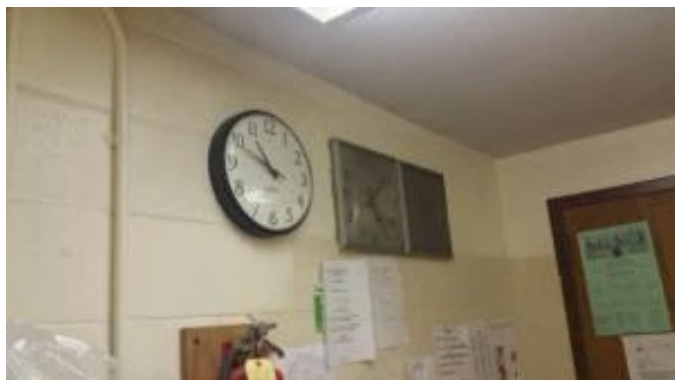
System: D5030 - Communications and Security

Location: throughout the building

Distress: Beyond Service Life

Notes: Install new clock system

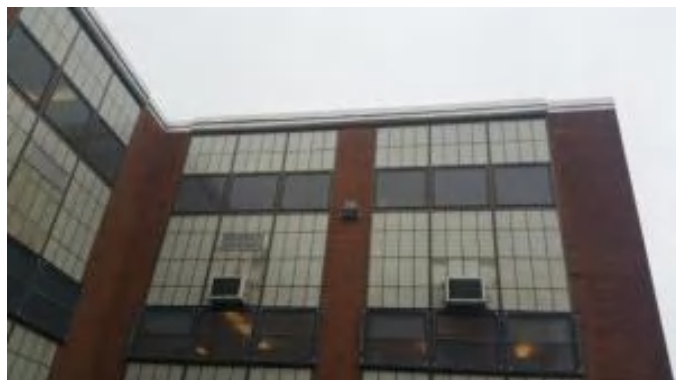
System: D5030 - Communications and Security

Location: throughout the building grounds

Distress: Inadequate

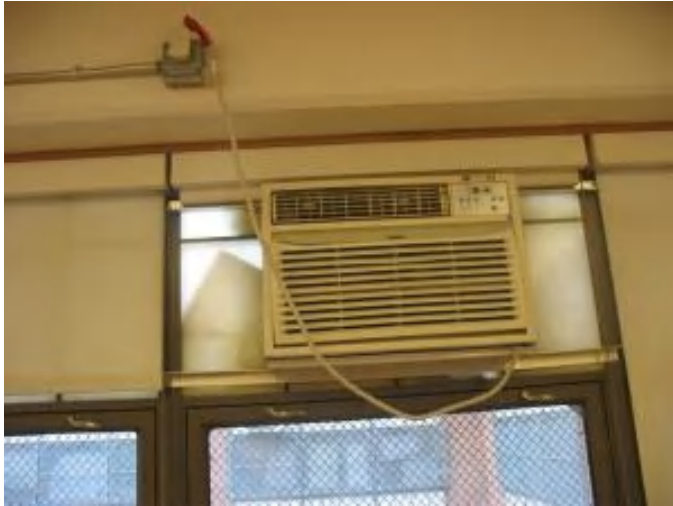
System: D3030 - Cooling Generating Systems

Location: Throughout building

Distress: Inadequate

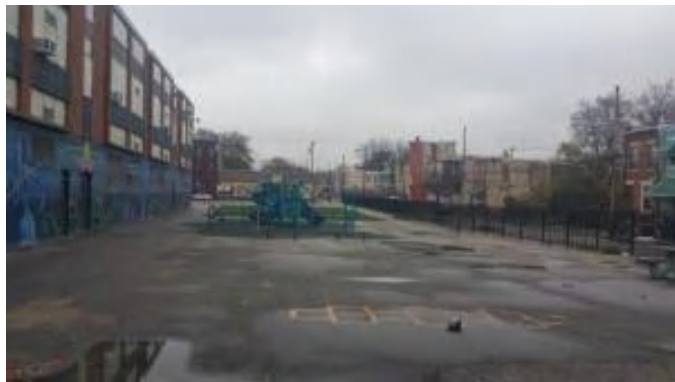
System: G4020 - Site Lighting

Location: grounds

Distress: Security Issue

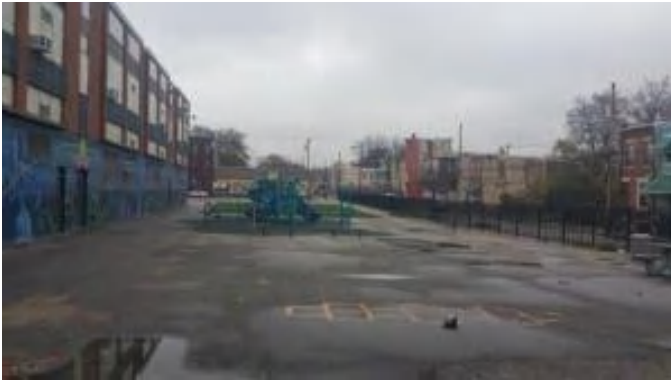
System: G4030 - Site Communications & Security

Location: grounds

Distress: Inadequate
