Facility Condition Assessment Summary Report

Kelly, JB School

Facility Assessment, December 2015

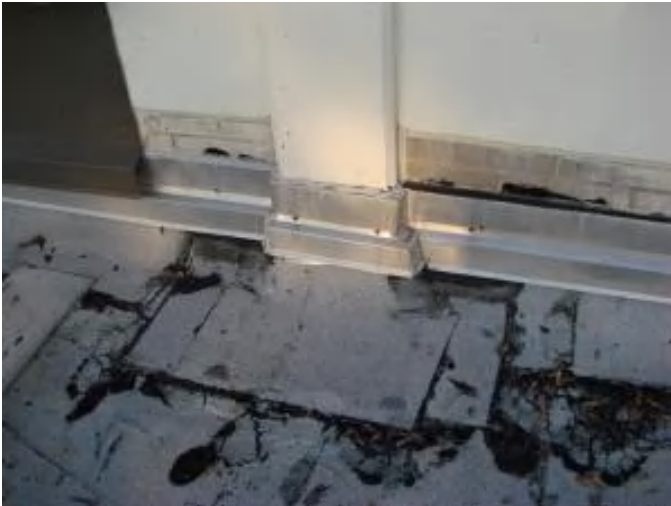
System: B3010105 - Built-Up

Location: Roof

Distress: Beyond Service Life

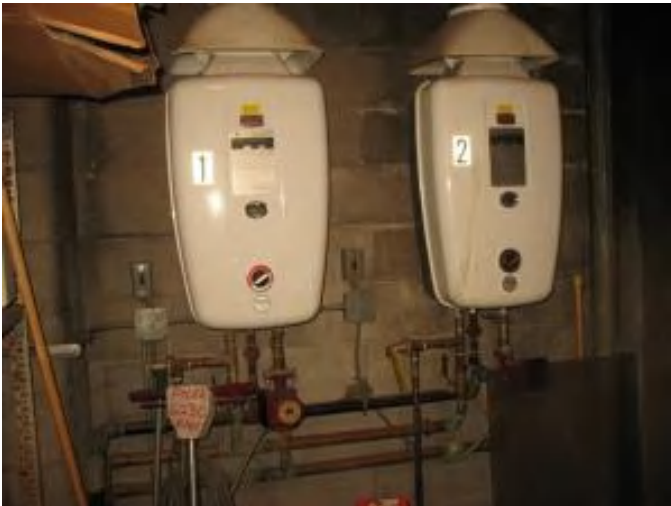
System: D2020 - Domestic Water Distribution

Location: Mechanical room

Distress: Beyond Service Life

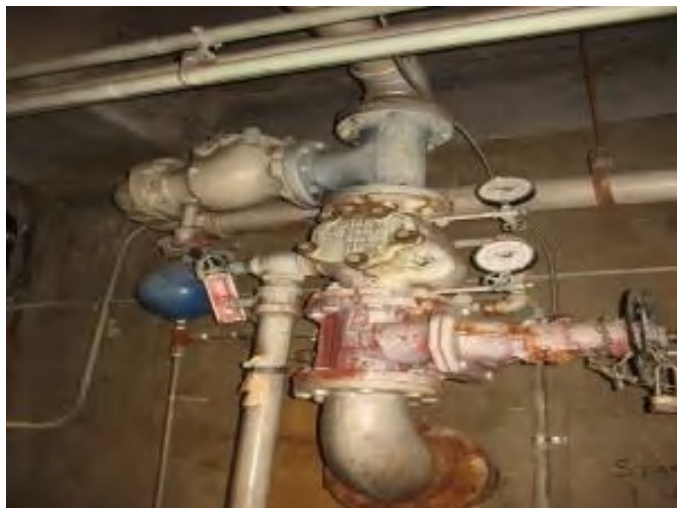
System: D4010 - Sprinklers

Location: Throughout building

Distress: Life Safety / NFPA / PFD

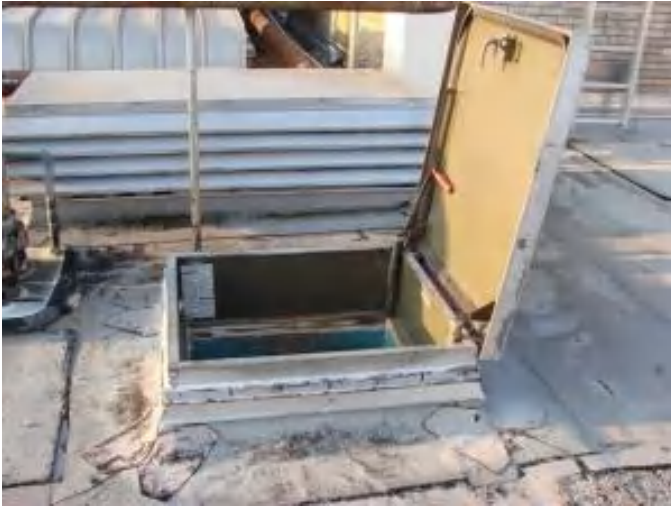
System: B3020 - Roof Openings

Location: roof

Distress: Beyond Service Life

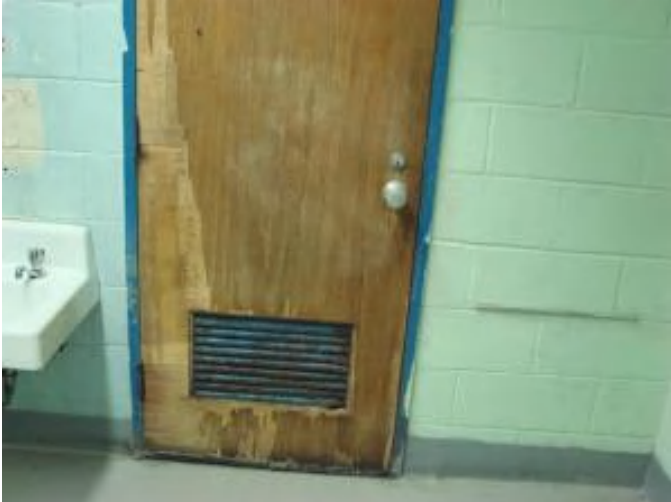
System: C1020 - Interior Doors

Location: Throughout

Distress: Beyond Service Life

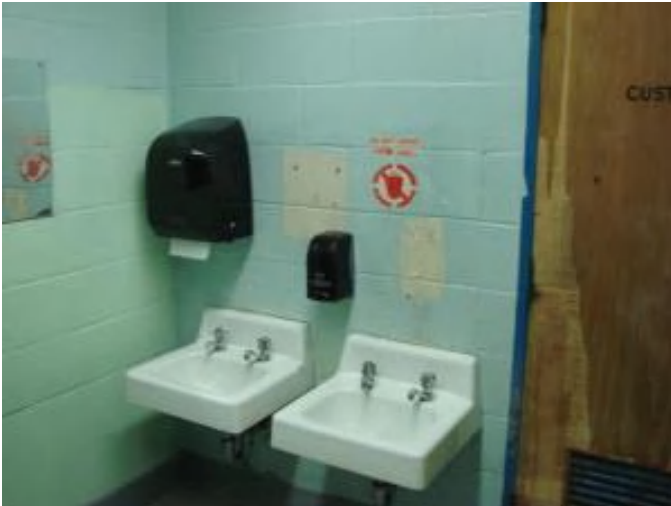
System: C1030 - Fittings

Location: Toilets
Distress: Damaged
Category: 3 - Operations / Maint.
Priority: 2 - Response Time (2-3 yrs)
Correction: Replace toilet accessories - select accessories and quantity
Qty: 80.00
Unit of Measure: Ea.
Estimate: \$157,299.46
Assessor Name: Craig Anding
Date Created: 02/24/2016

Notes: Replace toilet accessories – broken and missing

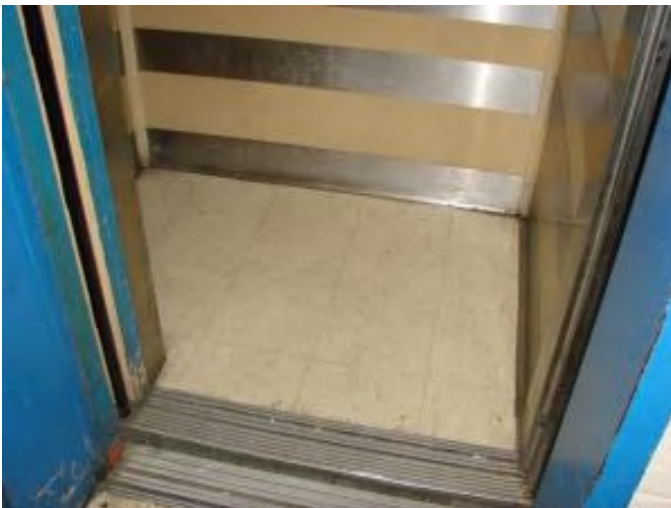
System: D1010 - Elevators and Lifts

Location: Elevator
Distress: Accessibility
Category: 2 - Code Compliance
Priority: 2 - Response Time (2-3 yrs)
Correction: Modernize or upgrade the elevator cab or to comply with ADA - exact scope of work estimate not available - total cost is sufficient
Qty: 1.00
Unit of Measure: Ea.
Estimate: \$39,791.67
Assessor Name: Craig Anding
Date Created: 02/24/2016

Notes: Replace existing elevator with an ADA compliant 2500 lb elevator serving all floors

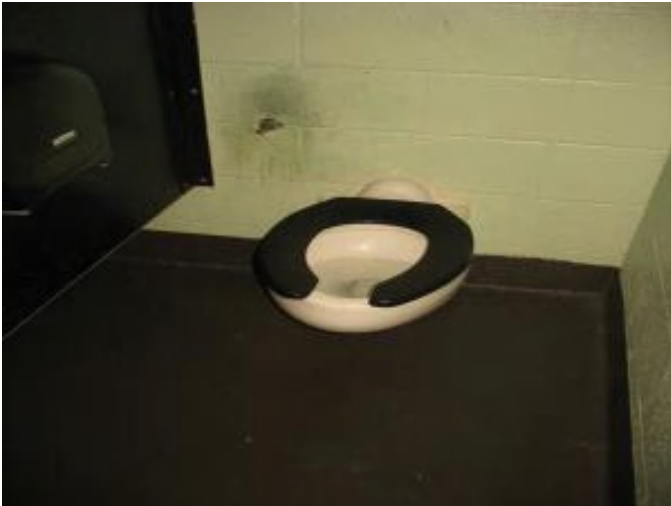
System: D2010 - Plumbing Fixtures

Location: Restrooms

Distress: Beyond Service Life

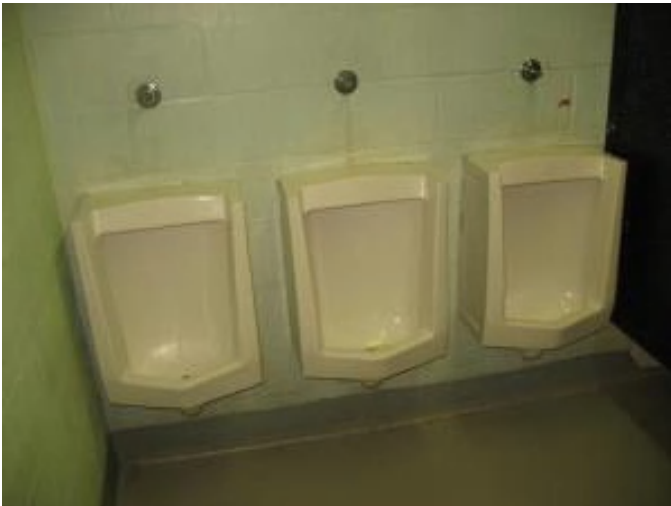
System: D2010 - Plumbing Fixtures

Location: Restrooms

Distress: Beyond Service Life

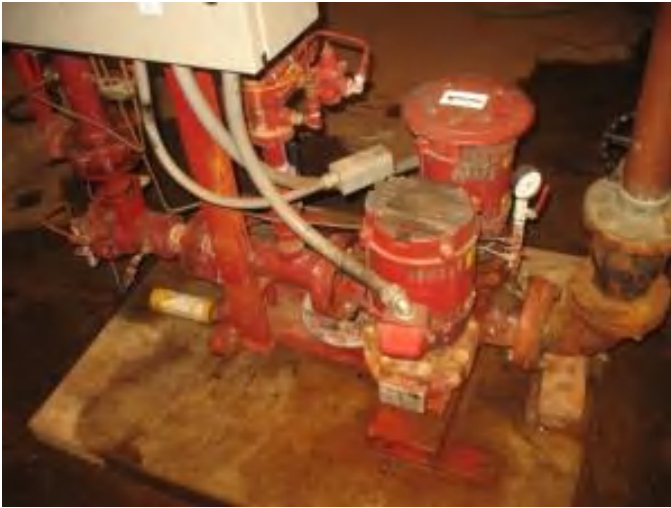
System: D2020 - Domestic Water Distribution

Location: Basement mechanical room
Distress: Damaged
Category: 3 - Operations / Maint.
Priority: 2 - Response Time (2-3 yrs)
Correction: Replace duplex domestic booster pump set (5 HP)
Qty: 1.00
Unit of Measure: Ea.
Estimate: \$54,205.69
Assessor Name: Craig Anding
Date Created: 02/11/2016

Notes: Replace the duplex 7.5HP domestic water booster pumps, expansion tank, and isolation valves on incoming domestic water line with a new skid mounted pressure booster system.

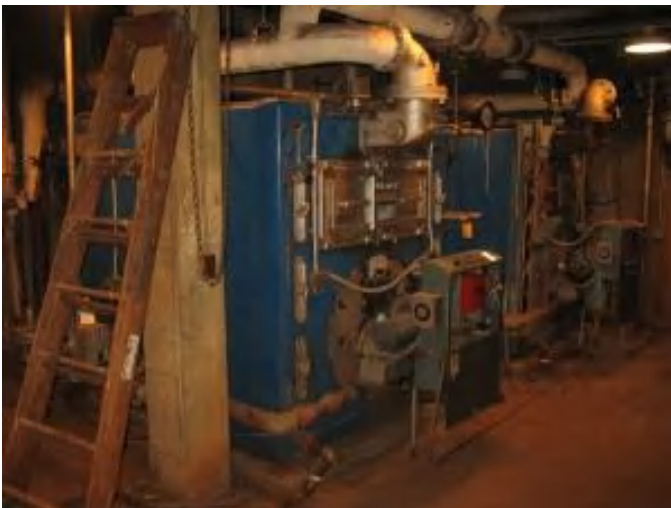
System: D3020 - Heat Generating Systems

Location: Basement mechanical room
Distress: Beyond Service Life
Category: 3 - Operations / Maint.
Priority: 2 - Response Time (2-3 yrs)
Correction: Replace boiler, cast iron sectional (100 HP)
Qty: 2.00
Unit of Measure: Ea.
Estimate: \$655,796.89
Assessor Name: Craig Anding
Date Created: 02/11/2016

Notes: Replace the two (2) existing 3,480MBH cast iron boilers, which are well beyond their service lives, including burners, and boiler stack.

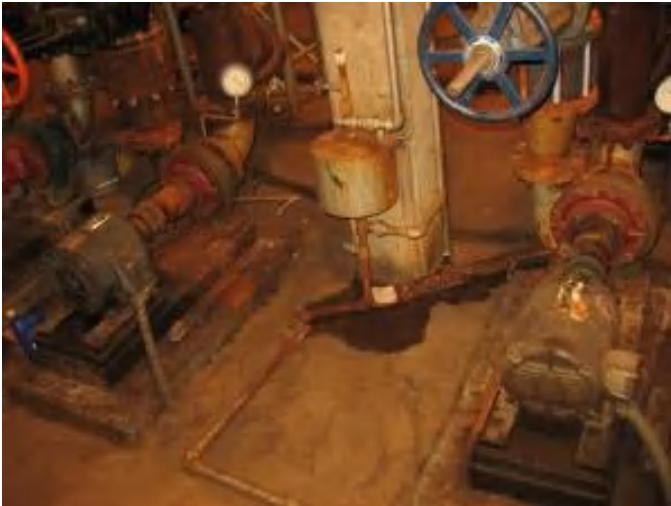
System: D3020 - Heat Generating Systems

Location: Basement mechanical room

Distress: Damaged

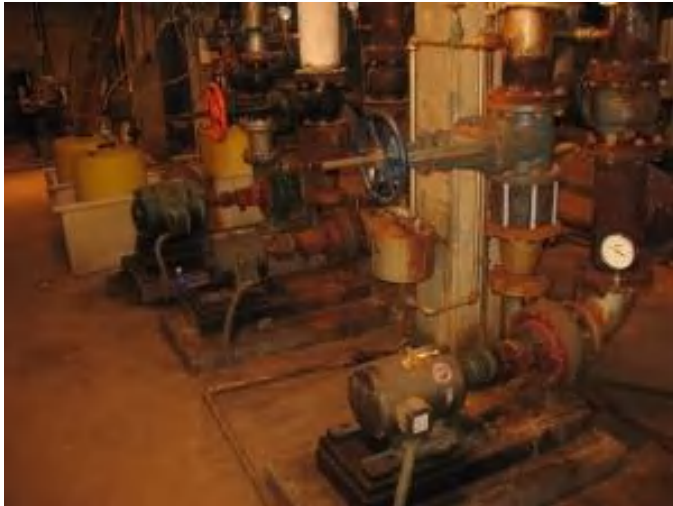
System: D3040 - Distribution Systems

Location: Throughout building
Distress: Beyond Service Life
Category: 3 - Operations / Maint.
Priority: 2 - Response Time (2-3 yrs)
Correction: Replace chilled water distribution piping (75KSF)
Qty: 101,976.00
Unit of Measure: S.F.
Estimate: \$1,370,925.52
Assessor Name: Craig Anding
Date Created: 02/11/2016

Notes: Hire a qualified contractor to examine the dual temperature distribution piping which is showing signs of rust damage, and perform additional testing to locate and replace any damaged piping and to further quantify the extent of potential failures.

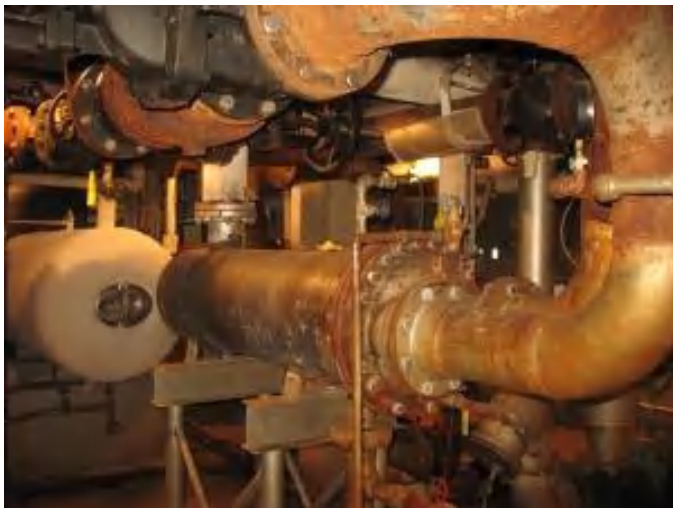
System: D3040 - Distribution Systems

Location: Basement mechanical room
Distress: Beyond Service Life
Category: 3 - Operations / Maint.
Priority: 2 - Response Time (2-3 yrs)
Correction: Replace shell and tube hydronic heat exchanger (240 gpm)
Qty: 1.00
Unit of Measure: Ea.
Estimate: \$200,755.91
Assessor Name: Craig Anding
Date Created: 02/11/2016

Notes: Replace the steam to water shell and tube heat exchanger serving the building heating water system.

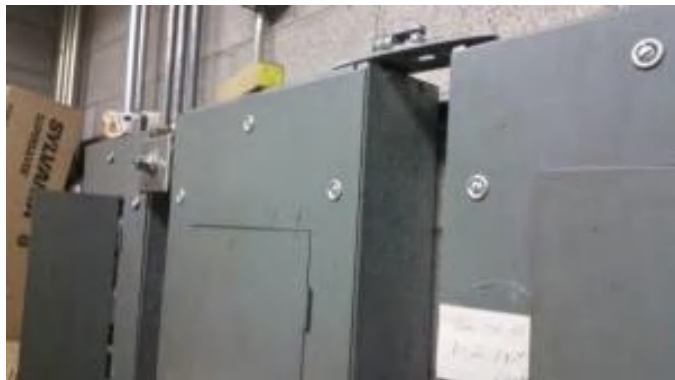
System: D5010 - Electrical Service/Distribution

Location: throughout the building

Distress: Beyond Service Life

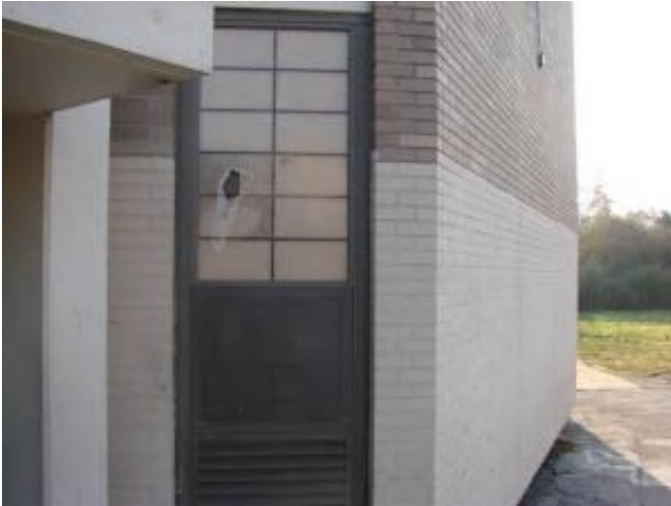
System: B2020 - Exterior Windows

Location: Throughout

Distress: Beyond Service Life

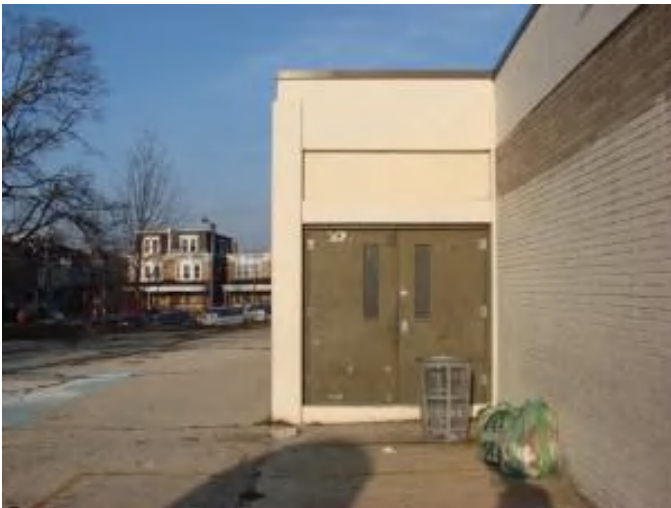
System: B2030 - Exterior Doors

Location: Throughout

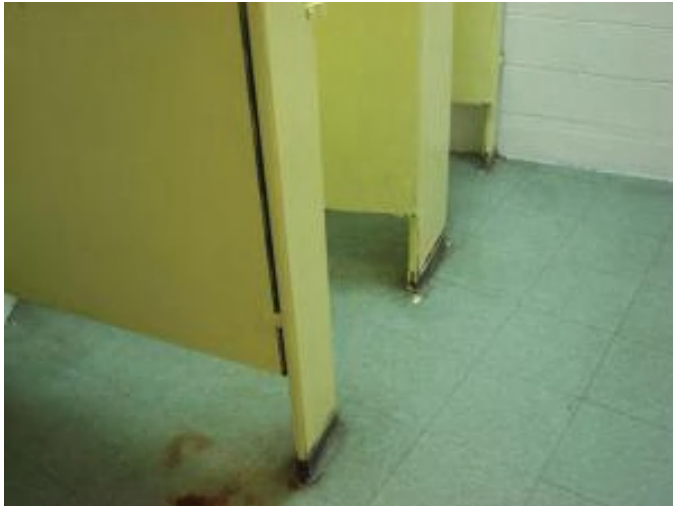
System: C1030 - Fittings

Location: Toilets
Distress: Beyond Service Life
Category: 3 - Operations / Maint.
Priority: 3 - Response Time (3-4 yrs)
Correction: Remove and replace toilet partitions
Qty: 80.00
Unit of Measure: Ea.
Estimate: \$205,312.38
Assessor Name: Craig Anding
Date Created: 02/24/2016

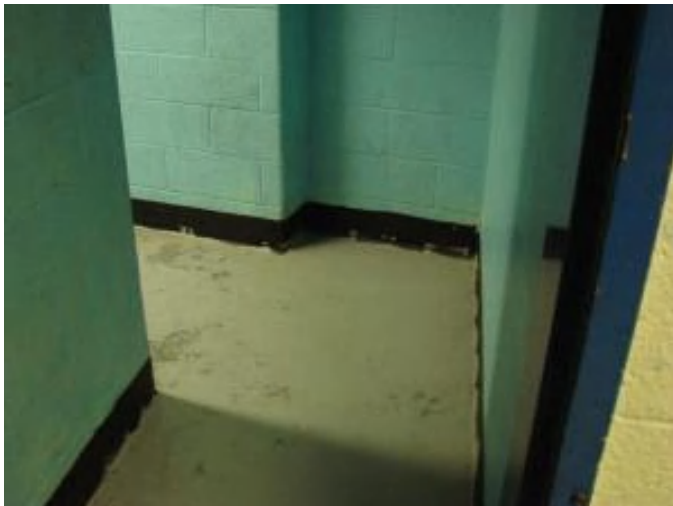
System: C3010230 - Paint & Covering

Location: Various
Distress: Appearance
Category: 3 - Operations / Maint.
Priority: 3 - Response Time (3-4 yrs)
Correction: Repair and repaint all interior walls - SF of wall surface
Qty: 40,000.00
Unit of Measure: S.F.
Estimate: \$270,955.08
Assessor Name: Craig Anding
Date Created: 02/24/2016

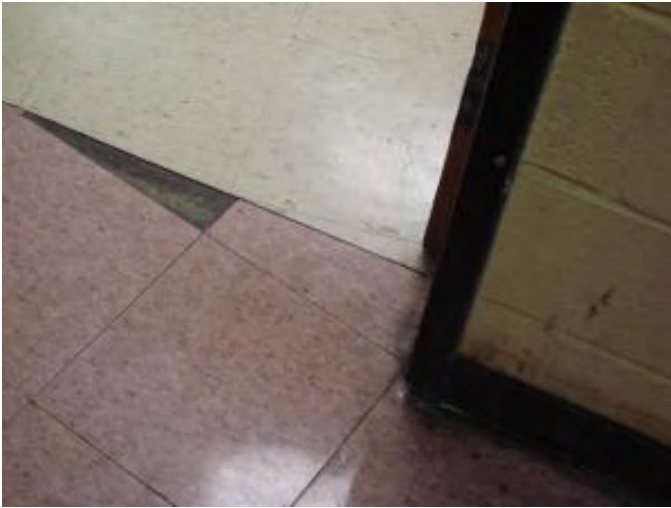
System: C3020413 - Vinyl Flooring

Location: Various
Distress: Damaged
Category: 3 - Operations / Maint.
Priority: 3 - Response Time (3-4 yrs)
Correction: Remove and replace VCT
Qty: 35,000.00
Unit of Measure: S.F.
Estimate: \$420,613.61
Assessor Name: Craig Anding
Date Created: 02/24/2016

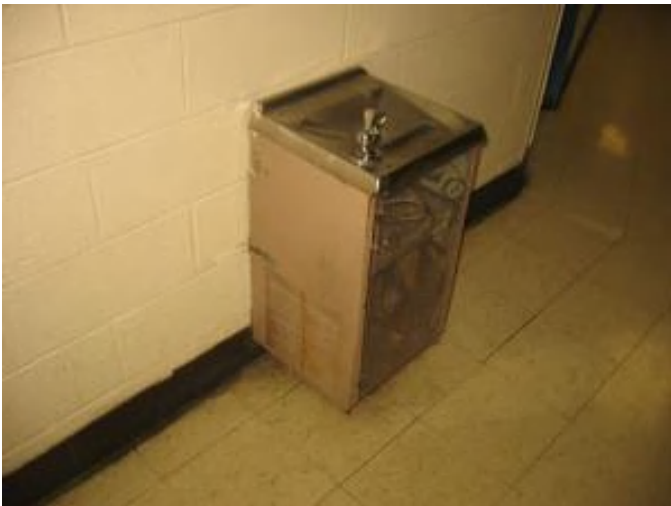
System: D2010 - Plumbing Fixtures

Location: Corridors
Distress: Beyond Service Life
Category: 3 - Operations / Maint.
Priority: 3 - Response Time (3-4 yrs)
Correction: Remove and replace water fountains to meet ADA - includes high and low fountains and new recessed alcove
Qty: 6.00
Unit of Measure: Ea.
Estimate: \$94,157.37
Assessor Name: Craig Anding
Date Created: 02/11/2016

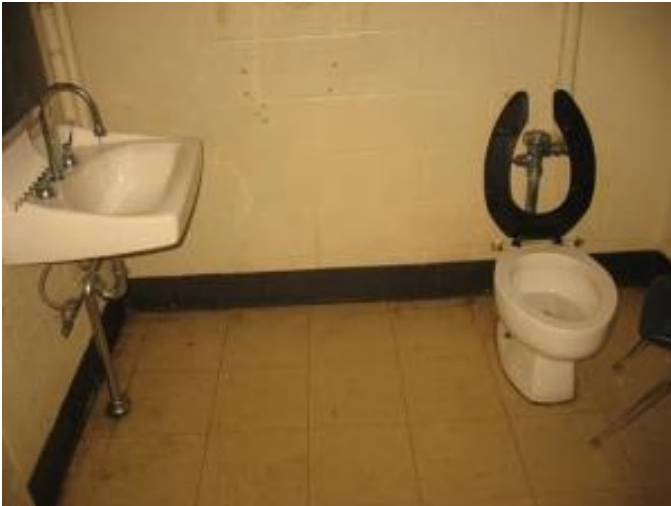
System: D2010 - Plumbing Fixtures

Location: Restrooms

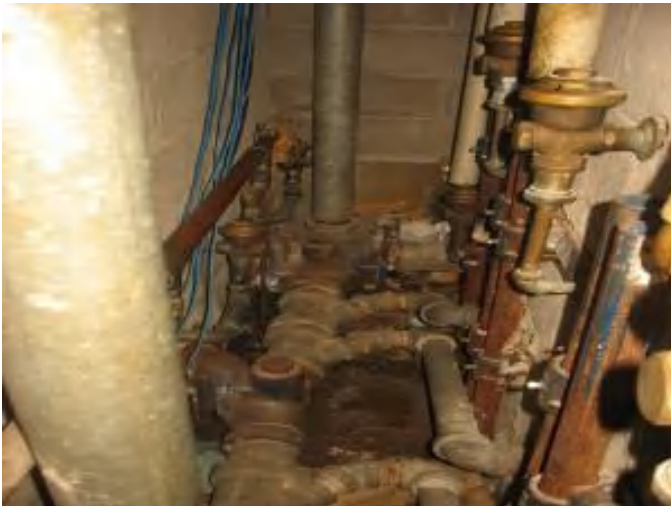
System: D2030 - Sanitary Waste

Location: Throughout building

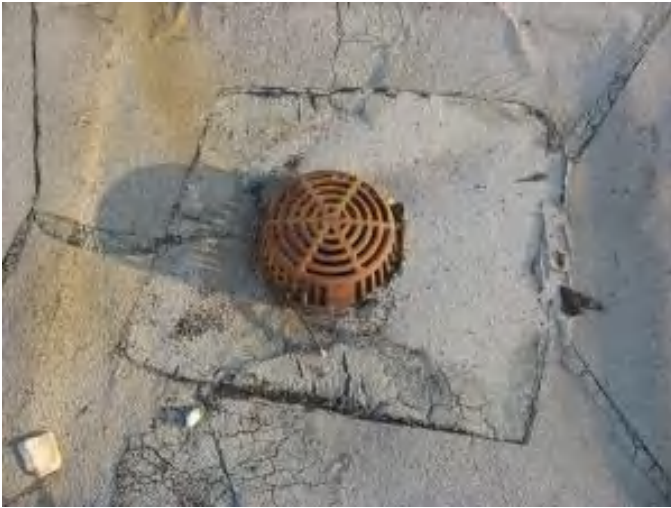
System: D2040 - Rain Water Drainage

Location: Throughout building

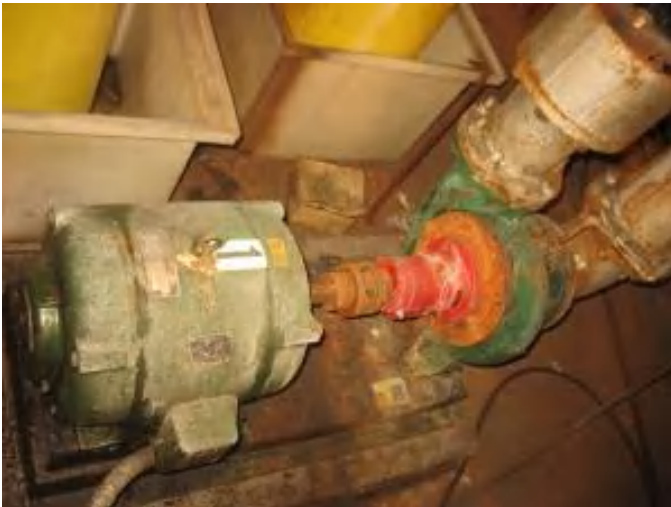
System: D3030 - Cooling Generating Systems

Location: Basement mechanical room

Distress: Damaged

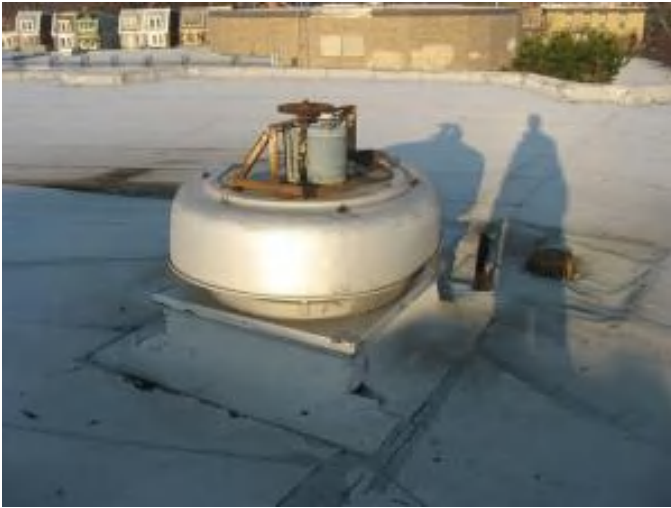
System: D3040 - Distribution Systems

Location: Roof
Distress: Damaged
Category: 3 - Operations / Maint.
Priority: 3 - Response Time (3-4 yrs)
Correction: Replace utility set exhaust fan (5 HP)
Qty: 50.00
Unit of Measure: Ea.
Estimate: \$1,072,643.81
Assessor Name: Craig Anding
Date Created: 02/11/2016

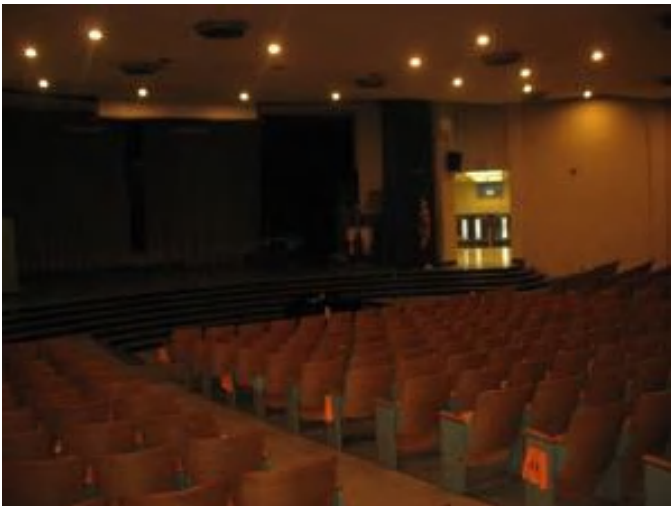
System: D3040 - Distribution Systems

Location: Auditorium
Distress: Beyond Service Life
Category: 3 - Operations / Maint.
Priority: 3 - Response Time (3-4 yrs)
Correction: Replace HVAC unit for Auditorium (200 seat).
Qty: 446.00
Unit of Measure: Seat
Estimate: \$742,798.08
Assessor Name: Craig Anding
Date Created: 02/11/2016

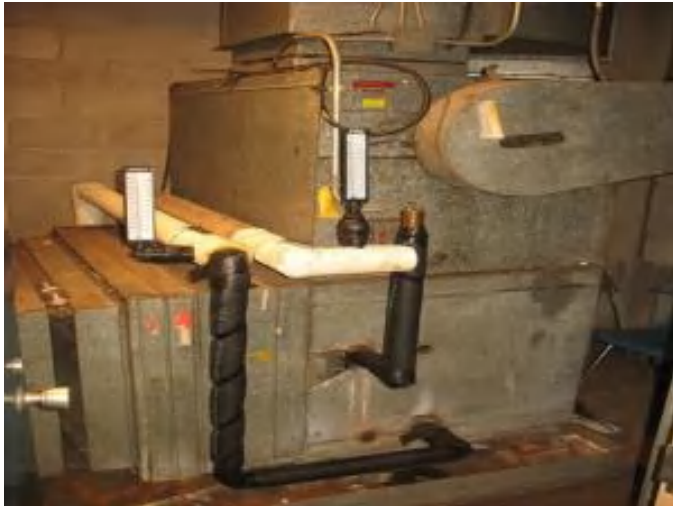
System: D3040 - Distribution Systems

Location: 2nd floor mechanical rooms

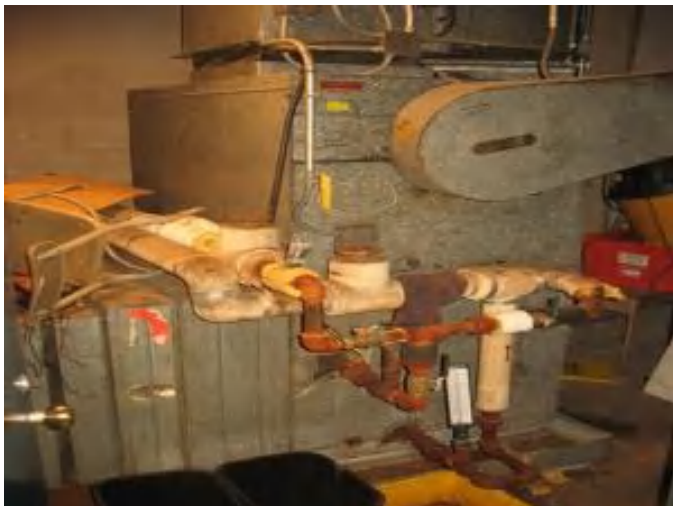
System: D3040 - Distribution Systems

Location: 2nd floor mechanical rooms

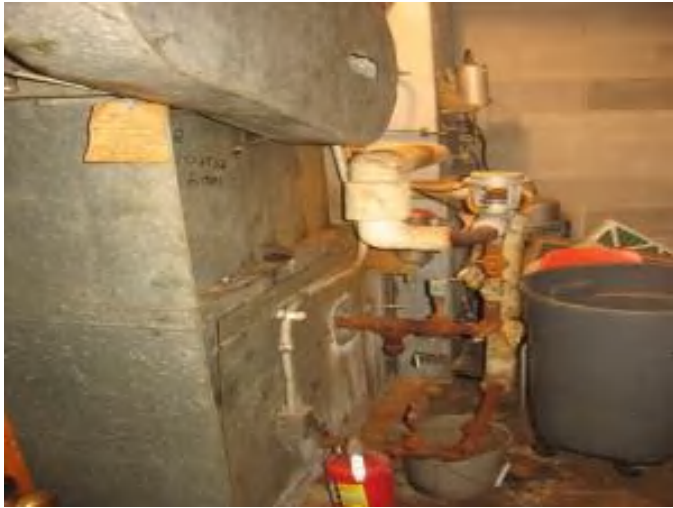
System: D3040 - Distribution Systems

Location: Administration offices
Distress: Beyond Service Life
Category: 3 - Operations / Maint.
Priority: 3 - Response Time (3-4 yrs)
Correction: Replace HVAC unit for Admin (2000 students).
Qty: 795.00
Unit of Measure: Student
Estimate: \$332,040.77
Assessor Name: Craig Anding
Date Created: 02/11/2016

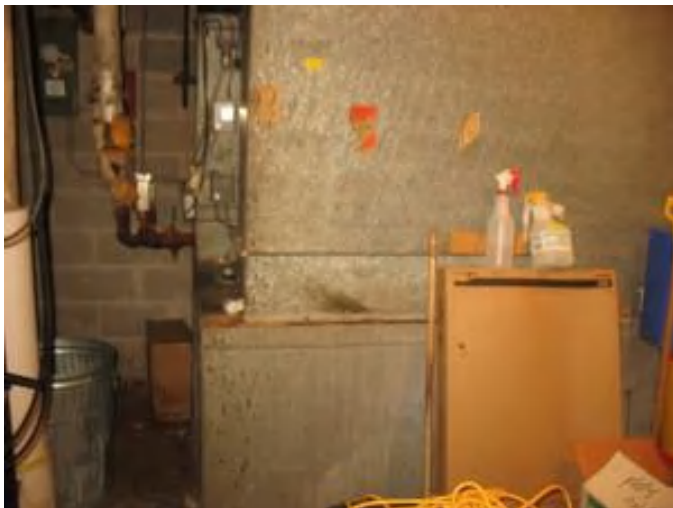
System: D3040 - Distribution Systems

Location: Gymnasium
Distress: Beyond Service Life
Category: 3 - Operations / Maint.
Priority: 3 - Response Time (3-4 yrs)
Correction: Replace HVAC unit for Gymnasium (single station)
Qty: 6,000.00
Unit of Measure: S.F.
Estimate: \$227,475.37
Assessor Name: Craig Anding
Date Created: 02/11/2016

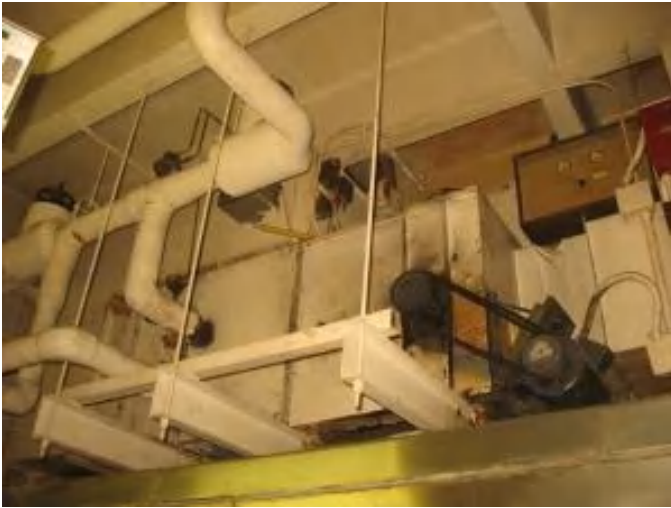
System: D3040 - Distribution Systems

Location: Cafeteria

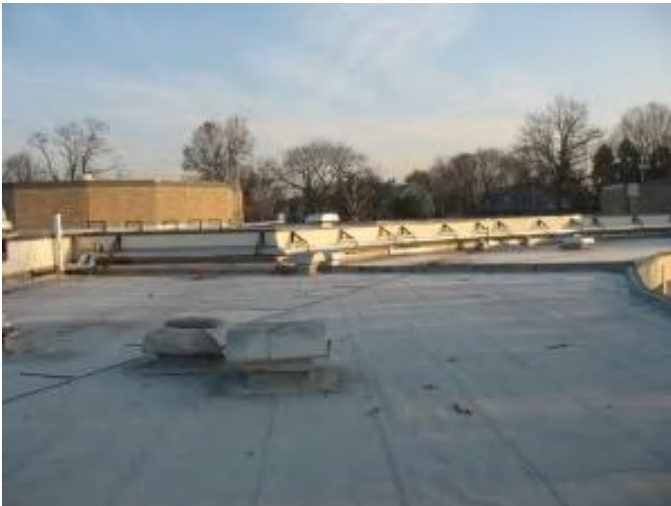
System: D3040 - Distribution Systems

Location: Roof

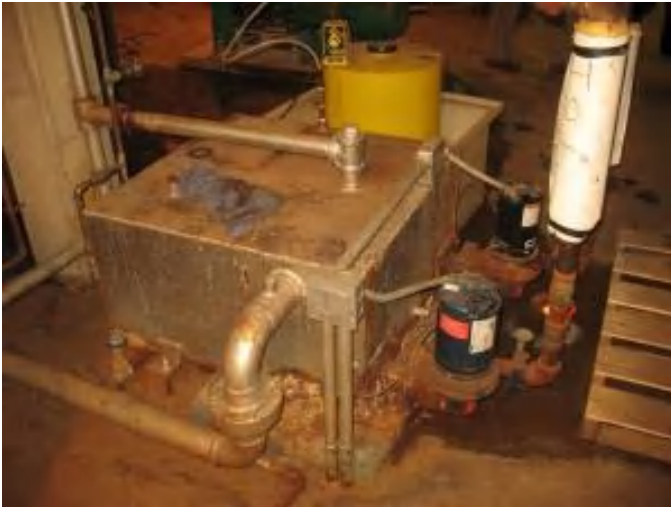
System: D3040 - Distribution Systems

Location: Basement mechanical room
Distress: Damaged
Category: 3 - Operations / Maint.
Priority: 3 - Response Time (3-4 yrs)
Correction: Replace Condensate Receiver Pump Set
Qty: 1.00
Unit of Measure: Ea.
Estimate: \$47,791.10
Assessor Name: Craig Anding
Date Created: 02/11/2016

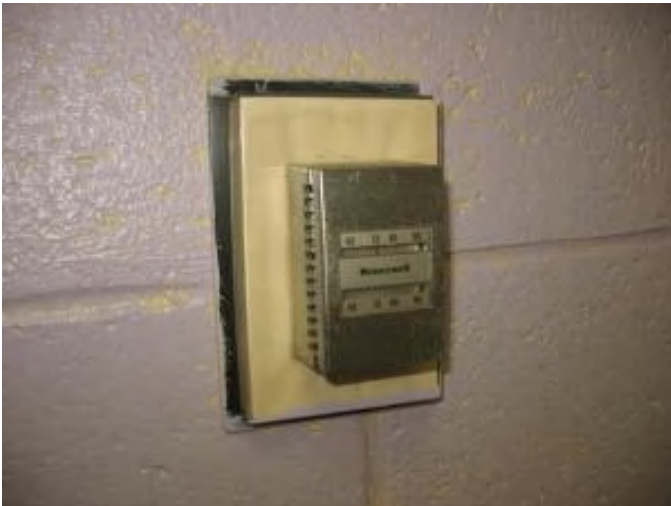
System: D3060 - Controls & Instrumentation

Location: Throughout building
Distress: Beyond Service Life
Category: 3 - Operations / Maint.
Priority: 3 - Response Time (3-4 yrs)
Correction: Replace pneumatic controls with DDC (75KSF)
Qty: 101,976.00
Unit of Measure: S.F.
Estimate: \$2,187,599.06
Assessor Name: Craig Anding
Date Created: 02/11/2016

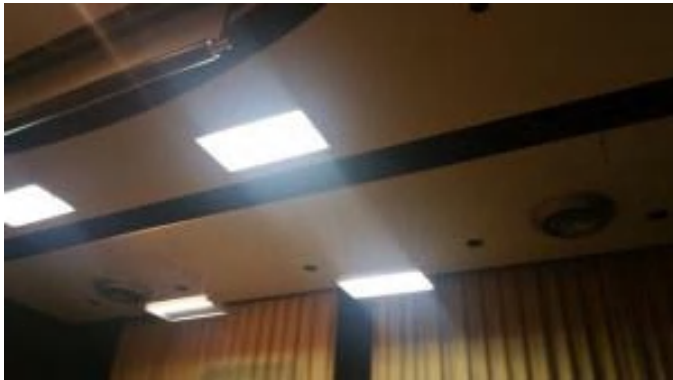
System: D5020 - Lighting and Branch Wiring

Notes: Install new lighting system for 80% of the building.
101,976 SF x 80% = 81,560 SF

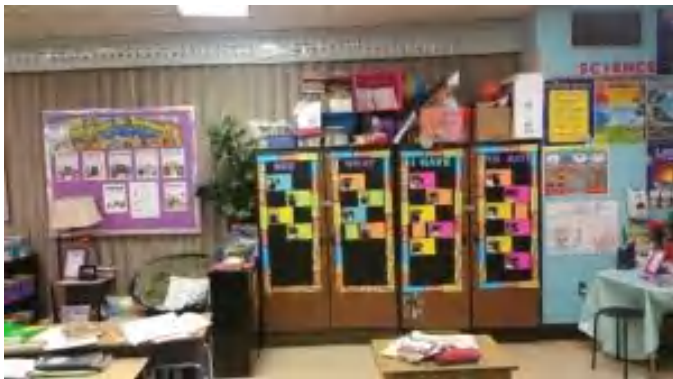
System: D5020 - Lighting and Branch Wiring

Notes: Install new receptacles for 80% of the building
101,976 SF x 80% = 81,580 SF

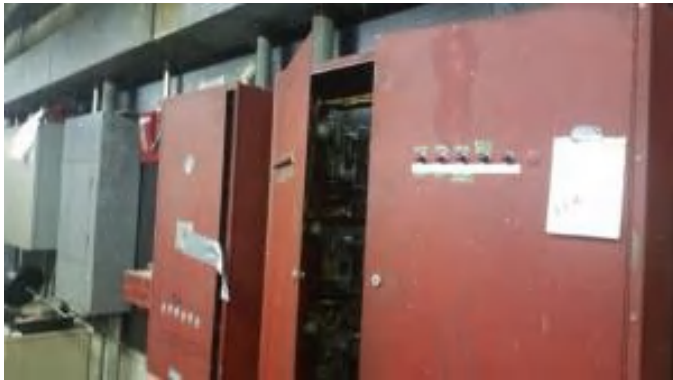
System: D5030 - Communications and Security

Location: throughout the building

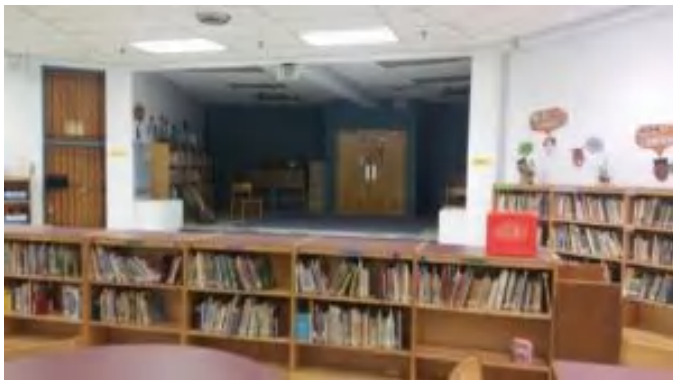
System: D5090 - Other Electrical Systems

Location: throughout the building

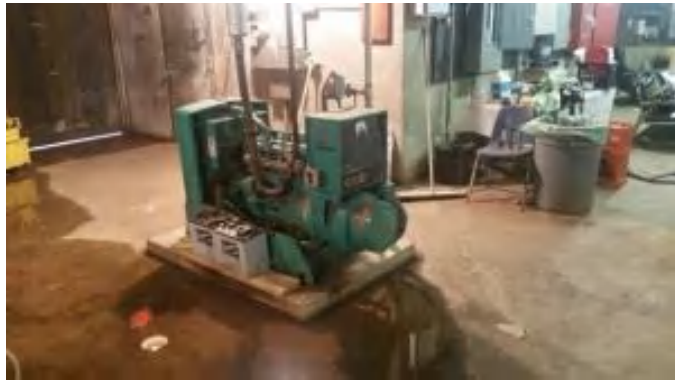
System: D5090 - Other Electrical Systems

Location: electrical room

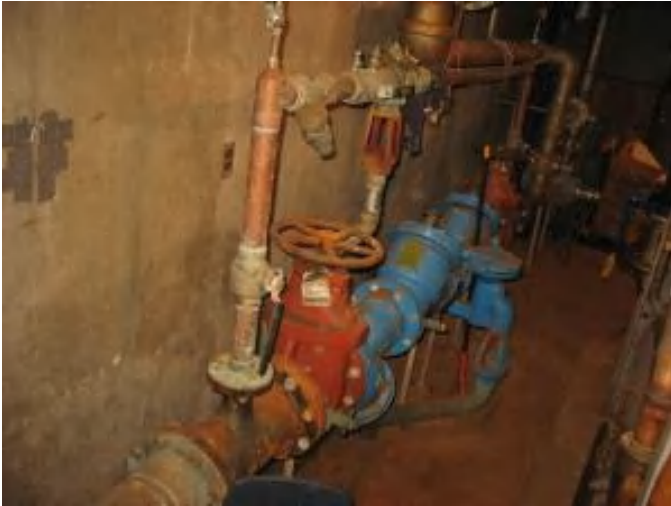
System: D2020 - Domestic Water Distribution

Location: Throughout building

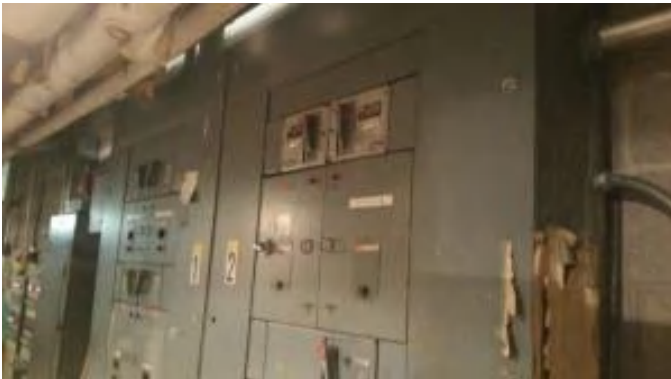
System: D5010 - Electrical Service/Distribution

Location: electrical room

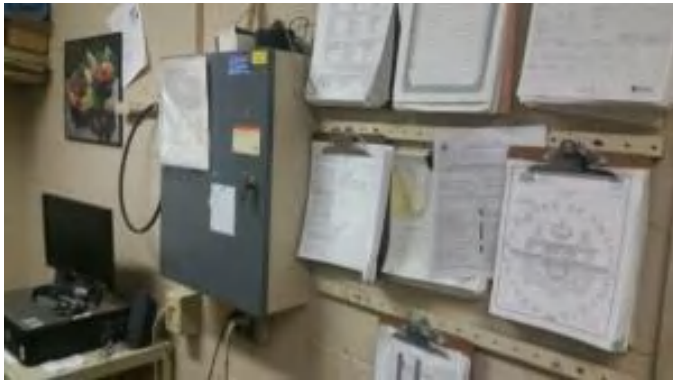
System: D5030 - Communications and Security

Location: throughout the building

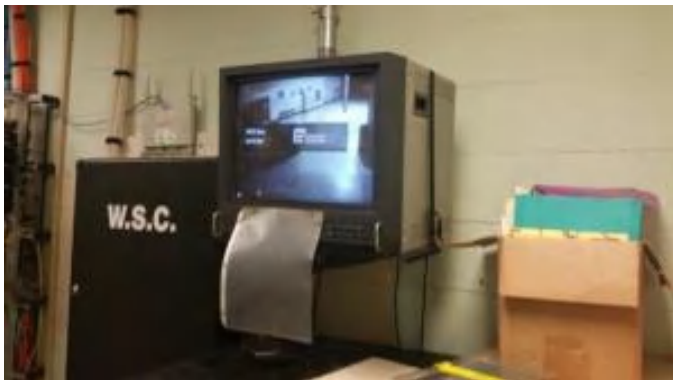
System: D5030 - Communications and Security

Location: throughout the building

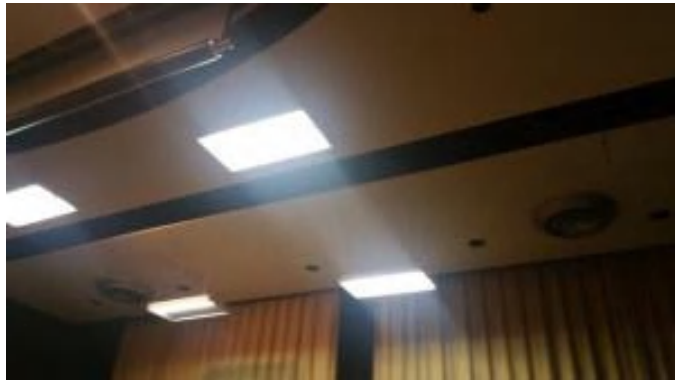
System: E1020 - Institutional Equipment

Location: Auditorium

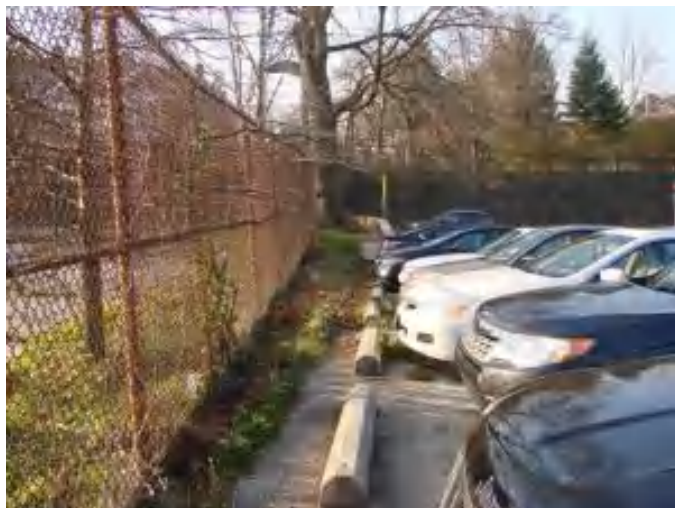
System: G2040 - Site Development

Location: Site

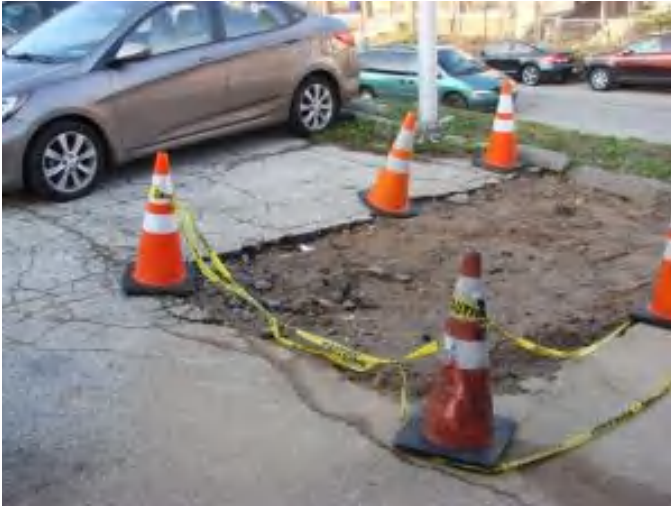
System: G2020 - Parking Lots

Location: Parking

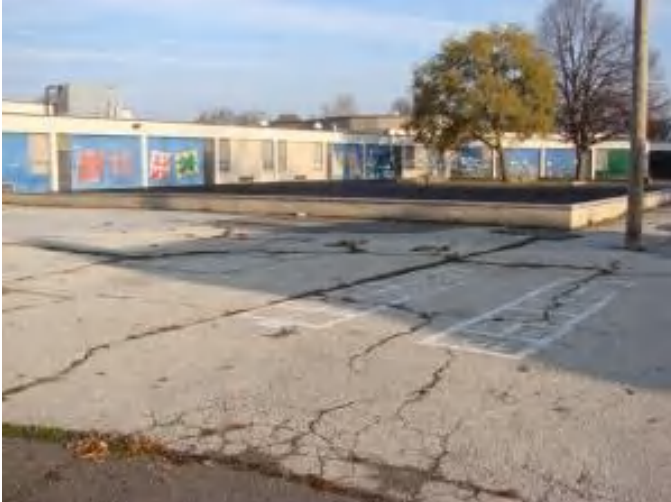
System: G2030 - Pedestrian Paving

Location: Play yard

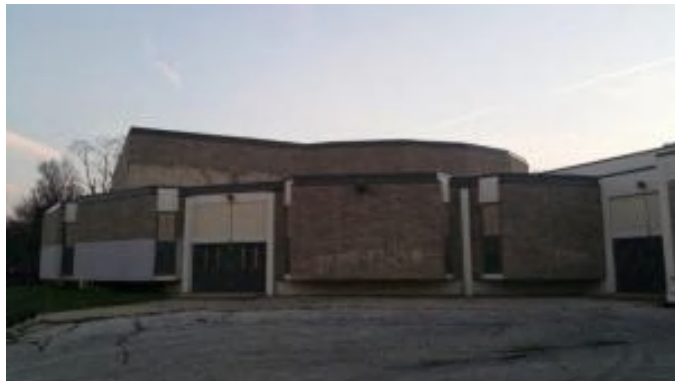
System: G4030 - Site Communications & Security

Location: grounds
